CANADIAN FOOD INSPECTION AGENCY

Hazardous Building Materials Assessment

National Centre for Animal Diseases – Main Laboratory Building
Lethbridge, Alberta

May 15, 2019

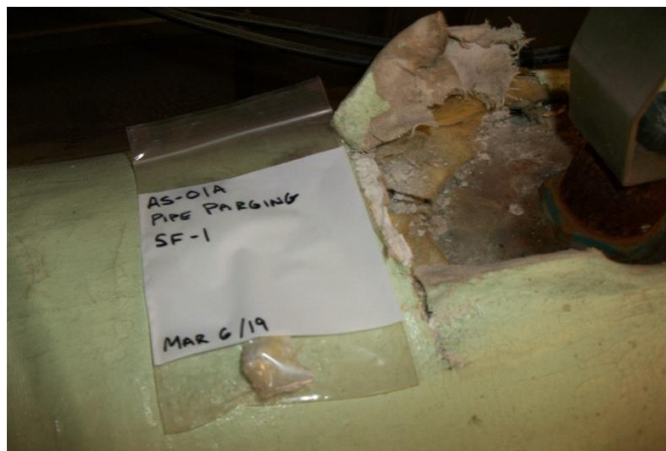
Photo 1

Sample AS-01 - Mechanical pipe "parging" insulating cement associated with air handling units. No asbestos was identified in samples of this material.

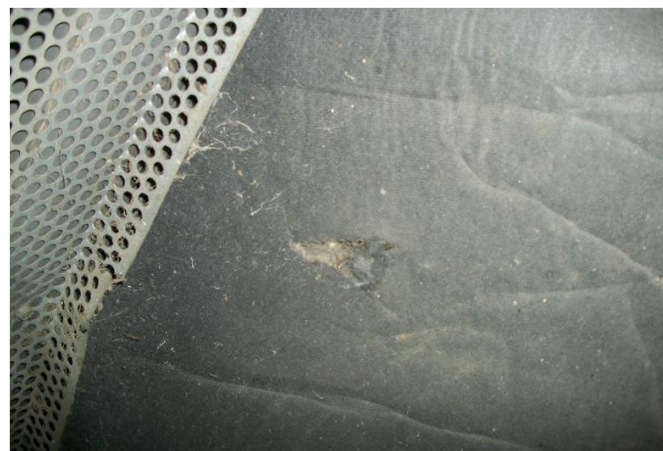
Photo 2

Sample AS-02 - Insulation (fibreglass with black paper) on the interior walls within the air handling units. No asbestos was identified in samples of this material.

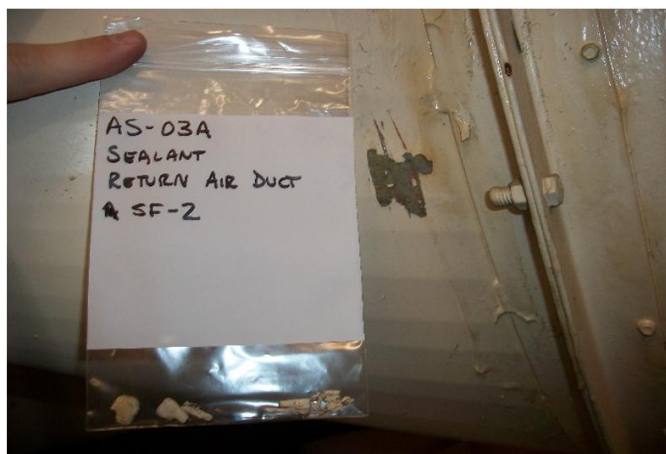
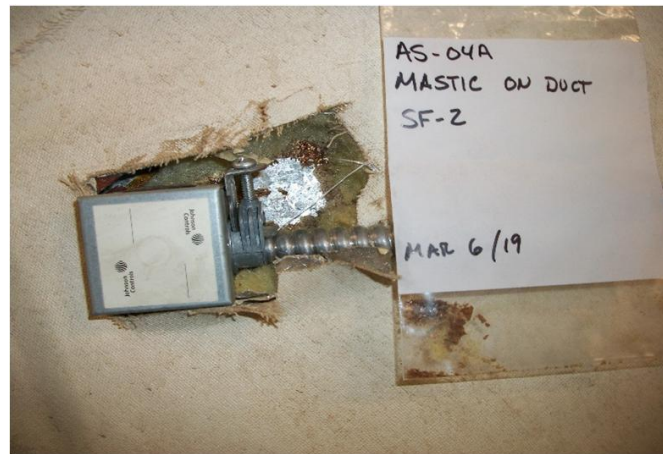
The red/brown sealant was observed to be located on seams of various duct systems including derelict fan units stored in the fan loft level and beneath canvass wrapped fibreglass insulation on ducts. These materials were	Materials Not Quantified

Sample AS-03A - Sealant associated with air duct seams (red/brown). This sample was found to contain 1.2% Chrysotile asbestos fibres, with the laboratory applying positive stop to the subsequent AS-03B and AS-03C samples.

Any work involving the disturbance, repair (*i.e.*, encapsulation), or removal of confirmed ACMs should be conducted by a qualified contractor in accordance with Alberta Government "Alberta Asbestos Abatement Manual" dated October 2012. Removal of duct sealant or insulation mastic may be conducted following "Low Risk" asbestos abatement procedures. It is presumed that the sealants and mastics will be removed and disposed with the associated substrate (*i.e.* metal ducting or fibreglass insulation). It was reported that the textured ceiling and built-up-roofing materials previously identified at the subject property, would not be disturbed as part of the proposed scope of work.

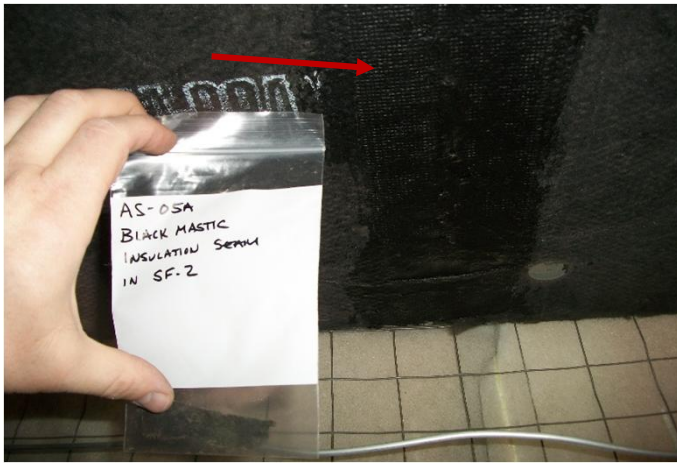
Photo 5

Sample AS-05A - Mastic seams (black) on fibreglass insulated walls within the air handling units. This material was found to contain 7.2% Chrysotile asbestos fibres, with the laboratory applying positive stop to samples AS-05B and AS-05C.

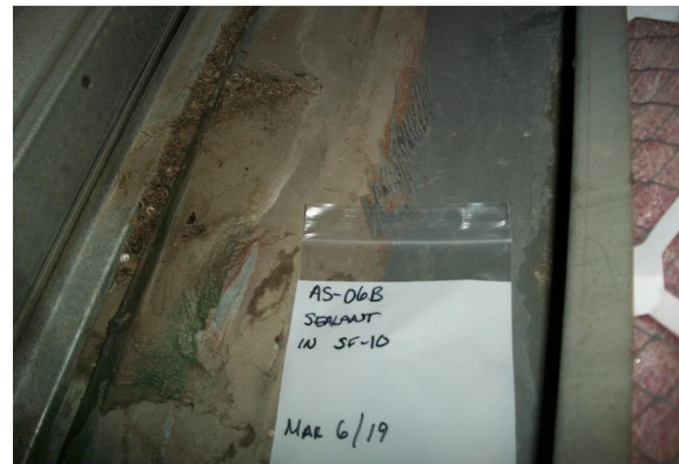
Photo 6

Sample AS-06 - Sealant (brown) on seam within air handling units. These materials were found to contain between 0.75% to 1.2% Chrysotile asbestos fibres.

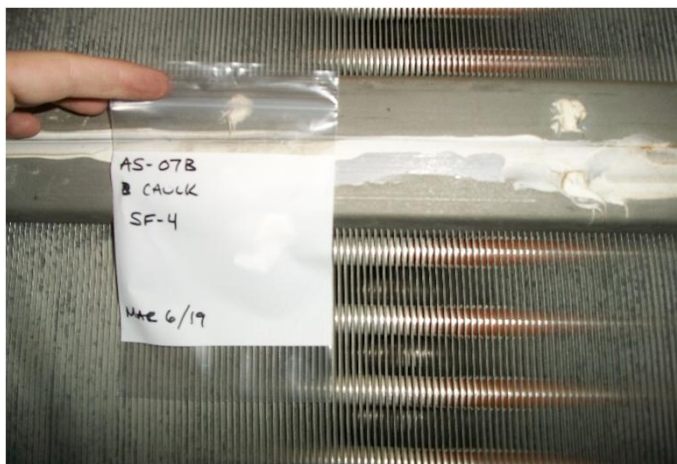
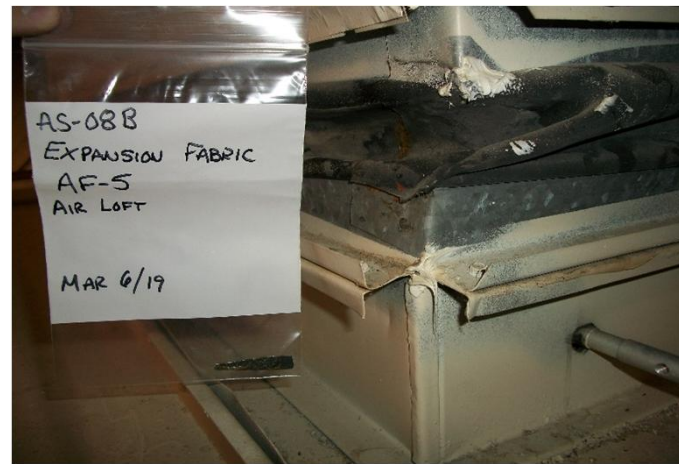
Sample AS-07 - Caulking (white) within the air handling units. No asbestos was identified in samples of this material.

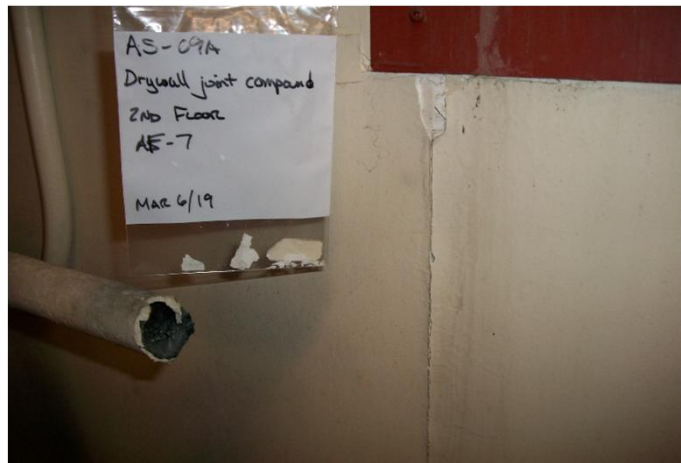
Photo 9

Sample AS-09 - Drywall joint compound (white) on walls. No asbestos was identified in the samples of this material.

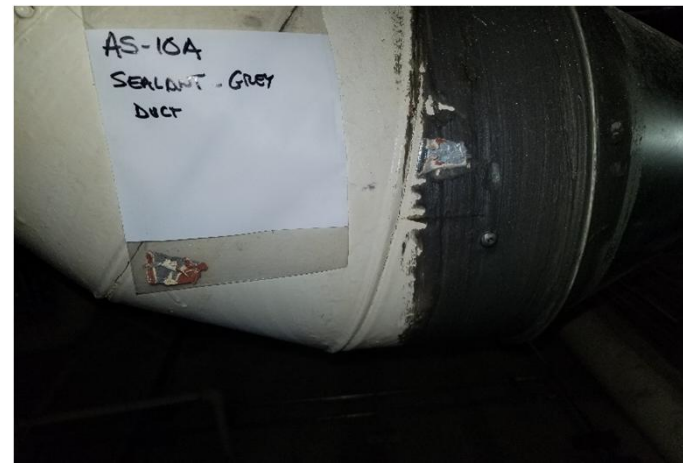
Photo 10

Sample AS-10 - Sealant (grey) on duct seams. Trace asbestos was found in samples AS-10A and AS-10B (0.36% and <0.25% Chrysotile respectively). No asbestos was identified in the sample AS-10C.

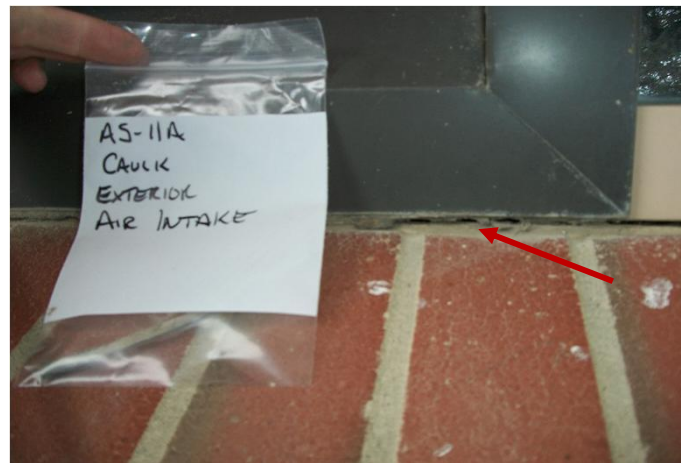
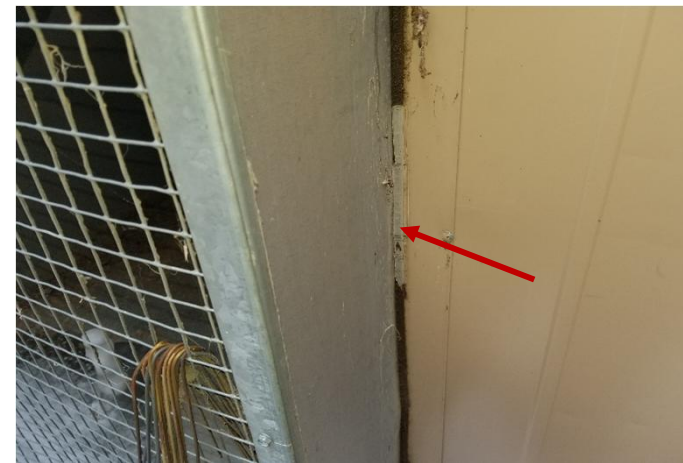
Sample AS-11 - Caulking (grey) along the exterior air in-take grill. No asbestos was identified in the samples of this material.

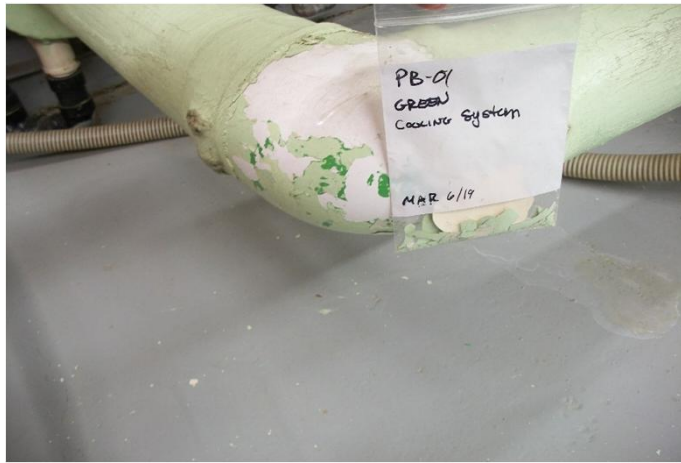
Photo 13

- Sample PB-01, green paint chips collected from the mechanical pipe insulation covering materials associated with the air handling unit (SF-1) was determined to have a lead concentration of 13,000 ppm. These materials were observed to be in good to poor condition, with paint peeling and flaking off its substrate in some areas.

Sample PB-01 - Light green paint on mechanical pipe insulation (canvass jacket and PVC cover). The total lead concentration in this light green paint was determined to be 13,000 ppm.

To determine the proper waste disposal locations, Dillon-Outcome recommends additional leachate toxicity analysis be conducted on the various surface coatings (paint colours) associated with the air handling unit mechanical pipe insulation materials (Sample PB-01) and the surface coating associated with the air handling units (Sample PB-04). Based on the proposed scope of work required for the air handling replacement project it is unlikely that sections of the concrete floor (Sample PB-03) will be removed for disposal. Worker precautions will be required should disturbance of the floor surface coating be required.

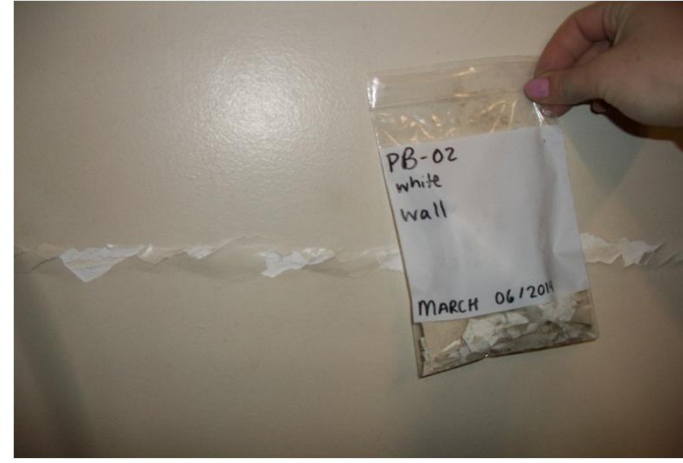
Photo 14

- Sample PB-02, white/beige paint chips collected from the gypsum board walls in the main mechanical room of the subject property was determined to have a concentration of <80 ppm. This paint was a typical surface coating throughout the targeted work area and was observed to generally be in good condition.

Sample PB-02 - White/beige paint on gypsum board wall in the mechanical room. The total lead concentration in this white/beige paint was determined to be below the detection limit of 80 ppm.

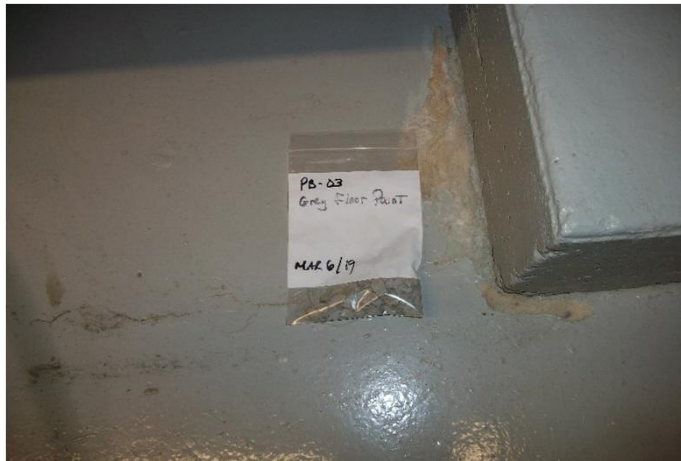
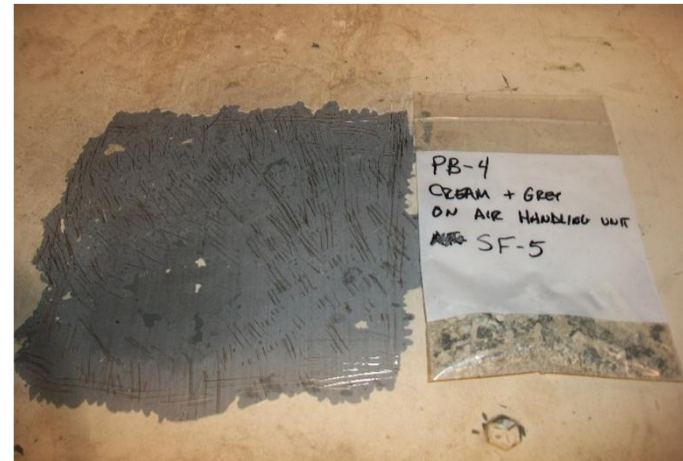
- Sample PB-03, dark grey paint chips collected from the concrete floor in the main mechanical room of the subject property was determined to have a lead concentration of 2,300 ppm. This paint was a typical surface coating throughout the targeted work area and was observed to be in good to poor condition, with paint peeling and flaking off its substrate in some areas.

Sample PB-03 - Grey paint on the floor of the mechanical room. The total lead concentration in this grey paint was determined to be 2,300 ppm.

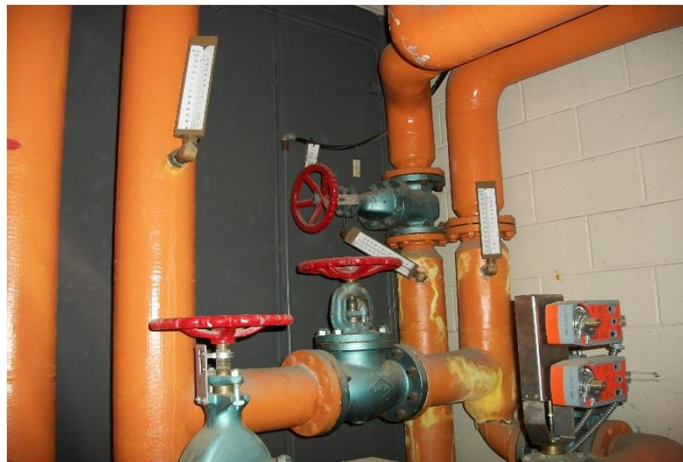
Photo 17

View of alcohol containing thermostats observed associated with heating system throughout the site. No mercury containing thermostats were observed with the work area.

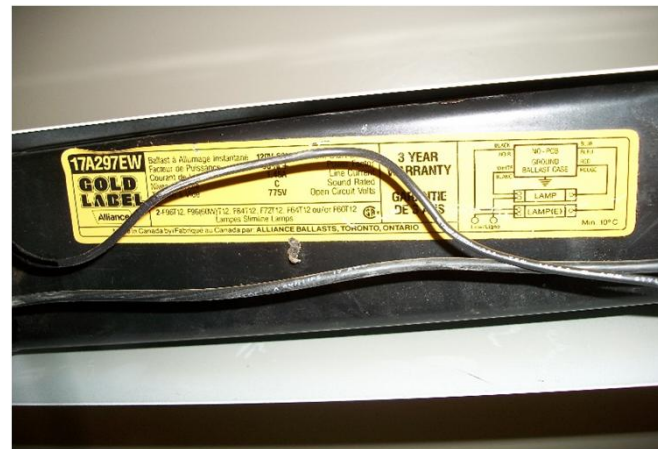
Photo 18

View of fluorescent light ballast with manufacturer's label identifying no PCBs present.

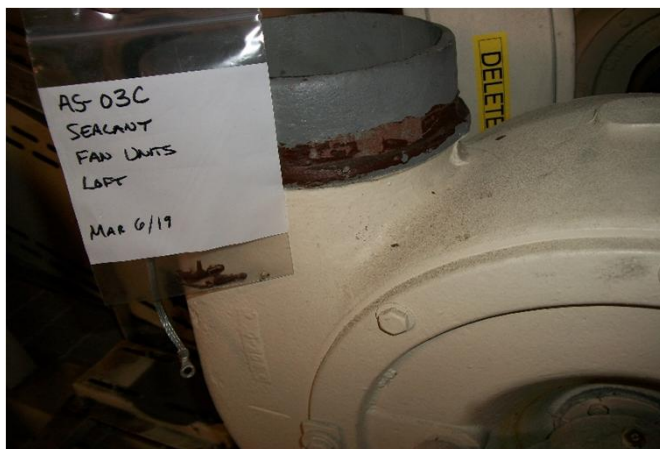
Photo 19

View of ACM sealant (red/brown) on derelict fan unit observed in the Fan Loft Level. Approximately 20 fan units were being stored in this location.

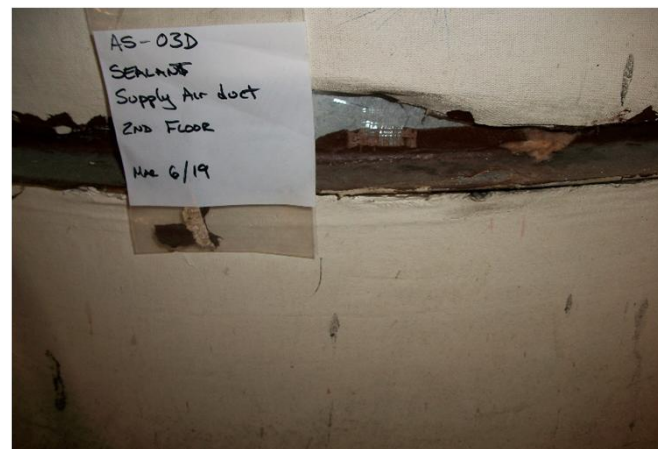
Photo 20

View of ACM sealant (red/brown) on duct underlaying fiberglass insulation and canvas jacketing.
