# DESIGNATED SUBSTANCE AND HAZARDOUS MATERIALS ASSESSMENT REPORT

ADMINISTRATIVE BUILDING #2, SAINT-  
REGIS, AKWESASNE

MARCH 31, 2020

PROJECT NO.: 181-09302-15  
DATE: MARCH 31, 2020

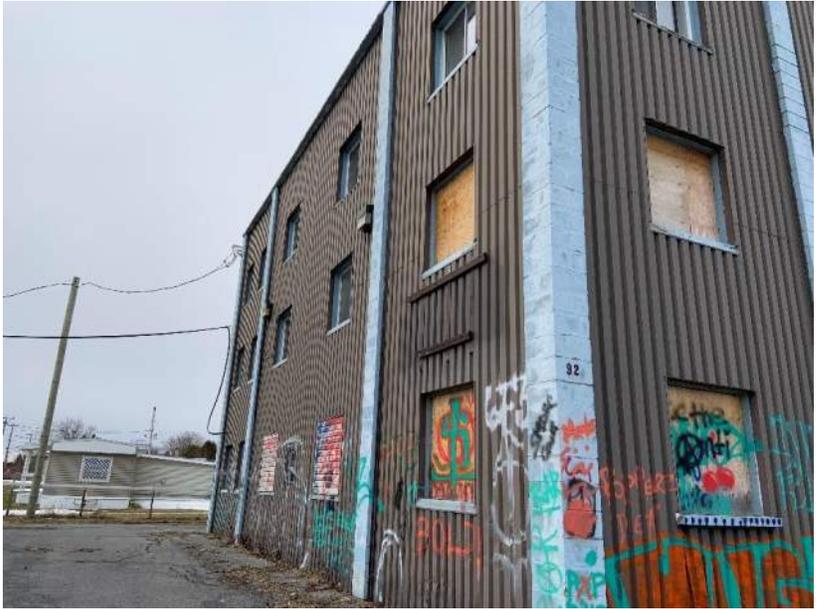
2	Asbestos-containing vinyl floor tiles, 12" x 12" white with black streak, Location #2.  <u>Sample ID:</u> 0001A-C (Pinchin, 2013)

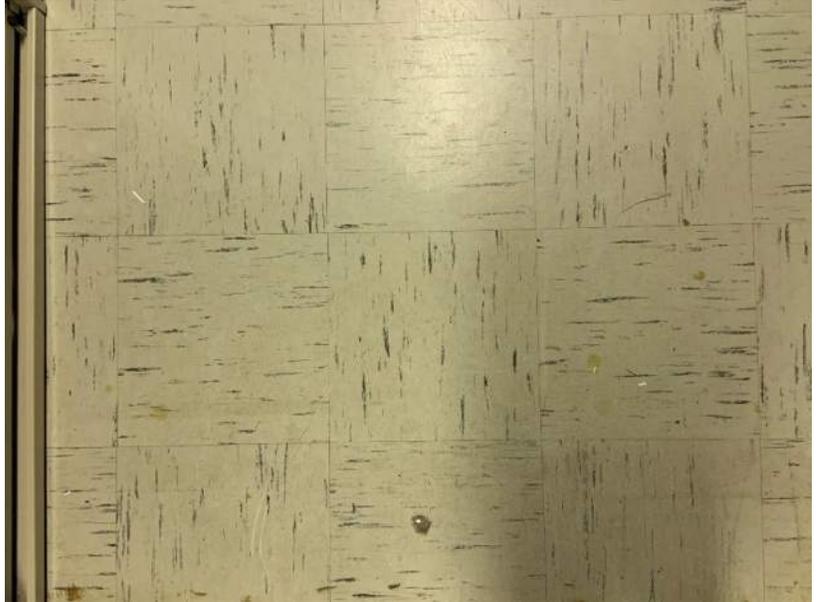
PHOTO NO.	MATERIAL DESCRIPTION & LOCATION	PHOTO
<p><u>3</u></p>	<p>Asbestos-containing acoustic ceiling tiles, 24" x 48", pinhole and lengthwise fissures, Location #8</p> <p><u>Sample ID:</u> 0006A-C (Pinchin, 2013)</p>

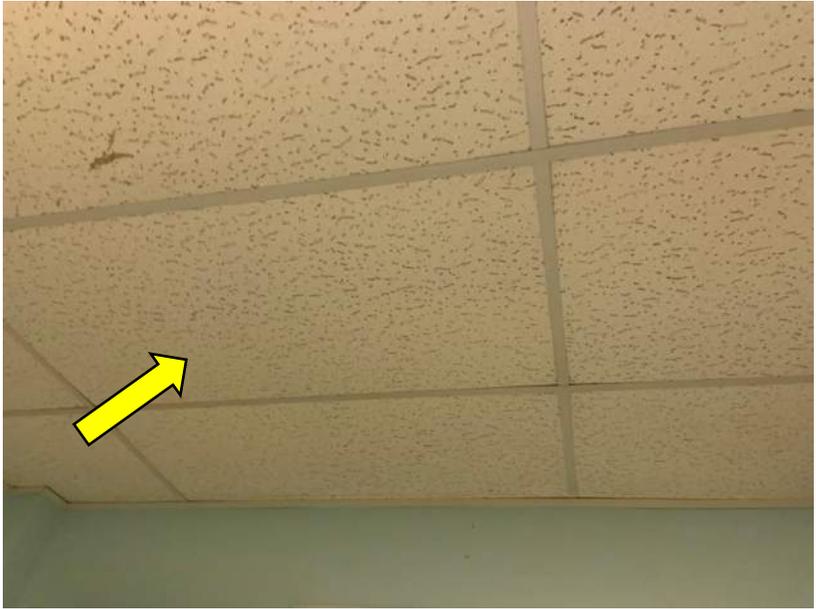
<p>A photograph showing a grid of acoustic ceiling tiles. A yellow arrow points to a small, dark pinhole on the surface of one of the tiles. The tiles are light-colored with a mottled texture.</p>
<p><u>4</u></p>	<p>Asbestos-containing vinyl floor tiles, 12" x 12", white with blue flecks concealed beneath carpet finishes, Location 11.</p> <p><u>Sample ID:</u> 0010A-C (Pinchin 2013), 0010A (Pinchin, 2017).</p>

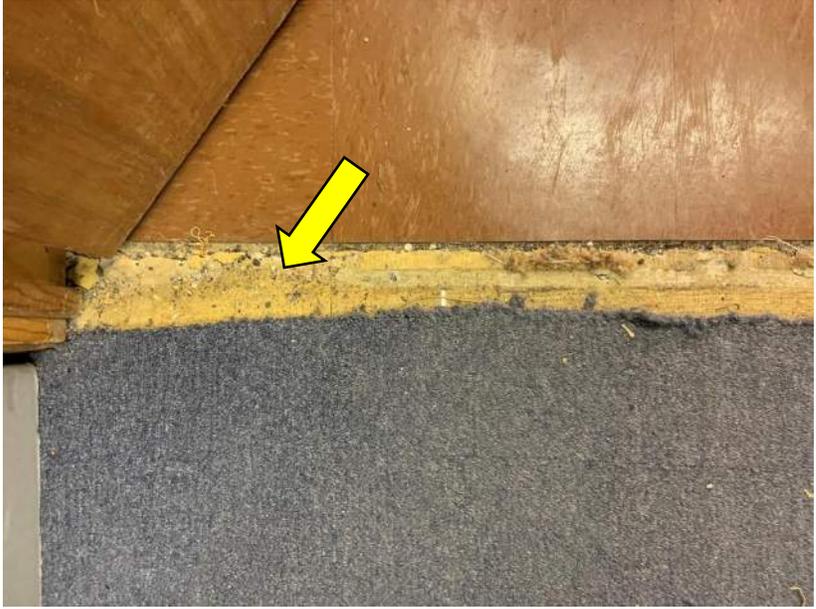
PHOTO NO.	MATERIAL DESCRIPTION & LOCATION	PHOTO
5	<p>Asbestos-containing vinyl floor tiles, 12" x 12", white with black flecks, Location 3.</p> <p><u>Sample ID:</u> 0012A-C (Pinchin, 2013), 0012A (Pinchin, 2017).</p>

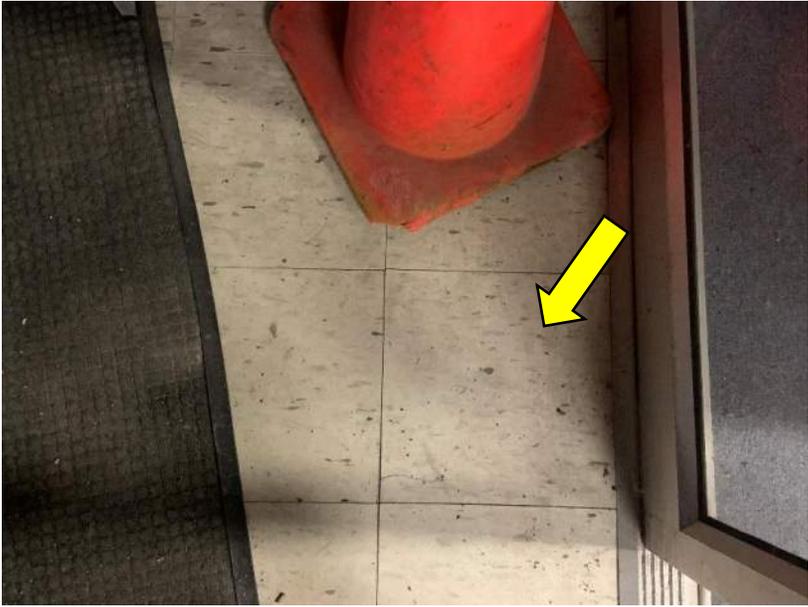
A photograph showing a close-up of a white vinyl floor tile with black flecks. A yellow arrow points to the tile. A red fire hydrant is visible in the background.
6	<p>View of asbestos-containing vermiculite from a previous spill (according to the Client) being stored in Location 18.</p> <p><u>Sample ID:</u> N/A</p>

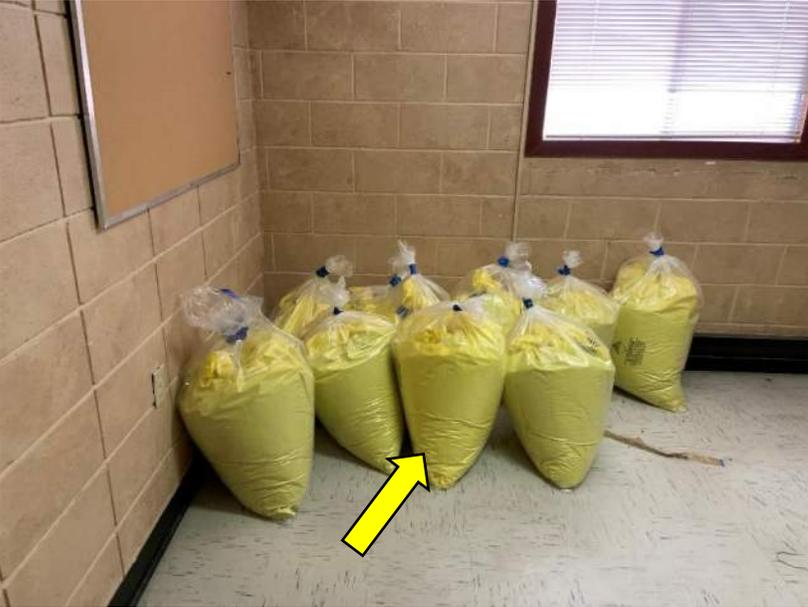
PHOTO NO.	MATERIAL DESCRIPTION & LOCATION	PHOTO
7	<p>Lead-containing grey paint on concrete flooring, Location 5.</p> <p><u>Sample ID:</u> L013</p> <p>Also, view of multiple patched cinder block locations where loose-fill vermiculite insulation was previously sampled.</p>

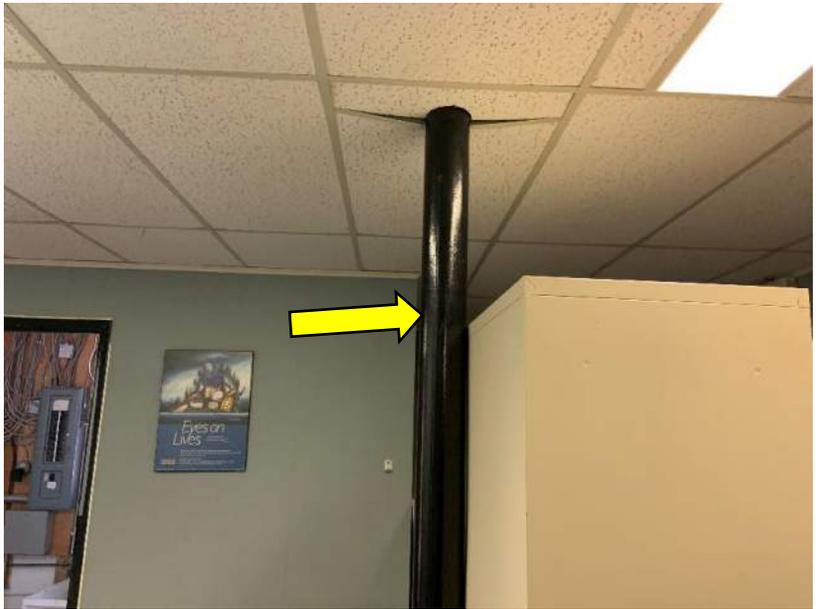
An interior photograph showing a black-painted structural column. A yellow arrow points to the column. In the background, there is a poster on the wall that says "Eyes on Lives" and a doorway.
10	Lead-containing brown paint on the exterior overhang. <u>Sample ID: L016</u>

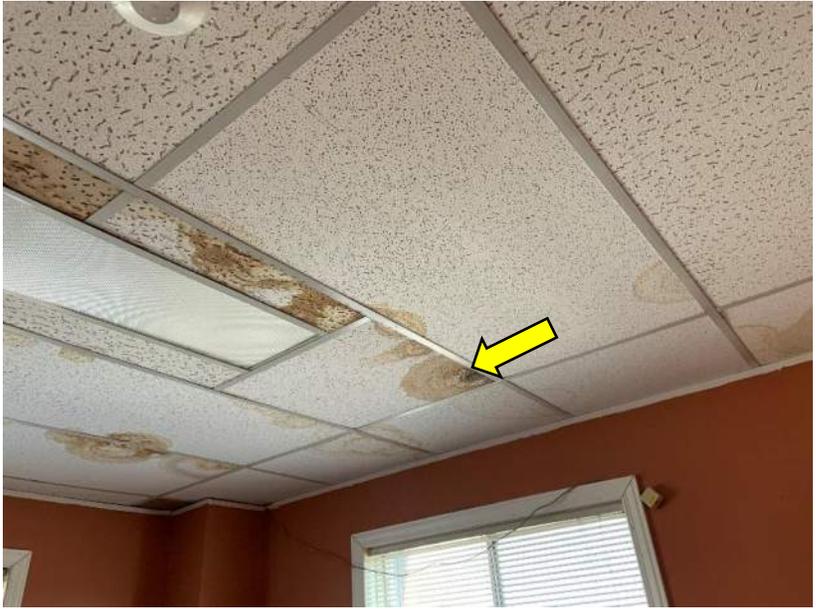
<u>12</u>	Visible mould growth on asbestos-containing acoustic ceiling tiles, Location 27. <u>Sample ID: N/A</u>

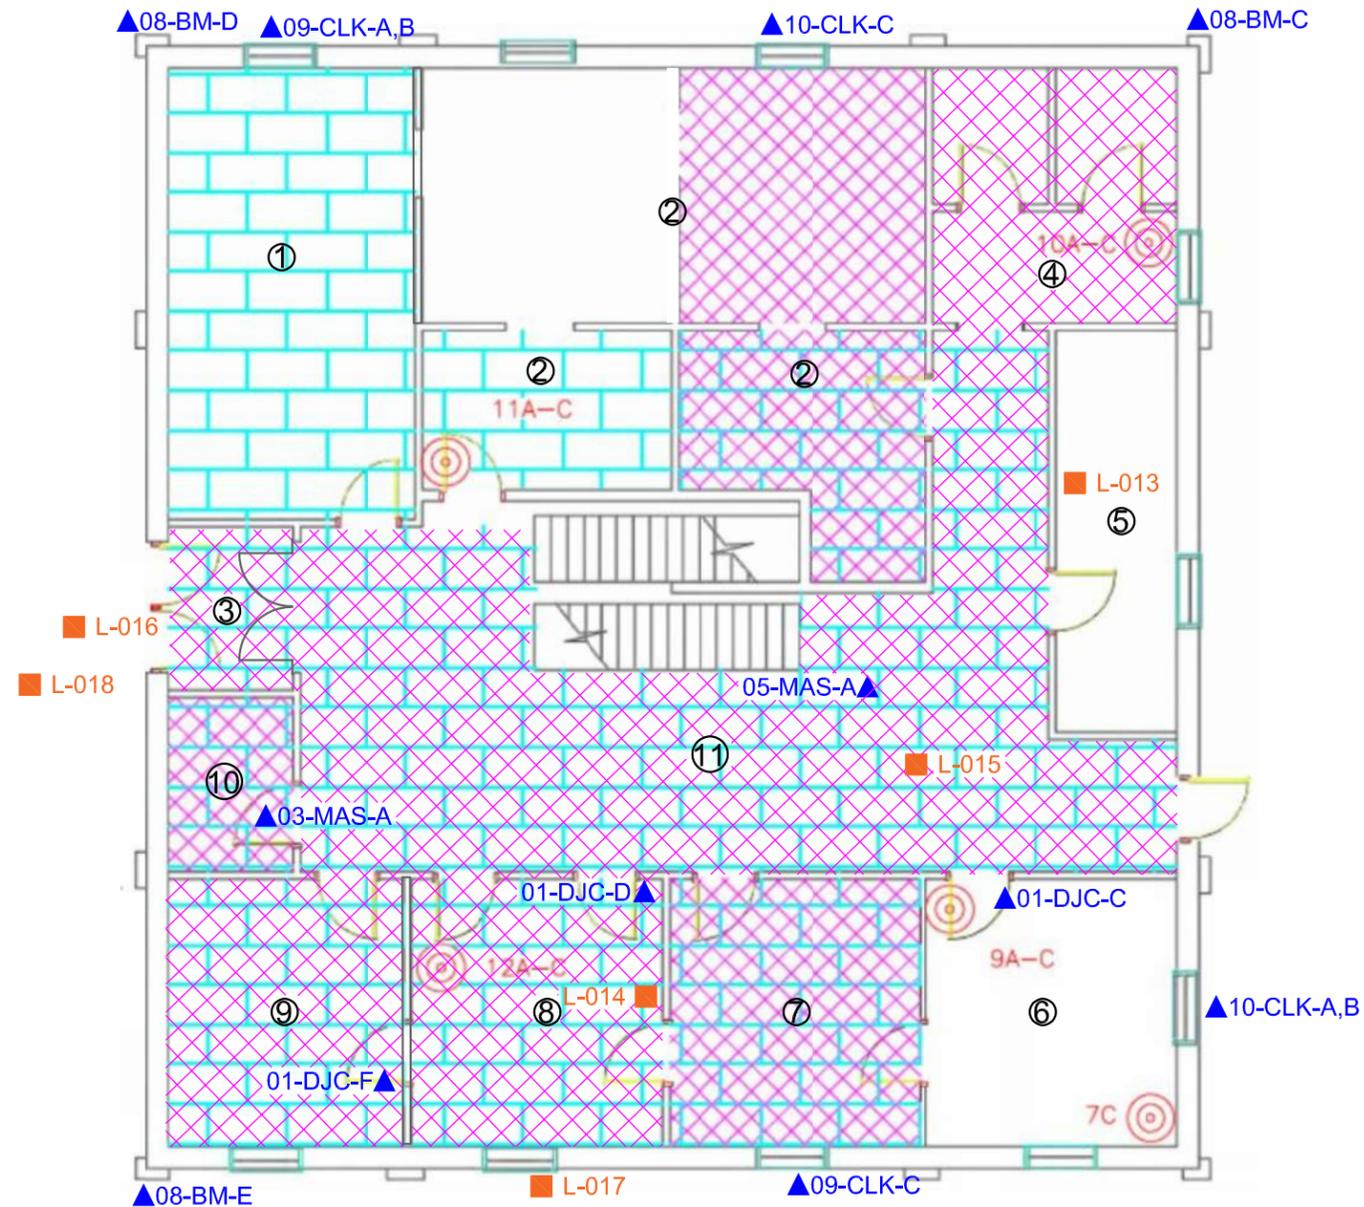
NOTE:  
 1) ASBESTOS-CONTAINING VERMICULITE IS PRESENT WITHIN PERIMETER CONCRETE BLOCK WALLS AT THE SUBJECT BUILDING.  
 2) NON ASBESTOS-CONTAINING ROOF CORE AND ASPHALT SAMPLE LOCATIONS ARE NOT SHOWN ON THIS FIGURE.  
 3) OTHER DESIGNATED SUBSTANCES OR HAZARDOUS MATERIALS MAY BE PRESENT WITHIN CONCEALED BUILDING SPACES.

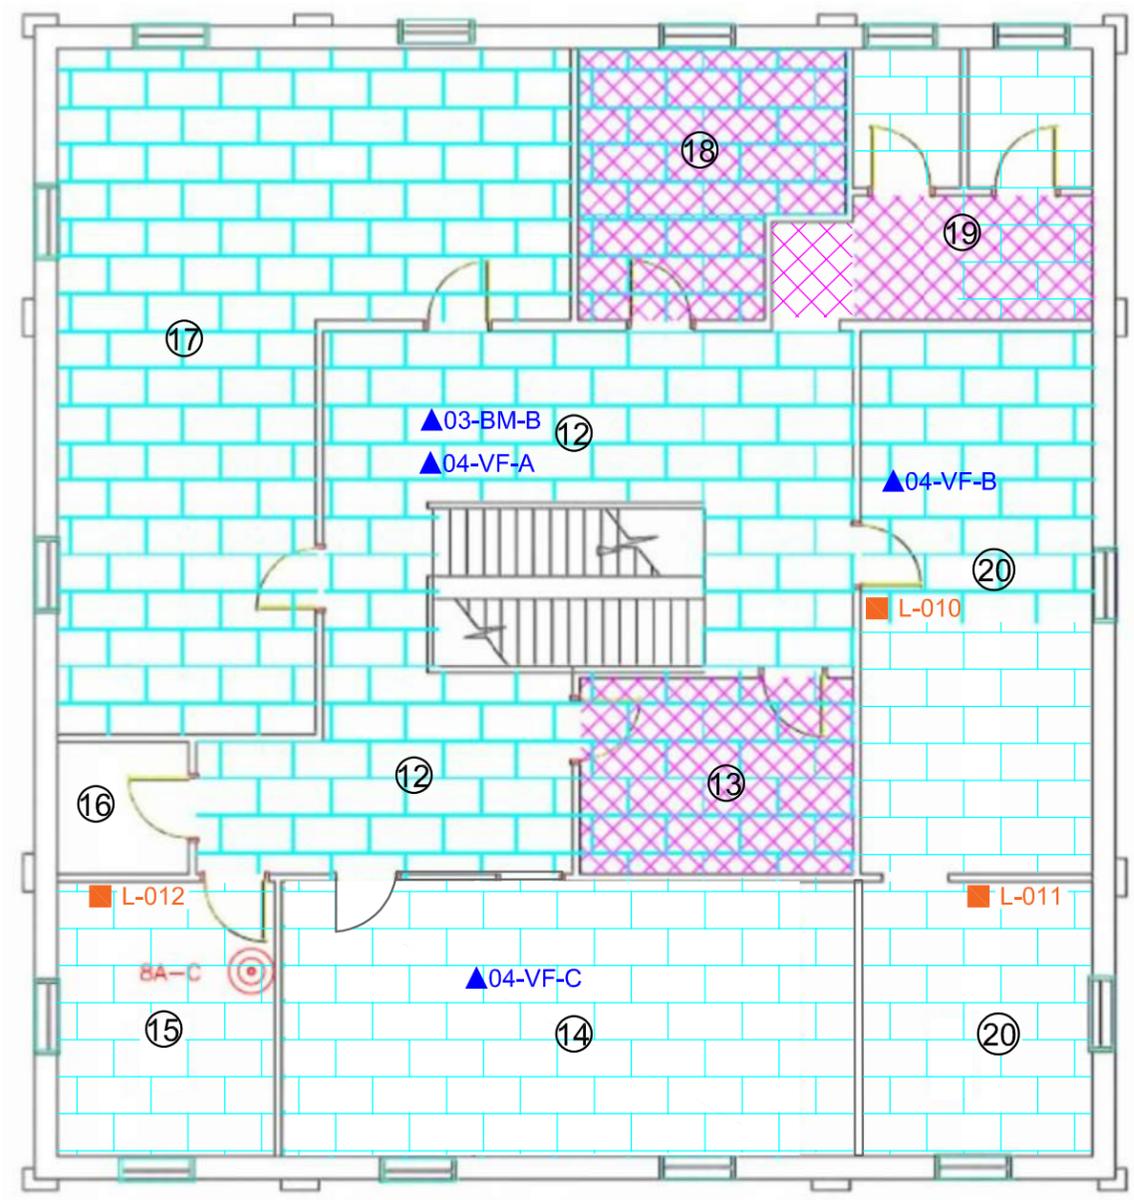
**LOCATIONS OF ASBESTOS & LEAD BULK SAMPLES  
 AND ASBESTOS-CONTAINING MATERIALS  
 ADMINISTRATION BUILDING NO. 2 -  
 SECOND FLOOR**

NOTE:  
 1) ASBESTOS-CONTAINING VERMICULITE IS PRESENT WITHIN PERIMETER CONCRETE BLOCK WALLS AT THE SUBJECT BUILDING.  
 2) TEN (10) BAGS OF ASBESTOS-CONTAINING WASTE FROM A PREVIOUS VERMICULITE SPILL ARE CURRENTLY BEING STORED WITHIN LOCATION 18. THE BAGS ARE DOUBLE-BAGGED AND SEALED IN YELLOW ASBESTOS WASTE BAGS AS PER O. REG. 278/05.  
 3) NON ASBESTOS-CONTAINING ROOF CORE AND ASPHALT SAMPLE LOCATIONS ARE NOT SHOWN ON THIS FIGURE.  
 4) OTHER DESIGNATED SUBSTANCES OR HAZARDOUS MATERIALS MAY BE PRESENT WITHIN CONCEALED BUILDING SPACES.

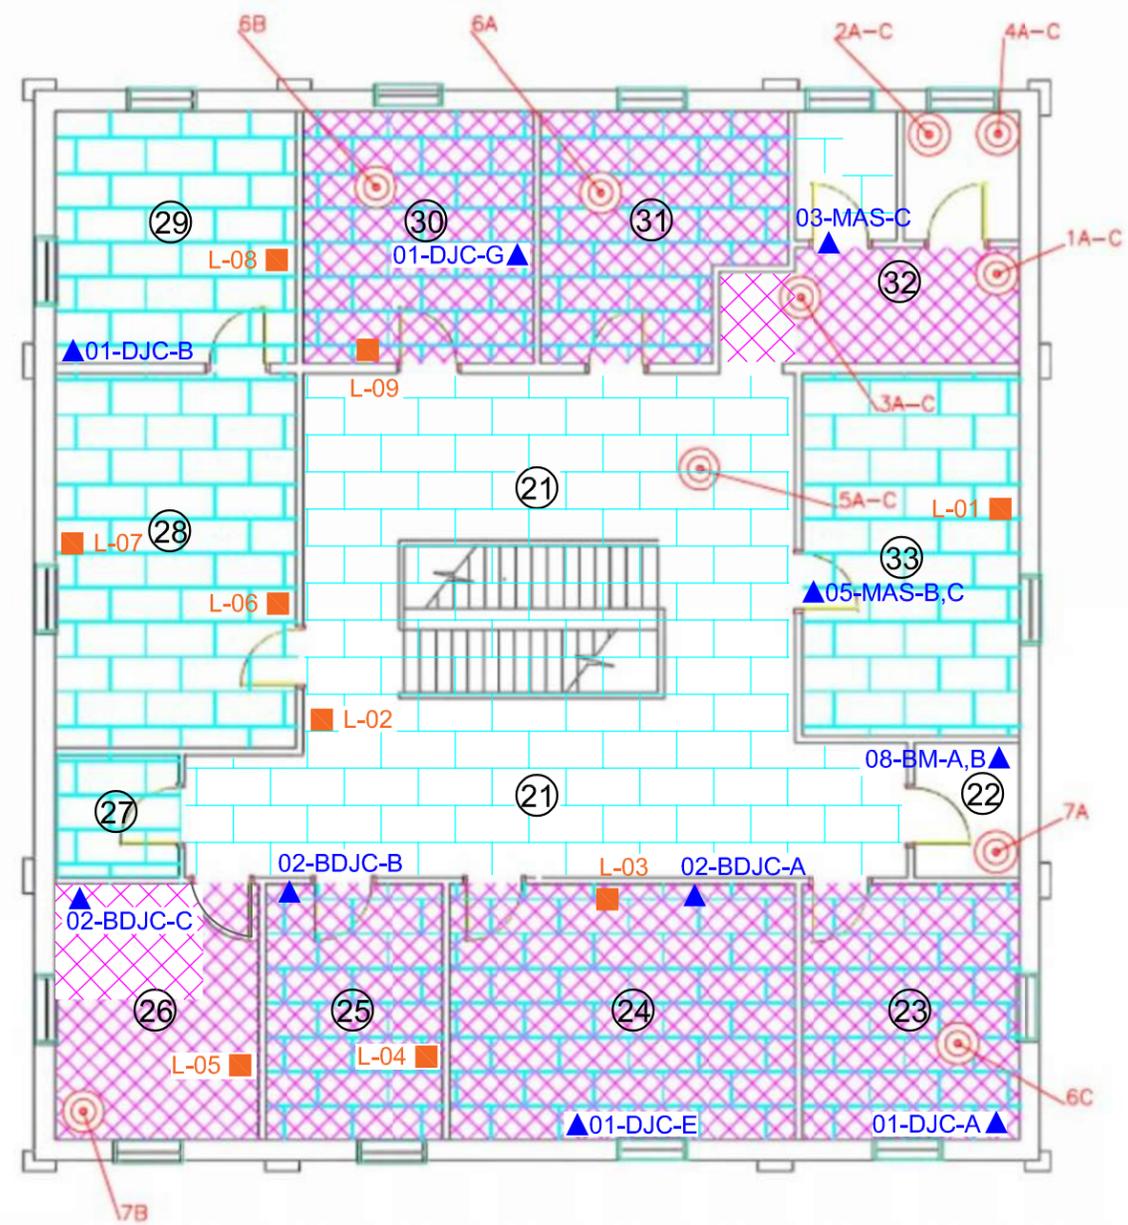
NOTE:  
 1) ASBESTOS-CONTAINING VERMICULITE IS PRESENT WITHIN PERIMETER CONCRETE BLOCK WALLS AT THE SUBJECT BUILDING.  
 2) NON ASBESTOS-CONTAINING ROOF CORE AND ASPHALT SAMPLE LOCATIONS ARE NOT SHOWN ON THIS FIGURE.  
 3) OTHER DESIGNATED SUBSTANCES OR HAZARDOUS MATERIALS MAY BE PRESENT WITHIN CONCEALED BUILDING SPACES.
