**SOLICITATION AMENDMENT  
MODIFICATION DE L'INVITATION**

<b>Title - Sujet</b> Life Safety System Replacement	
<b>Solicitation No. - N° de l'invitation</b> EW038-210713/A	<b>Amendment No. - N° modif.</b> 002
<b>Client Reference No. - N° de référence du client</b> DFO EW038-210713	<b>Date</b> 2020-08-18
<b>GETS Reference No. - N° de référence de SEAG</b> PW-\$PWU-201-11879	
<b>File No. - N° de dossier</b> PWU-0-43072 (201)	<b>CCC No./N° CCC - FMS No./N° VME</b>
<b>Solicitation Closes - L'invitation prend fin</b> <b>at - à 02:00 PM</b> <b>on - le 2020-09-01</b>	<b>Time Zone</b> <b>Fuseau horaire</b> Mountain Daylight Saving Time MDT
<b>F.O.B. - F.A.B.</b> <b>Plant-Usine:</b> <input type="checkbox"/> <b>Destination:</b> <input type="checkbox"/> <b>Other-Autre:</b> <input type="checkbox"/>	
<b>Address Enquiries to: - Adresser toutes questions à:</b> Ho (RPC), Hector	<b>Buyer Id - Id de l'acheteur</b> pwu201
<b>Telephone No. - N° de téléphone</b> (780) 901-0989 ( )	<b>FAX No. - N° de FAX</b> (780) 497-3510

**This amendment has been raised to answer the following question and to attach several reports**

BUILDING CONDITION REPORT  
F&O ADMINISTRATION/CCG  
TELECOM BUILDING  
CANADIAN C

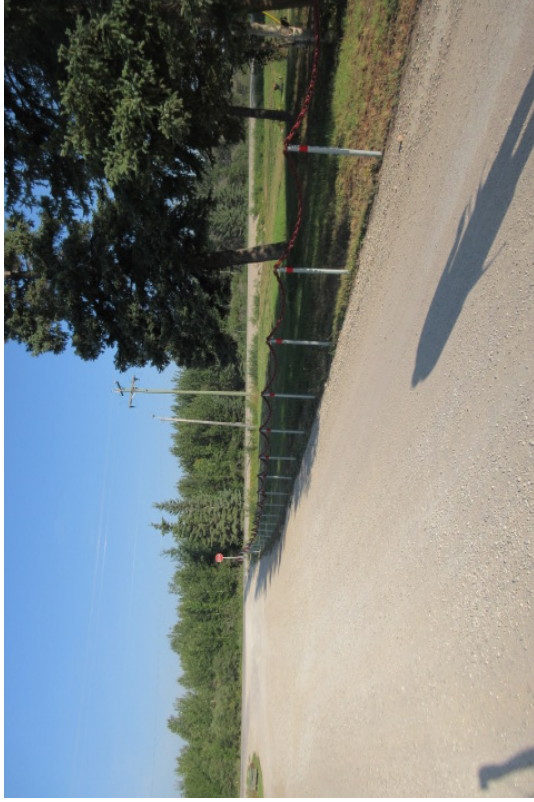
Signature - Exterior Elevation Access Road

The Hay River Canadian Coast Guard Base can be found at 42037 Mackenzie Highway, Hay River, Northwest Territories, X0E 0P9. The site infrastructure includes a paved, asphalt Access Road. Asset Code: C L 00002 17660, which leads onto the site from the Mackenzie Highway. The Access Road is approximately 8.5 meters wide by 250 lineal meters long.

Requirement Name	Renewal	Prime System	Category	Priority	Action Date	Estimated Cost
Roadway - Traffic Control - Painted Pavement Markings Renewal	Yes	G2015 - Painted Lines	Lifecycle	1- Due within 1 Year of Inspection	Aug 14, 2018	5,104
Roadway Flexible Pavement - Intermediate Course Renewal	Yes	G2011 - Bases and Sub-Bases	Lifecycle	3- Due within 5 Years of Inspection	Aug 14, 2023	69,380
Roadway Flexible Pavement - Surface Course Renewal	Yes	G2012 - Paving and Surfacing	Lifecycle	3- Due within 5 Years of Inspection	Aug 14, 2023	96,330
<b>Total</b>						<b>170,814</b>

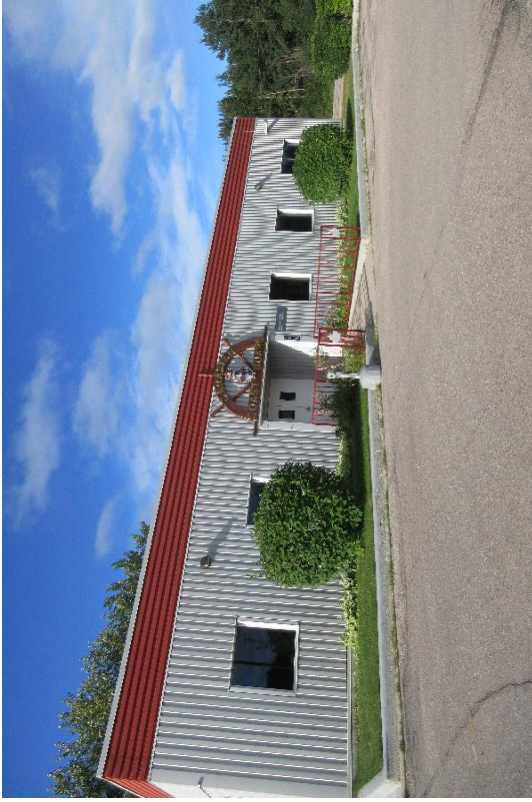
Signature - Front Elevation Administration Building

The Administration building, Asset Code C.I. 00002 16580, can be found on the Hay River Canadian Coast Guard Base at 42037 Mackenzie Highway, Hay River, Northwest Territories, X0E 0R9. The facility is a single level building with crawlspace foundation built in 1984. The Administration building contains 462 square meters of floor space.

Requirement Name	Renewal	Prime System	Category	Priority	Action Date	Estimated Cost
Air Cooled Condensing Unit Renewal	Yes	D3030 - Cooling Generating Systems	Lifecycle	3- Due within 5 Years of Inspection	Aug 14, 2021	31,855
Aluminum Windows Renewal	Yes	B2020 - Exterior Windows	Lifecycle	3- Due within 5 Years of Inspection	Aug 14, 2023	85,633
Branch Wiring - Equipment & Devices Renewal	Yes	D5021 - Branch Wiring Devices	Lifecycle	3- Due within 5 Years of Inspection	Aug 14, 2023	29,418
Carpeting Broadloom Renewal	Yes	C3020 - Floor Finishes	Lifecycle	2- Due within 2 Years of Inspection	Aug 14, 2018	34,354

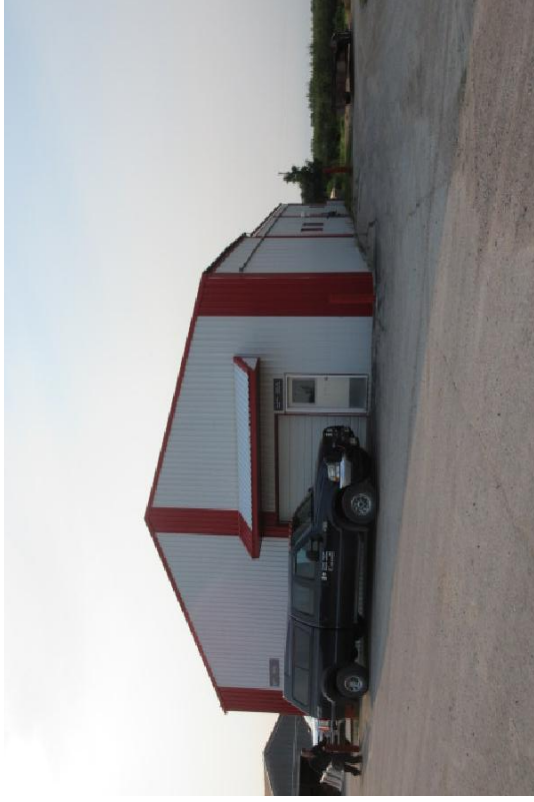
Signature - Exterior Elevation Carpenter Shop

The Carpenter Shop building, Asset Code C L 00002 17465, can be found on the Hay River Canadian Coast Guard Base at 42037 Mackenzie Highway, Hay River, Northwest Territories, X0E 0R9. The facility is a single level building with a slab on grade foundation built in 1968. The Carpenter Shop building contains 318 square meters of floor space.

Requirement Name	Renewal	Prime System	Category	Priority	Action Date	Estimated Cost
Air Handler with Ductwork Renewal	Yes	D3040 - Distribution Systems	Lifecycle	3 - Due within 5 Years of Inspection	Aug 14, 2023	24,065
Branch Wiring - Equipment & Devices Renewal	Yes	D5021 - Branch Wiring Devices	Lifecycle	3 - Due within 5 Years of Inspection	Aug 14, 2023	20,249
Concrete - Painted or Sealed Renewal	Yes	C3020 - Floor Finishes	Lifecycle	3 - Due within 5 Years of Inspection	Aug 14, 2023	7,253
Door Assembly - Single Renewal	Yes	B2030 - Exterior Doors	Lifecycle	3 - Due within 5 Years of Inspection	Aug 14, 2023	32,442
Electrical Distribution Equipment, Panelboards and Feeders Renewal	Yes	D5012 - Low Tension Service and Dist.	Lifecycle	3 - Due within 5 Years of Inspection	Aug 14, 2023	34,302
Emergency Battery Pack Lights Renewal	Yes	D5092 - Emergency Light and Power Systems	Lifecycle	1 - Due within 1 Year of Inspection	Aug 14, 2018	3,549
