Port Severn Dam

PUBLIC WORKS CANADA

PORT SEVERIN DAM

GEOTECHNICAL
INVESTIGATION

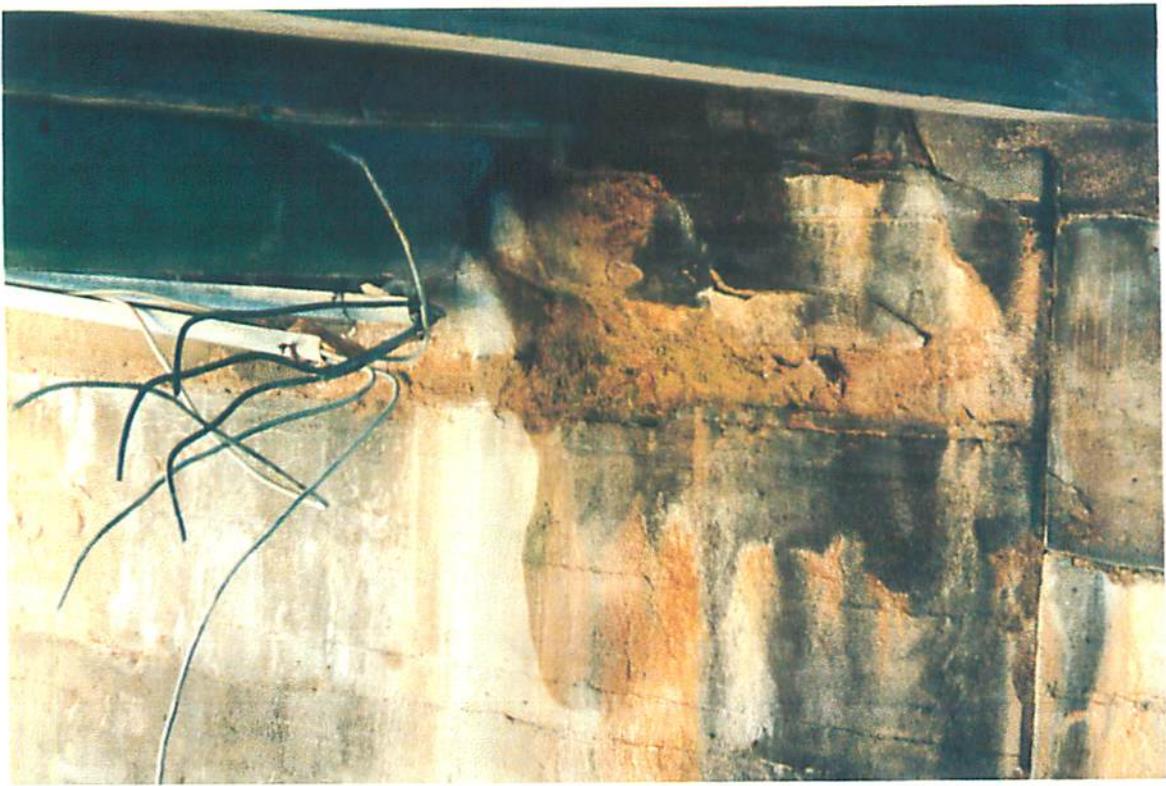
11/5
East Side Downstream Face

This pier also continues upstream and downstream as the canal wall. Under deck between first and second beams the face is badly eroded (roll 10/19). There is slight weathering into first timber slip. The column dividing both timber slips has a shear break just above steel plates, it runs full width of column (roll 11/1). Downstream there is a large eroded area under deck under fifth and sixth beams, also there is an assortment of electrical wiring coming out of conduit (roll 11/5). Downstream at Dam the face is badly eroded and allows water to leak through (roll 12/5). Further downstream, approximately 2.0 m, there is a badly eroded section about 1.0 m above water level. These above two sections are probably responsible for water leaking to west face of Pier 1 (roll 13/21). The downstream nose is also badly eroded and has a horizontal shift to it, about one of the construction joints (roll 12/3, 7).

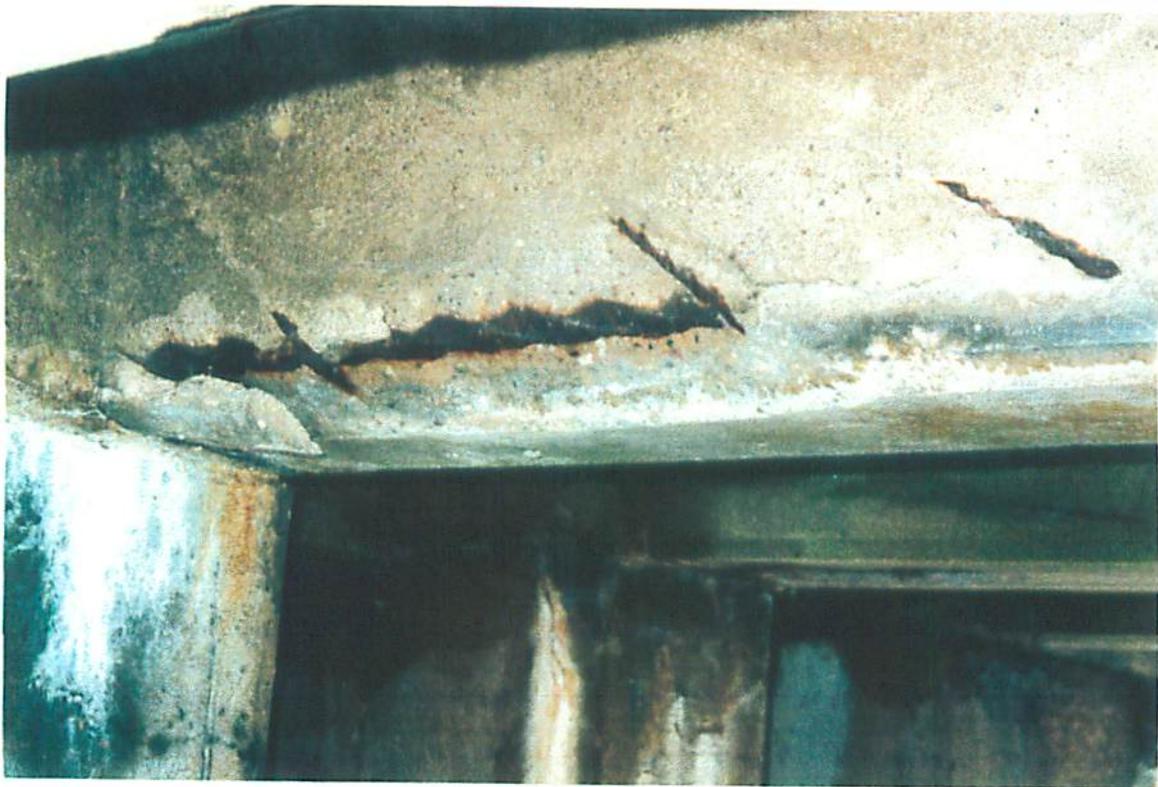
10/21
Upstream Face Beam No. 2

The deck over Pier 1 has several patches over concrete with cracks running in and out of these patches. These patches are parallel with the canal to the west. (roll 3/16, 17, 18, 19, 20, 21). The downstream face of the first beam has weathering at face of span, the surface concrete has lift and flaked off in some areas (roll 10/18). The second beam upstream face has two locations where the lower edge of the beam has broken off and exposed the rebar 1) at east end of beam, 0.6 m 1 long section and 0.3 m high (roll 10/21) and 2) at the centre of the span, 0.4 m long section (roll 10/20). The second beam on the downstream face has deep erosion gouges 25 mm deep at the west end of beam (roll 10/23). The upstream face of the third beam at east end has a horizontal crack (roll 11/2). The dam timber leaks across the width of the spillway and through eroded cracks in pier 1 face at dam (roll 12/1,2,5). Note major cracks along wall below stop logs (roll 12/1, 2).

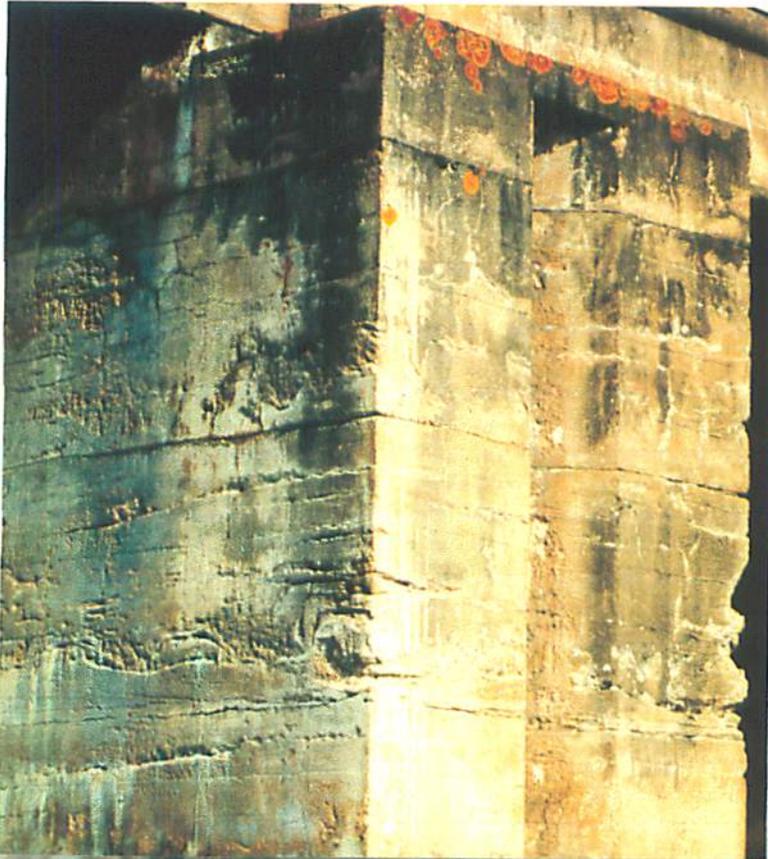
Downstream Pier No. 2

The upstream east face is not too bad except at the point where the first beam joins the pier, there is a wide eroded crack and some vertical cracking going down almost to the water level. Between the first and second beams there is some weathering across the face starting at the just below the beams. The downstream east face was not too bad. The west upstream face has a similar vertical diagonal crack starting where beam 1 joins face. The west face has weathering between first and second beams. The dam timber slip has some erosion at upper construction joint (roll 11/3). At the fifth and sixth beams there is a large loose section of concrete approximately 1.0 m high (roll 11/4). At the dam and downstream face there is considerable erosion (roll 12/6). The downstream nose has weathered and eroded mostly at the top third of pier (roll 12/8, 10).

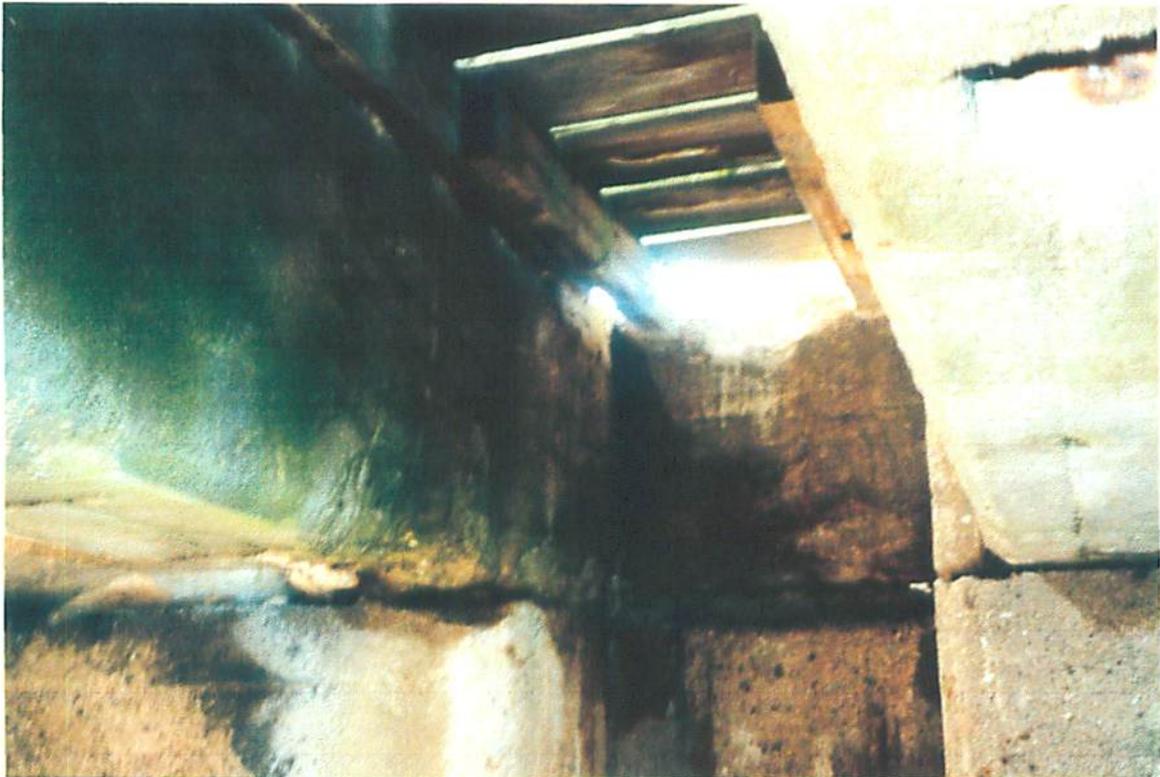
10/15
Beam No. 4 at Pier No. 2

The deck is generally good. On pier 2 at south rail going northwest to second timber slip the deck has a diagonal crack (roll 3/14, 15). Beam 1 has small vertical cracks at centre of span and at west end of upstream face there are erosion gouges running horizontal to pier 2. The downstream face at centre of span has a 0.5 m long eroded section at bottom of beam (roll 10/6). The downstream face of the second beam has erosion gouges running horizontal from pier 2 to 1 m east of pier 25 mm deep in places (roll 10/8, 9, 10). The fourth beam has a series of seven vertical cracks, basically at centre of span about 0.3 m apart (roll 10/14 shows two) on the upstream face. As well as at the west end there are a series of erosion gouges. This spillway is used mostly to control water level upstream, water leaks quite rapidly and the water level is quite deep.

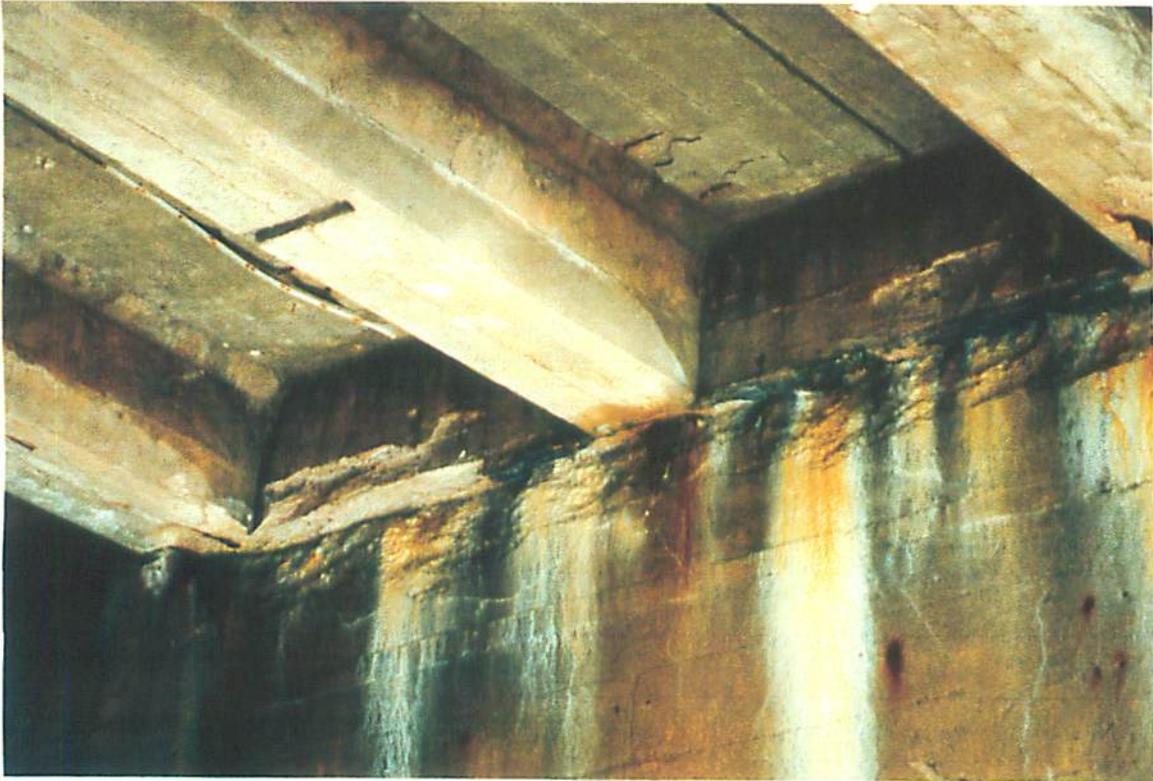
12/13
Downstream West Face

The east face has eroded in line with beam 1 and under beams down to first timber slip and into slip. Downstream of dam and under highway bridge beams the east face of pier has eroded severely (roll 9/22). Further downstream there is 1.0 m vertical crack, 4.5 m upstream from downstream nose of pier (roll 12/19). The downstream nose and up the east face has eroded severely as well (roll 12/15, 16). The upstream nose has a hole into it 0.5 m down from the top of the pier. On the west face is line with beam 1 more erosion can be seen as well as vertical cracking with calcium deposits (roll 10/1). More erosion under deck from first and second beam. The column between timber slips has eroded severely directly under beam, a 0.3 m high section of concrete has broken out (roll 11/11). Downstream from dam under highway bridge directly under beams, the face has eroded (roll 10/12, 13 and roll 12/13). Further downstream and 1.0 m above waterline there is an eroded hole into pier 0.6 m long, 0.2 m high and 170 mm deep (roll 12/12, 14).

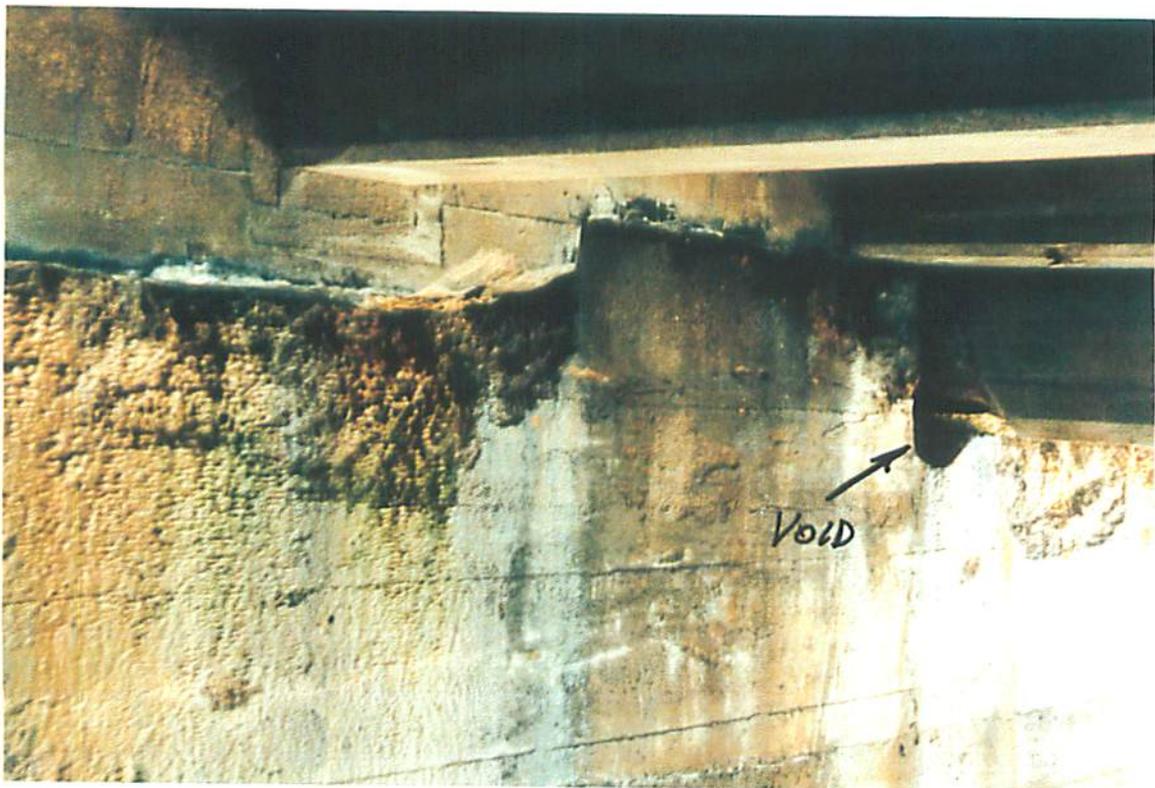
10/13
West Face Note Void Under Beam

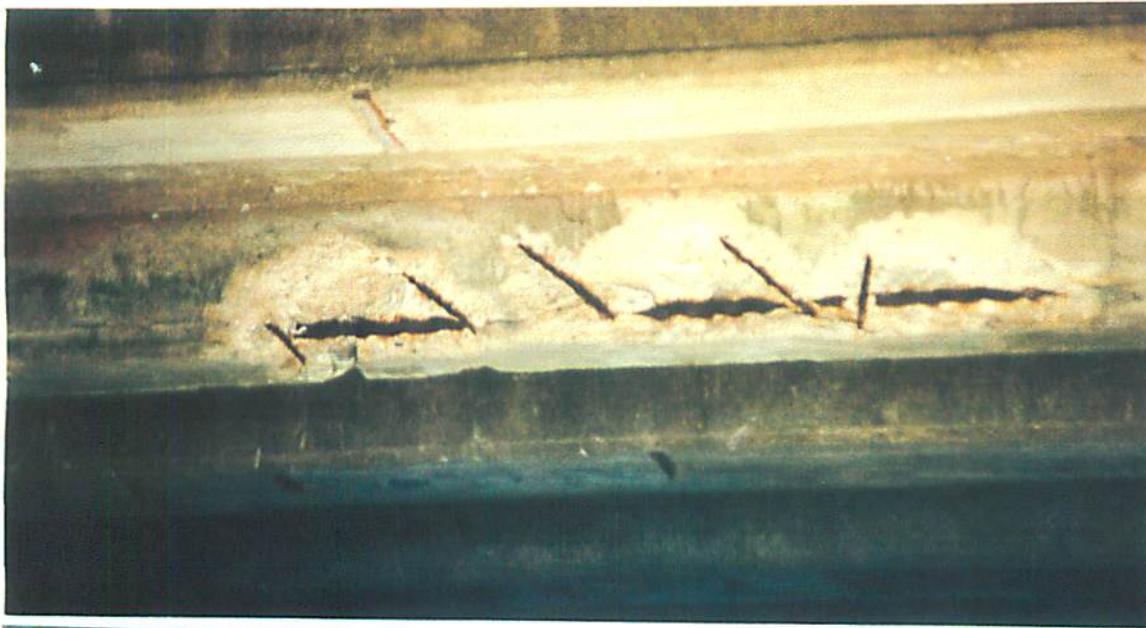
West of pier 4 just to the west and at second timber slip from south rail northwest to slip 45 ° crack. The deck over pier 3 has a construction joint that was patched and subsequently cracked, the full width of deck. From north rail southeast to first timber slip deck has 45° crack, from centre rail southeast into second timber slip and from south rail northeast into second timber slip both are wide cracks. The first beam has some weathering and cracking, at east end and two vertical cracks, 1.8 m west of pier 6 and 2.7 m east of pier 3. Where the first beam meets pier 3 there is erosion at bottom edge of beam 1, 0.5 m east of pier. On the bottom face of beam there is a long crack running down centre of beam to Pier 4, 2.2 m west of Pier 4 the downstream bottom edge of second beam has eroded off and 2.4 m west of pier 6 there is a hole in the bottom of beam 0.1 m in diameter and 50 mm deep (roll 9/5, 9, 3). The second beam one area 1.5 m east of Pier 3 0.1 m exposed rebar on the upstream face and on the downstream face there are two 1) 1.1 m west of Pier 4 and 2) at centre of span the face is weathered. The third beam has one crack on the bottom face 1.3 m west of Pier 6, rebar exposed in eroded area 0.6 m by 0.1 m (roll ;9/15). The fourth beam bottom upstream edge has eroded off close to Pier 4. On the downstream face of the fourth beam a 1.0 m long section has eroded off exposing rebar up the entire downstream face :(roll 9/17) and at the centre of the span a 0.5 m long section at bottom of beam has eroded and exposed the rebar. The dam timbers leak quite badly +1.5 m deep water. This spillway and the next one west are the two spillways used to control water level upstream.

12/17
Exposed
Reinforcement
Beam No. 4

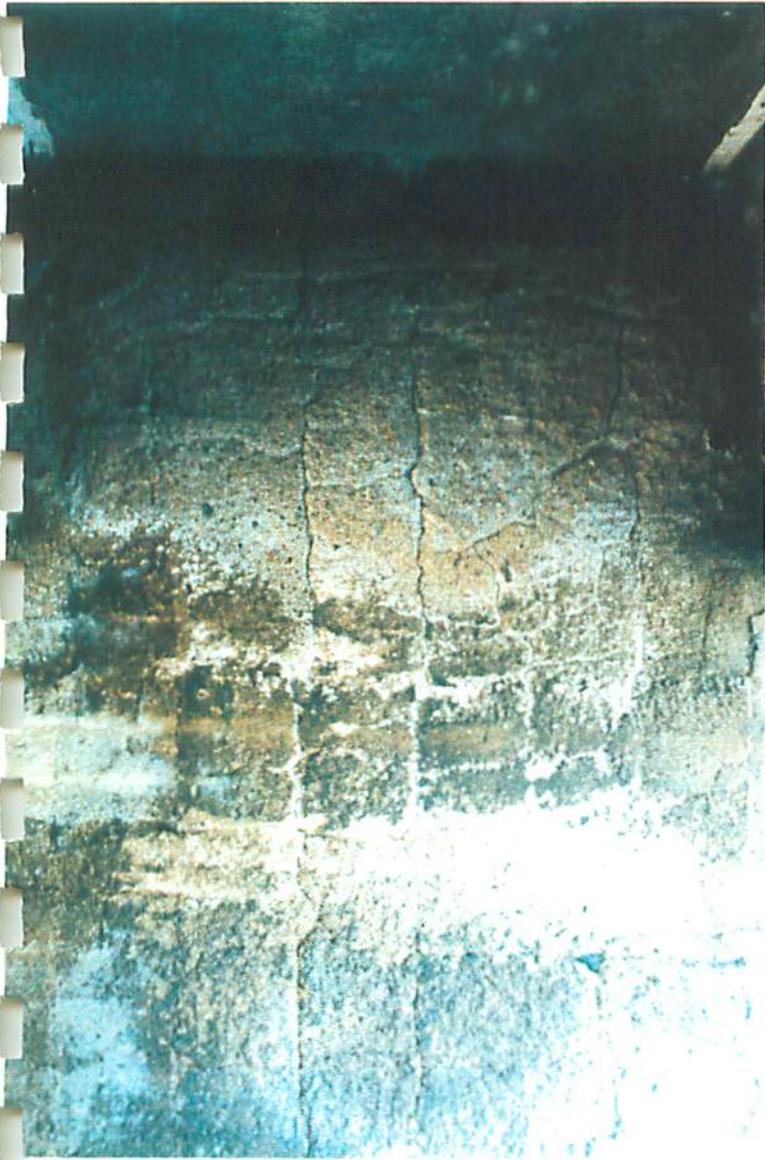
8/14
Upstream East
Face Pier No. 4

The east face has a large weathered area between first and second beams, upstream there are several vertical cracks, parallel to one another in a regular pattern. Probably, this pattern is showing form work configuration. The column between the two timber slips on east face of Pier 4 has erosion gouges at 0.3 m below bottom of third beam. Downstream of dam there is some erosion/weathering under highway bridge (roll 8/23). The west face of pier at upstream has some weathering at lower construction joint. The column separating timber slips has cracking, 0.3 m and 0.5 m below bottom of beam in the dam slip just above timber there is an eroded area full width of slip (roll 9/19), this eroded area runs downstream of slip for approximately 1 m in length. Further downstream, approximately 1.5 m from downstream nose and halfway up the face is weathered such as in (roll 12/21).

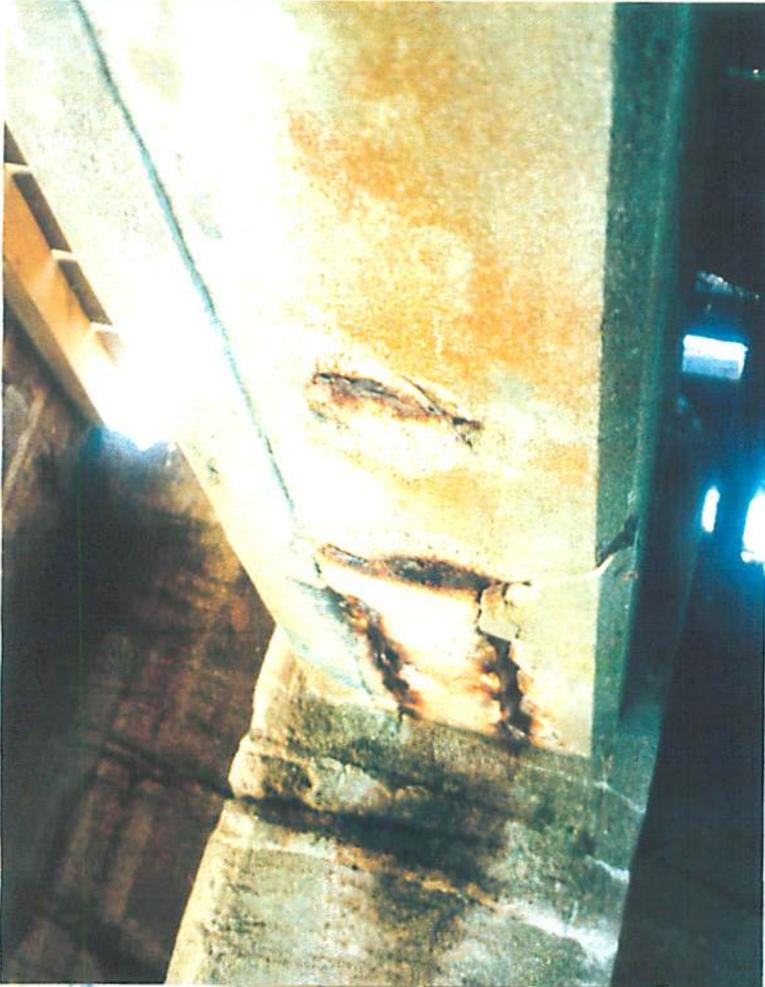
8/19
Bottom Face
Beam No. 3

The deck is generally in good condition with the exception of a crack that starts at centre of pier and runs on a diagonal to the southeast corner of opening over first timber slip. (roll 3/4). The upstream face of beam 1 has one major crack in it at the center of span at the bottom of the beam (roll 8/23, tape 50 x 100 mm). The downstream face of the first beam has a large section at the lower third of beam broken off exposing rebar 1.0 m in length at Pier 5 (roll 8/10) and at the west end of beam 1 downstream face 1.0 east of Pier 4 there is an exposed section of rebar (roll 8/9). The upstream face of beam 2 has three areas of concern: 1) the concrete from bottom edge of beam up to middle of beam has broken off exposing the rebar 0.5 m in length (roll 8/11), 2) at approximately the centre of span the bottom edge has broken off approximately 280 mm in length (roll 8/12 and 3) the bottom edge of the beam has broken off exposing the rebar for 1.2 m length at Pier 4. The bottom of the second beam has a weathered section at centre of span (roll 8/20). The downstream face has a weathered section 1.3 m east of Pier 4 some gouges are 40 mm deep (roll 8/15, 16). The third beam has one major area located at Pier 4 the bottom face of beam has eroded out exposing rebar, 0.5 m in length (roll 8/18, 19). The fourth beam has two major areas of concern, the first being at Pier 5, the bottom face of beam has eroded off exposing rebar and the second, the downstream face has eroded exposing three sections of rebar. Dam leaks and the water level just downstream of dam is quite deep +1.0 m.

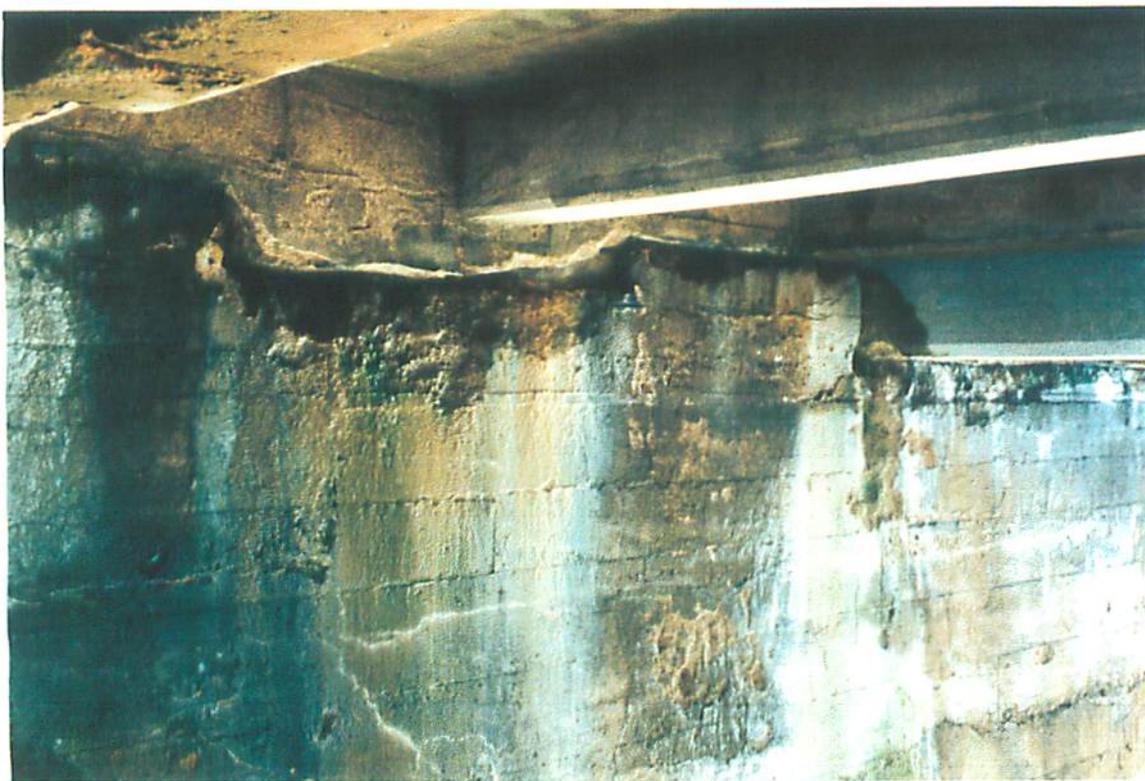
5/22
Underside at
Highway Bridge

The upstream east face has quite extensive erosion directly below the beams, three severe locations are 1) from first to second beams, 2) in column between timber slips and 3) downstream of dam under highway bridge (roll 8/5, 4, 6). Downstream on east side of pier there is extensive erosion halfway up the face at the dam. On the west face upstream of dam erosion starts again at first beam and runs downstream to first timber slip downstream of dam there is large erosion directly below beams (roll 13/3). Also noted is the extensive cracking of the top of the downstream nose of Pier 5 (roll 13/1, 23).

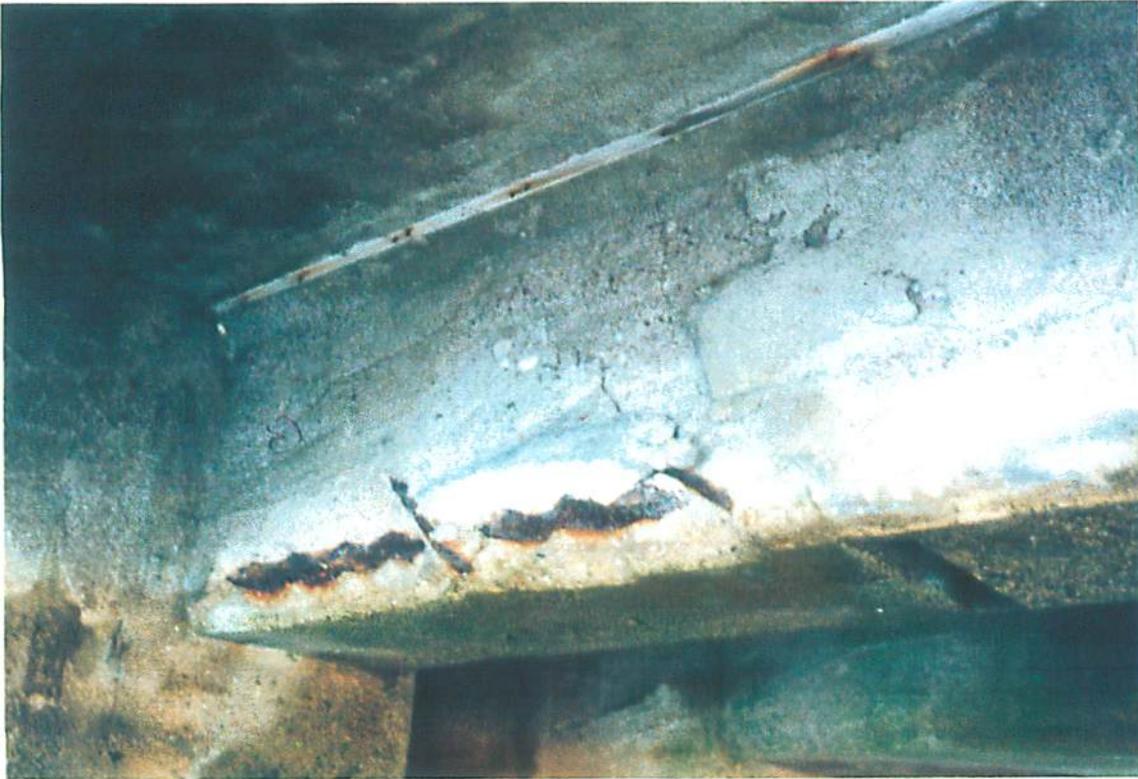
7/20
Underside
Beam No. 2
Upstream

The deck from Pier 6 to Pier 5 is generally in good shape except for a crack 0.94 m west of centreline of Pier 6 running north from north rail to upstream edge of deck. The construction joint in Pier 5 has been patched and subsequently cracked. It runs from the north edge of deck south past south rail. The downstream face of first beam has some weathered section approximately 2.1 m west of Pier 6 and 1.3 m east of Pier 5 there is a crack exposing rebar. The second beam has quite a number of bad locations starting at Pier 6. The bottom edge of beam has eroded exposing a 0.6 m long section of rebar, closer to centre of span, there is a section of bad weathering, (photo's roll 7/21, 22, the tape strip is 50 x 100 mm) and this weathering is also on the upstream face of second beam at Pier 5. The downstream face of second beam has a couple of noticeable spots. The first is at Pier 6, there is bad weathering gouges and the second, towards the center of span. The surface concrete has eroded off exposing rebar in two spots. The third beam shows only a little wear 1) at centre of span on the upstream face the surface concrete has eroded exposing rebar, 2) the underside at centre of beam the concrete has eroded exposing rebar and further along there is a crack at bottom edge of beam (roll 8/3). The dam leaks up to third timber above water line.

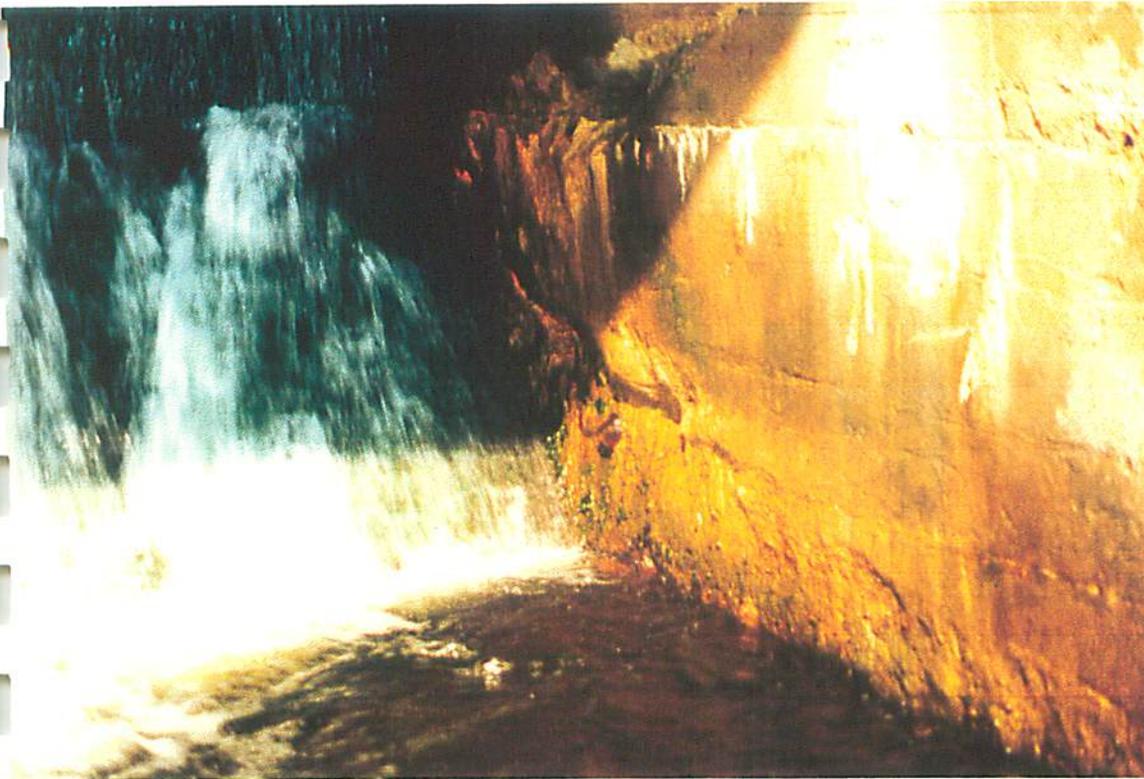
The upstream nose has a large section of concrete eroded out. It starts 0.6 m below top, it is 0.37 m high, 0.25 m wide at the bottom and is 40 m m deep. Continuing downstream on the east face to the first timber slip the entire wall is badly weathered which includes a section of concrete eroded out 0.51 m high, 0.42 m wide, at widest point, and 40 mm deep and erosion gouges starting directly under first beam and running horizontal to first timber slip, some of these gouges are 50-70 mm deep and 0.23 m high. The upstream west face weathered, but not as badly as the east face. Mostly, under deck between first and second beams and a few horizontal cracks running downstream to first timber slip. Downstream of dam, the east face Pier 4 is not too bad however, on the west face there is some weathered erosion at top just under the highway bridge. Down at water level at dam there is quite a bit of erosion into face created by water leaking through the dam.

13/4
Downstream
Pier No. 6 Showing
Erosion and
Deterioration West
Side

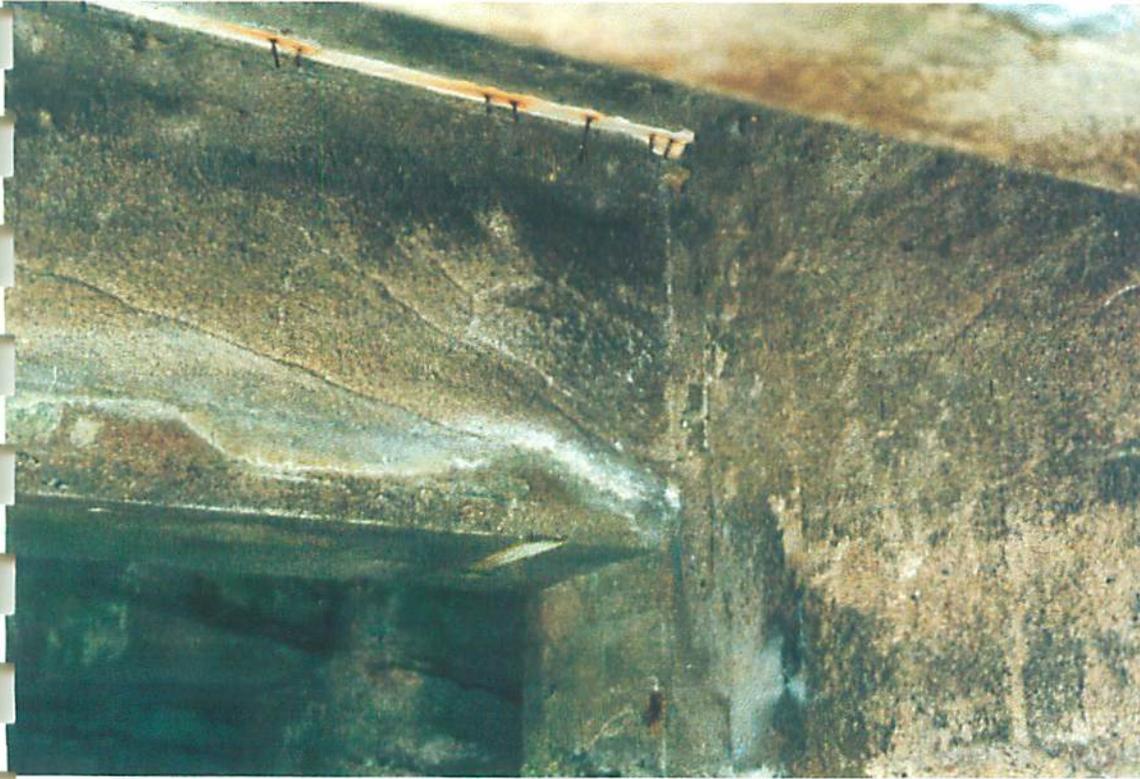
7/9
Beam No. 2
Upstream Face
Note Conditions of
Beam No.'s 3 and 4

- 3) A series of cracks running from the north rail to north edge of deck at distances from centreline Pier 6, 0.95 m, 1.7 m, 2.3 m, 3.6 m and 4.7 m. The upstream face of the first beam is badly weathered total length of span, numerous vertical cracks and horizontal erosion cracks. The downstream face of the first beam at Pier 7 is cracked at centre of span at the bottom of beam. As well as some areas just east of centre and at Pier 6 where the surface concrete has scaled off. The upstream face of the second beam has weathered and cracked for most of its length. Approximately 2.0 m from Pier 7 the bottom face of second beam has broken out exposing rebar basically at centre of beam. At this location there is a crack running along bottom face to upstream face of beam and up and runs parallel to beam for 0.3 m.

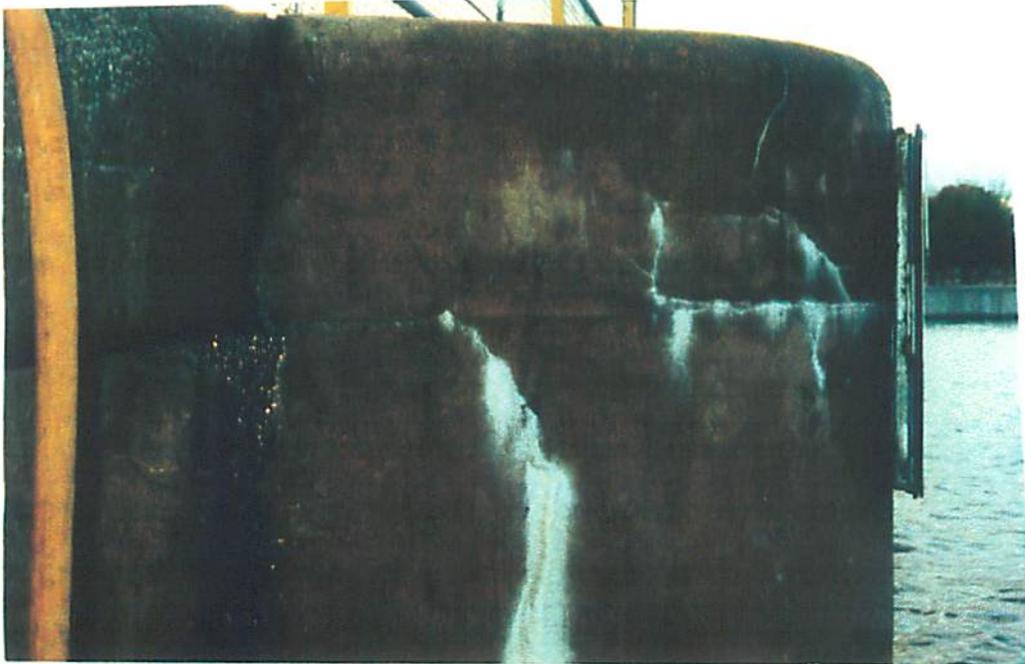
6/1
East Face
Upstream

Upstream east face of Pier 7 a number of cracks, the first being almost at the upstream nose of pier. There is a crack that runs down 0.2 m almost vertically 0.2 m and 0.3 m across top of pier towards the centre. There is a 0.38 m long vertical crack that runs from first construction joint down to second construction joint with calcium deposits. Under deck between first and second beams the east face has weathered badly, two sections of concrete broken off and smaller vertical and horizontal cracks below. In the calcium between the two timber slips 0.3 m down from bottom of beam 3 there are erosion cracks and a vertical crack. Downstream the east face is quite badly eroded including the top half (1/2) of the downstream nose. The west face is slightly eroded.

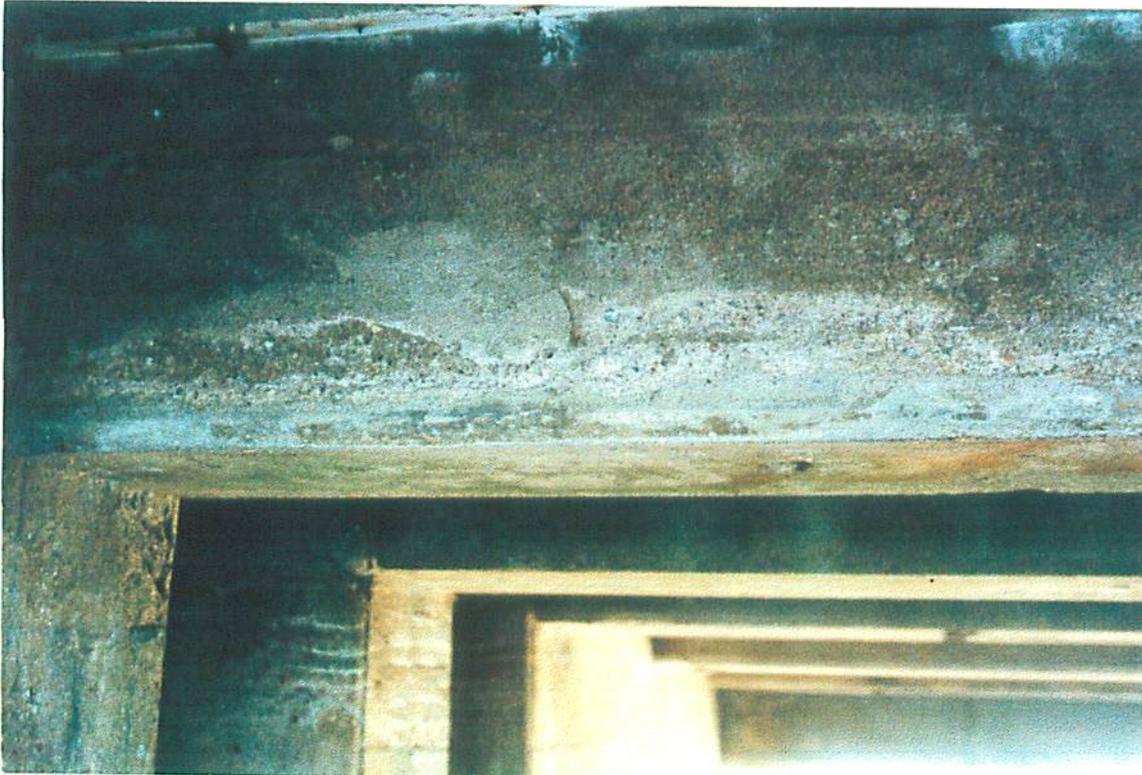
5/19
Beam No. 2
at P8

The deck is in fairly good condition with the exception of a series (five) cracks running from the north rail to the north edge of the deck, the distance from the centre of Pier 8 west to each crack is 1.3 m, 2.1, 2.6, 3.1, 3.6 m. The next area is directly over Pier 7 running full width of the deck along the expansion joint. It has been repaired and subsequently it has cracked and at approximately 1.0 m south of the south rail it has lifted out. The upstream face of the first beam (deck) has a series of erosion cracks at lower portion of face at Pier 8. Continuing west along face towards the centre of the span there is more erosion where marks running from deck down on a 15 degree angle and 0.2 m long. The second beam is quite weathered starting at Pier 8 running 1.0 m toward Pier 7. Then 0.6 m further there is a section 1.5 m long where the surface concrete has (scaled) lifted. The dam timbers leak up to the third timber from bottom.

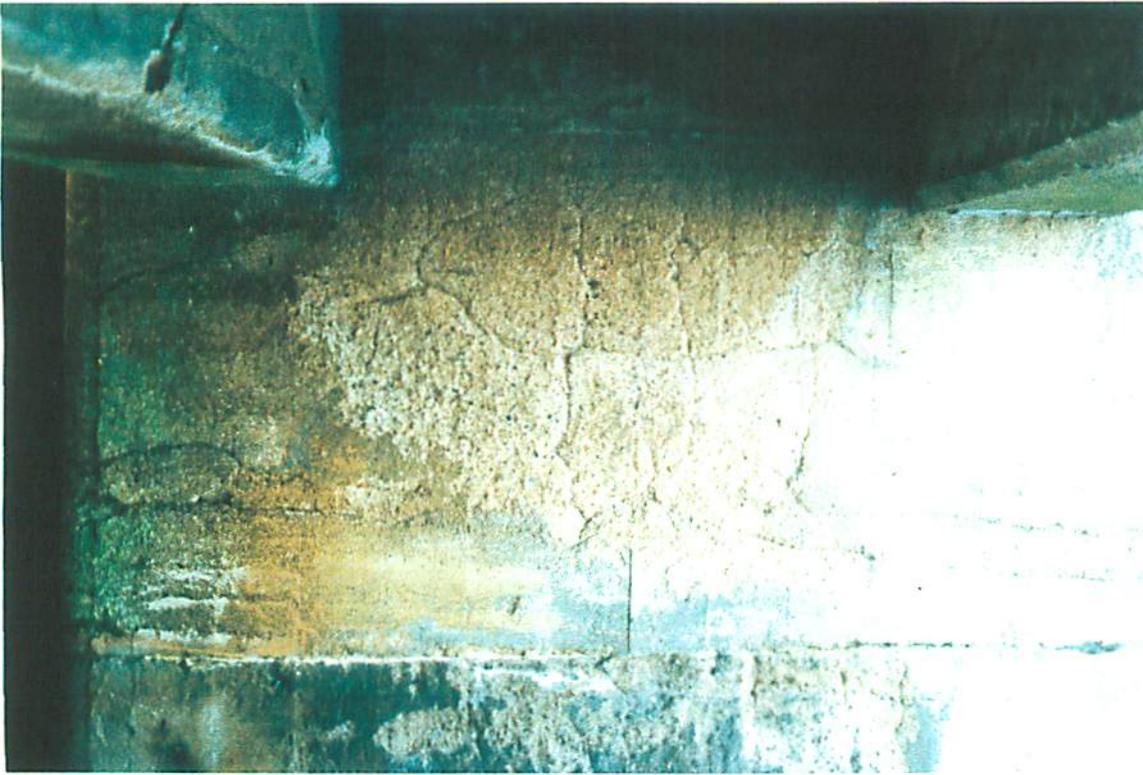
5/10
Pier No. 8
Between
Support
Beams

The upstream east side of Pier 8 is in fairly good condition except for a few vertical cracks. Directly under first beam there are a couple of horizontal cracks running downstream into a large weathered area, 0.6 m wide, 0.3 m high. This weathered section runs into upstream timber slip. The column between the two slips is badly weathered and cracked at waterline. It is eroded to 0.2 m above water. The very upstream nose of Pier 2 has a section of concrete eroded out 0.3 m high, 0.15 m high starting 0.7 m down from top of pier. The upstream west face of the pier has an eroded section at lower construction joint, 0.9 m down from top and just above lower construction joint, 0.9 m down from top and just above there are a few cracks. The eroded area at the construction joint downstream under first beam. The pier face under deck down to upper timber slip has weathered and cracked. It is 0.7 m long and 0.2 m high. Erosion can be seen in the column separating the two slips. Downstream of dam which leaks up to sixth timber from bottom, mostly from third down. The west face at water level has erosion cut into concrete running almost full downstream length. The downstream nose of Pier 8 is badly eroded around full width of nose, mostly at third construction joint down from top of pier.

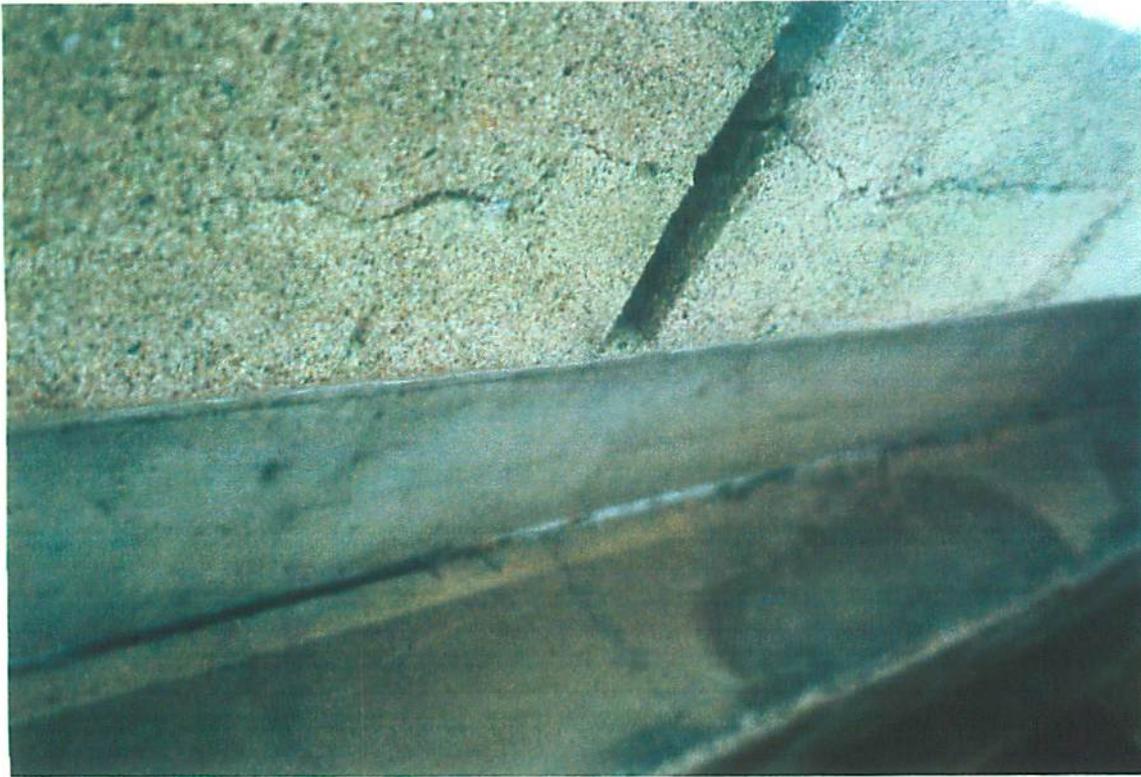
5/23
Beam No. 1
Underside
Face

Deck surface from Pier 9 to Pier 8 is generally good except for weathering and few slight cracks (roll 2/1, 4-6). These cracks are just east of Pier 8. Number one runs from north rail to upstream edge of deck and four to six runs from the south rail to the south approximately 1.0 m in length. Photo number 24 on roll 1 shows general condition of concrete on deck surface. The underside of deck between first and second beams at the west face of Pier 9 has broken off and runs 0.2 m along beam, 0.13 m wide and 30 mm deep into the concrete. The beams shown some signs of erosion. The first beam is eroded and chipped exposing the rebar also the underside is cracked basically at the centre of the span for 1.24 m in length. The second beam has a number of bad spots starting 0.43 m east of Pier 8 on the upstream face surface concrete has eroded off exposing rebar, then 1.17 m east of Pier 8 the upstream face at bottom of beam has eroded off exposing 0.4 m of rebar and then 0.74 m. Further there are two sections on the underside face of the second beam that eroded and exposing the rebar. The dam timber are leaking up to the fifth timber from water line.

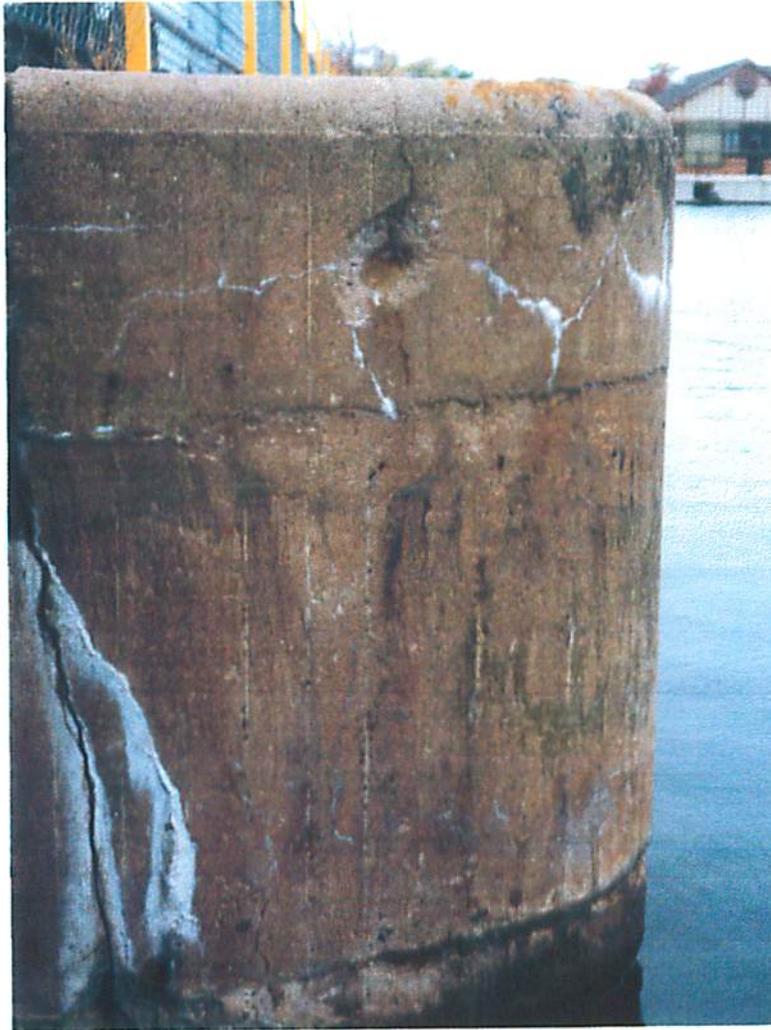
4/20
East Face
Pier No. 9
Upstream

On the east side of Pier 9, there are small cracks in the top 0.4 m with a section of concrete broken out. In line with first beam a vertical crack runs down to water line approximately 0.8 m and then continuing downstream to dam there are numerous small cracks running both vertically and horizontally. Downstream of dam Pier 9 was generally good except for erosion at water line. On west face of Pier 9 again small vertical and horizontal cracks in top of 0.4 m then directly under first beam runs down to water line 0.7 m long. Under deck to first timber slip the pier face has weathered in quite a large area 0.5 m long, 0.3 m high, starting 0.3 m below beams. Downstream on west face of Pier 1 is generally good except for erosion at water line.

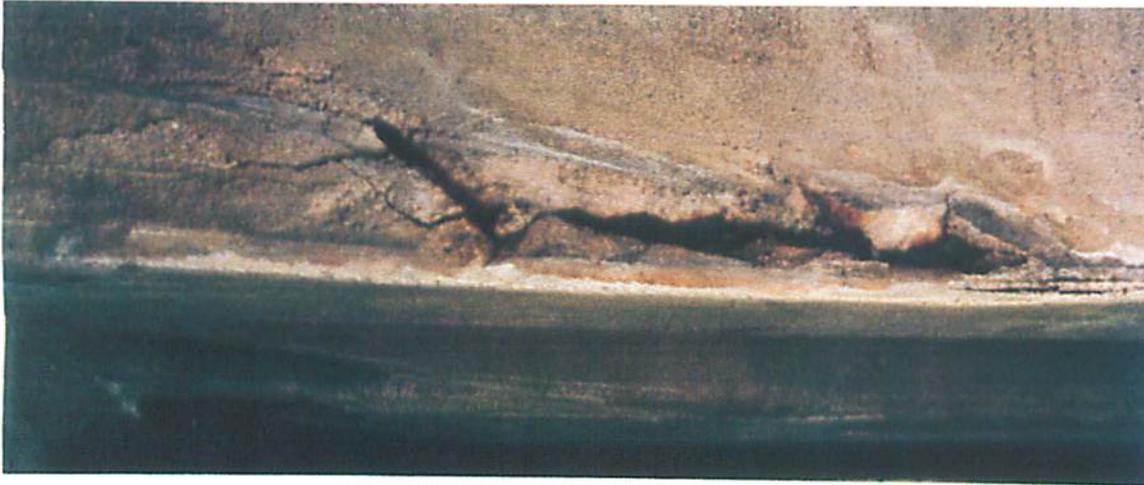
4/7
Support
Beam No. 2

The deck surface is good, no major or minor cracks noted in this section. Deck over Pier 9 has a large patch running full length of deck, and now this patch is cracking. The front face of deck (first beam) has erosion wear marks but generally in good condition except for a spot 1.5 m from East Abutment. The concrete has cracked and exposed the rebar. The second beam has a number of bad spots, the first one is within one metre from the East Abutment. The concrete has cracked and exposed the rebar from 0.5 m long and 50 mm high, the second is 1.5 m from the East Abutment. The upstream face of the beam is good at 1.5 m from East Abutment. The underside of beam has spalled and cracked exposing the rebar and then 0.3 m further toward Pier 9 another eroded section of concrete broken off exposing rebar. The section of concrete is 0.3 m long full width of second beam and 50 mm deep into concrete. The third beam has eroded, cracked and exposing rebar on the underside of beam at the east abutment, full width of beam and 0.45 m long. The dam timbers leak at bottom and up to fifth timber.

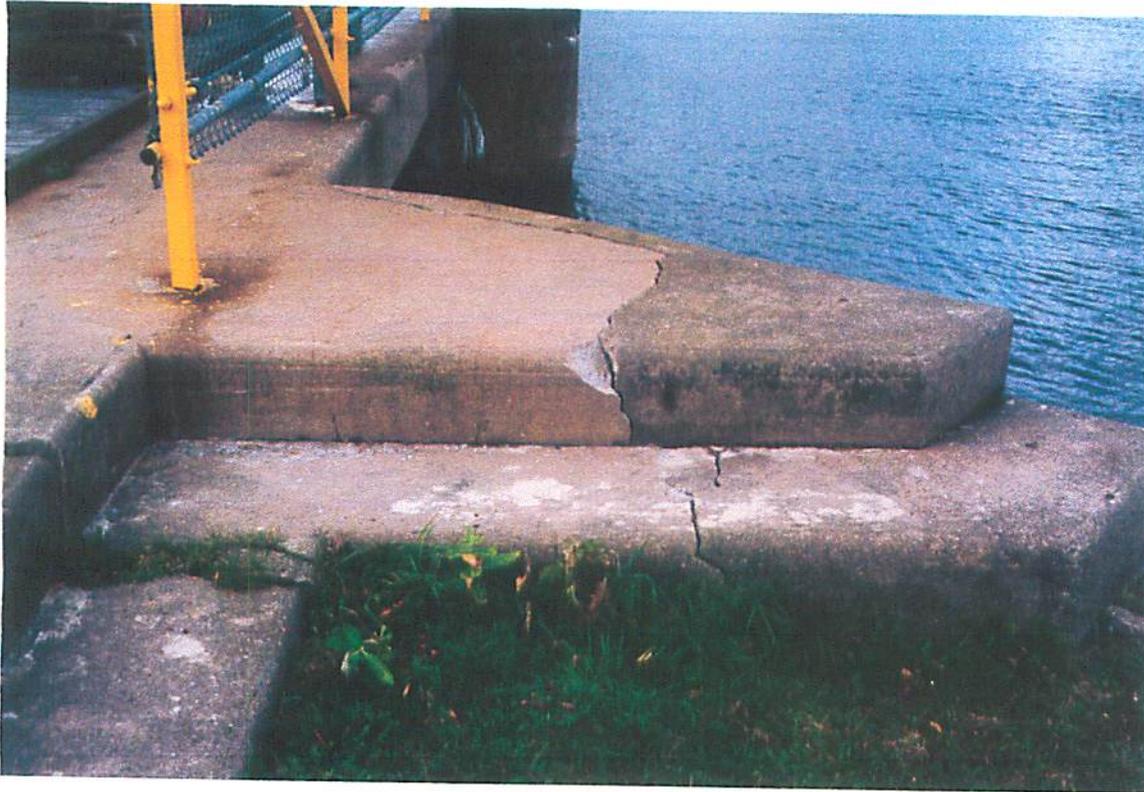
1/6

The East Abutment upstream is very badly cracked both on the deck surface as well as vertically through the structure. Most of the major cracking is from the upper construction joint to the top of structure (roll 4/1, 2, 3, 4). Sections of concrete have broken away from the structure face along the same construction joint and at the water level (roll 4/4). The structure also has some differential cracking, 25 mm in height (roll 1/5) moving towards dam the structure is not that bad except for a local spalled or sealed spot between first and second support beam just under the deck. The downstream section is also not that bad except for some erosion into structure face at the water line and approximately 1.0 m from the concrete spillway. There is some vertical cracking about 1 m from dam from water level up to first construction joint. At downstream end of abutment, there is some erosion in the middle third of structure, possibly runoff freezing and thawing from highway bridge. Between second and third and third and fourth beams are the timber slips, the dam timbers are in the second one, under the third beam is the dividing 'column' both these are eroded and cracked in the abutment.

**Cracking of
Upstream
Wing/Wall
and Abutment
General
Deterioration
and Aging Shows
Need of Removal
and Repair**
