Port Severn Dam

PUBLIC WORKS CANADA

PORT SEVERIN DAM

GEOTECHNICAL
INVESTIGATION

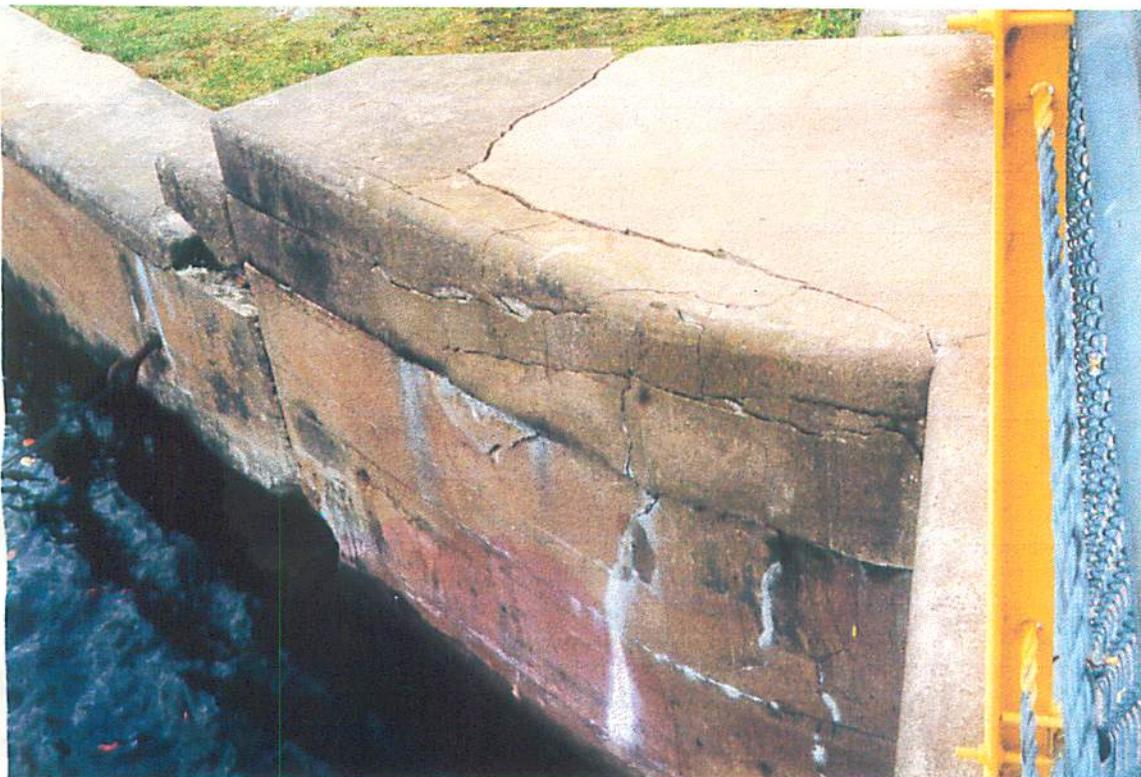
1/11

The East Abutment upstream is very badly cracked both on the deck surface as well as vertically through the structure. Most of the major cracking is from the upper construction joint to the top of structure (roll 4/1, 2, 3, 4). Sections of concrete have broken away from the structure face along the same construction joint and at the water level (roll 4/4). The structure also has some differential cracking, 25 mm in height (roll 1/5) moving towards dam the structure is not that bad except for a local spalled or sealed spot between first and second support beam just under the deck. The downstream section is also not that bad except for some erosion into structure face at the water line and approximately 1.0 m from the concrete spillway. There is some vertical cracking about 1 m from dam from water level up to first construction joint. At downstream end of abutment, there is some erosion in the middle third of structure, possibly runoff freezing and thawing from highway bridge. Between second and third and third and fourth beams are the timber slips, the dam timbers are in the second one, under the third beam is the dividing 'column' both these are eroded and cracked in the abutment.

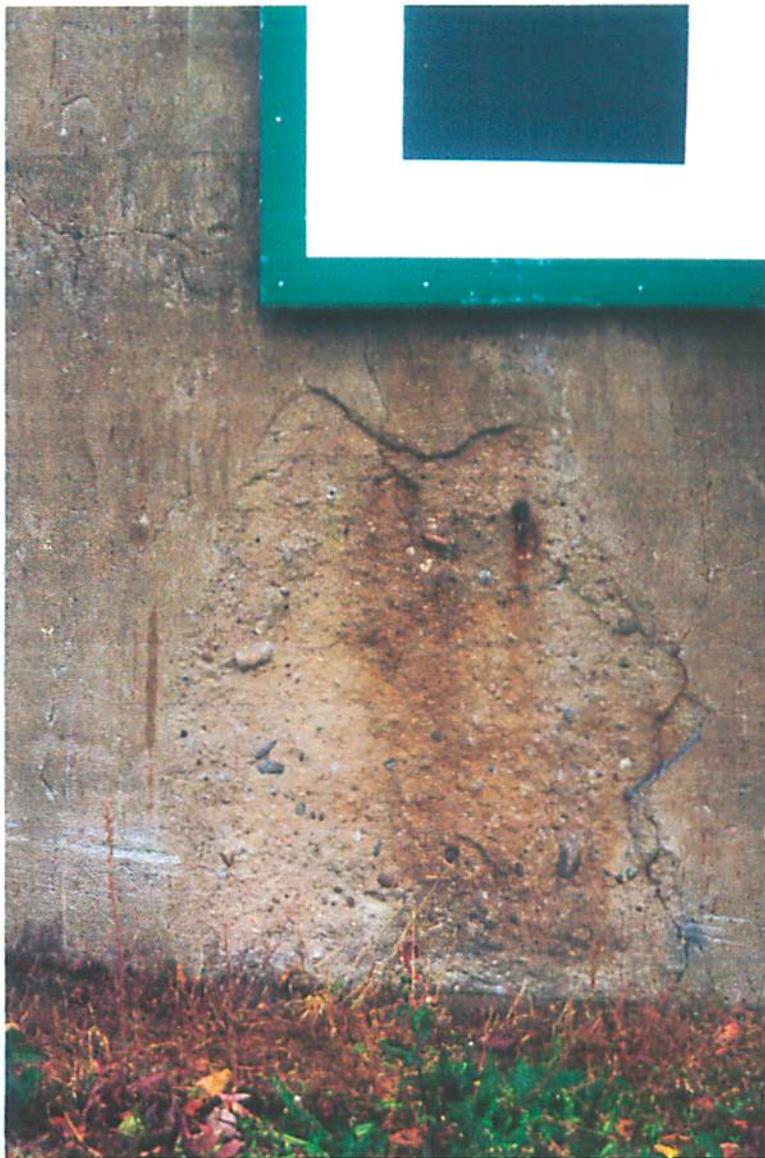
The foundation for the bridge is not too bad on the north hemisphere but on the south hemisphere there are a number of bad areas. At the bottom centre a 1.0 m by 0.8 m area is badly weathered (roll 3/22). The top third of the foundation also at the centre there are numerous cracks (roll 3/23, 24). On the west side there is also cracking at about 1.0 m from the ground (roll 3/25).

3/22
Weathering and
Spalling
South Centre

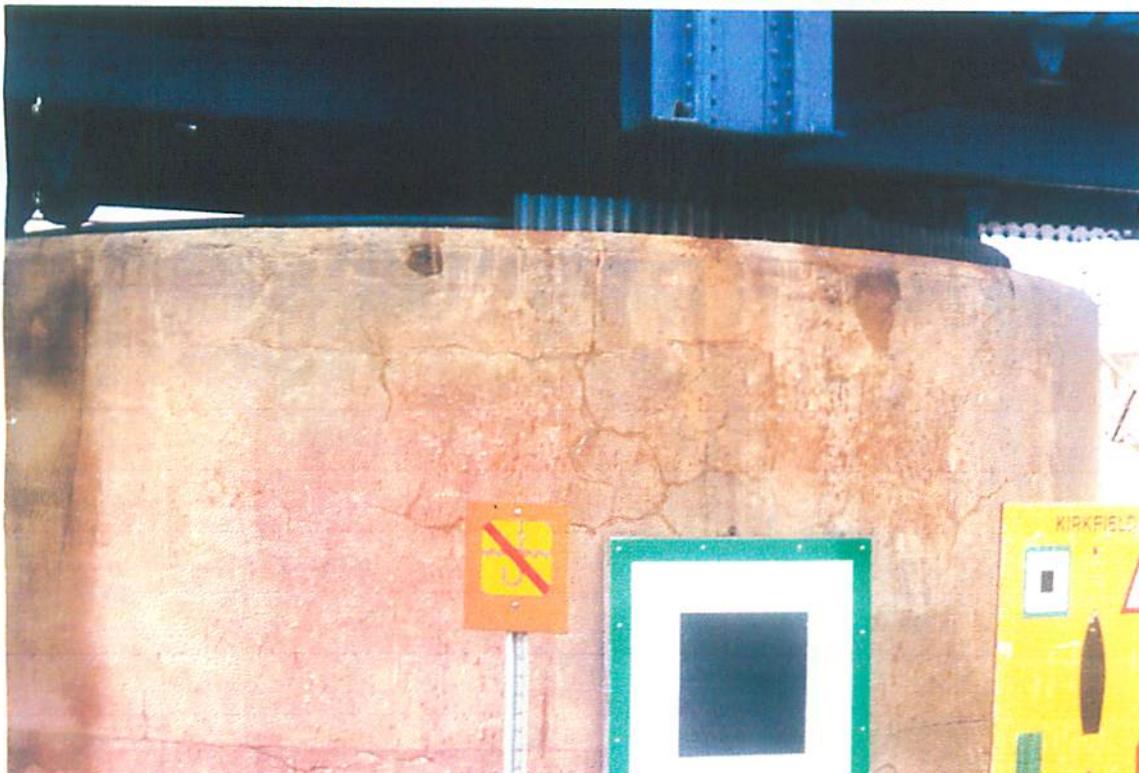
3/23
Top South
Possible
Delamination
Potential
