Project No.: R.051116.002

December 2013

Dam Safety Reviews: Port Severn Dams Main Dam, Lock 45, Upstream Shoreline Wall and Dam D

**Dam Safety Review Report
Final**

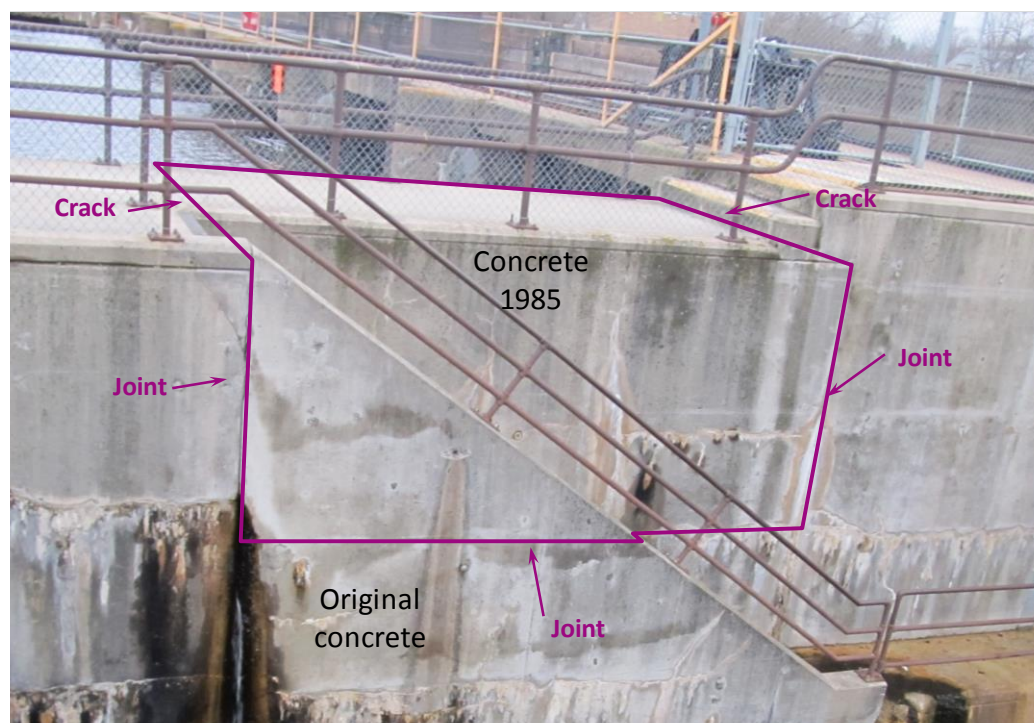
Figure 7.14 Lock 45 Left Wall – Identified Issue

Figure 7.14 illustrates the left wall of Lock 45 and the location of the cracks and joints.

The worst case scenario concerning this repair would be when the original and rehabilitated (1985) concrete sections are not properly joined, by way of anchors or a shear key. In this case, only the friction between the two concrete sections (in the horizontal joint) would maintain the block in place under water and ice pressure from the reservoir. This friction is sufficient to resist the load when there is water pressure on the wall. However, there is a sliding of the block toward the lock chamber under all ice loads.

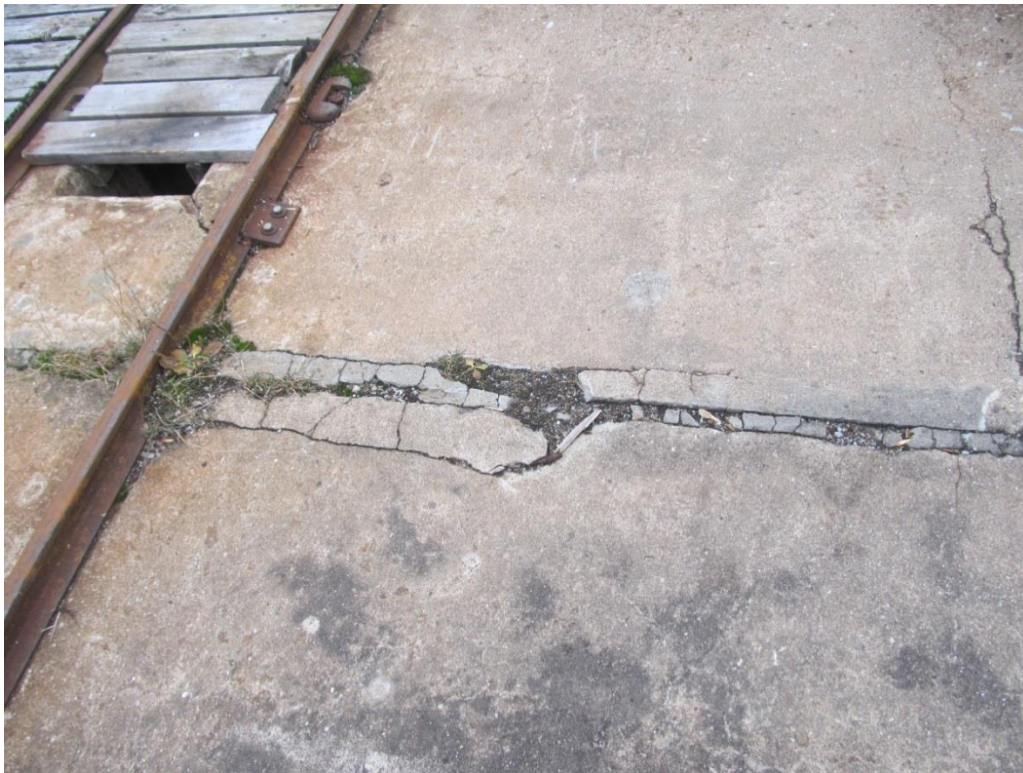
Photo 4: Evidence of repair of construction joint at pier 5

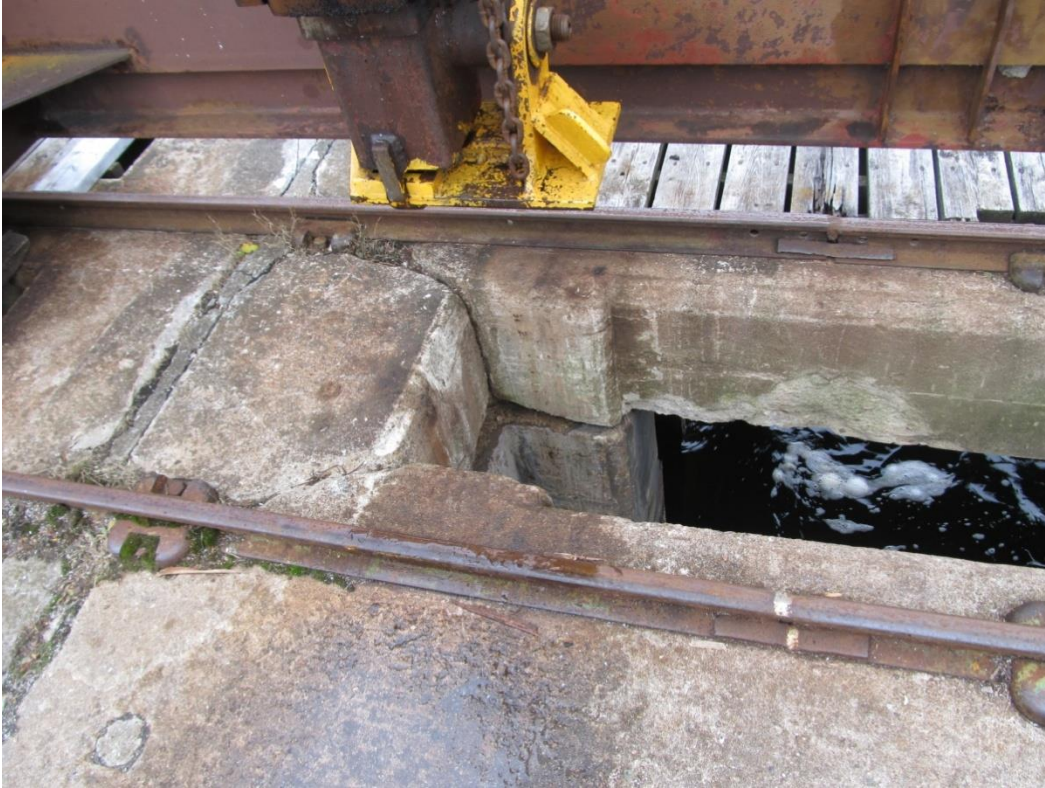
Photo 5: Crack on the deck at sluice 3

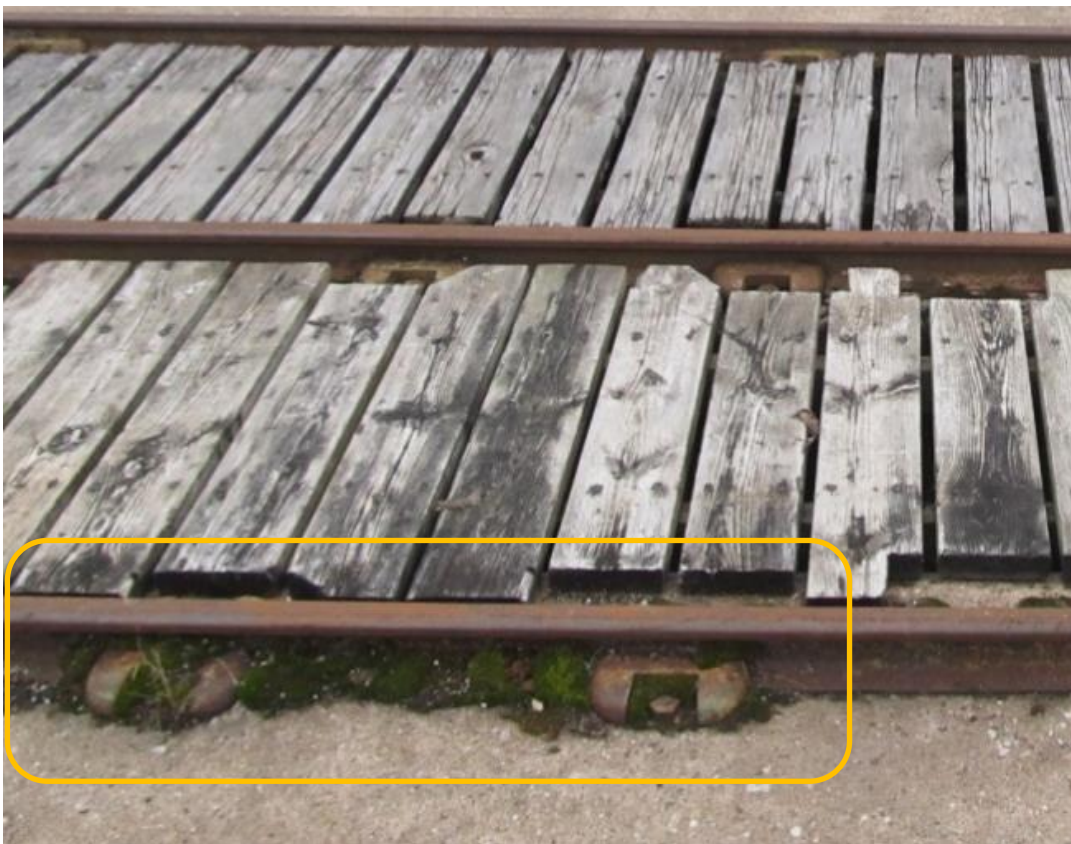
Photo 6: Moss along the rails at sluice 6

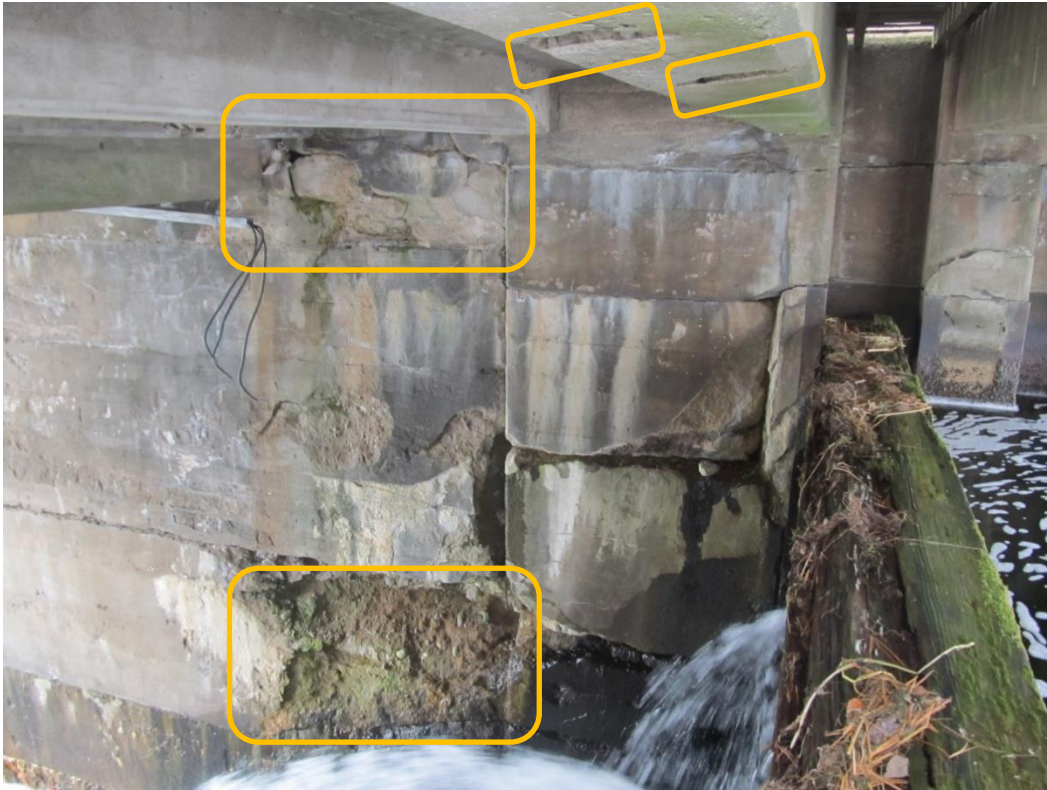
Photo 7 : Damaged concrete on gains and downstream wall at sluice 1

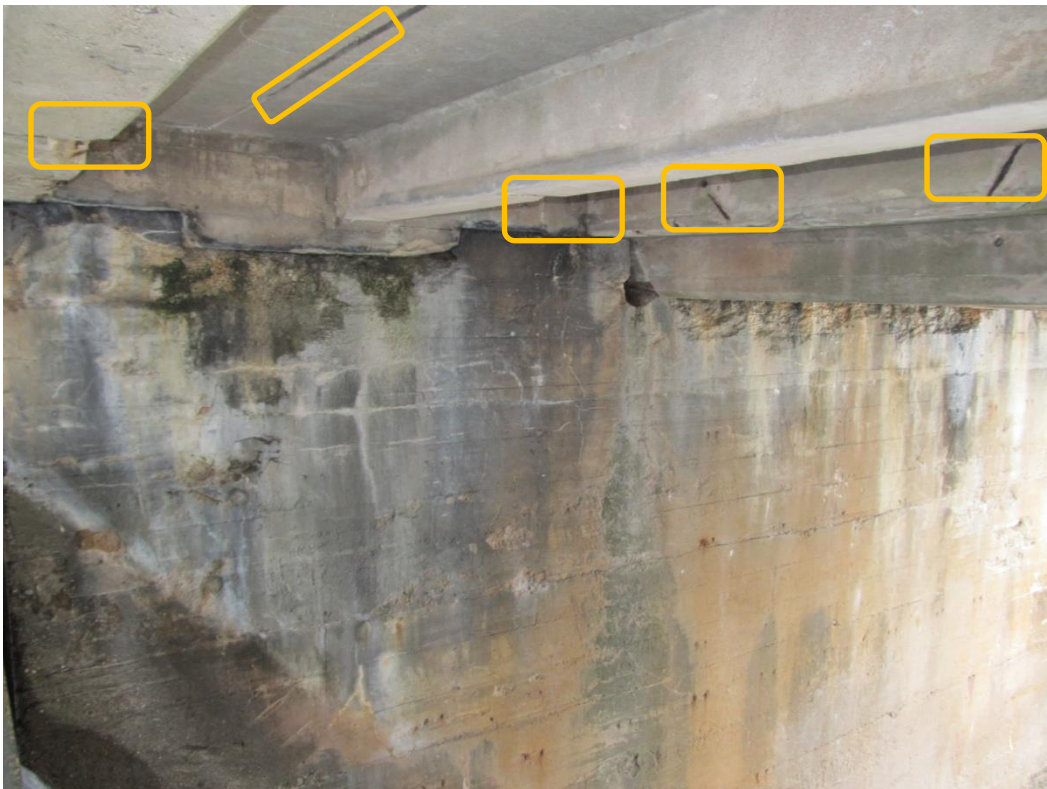
Photo 8: Under-deck concrete in good condition at sluice 2, except for a few apparent stirrups

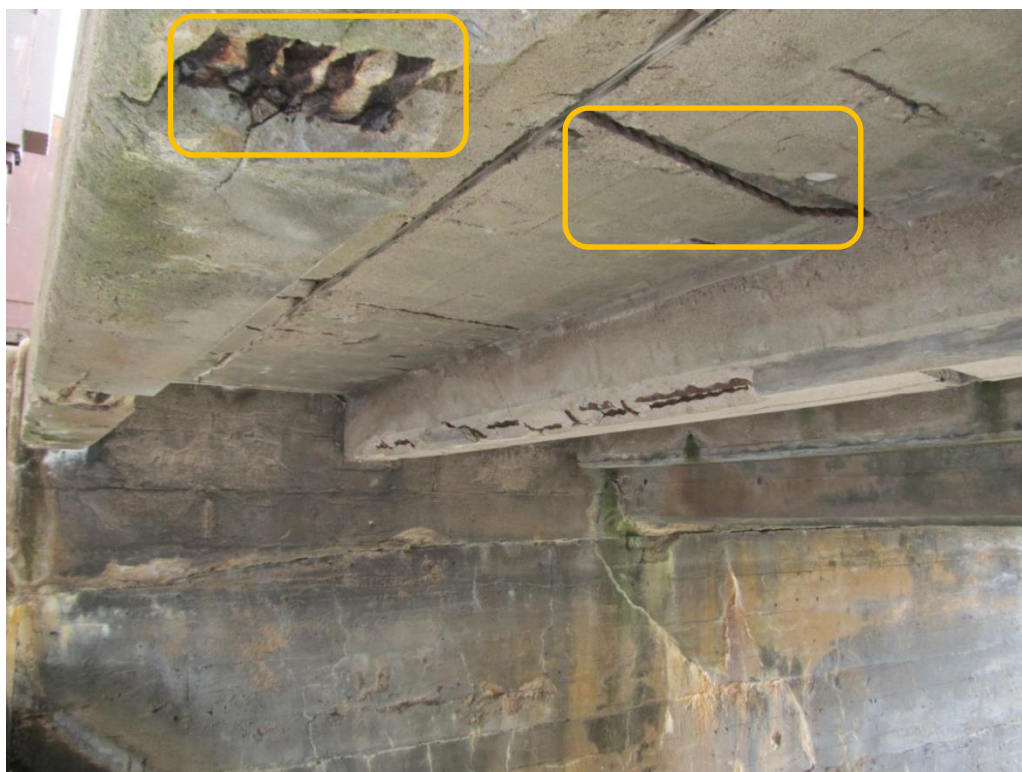
Photo 9: Apparent rusted rebar at sluice 3 under-deck

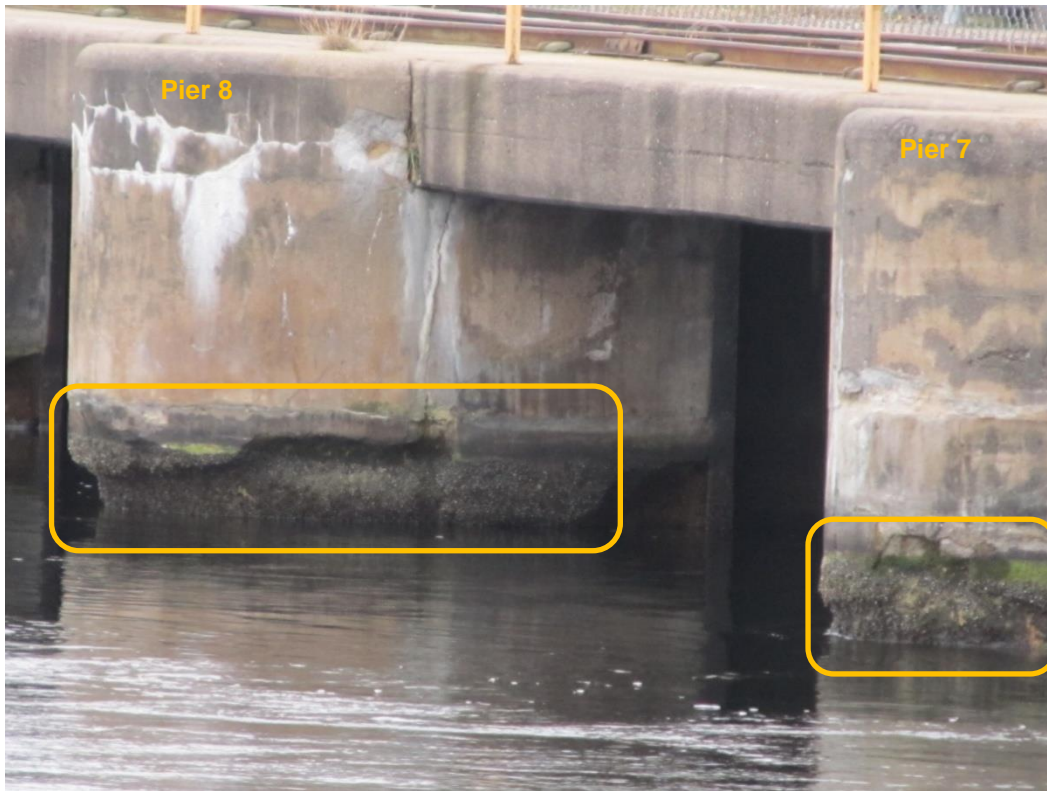
Photo 11: Deteriorated concrete at the piers 7 and 8

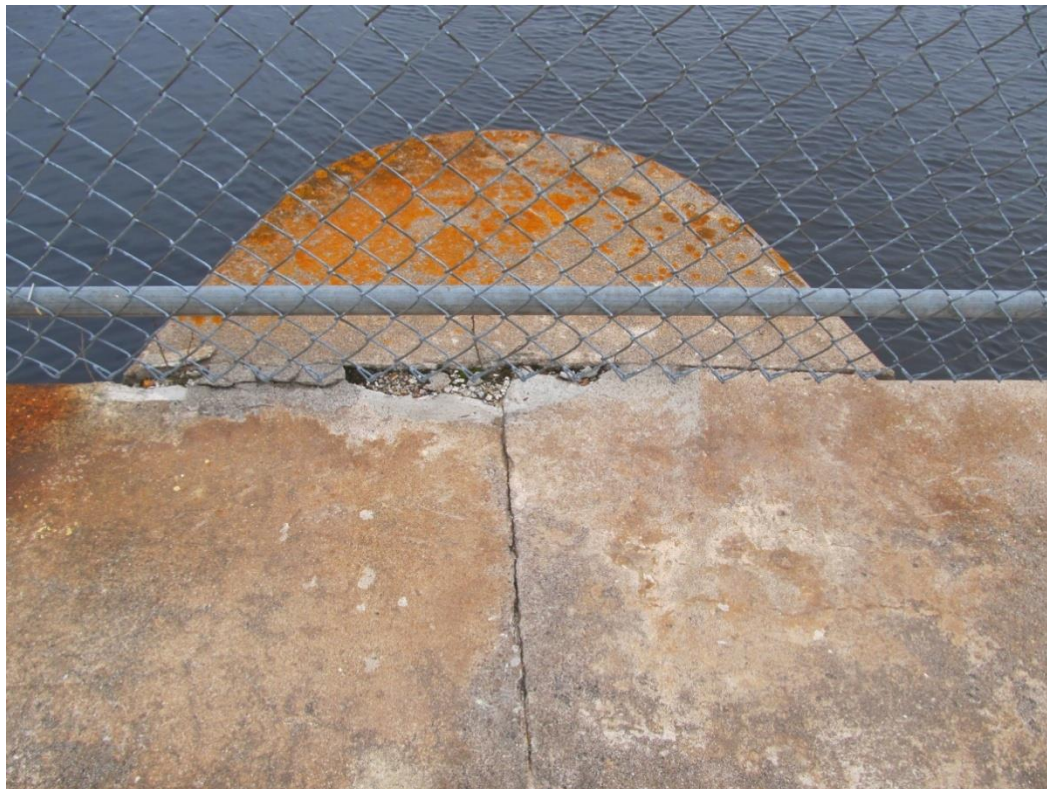
Photo 12: Crack at the nose of pier 2

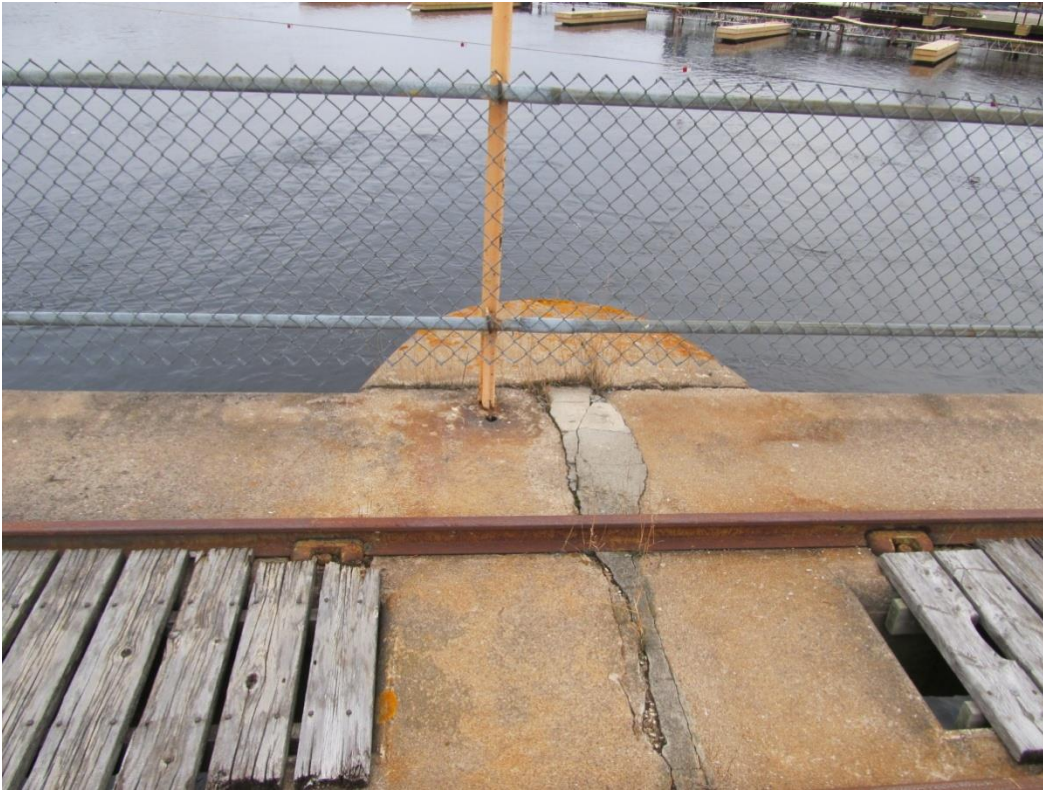
Photo 13: Crack at the nose of pier 7

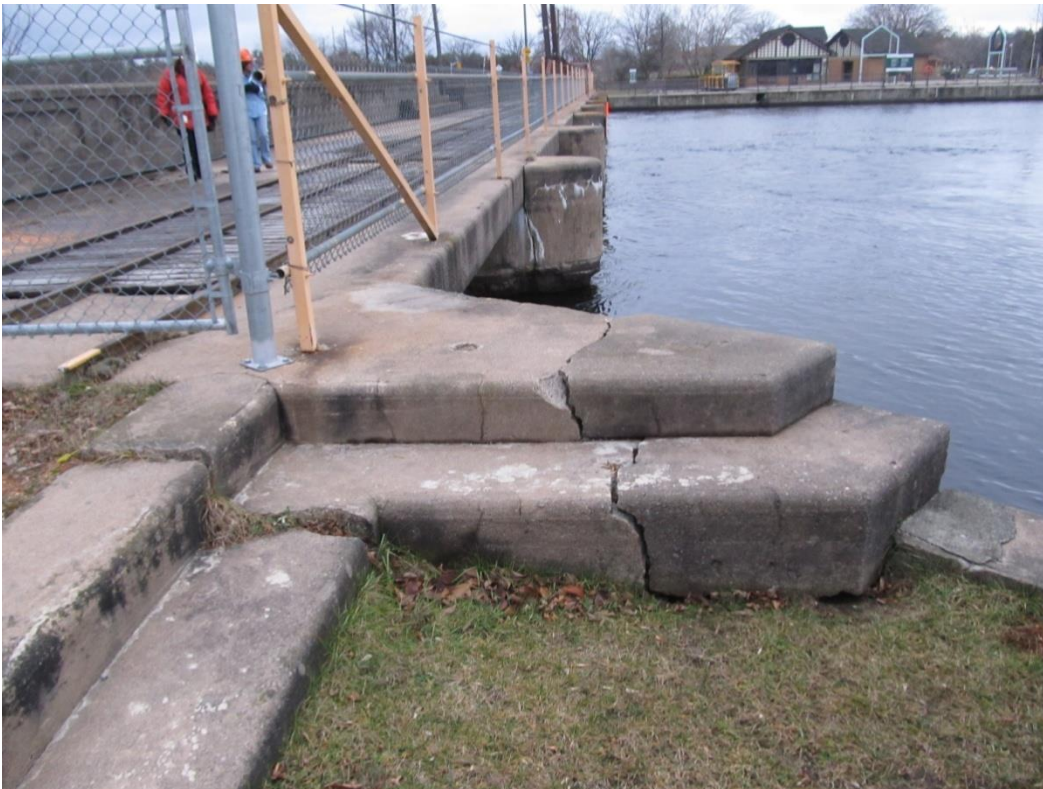
Photo 14: Large crack on left bank abutment

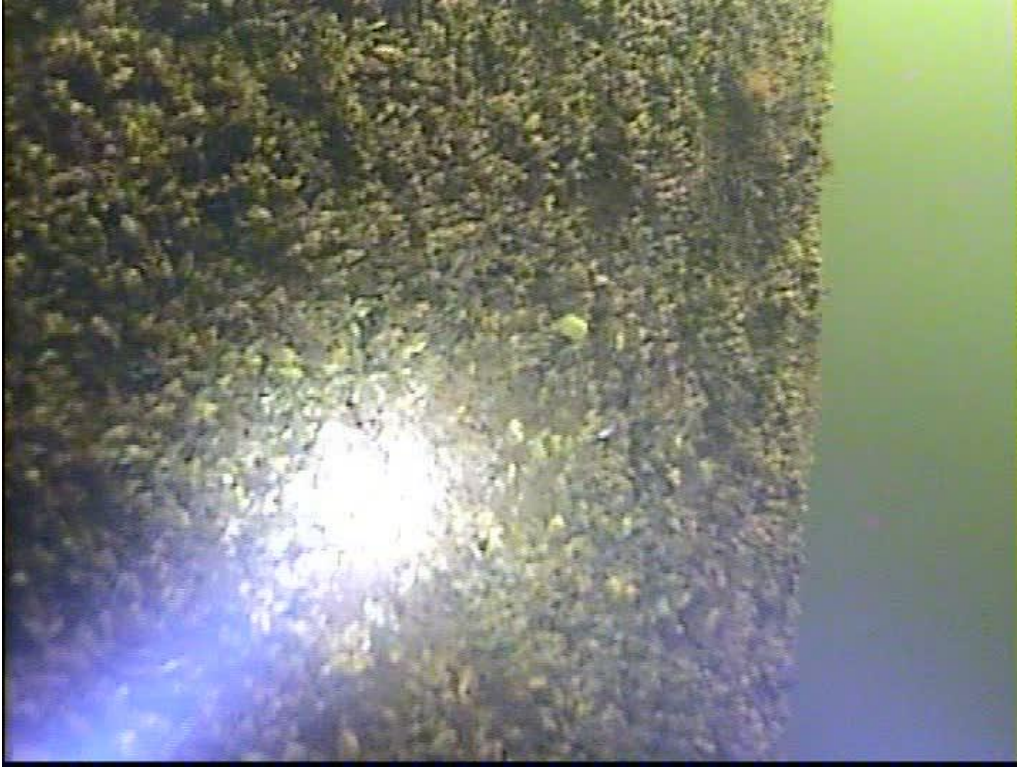
Photo 15: Zebra mussels on concrete surface

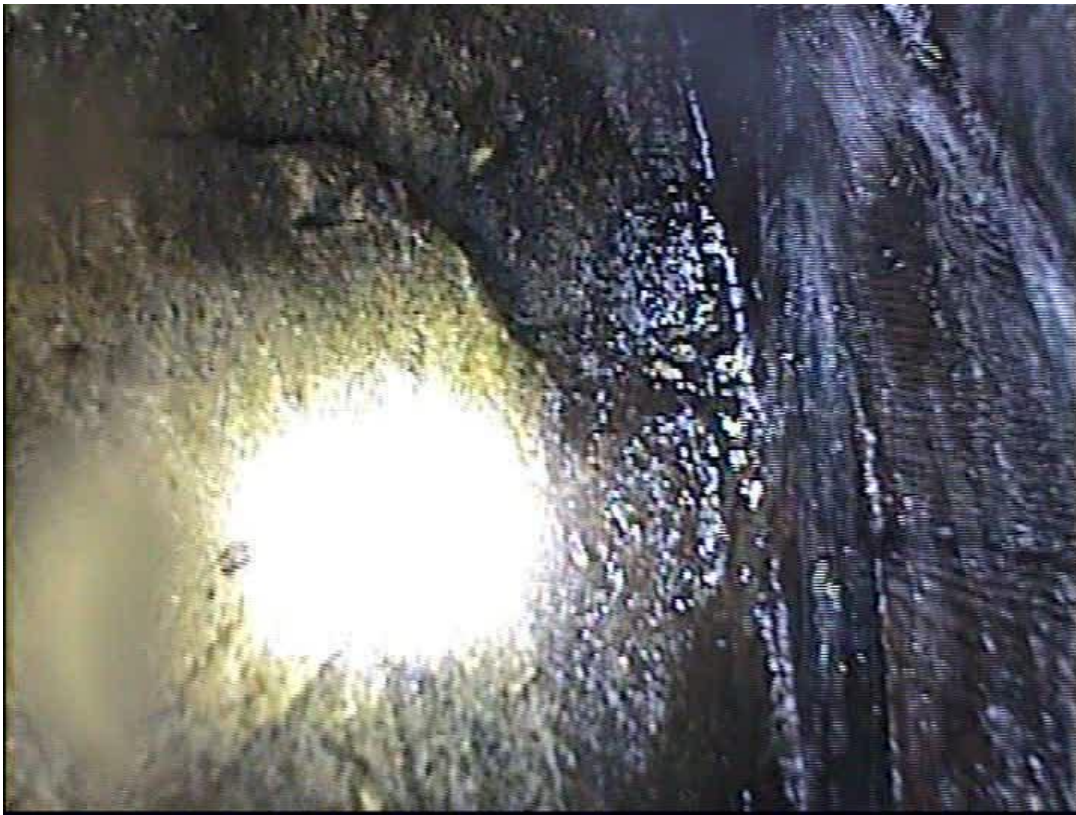
Photo 16: Left side of pier 2, with deteriorated concrete

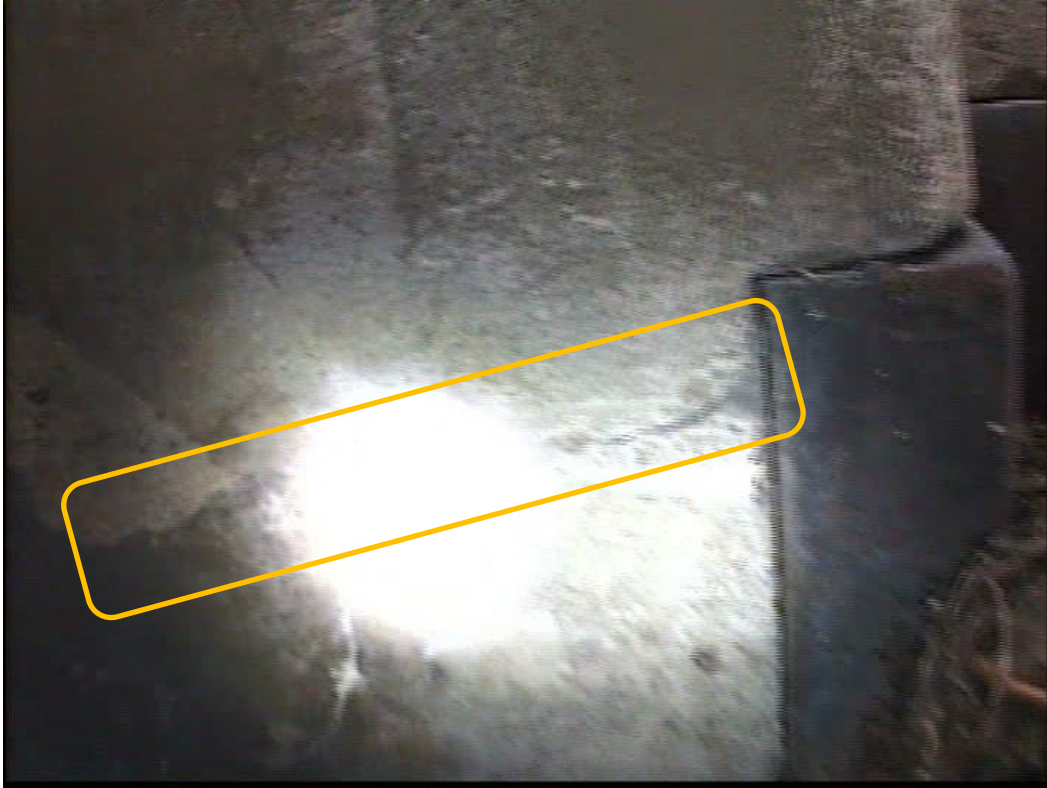
Photo 17: Open construction joint on the left side of pier no. 2

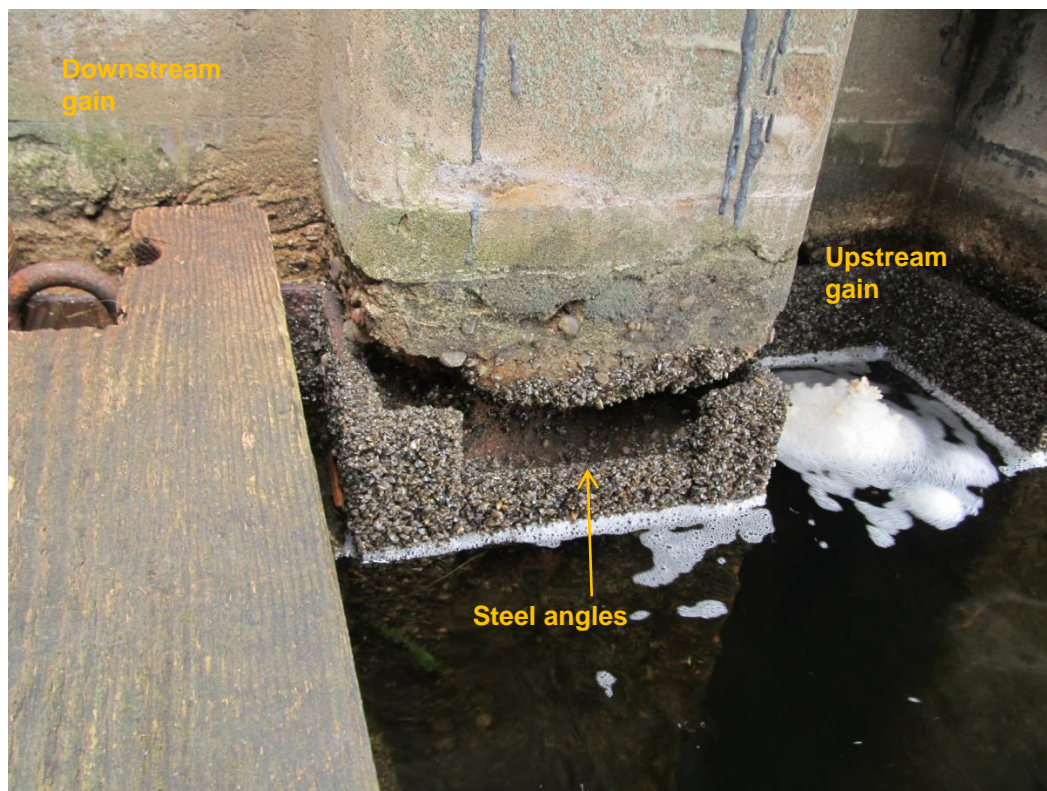
Photo 23: Extensively damaged concrete at junction with embedded steel angles covered in zebra mussels

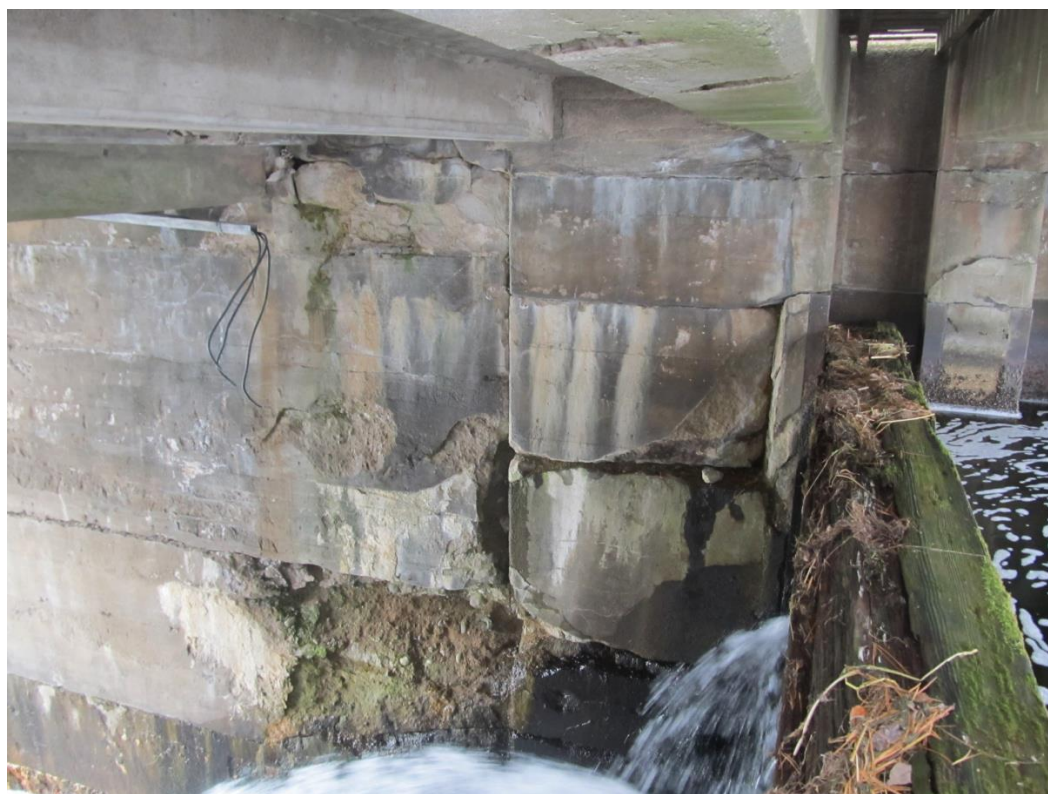
Photo 24: Secondary concrete losing its integrity

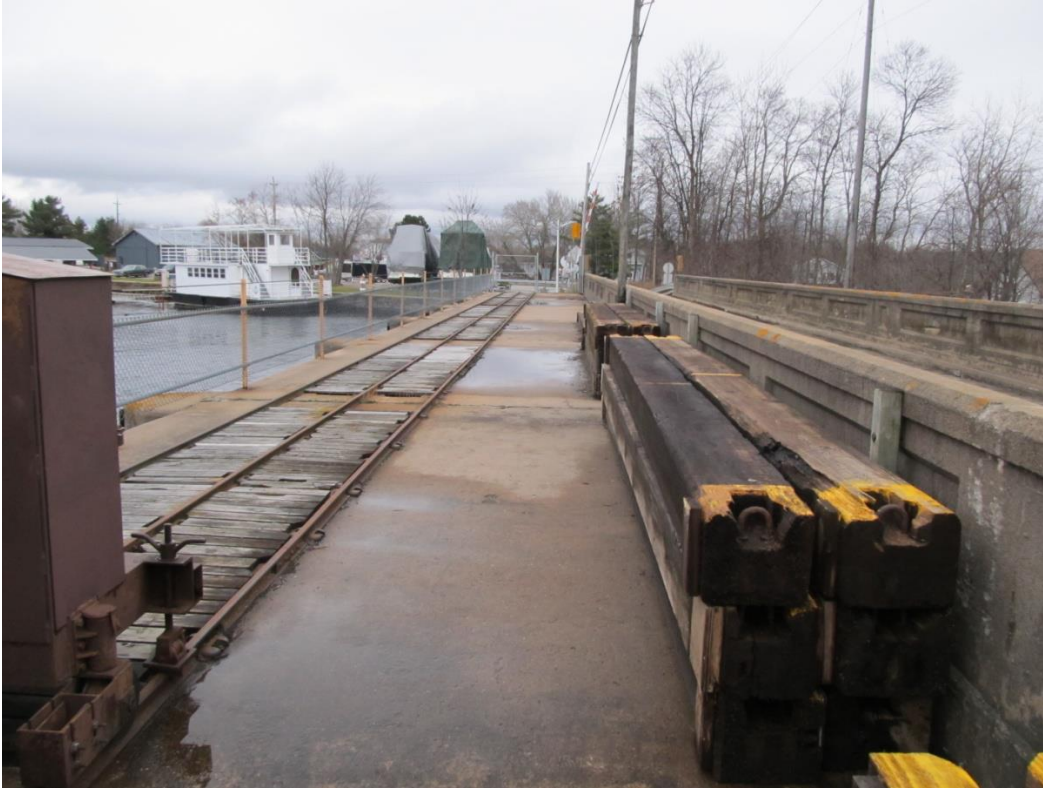
Photo 25: Unlocked wooden gain covers (covers in good condition)

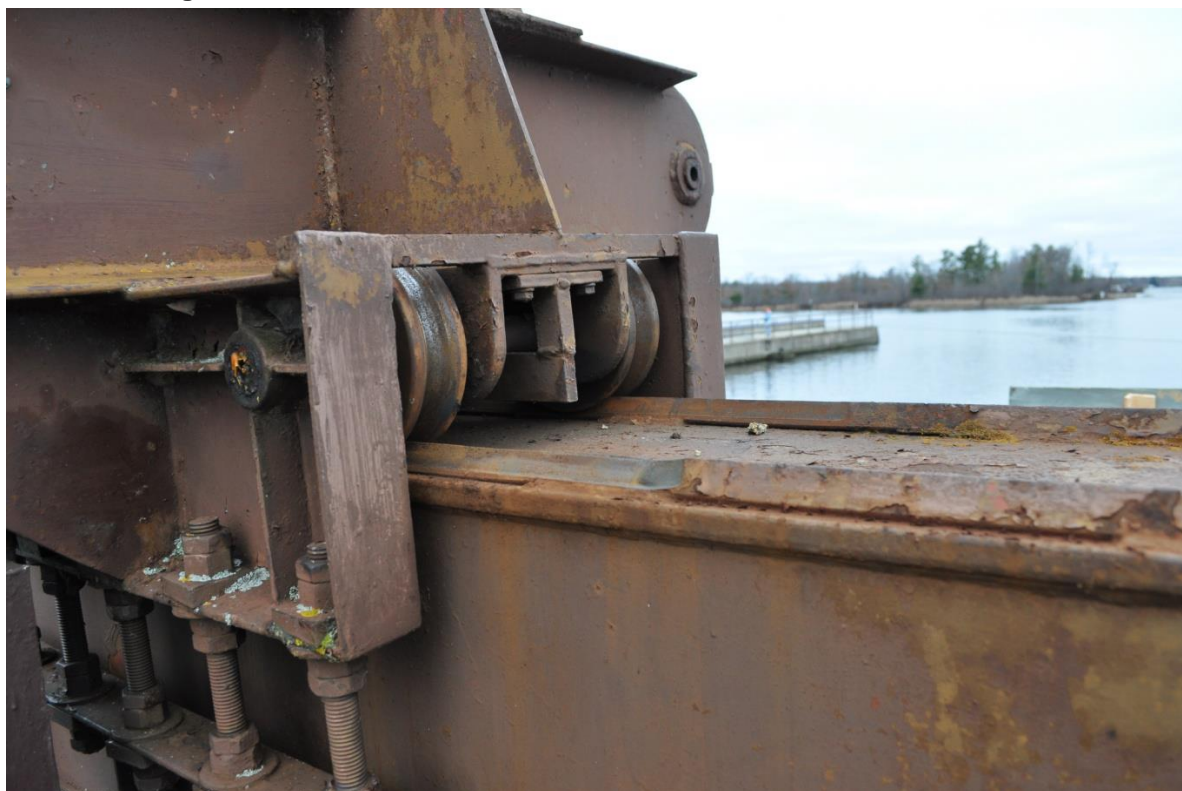
Photo 30: Sideway adjusting rails in poor condition

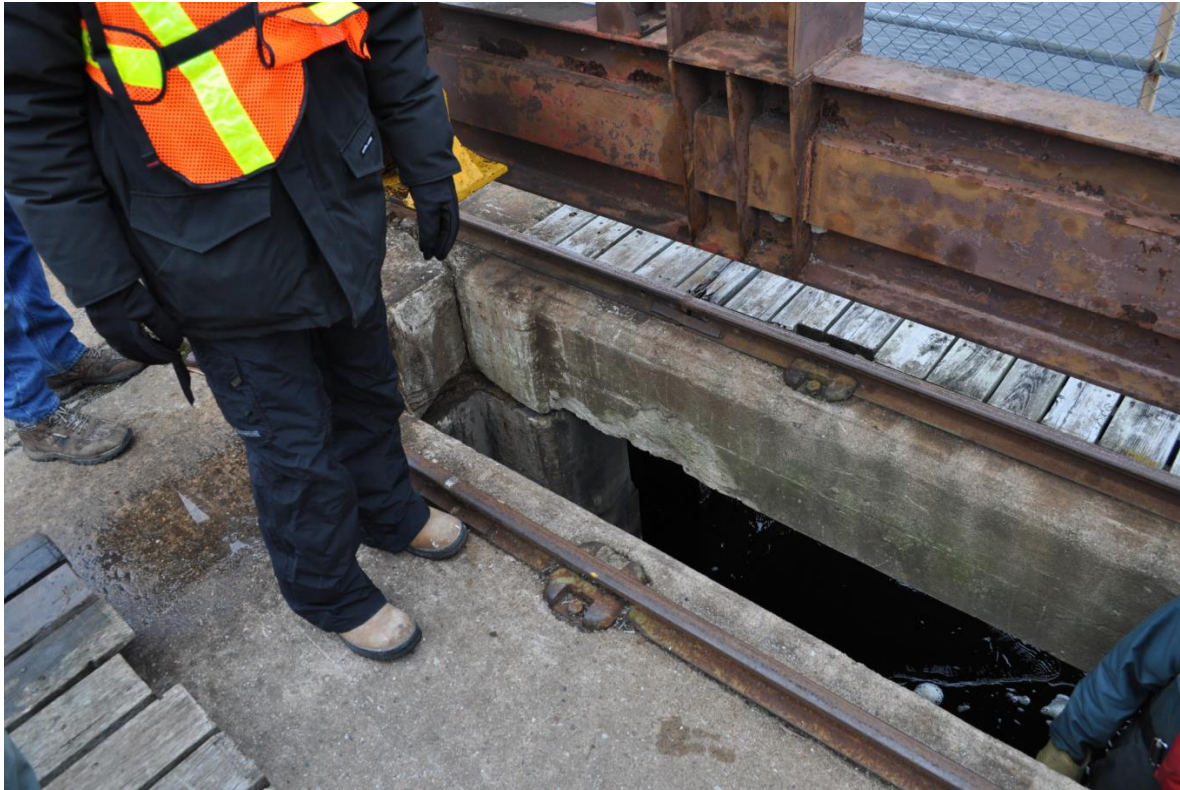
Photo 31: Used rails and damaged concrete due to “jacking”

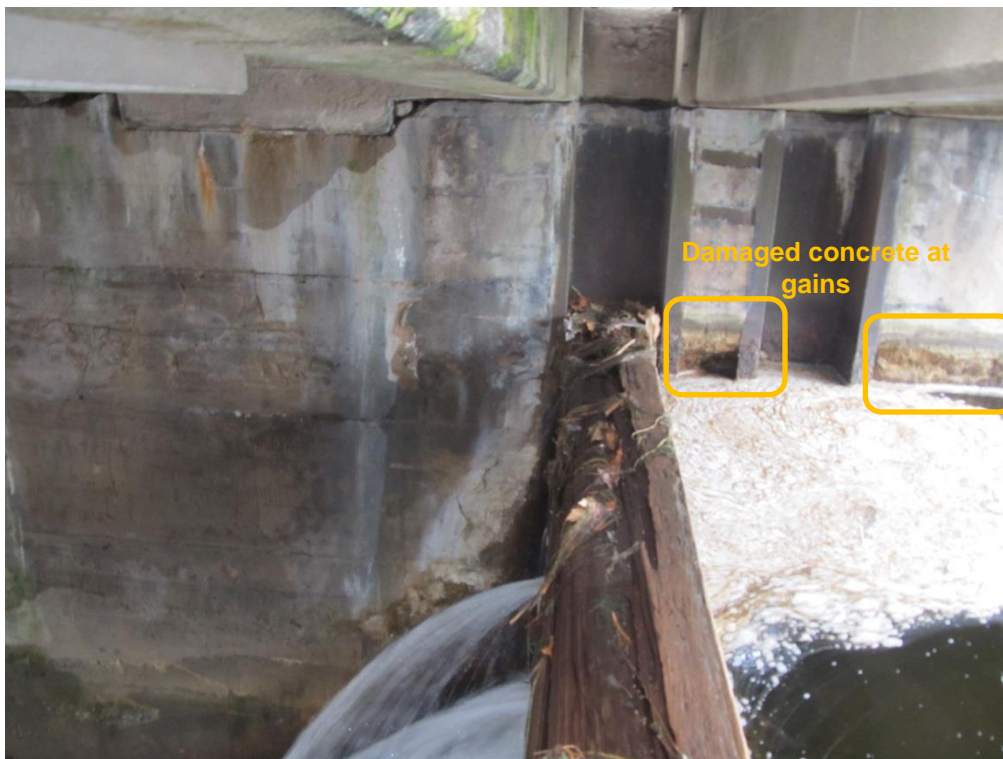
Photo 40: Leakage through a damaged stop log

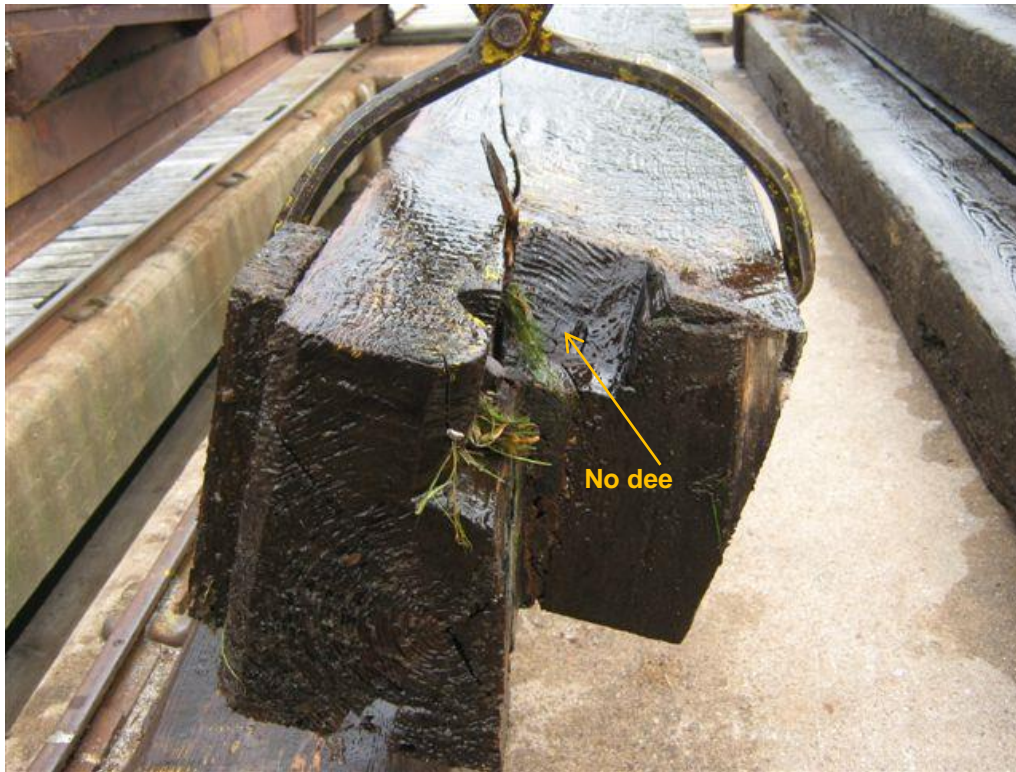
Photo 43: Use of tongs to remove a log with a broken dee

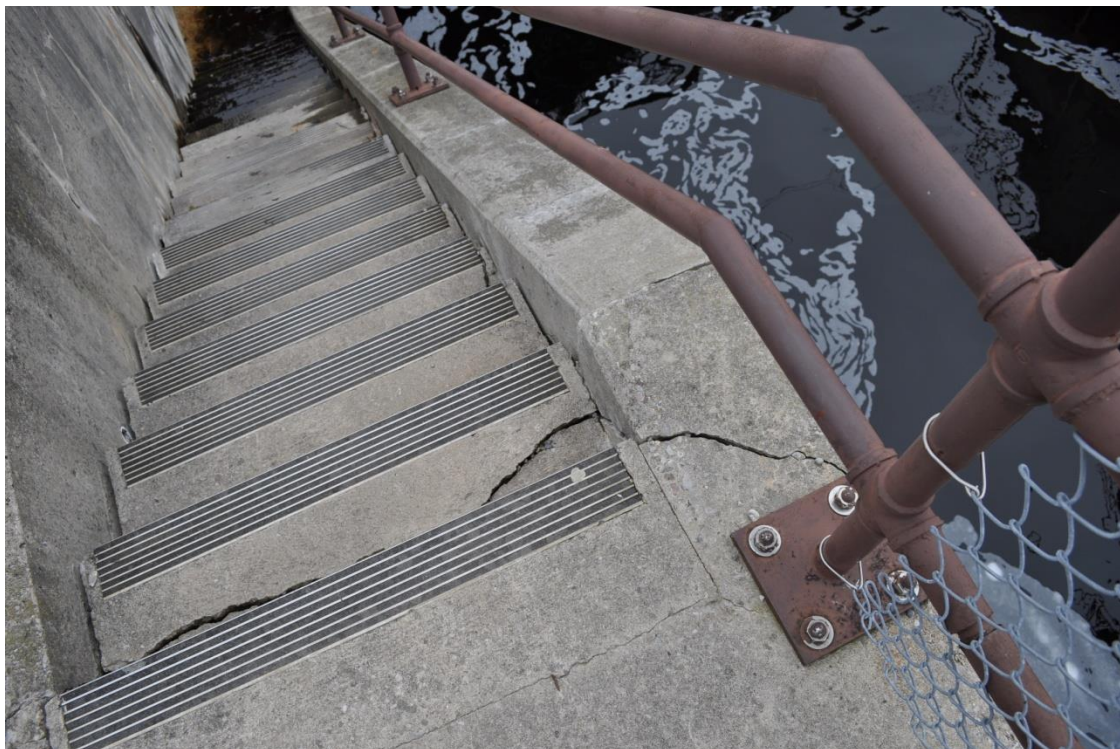
Photo 2: Crack at the top of the stairs

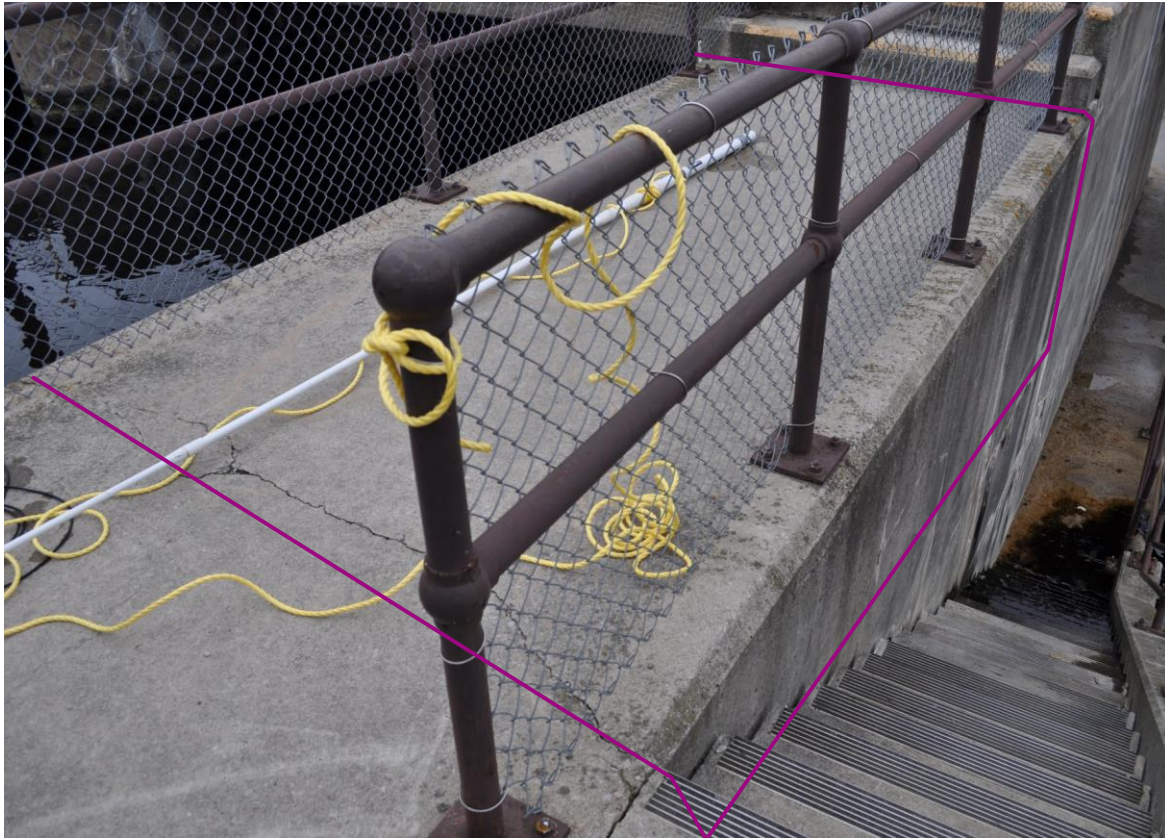
Photo 2a: System of cracks and joints at the top of the stairs

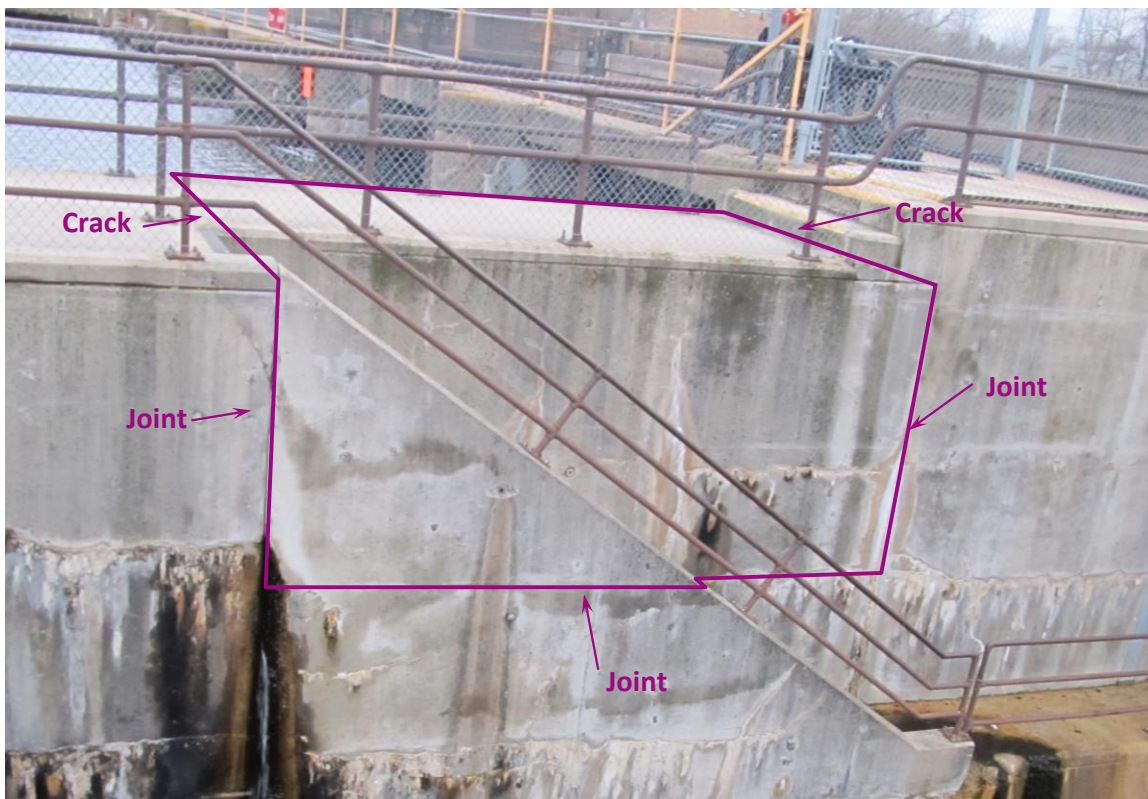
Photo 2b: System of cracks and joints at the top of the stairs

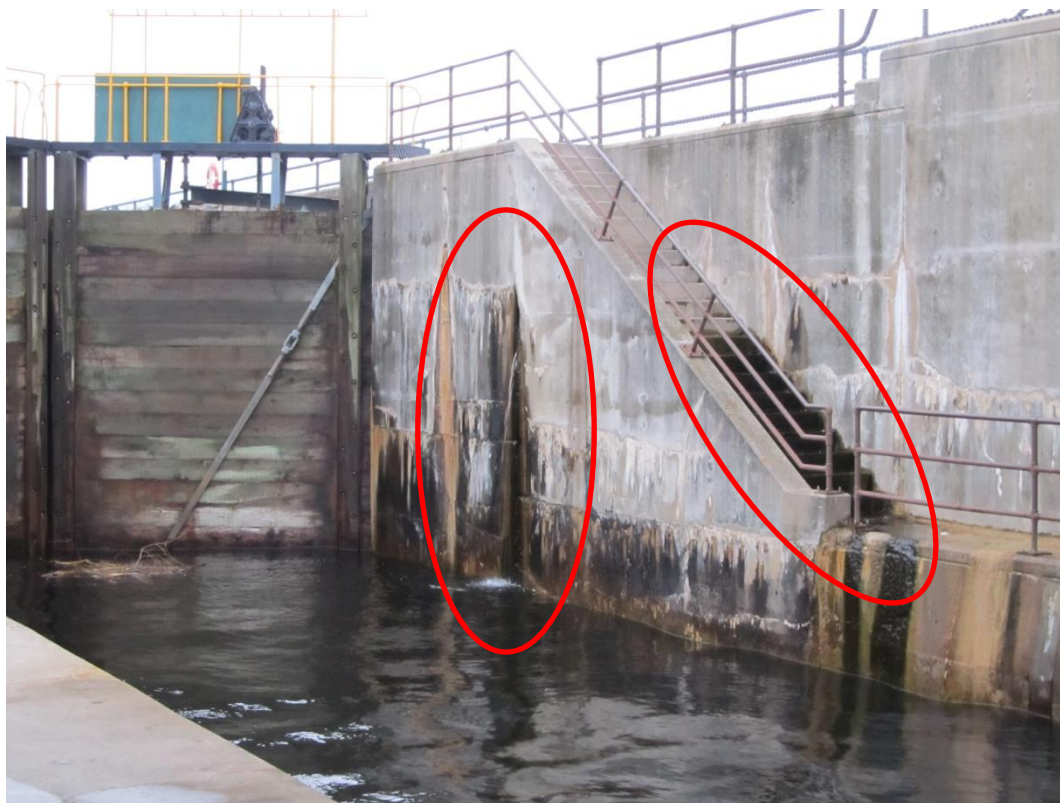
Photo 3: Left wall and leaking crack

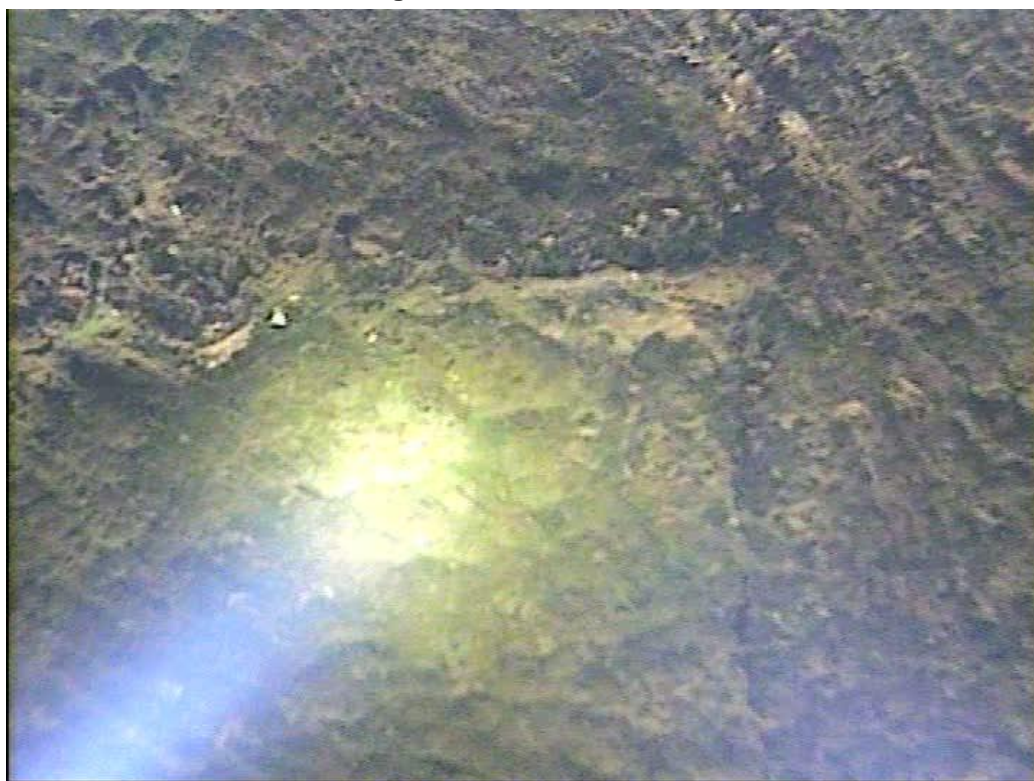
Photo 4: Junction of horizontal and vertical open construction joints on dam side of left lock wall

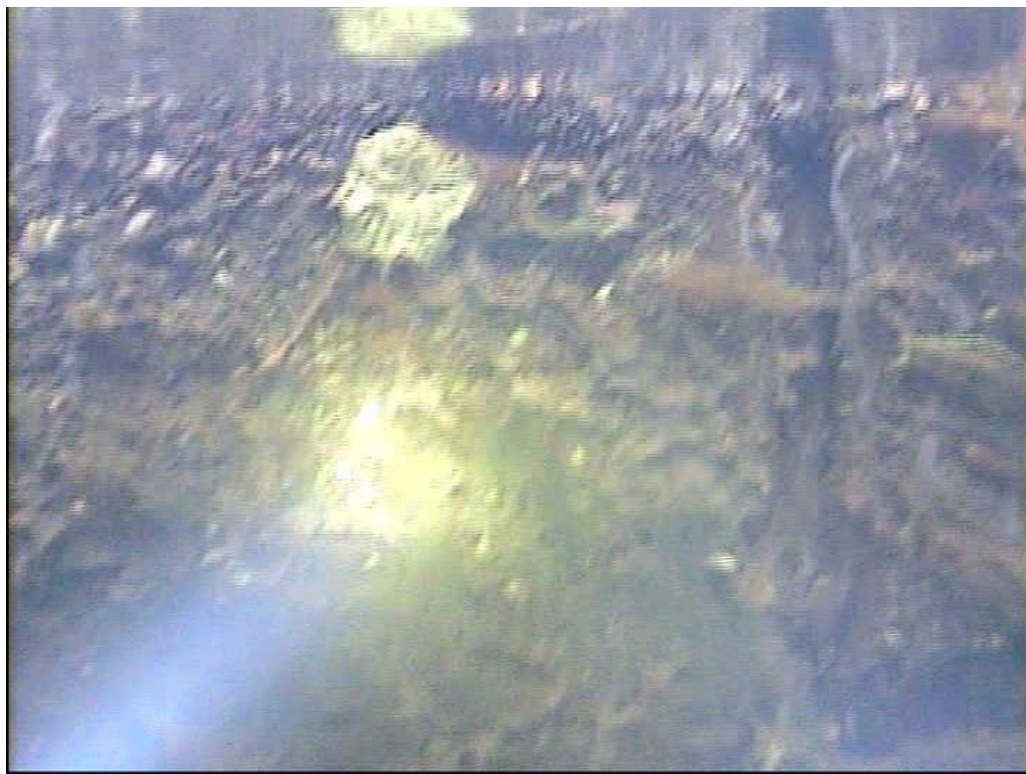
Photo 5: Vertical crack under water (open construction joint) on dam side of left lock wall
