Project No.: R.051116.002

December 2013

Dam Safety Reviews: Port Severn Dams Main Dam, Lock 45, Upstream Shoreline Wall and Dam D

**Dam Safety Review Report
Final**

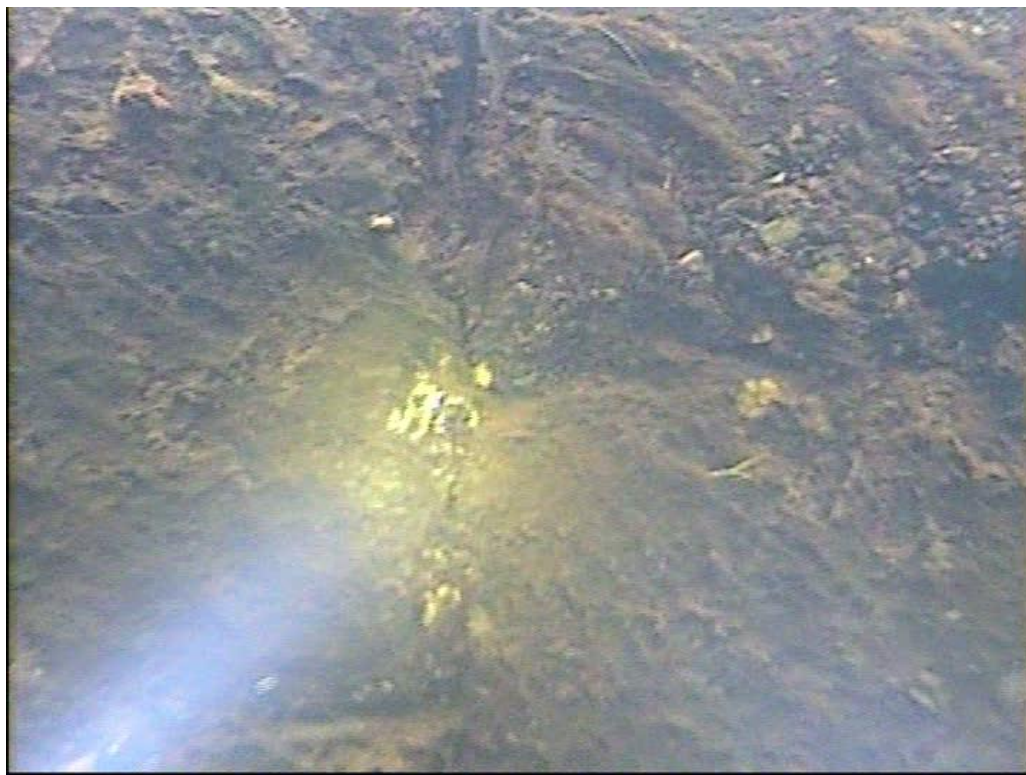
Photo 6: Vertical crack (open construction joint) on dam side of left lock wall

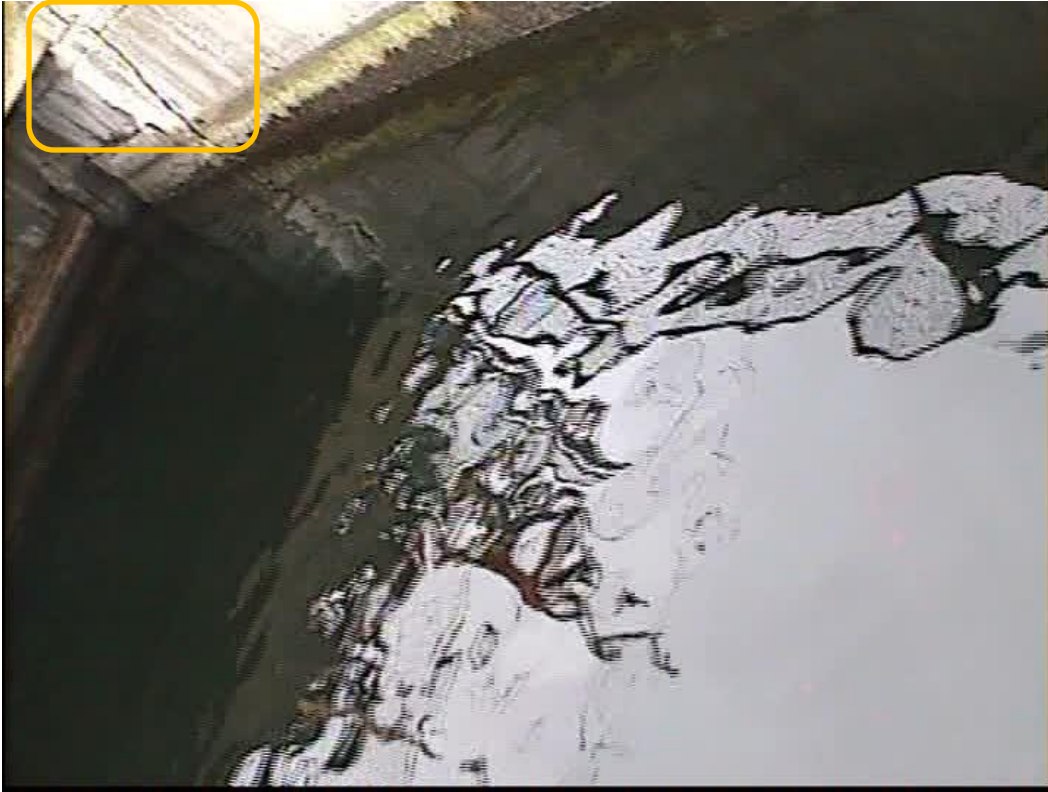
Photo 7: Large vertical crack at junction with Main Dam on reservoir side

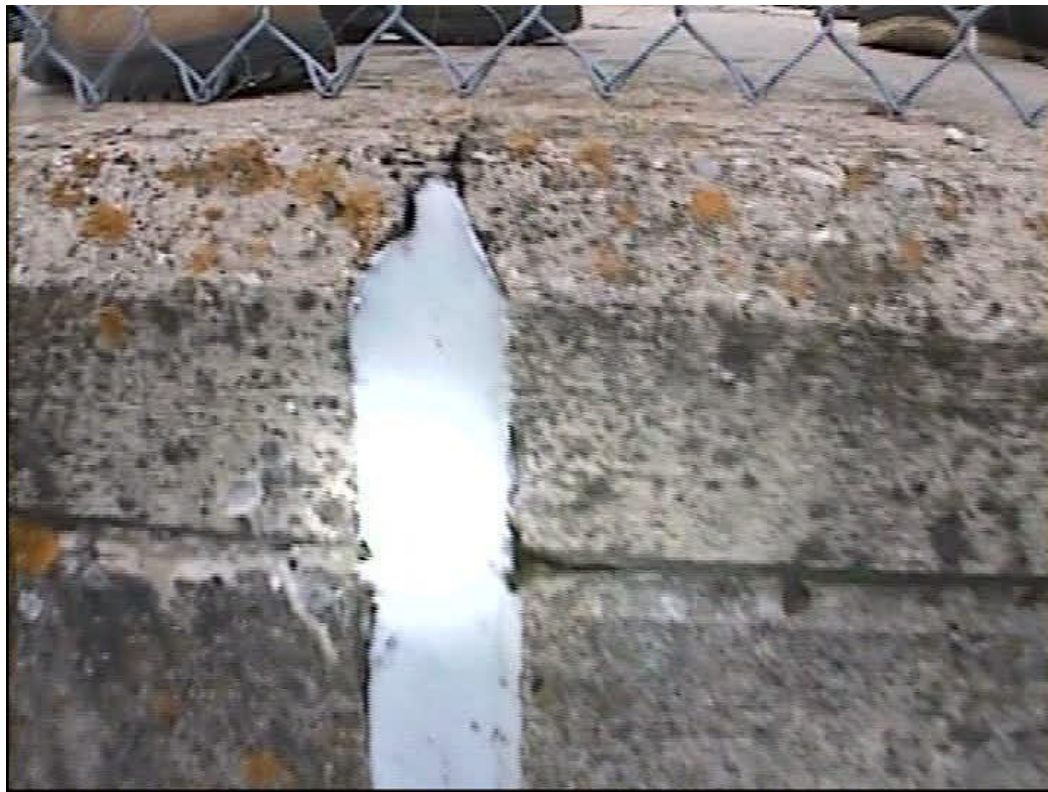
Photo 8: Caulked vertical crack at slab level

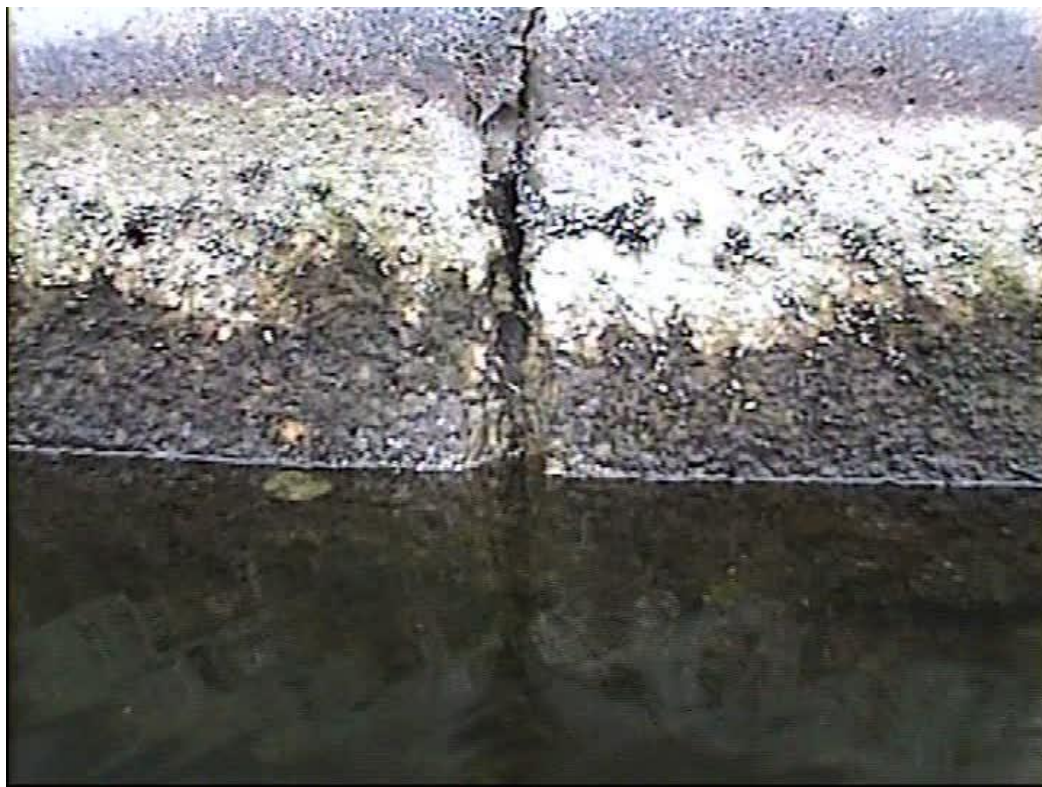
Photo 9: Vertical crack at water level on reservoir side (open construction joint)

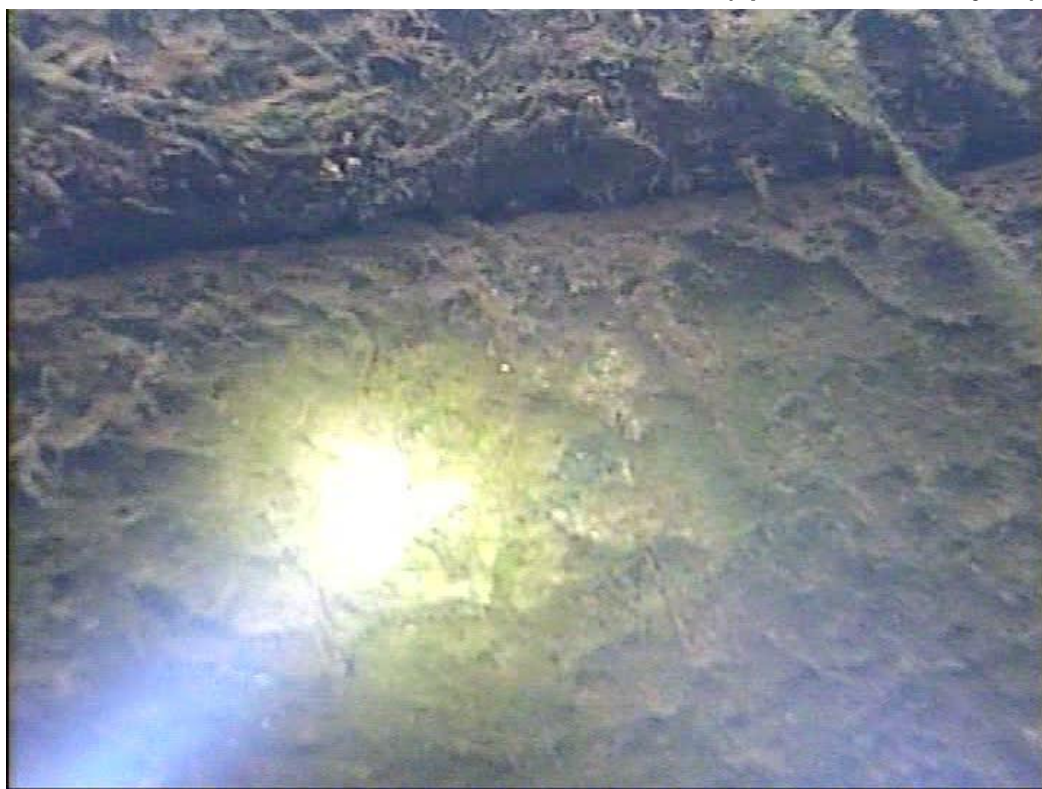
Photo 10: Open horizontal open construction joint dam side of left lock wall

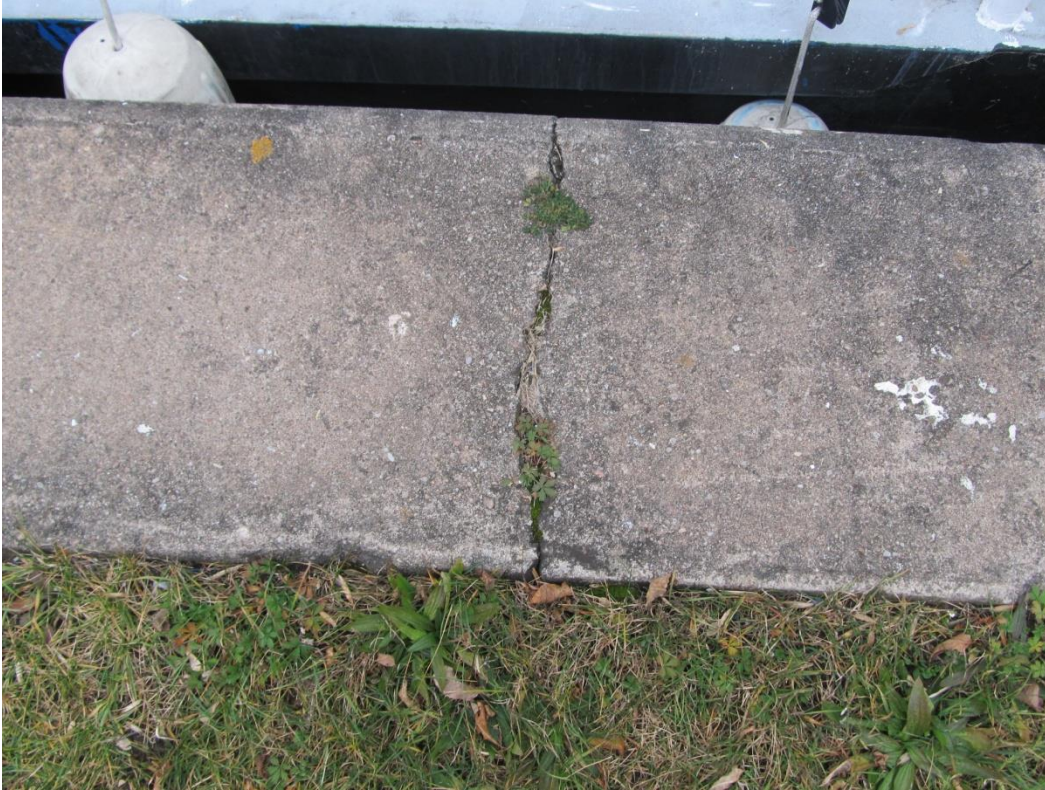
Photo 1: Minor crack on wall

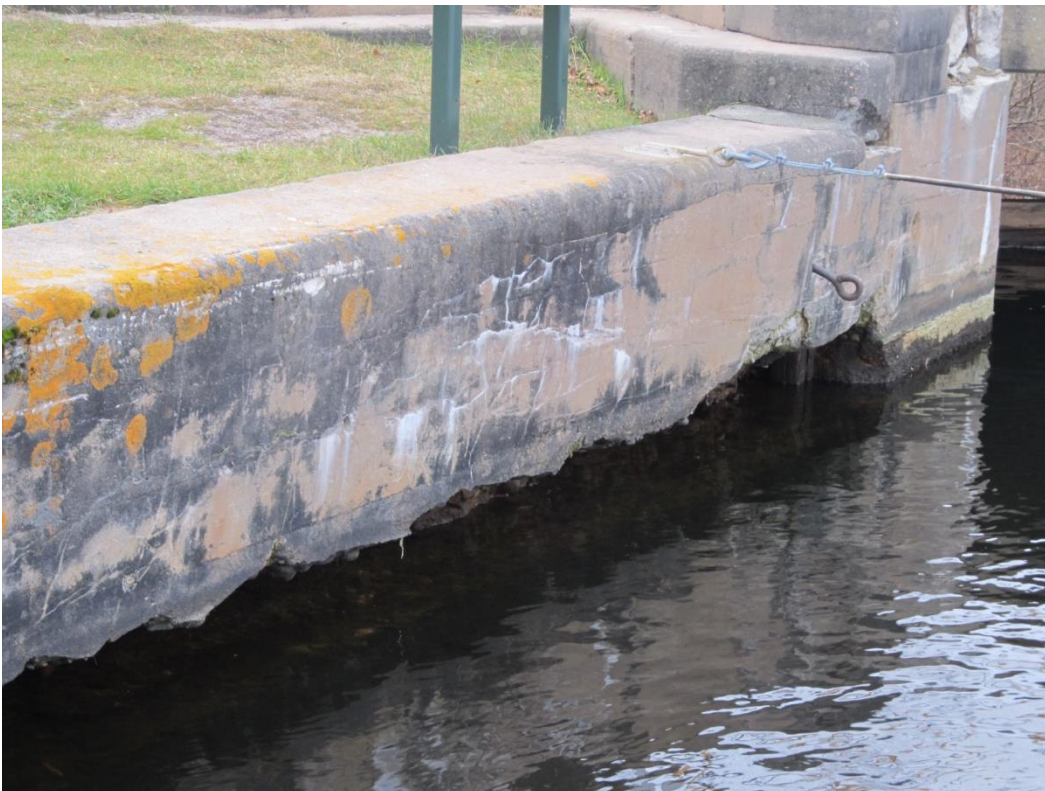
Photo 2: Detached pieces of concrete in the drawdown zone

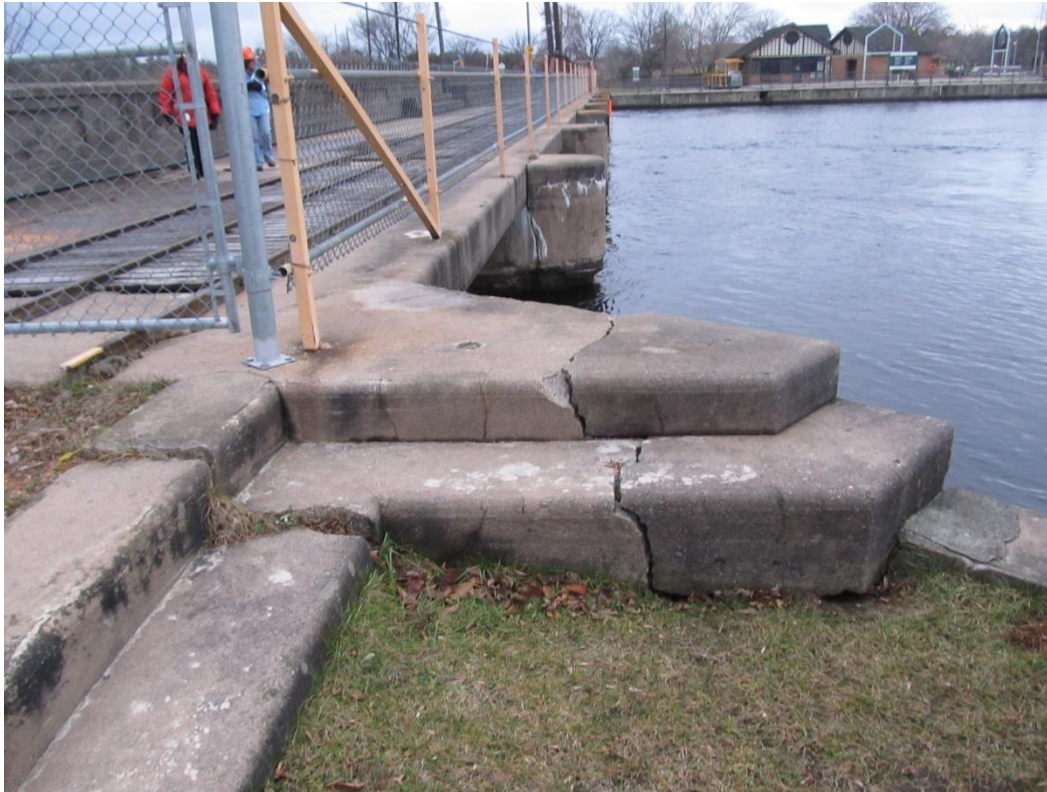
Photo 3: Large cracks at junction with Main Dam

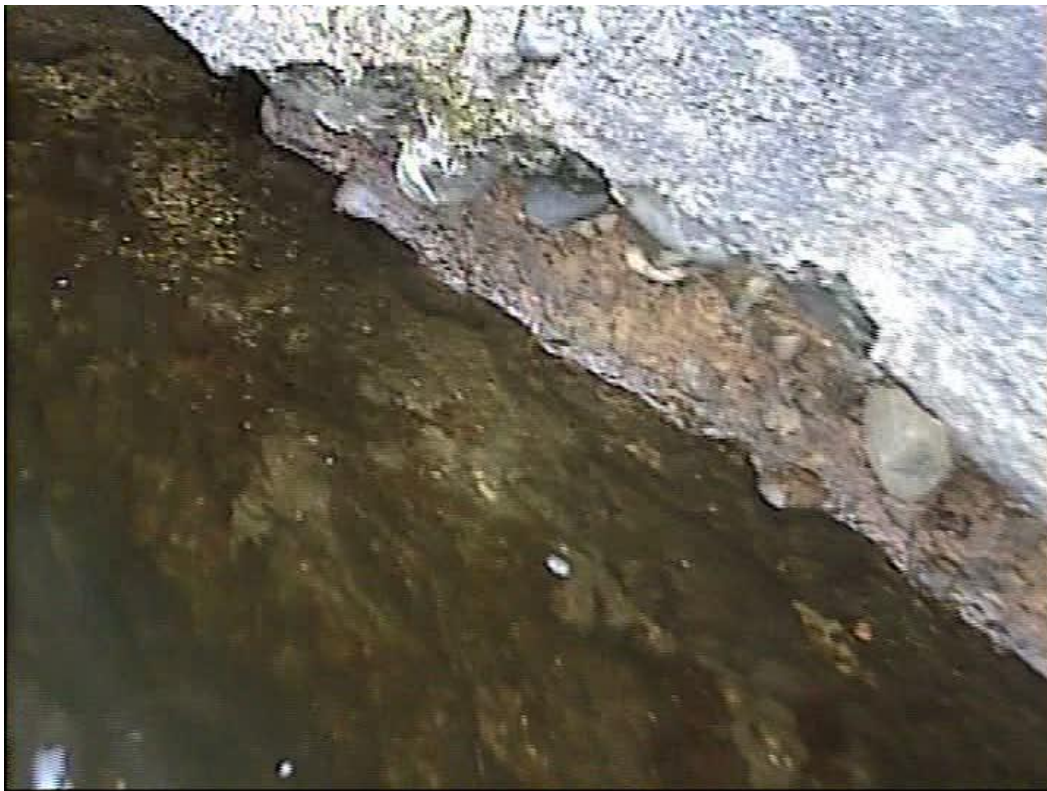
Photo 4: Degradation of submerged concrete

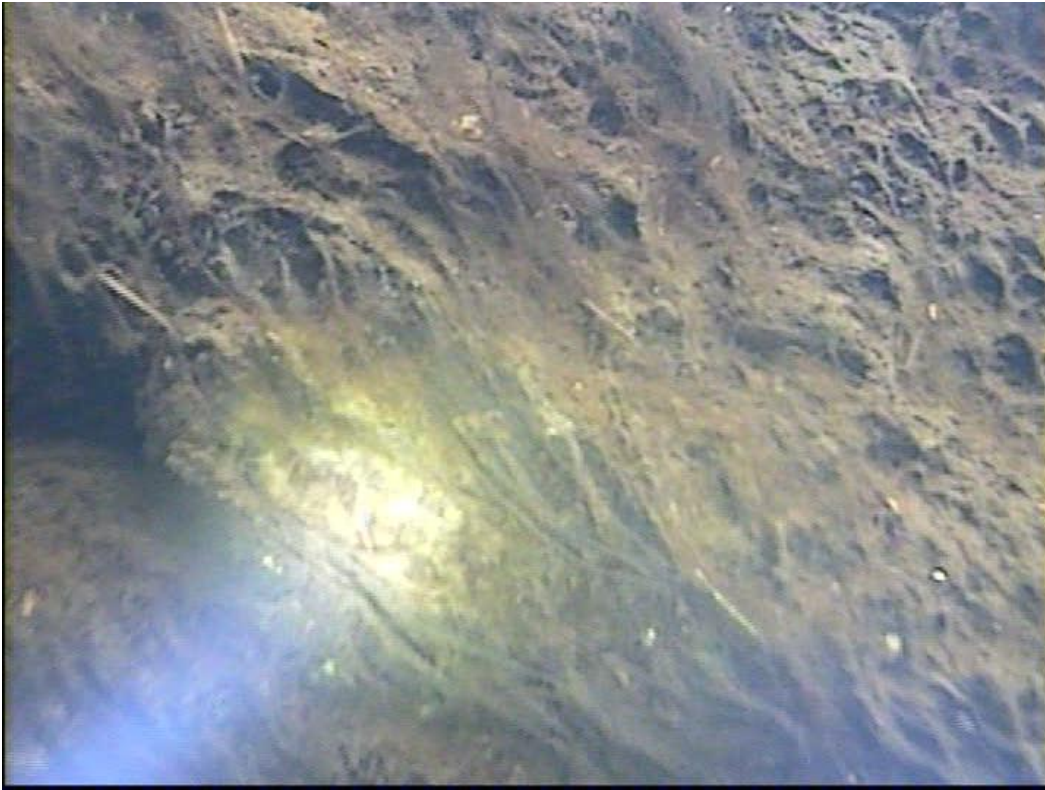
Photo 5: Presence of algae on submerged concrete

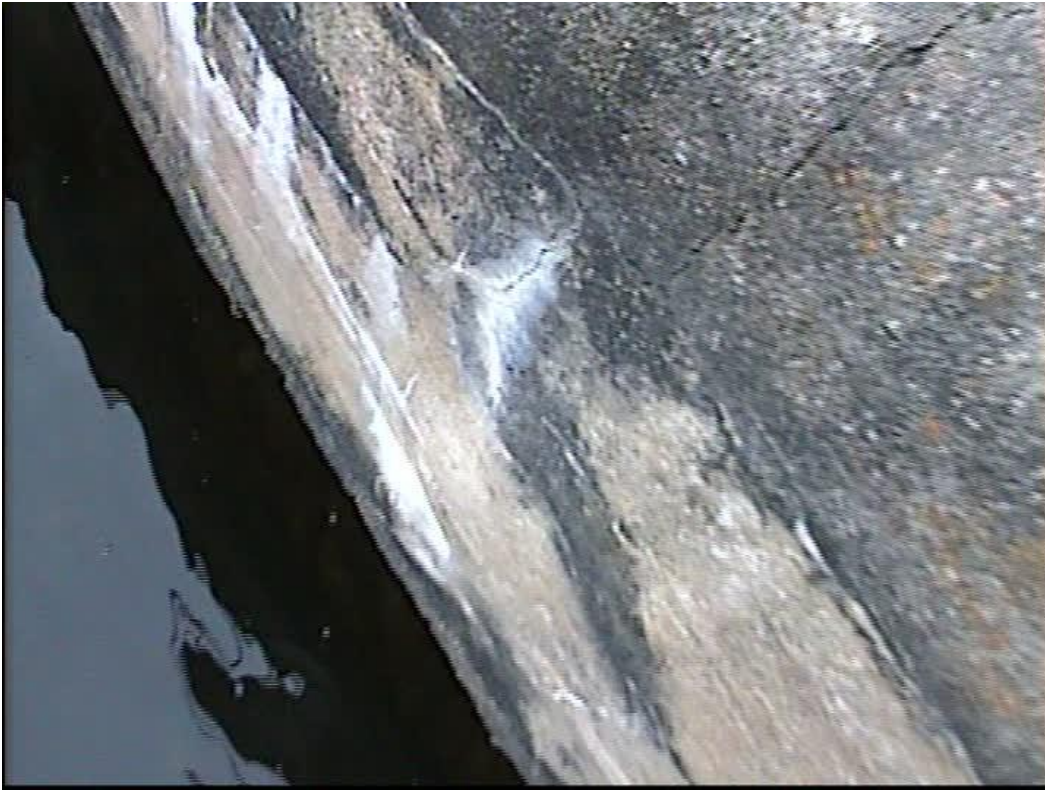
Photo 7: Small cracks and minor efflorescence on concrete

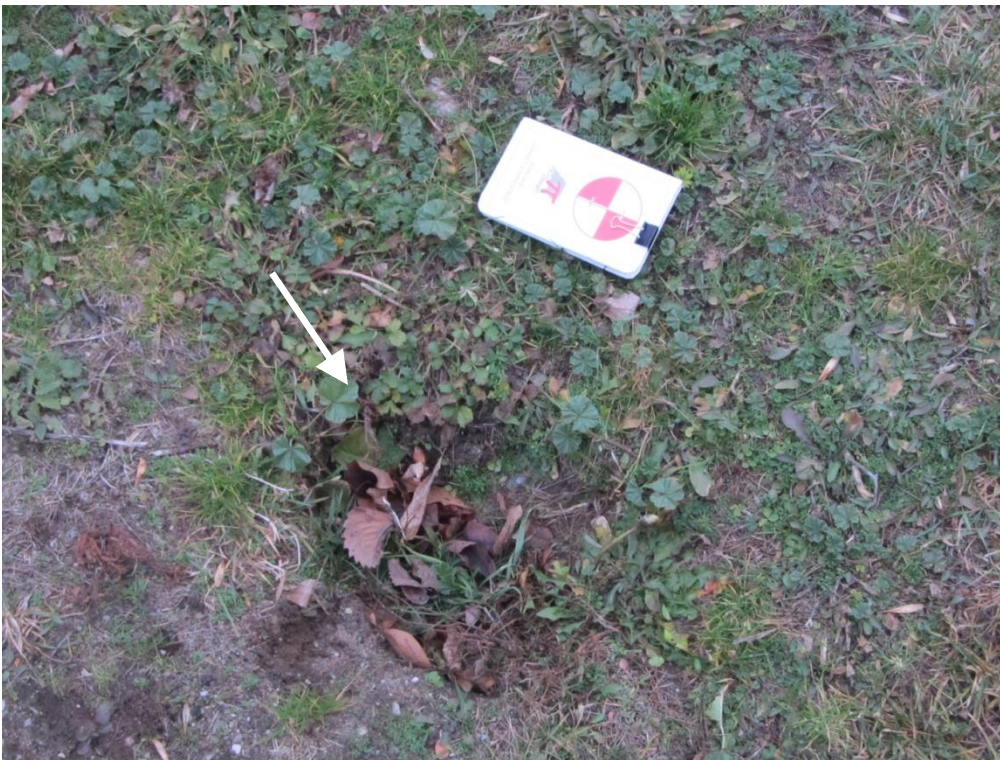
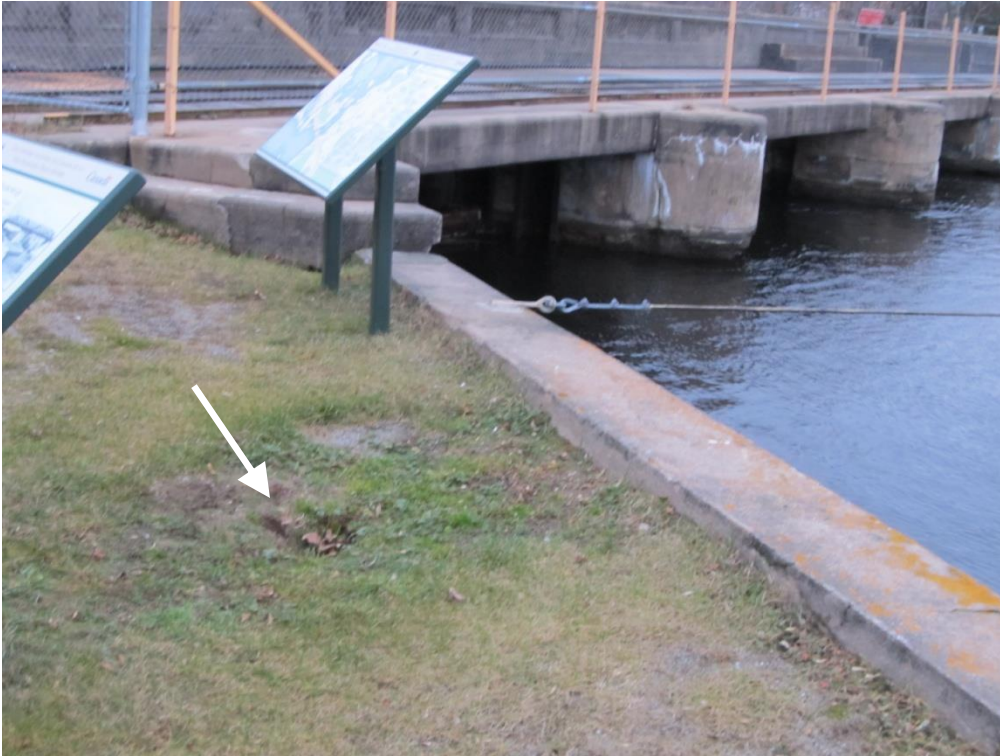
Photo 8: Sinkhole #1 observed near Dam D

Photo 9: Sinkhole #1 observed near Dam D

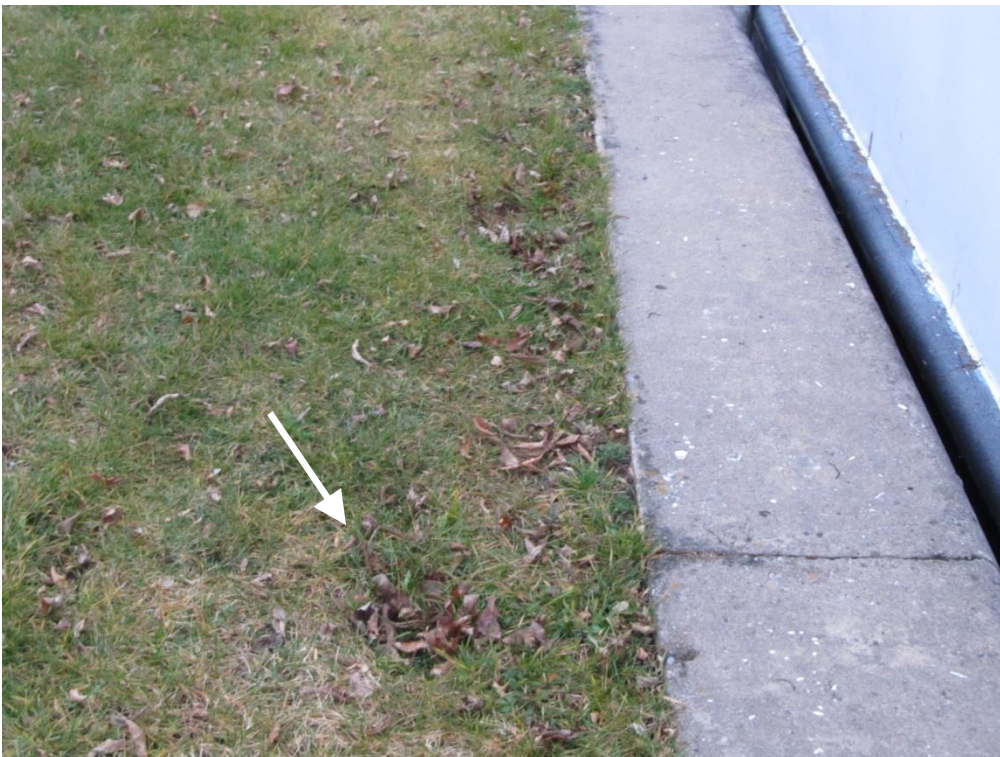
Photo 10: Sinkhole #2 observed near Dam D

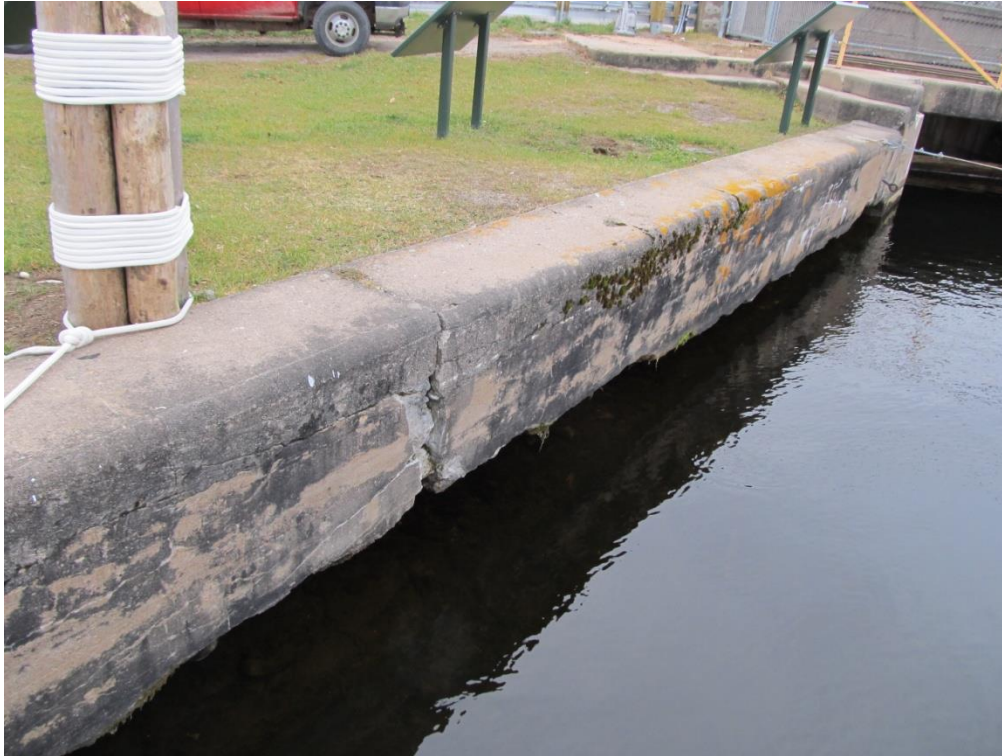
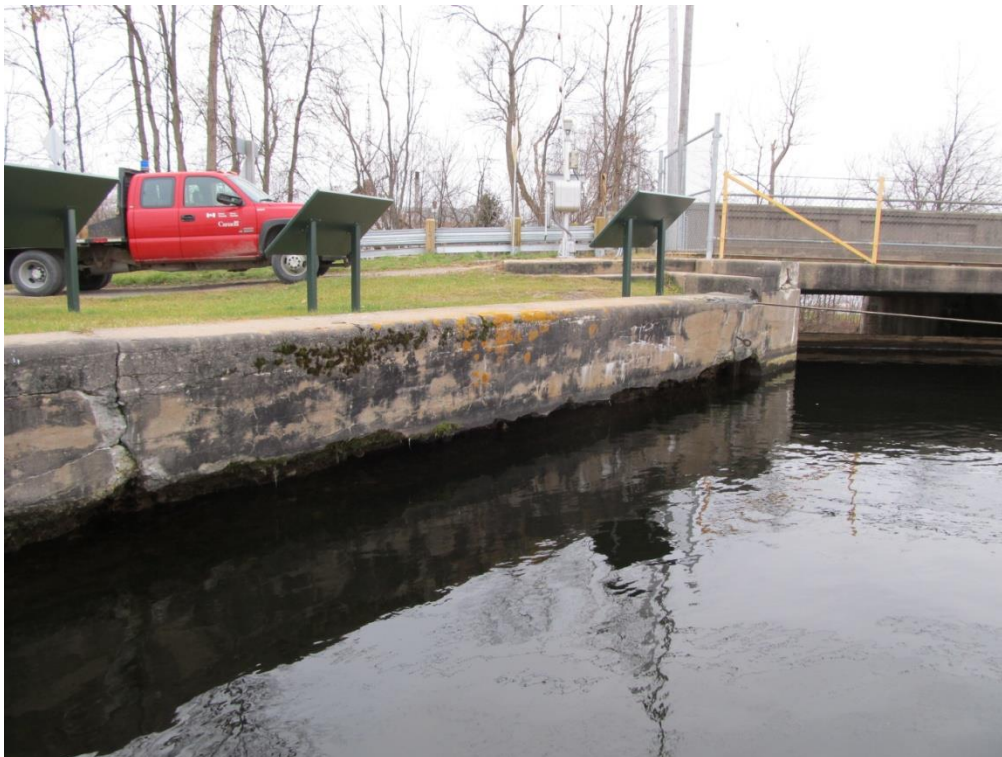
Photo 11: Upstream view of concrete deterioration of Dam D

Photo 12: Upstream view of concrete deterioration of Dam D

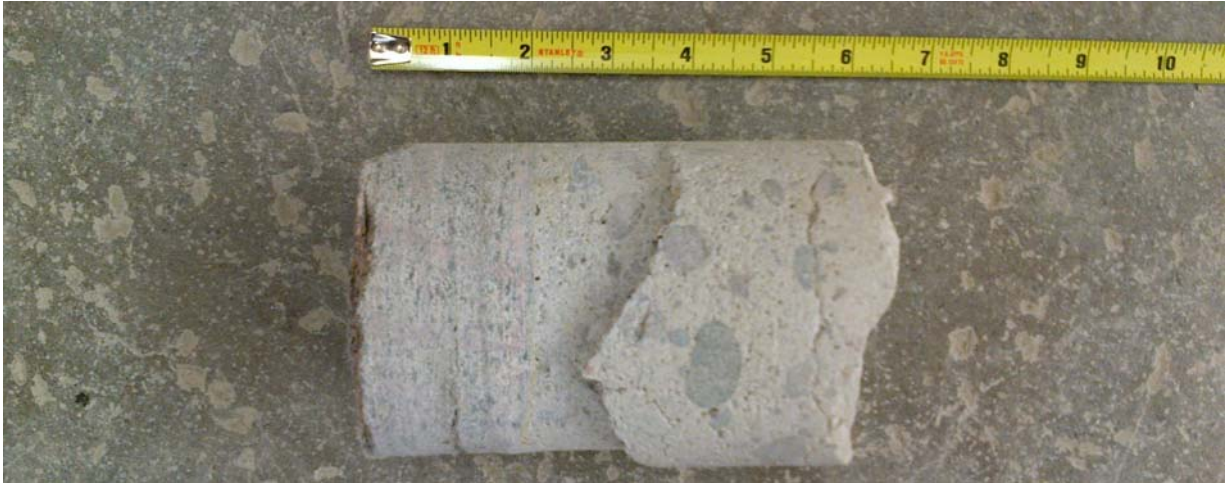
Picture 4: Dam C: Last section of 100mm diameter concrete core at 550mm depth Corehole CH-C03. A 50mm portion of Schist cobble shown, pyrite present along fracture.

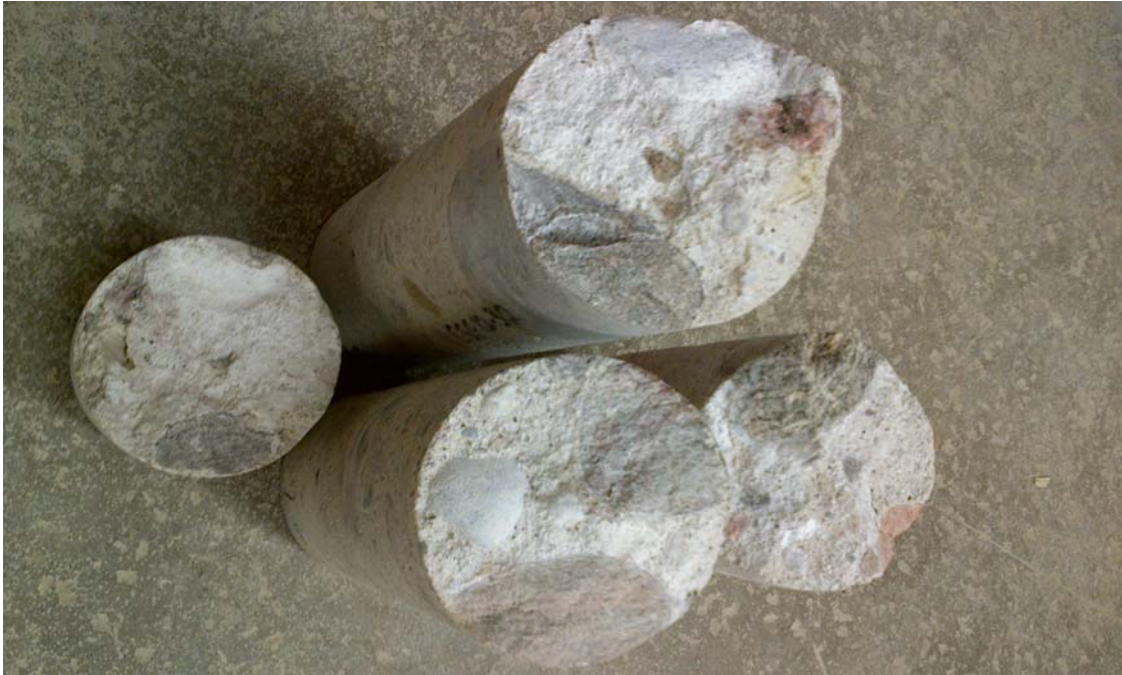
Picture 7: Concrete cores, Dam C, chalky white paste on faces of fractures.
