Rehabilitation of Port Severn Area Dams, Fixed Bridge and Lock

Investigation Report

Public Works and Government Services Canada

November 21 2017

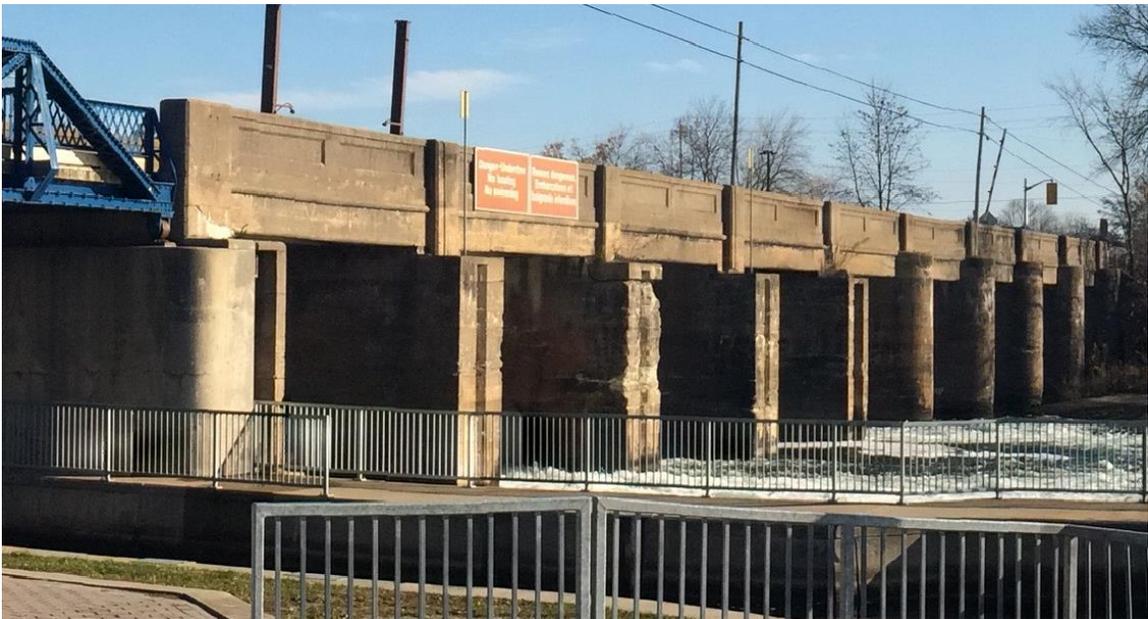
The upstream side of the Main Dam shows cracks, efflorescence, and eroded concrete in the drawdown zone of the piers. On the downstream side, AECOM has observed considerable loss of concrete on the downstream end of Pier 3 (starting from the right bank or west side).

Deteriorated concrete on downstream side of dam

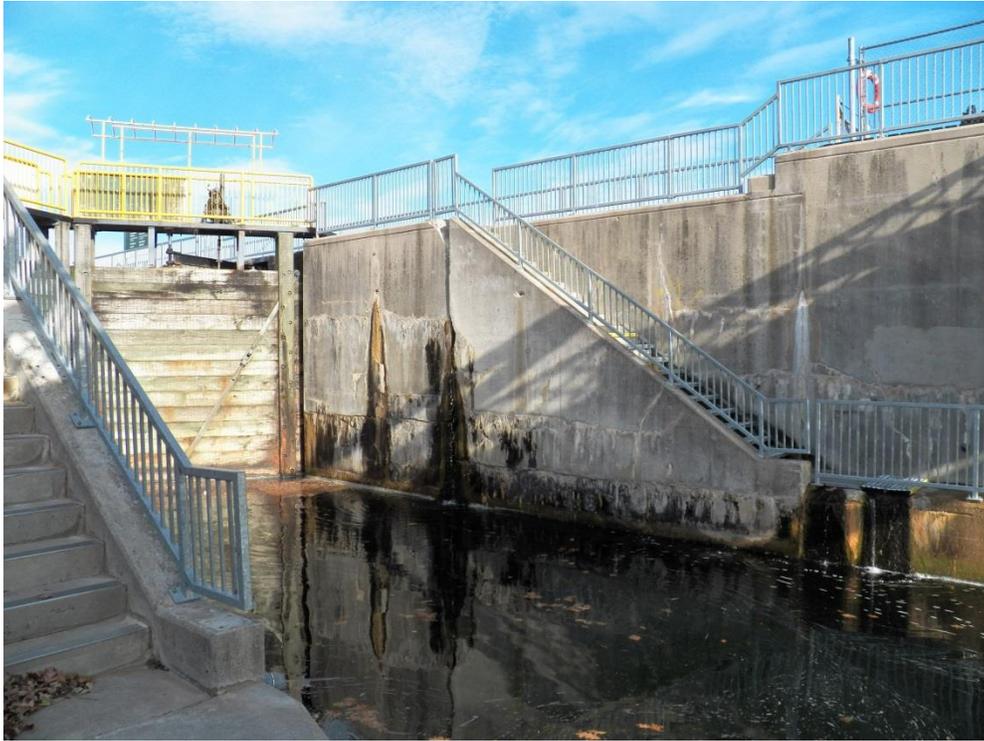
The lock was closed and full at the time of inspection and we were unable to observe the walls within the lock. We were able to identify three places where water is leaking through the common wall downstream of the lock walls, the most critical leak being the one at the stair to the lower approach wall. There were also numerous places on the wall where exudation and efflorescence were visible. This is a sign of either water within the concrete leaking through the wall, or frequent wetting of the wall from the operation of the lock.

Lock 55 showing water leakage

1. Seal the cracks, remove and replace the concrete stair.
2. Seal the cracks, reface the wall, and remove and replace the concrete stair.

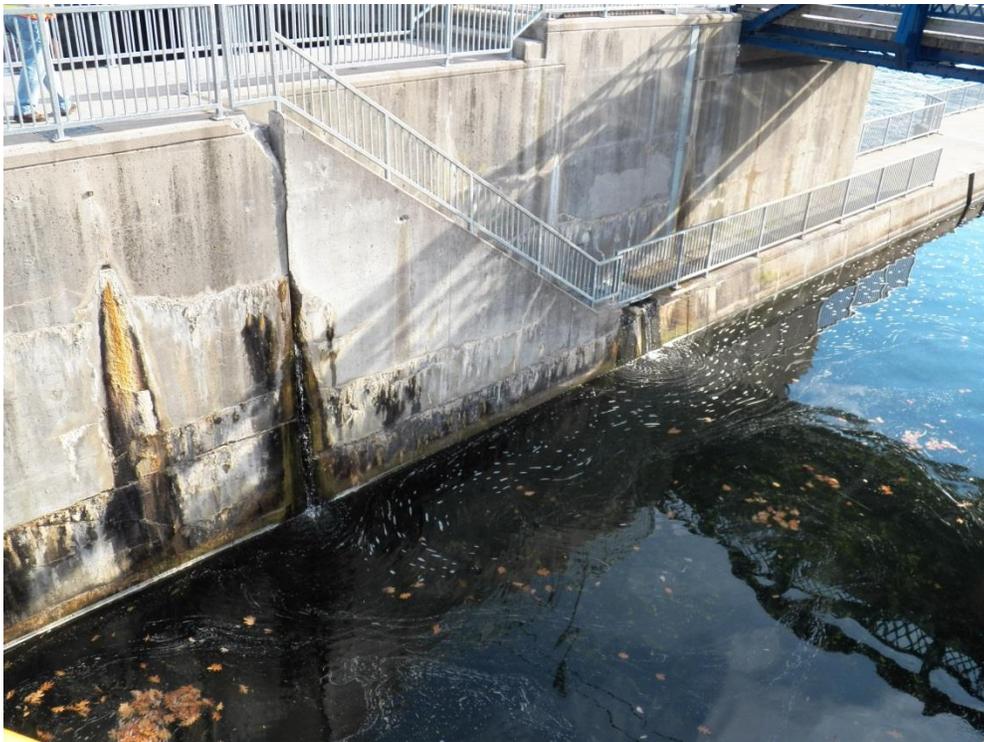
The PA identified a problem with leakage through the common wall. The leakage is causing problems related to ice, algae, and pooling water on the stair to the lower approach wall. Ice jacking from the leak is causing the stairs to separate from the wall. There is a large crack at the top of the staircase. The remainder of the walls are reported to be in good condition.

Lock 55 showing displacement of the stairs

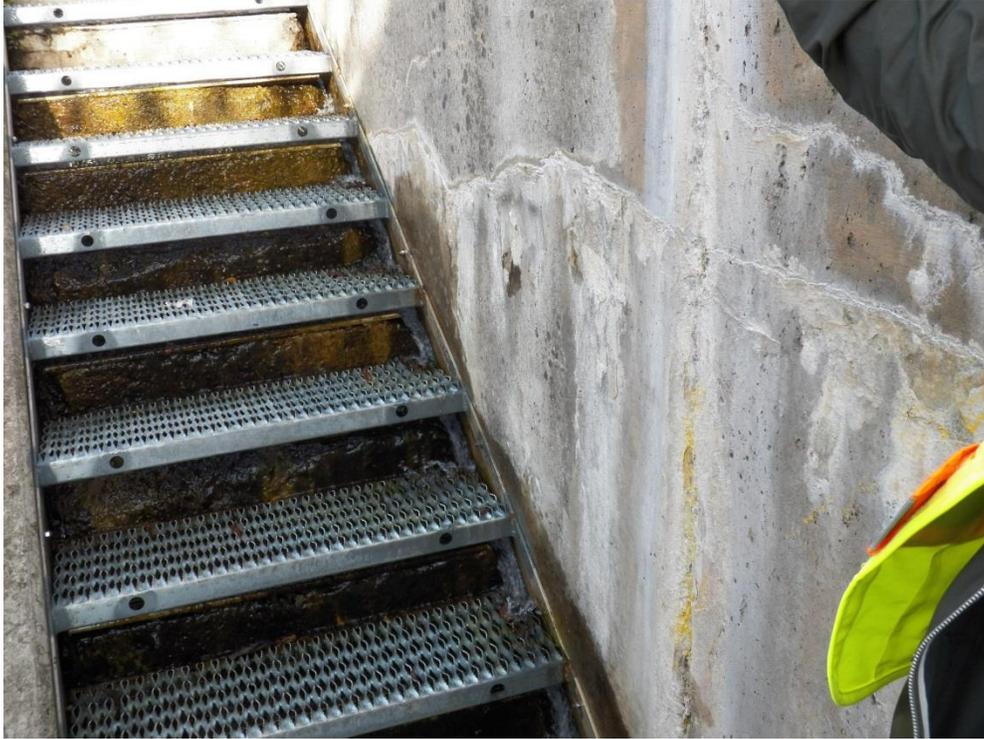
Water leakage under stairs

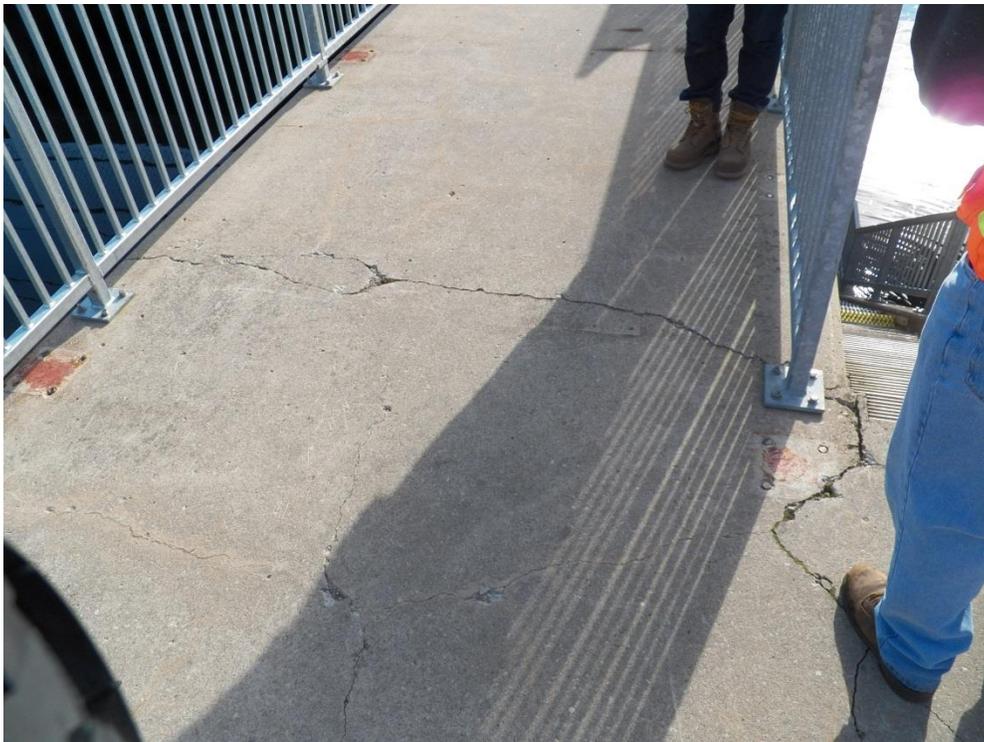
Crack at top of the stairs

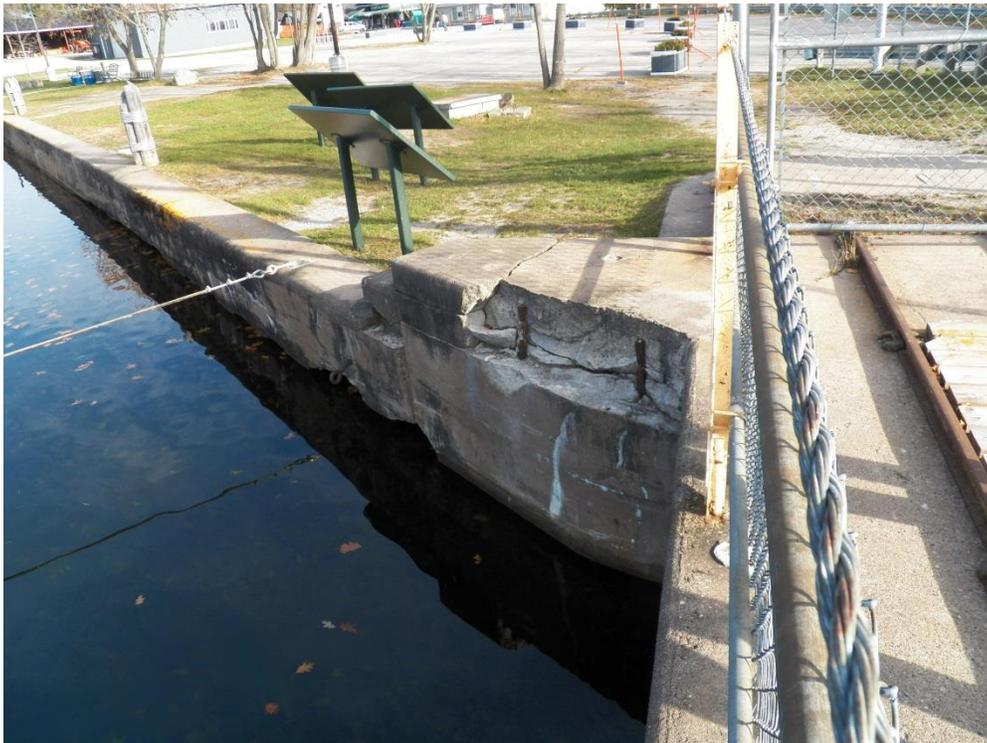
AECOM reviewed the structure and found the concrete to range from generally poor to fair condition with large cracks and spalls observed. There are large spalls in the concrete just above the waterline. The sink holes identified in the PA could not be observed, as granular fill had been used to fill the holes.

Dam D (spalled concrete)

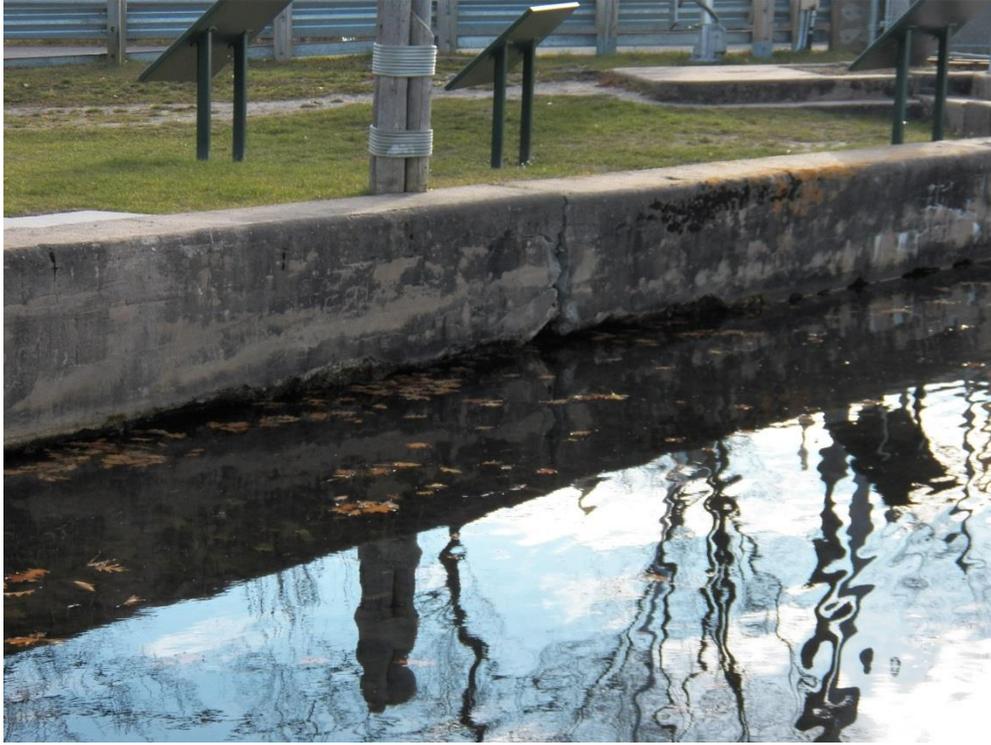
The dam is in generally poor condition with multiple large cracks where it meets the Main Dam. This is likely due to large stresses induced by the relatively rigid concrete dam compared to the ductile behaviour of the soil along the rest of the length of the dam.

Dam D (cracks in concrete)

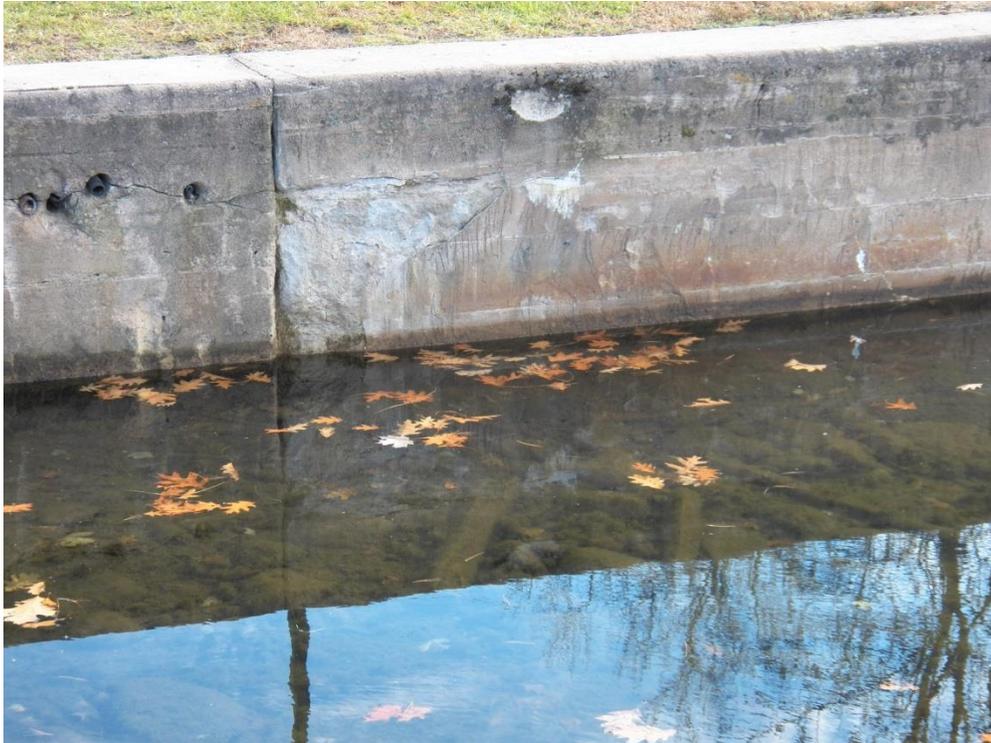
Dam D (spalling concrete)

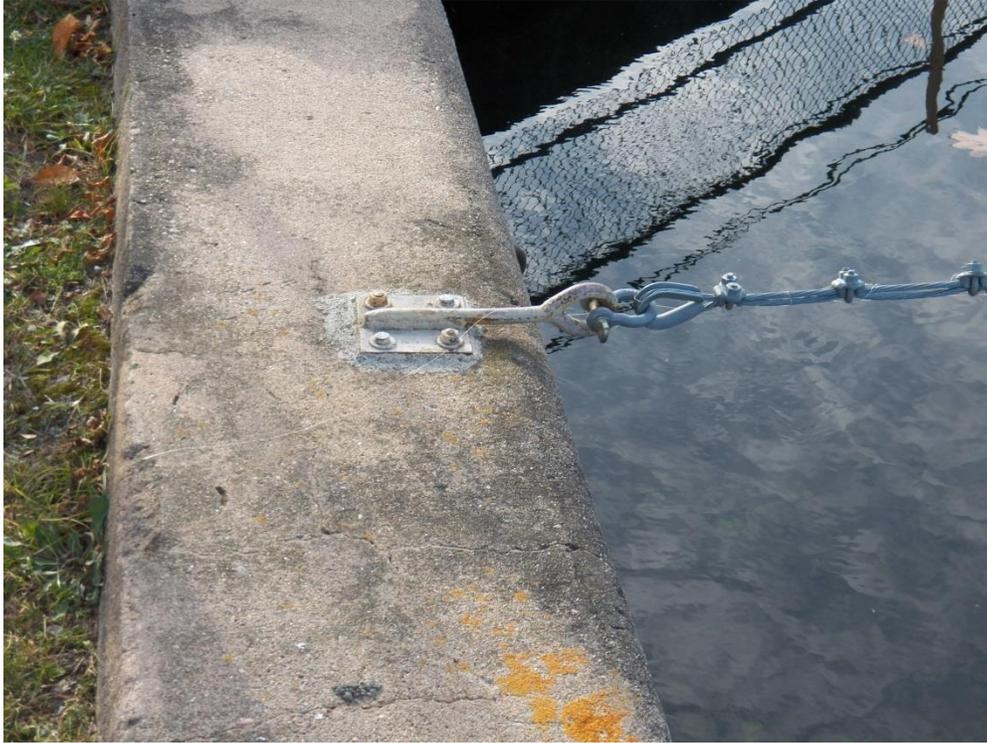
Dam D (anchor pulling on wall)

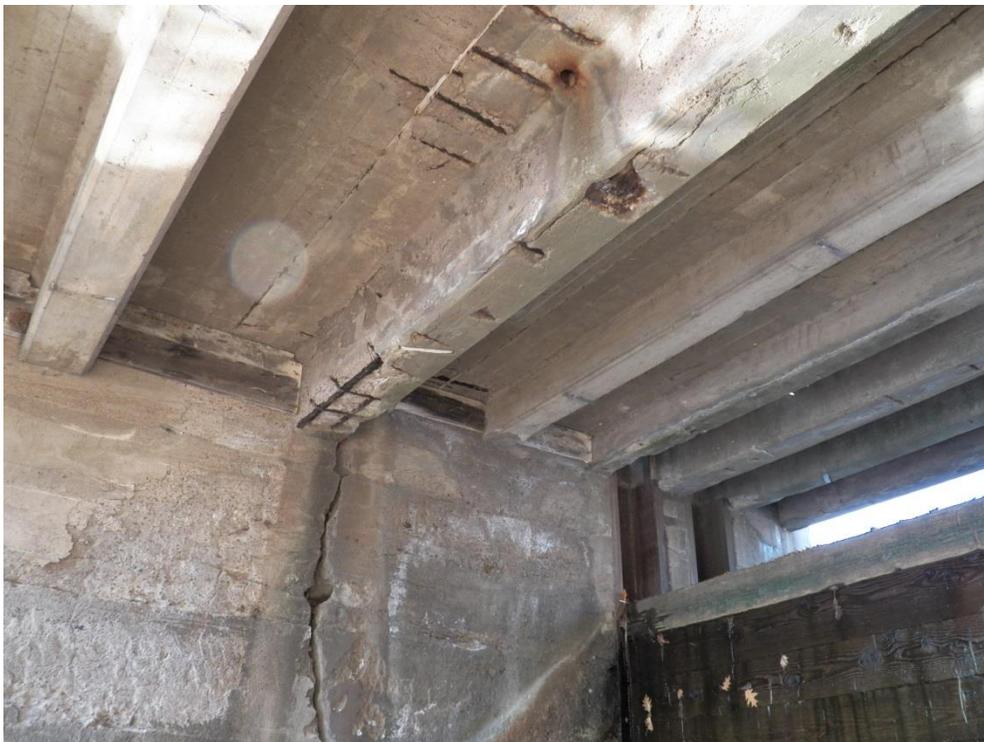
AECOM observed the dam and noted that the concrete deck beams under the bridge deck and the service deck are in poor condition with large spalls, exposed rebar, and rust staining. The deck beams that frame the joint between the bridge deck and the service deck are in especially poor condition due to years of exposure to chloride contamination. Note that there is no curb to keep surface runoff containing deicing salts from draining through this joint and exposing the deck beams to chloride contamination. In our opinion, the bridge deck cannot be salvaged and must be replaced in its entirety. While the service

Dam E (deck girders failing due to chloride contamination)

deck is salvageable, we recommend a full replacement as there is little merit in preserving an old service deck beside a new bridge deck.

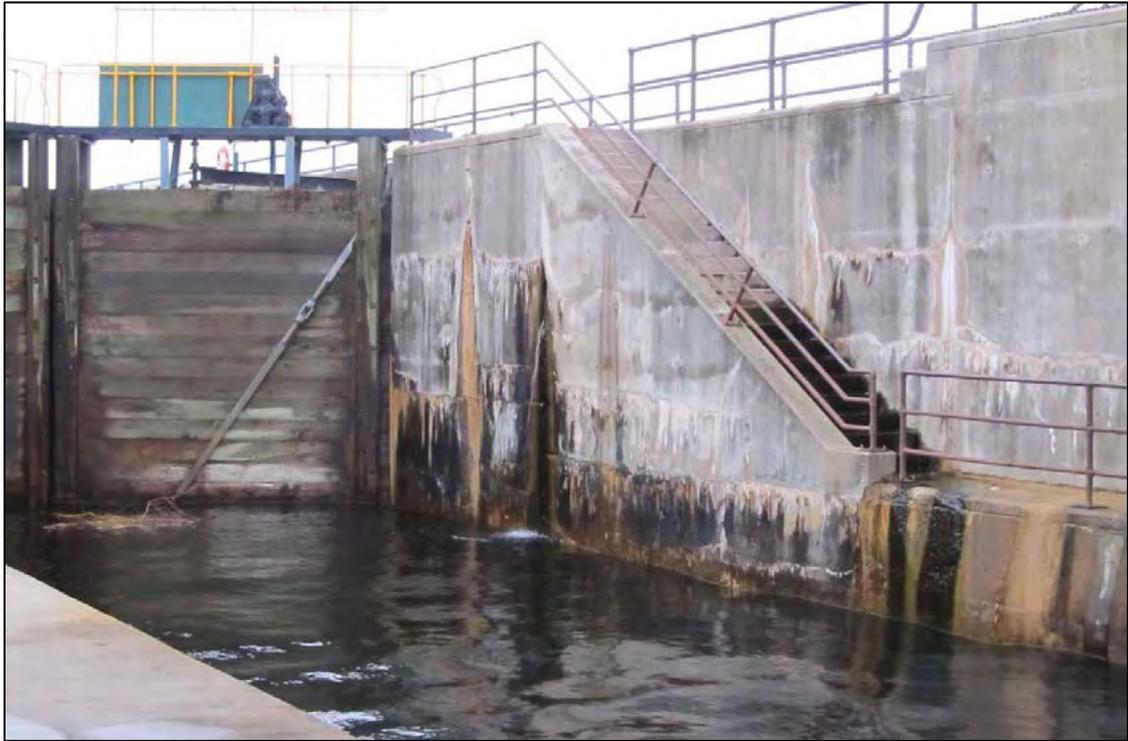
Figure 7: Lock 45 displaying apparent water leakage on the east wall

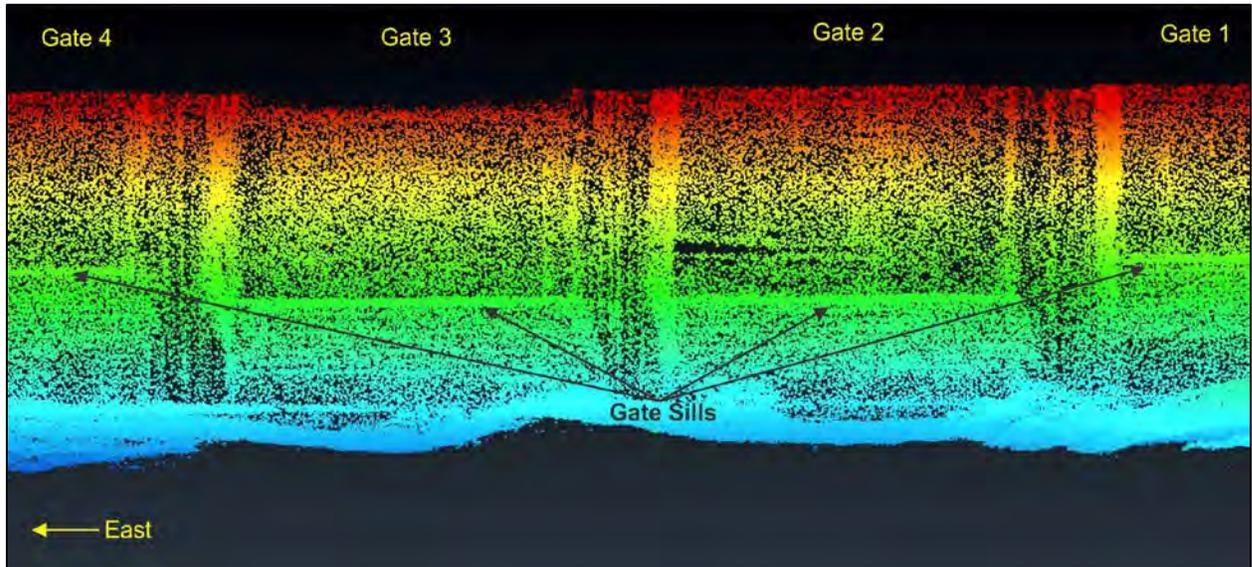
upstream of the stop logs was observed to be 0.6 m to 0.7 m below the remaining gates as seen in Figure 23.

Figure 23: Gates 1 to 4 upstream sill elevations
