REVISED Limited Hazardous Building Materials Assessment

1411 Oxford Street, Halifax,
Nova Scotia

**National Research Council
Canada**

August 18, 2020

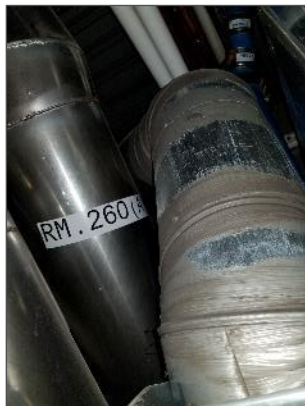
Grey mastic is present on seams / joints on ducts throughout the assessed area. Three samples were collected (samples S0015A-C) and analysis did not identify the presence of asbestos.

View of non-asbestos, grey duct mastic present throughout the assessed area.

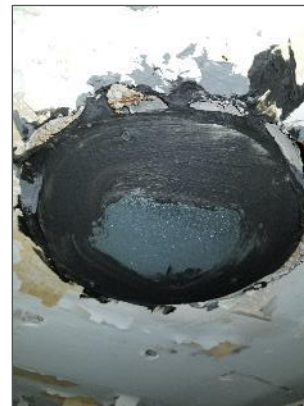
Dark grey mastic is present on seams / joints around a ceiling vent in the assessed area. Three samples were collected (samples S0017A-C) and analysis did not identify the presence of asbestos.

View of non-asbestos, dark grey mastic present around a ceiling vent in Room 235.

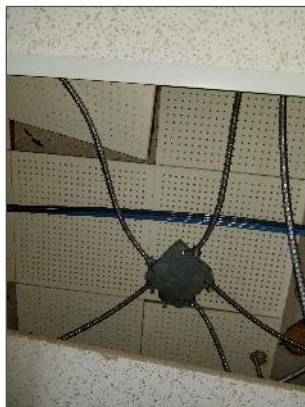
Asbestos was not identified in the ceiling tile sampled or associated mastic (samples S0018A-C and S0019A-C). The ceiling tile not sampled is presumed to be non-asbestos based on the date of manufacture determined from the date stamp applied to the top of the tiles. The tiles were manufactured after asbestos was no longer being used in acoustic ceiling tiles.

View of the non-asbestos, 12" x 12", glue-on, wood fibre tiles and 12" x 12", fissure pinhole tiles.

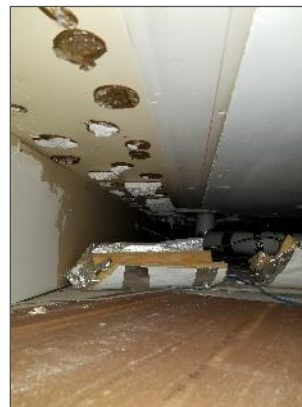
View of non-asbestos, brown mastic associated with the wood fibre tiles.

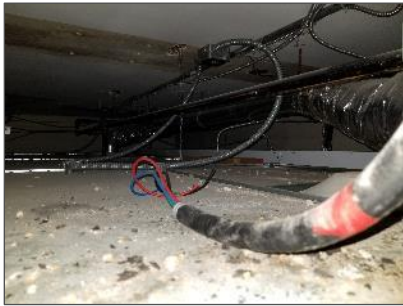
Plaster is present as a wall and ceiling finish throughout the building. Seventeen samples of plaster were previously collected (samples 01-02-00067-S003, 01-02-00067-S009, 01-02-00067-S025, 01-02-00067-S026, 01-02-00067-S027, 01-02-00067-S032, 01-02-0067-S0033, 01-02-00067-S041, 01-02-00067-S043, 01-02-00067-S046, 01-02-00067-S047, 01-02-00067-S048, 01-02-1193.01-S025B-C, 01-02-1193.01-S073A-C). Analysis identified chrysotile asbestos in at least one sample. Assume all plaster to contain chrysotile asbestos unless further sampling proves otherwise. Plaster is a non-friable material while in place but may become friable upon demolition.

View of plaster debris present in the North West Corner Offices above the acoustic ceiling tile.

Material, Quantity & Condition	Location	Recommended Procedure
Plaster, 2 SF of debris	3 rd Floor Hall	Remove in accordance with Type 2 asbestos abatement procedures
Plaster, 2 SF of debris	2 nd Floor, Room 241	Remove in accordance with Type 2 asbestos abatement procedures
Plaster, 1 SF of debris	2 nd Floor, Room 242	Remove in accordance with Type 2 asbestos abatement procedures
Plaster, 1 SF of debris	2 nd Floor, Room 244	Remove in accordance with Type 2 asbestos abatement procedures
Plaster, 3 SF of debris	2 nd Floor, North West Corner Offices	Remove in accordance with Type 2 asbestos abatement procedures

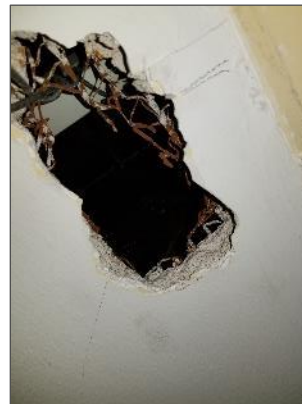
View of plaster present throughout the assessed area.

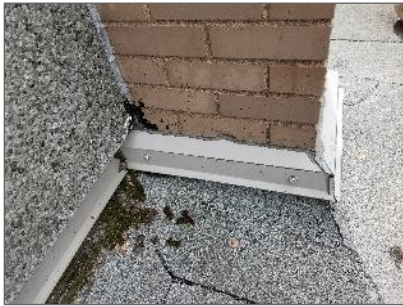
The white caulking is a non-friable material.

View of asbestos-containing, white caulking present on Phase 1 – Roof 4.

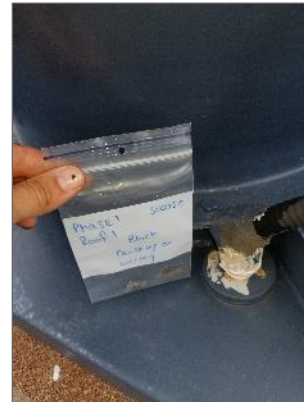
View of non-asbestos, black caulking on wiring present on Phase 1 - Roof 1.

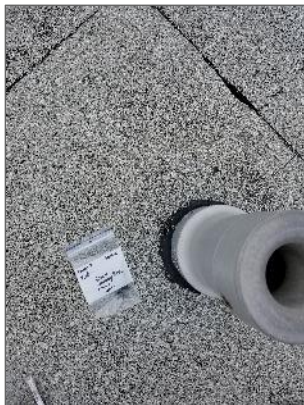
View of non-asbestos, black putty present around vent/roof connections.

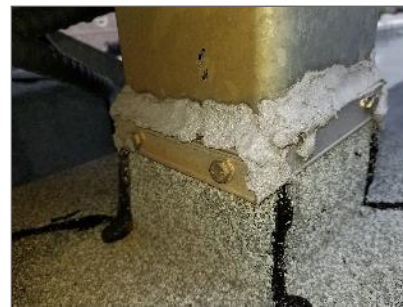
View of non-asbestos, grey caulking present around a roof/vent connection on Phase 1 - Roof 3.

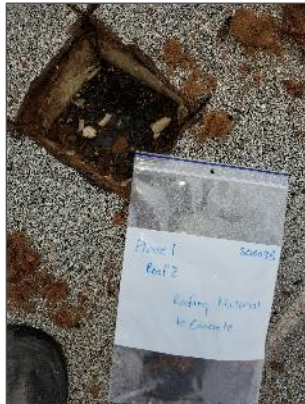
View of one of the non-asbestos, roofing materials.

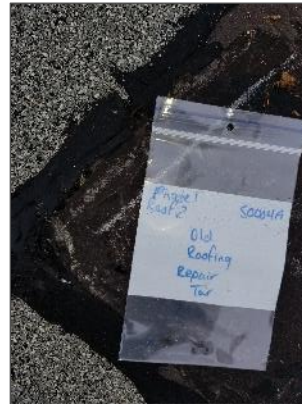
Tar associated with roofing repairs was sampled (samples S0004A-C) and analysis did not identify the presence of asbestos.

View of non-asbestos, tar associated with roofing repairs.

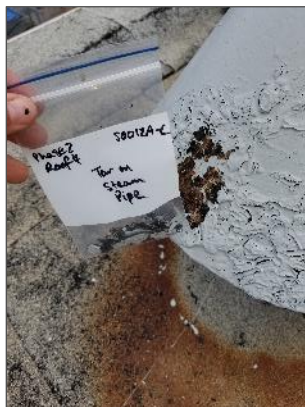
Tar present on the steam pipe on Phase 2 - Roof 4 was sampled (samples S0012A-C) and analysis did not identify the presence of asbestos.

View of non-asbestos, tar on the Phase 2 - Roof 4 steams pipes.

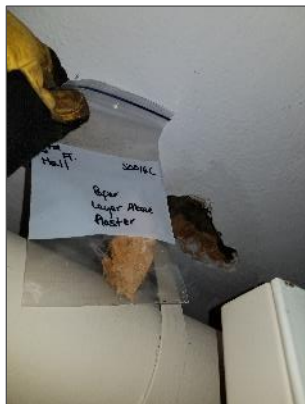
A paper layer present above the plaster in the 3rd Floor hall was sampled (samples S0016A-C) and analysis did not identify the presence of asbestos.

View of non-asbestos, paper layer.

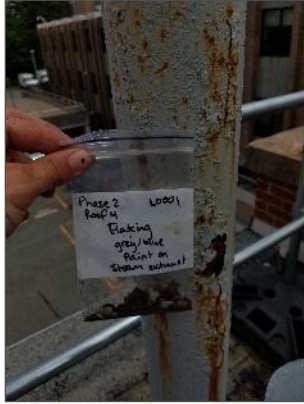
View of low level, lead-containing, grey/blue paint on the steam exhaust pipe.

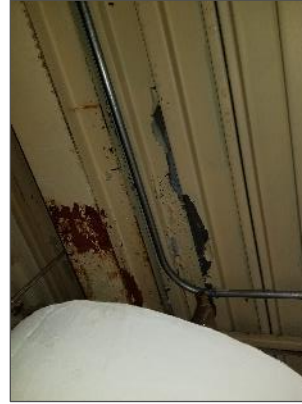
Analysis of the cream paint (sample L0002) identified lead concentrations above 0.1% (1,000 ppm), but below 0.5% ($< 5,000$ ppm), and is considered lead-containing. The lead concentration also exceeded the

waste screening guideline of 1,000 mg/kg and therefore will require leachate testing should this paint be impacted by the roof replacement and require disposal.

View of lead-containing, cream paint on the steel deck in the Penthouse.

Items painted with paints containing elevated levels of lead may be a hazardous waste. Test lead-painted materials for leachable lead and other metals prior to disposal.

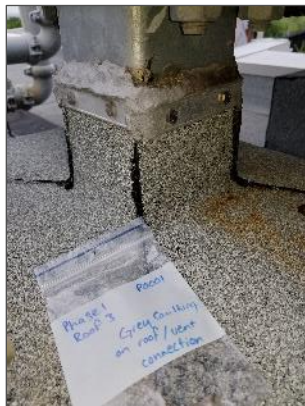
Both caulking's are considered non-PCB solid based on the threshold (50 ppm).

View of non-PCB, grey caulking on roof/vent connections.

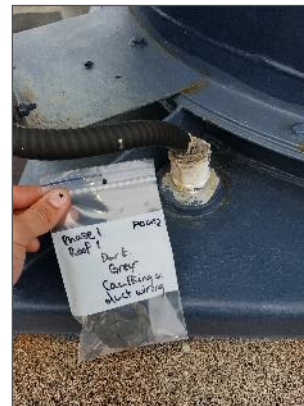
View of non-PCB, dark grey caulking on duct wiring.
