Addendum No. 1

Date: September 2, 2020
Addendum No.: 01
Project No.: R.21850.003
Henry Traill Community Correctional Centre, Kingston Ontario

REVISED Hazardous Building Materials Assessment

Exterior Façade Replacement
Henry Trail Correctional Centre
(HTCC)
1453 Bath Road, Kingston,
Ontario

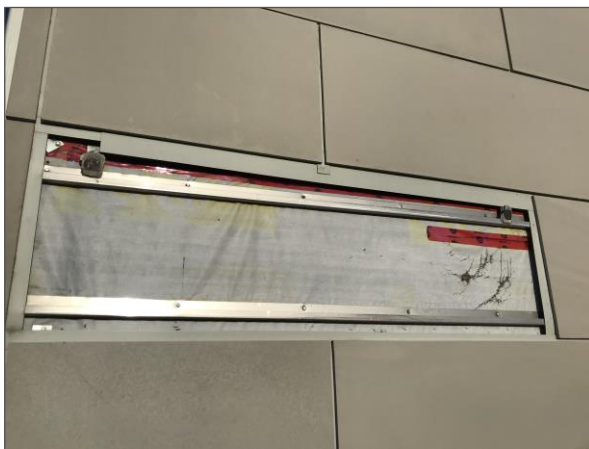
The prefabricated concrete panels present as exterior cladding do not contain asbestos (samples S0001A-C).

Non-asbestos prefabricated concrete panels.

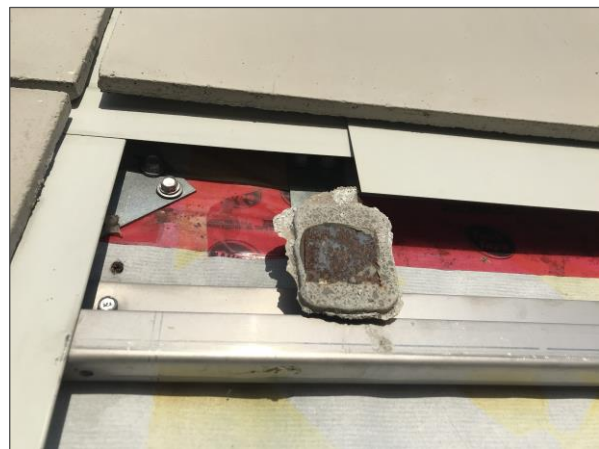
The mastic on the backside of the prefabricated concrete panels present as exterior cladding does not contain asbestos (samples S0002A-C).

Non-asbestos mastic present behind prefabricated concrete panels.

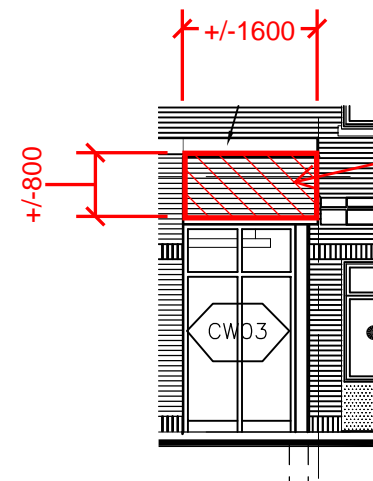
EXTENT OF NEW VINYL SIDING TO REPLACE EXISTING CEMENT BOARD CLADDING

REFER TO SHEET A106 FOR TYPICAL VINYL ASSEMBLY DETAILS. WORK INCLUDES DEMOLITION OF EXISTING CEMENT BOARD PANELS AND SUBSTRATES AS ILLUSTRATED IN SHEET A103.

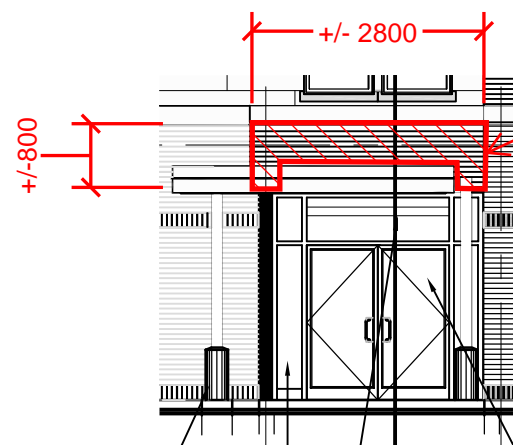
4 WEST ELEVATION
SK-1 SCALE: 1:100

EXTENT OF NEW VINYL SIDING TO REPLACE EXISTING CEMENT BOARD CLADDING
