**FINAL MODIFIED PHASE I ENVIRONMENTAL SITE  
ASSESSMENT AND HAZARDOUS MATERIALS SURVEY**

**CAVENDISH ASSETS  
PRINCE EDWARD ISLAND NATIONAL PARK  
CAVENDISH, QUEENS COUNTY, PEI**

**PUBLIC WORKS AND GOVERNMENT SERVICES CANADA FOR  
PARKS CANADA**

**JANUARY 13, 2011**

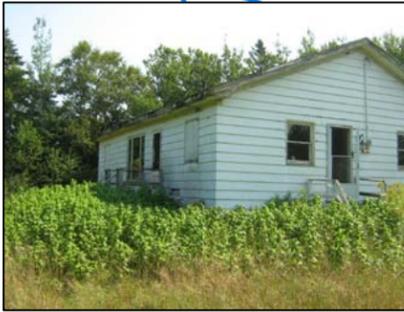
Evidence of moisture damage and mold was observed in the Asset No.112 (i.e., Sheppard Cottage), Asset No. 108 (i.e., Staff Housing) and the Art Barn at the time of the site visit. Mold was not observed in any of the other assets assessed during the site visit.

PHOTO 29 - VIEW FACING SOUTHEAST TOWARD ASSET #112 (SHEPPARD COTTAGE)

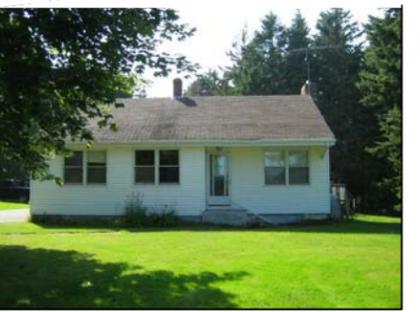
PHOTO 45 - VIEW FACING WEST TOWARD ASSET #108 (STAFF HOUSING STRUCTURE)

- Existing heating fuel ASTs associated with the Staff Houses on Route No. 13 (Asset Nos. 108 and 106). The existing heating fuel ASTs should be checked for leaks or any sign of spill or stained areas beneath the tank or associated infrastructure. Decommissioning and disposal of all fuel oil ASTs must be completed according to applicable Provincial and Federal Regulations;

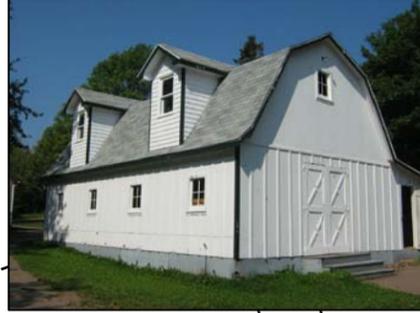
PHOTO 12 - VIEW FACING NORTHWEST TOWARD ART BARN

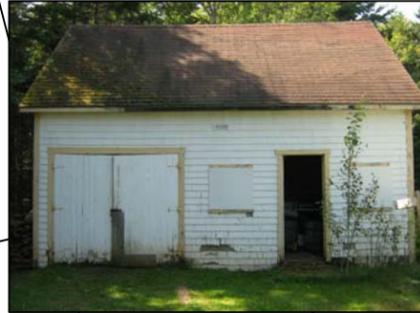
PHOTO 43 - VIEW FACING WEST TOWARD ASSET #106 (GARAGE)
