**FINAL MODIFIED PHASE I ENVIRONMENTAL SITE
ASSESSMENT AND HAZARDOUS MATERIALS SURVEY**

**DALVAY ASSETS
PRINCE EDWARD ISLAND NATIONAL PARK
DALVAY, QUEENS COUNTY, PEI**

**PUBLIC WORKS AND GOVERNMENT SERVICES CANADA FOR
PARKS CANADA**

JANUARY 13, 2011

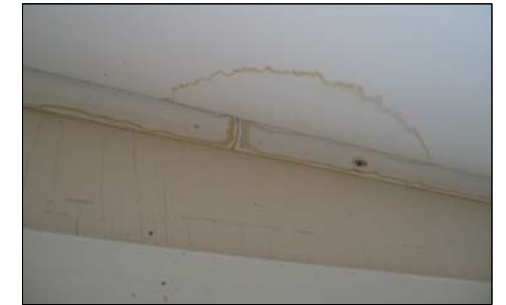
Photo 8: Water Stains on the Ceiling

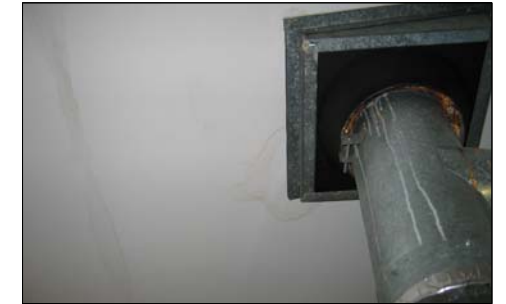
Photo 9: Water Stains at Chimney

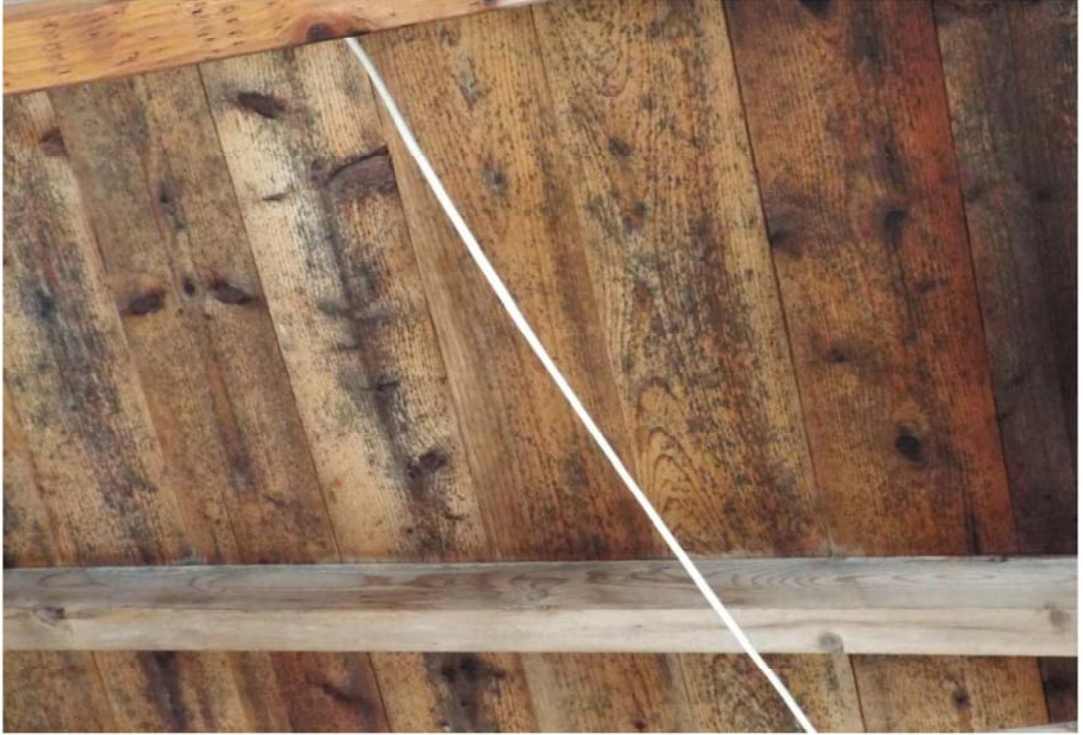
<p>A photograph showing the exterior front view of a white, single-story building with a dark roof. The building has two large white garage doors with green trim. A person in dark clothing is visible in the lower-left corner, working in the snow. The ground is covered in snow, and there are bare trees in the background under a clear blue sky.</p>
P2	Visible mould on interior wood framing

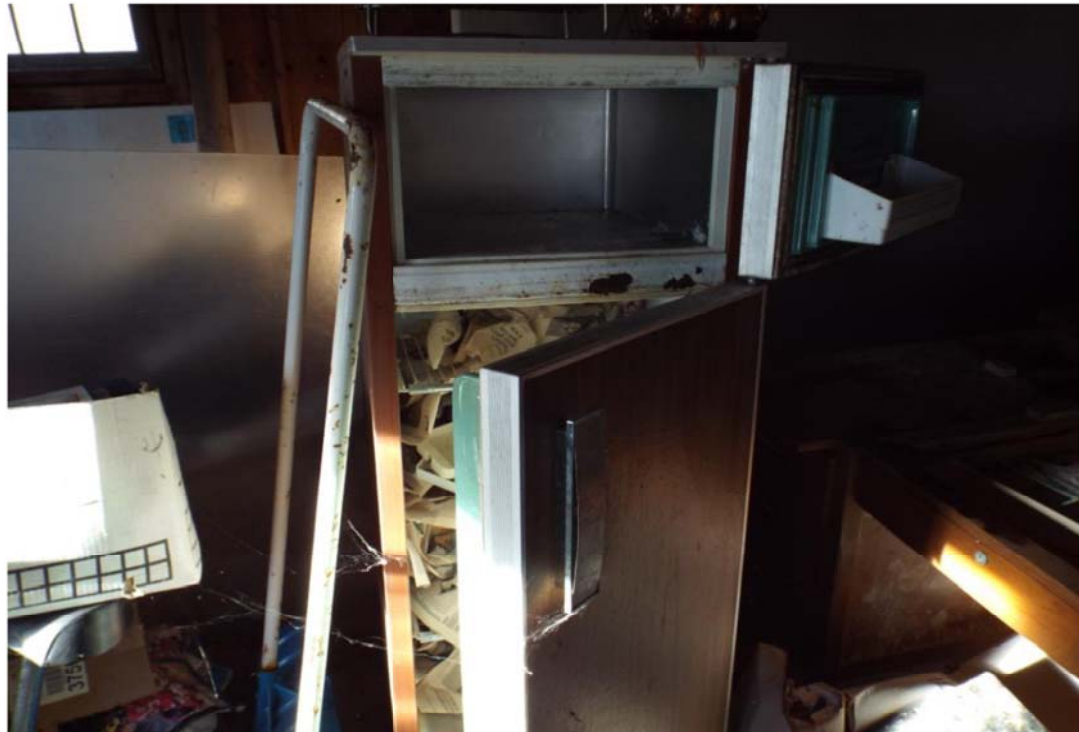
A photograph of a single incandescent light bulb hanging from a wooden ceiling. The ceiling is made of dark wood planks and has several wooden joists visible.
<p>P5</p>	<p>Older refrigerator in storage - suspect CFC containing</p>

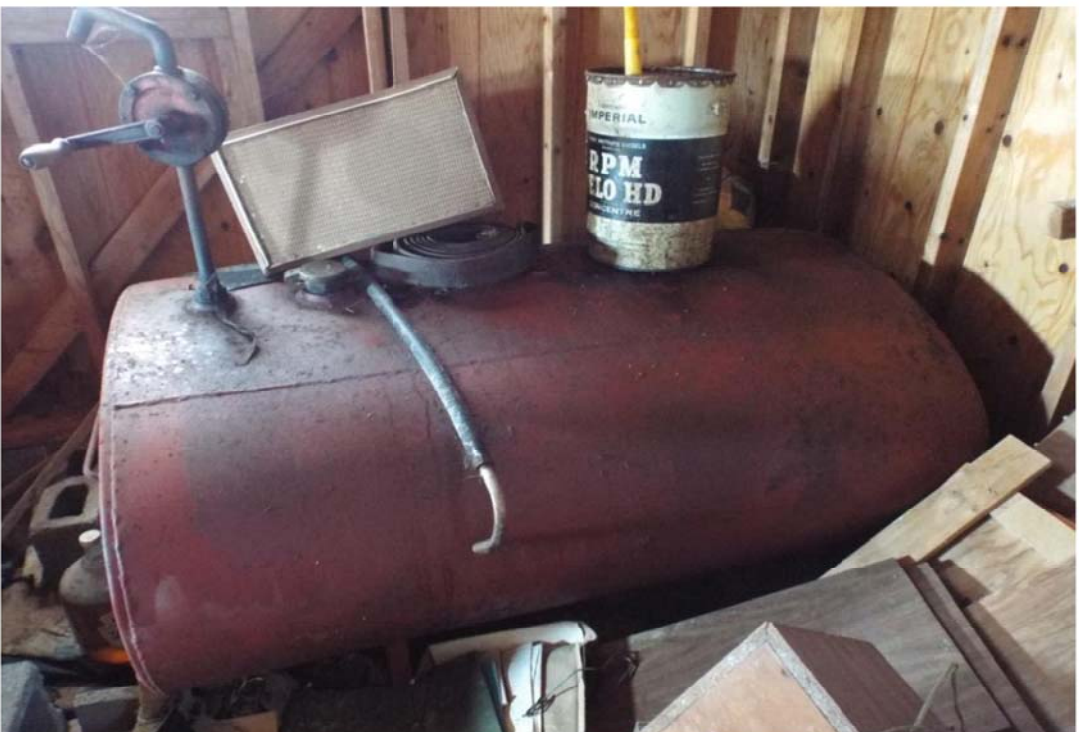
<p>P6</p>	<p>Printed matter and other miscellaneous items with visible mould</p>	  A photograph showing a cluttered storage area. In the center, there are several large, thick stacks of old, yellowed paper or books. To the left, there are blue plastic bags and other miscellaneous items. The overall appearance is one of significant age and potential mold growth.
<p>P7</p>	<p>Air conditioning unit - suspect CFC containing</p>	  A photograph of an air conditioning unit, possibly a window unit, installed in a wooden structure. The unit is dark-colored with a metal grille. The surrounding area is cluttered with various items, including a white plastic container and some debris on the floor.
<p>P8</p>	<p>Petroleum storage tank - staining on tank</p>

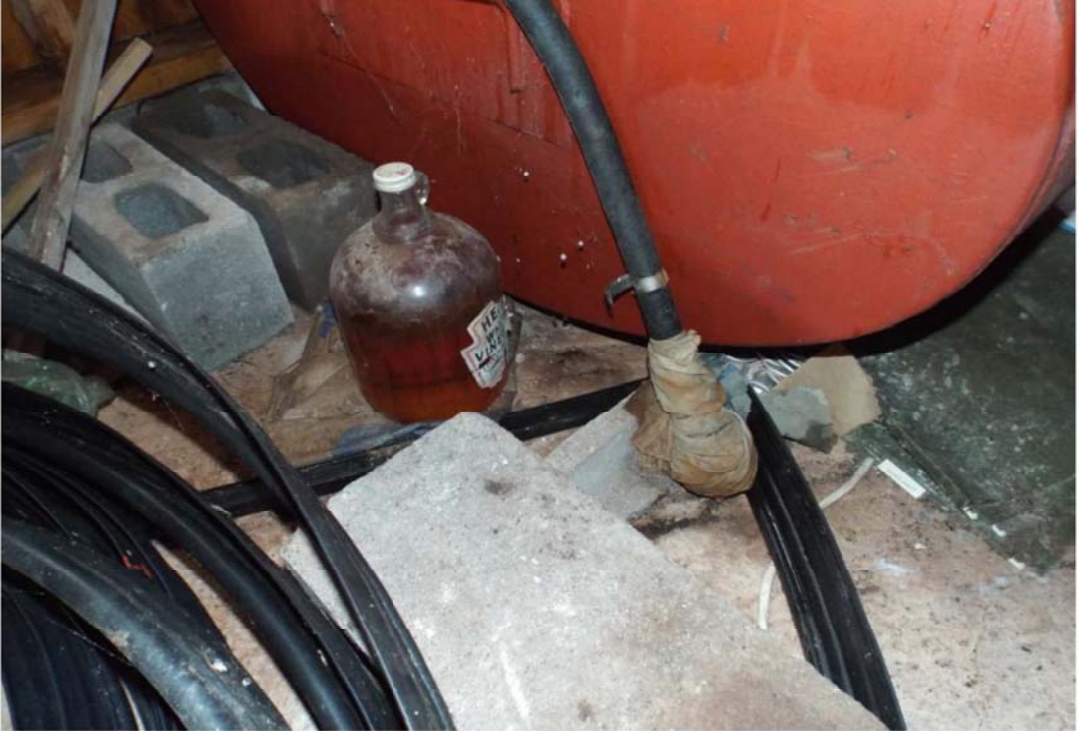
<p>P9</p>	<p>non marked - suspect petroleum product in storage bottle</p>

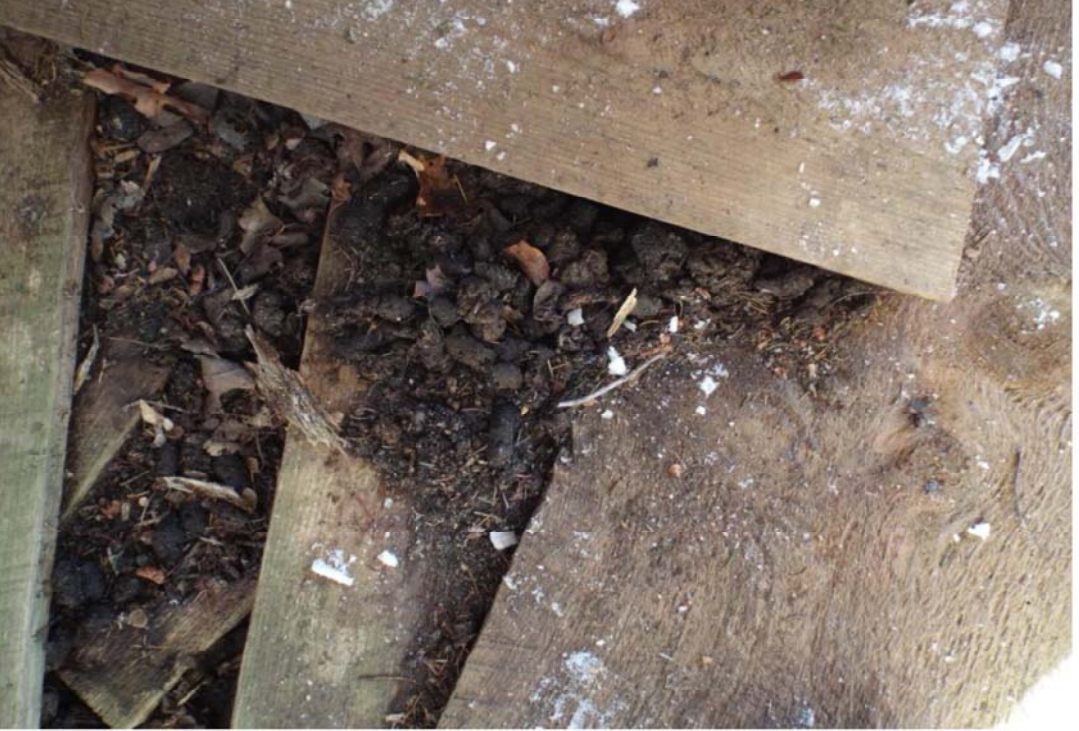
<p>P8</p>	<p>Accumulation of animal feces in floor space</p>

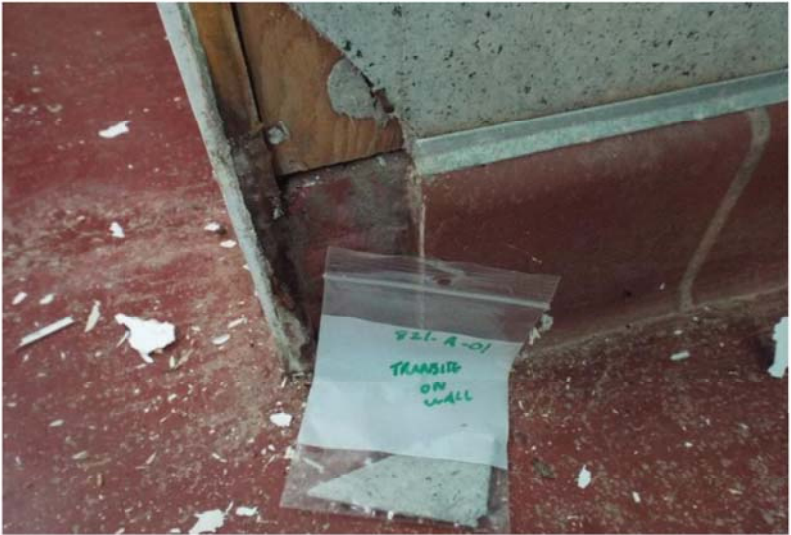
<p>A close-up photograph of a red Transite panel on a wall. The panel is peeling and damaged, with white debris scattered on the red surface. A clear plastic bag containing a sample of the material is placed on the ground in front of the panel. The bag has a white label with green handwritten text that reads "821-A-01 TRANSITE ON WALL".</p>

- Confirmed ACMs, and all visually similar materials throughout the buildings, should be removed in accordance with Part 49-Asbestos Regulations of the Occupational Health & Safety Act Regulations, R.S.P.E.I. 1988, Cap 0-1.
- ACMs should be removed by a certified contractor and disposed of in a provincially approved manner.
- Asbestos may also be present in the other building materials not accessible during the survey. If potential ACMs are identified they should be sampled and, if found to contain asbestos, should be removed in accordance with the regulations noted above.

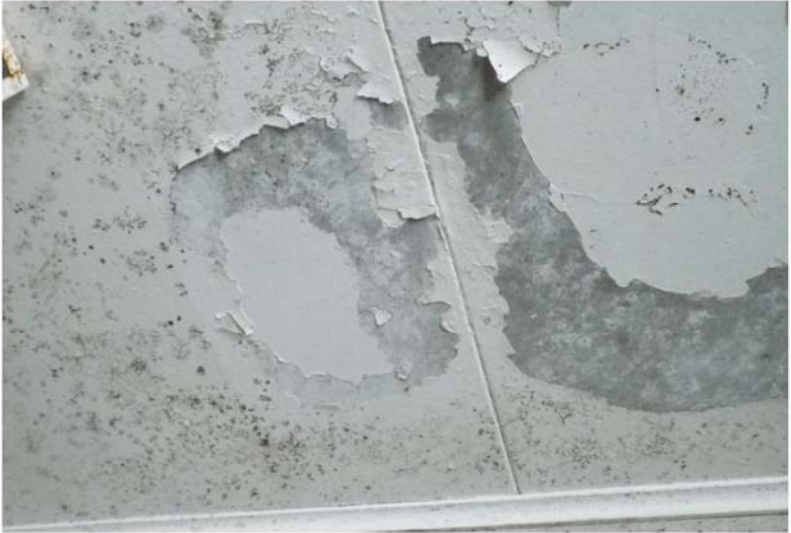
P16	Visible mould on interior ceiling asbestos transite panels

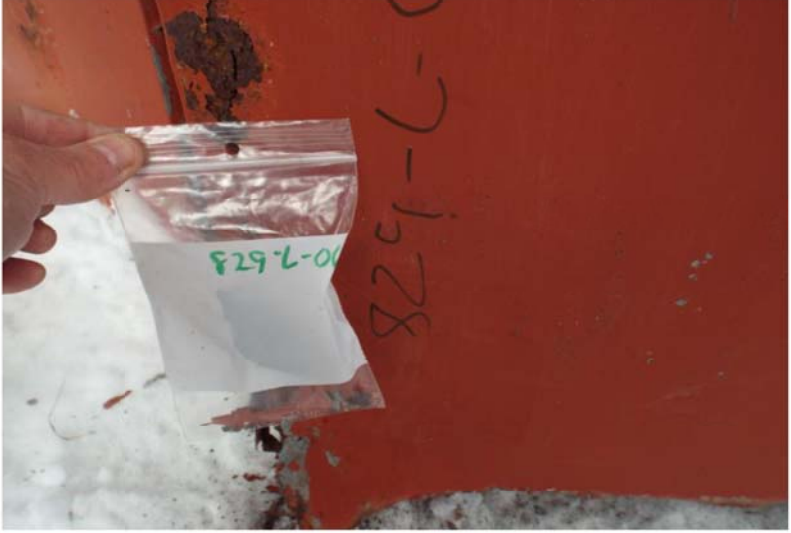
<p>P9</p>	<p>Sample 829-L-06 Rust colour paint on metal door (Results - 0.55% lead by weight)</p>
