Environment and
Climate Change Canada

Environnement et
Changement climatique Canada

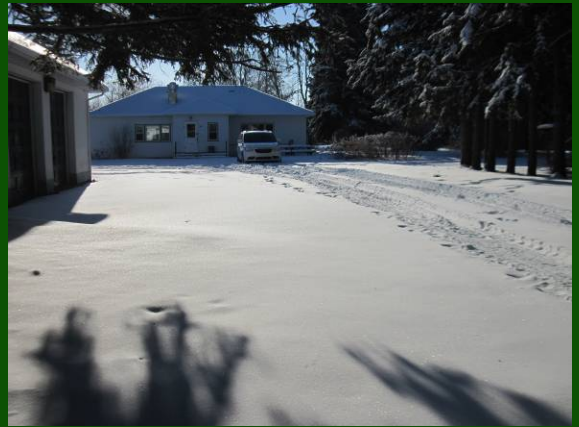
Prepared by:
Technical Services
Professional and Technical Services
Real Property Branch
Ontario Region
PWGSC

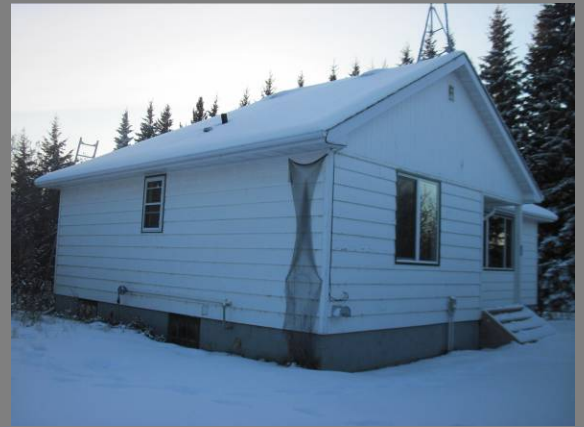
This page intentionally left blank

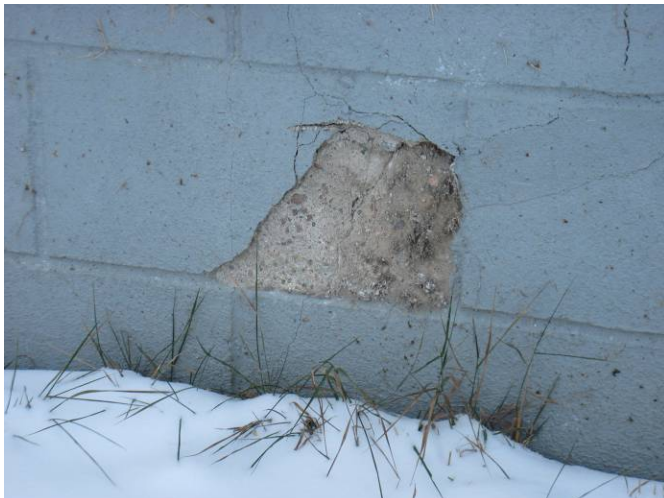
AR-003 – Area of deteriorated concrete at foundation wall exterior surface.

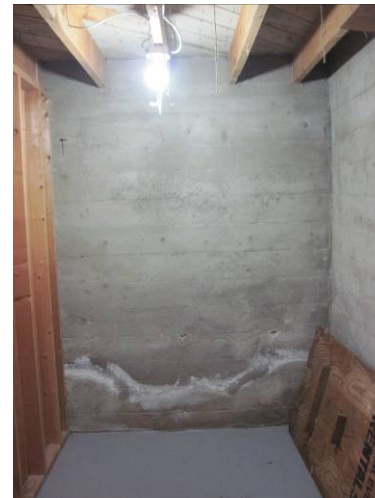
AR-004 – Localized efflorescence at interior surface of foundation wall.

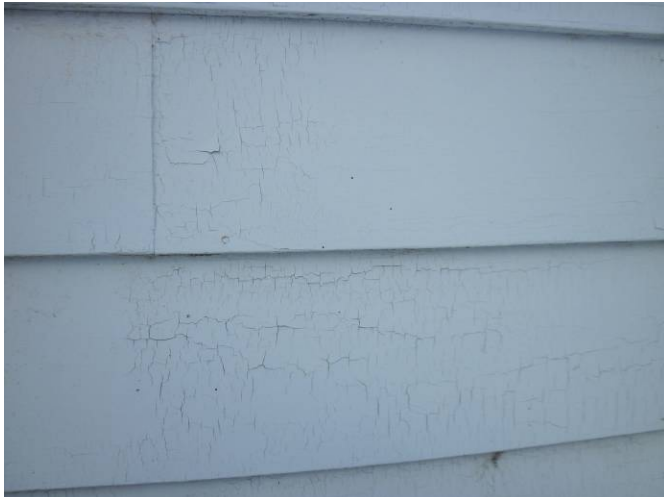
AR-005 - Deteriorated paint finish at exterior wall.

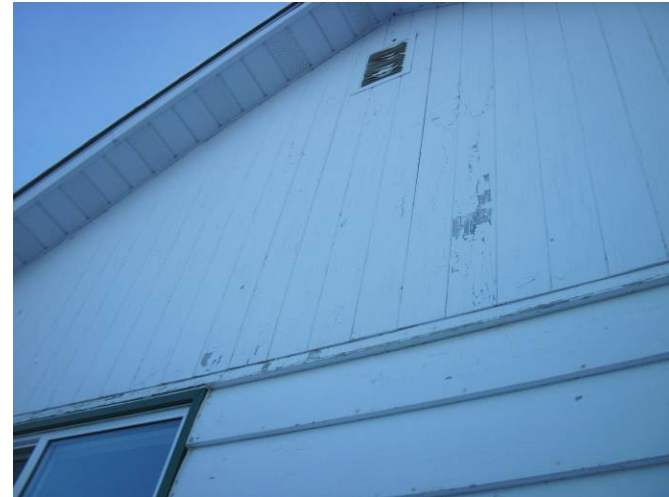
AR-006 – Deteriorated paint finish at gable.

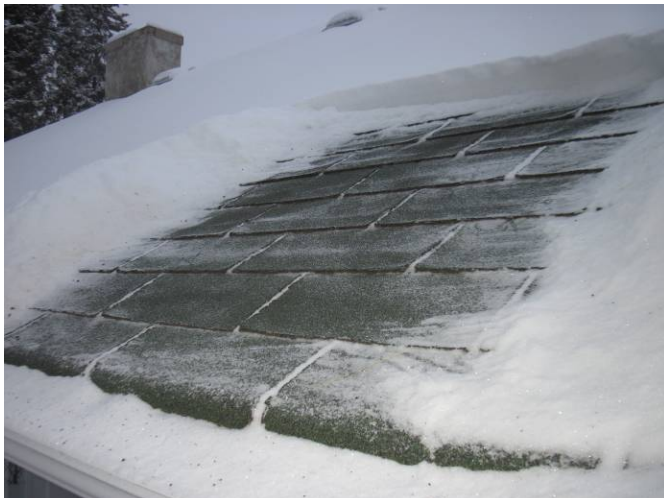
AR-007 – Initial deterioration of asphalt shingles.

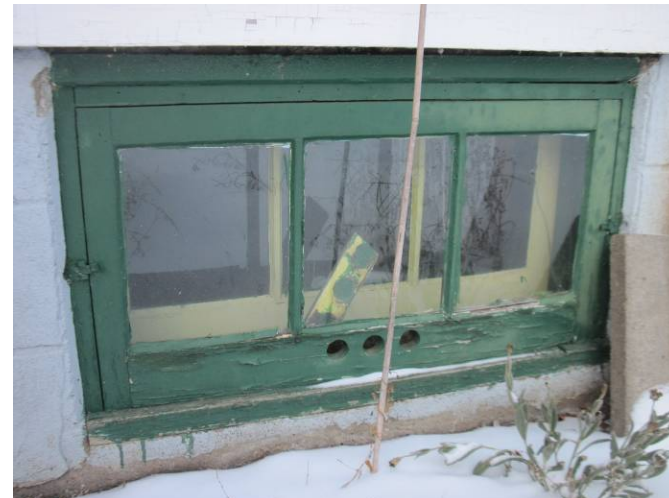
AR-008 – Deteriorated paint finish at window.

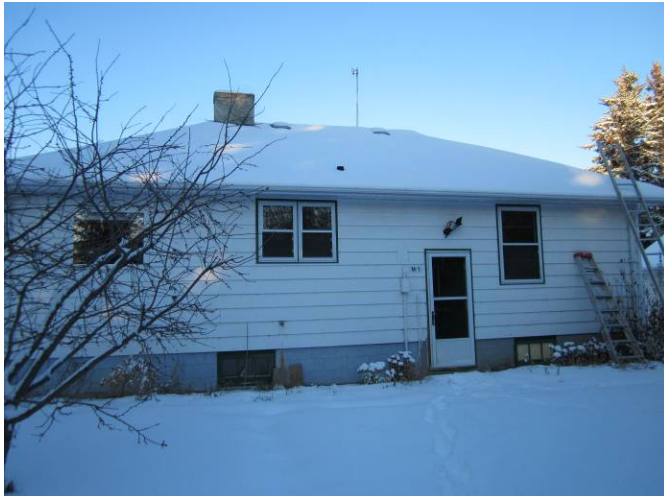
ME-001 – Building M1 view from south side.

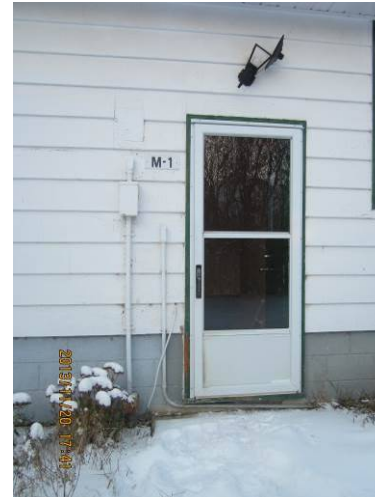
EL-002 – Incoming service, with BX and conduit installation outdoors in poor condition.

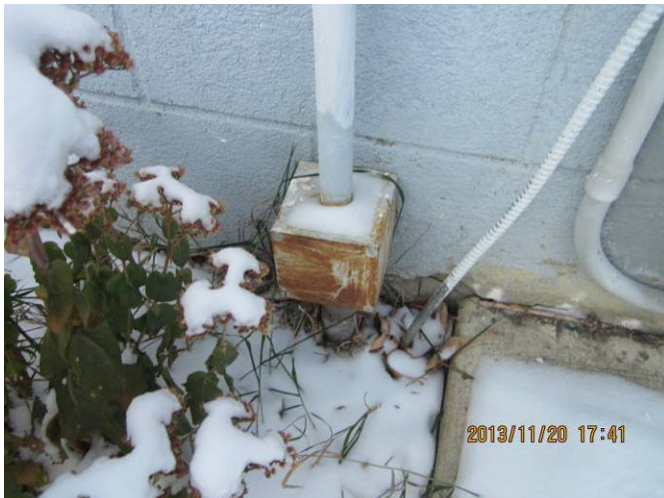
EL-003 – Main service junction box showing corrosion and metallic sheathed cable not design for outside use.

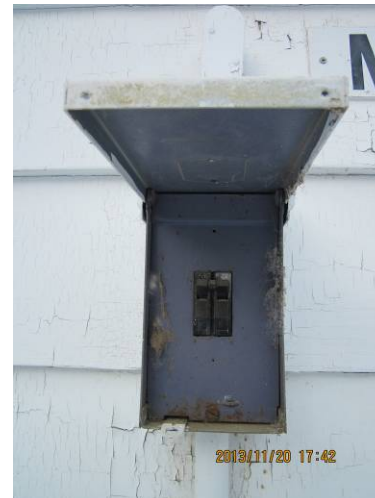
EL-004 – Main service disconnect on the exterior of building showing insect infestation.

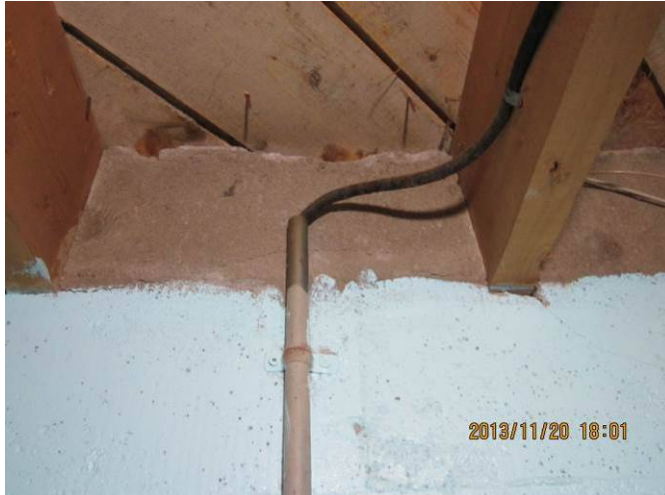
EL-009 – Protective bushing required to prevent damage to non-metallic sheathed cables.

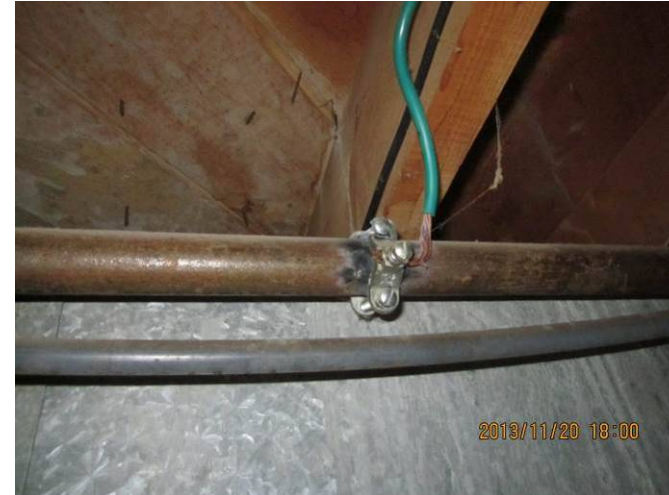
EL-010 – Ground conductor not effectively connected to ground; see area burnt due to short circuit, to be completed.

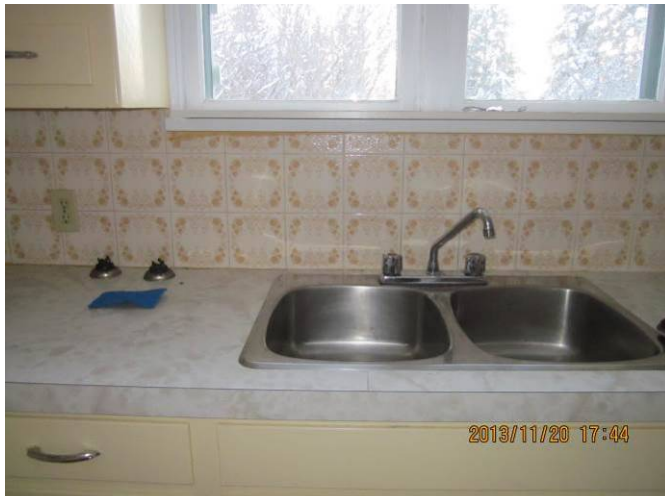
EL-011 – Receptacles within 1 m of sinks to be replaced with GFCI or install GFCI breakers in panel.

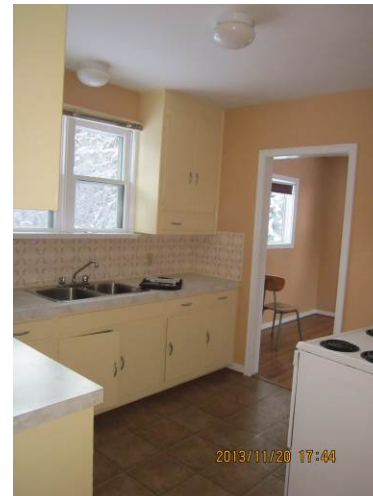
EL-012 – Interior lighting in kitchen.

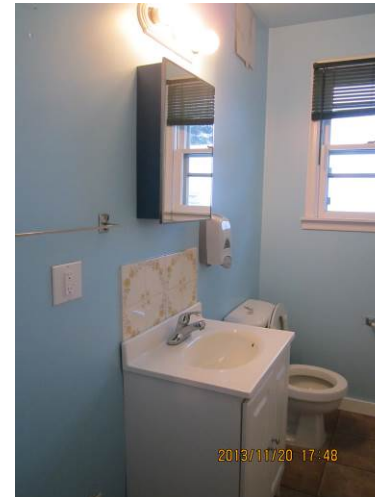
EL-014 – Interior lighting in washroom with GFCI that must be replaced.

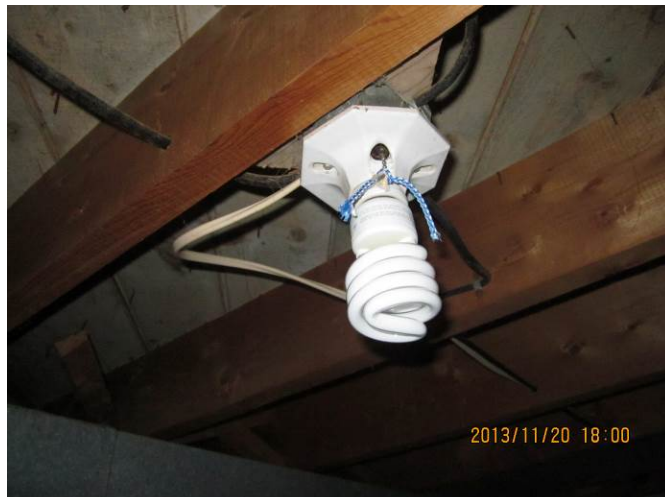
EL-015 – Compact fluorescent lamp used in other fixture in basement.
Note the various wiring.

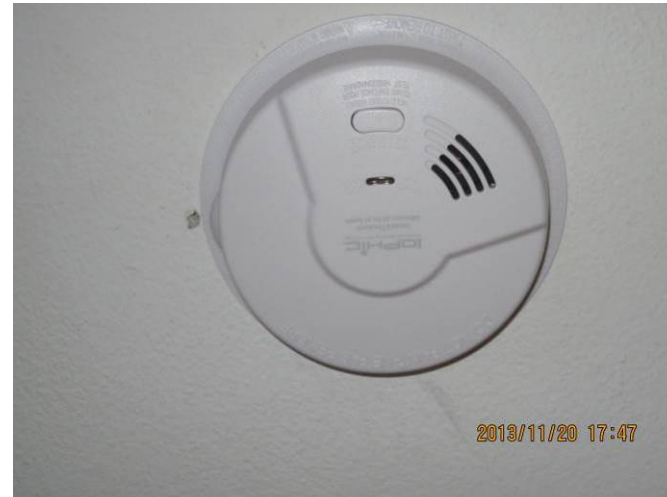
EL-018 – Smoke alarm to be replaced.

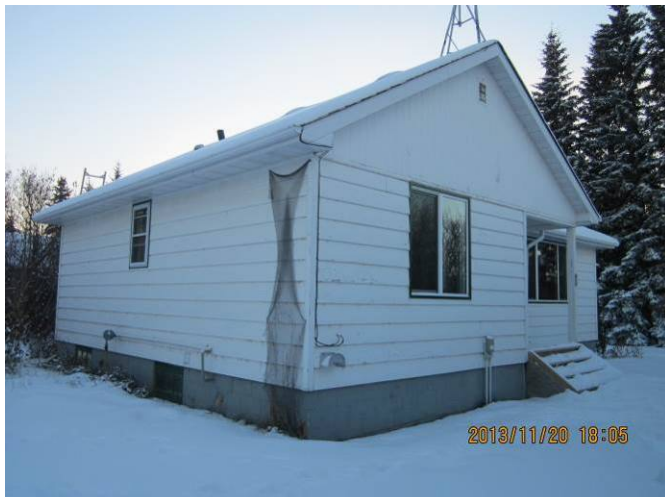
EL-019 – View of telephone junction box at front of building.

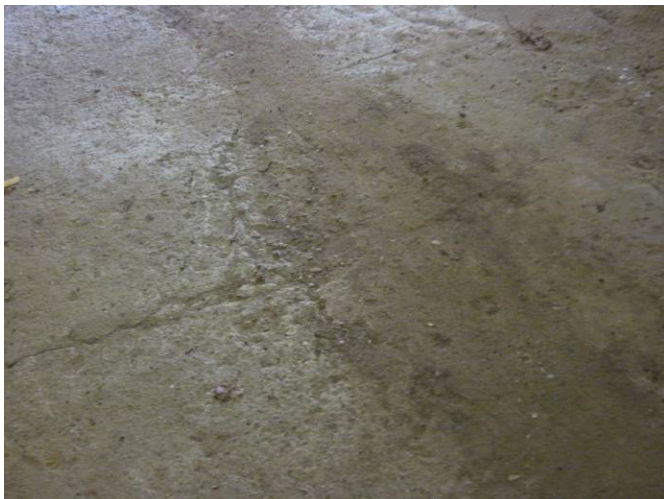
AR-003 – Cracked/pitted concrete floor surface.

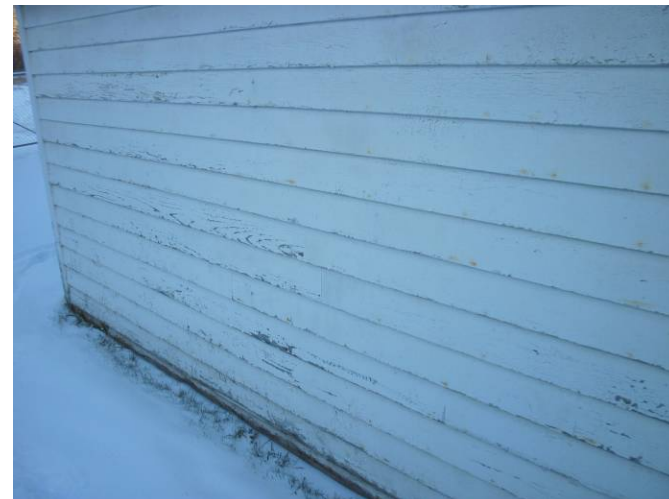
AR-004 – Deteriorated paint finish at exterior wall.

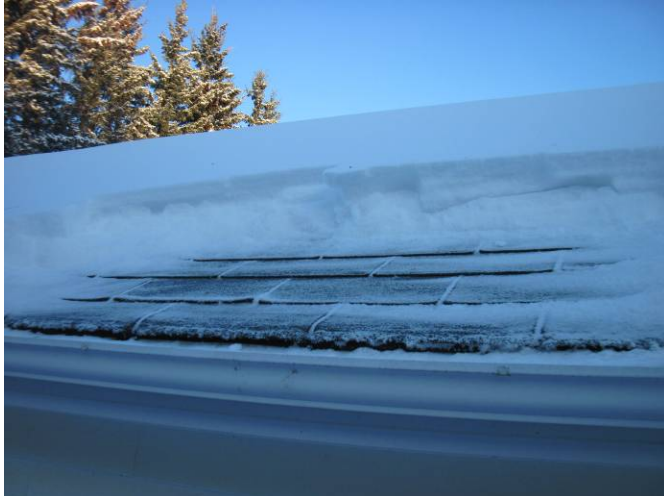
AR-005 – Initial deterioration of asphalt shingles.

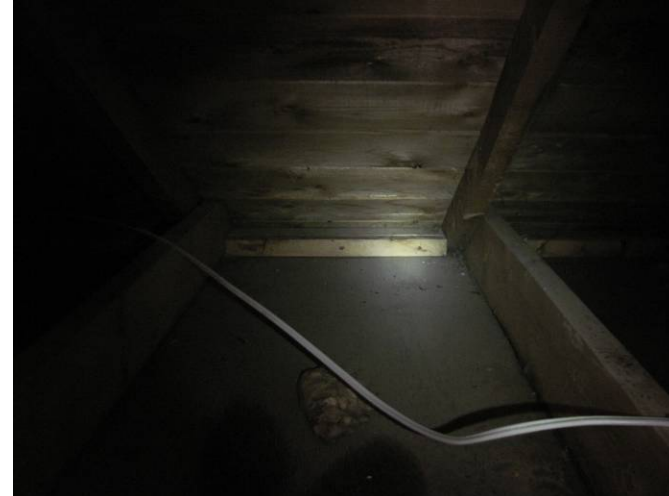
AR-006 – Attic view of uninsulated portion of ceiling.

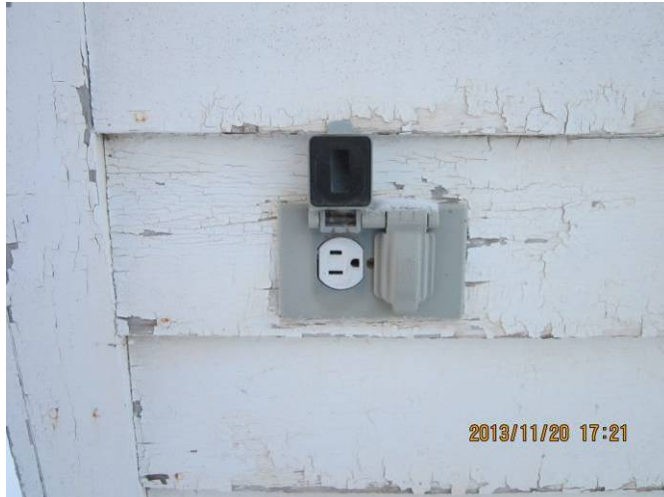
EL-005 – Exterior receptacle to be replaced with GFCI.

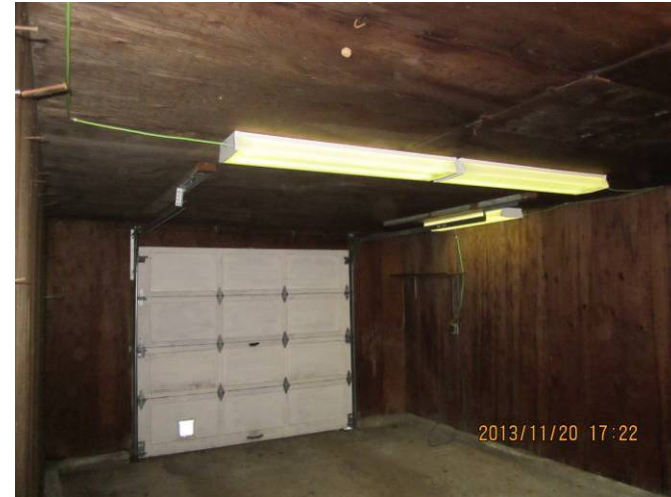
EL-006 – View of extension cord used to wire through light fixtures running across ceiling.

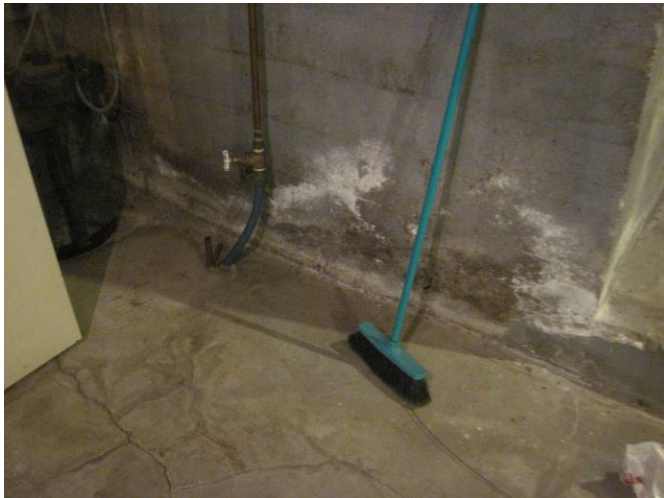
AR-003 – Efflorescence at foundation wall and cracked concrete floor.

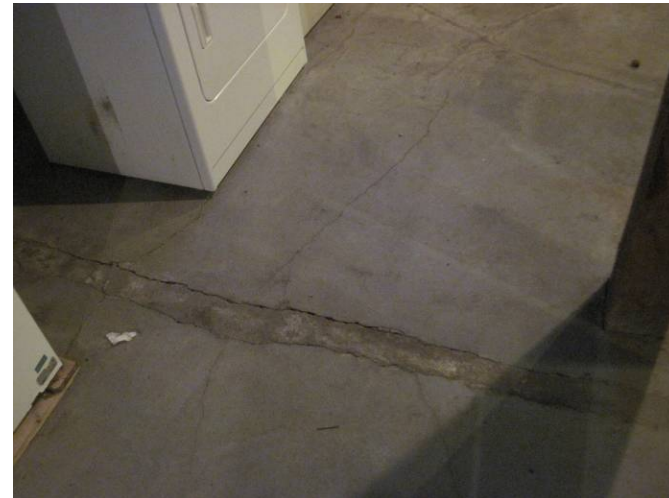
AR-004 – Area of unstable concrete floor.

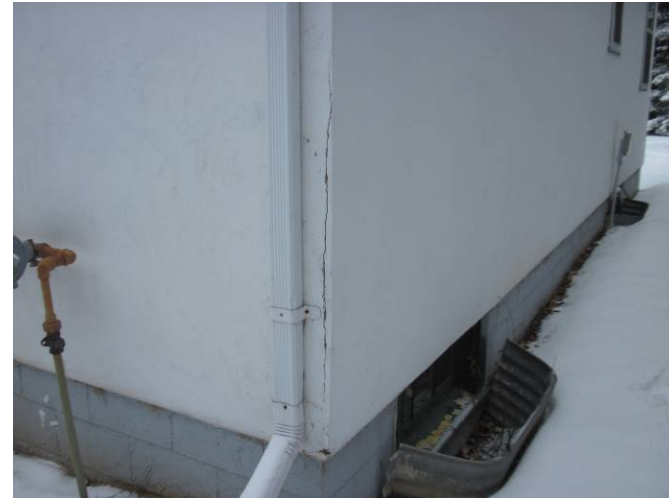
AR-006 – Deteriorated stucco finish.

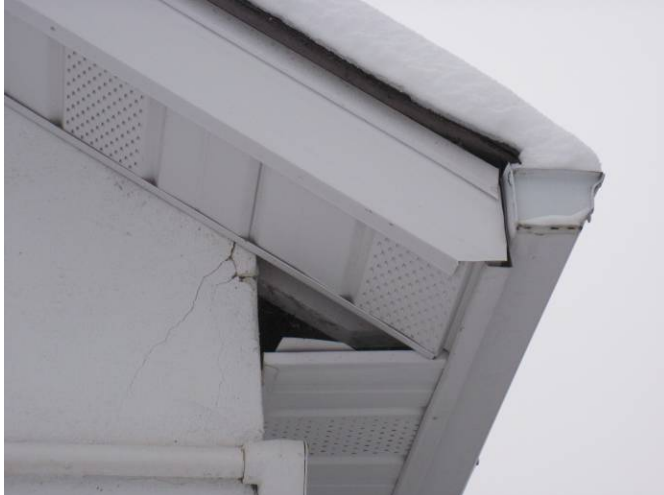
AR-007 – Missing metal soffit piece providing opening to attic space.

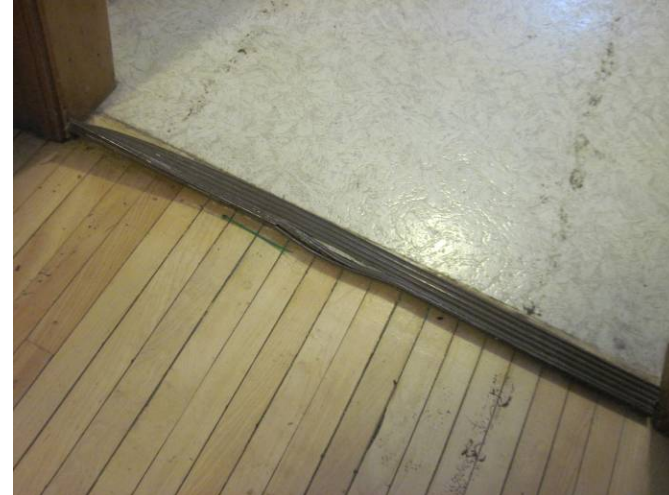
AR-008 – Damaged flooring termination strip.

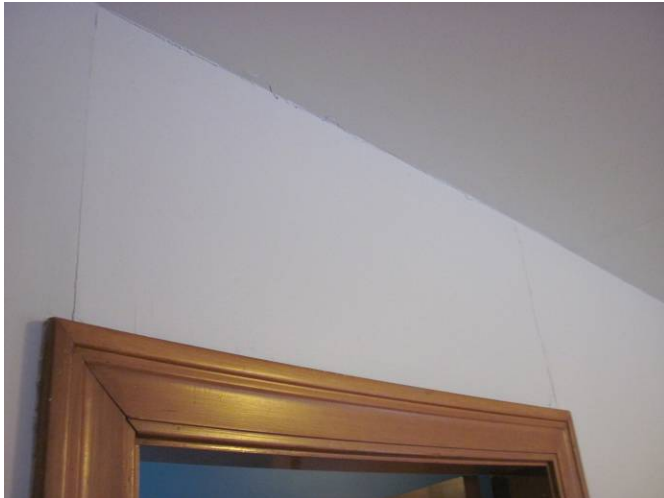
AR-009 – Cracked gypsum board at wall.

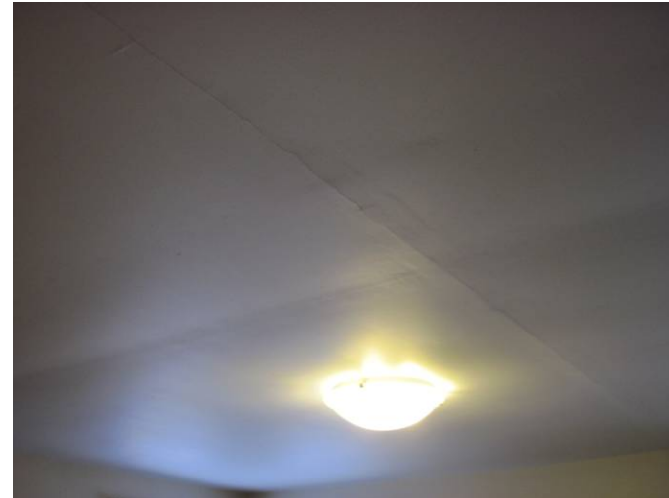
AR-010 – Cracked gypsum board at ceiling.

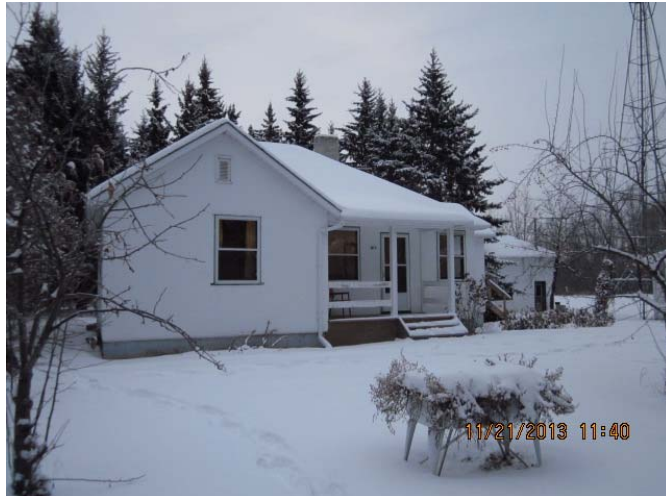
ME-001 – Building M3 view from west side.

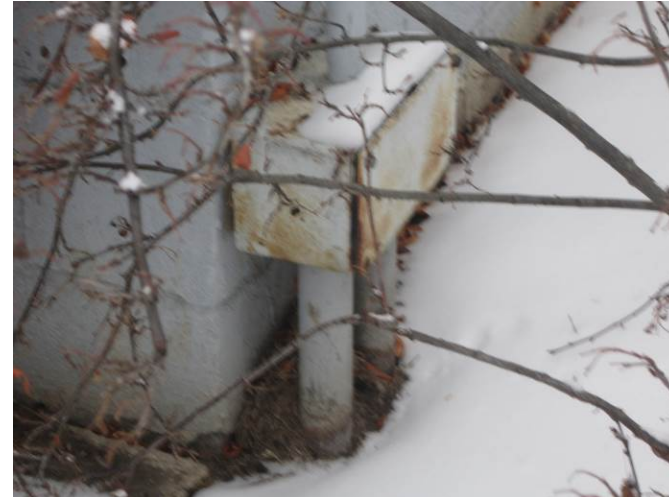
EL-002 – Incoming service junction box showing signs of deterioration, with opening in side allowing water penetration.

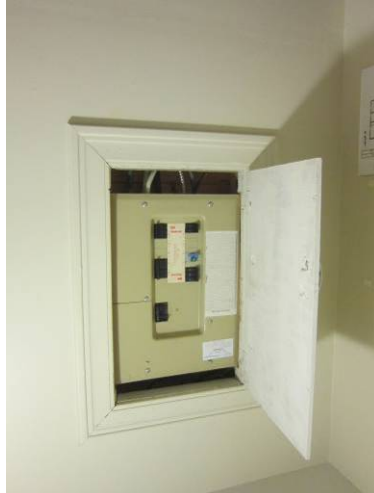
EL-003 – Branch circuit panel recessed in wall at main entrance.

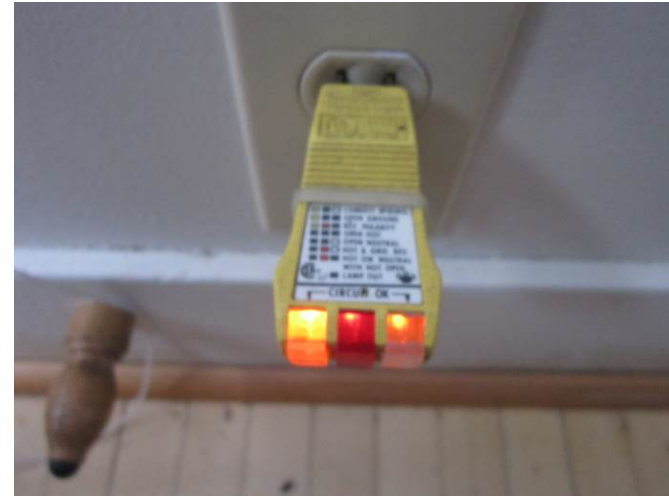
EL-010 – Test of electrical installation indicating missing ground and open neutral.

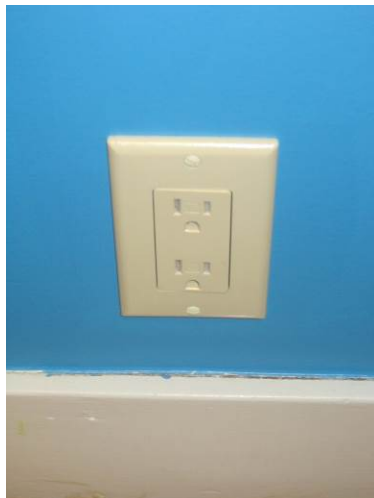
EL-011 – Type of receptacle used in building that are presently incorrectly wired.

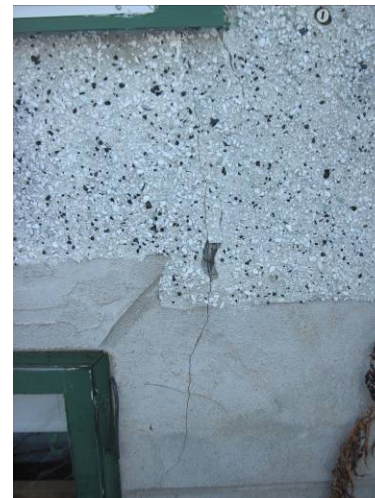
AR-004 – Crack and minor deterioration of stucco finish.

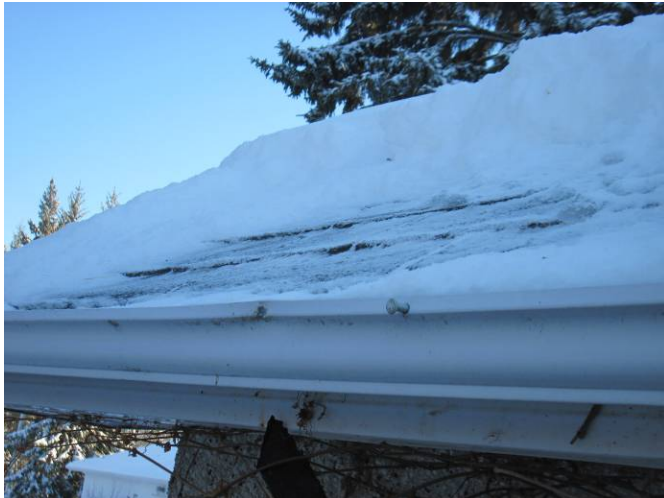
AR-005 – Initial deterioration of asphalt shingles.

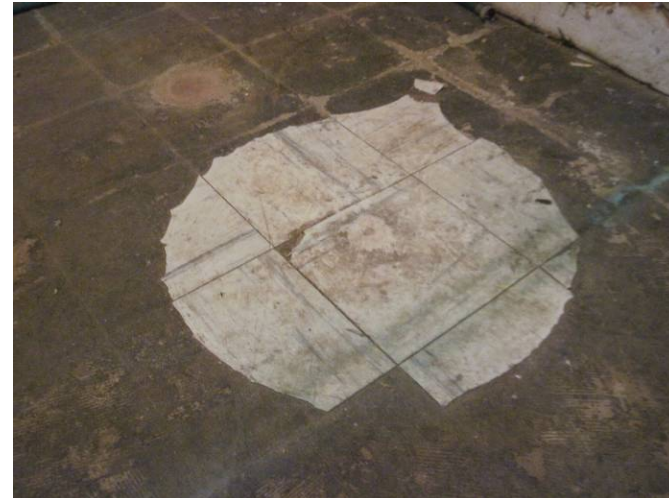
AR-006 – Deteriorated flooring in basement service area.

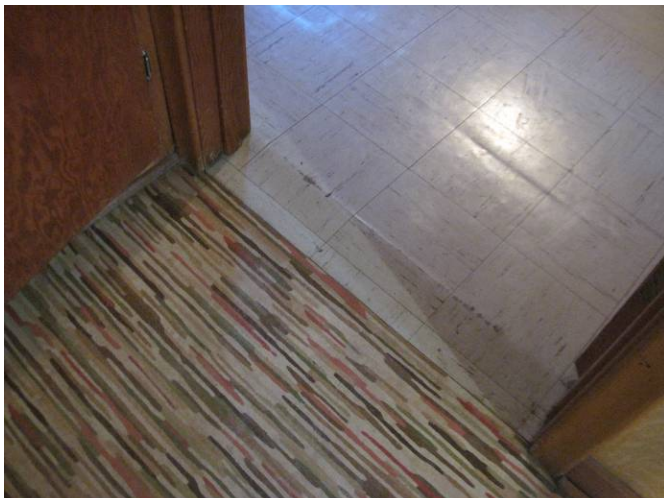
AR-007 – Suspect ACM flooring at basement bedroom/corridor.

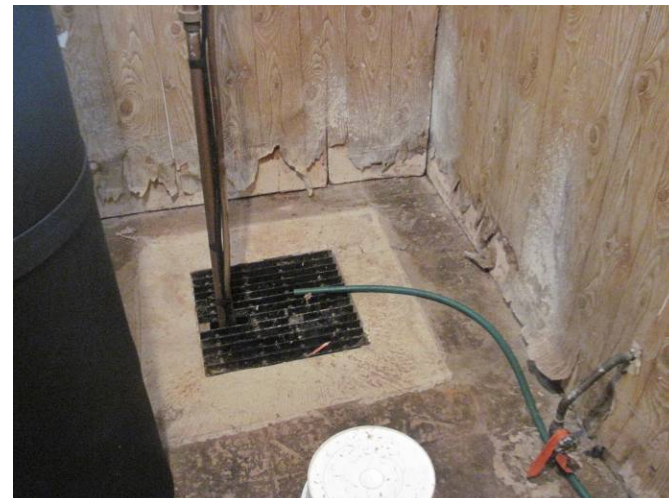
AR-008 – Deteriorated wall finish at basement service area.

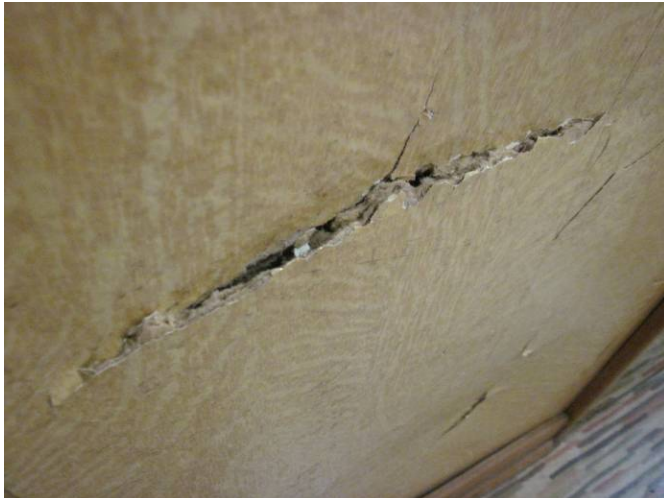
AR-009 – Damaged basement wall in basement corridor.

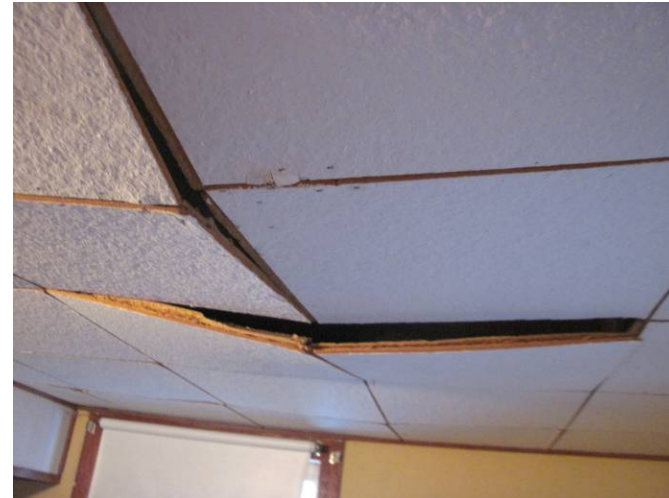
AR-010 – Ceiling falling down in basement bedroom.

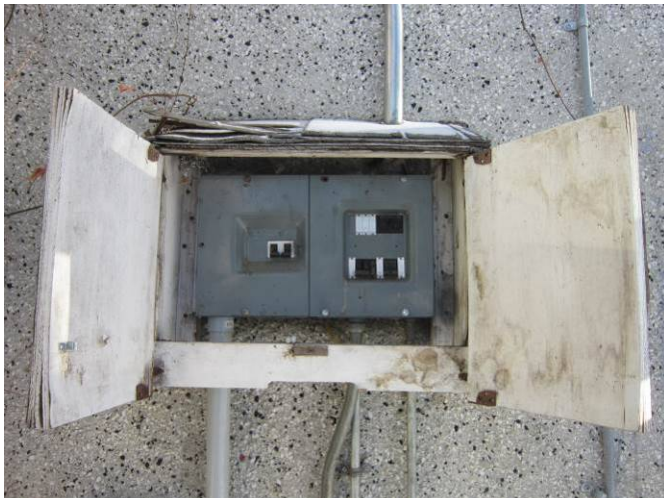
EL-003 – Frontal view and condition of exterior branch circuit panel without panel directory.

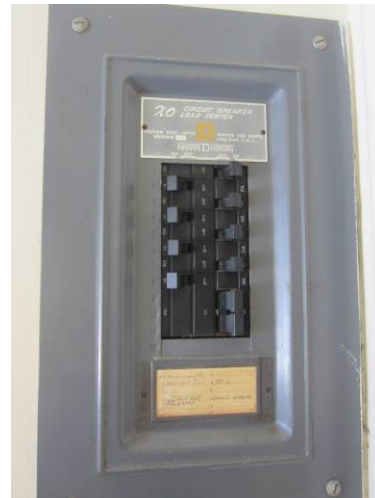
EL-004 – Recessed branch circuit panel in rear entrance hallway with incomplete panel directory and very old circuit breakers.

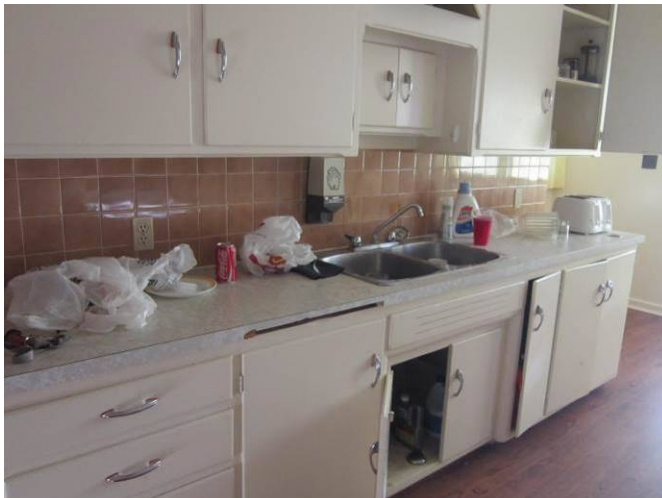
EL-015 – Receptacle within 1 M of kitchen sink to be replaced with GFCI.

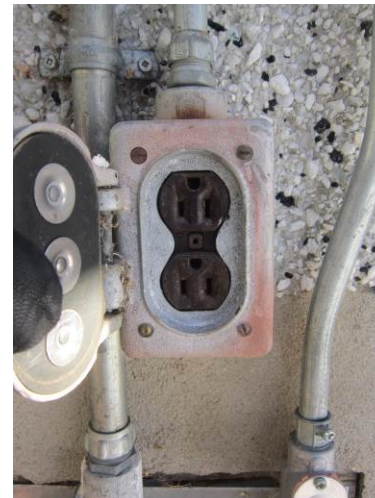
EL-016 – Exterior receptacle to be replaced with GFCI, weatherproof gasket and cover plate, conduit fitting incorrect and not rain tight.

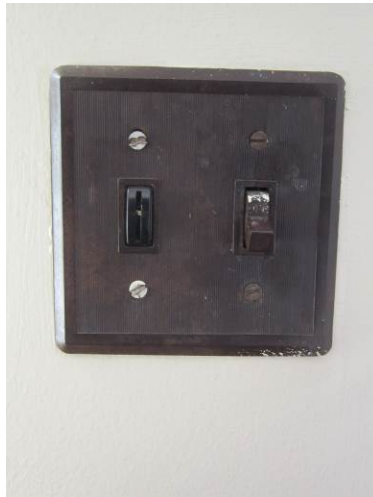
EL-017 – A very old combination key and toggle switch.

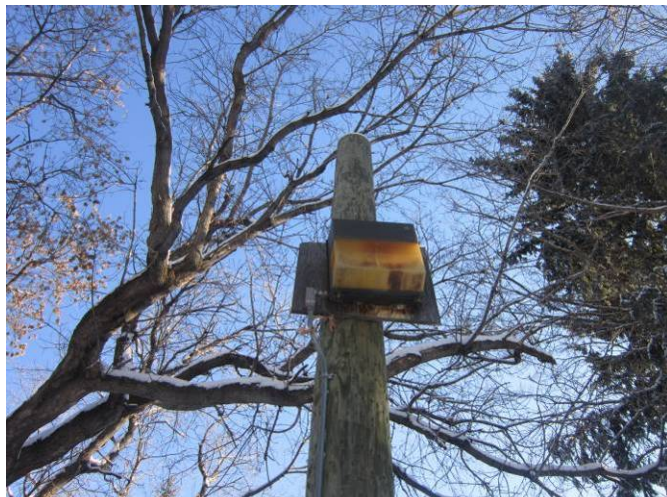
EL-027 – A close view and present condition of exterior pole mounted light with water penetration.

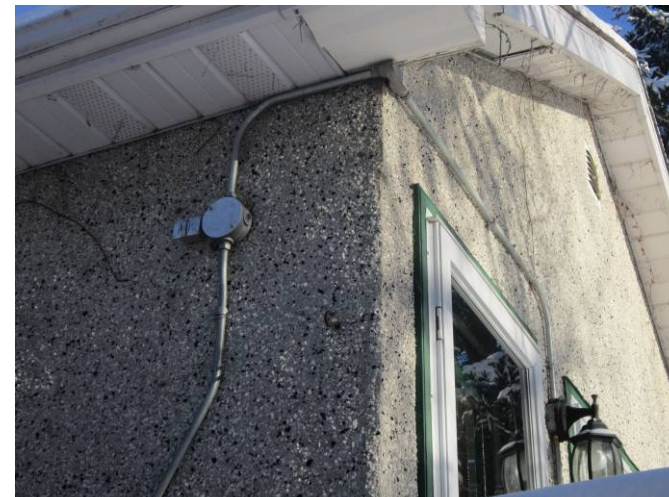
EL-028 – View of photocell that controls exterior lighting

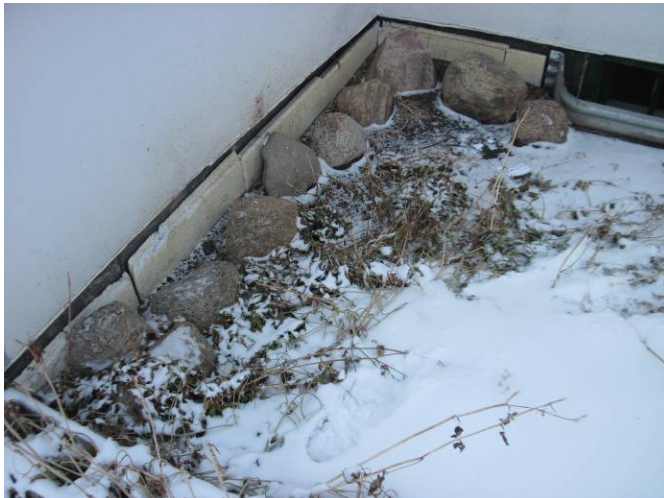
AR-003 – Exposed and deteriorating insulation at foundation perimeter.

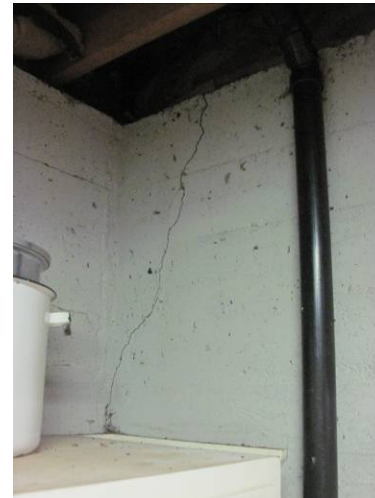
AR-004 – Crack in foundation wall below main entrance.

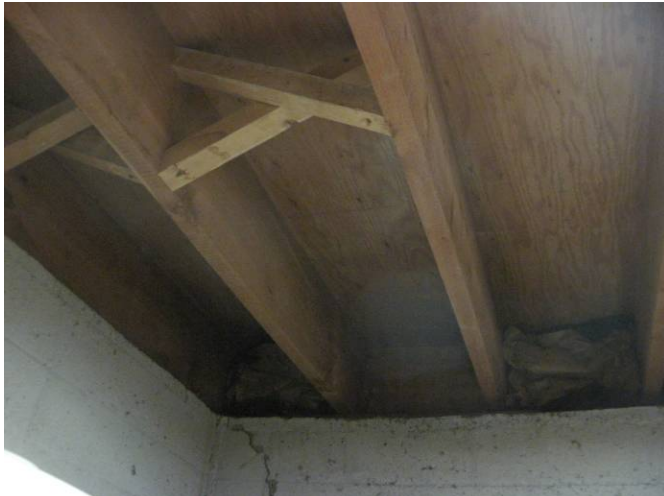
AR-005 – Uninsulated portions of rim joist.

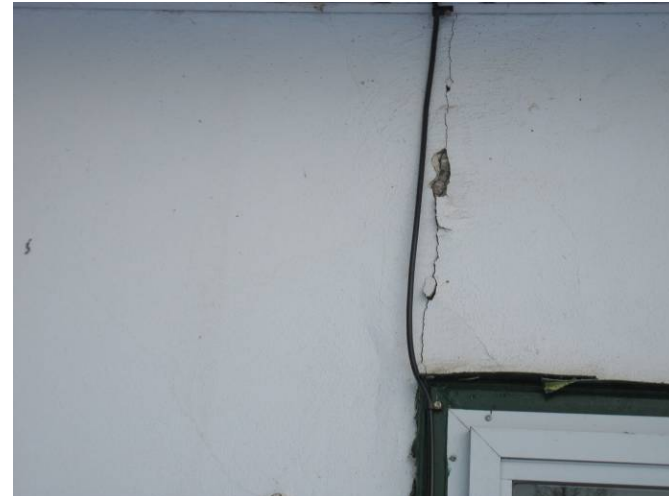
AR-006 – Cracked/broken stucco finish.

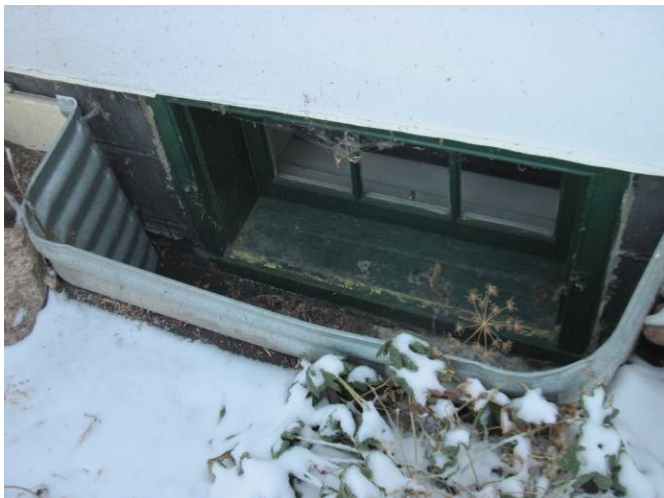
AR-007 – Deteriorated paint finish at wood window,
and uninsulated portion of foundation wall.

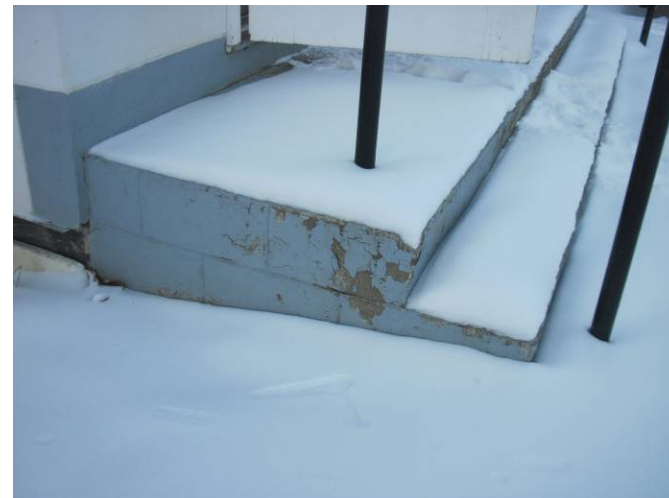
AR-008 – Deteriorated paint finish at concrete entrance landing/steps.

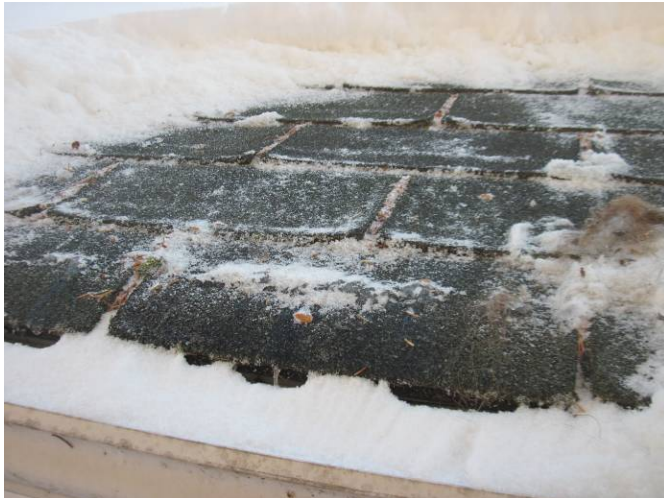
AR-009 – Deteriorating asphalt shingles.

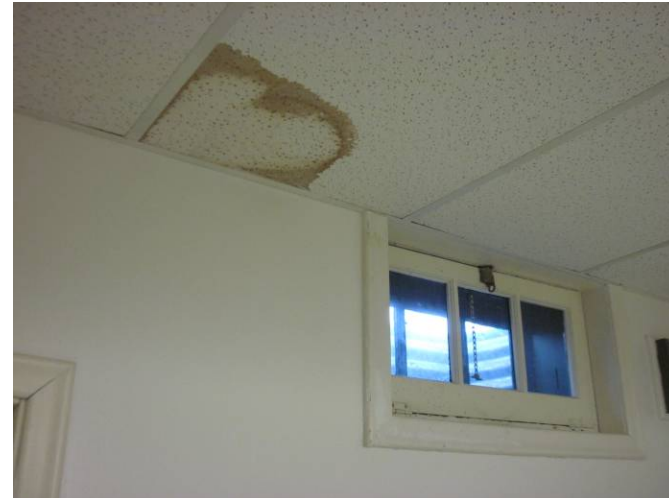
AR-010 – Water stained/damaged tile at basement ceiling below main entrance.

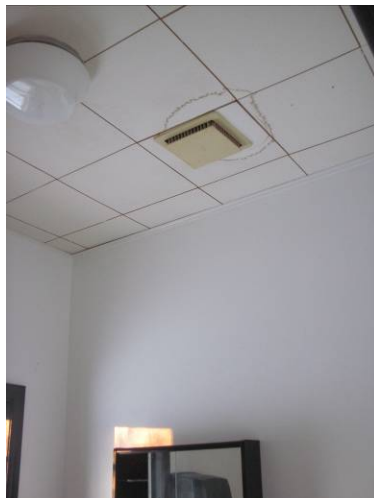
AR-011 – Water stained/damaged tile at ground floor washroom ceiling.

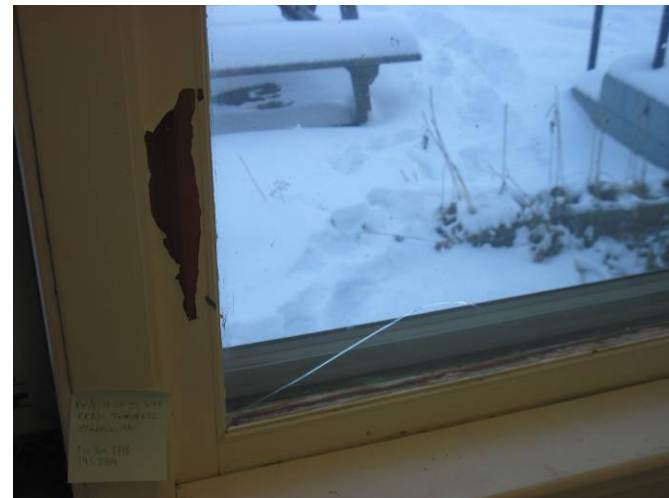
AR-012 – Damaged paint finish and broken glass at window.

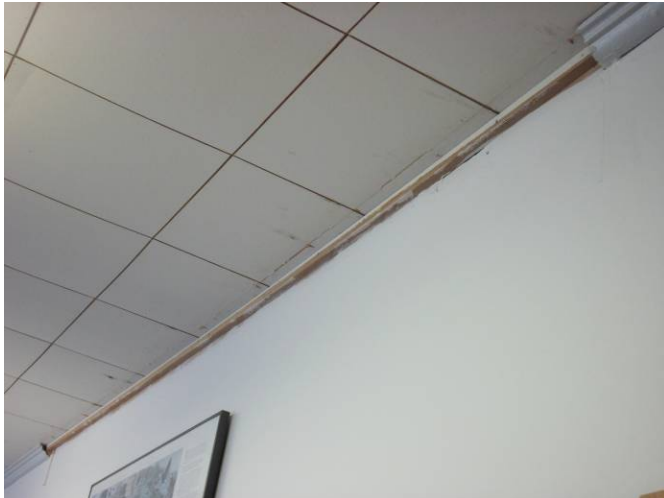
AR-013 – Missing fibreboard crown moulding in lounge.

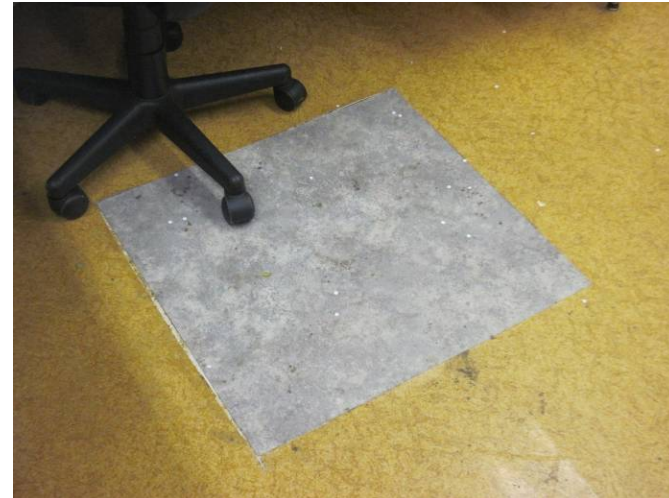
AR-014 – Patched floor finish in office.

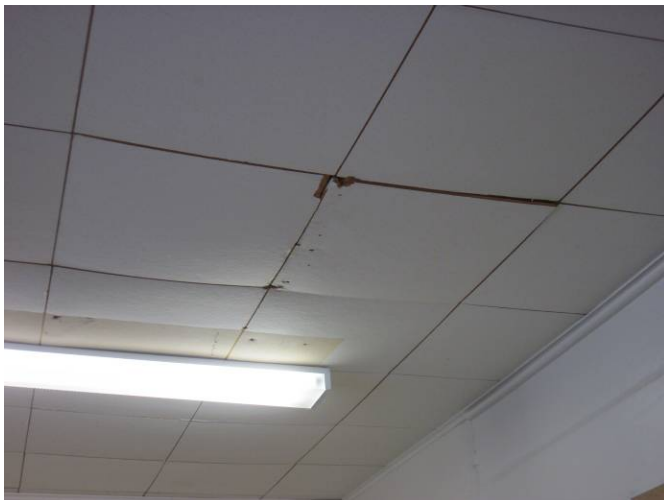
AR-015 – Loose and damaged fibreboard ceiling.

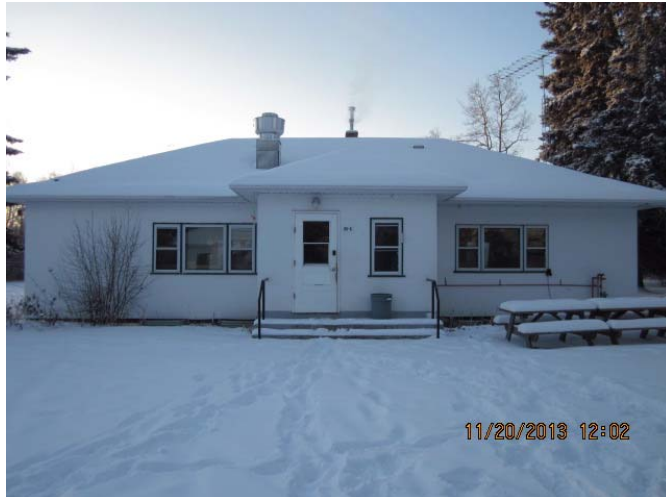
ME-001 – Building M6.

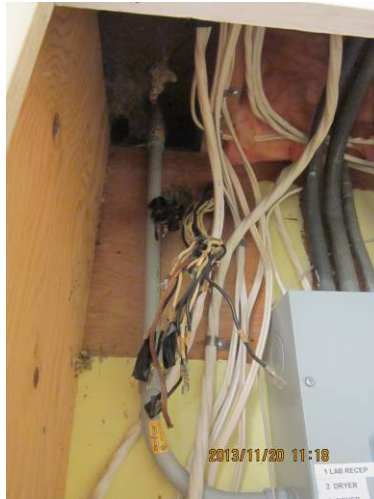
EL-005 – Condition of some of the wiring left hanging by the panel.

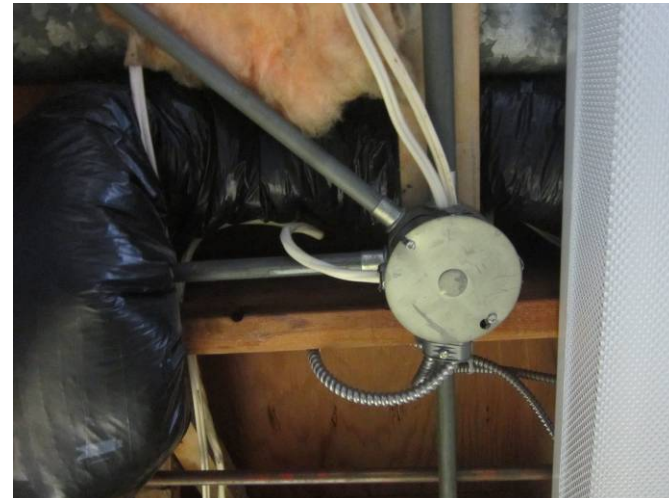
EL-006 – View of an undersized junction in ceiling.

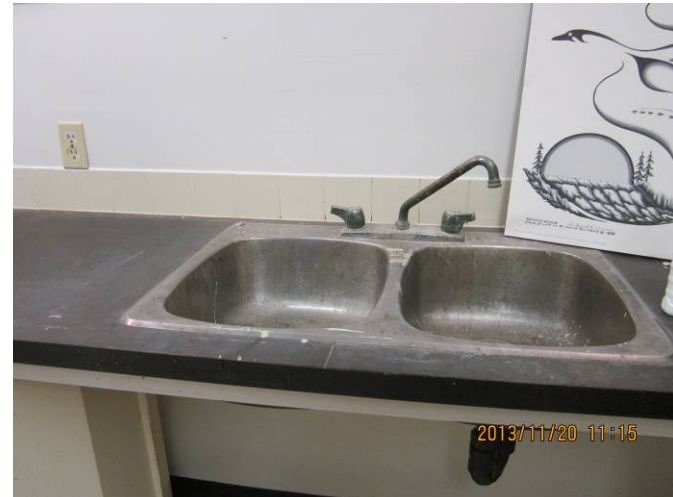
EL-010 – Receptacles within 1 m of sinks to be replaced with GFCI.

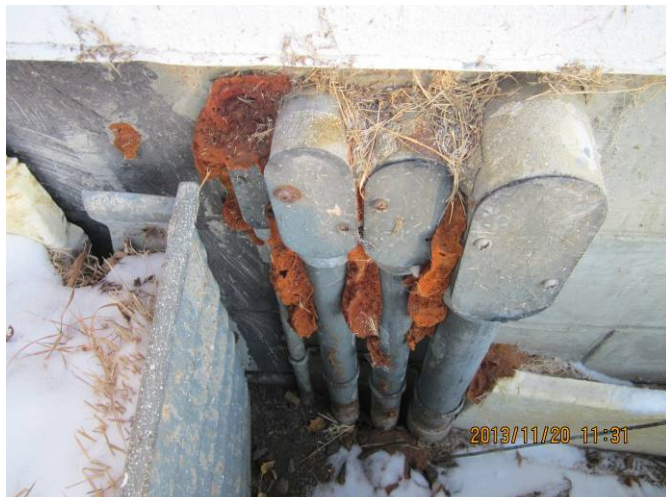
EL-011 – Conduits penetrating wall presently sealed with mono foam is deteriorating, a certified fire retardant material must be used.

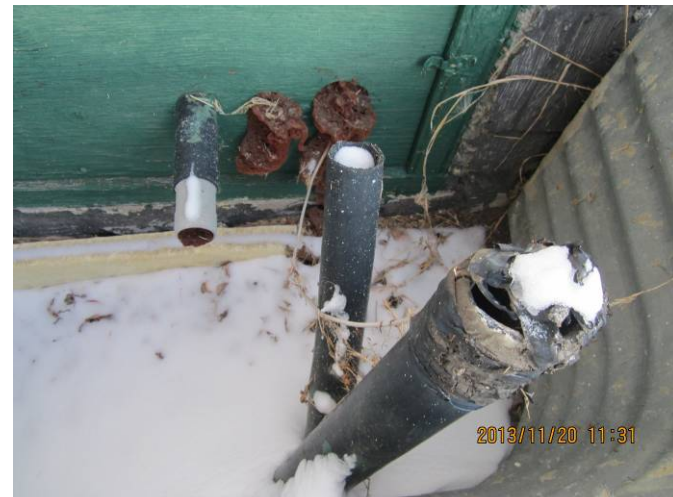
EL-012 – Abandoned conduits to be removed, cut off and holes fire stopped.

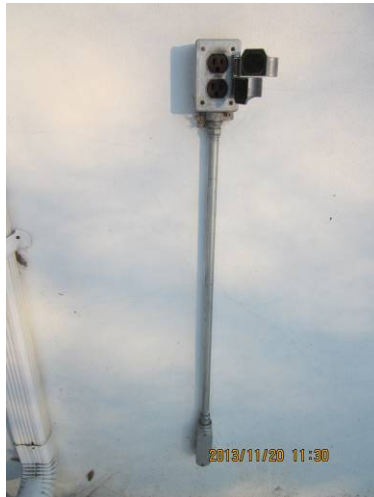
EL-013 – Exterior receptacle to be replaced with GFCI and rainproof cover.

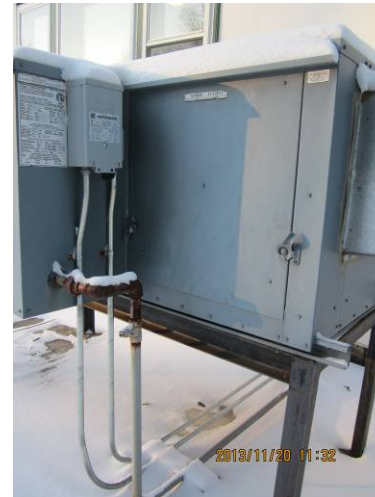
EL-014 – Exterior exhaust fan with local disconnect to be labelled.
