Environment and
Climate Change Canada

Environnement et
Changement climatique Canada

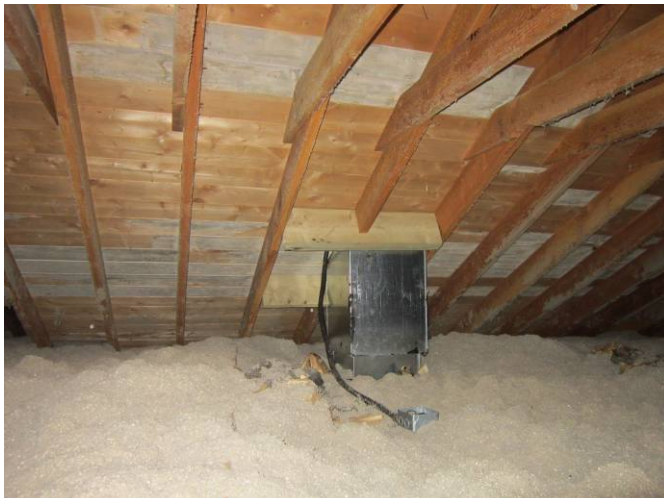
EL-015 – Open junction box above kitchen stove with missing cover plate.

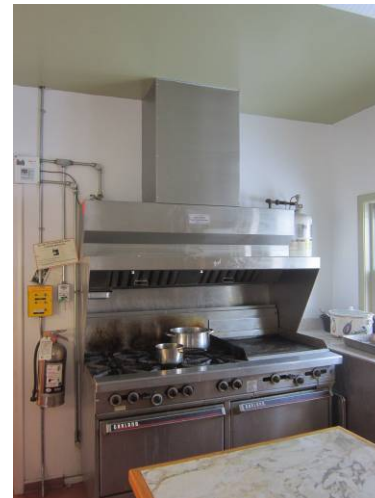
EL-016 – View of kitchen stove with junction box above.

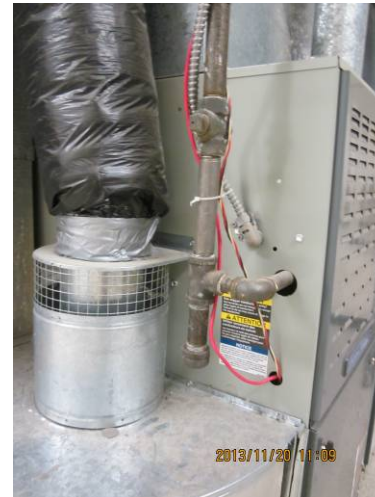
EL-018 – Missing rubber grommet for cables on furnace.

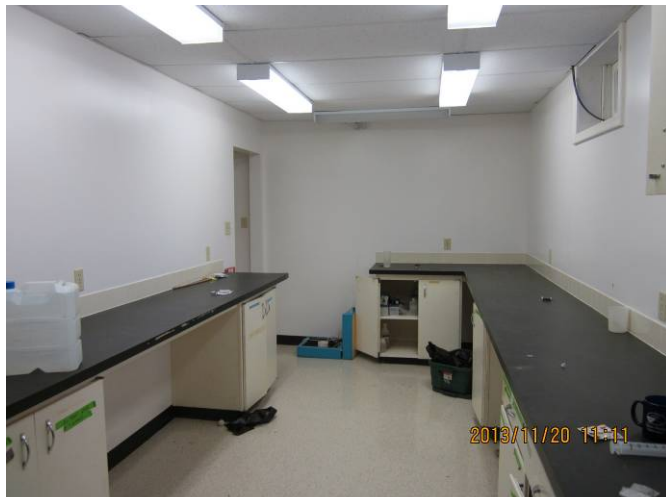
EL-019 – Two-lamp ceiling mounted, wrap-around fluorescent fixtures and cable run through window casing.

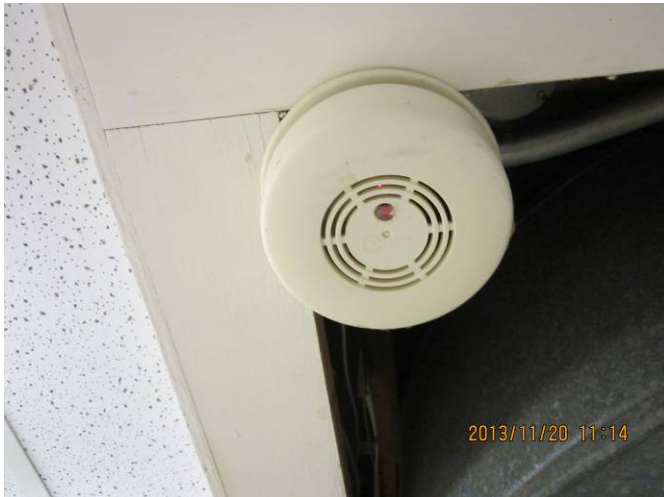
EL-025 – 120 volt smoke alarm to be replaced with combined smoke and carbon monoxide units and dual voltage.

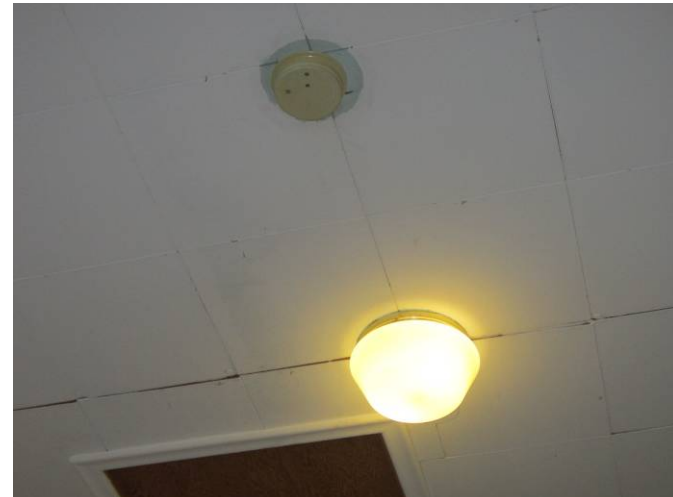
EL-026 – A different style of smoke alarm all to be replaced and interconnected when installing new units.

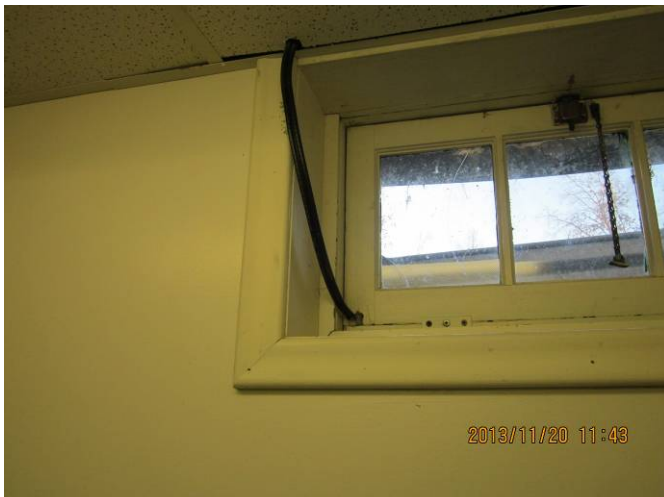
EL-027 – Cable to be re-routed removed from window casing.

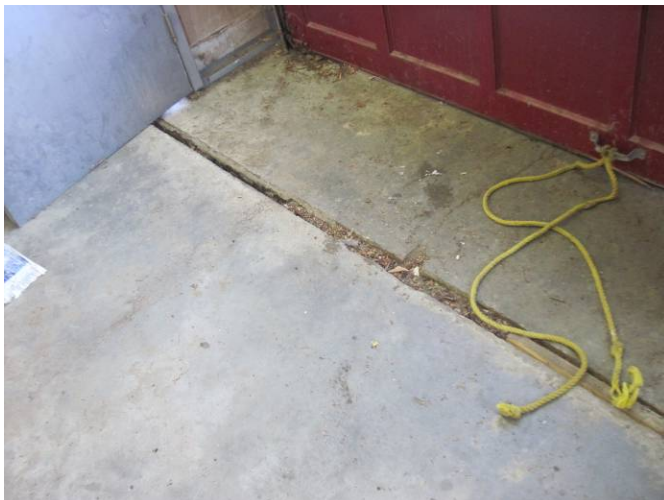
AR-003 – Shifted foundation/floor - binding interior door.

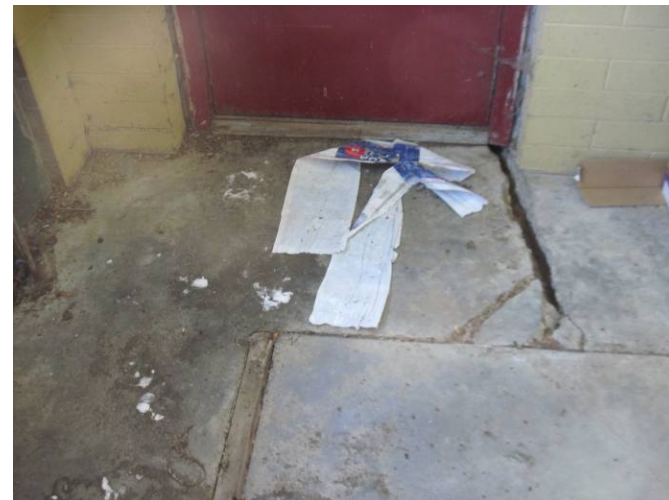
AR-004 – Cracked/shifted foundation at southwest corner.

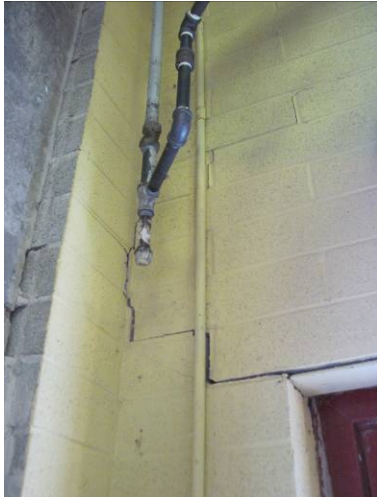
AR-005 - Cracked/shifted concrete block at southwest corner.

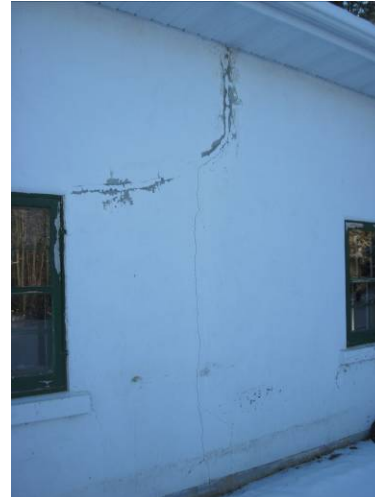
AR-006 – Cracks, including previous repairs, at stucco finish.

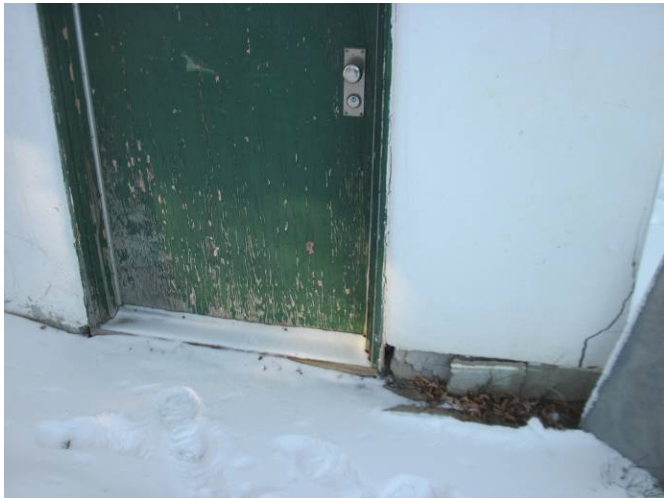
AR-007 – Deteriorated paint finish at door.

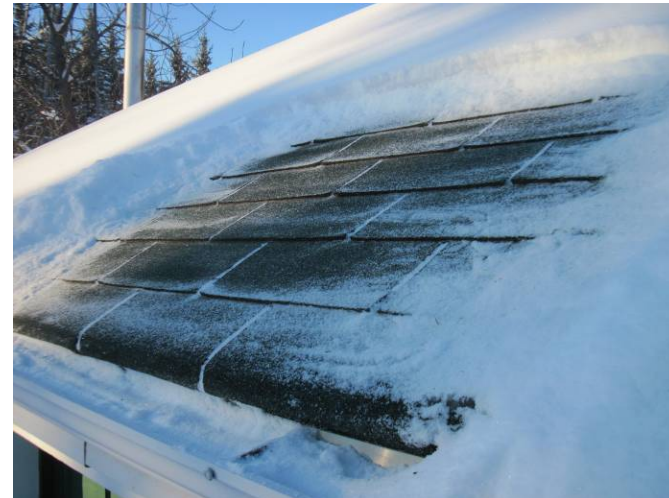
AR-008 – Initial deterioration of asphalt shingles.

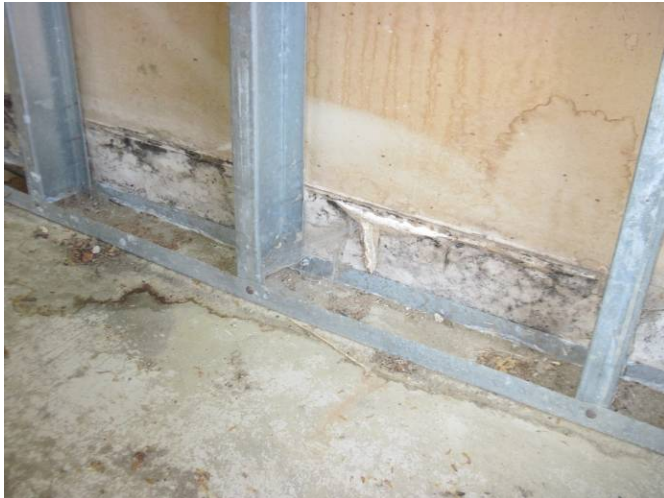
AR-009 – Suspect mould along bottom of interior partition.

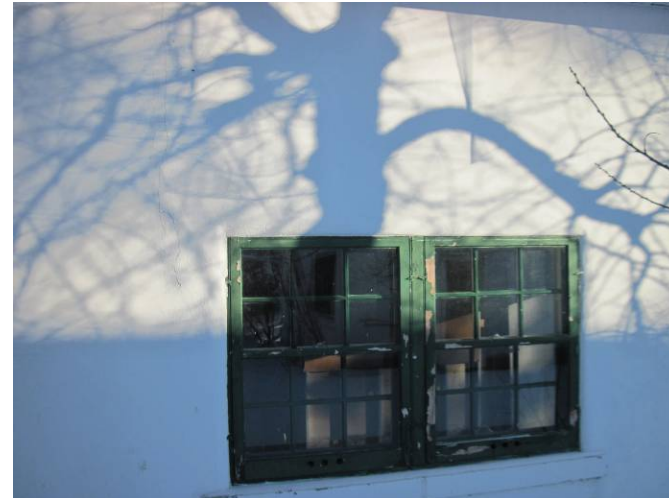
AR-010 – Deteriorated paint finish at window.

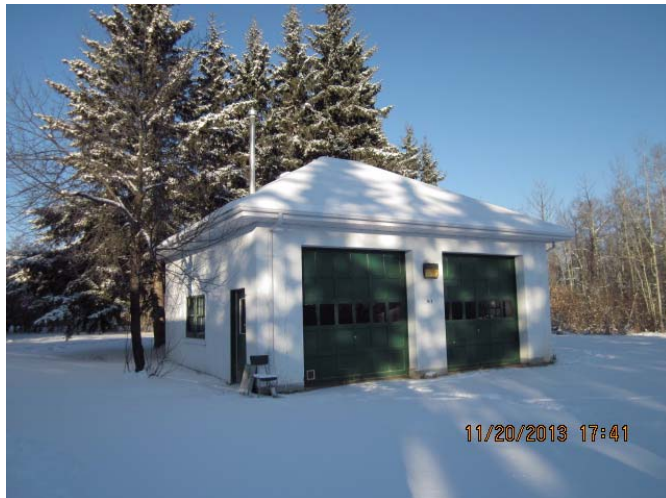
ME-001 – Building M9 view from south side.

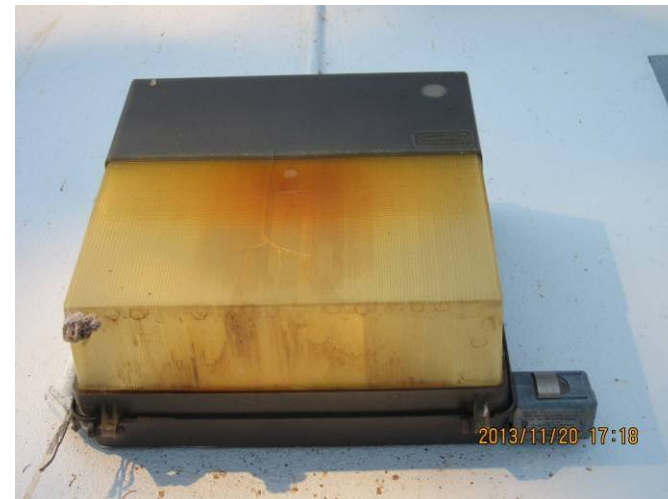
EL-008 – Existing high intensity discharge fixture to be replaced with LED wall pack fixture and photocell.

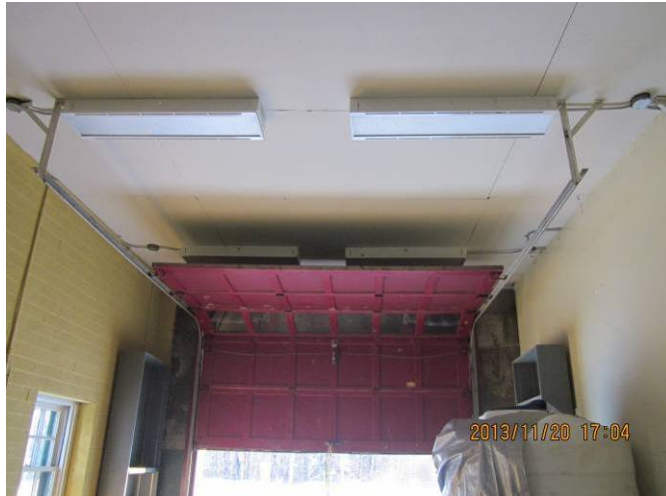
EL-009 – Interior lighting in one half of the building.

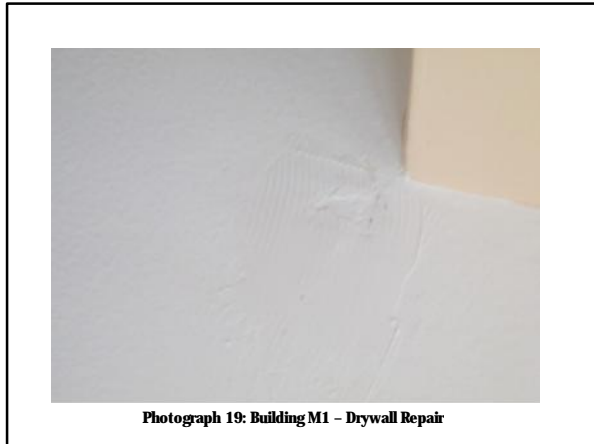
Photograph 19: Building M1 - Drywall Repair

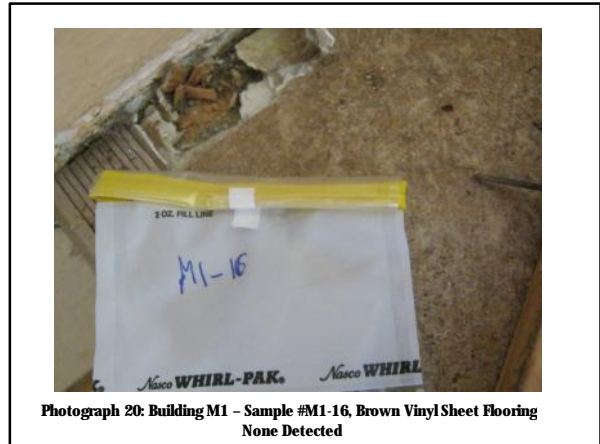
Photograph 20: Building M1 - Sample #M1-16, Brown Vinyl Sheet Flooring
None Detected

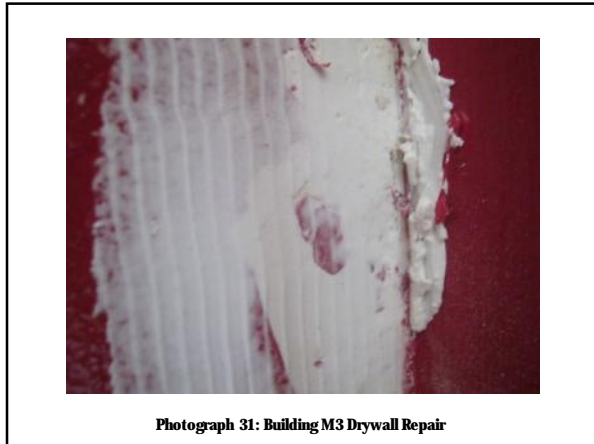
Photograph 31: Building M3 Drywall Repair

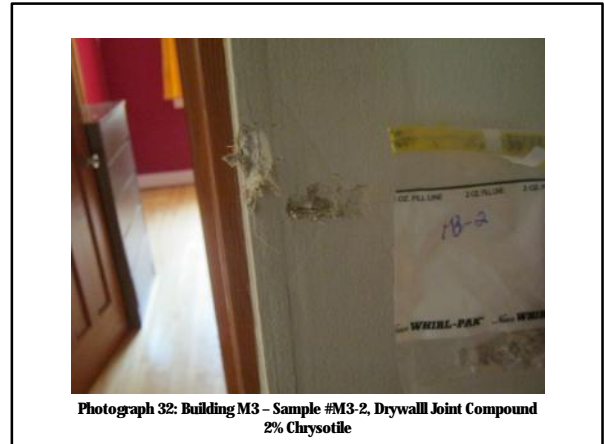
Photograph 32: Building M3 - Sample #M3-2, Drywall Joint Compound
2% Chrysotile

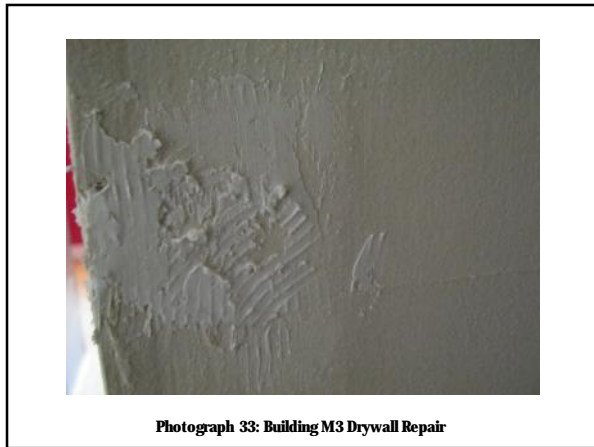
Photograph 33: Building M3 Drywall Repair

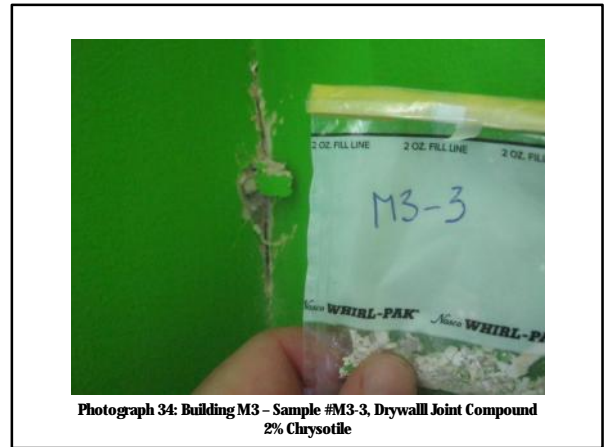
Photograph 34: Building M3 - Sample #M3-3, Drywall Joint Compound
2% Chrysotile

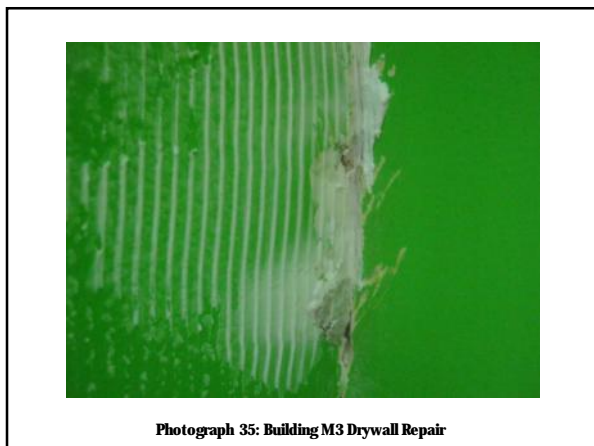
Photograph 35: Building M3 Drywall Repair

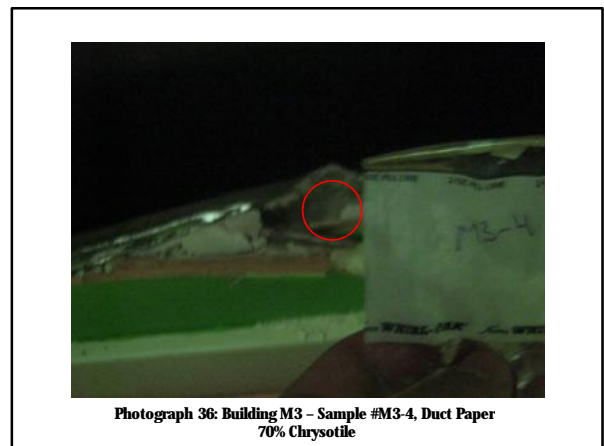
Photograph 36: Building M3 - Sample #M3-4, Duct Paper
70% Chrysotile

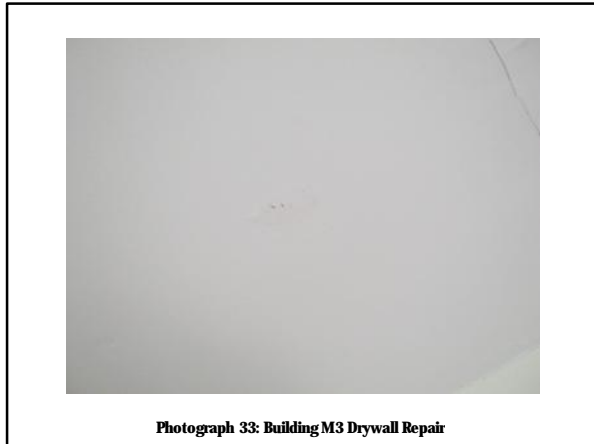
Photograph 33: Building M3 Drywall Repair

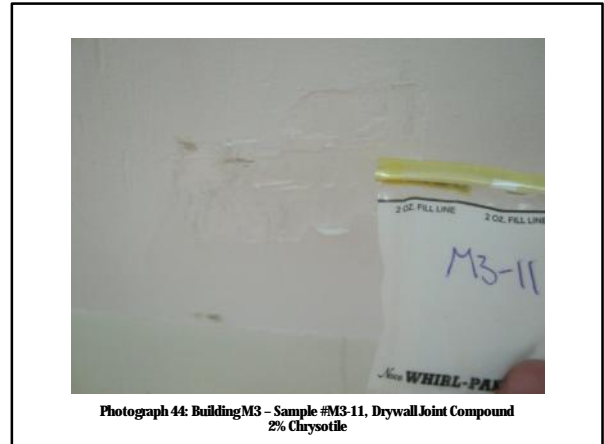
Photograph 44: Building M3 - Sample #M3-11, Drywall Joint Compound 2% Chrysotile

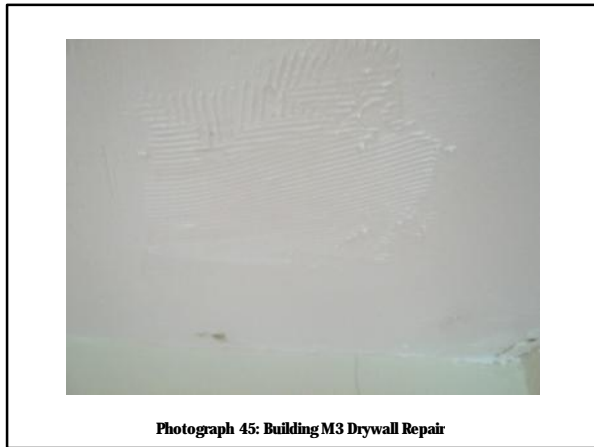
Photograph 45: Building M3 Drywall Repair

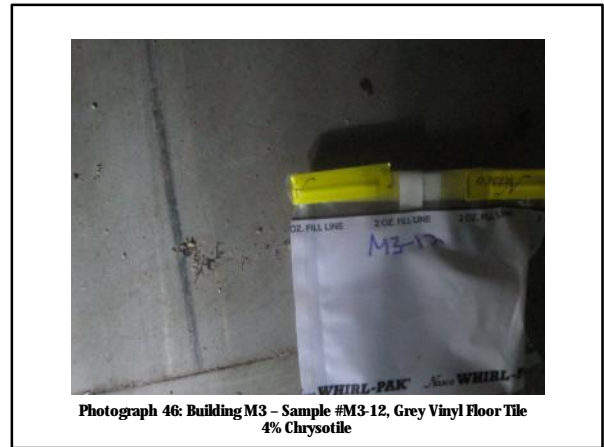
Photograph 46: Building M3 - Sample #M3-12, Grey Vinyl Floor Tile 4% Chrysotile

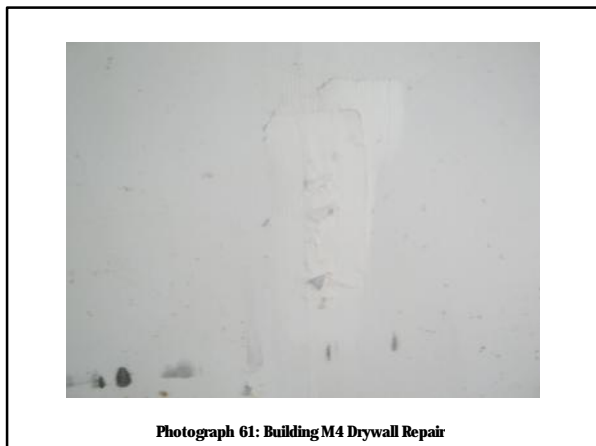
Photograph 61: Building M4 Drywall Repair

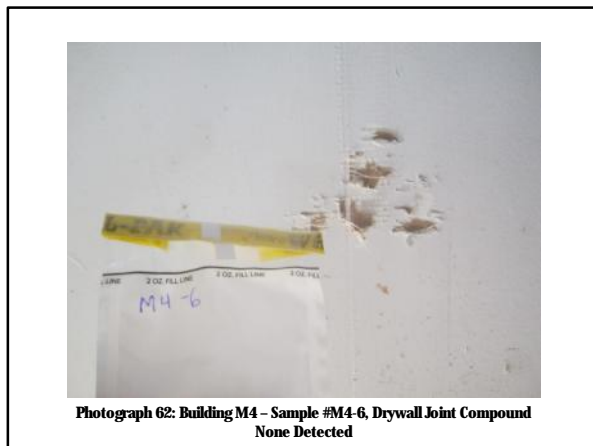
Photograph 62: Building M4 - Sample #M4-6, Drywall Joint Compound
None Detected

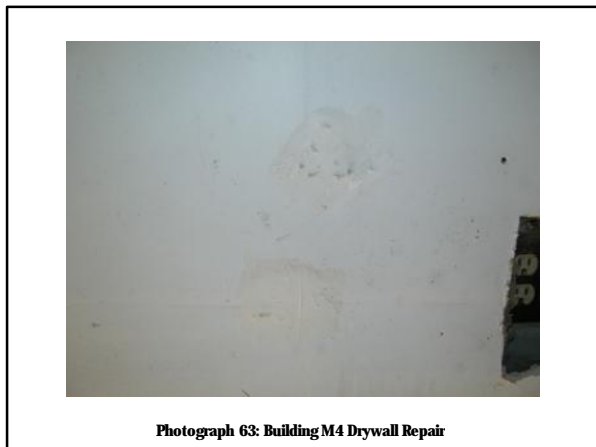
Photograph 63: Building M4 Drywall Repair

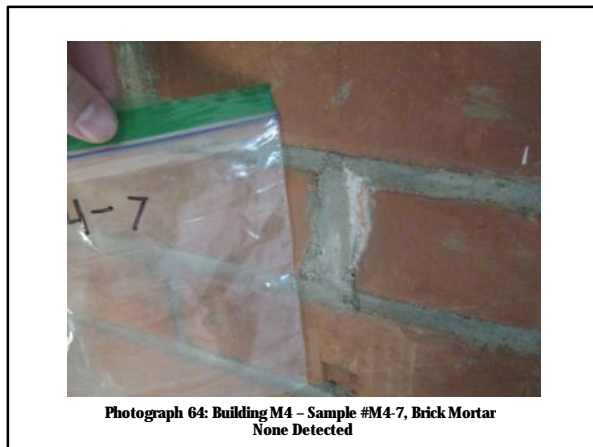
Photograph 64: Building M4 - Sample #M4-7, Brick Mortar
None Detected

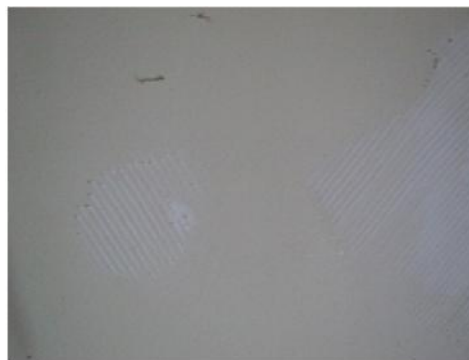
Photograph 74: Building M5 Drywall Repair

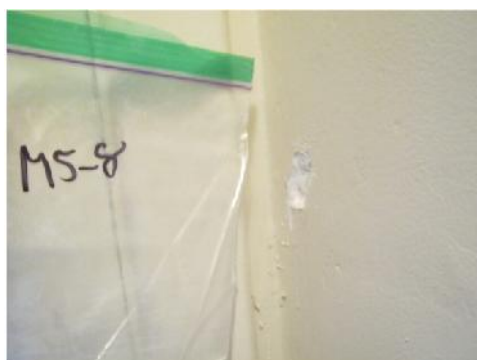
**Photograph 75: Building M5- Sample #M5-8, Drywall Joint Compound
None Detected**

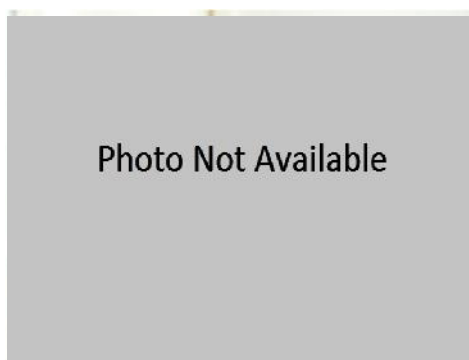
Photograph 76: Building M5 Drywall Repair

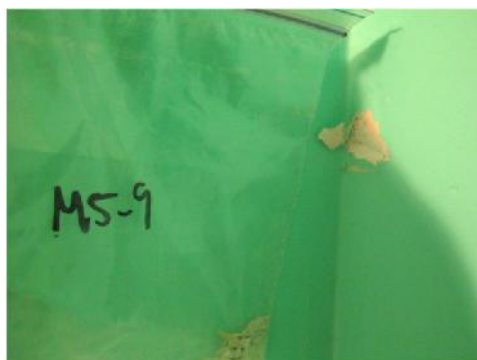
**Photograph 77: Building M5- Sample #M5-9, Drywall Joint Compound
None Detected**

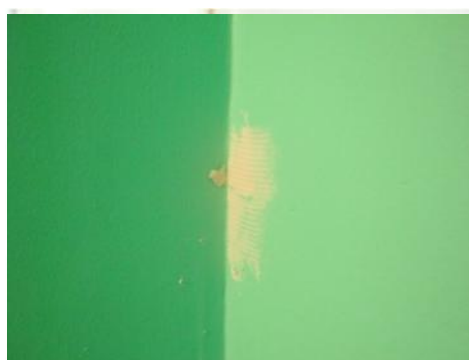
Photograph 78: Building M5 Drywall Repair

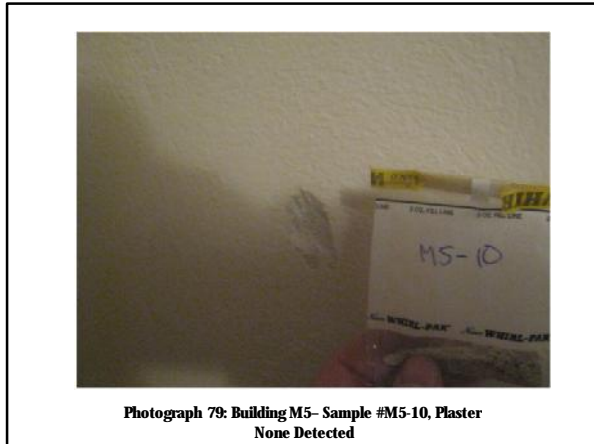
Photograph 79: Building M5- Sample #M5-10, Plaster
None Detected

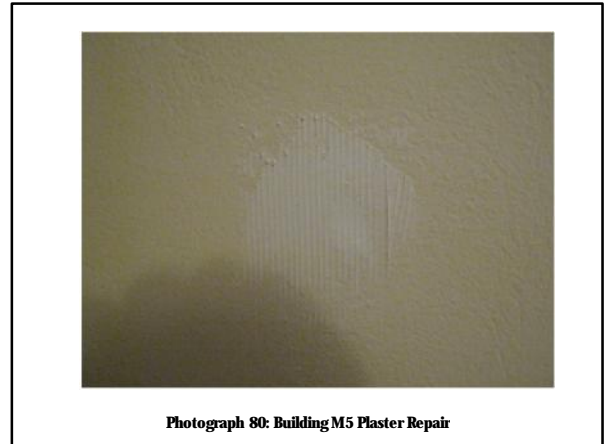
Photograph 80: Building M5 Plaster Repair

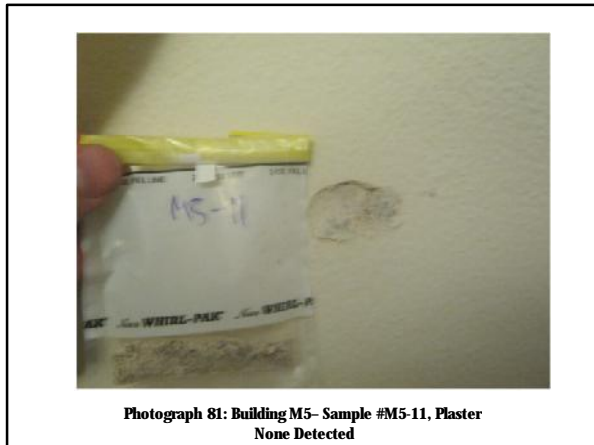
Photograph 81: Building M5- Sample #M5-11, Plaster
None Detected

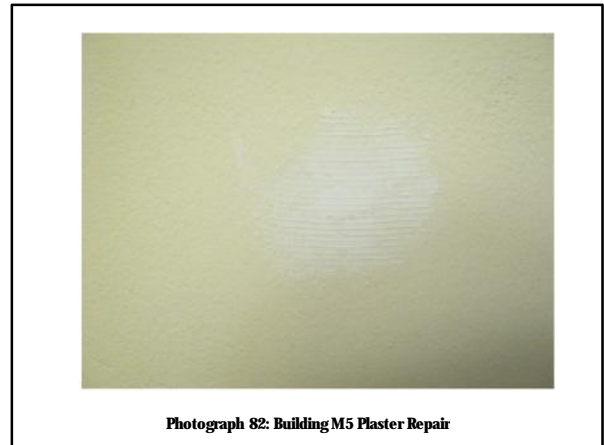
Photograph 82: Building M5 Plaster Repair

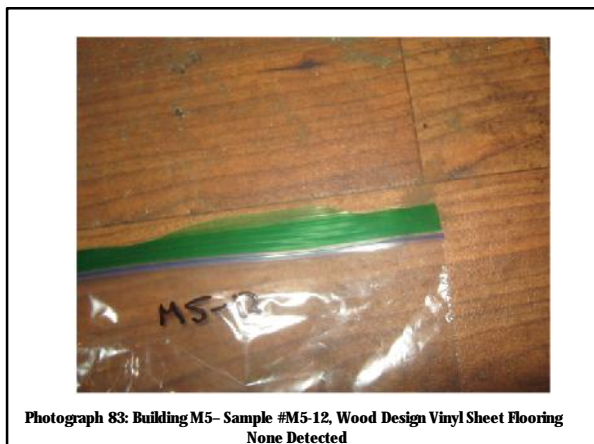
Photograph 83: Building M5- Sample #M5-12, Wood Design Vinyl Sheet Flooring
None Detected

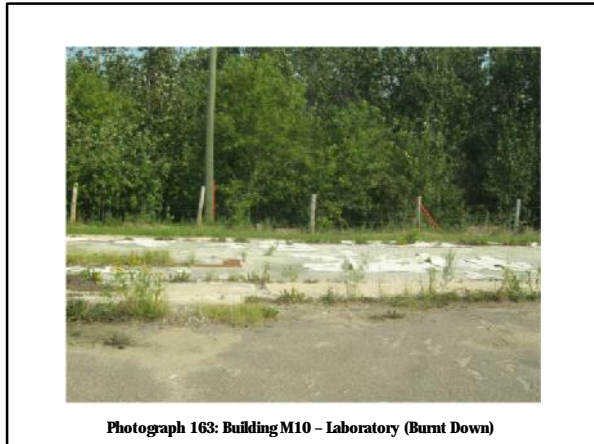
Photograph 163: Building M10 - Laboratory (Burnt Down)

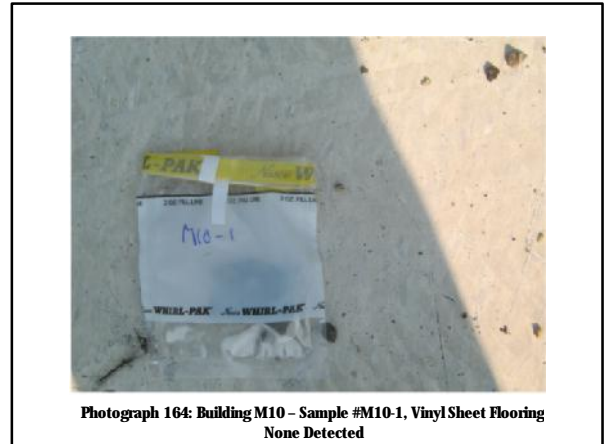
Photograph 164: Building M10 - Sample #M10-1, Vinyl Sheet Flooring
None Detected
