GESTION DES MATIÈRES DANGEREUSES

NGCC PIERRE RADISSON

RAPPORT FINAL

PROJET N° : 171-09529-52
DATE : NOVEMBRE 2019

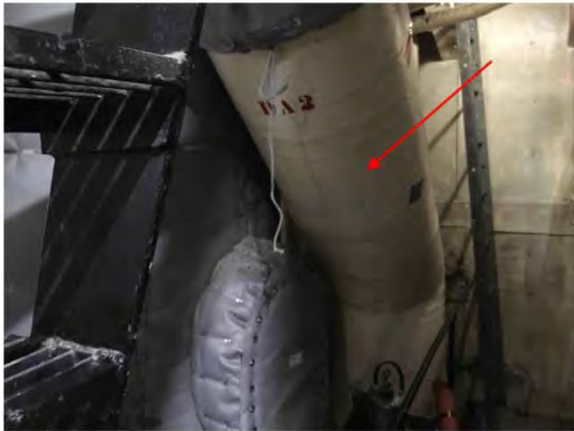
119 Tuyauterie
Échappement — Génératrice — Irrégulière et rectiligne — Magnésie
+canevas+pâte cimentaire — 33 po. — 0 m. lin. — Navigation — Accès salle des
machines — 211 — Pastille 107
Alexandre.Caza - 2017-06-30 09:00

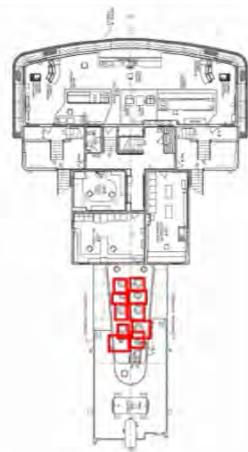
119 Tuyauterie
Échappement — Génératrice — Irrégulière et rectiligne — Magnésie
+canevas+pâte cimentaire — 33 po. — 0 m. lin. — Navigation — Accès salle des
machines — 211 — Pastille 107
Alexandre.Caza - 2017-06-30 09:03

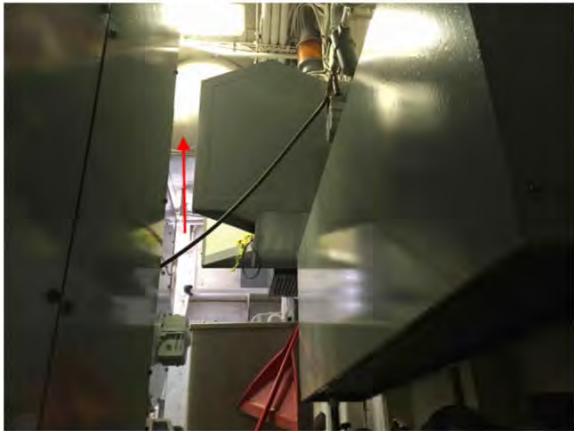
104

Tuyauterie
Échappement — Génératrice d'urgence — Irrégulière et rectiligne — Canevas et magnésie — 22 po. — 12 m. lin. — Officiers — Salle des génératrices — 319 — N/A
Alexandre.Caza - 2017-06-29 12:58

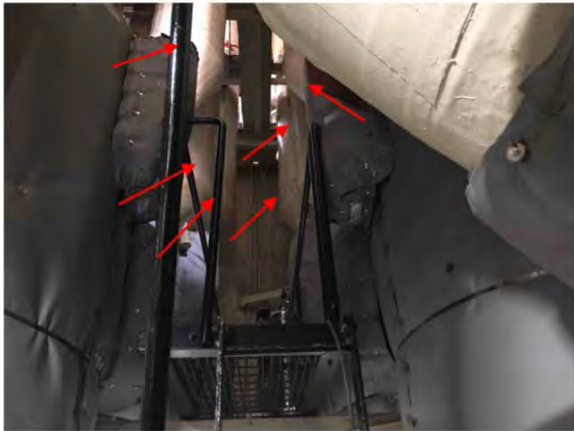
108 Tuyauterie
Échappement — Moteur — Irrégulière et rectiligne — Canevas+pâte cimentaire +magnésie — 33 po. — 72 m. lin. — Officiers — Salle des cheminées — 0 — Pastille 107
Alexandre.Caza - 2017-06-29 13:16

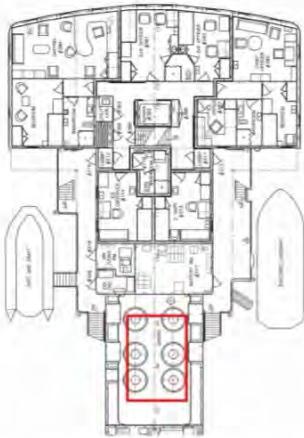
108 Tuyauterie
Échappement — Moteur — Irrégulière et rectiligne — Canevas+pâte cimentaire +magnésie — 33 po. — 72 m. lin. — Officiers — Salle des cheminées — 0 — Pastille 107
Alexandre.Caza - 2017-06-29 13:17

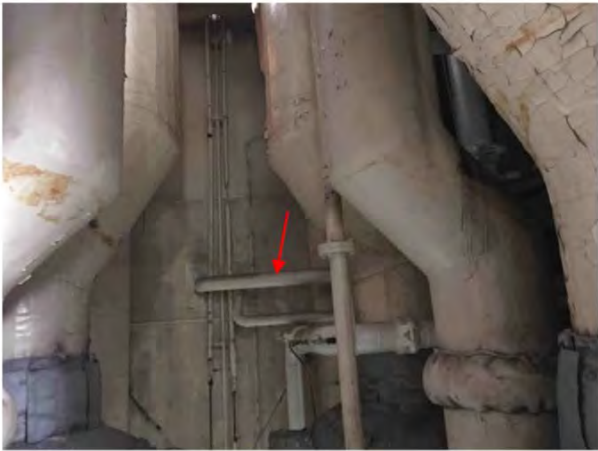
110 Tuyauterie
Vapeur (alimentation) — Rectiligne — Magnésie — 5 po. — 3 m. lin. — Officiers — Salle des cheminées — 0 — Pastille 5
Alexandre.Caza - 2017-06-29 13:21

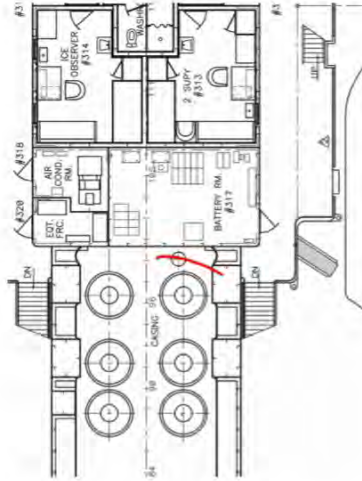
110 Tuyauterie
Vapeur (alimentation) — Rectiligne — Magnésie — 5 po. — 3 m. lin. — Officiers — Salle des cheminées — 0 — Pastille 5
Alexandre.Caza - 2017-06-29 13:31

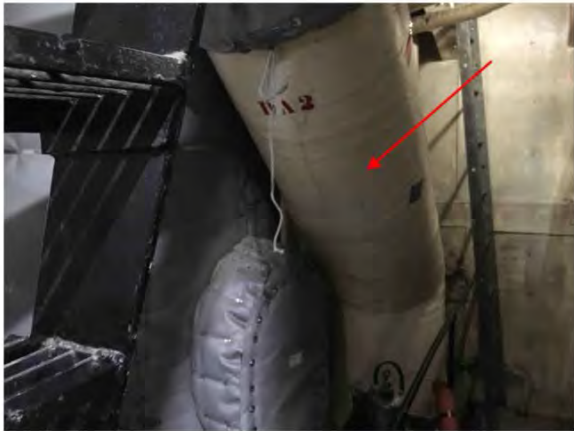
107 Tuyauterie
Échappement — Génératrice — Irrégulière et rectiligne — Magnésie +canevas+pâte cimentaire — 33 po. — 10 m. lin. — Embarcations — Salle des machines — 409 — N/A
Alexandre.Caza - 2017-06-29 13:12

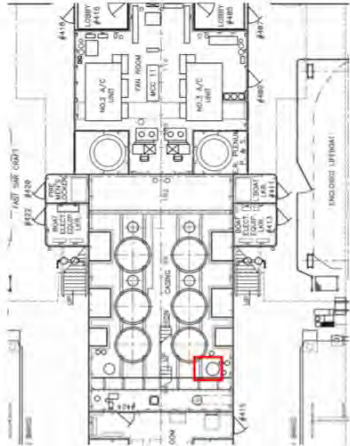
107 Tuyauterie
Échappement — Génératrice — Irrégulière et rectiligne — Magnésie +canevas+pâte cimentaire — 33 po. — 10 m. lin. — Embarcations — Salle des machines — 409 — N/A
Alexandre.Caza - 2017-06-29 13:12

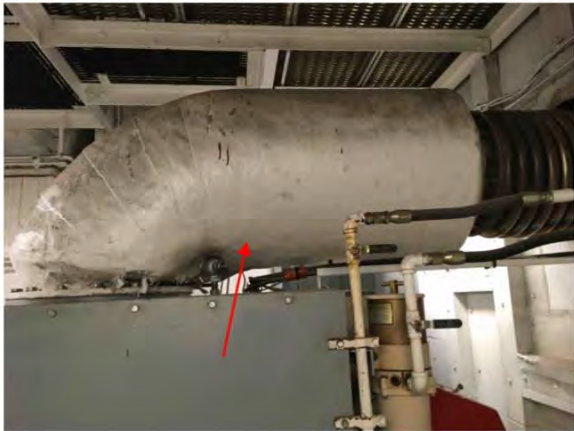
120 Tuyauterie
Échappement — Incinérateur — Irrégulière et rectiligne — Canevas et pâte cimentaire et magnésie — 22 po. — 0 m. lin. — Embarcations — Salle des machines — 409 — Pastille 34
Alexandre.Caza - 2017-06-30 09:11

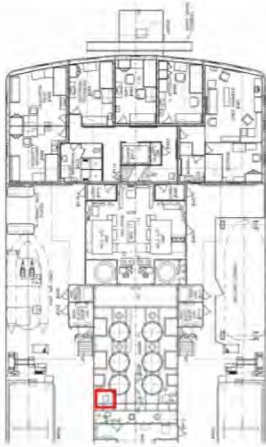
120 Tuyauterie
Échappement — Incinérateur — Irrégulière et rectiligne — Canevas et pâte cimentaire et magnésie — 22 po. — 0 m. lin. — Embarcations — Salle des machines — 409 — Pastille 34
Alexandre.Caza - 2017-06-30 09:13

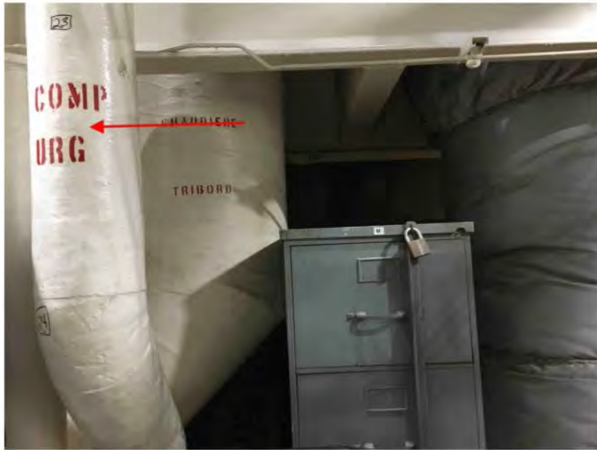
36 Tuyauterie
Échappement — Moteur — Rectiligne — Magnésie — 5 po. — 2 m. lin. — Supérieur — Salle des machines — 0 — Pastille 23
Alexandre.Caza - 2017-06-28 15:22

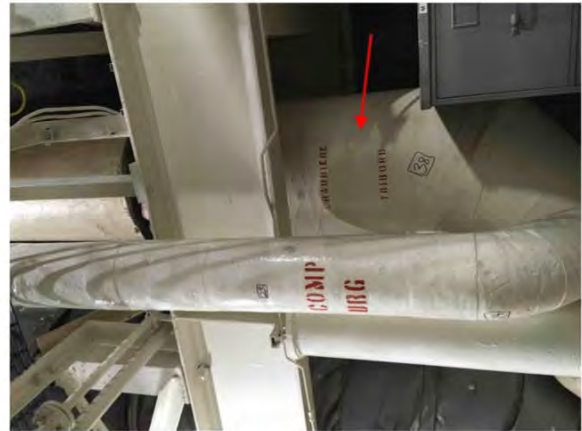
38 Tuyauterie
Échappement — Chaudière tribord — Irrégulière et rectiligne — Pâte cimentaire, magnésie et canevas — 22 po. — 28 m. lin. — Supérieur — Salle des machines — 0 — N/A
Alexandre.Caza - 2017-06-28 15:28

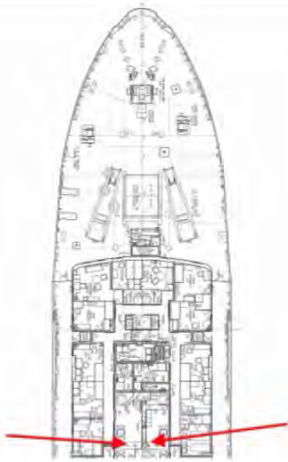
38 Tuyauterie
Échappement — Chaudière tribord — Irrégulière et rectiligne — Pâte cimentaire, magnésie et canevas — 22 po. — 28 m. lin. — Supérieur — Salle des machines — 0 — N/A
Alexandre.Caza - 2017-06-28 15:35

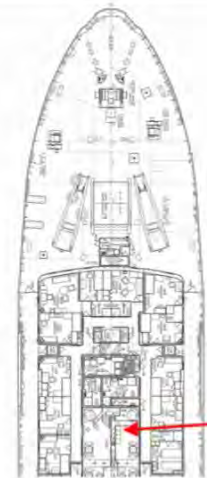
41 Tuyauterie
Vapeur (alimentation) — Rectiligne — Magnésie — 5 po. — 4 m. lin. — Supérieur — Salle des machines — 0 — Pastille 5
Alexandre.Caza - 2017-06-28 15:43

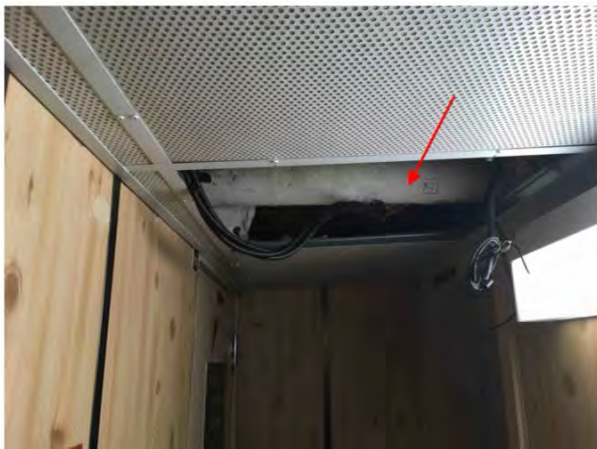
81 Tuyauterie
Vapeur (alimentation) — Rectiligne — Magnésie — 5 po. — 1 m. lin. — Supérieur — Salle des machines — 517 — Pastille 5
Alexandre.Caza - 2017-06-29 09:36

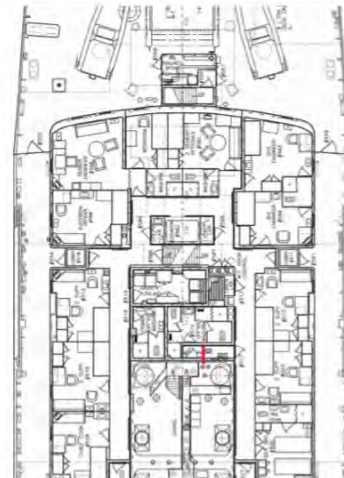
81 Tuyauterie
Vapeur (alimentation) — Rectiligne — Magnésie — 5 po. — 1 m. lin. — Supérieur — Salle des machines — 517 — Pastille 5
Alexandre.Caza - 2017-06-29 09:39

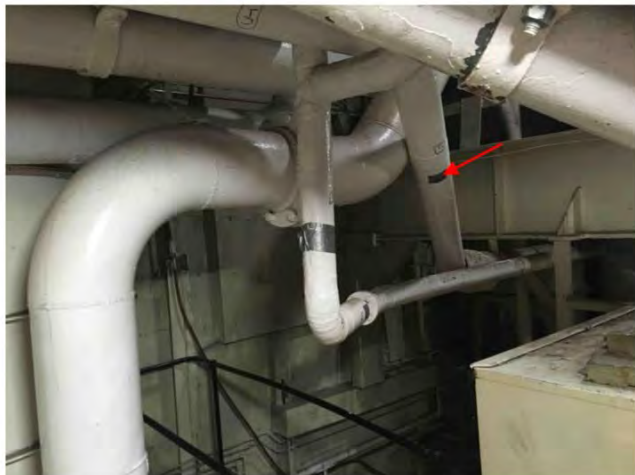
99 Tuyauterie
Vapeur (alimentation) — Rectiligne — Magnésie — 5 po. — 0 m. lin. — Supérieur
— Salle des machines — 0 — Pastille 5
Alexandre.Caza - 2017-06-29 12:04

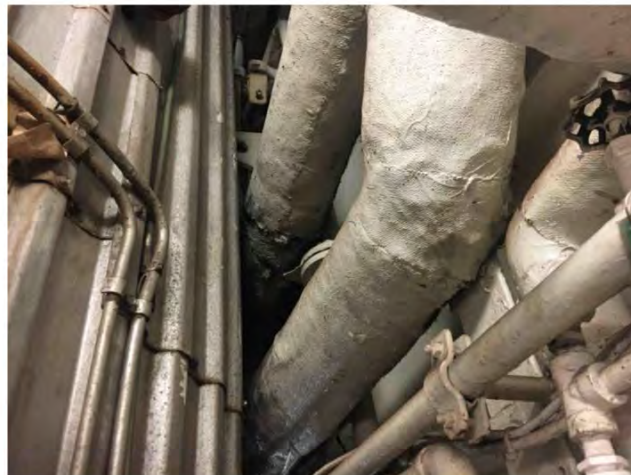
41 Tuyauterie
Vapeur (alimentation) — Rectiligne — Magnésie — 5 po. — 4 m. lin. — Supérieur
— Salle des machines — 0 — Pastille 5
Chantal.Soulard - 2019-11-22 09:17

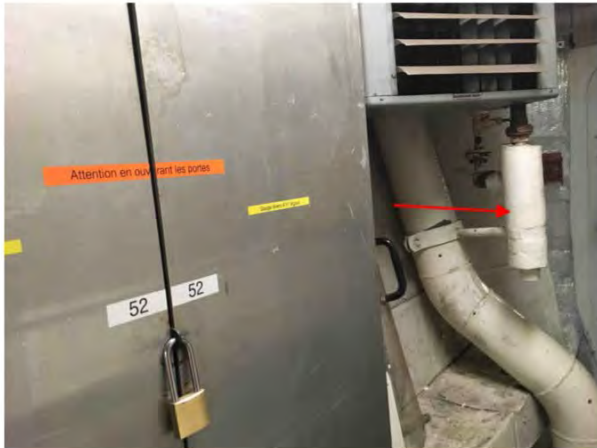
67 Tuyauterie
Vapeur (alimentation) — Rectiligne — Magnésie — 5 po. — 20,5 m. lin. — Principal
— Pont arrière — 689 — Pastille 5
Alexandre.Caza - 2017-06-29 08:22

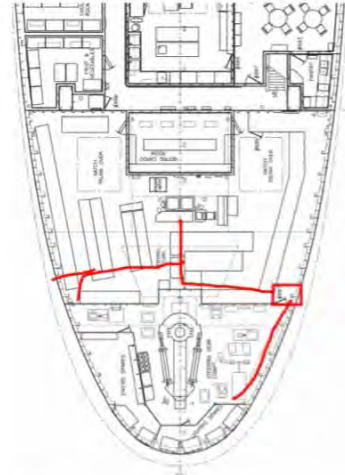
67 Tuyauterie
Vapeur (alimentation) — Rectiligne — Magnésie — 5 po. — 20,5 m. lin. — Principal
— Pont arrière — 689 — Pastille 5
Alexandre.Caza - 2017-06-29 08:49

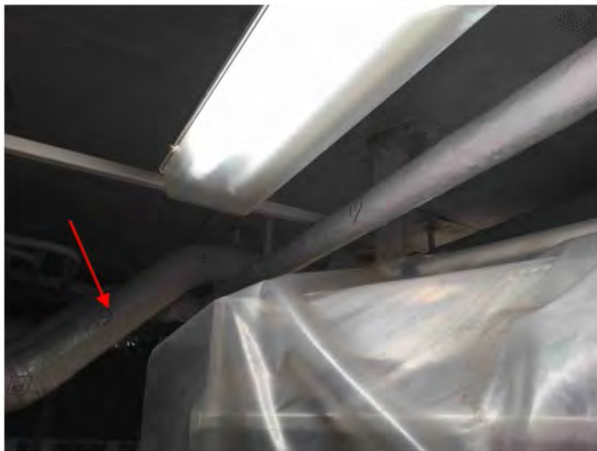
116 Tuyauterie
Vapeur (alimentation) — Rectiligne — Magnésie — 5 po. — 0 m. lin. — Principal —
Pont arrière — 689 — Pastille 5
Alexandre.Caza - 2017-06-29 15:13

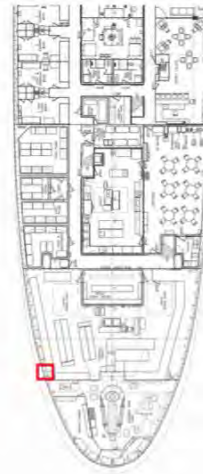
116 Tuyauterie
Vapeur (alimentation) — Rectiligne — Magnésie — 5 po. — 0 m. lin. — Principal —
Pont arrière — 689 — Pastille 5
Alexandre.Caza - 2017-06-29 15:13

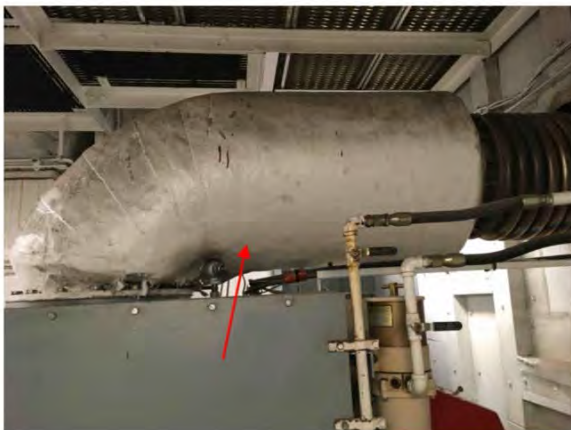
34 Tuyauterie
Échappement — Incinérateur — Irrégulière et rectiligne — Canevas et pâte
cimentaire et magnésie — 22 po. — 16 m. lin. — Principal — Incinérateur — 642 —
N/A
Alexandre.Caza - 2017-06-30 08:34

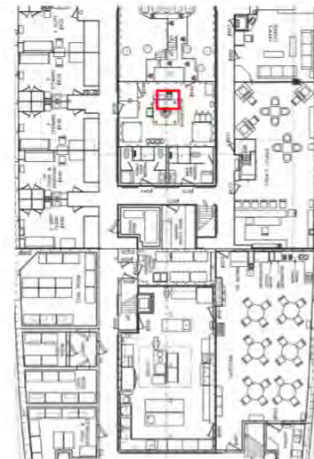
34 Tuyauterie
Échappement — Incinérateur — Irrégulière et rectiligne — Canevas et pâte
cimentaire et magnésie — 22 po. — 16 m. lin. — Principal — Incinérateur — 642 —
N/A
Alexandre.Caza - 2017-06-30 08:34

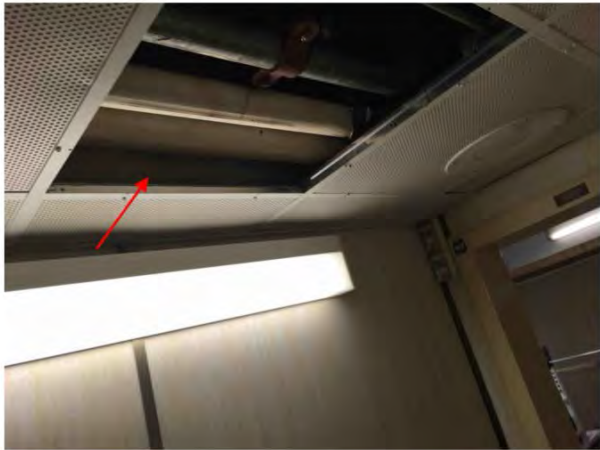
47 Tuyauterie
Vapeur (alimentation) — Rectiligne — Magnésie — 5 po. — 1 m. lin. — Principal — Corridor — 0 — Pastille 5
Alexandre.Caza - 2017-06-28 16:06

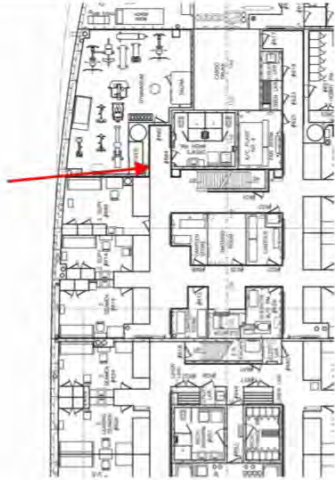
47 Tuyauterie
Vapeur (alimentation) — Rectiligne — Magnésie — 5 po. — 1 m. lin. — Principal — Corridor — 0 — Pastille 5
Alexandre.Caza - 2017-06-28 16:07

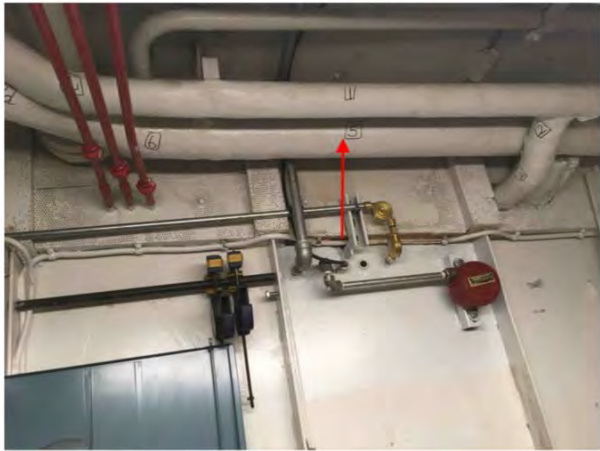
59 Tuyauterie
Vapeur (alimentation) — Rectiligne — Magnésie — 5 po. — 2,5 m. lin. — Principal — Atelier menuiserie — 600 — Pastille 5
Alexandre.Caza - 2017-06-28 16:35

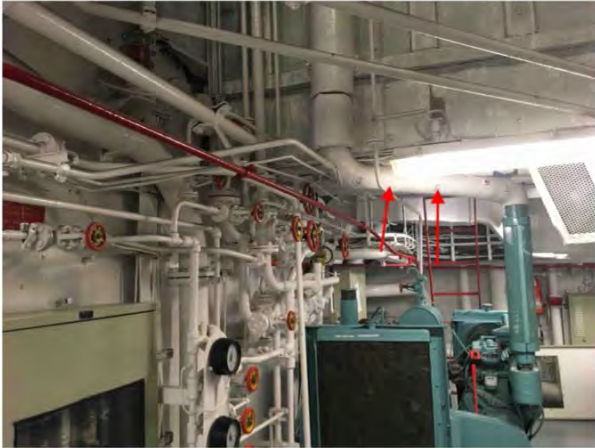
23 Tuyauterie
Échappement — Moteur — Rectiligne — Magnésie — 5 po. — 2 m. lin. — Salle des moteurs — Salle des moteurs 17pi — 0 — N/A
Alexandre.Caza - 2017-06-28 13:33

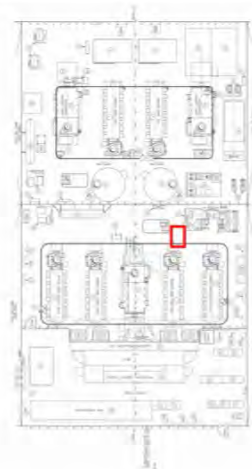
23 Tuyauterie
Échappement — Moteur — Rectiligne — Magnésie — 5 po. — 2 m. lin. — Salle des moteurs — Salle des moteurs 17pi — 0 — N/A
Alexandre.Caza - 2017-06-28 13:37

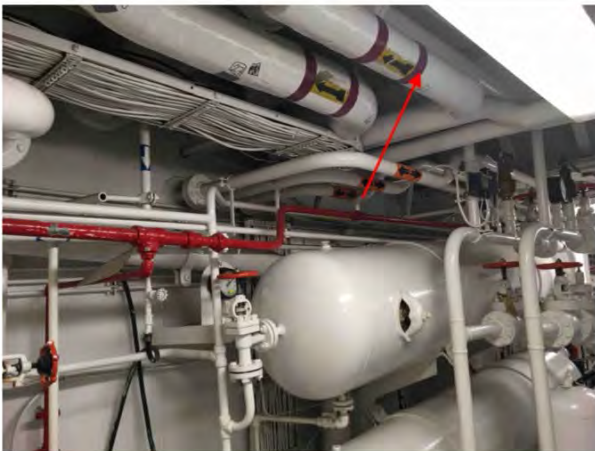
28 Tuyauterie
Vapeur (alimentation) — Rectiligne — Magnésie — 5 po. — 4 m. lin. — Salle des moteurs — Salle des moteurs 17pi — 0 — Pastille 5
Alexandre.Caza - 2017-06-28 14:16

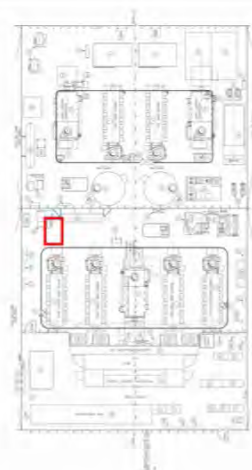
28 Tuyauterie
Vapeur (alimentation) — Rectiligne — Magnésie — 5 po. — 4 m. lin. — Salle des moteurs — Salle des moteurs 17pi — 0 — Pastille 5
Alexandre.Caza - 2017-06-28 14:19

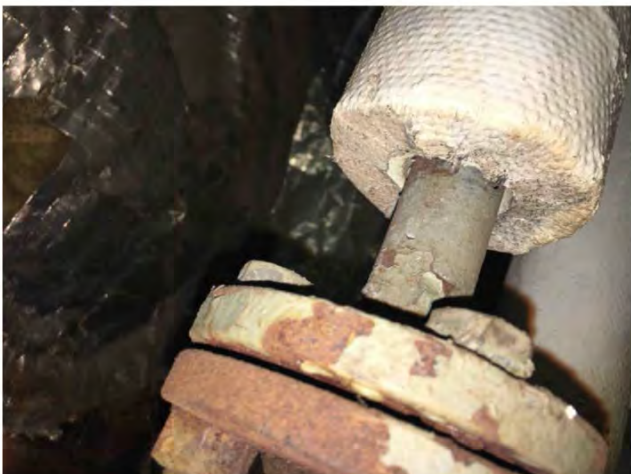
121 Tuyauterie
Non identifié — Rectiligne — Bloc magnésie — S/O po. — 13 m. lin. — 17' — Compartiment « Cargo Hold » — S/O — N/A
Chantal.Soulard - 2019-11-22 08:43

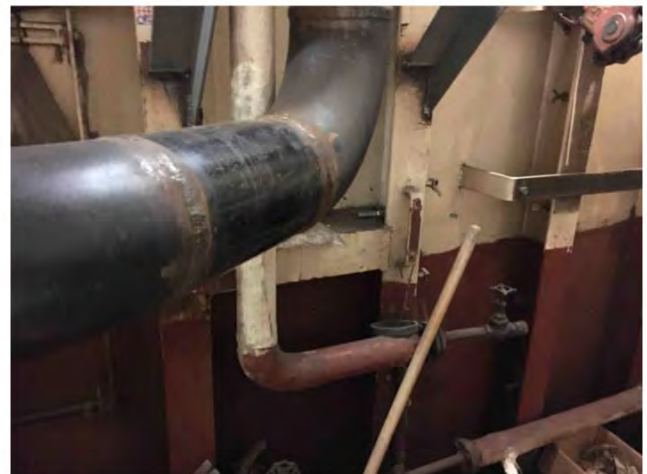
122 Tuyauterie
Non identifié — Irrégulière et rectiligne — Bloc magnésie — S/O po. — 13 m. lin. — 17' — Compartiment « Heeling pump » — S/O — N/A
Chantal.Soulard - 2019-11-22 08:45

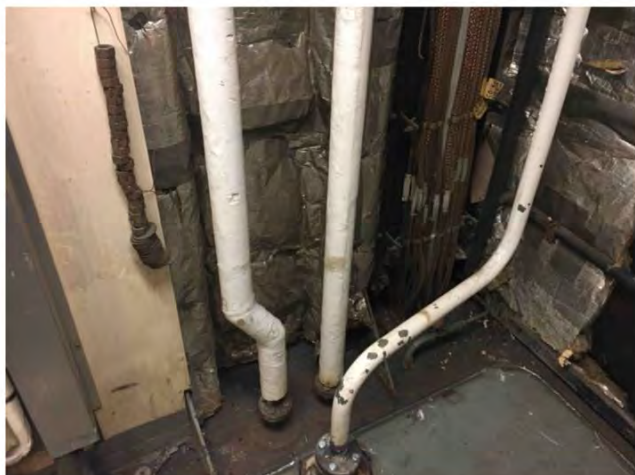
123

Non identifié — Irrégulière et rectiligne — Bloc magnésie — S/O po. — 10 m. lin. —
17' — « Main laundry room » — S/O — N/A
Chantal.Soulard - 2019-11-22 08:49

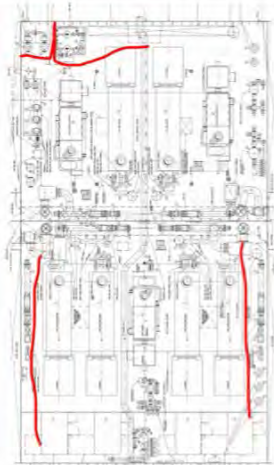
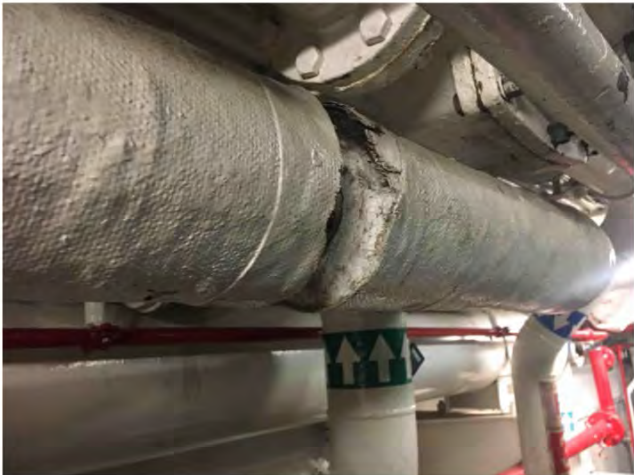
21 Tuyauterie
Vapeur (alimentation) — Rectiligne — Magnésie — 5 po. — 45 m. lin. — Salle des
moteurs — Salle des moteurs — 0 — Pastille 5
Alexandre.Caza - 2017-06-29 18:04

21 Tuyauterie
Vapeur (alimentation) — Rectiligne — Magnésie — 5 po. — 45 m. lin. — Salle des
moteurs — Salle des moteurs — 0 — Pastille 5
Chantal.Soulard - 2019-11-22 09:17

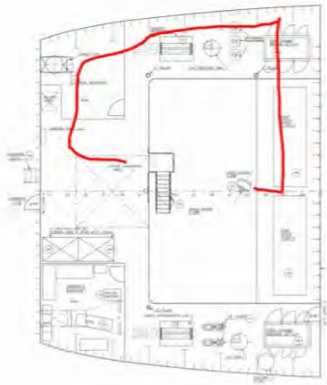
13 Tuyauterie
Vapeur (alimentation) — Rectiligne — Magnésie — 5 po. — 35 m. lin. — Salle des propulseurs — Salle des propulseurs — 0 — Pastille 5
Alexandre.Caza - 2017-06-28 10:56

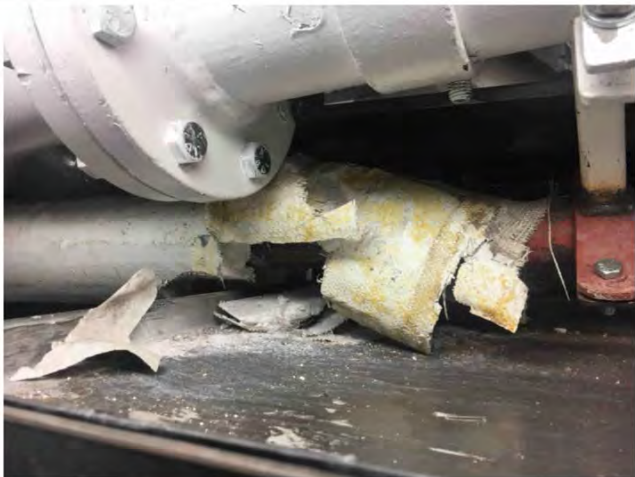
13 Tuyauterie
Vapeur (alimentation) — Rectiligne — Magnésie — 5 po. — 35 m. lin. — Salle des propulseurs — Salle des propulseurs — 0 — Pastille 5
Chantal.Soulard - 2019-11-22 09:18

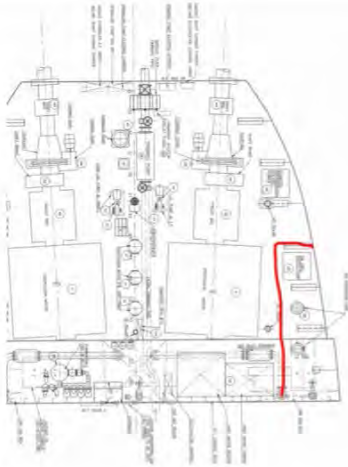
5 Tuyauterie
Vapeur (alimentation) — Rectiligne — Magnésie — 5 po. — 9 m. lin. — Salle des propulseurs — Salle des propulseurs — 0 — N/A
Alexandre.Caza - 2017-06-28 09:46

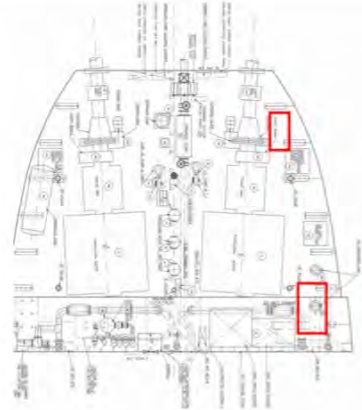
8 Tuyauterie
Vapeur (alimentation) — Irrégulière — Canevas et pâte cimentaire — 4 po. — 6 unité — Salle des propulseurs — Salle des propulseurs — 0 — N/A
Alexandre.Caza - 2017-06-28 10:01

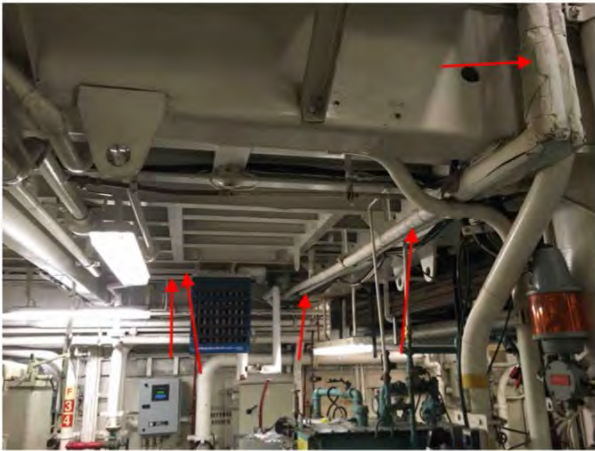
9 Tuyauterie
Vapeur (alimentation) — Rectiligne — Fibre et carton — 2-3 po. — 31 m. lin. — Salle des propulseurs — Salle des propulseurs — 0 — N/A
Alexandre.Caza - 2017-06-28 10:16

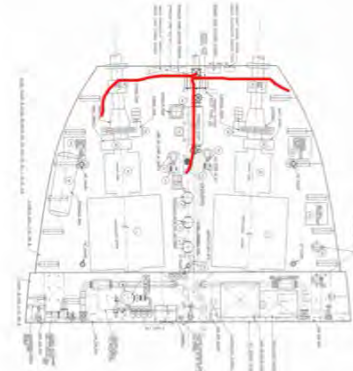
9 Tuyauterie
Vapeur (alimentation) — Rectiligne — Fibre et carton — 2-3 po. — 31 m. lin. — Salle des propulseurs — Salle des propulseurs — 0 — N/A
Alexandre.Caza - 2017-06-28 10:17

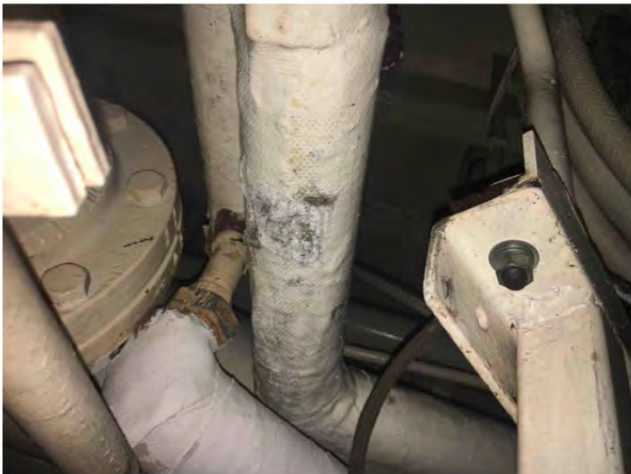
5 Tuyauterie
Vapeur (alimentation) — Rectiligne — Magnésie — 5 po. — 9 m. lin. — Salle des propulseurs — Salle des propulseurs — 0 — N/A
Chantal.Soulard - 2019-11-22 08:56

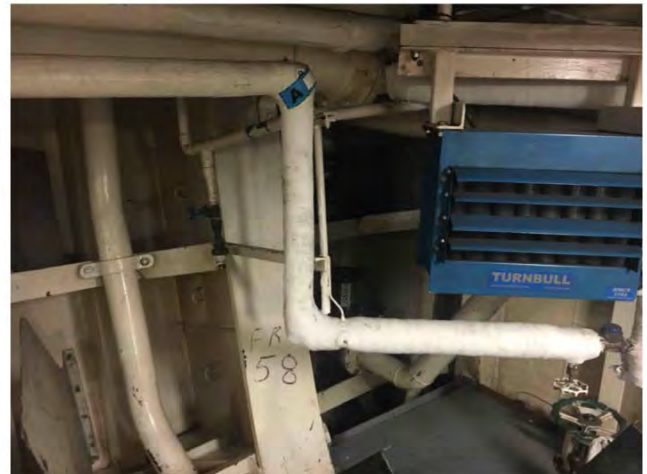
8 Tuyauterie
Vapeur (alimentation) — Irrégulière — Canevas et pâte cimentaire — 4 po. — 6 unité — Salle des propulseurs — Salle des propulseurs — 0 — N/A
Chantal.Soulard - 2019-11-22 09:20

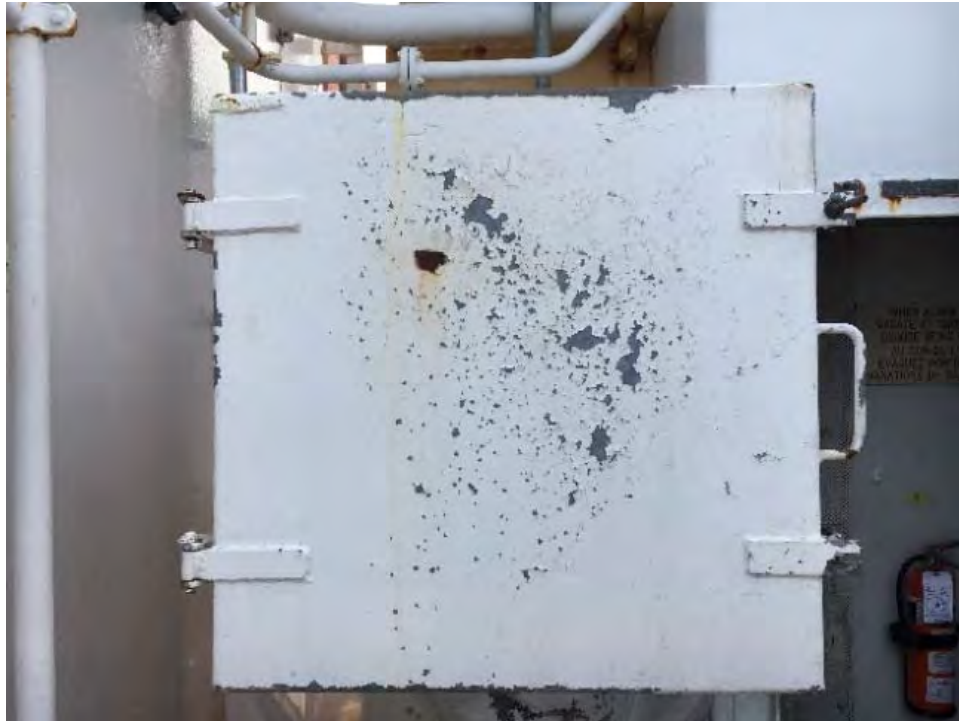
Photo 1 Peinture blanche en mauvais état à l'extérieur du navire, adjacent au local 319.

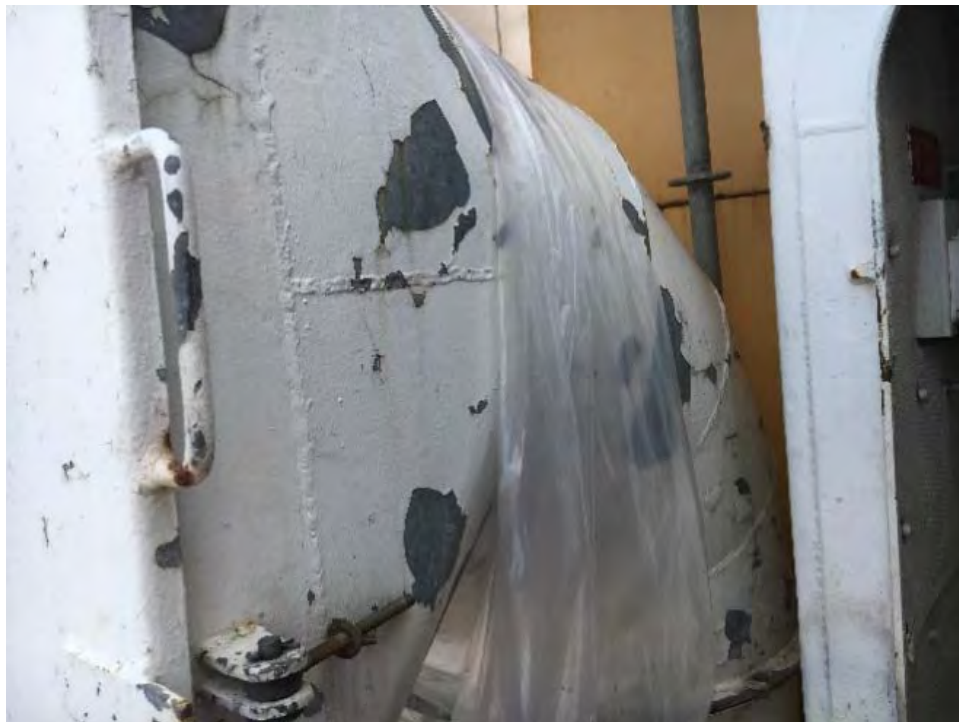
Photo 2 Peinture blanche en mauvais état à l'extérieur du navire, adjacent au local 319.
