## **EX HMCS CORMORANT**

### **Condition Survey, Pollution Risk Assessment & Towage Assessment**

**At Bridgewater, Nova Scotia  
10 & 27 July 2019**

**Our Ref: 20989.00/LOCC/CCG/R001/0**

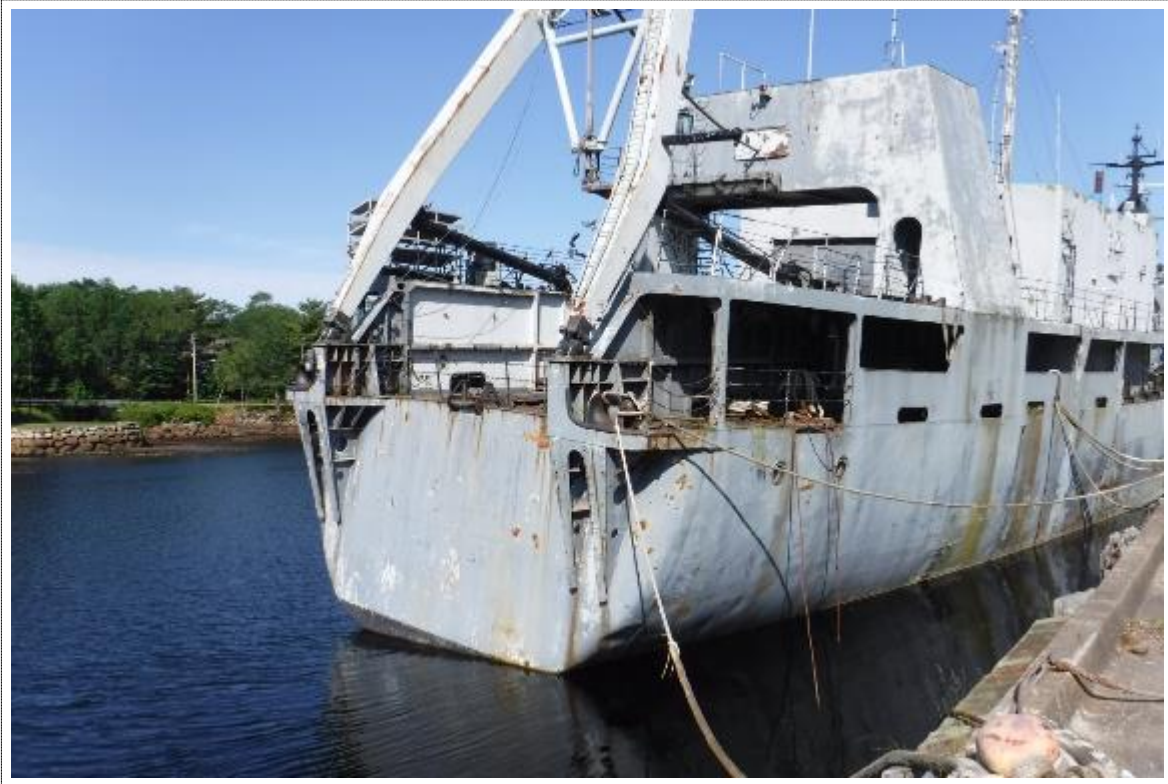
At the time of the initial survey on 10 July 2019, the vessel was moored stbd side to at the jetty with access via a gangway. The vessel was found to have a notable list to stbd (later calculated to be around 4 degrees) and was trimmed approximately 3m by the stern.

3. Stern, stbd side – note list to stbd

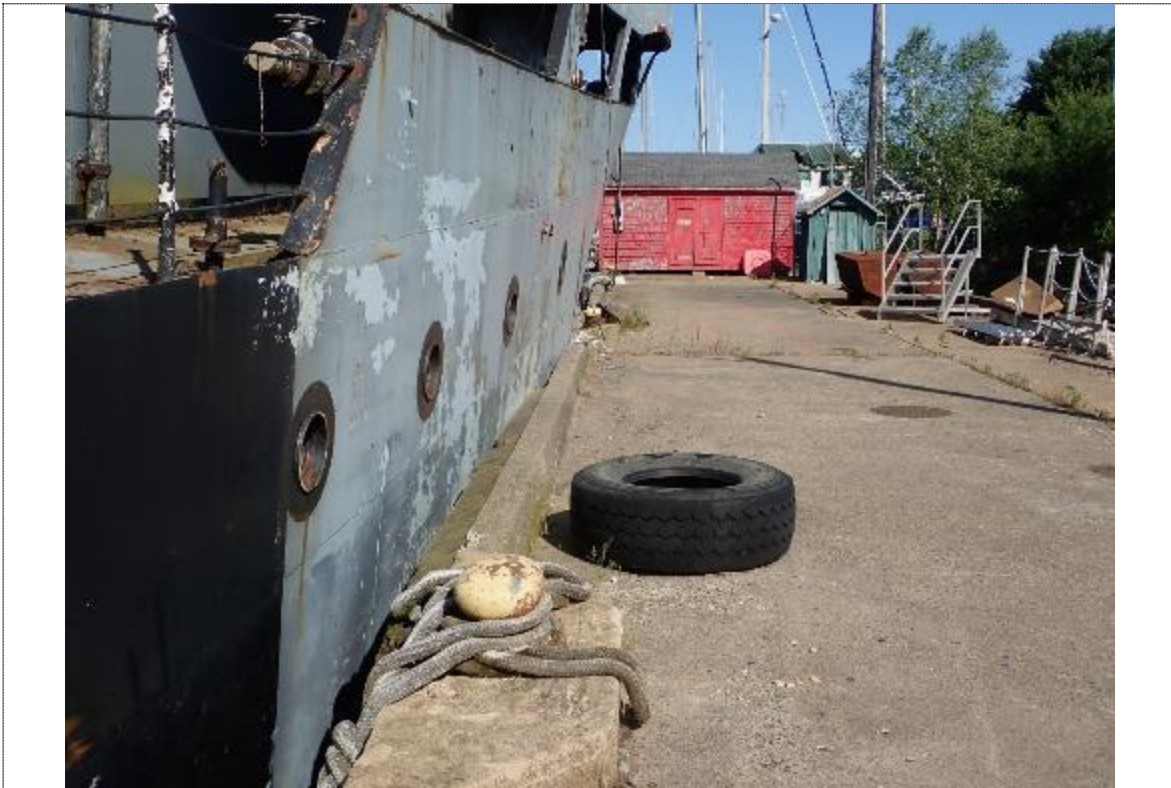
- 3.3.1 A total of 12 mooring lines were noted to be in place. One of these was noted to have failed at some point in the past.
- 3.3.2 All were noted to be in poor condition and only one bow line and one stern line appeared to be taking any load.
- 3.3.3 During the course of the survey the vessel was noted to move a considerable distance off the jetty under the influence of the changes in tide and wind.

6. Stbd side looking forward – note condition of mooring ropes and minimal fendering

- 8.10 If the vessel is to remain in its current location, the condition of the moorings is such that they should be replaced as soon as possible. At the same time, proper fendering should be placed between the vessel and jetty. As the jetty has been damaged, we would also recommend that an engineering assessment be carried out on the jetty to establish if any remedial work is required.

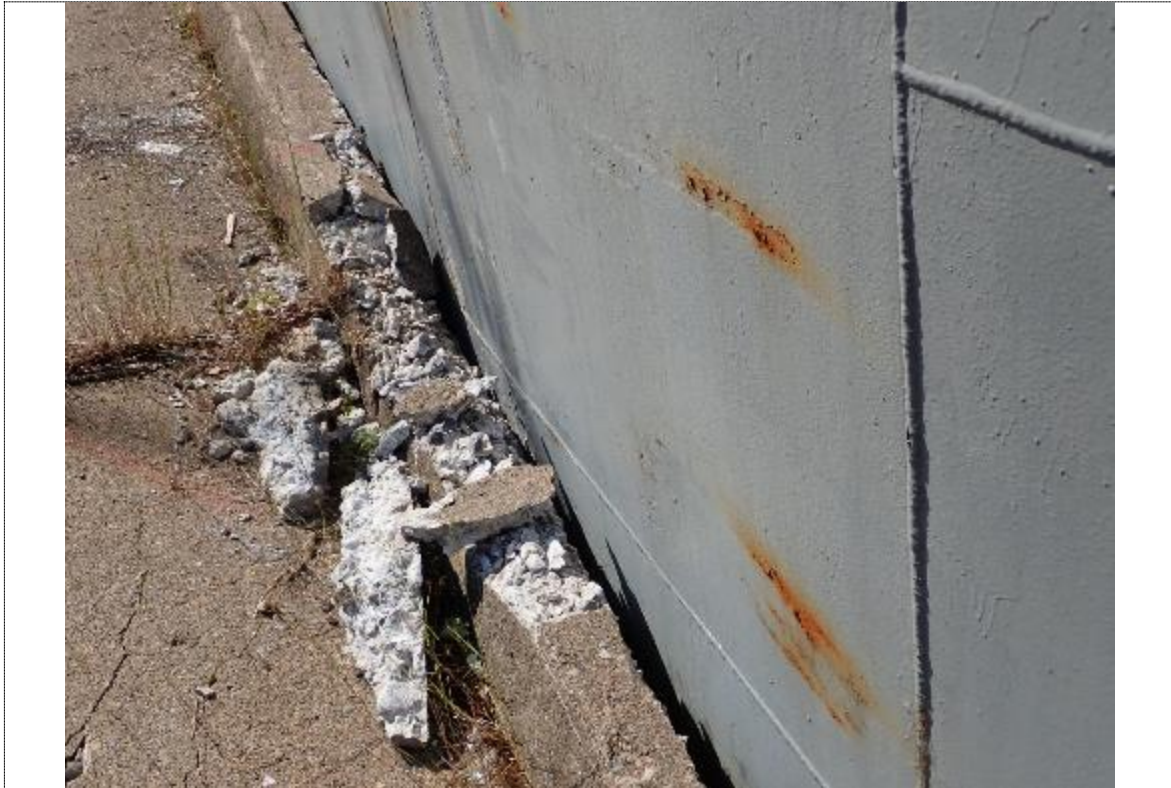
- 3.1.1 The jetty consists of wooden piles fitted with a concrete cap. Fendering consists of wooden rubbing strips. No rubber fendering is fitted. We did note a number of commercial tires in the vicinity of the vessel but none of these have been utilized to provide additional fendering.
- 3.1.2 In way of the forward section of the vessel the wooden fendering was missing allowing the hull plating to make contact with the concrete apron. There is evidence of recent damage to the concrete as result of contact with the vessel; at present damage to the vessel is limited to paint scuffing. See Photograph #7.
- 3.1.3 The jetty area where it was contacted by the stbd bridge wing in 2015 shows evidence of cracking and is displaced vertically downwards. This area has been marked up "Do Not Load" at some point in the past.

7. Stbd side fwd – missing fendering / vessel

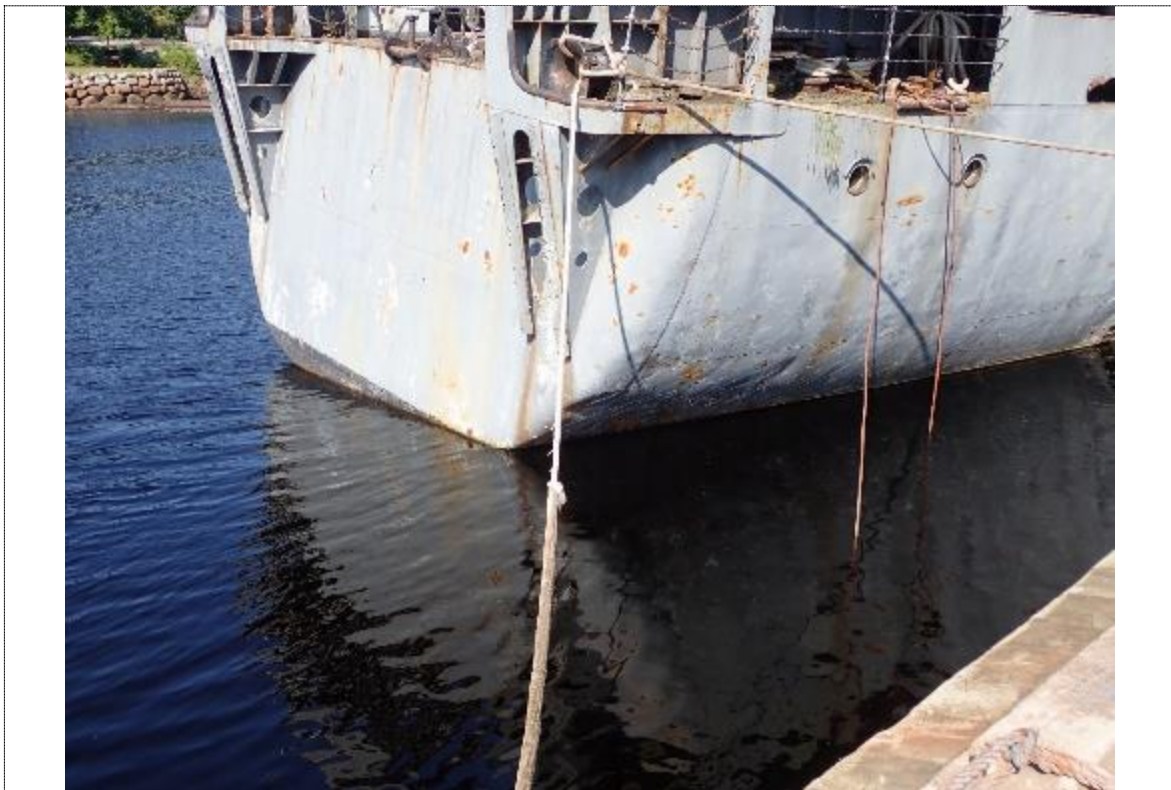
8. Stern view – note slack mooring lines

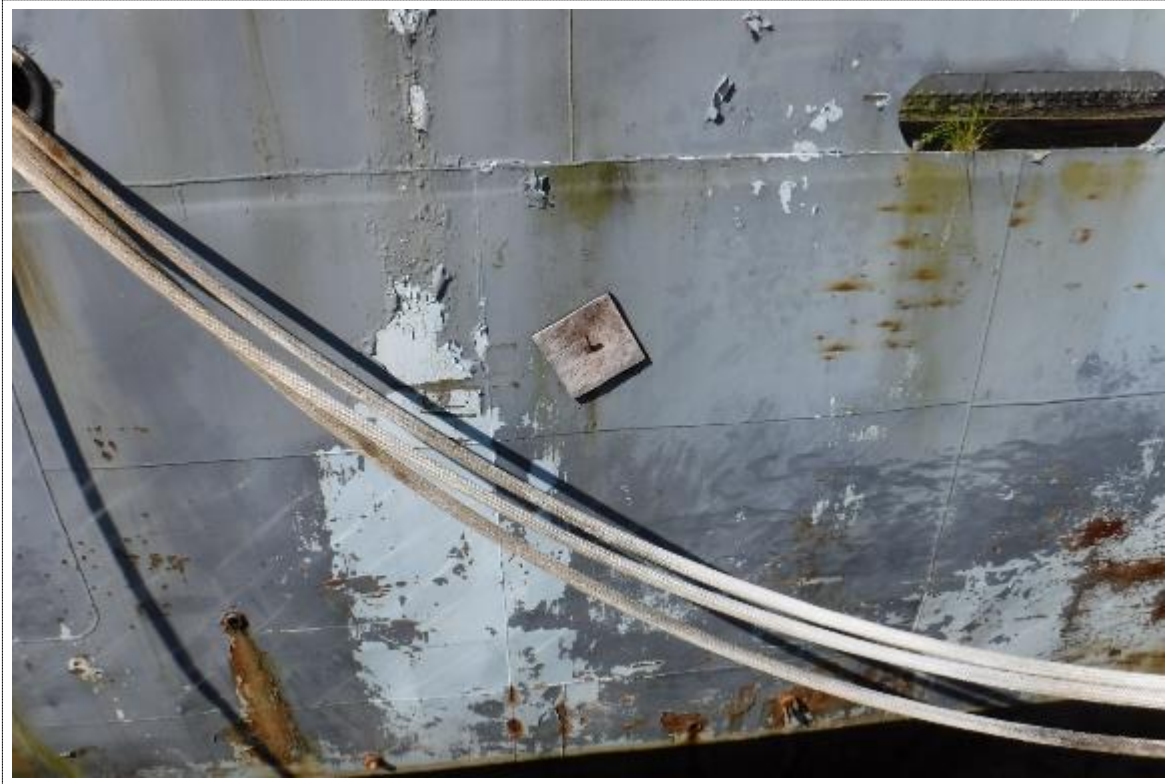
- 3.4.1 The hull above the waterline was noted to be cosmetically poor but there was no evidence of major corrosion.
- 3.4.2 There is one plywood patch on the stbd hull towards the stern but is located well above the waterline.
- 3.4.3 It was noted that there have been wooden plugs fitted to overboard hull penetrations at and above the waterline. Many of these appear in poor condition.

9. Temporary plywood plug on ship's hull (stbd side)

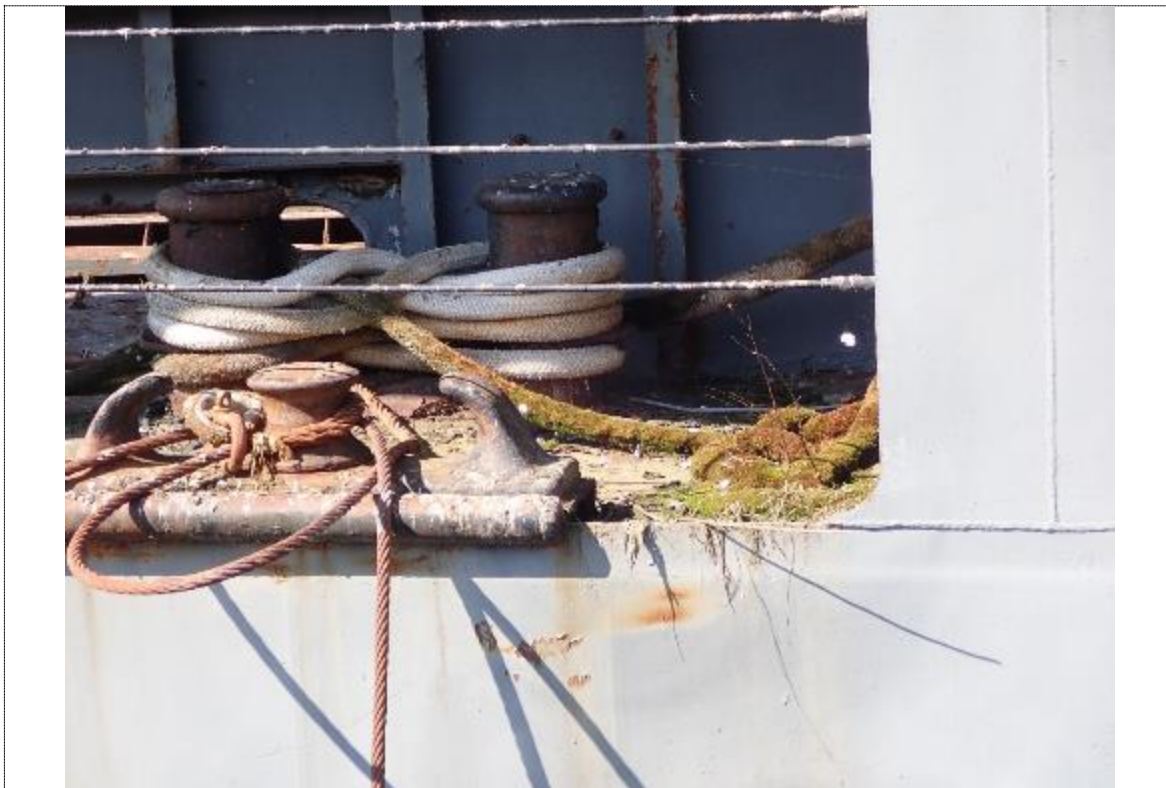
10. General condition of mooring ropes and wires

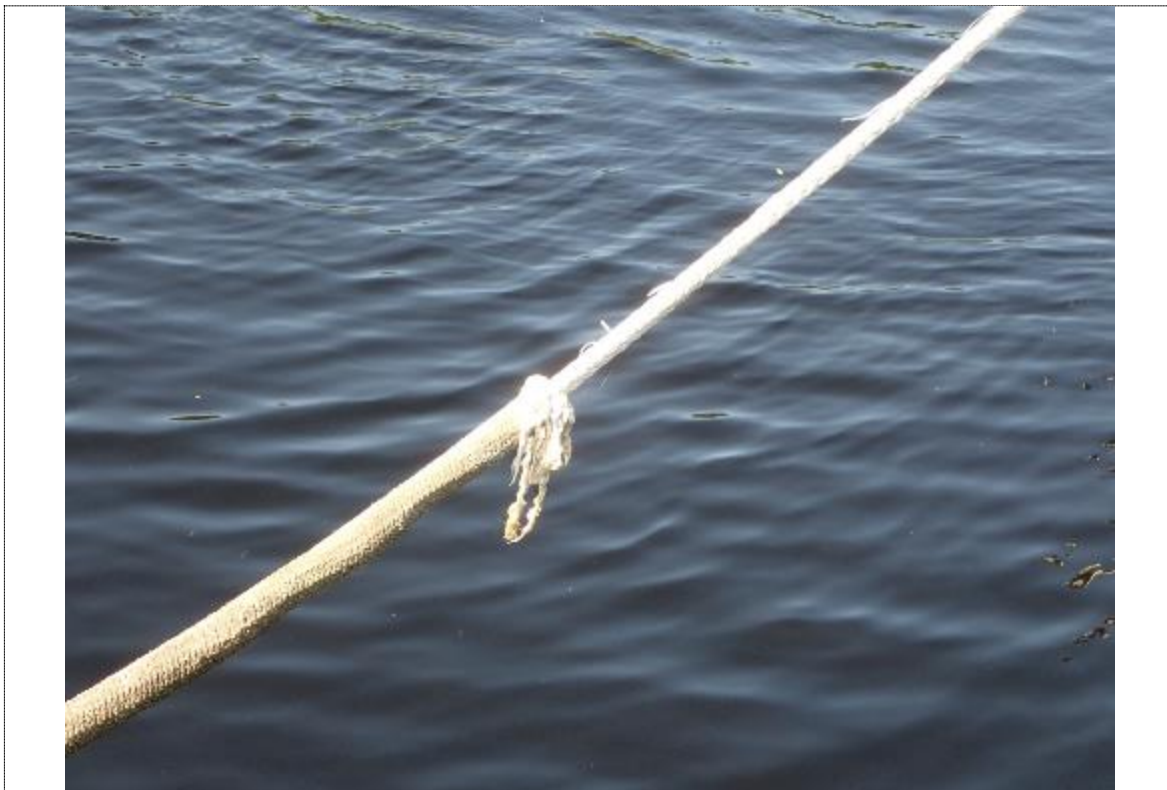
11. Stern line outer cover

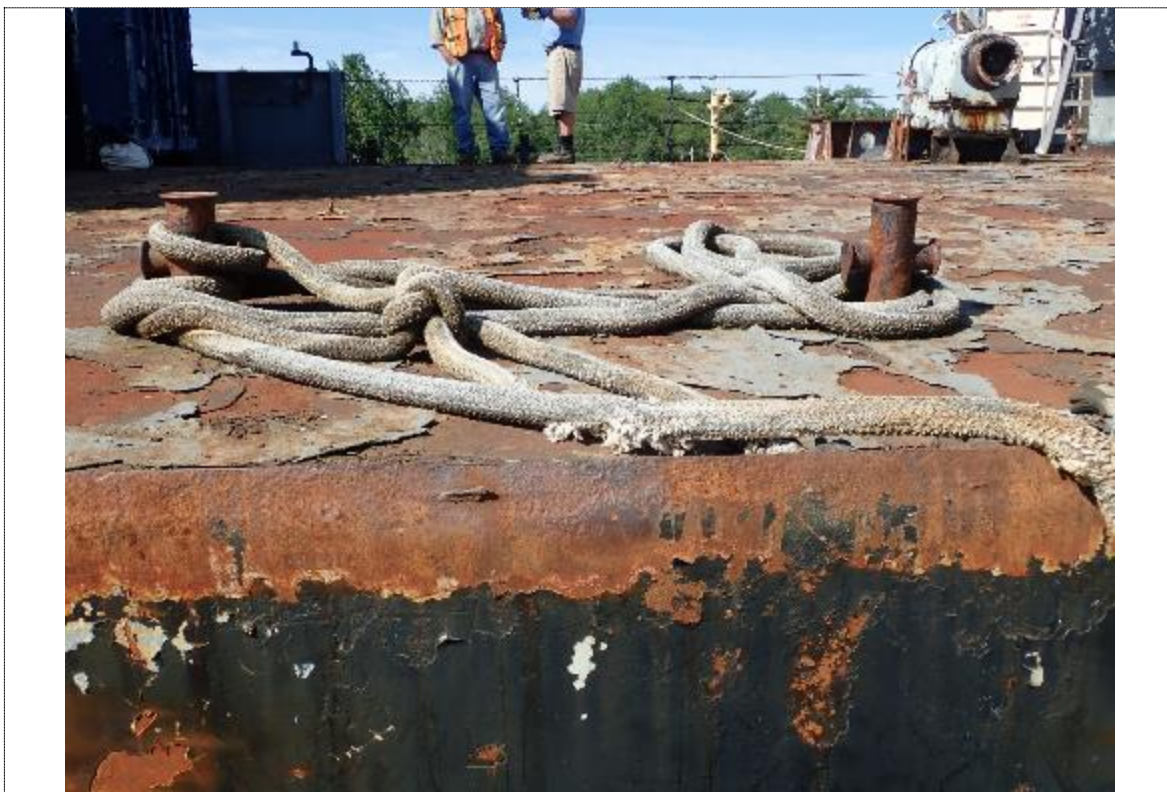
12. Midship mooring lines

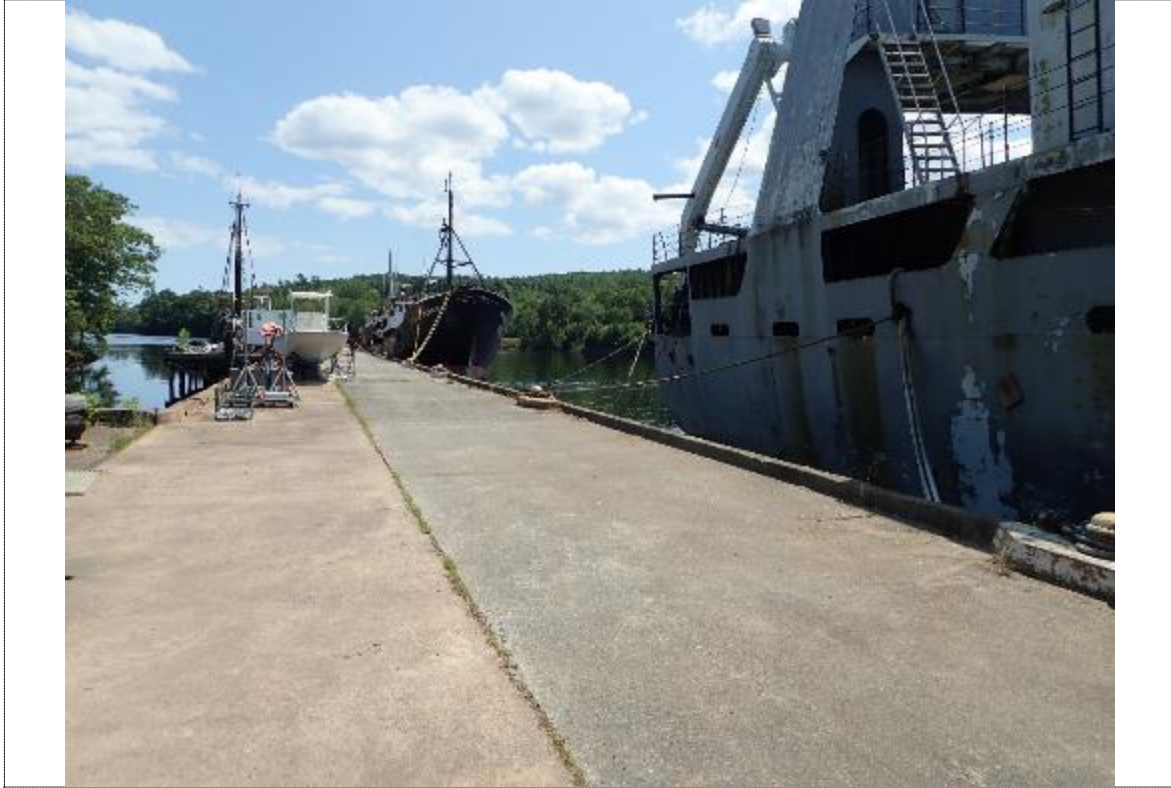
3.12.2 Both of these vessels are in poor condition and are clearly not being maintained.

3.12.4 Should there be a failure of the moorings of one of these vessels there is a risk of contact with the CORMORANT.

13. General view of jetty looking aft - note vessels astern

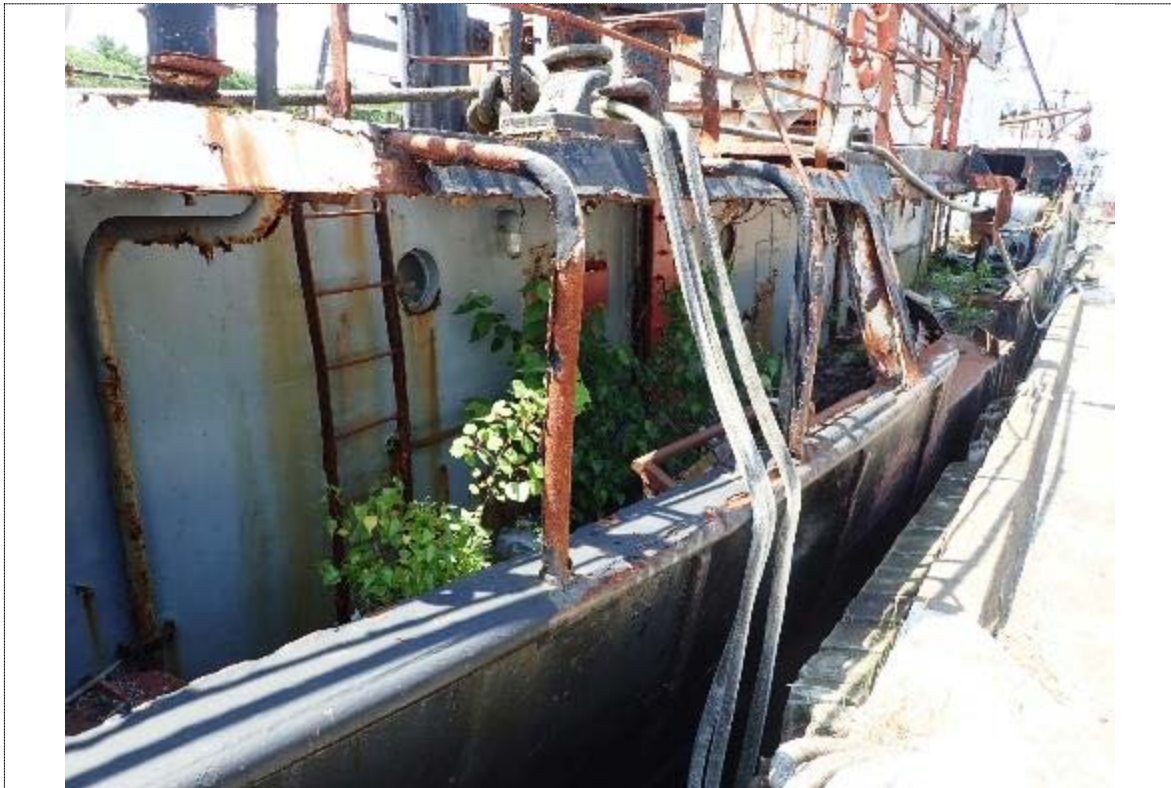
3.12.3 Moorings for both vessels are in poor condition.

14. HANNAH ATLANTIC Condition of Moorings (first vessel astern of CORMORANT)

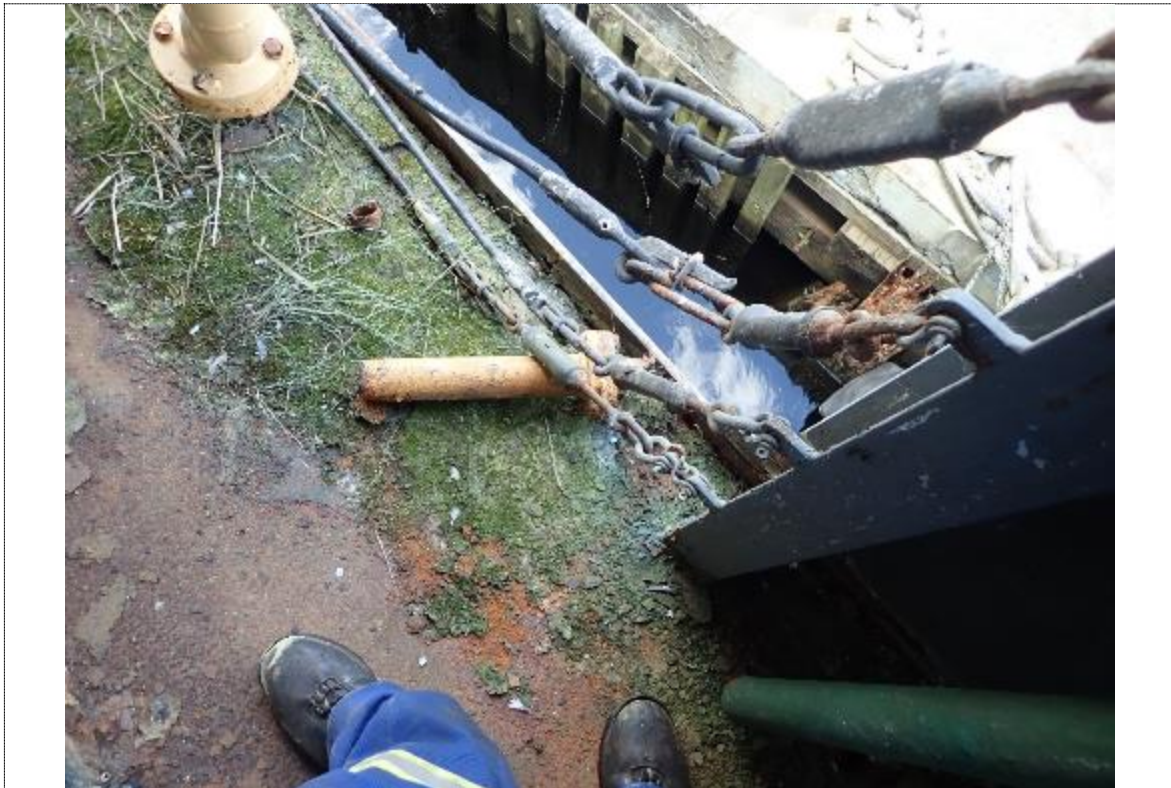
- 3.6.1 The deck is in cosmetically poor condition but there are no areas of major corrosion.
- 3.6.2 Many of the deck fittings, such as tank sounding pipes and tank air vents, are in poor condition, particularly where they penetrate the deck. Several of these were noted to have broken off.

18. Broken sounding pipe for No.13 stbd fuel oil tank

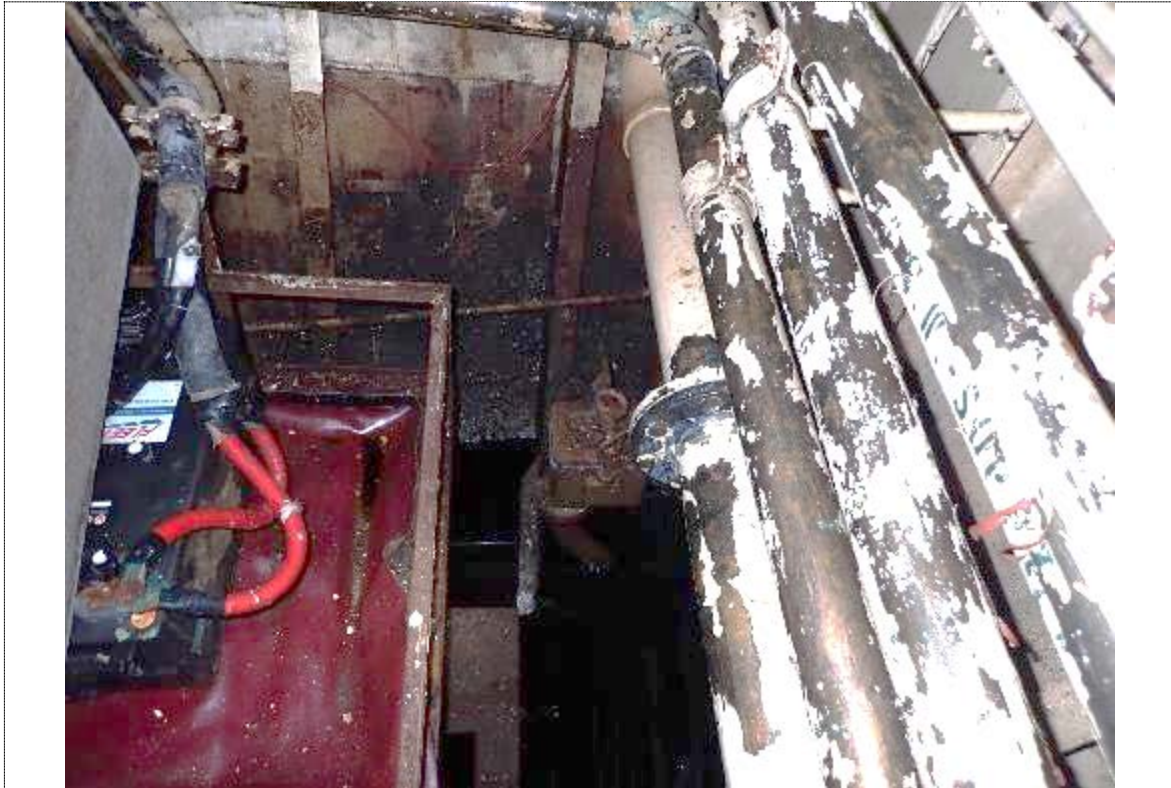
3.8.3 Water with oil on top was noted in the bilge. Due to the vessel's list and trim, this had collected in the stbd aft corner of the space.

21. Diesel generator compartment bilge well – oil layer on top of water

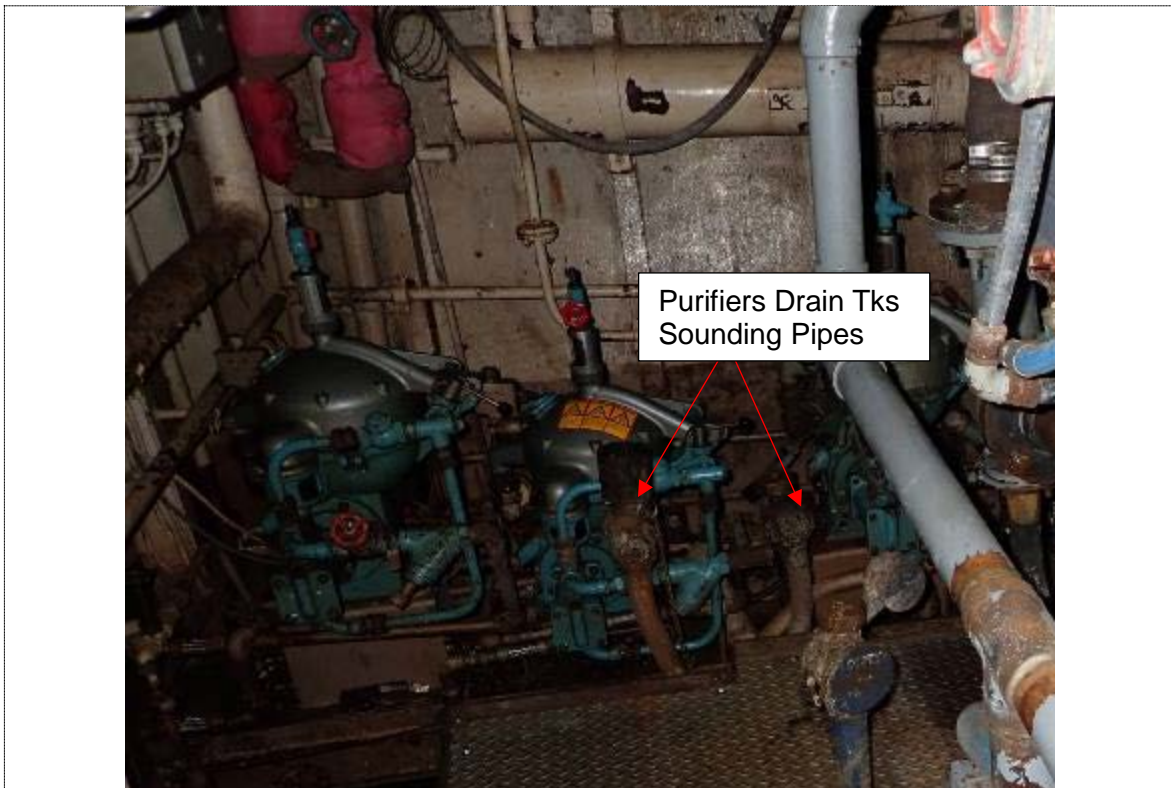
22. Purifiers – note sounding pipes for sludge tanks. FO sludge tank 70cm oil

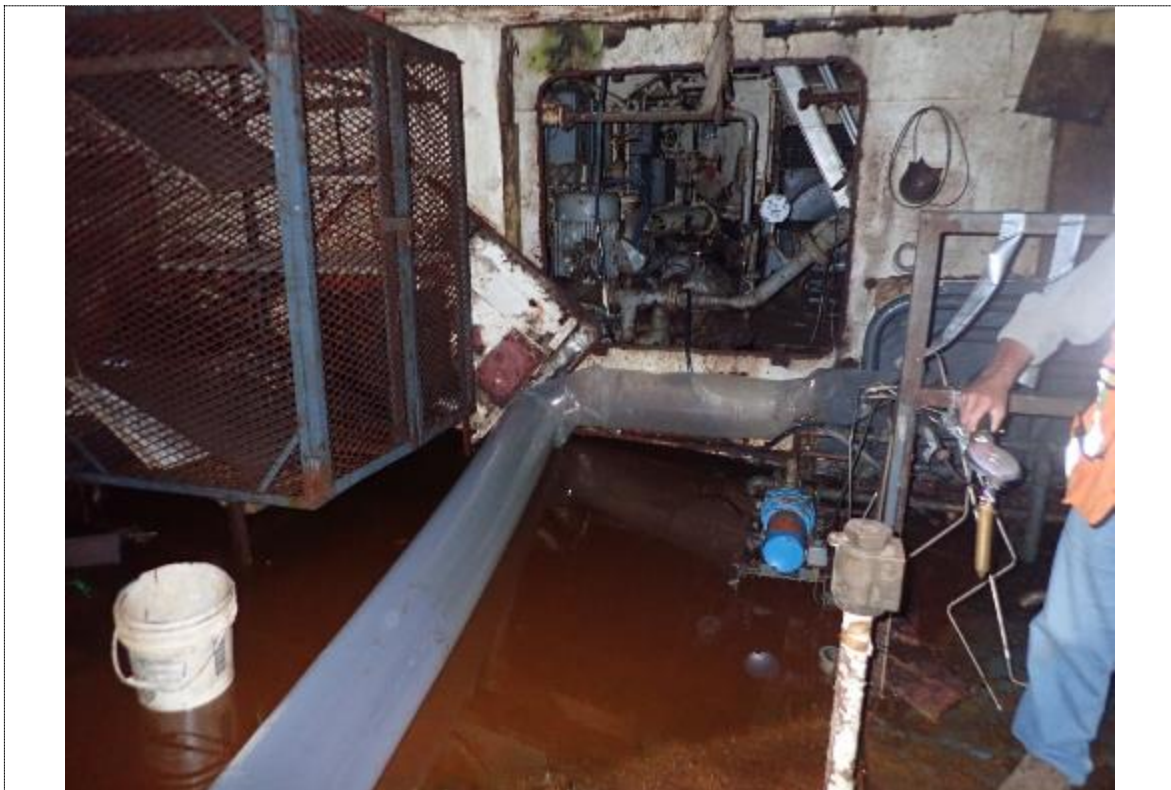
It was noted that a large section of the bulkhead between the Propulsion Machinery Room and the Gas Mixing Compartment has been removed for access. Therefore, these two spaces should be considered common. In addition, it was noted that the port and stbd main sea suction valves were in the open position. During the dive survey it was noted that there were two plywood patches in locations that appear to correspond with the location of the sea suction. The integrity of internal sea water pipework connected to the sea chests cannot be verified. In addition, the vent cocks on the top of the main sea strainers were showing signs of corrosion. Should these fail, or if the internal pipework is compromised, in the current situation there is only the plywood patch preventing water ingress.

- 6.1        The lack of watertight subdivision between the Propulsion Machinery Room and the Gas Mixing Compartment raises questions regarding damaged stability. This will need to be assessed prior to towage.

26. Bulkhead between gas mixing compartment and main propulsion room cut open

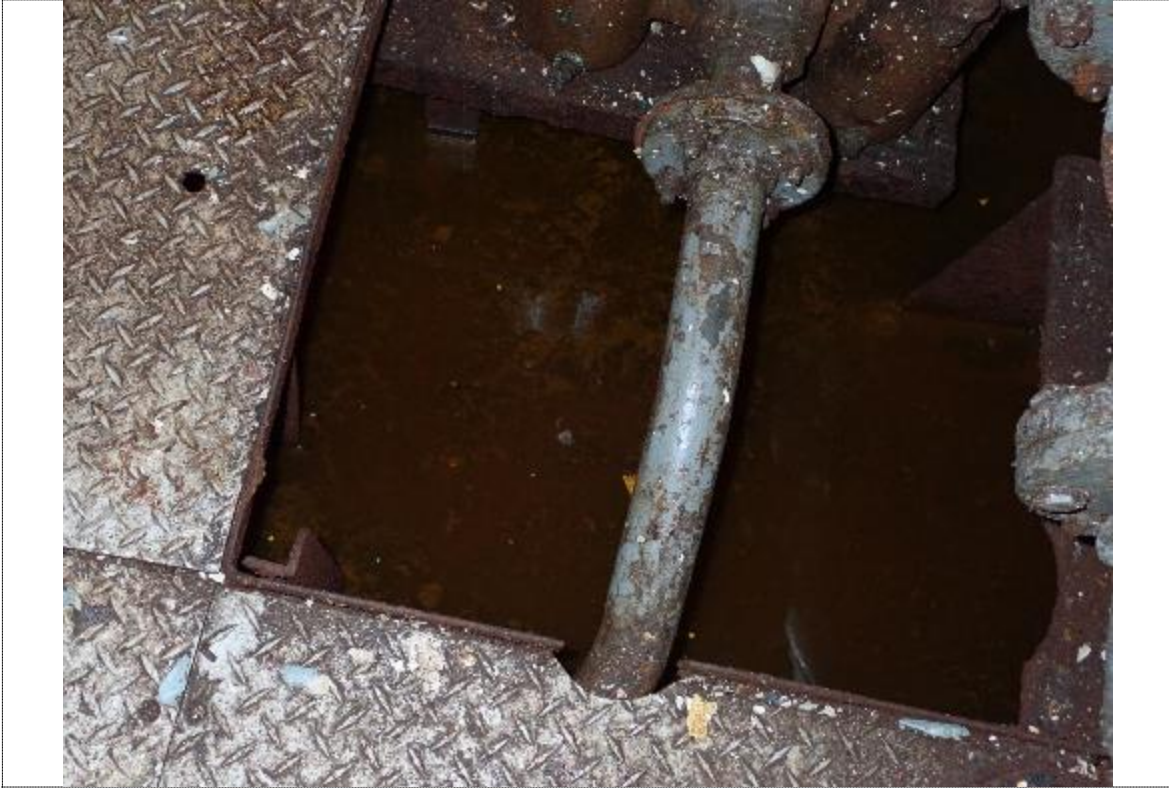
- 3.10.2 Access was made to this space via the hole made in the bulkhead at the aft end of the Gas Mixing Compartment.
  - 3.10.3 The bilges were noted to contain significant amounts of water and we noted a layer of approximately 50mm of emulsified oil on top of approximately 400mm water.

27. Main propulsion room bilges – approx. 50mm emulsified oil on top of water

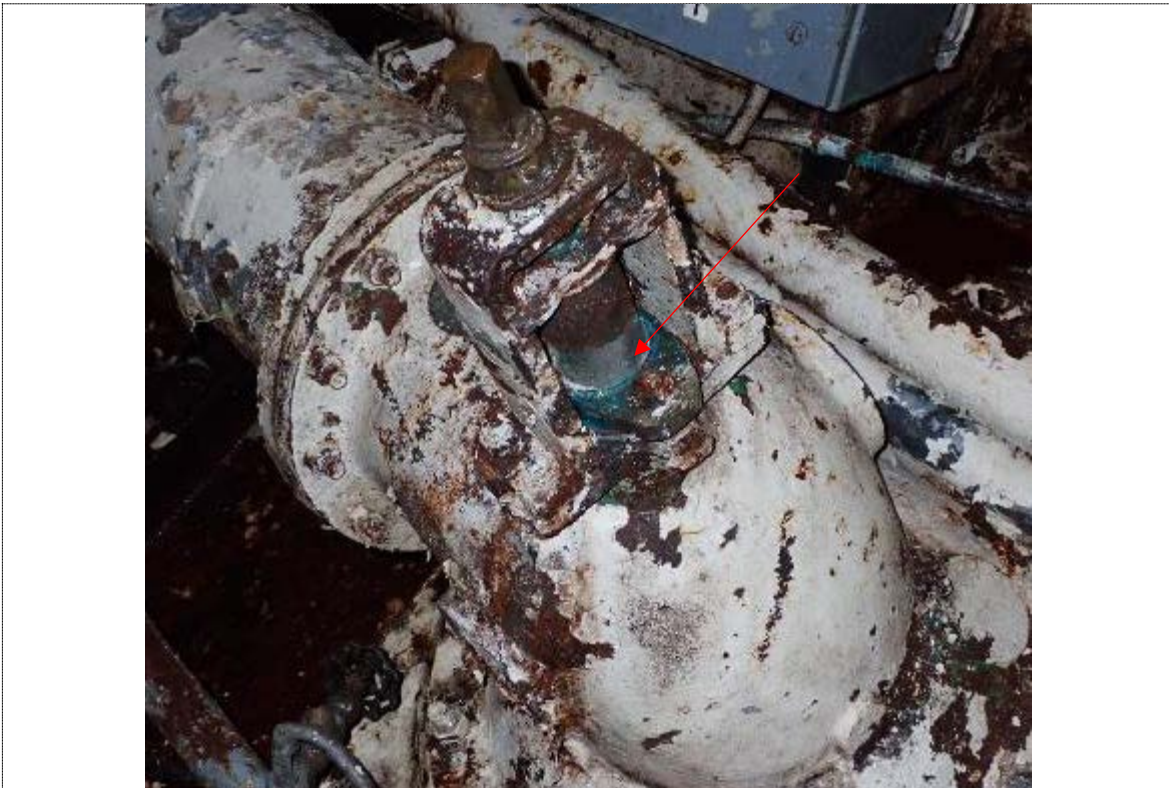
- At present with the main sea valves open in the Propulsion Machinery Room there is only the plywood patches on the sea chests preventing water ingress should there be an internal leak. In addition, as the watertight bulkhead between the Propulsion Machinery Room and the Gas Mixing Compartment has been opened up then any ingress of water would fill both of these spaces and likely migrate further through the vessel resulting in the vessel again sinking.

28. Stbd main sea valve in propulsion room in open position - port side same

- 8.3 The dive survey did identify plywood patches on the hull port and stbd towards the stern. These appear to be in the location of the Propulsion Machinery Room sea suction and were most likely fitted during the refloating operation in 2015 to prevent water ingress. Internally both main sea suction valves were found in the open position. We would consider plywood patches to be only a temporary measure and would recommend that these plywood patches are replaced with steel patches or that internally other means are employed to ensure the watertight integrity of the hull as a matter of urgency.

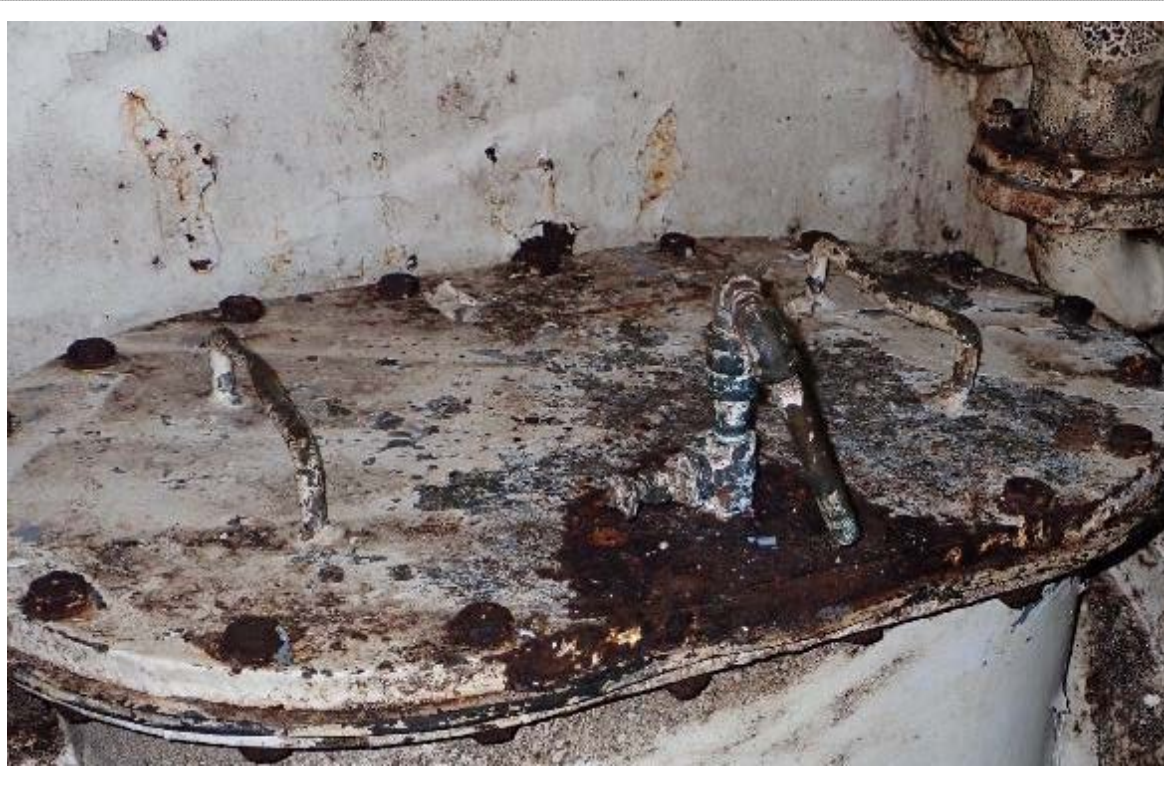
29. Sea strainer vent cock starting to corrode

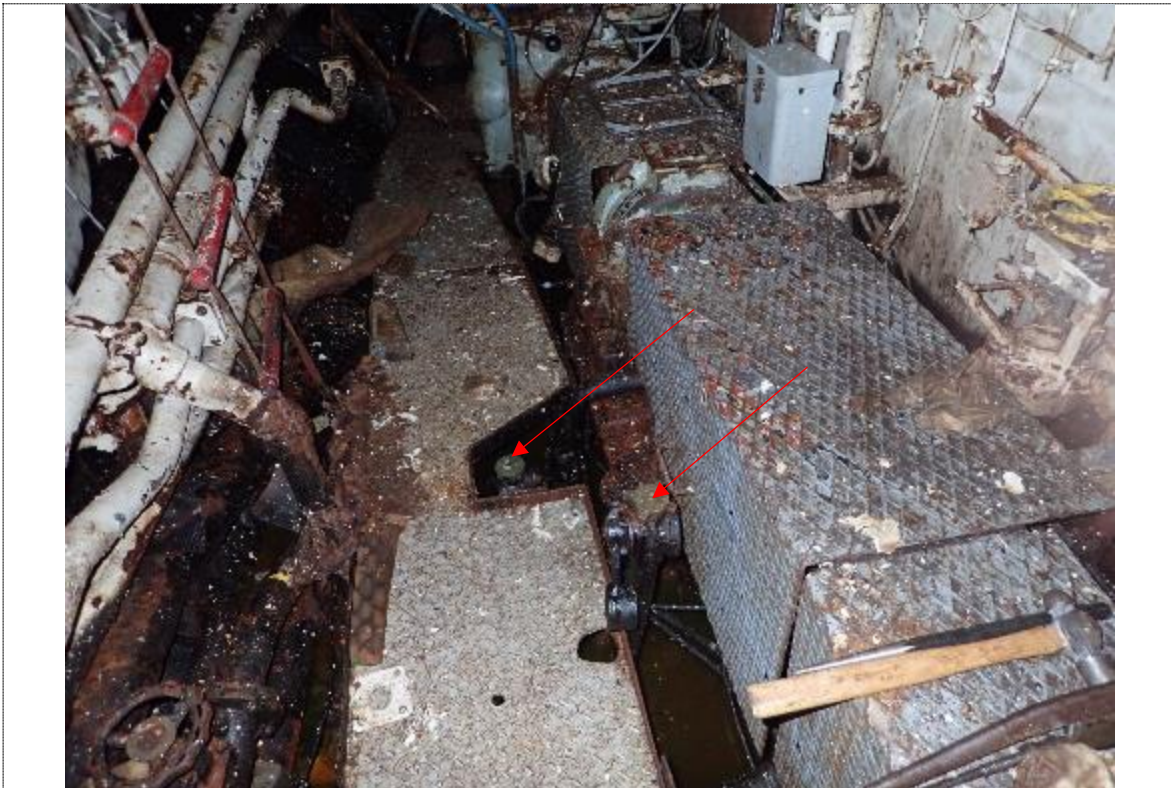
- 3.10.4 Three sounding pipes aft of the main gear box on the centre line were checked for contents and found to contain clean lubricating oil which would suggest that they were not pumped out following the vessel's re-floating in 2015.

30. CPP and gear oil storage tank sounding pipes – tanks found full of clean lube oil

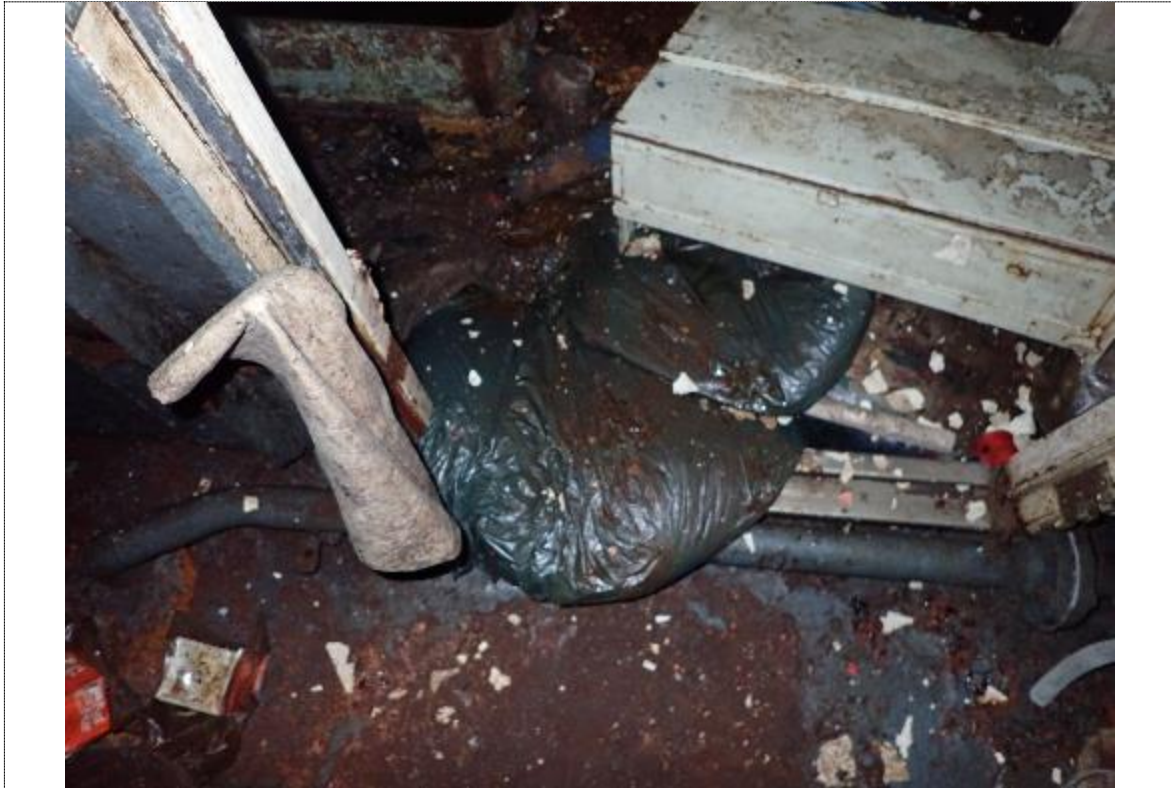
3.7.1 Generally, this area was in very poor condition with evidence of mould in many areas. There were a number of black plastic garbage bags in several locations which appeared to be filled with water and oil sodden materials.

31. Bags of oil and water soaked "garbage"

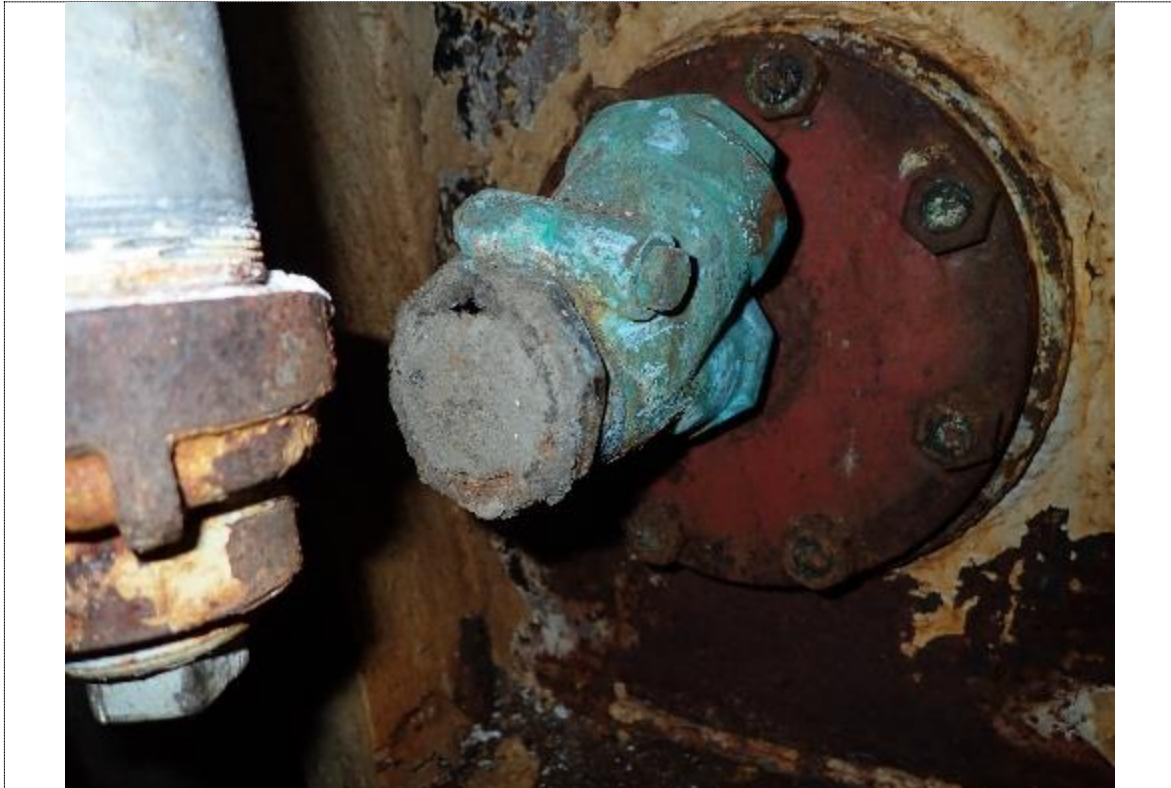
33. Overboard drain non-return fitted with cement plug

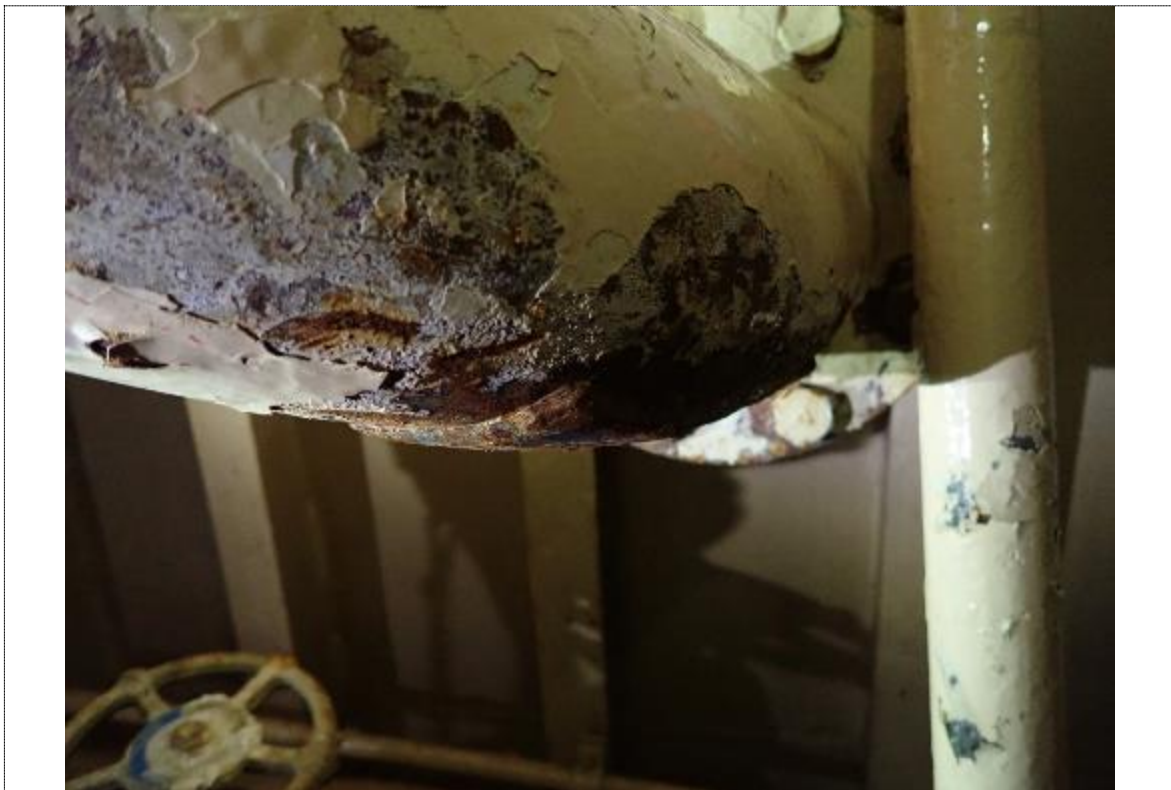
34. Patched overboard line starting to weep

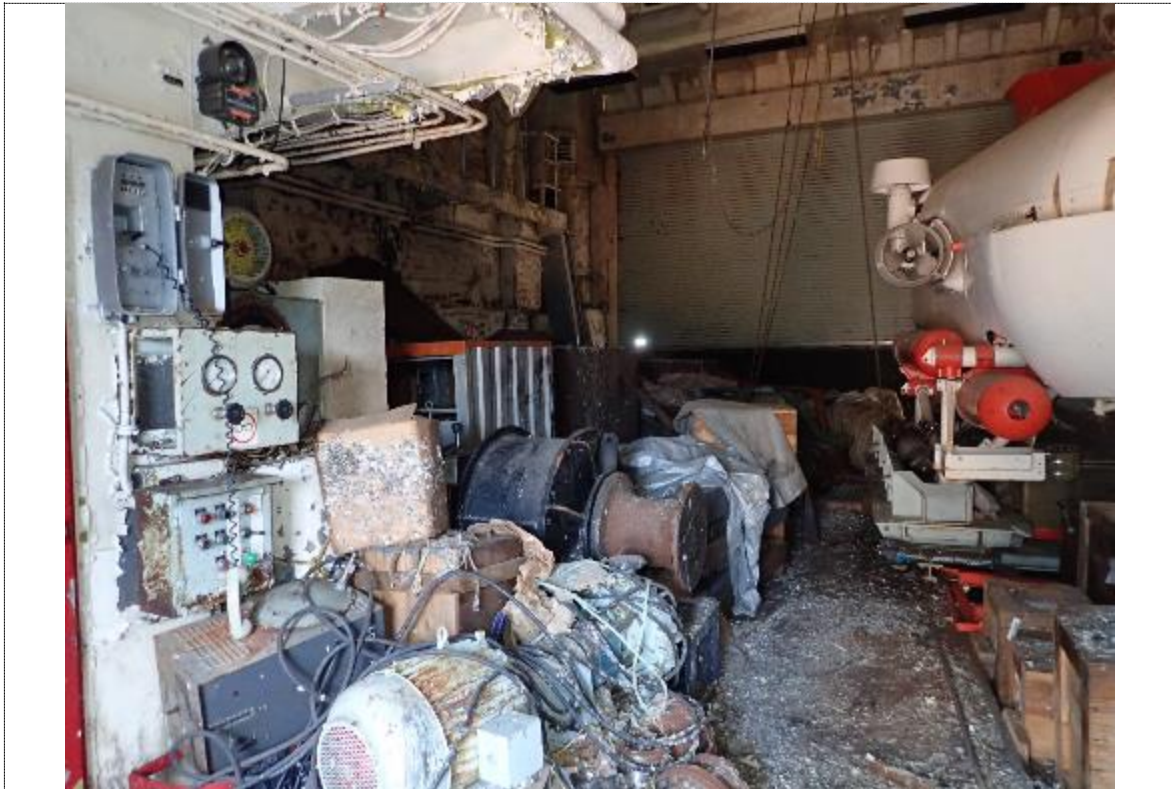
3.6.3 In addition to the submersible vehicle, the hanger area was noted to contain a large number of stores, spares and general rubbish, all of which was covered in bird droppings.

35. Submersible and general spares / stores in hanger
