Part 1 General

RE: Stony Mountain Institution: CSC C12 Powerhouse Structural Repair Geotechnical Recommendations and Considerations

Dyregrov Robinson Inc. (DRI) has undertaken a review of the project information provided and made two site visits in order to provide geotechnical recommendations and considerations for the proposed repairs to the CSC C12 Powerhouse structure located at the Stony Mountain Institution, Stony Mountain, MB.

**RE: Assessment of Powerhouse Coal Storage Area
 Stony Mountain Institute, Stony Mountain, Manitoba**

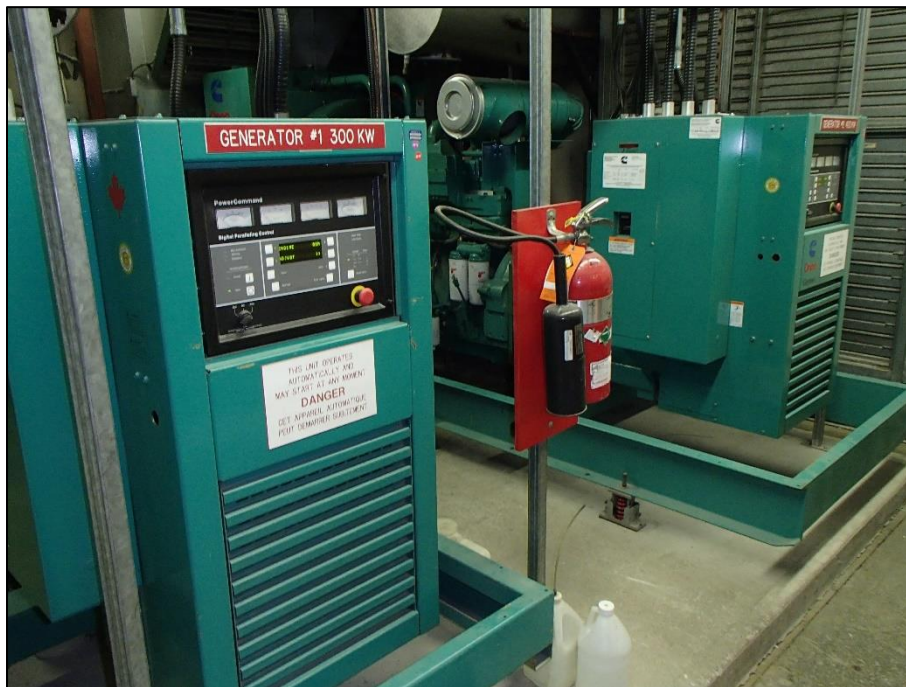
On January 21st, 2020, DRI participated a site visit of the CSC C12 Powerhouse building arranged for and led by CKP. The first part of the site visit consisted of touring the generator room, electrical room, and work area on the main floor directly above the coal bunker (refer to Ground Floor Plan in Appendix A). The generators and electrical equipment sit on concrete slab floor that also extends into the work area room to the large overhead door. The work area room, as we understand, originally provided railcar access above the coal bunker to replenish the coal reserves. Photograph 1 shows the generators on the concrete slab floor in the generator room.

Photograph 1: Generators on concrete main floor slab in generator room

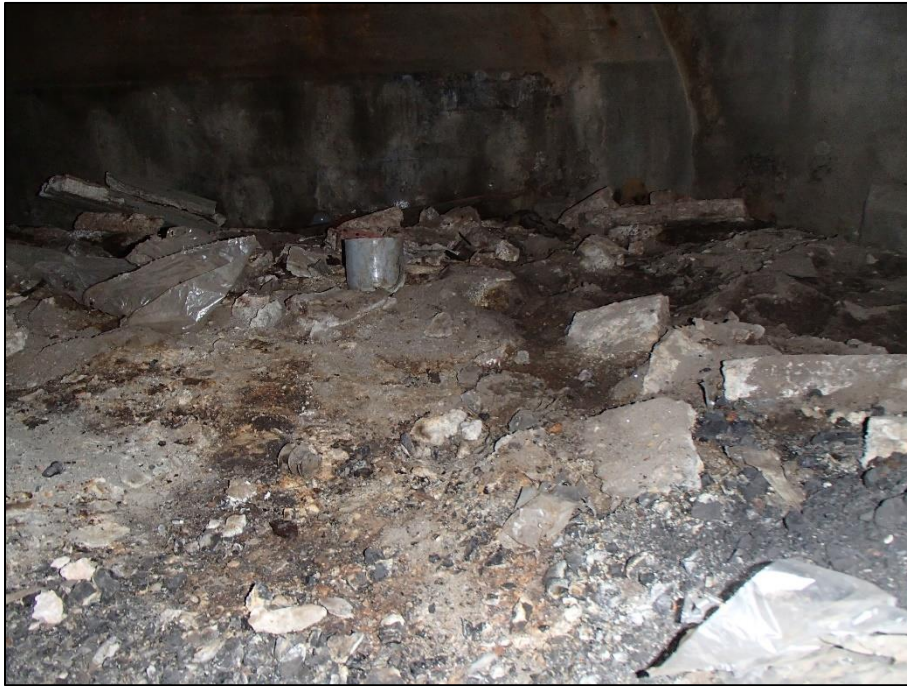
The second part of the site visit consisted of examining the condition of the coal bunker from the basement level. Various access points were cut through the coal bunker concrete wall in order to provide an inside view. The coal bunker is an open space with reinforced concrete beams and columns and angled concrete side walls. The beams and columns show signs of deterioration with the corroded reinforcing steel visible in many locations. Water, concrete debris, and some coal has accumulated at the bottom of the coal bunker creating an uneven surface at the bottom with debris piling up higher than 2 feet in some areas. Photograph 2 illustrates the general observed conditions at the bottom of the coal bunker.

Photograph 2: Concrete rubble and coal residue at the base of the coal bunker

The bottom of the coal bunker should be cleaned before backfilling to dispose of the water and other debris that has accumulated at the base.

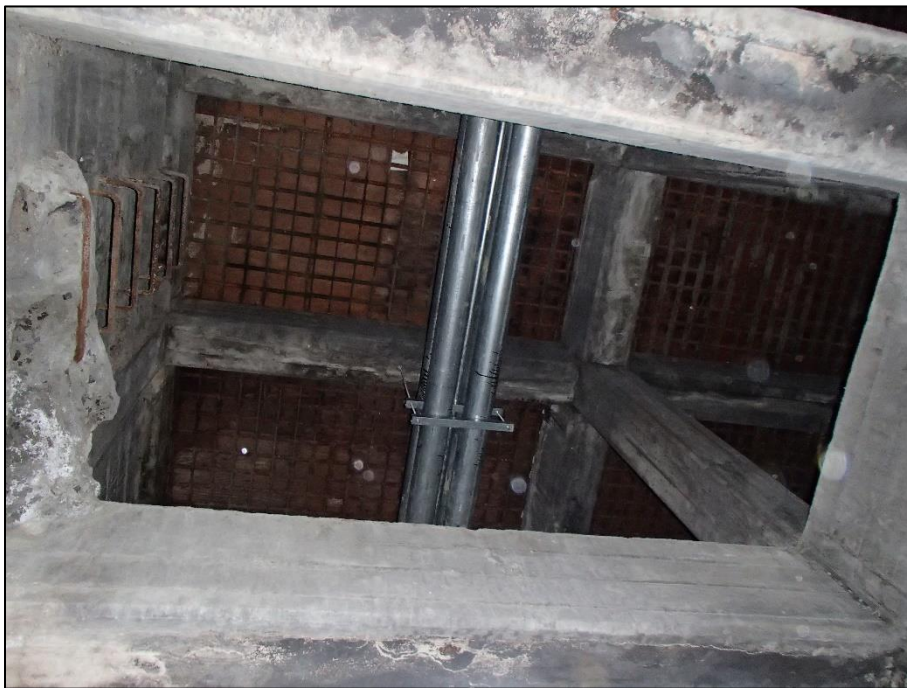
Just below the grated floor over the coal bunker and directly below the generator room, there are a few electrical conduit lines hung from the concrete beams (see Photograph 3). We understand that the conduits must remain operational throughout the construction process along with the generators and electrical equipment above.

Photograph 3: Electrical conduit below the original steel grate over the coal bunker

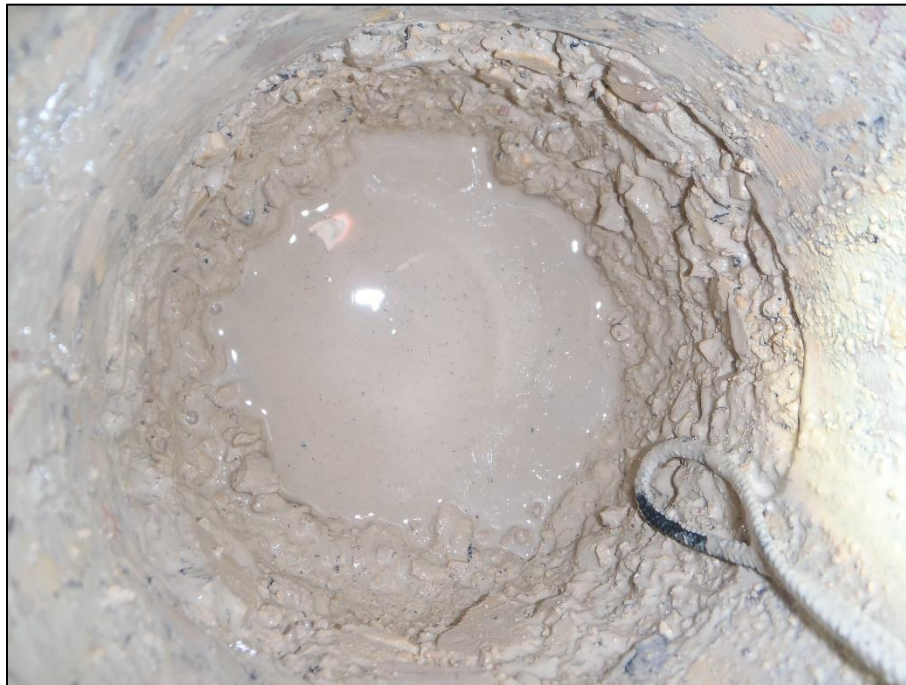
At the three 5 inch diameter core hole locations, crushed limestone gravel was observed directly below the concrete floor slab. The gravel is assumed to be a leveling course of gravel that would have been placed over the bedrock after bedrock blasting was completed during the original excavation work for the coal bunker. Photograph 4 shows an example of the leveling base structure directly beneath the floor slab in Core #1 completed in Coal Access Bay 'D'. Note that the water in Photograph 4 is from the coring process.

Photograph 4: Gravel leveling base below the concrete slab in Core #1

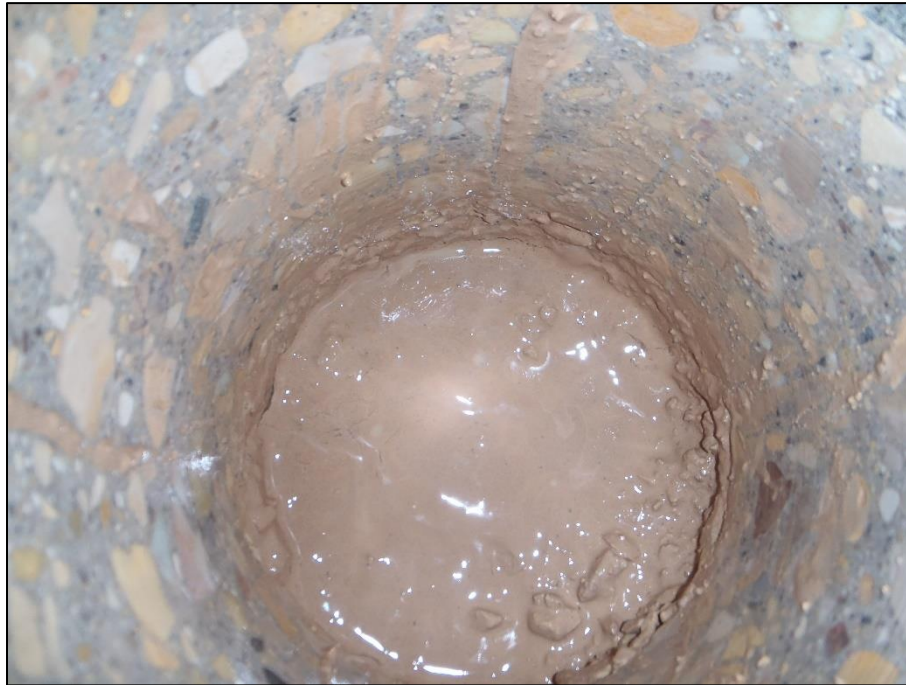
Core #2 was completed in Coal Access Bay 'H' in order to target an area where clay was observed on the probe hole drill bit during a previous site visit by CKP. The conditions observed below the floor slab at this location appeared to be crushed limestone gravel with some clay intermixed. Photograph 5 shows the natural bedrock conditions encountered directly below the floor slab in Core #2 completed in Coal Access Bay – H. Note that the water in the photograph is from the coring process.

Photograph 5: Clay intermixed in crushed gravel below the concrete slab at Core #2

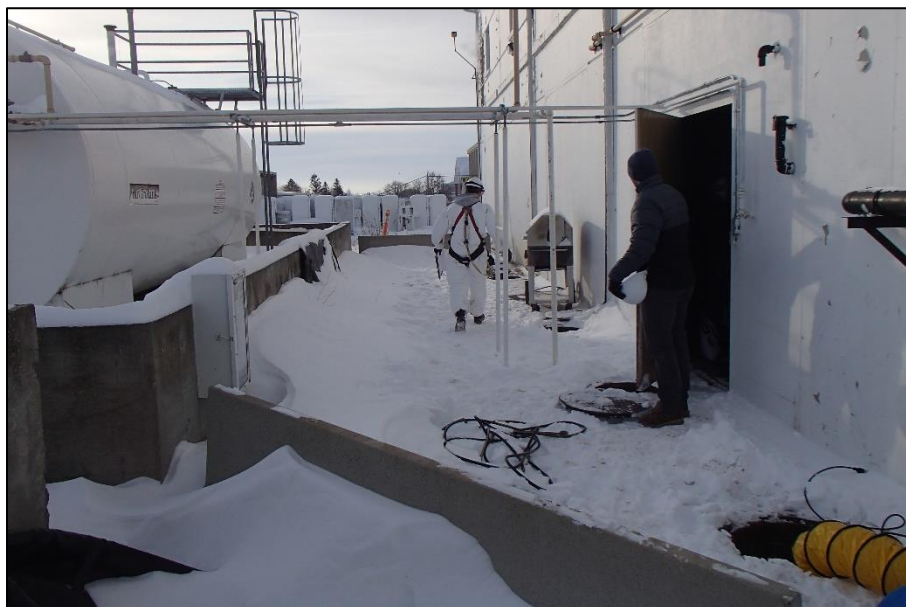
Photograph 6: Exterior manholes with access to coal bunker

Flowable cement stabilized fill eliminates many of the challenges with using compacted granular backfill. The material could be pumped into the coal bunker eliminating the need for personnel and compaction equipment to be working in the bunker, which is considered to be a confined space. The material can be pumped through relatively small openings from the main floor level and the flowable fill should also fill the voids beneath the existing beams compared to the use of granular fill materials. Photograph 6 shows a series of manholes outside of the generator and electrical room that were opened in order to provide air and emergency access to the coal bunker below. These access points may potentially be suitable for placement of flowable cement stabilized fill into some areas of the coal bunker.

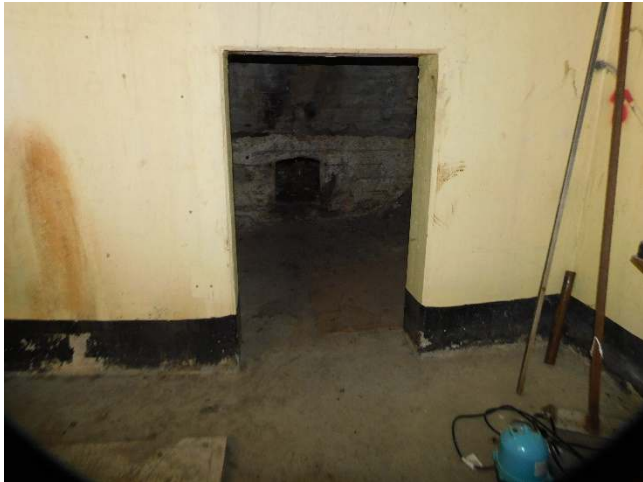
Photo 1: View of access point in powerhouse to coal vault chute.

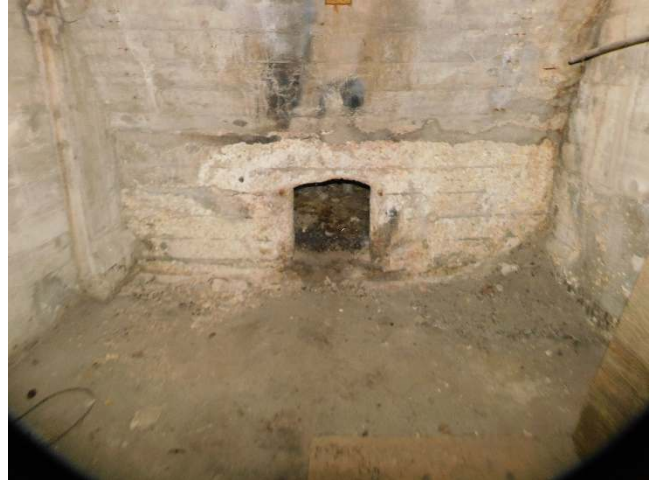
Photo 2: Coal chute location within access point shown in photo 1. Metal chute was removed to allow access.

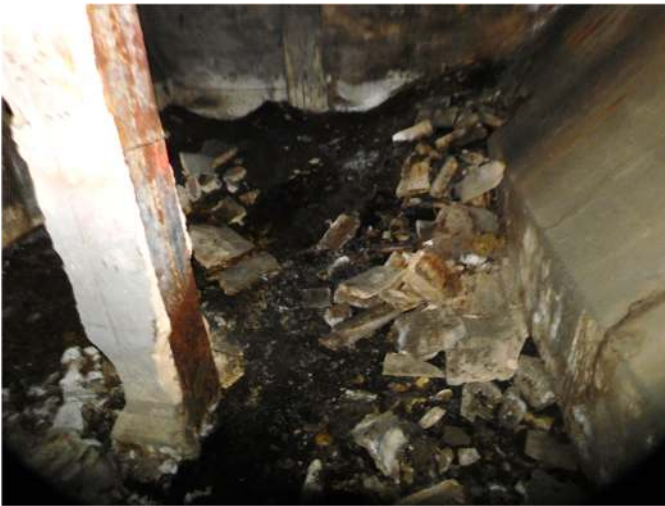
While coal dust was observed to be present in the space as a contaminant, it was present in relatively small quantities. Wood does not expect that this material will cause extraneous hazards for workers, provided that it remains reasonably undisturbed and not posing an airborne hazard. If the material is to be removed, it should be removed in a manner using excellent dust control measures. The level of respiratory protection and disposable coveralls cited above would be anticipated to provide an adequate level of protection for workers. While the amount of coal dust present would not be reasonably expected to pose a fire/explosion risk, dust control measures would mitigate this hazard.

Photo 3: View of largest area of coal dust in coal storage vault.

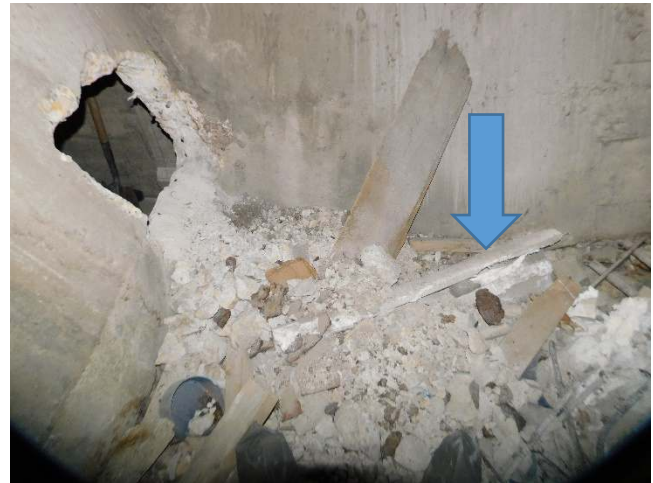
Wood collected two sample of linear pipe insulation debris. Sample ACM-01 was collected off the floor within the space (Photo 4). Sample ACM-02 was collected from the top of a chute outside the space (Photo 6).

Both samples were determined to be none-detected for asbestos fibres. It should be noted that while the two samples collected appeared to be representative of the suspect debris observed in the space, not all debris was sampled.

Photo 4: Pipe insulation debris (Sample ACM-01) located within coal storage vault.

Based on the laboratory results, the linear pipe insulation debris sampled did not contain asbestos fibres. Consider that Wood did not sample all linear pipe insulation debris in the space. Asbestos containing parging cement fitting insulation is commonly associated to installations that include the type of lineal pipe insulation observed. While parging cement was not observed, there is a potential to find it comingled with linear pipe insulation. Wood was not provided with information on past abatement in the space to determine if parging cement may have been previously abated. If the debris in the space requires removal, Wood recommends that this be conducted by a qualified contractor in accordance with an appropriate safe work plan. If debris suspect of containing asbestos fibres is observed, work should be suspended until a further assessment can be conducted. Alternately, all debris could be removed by workers in keeping with typical moderate risk asbestos abatement procedures, in addition to following confined space entry procedures.

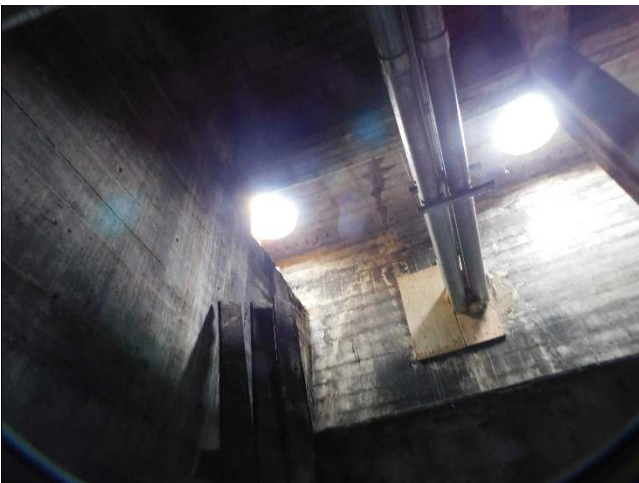
Photo 5: View of manholes at top of coal storage vault.

In the absence of an engineered solution for the rescue of a worker from the space such as larger openings and/or a worker retrieval system, a standby rescue team may be required. If a rescue team is the rescue provision selected, a suitable number of rescue personnel are required to affect a timely rescue. In Wood's experience, even a suitable staffed team would be challenged to rescue a worker for the space without increasing the size of the openings or having provisions in place for a top rescue through a manhole at the top of the space.

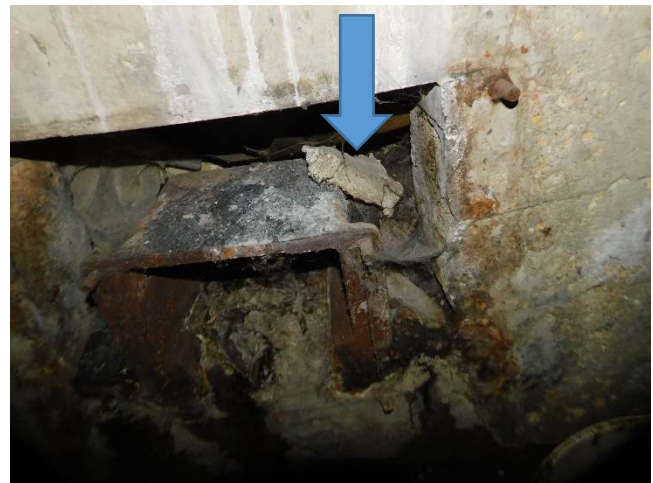
Photo 6: Pipe insulation debris (Sample ACM-02) located on coal chute in powerhouse outside vault.
