**FACILITY CONDITION ASSESSMENT
BOWDEN INSTITUTION
Innisfail, Alberta
TS: 11344**

Prepared for:
Correctional Services Canada

Prepared by:
ALTUS GROUP COST CONSULTING

Issued: **April 30, 2012**

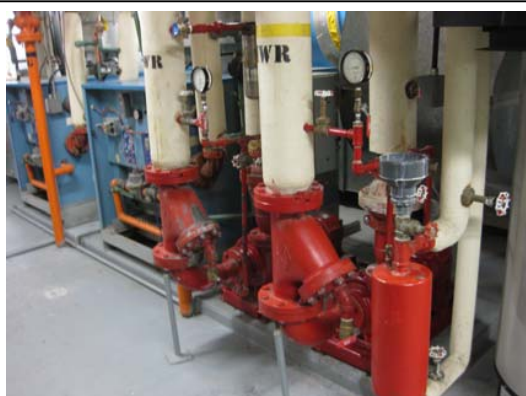
The gas fired hot water heating boilers and heating circulation pumps are past their useful service life and should be scheduled for replacement in the near future. Maintenance staff confirmed that frequent maintenance is required to keep the boilers operational, and sourcing replacement components has been an issue and will continue to exacerbate with time.

Typical Heating Pumps - Replace

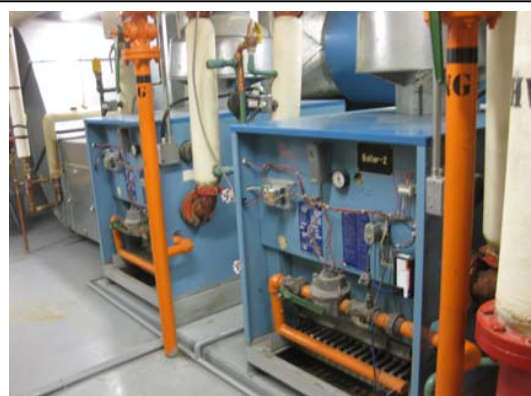
Typical Heating Boilers - Replace

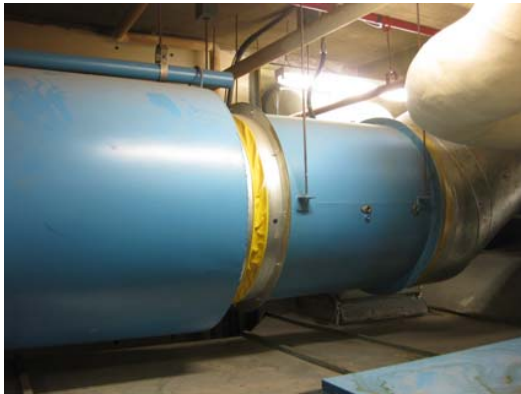
The buildings' supply air handling units and return air fans are in serviceable condition; however, they are past their useful service life and should be scheduled to have their internal components upgraded. We recommend replacing the unit motors, shafts, belts and coils to extend the life of the equipment.

Typical Return Air Fan – Refurbish Components

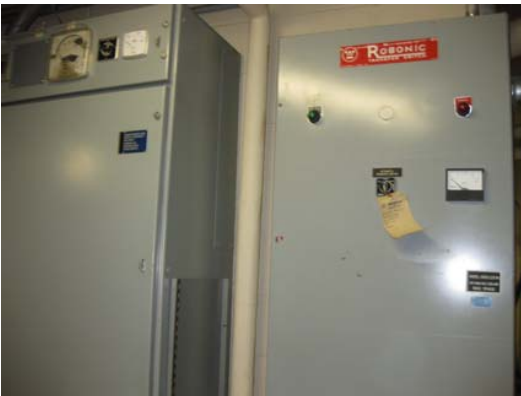
Typical Transfer Switch - Replace

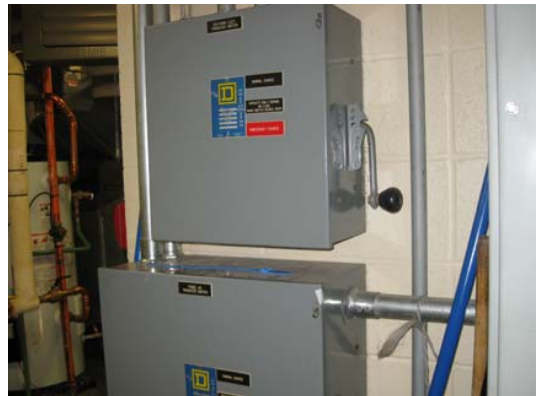
Typical Main Disconnect – Replace

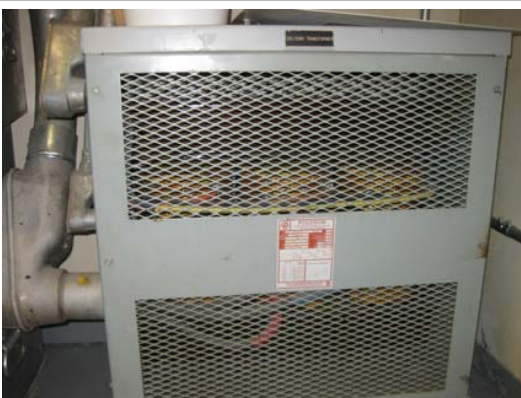
Typical Transformer - Replace

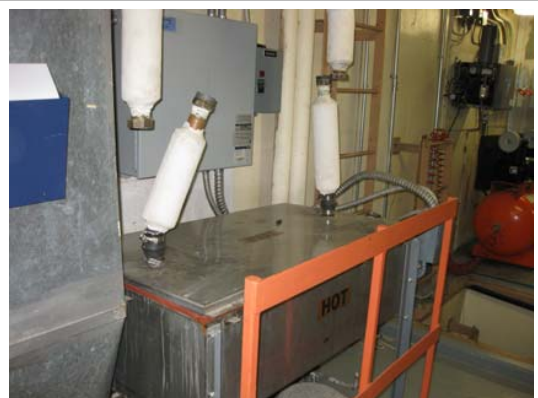
The humidifiers for the air handling units are past their useful service life and should be scheduled for replacement.

Typical Humidifier (AHU) - Replace

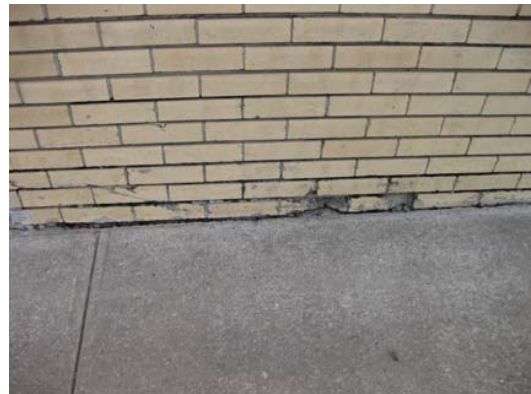
Generally, the exterior brick walls appear to be in serviceable condition; however, there are signs of efflorescence at grade and locations of previous repairs. There are some areas of cracked/spalled bricks that require replacement and, in general, the brick mortar joints should be reviewed and repointed. The estimated cost for this work is included in the cost table.

Brick Spalling/Deterioration at Grade

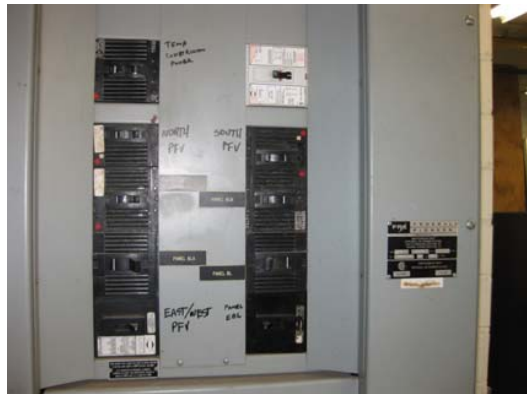
Main Switchgear - Replace

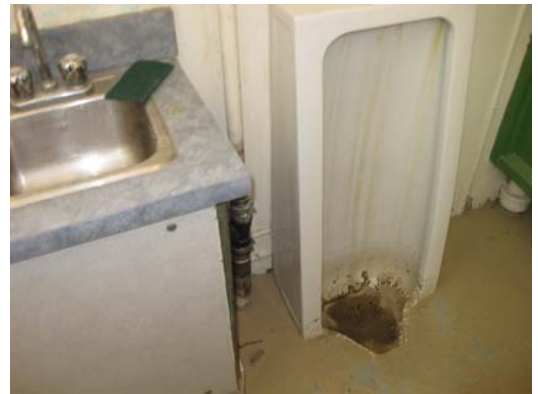
Plumbing Fixtures – Upgrade

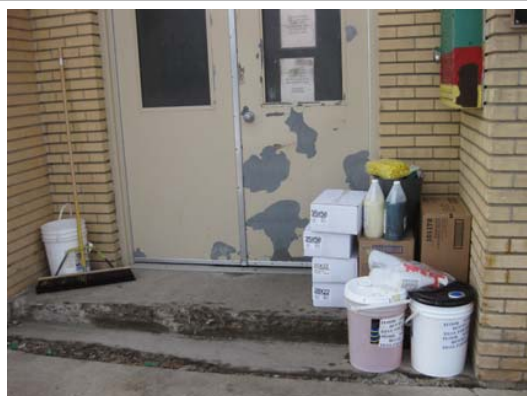
Concrete Stair Deterioration

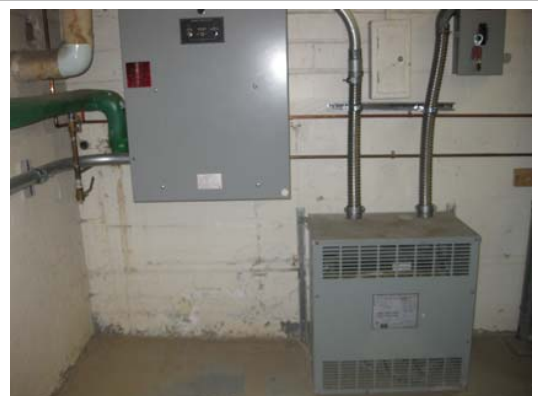
Transformer - Replace

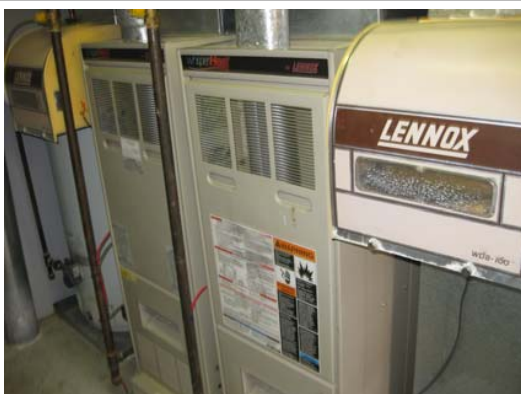
Furnaces (Typical for PFV 14 & 15) - Replace

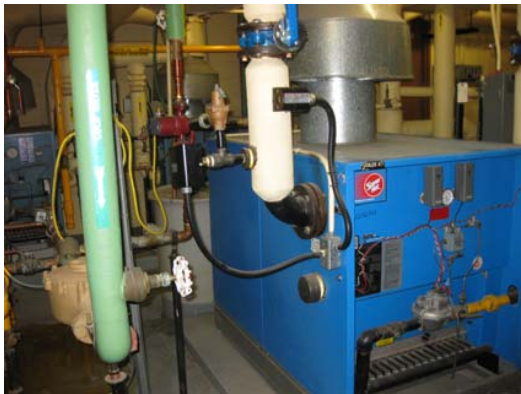
Heating Boilers - Replace

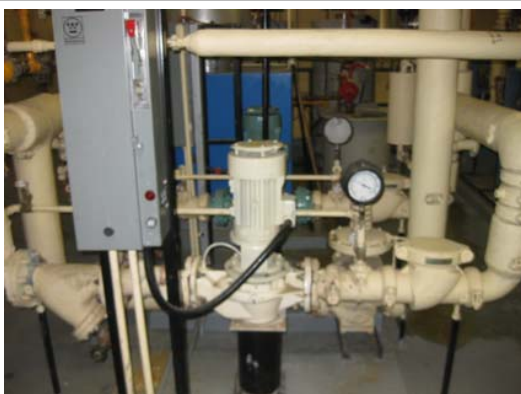
Heating Pumps - Replace

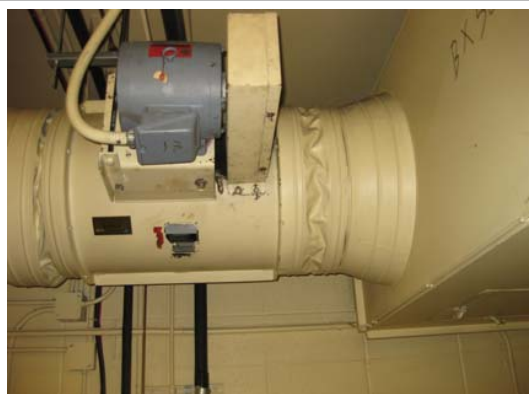
Return Air Fan – Refurbish Components

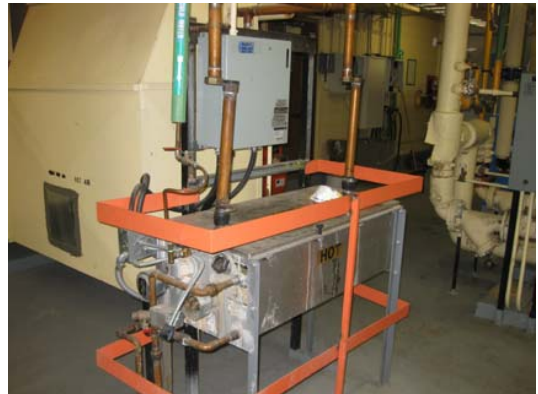
Humidifier (AHU) - Replace

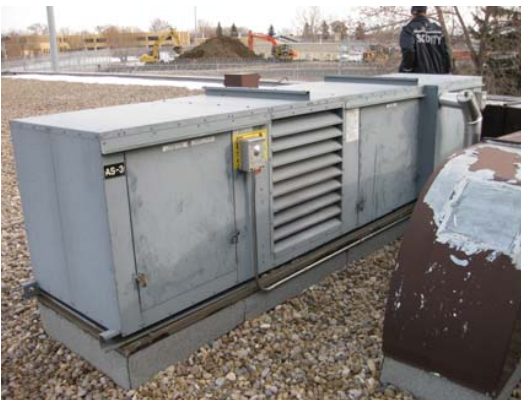
Rooftop Unit - Replace

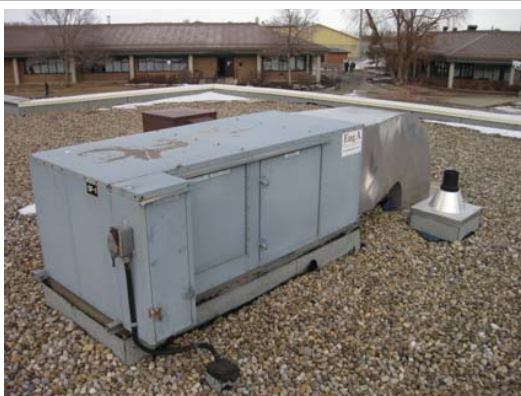
Rooftop Unit - Replace

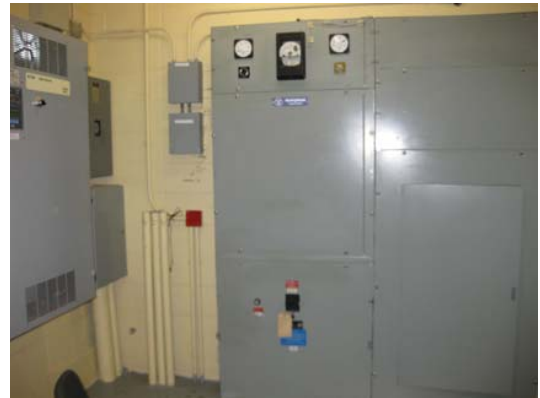
Main Breaker & Transfer Switch - Replace

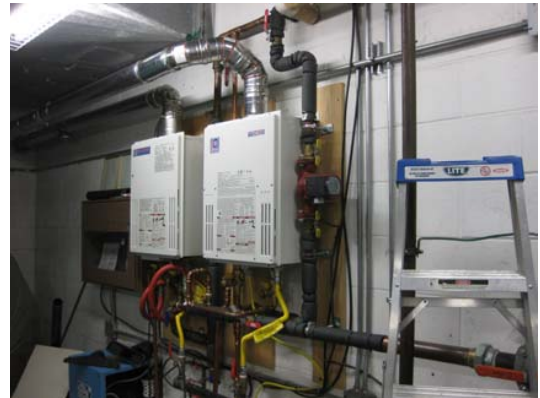
Heating Boiler - Replace

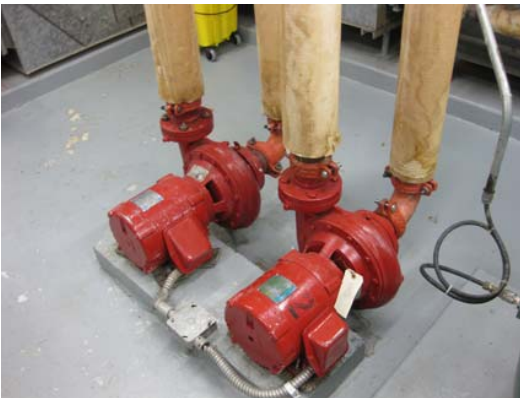
Heating Pumps - Replace

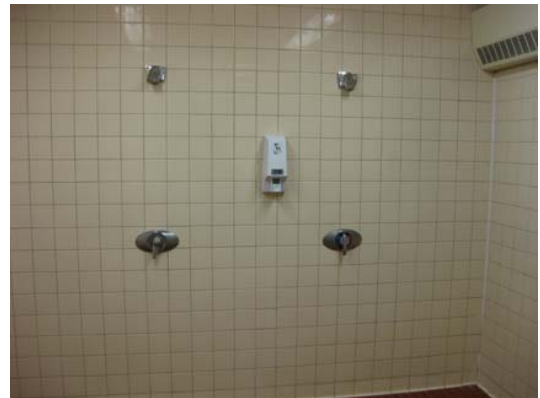
Upgrade Plumbing Fixtures

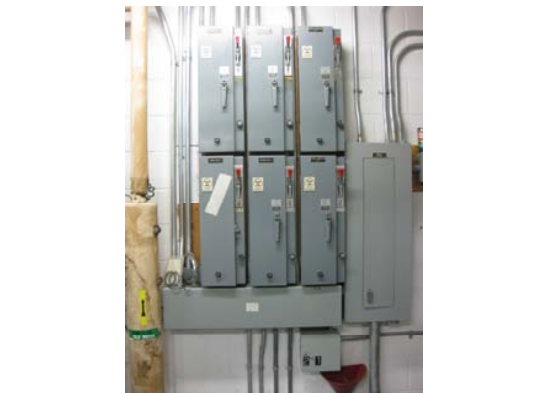
Main Breakers - Replace

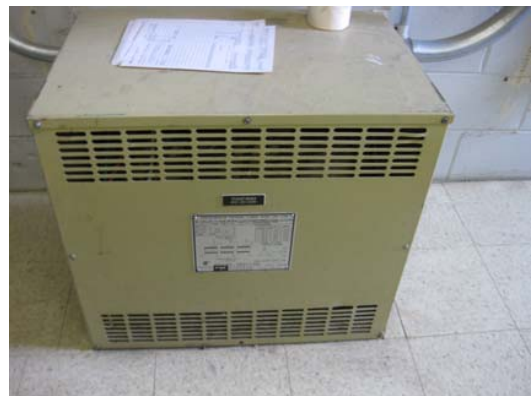
Transformer - Replace

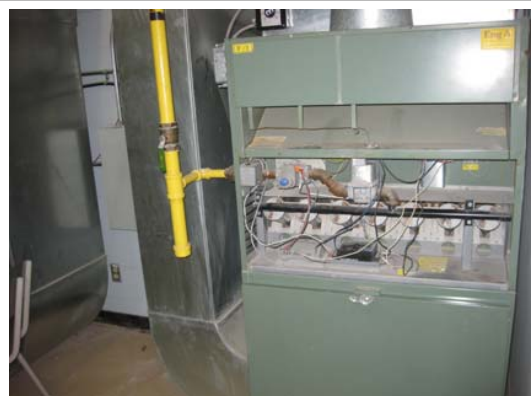
Air Handling Unit - Replace

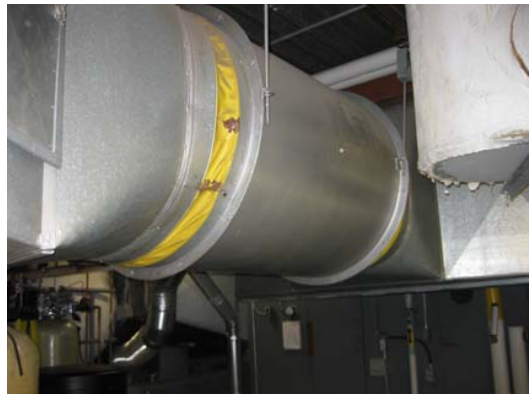
Return Air Fan (AHU-1) – Refurbish

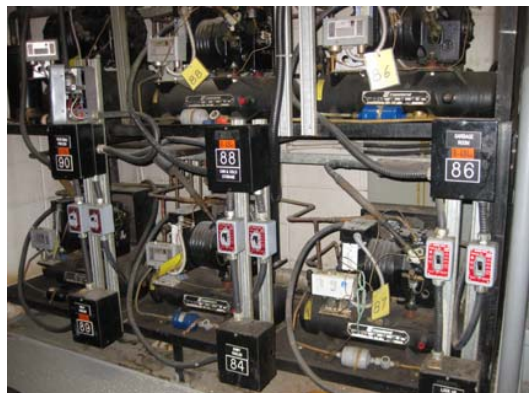
Compressors (Kitchen Equipment) - Replace

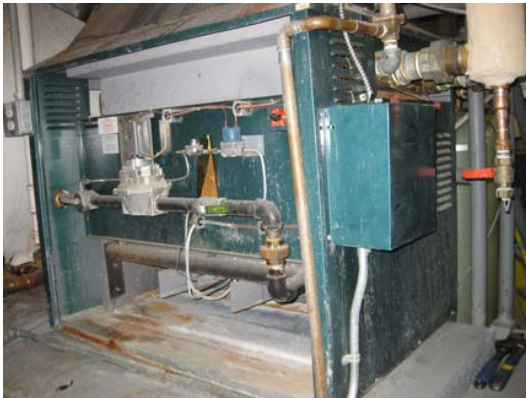
Heating Boilers - Replace

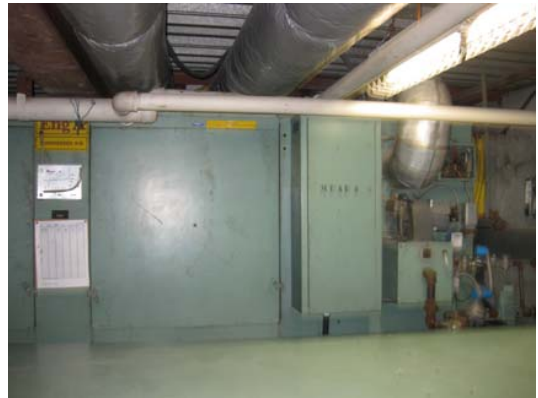
Typical Make-Up Air Unit – Upgrade Components

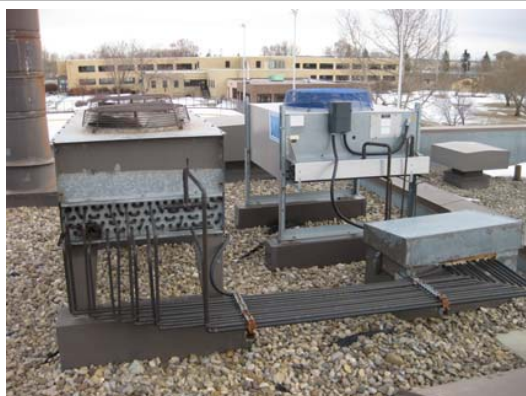
Condensing Units – Replace Older Unit

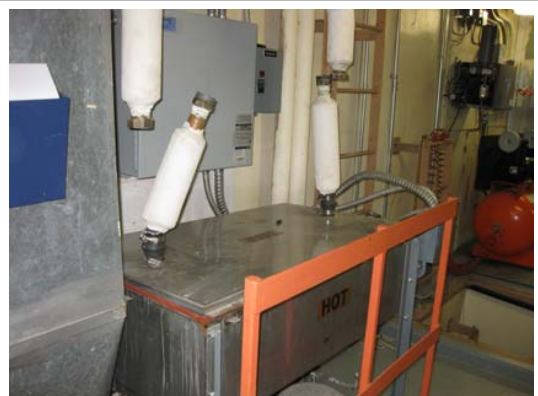
Humidifier (AHU) - Replace

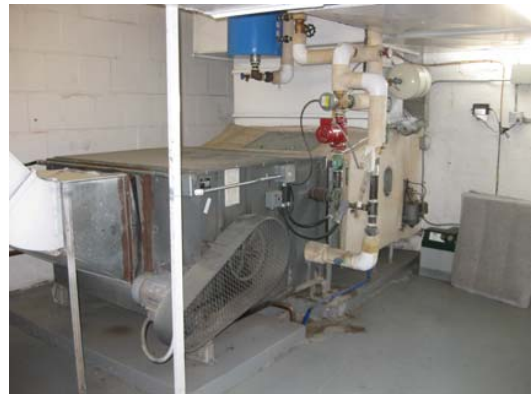
Air Handling Unit – Refurbish

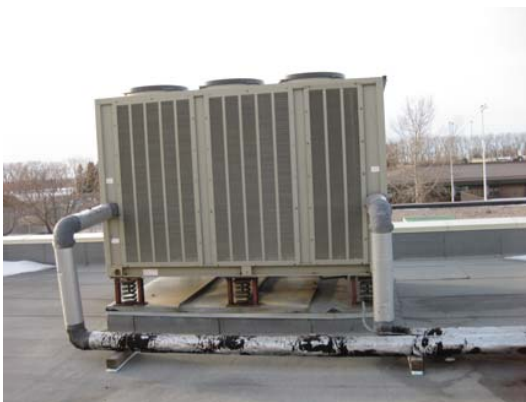
Air Cooled Chiller - Replace

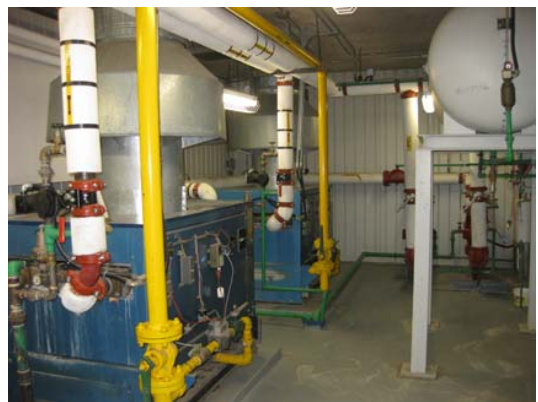
Heating Boilers – Replace

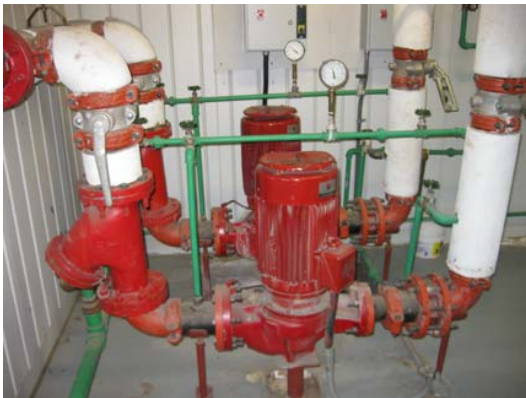
Heating Pumps - Replace

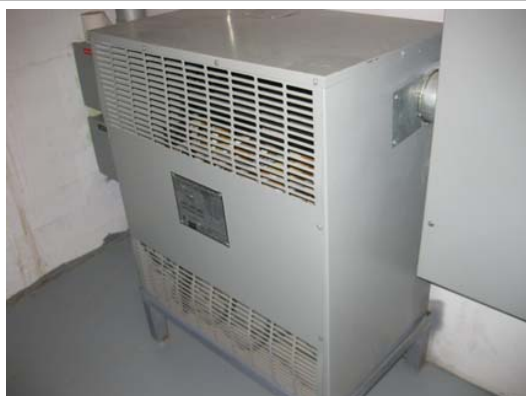
Transformer - Replace

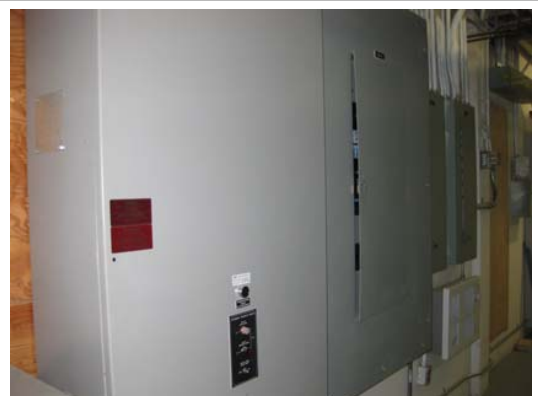
Transfer Switch - Replace

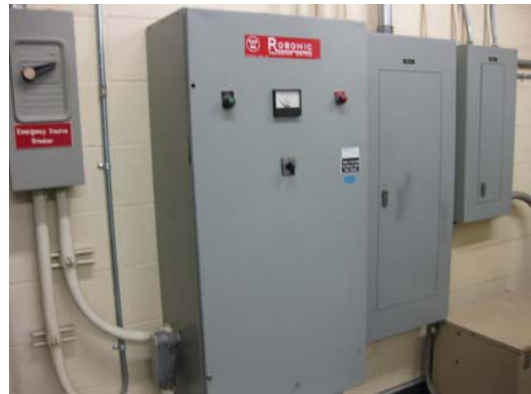
Transfer Switch - Replace

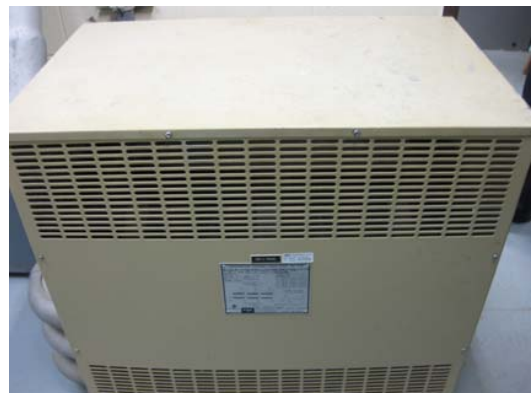
Transformer - Replace

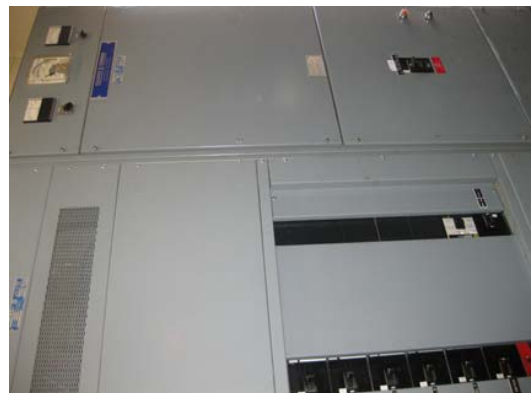
Main Disconnect - Replace

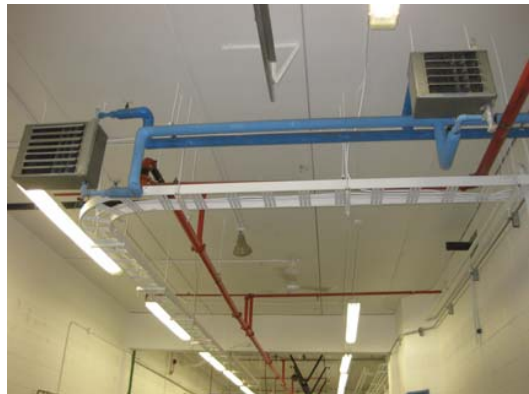
Hot Water Unit Heaters - Replace

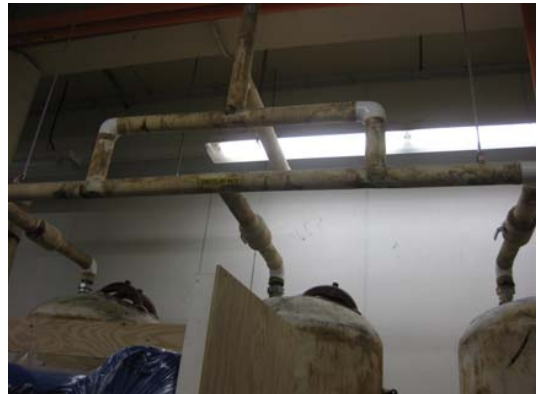
Domestic Hot Water Insulation - Replace

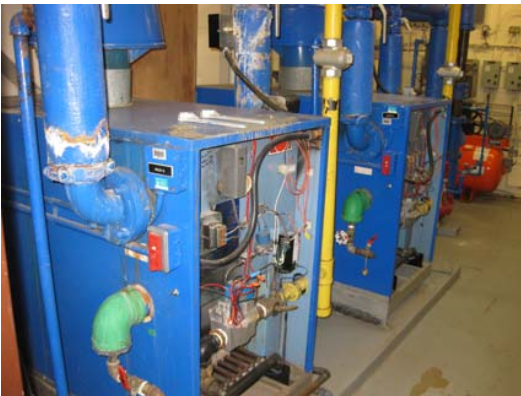
Heating Boilers - Replace

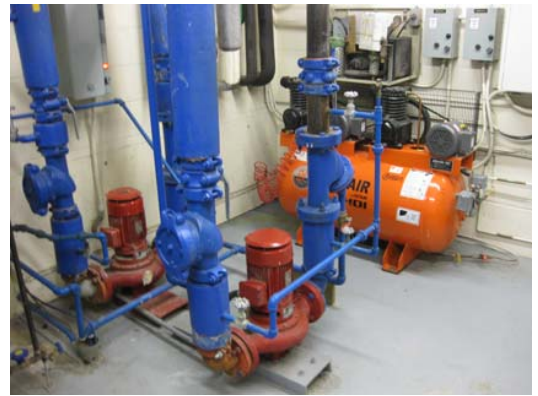
Heating Pumps - Refurbish

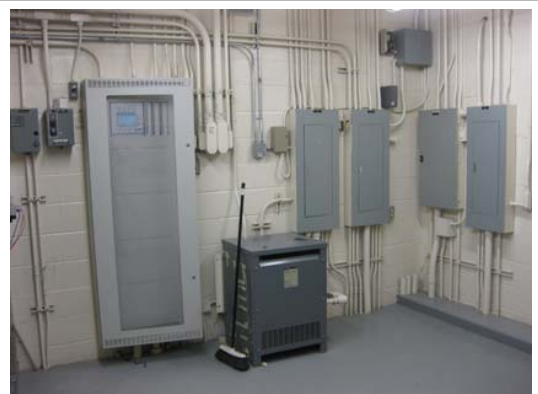
Fire Alarm Panel / Transformer - Replace

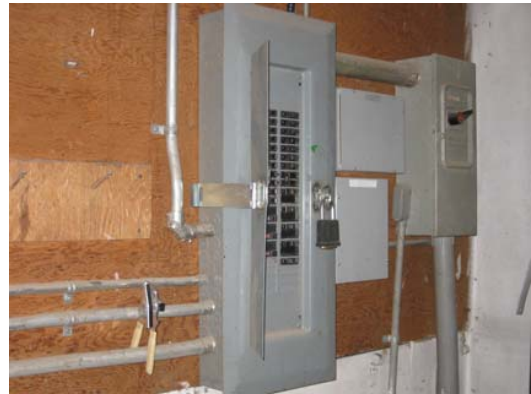
Main Disconnect & Distribution Panel - Replace

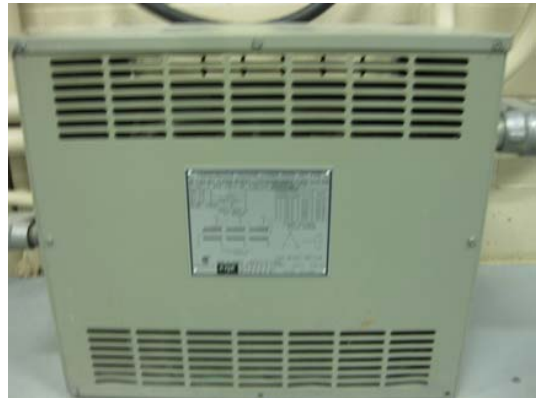
Transformer - Replace

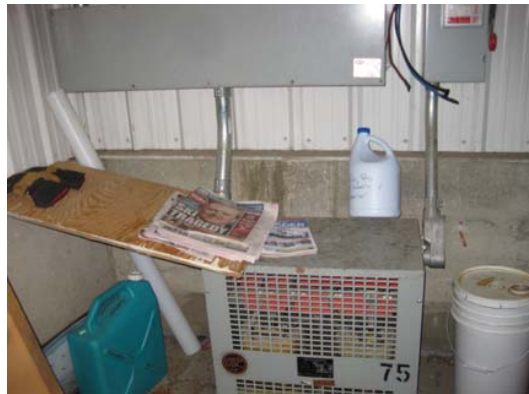
75 kVa Transformer - Replace

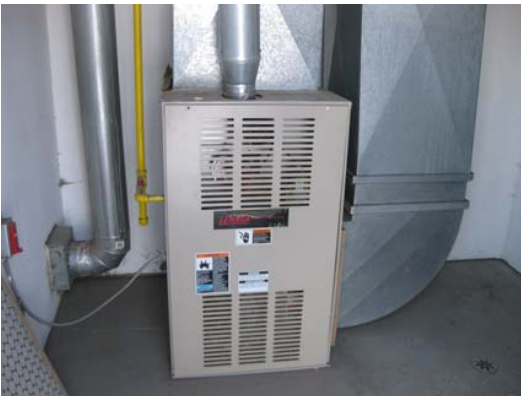
Office Area Furnace - Replace

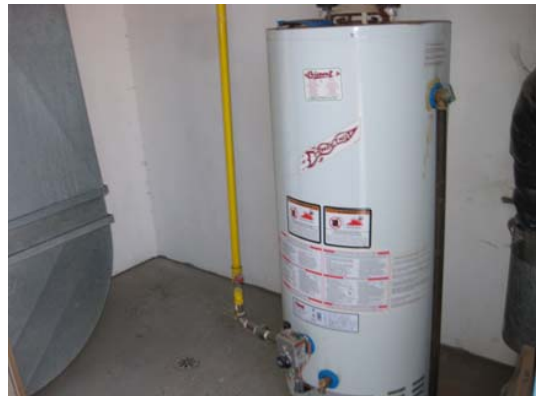
Domestic Hot Water Tank – Replace
