**SOLICITATION AMENDMENT  
MODIFICATION DE L'INVITATION**

<b>Title - Sujet</b> Electrical Infrastructure Upgrades	
<b>Solicitation No. - N° de l'invitation</b> EP922-210870/A	<b>Amendment No. - N° modif.</b> 001
<b>Client Reference No. - N° de référence du client</b> CSC EP922-210870	<b>Date</b> 2020-09-23
<b>GETS Reference No. - N° de référence de SEAG</b> PW-\$PWU-201-11898	
<b>File No. - N° de dossier</b> PWU-0-43084 (201)	<b>CCC No./N° CCC - FMS No./N° VME</b>
<b>Solicitation Closes - L'invitation prend fin</b> <b>at - à 02:00 PM</b> <b>on - le 2020-10-13</b>	<b>Time Zone</b> Fuseau horaire Mountain Daylight Saving Time MDT
<b>F.O.B. - F.A.B.</b> <b>Plant-Usine:</b> <input type="checkbox"/> <b>Destination:</b> <input type="checkbox"/> <b>Other-Autre:</b> <input type="checkbox"/>	
<b>Address Enquiries to: - Adresser toutes questions à:</b> Ho (RPC), Hector	<b>Buyer Id - Id de l'acheteur</b> pww201
<b>Telephone No. - N° de téléphone</b> (780) 901-0989 ( )	<b>FAX No. - N° de FAX</b> (780) 497-3510

**FACILITY CONDITION ASSESSMENT  
BOWDEN INSTITUTION  
Innisfail, Alberta  
TS: 11344**

Prepared for:  
**Correctional Services Canada**

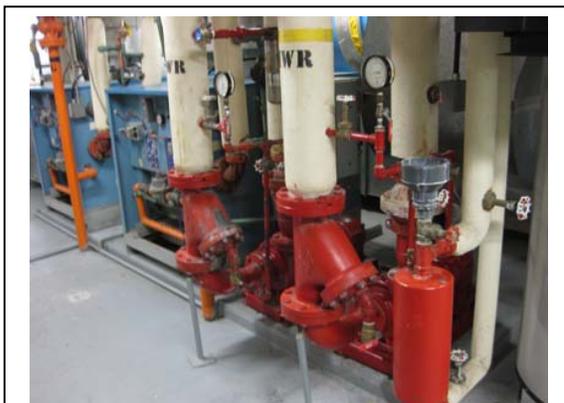
The gas fired hot water heating boilers and heating circulation pumps are past their useful service life and should be scheduled for replacement in the near future. Maintenance staff confirmed that frequent maintenance is required to keep the boilers operational, and sourcing replacement components has been an issue and will continue to exacerbate with time.

Typical Heating Pumps - Replace

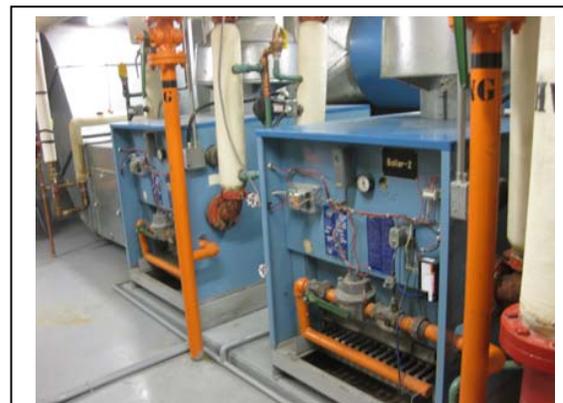
Typical Heating Boilers - Replace

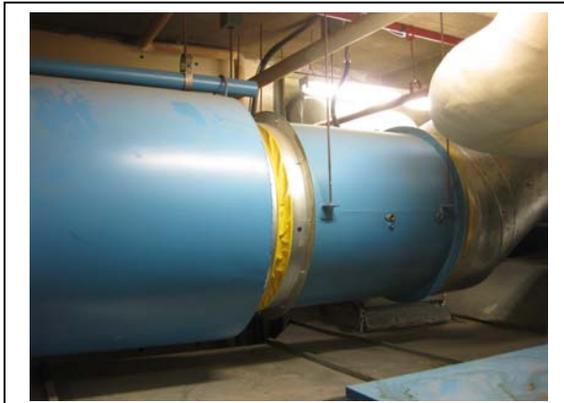
The buildings' supply air handling units and return air fans are in serviceable condition; however, they are past their useful service life and should be scheduled to have their internal components upgraded. We recommend replacing the unit motors, shafts, belts and coils to extend the life of the equipment.

Typical Return Air Fan – Refurbish Components

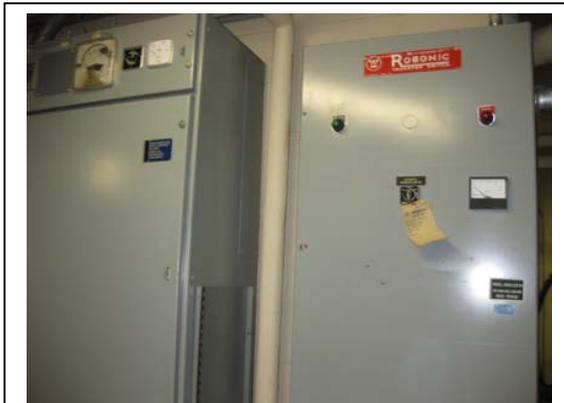
Typical Transfer Switch - Replace

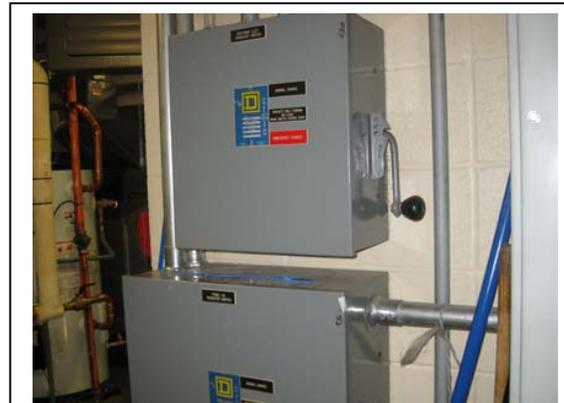
Typical Main Disconnect – Replace

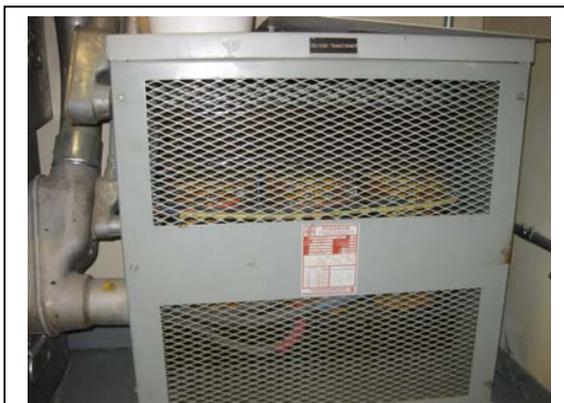
Typical Transformer - Replace

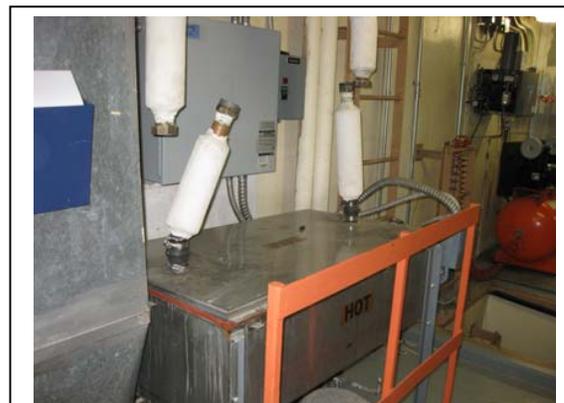
The humidifiers for the air handling units are past their useful service life and should be scheduled for replacement.

Typical Humidifier (AHU) - Replace

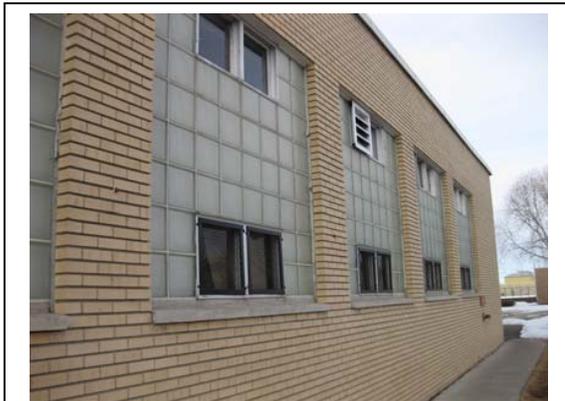
All of the window units throughout the building should be replaced/upgraded. The estimated cost for this work is included in the cost table.

South Elevation Windows - Replace

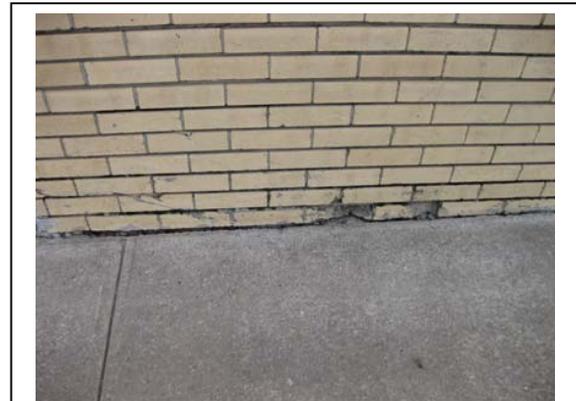
Generally, the exterior brick walls appear to be in serviceable condition; however, there are signs of efflorescence at grade and locations of previous repairs. There are some areas of cracked/spalled bricks that require replacement and, in general, the brick mortar joints should be reviewed and repointed. The estimated cost for this work is included in the cost table.

Brick Spalling/Deterioration at Grade

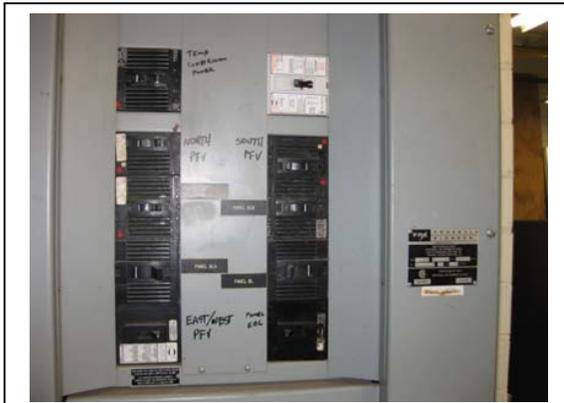
Main Switchgear - Replace

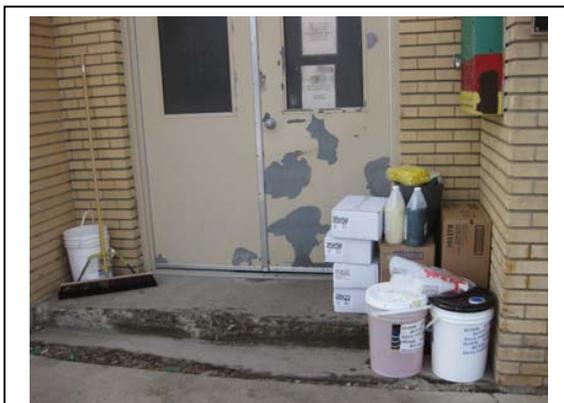
Concrete Stair Deterioration

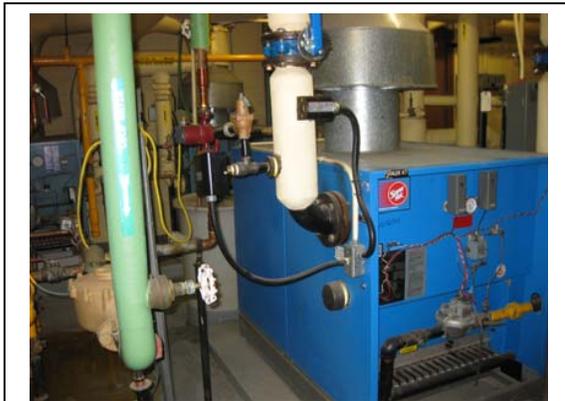
Heating Boilers - Replace

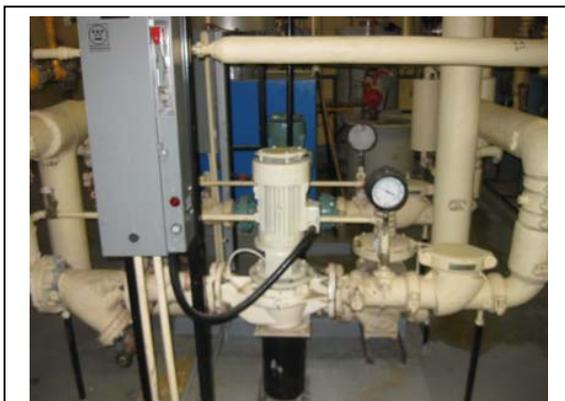
Heating Pumps - Replace

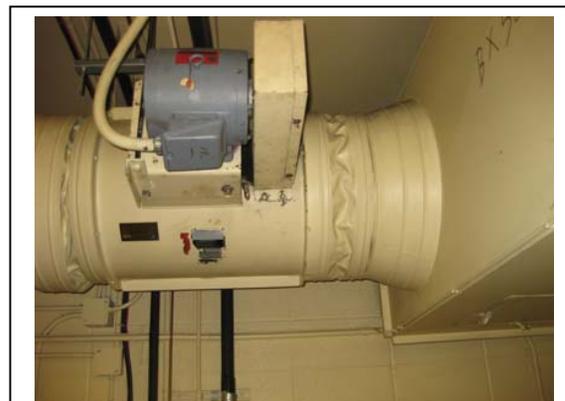
Return Air Fan – Refurbish Components

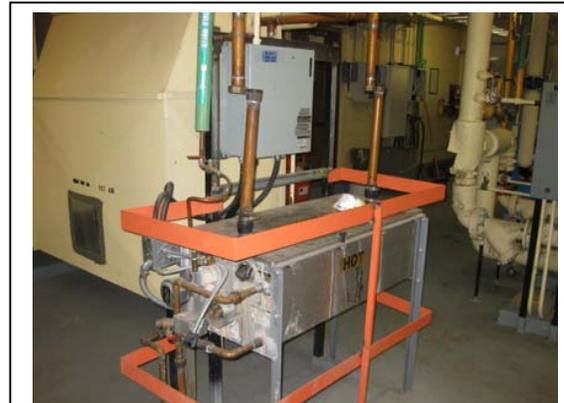
Humidifier (AHU) - Replace

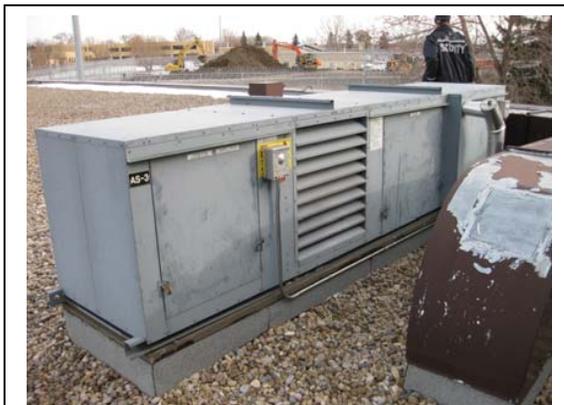
Rooftop Unit - Replace

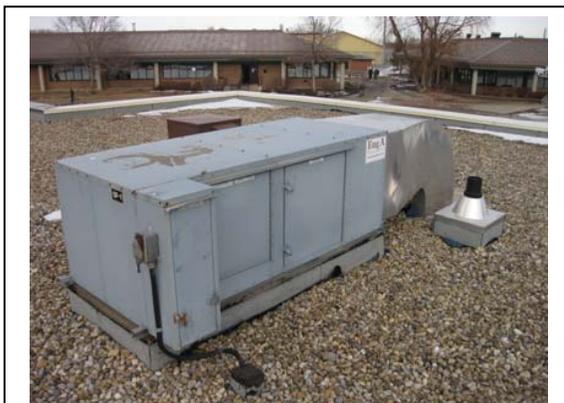
Rooftop Unit - Replace

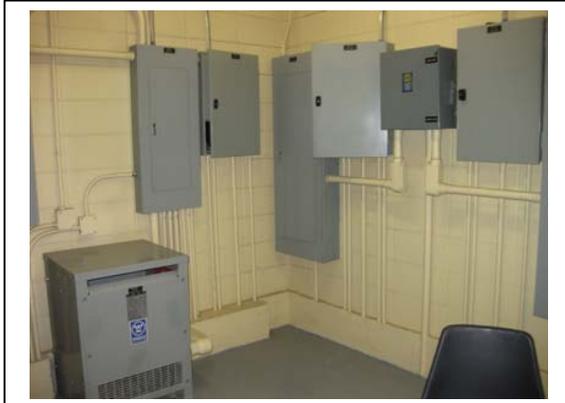
Transformer - Replace

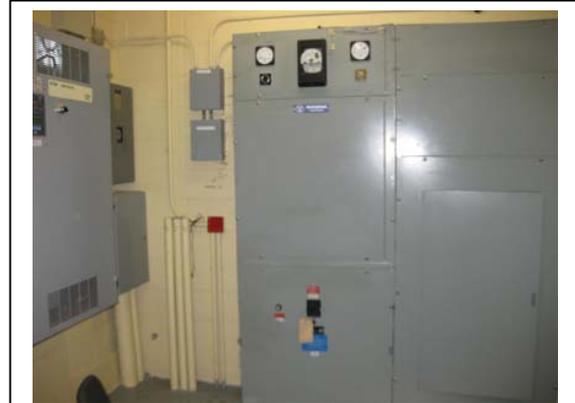
Main Breaker & Transfer Switch - Replace

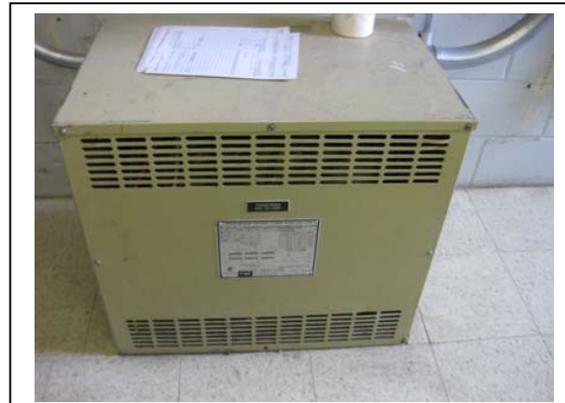
Transformer - Replace

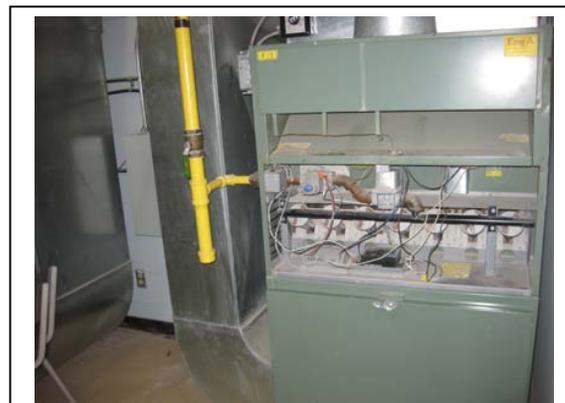
Air Handling Unit - Replace

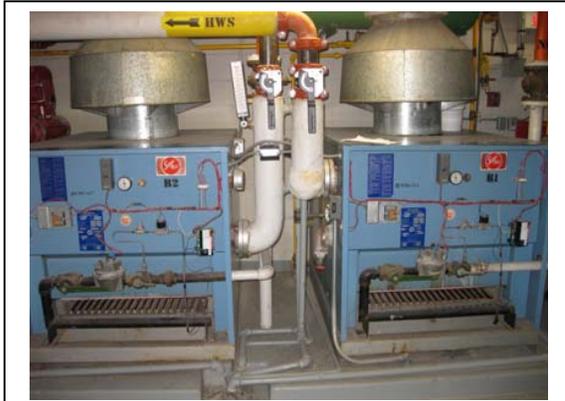
Domestic Hot Water Boilers - Replace

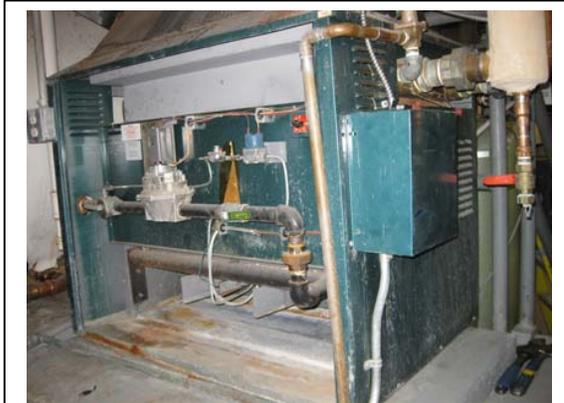
Heating Boilers - Replace

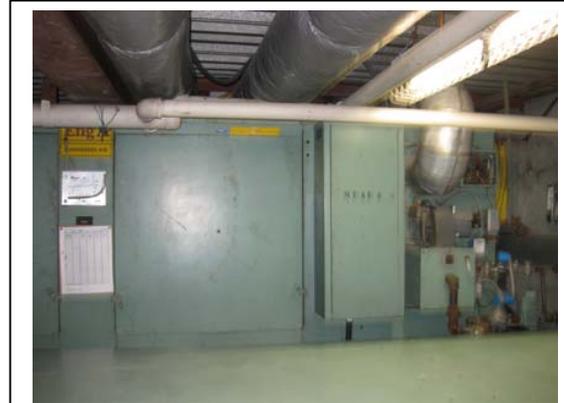
Typical Make-Up Air Unit – Upgrade Components

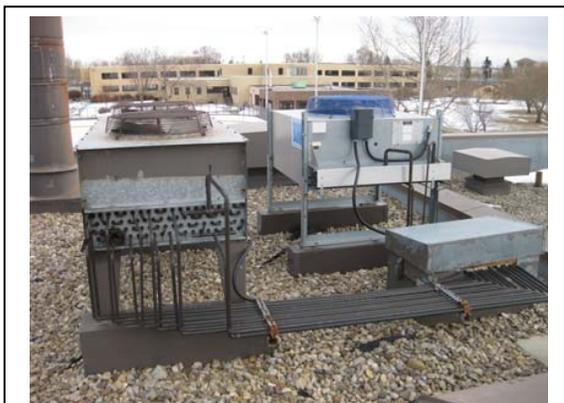
Condensing Units – Replace Older Unit

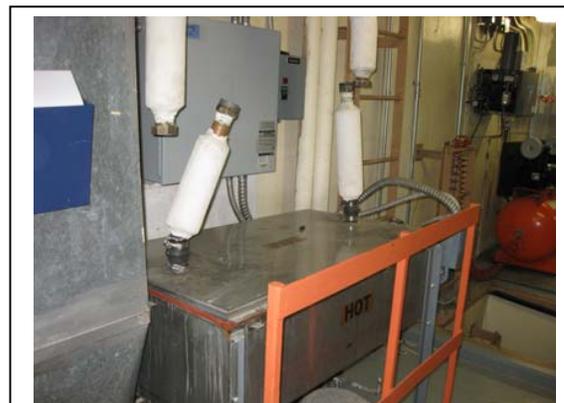
Humidifier (AHU) - Replace

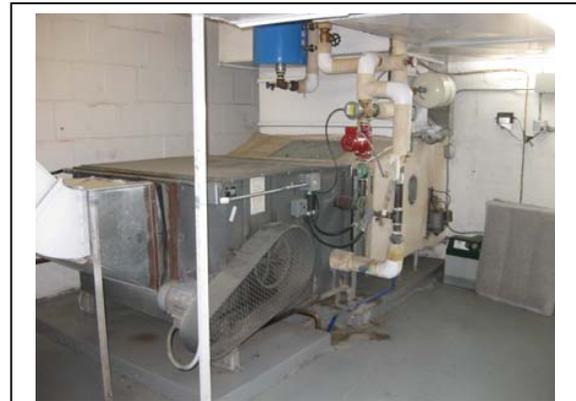
Air Handling Unit – Refurbish

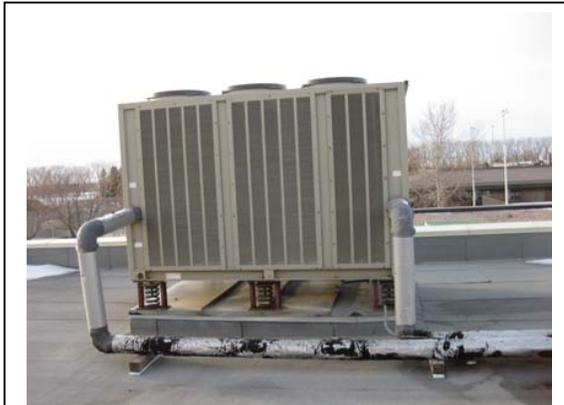
Air Cooled Chiller - Replace

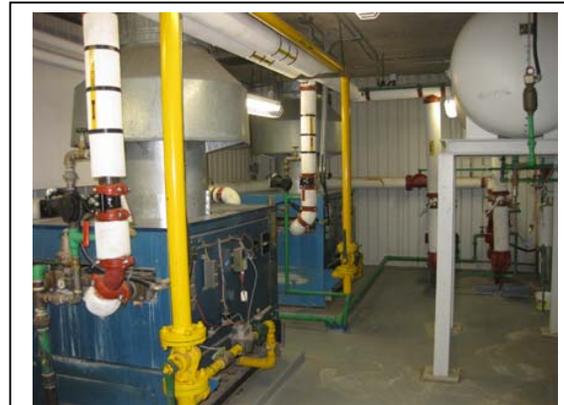
Heating Boilers – Replace

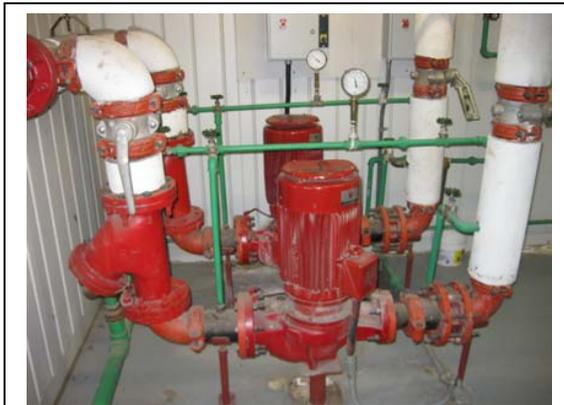
Heating Pumps - Replace

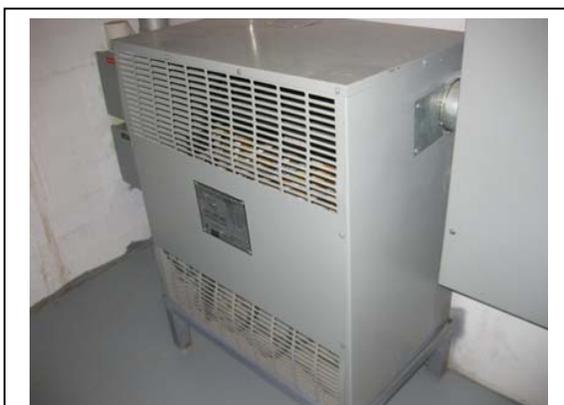
Transformer - Replace

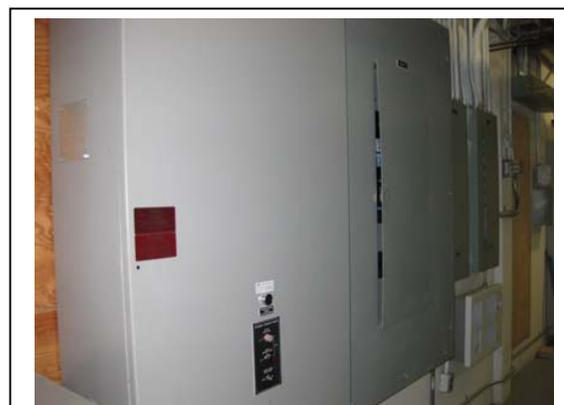
Transfer Switch - Replace

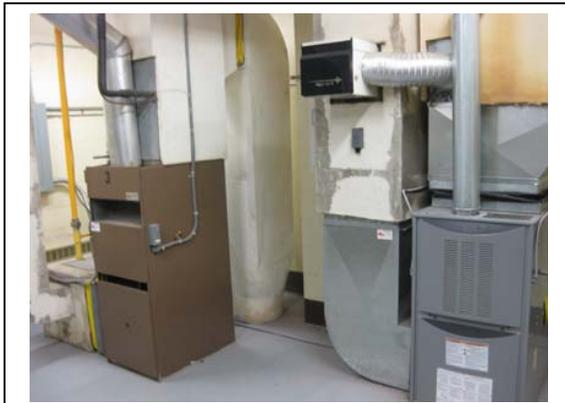
Office Furnaces – Replace Old Unit

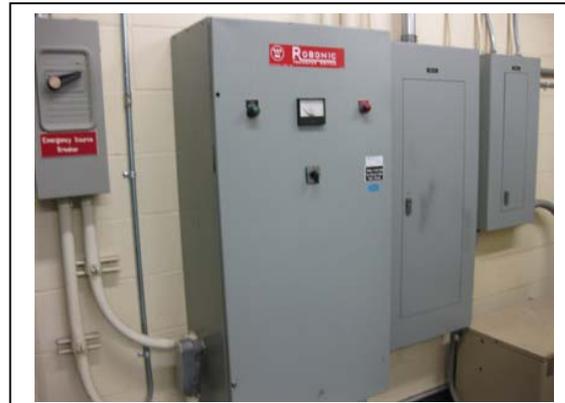
Transfer Switch - Replace

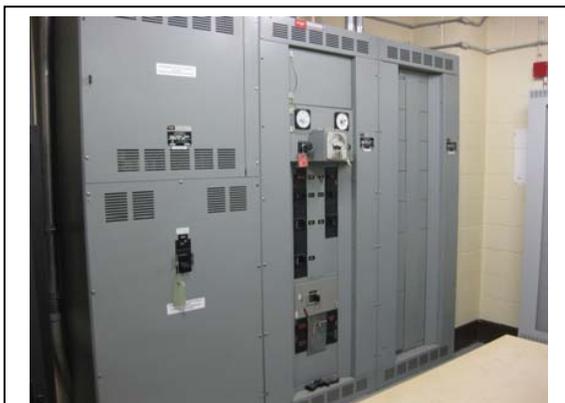
Main Electrical Breakers - Upgrade

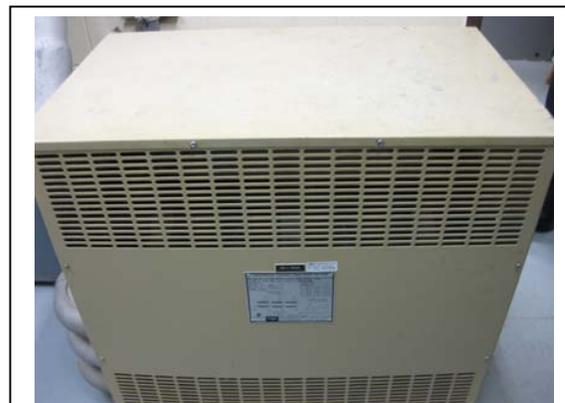
Transformer - Replace

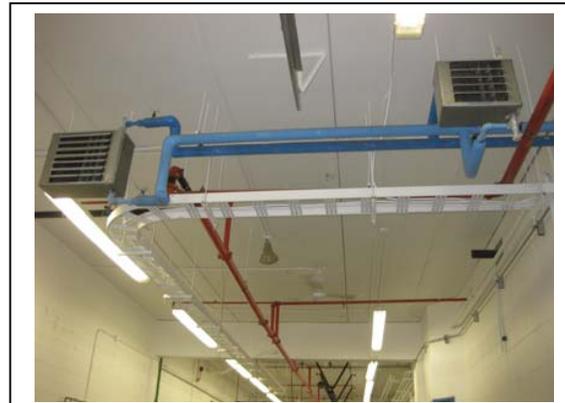
Hot Water Unit Heaters - Replace

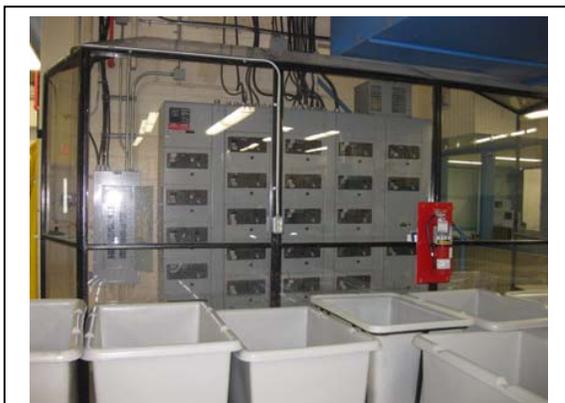
MCC - Upgrade

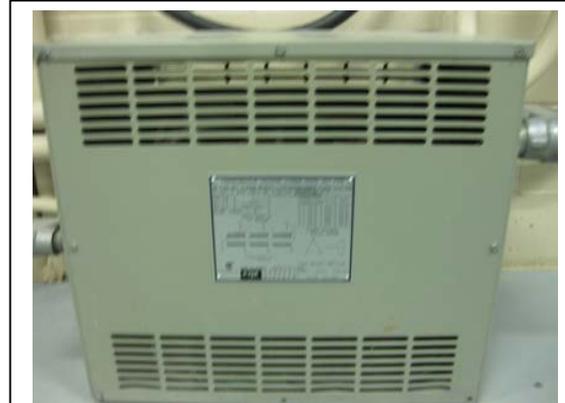
Transformer - Replace

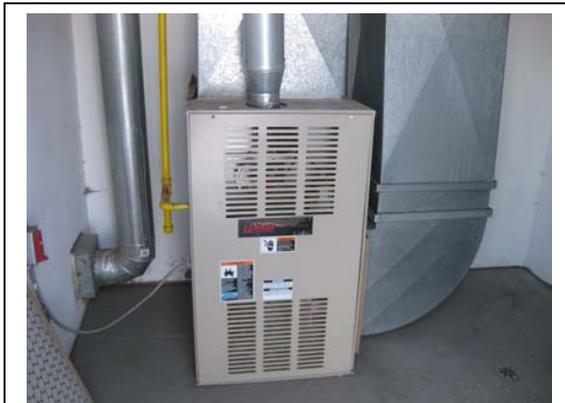
Office Area Furnace - Replace

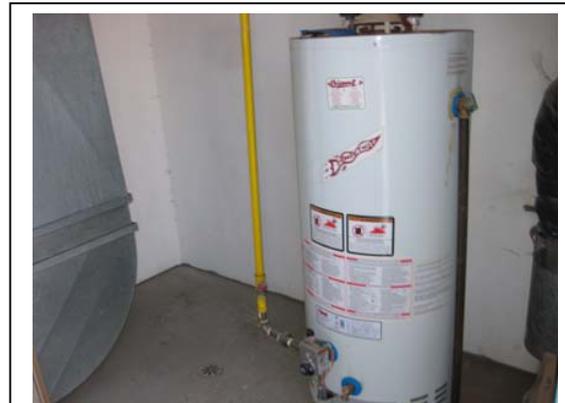
Domestic Hot Water Tank - Replace
