DRAWINGS & SPECIFICATIONS
for

R.111921.001
RCMP Teslin, YK
Hazardous Building Material Abatement Project

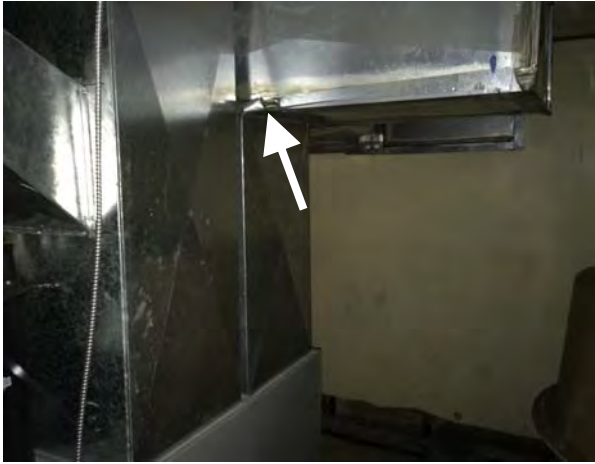
Identified ACM Description and Condition Information		Photo
Brown duct mastic throughout.

Content	0.90% Chrysotile	
Friability	Non-friable	
Condition	Good	
Cement panel exterior siding under first layer of siding around the entire perimeter.

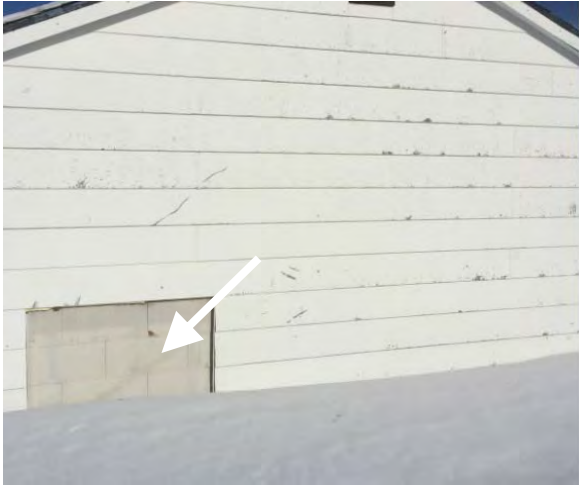
Content	12% Chrysotile	
Friability	Non-friable	
Condition	Good

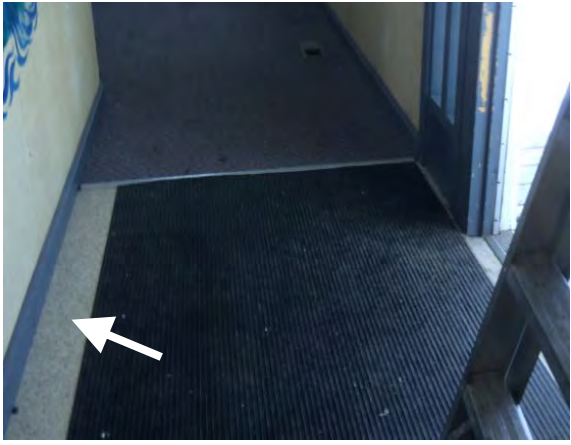
Identified ACM Description and Condition Information		Photo
<p>Tan sheet flooring with grey dots in the front foyer, central stairwell to basement and stairwell to cells.</p>

Content	2.6% Chrysotile	
Friability	Non-friable in situ, friable during removal	
Condition	Good	
<p>Orange and yellow sheet flooring in second floor bathroom.</p>

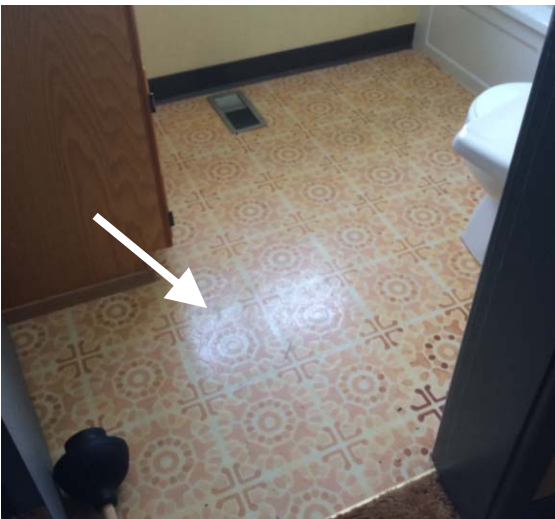
Content	21.1% Chrysotile	
Friability	Non-friable in situ, friable during removal	
Condition	Good

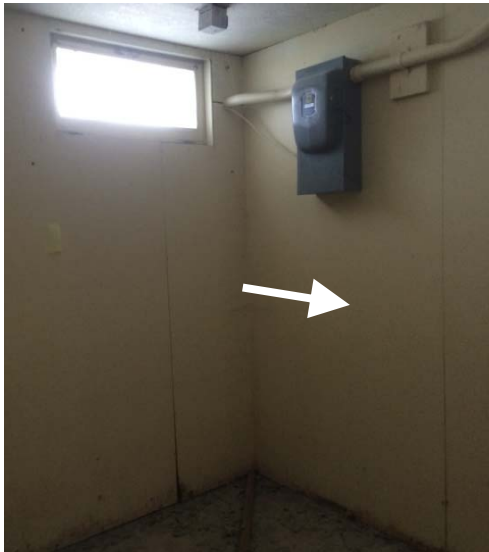
<p>Cream paint on interior basement walls. This paint was observed to be in poor condition (bubbling, flaking or peeling).</p>

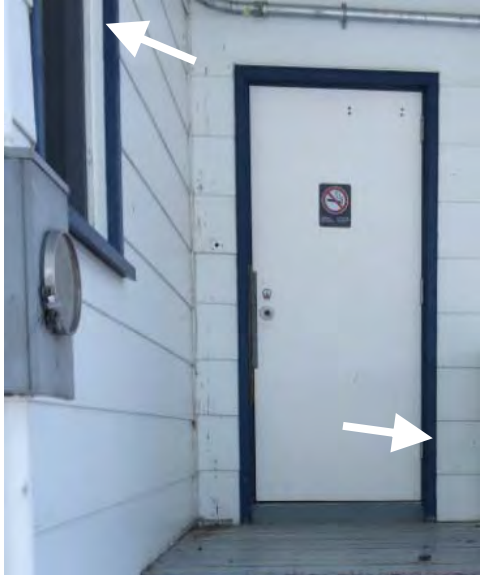
Identified LCP Description	Photo
<p>Blue paint on exterior trim This paint was observed to be in good condition (not bubbling, flaking or peeling).</p>

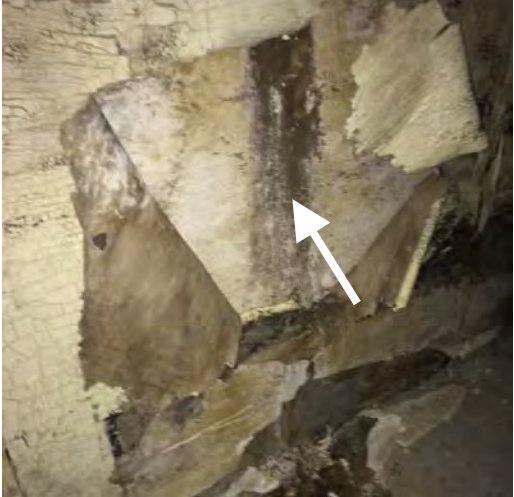
Identified Mould and/or Moisture Impacted Materials Description	Photo
<p>Moisture-impacted drywall was observed throughout the basement. The suspected source of moisture is condensation due to the building not being heated and/or insufficient ventilation/dehumidification.</p>

- Drywall materials within the basement that are impacted by moisture and suspect mould (the majority of, if not all drywall, approximately 500 square feet) should be removed accordance with applicable guidelines and accepted standards for such work (e.g., CCA 82). This will likely require the involvement of an experienced mould abatement contractor.
- The source of moisture is likely condensation due to the building not being heated and or insufficient ventilation/dehumidification. If these issues causing condensation are not planned to be addressed then mould and moisture impacted materials should not be replaced as the mould/moisture issues will likely reoccur.

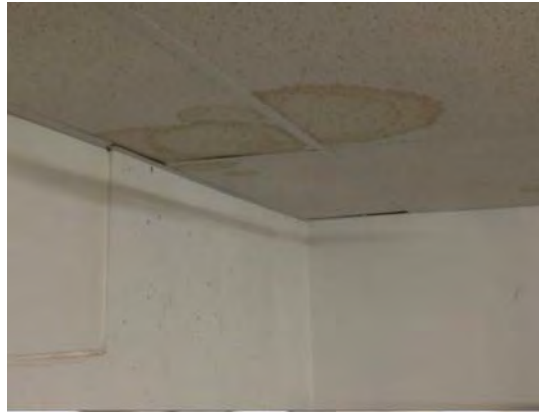
Identified Mould and/or Moisture Impacted Materials Description	Photo
<p>Water stained ceiling tiles observed in the basement by the oil storage tanks.</p> <p>Suspected source of moisture was pipe leaks in the ceiling space – or potentially condensation from HVAC systems and associated drip-pan overflow.</p>

- An assessment to determine the likely source(s) of water staining should be undertaken. Issues leading to moisture impacts and/or mould growth should be identified and addressed prior to reinstating building materials to areas where mould abatement is conducted, to avoid the potential for re-wetting of new materials, and repeated mould growth.

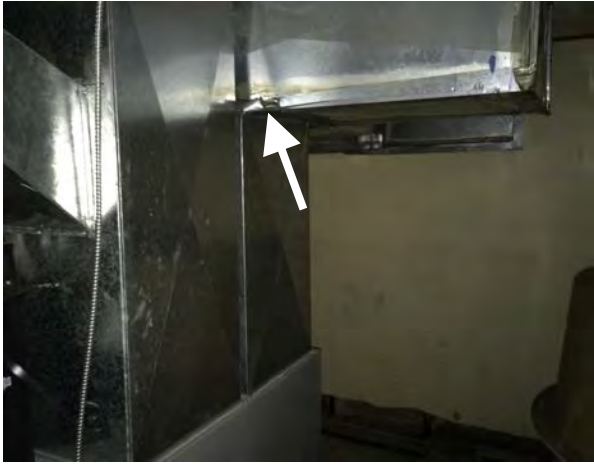
Identified ACM Description and Condition Information		Photo
Brown duct mastic throughout.

Content	0.90% Chrysotile	
Friability	Non-friable	
Condition	Good	
Cement panel exterior siding under first layer of siding around the entire perimeter.

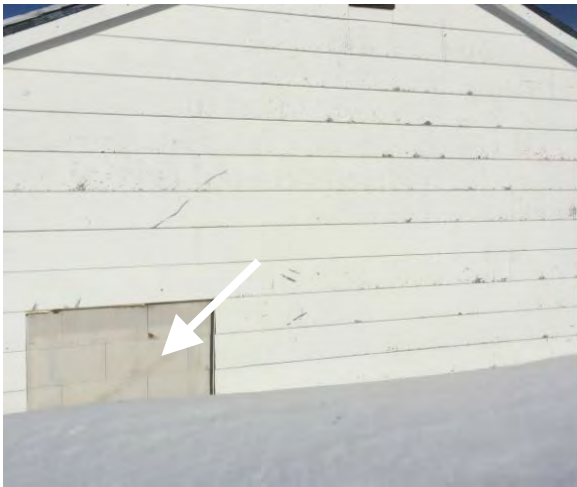
Content	12% Chrysotile	
Friability	Non-friable	
Condition	Good

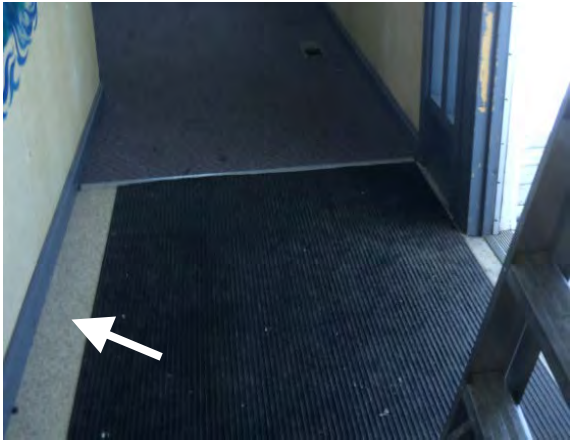
Identified ACM Description and Condition Information		Photo
<p>Tan sheet flooring with grey dots in the front foyer, central stairwell to basement and stairwell to cells.</p>

Content	2.6% Chrysotile	
Friability	Non-friable in situ, friable during removal	
Condition	Good	
<p>Orange and yellow sheet flooring in second floor bathroom.</p>

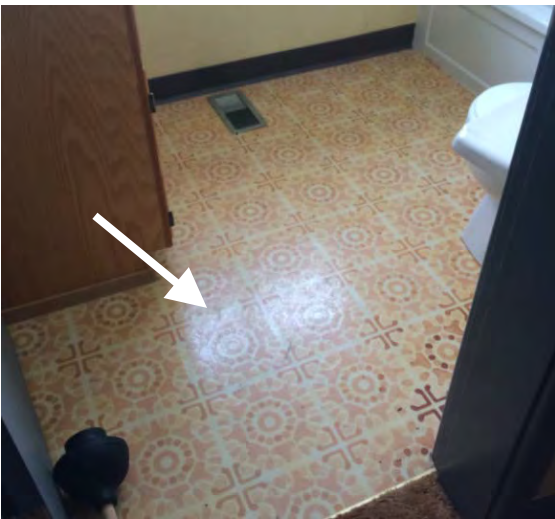
Content	21.1% Chrysotile	
Friability	Non-friable in situ, friable during removal	
Condition	Good

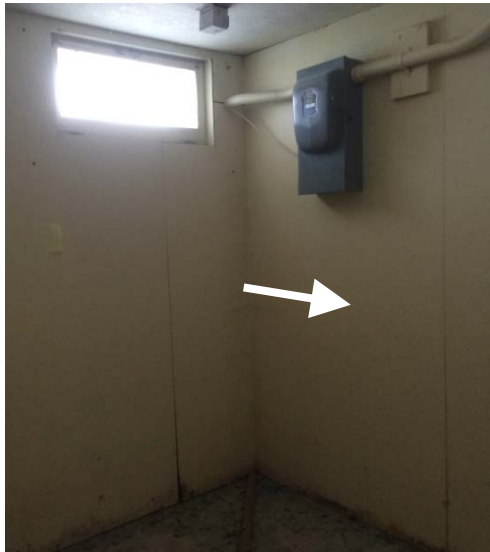
<p>Cream paint on interior basement walls. This paint was observed to be in poor condition (bubbling, flaking or peeling).</p>

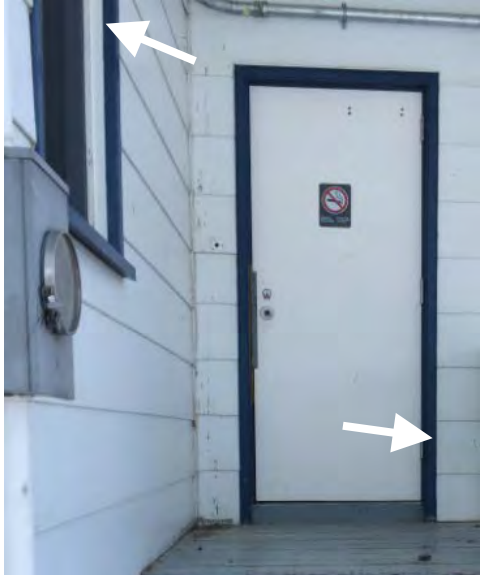
Identified LCP Description	Photo
<p>Blue paint on exterior trim This paint was observed to be in good condition (not bubbling, flaking or peeling).</p>

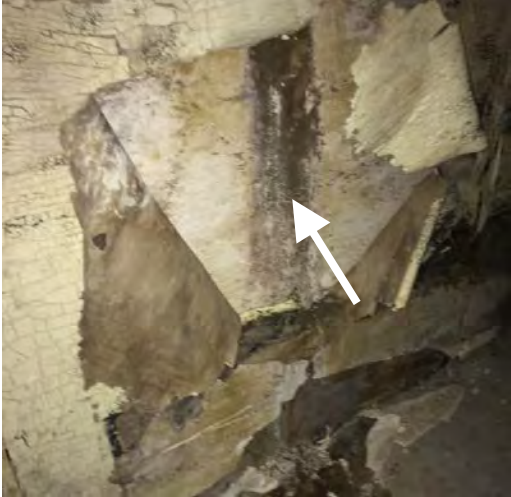
Identified Mould and/or Moisture Impacted Materials Description	Photo
<p>Moisture-impacted drywall was observed throughout the basement. The suspected source of moisture is condensation due to the building not being heated and/or insufficient ventilation/dehumidification.</p>

- Drywall materials within the basement that are impacted by moisture and suspect mould (the majority of, if not all drywall, approximately 500 square feet) should be removed accordance with applicable guidelines and accepted standards for such work (e.g., CCA 82). This will likely require the involvement of an experienced mould abatement contractor.
- The source of moisture is likely condensation due to the building not being heated and or insufficient ventilation/dehumidification. If these issues causing condensation are not planned to be addressed then mould and moisture impacted materials should not be replaced as the mould/moisture issues will likely reoccur.

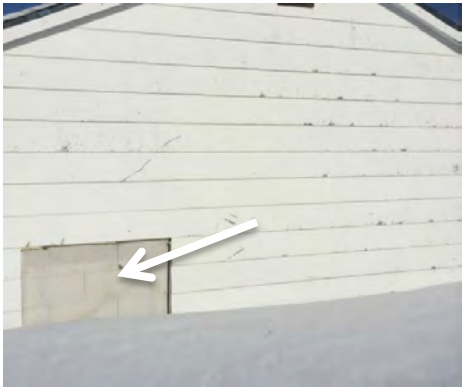
Cement panel exterior siding under first layer of siding around entire perimeter	
% Type	12% Chrysotile
Friability	Non-friable
Condition	Good

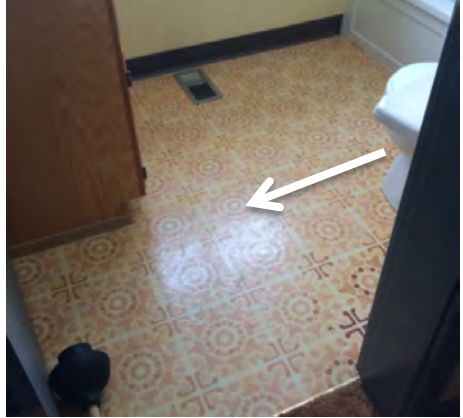
<p>Orange and yellow sheet flooring in second floor bathroom</p> <p>% Type: 21.1% Chrysotile</p> <p>Friability: Non-friable in situ, friable during removal</p> <p>Condition: Good in most locations – observed to be damaged near the floor vent during the current assessment</p>

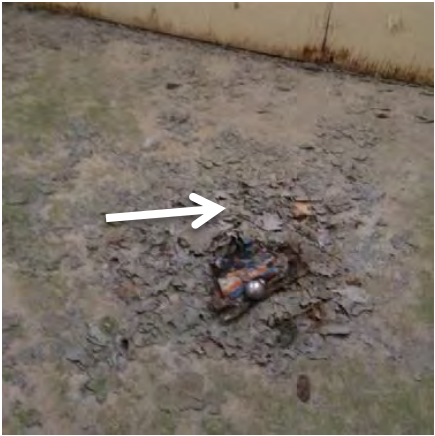
Substrate	Cement	
Location/approx. extent	Basement floor	
Lead content	3,700 ppm	
Condition	Poor (bubbling, flaking and peeling)	
Paint colour	Cream

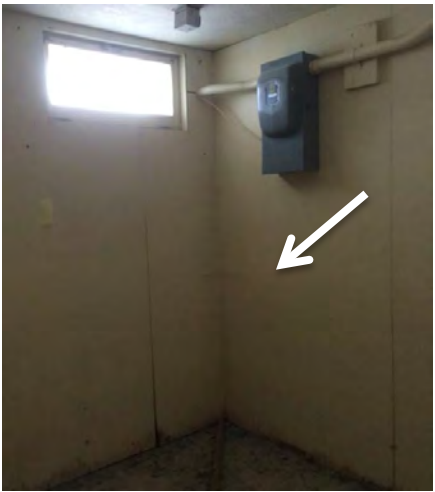
Substrate	Wood	
Location/approx. extent	Basement walls	
Lead content	2,500 ppm	
Condition	Poor (bubbling, flaking and peeling)	
Paint colour	Blue (over red)

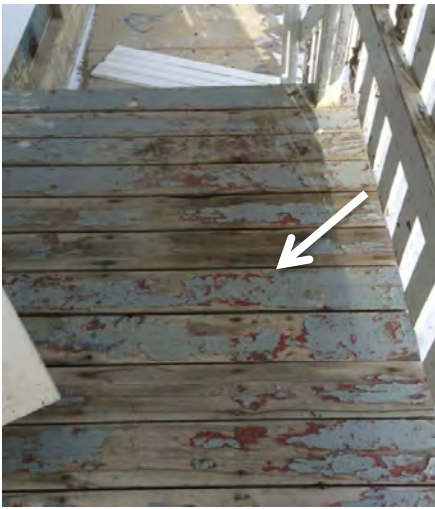
Substrate	Wood	
Location/approx. extent	Exterior deck	
Lead content	1,500 ppm	
Condition	Poor (bubbling, flaking and peeling)

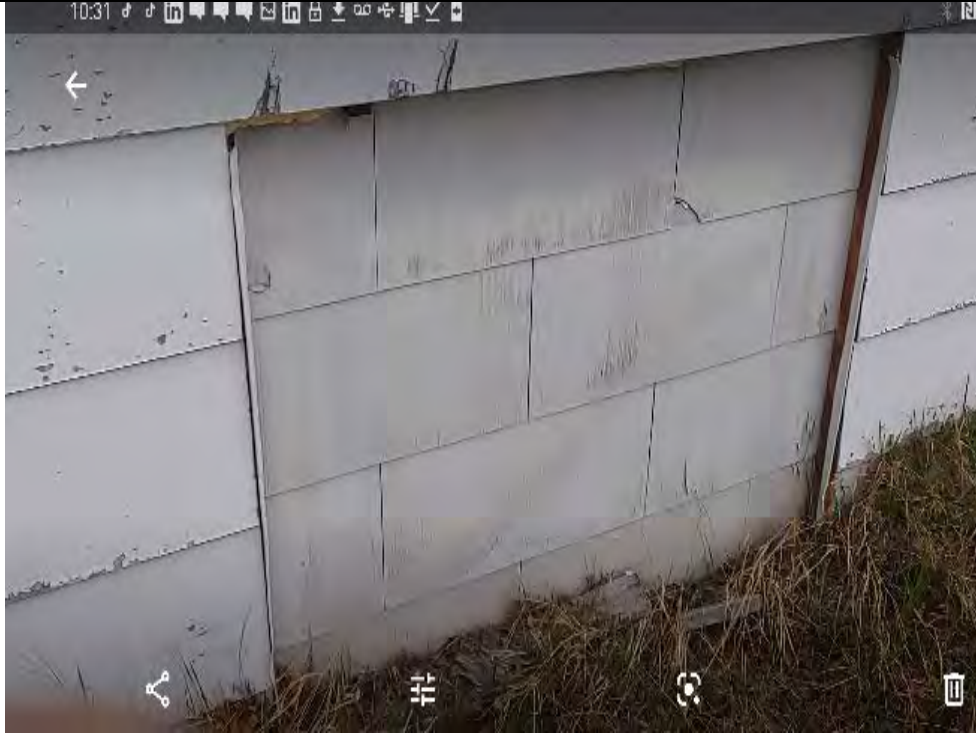
2. Cement board was observed over the cellblock addition foundation. 3 samples were collected for ACM testing:

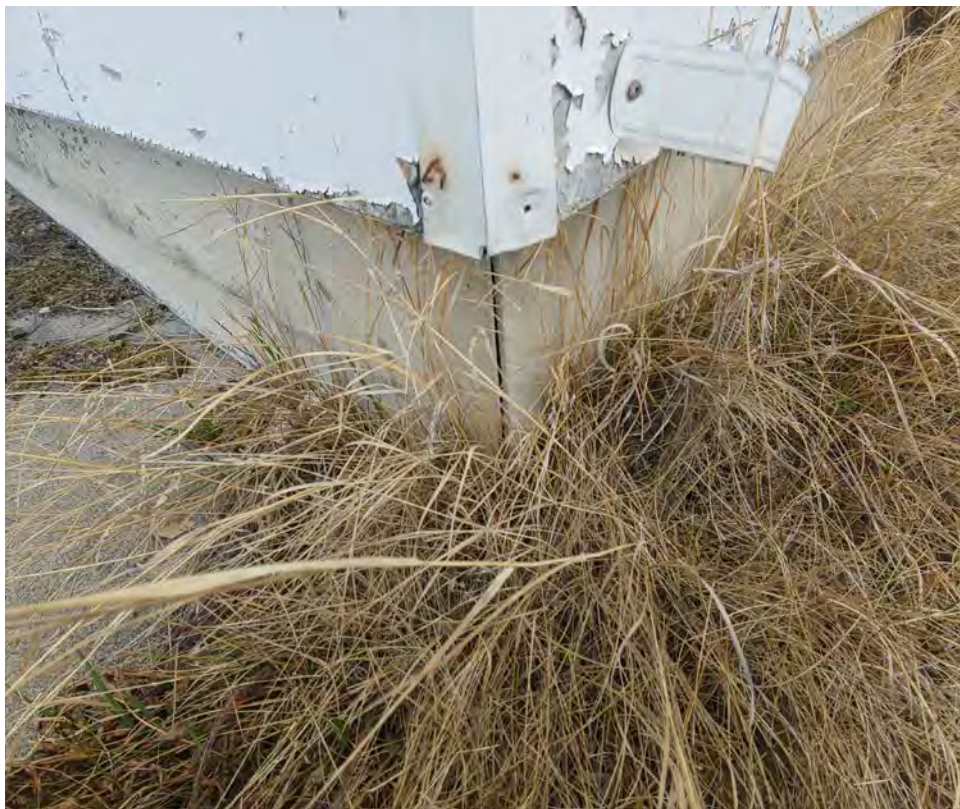
3. Exterior paint and substrate samples were collected for lead content analysis at decking, painted trim and hardboard siding locations.

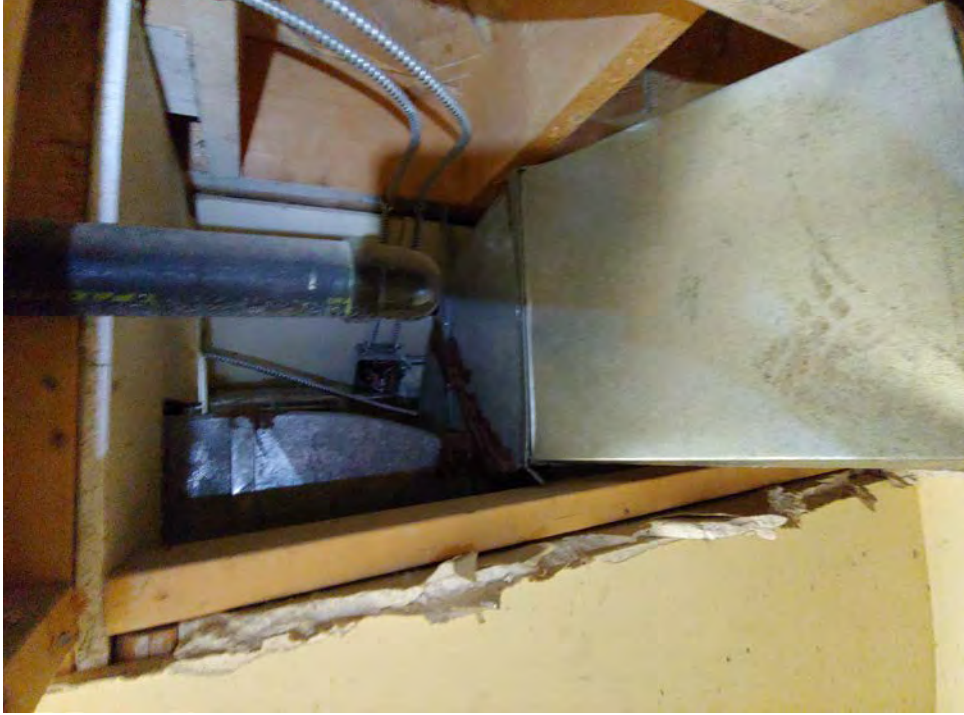
2. There was no brown mastic apparent on the forced air furnace and ductwork (it appeared the furnace and ductwork may have been upgraded at some point):
