## ARVA CRANE PRE-INSPECTION – 5 YEAR

MANUFACTURER: ARVA INDUSTRIES  
MODEL: PE-48M  
CRANE SERIAL NUMBER: 1831-A171660  
SHIP: CCGS LIMNOS  
IMO: 6804903  
CUSTOMER: CANADIAN COAST GUARD

PRELIMINARY INSPECTION: NOVEMBER 15, 2019

AUTHOR: SCOTT KNIERIEM, P.ENG.

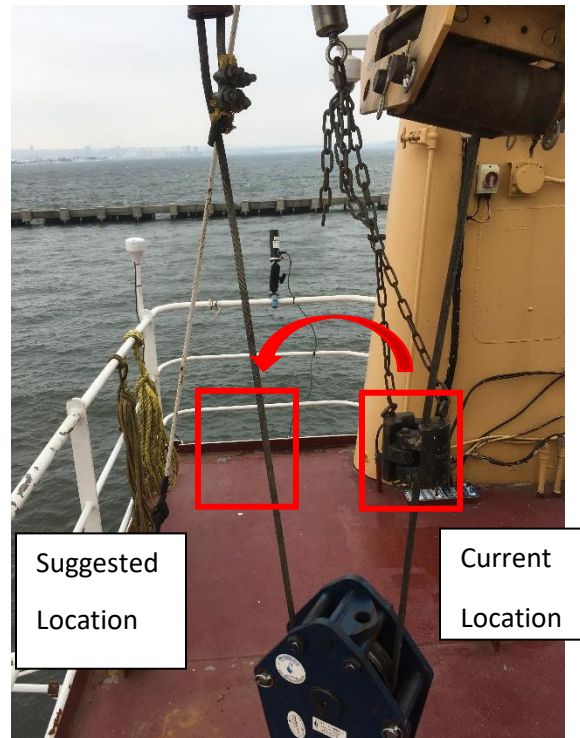
The anti-two block ball was observed as being installed the live line section of the crane rope. It is recommended the anti-two block ball be installed on the tag end of the crane line.

Figure 1: Suggested location of anti-two block ball.

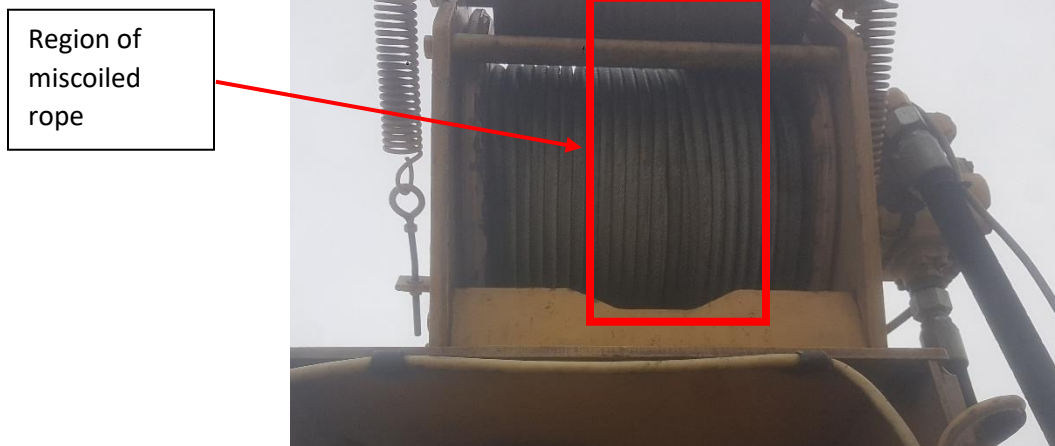
The winch was observed to operate normally without any unusual noises or vibration. The rope follower was observed to roll and apply tension to the rope spooling onto the drum. The rope was observed as not spooling onto the drum in uniform and even fashion. Miscoiling of rope was observed in previous layers of rope. Clearing the miscoiled rope is highly recommended. The rope needs to be paid out to the extend to clear the miscoil. The rope is to be hauled in, under tension to insure correct spooling of the rope. Continued operation of the winch with a miscoiled rope can cause unsafe operating conditions and accelerated rope wear.

*Figure 2: Miscoiled rope observed on the winch drum.*

The winch is to be rebuilt during the crane overhaul.

1. All pilot cut-out valves (A115241) valves be replaced and an additional valve be purchased and kept as a spare.
2. Correct miscoiled rope observed on the winch drum.
