# 2018 COMPREHENSIVE DETAILED ANNUAL INSPECTION BURLINGTON CANAL LIFT BRIDGE

Contract No. EQ754-181509/001/PWL Project No. R.090046.001

**December 2019** (Rev .00)

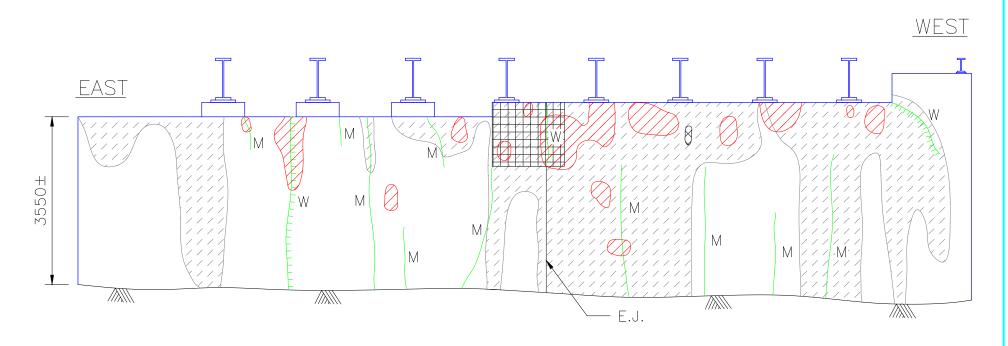
NORTH ABUTMENT

W WIDE CRACK		
DELAMINATIO	N	
SPALLS		
WET AREAS		
PATCHED AF	REAS	
MORRISON HERSHFIELD	DESIGNED:	S.S.Q.
	DRAWN:	P.L.
BURLINGTON LIFT BRIDGE – NORTH & SOUTH APPROACH SPANS SURFACE DETERIORATION – ABUTMENTS	SKETCH:	SK-1

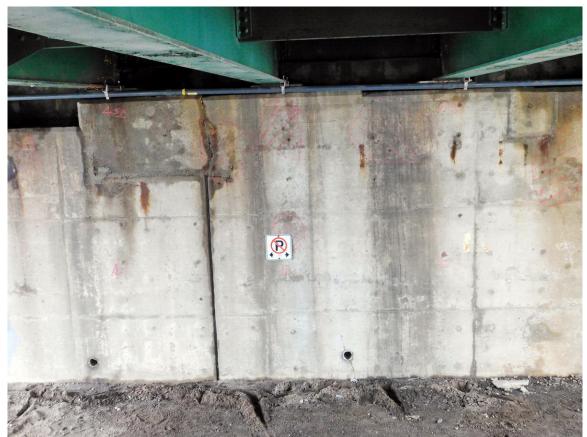
09 South Abutment, Wide Vertical Crack with Rust & Delamination on Wall between Stringers 1&2

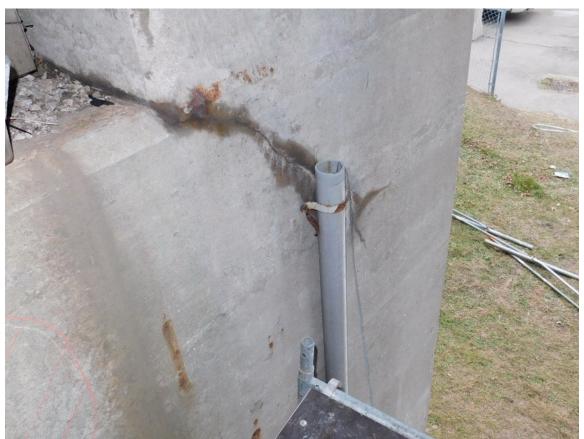
11 South Abutment, Stained Cracks & Local Delamination on Upper West Section of Wall

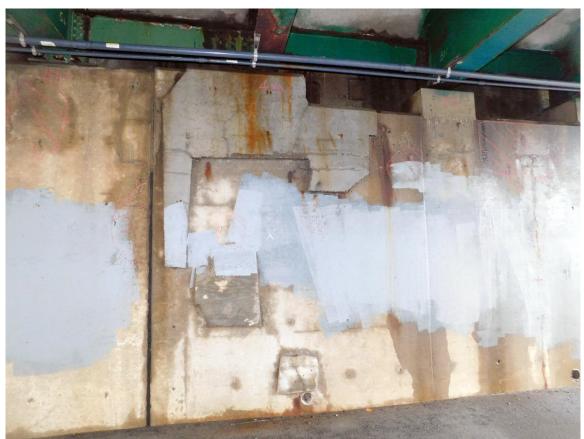
13 North Abutment, Heavy wet-Rust Stains, Medium-Wide Vertical Crack, and Local Delam on West Section of Wall

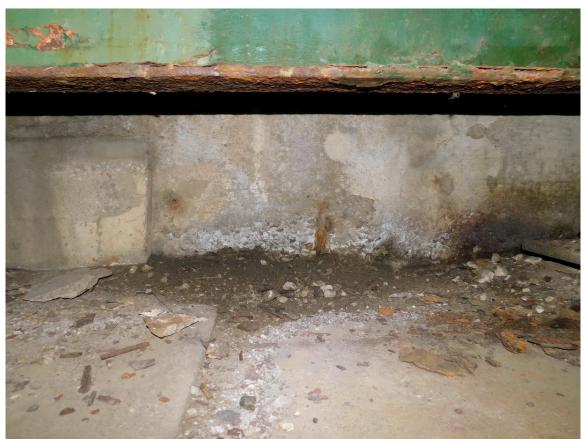
17 South Ballast Wall, Large Patch & Local Spall behind Diaphragm between Stringer 4&5

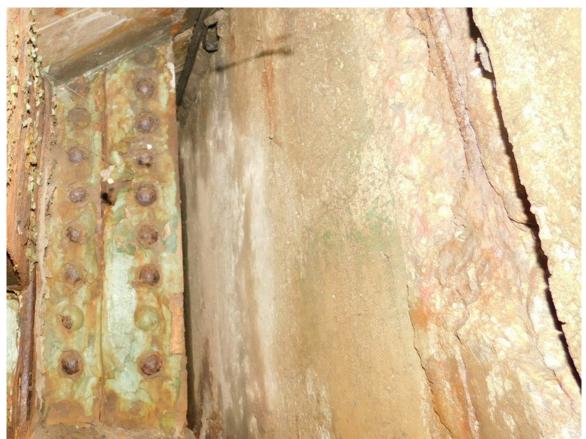
19 North Ballast Wall, Cracks with Heavy Rust Stains between Stringer 3&4

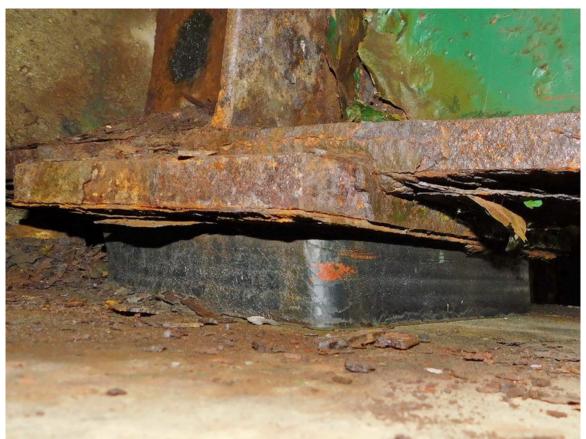
23 Laminated Bearing under Stringer 7 at North Abutment (TYP)

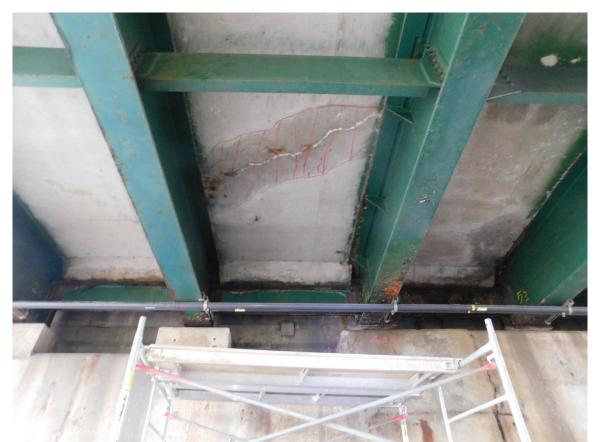
47 Large Wet with Stained Cracks and Local Severe Delamination on East Section of South Approach Soffit, looking S

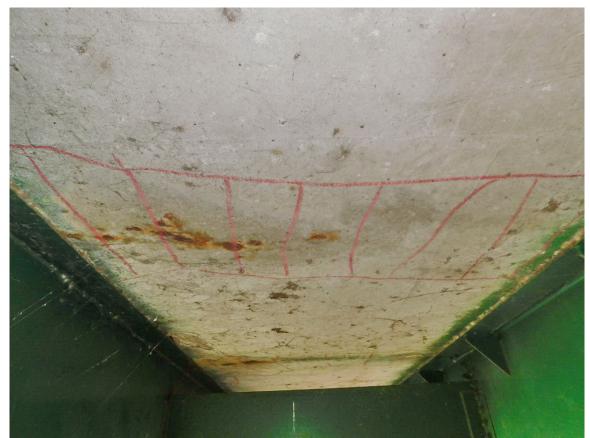
49 Wet Areas with Local Severe Delamination on SW Section of South Approach Soffit, looking South

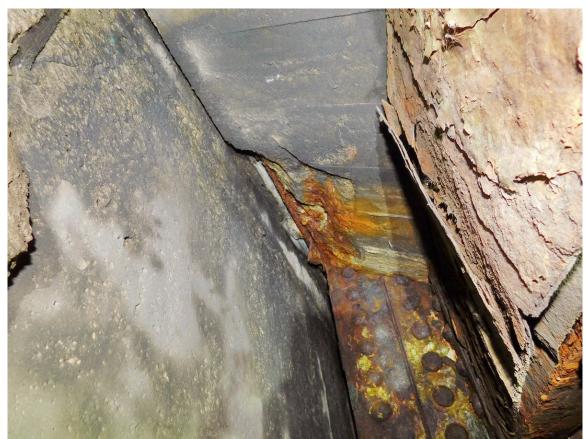
51 Heavy Wet with Local Severe Delamination at South Abutment End of Soffit between Stringers 4&5 (TYP)

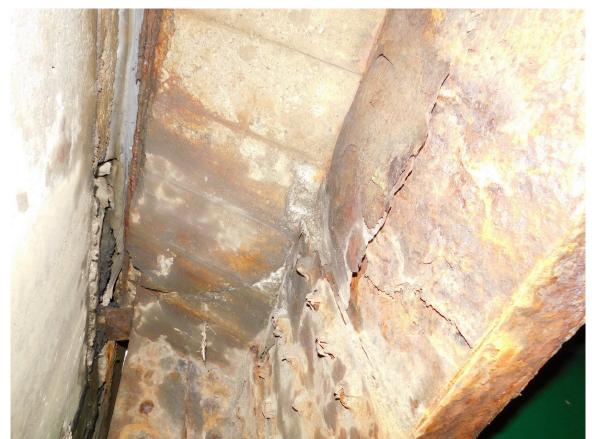
53 Wet Area & Spalls on South Abutment End Soffit between Stringers 6&7

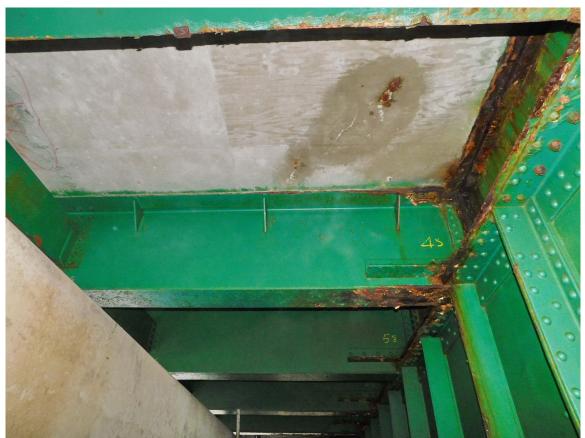
55 Typical Wet Area on North End of South Approach Span Soffit, Section between Stringers 2&3 Shown

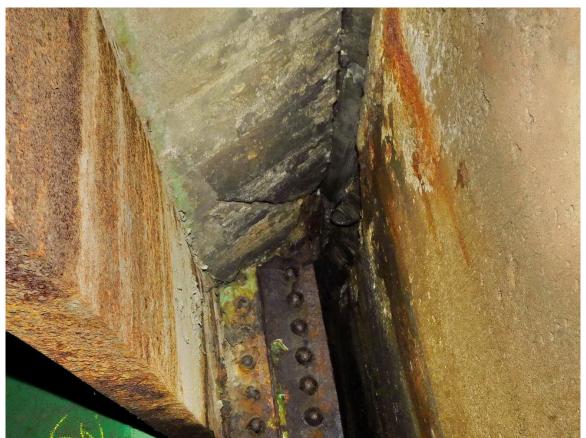
69 Stained Cracks & Large Delamination on North Abutment End Soffit between Stringers 4&5

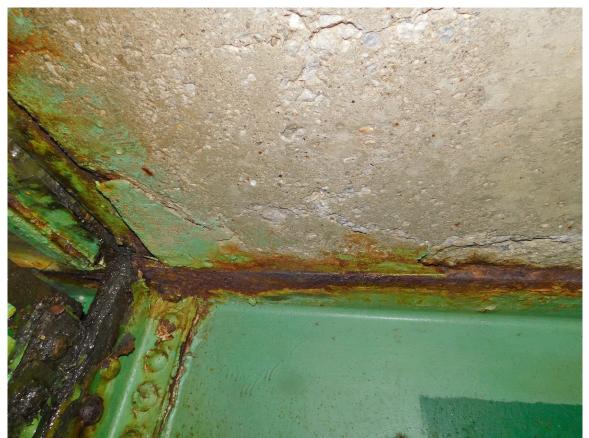
73 Large Wet with Local Severe Spall on North Span between Stringers 7&8

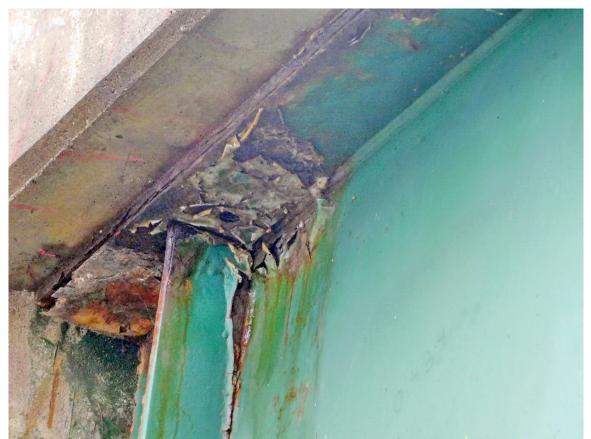
77 Local Peeled Paint showing Light Rust Surface Rust on Exterior Face at South End of Stringer 1

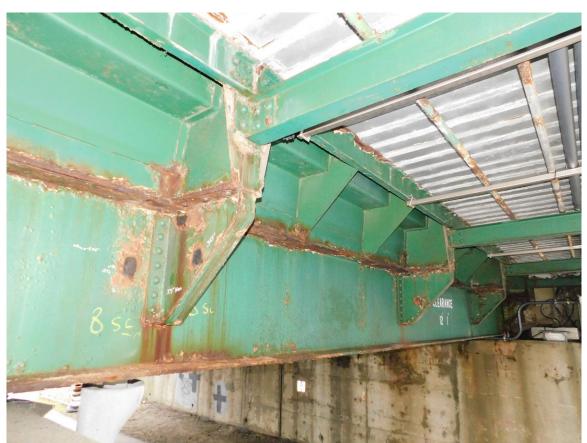
85 S Approach Span, Typical Heavy Wet with Local Severe Corrosion on Diaphragm under Exp Joint with S Tower Span

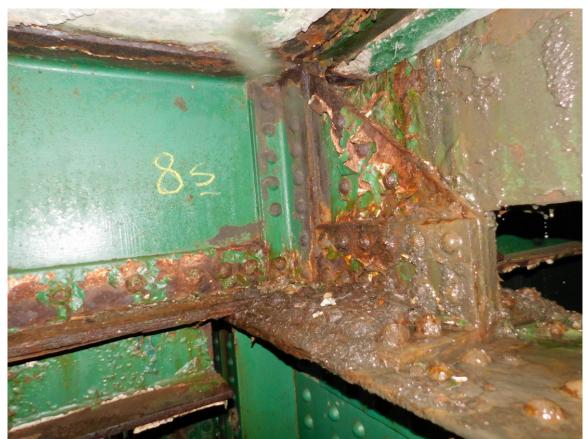
89 S Approach Span, Severe Corrosion on Top Flange of Stringer 8 at Central North Section of Span

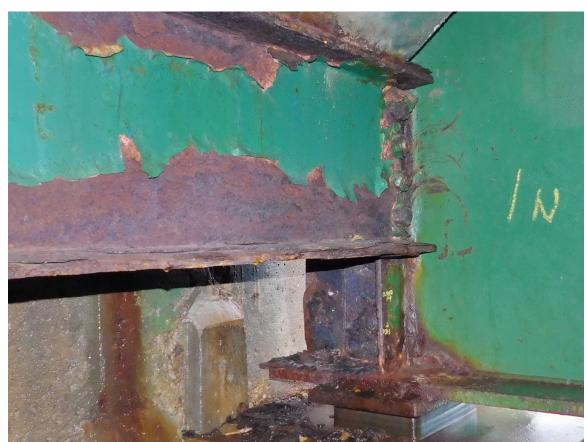
91 N Approach Span, Typical Heavy Corrosion on Stringers & Diaphragm at North Abutment, Stringers 7&8 Shown

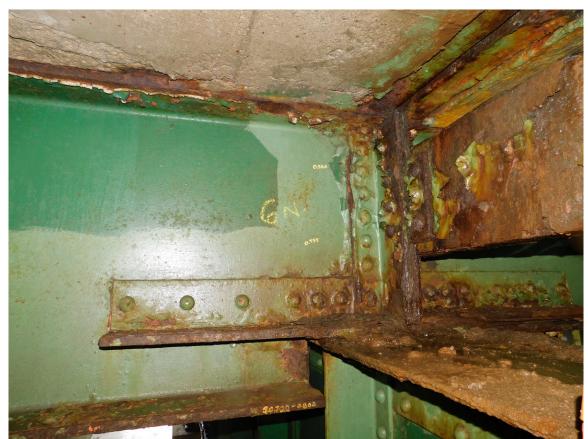
95 N Approach Span, Typical Severe Corrosion on Back Face of Diaphragm at North Abutment, Stringers 3&4 Shown

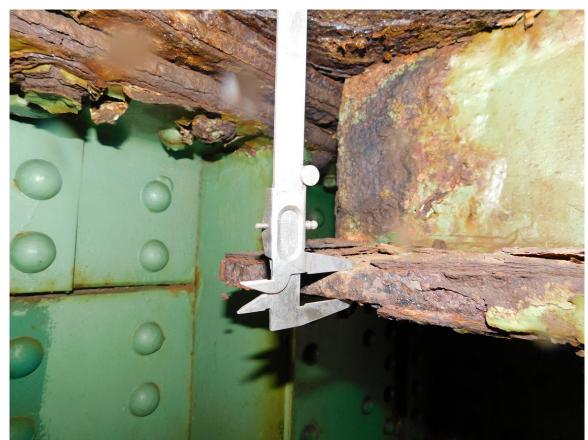
97 N Approach Span, Heavy Wet and Severe Corrosion on Diaphragm @ Stringers 6&7 under Exp Joint with N Tower

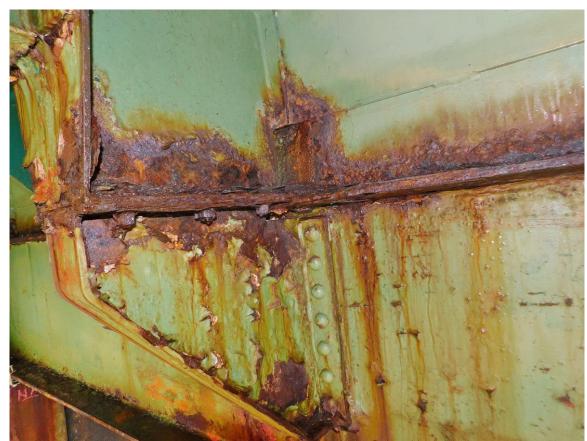
99 N Approach Span, Heavy Corrosion on Outside Face of Stringer 8 @ Central Section of Span, looking South

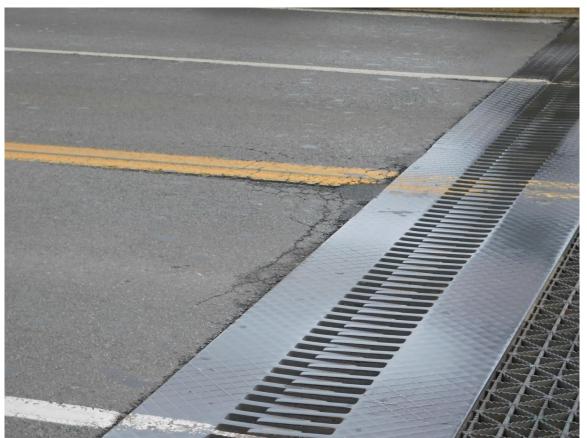
111 North Approach Span, Large Unsealed Pattern Cracks on Central North End of Deck

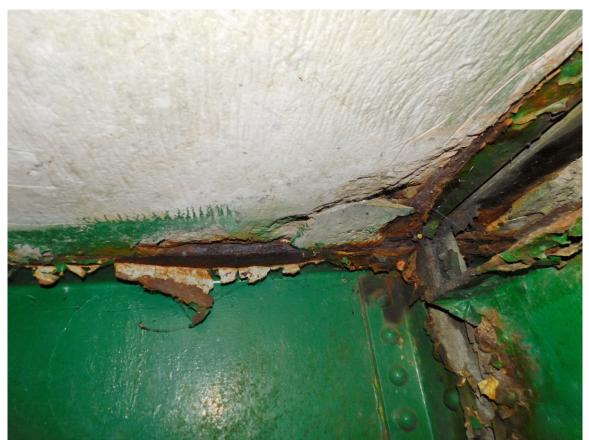
119 South Tower Span, Heavy Wet with Isolated Light Stained Crack at SE Corner of Deck Soffit

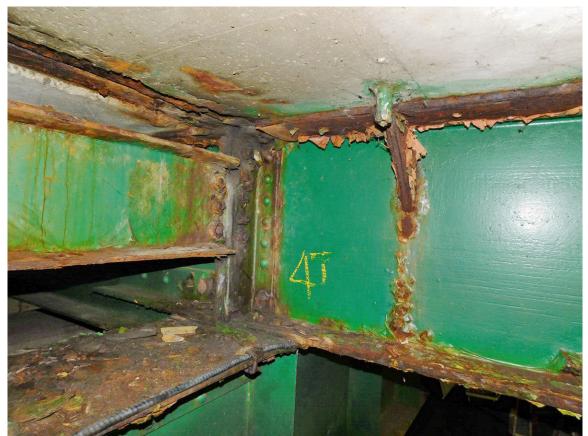
121 South Tower Span, Local Light Wet Area on Central North End of Soffit

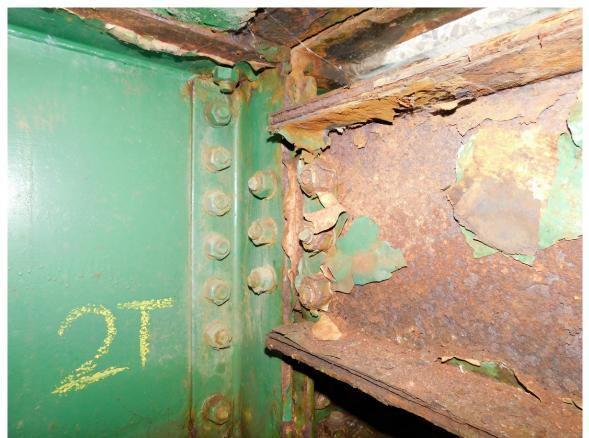
123 South Tower Span, Heavy Corrosion at North End Section of Stringer 1 (TYP)

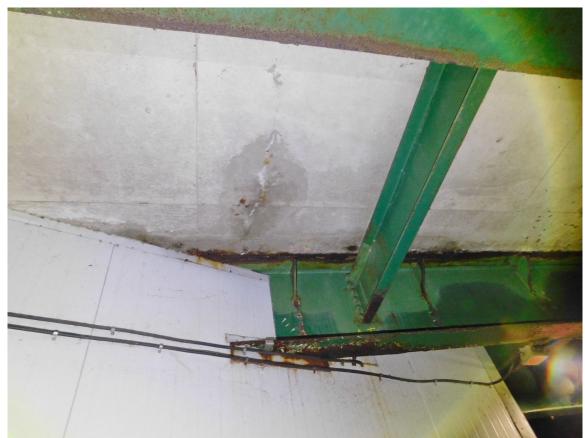
131 North Tower Span, Stained Crack with Wet and Rust Stains on North Central Section of Soffit between Stringers 3&4

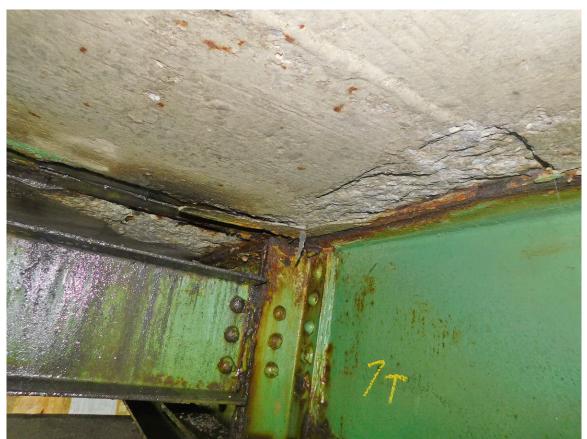
133 North Tower Span, Large Delamination Area at North End of Soffit between Stringers 3&4

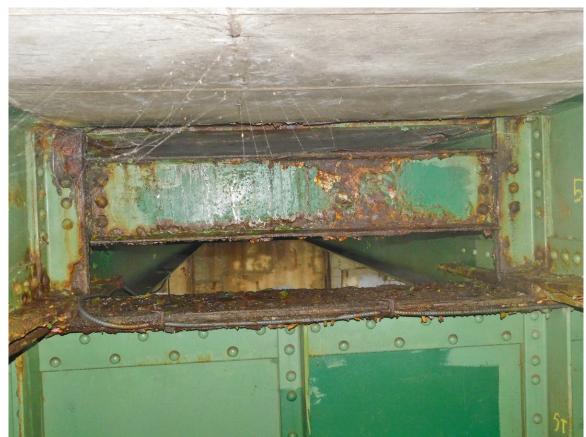
137 North Tower Span, Local Medium-Severe Corrosion on Stringer 4 and Diaphragm near Exp Joint with Lift Span

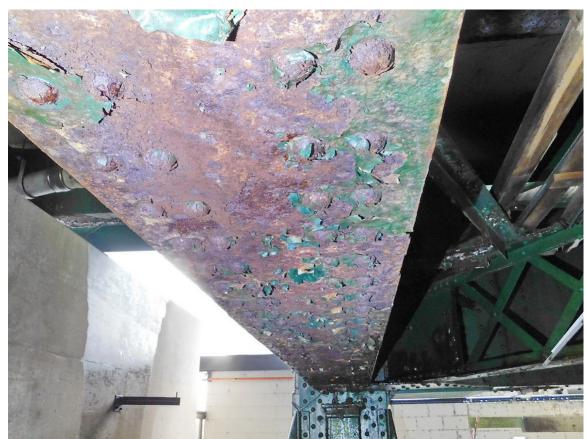
149 South Tower, Heavy Corrosion on Top Flange of Rear Floor Beam below South Exp Joint with South Approach Span

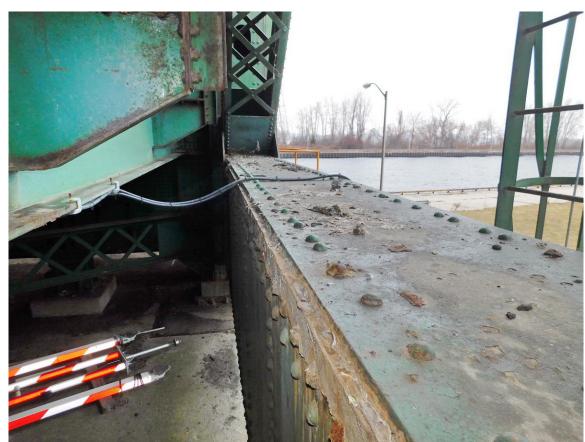
153 South Tower, Local Light-Medium- Corrosion on Stiffener Plate at Bottom East Corner of Front Floor Beam

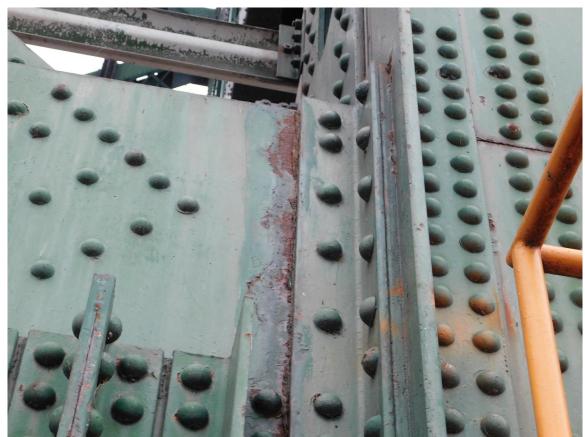
155 South Tower, Local Peeled Paint with Light Surface Rust on Bottom South Section of East Jacking Girder

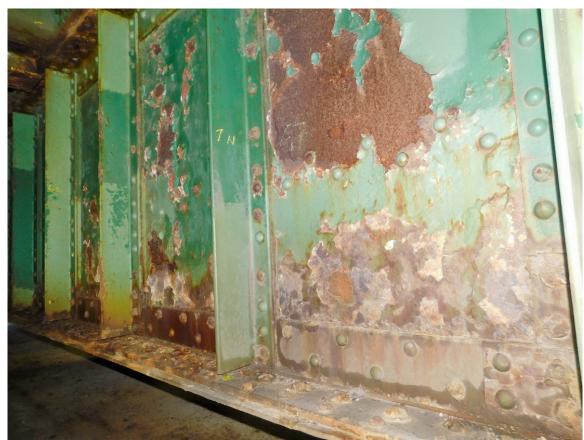
165 North Tower, Local Light-Medium Corrosion on Bottom East Section of Rear Floor Beam

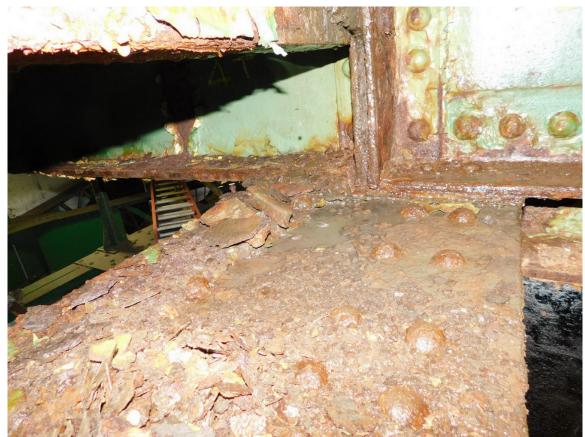
167 North Tower, Large Severe Corrosion Area on lower South Face of Rear Floor Beam below Stringers 7&8

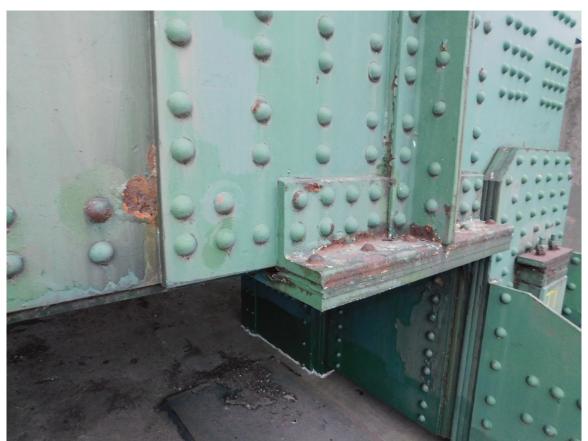
171 North Tower, Severe Corrosion on Top of Front Floor Beam at Stringer 8 (TYP)

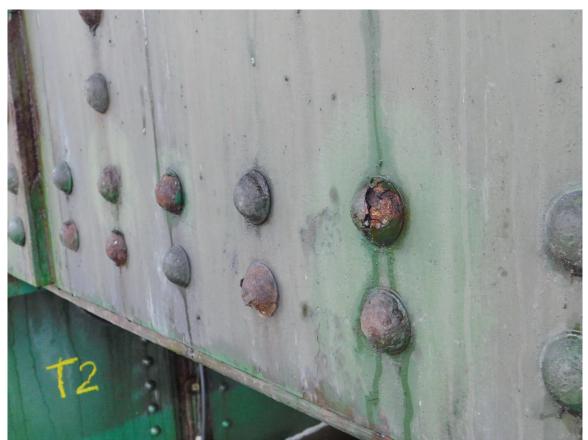
173 North Tower, Local Medium Corrosion on Bottom North Section of West Jacking Girder (TYP)

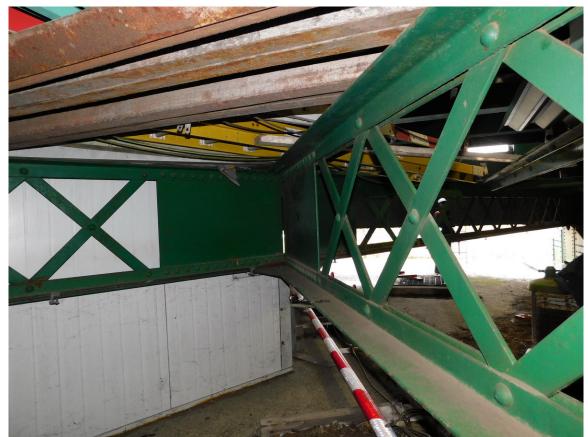
177 Typical Sediment & Local Medium Corrosion on Bottom Interior Surface of Front Columns, NE Column at S Tower

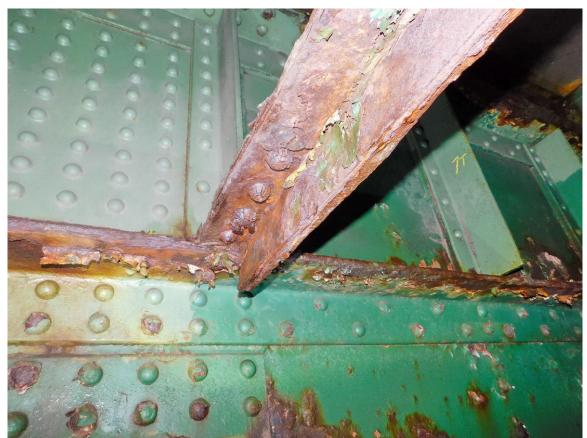
182 Light-Medium Corrosion on Wind Bracing at Connection Rear Floor Beam near NW Column at North Tower Page A2 [91] of A2 [169]

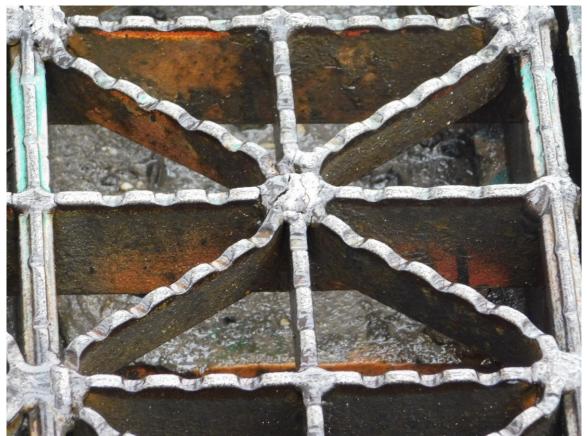
230 Cracked Grating @ Previous Repaired Weld on Stringer 11 near NW Corner of Lift Span Page A2 [115] of A2 [169]

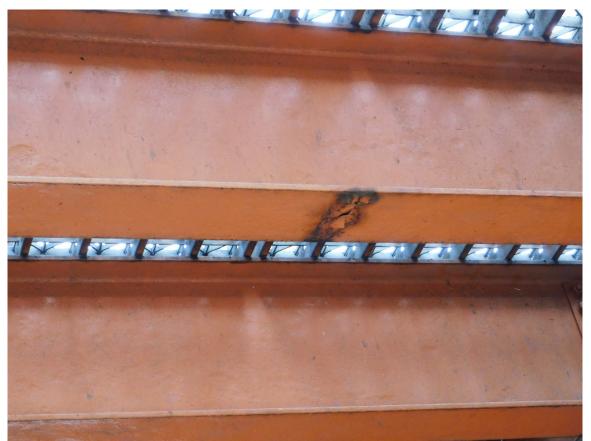
264 Local Light Surface Rust on Stringer 4 in Bay 1

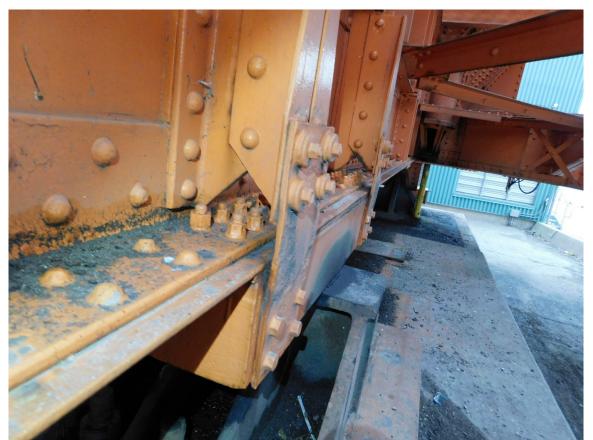
266 Local Light Rust Jacking on Gusset Plate & Centering Shoe at Bottom of South Floor Beam A1-B1 Page A2 [133] of A2 [169]

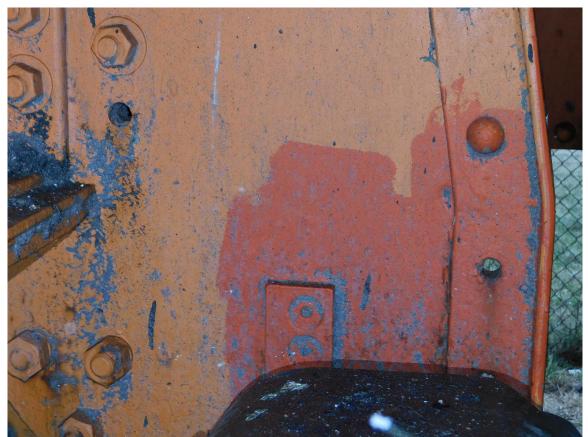
276 Missing Bolt & Rivet on Steel Plate for Span Lock behind East Corner of South Floor Beam (Node A1) Page A2 [138] of A2 [169]

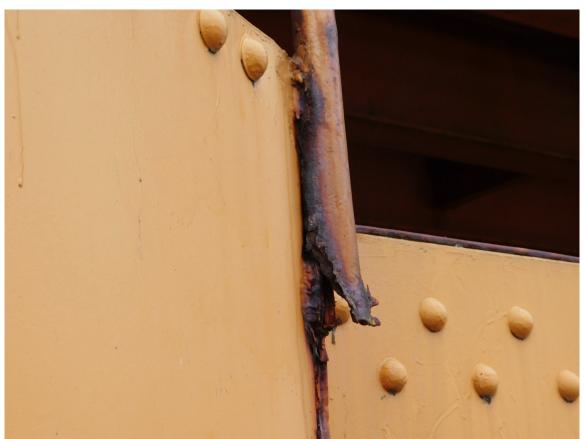
278 Severe Corrosion on North Railing Post atop SE Lower Guide Roller Assembly Page A2 [139] of A2 [169]

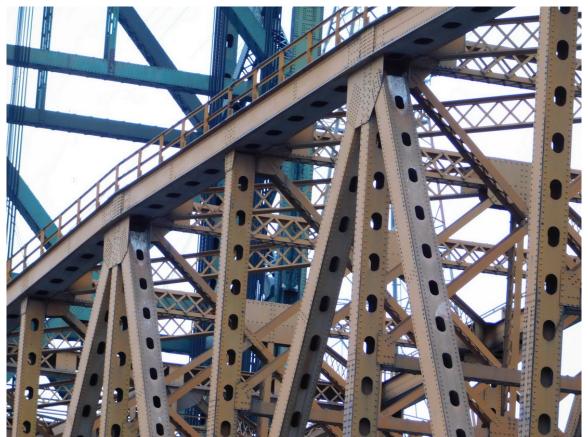
282 Typical Faded Coating & Light Surface Rust on Steel Truss above Deck

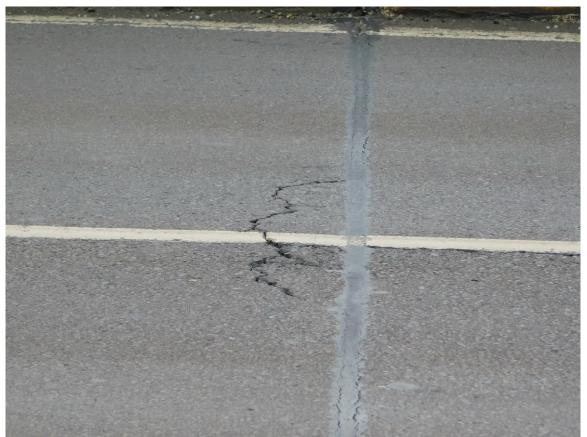
298 North Abutment Joint, Unsealed Pattern Crack adjacent to Joint on NBL looking East Page A2 [149] of A2 [169]

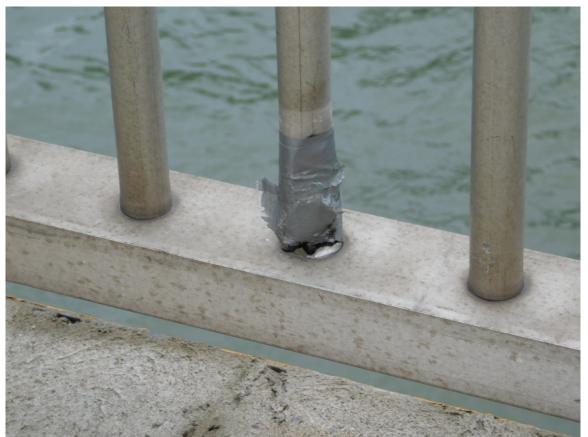
314 Broken Spindle at Bottom Rail on West Pedestrian Railing in Lift Span near Node Point B5 Page A2 [157] of A2 [169]

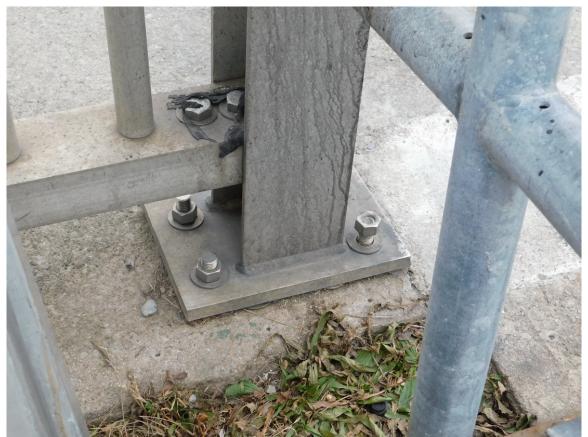
316 Typical Loose Anchor Bolts on Pedestrian Railing Post, South Post of West Railing Shown Page A2 [158] of A2 [169]

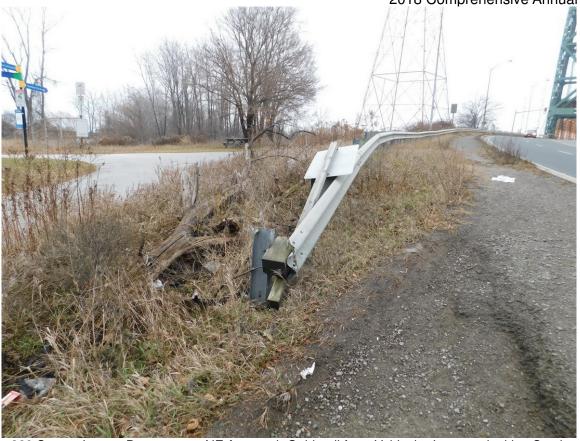
329 Severe Impact Damages on NE Approach Guiderail from Vehicular Impacts, looking South

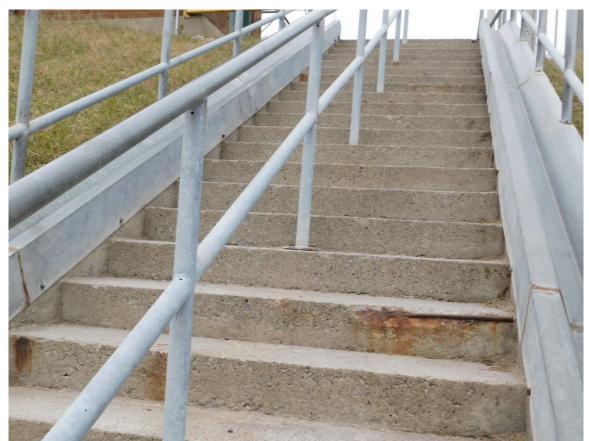
332 Local Shallow Spalls on Northwest Stairs (TYP)

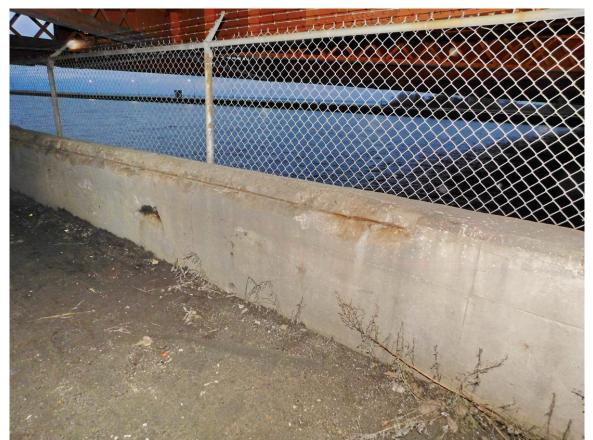
338 Severe Delamination & Spalls on Concrete Parapet Wall on South Perimeter @ North Tower Compound Page A2 [169] of A2 [169]
