Asbestos and Lead Reassessment Survey

Burlington Lift Bridge

Hamilton, Ontario

FINAL REPORT

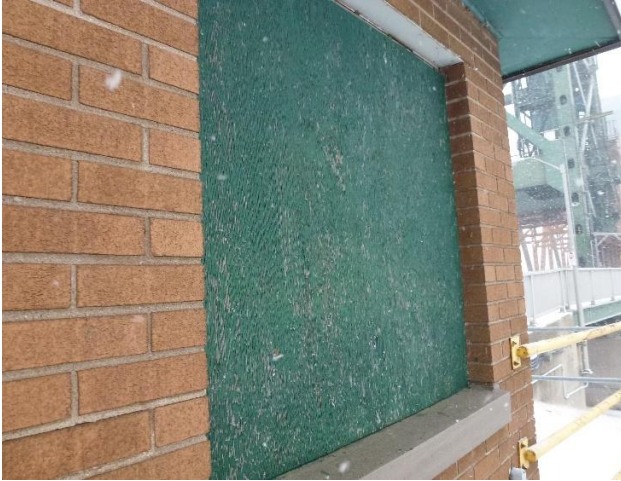
Photo 1 : Gatehouse peeling paint

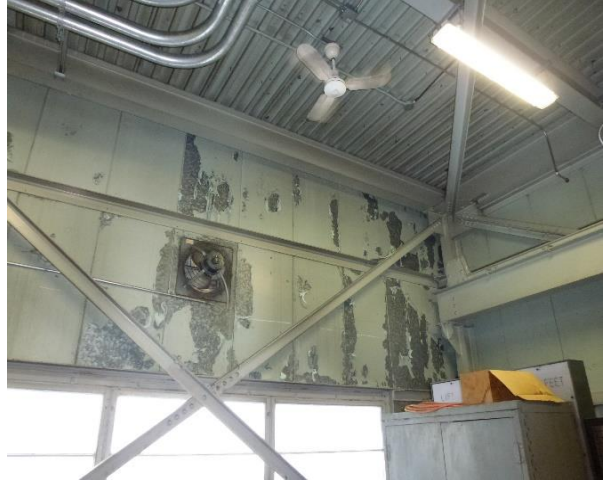
Photo 2: Peeling wall paint North Tower

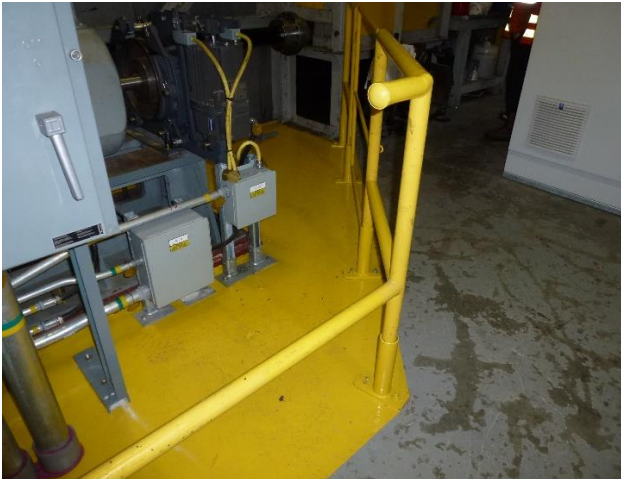
North tower yellow paint on the bollards	Assumed ²	Good	Good	Bollards re-painted in 2011. Assuming lead paint remains beneath new paint.	Photo 3
	North tower green exterior paint	Assumed ²	Fair – Poor	Fair - Poor	Limited visibility of exterior cladding paint from windows, and ground Visible paint appears to range from Fair to Poor condition.	Photo 22
Bridge	Lift span and towers (red primer)	Assumed	Fair	Fair	The entire lift span structure observed to have moderate peeling, flaking, etc. The red primer at the ‘splash- zone’ has been removed and repainted. Ten feet above the deck was repainted.	Photo 9

Photo 3: North tower 9peeling floor paint and bollards

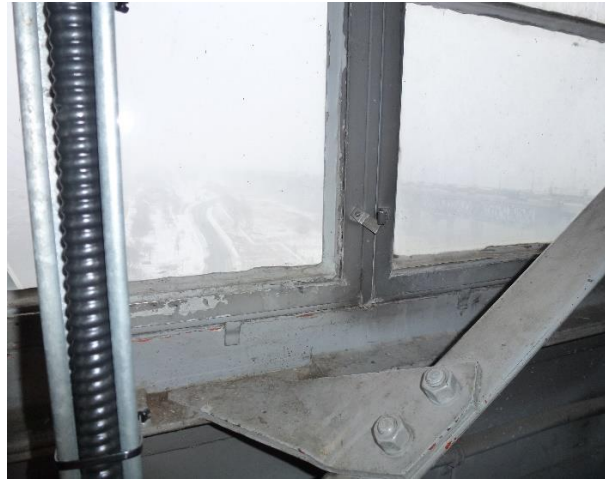
Photo 4: Window caulking South Tower

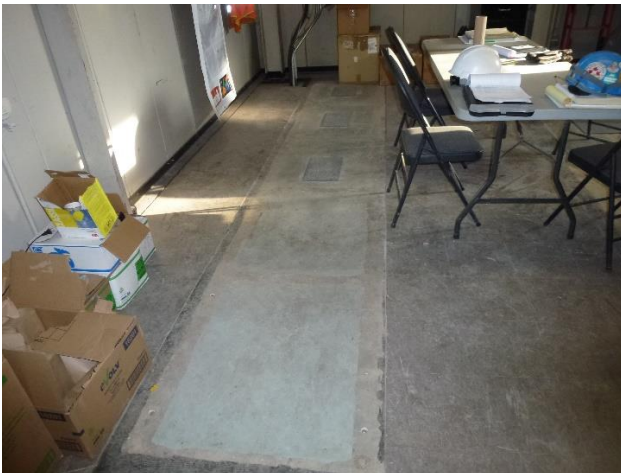
Photo 5: Vinyl tiles (ACM) removed electrical room

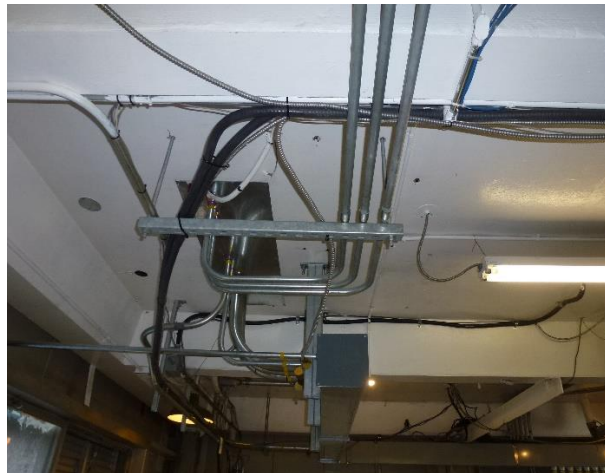
Photo 6: ACM high voltage cables removed

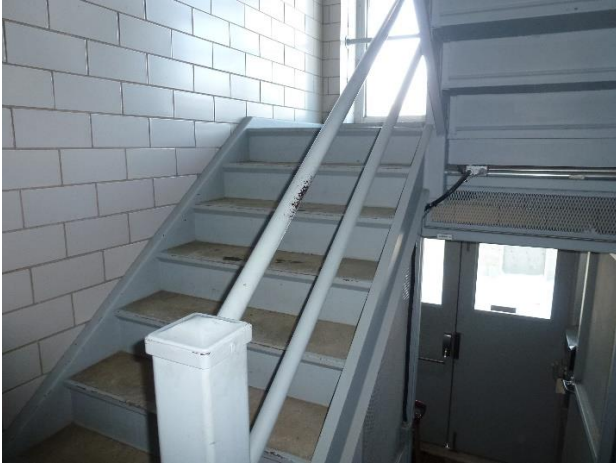
Photo 7: Control house stairwell wearing paint

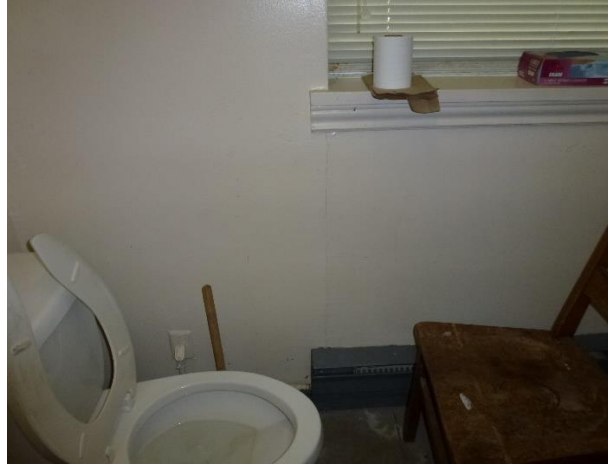
Photo 8: Old workshop ACM drywall joint compound

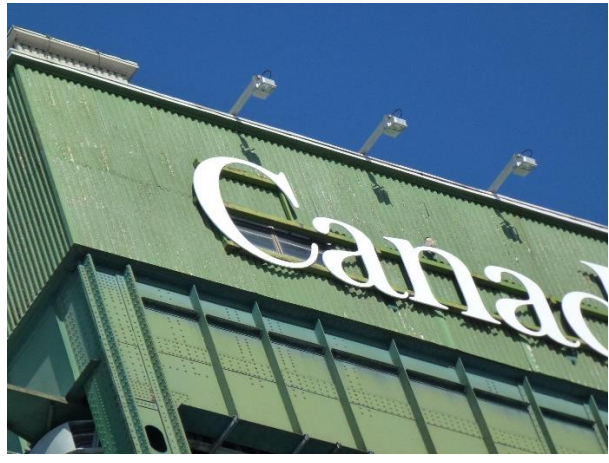
Photo 10: South tower machine room exterior

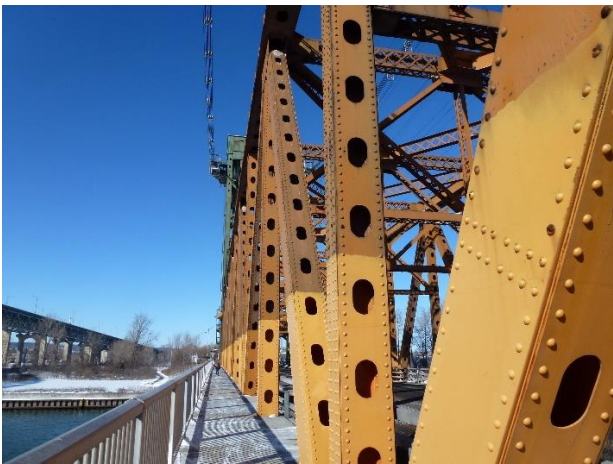
Photo 11: LCM removed and painted yellow

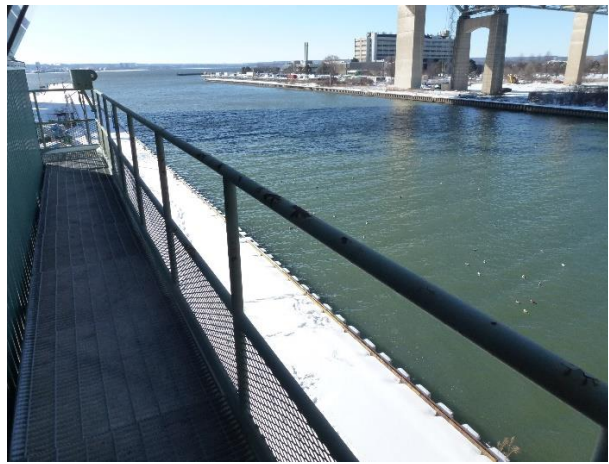
Photo 12: Control house catwalk peeling LCM paint

- 2) It is recommended that areas of lead-containing paints observed to be in *poor* condition (severe cracking/chipping/flaking and debris) as listed in Table 4-4 (control house mechanical room walls, control house catwalk, gatehouse ceiling and walls, gatehouse exterior window covering, south tower interior walls and floors, south tower exterior mechanical room, north tower interior walls, north tower mechanical room exterior and lift span read primer) be removed by a professional environmental abatement contractor following either Type 2a Operations (using non-powered hand tools) or Type 3 Operations (using power tools as stipulated in the Ministry of Labour Guideline, "*Lead on Construction Projects*").

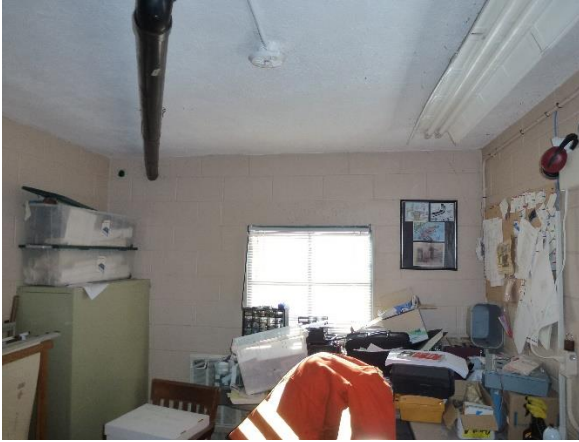
Photo 13: Ceiling Stucco old workshop

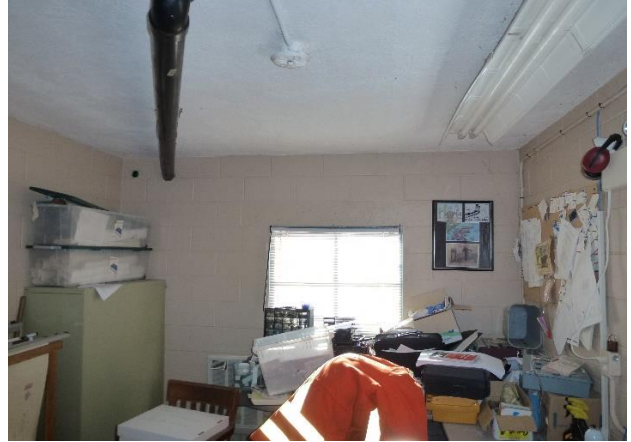
Photo 14: Beige wall paint old workshop

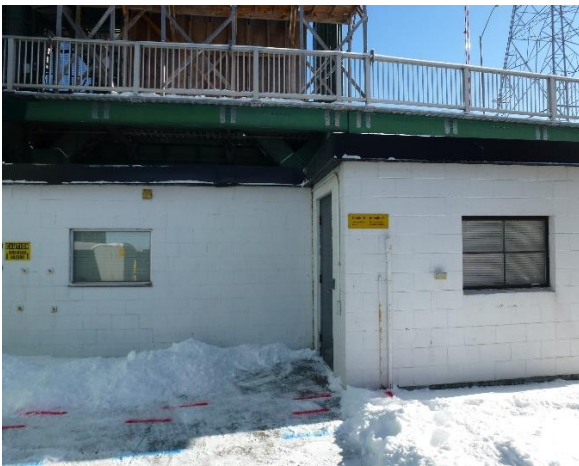
Photo 15: White over beige over grey old workshop

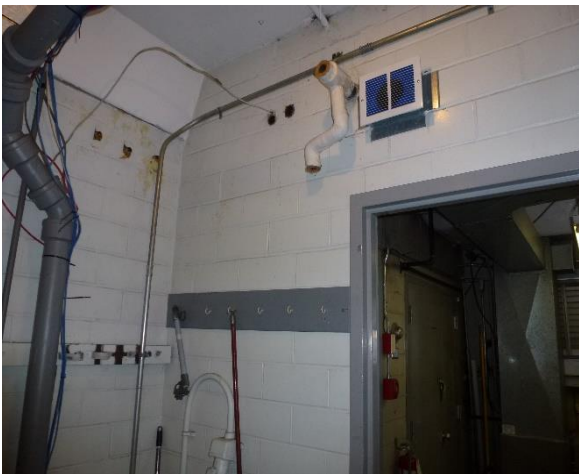
Photo 17: Control house 2nd floor white wall paint

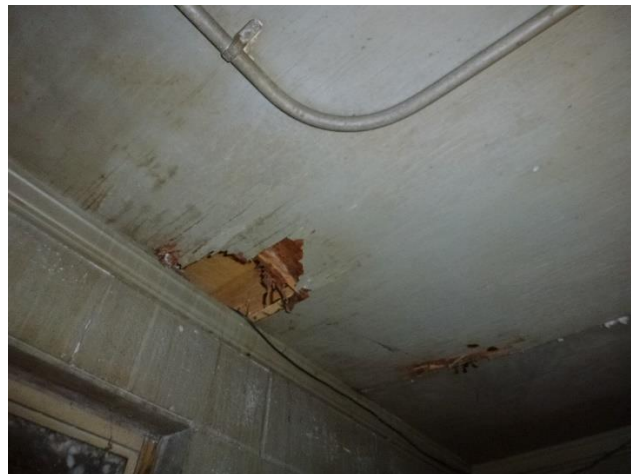
Photo 18: Gate house ceiling & wall LCM

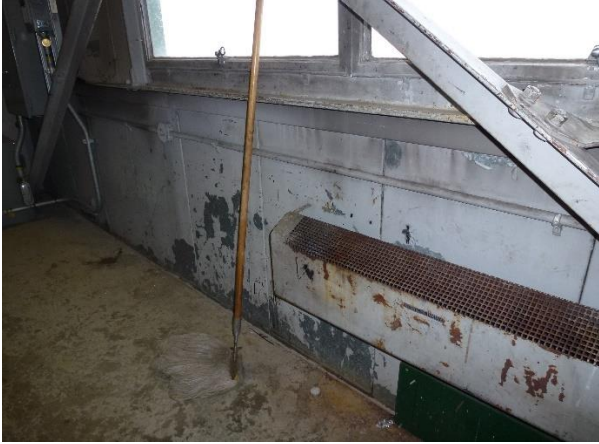
Photo 19: South tower interior grey wall paint.

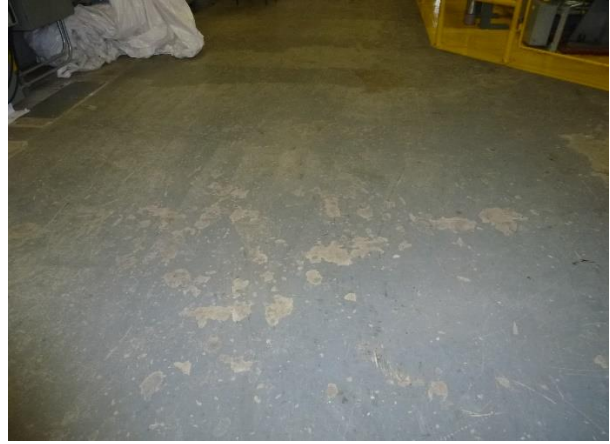
Photo 20: South tower interior floor paint.

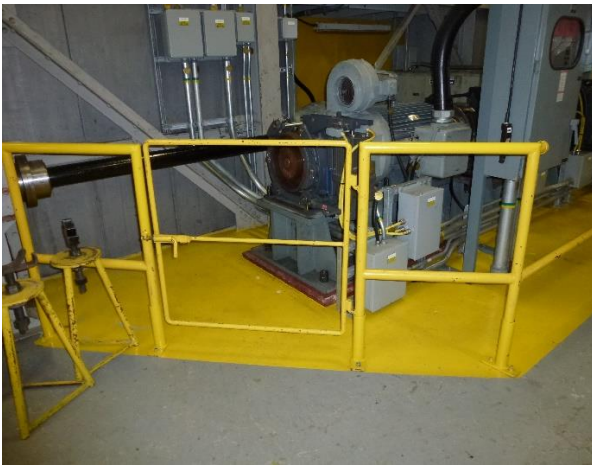
Photo 21: South tower yellow paint on bollards

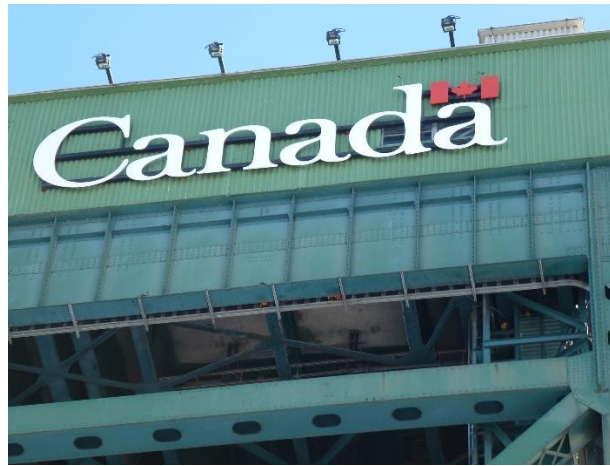
Photo 22: North tower machine room exterior
