Hazardous Building Materials Assessments

6 Buildings/Structures at the Victoria
Coast Guard Base, 25 Huron Street,
Victoria, BC

March 18, 2019

Public Services and Procurement
Canada
401-1230 Government Street
Victoria, BC V8W 3X4

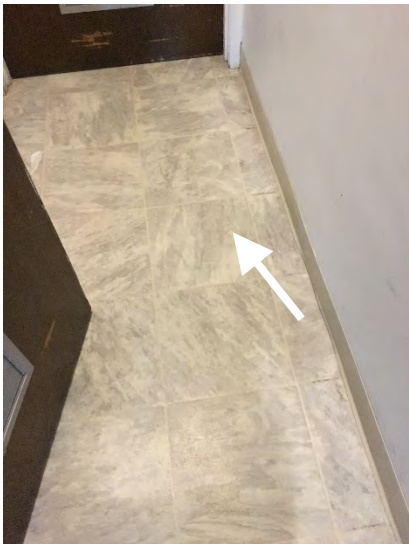
Identified ACM Description and Condition Information		Photo
Tan vinyl sheet flooring beneath cream 12"x12" patterned vinyl sheet flooring in the Male Washroom.

Friability	Non-friable	
Condition	Good	
Total Quantity	Approximately 15 m ²	
Content	10.2% Chrysotile	
12"x12" cream vinyl floor tile with beige smudges in the Electrical/Telephone room and west portion of the Mail/Files room.

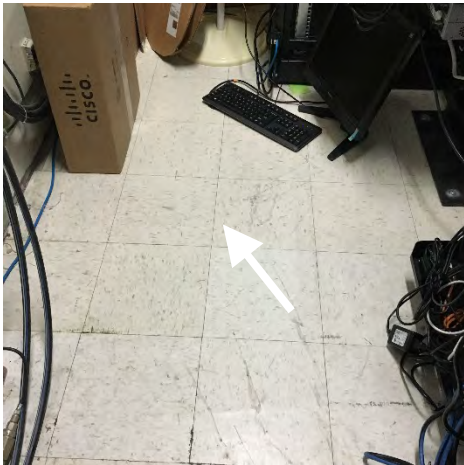
Friability	Non-friable	
Condition	Good	
Total Quantity	Approximate 25 m ²	
Content	1.3% Chrysotile (current assessment) 1-10% Chrysotile (Golder Report, 2004)

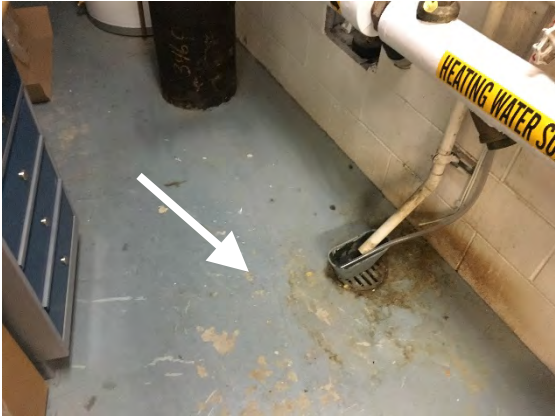
Substrate	Concrete	
Location/approx. extent	Interior walls	
Lead content	800 ppm	
Condition	Good	
Paint colour	Grey

Substrate	Concrete	
Location/approx. extent	Mechanical room floor	
Lead content	3,600 ppm	
Condition	Good in general, worn from surface in localized areas

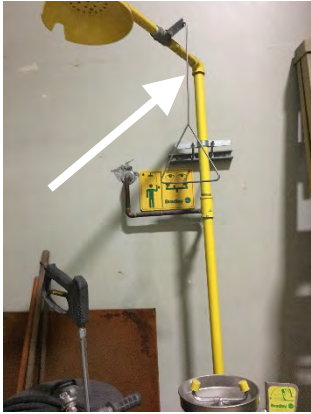
Identified ACM Description and Condition Information		Photo
Blue pipe sealant applied to threads of the wash station pipes.

Friability	Non-friable	
Condition	Good	
Total Quantity	Wash station pipe fittings	
Content	1% Chrysotile	
Cream pipe sealant applied to threads of compressed air lines throughout. See section 5.2.1.1

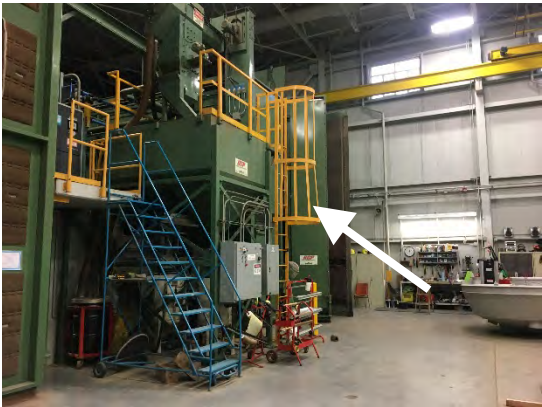
Identified LCP Description		Photo
Paint colour	Yellow

Substrate	Metal	
Location/approx. extent	Mezzanine railings and ladder	
Lead content	690 ppm	
Condition	Good

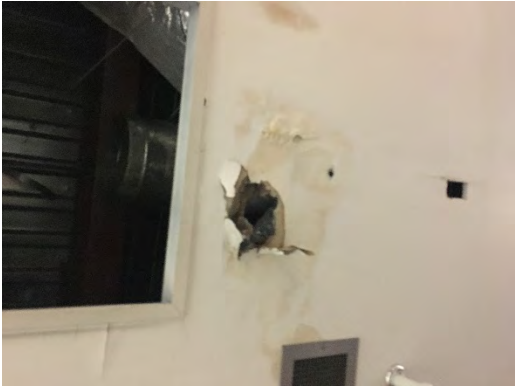
Envir. Crew Storage	Moisture impacted drywall ceiling	Pipe leaks, condensation tray overflow, roof leaks

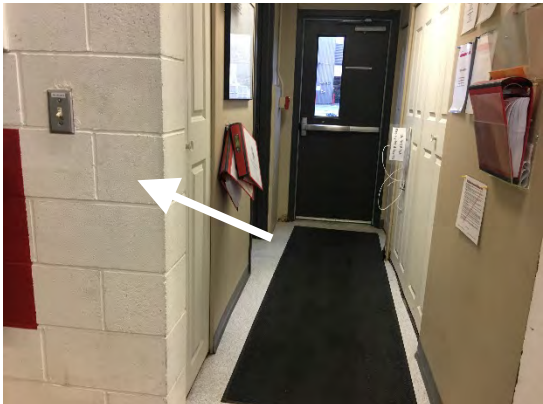
Identified LCP Description		Photo
Paint colour	White

Substrate	Concrete	
Location/approx. extent	Interior walls	
Lead content	710 ppm	
Condition	Good

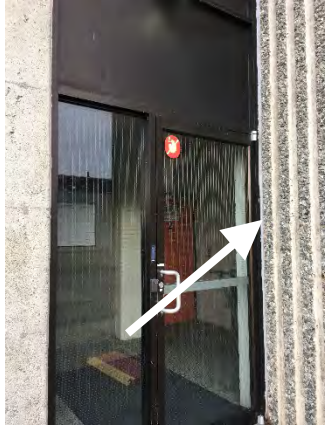
Identified ACM Description and Condition Information		Photo
Grey wall sealant applied to exterior concrete vertical seams.

Friability	Non-friable	
Condition	Good	
Total Quantity	Vertical seams throughout exterior	
Content	1.5% Chrysotile	
Black window pane caulking applied to windows throughout.

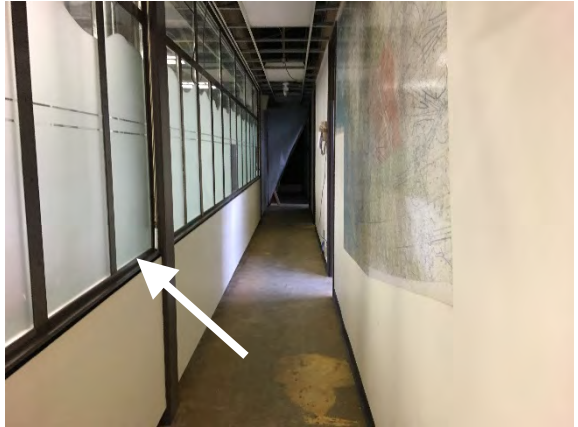
Friability	Non-friable	
Condition	Good	
Total Quantity	Windows throughout	
Content	1.4% Chrysotile

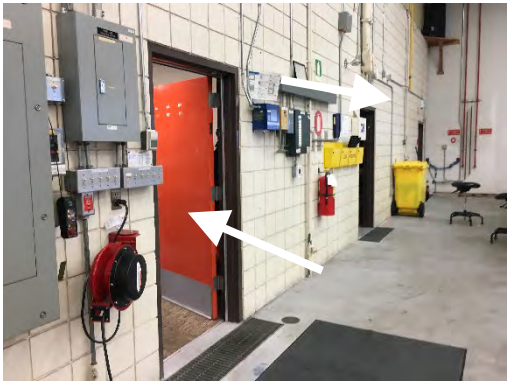
Substrate	Concrete	
Location/approx. extent	Interior walls	
Lead content	780 ppm	
Condition	Good	
Paint colour	Orange

Substrate	Metal	
Location/approx. extent	Doors	
Lead content	20,000 ppm	
Condition	Good	
Paint colour	Brown

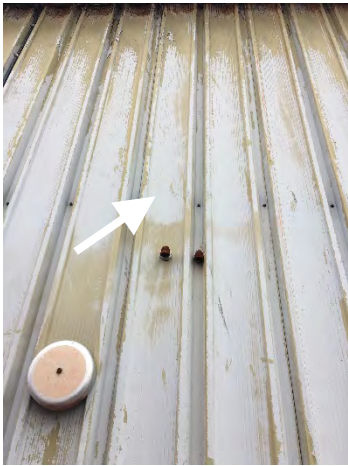
Identified LCP Description		Photo
Paint colour	Light blue/grey

Substrate	Metal	
Location/approx. extent	Exterior siding	
Lead content	3,500 ppm	
Condition	Good

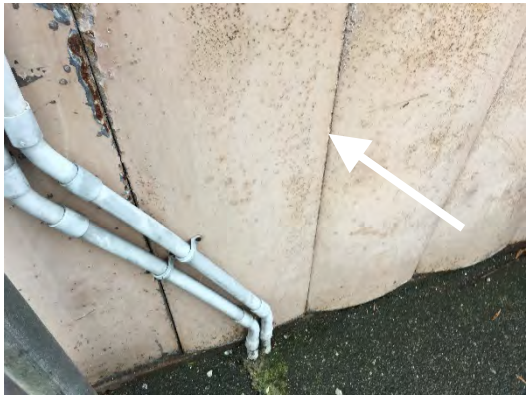
Identified LCP Description		Photo
Paint colour	Pink/peach

Substrate	Metal	
Location/approx. extent	Exterior walls	
Lead content	32,000 ppm	
Condition	Good in general, some localized damage

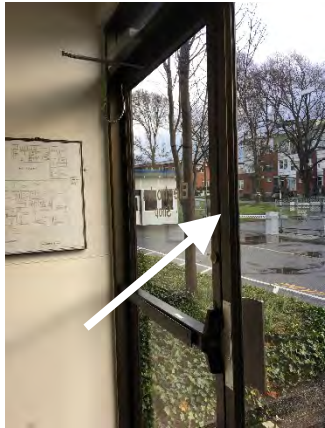
Identified ACM Description and Condition Information	Photo								
<p>Grey window pane caulking applied to windows throughout.</p> <table border="1" data-bbox="190 468 836 858"> <tr> <td data-bbox="190 468 336 527">Friability</td> <td data-bbox="336 468 836 527">Non-friable</td> </tr> <tr> <td data-bbox="190 527 336 588">Condition</td> <td data-bbox="336 527 836 588">Good</td> </tr> <tr> <td data-bbox="190 588 336 659">Total Quantity</td> <td data-bbox="336 588 836 659">Windows throughout</td> </tr> <tr> <td data-bbox="190 659 336 858">Content</td> <td data-bbox="336 659 836 858">3.2% Chrysotile (current assessment) 1–10% Chrysotile (Golder Report, 2004)</td> </tr> </table>	Friability	Non-friable	Condition	Good	Total Quantity	Windows throughout	Content	3.2% Chrysotile (current assessment) 1–10% Chrysotile (Golder Report, 2004)

Friability	Non-friable								
Condition	Good								
Total Quantity	Windows throughout

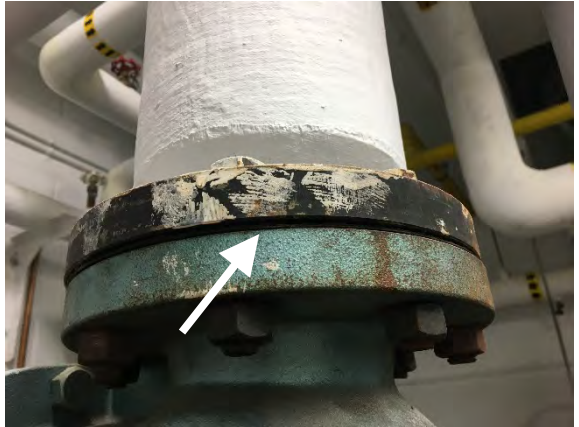
Content	3.2% Chrysotile (current assessment) 1–10% Chrysotile (Golder Report, 2004)								
<p>Black mechanical gaskets in pipe flanges.</p> <table border="1" data-bbox="190 905 836 1337"> <tr> <td data-bbox="190 905 336 945">Friability</td> <td data-bbox="336 905 836 945">Non-friable</td> </tr> <tr> <td data-bbox="190 945 336 987">Condition</td> <td data-bbox="336 945 836 987">Good</td> </tr> <tr> <td data-bbox="190 987 336 1056">Total Quantity</td> <td data-bbox="336 987 836 1056">Flanges throughout</td> </tr> <tr> <td data-bbox="190 1056 336 1337">Content</td> <td data-bbox="336 1056 836 1337">45% Chrysotile</td> </tr> </table>	Friability	Non-friable	Condition	Good	Total Quantity	Flanges throughout	Content	45% Chrysotile

Friability	Non-friable								
Condition	Good								
Total Quantity	Flanges throughout								
Content	45% Chrysotile								
<p>12" x 12" beige vinyl floor tile with brown streaks in the Carpentry Shop mezzanine and shop foreman (concealed beneath linoleum), Maintenance Garage equipment and systems storage.</p> <table border="1" data-bbox="190 1467 836 1831"> <tr> <td data-bbox="190 1467 336 1507">Friability</td> <td data-bbox="336 1467 836 1507">Non-friable</td> </tr> <tr> <td data-bbox="190 1507 336 1547">Condition</td> <td data-bbox="336 1507 836 1547">Good</td> </tr> <tr> <td data-bbox="190 1547 336 1619">Total Quantity</td> <td data-bbox="336 1547 836 1619">Approximately 35 m²</td> </tr> <tr> <td data-bbox="190 1619 336 1831">Content</td> <td data-bbox="336 1619 836 1831">1.3% Chrysotile (current assessment) 2.5% Chrysotile (WSP Workshop Report, 2018) 1–10% Chrysotile (Golder Report, 2004)</td> </tr> </table>	Friability	Non-friable	Condition	Good	Total Quantity	Approximately 35 m ²	Content	1.3% Chrysotile (current assessment) 2.5% Chrysotile (WSP Workshop Report, 2018) 1–10% Chrysotile (Golder Report, 2004)

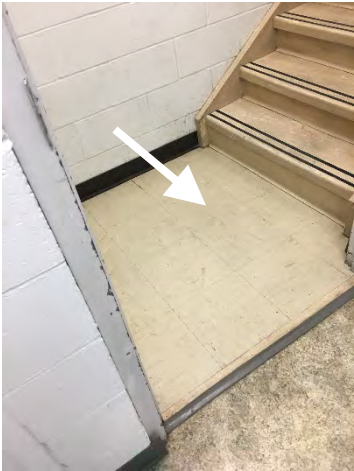
Identified ACM Description and Condition Information		Photo
12"x12" white with grey floor tile at the base of the stairwell in the electrical shop and open storage.

Friability	Non-friable	
Condition	Good	
Total Quantity	Approximately 5 m ²	
Content	1–10% Chrysotile (Golder Report, 2004)

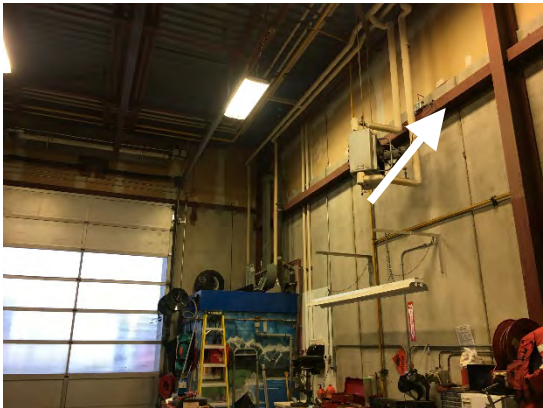
Identified LCP Description		Photo
Paint colour	Red

Substrate	Metal	
Location/approx. extent	Structural steel	
Lead content	2,300 ppm	
Condition	Good	
Paint colour	Red

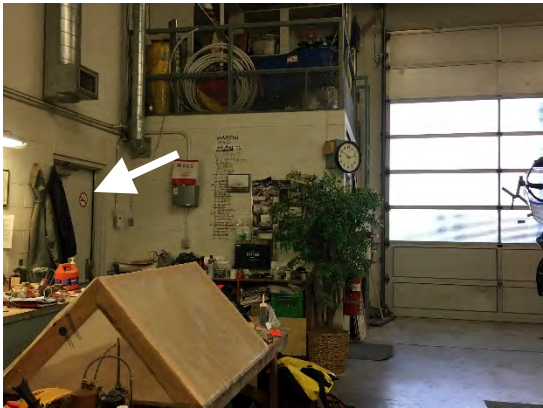
Substrate	Metal	
Location/approx. extent	Carpentry shop stairwell	
Lead content	44,000 ppm	
Condition	Good	
Paint colour	White

Substrate	Metal	
Location/approx. extent	Doors and frames	
Lead content	1,100 ppm (current assessment) 2,100 ppm (WSP Workshop Report, 2018)	
Condition	Good	
Paint colour	Orange	 
Substrate	Metal	
Location/approx. extent	Doors	
Lead content	120,000 ppm	
Condition	Good
