Underground Water Reservoir Tank Inspection Program

Presented To: **Agriculture and Agri-Food Canada**
4200 BC-97
Summerland, BC V0H 1Z0

Dated: May 2020

Omega File No.: 2020.080.02CH

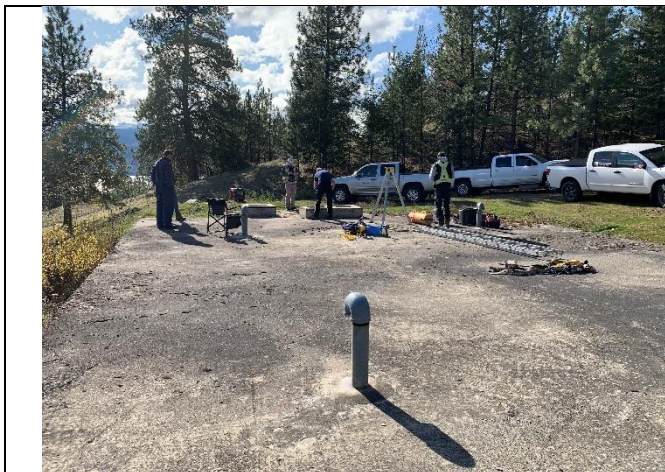
1: View of tank facing south

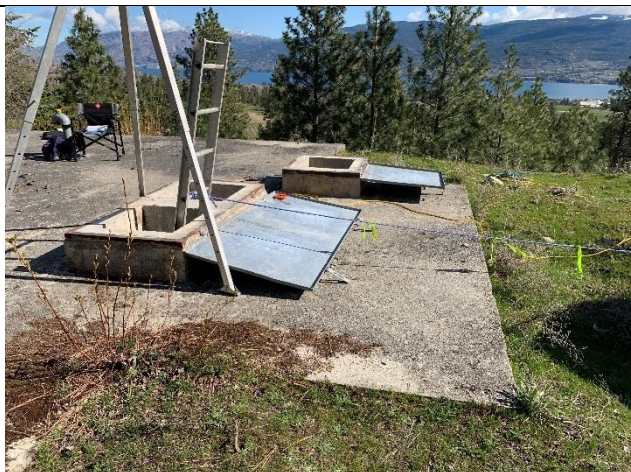
2: View of entrances to tank cells

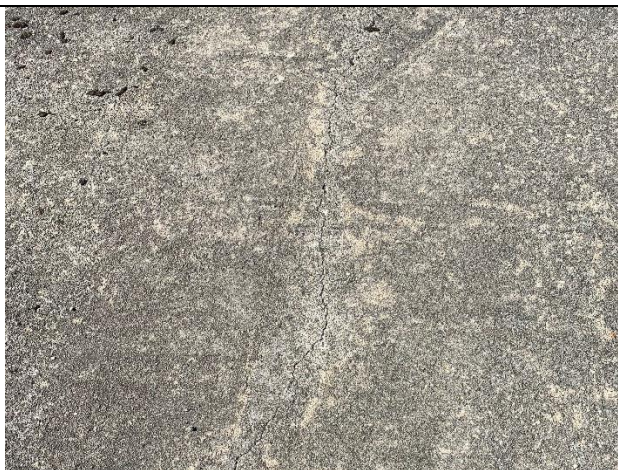
3: Visible hairline crack on top slab

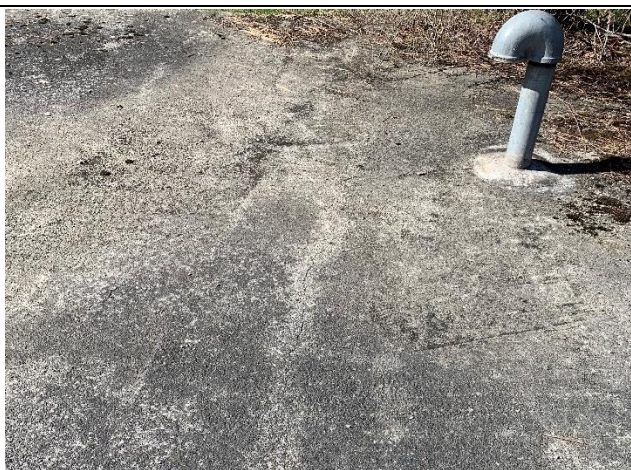
4: Extend of crack on top slab towards west

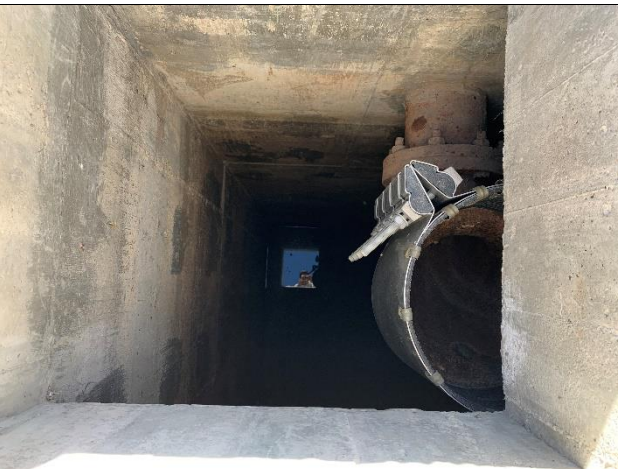
5: View of entrance to cell 1. Access ladder not present

- Access ladder inside the chambers shall be installed.
- To ensure proper functionality and performance of the reservoir tanks, accumulated silt and debris shall be removed from the bottom of the reservoir. While the accumulated silt does not seem to have an adverse affect on the functionality of the tanks at the present time, Ecora recommends that the depth of accumulated silt be monitored to determine the frequency of cleanup of the tanks.
- Vegetation root growth next to concrete walls of the tank shall be cleared.
- Loose electrical box inside the control chamber shall be fixed in place.
- A summary of deficiencies and recommended actions are provided in Appendix A. There is nothing of immediate urgency worth noting, but the items should be reviewed and rectified at first available opportunity

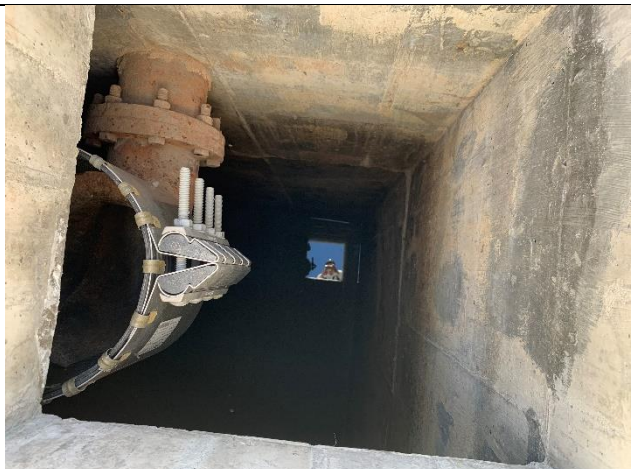
6: View of entrance to cell 2. Access ladder not present

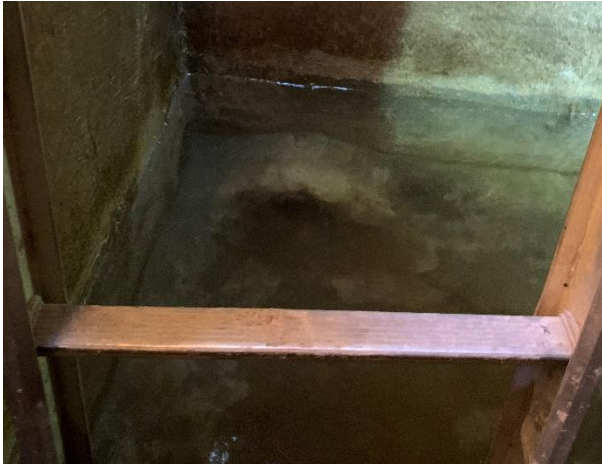
7: 4" drainpipe located at the bottom of cell 1

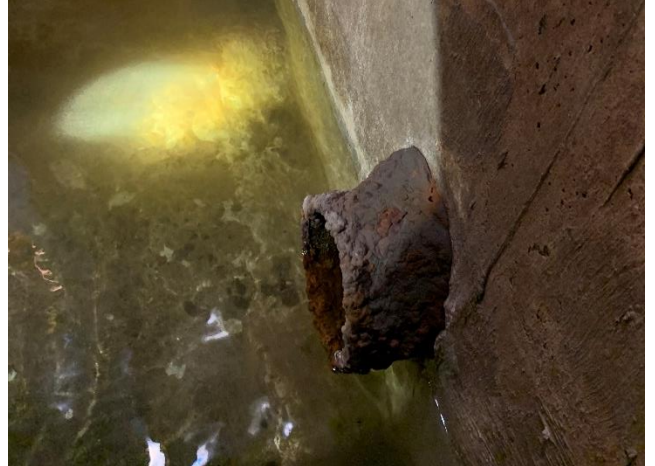
8: Corroded 8" inlet/outlet in south wall in cell 1

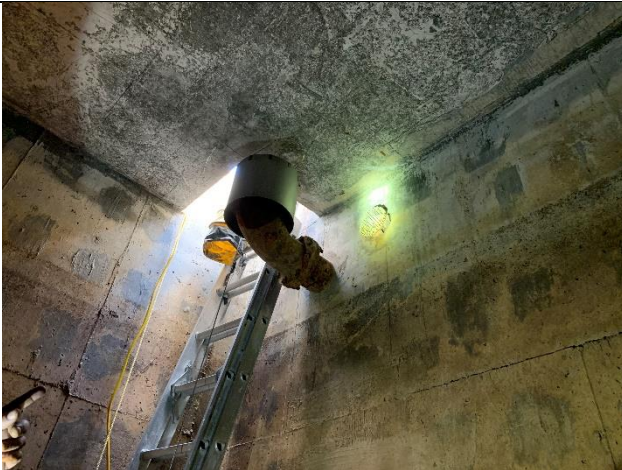
9: View of 6" overflow pipe along with sensor in cell 1

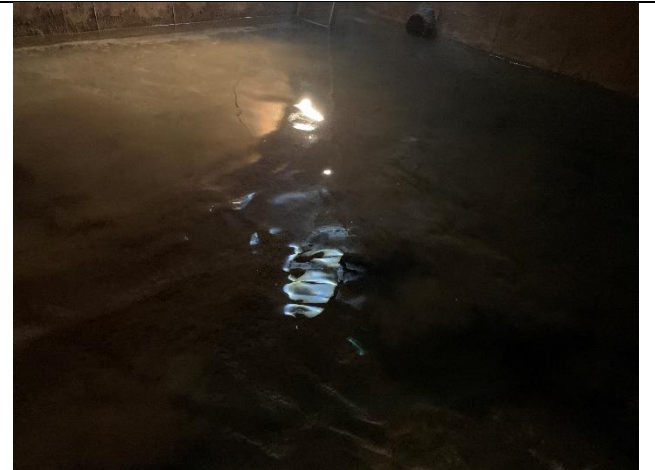
10: Up to 10" of ponding water and accumulated silt

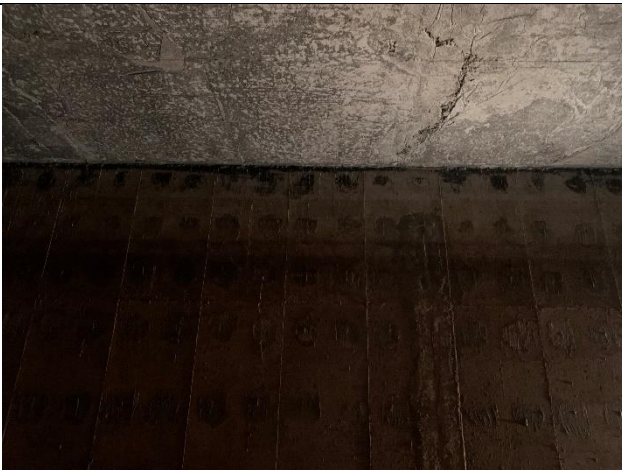
11: Concrete sealant material was noted on walls in cell 1

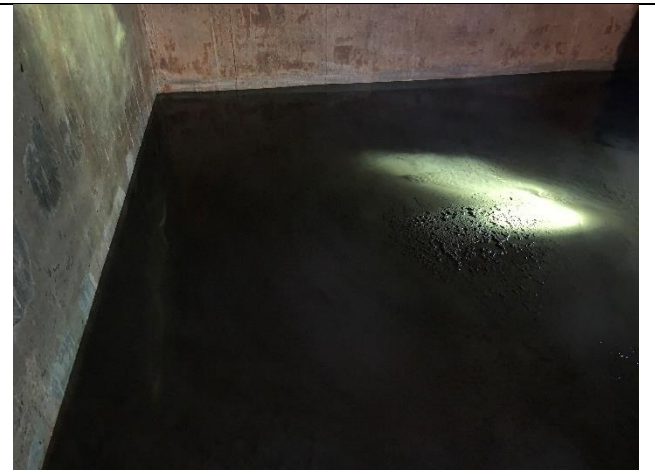
12: More accumulated silt at bottom of cell 1 up to 10"

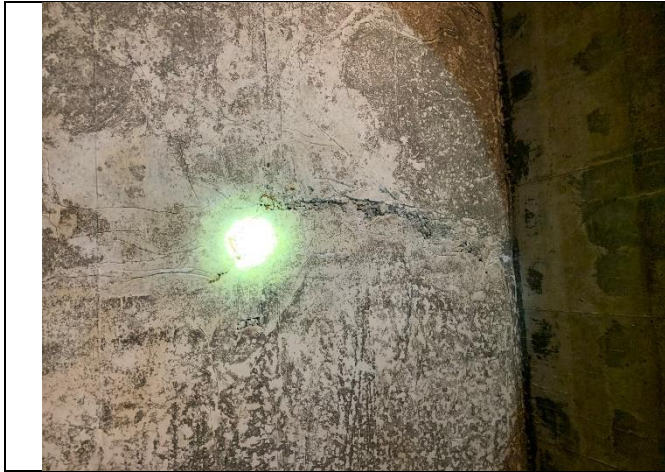
13: Minor cracking on top slab

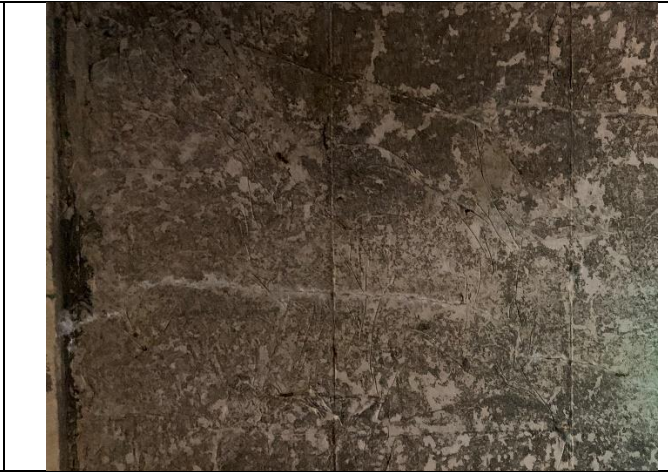
14: Minor concrete cracking on dividing wall

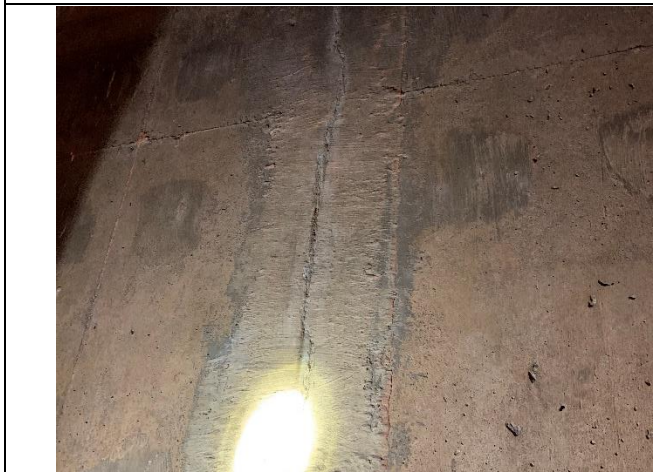
15: Concrete sealant was observed at the location of crack on western wall

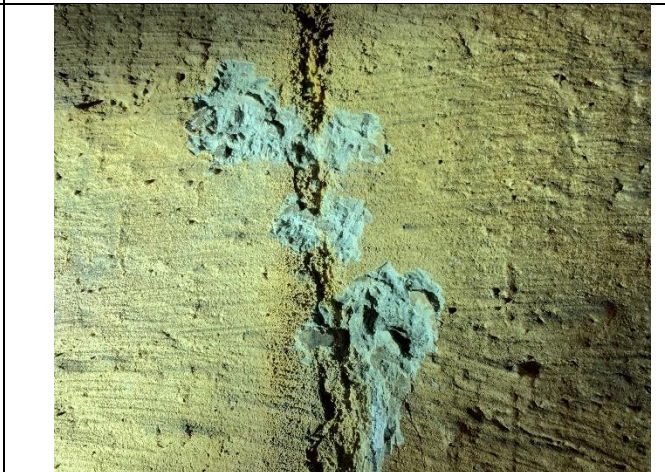
16: Performed hammer test. Note no concrete delamination

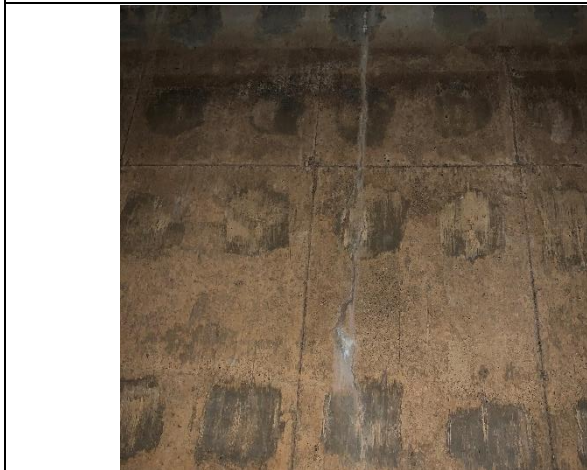
17: Noted more concrete crack on dividing wall

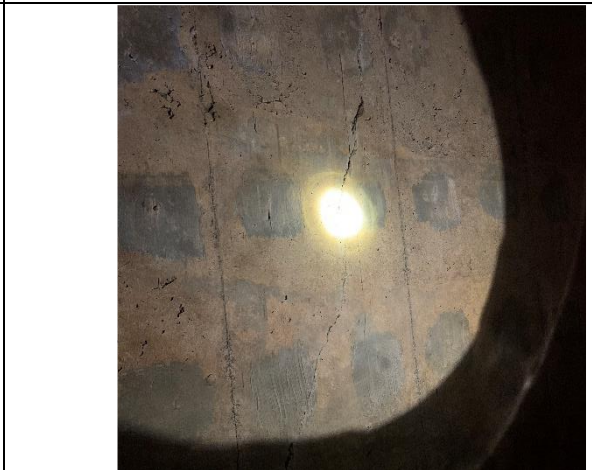
18: Diagonal concrete crack at dividing wall

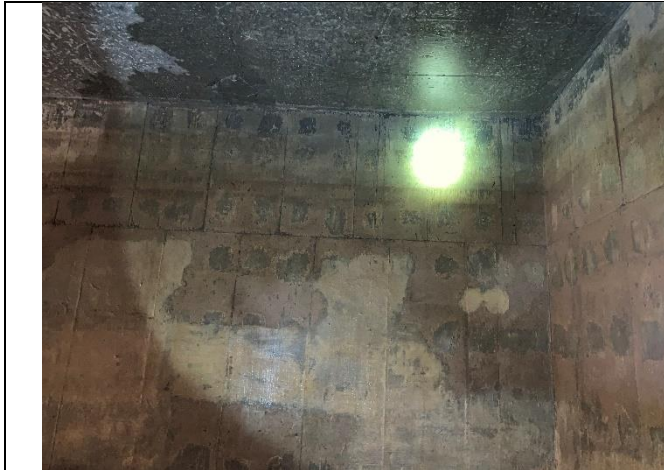
19: Moisture and leakage of water was observed on northern wall due to proximity of vegetation

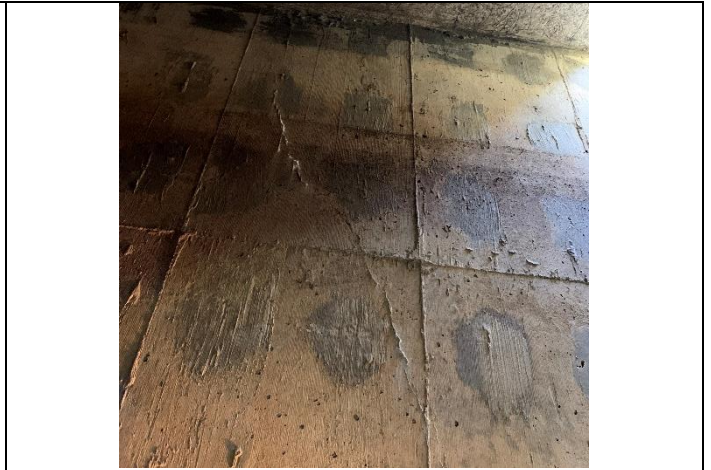
20: Minor crack on western wall of cell 1

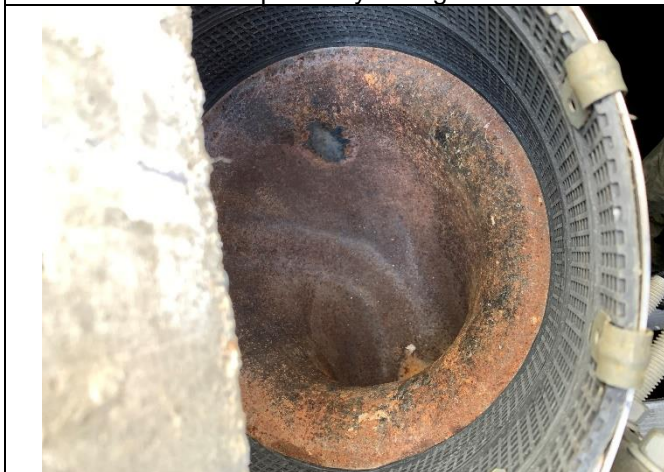
21: View of 6" overflow in cell 1 in good condition

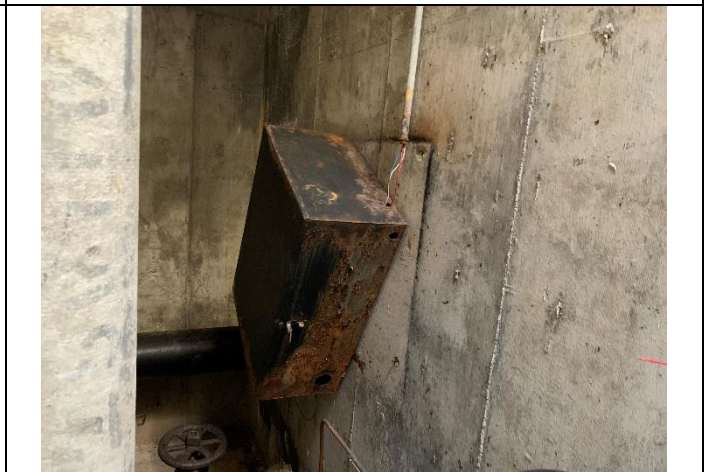
22: Loose electrical box inside control chamber

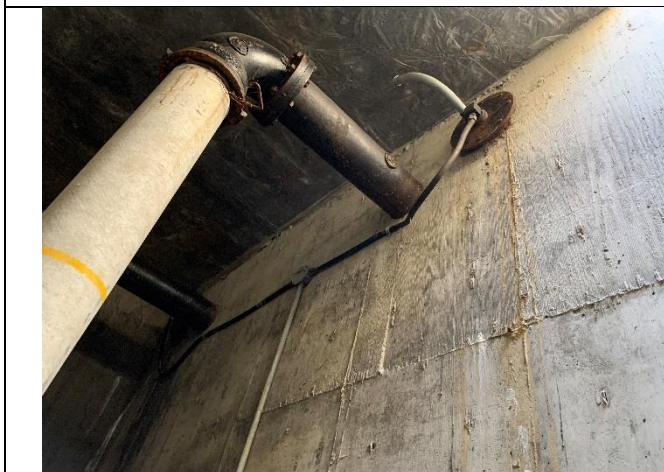
23: View of 6" overflow pipes inside control chambers

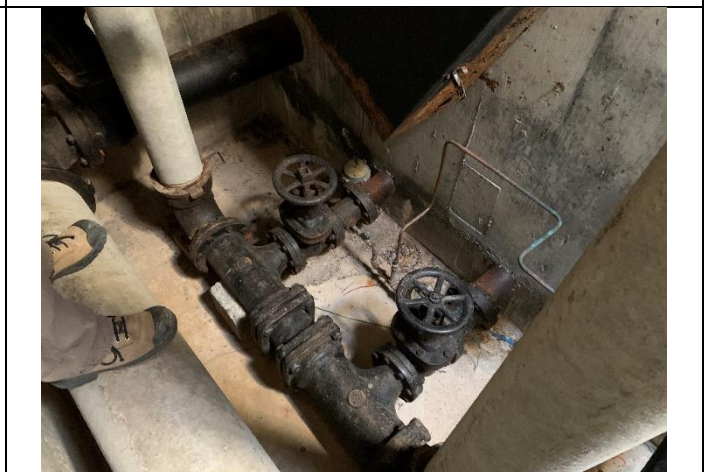
24: 4" drainpipes join 6" overflow pipe

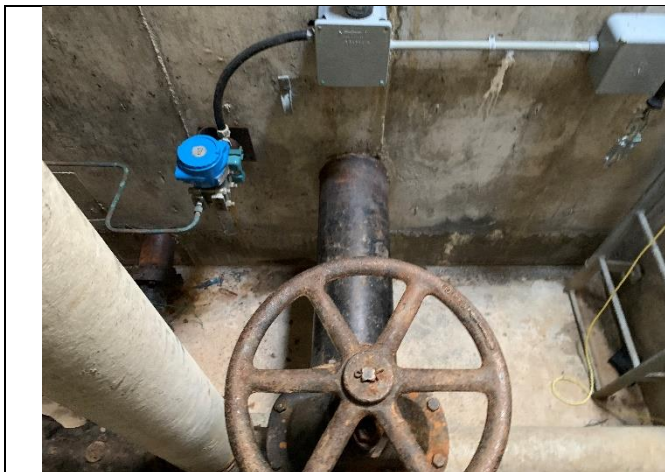
25: 8" inlet/outlet pipe to cell 2 located above 4" drainpipe

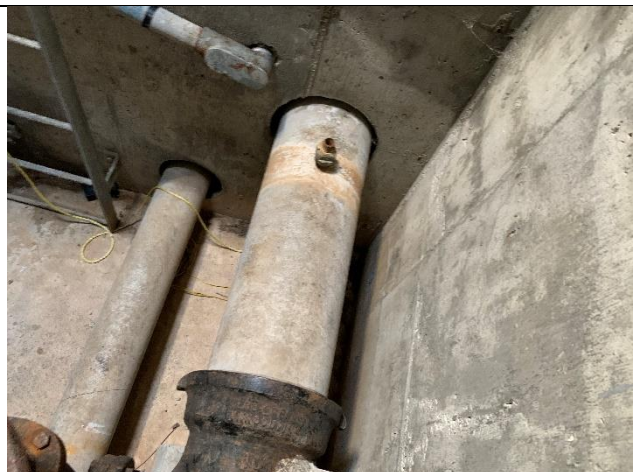
26: View of 10" inlet/outlet pipe along with 6" drainpipe

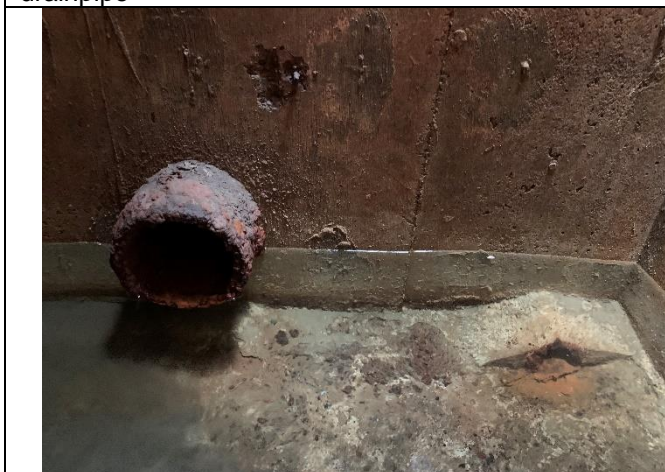
27: View of 8" inlet/outlet pipe along with 4" drainpipe in cell 2

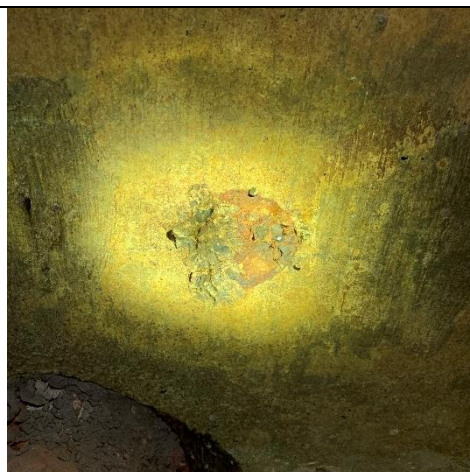
28: Minor concrete delamination is observed on south wall

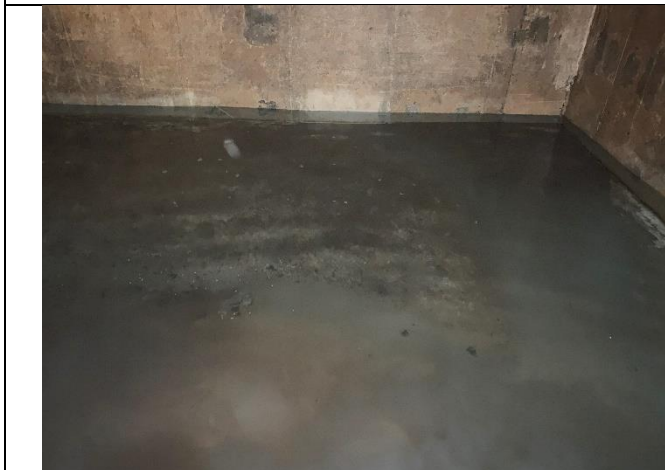
29: Up to 9" of accumulated silt near entrance to the tank

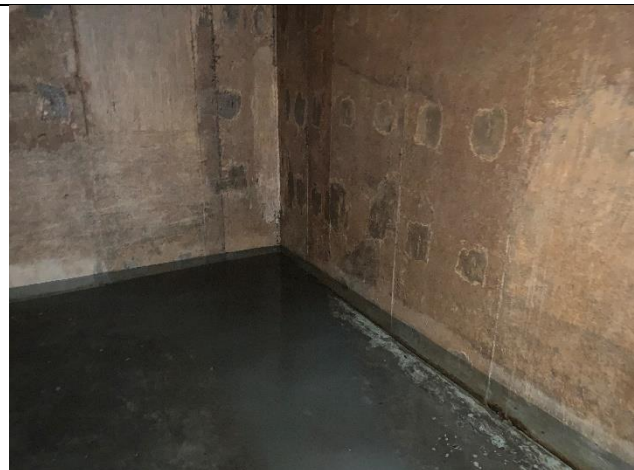
30: Concrete sealant patches were visible on cell 2 walls

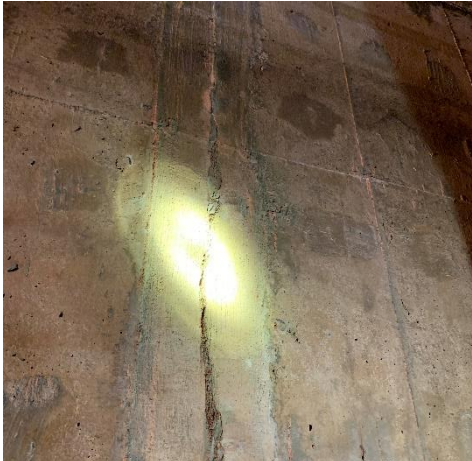
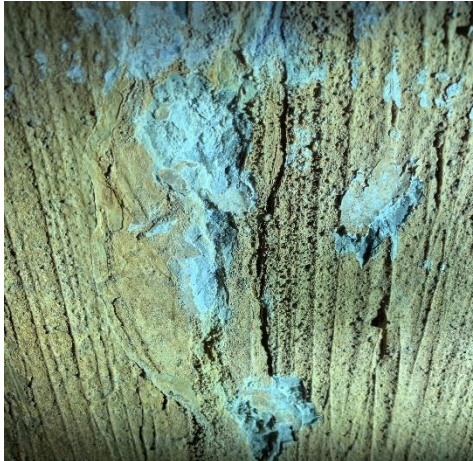
<p>25: Crack on east wall is patched with concrete sealant</p>	<p>26: Hammer sound test was conducted on the crack. No sign of concrete delamination</p>

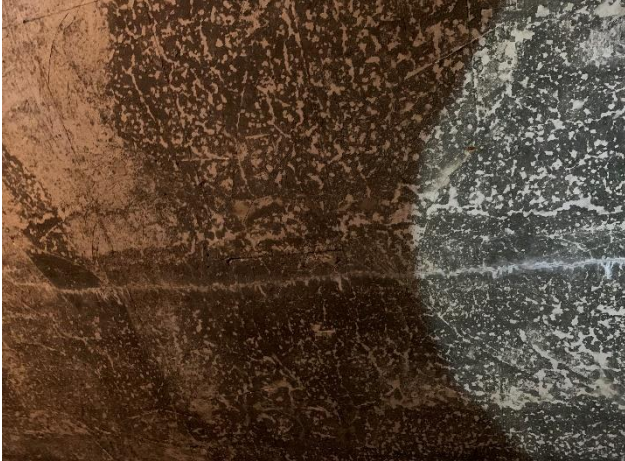
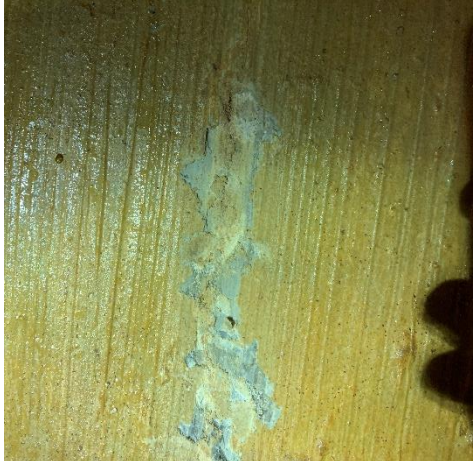
<p>27: Visible shrinkage cracking on top slab</p>	<p>28: Performed hammer test on northern wall. No sign of concrete delamination</p>

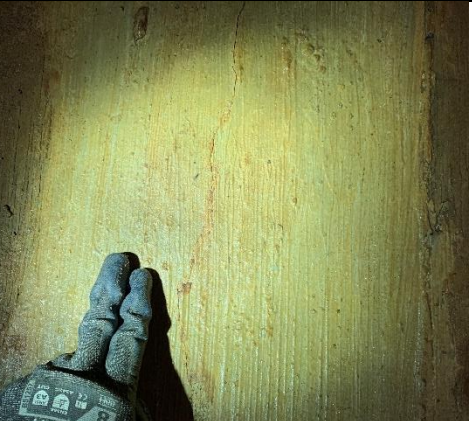
<p>29: Hairline shrinkage cracking on northern wall</p>

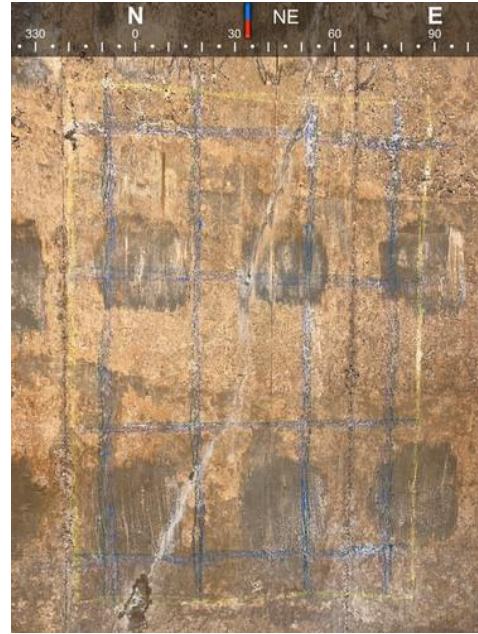
Location: West Chamber - Location #2 -
Partition Wall

Notes: Long surface cracks with visible
efflorescence. No corrosion noted. Location
selected by EIT.

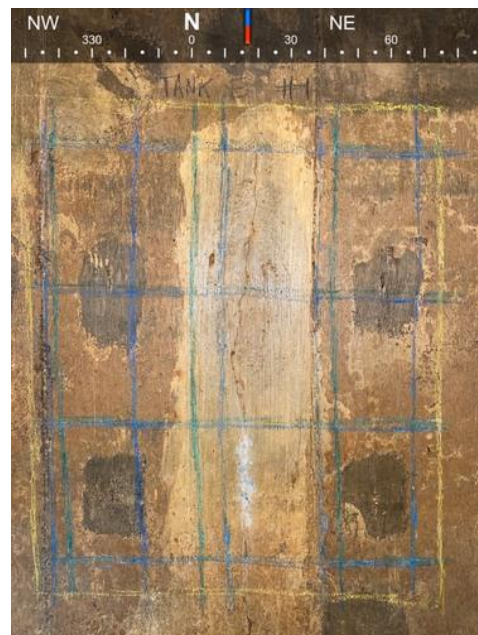
Location: East Chamber - Location #1 -
Exterior Wall (East)

Notes: Minor surface crack. Not corrosion
noted. Section tested by EIT using hammer -
note the "white" section on the image.
