XCG File No. 1-3266-02-01
March 25, 2020
REVISION 1

**DESIGNATED SUBSTANCES AND
HAZARDOUS MATERIALS SURVEY
BUILDING F – CANADIAN COAST GUARD BASE
401 KING STREET,
PRESCOTT, ONTARIO**

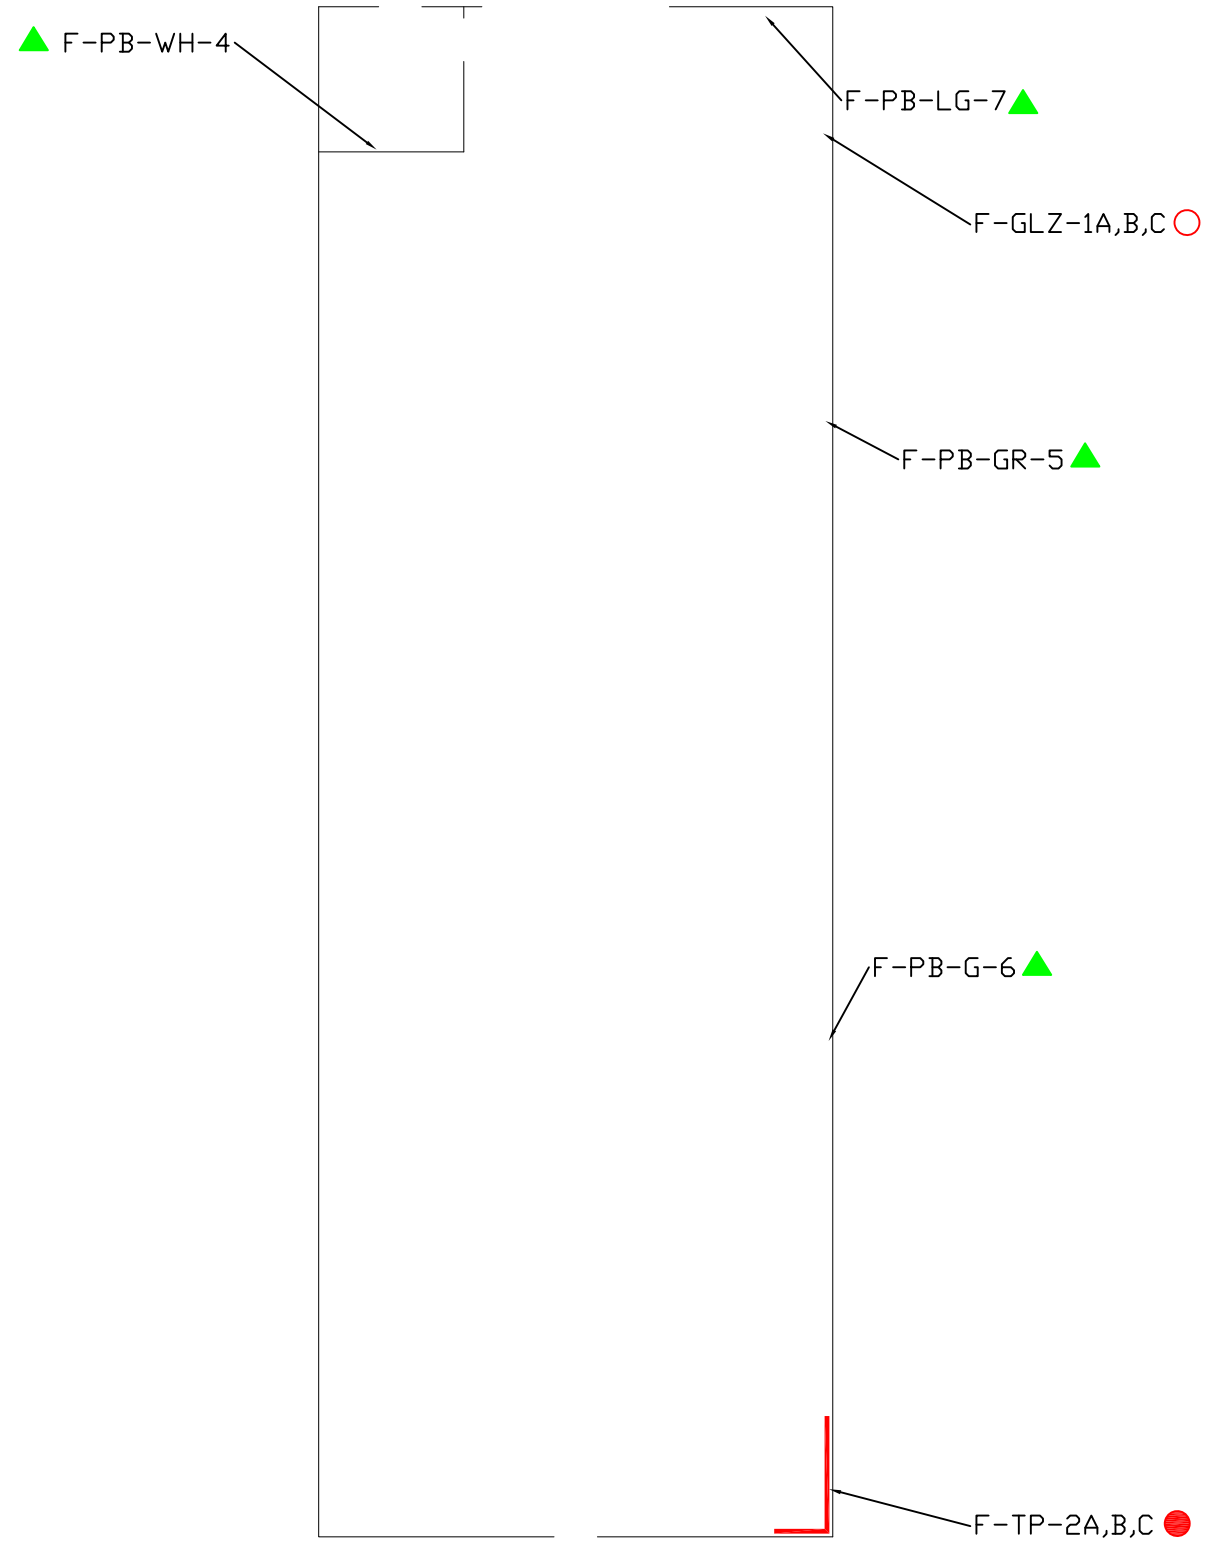
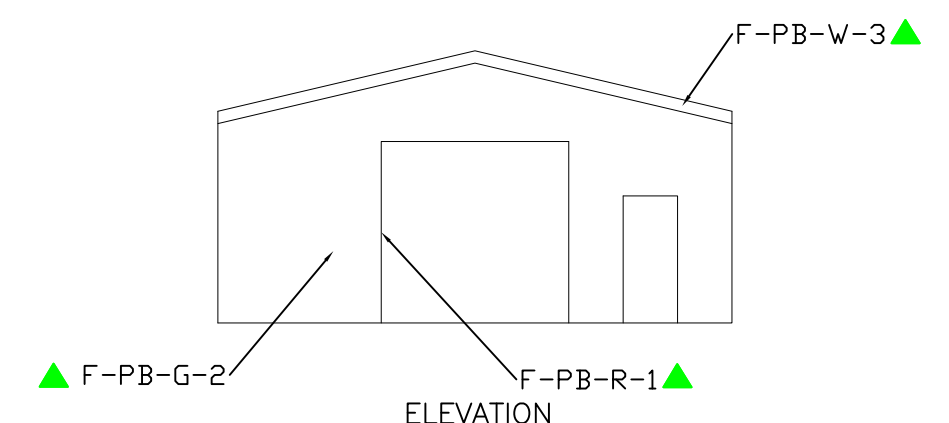
TITLE:
DESIGNATED SUBSTANCES
AND HAZARDOUS MATERIALS
BUILDING F STORAGE
SAMPLE LOCATIONS

Figure 1 can be found in Appendix A. Figure 1 identifies the sample collection locations for both ACMs and lead-based paint within the subject building. Laboratory certificates of analysis are provided in Appendix B. Select photographs showing ACMs and lead-based paint locations within the building are presented in Appendix C.

* BASED ON ANALYTICAL RESULTS ALL SURFACE COATINGS ARE CONSIDERED TO BE LEAD-CONTAINING.

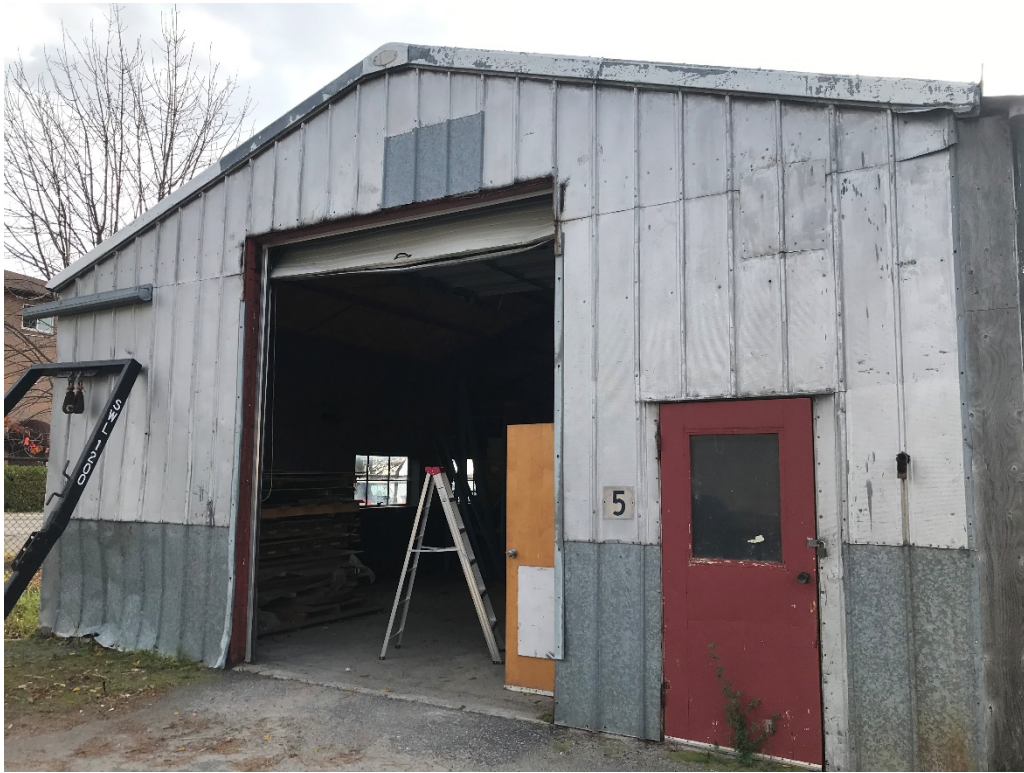
Photo 1: Subject site front view looking south.

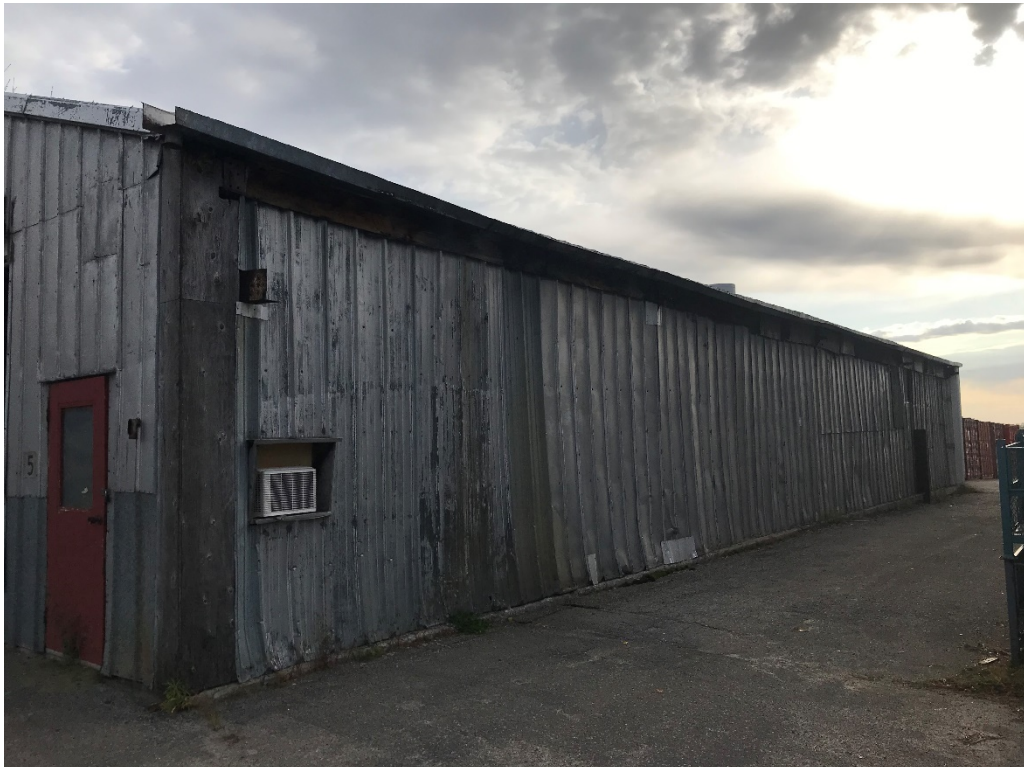
Photo 2: Subject site exterior view looking east.

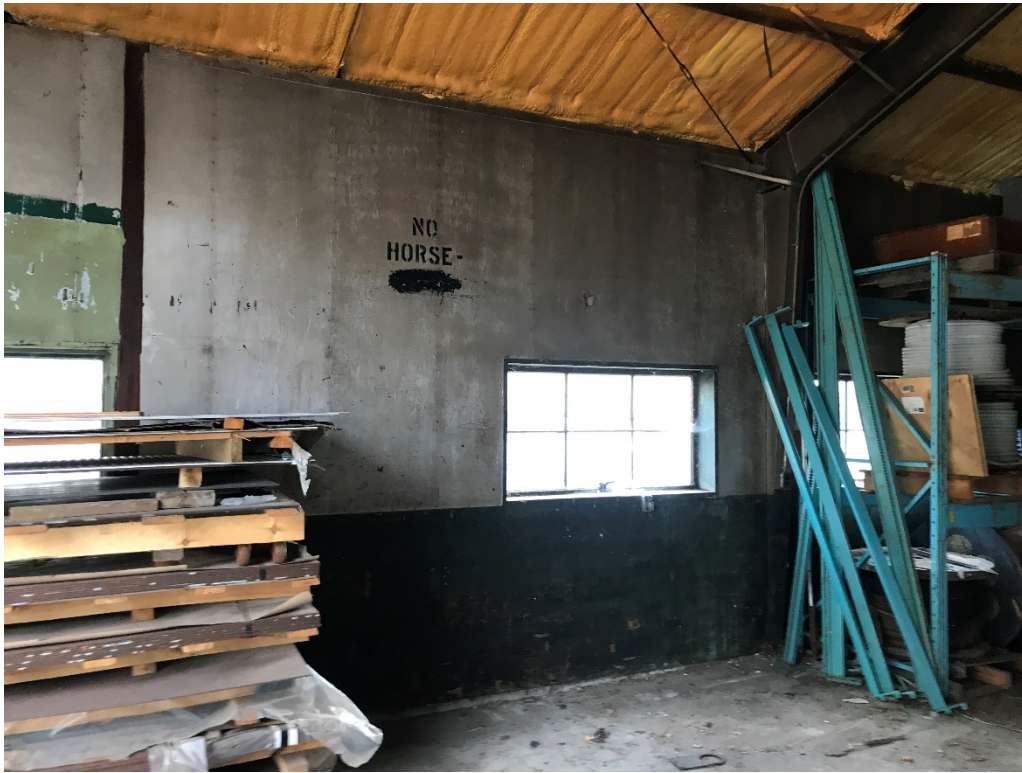
Photo 3: Subject building interior representative finishes.

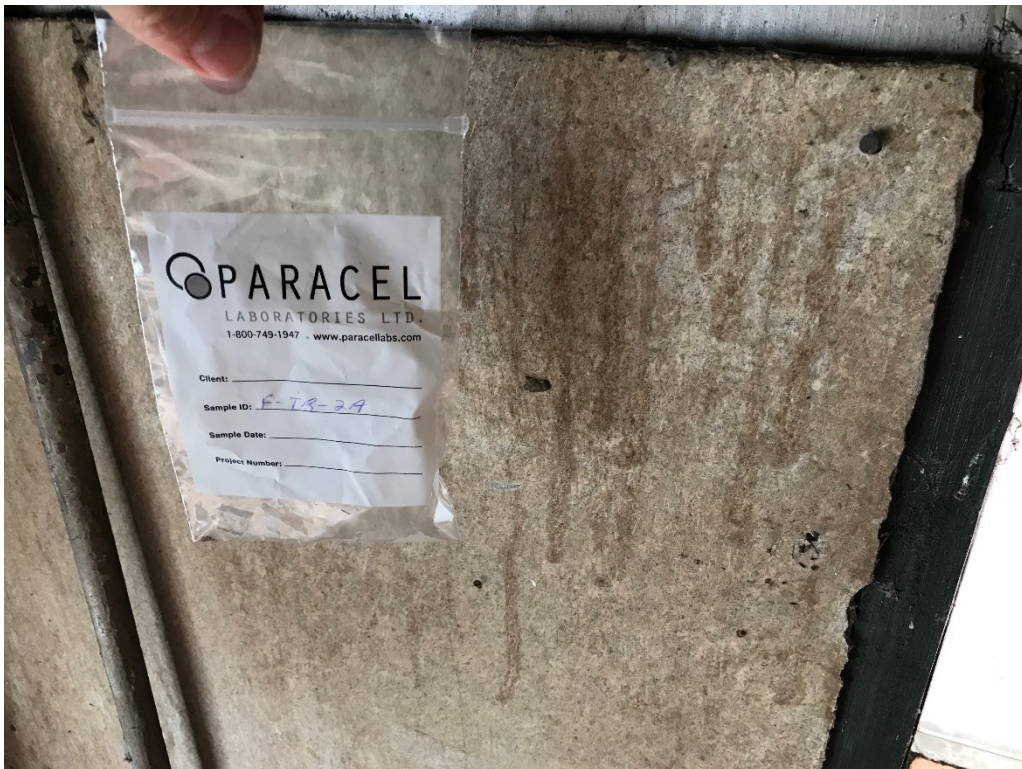
- Grey transite board, 20% chrysotile asbestos (approximately 8 m³)

Photo 4: Asbestos-containing transite board. See sample F-TB-2A.

Follow O. Reg. 278/05 Type 1 measures and procedures when disturbing the following:

All confirmed ACMs should be managed and/or disposed of in accordance with O. Reg. 490/09, O. Reg. 278/05, and O. Reg. 347. Prior to any demolition activities contractors must be provided with a copy of this DSHMS report. All asbestos abatement activities should be conducted by a qualified asbestos abatement contractor.
