**XCG File No. 5-336-200-01**  
**COLE File No. 2018-0565**  
March 26, 2019

**DESIGNATED SUBSTANCES AND  
HAZARDOUS MATERIALS SURVEY  
PIN 614124  
10725 REESOR ROAD  
MARKHAM, ONTARIO**

**PUBLIC SERVICES AND PROCUREMENT CANADA**  
4900 Yonge Street  
11th Floor  
Toronto, Ontario M2N 6A6

**PARKS CANADA AGENCY  
ROUGE NATIONAL URBAN PARK**

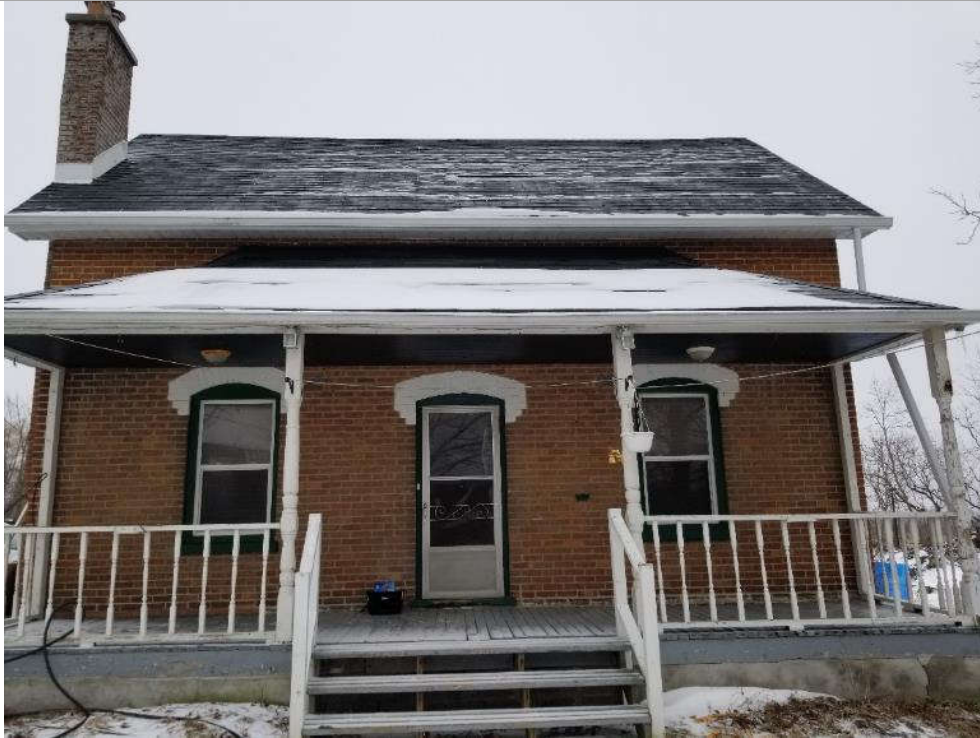
**Photo 1: View of the exterior of the residential dwelling.**

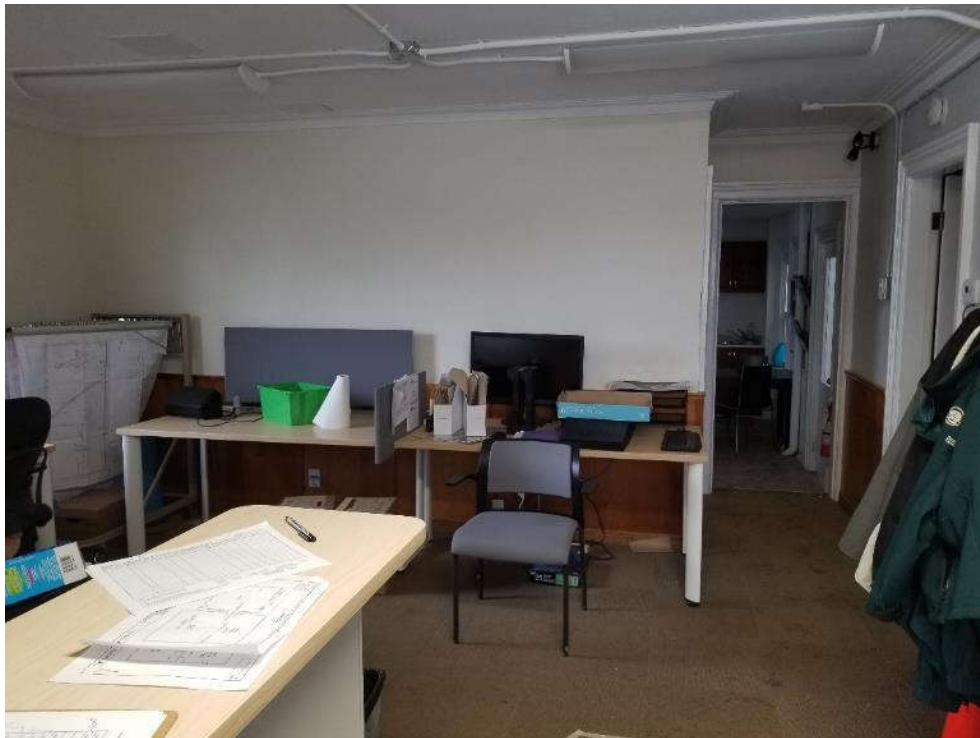
At the time of the Designated Substances Survey conducted in 2009, eight types of materials were submitted for laboratory analysis. The plaster and cement parging (composite) was confirmed to be ACM. In this survey (2019), six types of materials were submitted for laboratory analysis of asbestos, none of the samples analyzed were ACM. It should be noted that roofing materials were not collected due to the height and safety precautions, however some roofing materials are known to have been manufactured with asbestos and therefore these materials are presumed to be ACM.

**Photo 2: View of the asbestos-containing plaster walls and ceiling throughout the subject dwelling.**

Airborne asbestos fibres can be generated through such processes as drilling, grinding, cutting, and abrading non-friable asbestos-containing material, or by crumbling or deteriorating friable asbestos-containing materials. Precautions must be taken to prevent asbestos-containing particles from becoming airborne during the application of such processes. All handling and removal of asbestos should be conducted as specified in O. Reg. 278/05 (amended to O. Reg. 493/09) and PCA Guide.

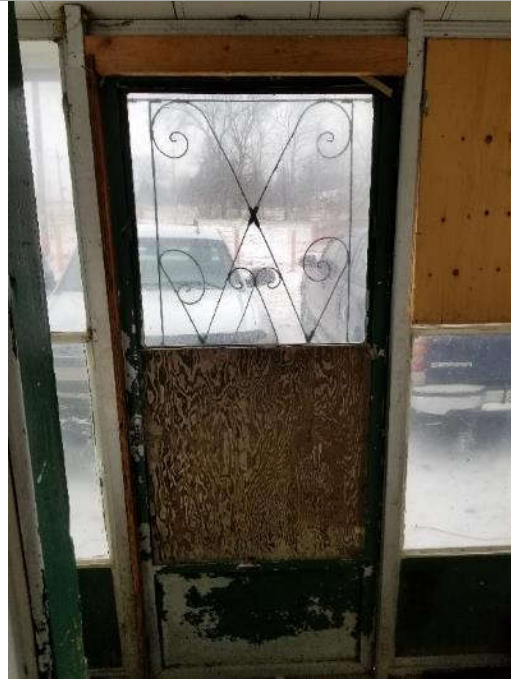
Lead Paint	P-4 (Historic Sample)	Green paint	Kitchen door. Visually similar paint on west door and exterior window frames.	12	Poor at kitchen and west doors.	Remove chipped or flaking paint and paint over damaged areas. (Moderate)	Photo 3
Lead Paint	P-6 (Historic Sample)	Brown and beige paint (two layers)	Basement	-	Good (repainted)	None	-
Lead Paint	P-7 (Historic Sample)	Turquoise/blue paint	Basement	4	Good (repainted)	None	-
Lead Paint	P-8 (Historic Sample)	White paint	Basement	-	Good	None	Photo 4
Lead Paint	P-10 (Historic Sample)	Sky blue paint	Bedroom N (Office N)	-	Good (repainted)	None	-
Lead Paint	P-12 (Historic Sample)	Beige/pink paint	Bedroom N (Office N)	-	Good (repainted)	None	-
Lead Paint	P-13 (Historic Sample)	Beige paint	Bedroom SW (Office SW)	-	Good (repainted)	None	-
Lead Paint	P-14 (Historic Sample)	Brown/dark beige paint	Bedroom SW (Office SW)	-	Good (repainted)	None	-

**Photo 3: View of the green lead-based paint on the west door frame of the subject dwelling.**

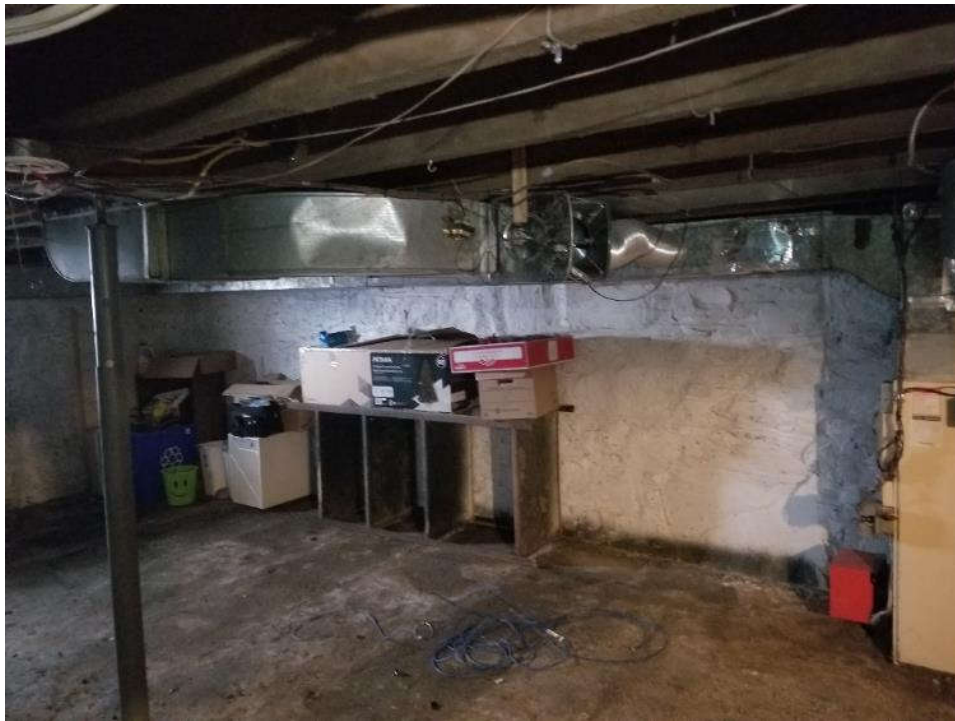
**Photo 4: View of the white lead-based paint on the wall in the basement of the subject dwelling.**

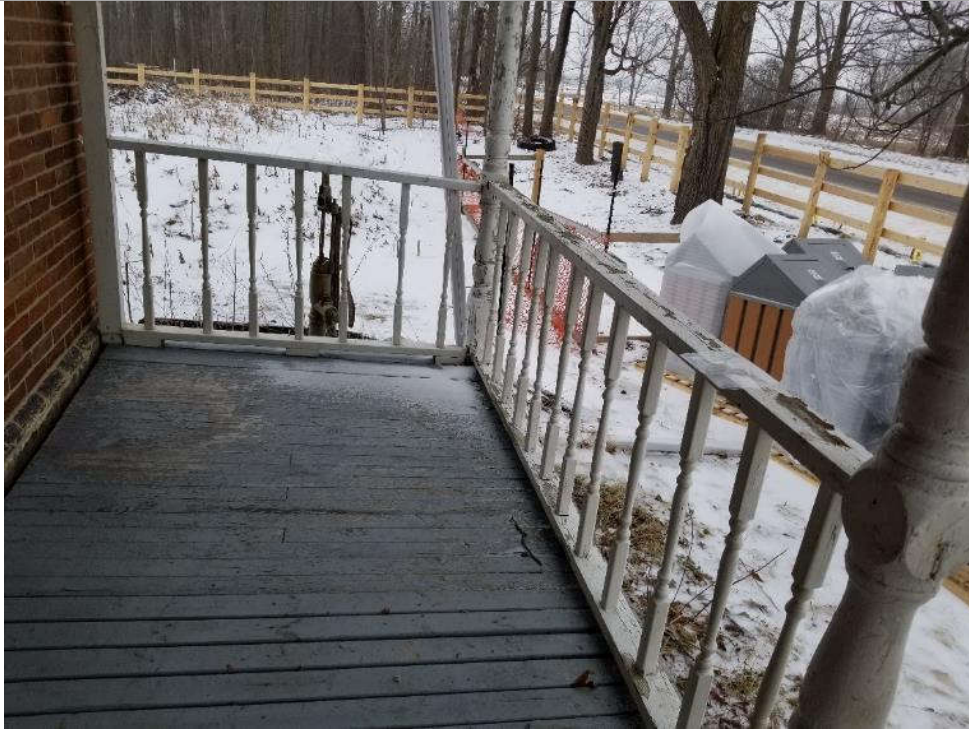
**Photo 5: View of the white lead-based paint in the porch of the subject dwelling.**

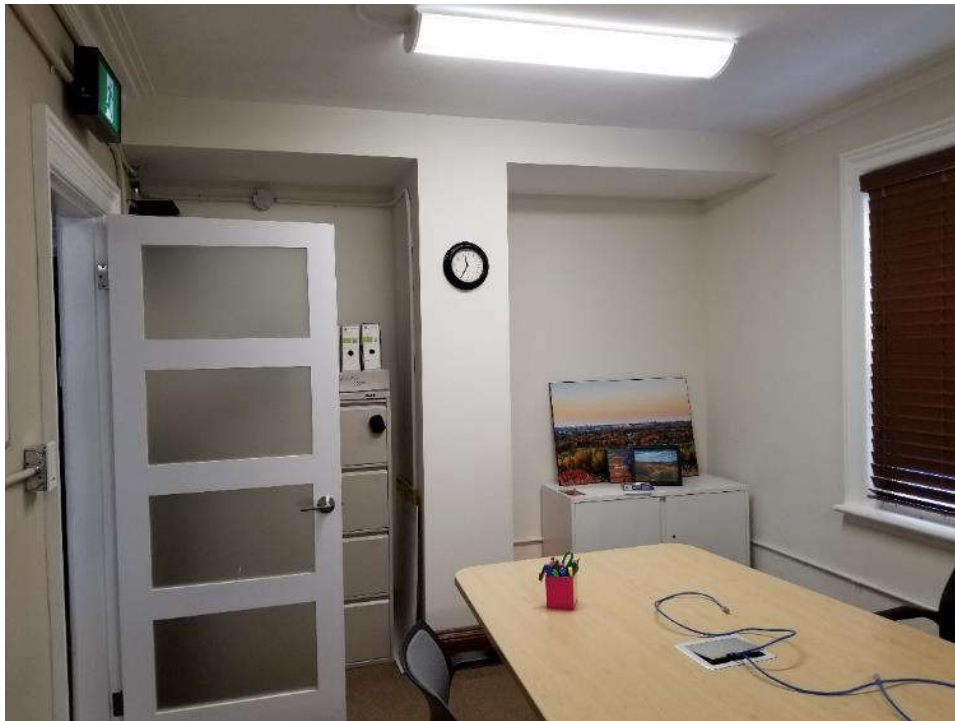
Small quantities of mercury are likely present within fluorescent lighting observed throughout in the building. Thermostats within the dwelling were digital and did not contain mercury. No samples were collected or submitted for laboratory analysis.

**Photo 6: View of suspect mercury-containing fluorescent light tubes on the ceiling throughout the subject dwelling.**

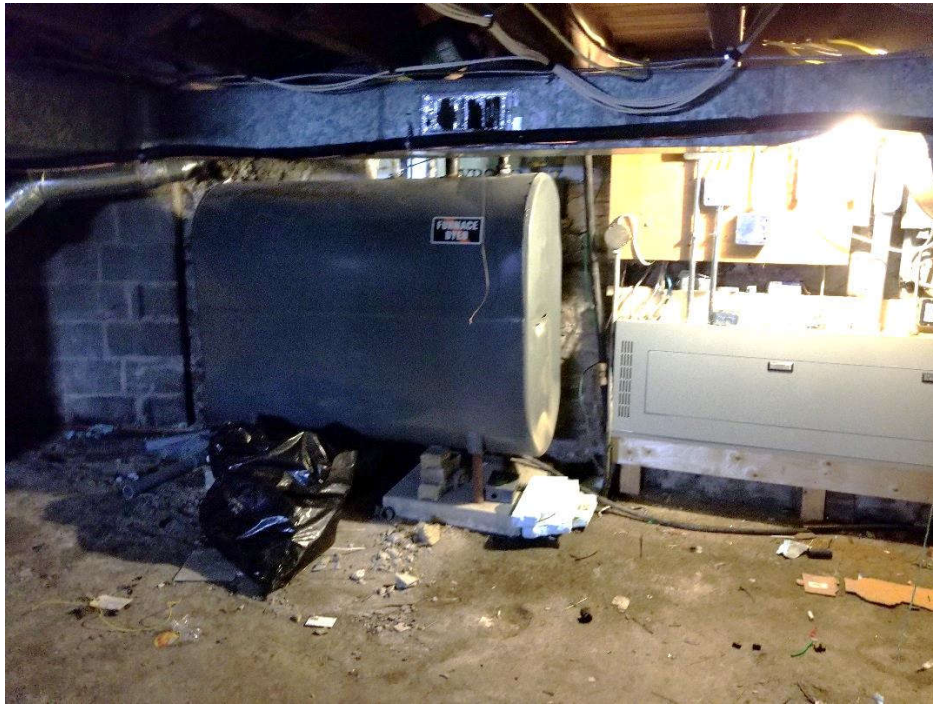
These designated substances are typically found in industrial settings and are unlikely to be located within the residential dwelling, with the exception of benzene, which is present within the furnace oil in the AST in the basement.

**Photo 7: View of the furnace oil AST located in the basement of the subject dwelling.**

Fuel oil	-	Furnace oil	Steel AST in basement	900 litres	Good	Manage any fuel oil tank and its contents in accordance with the Storage Tank Systems for Petroleum Products and Allied Petroleum Products (SOR/2008-197) requirements.	Photo 7
<p>Notes:            Urgency Level: Identified for ACMs or lead-containing paint in poor condition only. Additional information provided in Section 6.0 for each material.            (High): Immediate repairs required.            (Moderate): Repairs required.            -: Not applicable.</p>
