**Final Report: Hazardous  
Materials Survey and  
Materials Quantification –  
Bedford Institute of  
Oceanography Fish Lab  
Building, Dartmouth, Nova  
Scotia**

Prepared for:  
Environmental Services  
Public Services Procurement  
Canada  
1713 Bedford Row  
Halifax, NS B3J 3C9

Prepared by:  
Stantec Consulting Ltd.  
102-40 Highfield Park Drive  
Dartmouth, Nova Scotia B3A 0A3  
Tel: (902) 468-7777  
Fax: (902) 468-9009

June 11, 2018

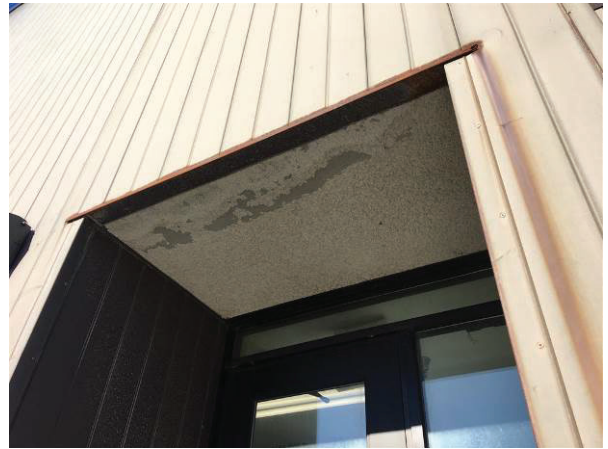
- BS034A – Friable exterior texture coat in good condition (2% Chrysotile); sampled and identified on exterior entrance ceilings over cement board.

**Photo 4: Asbestos-containing exterior texture coat (BS034A & 34B) on PACM cement board**

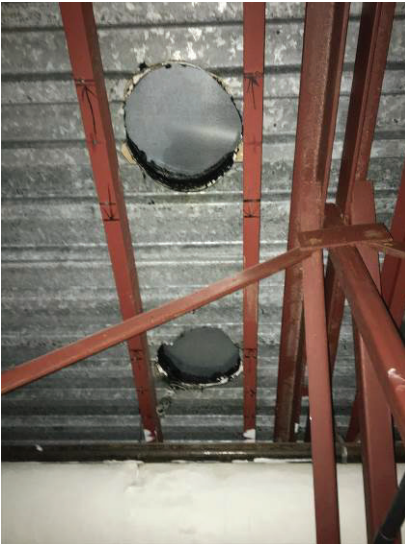
- BS004A – Non-friable sealant (brown) in good condition associated with ductwork (1.8% Chrysotile); sampled on insulated ducts;
- BS015A – Non-friable tar (black) in good condition associated with historical roof vents (3.1% Chrysotile); sampled and identified on historical roof penetrations (previous ventilation); and

**Photo 5: Asbestos-containing tar (black) associated with historical roof vents (BS015)**

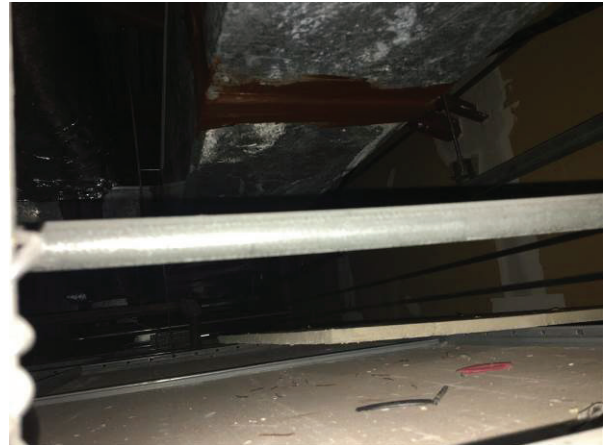
Brown sealant associated with ductwork was noted on both the insulated and un-insulated ductwork. Quantities reported below in Table 3 are an approximate linear measurement of ductwork and not the brown sealant associated with the material. For the cost estimate it was assumed that the duct work plus mastic would be removed as a system and that individual abatement of each joint was not going to be completed. For the tar (black) associated with historical roof penetrations it was assumed that this material may be present across the entire roof as part of the vapour barrier and remains beneath the new roofing materials. For the purpose of the estimate we have assumed the worst case that this tar was associated with the vapour barrier and covers the entire roof under the new roofing materials, but may in fact only be associated with an area directly associated with the roof penetrations.

**Photo 6: Asbestos-containing sealant (brown) associated with ductwork (BS004A)**

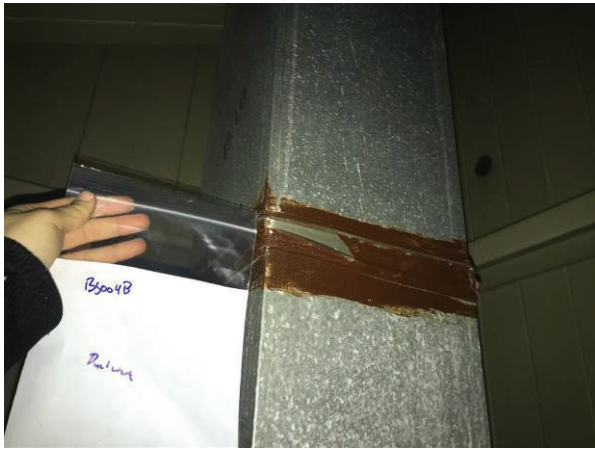
**Photo 7: Asbestos-containing sealant (brown) associated with ductwork (BS004B)**

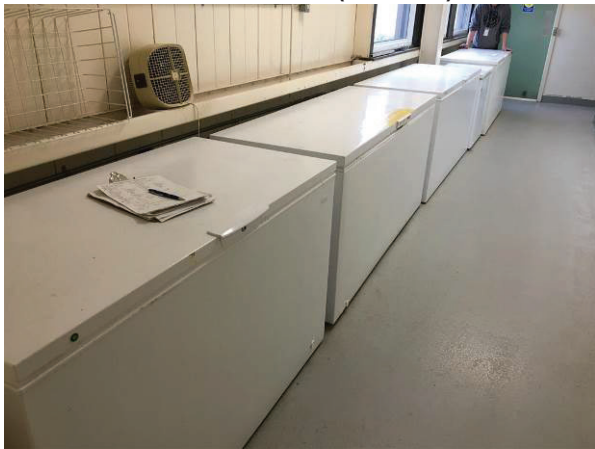
During our March 2018 assessment, Stantec noted approximately 40 refrigerant containing sources. Each source had “Ozone Depleting Substance MAR” tags with an identification number. Sources included fridges, freezers, condensing units, evaporation units, and dehumidifiers. During this site visit no sources were found to contain the refrigerant R-12, however some units were inaccessible at the time of the assessment.

**Photo 9: View of typical refrigeration equipment**

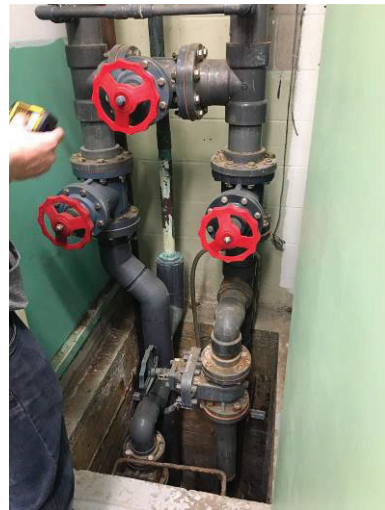
**Photo 10: PACM Gasket material**

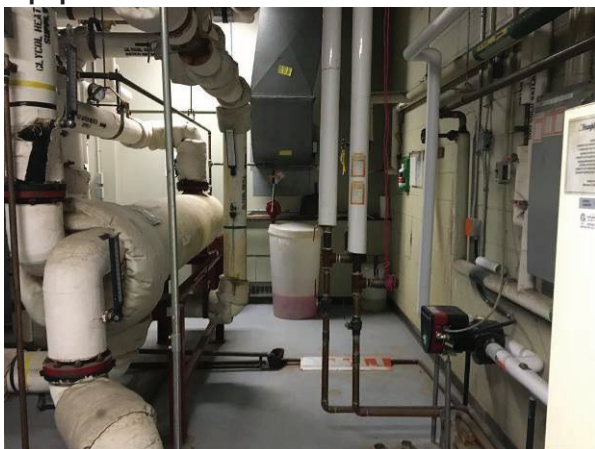
**Photo 11: Mechanical equipment with PACM gaskets and asbestos-containing sealant associated with ductwork**

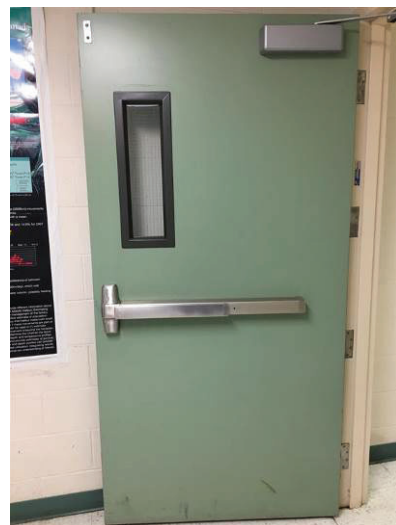
**Photo 12: PACM Fire Door**

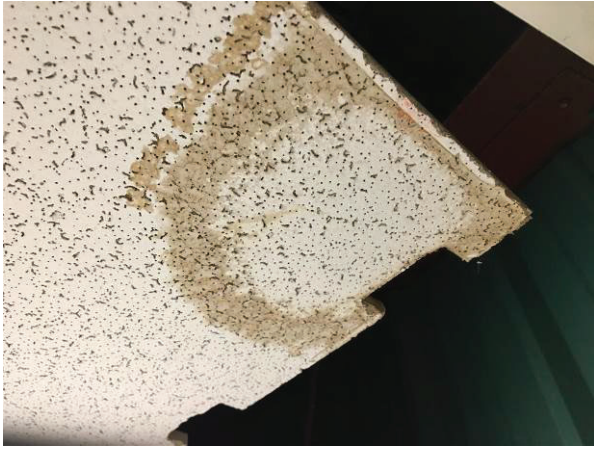
**Photo 13: Water damage on acoustic ceiling tile – typical example**

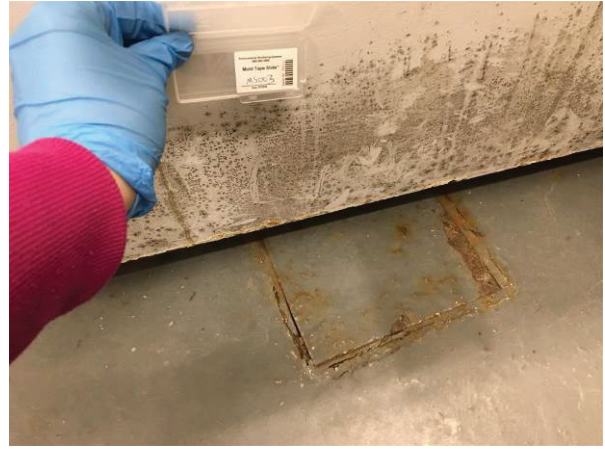
**Photo 14: Deep freeze exterior in FLG-47 (MS003)**

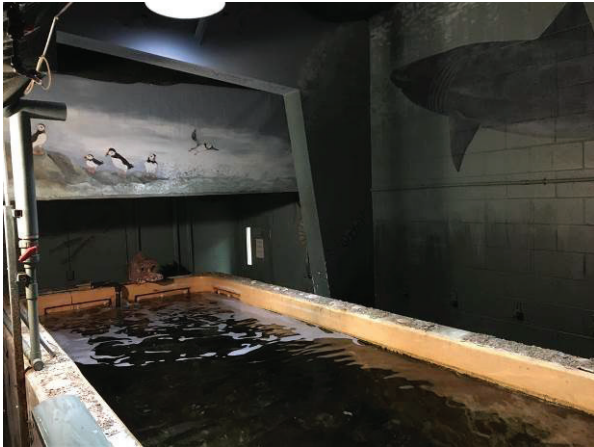
**Photo 15: View of drywall beam in FLG-39 (MS004)**

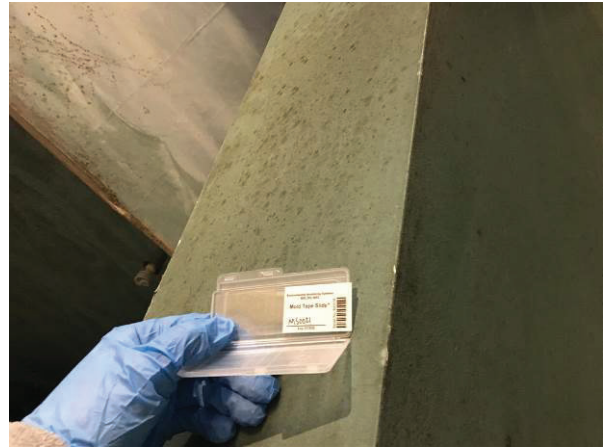
**Photo 16: Drywall beam in FLG-39 (MS004)**

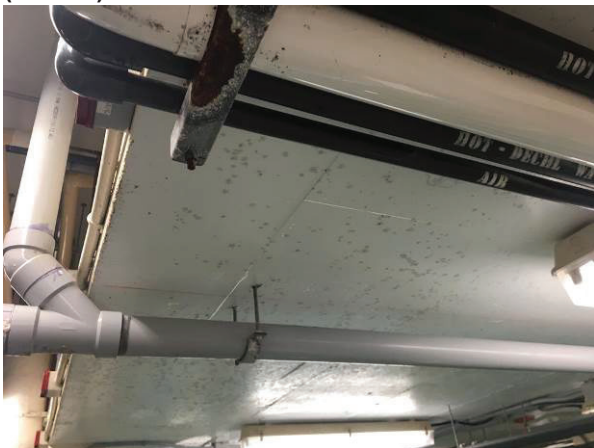
**Photo 17: Concrete ceiling in FLG-33 (MS007)**

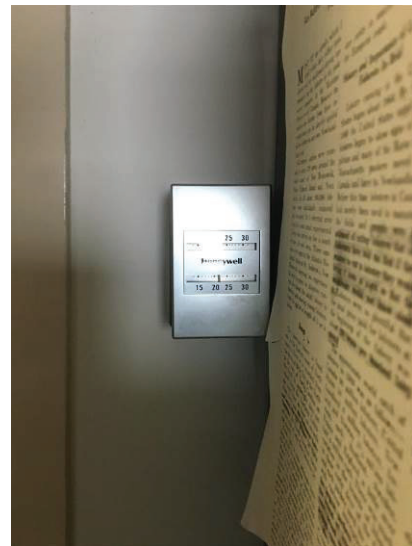
Approximately 60 thermostats and thermometers were noted throughout the building that potentially contained mercury. Thermometers were associated with mechanical equipment while thermostats were in occupied rooms.

**Photo 18: Potential mercury-containing Thermostat**
