## Designated Substances Reports

Project #: NL7689

**HAZARDOUS MATERIALS ASSESSMENT**  
**Building 11**  
**308 Brookfield Road**  
**St. John's, NL**

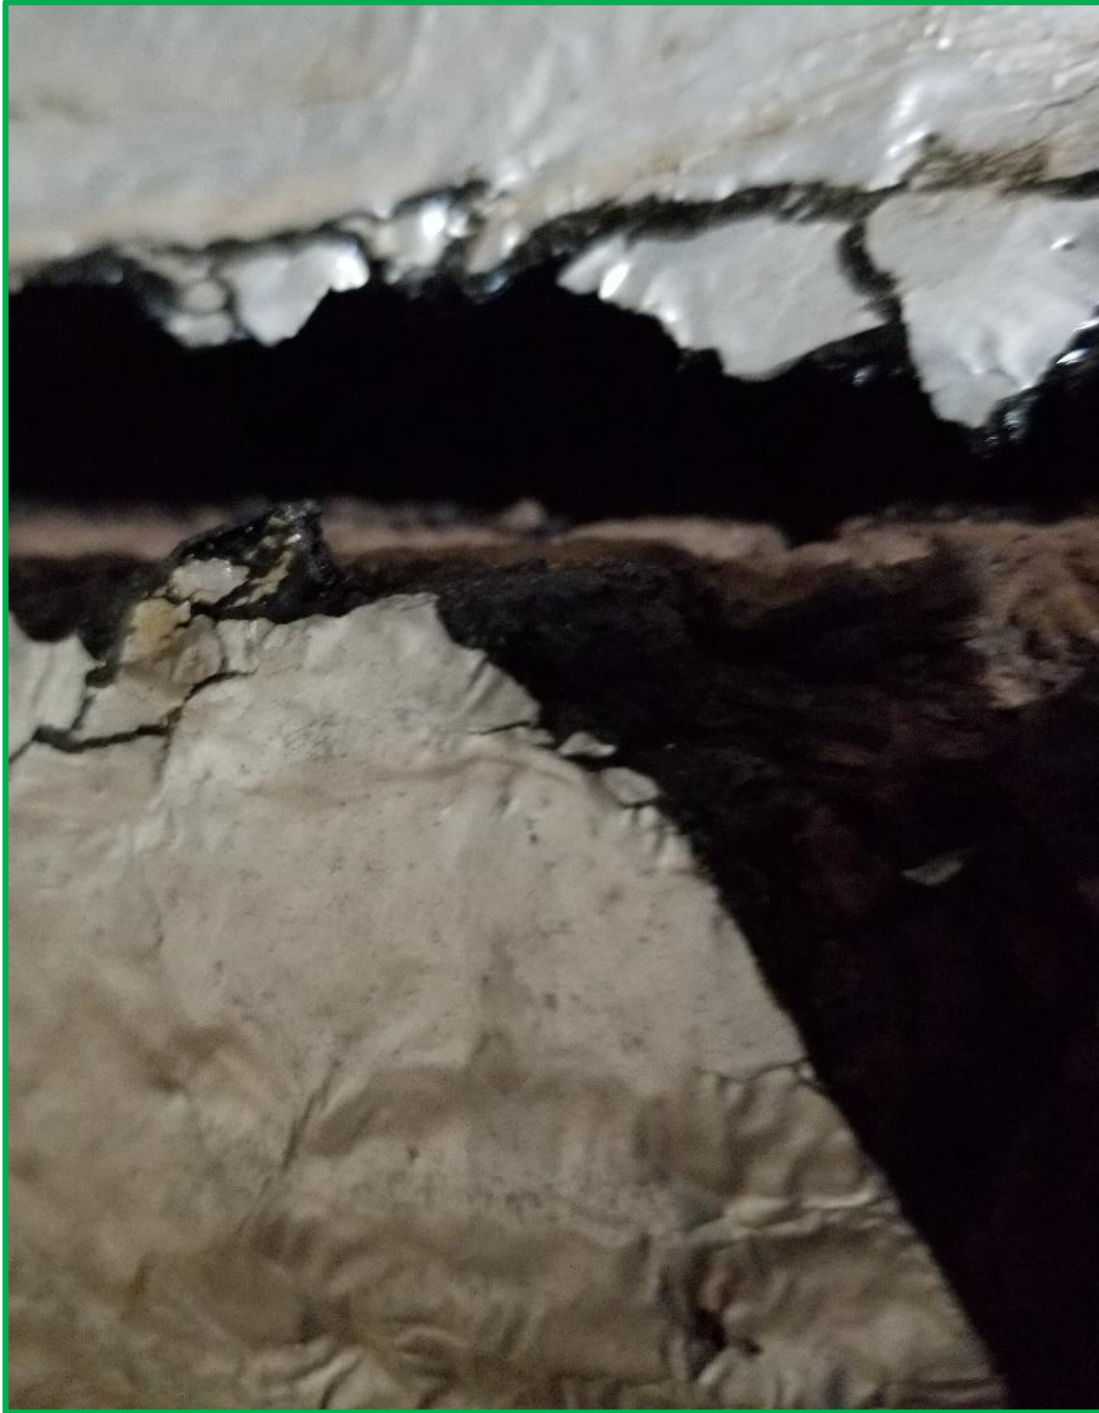
Straight-run pipe insulation material was not observed throughout the building. A total of one (1) suspect asbestos-containing pipe insulation material sample was collected and analyzed for asbestos content using the PLM detection method. Analysis of the material determined that the sample analyzed did not contain asbestos (See sample NL7689-A06 in Appendix I-Laboratory Asbestos Results).

**Photograph #1:** Sample NL7689-A06 sample location. Insulation panel within the Basement Cellar. Photo taken on November 16, 2020.

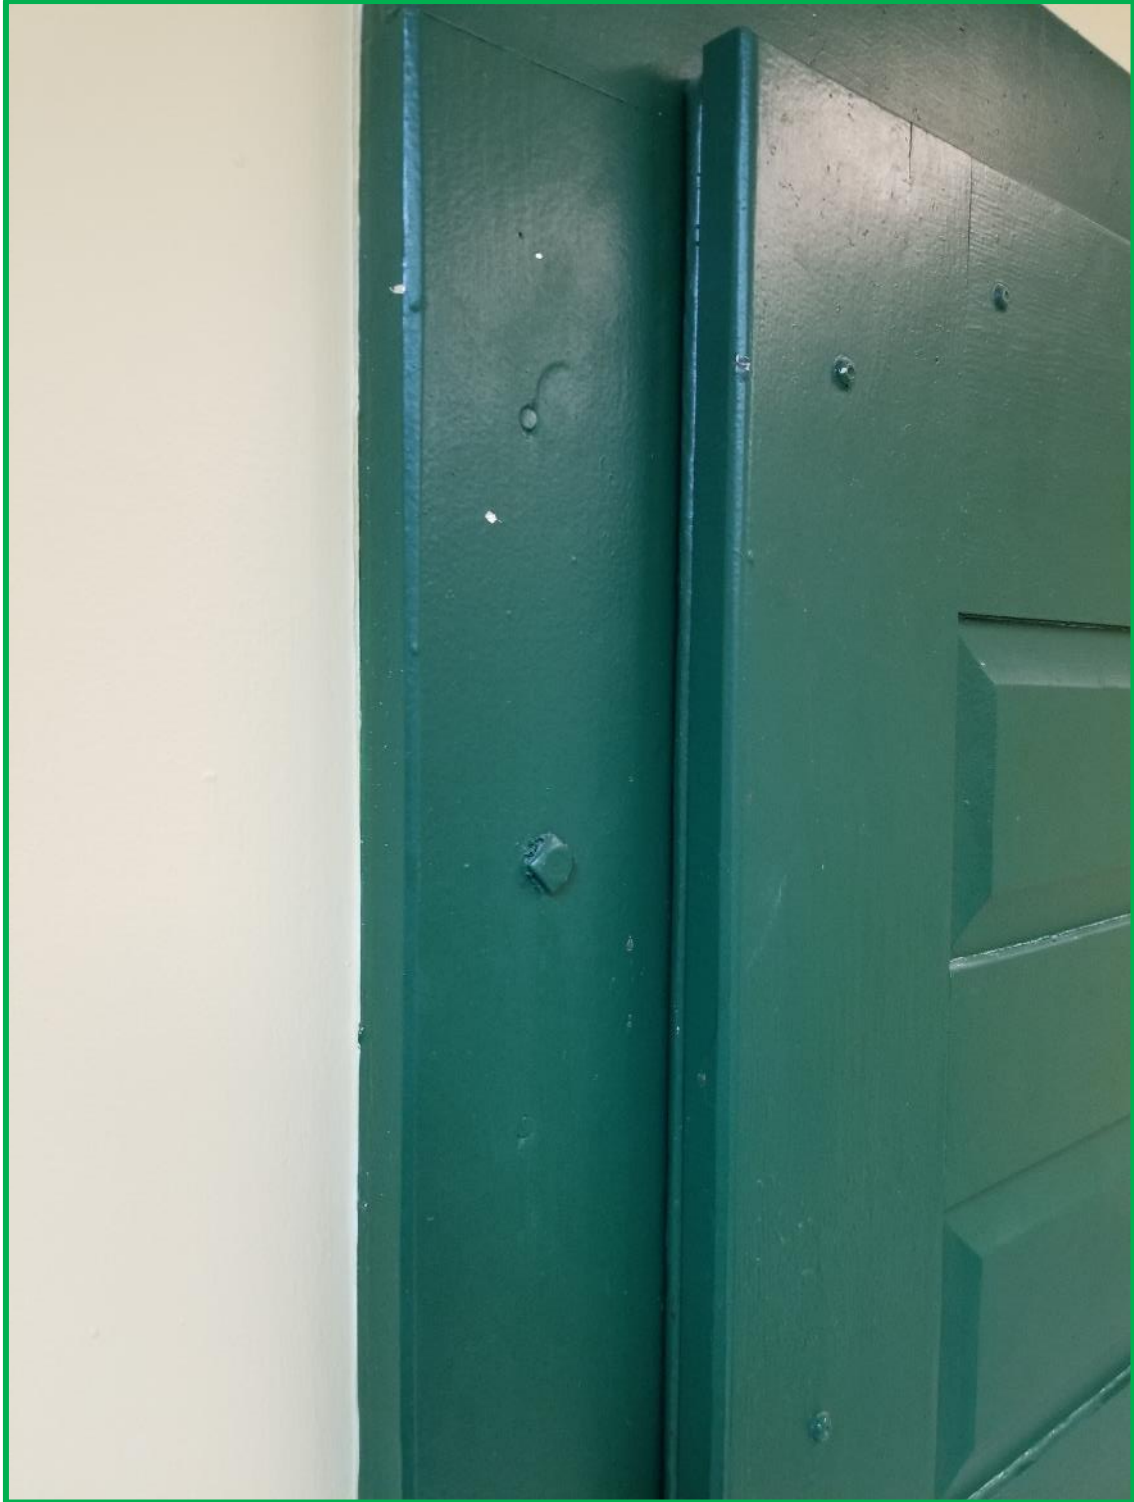
Sample No.	Sample Description	Location	Lead Content (%wt)	Photograph
NL7689-L03	Green Paint	Cellar Door, Basement	0.4100	Photograph #2
NL7689-L04	Grey Paint	Boiler Room, Basement	0.2300	Photograph #3
NL7689-L05	White Ceiling Paint	Boiler Room, Basement	<0.0081	---
NL7689-L06	Grey Foundation Paint	Building Exterior	0.092	Photograph #4
NL7689-L07	White Paint (Beneath Siding)	Building Exterior	5.700	Photograph #5

**Photograph #2:** Sample NL7689-L03 sample location. Green paint on Basement Cellar door. Photo taken on November 16, 2020.

- Due to the confirmed presence of lead containing paint, all lead containing material in the structure must be removed prior to demolition/renovations in areas where lead paint is present.
  - An external contractor is recommended.
  - The lead containing paint to be removed is located on various locations within the building.
    - i. Areas where paint is to be removed are to be enclosed, be provided with HEPA negative air filtration, and have worker decontamination chambers present, where applicable.
    - ii. All workers inside the enclosure are required to wear tight fitting respirators equipped with HEPA filters while removing the material.
    - iii. ***All material is to be disposed of as lead contaminated waste unless further lead leachate testing proves that the leachable lead level is below the provincial guidelines of 5 mg/L.***

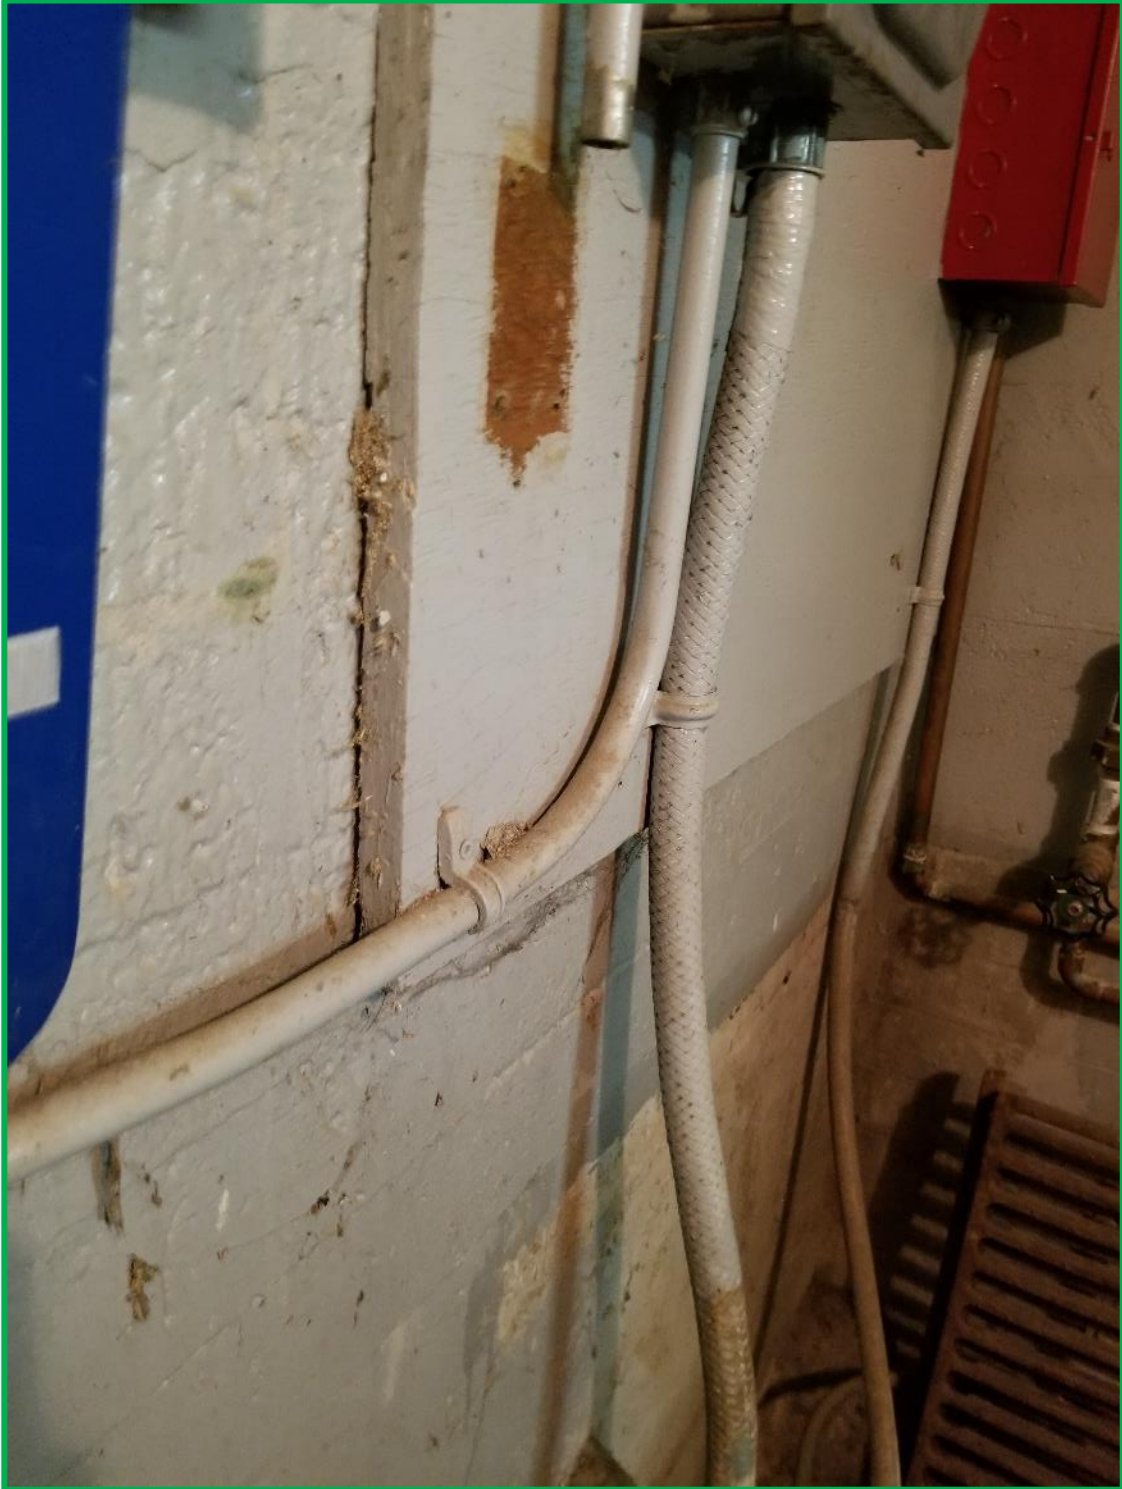
**Photograph #3:** Sample NL7689-L04 sample location. Grey paint within Boiler Room, Basement. Photo taken on November 16, 2020.

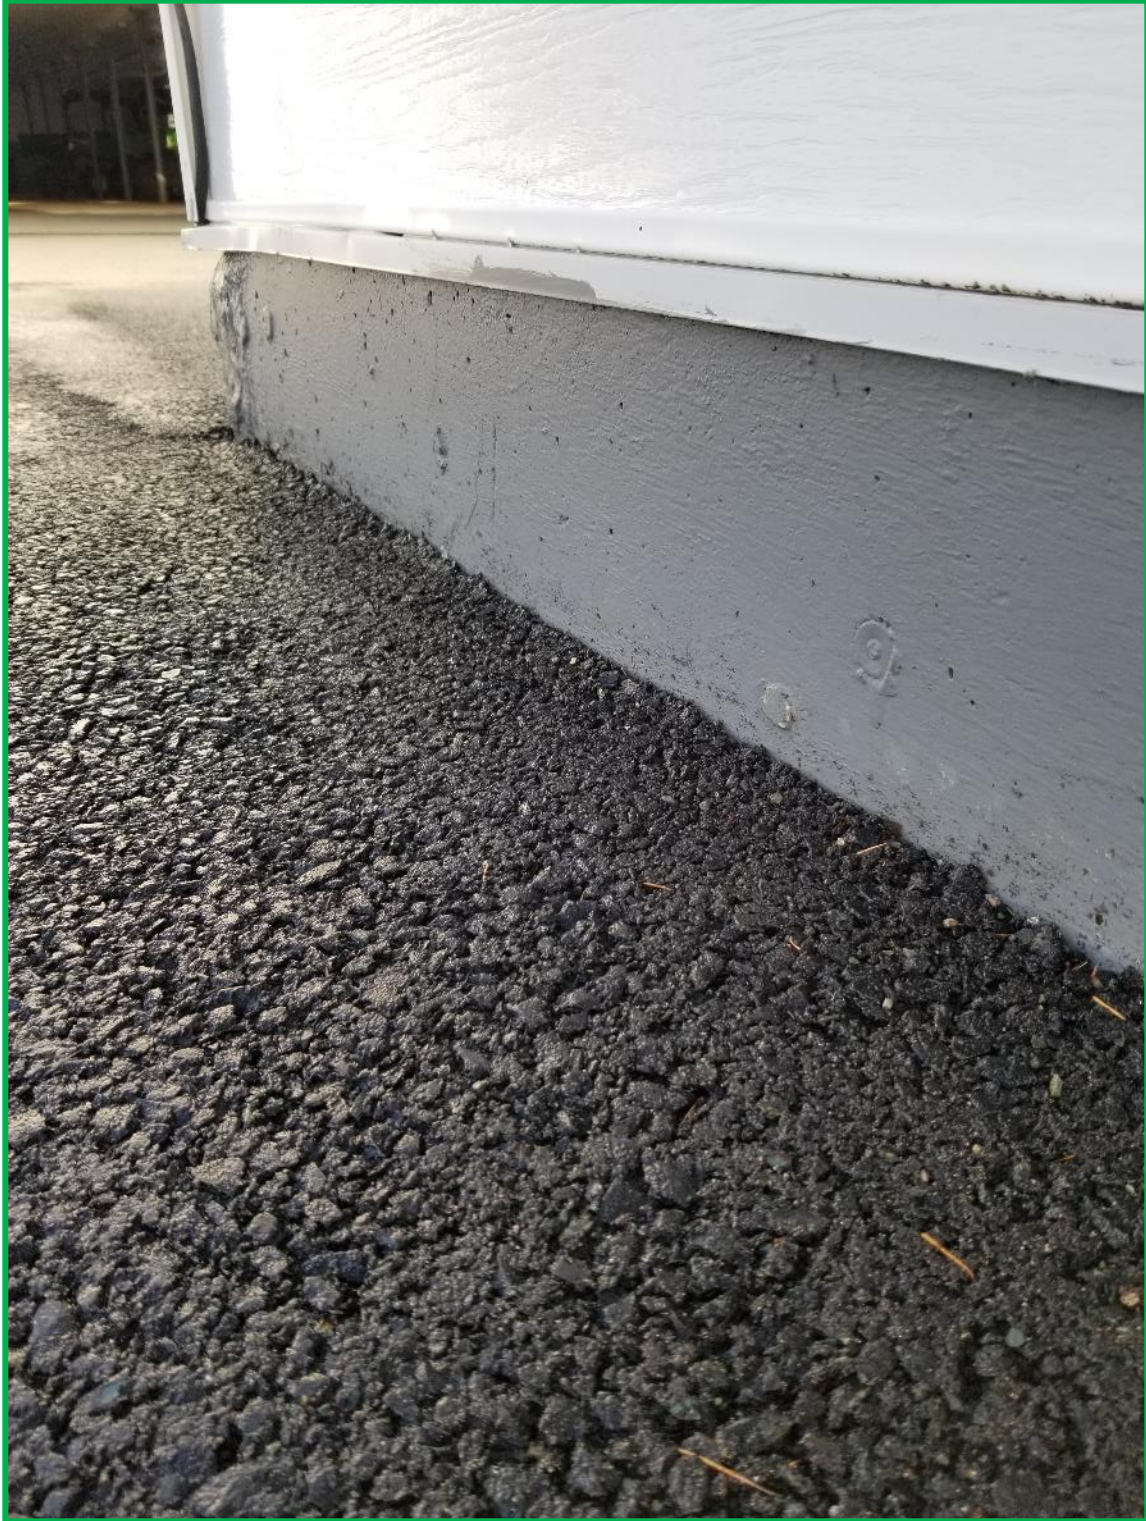
**Photograph #4:** Sample NL7689-L06 sample location. Grey paint on building foundation. Photo taken on November 16, 2020.

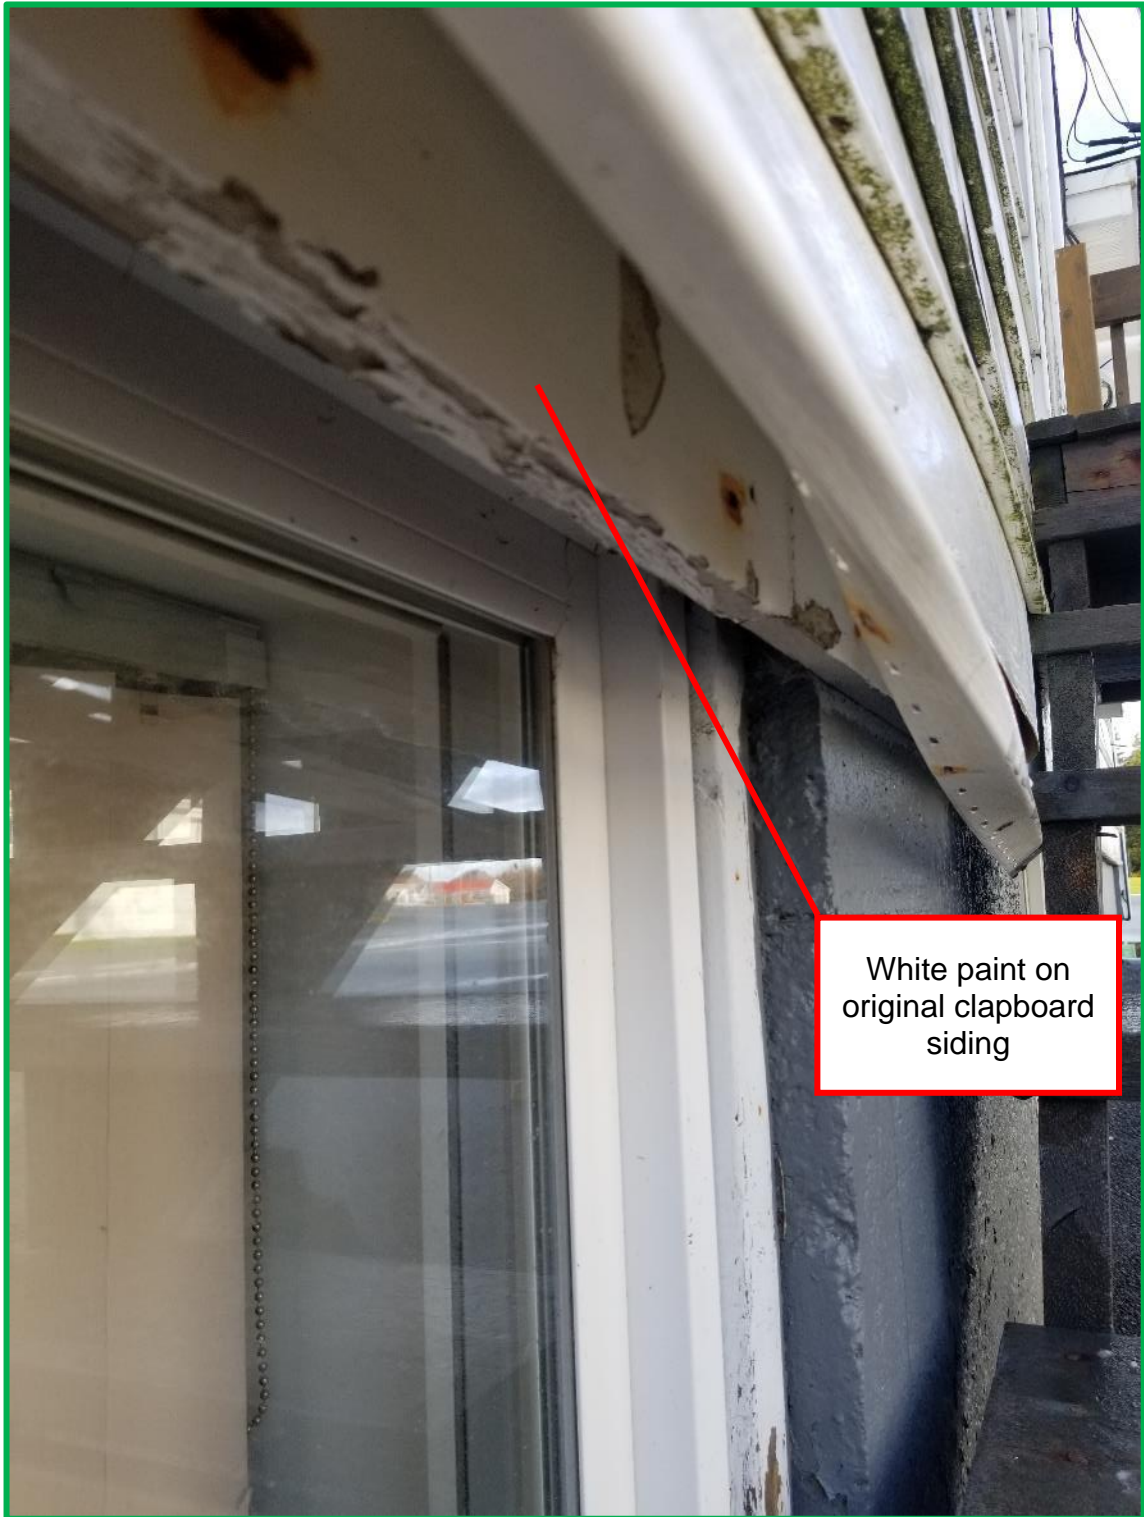
**Photograph #5:** Sample NL7689-L07 sample location. White paint on original clapboard siding (beneath existing vinyl siding). Photo taken on November 16, 2020.

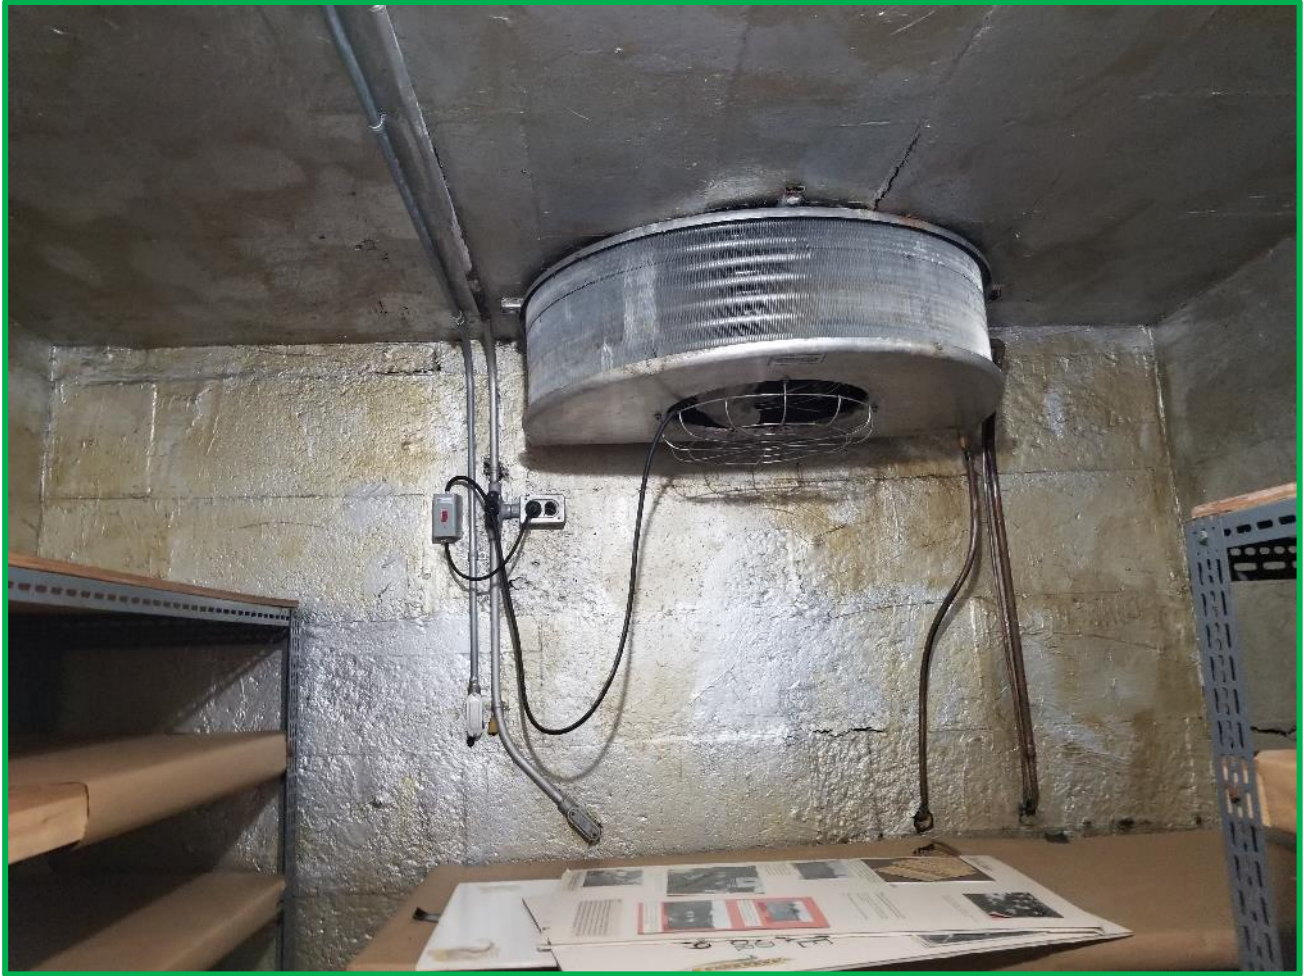
One (1) cooler unit within the Basement Cellar was observed to potentially contain ODS at the time of the assessment (Please see Photograph #6 in Appendix V – Photographs of Potential ODS Equipment).

**Photograph #6:** Example of cooler unit potentially containing ODS within the Basement Cellar. Photo taken on November 16, 2020.

Any units that may potentially contain ODS should be inspected on a regular basis to ensure that the unit remains sealed and in good condition. Prior to disposal, all units containing ODS must be drained by a certified technician and disposed of in accordance with applicable regulatory guidelines

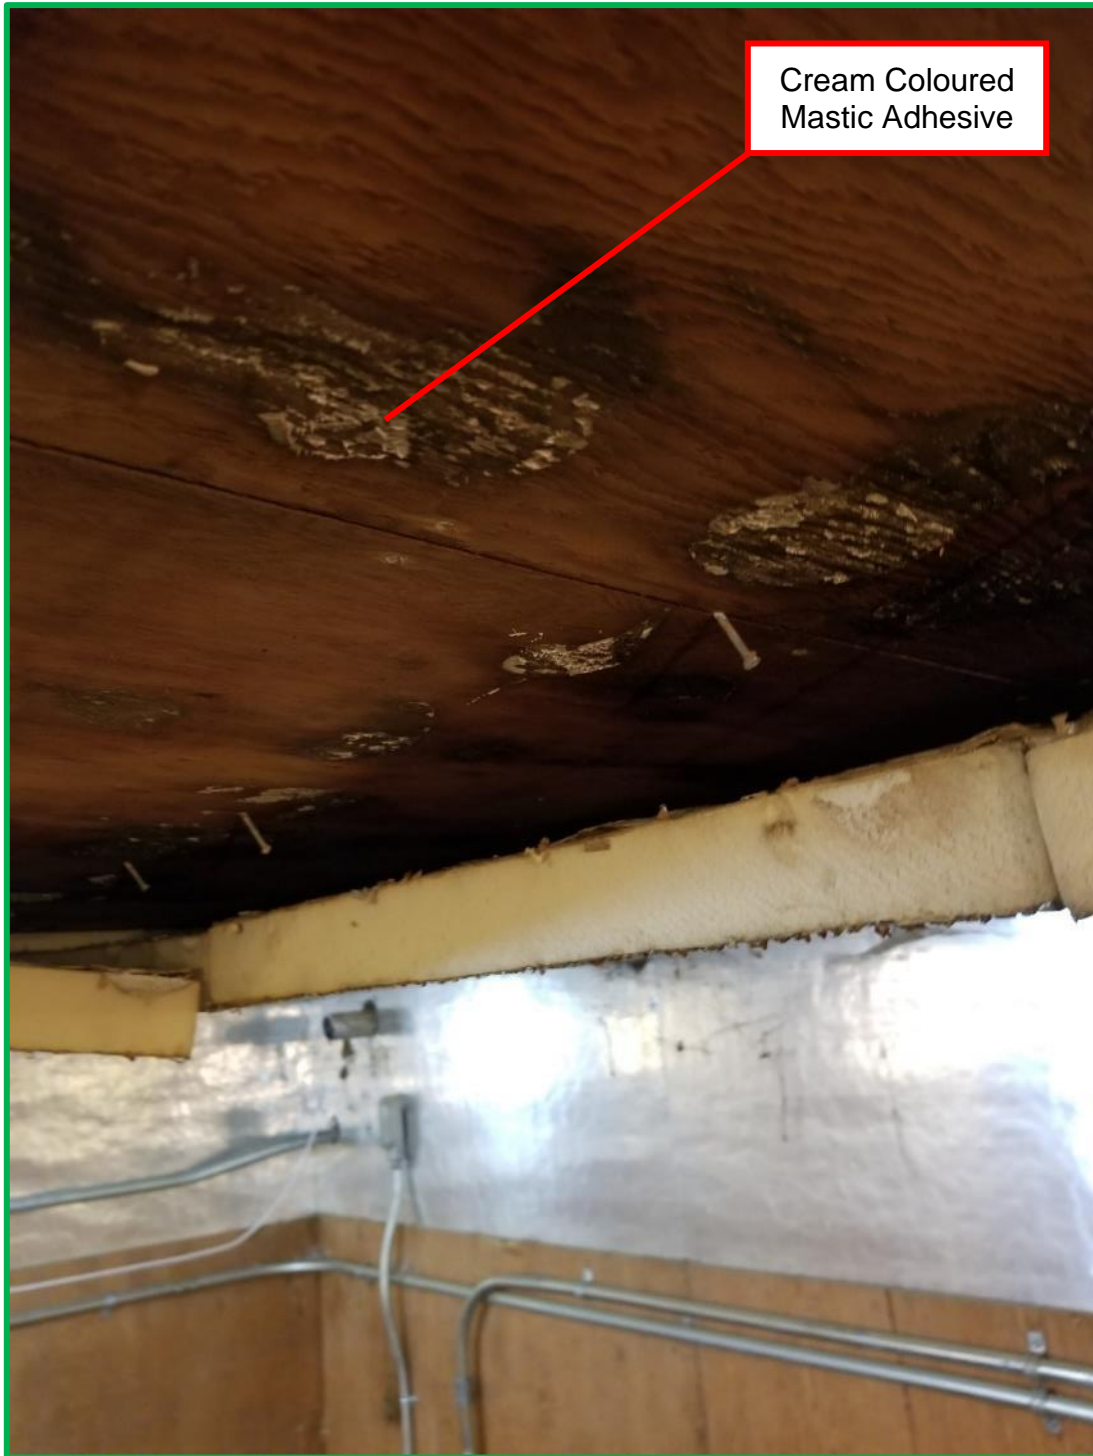
**Photograph #1:** Sample NL7687-A04 sample location. Cream coloured insulation panel adhesive. Photo taken on November 16, 2020.

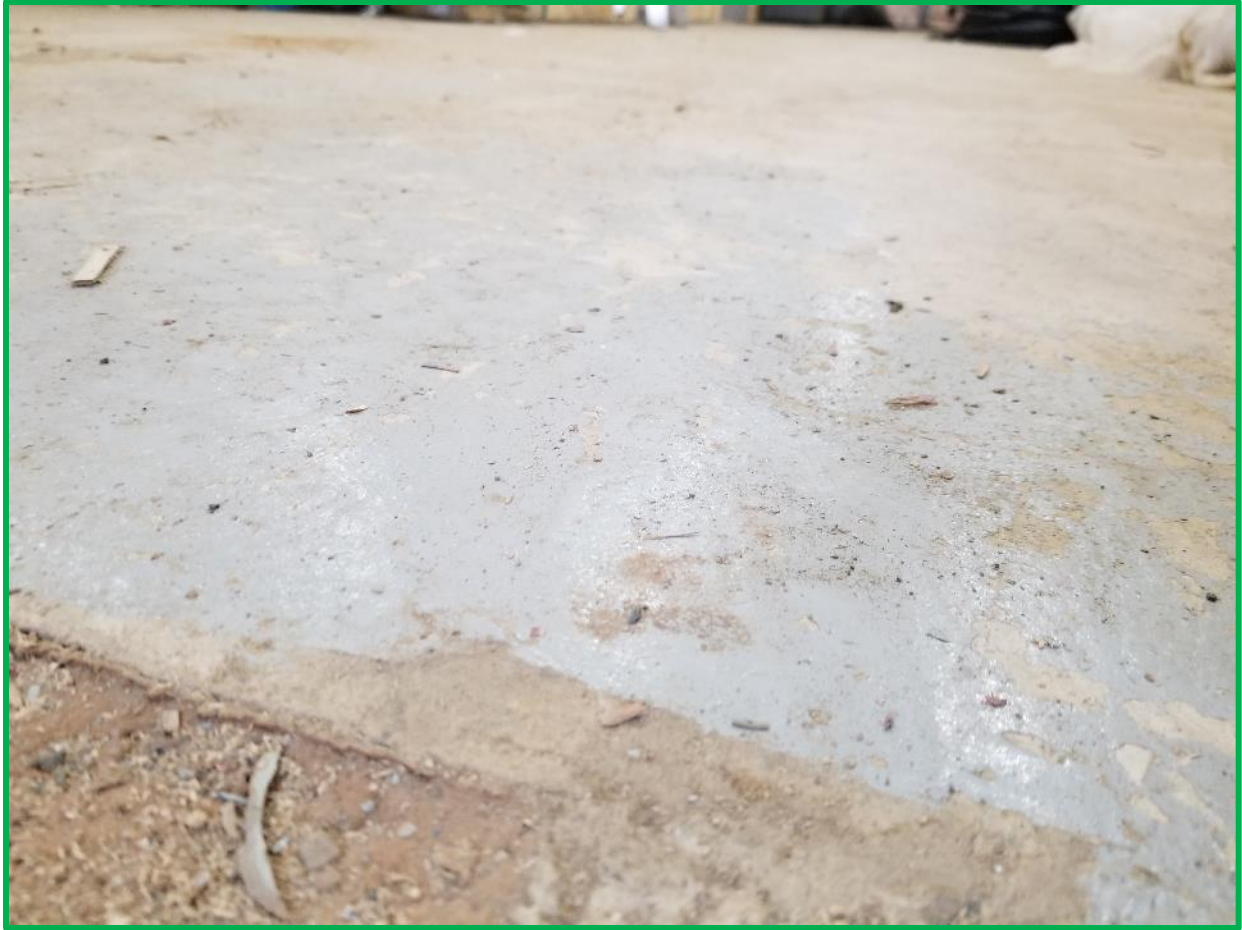
**Photograph #2:** Sample NL7687-L02 sample location. Grey foundation paint.  
Photo taken on November 16, 2020.

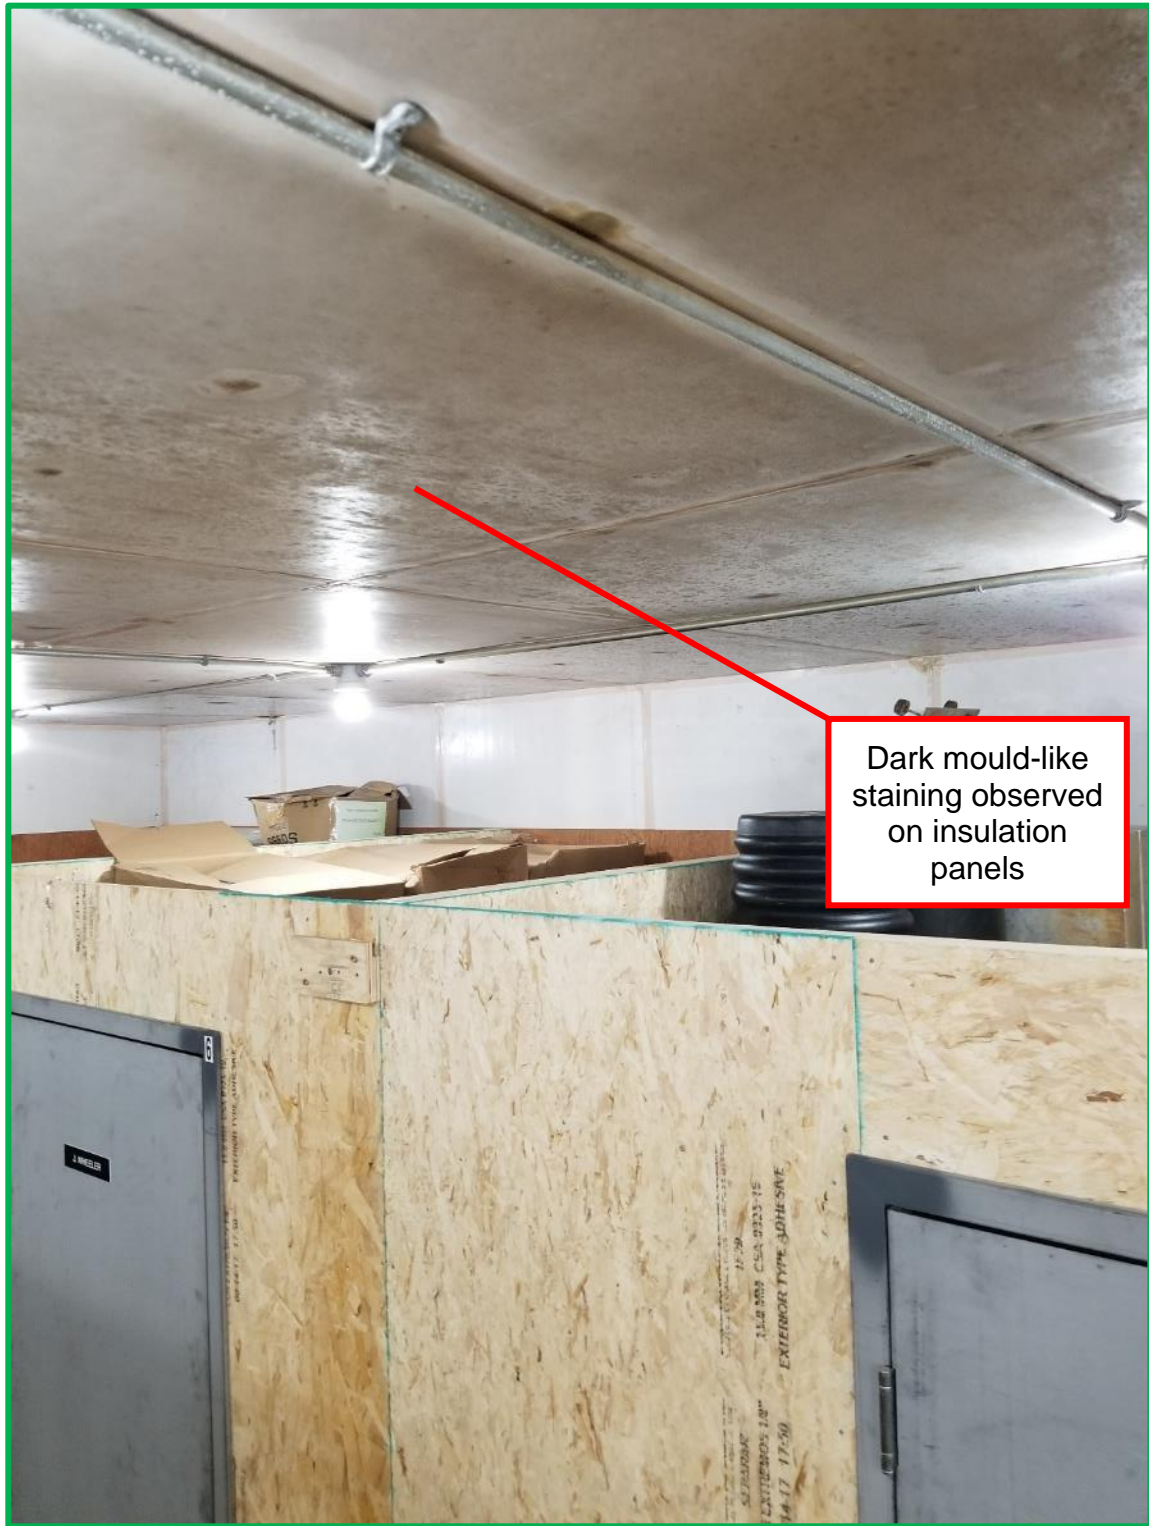
Dark mould-like staining observed on insulation panels

**Photograph #3:** Dark mould-like staining observed on the insulation panels within the Main Cooler/Storage Area on the Main Floor of the Building.  
Photo taken on November 16, 2020.
