## **Hazardous Building Materials Assessment**

Parts of Millhaven Institution  
5775 Bath Road, Bath, Ontario

February 18, 2020

Pinchin File: 269554

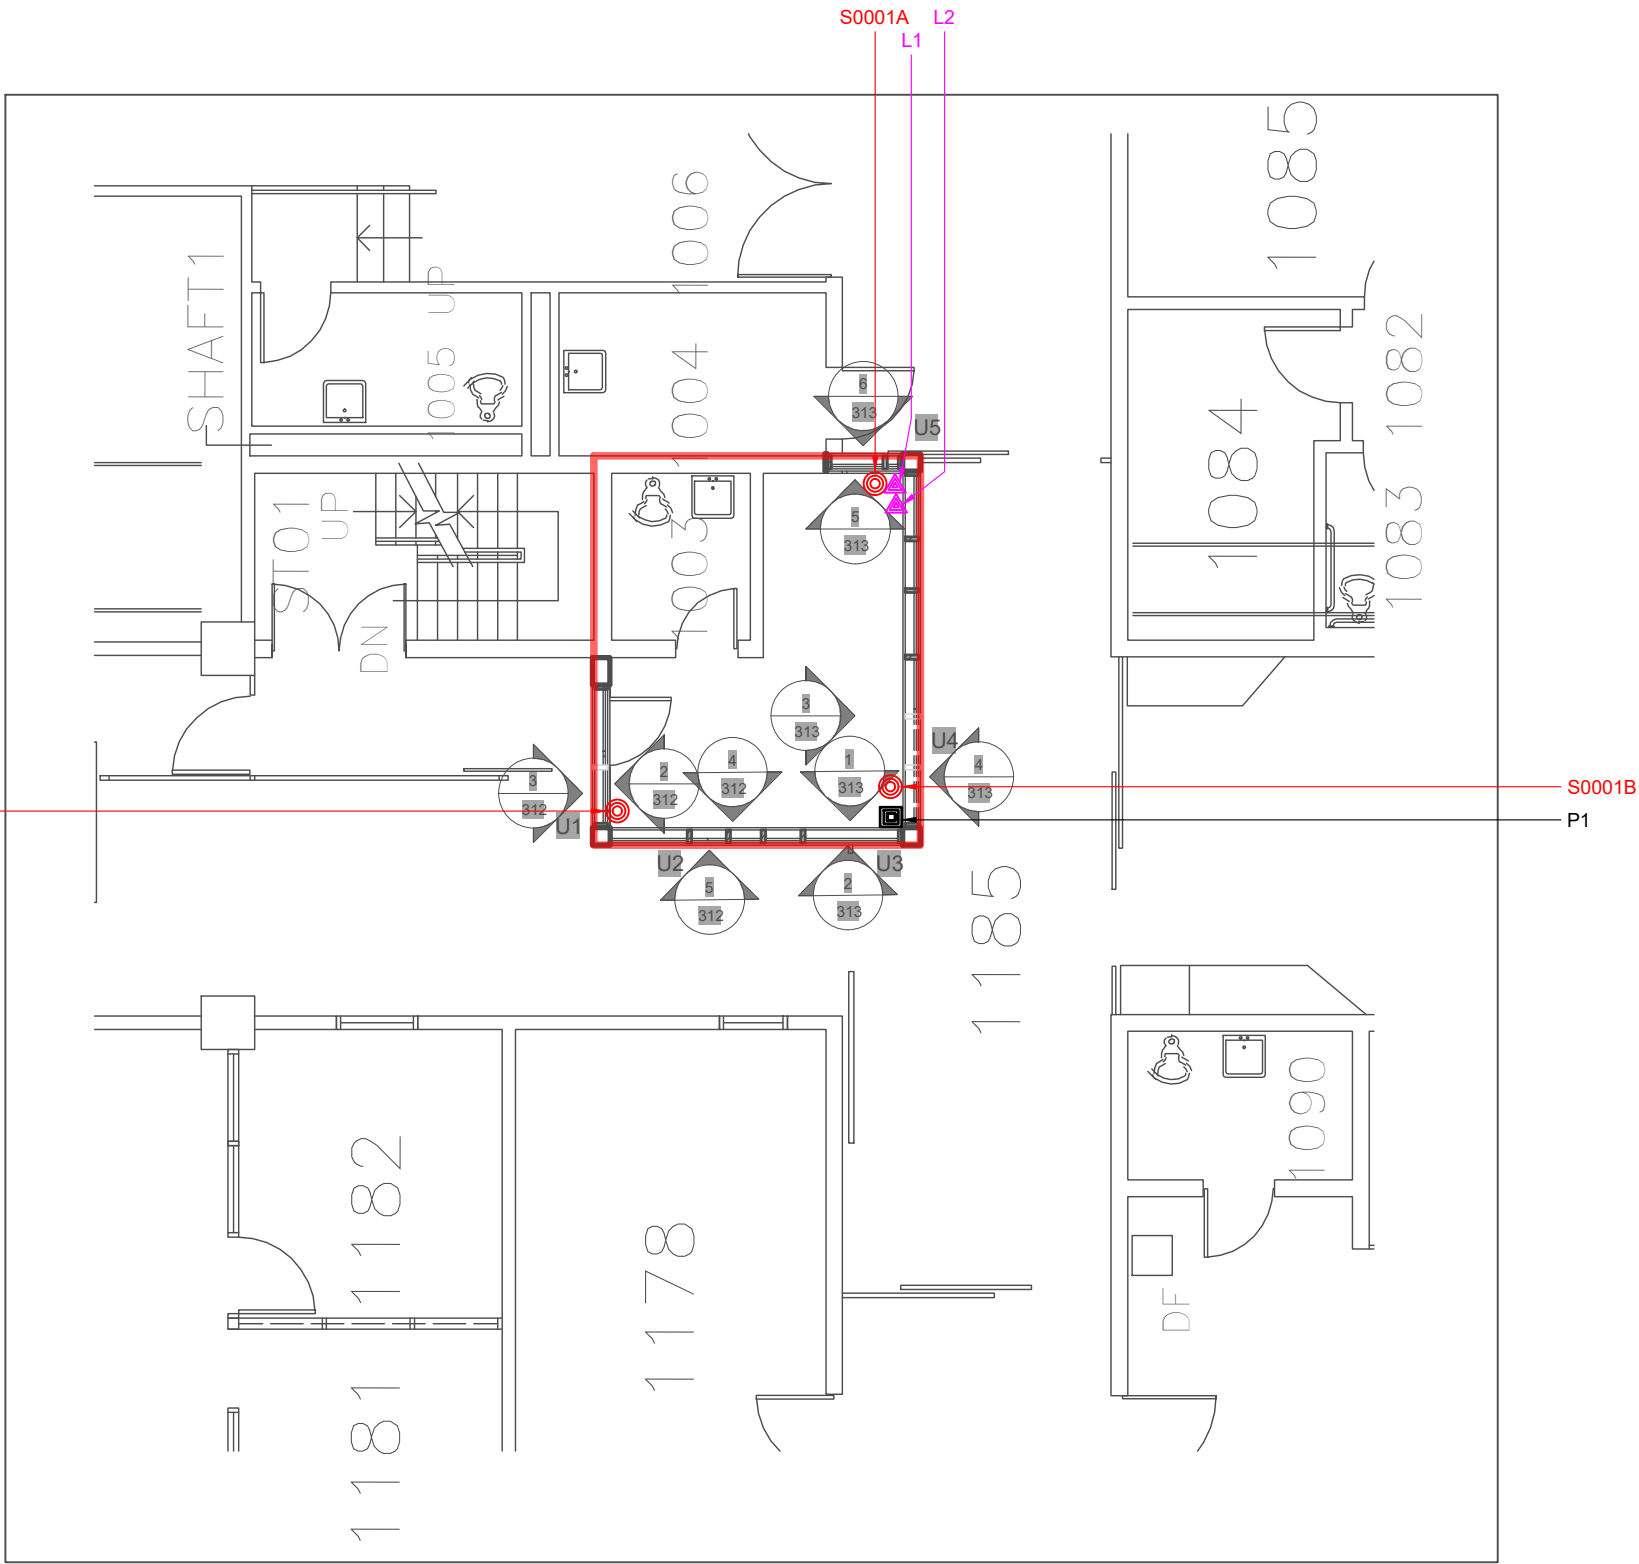
FIGURE NAME:  
U CONTROL

Sample Number	Colour, Substrate Description	Location (Location #)	Lead (%)
L1	Black on metal bars	Exterior of U control windows (location 1)	0.433
L2	Red on metal window frames	Interior window frames, U control (location 1)	0.540
L3	Grey on metal bars and metal window frames	Interior and exterior of S control (location 2)	0.241
L4	Black on metal bars and metal window frames	Interior and exterior of N control (location 3)	0.200
L5	Black and blue on metal bars and metal window frames	Exterior of A control (location 4)	0.0049
L6	Red on metal window frames	Interior of A control (location 4)	0.0636
L7	Blue on metal bars and metal window frames	Exterior of J control (location 5)	0.0030
L8	Red on metal window frames	Interior of J control (location 5)	0.0433
L9	Blue on metal window frames	Interior of E control (location 6)	0.0301
L10	Blue on metal bars and metal window frames	Exterior of E control (location 6)	0.0655

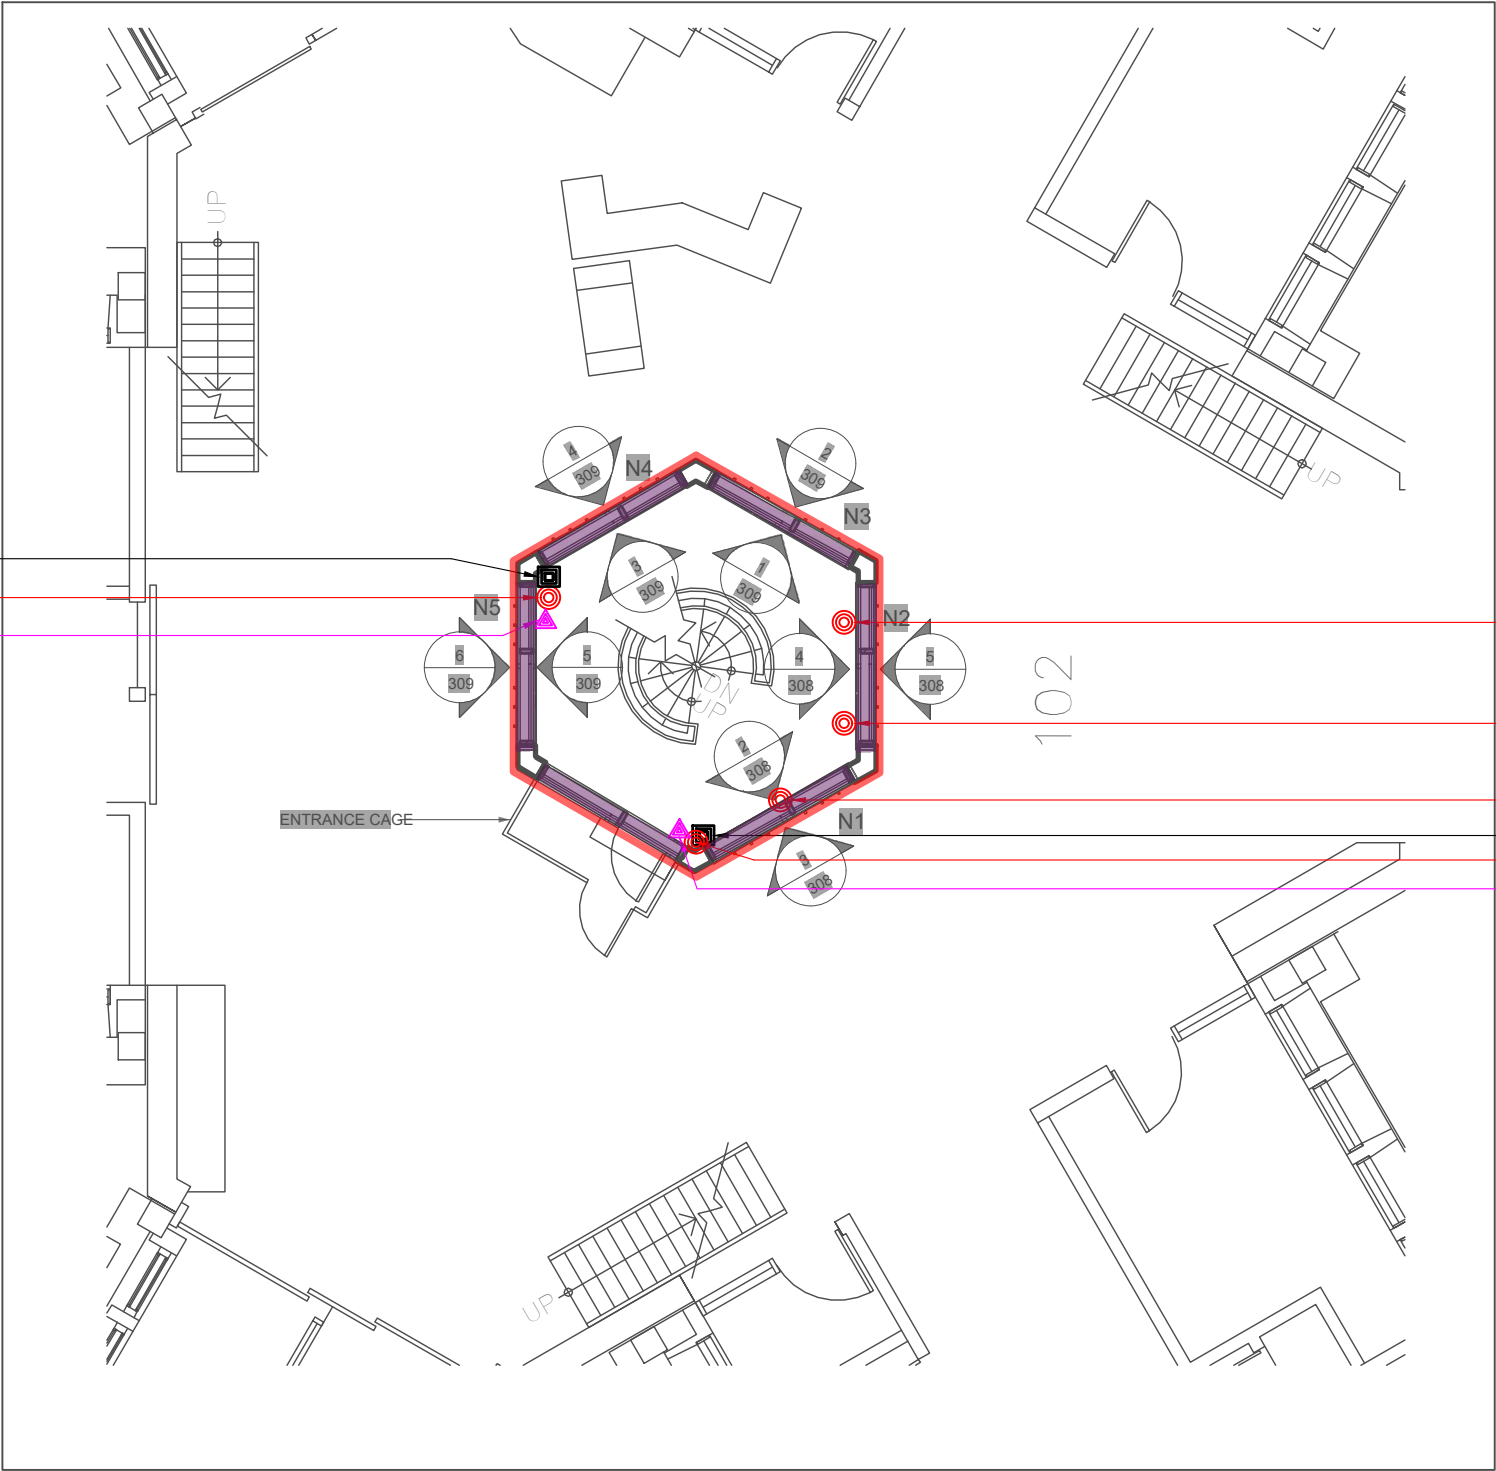
N CONTROL

- PCBs are presumed to be present in light ballasts; and
- Black butyl sealant present at window frames in N control are considered PCB solids, butyl sealants are in good condition.

Material and Colour	Location (location #)	Quantity	Sample Number	PCB concentration (ppm)
<b>Butyl sealant, black</b>	<b>Windows between glass and frame, N control (location 3)</b>	<b>50 LF</b>	<b>P4</b>	<b>67.6</b>
Caulking, black	On metal window frames, N control (location 3)	-	P5	<38.5
Butyl sealant, black	Windows between glass and frame, A control (location 4)	-	P6	<5.00
Caulking, hard black	On metal window frames, J control (location 5)	-	P7	<9.43
Butyl sealant, black	Windows between glass and frame, J control (location 5)	-	P8	<5.00
Butyl sealant, black	Windows between glass and frame, E control (location 6)	-	P9	<5.00
Caulking, hard black	On metal window frames, E control (location 7)	-	P10	<7.04

Caulking highlighted in the table above is considered a PCB solid based on the regulatory threshold (50 ppm).

Remove PCB caulking prior to building demolition or if affected by the renovation work. PCB caulking is a hazardous waste; package and ship for destruction at a federally permitted facility.

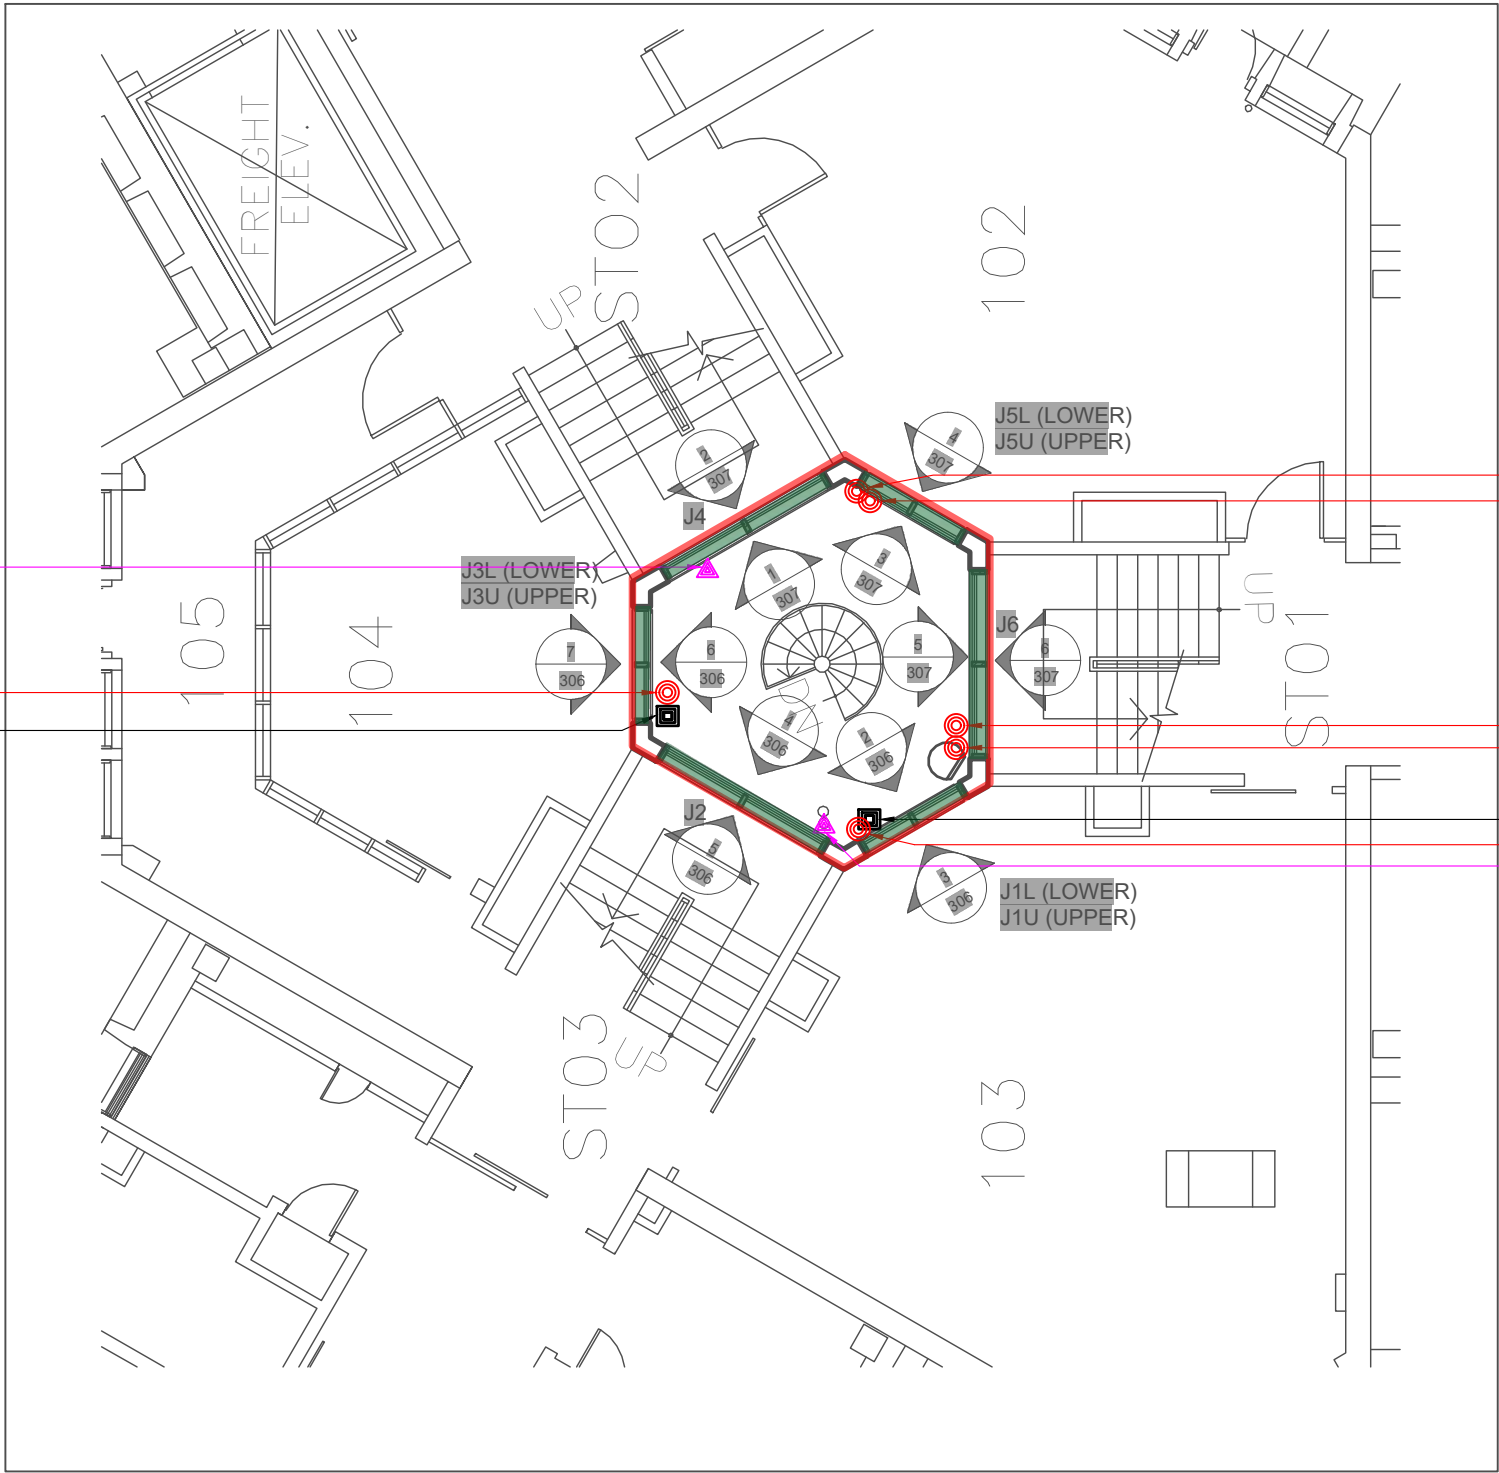
J CONTROL

- Non-friable hard black caulking, containing chrysotile asbestos, is present on metal window frames in J control (location 5). Caulking is in good condition; and
- Non-friable hard black caulking, containing chrysotile asbestos, is present on metal window frames in E control (location 6). Caulking is in good condition.

Remove asbestos-containing materials (ACM) prior to renovation, alteration, or maintenance if ACM may be disturbed by the work.

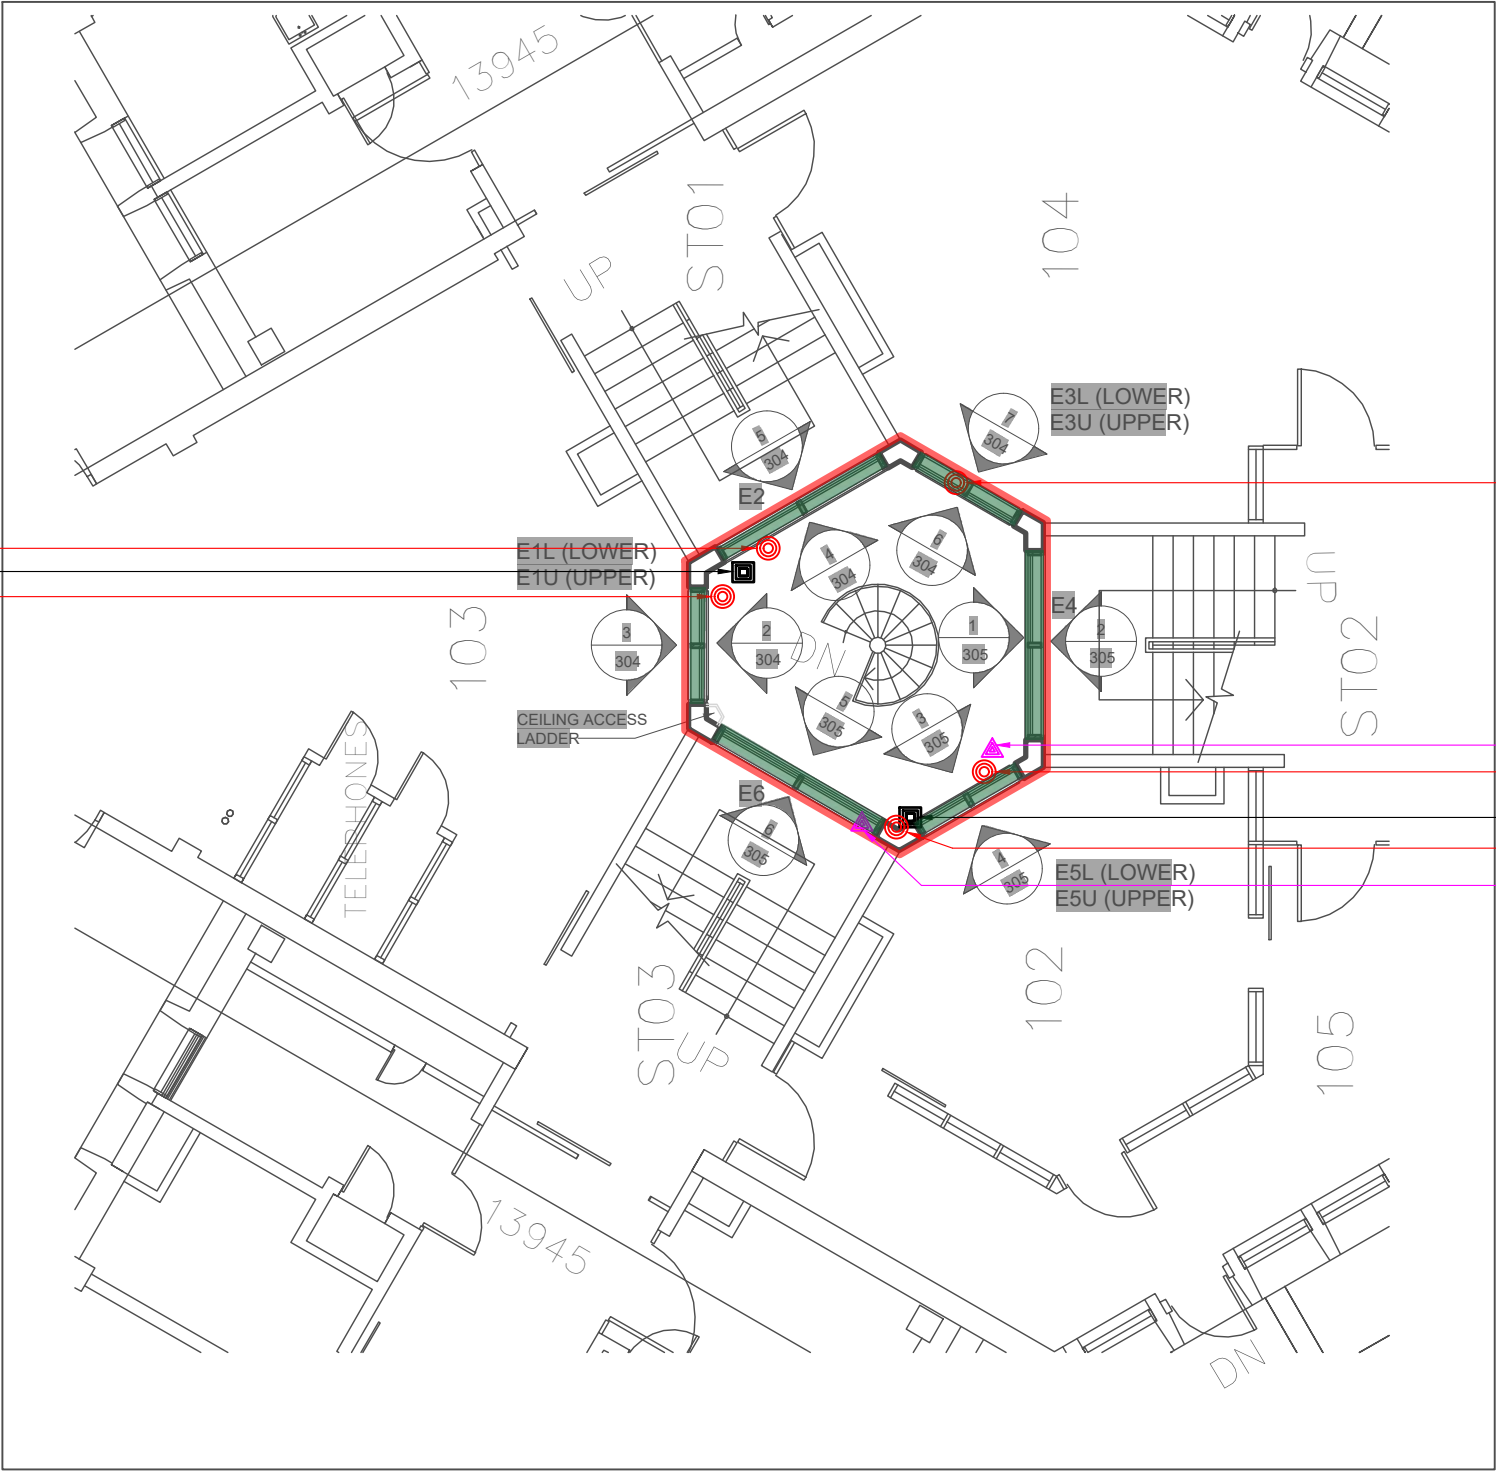
<b>Caulking, hard black</b>	<b>On metal window frames, E control (location 6)</b>	<b>200 LF</b>	<b>S0010A-C</b>	<b>Chrysotile</b>

Caulking and sealants are non-friable materials and in good condition.
