December 9, 2019

Subject: Designated Substances Survey – Update  
West Annex, Former Sir John Carling Building  
930 Carling Avenue, Ottawa, Ontario

DST File No.: GVOT-034335 - Phase 27.0

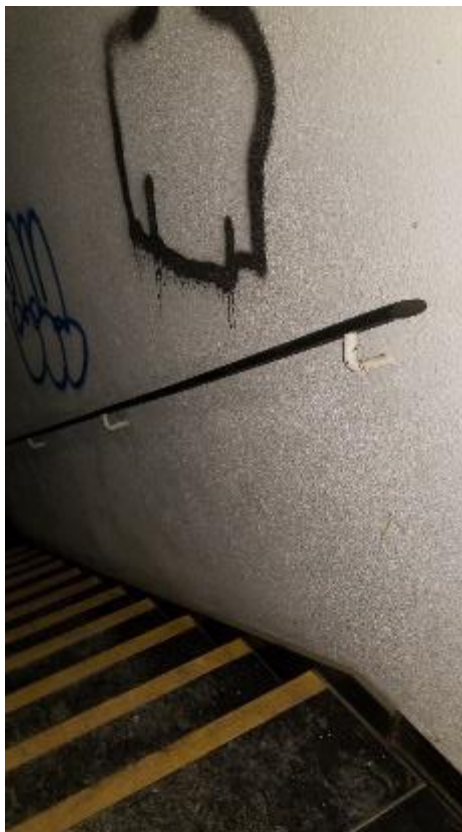
- Friable (intact and in good condition) textured plaster wall/ceiling coat materials – top layer of texture coat (DST 2014 Samples 19779-01A, 19779-25A, 19779-31, 19779-10A, 19779-37) contains 0.93-2% Chrysotile asbestos. This material was observed present in select areas throughout the building, including, but not limited to:

**Photo 1:** Textured wall coat and ceiling materials throughout select areas of the building, contains 1-2% Chrysotile asbestos (stairwell from first floor to basement pictured above)

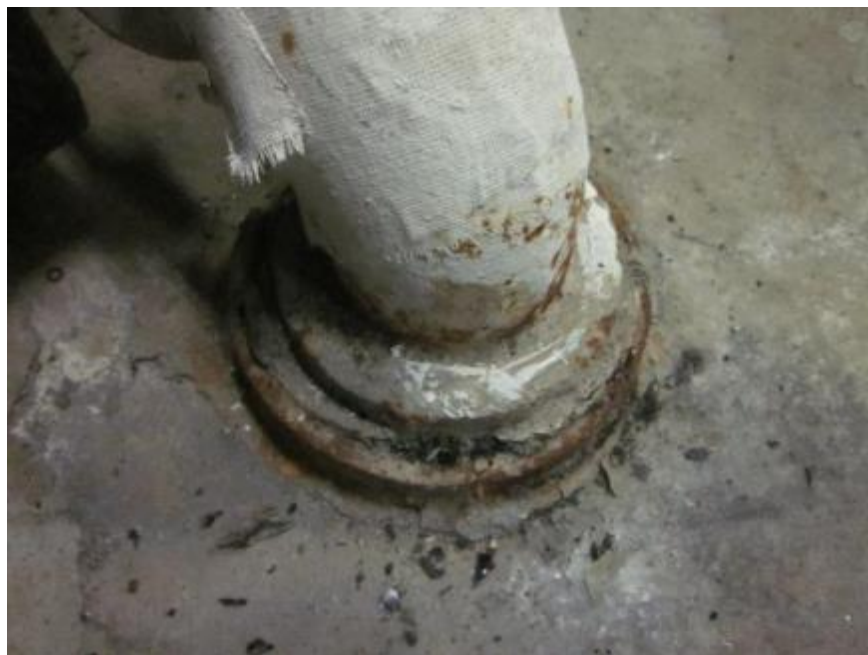
- Friable firestop material at floor penetrations throughout the building (JWEL 1999 Sample) contains 50-75% Chrysotile asbestos. Firestop materials are generally in good condition,

**Photo 2:** Floor fireproofing/packings contain 50-75% Chrysotile asbestos.

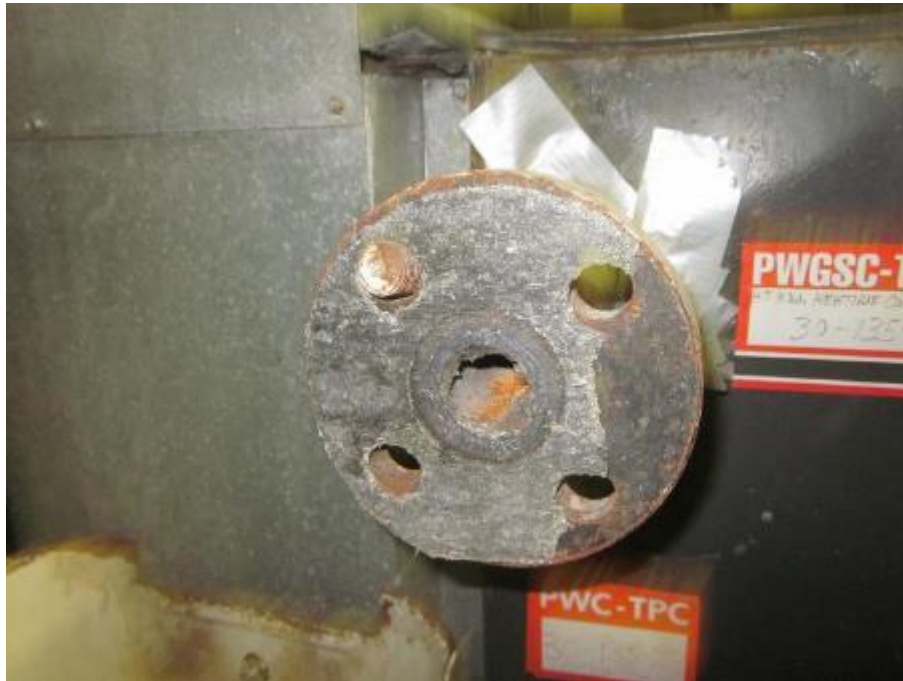
- Friable pipe gasket historically present in sub-basement mechanical room (two (2) gaskets historically observed, survey location 7) (DST 2014 Sample 19779-30A) contain 50%

Chrysotile asbestos. One (1) gasket was observed in basement mechanical room – location 13) and one (1) gasket was observed on the exterior of the building in the loading dock. Based on the analytical results, all pipe gaskets, where present, throughout the building should be assumed to contain asbestos. Observed pipe gaskets were generally in good condition,

**Photo 3:** Pipe gaskets throughout the building contain 50% Chrysotile asbestos.

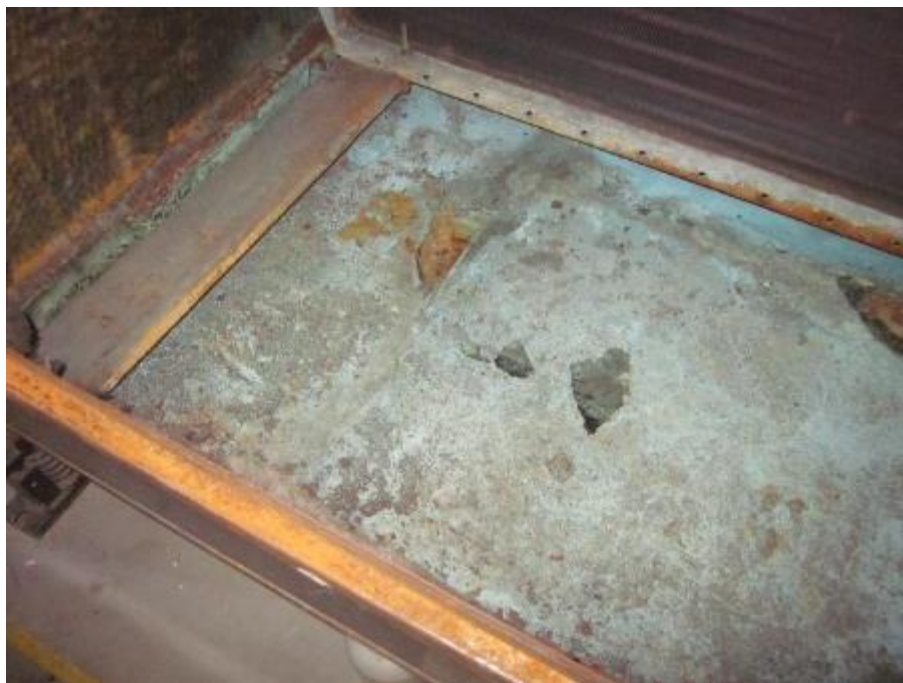
- Friable interior flooring materials and associated layers of the air handling units in the sub-basement and basement mechanical rooms (approximately 10 square meters - survey locations 2 and 13) (DST 2014 19779-05A and duplicate sample 19779-34) contains 3.02-9.33% Chrysotile asbestos. This material inside the air handling units was observed to be in good condition,

**Photo 4:** Floor layers of interior of air handling units (basement AHU pictured above) contains 3.02-9.33% Chrysotile asbestos.

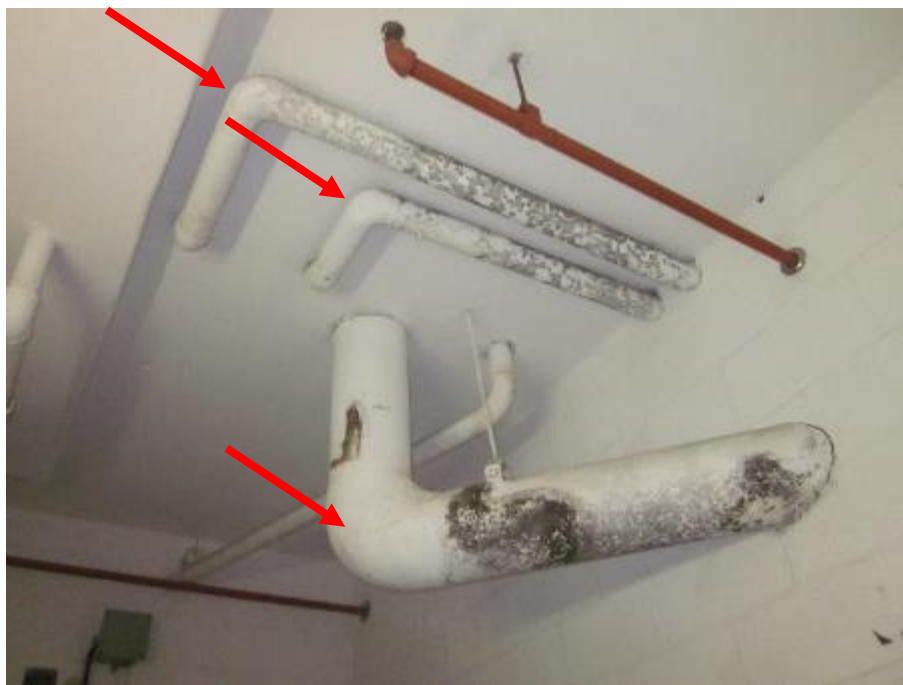
- Friable pipe fitting insulation/elbow parging contains 25-50% Chrysotile asbestos (JWEL 1999 Sample). Pipe fitting insulation was observed throughout select areas of the building, including, but not limited to:
  - historically present in the sub-basement stairwell (approximately 5 fittings - survey location 10), assumed to present in air ventilation shafts associated with confirmed non-ACM layered cardboard wrap pipe insulation (not accessible, quantity unknown),
  - west basement storage, mechanical, and washroom areas (approximately 75 fittings - select areas of survey locations 14 to 20), and
  - first floor shaft in kitchen area (approximately two (2) fittings and less than one (1) square metre of debris- survey location 34),

**Photo 5:** Grey cement compound pipe fitting insulation contains 25-50% Chrysotile asbestos and mould impacted pipe insulation canvas, sub-basement stairwell. Layered cardboard wrap pipe insulation was confirmed to not contain regulated concentrations of asbestos.

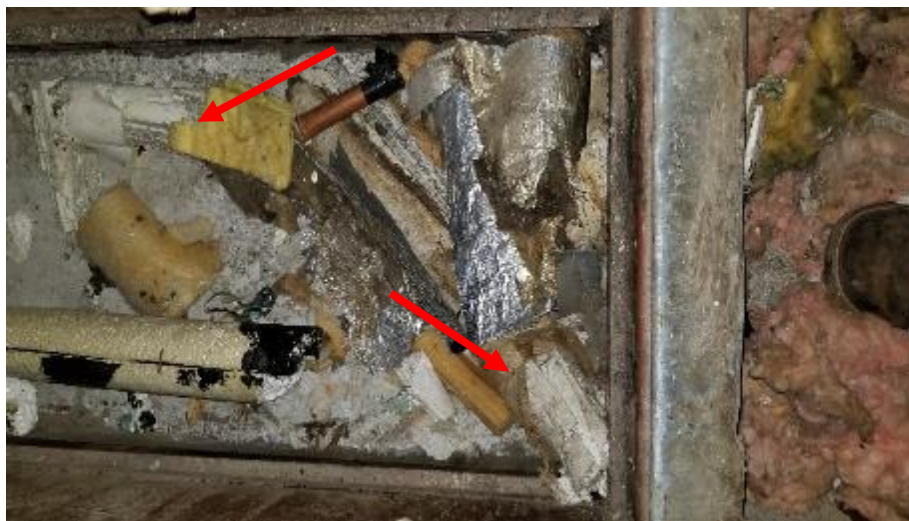
- Friable aircell pipe insulation (JWEL 1999 Sample) contains 5-25% Chrysotile asbestos. Pipe fitting insulation was observed throughout select areas of the building, including, but not limited to:

- first floor kitchen shaft (approximately 1 linear meter and less than one (1) linear metre of debris - survey location 34), and
  - remnant poor condition aircell pipe insulation was also observed at select wall/ceiling penetration where aircell pipe insulation would have passed through solid wall/ceiling materials throughout the building and was not abated (typical examples including, but not limited to, survey location 12, 14).

**Photo 6:** Aircell pipe insulation contains 5-25% Chrysotile asbestos. Aircell debris, pictured in the first floor kitchen pipe shaft.

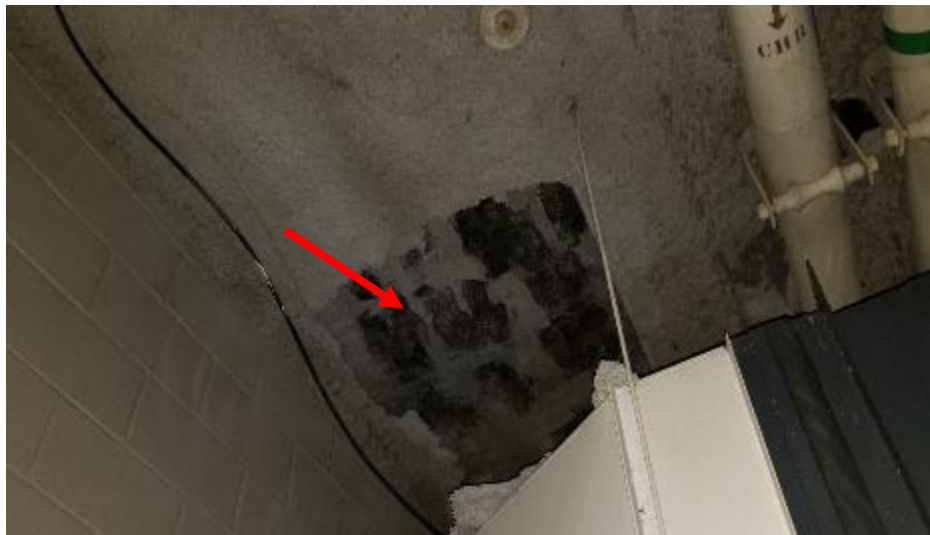
- Non-friable tar layer present beneath sprayed fireproofing in basement mechanical room contains 20.43-31.06% Amosite and 3.4-7.77% Chrysotile asbestos. Due to the concealed nature of the material, an accurate quantity could not be ascertained, however approximately one hundred twenty (120) square meters of fireproofing was observed in survey location 13) (DST 2014 Sample 19779-12A and duplicate sample 19779-38), Although representative samples of the fireproofing insulation were collected by Greenough and Stantec (2010) and were confirmed to not contain asbestos, the bottom tar layer of the fireproofing and debris associated with the tar was confirmed by DST to be asbestos-containing. DST is of the opinion that the tar layer cannot be effectively separated from the fireproofing insulation material (physically and without cross-contamination), and as such, disturbance/removal of fireproofing insulation materials should be completed using appropriate asbestos-precautionary measures. DST is also of the opinion that the tar layer cannot be effectively removed without the use of power tools. The majority of fireproofing materials were generally in good condition. Approximately ten (10) square metres of poor condition material and ten (10) square metres of debris was observed,

**Photo 7:** Tar layer beneath spray fireproofing in basement mechanical room contains 20.43-31.06% Amosite and 3.4-7.77% Chrysotile asbestos.

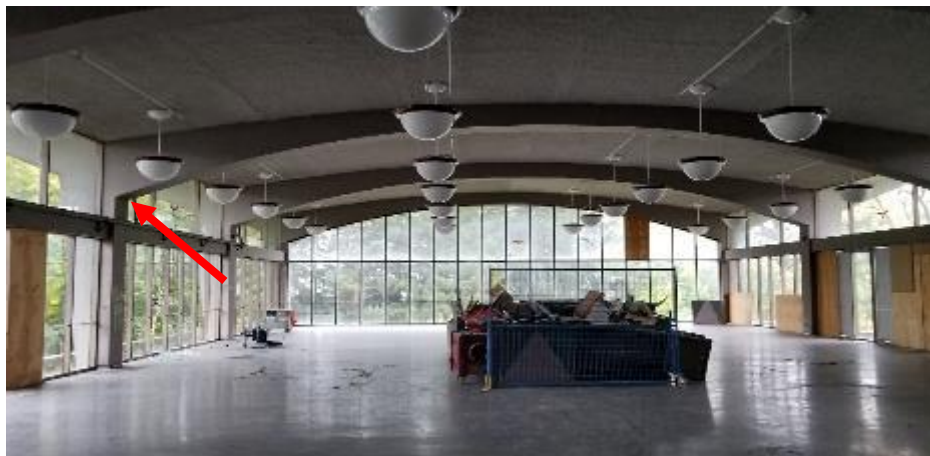
- Friable plaster columns and ceiling bulkheads throughout the first floor kitchen and cafeteria area (approximately 175 square meters - survey location 32, 33) (DST 2014 Sample 19779-21A) contain 1% Tremolite asbestos. Column and bulkhead plaster materials in the first floor kitchen and cafeteria area were generally in good condition,
- Friable plaster associated with columns historically present throughout the sub-basement (approximately 85 square meters - survey location 9) (DST 2014 Sample 19779-07A and duplicate Sample 19779-35) contains 0.79-1% Chrysotile asbestos. The columns were historically intact and in good condition, and
- One (1) friable light heat shield was observed in the south-west walk-in freezer on the first floor, kitchen area (survey location 24) contains 75% Chrysotile asbestos (DST 2019 Sample 34335-04A-C).

**Photo 8:** Plaster columns and ceiling bulkheads throughout the first floor kitchen and cafeteria area contain 1% Tremolite asbestos.

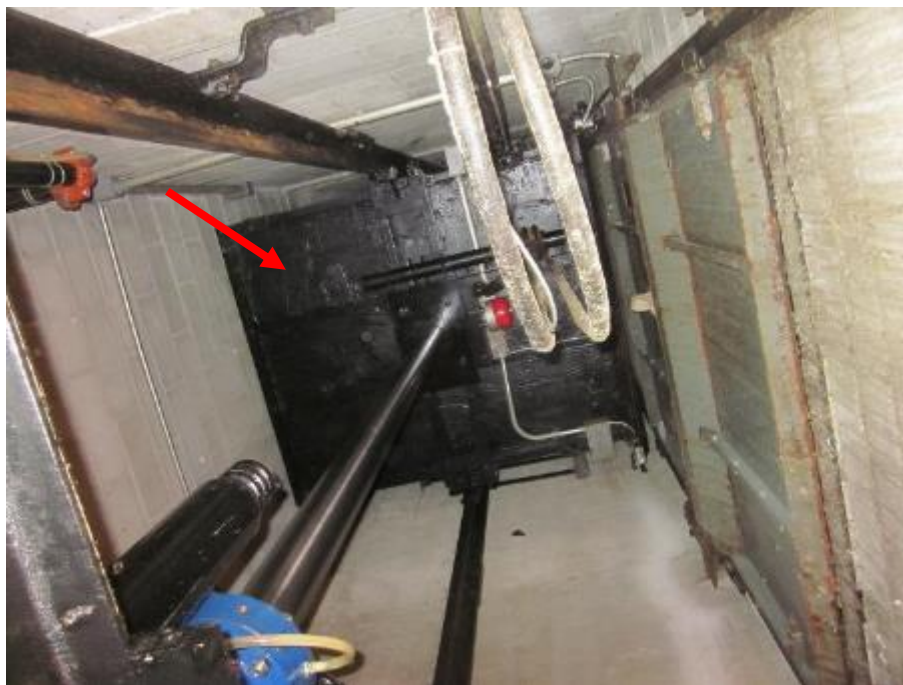
**Photo 9:** Black tar applied to bottom of elevator cab has been confirmed to contain 5.77% Chrysotile asbestos.

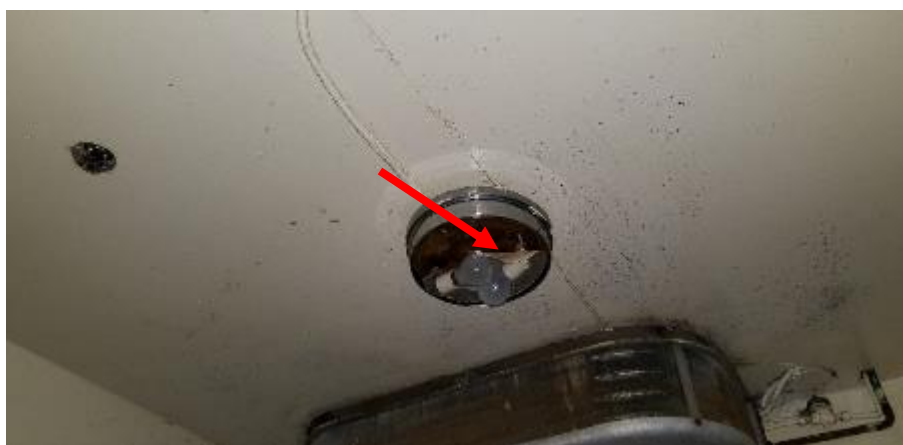
**Photo 10:** Light heat shield was observed in the south-west walk-in freezer on the first floor, kitchen area contains 75% Chrysotile asbestos.

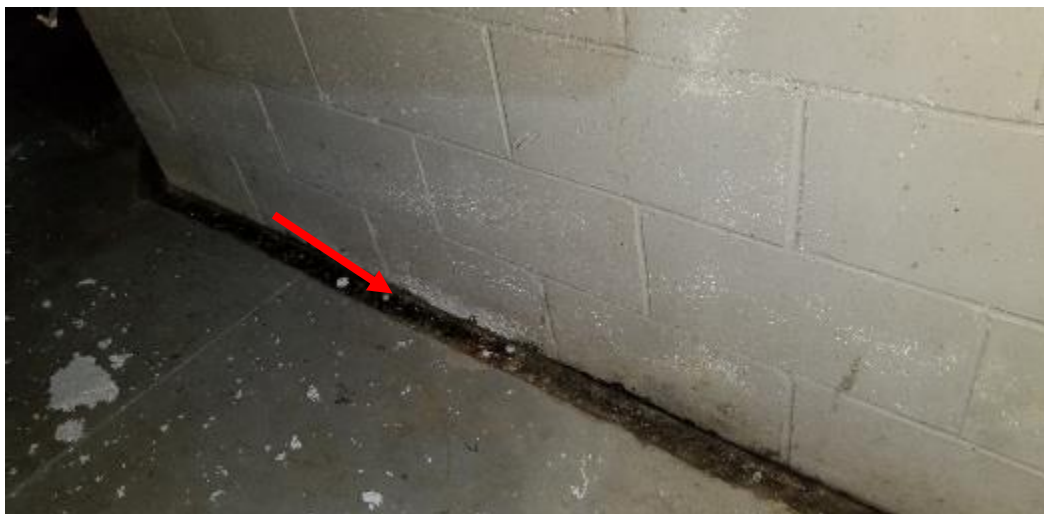
- Non-friable black tar layer, observed around the perimeter of the floor of the electrical room in the basement mechanical room (approximately 10 linear meters - survey location 13) (DST 2014 Sample 19779-13A and duplicate Sample 19779-39) contains 23.68-26.57% Chrysotile asbestos. This material was in good condition.

**Photo 11:** Black tar layer, observed around the perimeter of the floor of the electrical room in the basement mechanical room contains 23.68-26.57% Chrysotile asbestos.

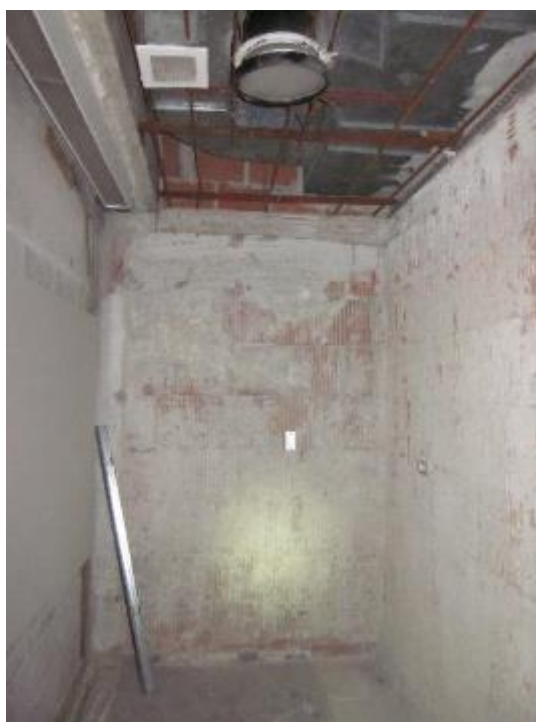
- First floor former conference room storage rooms (approximately 2 square meters - survey location 31).
- Friable remnant plaster materials, observed applied to terracotta block/wall materials inside the first floor former storage rooms of the former conference room and adjacent link areas on the first floor (approximately 30 square meters - survey location 29, 31) (DST 2014 Sample 19779-19A) contains 1% Tremolite asbestos. Based on visual observations, this material has already been selectively abated/chipped, and thus this material is in poor condition,

**Photo 12:** Remnant wall texture coat materials were confirmed to contain 1% Tremolite asbestos, in storage rooms adjacent to former first floor conference room. Based on visual observations, this areas appears to have already been selectively abated/chipped.

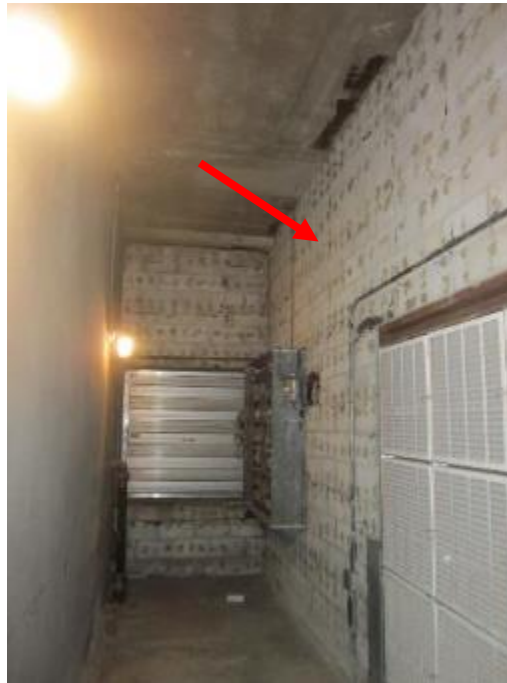
- Non-friable remnant wall mastic/pucks (Greenough 2006 Sample SA-1a) contains 0.5% Chrysotile asbestos. Remnant beige and black mastic was historically observed in sub-basement air plenums and rooms adjacent to air plenums (survey location 1, 5, 6, 8, 13). Due to the sporadic nature of the materials installation, an accurate quantity of the material could not be ascertained. Approximately twenty-four (24) square metres was observed in the basement, north rooms off the mechanical room- locations B4-B5). This material is generally in good condition.

**Photo 13:** Adhesive pucks present throughout sub-basement and basement air plenums and rooms adjacent to plenums contains 0.5% Chrysotile asbestos.

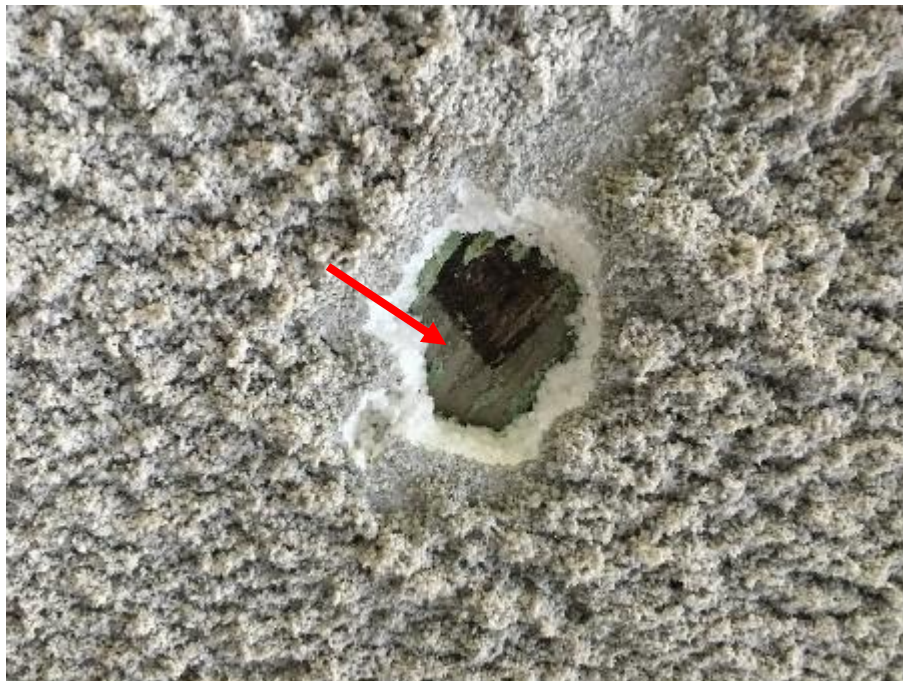
- Non-friable green mastic beneath sprayed ceiling fireproofing and white Styrofoam layer assumed present throughout the first floor Kitchen and cafeteria area was determined to contain 0.7-2.25% Chrysotile asbestos (DST 2015 Sample 19779-05A-C), Due to the concealed nature of the material, an accurate quantity could not be ascertained, however approximately nine hundred (900) square metres of fireproofing was observed in locations 32 and 33).

- Non-friable tar layer present beneath sprayed fireproofing and white Styrofoam, and beneath drywall on upper ceiling arches throughout the first floor kitchen and cafeteria area, contains 7.51% Amosite and 10.01% Chrysotile asbestos (DST 2015 Samples 19779-07A-C) (due to the concealed nature of the material, an accurate quantity could not be ascertained, however approximately nine hundred (900) square metres of fireproofing was observed in locations 32 and 33). Although representative samples of the fireproofing

**Photo 14:** Green mastic and black tar beneath Styrofoam insulation, which is present beneath fireproofing materials, and drywall materials on the ceiling arches in the kitchen and cafeteria have both been confirmed to contain asbestos.

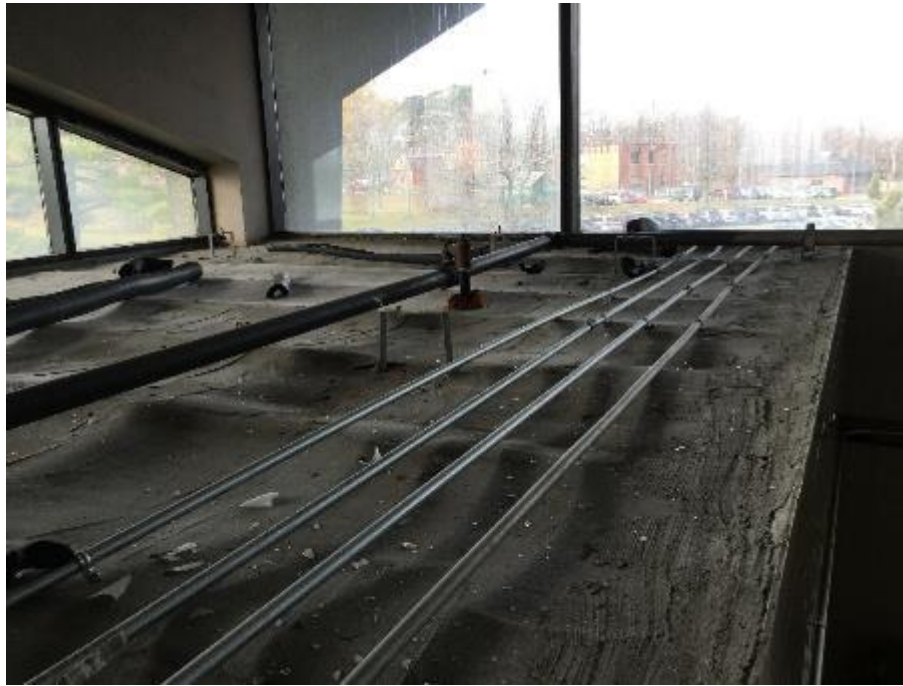
- Non-friable cementitious layer (approximately seventy-five (75) square metres- locations 22-26) that would comprise the tops of the walk in refrigerators in the first floor kitchen area was determined to contain 1% Chrysotile asbestos (DST 2015 Sample 19779-08A). The material was generally in good condition,

**Photo 15:** The cementitious layer on top of kitchen ceilings (such as walk-in fridges) has been confirmed to contain asbestos.

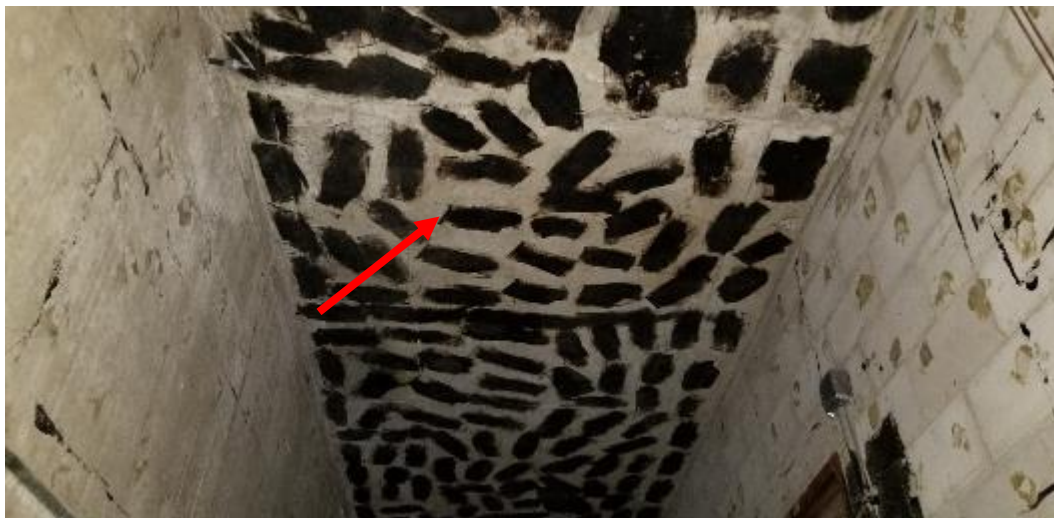
- Non-friable black wall/ceiling mastic, contains 11.67% Chrysotile asbestos (DST 2014 Sample 19779-26A). This material is adhered to concrete materials and is in good condition. Due to the sporadic nature of this material installation, an accurate quantity could not be ascertained but the material was confirmed in the following locations and quantities:

**Photo 16:** Black wall/ceiling mastic contains 11.67% Chrysotile asbestos

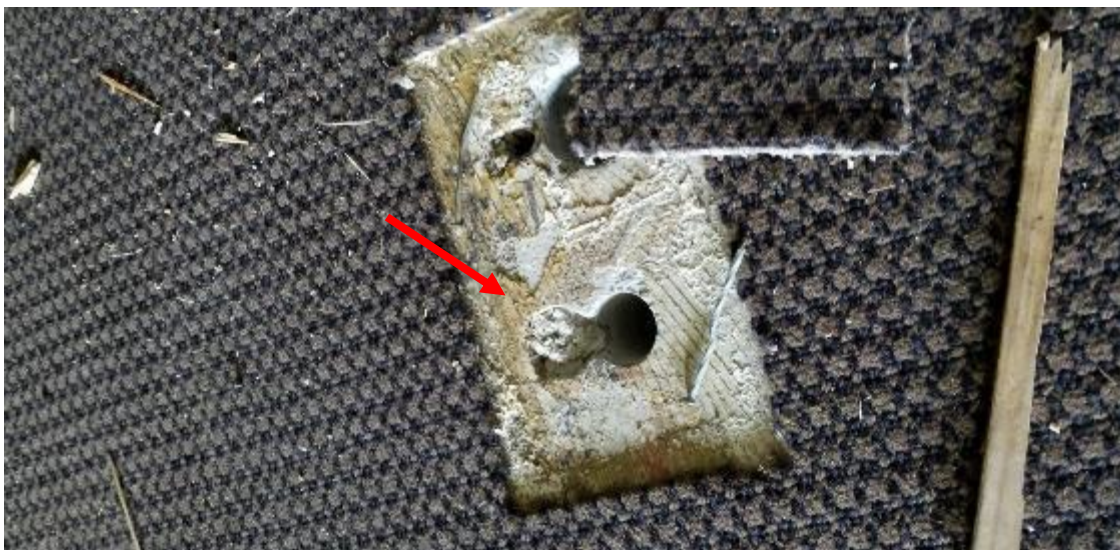
**Photo 17:** Carpet mastic, associated with carpet materials in the first floor former conference room contains 0.91% Chrysotile asbestos.

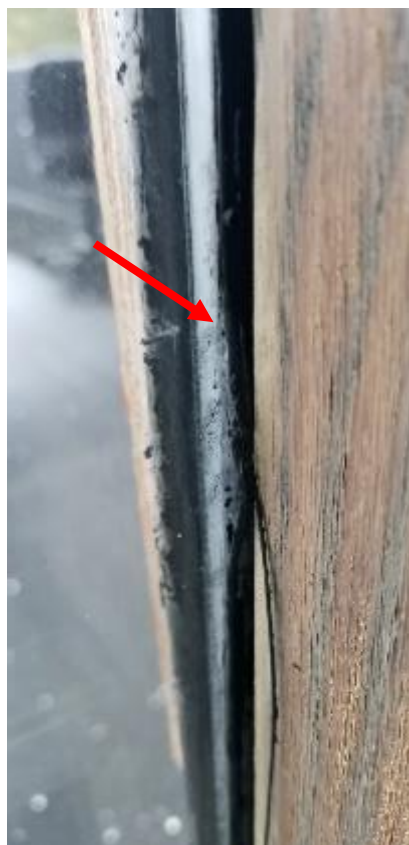
- Non-friable black window caulking contains 4% Chrysotile asbestos (DST 2019 Samples 34335-01A). Approximately four hundred and fifty (450) linear metres was observed on windows throughout the building);

**Photo 18:** Black window caulking contains 4% Chrysotile asbestos and was observed on windows throughout the building.

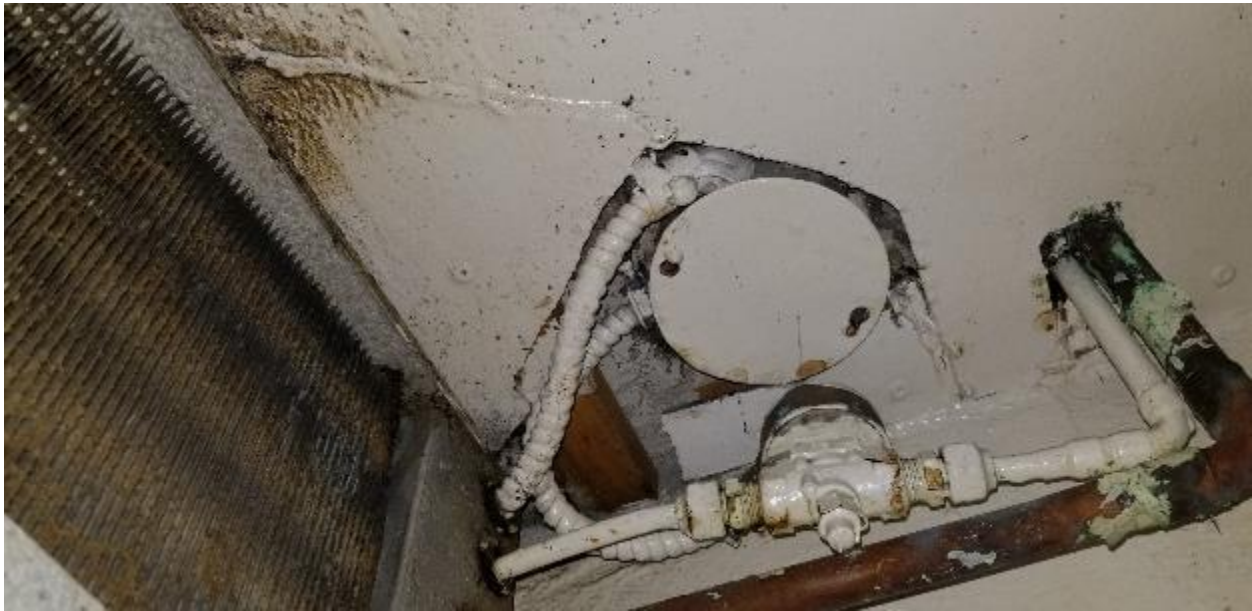
**Photo 19:** Transite ceiling panels in the south-west walk-in freezer on the first floor, kitchen area contains 9% Chrysotile asbestos.

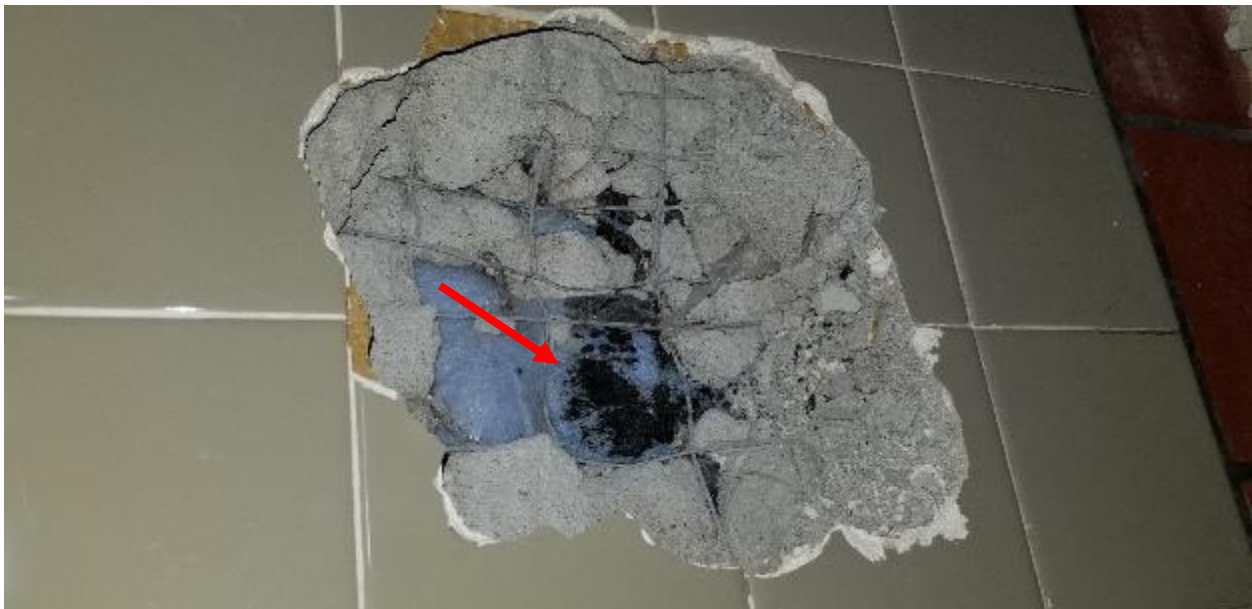
- Non-friable black tar, applied to blue foam insulation contains 7% Chrysotile asbestos (DST 2019 Sample 34335-11A). The tar is concealed behind ceramic tiles and grey plaster on first floor kitchen walls. Due to the concealed nature of the material, an accurate quantity could not be ascertained, however approximately four-hundred fifty (450) square metres of walls with similar ceramic tile/plaster was observed in location 33).

**Photo 20:** Black tar, applied to blue foam insulation contains 7% Chrysotile asbestos. The tar is concealed behind ceramic tiles and grey plaster on first floor kitchen walls.

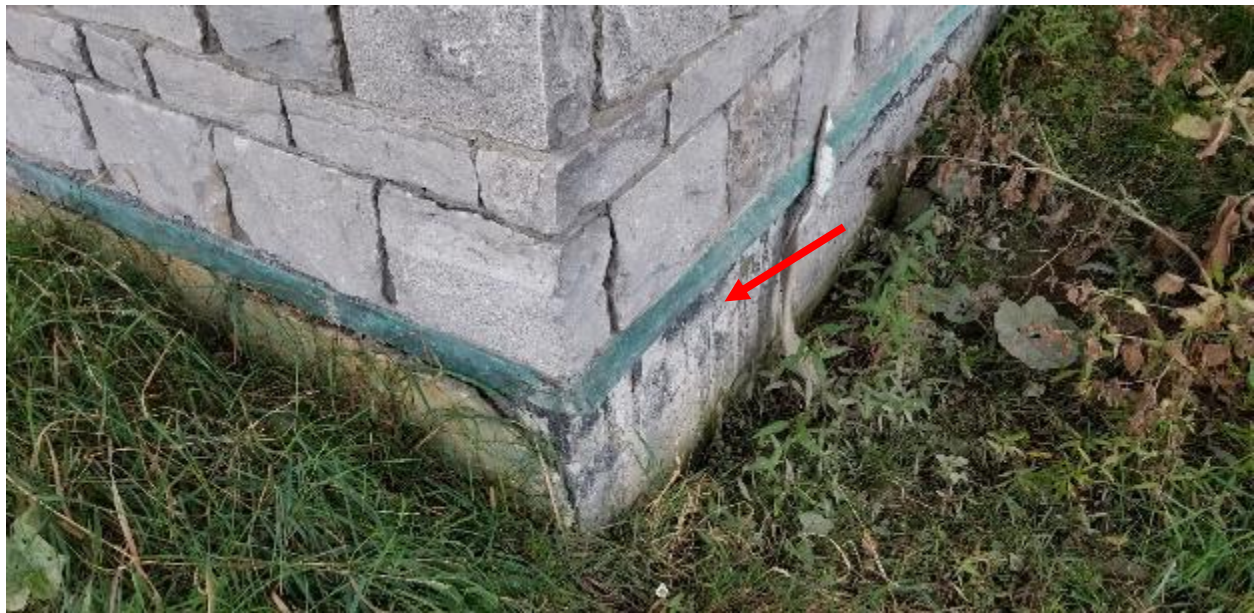
- Non-friable exterior foundation tar contains 2% Chrysotile asbestos (DST 2019 Samples 34335-17A).

**Photo 21:** Non-friable exterior foundation tar contains 2% Chrysotile asbestos

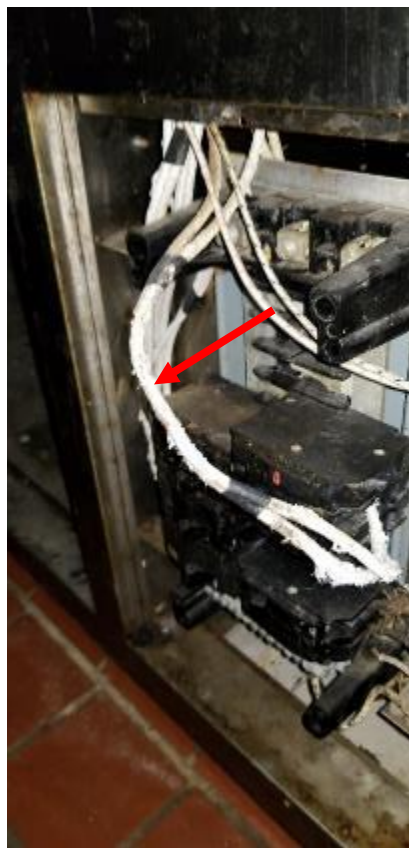
- Friable, white fibrous electrical wire sheathing, observed in the first floor kitchen area (less than one linear meter - survey location 33) (DST 2014 Sample 19779-29A) contains 65% Chrysotile asbestos. All fibrous electrical cable sheathing throughout the building, where present, should be assumed to contain asbestos. This material is generally in good condition,

**Photo 22:** Friable, white fibrous electrical wire sheathing, observed in the first floor kitchen area contains 65% Chrysotile asbestos.

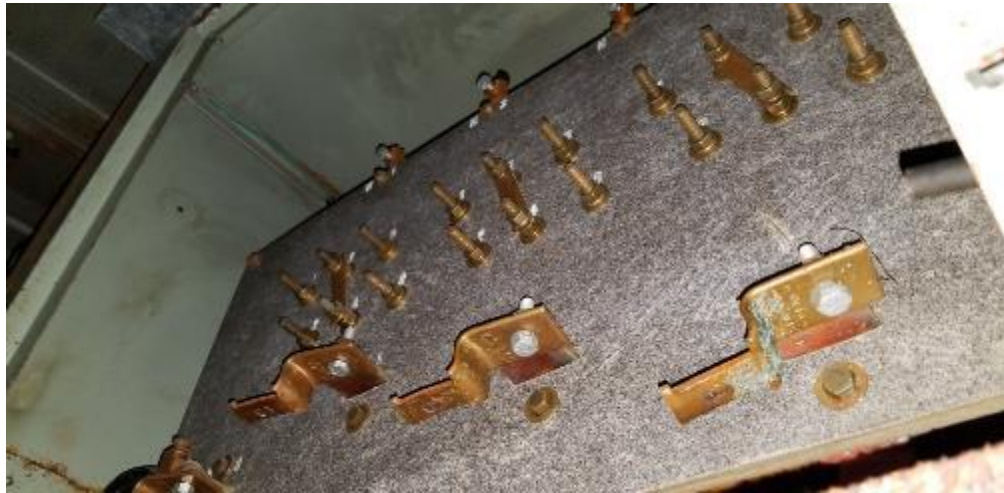
**Photo 23:** Suspect asbestos-containing transite panel observed in the basement west electrical room.

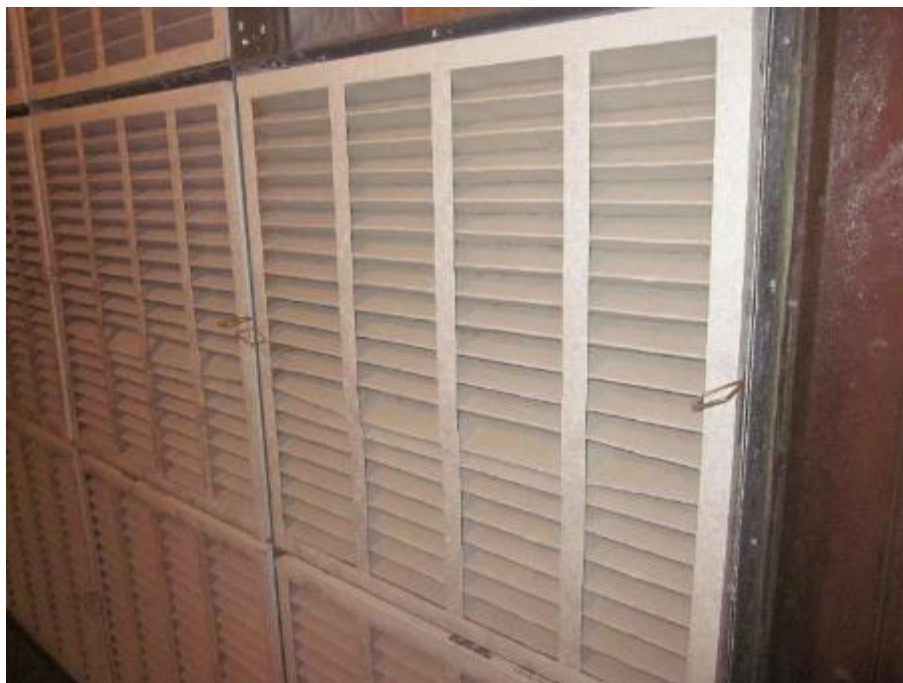
**Photo 24:** Suspected mould impacted air filters observed in sub-basement mechanical room.

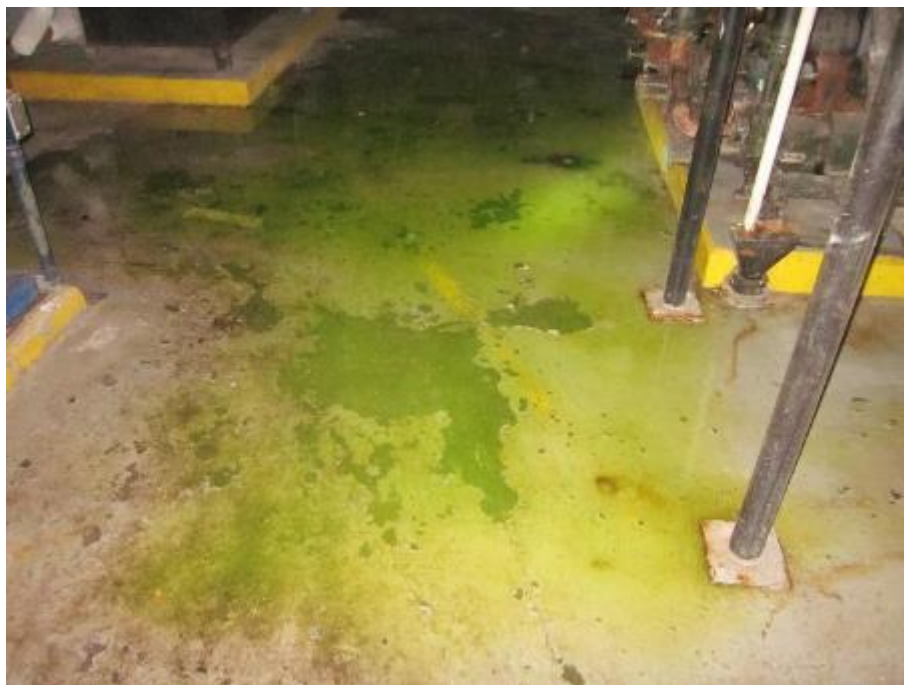
**Photo 25:** Suspected glycol and/or coolant leak was historically observed throughout the concrete floor of the sub-basement mechanical room (not accessible 2019 due to flooding).

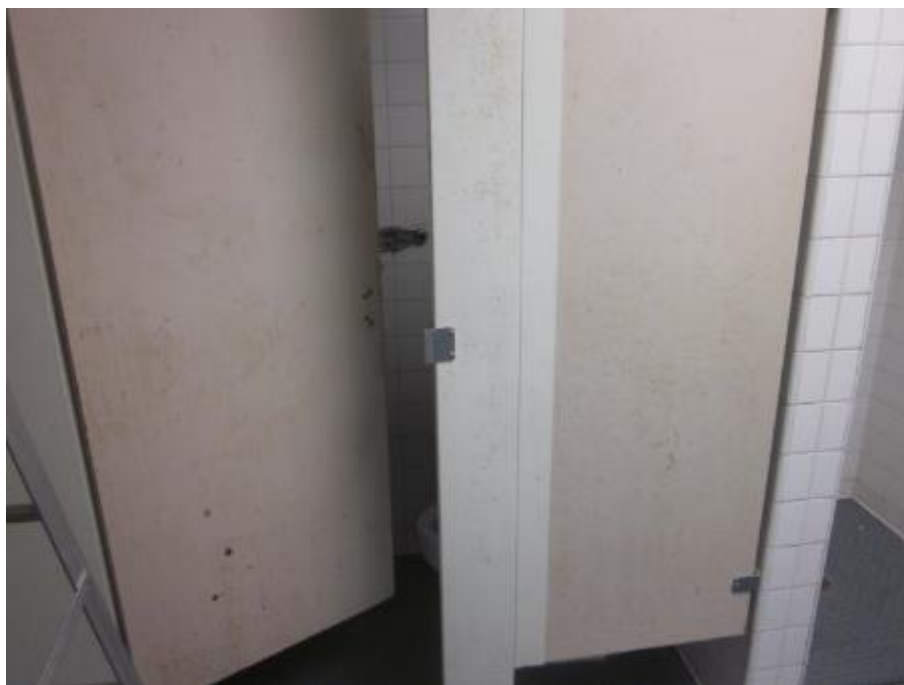
**Photo 26:** Suspected mould impacted washroom stalls in basement washroom areas (most surfaces visually impacted by mould growth).

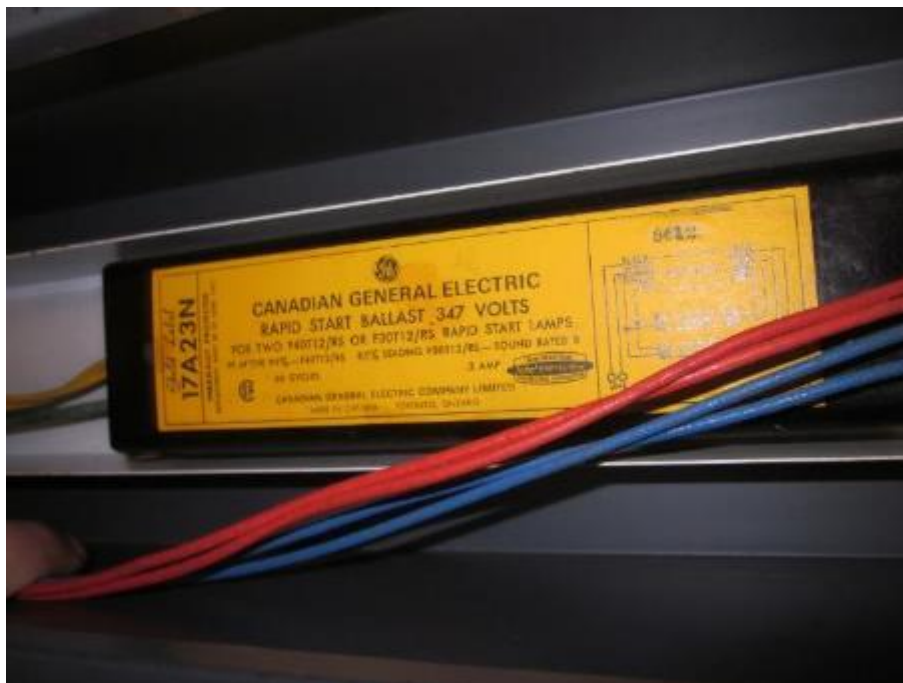
**Photo 27:** Based on limited visual observations, select exposed PCB-containing ballasts were identified in the building. All ballasts throughout the building should be assumed to contain PCBs, unless proven otherwise by additional investigation.

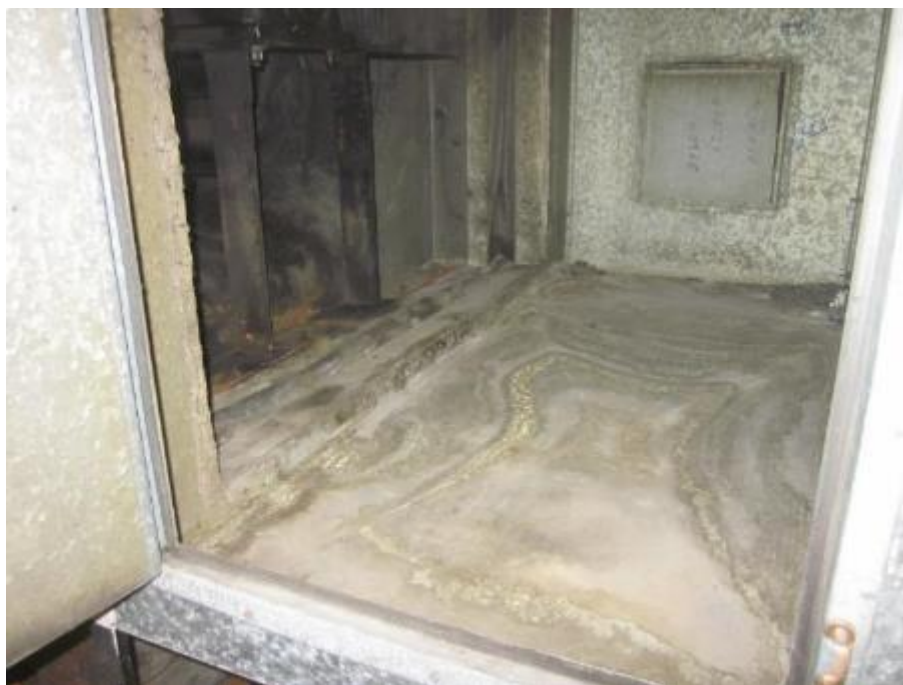
**Photo 28:** Interior of ventilation ductwork (basement mechanical room shown above) was observed to be impacted by suspected mould.
