**Designated Substances and
Hazardous Building Materials
Assessment – SAR Station**

Search and Rescue Station (SAR)
Cobourg, Ontario

February 21, 2020

Stantec Consulting Ltd.
150-1555 Wentworth Street
Whitby ON L1N 9T6

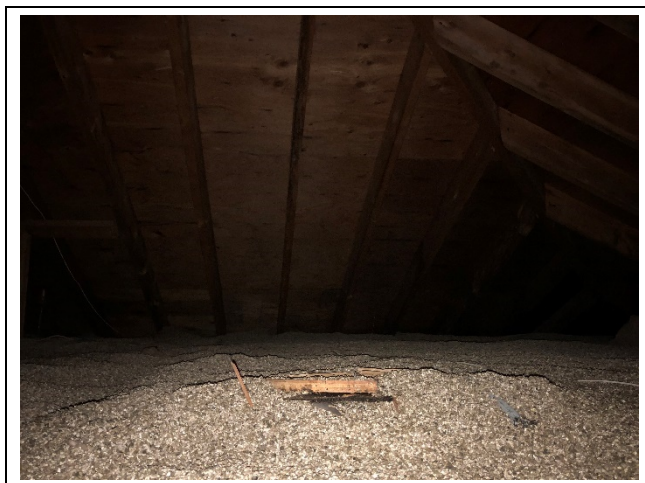
Photo 2: House – Asbestos-containing vermiculite insulation located in the attic.

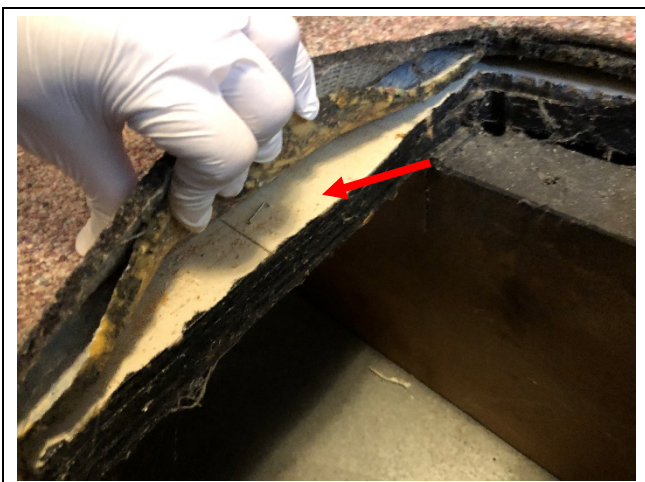
Photo 3: House – Asbestos-containing vinyl floor tiles – beige found beneath carpet in bedrooms 1-3, hallway and living room.

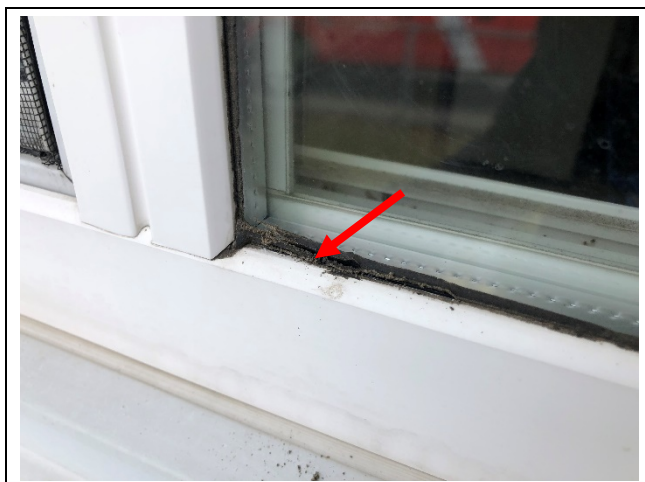
Photo 4: House – Asbestos-containing exterior window glazing compound – back on the exterior laundry room and kitchen windows.

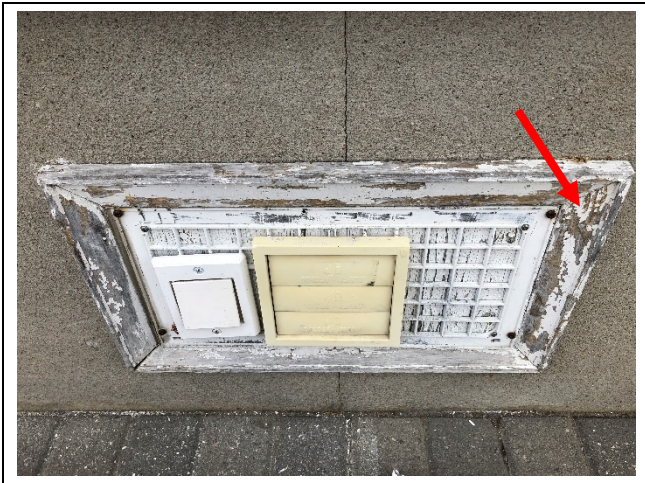
Photo 5: House – Damaged lead-containing white coloured paint on exterior wood finishes.

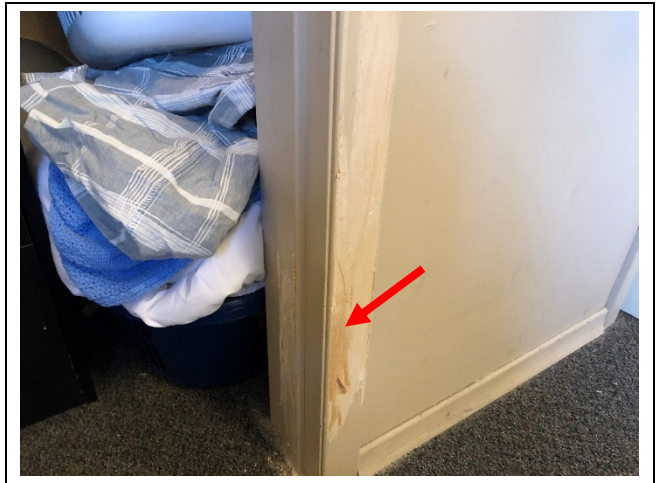
Photo 6: House – Lead-containing white coloured paint on interior wood finishes.

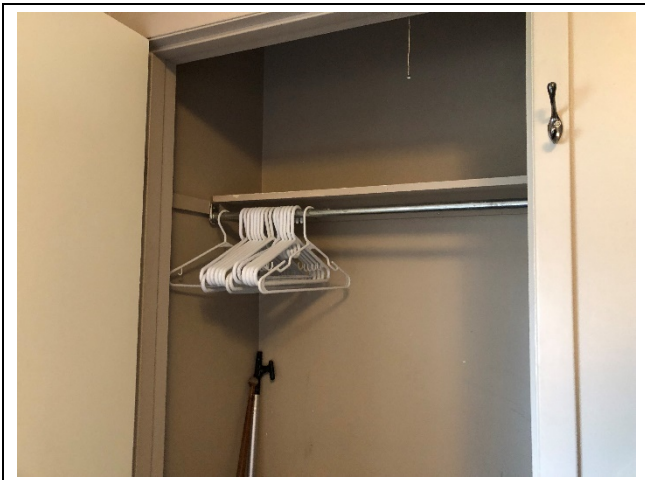
Photo 7: House – Lead-containing brown coloured paint on interior closet door frame.

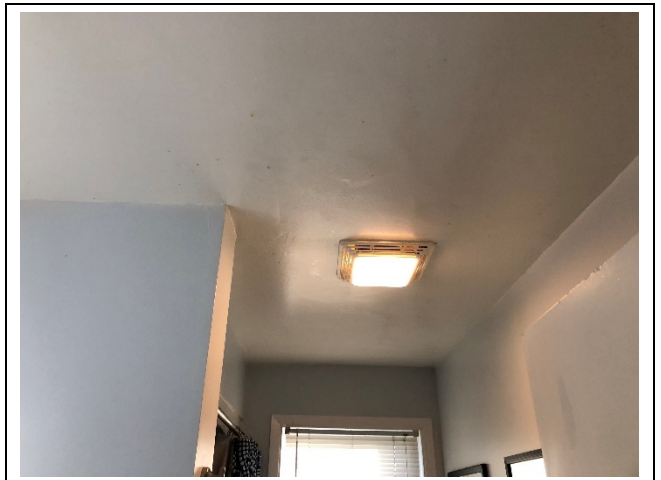
Photo 8: House – Water damaged drywall ceiling within washroom 2 of the addition.

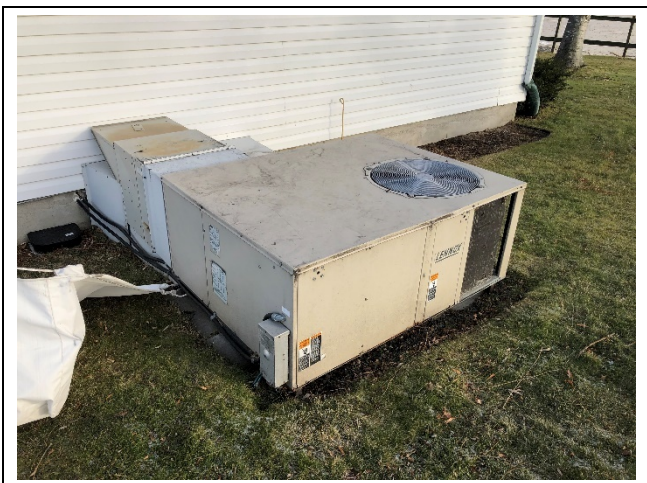
Photo 9: House – Lennox HVAC unit containing R-22 ozone depleting substances on exterior.

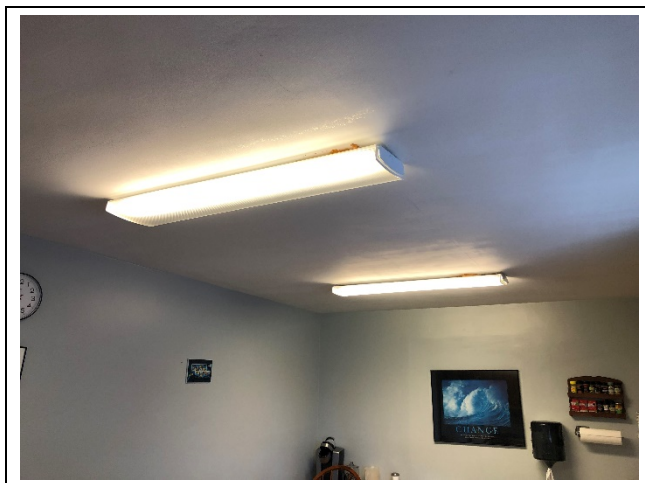
Photo 10: House – Fluorescent light tubes containing mercury vapour in kitchen.

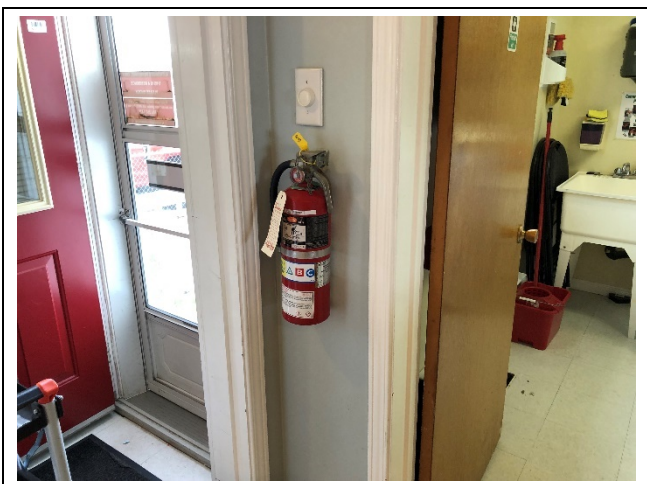
Photo 11: House – Fire extinguisher on wall within kitchen.

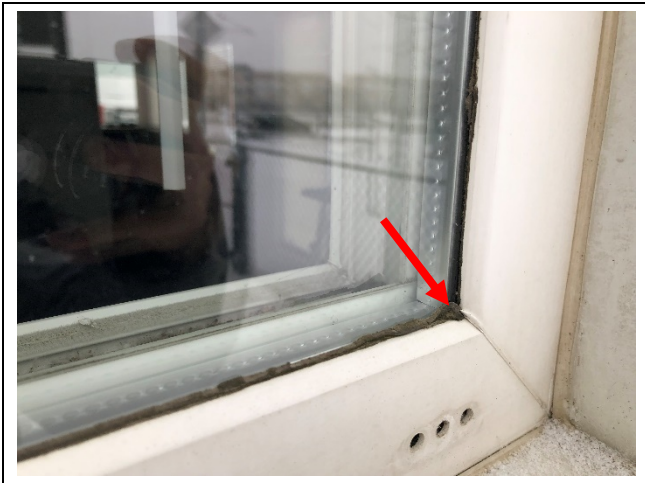
Photo 13: Office Building – Asbestos-containing exterior window glazing – black on exterior windows.

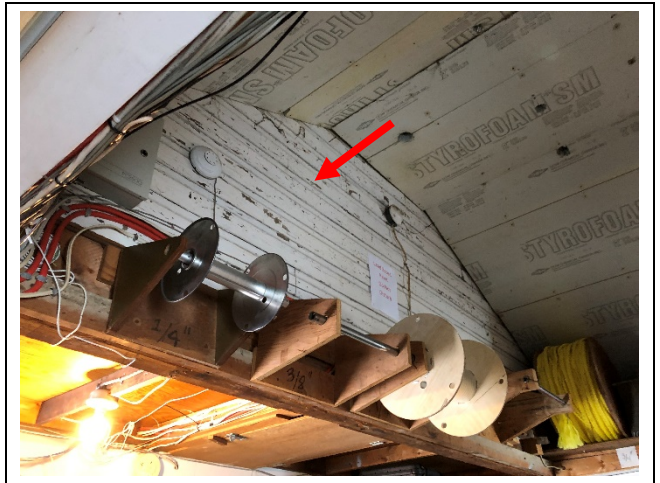
Photo 14: Office Building – Damaged lead-containing white coloured paint on wood siding in the locker room.

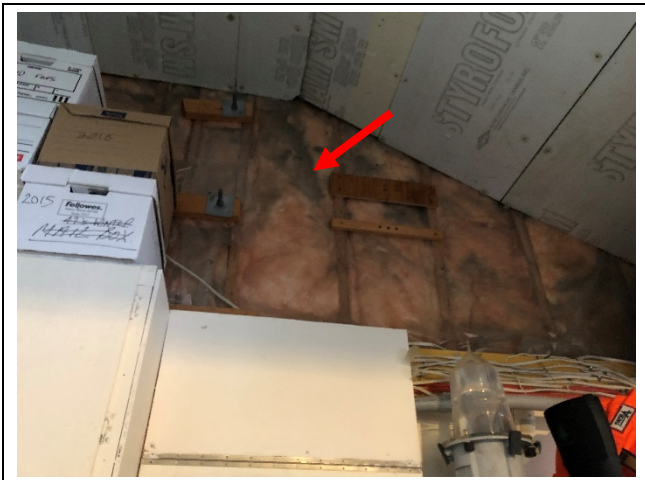
Photo 15: Office Building – Water damaged fiberglass wall insulation in the locker room area.

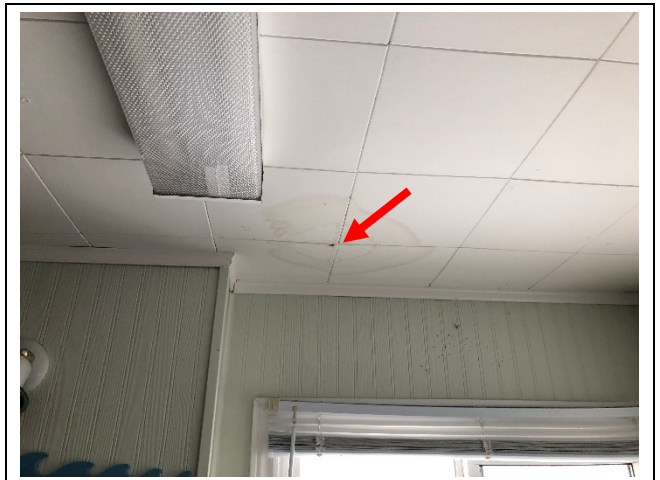
Photo 16: Office Building – Water stained ceiling tiles on office 1 ceiling.

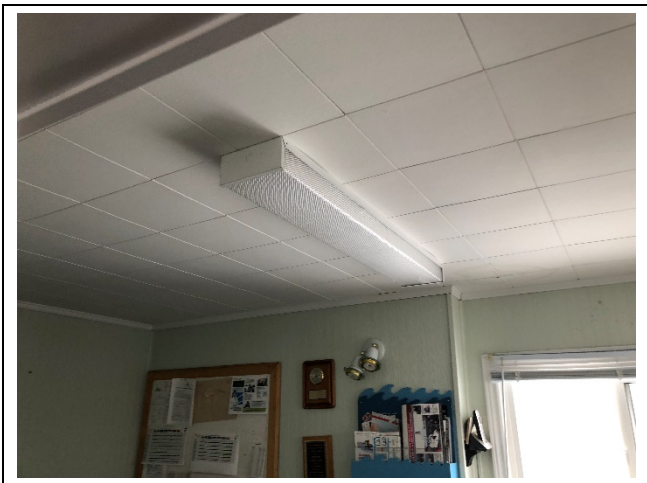
Photo 17: Office Building – Fluorescent light tubes containing mercury vapour in office 1.

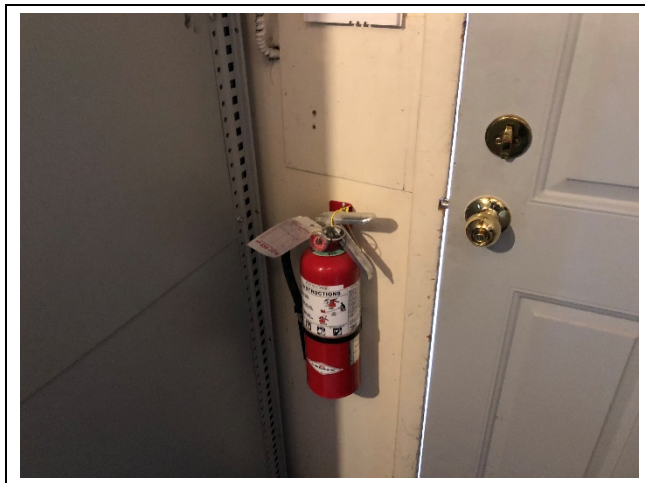
Photo 18: Office Building – Fire extinguisher on wall within locker room.

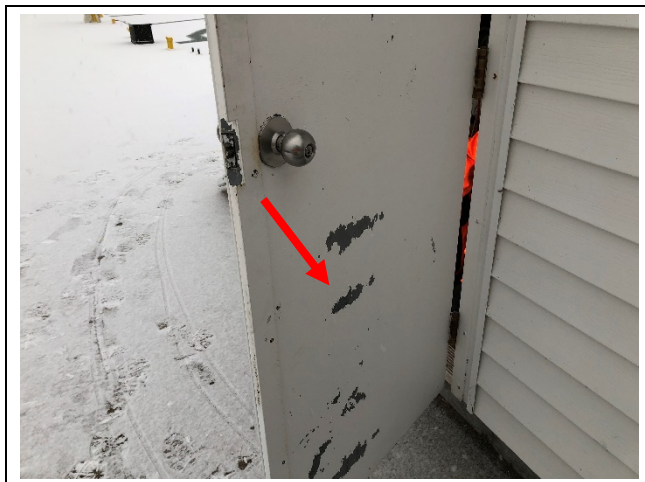
Photo 20: Pier Building – Damaged lead-containing white coloured paint on exterior doors.

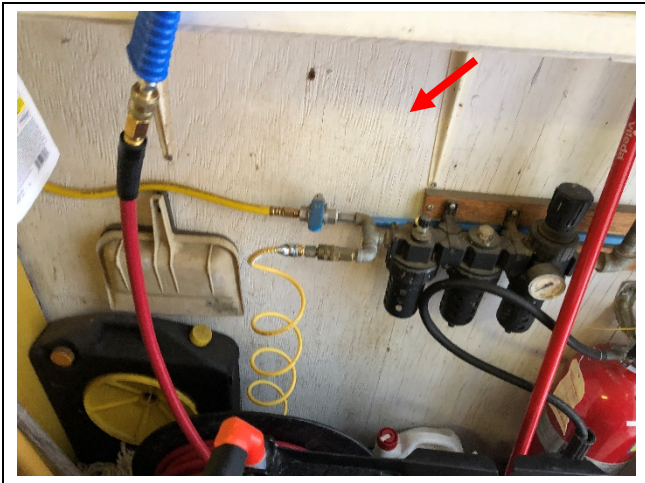
Photo 21: Pier Building – Lead-containing white coloured paint on interior wood board walls.

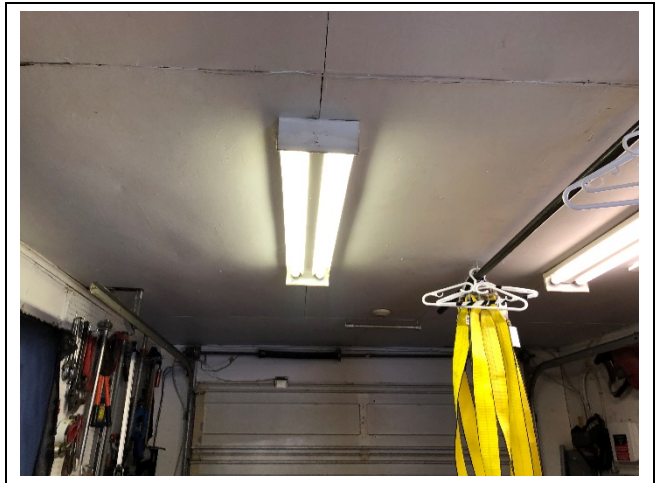
Photo 22: Pier Building – Fluorescent light tubes containing mercury vapour.

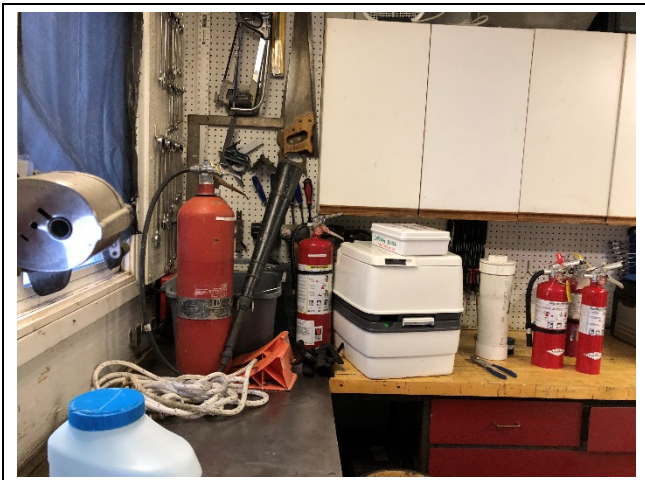
Photo 23: Pier Building – Fire extinguishers stored within workshop.

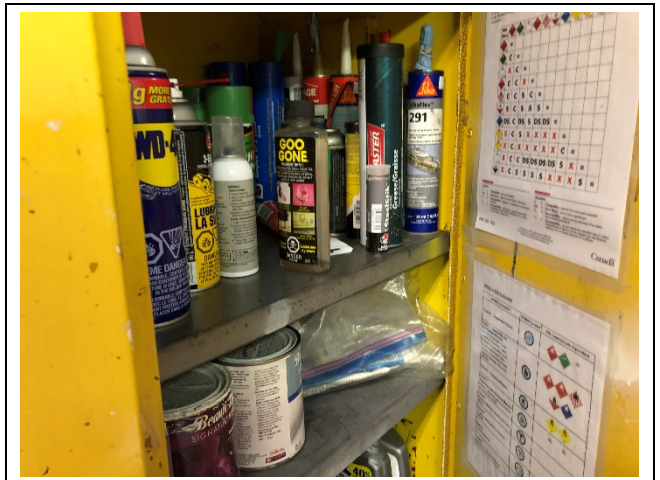
Photo 24: Pier Building – Chemical cabinet containing motor oils, paints, insecticides, spray cans and lubricants within workshop.

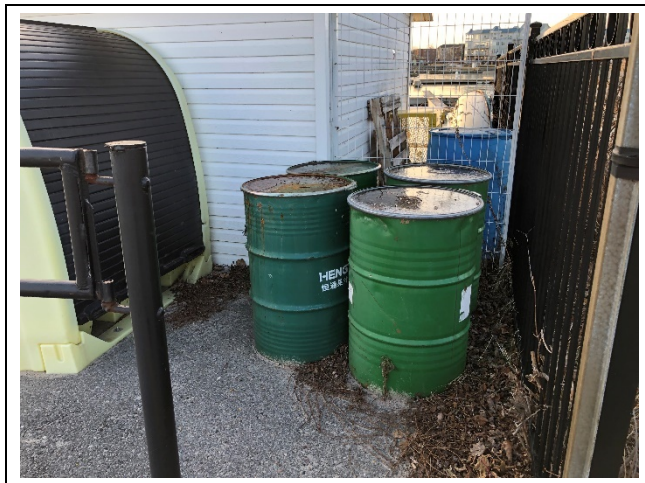
Photo 26: Garden Shed – Four unlabelled drums on exterior of shed.

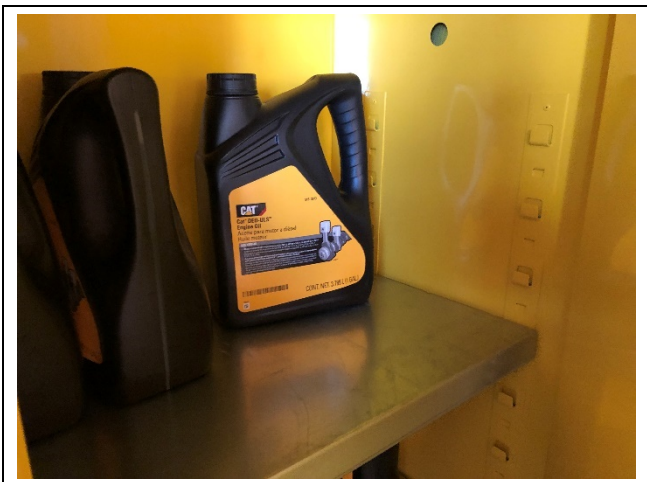
Photo 27: Garden Shed – Chemical cabinet containing motor oils, antifreeze, gasoline and diesel.

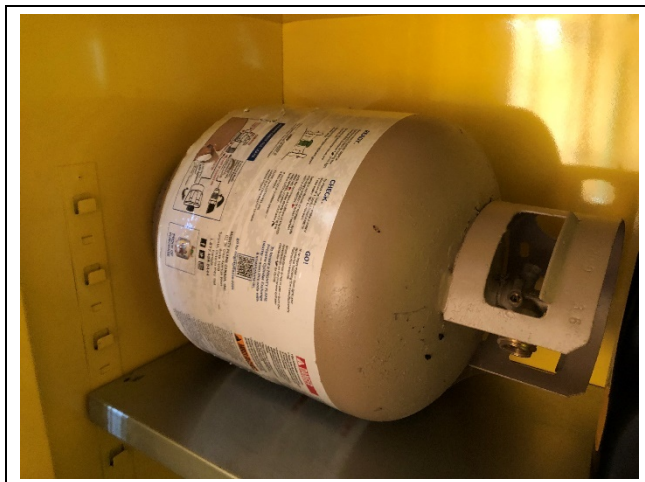
Photo 28: Garden Shed – Chemical cabinet containing liquified petroleum gas.

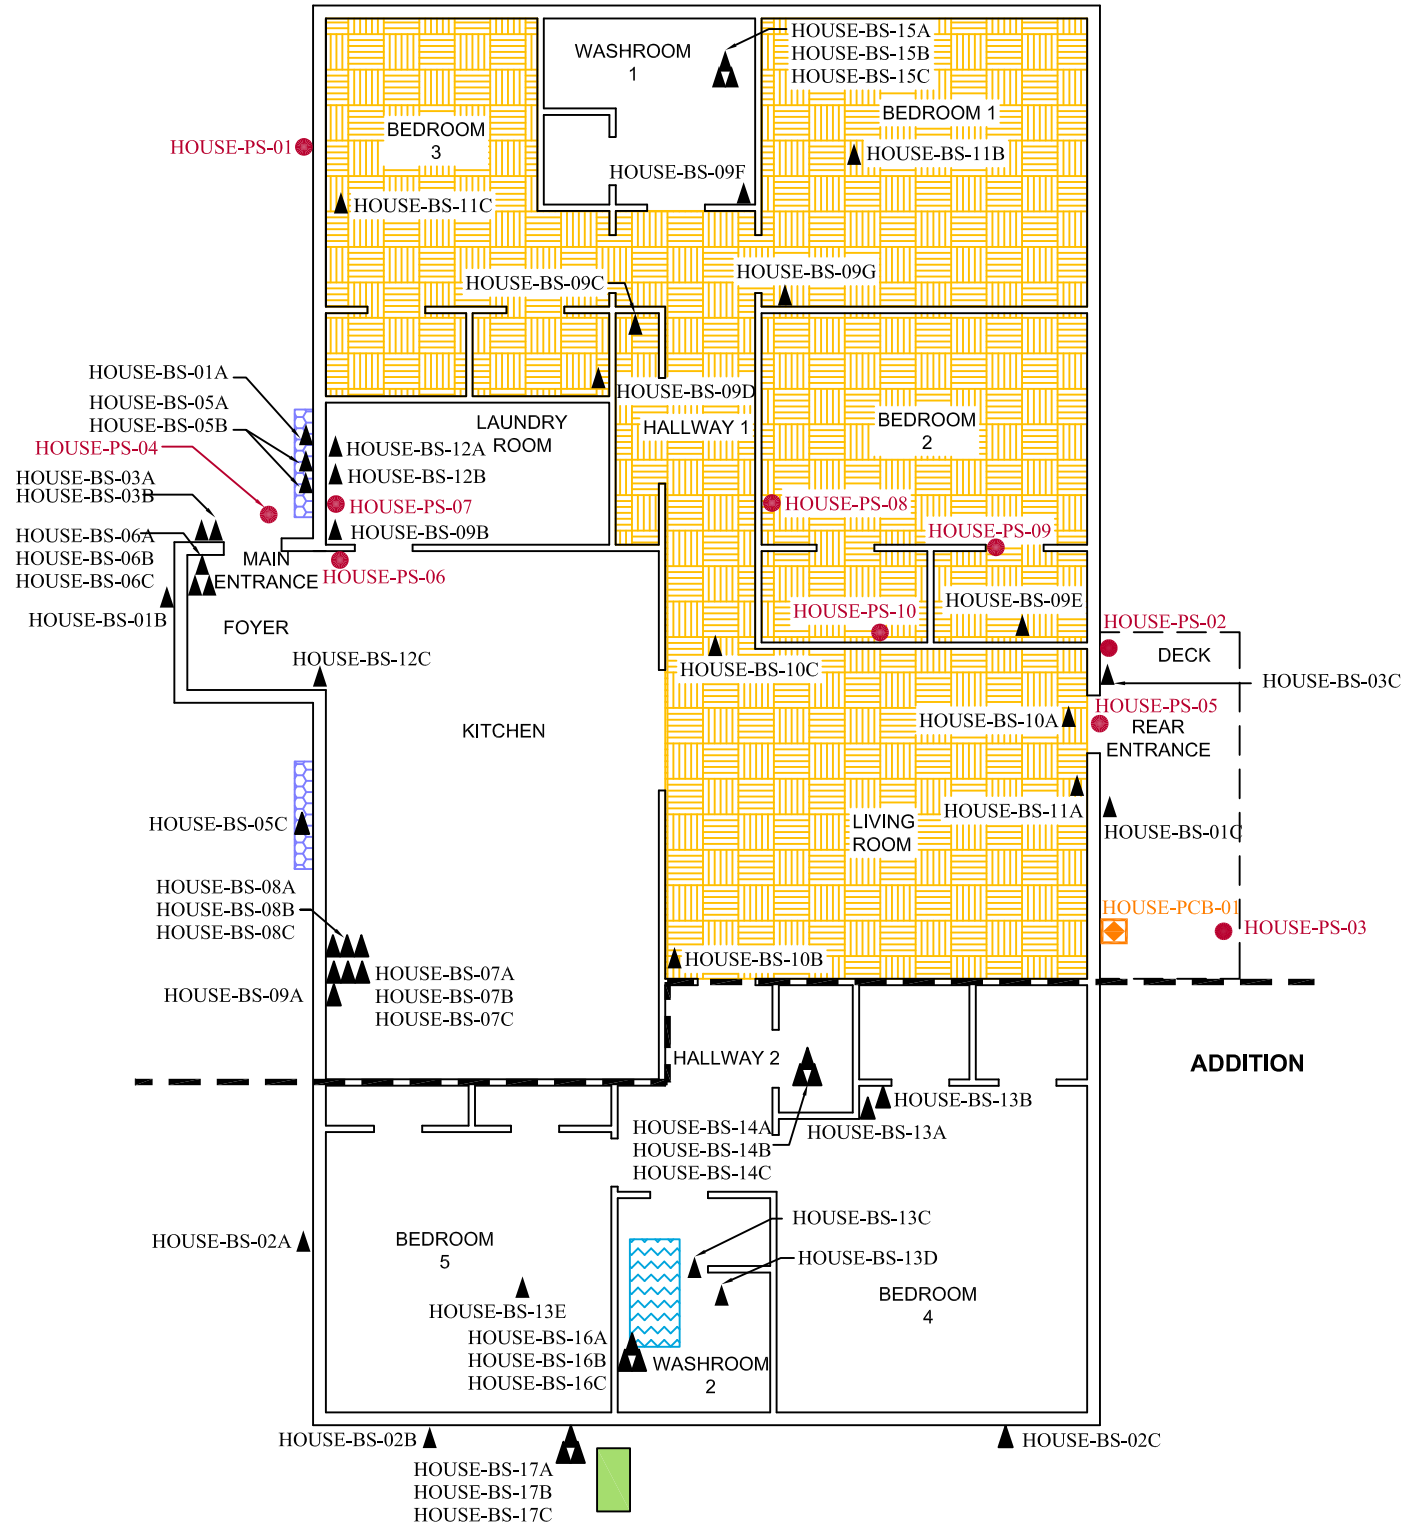
NOTE: ASBESTOS-CONTAINING VERMICULITE IS PRESENT IN THE ATTIC.
