Public Works and  
Government Services  
Canada

Travaux publics et  
Services gouvernementaux  
Canada

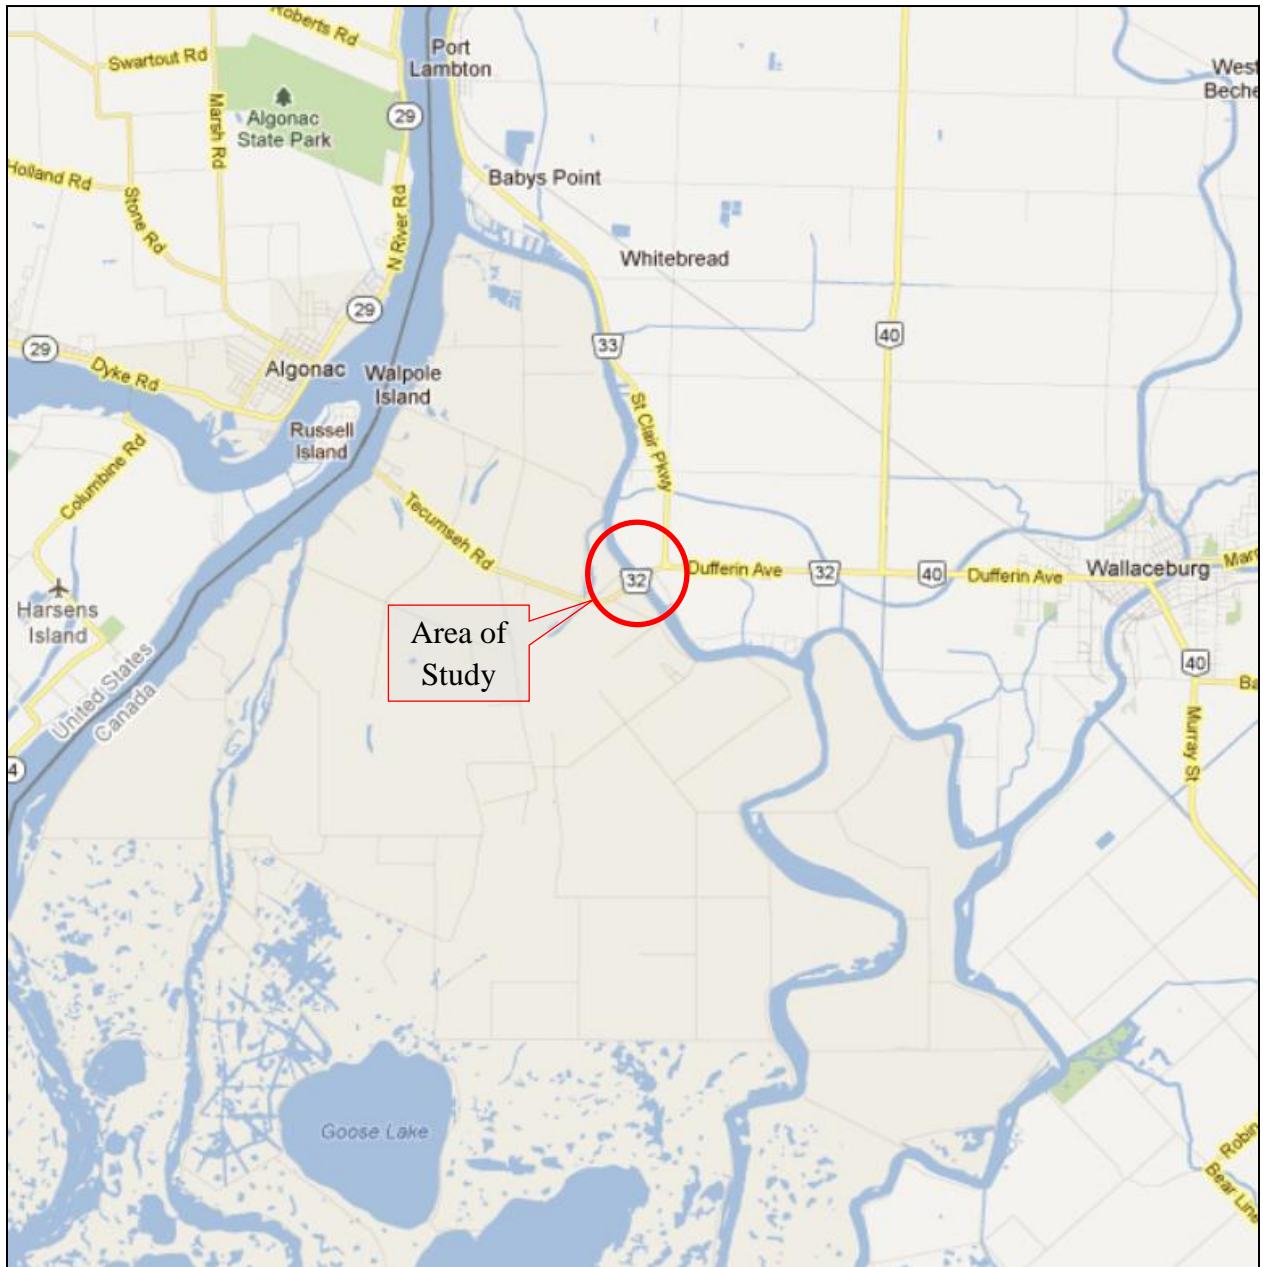
Walpole Island Swing Bridge  
Wallaceburg, Ontario

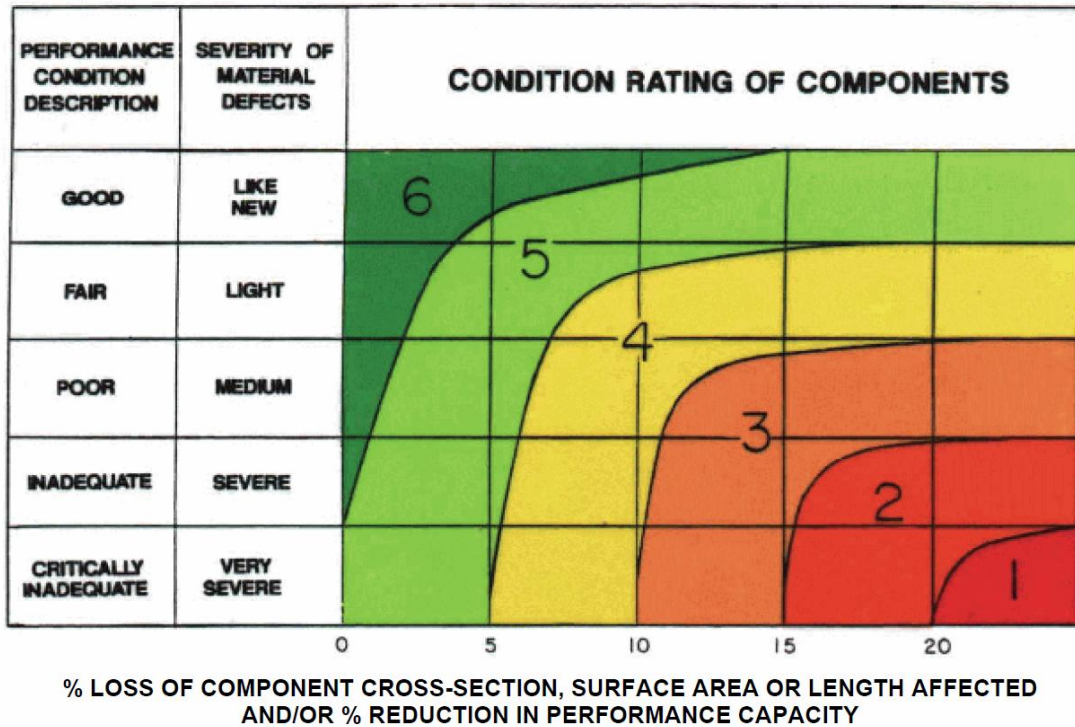
Figure 2.2 Condition Rating of Components

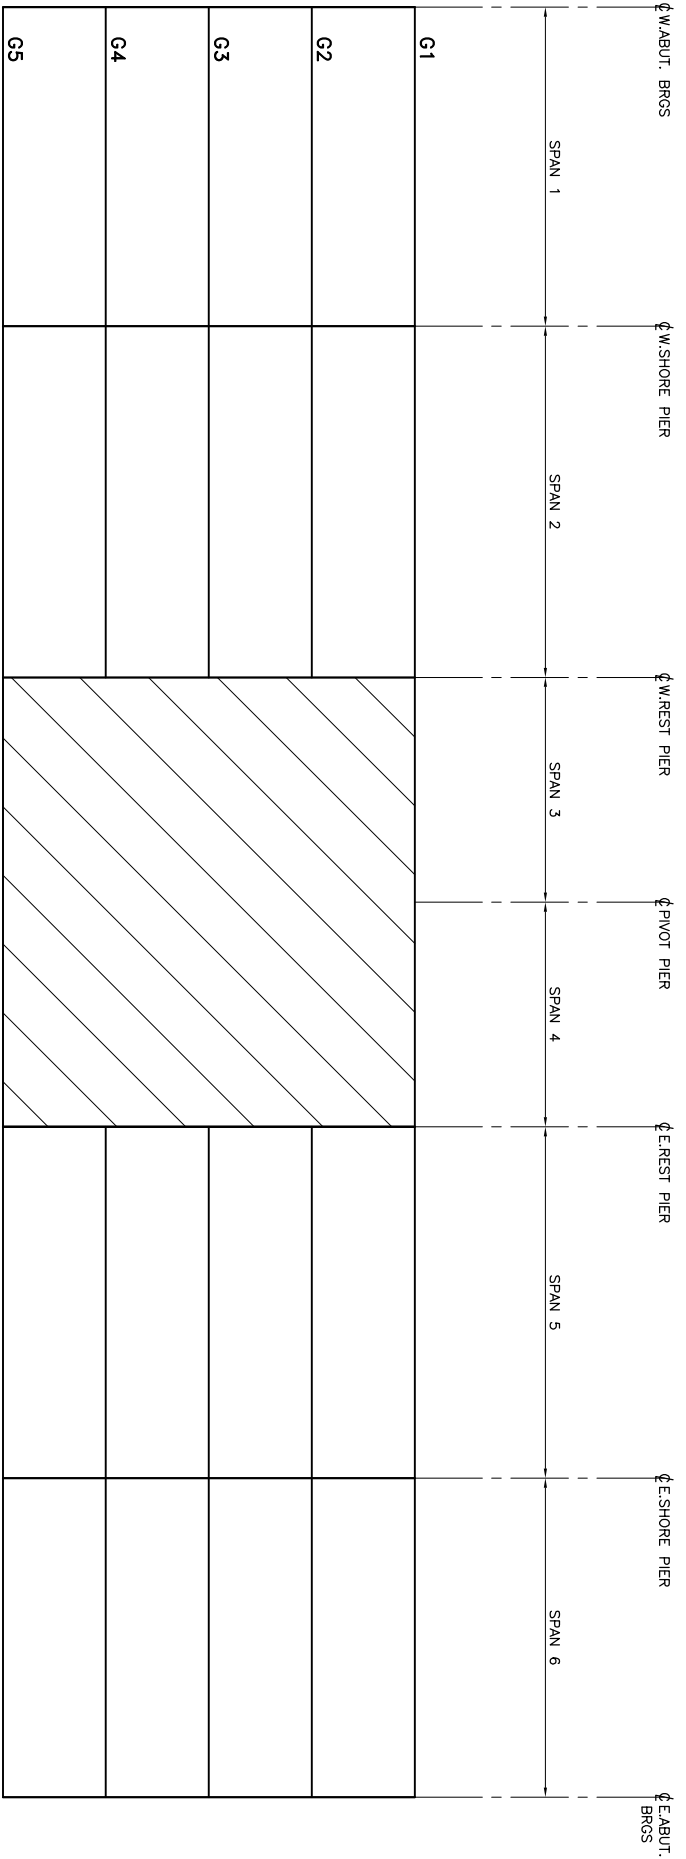
For the purpose of this report, the bridge is considered to be oriented in the west-east direction. The spans have been numbered from west (span 1) increasing to the east (span 6), as shown in Figure 1. For clarity and simplification, the main swing span has been divided into two (2) spans on either side of the pivot pier, thus resulting in a total of six (6) spans. The girders and bearings have been numbered from north increasing to the south and are distinguished according to the appropriate span.

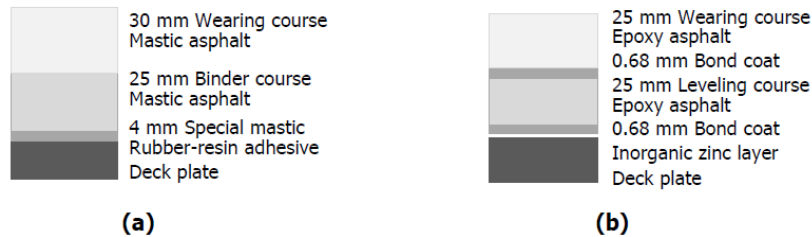
Figure 2 – Typical Component Layers: (a) Mastic Asphalt; and (b) Epoxy Asphalt.

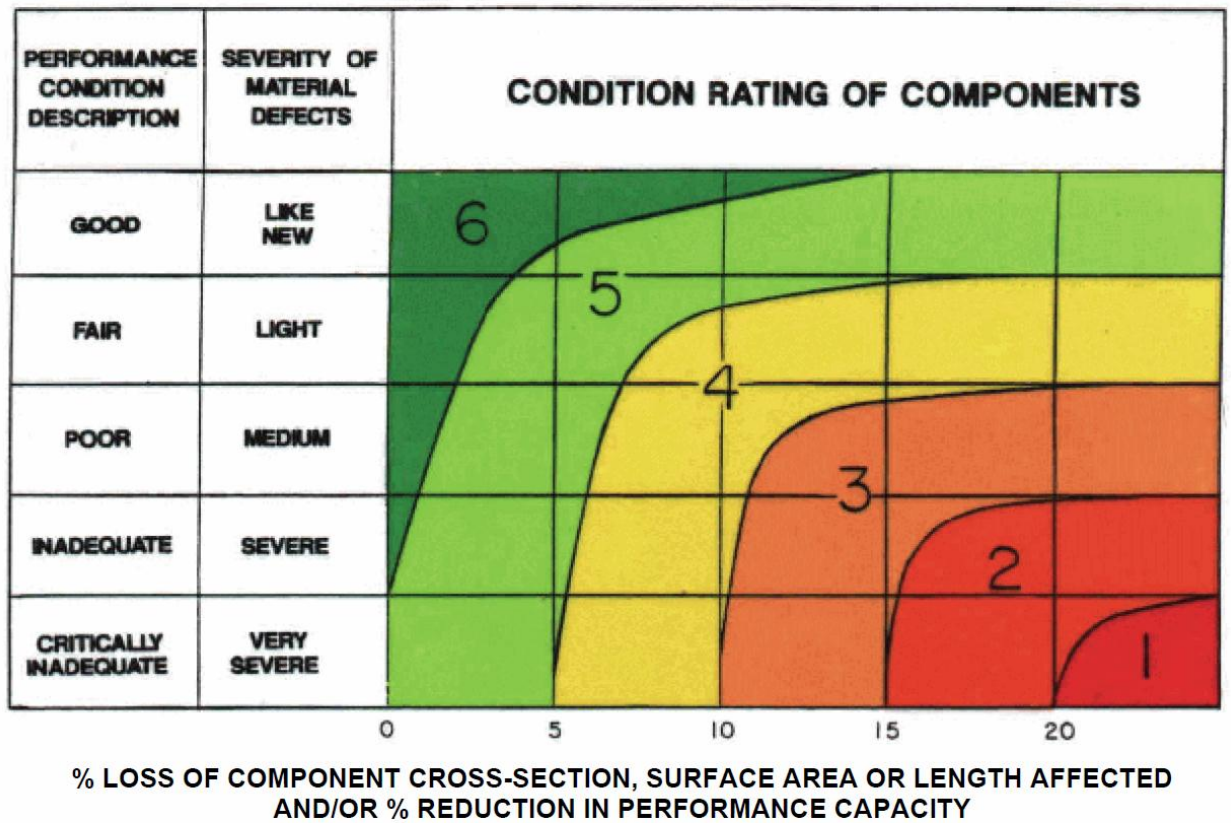
Figure 2.2 Condition Rating of Components

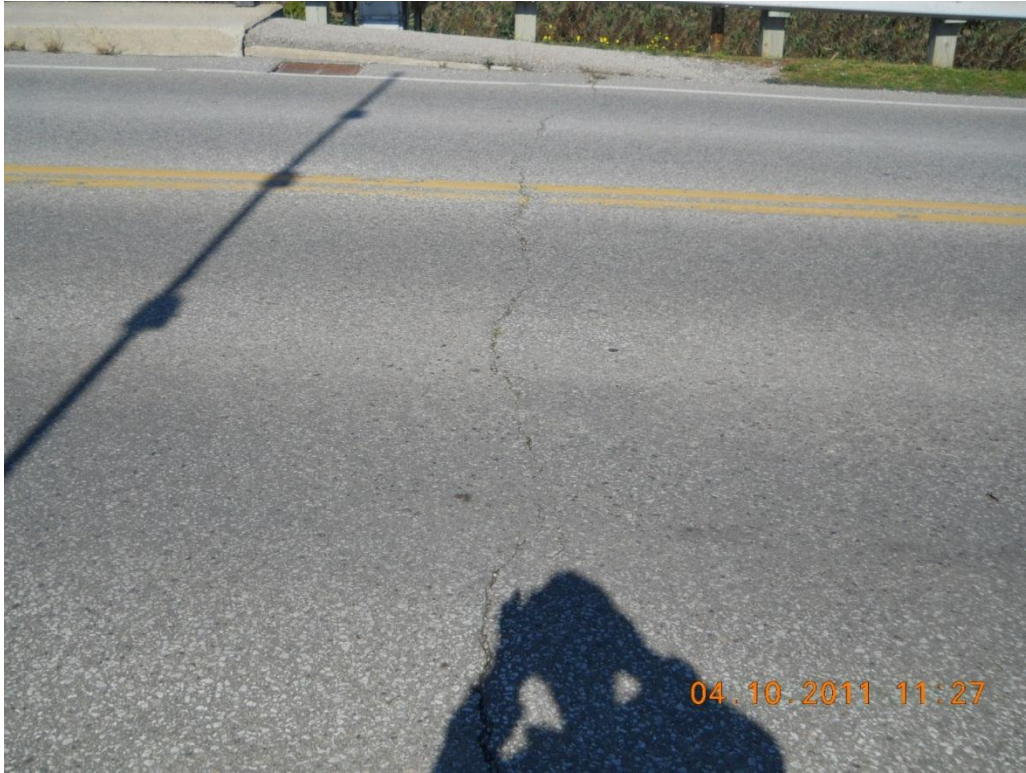
Photograph 11 - East approach slab wearing surface, note transverse crack

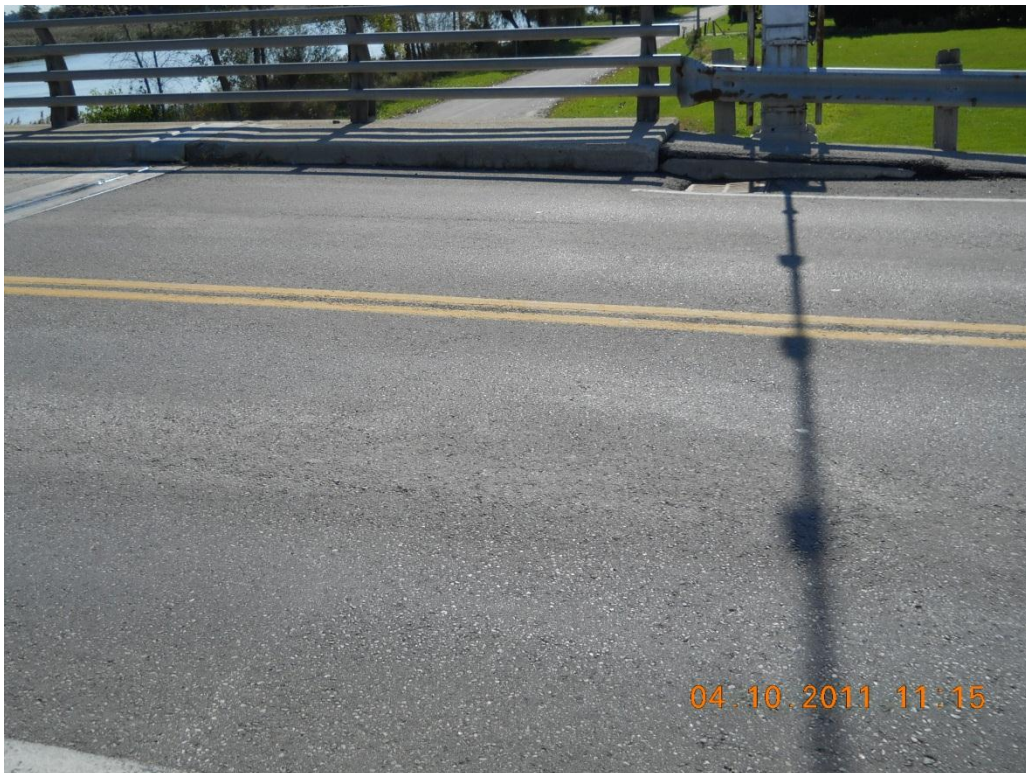
Photograph 12 - West approach slab wearing surface

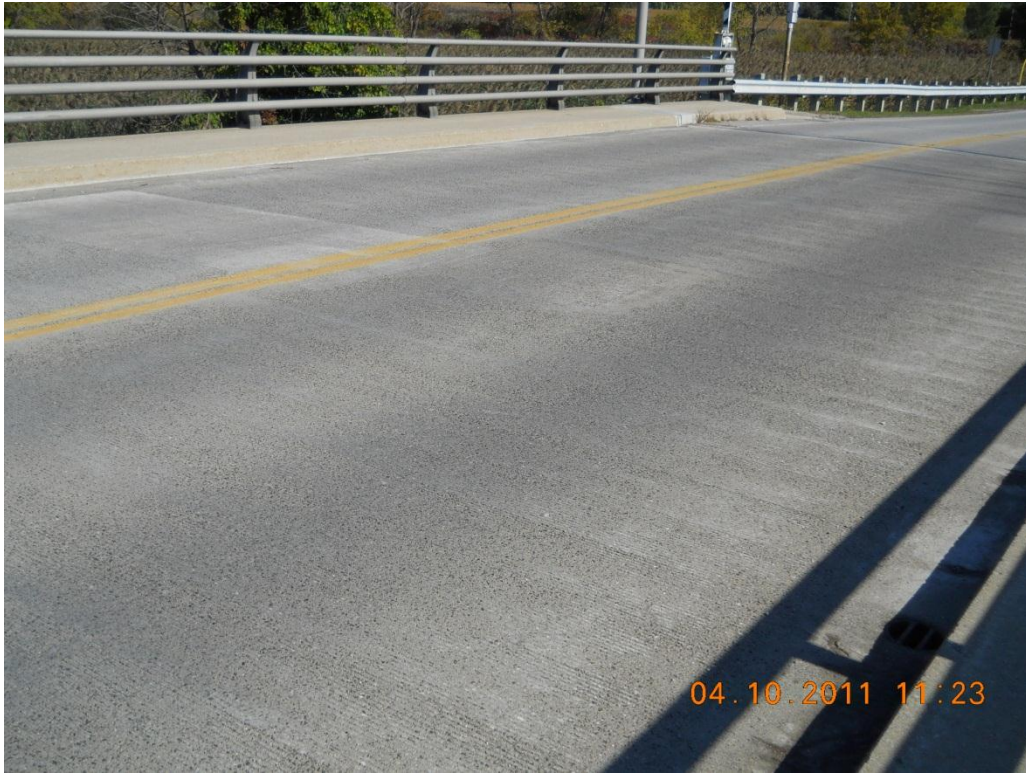
Photograph 13 - Span 6 wearing surface looking east

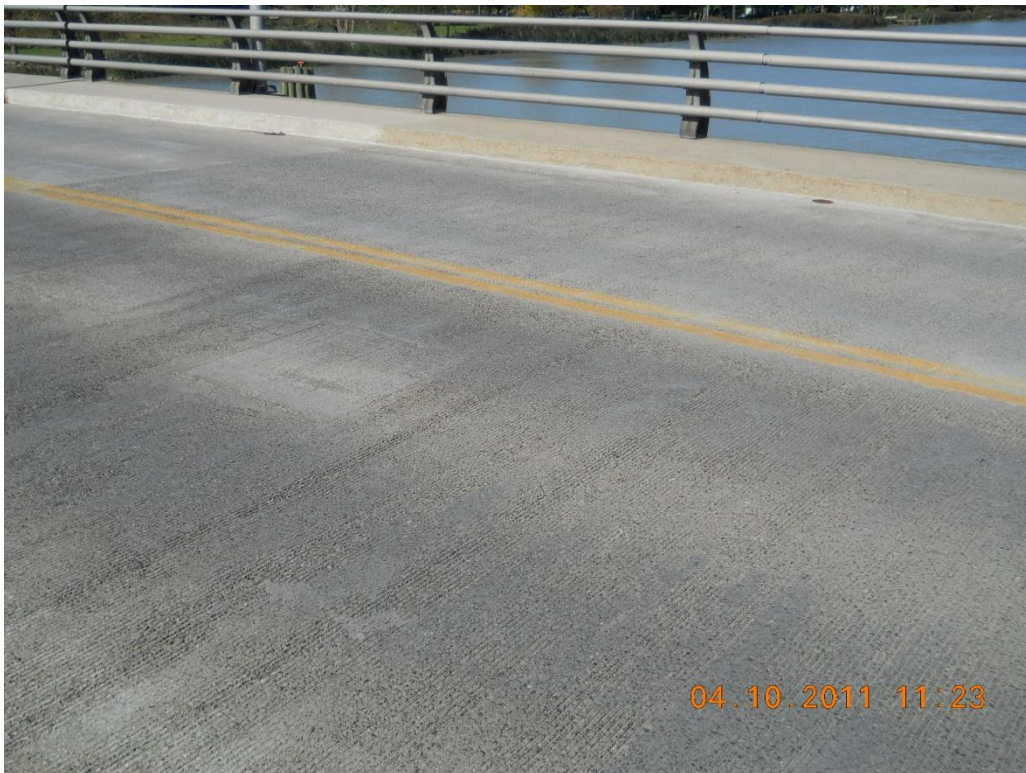
Photograph 14 - Span 5 wearing surface looking west

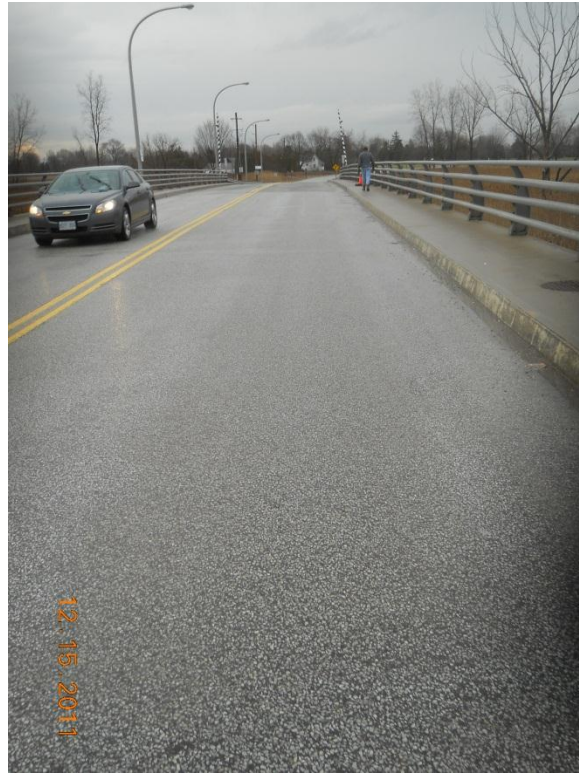
Photograph 15 - Span 4 asphalt wearing surface looking east, eastbound lane

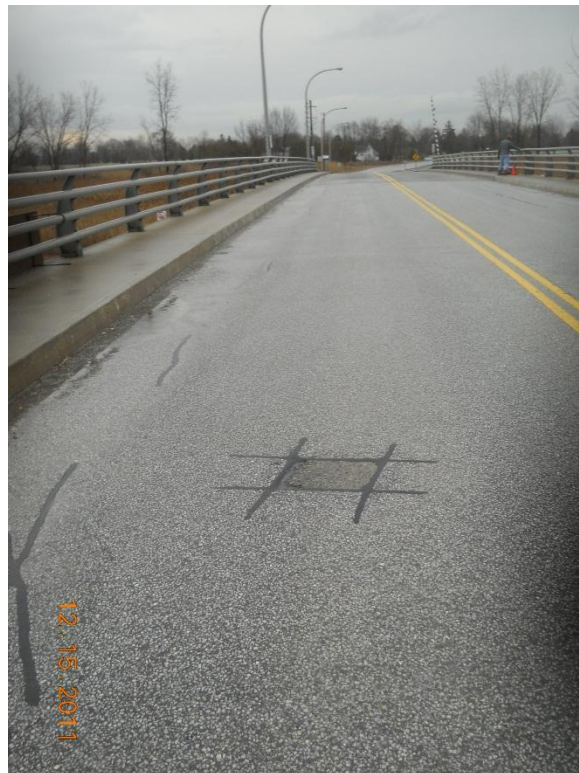
Photograph 16 - Span 4 asphalt wearing surface looking east, westbound lane, note patch

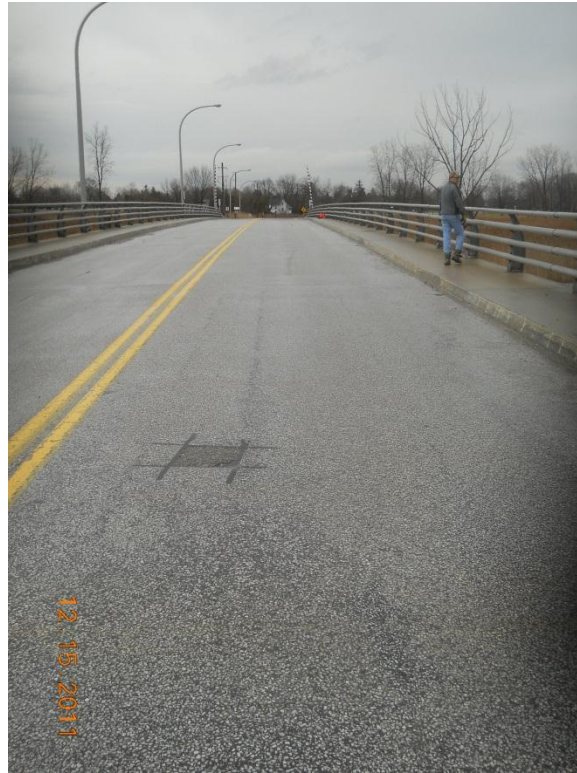
Photograph 17 - Span 3 asphalt wearing surface looking east, eastbound lane, note patch

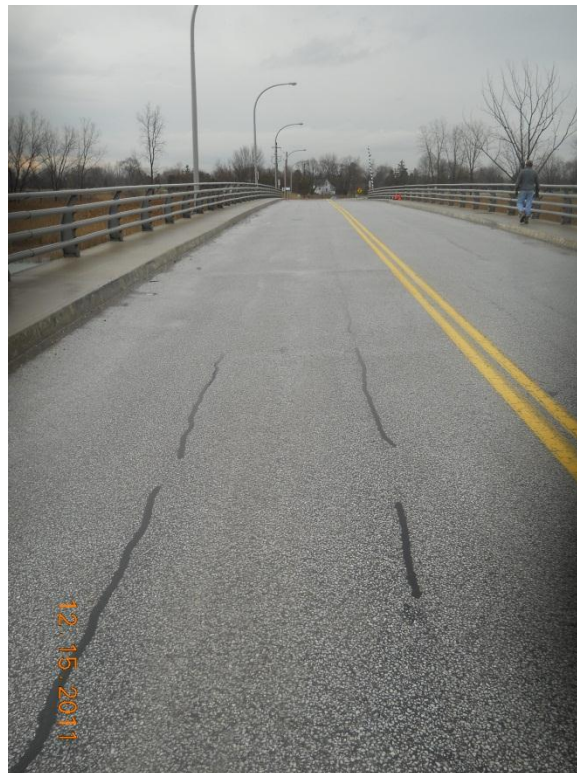
Photograph 18 - Span 3 asphalt wearing surface looking east, westbound lane, note sealed crack

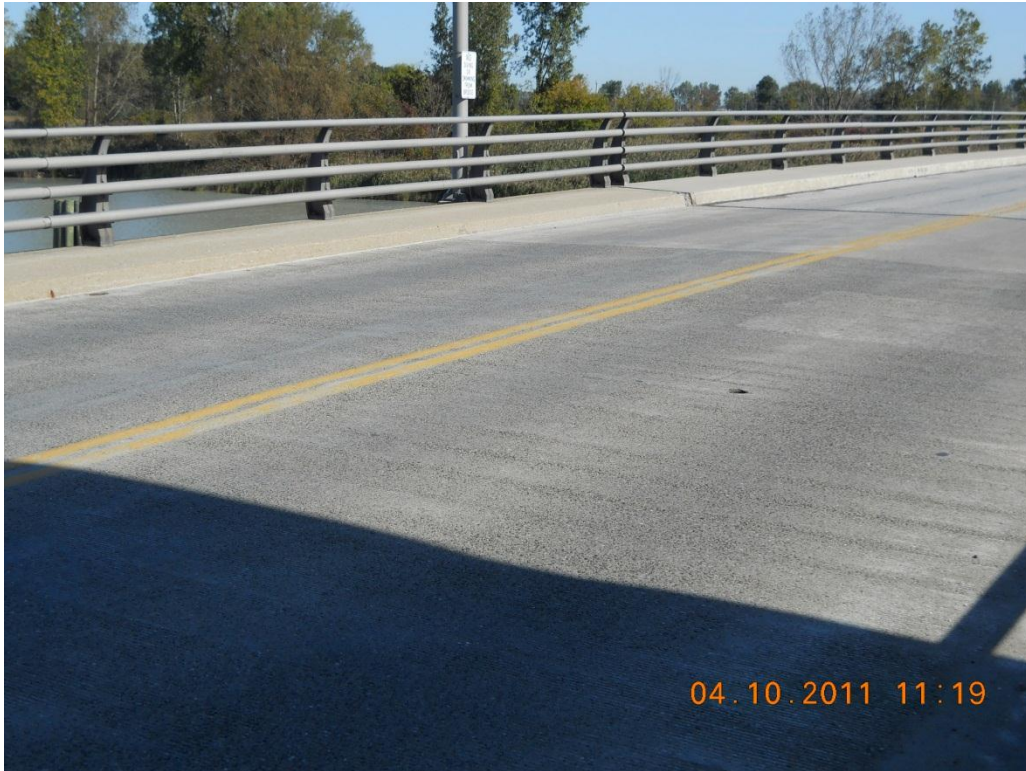
Photograph 19 - Span 2 wearing surface looking east

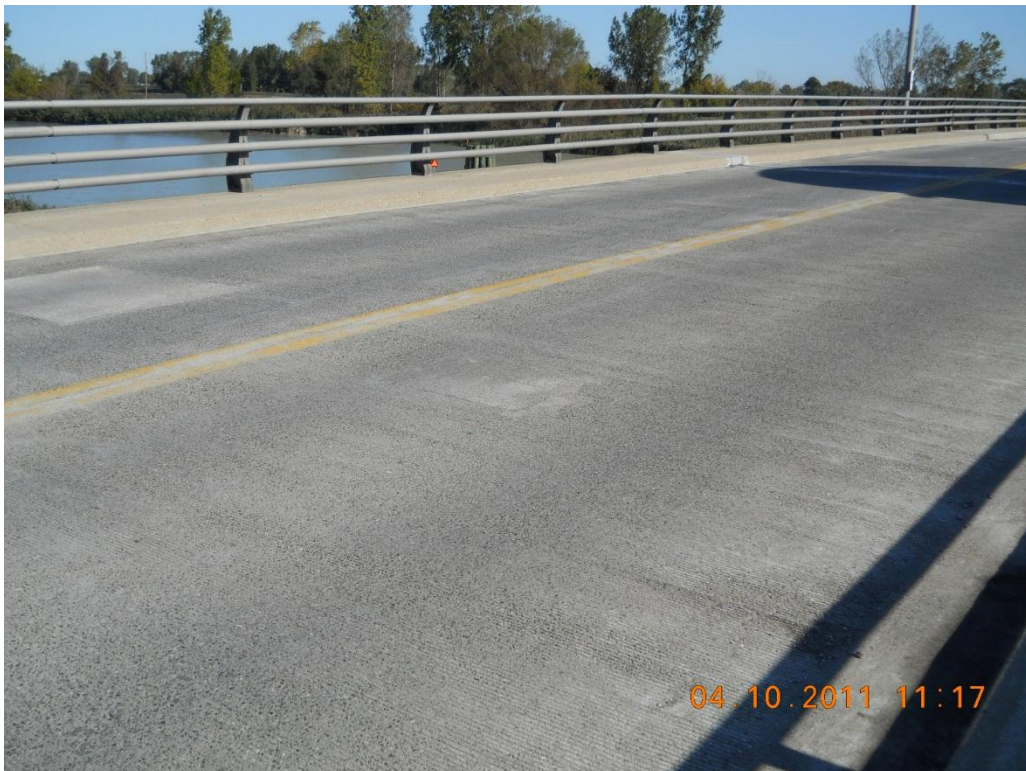
Photograph 20 - Span 1 wearing surface looking east

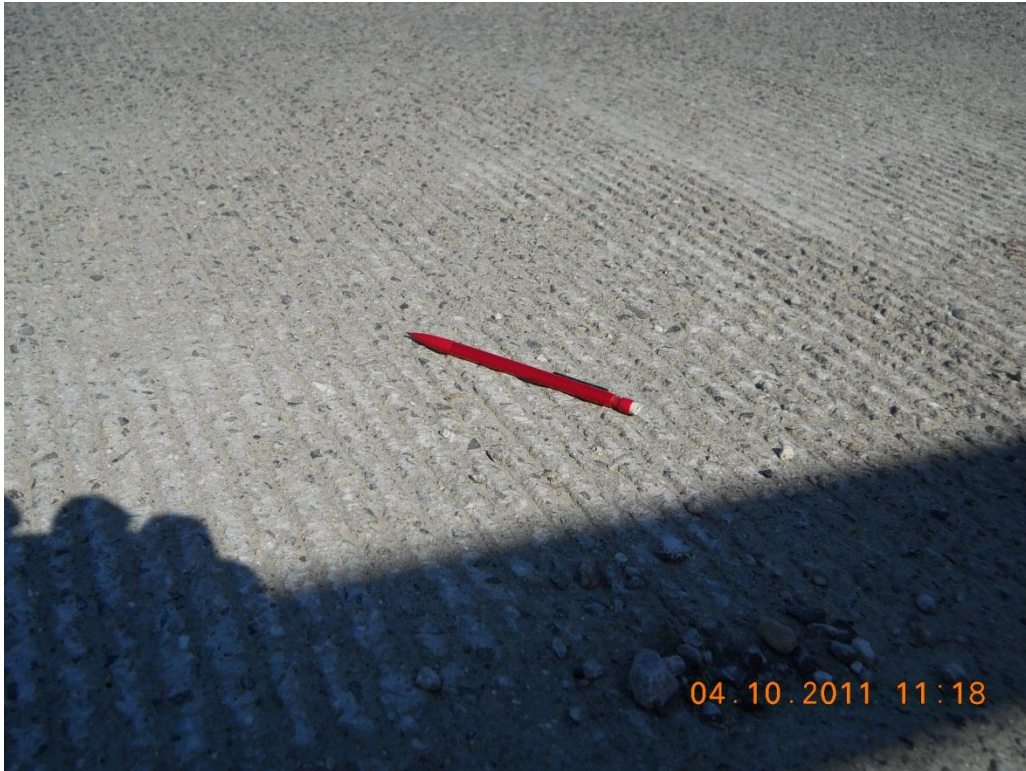
Photograph 21 - Typical span 1, 2, 5, 6 wearing surface

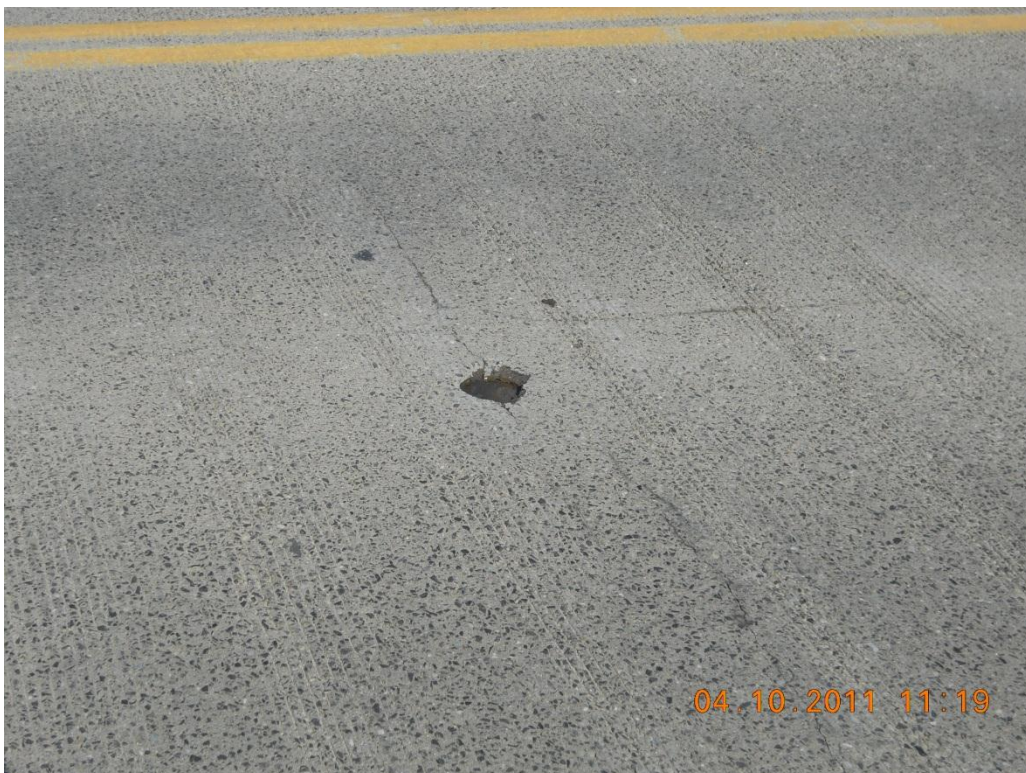
Photograph 22 - Span 2, note core hole and cracking

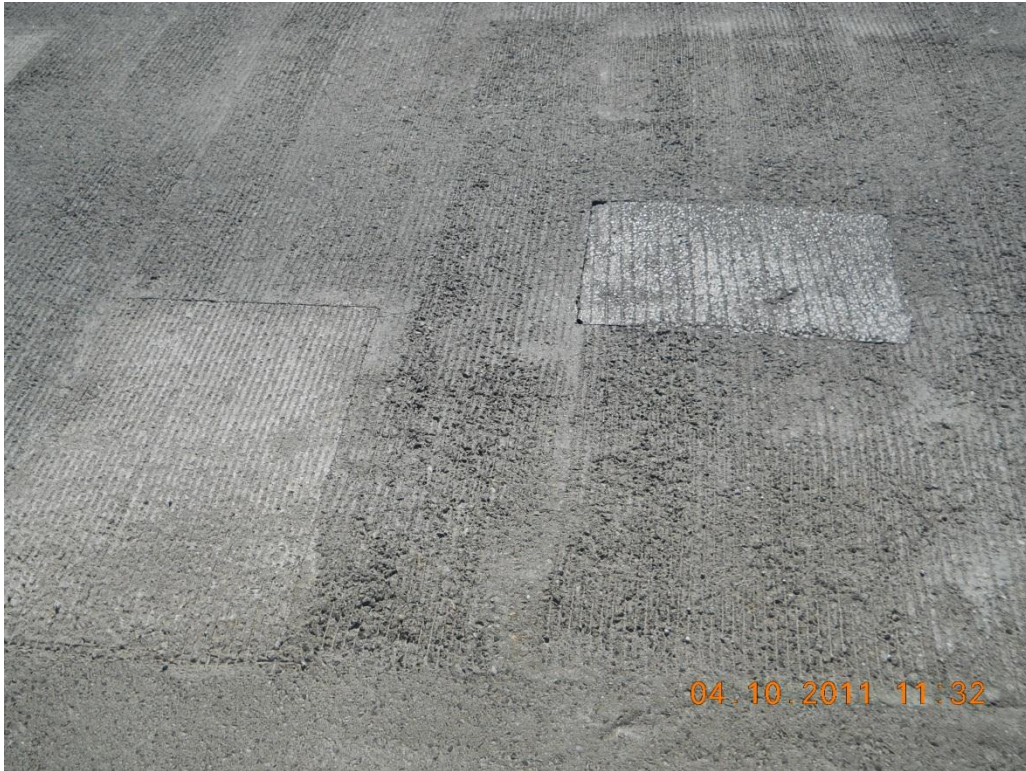
Photograph 23 - Span 1 concrete patches

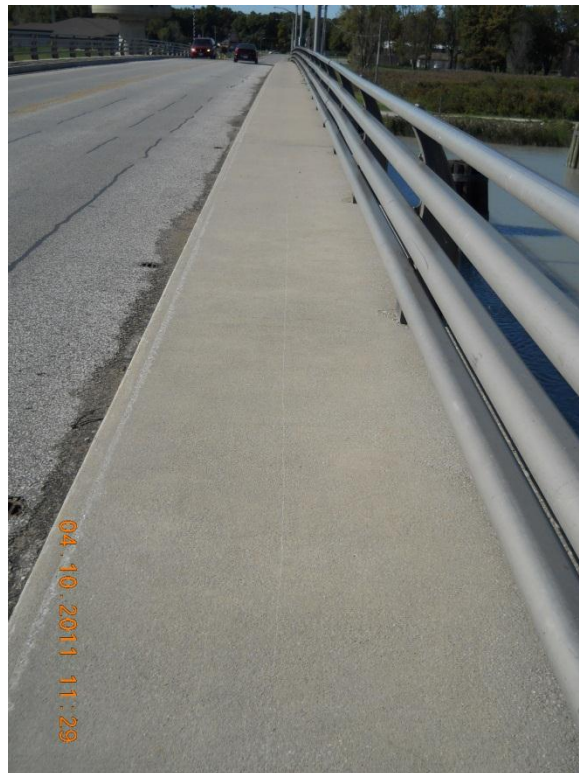
Photograph 24 - North sidewalk looking west, typical condition

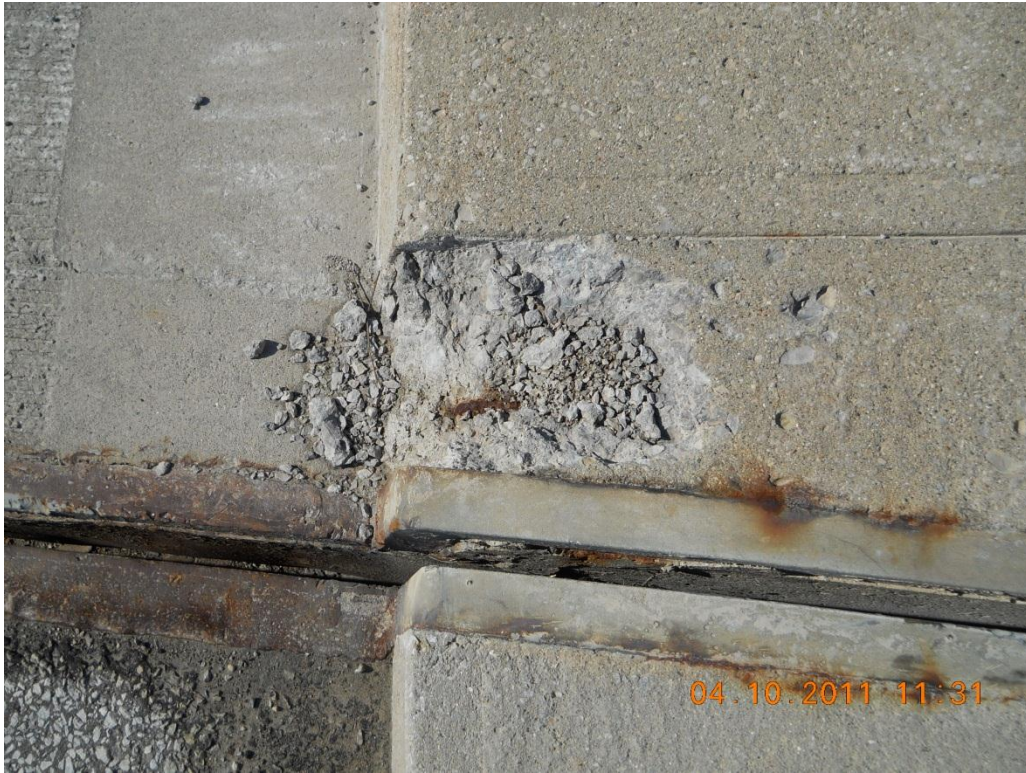
Photograph 25 - Spall on north curb at west rest pier

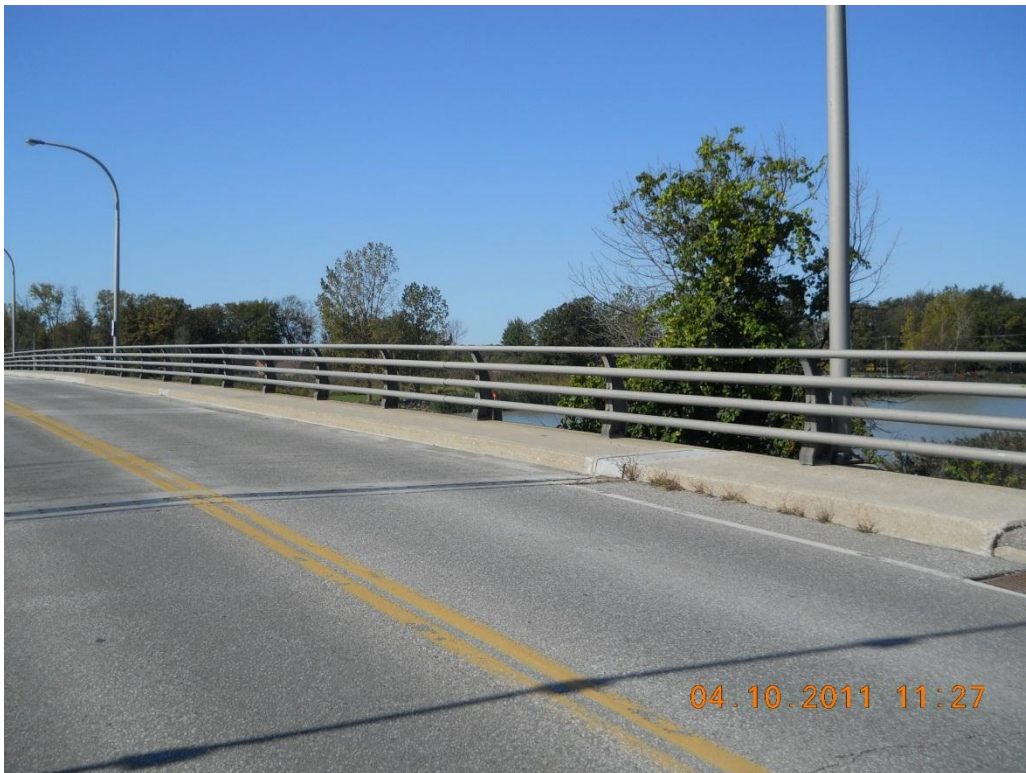
Photograph 26 - North railing looking west

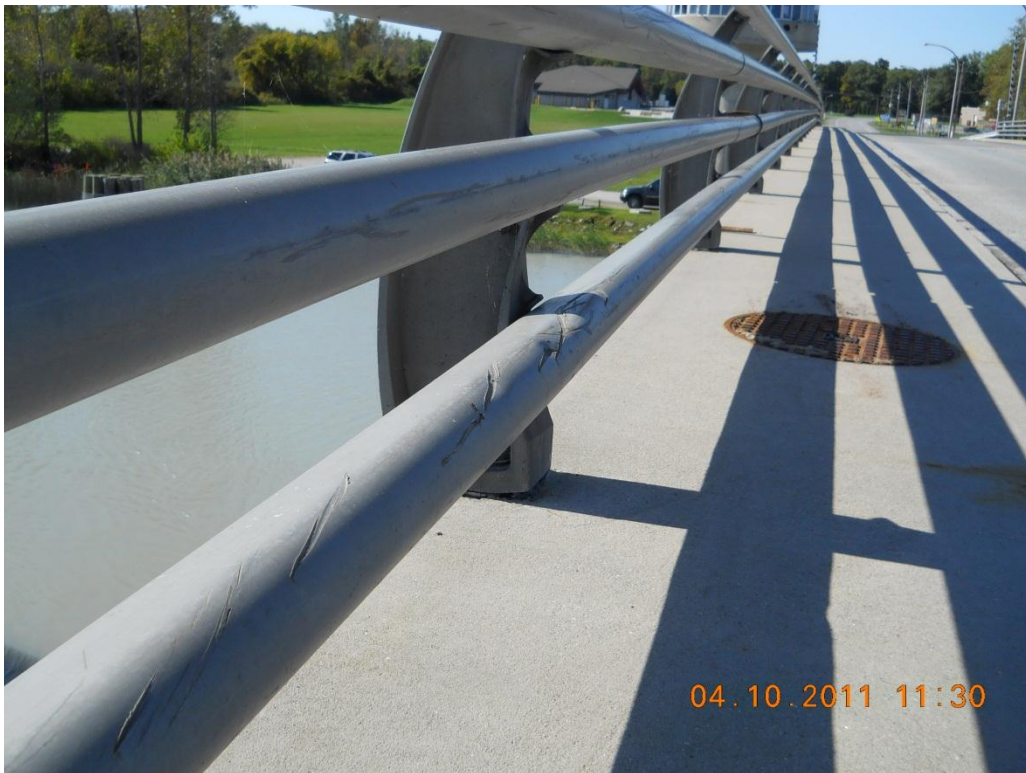
Photograph 28 - South railing, note impact damage above west rest pier

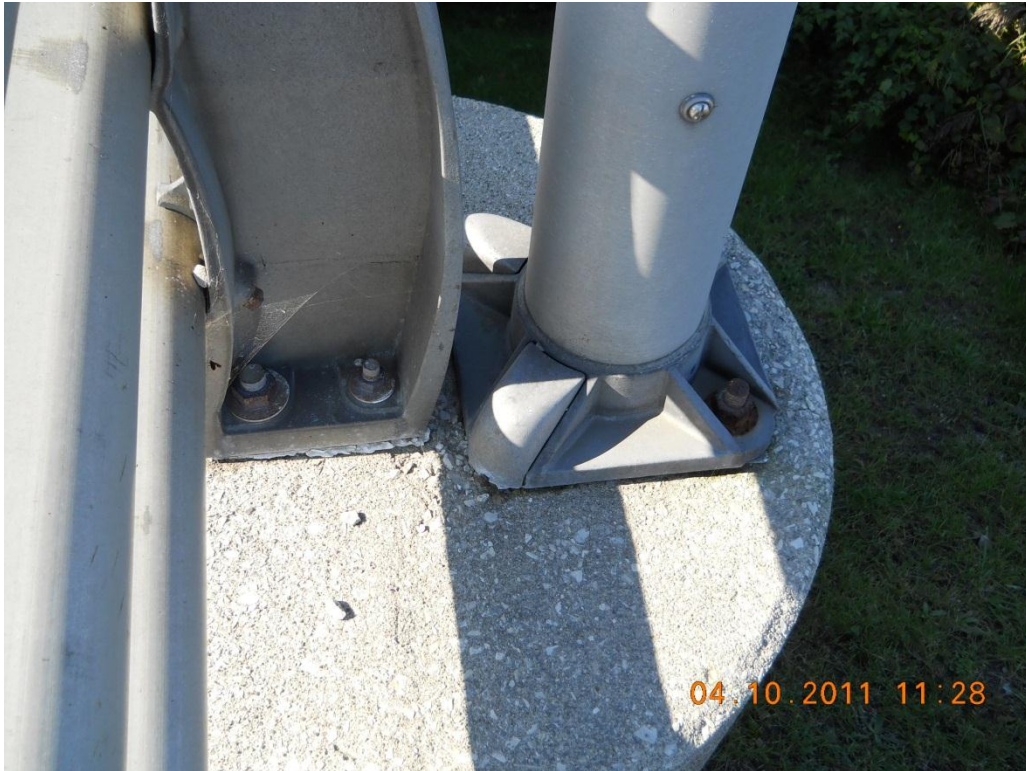
Photograph 29 - Typical railing and lamp post anchorages

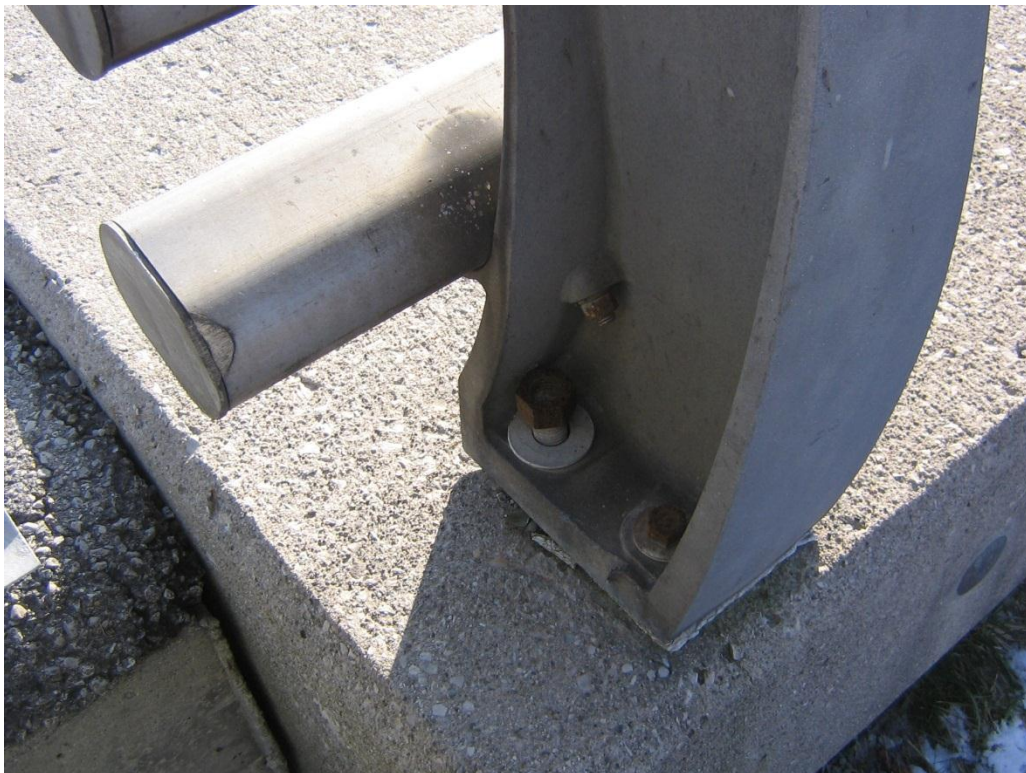
Photograph 30 - Note loose bolt on railing post at northeast corner

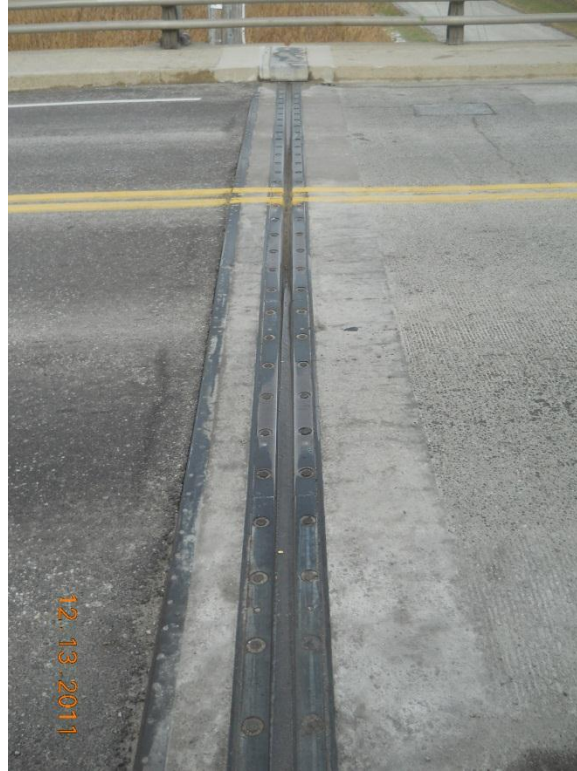
Photograph 31 - West abutment expansion joint looking north, note some debris accumulation

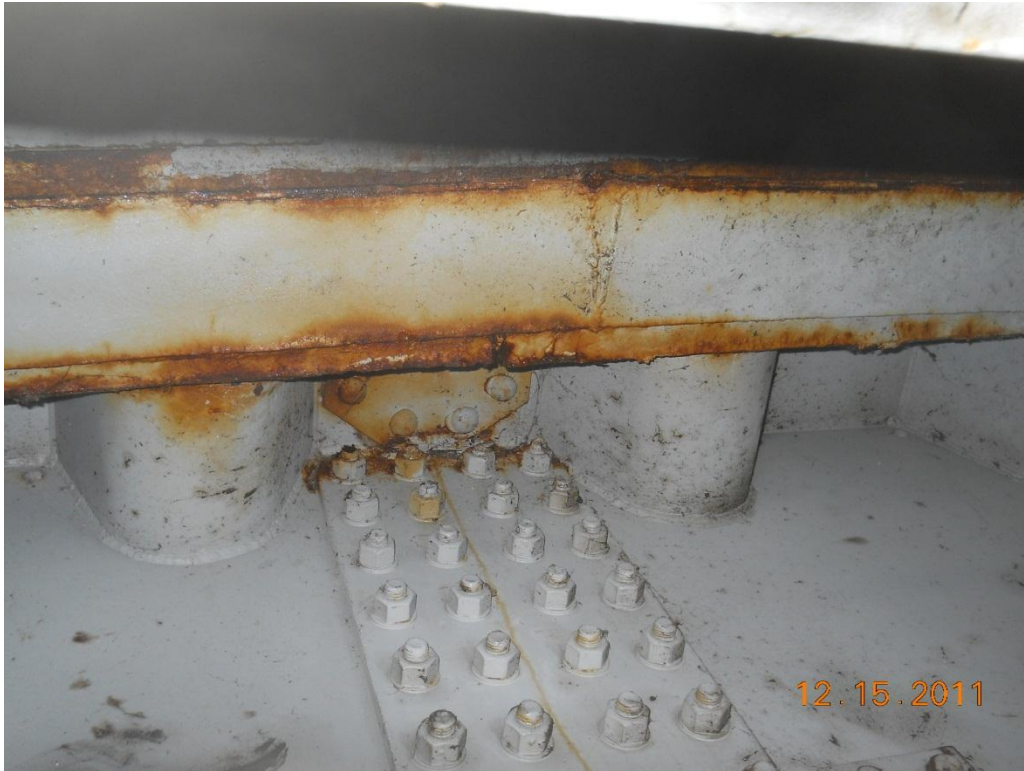
Photograph 35 - East rest pier underside of joint looking up from centre, note corrosion

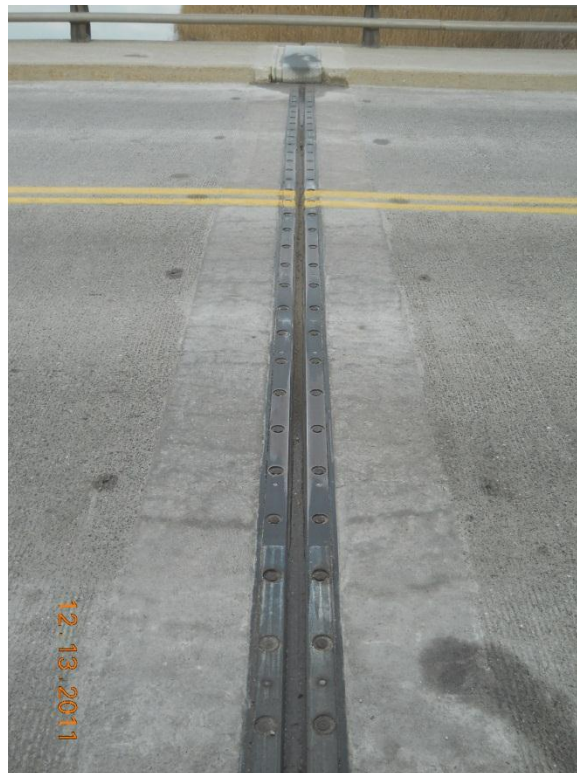
Photograph 36 - East shore pier expansion joint looking north, note some debris accumulation

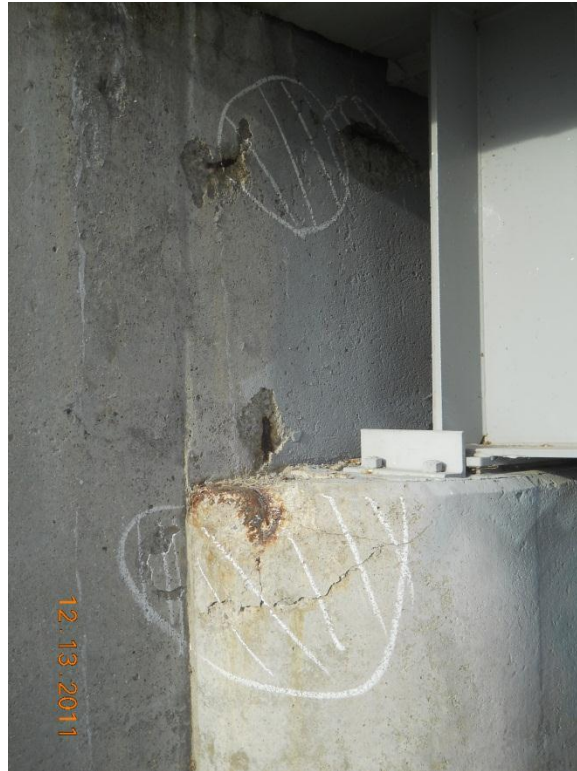
Photograph 49 - South end of west abutment, note spalling and delamination

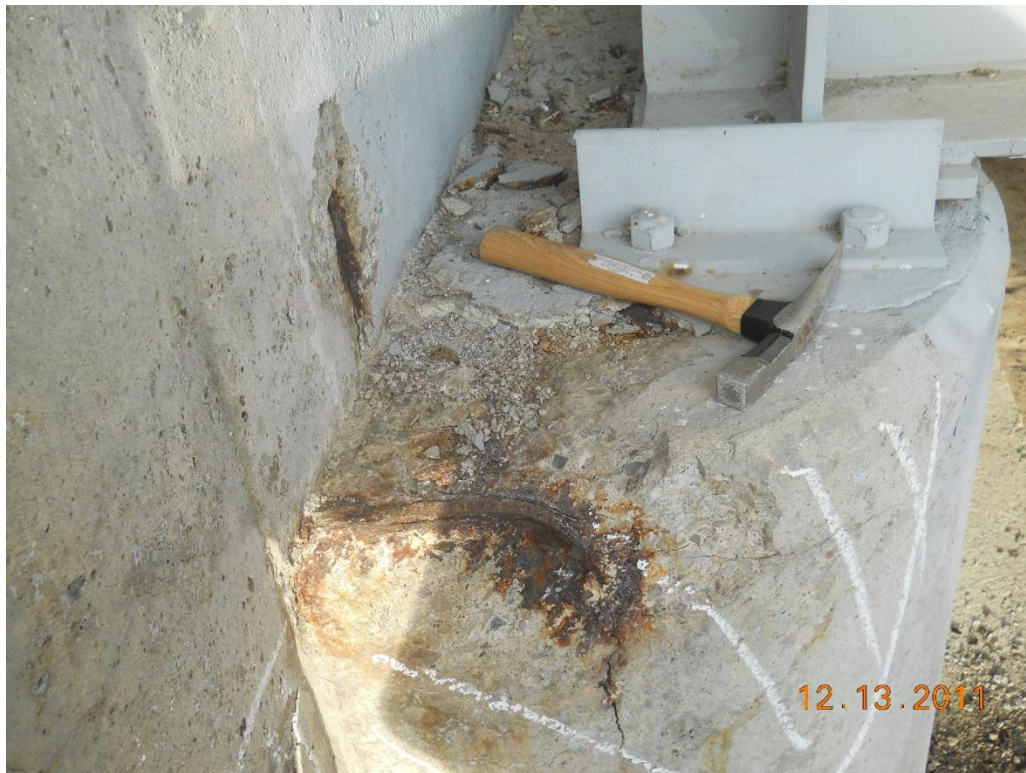
Photograph 50 - South end of west abutment bearing seat, note spalling and delamination

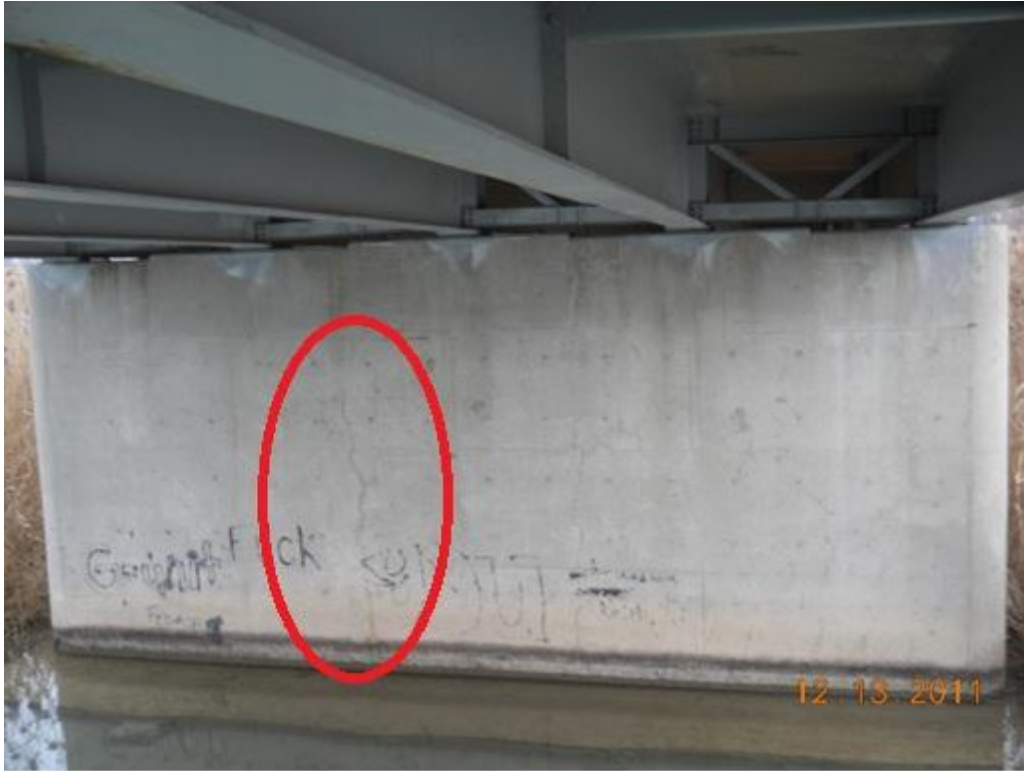
Photograph 51 - West face of east shore pier, note vertical crack near centre
