Public Works and  
Government Services  
Canada

Travaux publics et  
Services gouvernementaux  
Canada

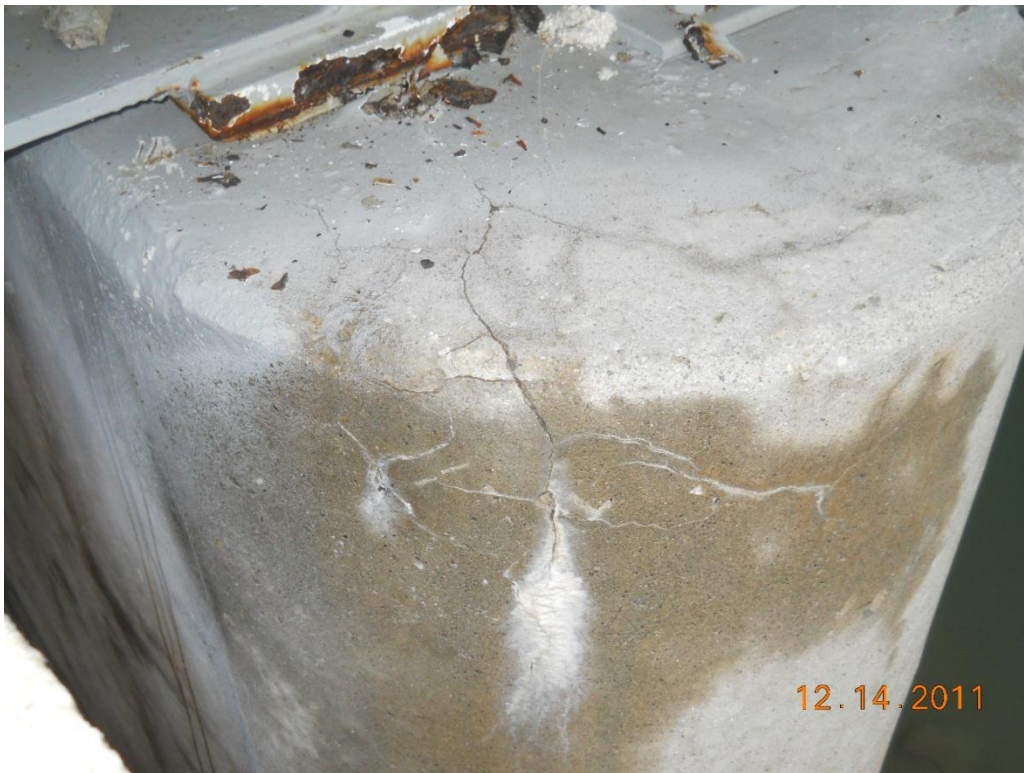
Photograph 52 - North end of bearing seat of east shore pier, note cracking and efflorescence

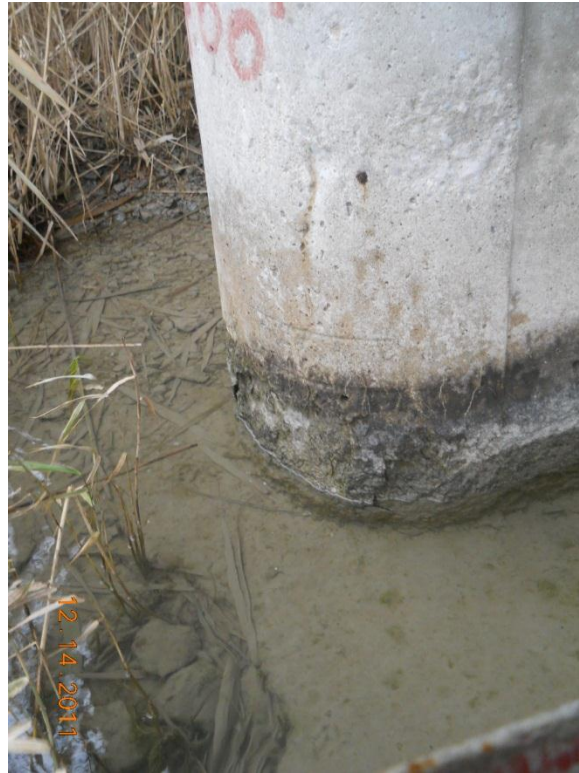
Photograph 53 - North end of east shore pier, note light concrete erosion at waterline

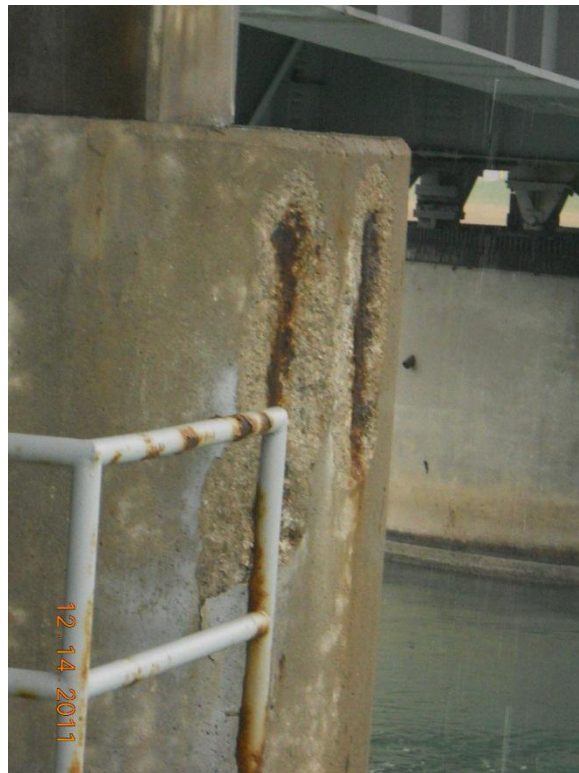
Photograph 56 - North face of east rest pier, note exposed corroded reinforcing steel bars

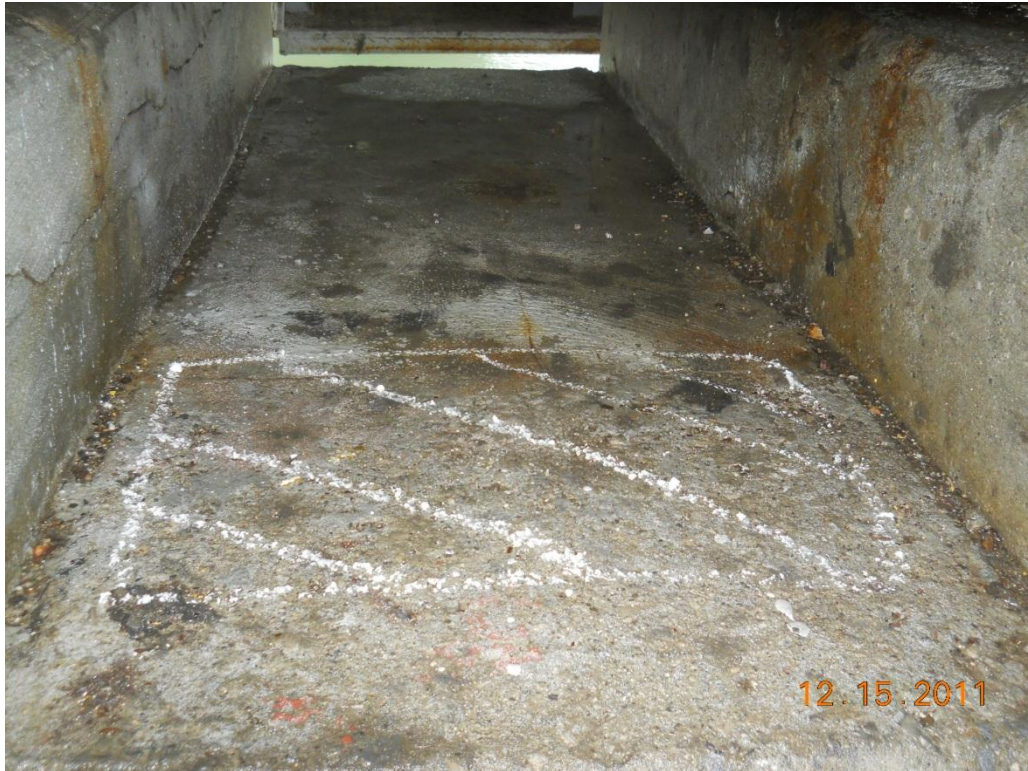
Photograph 57 - Top of east rest pier, note delamination

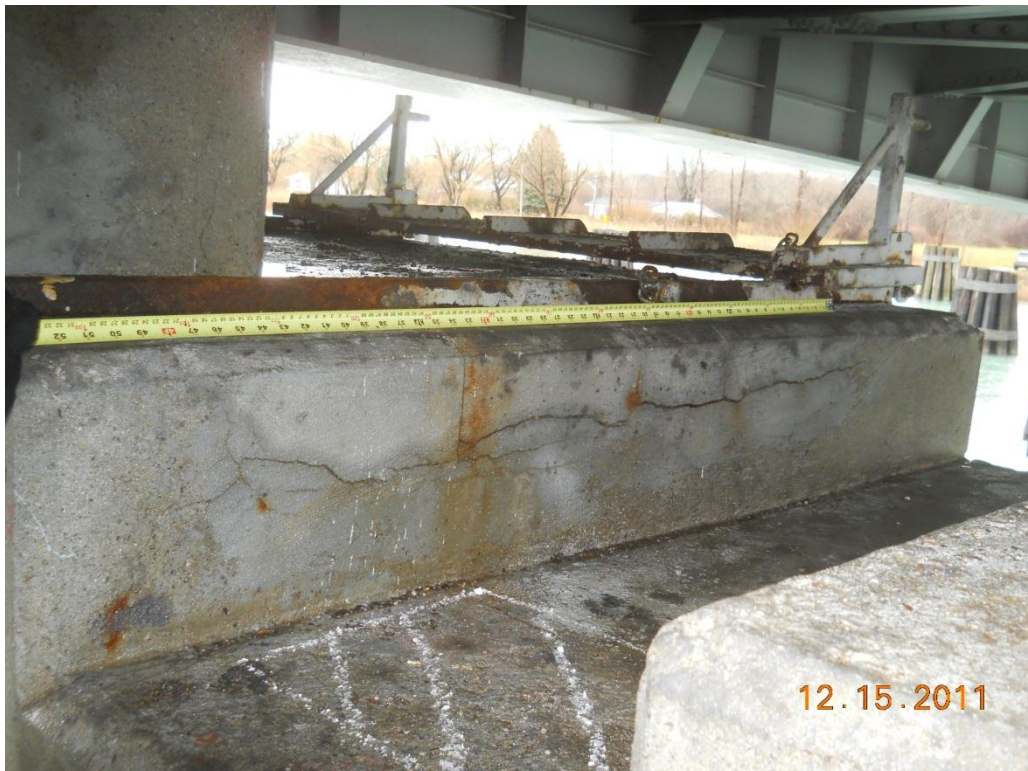
Photograph 58 - Top of east rest pier, note crack

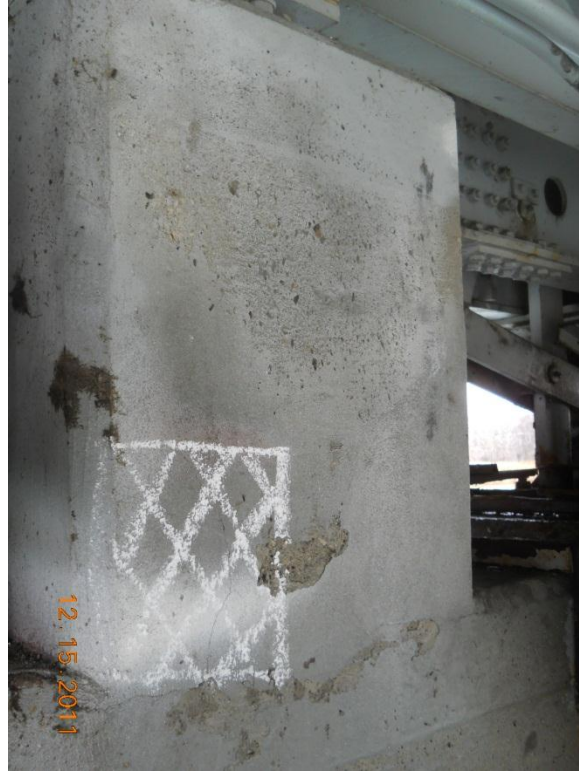
Photograph 59 - Span 5 girder 3 bearing pedestal, note delamination

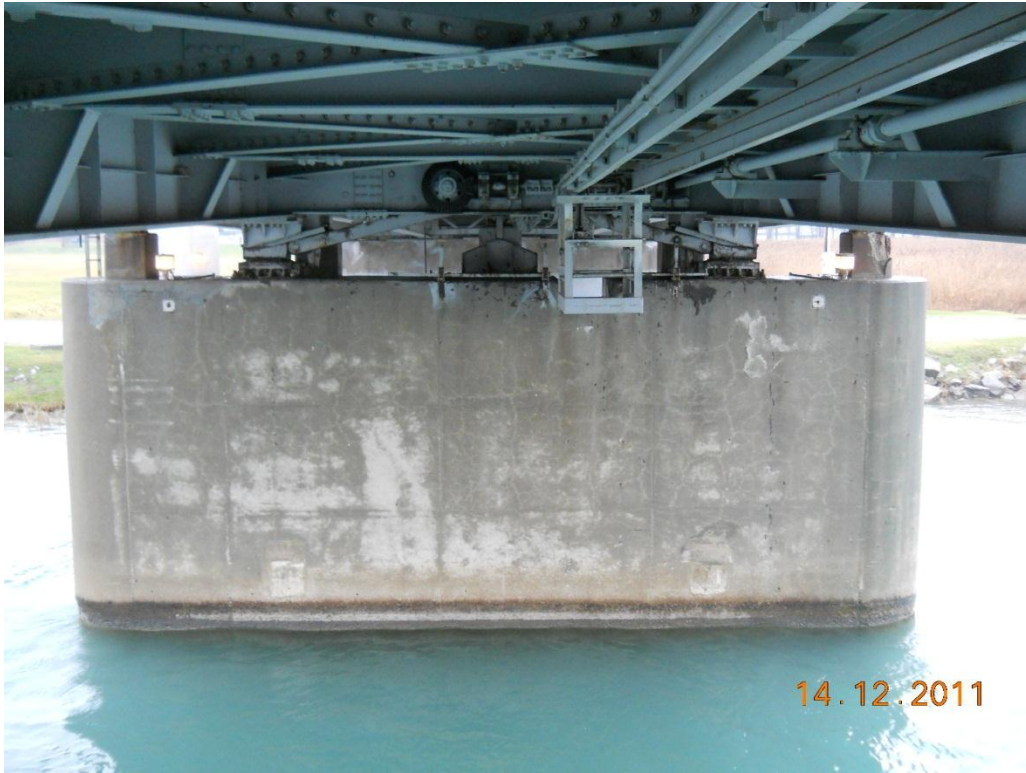
Photograph 61 - East face of west rest pier, note random cracking

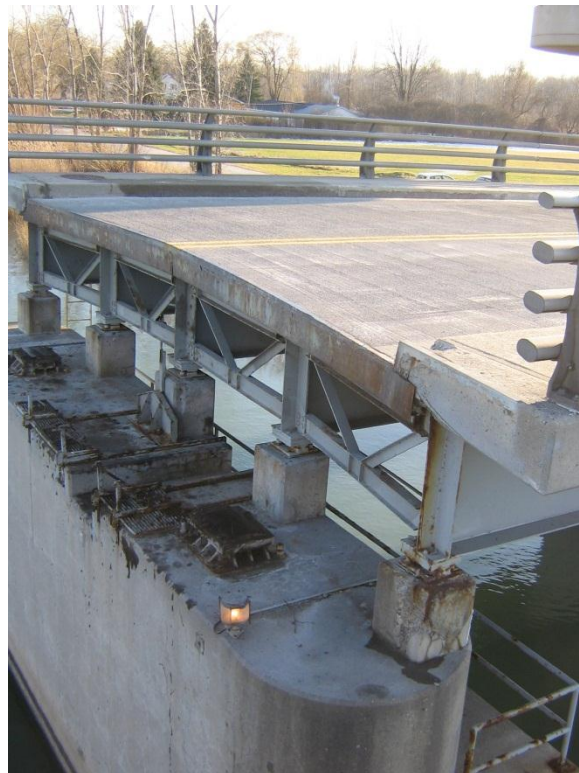
Photograph 62 - Top of west rest pier looking south with swing span in open position

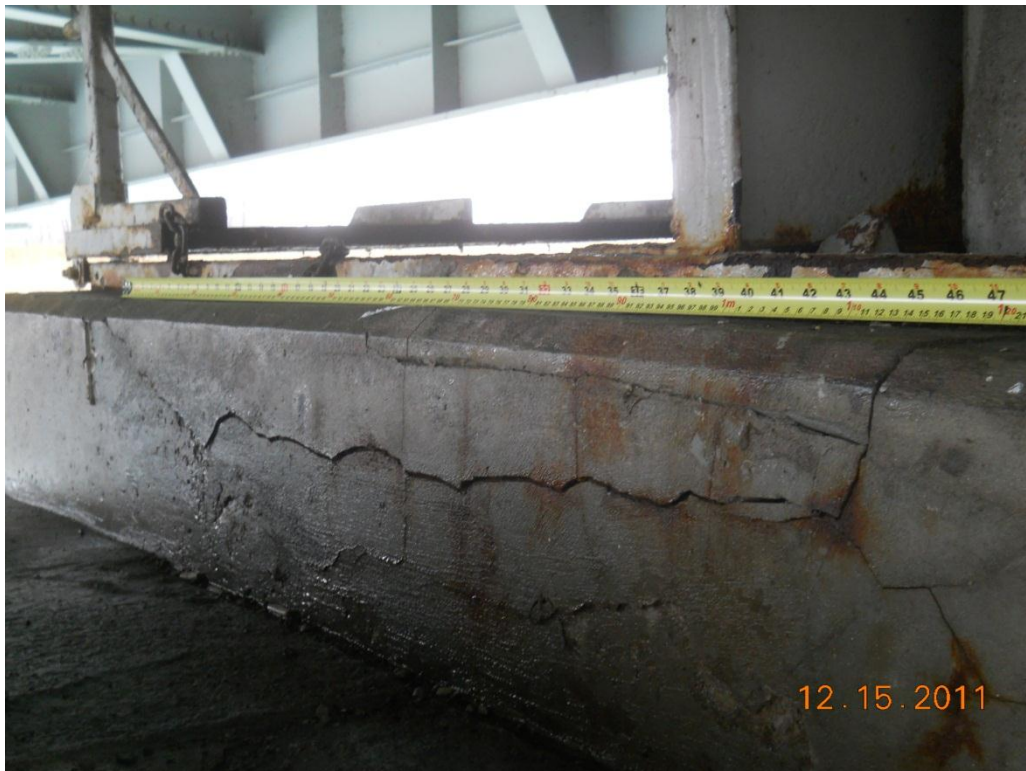
Photograph 66 - Top of west rest pier, note cracking and delamination

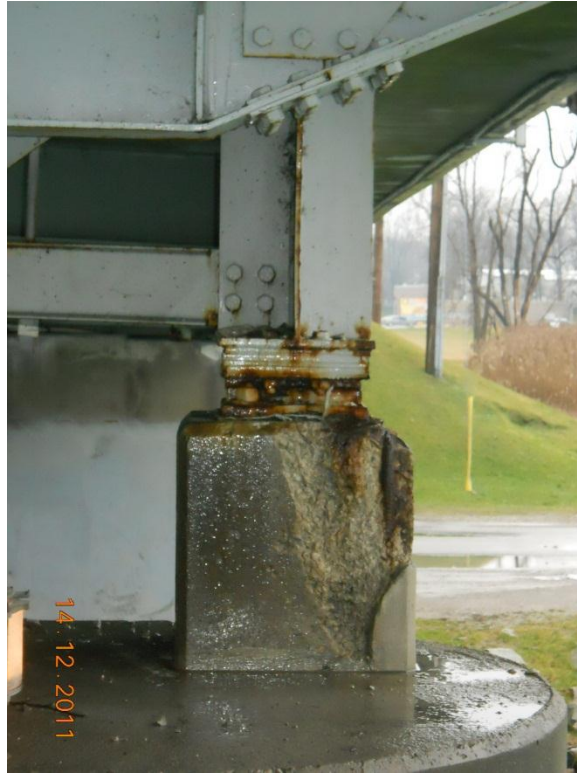
Photograph 67 - West rest pier, span 2 girder 1 bearing pedestal, note spalling and delamination

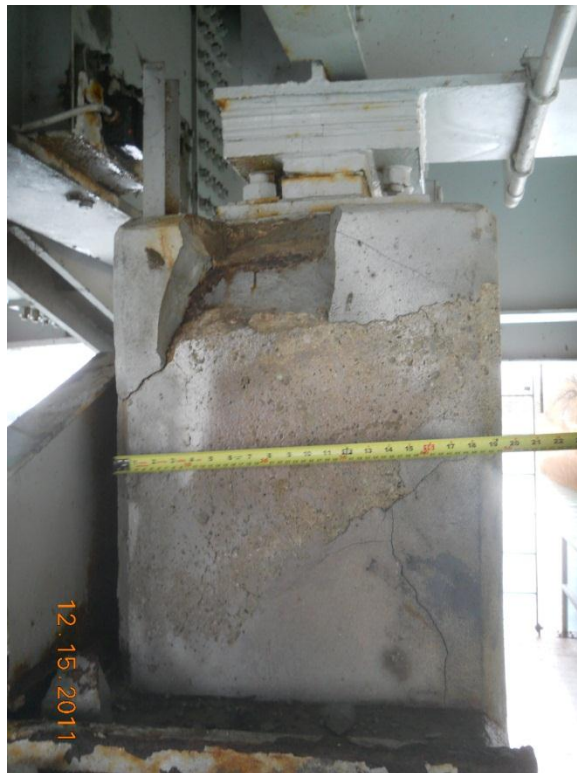
Photograph 68 - West rest pier, third bearing pedestal from north, note spalling

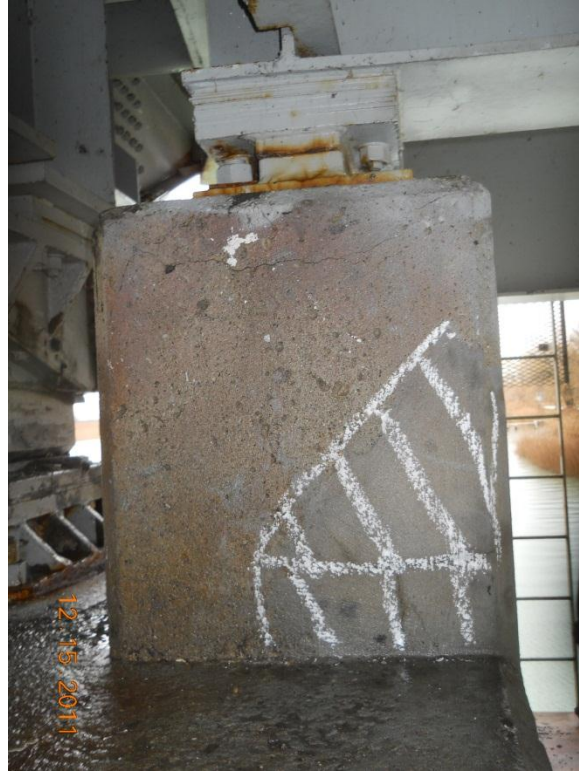
Photograph 69 - West rest pier, fourth bearing pedestal from north, note delamination and cracks

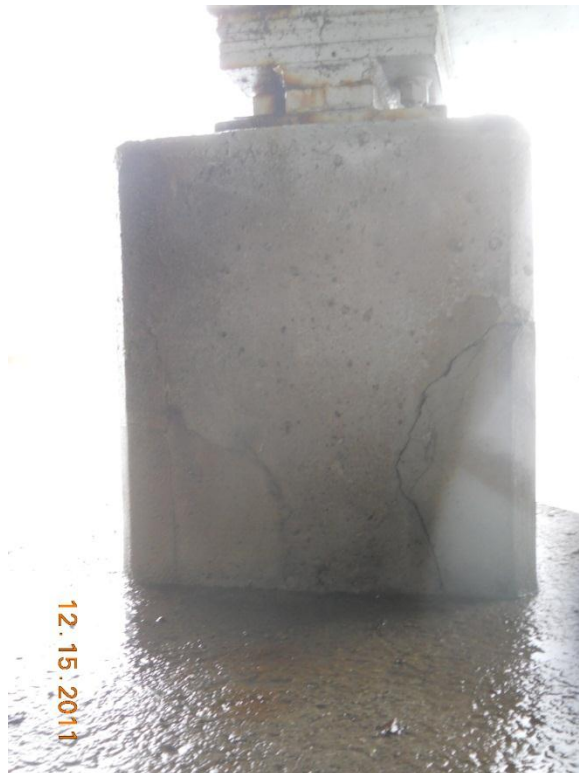
Photograph 70 - West rest pier, fifth bearing pedestal from north, note delamination and cracks

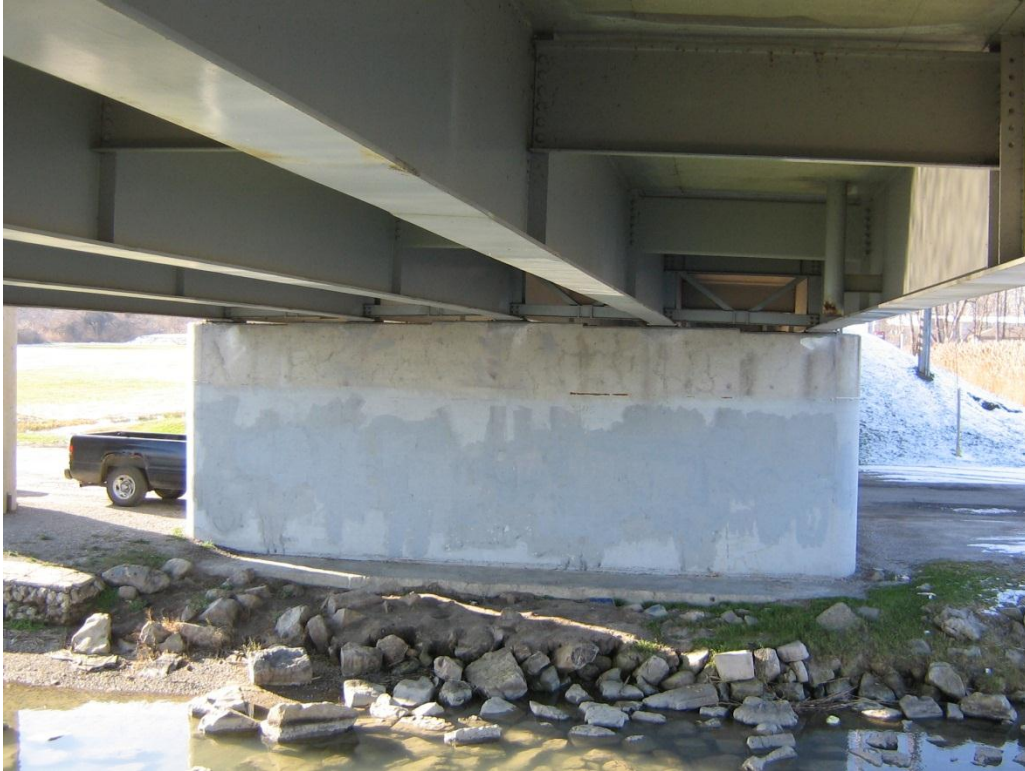
Photograph 71 - East face of west shore pier, note exposed footing

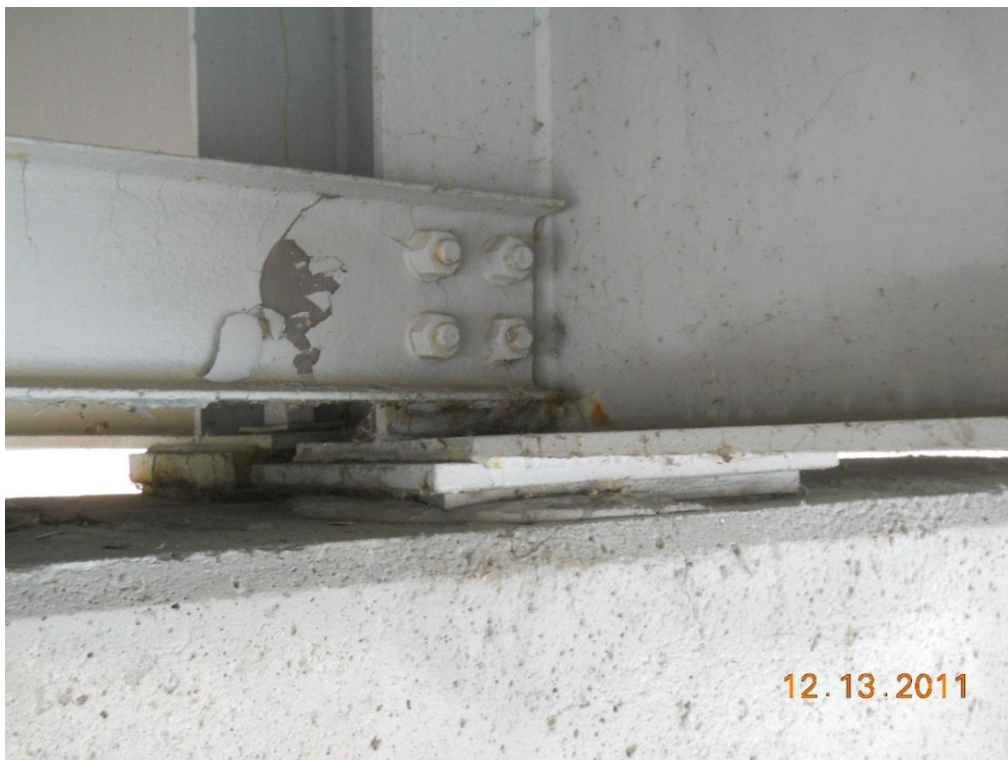
Photograph 80 - Span 2 west shore pier bearing second from north end, note coating failure on bracing, typical to others

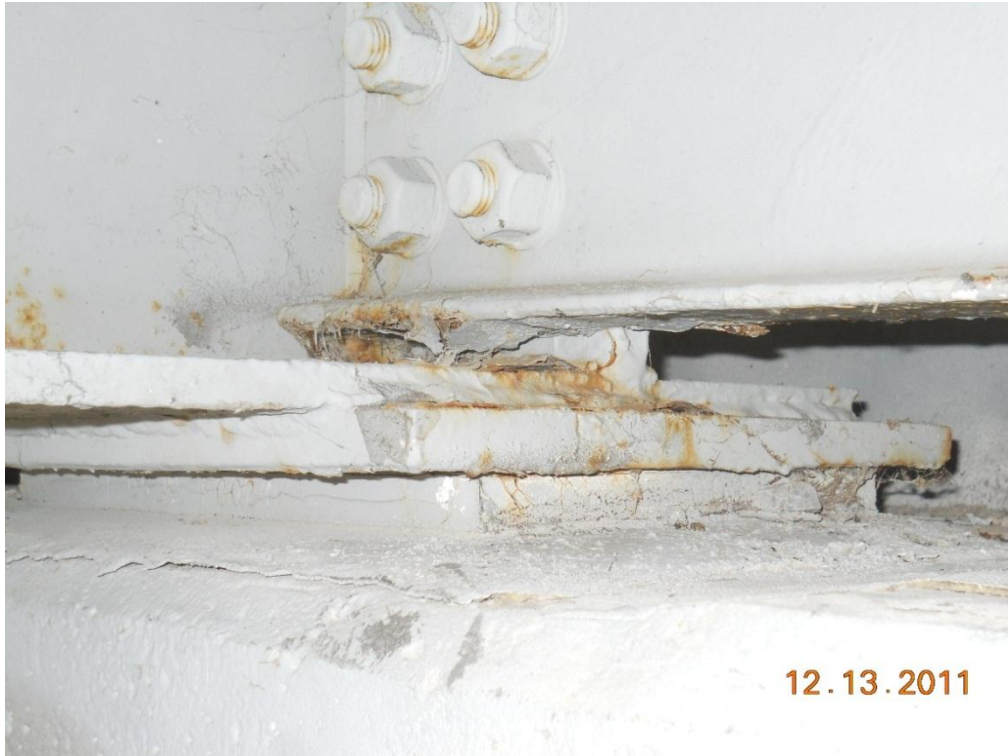
Photograph 81 - West abutment bearing second from north end, note typical coating breakdown

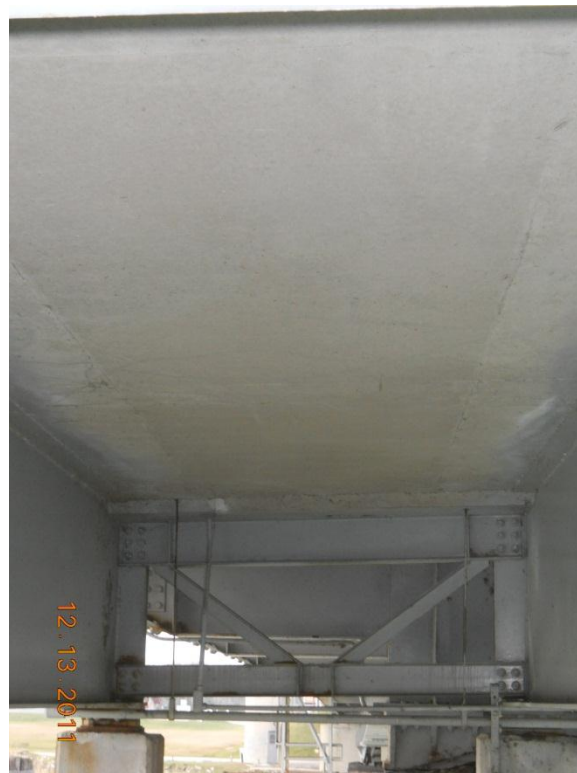
Photograph 84 - Soffit, span 5 looking west, typical condition

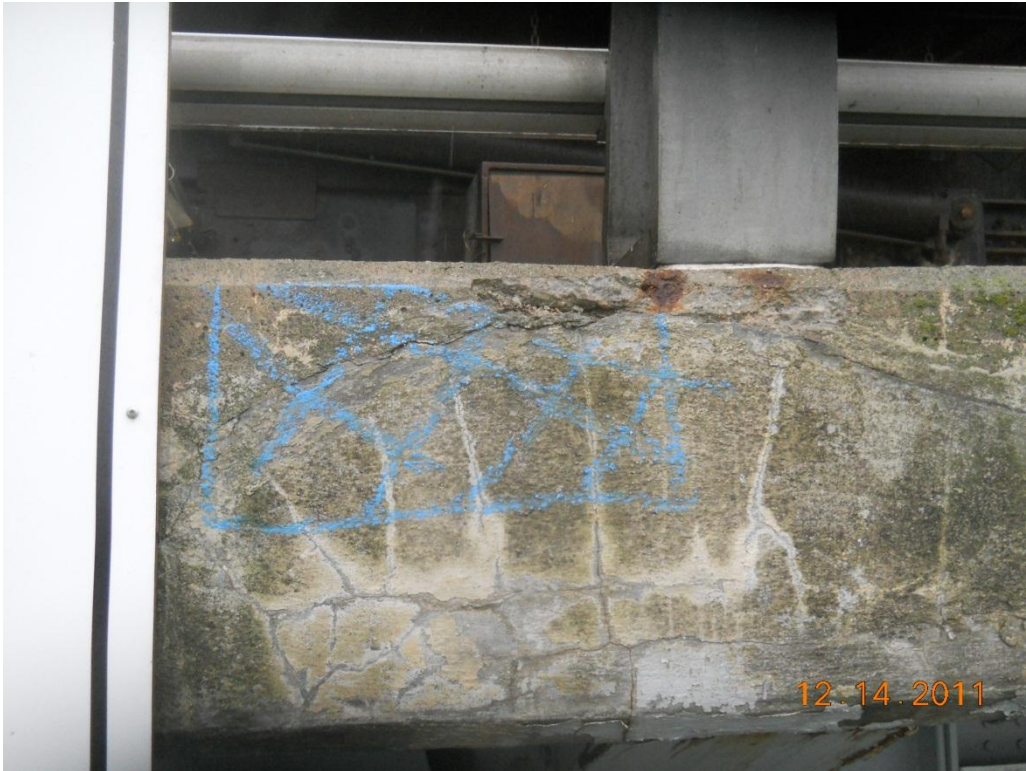
Photograph 85 - Fascia, span 4 north side, note delamination and cracking

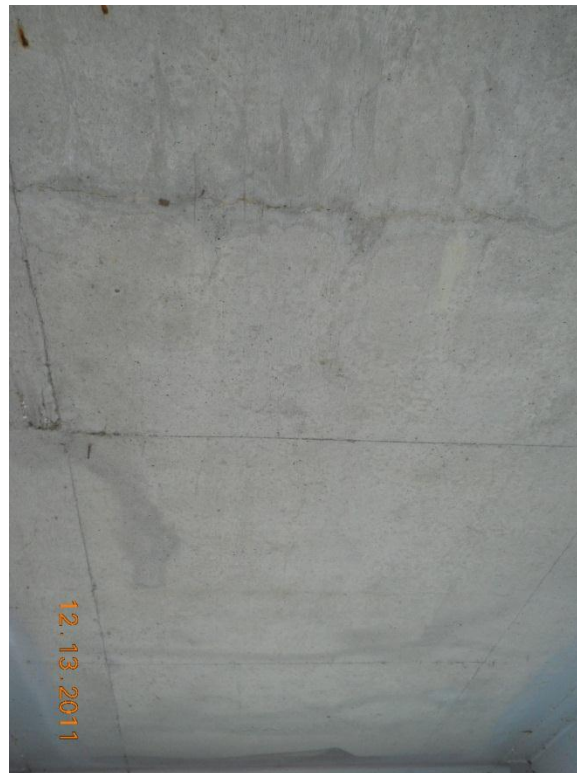
Photograph 86 - Soffit, span 2, typical condition

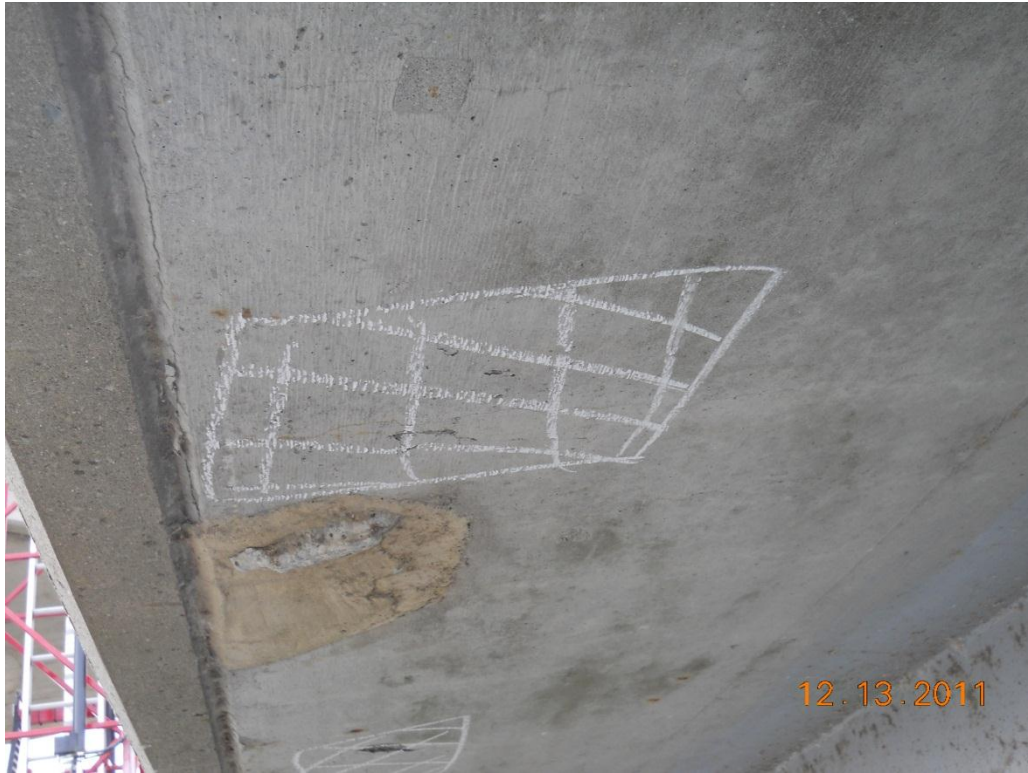
Photograph 87 - Soffit, span 2 south exterior, note delamination and previous patching

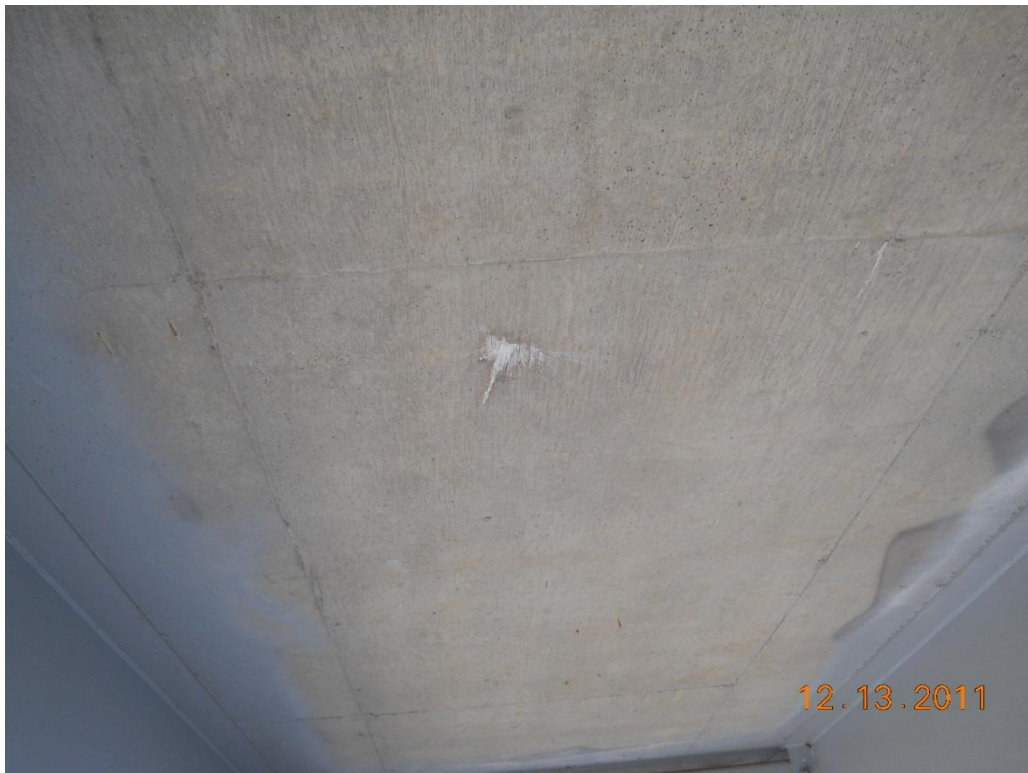
Photograph 88 - Soffit, span 1, typical condition

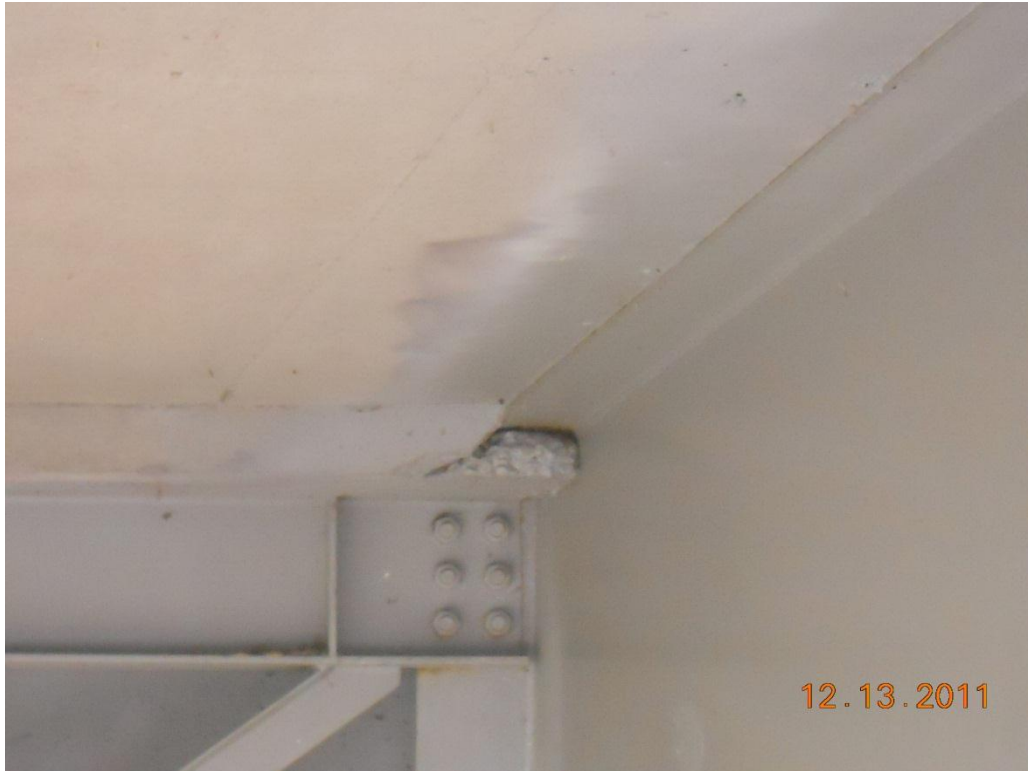
Photograph 89 - Soffit, span 1, note spall near haunch at girder 4

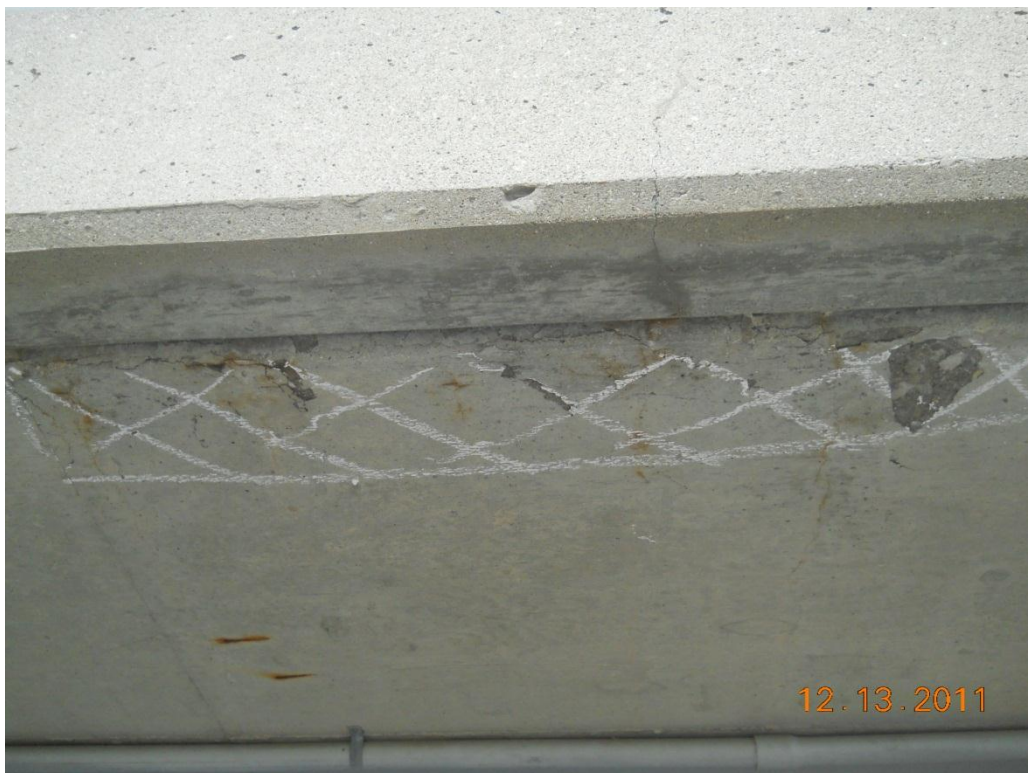
Photograph 90 - Soffit, span 1 south exterior, note delamination and spalling

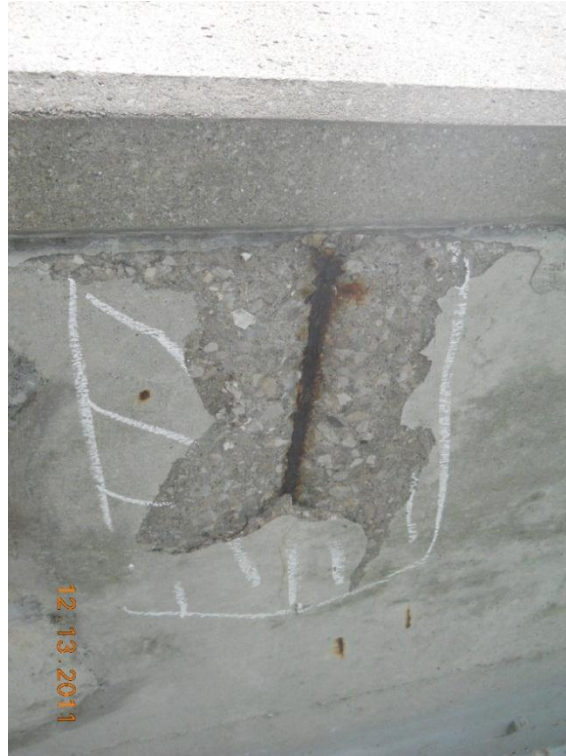
Photograph 91 - Soffit, span 1 south exterior, note delamination and exposed reinforcing steel

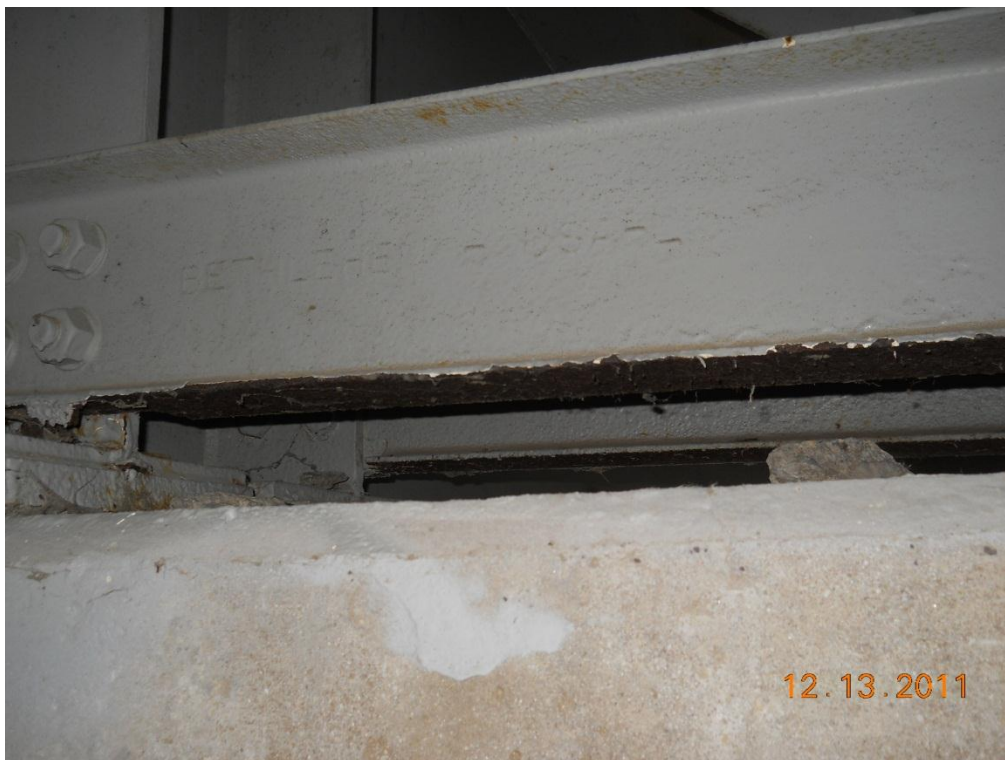
Photograph 92 - Bracing, east shore pier, note coating failure on bottom of bottom flange -  
typical of most bracing

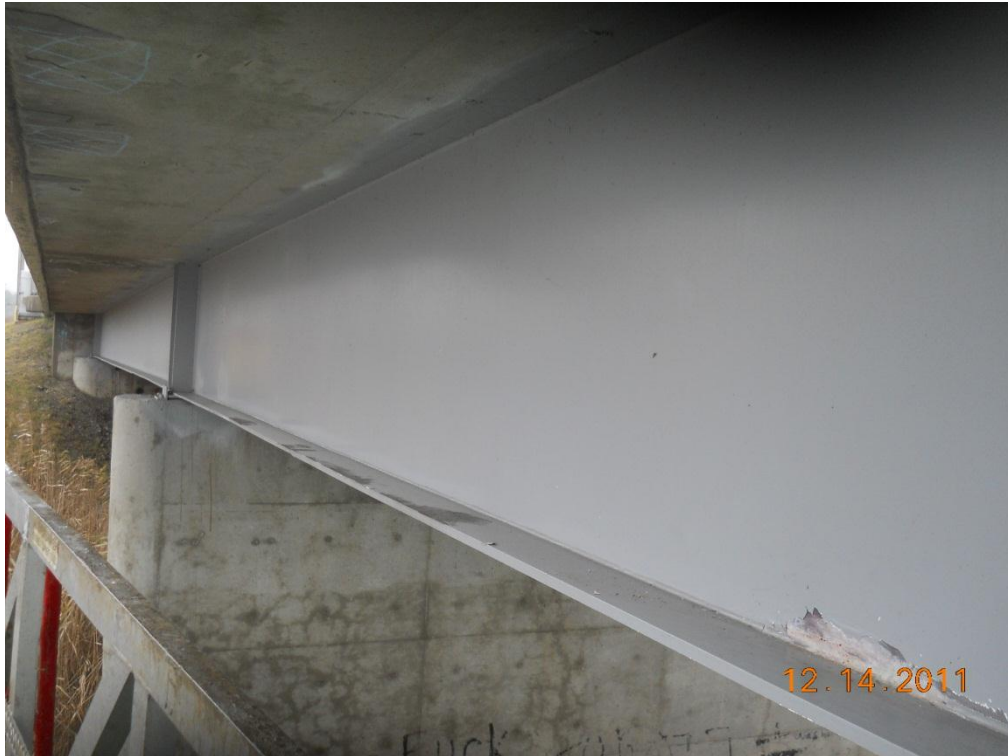
Photograph 93 - Span 5, north exterior soffit and girder 1, note coating failure on bottom of web

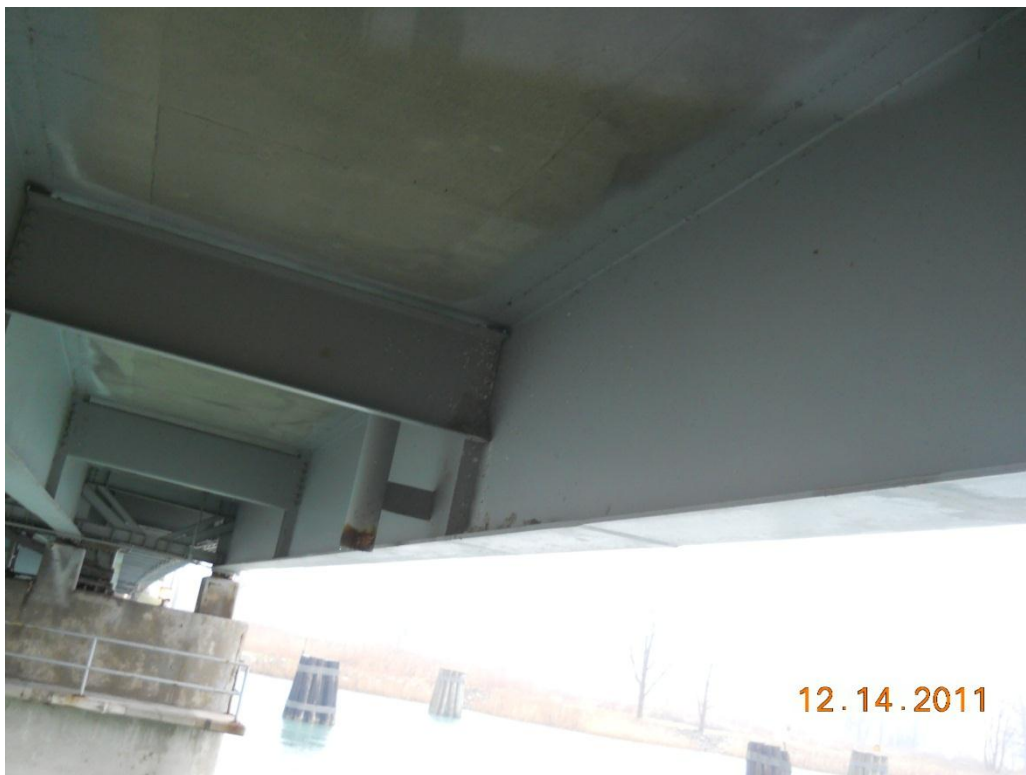
Photograph 94 - Soffit and girder 1, span 5 looking west, note coating failure on bottom of web

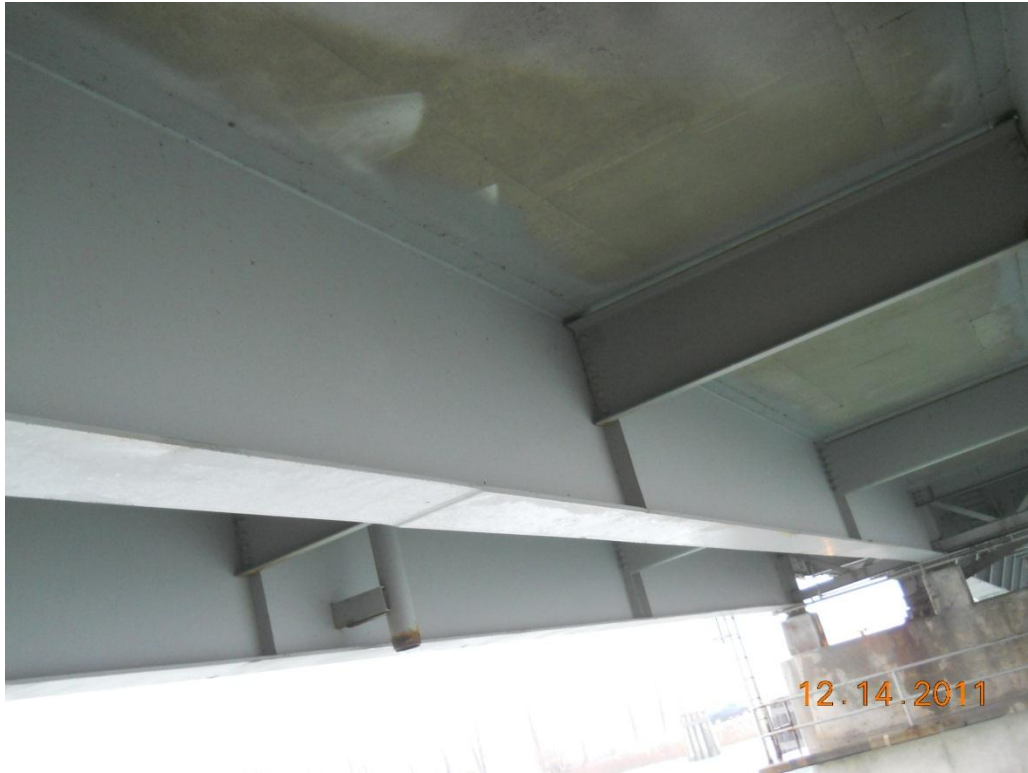
Photograph 95 - Soffit and girders 4, 5, span 5 looking west

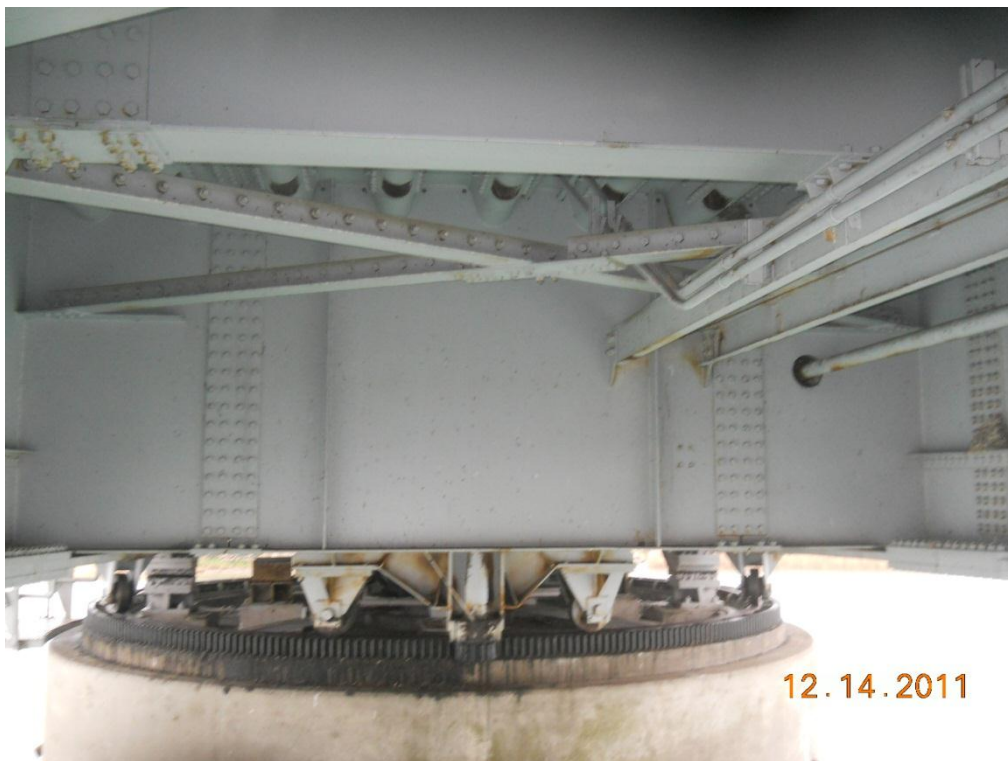
Photograph 96 - Diaphragm, span 4 near pivot pier, note localized areas of rusting

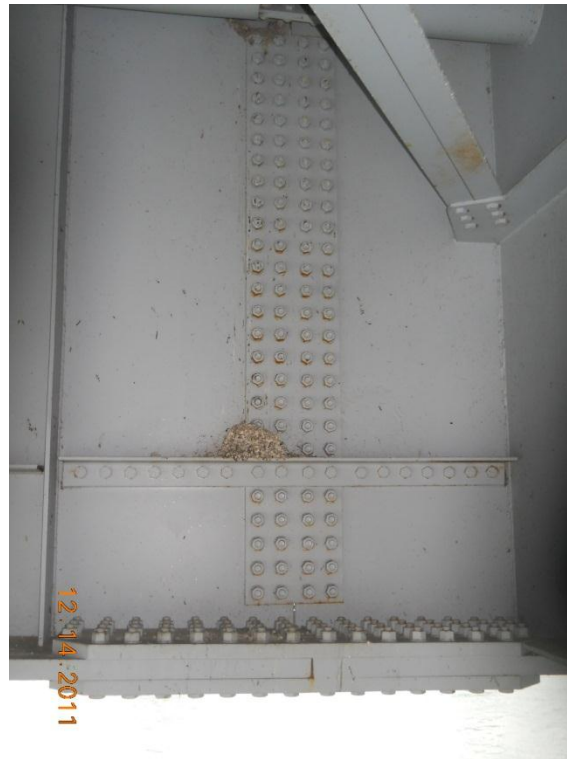
Photograph 97 - Transverse splice, span 4, typical

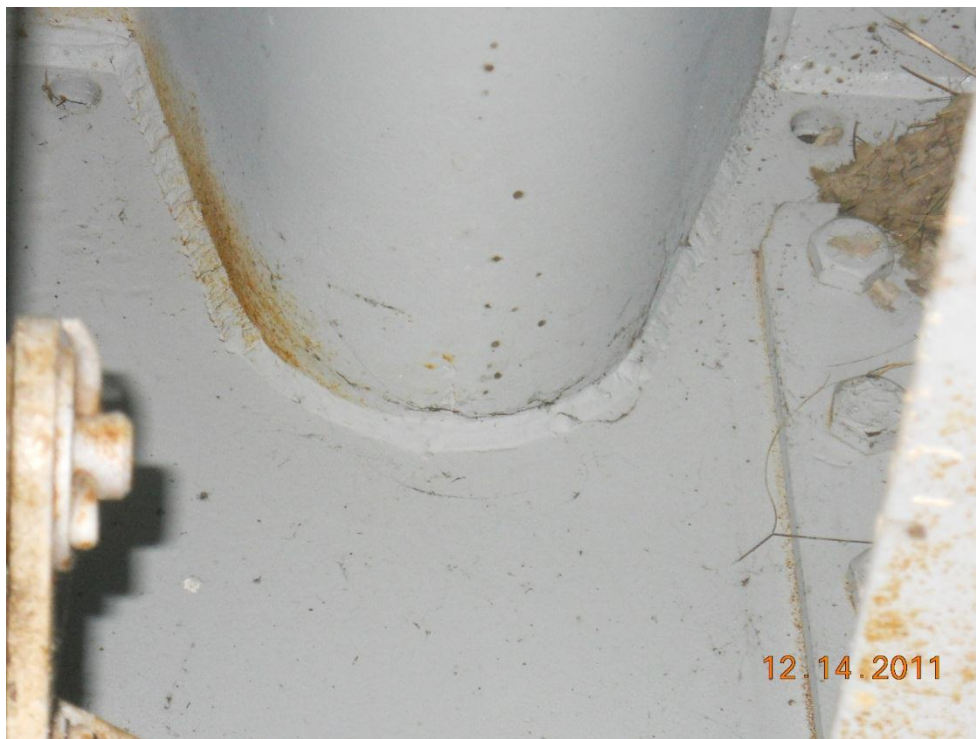
Photograph 98 - Longitudinal trough, span 4, third trough south of girder 1 east of transverse splice, note potential crack near weld

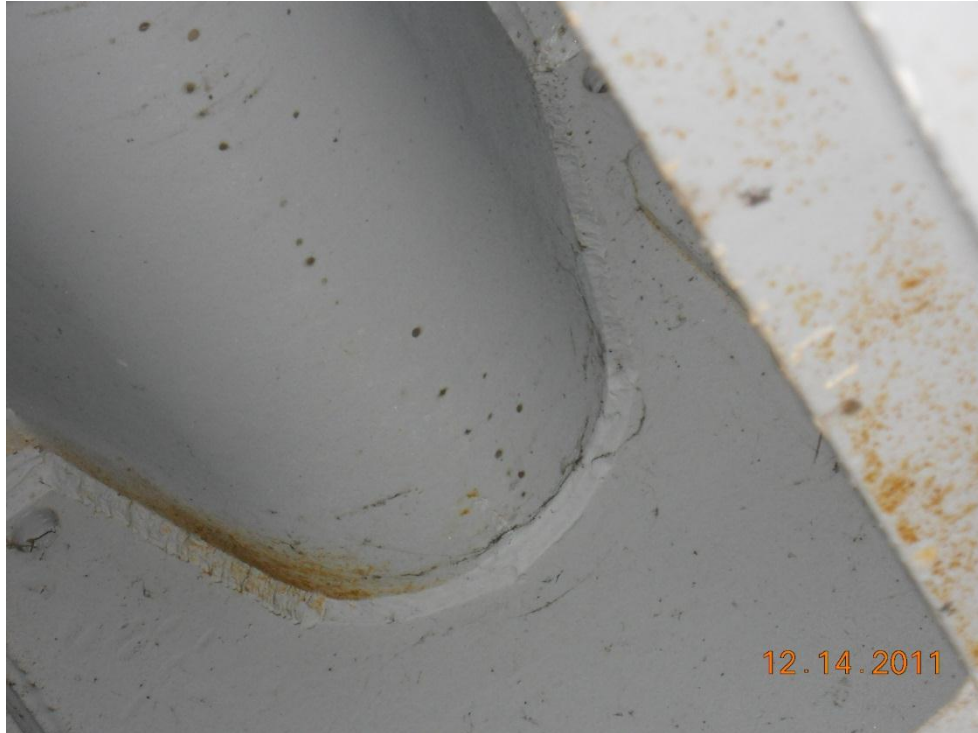
Photograph 99 - Longitudinal trough, span 4, third trough south of girder 1 east of transverse splice, note potential crack near weld

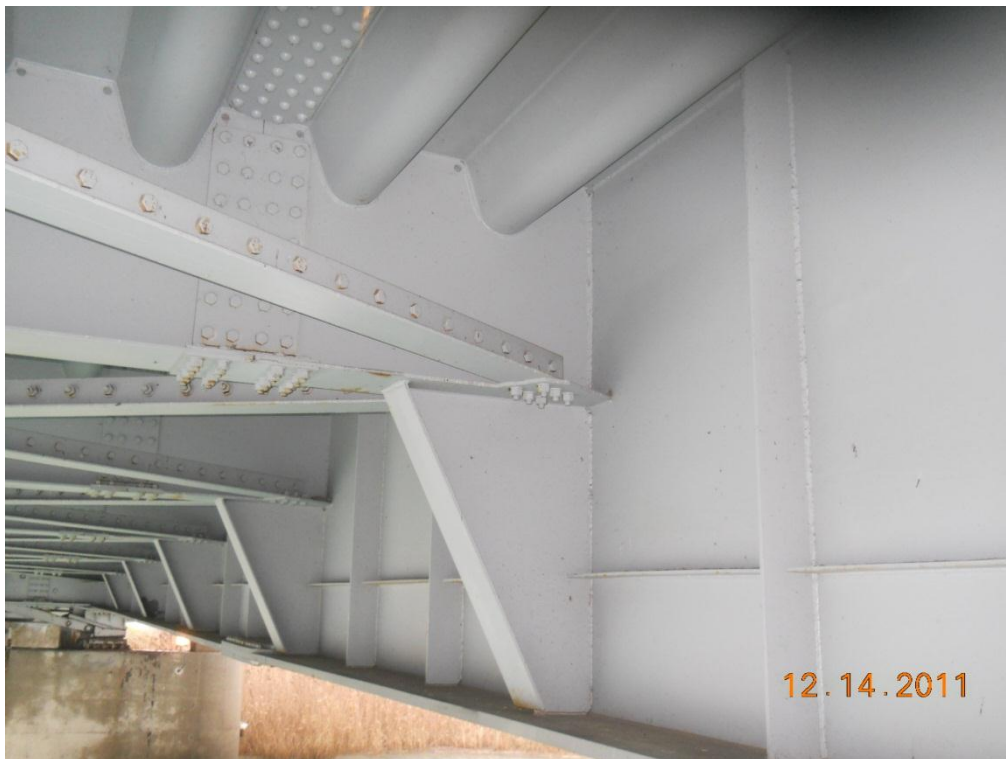
Photograph 100 - Span 4, girder 2 looking east, typical condition

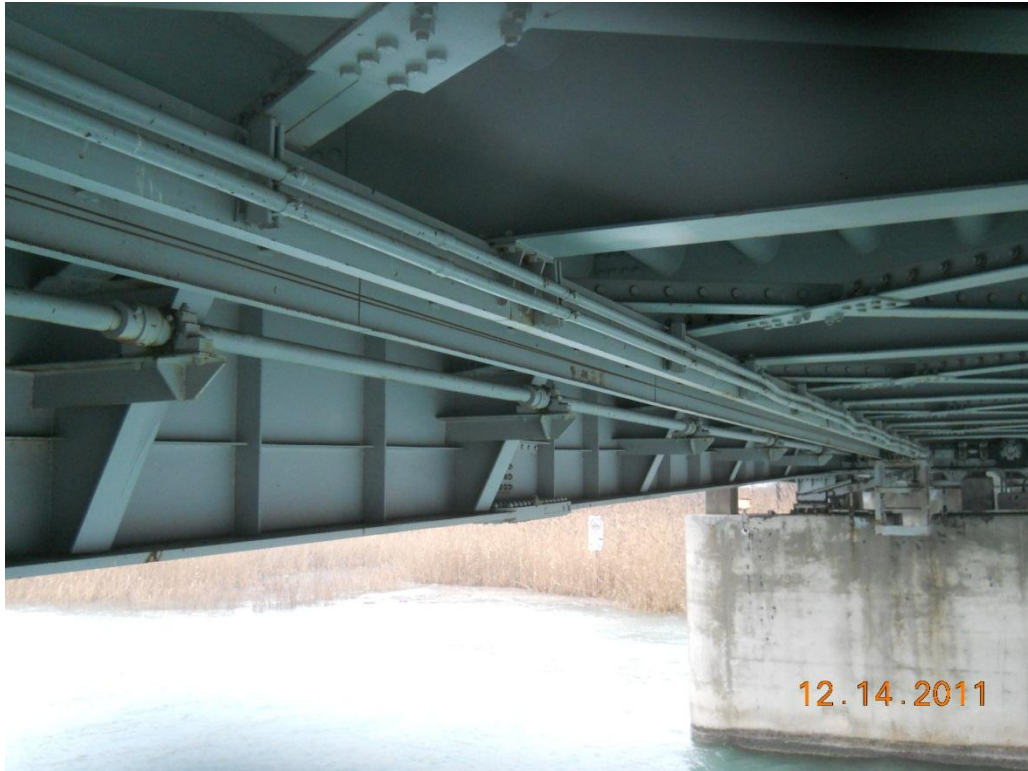
Photograph 101 - Span 4, girder 1 looking east, typical condition
