Public Works and  
Government Services  
Canada

Travaux publics et  
Services gouvernementaux  
Canada

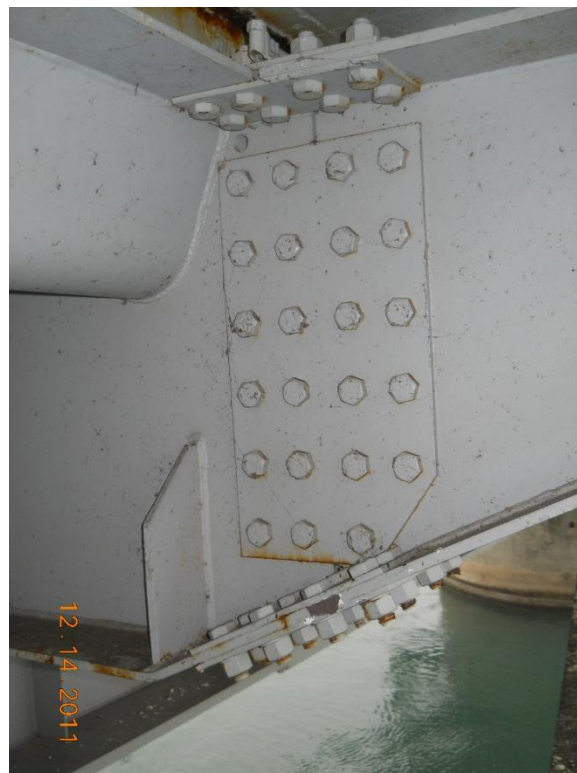
Photograph 102 - Span 4, typical connection of exterior cross beams

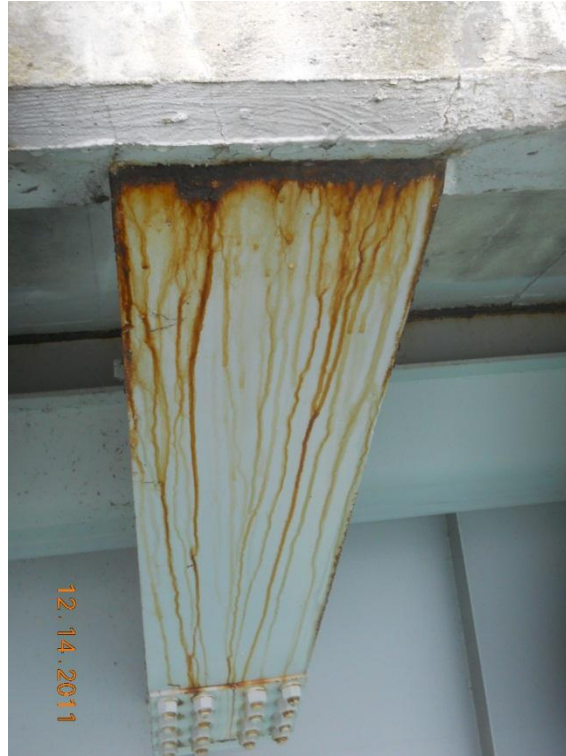
Photograph 103 - Span 4, exterior end of cross beam, typical condition

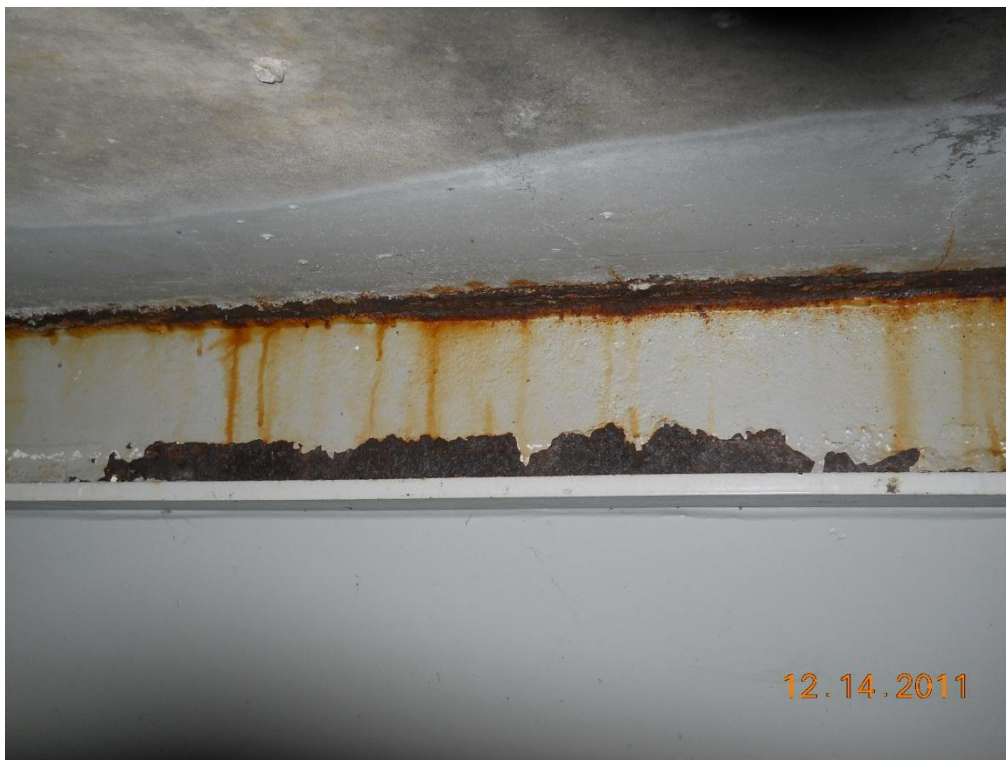
Photograph 104 - Span 4, coating failure and rusting on north side of north exterior longitudinal trough

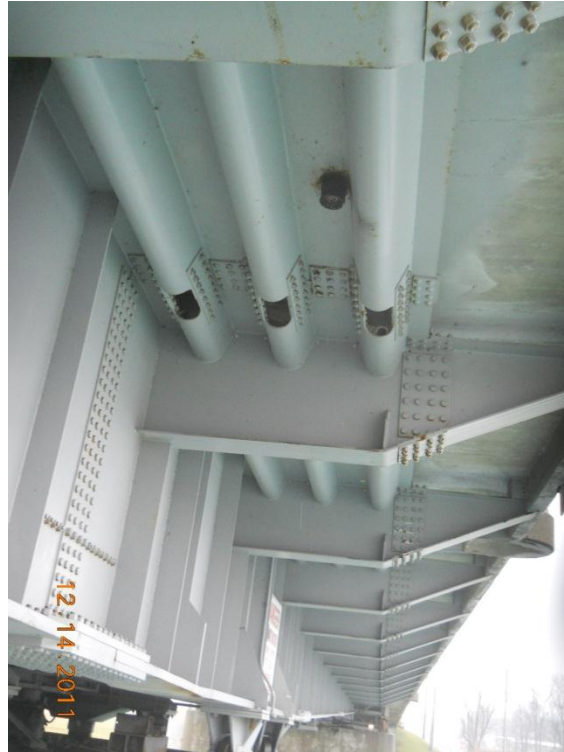
Photograph 105 - Span 4, north exterior soffit looking west

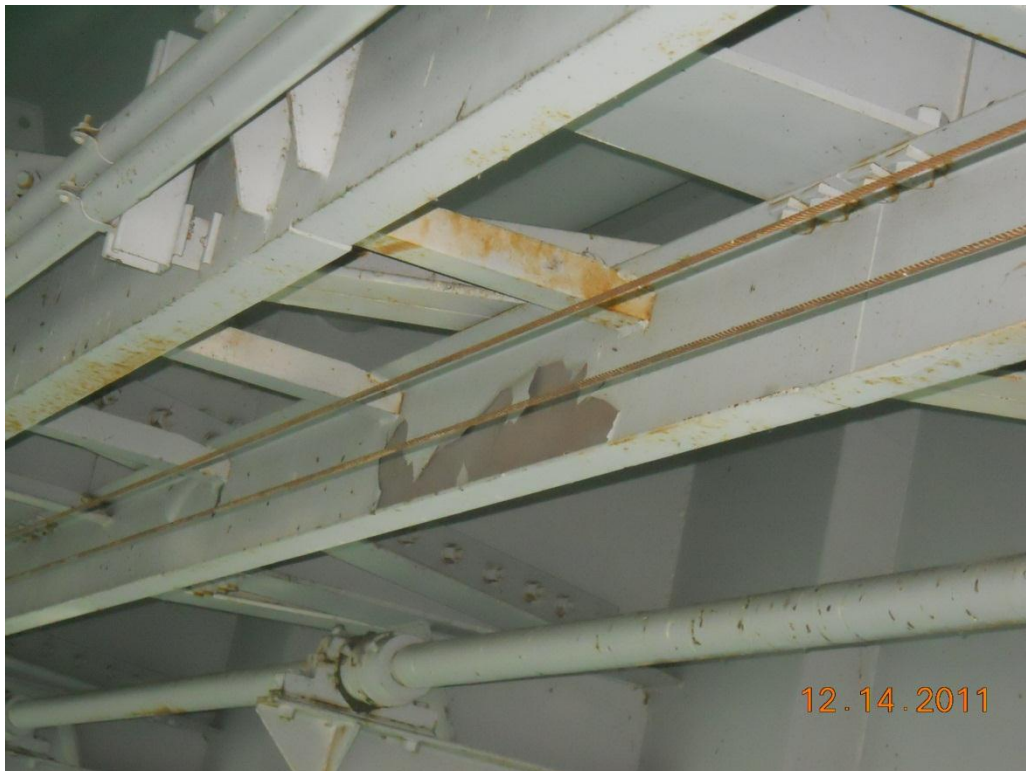
Photograph 108 - Span 3, note coating failure on machinery beam

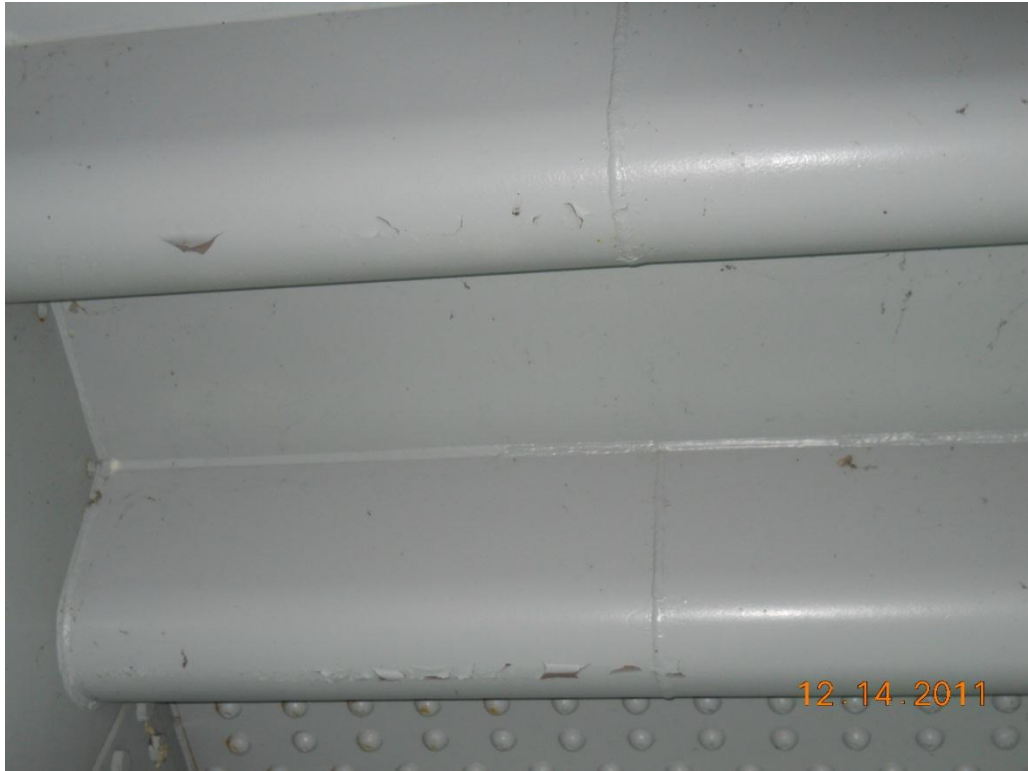
Photograph 109 - Soffit, span 3, note coating failure on bottom of troughs

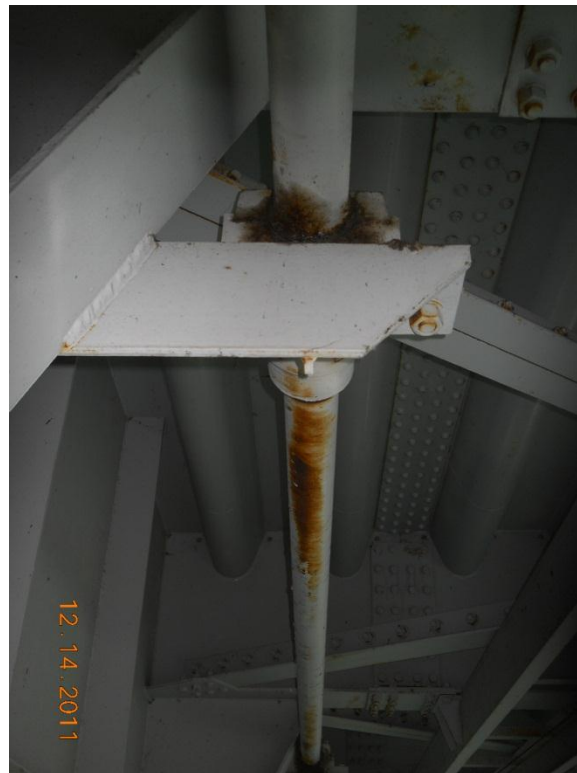
Photograph 110 - Span 3, note rusting on bottom of rest pier wedge driveshaft

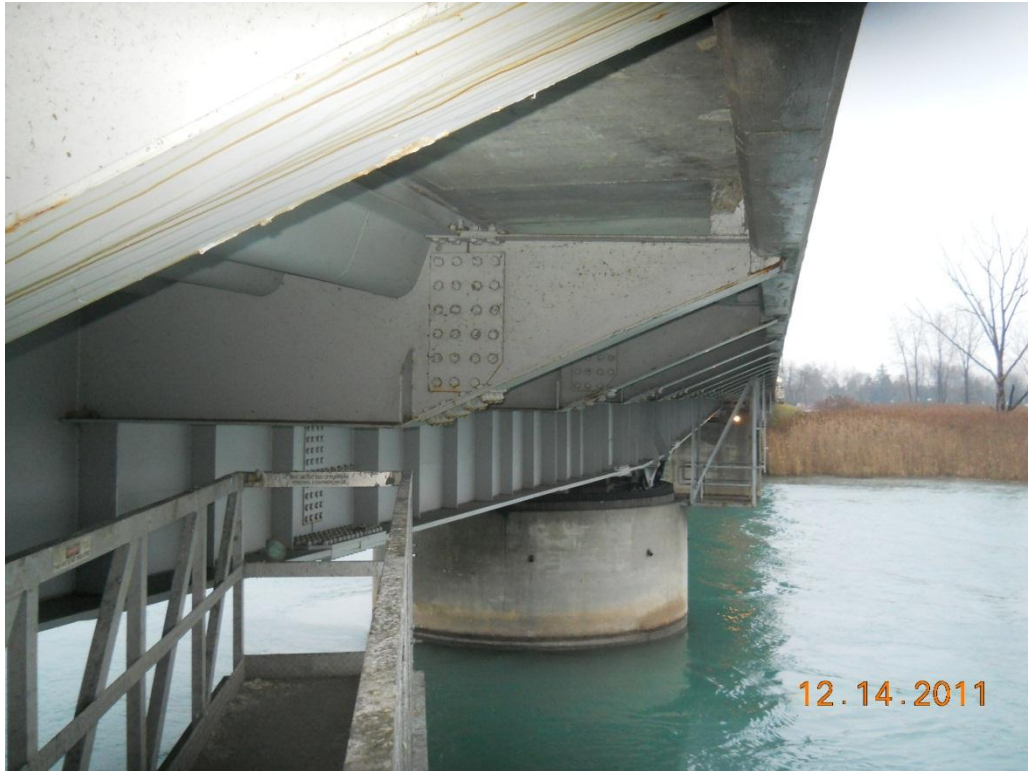
Photograph 111 - Span 3, south exterior soffit looking east

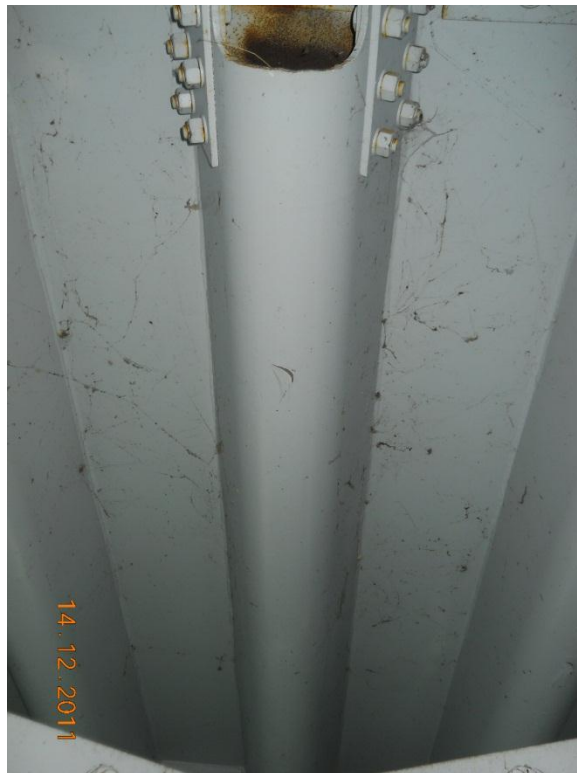
Photograph 112 - Soffit, span 3, typical condition

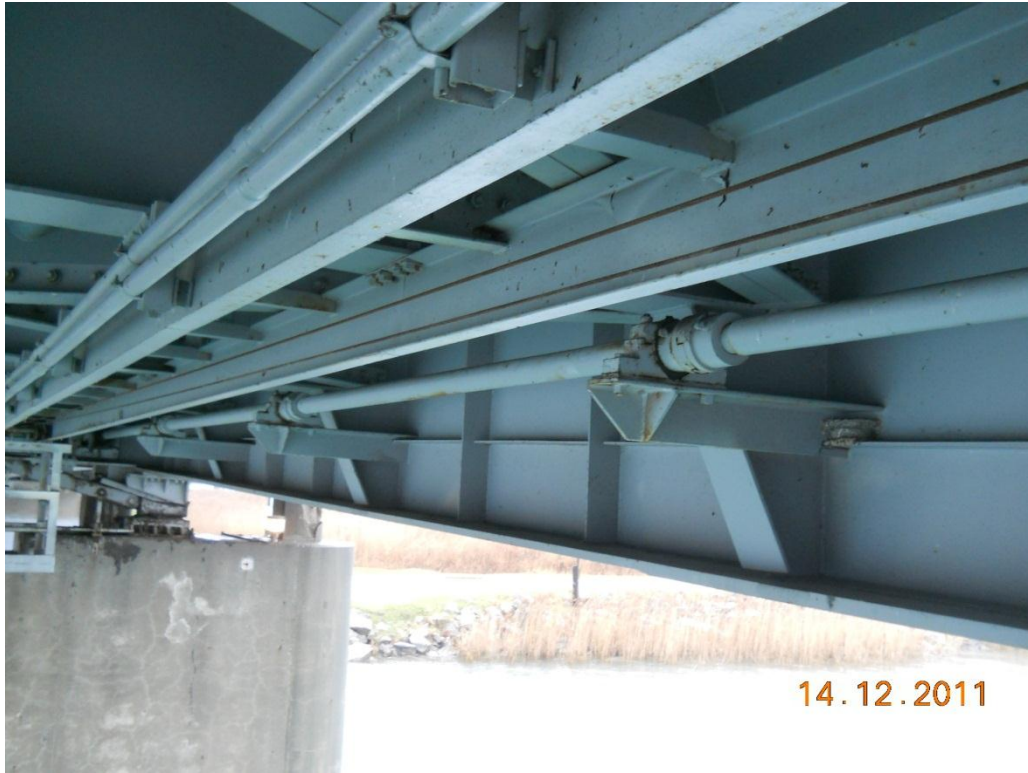
Photograph 113- Span 3, girder 1 looking west

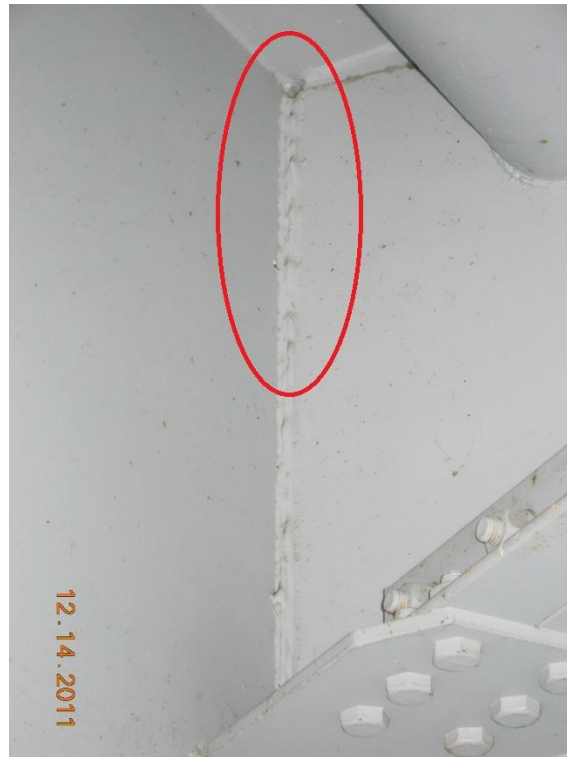
Photograph 115 - Span 3, girder 2 at fifth cross beam from pivot pier, note potential crack in vertical weld (limited access during inspection prevented confirmation of crack)

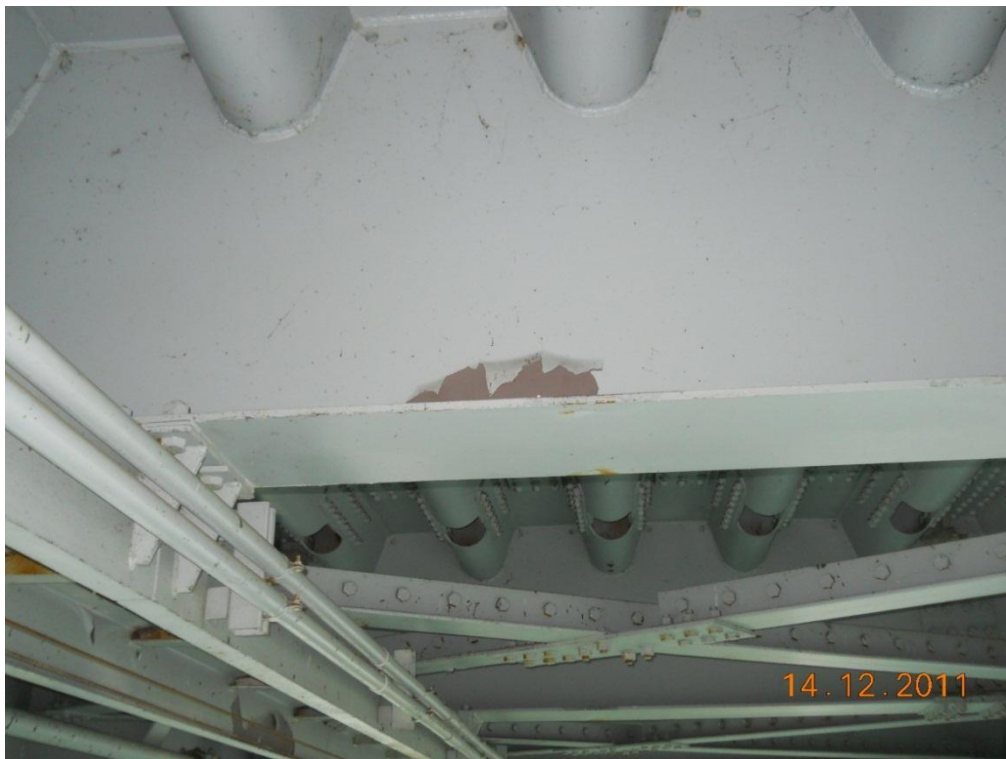
Photograph 116 - Span 3, note coating failure on cross beam web

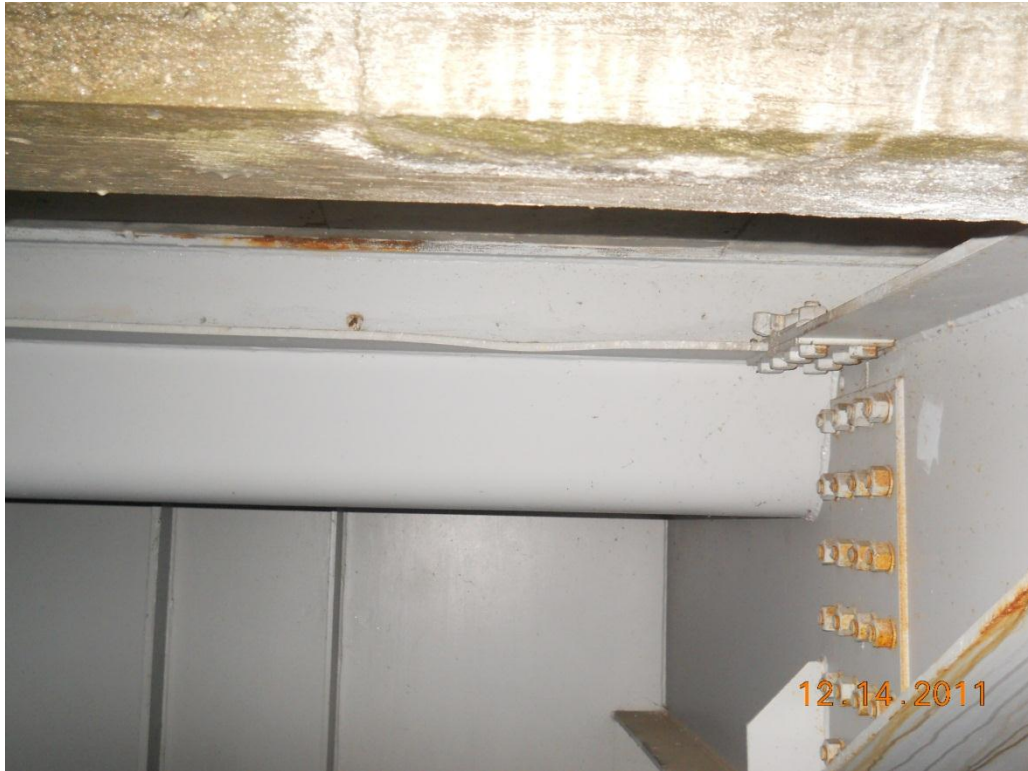
Photograph 117 - Span 3, note deformation in south exterior deck plate

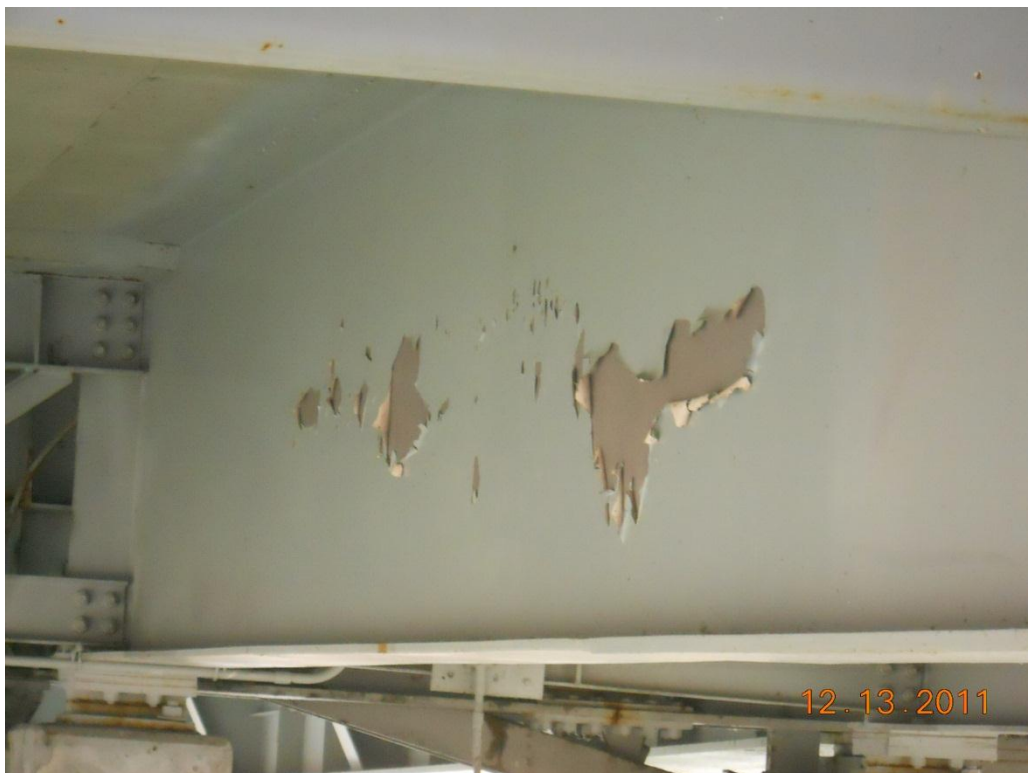
Photograph 118 - Span 2, girder 3, note coating failure on web

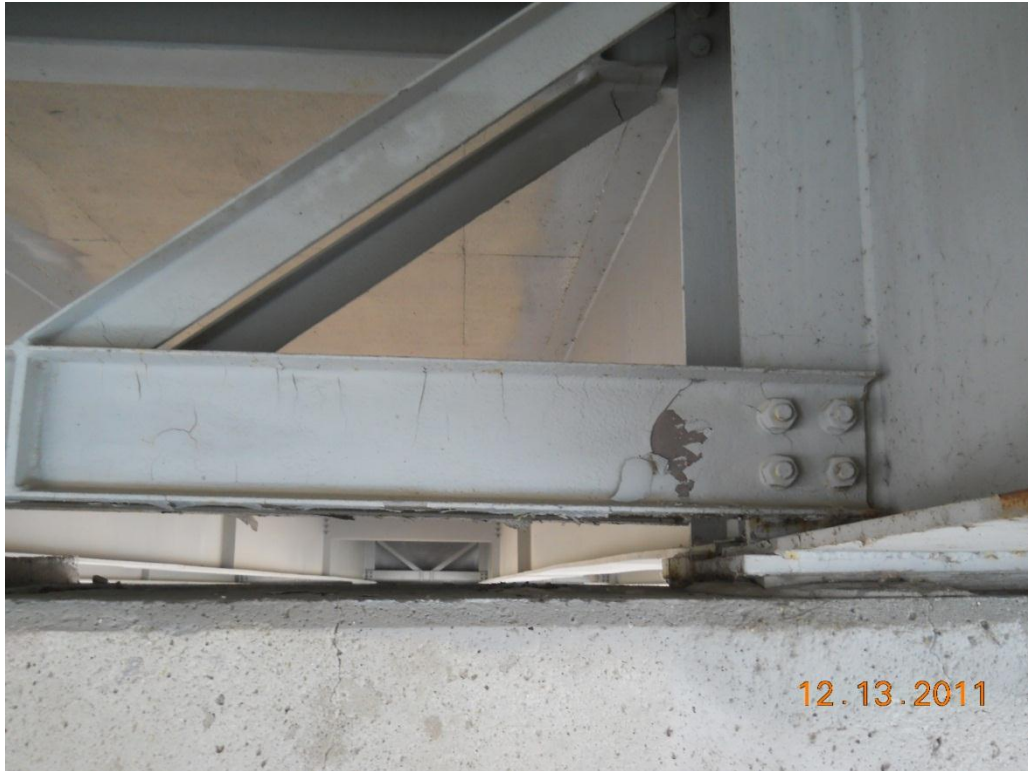
Photograph 119 - Bracing, west shore pier, note coating failure on bottom member

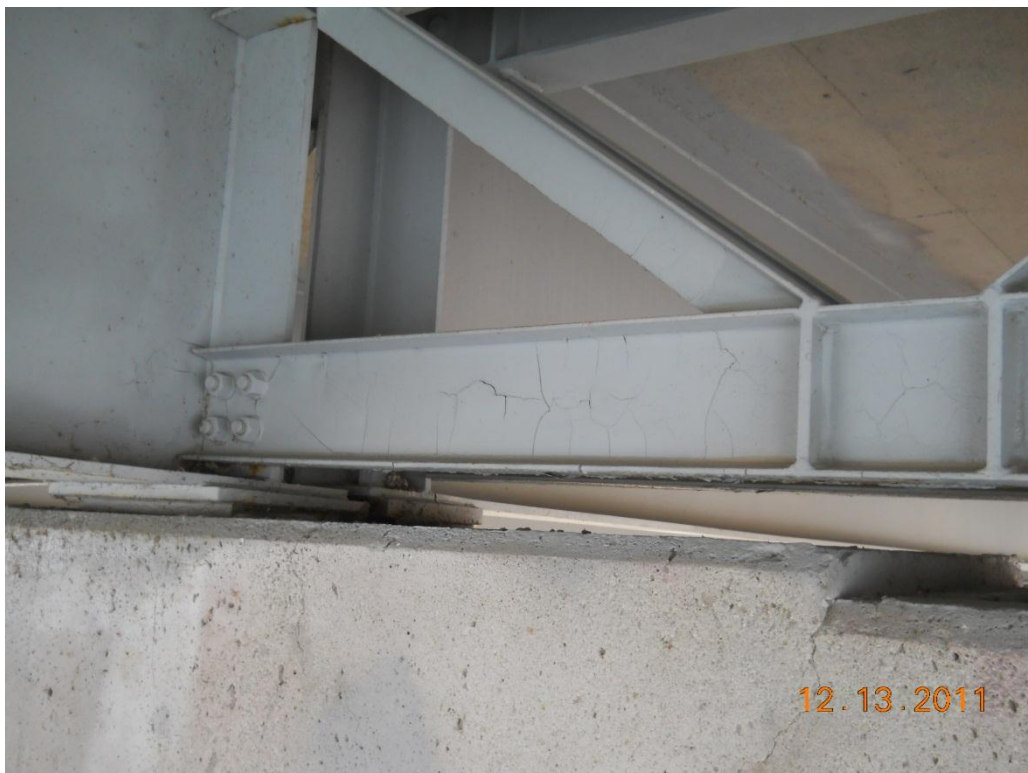
Photograph 120 - Bracing, west shore pier, note coating failure on bottom member

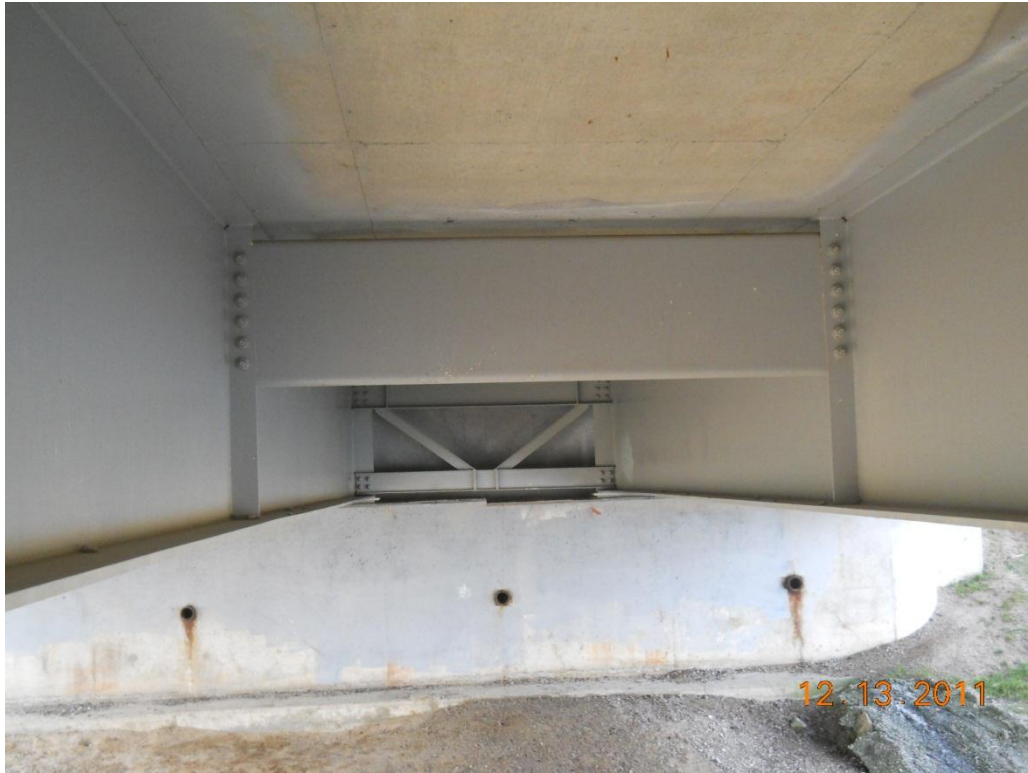
Photograph 121 - Diaphragm, span 1 looking west, typical condition

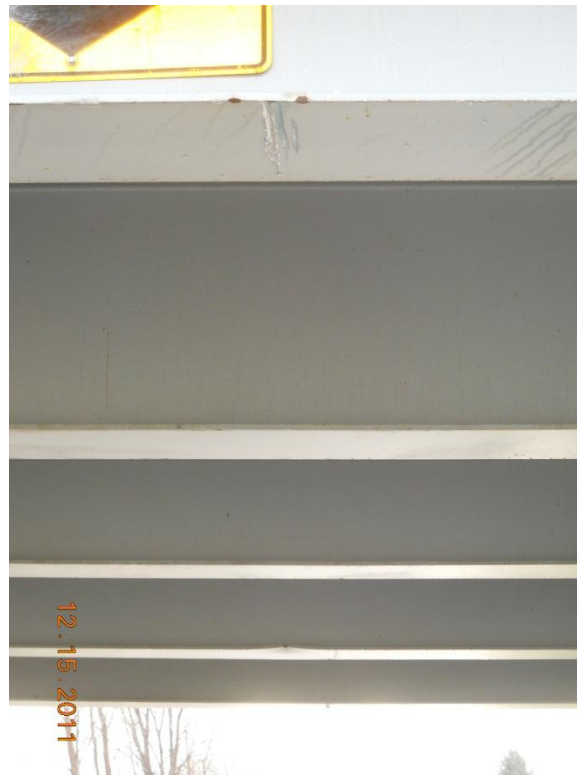
Photograph 122 - Span 1 girders looking south, note impact damage

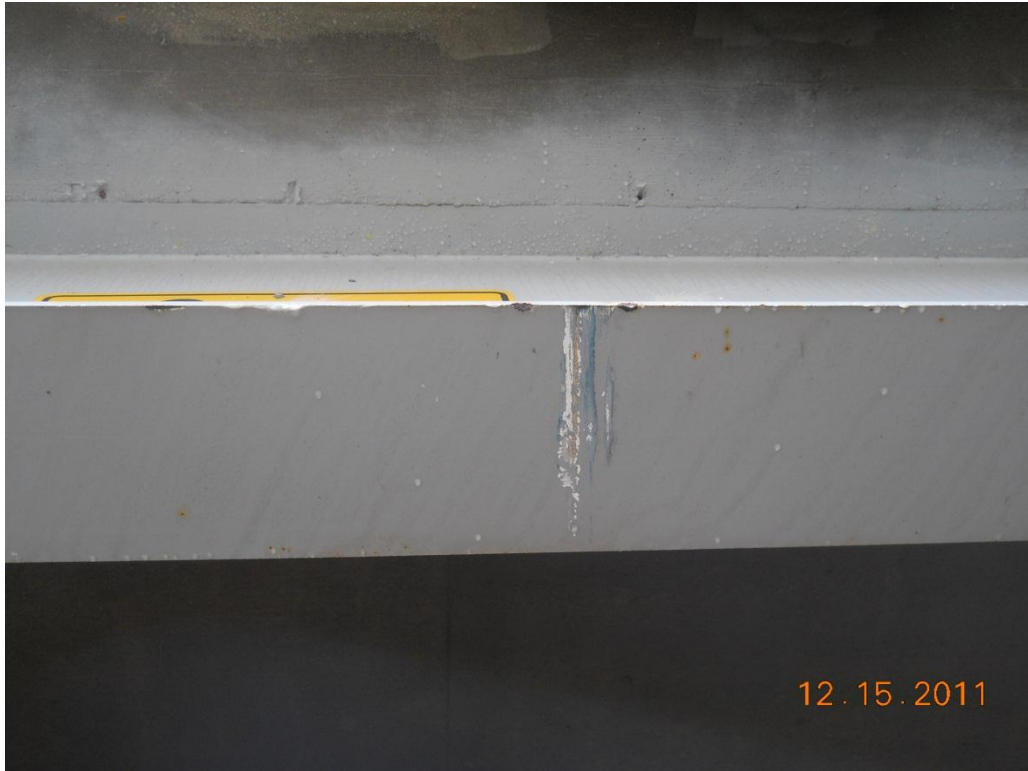
Photograph 123 - Span 1, girder 1, note impact damage

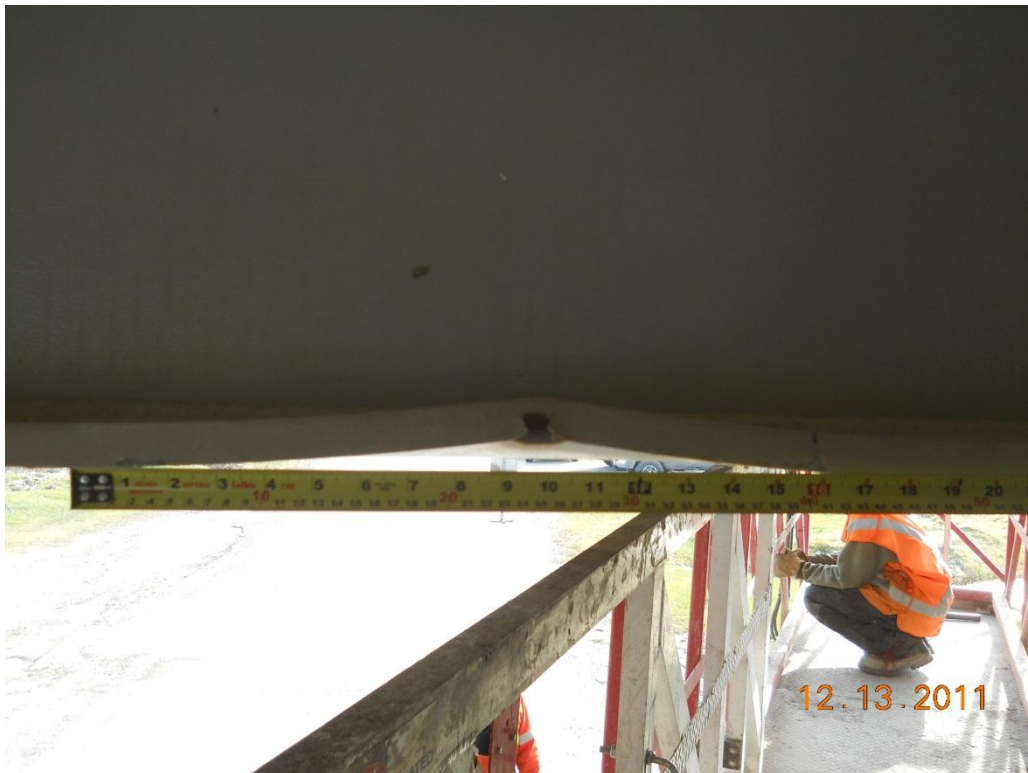
Photograph 124 - Span 1, girder 4, note impact damage

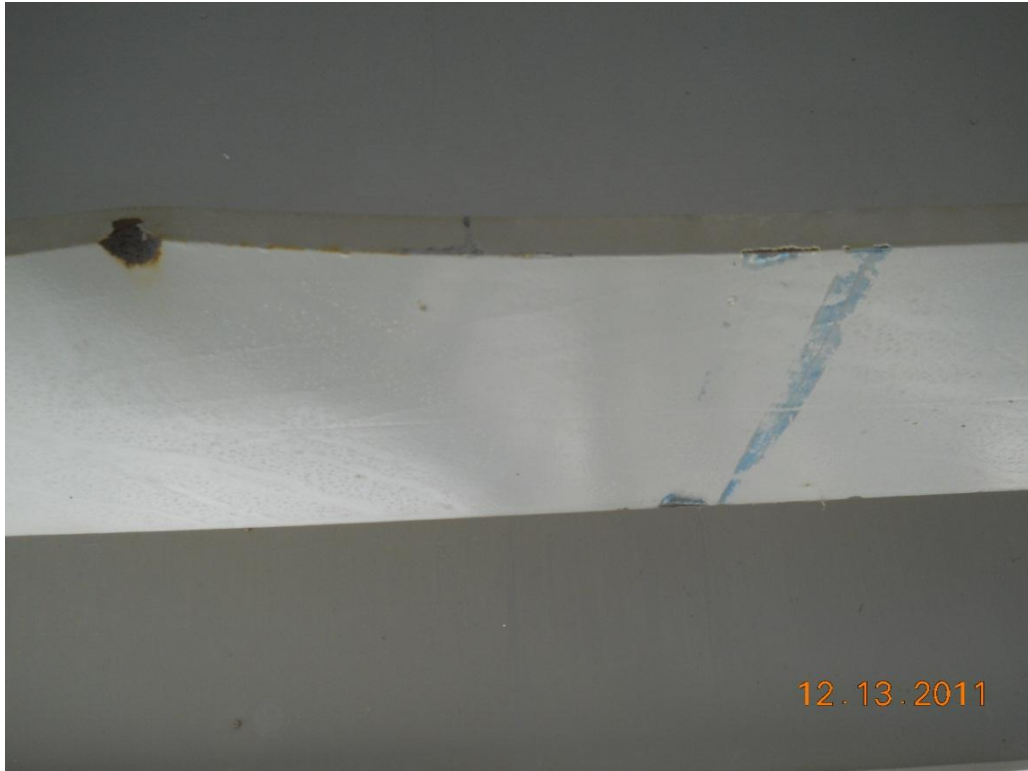
Photograph 125 - Span 1, girder 4, note impact damage

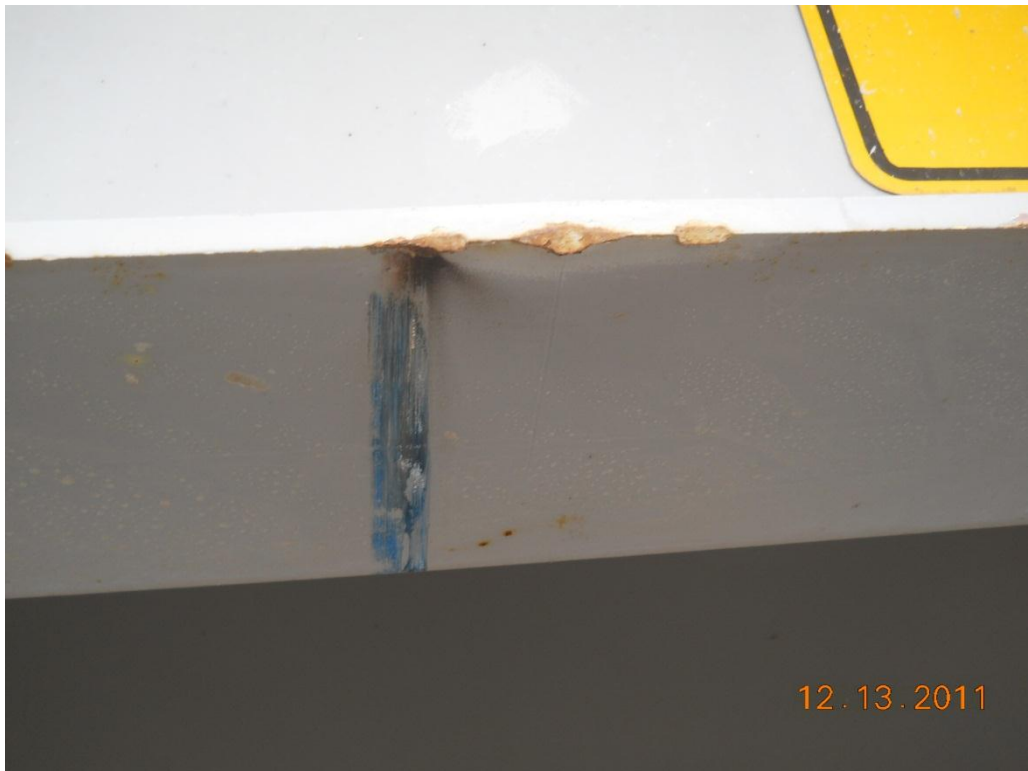
Photograph 126 - Span 1, girder 5, note impact damage

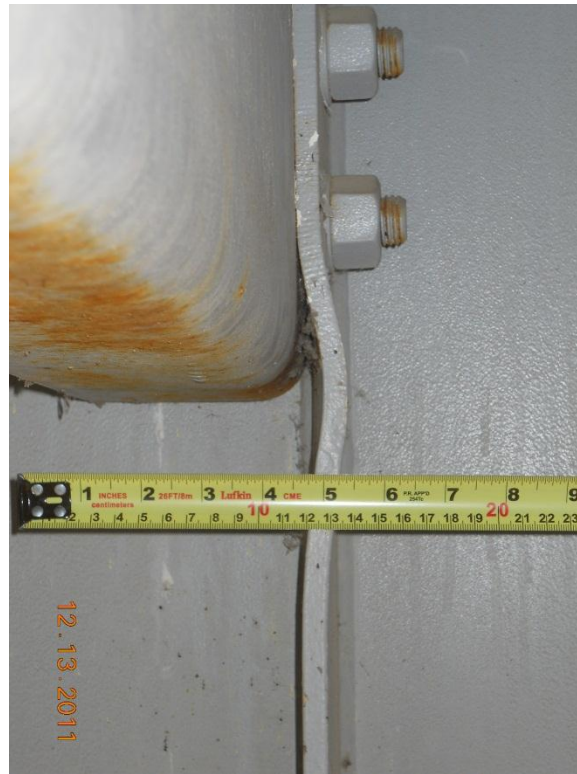
Photograph 127 - Span 1, diaphragm 2 connection to girder 5, note deformation of stiffener

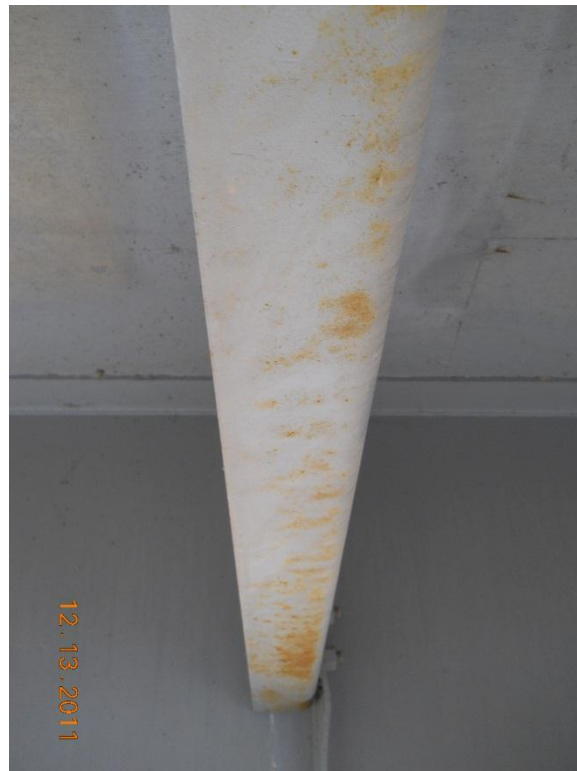
Photograph 128 - Span 1, diaphragm 2, note rusting on bottom of member

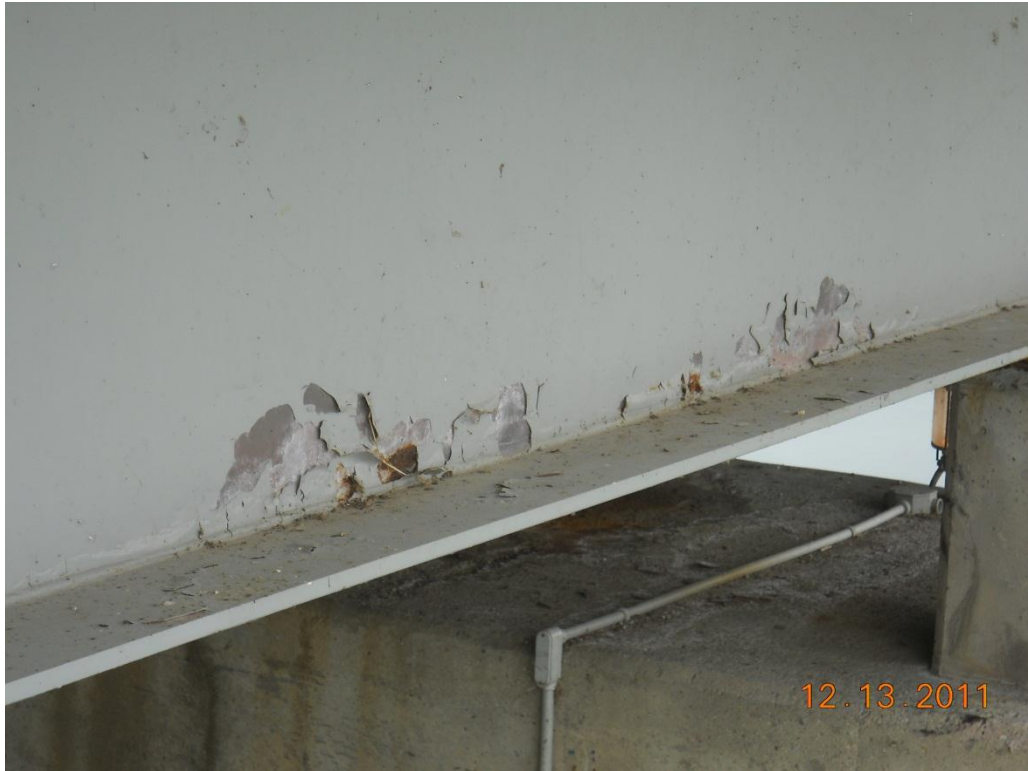
Photograph 129 - Span 1, girder 5 exterior, note coating failure

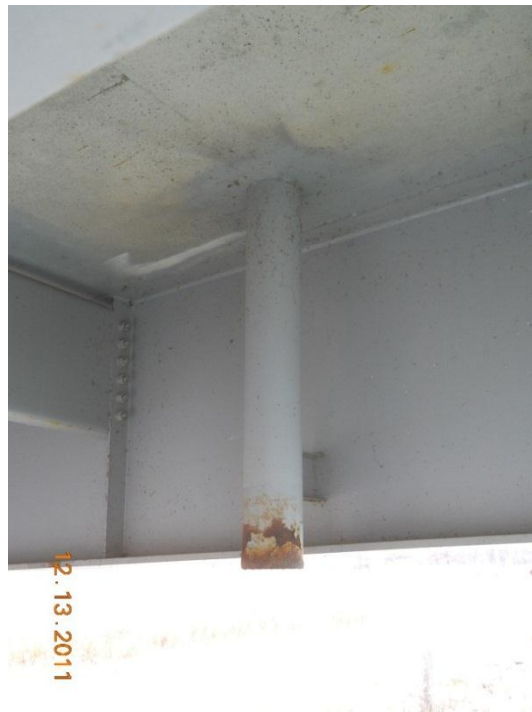
Photograph 130 - Deck drain, typical for spans 1, 2, 5, 6, note corrosion at bottom. Deck drain does not extend far enough beyond girder bottom flange.

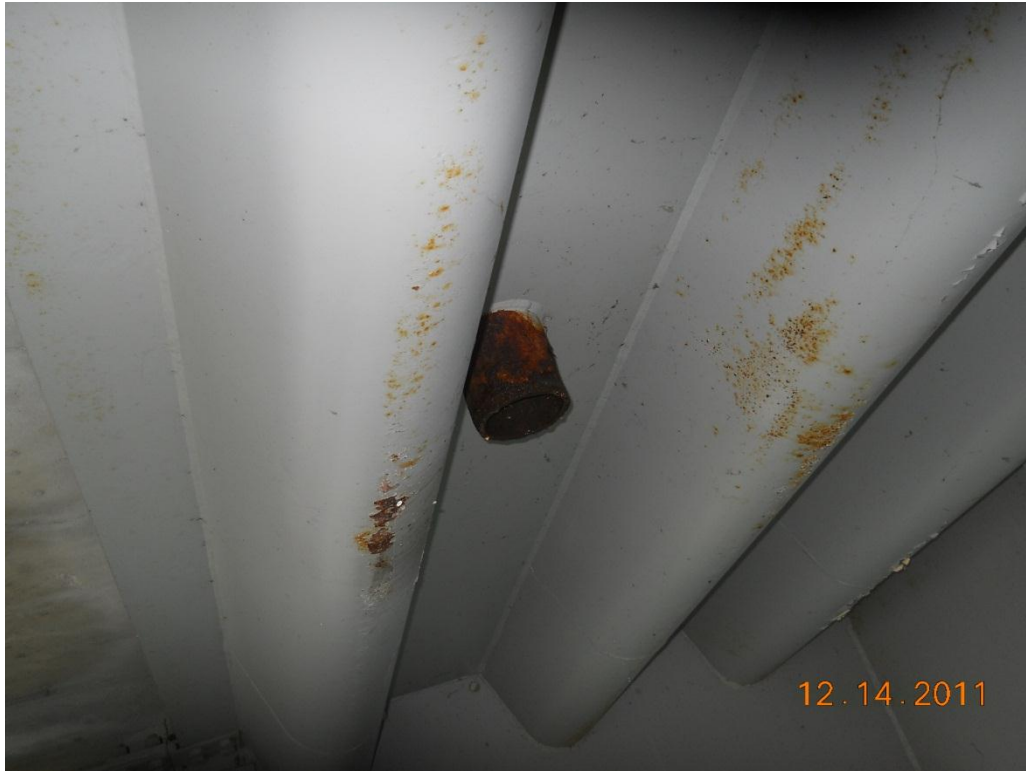
Photograph 131- Deck drain, typical for spans 3, 4, note drain does not extend below trough

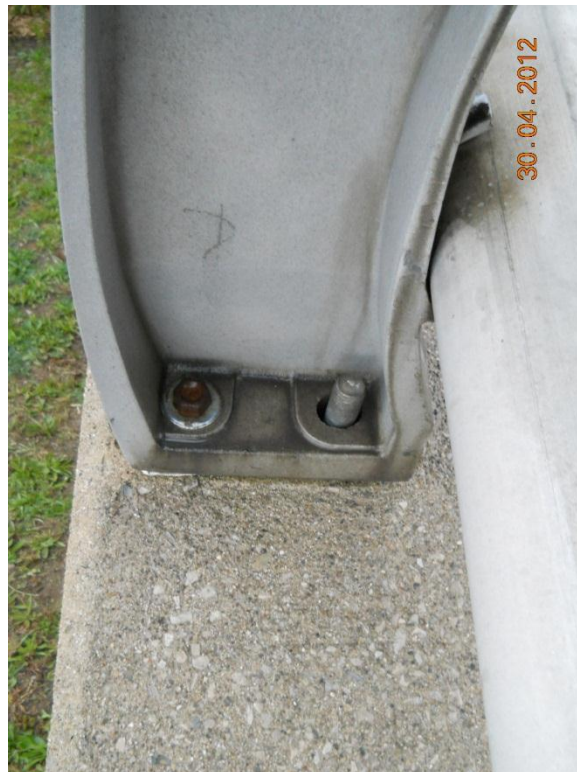
Photograph 140 – South railing post, second from east abutment - Note missing bolt at base.

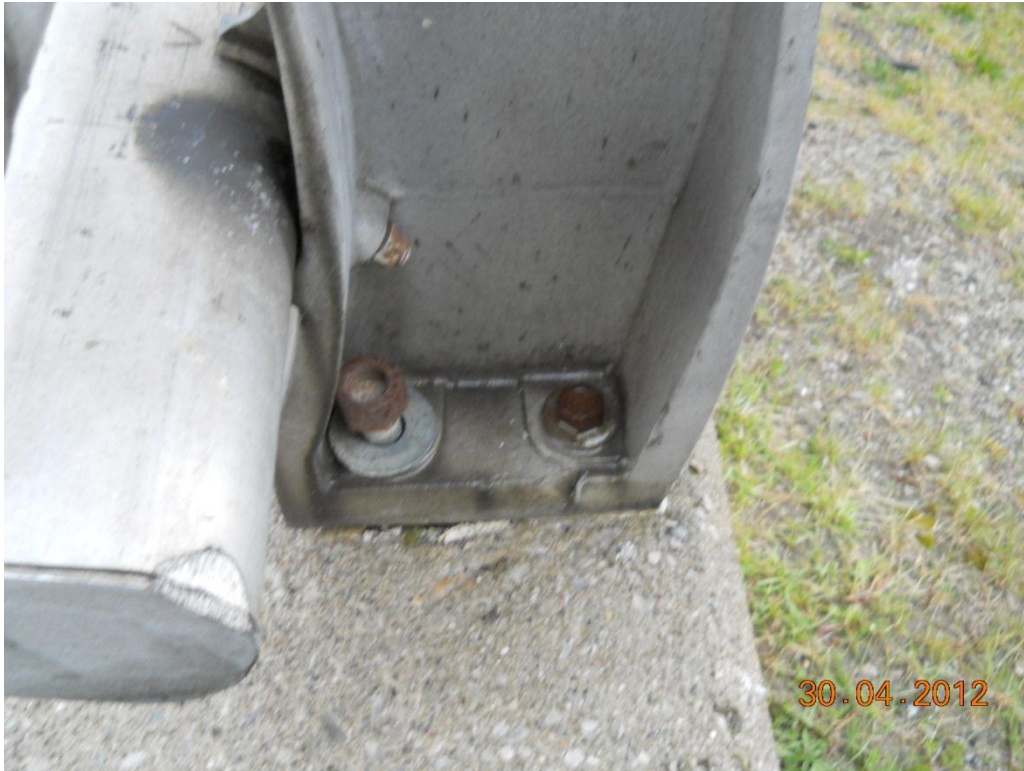
Photograph 141- North railing post, first from east abutment - Note loose bolt at base

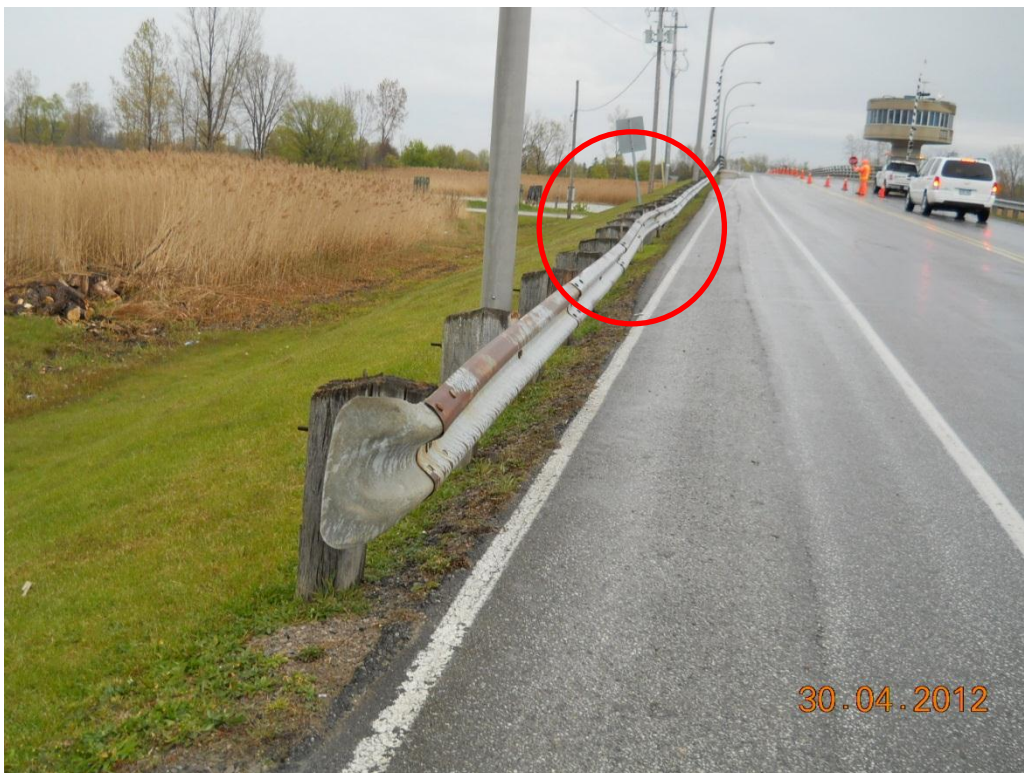
Photograph 142 - Northwest approach SBGR - Note deformation near mid length.

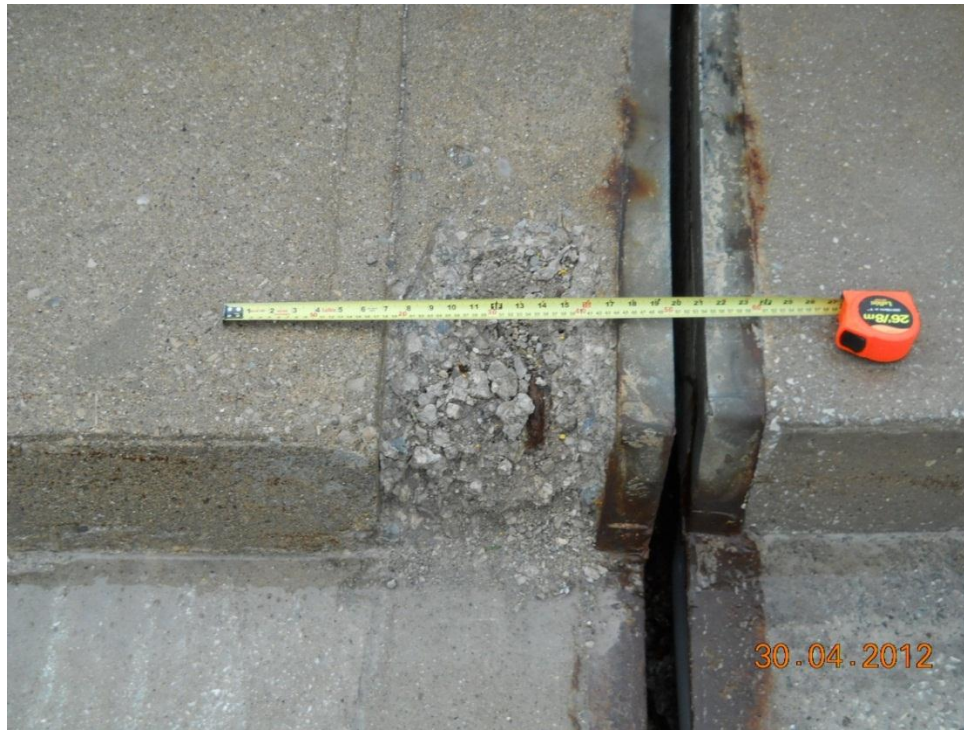
Photograph 143 - North sidewalk, east end of span 2 - Note spall with exposed corroded reinforcing steel bar.

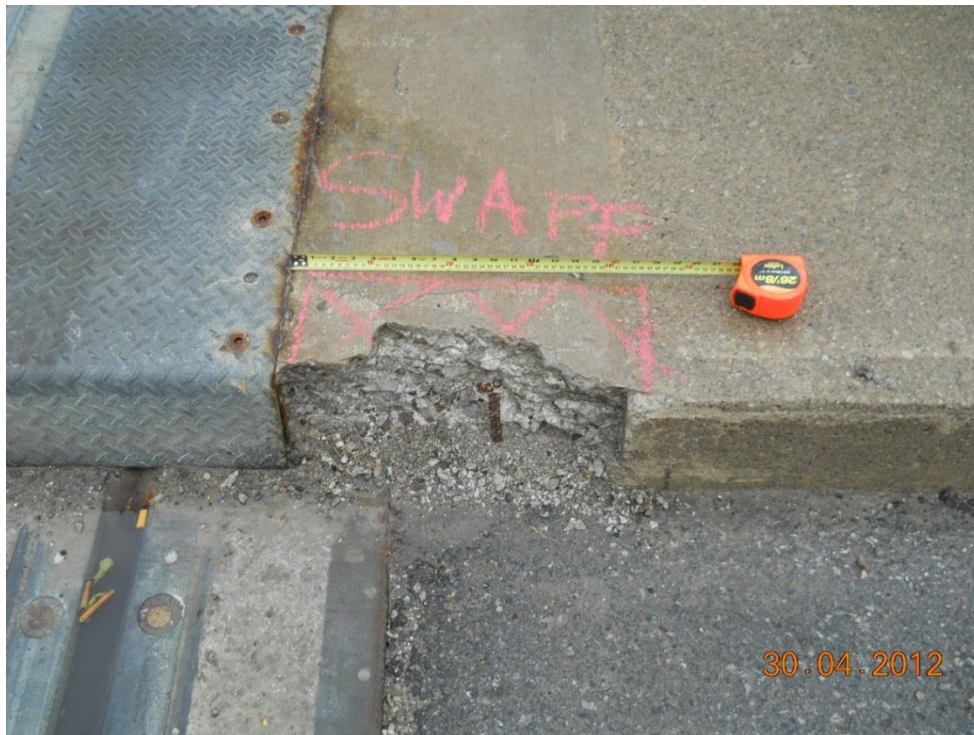
Photograph 144 - South sidewalk, east end of span 1 - Note spall with exposed corroded reinforcing steel bar.

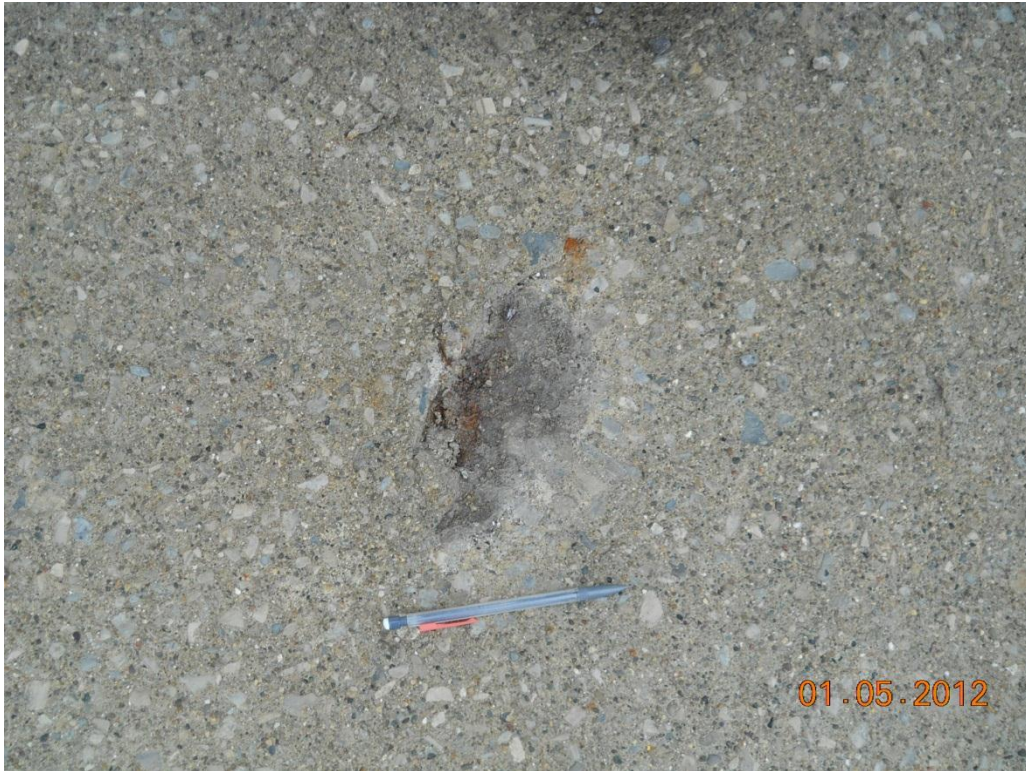
Photograph 145 - North sidewalk near west end of span 1 - Note spall

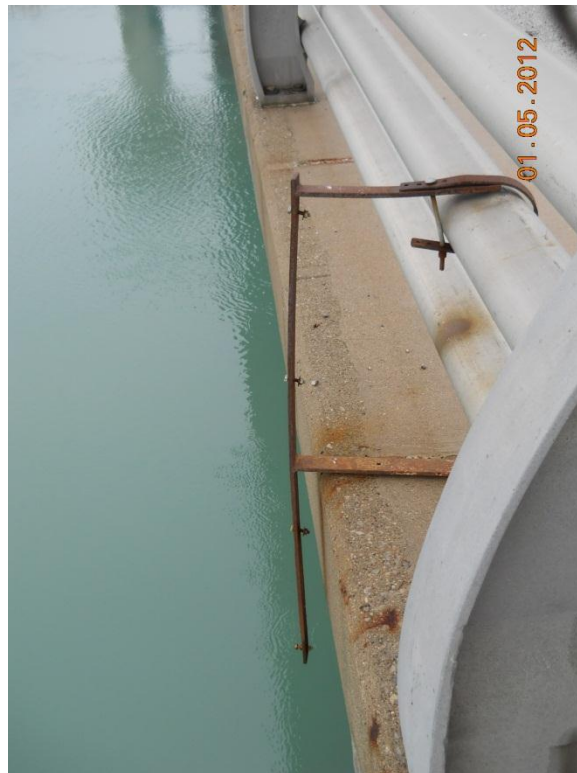
Photograph 146 - Sign support bracket, south face of span 4 - Note missing sign.
