Public Works and  
Government Services  
Canada

Travaux publics et  
Services gouvernementaux  
Canada

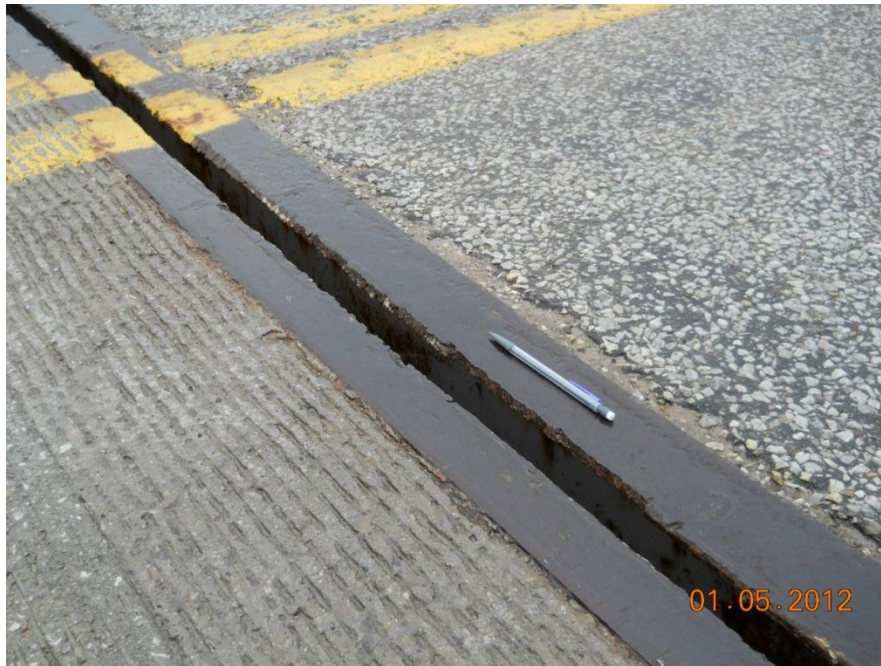
Photograph 147 - Joint over east rest pier - Note abrasion damage to armouring angles.

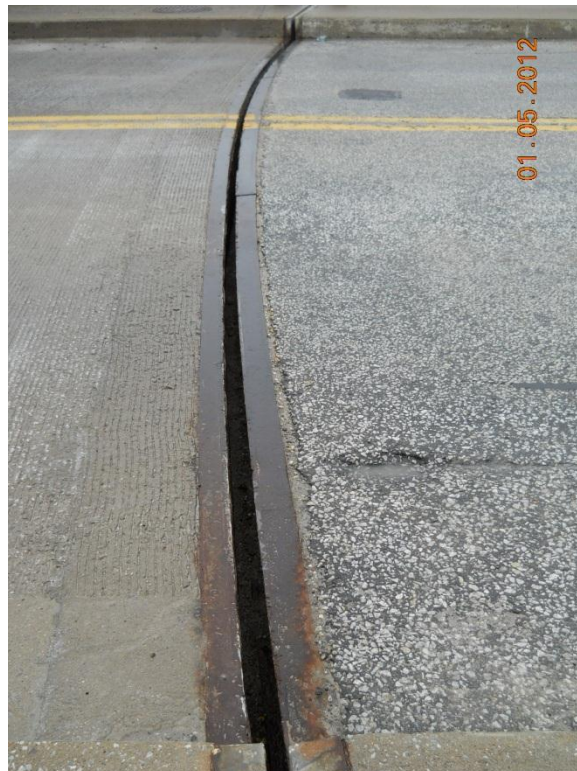
Photograph 148 - Joint over east rest pier looking south - Note corrosion of armouring angles.

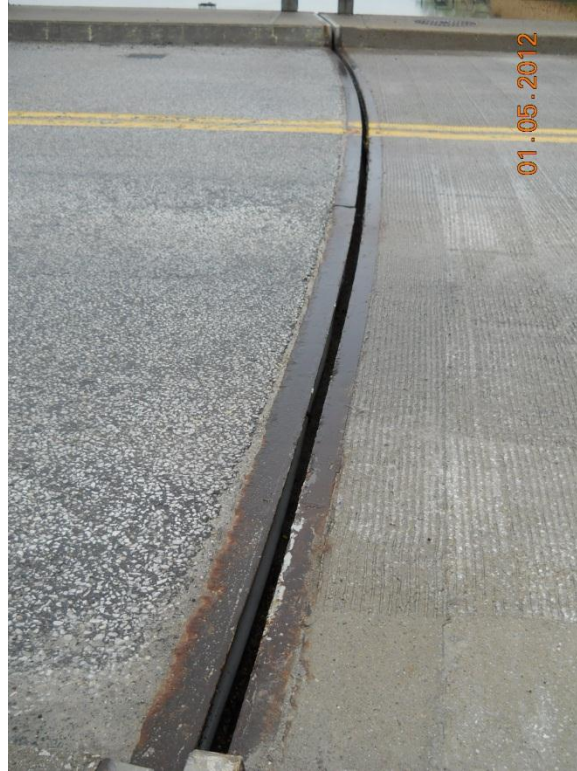
Photograph 149 - Joint over west rest pier looking south - Note corrosion of armoring angles.

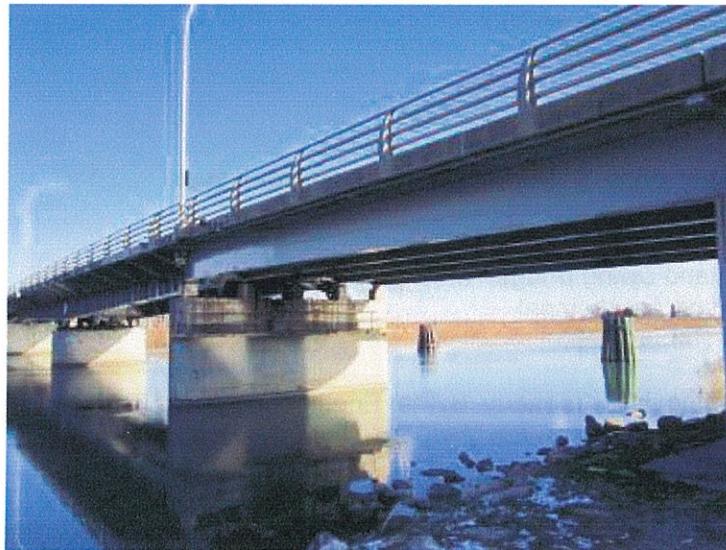
**WALPOLE ISLAND FIRST NATION PUBLIC WORKS  
GD. STN. MAIN, WALLACEBURG, ONTARIO N8A 4L4**

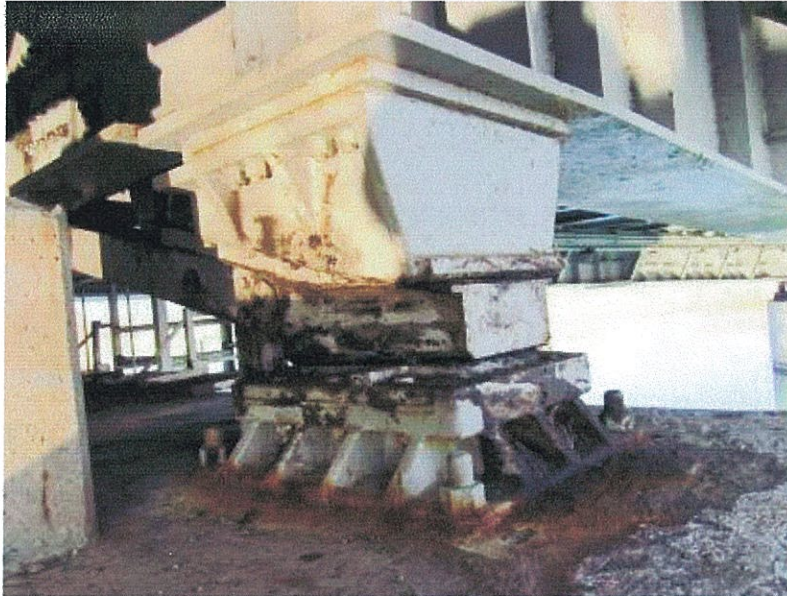
**PHOTOGRAPH 1: SPAN WEDGE WITH CORRODED BASE PLATE ON THE SOUTH SIDE OF THE WEST REST PIER**

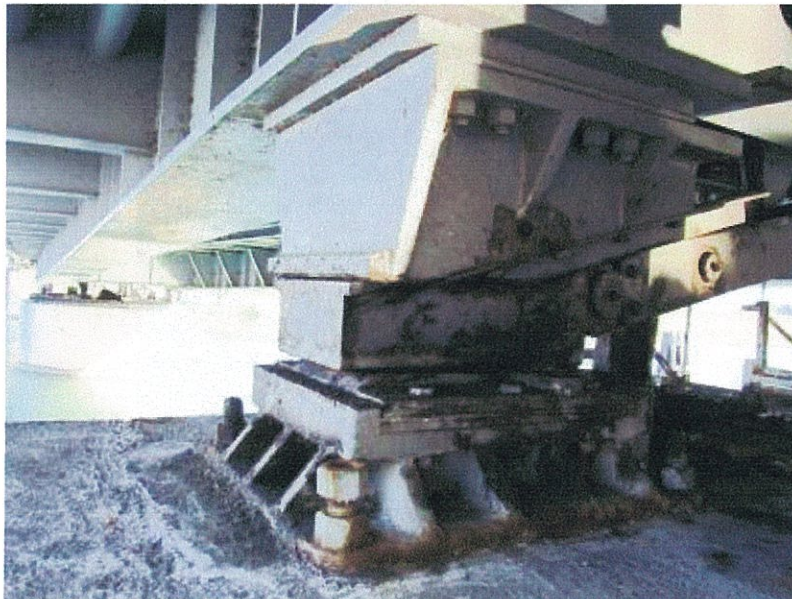
**PHOTOGRAPH 2: SPAN WEDGE WITH CORRODED BASE PLATE ON THE NORTH SIDE OF THE WEST REST PIER**

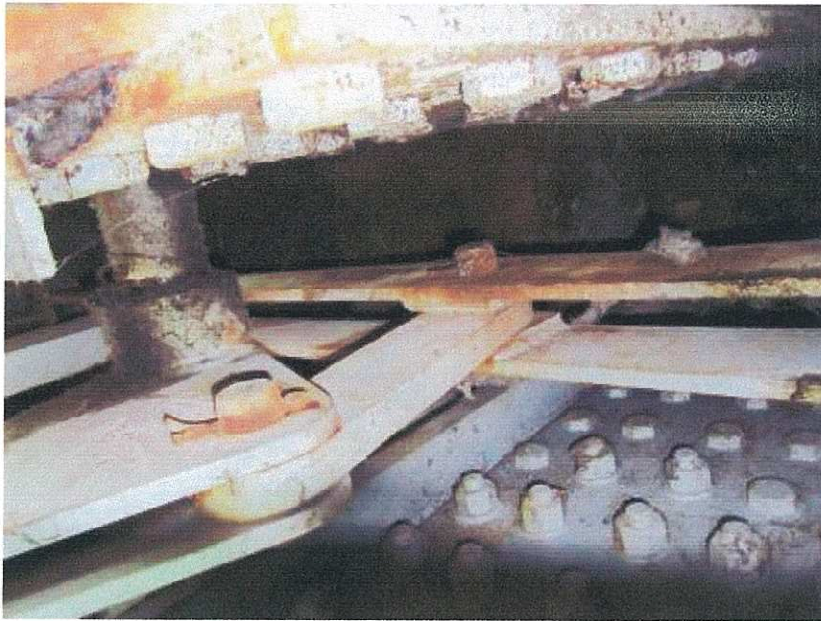
**PHOTOGRAPH 3: WEDGE MECHANISM ON THE WEST REST PIER SHOWING LACK OF LUBRICATION AND CORROSION**

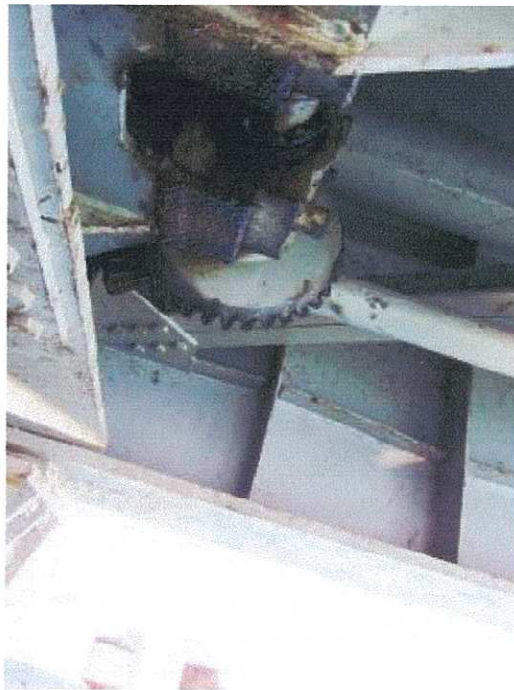
**PHOTOGRAPH 4: WEDGE DRIVE SHAFT AND BEVEL GEARS ON THE WEST REST PIER SHOWING LACK OF LUBRICATION AND CORROSION**

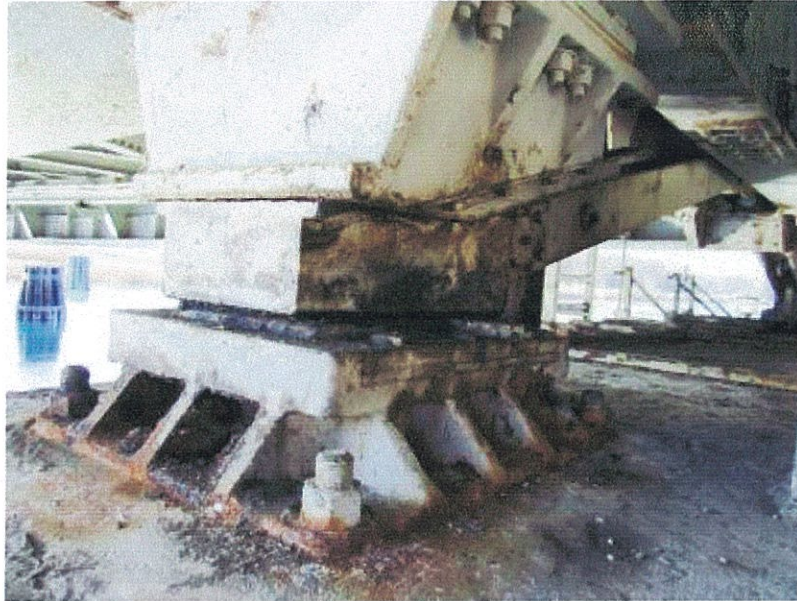
**PHOTOGRAPH 5: SPAN WEDGE WITH CORRODED BASE PLATE ON THE SOUTH SIDE OF THE EAST REST PIER**

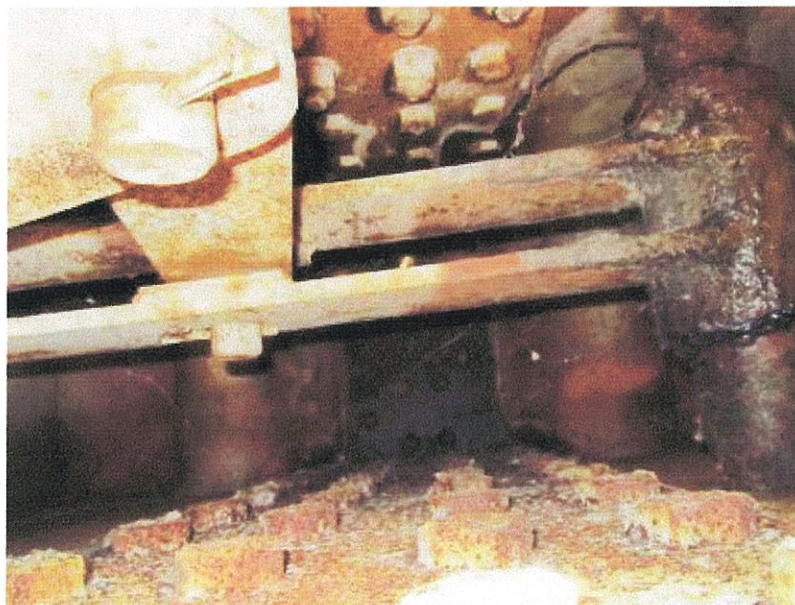
**PHOTOGRAPH 6: WEDGE MECHANISM ON THE EAST REST PIER, SOUTH SIDE SHOWING LACK OF LUBRICATION AND CORROSION**

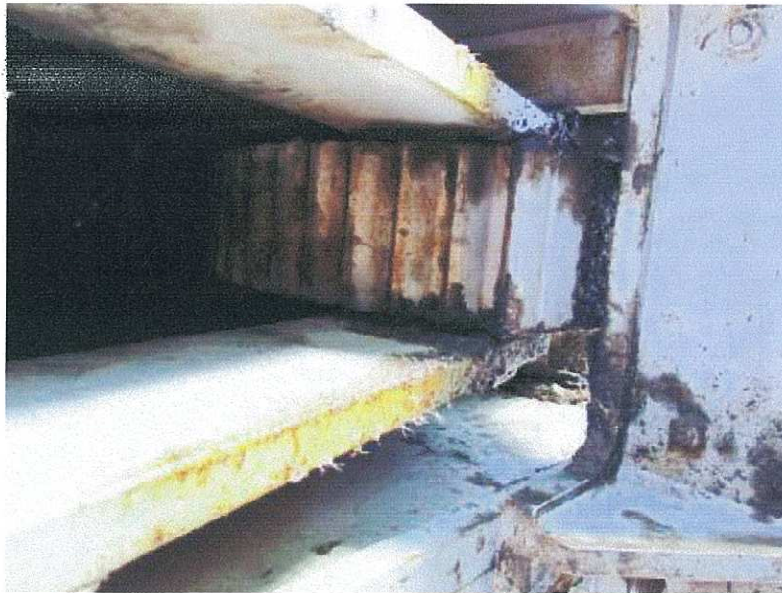
**PHOTOGRAPH 7: WEDGE MECHANISM GEAR SECTOR ON THE REST PIER  
SHOWING LACK OF LUBRICATION AND CORROSION**

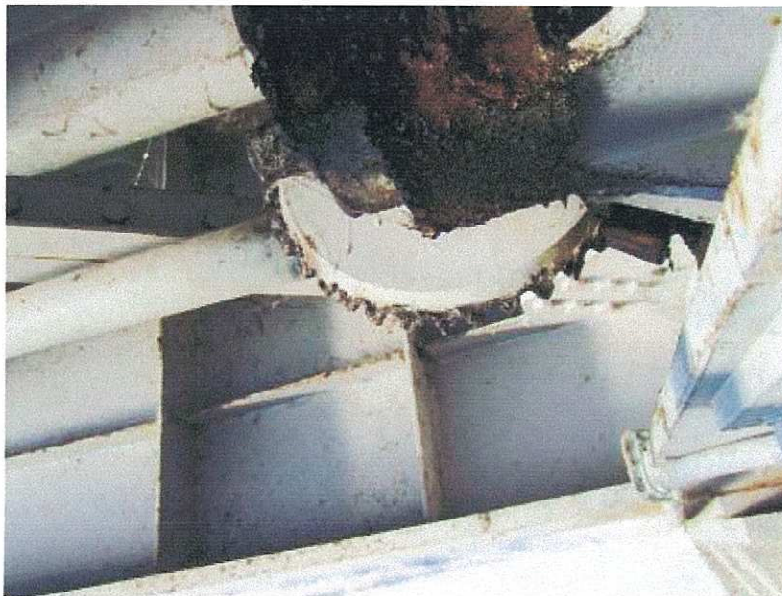
**PHOTOGRAPH 8: WEDGE DRIVE SHAFT AND BEVEL GEARS ON THE EAST  
REST PIER SHOWING LACK OF LUBRICATION AND CORROSION**

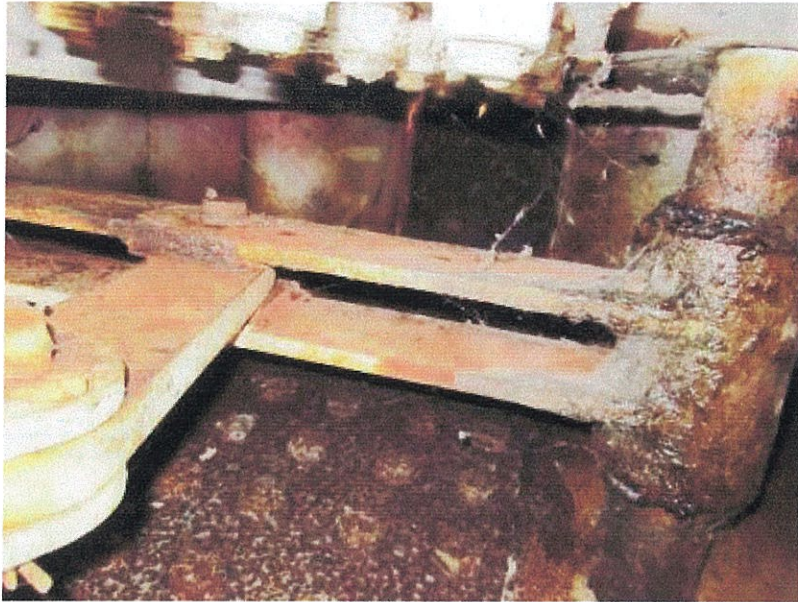
**PHOTOGRAPH 9: WEDGE MECHANISM ON THE EAST REST PIER, NORTH SIDE  
SHOWING LACK OF LUBRICATION AND CORROSION**

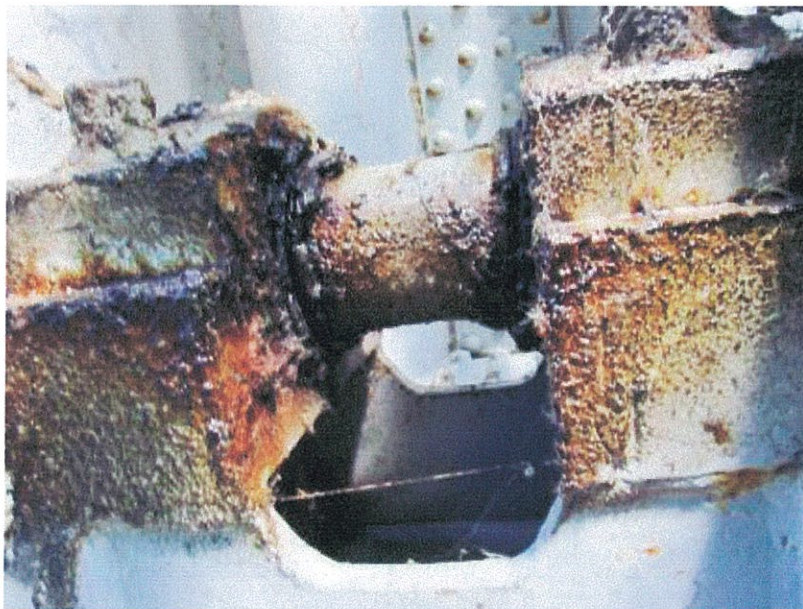
**PHOTOGRAPH 10: SLEEVE BEARINGS SHOWING LACK OF LUBRICATION**

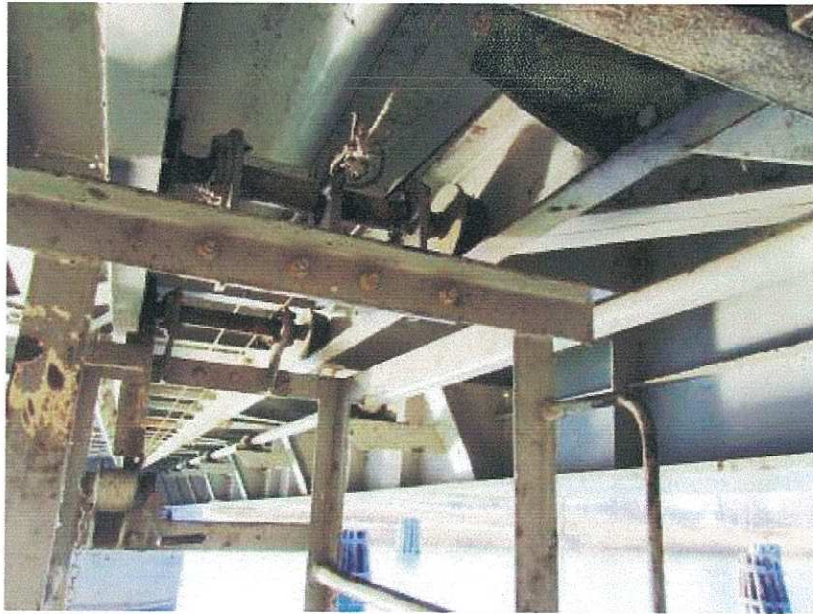
**PHOTOGRAPH 11: INSPECTION CRADLE AND TRACK SHOWING LACK OF LUBRICATION AND CORROSION**

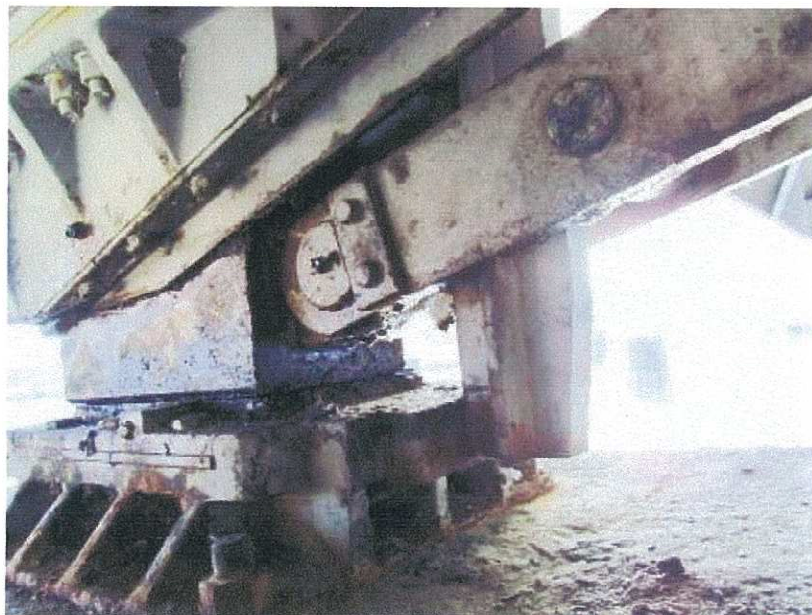
**PHOTOGRAPH 12: SPAN WEDGE WITH CORRODED BASE PLATE ON THE NORTH SIDE OF THE EAST REST PIER**

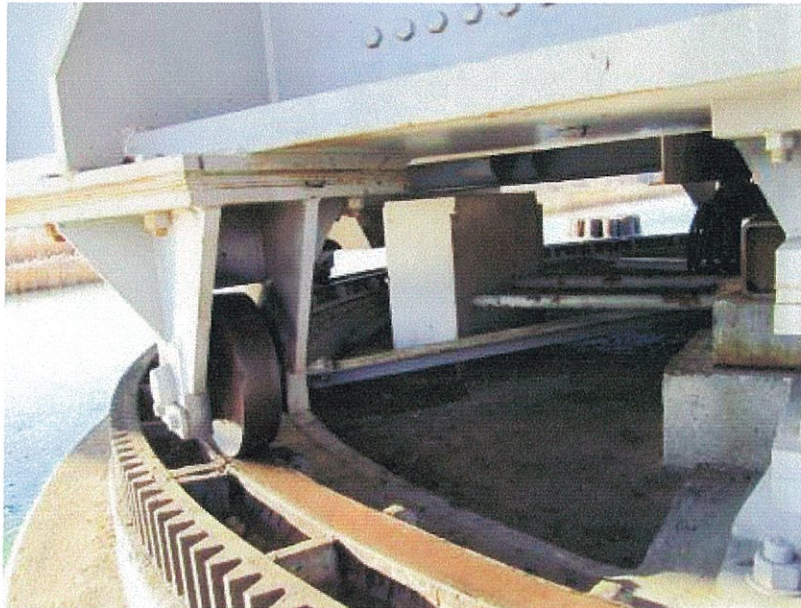
**PHOTOGRAPH 13: CENTRE PIER BALANCE WHEELS ON TRACK WITH SPUR GEAR**

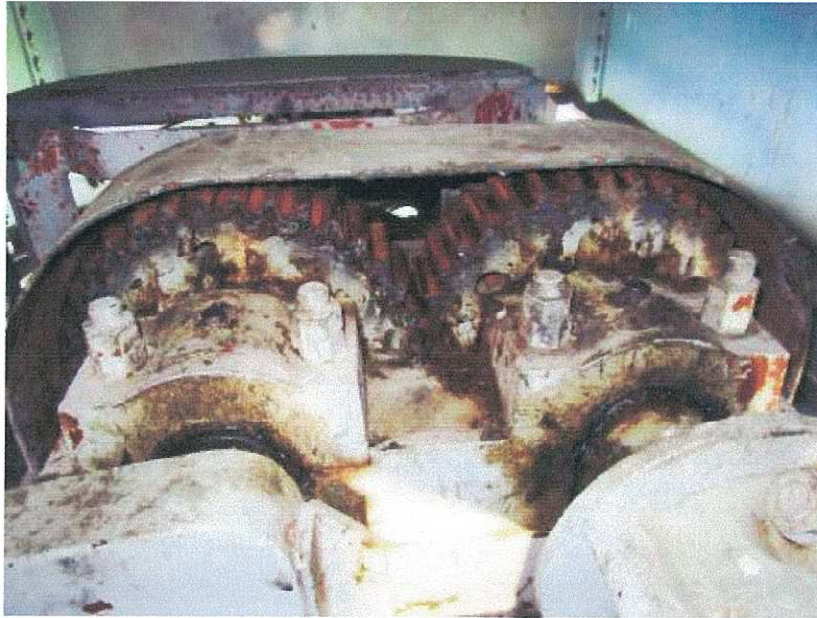
**PHOTOGRAPH 19: CENTRE PIER SWING DRIVE SPUR GEARS SHOWING LACK OF LUBRICATION AND CORROSION**

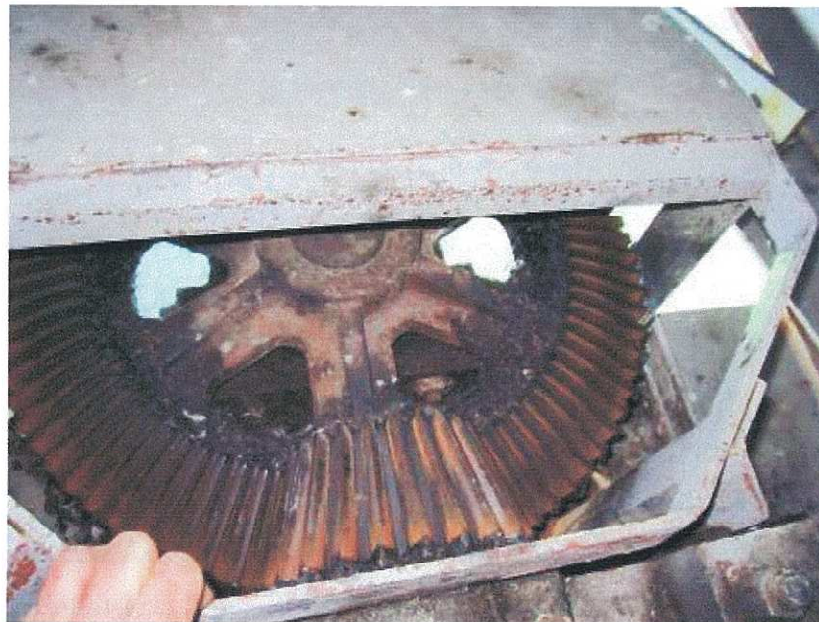
**PHOTOGRAPH 20: CENTRE PIER EAST SIDE SWING DRIVE BEVEL GEARS SHOWING LACK OF LUBRICATION AND CORROSION**

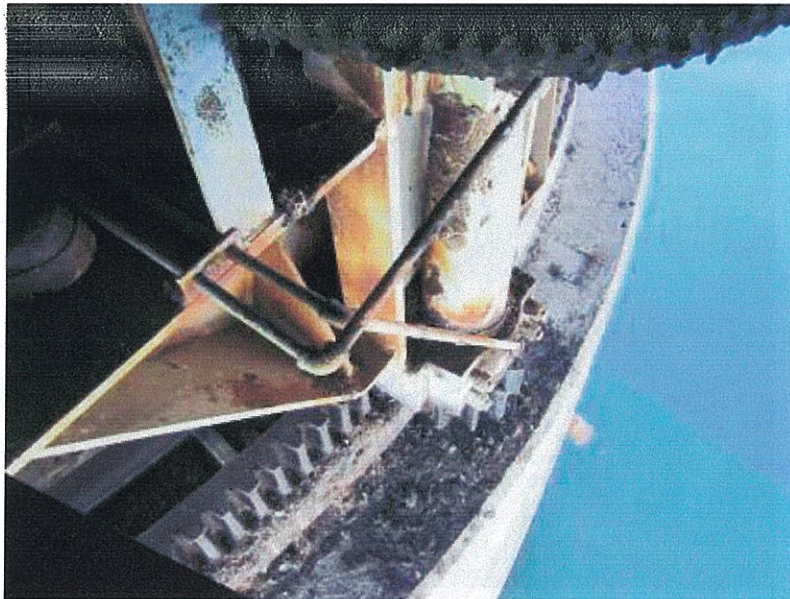
**PHOTOGRAPH 21: CENTRE PIER EAST SIDE SWING DRIVE GEAR SHOWING LACK OF LUBRICATION AND CORROSION**

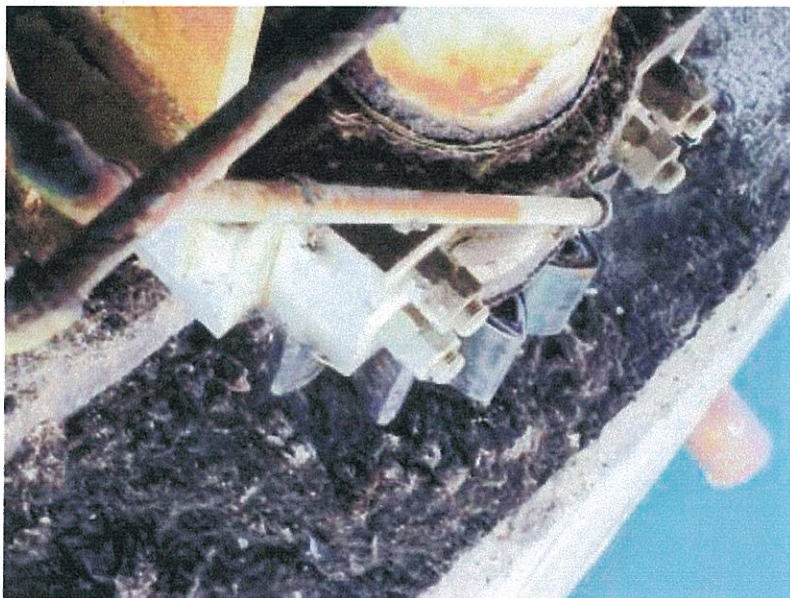
**PHOTOGRAPH 22: CENTRE PIER EAST SIDE SWING DRIVE FINAL GEAR SHOWING LACK OF LUBRICATION AND CORROSION**

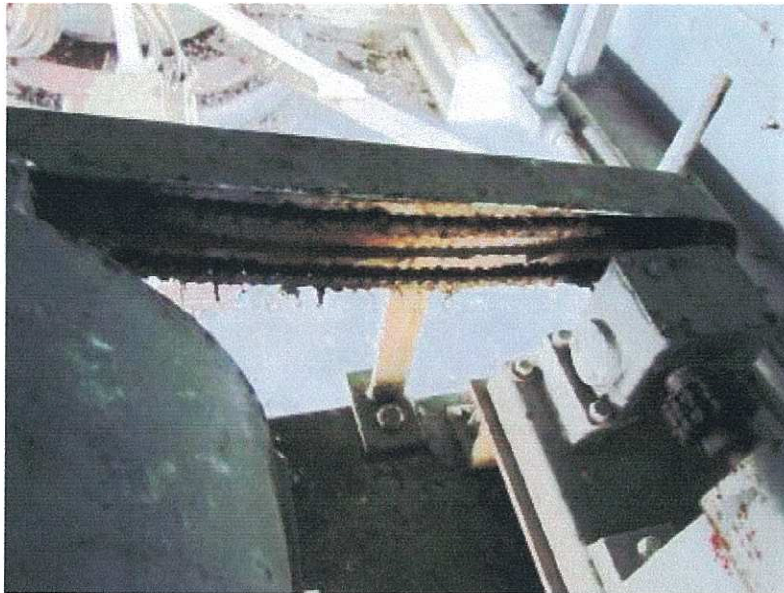
**PHOTOGRAPH 23: CENTRE PIER SWING DRIVE POSITION CONTROLLER TRANSMISSION SHOWING LACK OF LUBRICATION AND CORROSION**

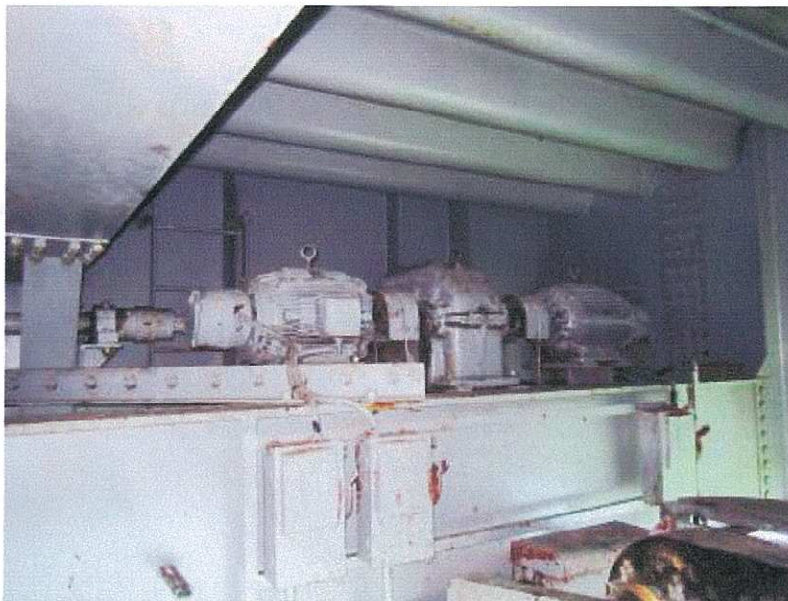
**PHOTOGRAPH 24: CENTRE PIER WEDGES DRIVE MOTORS AND REDUCER**

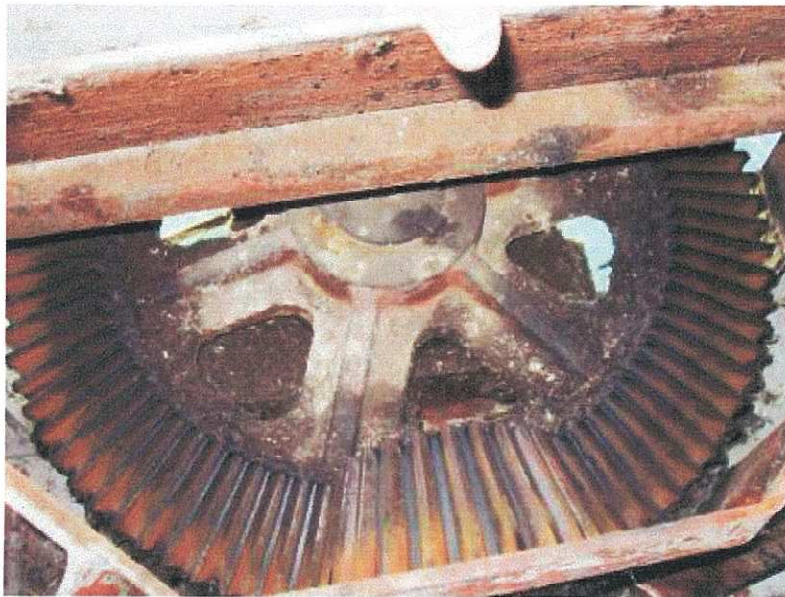
**PHOTOGRAPH 28: CENTRE PIER WEST SIDE SWING DRIVE BEVEL GEARS  
SHOWING LACK OF LUBRICATION AND CORROSION**

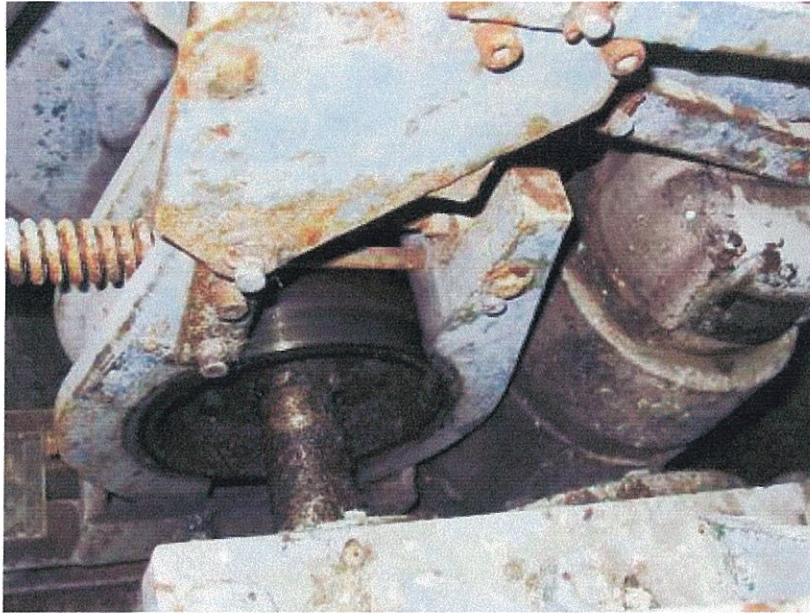
**PHOTOGRAPH 29: EAST SIDE SWING DRIVE BRAKE HUB SHOWING CONTAMINATION WITH LUBRICANT**

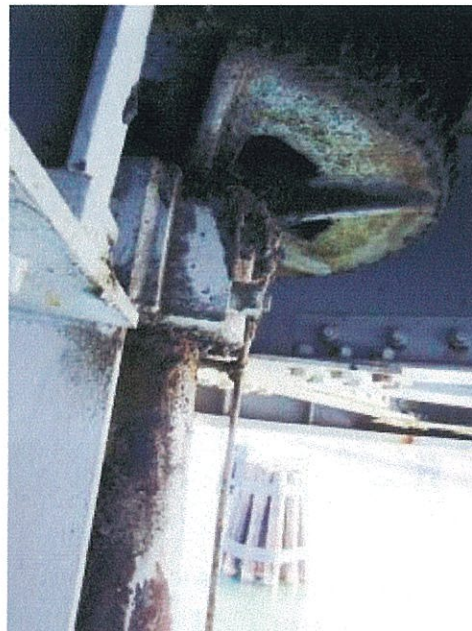
**PHOTOGRAPH 30: CENTRE PIER WEST SIDE SWING DRIVE GEAR SHOWING LACK OF LUBRICATION AND CORROSION**

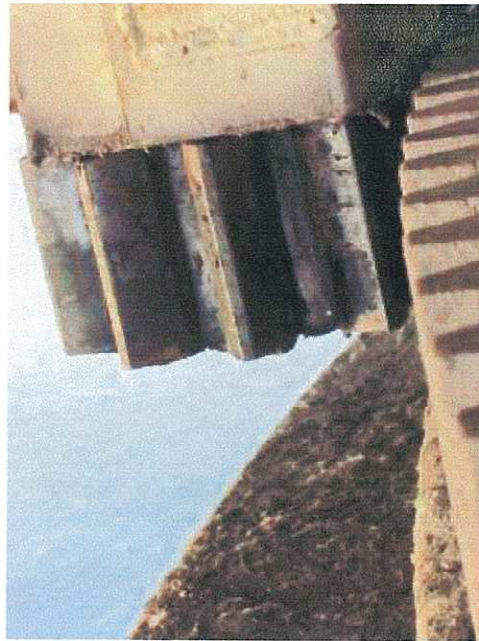
**PHOTOGRAPH 31: CENTRE PIER EAST SIDE SWING DRIVE FINAL GEAR AND CIRCULAR RACK SHOWING LACK OF LUBRICATION AND CORROSION**

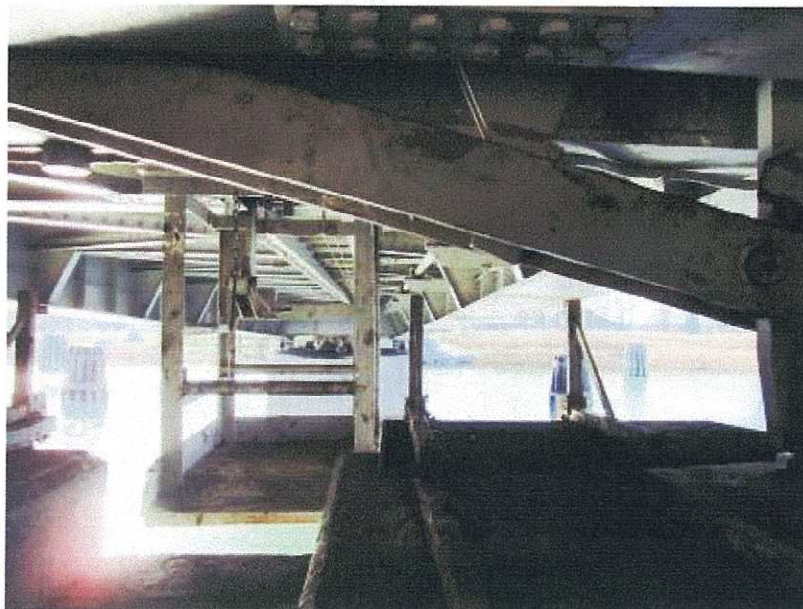
**PHOTOGRAPH 32: WEST REST PIER MAINTENANCE PLATFORM SHOWING CORROSION**

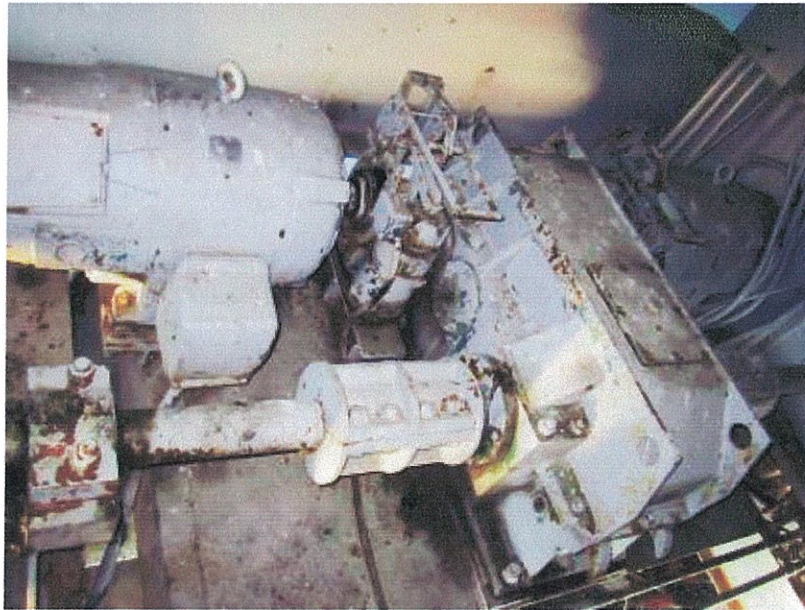
**PHOTOGRAPH 33: CENTER PIER SWING DRIVE MOTORS AND REDUCER**

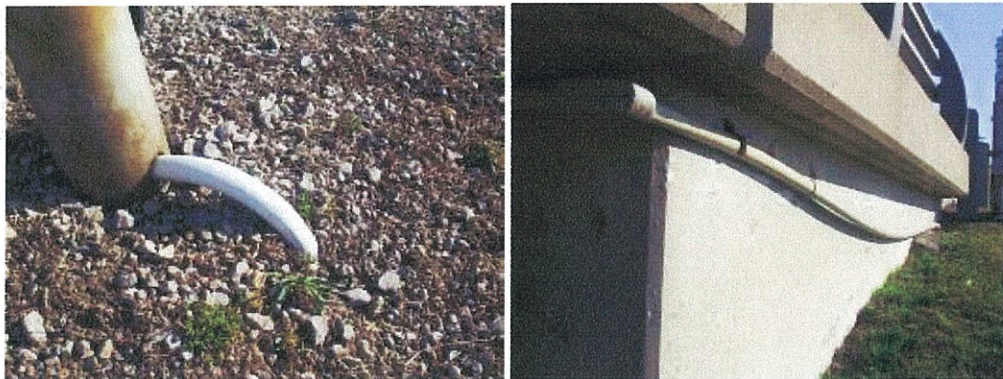
**PHOTOGRAPH 43: UNPROTECTED CONDUITS**

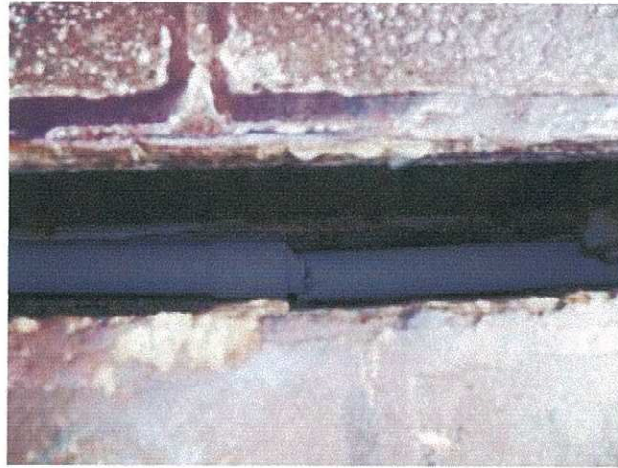
**PHOTOGRAPH 44: CONDUIT REPAIRS**

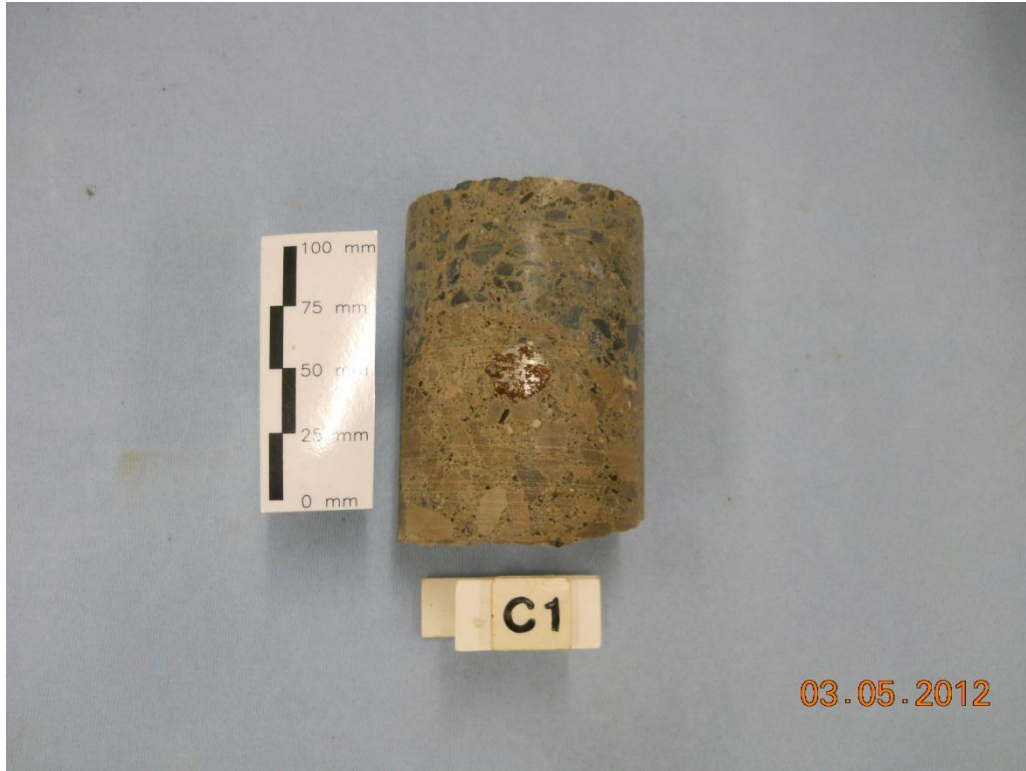
Core C1 - Note light surface rusting on reinforcing steel bar

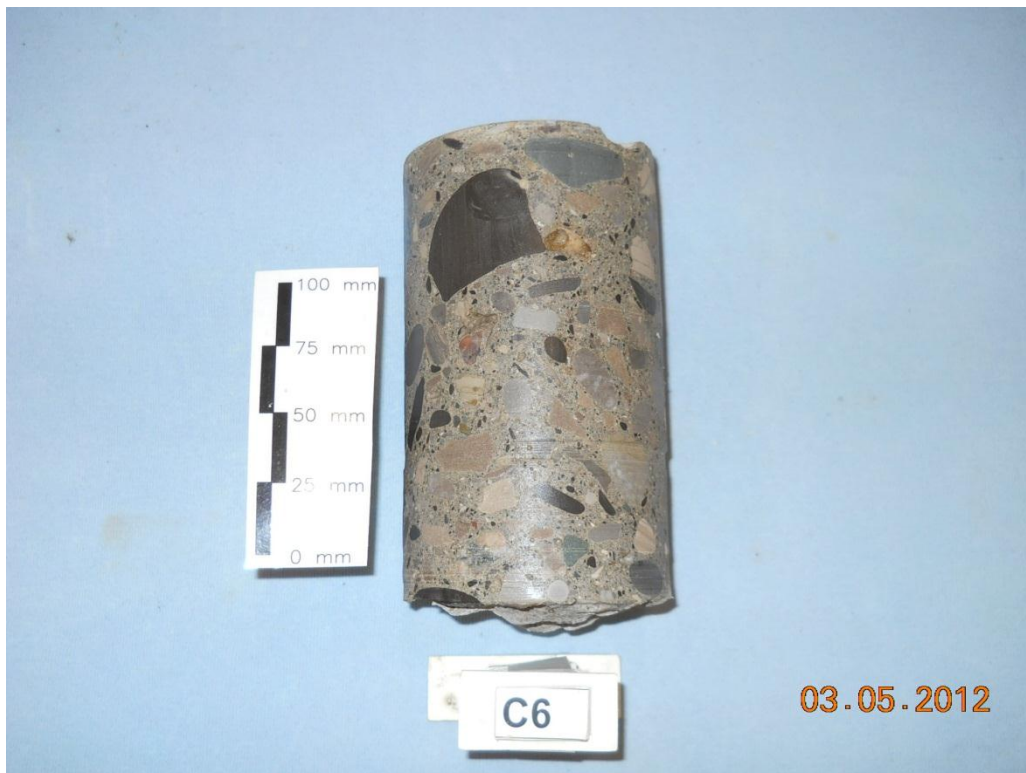
Core C6 - Note core removed from sidewalk; air voids noted

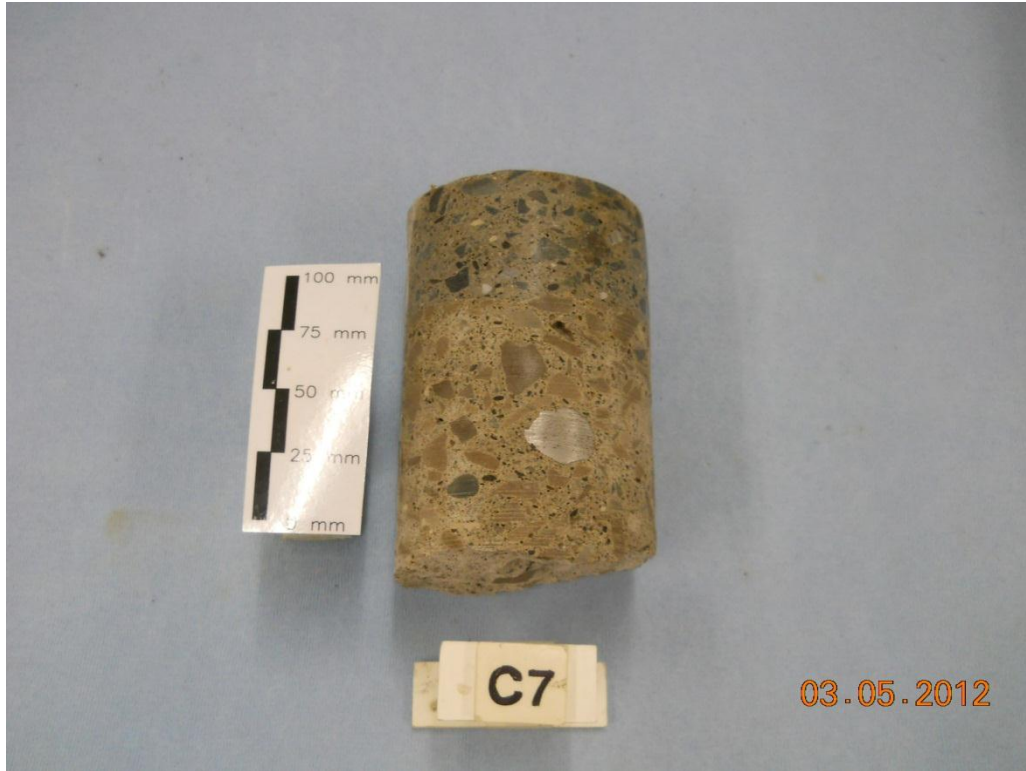
Core C7 - Note air voids noted

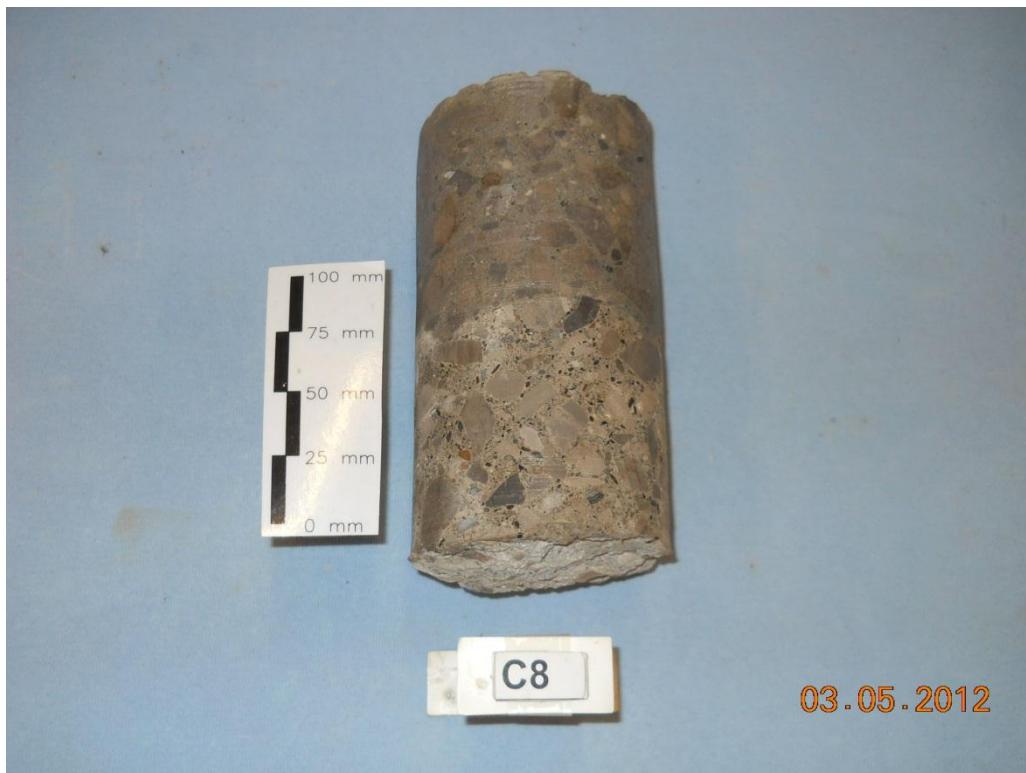
Core C8 - Note core removed from area of deck patching

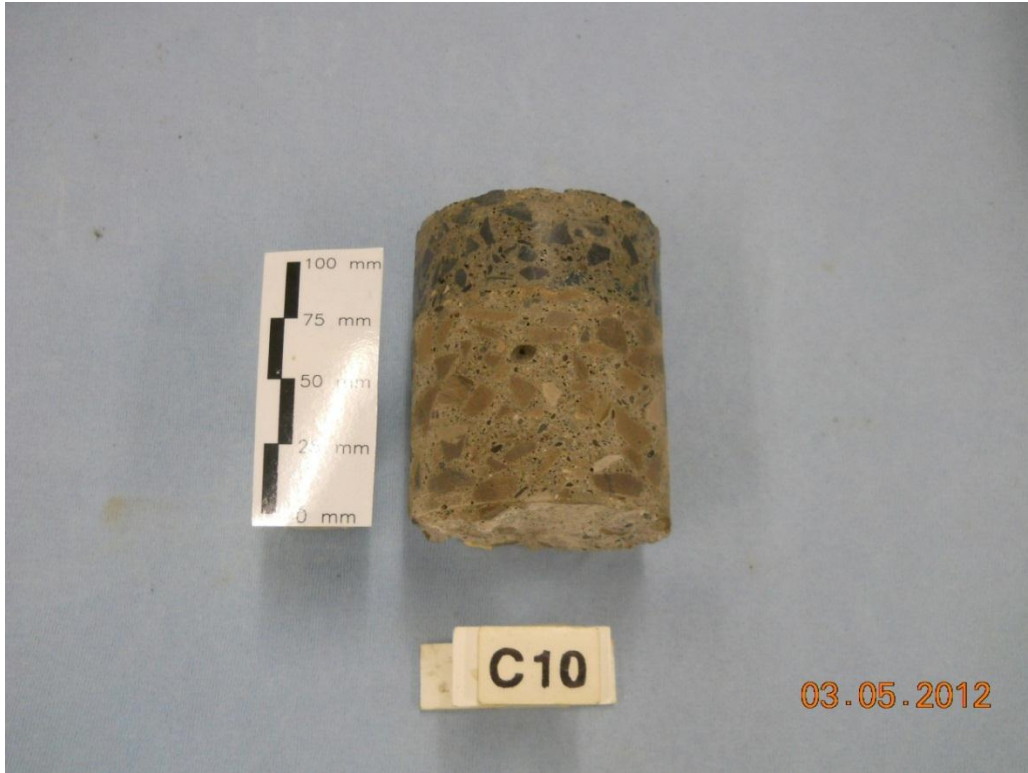
Core C10 - Note air voids noted

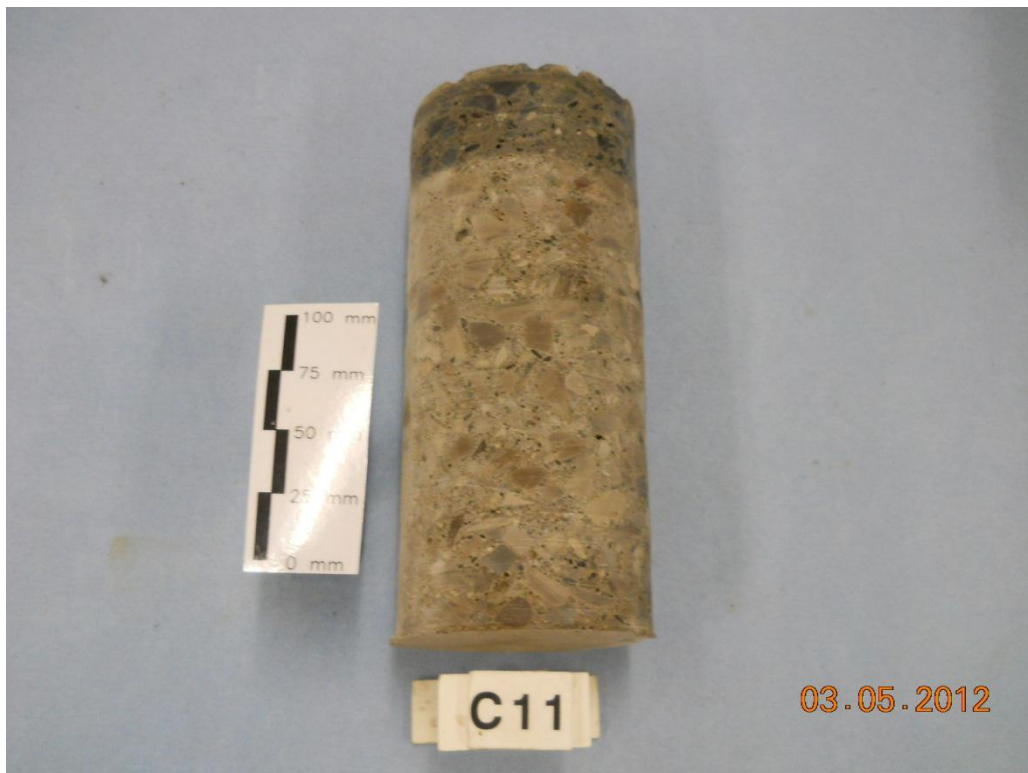
Core C11 - Note air voids noted

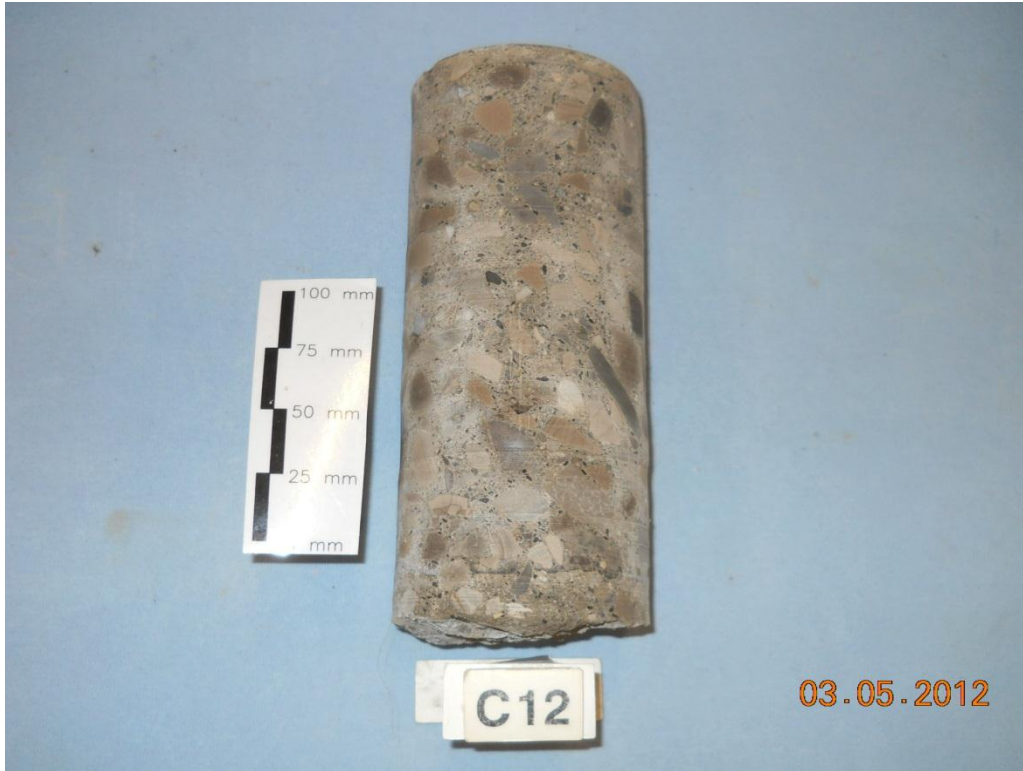
Core C12 - Note core removed from sidewalk, note air voids

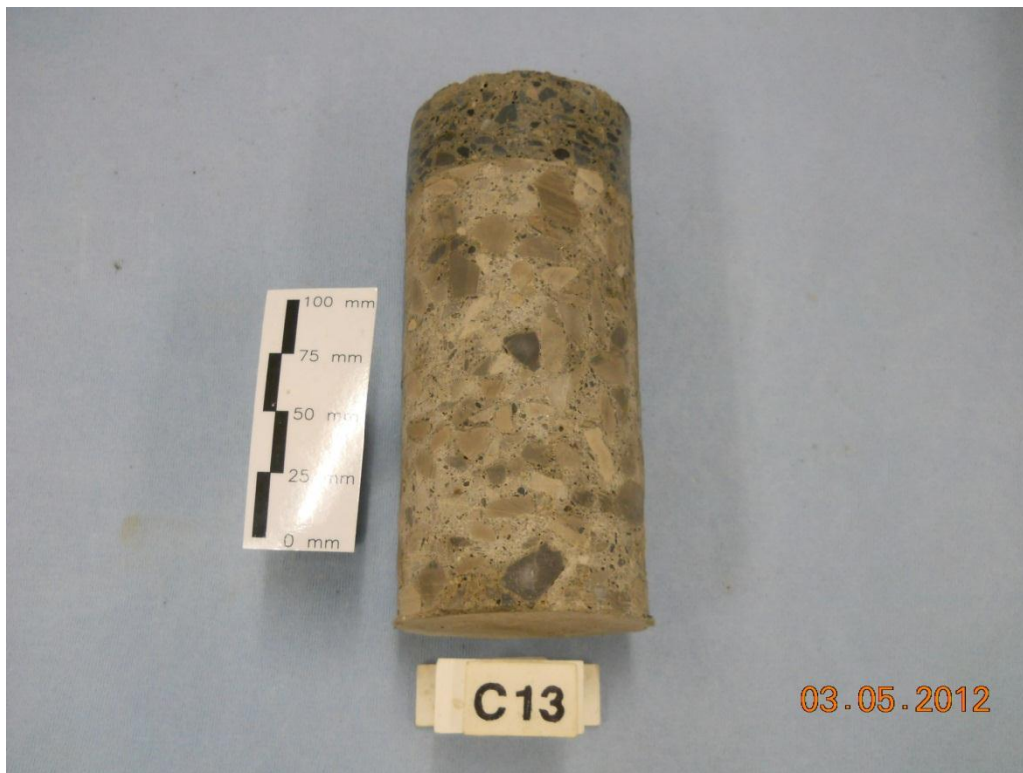
Core C13 - Note narrow horizontal crack at overlay/deck interface

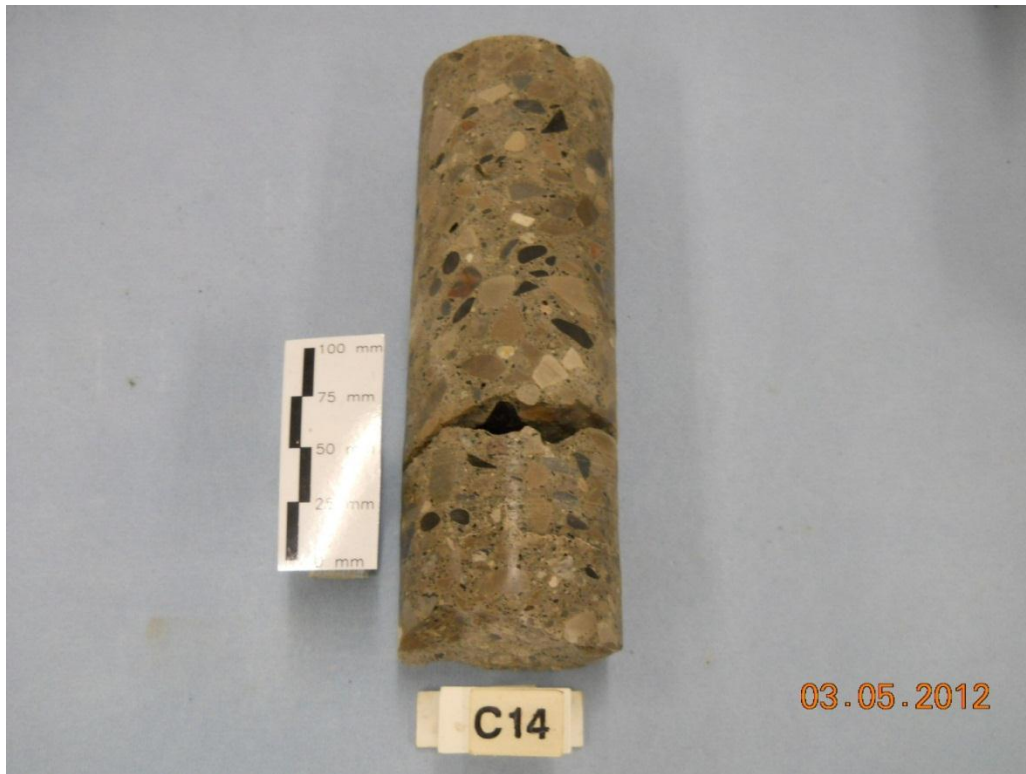
Core C14 - Note, core split during coring operation. Note narrow horizontal crack along sidewalk/deck interface below split

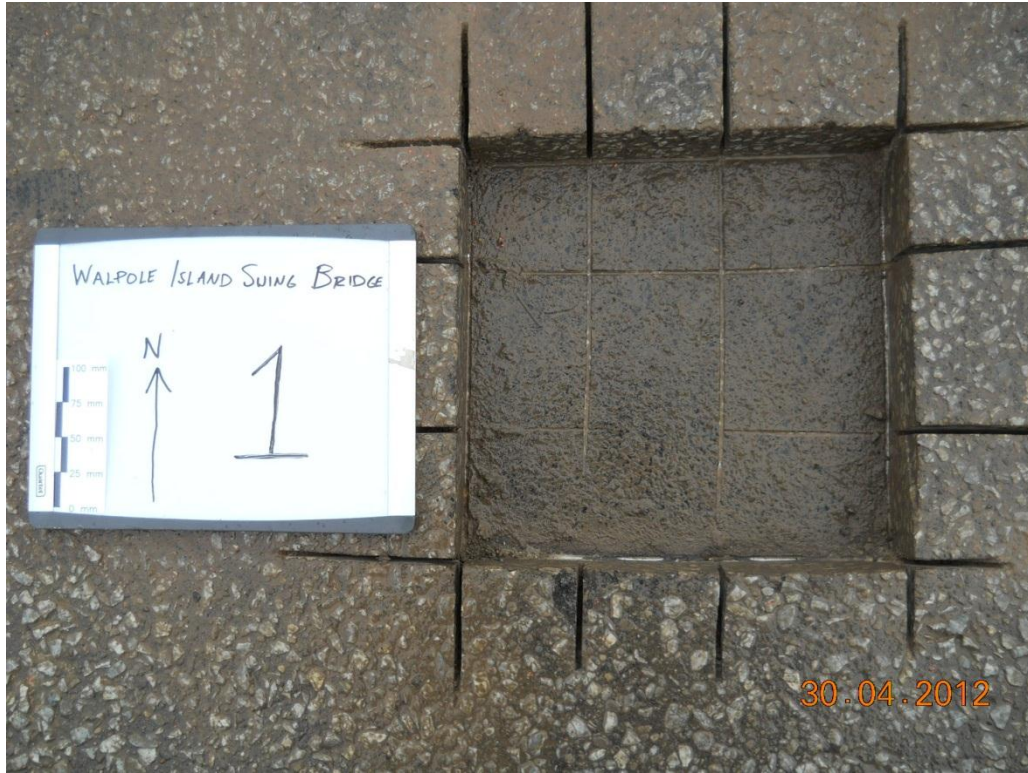
1. Condition: G = Good, F = Fair, P = Poor
2. Defects: C = Cracked, D = Delamination, R=Rough, Sc = Scaling, S = Spalling, N =None
