Public Works and  
Government Services  
Canada

Travaux publics et  
Services gouvernementaux  
Canada

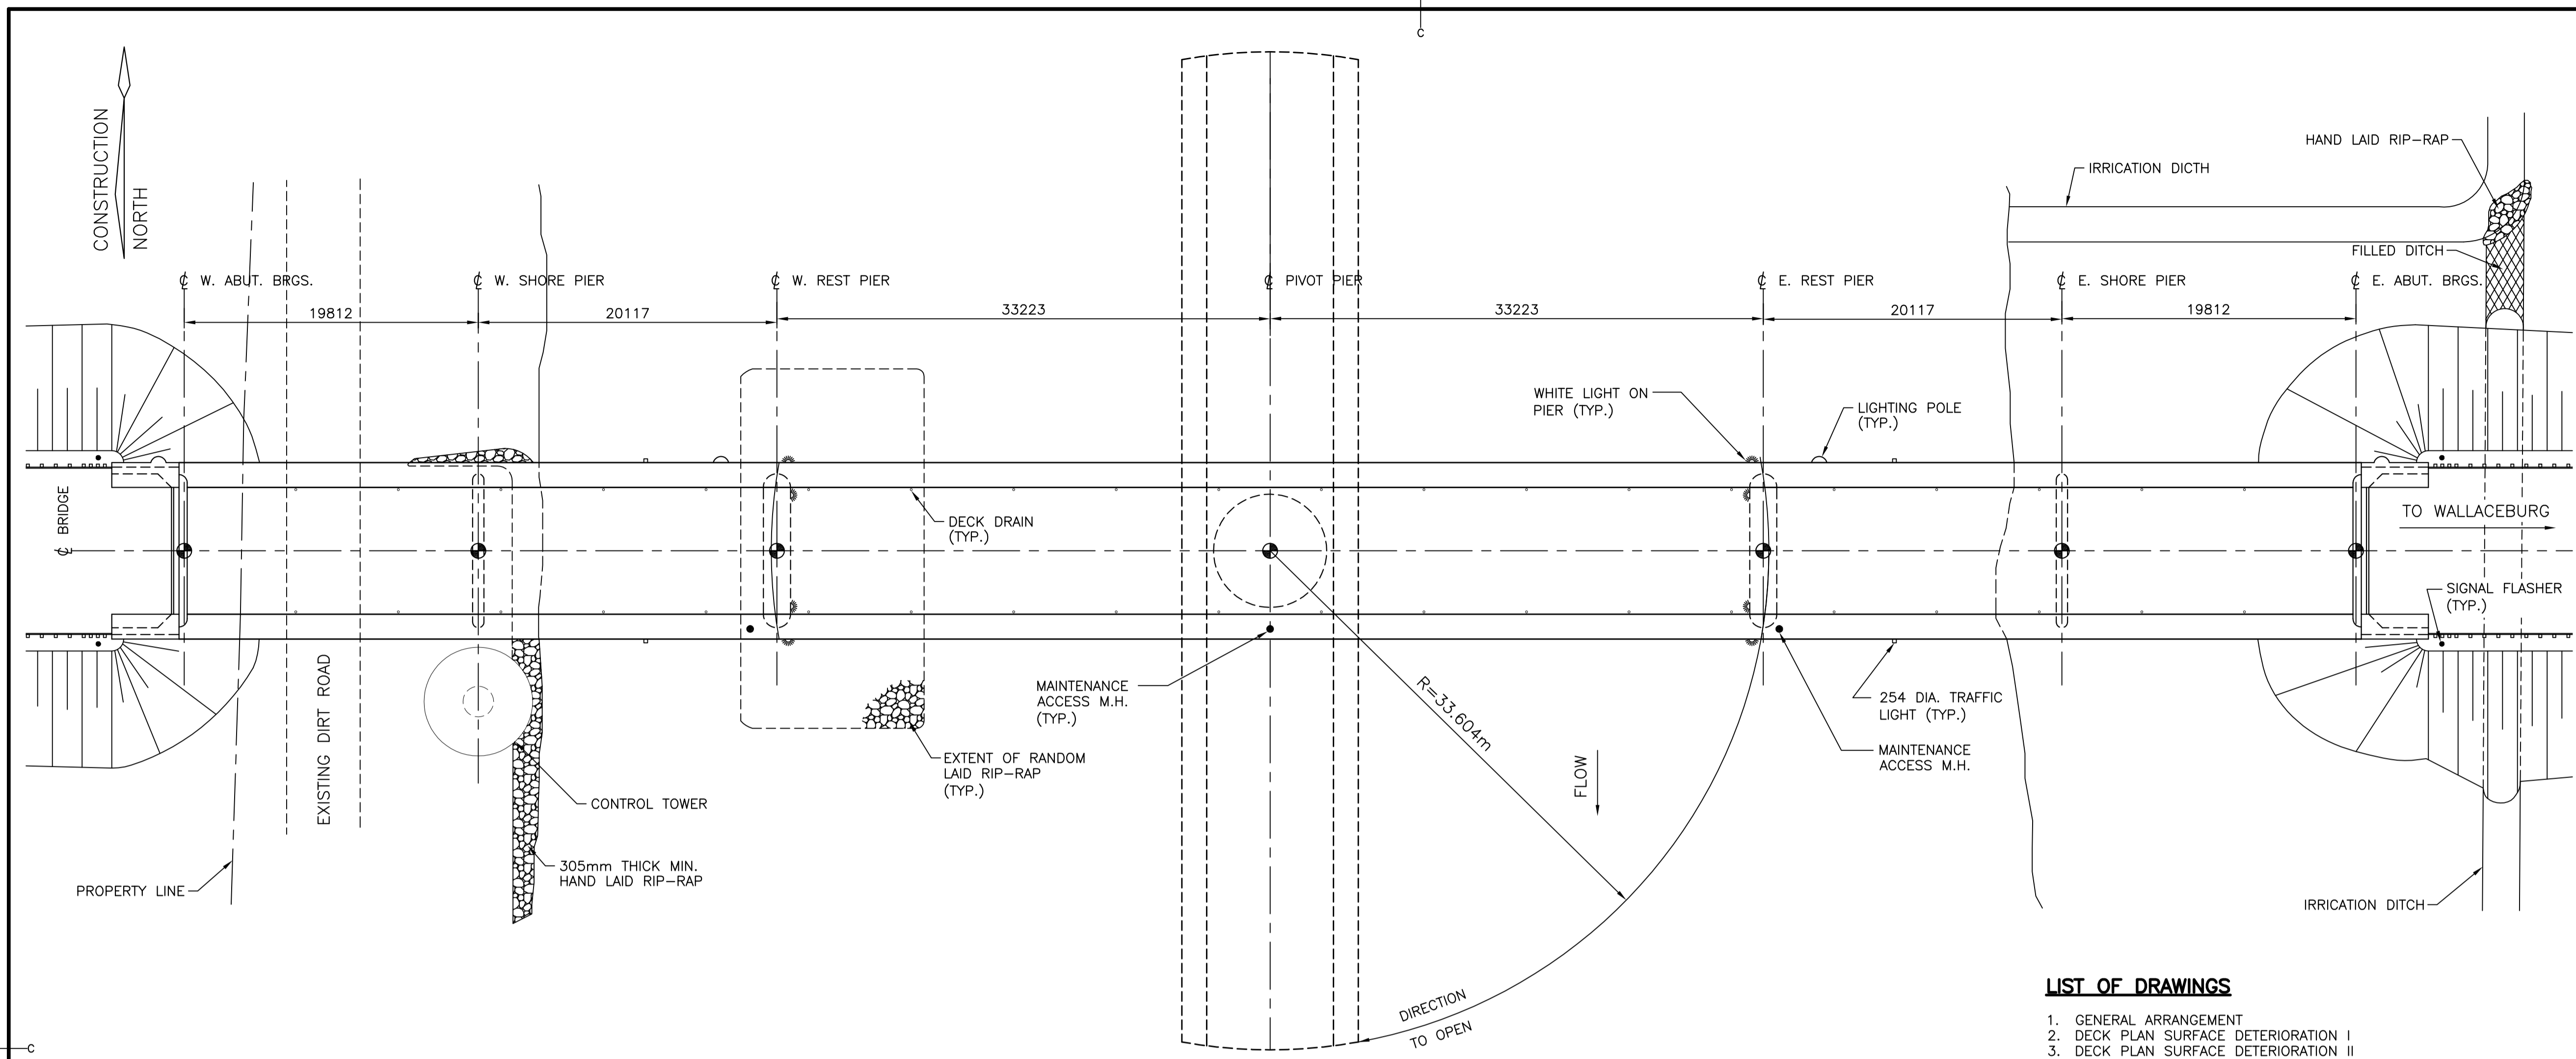
**LIST OF DRAWINGS**

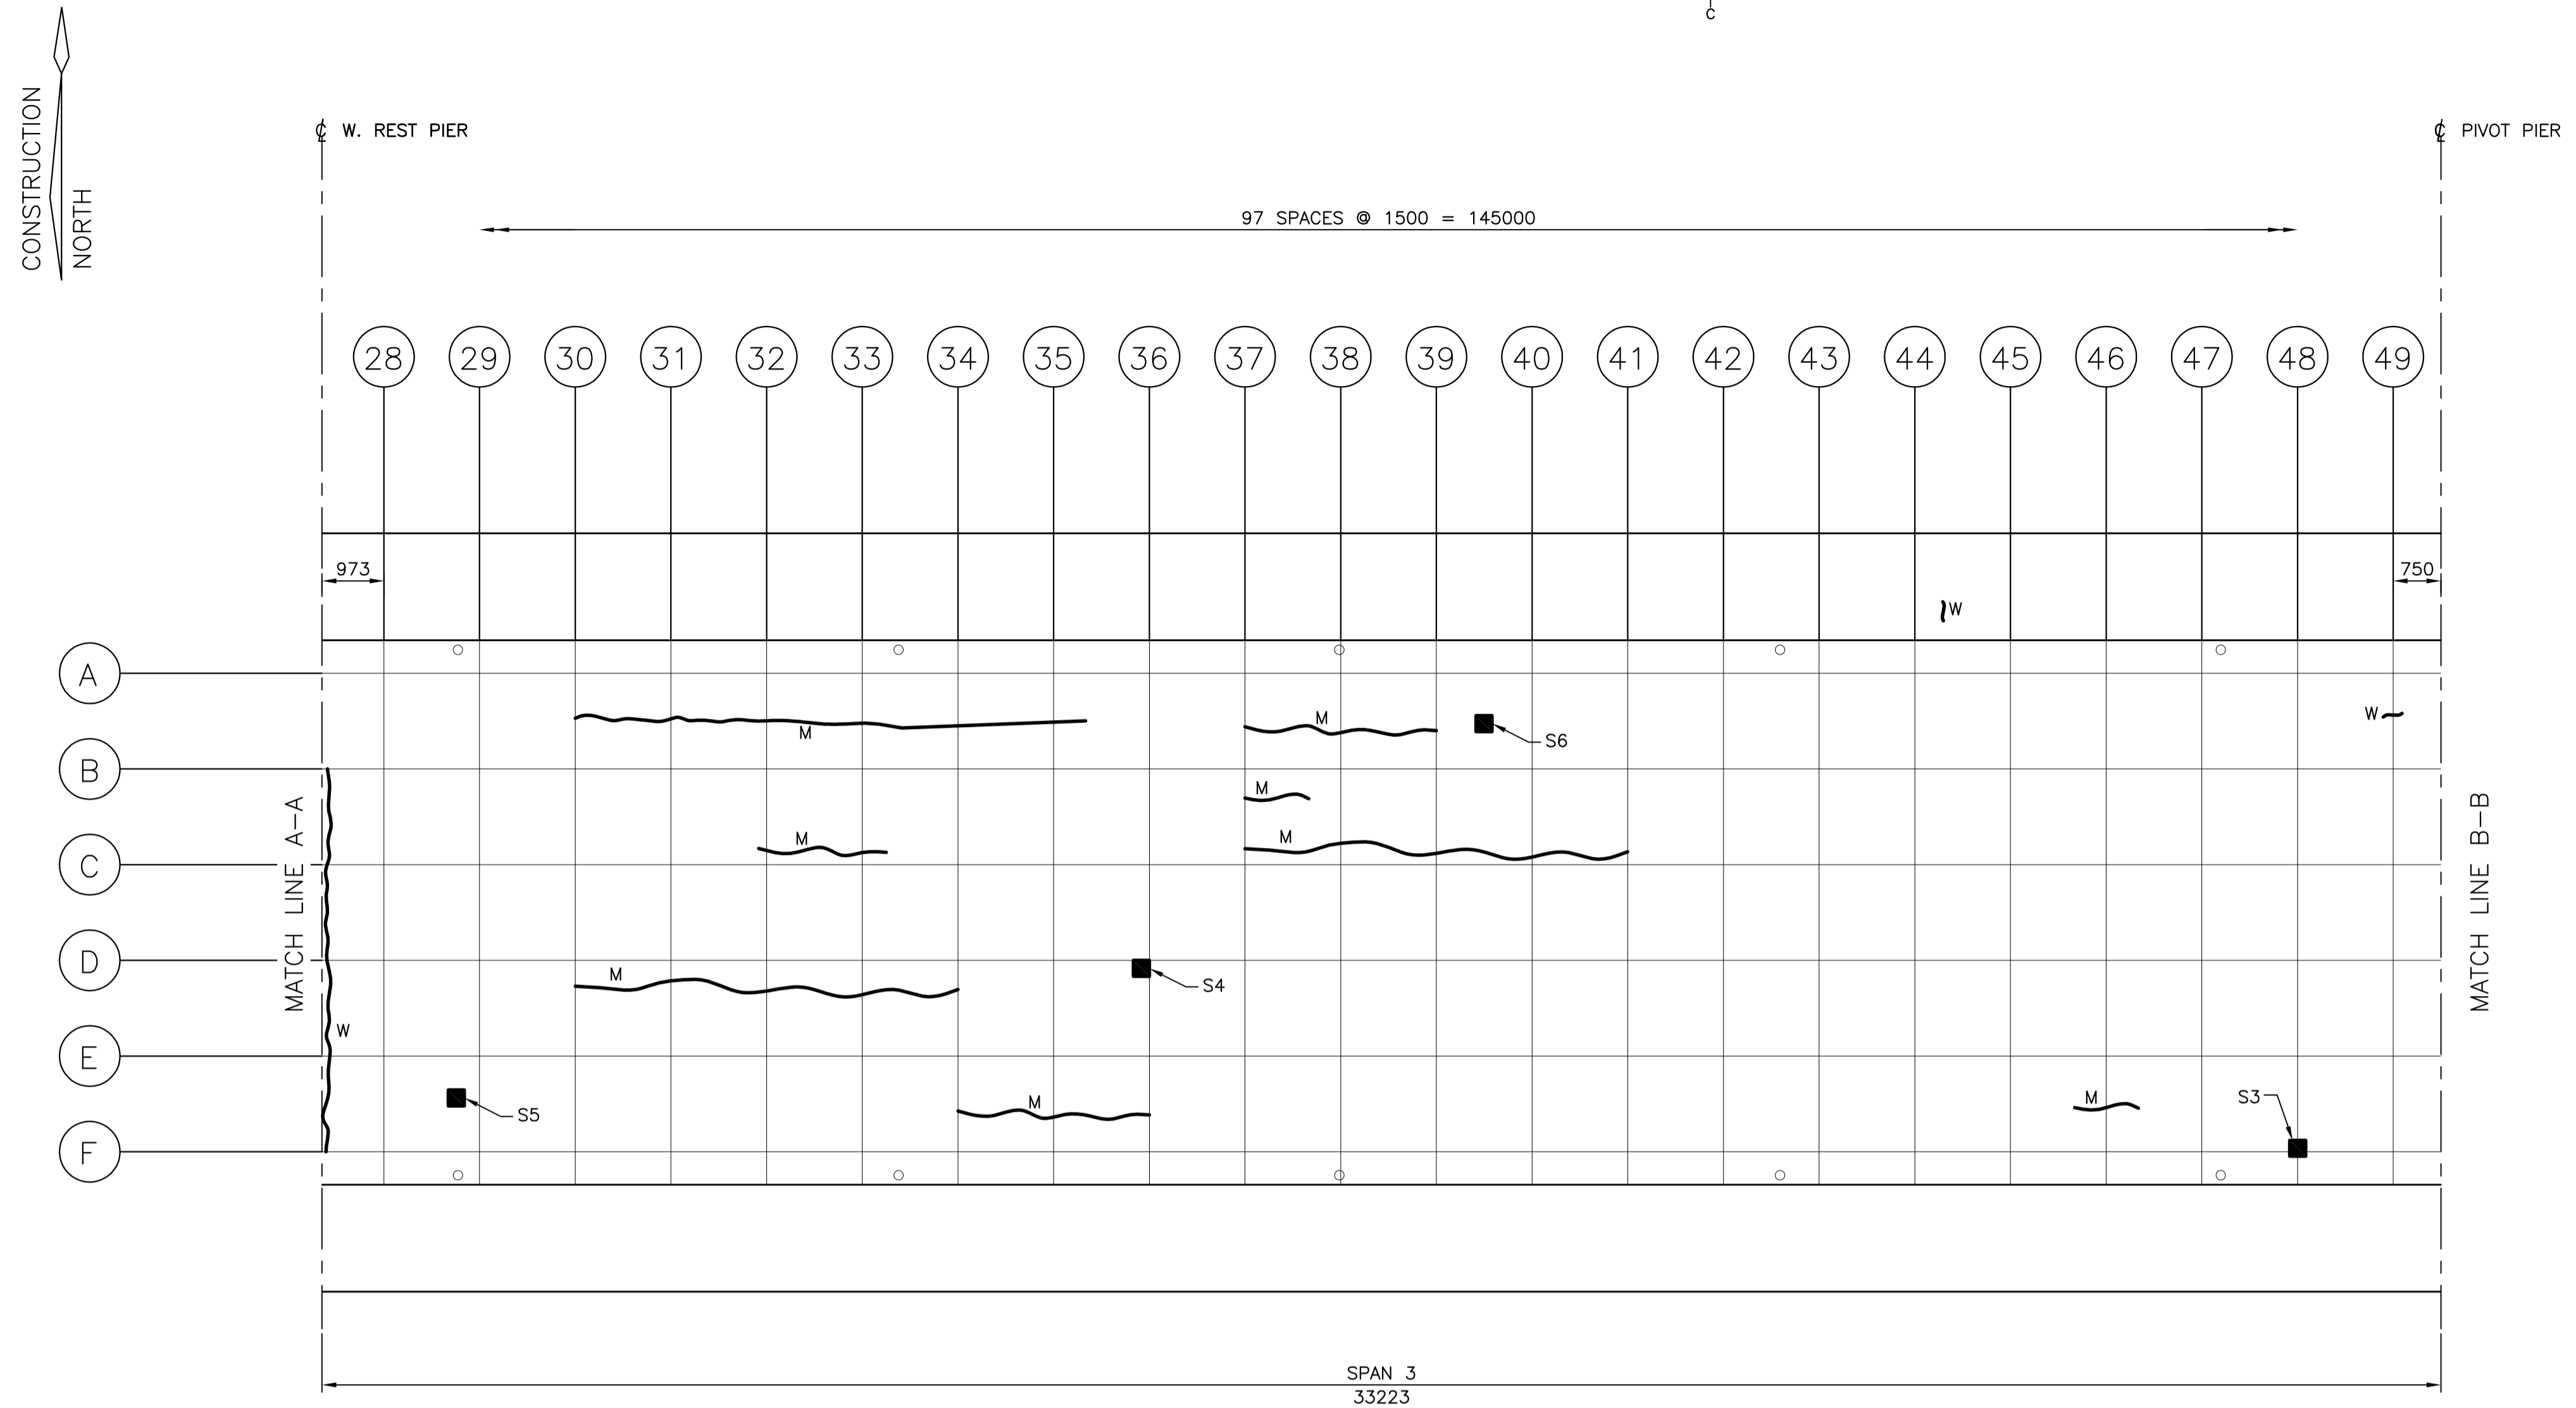
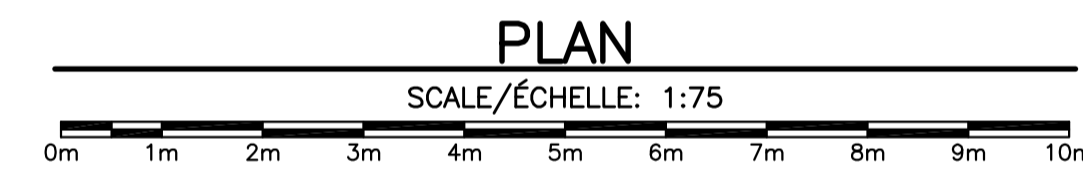
CAD FILE LOCATION AND NAME: S:\2011\32\3211121\300\051213B02-05.dwg  
MODIFIED: 6/1/2012 9:36:12 AM BY: ZHAOX  
DATE PLOTTED: 6/1/2012 10:17:28 AM BY: XING ZHAO

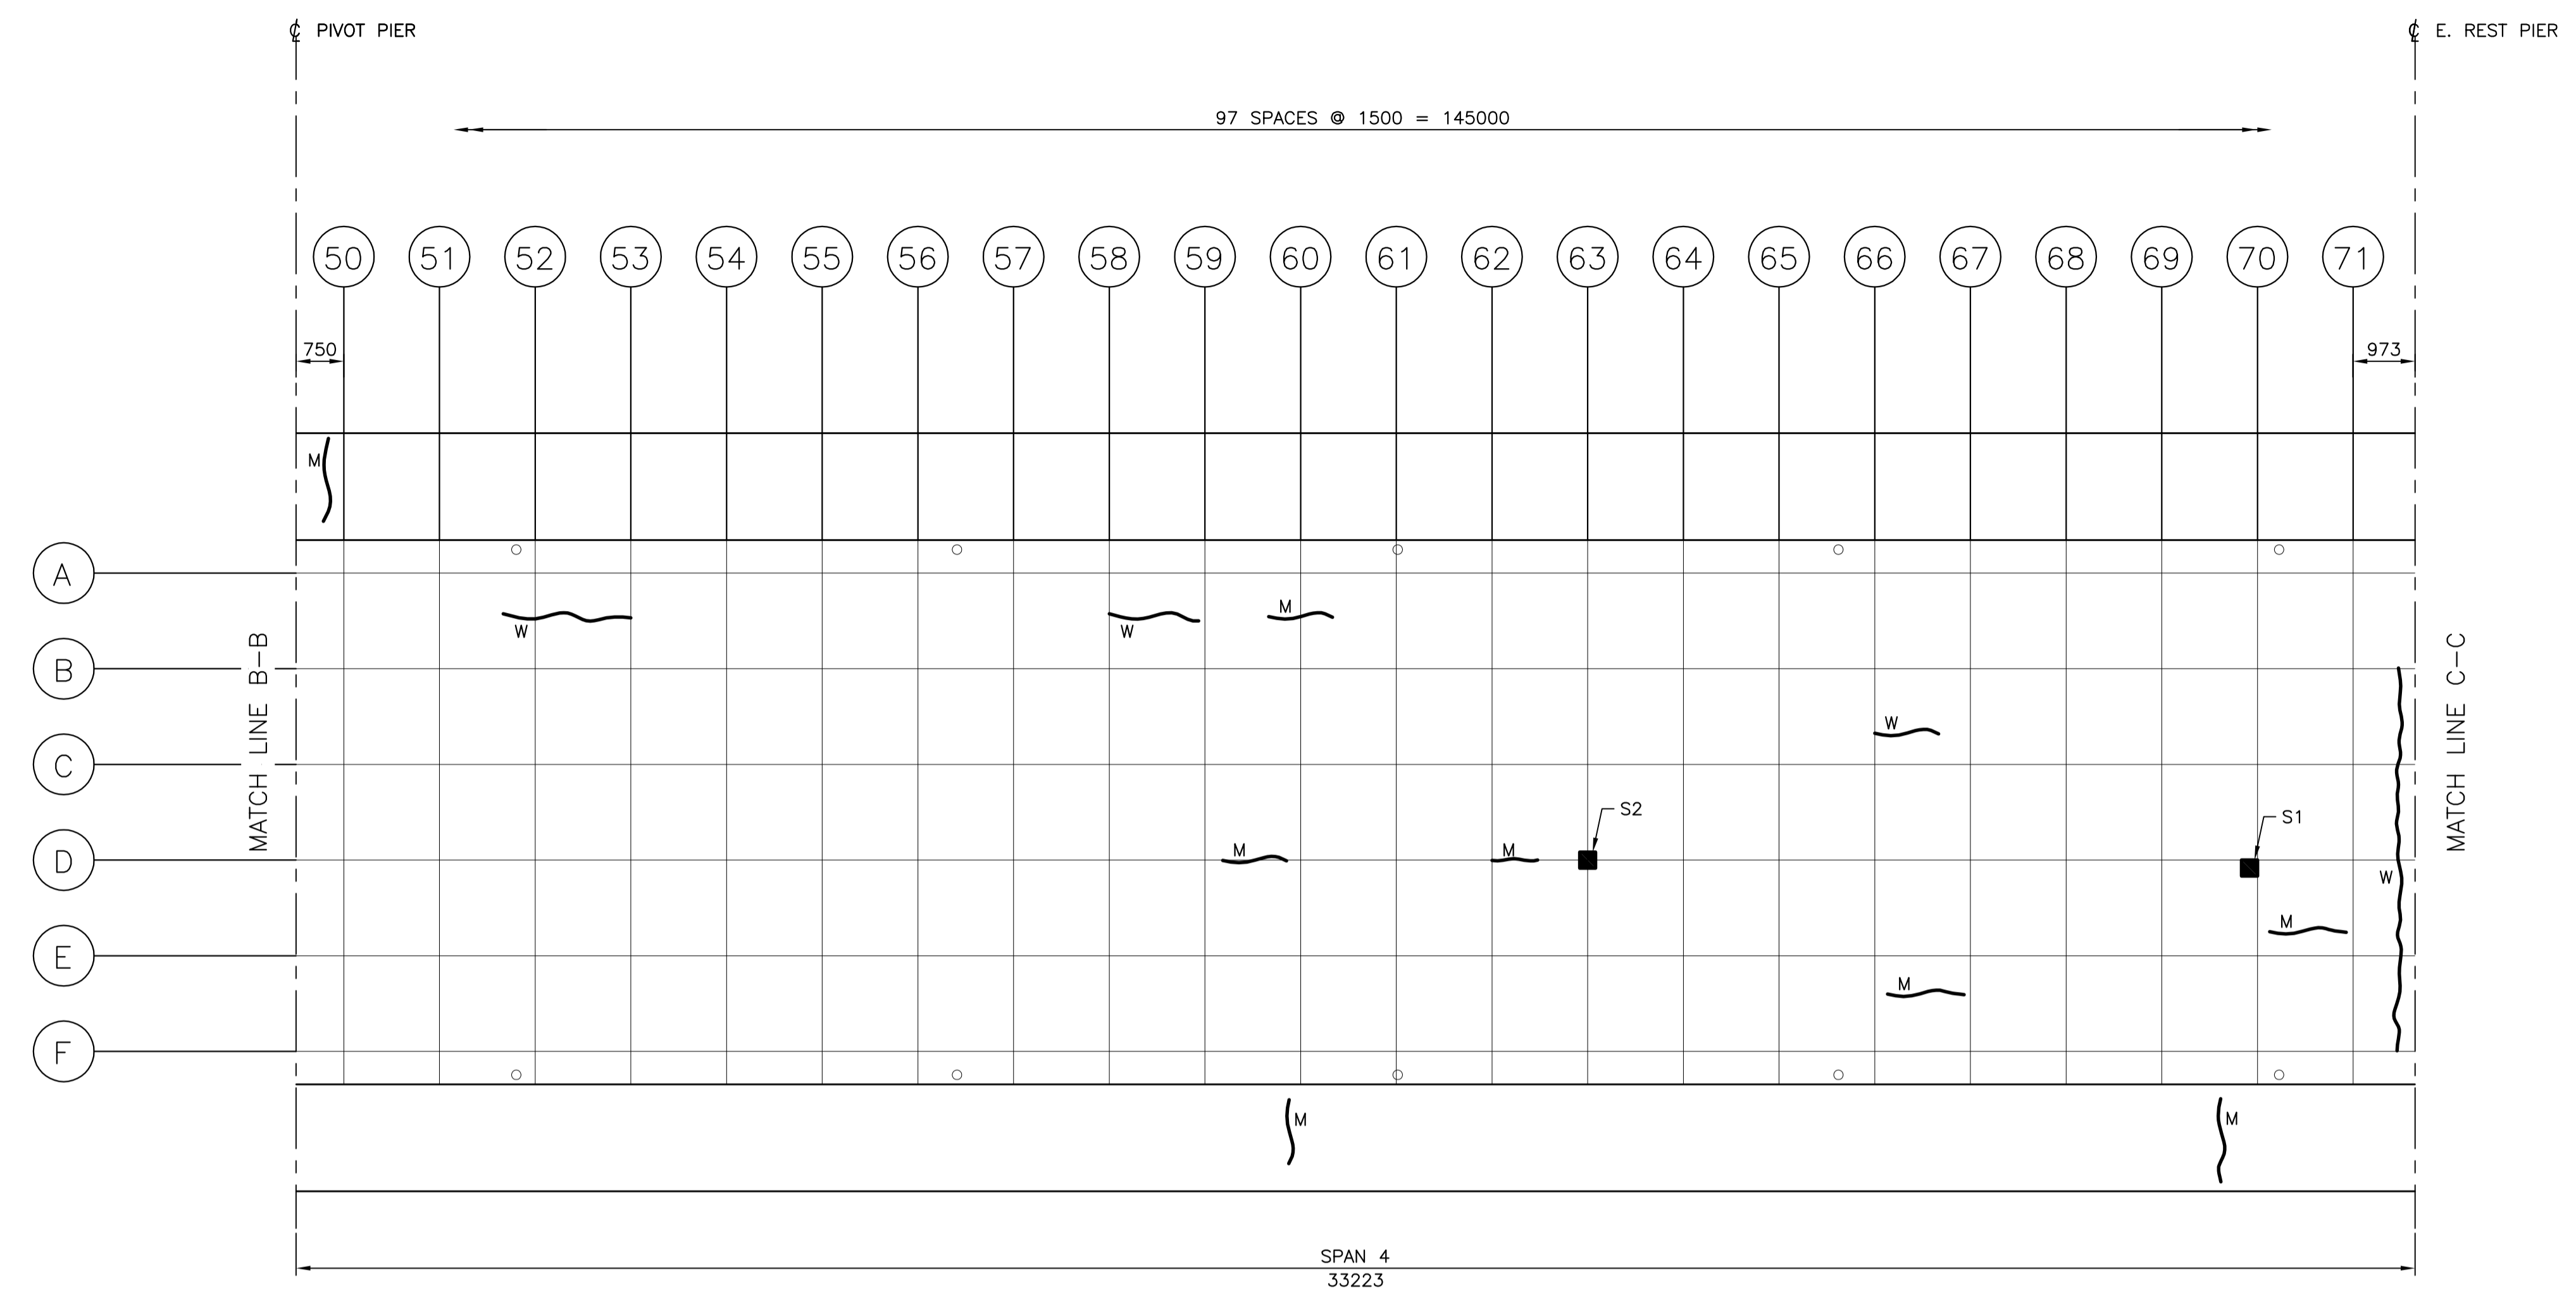
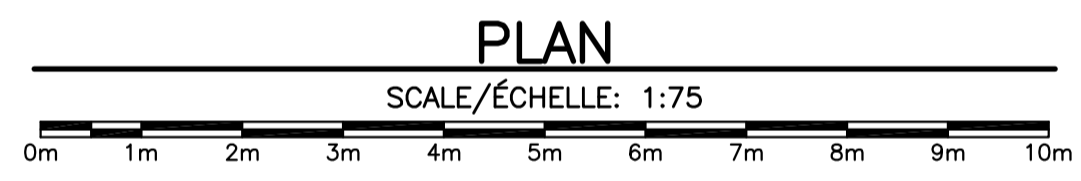
CAD FILE LOCATION AND NAME: S:\2011\32\3211121\300\051213B02-05.dwg  
MODIFIED: 6/1/2012 9:36:12 AM BY: ZHAOX  
DATE PLOTTED: 6/1/2012 10:17:32 AM BY: XING ZHAO

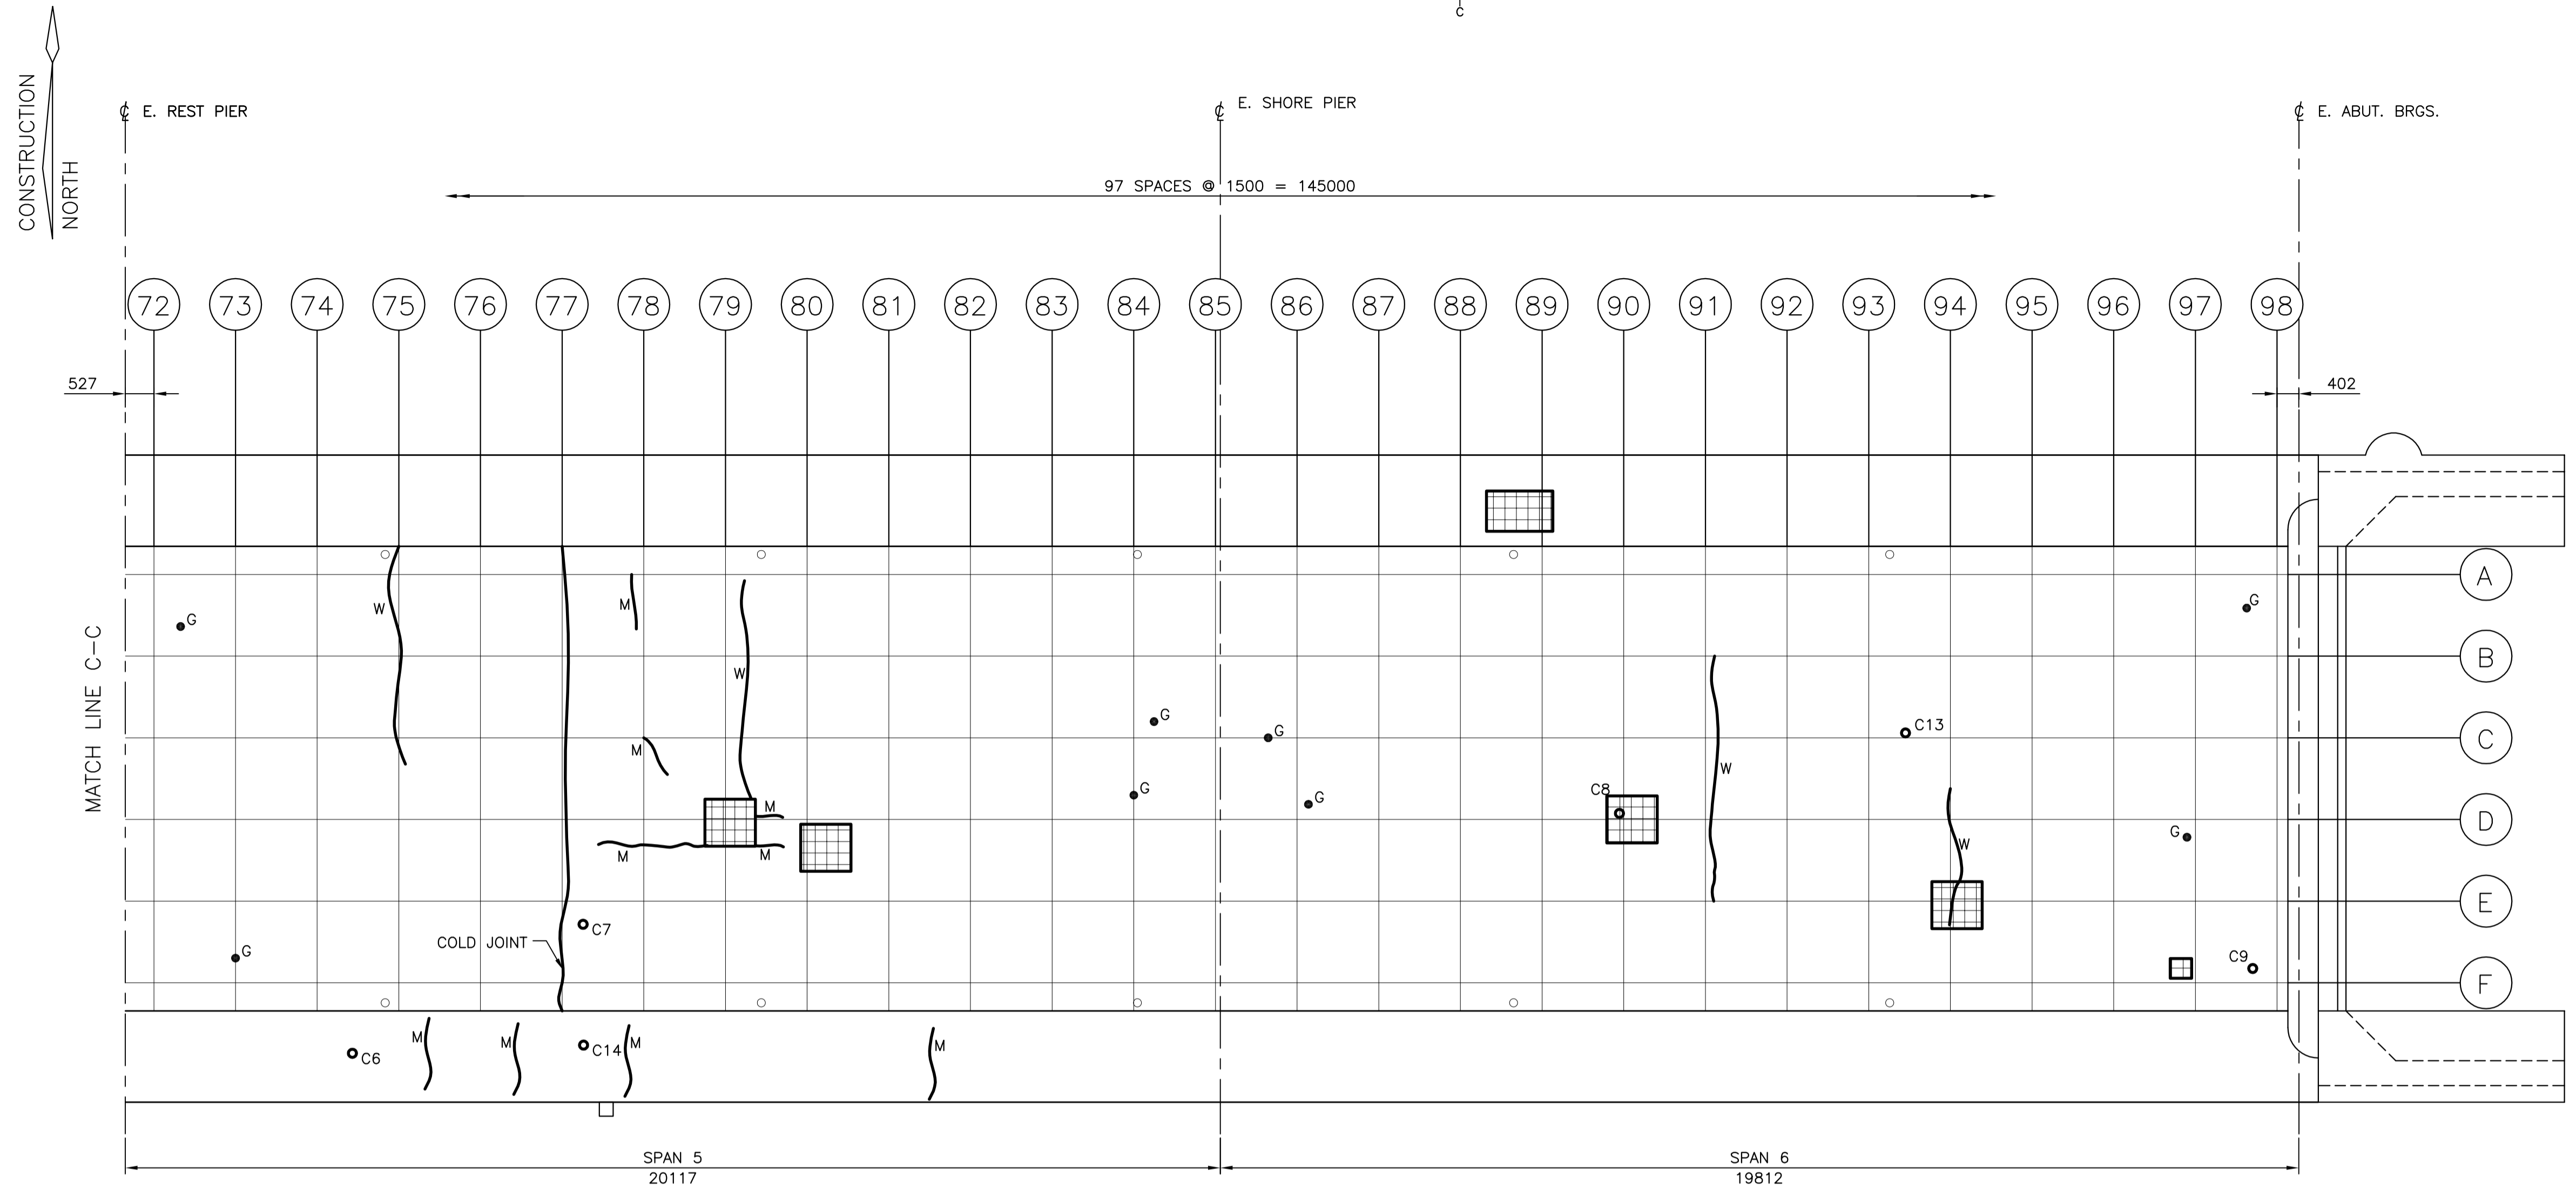
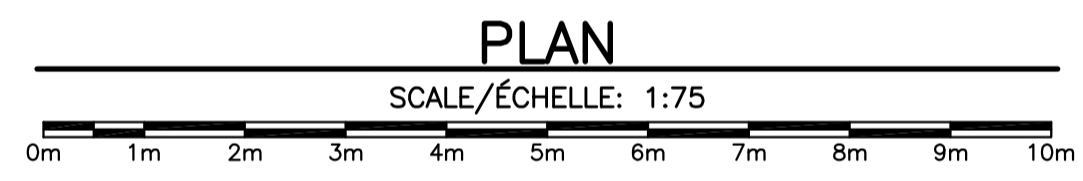
CAD FILE LOCATION AND NAME: S:\2011\3213211121\300\051213B02-05.dwg  
MODIFIED: 6/1/2012 9:36:12 AM BY: ZHAOX  
DATE PLOTTED: 6/1/2012 10:17:37 AM BY: XING ZHAO

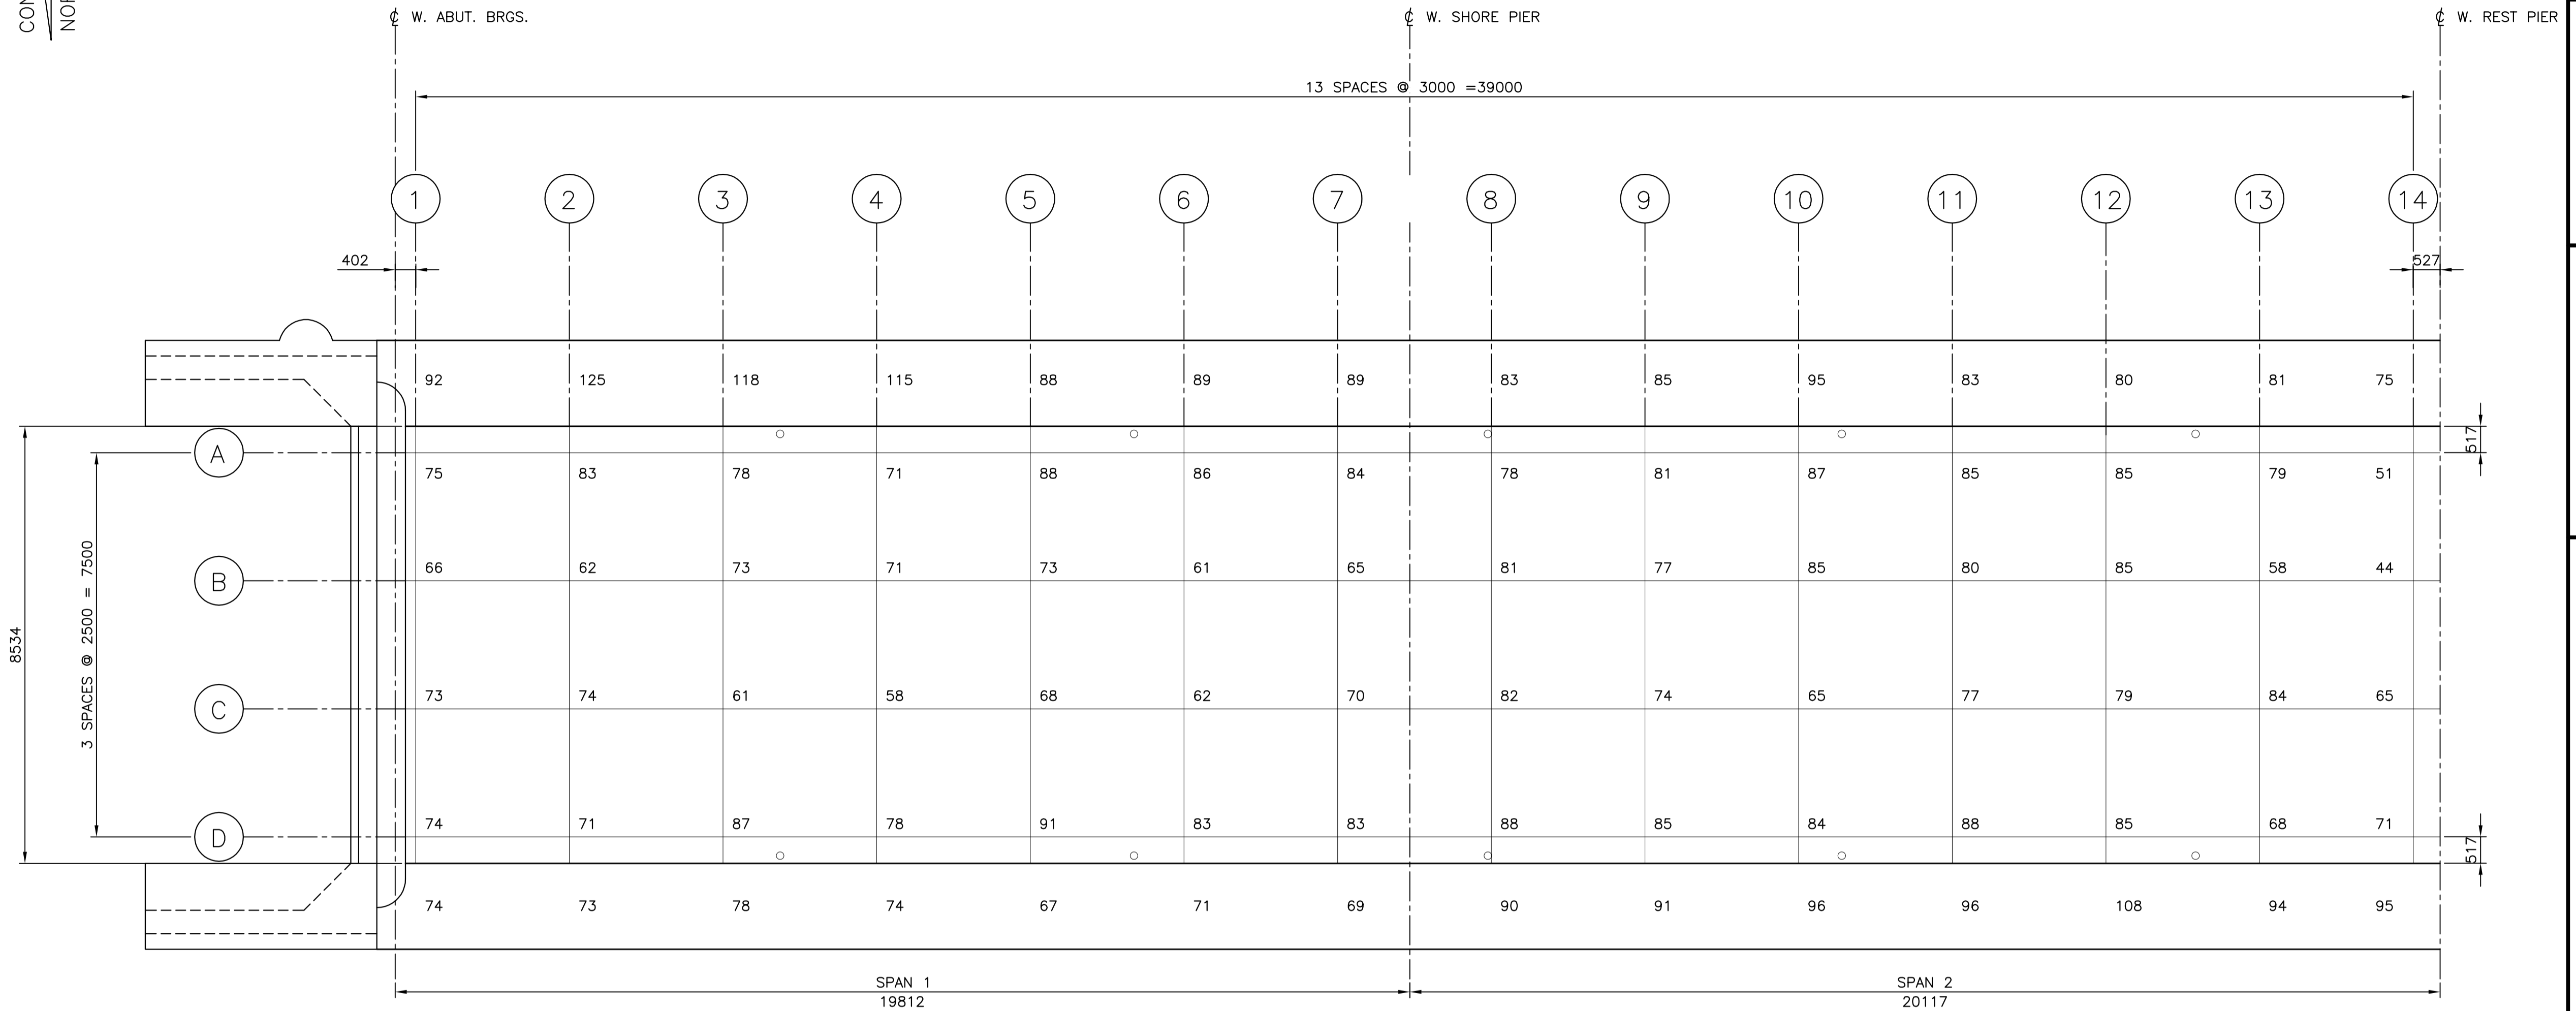
0	
revisions	date
project	projet

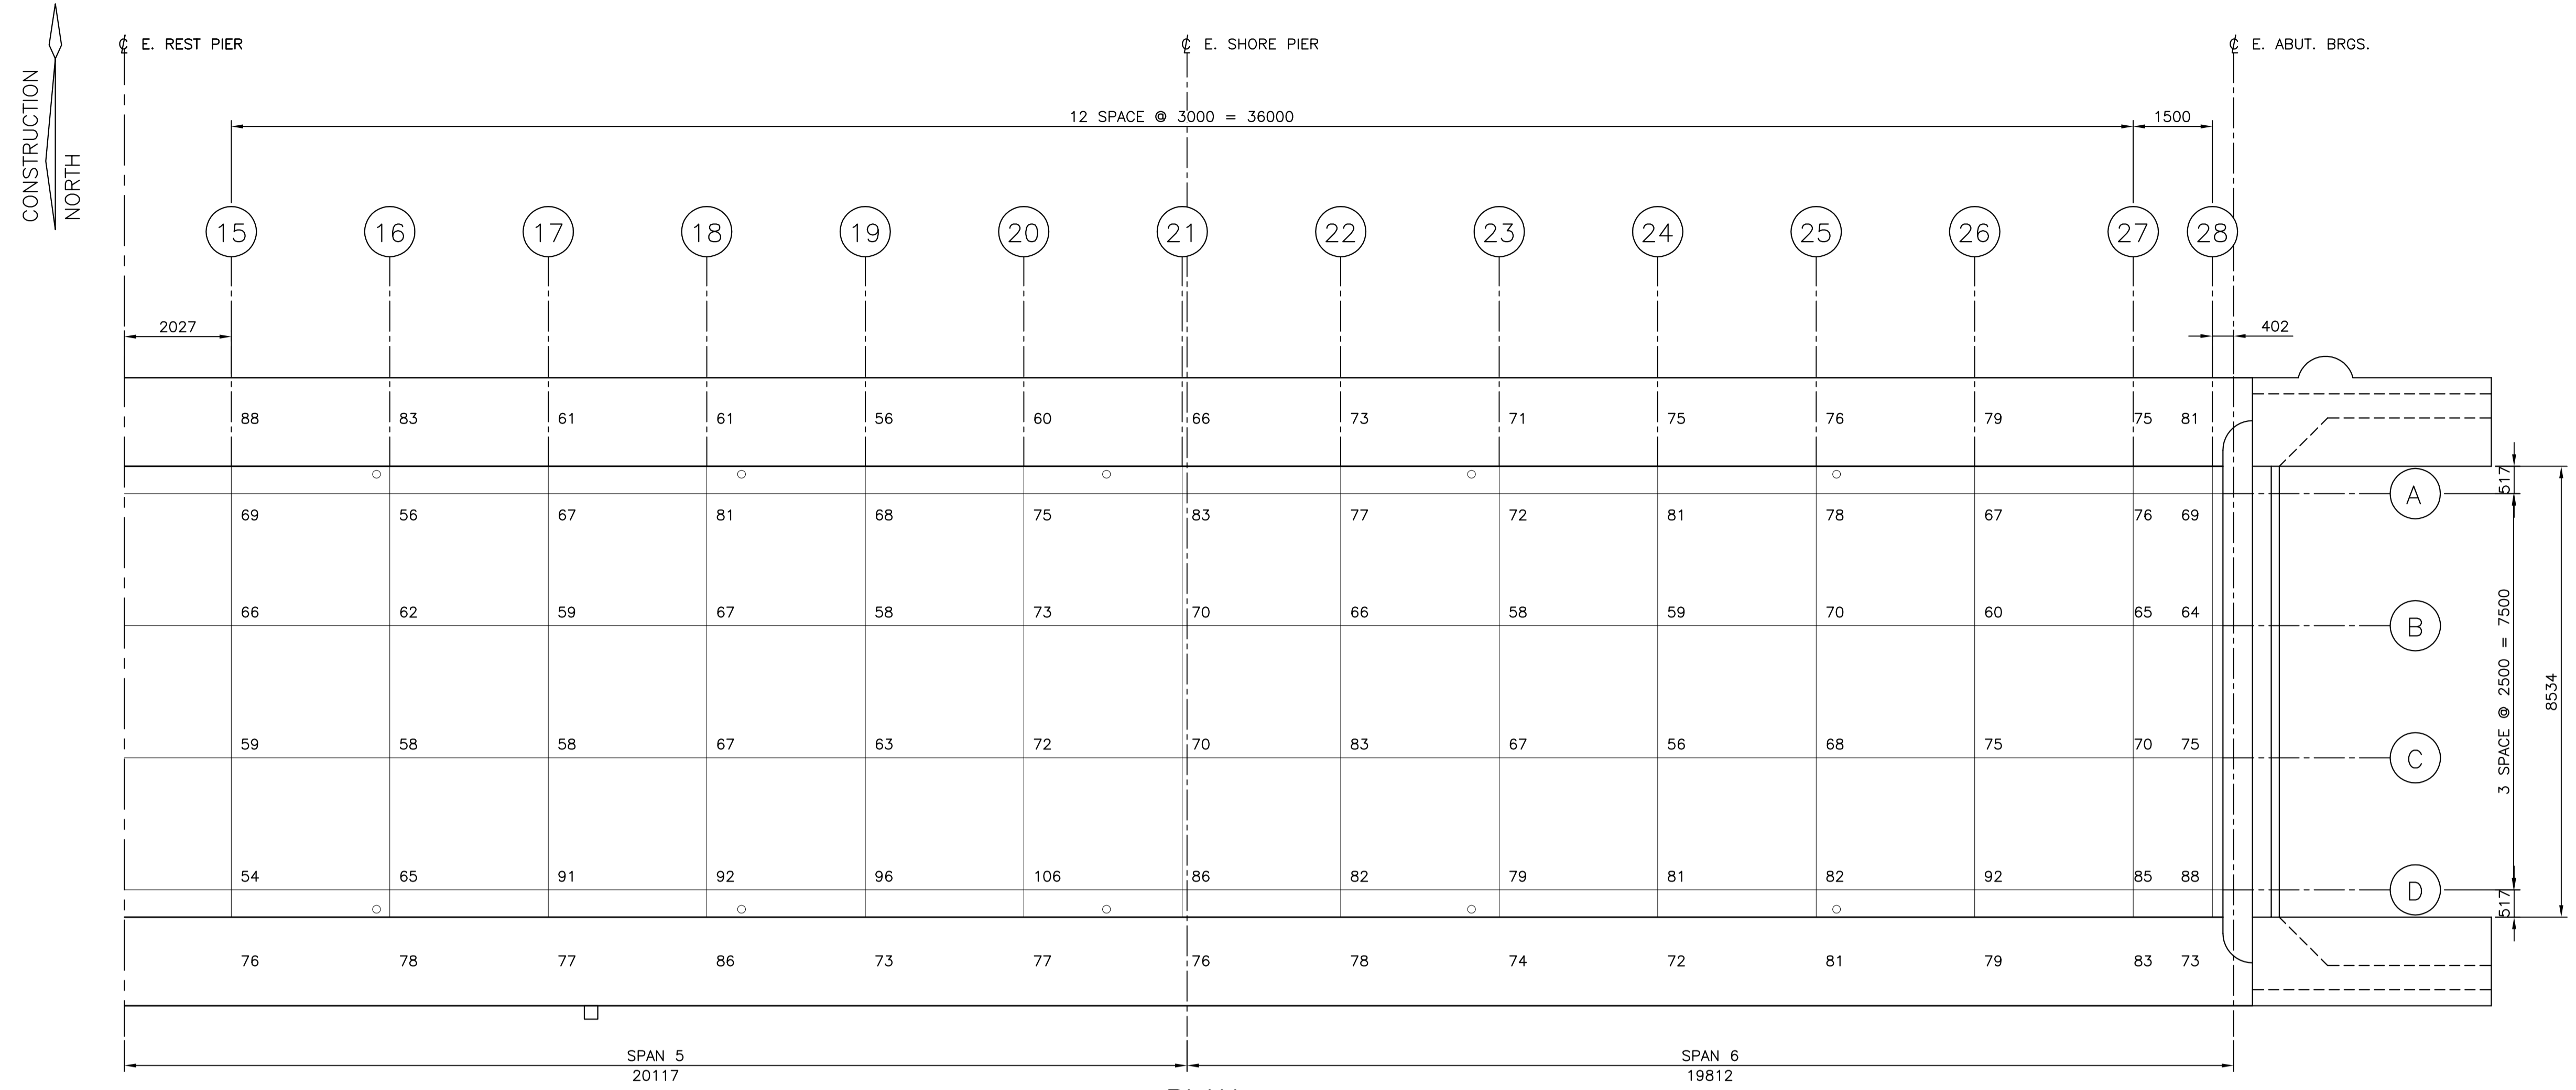
0	
revisions	date
project	projet

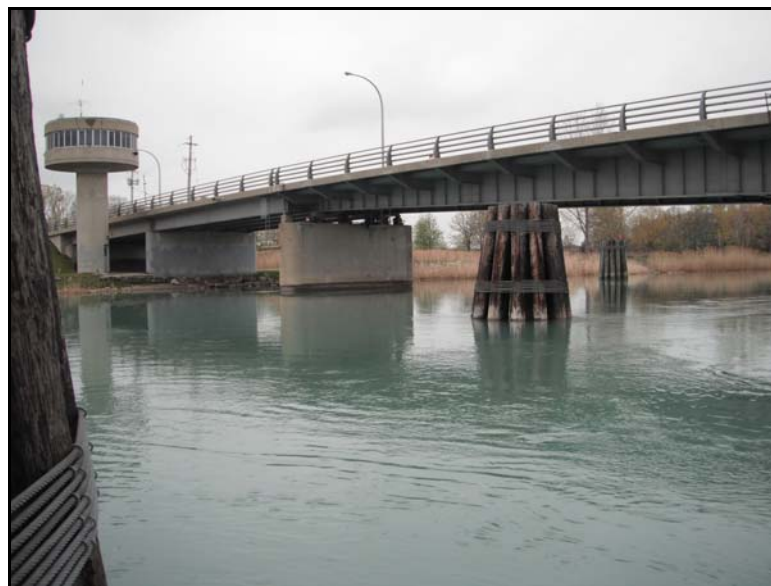
Figure 2: West Rest Pier, East Face

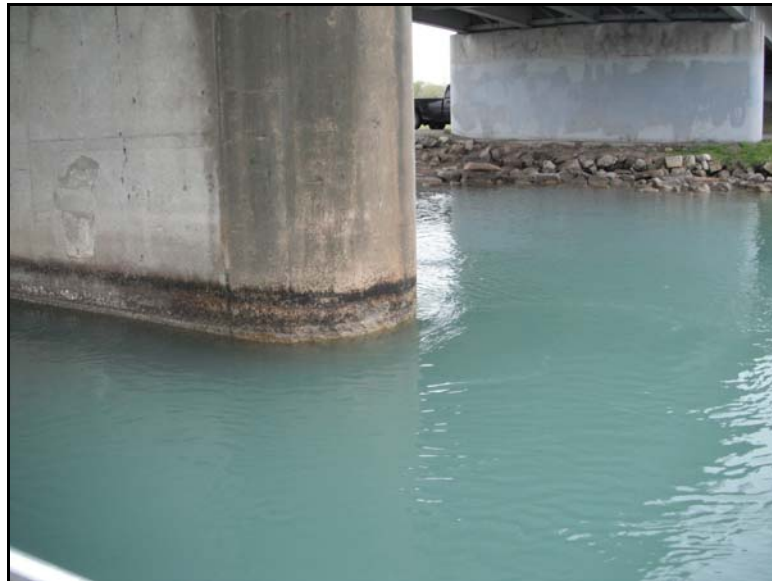
Figure 3: West Rest Pier, North Nose showing Spall at Water Line

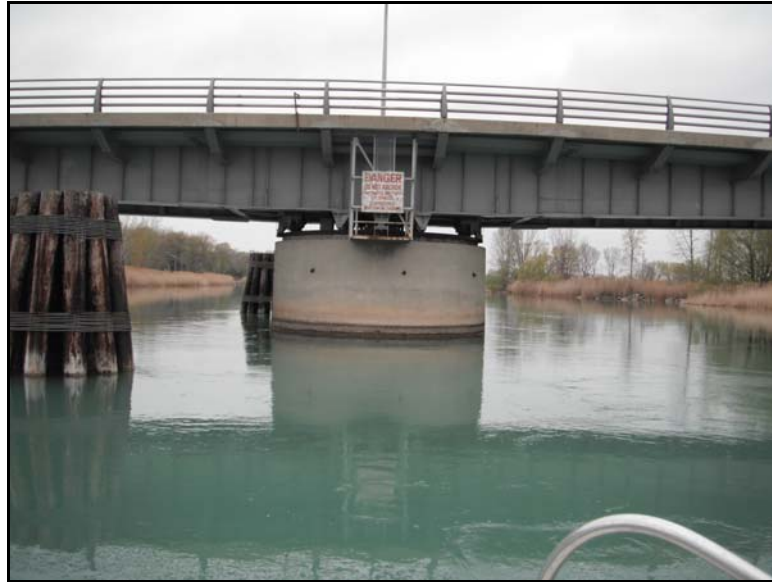
Figure 4: Pivot Pier, South Face

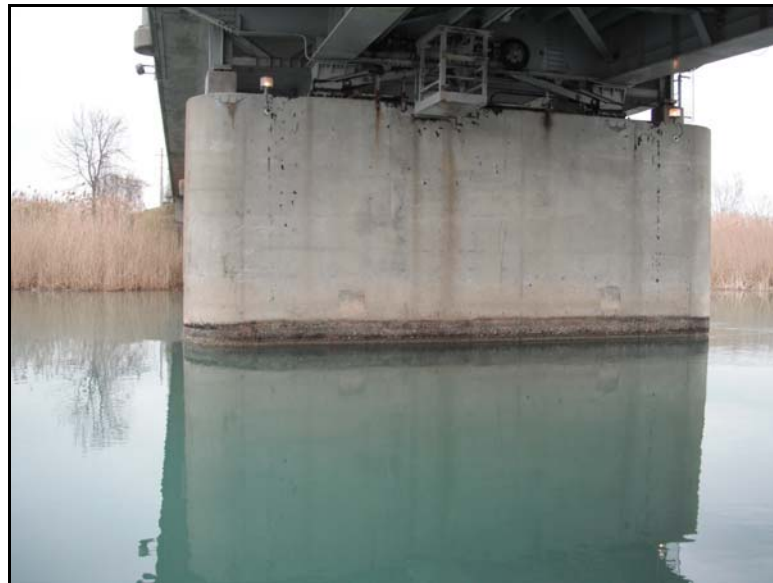
**Figure 6: East Rest Pier, West Face**

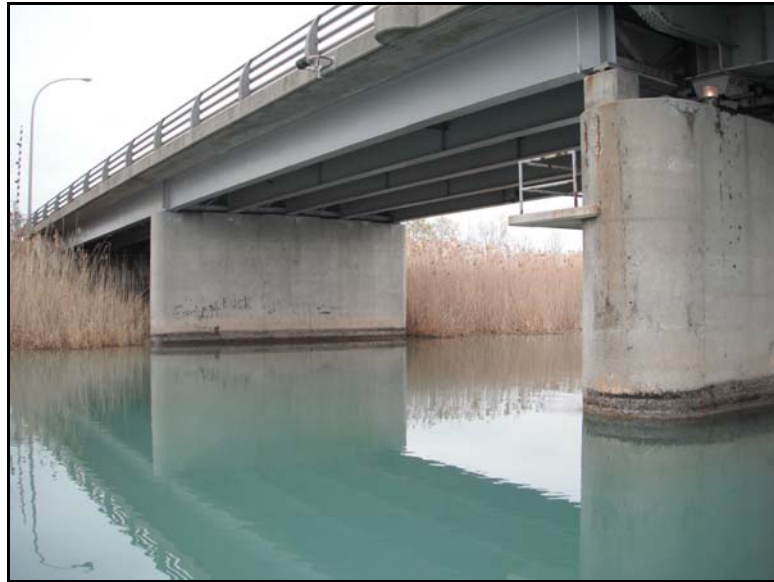
**Figure 7: East Shore Pier, West Face**

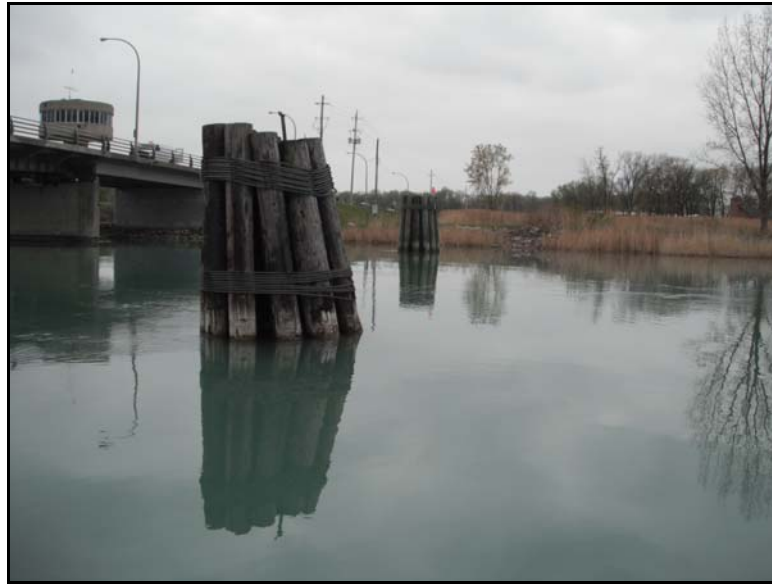
Figure 8: North Dolphin showing lean toward the bridge. Dolphin in the background shows only one band at the top and missing band above the waterline
