Designated Substances Survey

303 Main Street,
Winnipeg, Manitoba

DESIGNATED SUBSTANCES

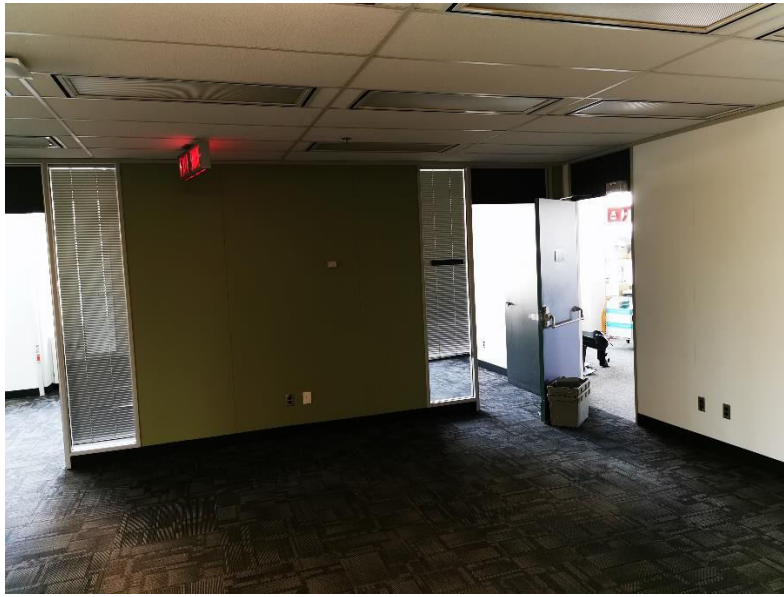
SAMPLE NUMBER	SAMPLE IDENTIFICATION	LEAD IN PAINT (mg/kg)	TREAT AS LEAD CONTAINING?
303-LP-1	White Paint	71.1	NO
303-LP-2	Green Paint	19.3	NO

As outlined in section 4.2 above, TEC considers any paint with a detectable presence over 90 mg/kg of lead to be lead-containing paint. From these results, no additional precautions are required for impact to painted surfaces.

Photo 1: North east section of the work area. Green and white paint throughout is non-lead containing. Propped door leads into the previously renovated area.

None of the paint encountered in the work area was found to be lead containing, and no additional precautions are required for impact to painted materials, aside from any applicable asbestos precautions.

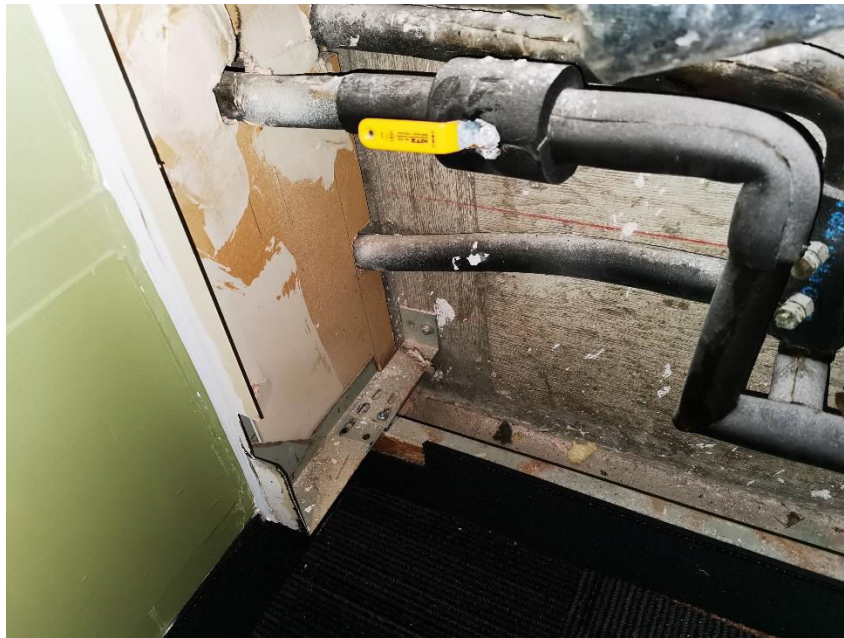
Non-suspect panelling was observed on walls throughout the area, with drywall beneath the panelling. Drywall was also observed within the heater units, and as the partition wall linking the panel/drywall partition to the exterior wall in each room. Samples of the joint compound (samples 303-4, 303-5 and 303-6) **were found to contain 2% Chrysotile asbestos.**

The renovation area was also visually assessed for the presence of fungal growth, or any indications of fungal contamination. Visually, TEC did not observe any signs of water staining, or fungal growth on walls or inside heater units. TEC was advised that in a previous renovation, in an adjacent space, fungal growth was encountered on

Photo 3: Drywall, sealed with asbestos containing joint compound located inside the heater units. No fungal contamination was observed.

Friable, asbestos containing drywall joint compound was found throughout the renovation area. Disturbance to less than one square metre of drywall joint compound may be completed under **Type 2 precautions**. If greater than one square metre, or for removal requiring greater than 3 hours of work, these precautions must be raised to **Type 3**.

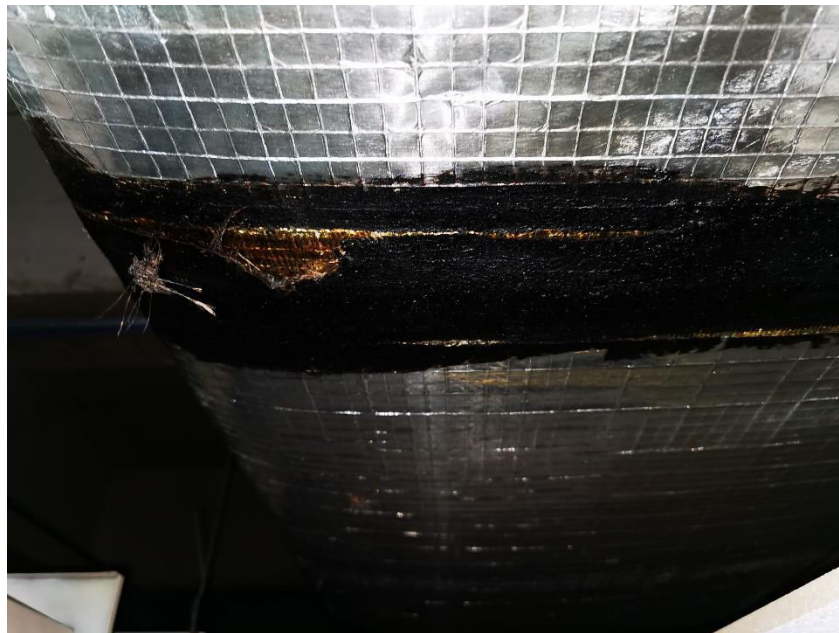
Within the heater units, fiberglass insulation with black mastic was observed on mechanical lines. Black mastic was also observed on foil wrapped fiberglass insulated ducting found within the ceiling space of the area. Samples of the black mastic **were found to contain 4% Chrysotile asbestos.**

Photo 4: Asbestos containing black mastic found on insulated ducting in the ceiling space, and on mechanical lines within the heater units.

Non-friable, asbestos containing black mastic was observed on mechanical lines inside heater units, as well as on insulated ducting in the ceiling space. This material may be safely removed following Type 1 precautions, or may be removed within any larger Type 2 or Type 3 work area.

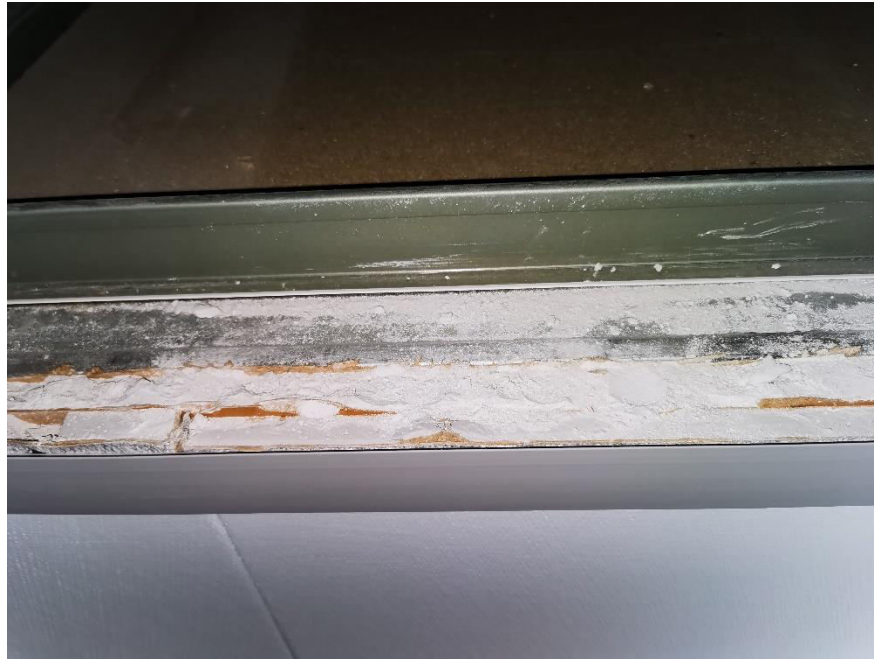
partition walls, near the heater units. TEC was unable to remove the wall panels on the partition walls without damaging the underlying drywall, as such intrusive investigation was unable to be completed.

Although the air quality within the area has not been impacted, given the similarity of the work areas, it would be reasonable to presume that areas near the heaters in Room 303 would likely show some fungal growth.

Photo 5: Wall panels were installed overtop of asbestos containing drywall materials.

TEC was unable to assess beneath the wall panels without damaging the underlying drywall. As such, intrusive investigation could not be completed. However, current demolition drawings provided, the panel walls, and partition walls are scheduled for full demolition, and any impact must be conducted following the applicable asbestos abatement precautions.

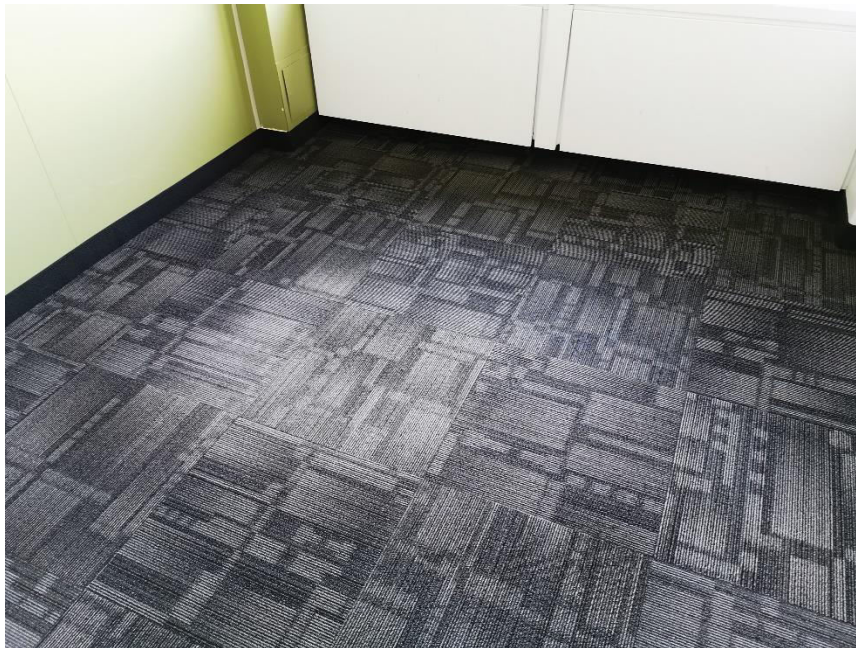
Flooring throughout room 303 was observed to be non-suspect carpet, and where assessed, was applied directly to the concrete subfloor.

Photo 6: Flooring throughout was observed to be non-suspect carpet applied ontop of concrete subfloor.
