**DESIGNATED SUBSTANCE AND HAZARDOUS BUILDING MATERIAL SURVEY
CENTRAL HEATING AND COOLING PLANT (CHCP), BUILDING 3,
COMMUNICATIONS RESEARCH CENTRE CANADA (CRCC),
3701 CARLING AVENUE, OTTAWA, ON**

Project Number: 200224-69

Draft Report Submitted: 17 May 2021
Final Report Submitted: 26 May 2021

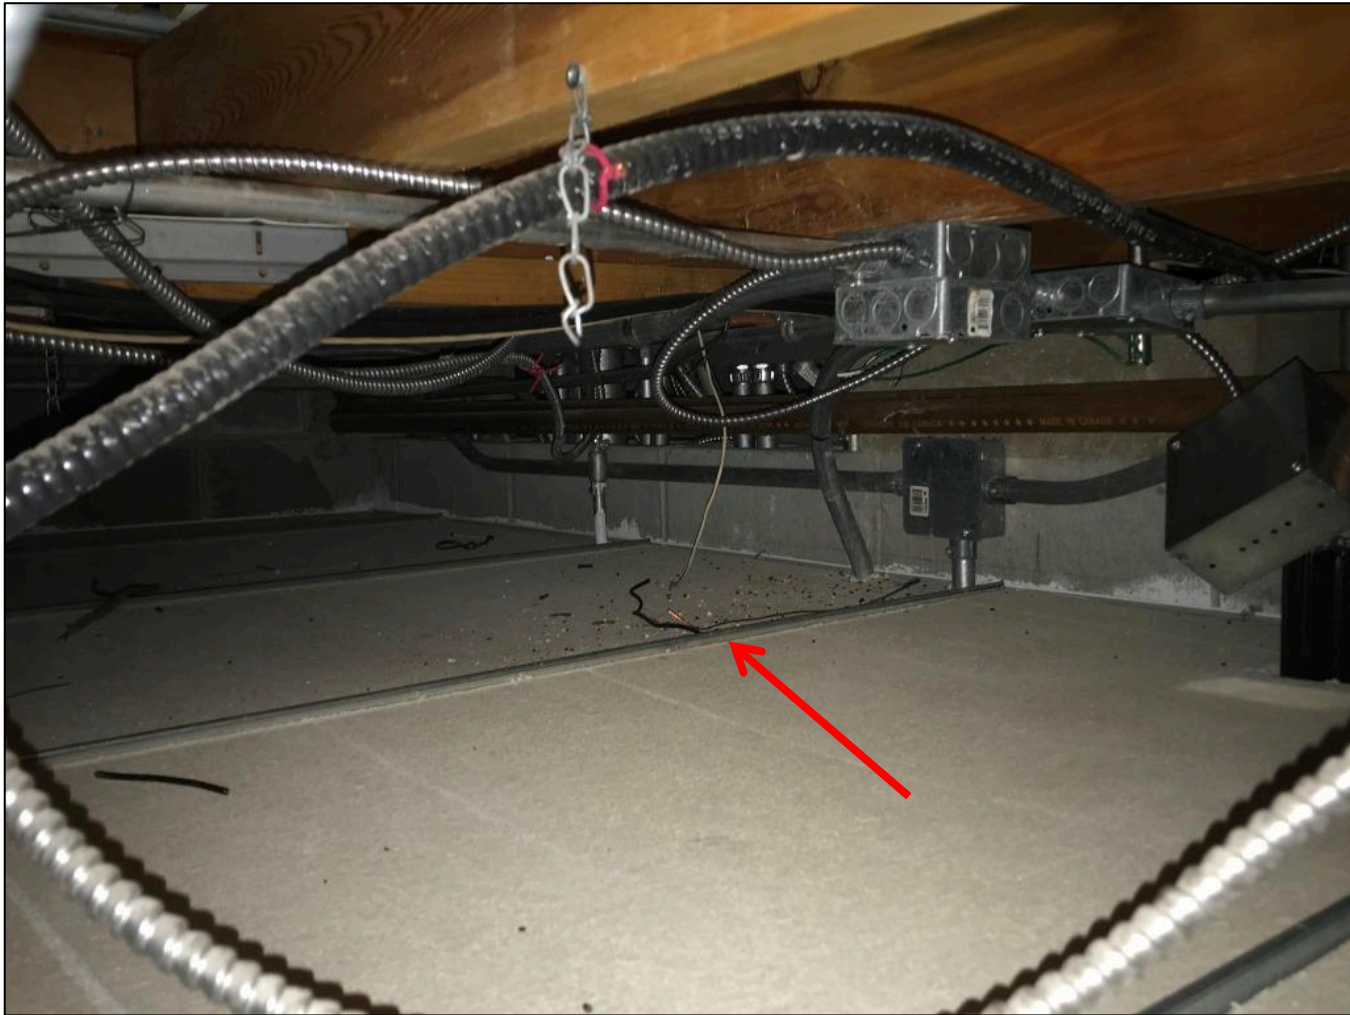
Photo 3 – Debris and rodent droppings above ceiling tiles in Room 106 (directly over where tiles are to be disturbed)

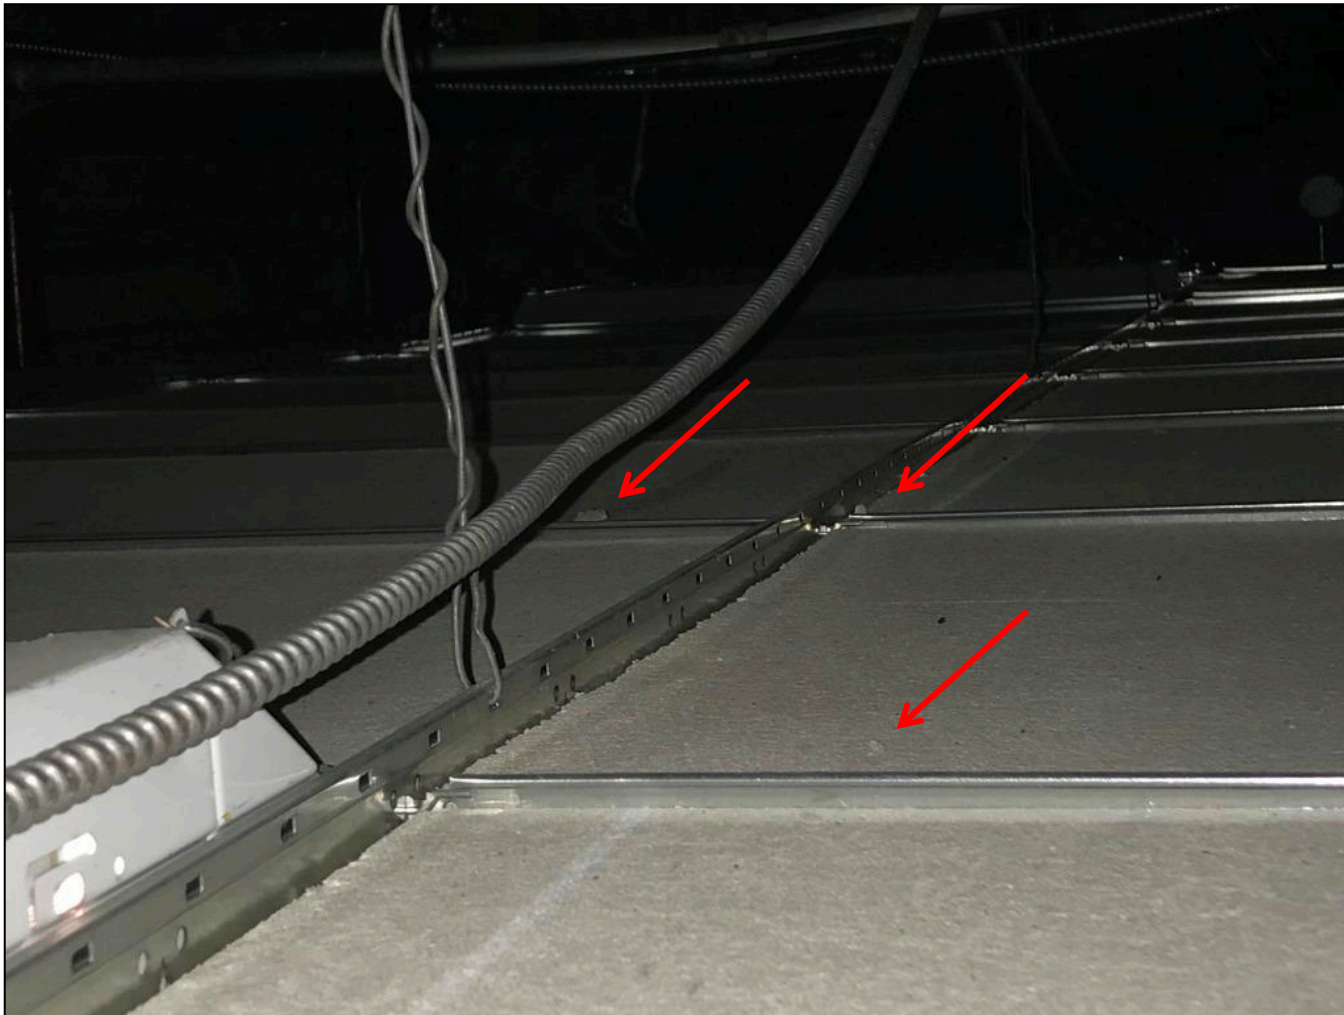
Photo 4 – View of small amounts of mortar and/or vermicrete debris above ceiling tiles (room 107)

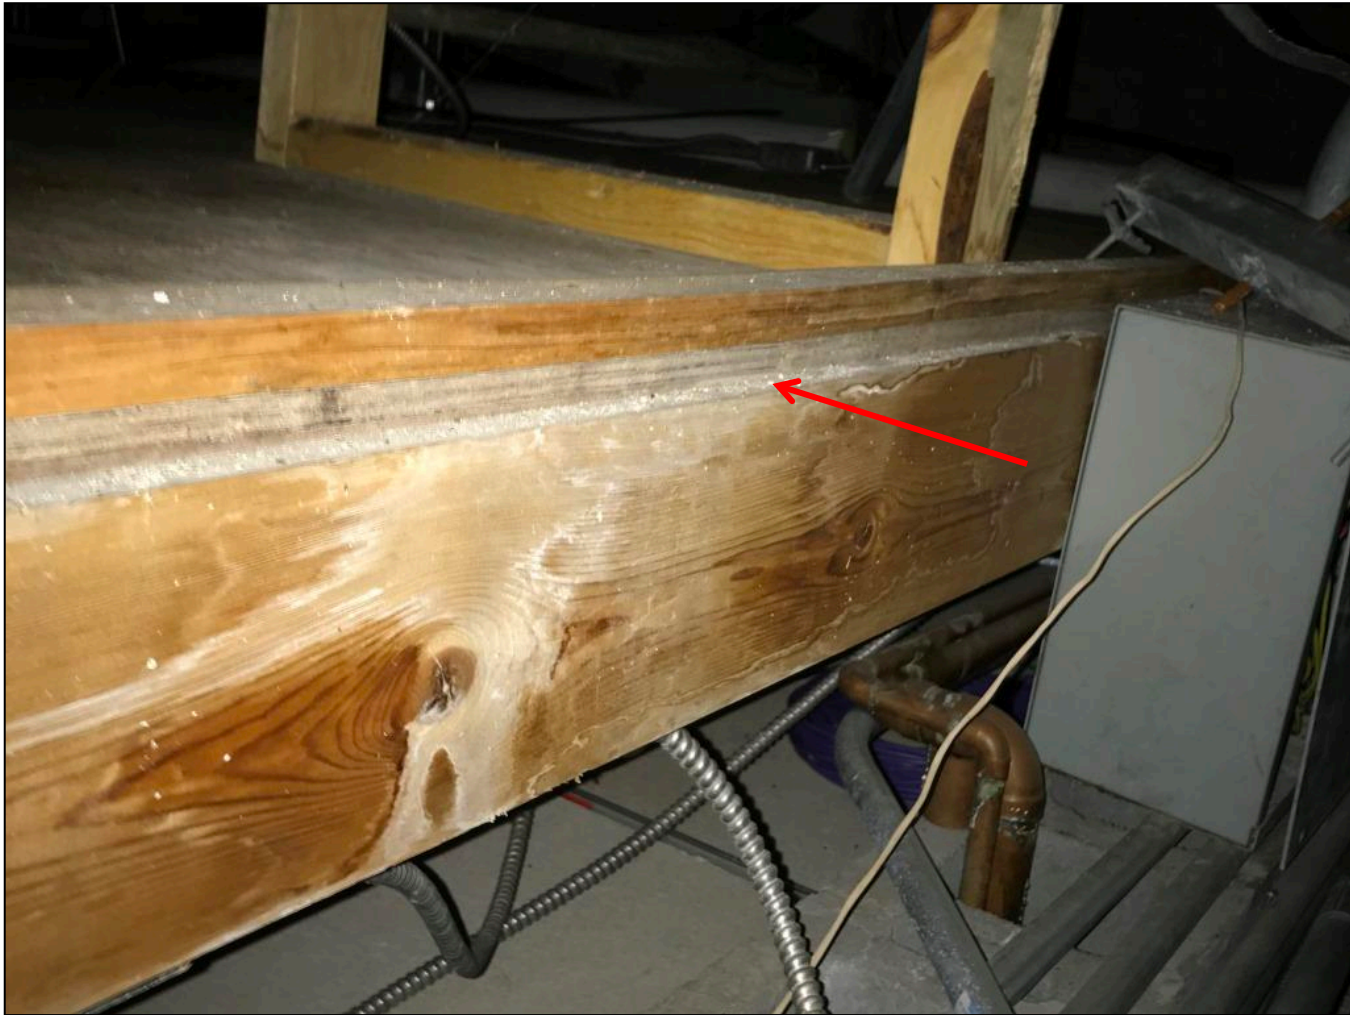
Photo 5 – View of small amounts of mortar and/or vermicrete debris on wooden shelf, above ceiling tiles (room 106)

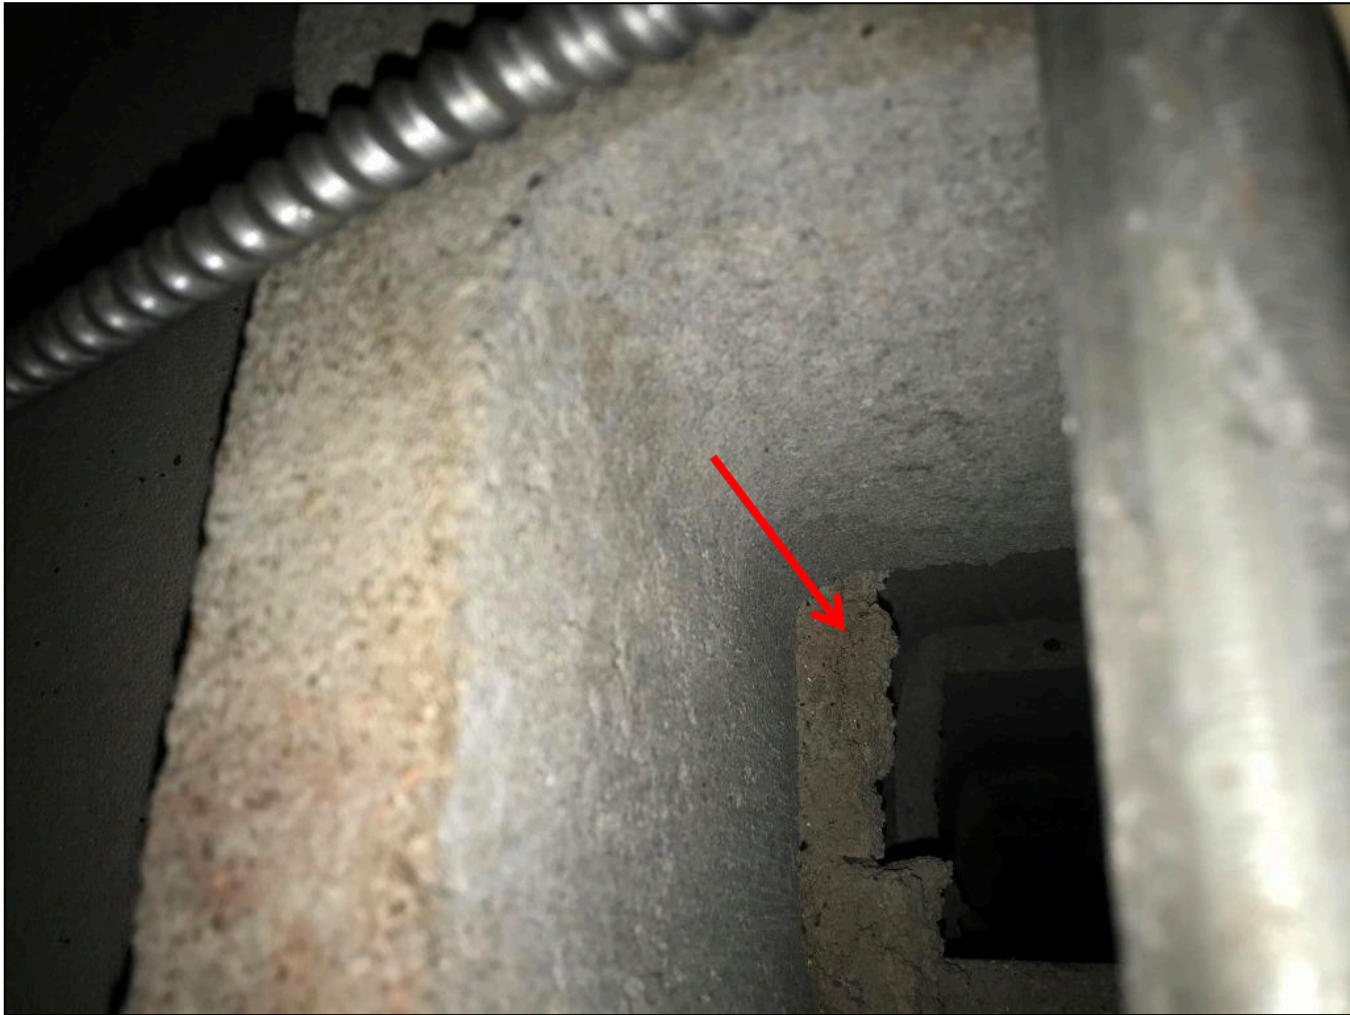
Photo 6 – View of possible vermicrete-like material inside of cinderblocks

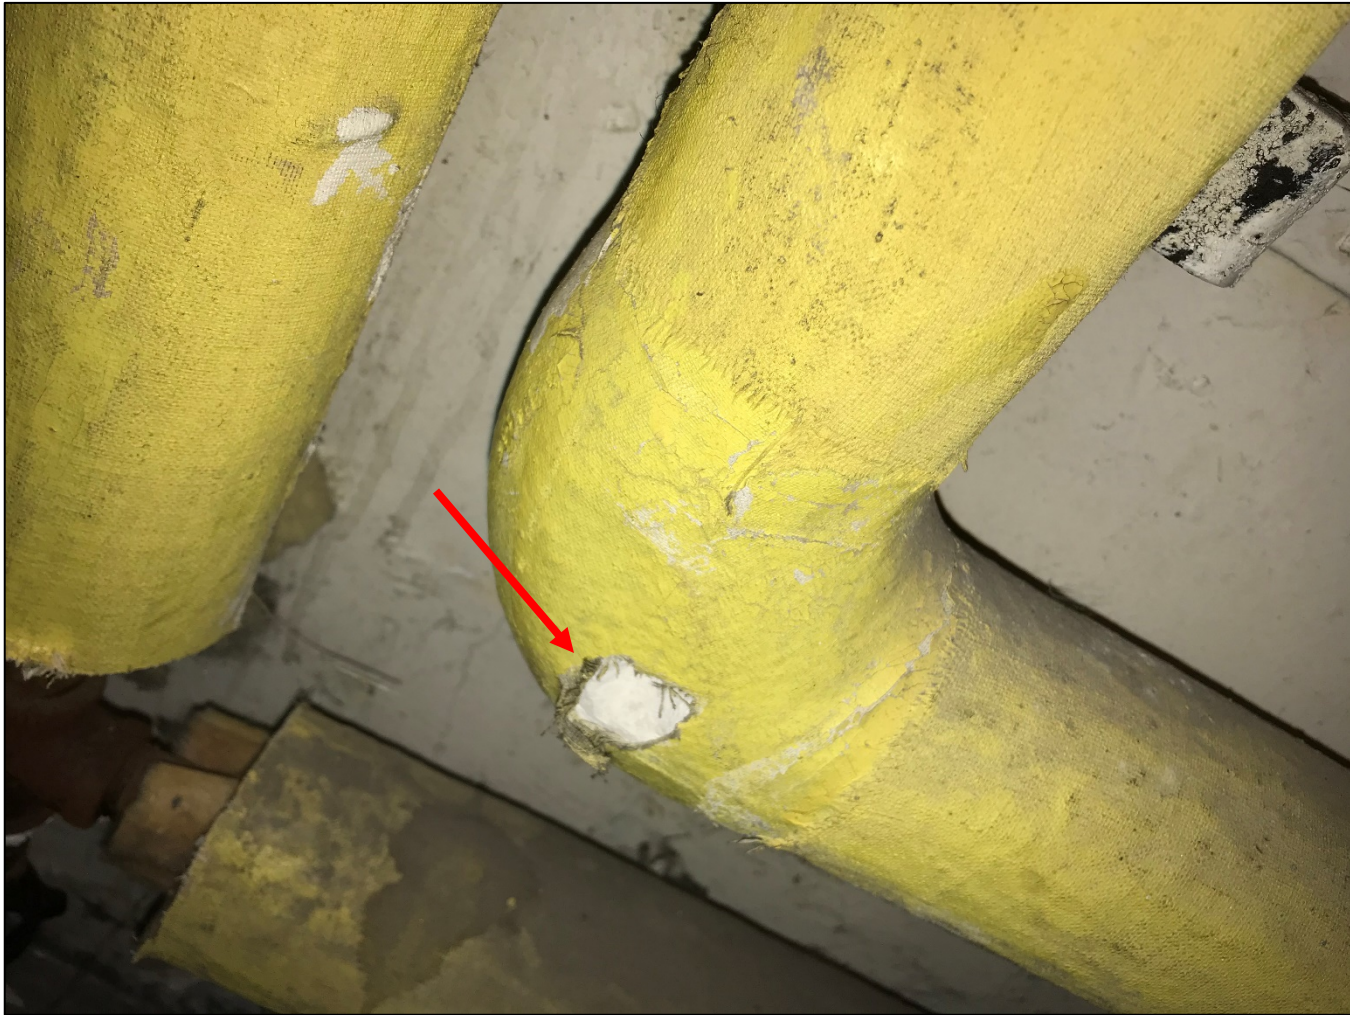
Photo 7 – View of exposed white pipe insulation in Room 110.

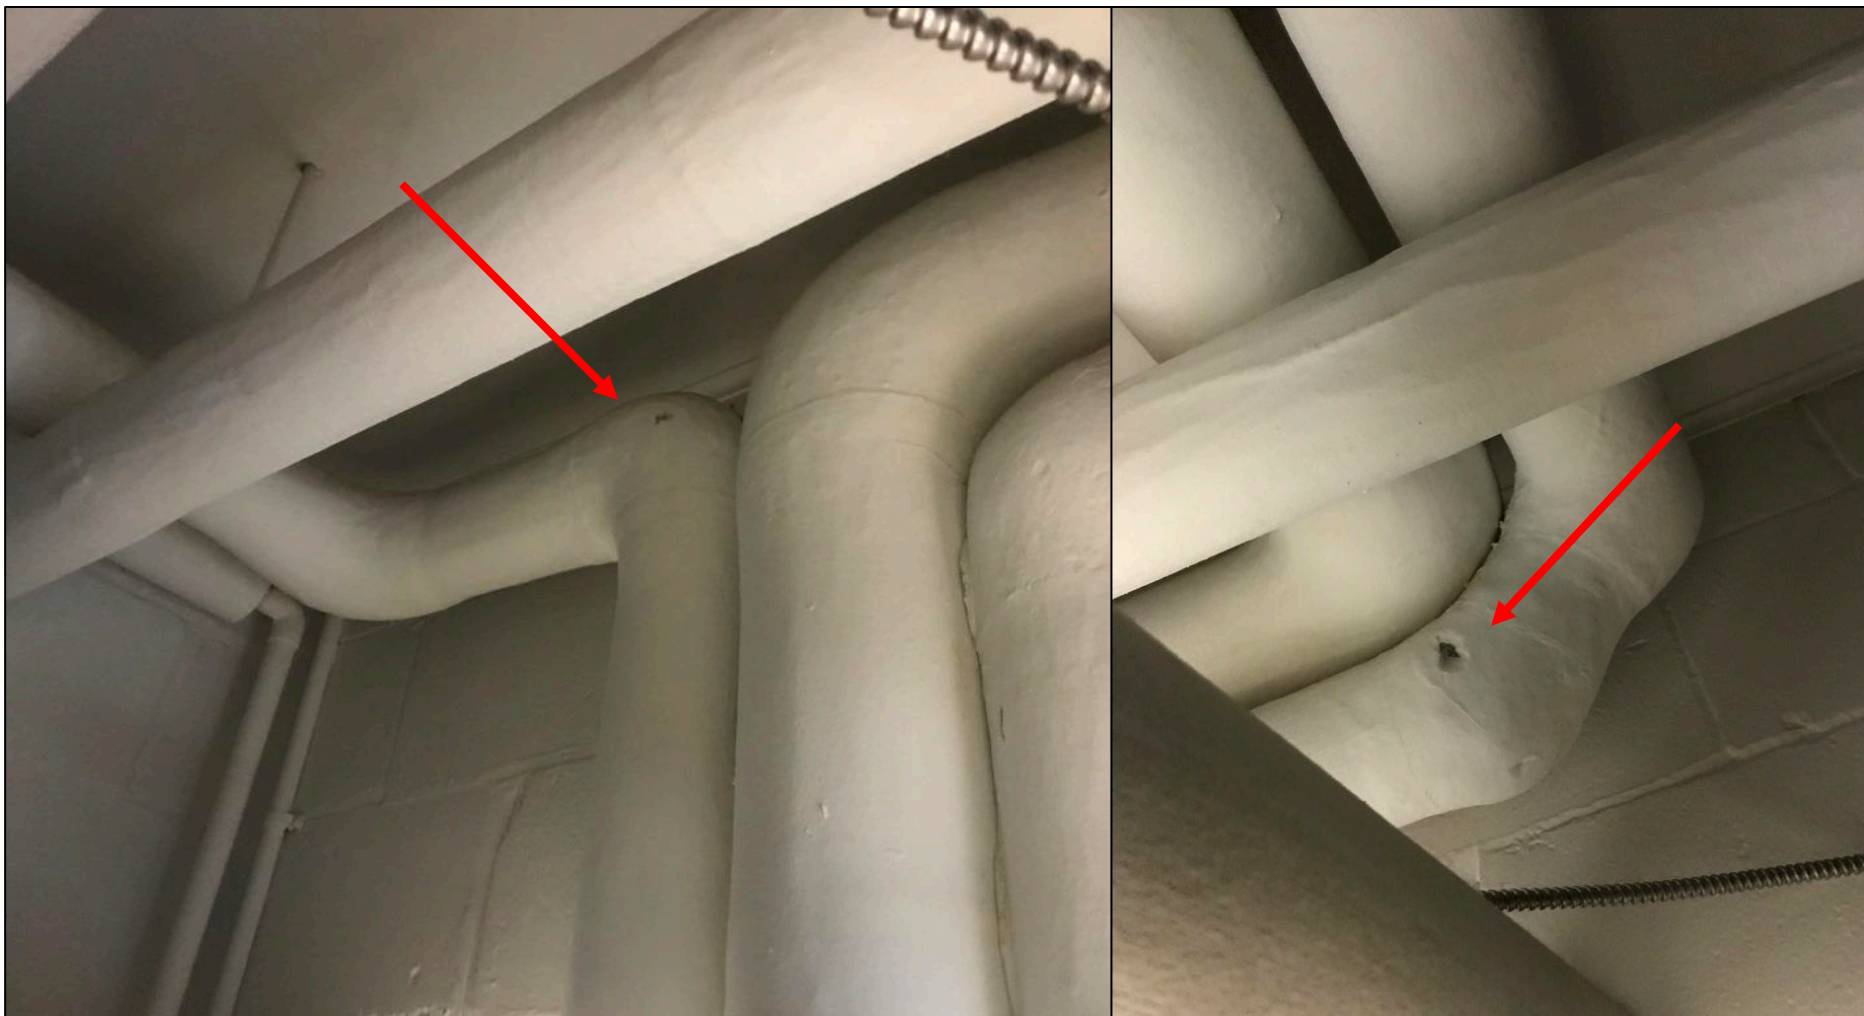
Photo 8 – View of fittings in poor condition above ceiling tiles in Room 109.

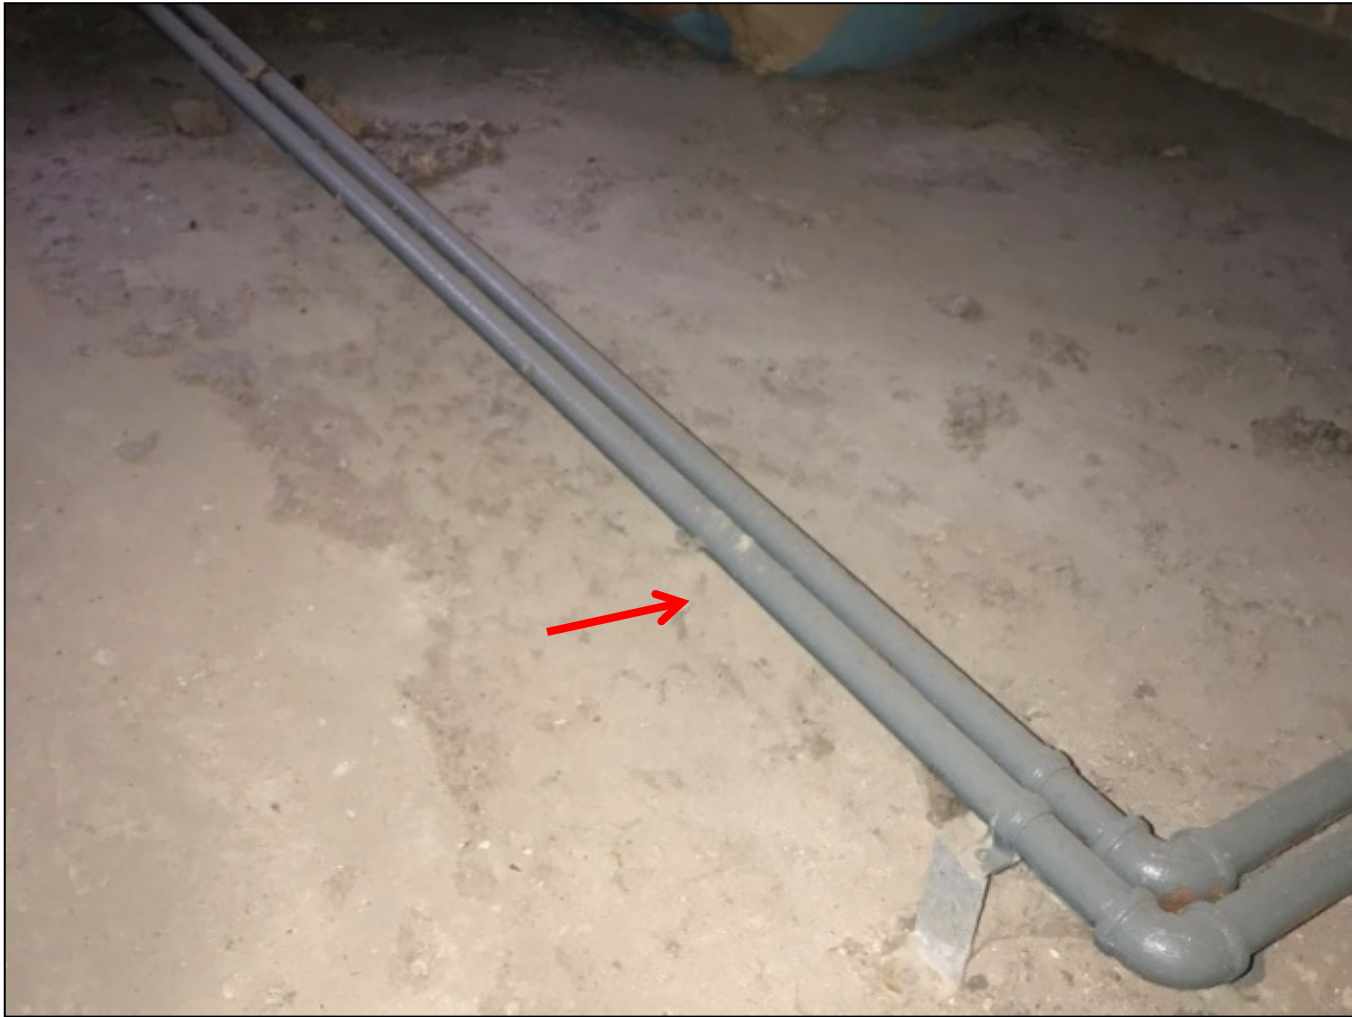
Photo 1: Main Floor, Room 112 – Grey Paint (Lead Containing)

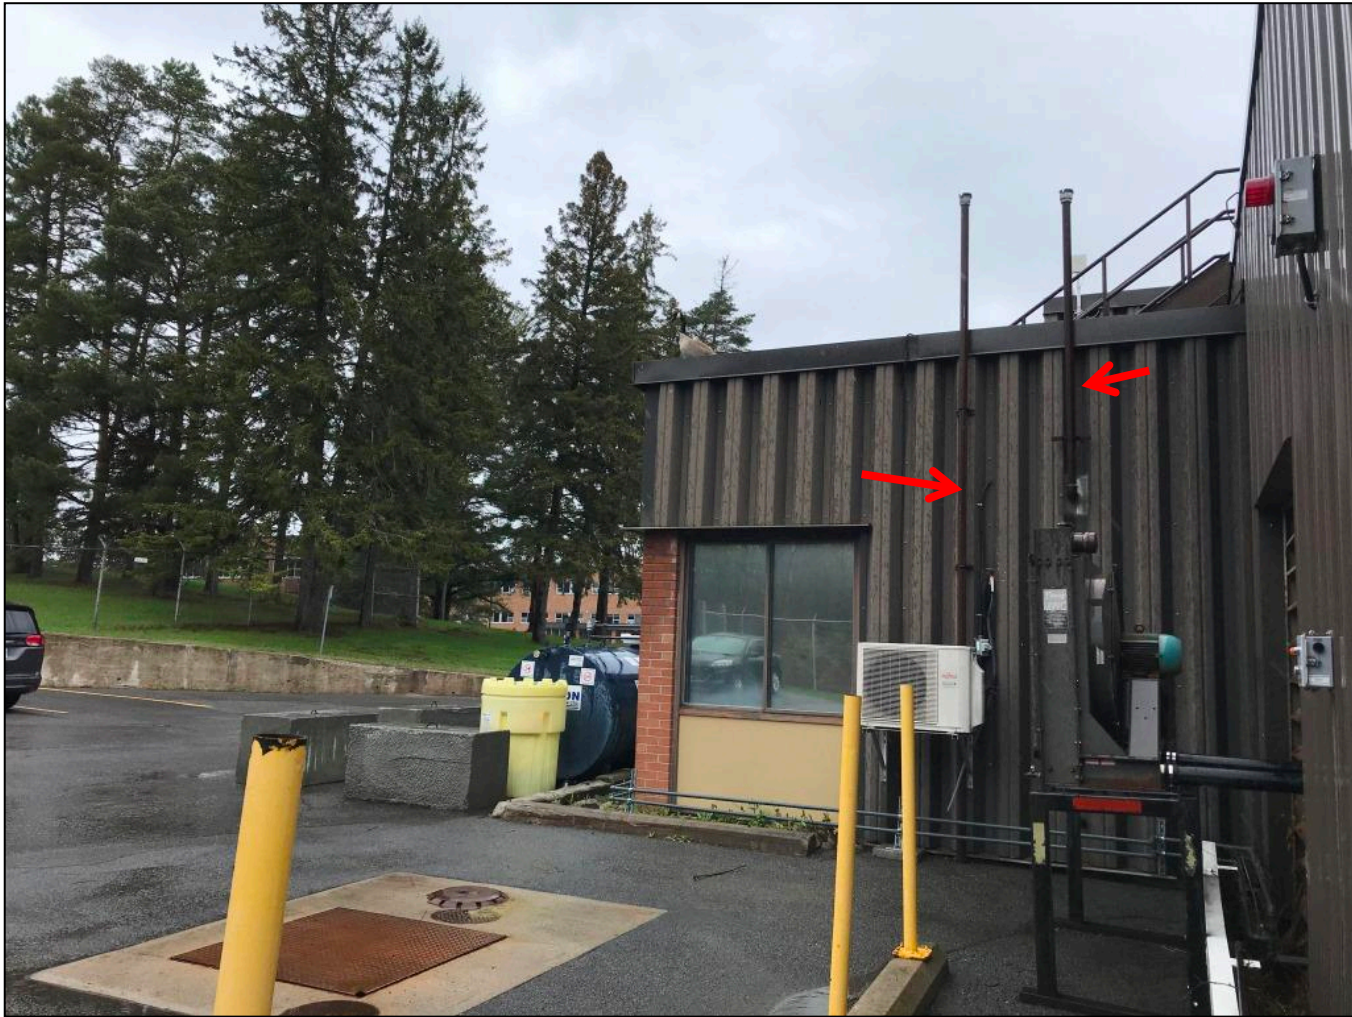
Photo 2: Exterior Piping – Brown. White Paint (Lead Containing)

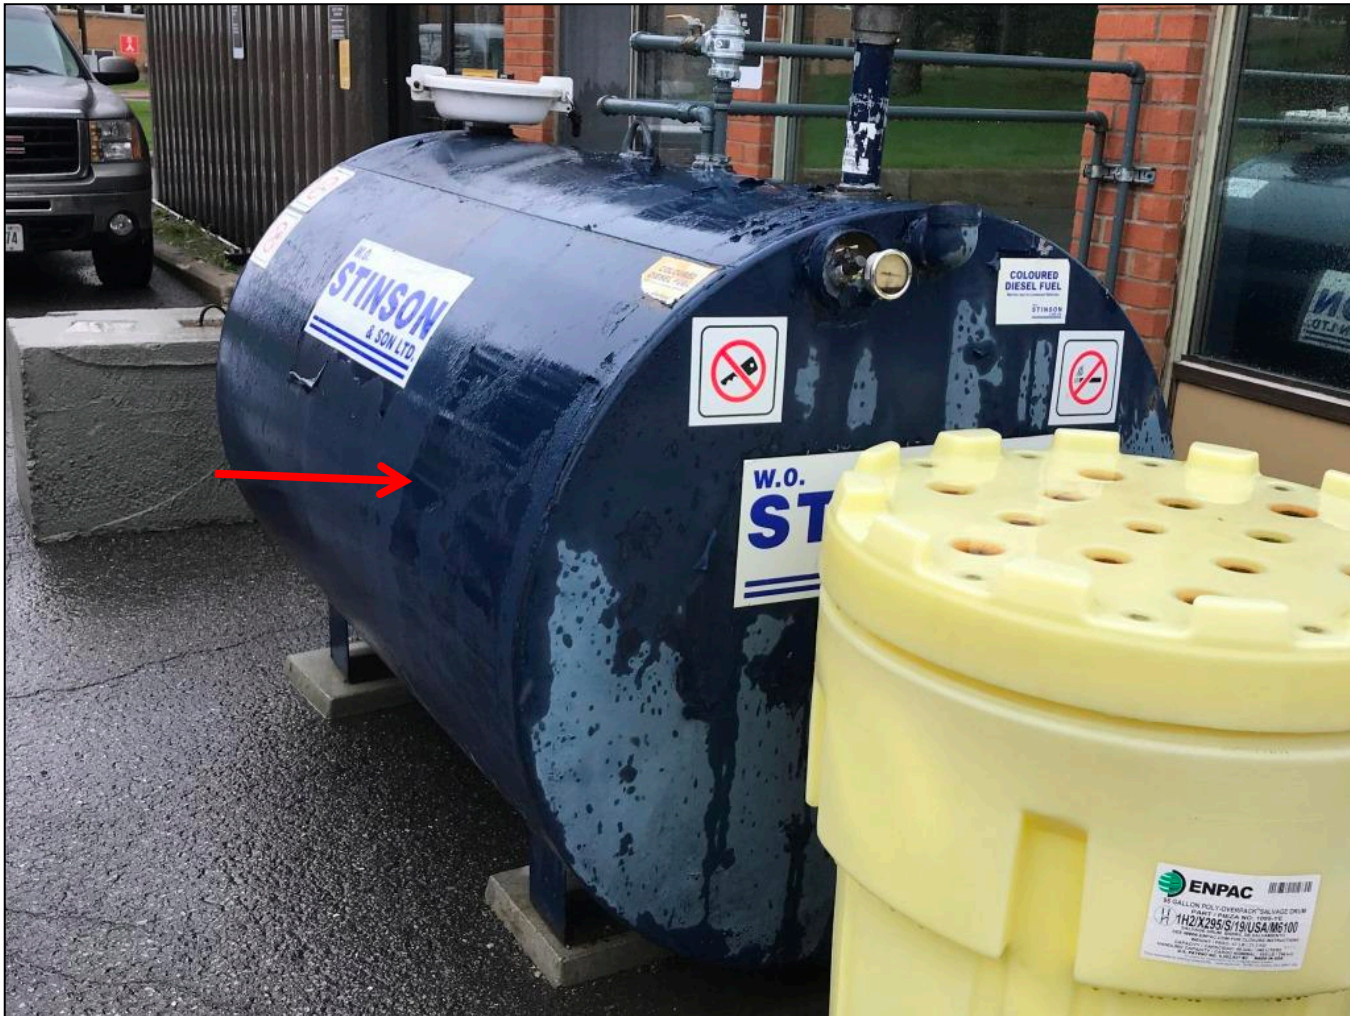
Photo 3: Exterior – Blue Paint (Low Lead Containing)

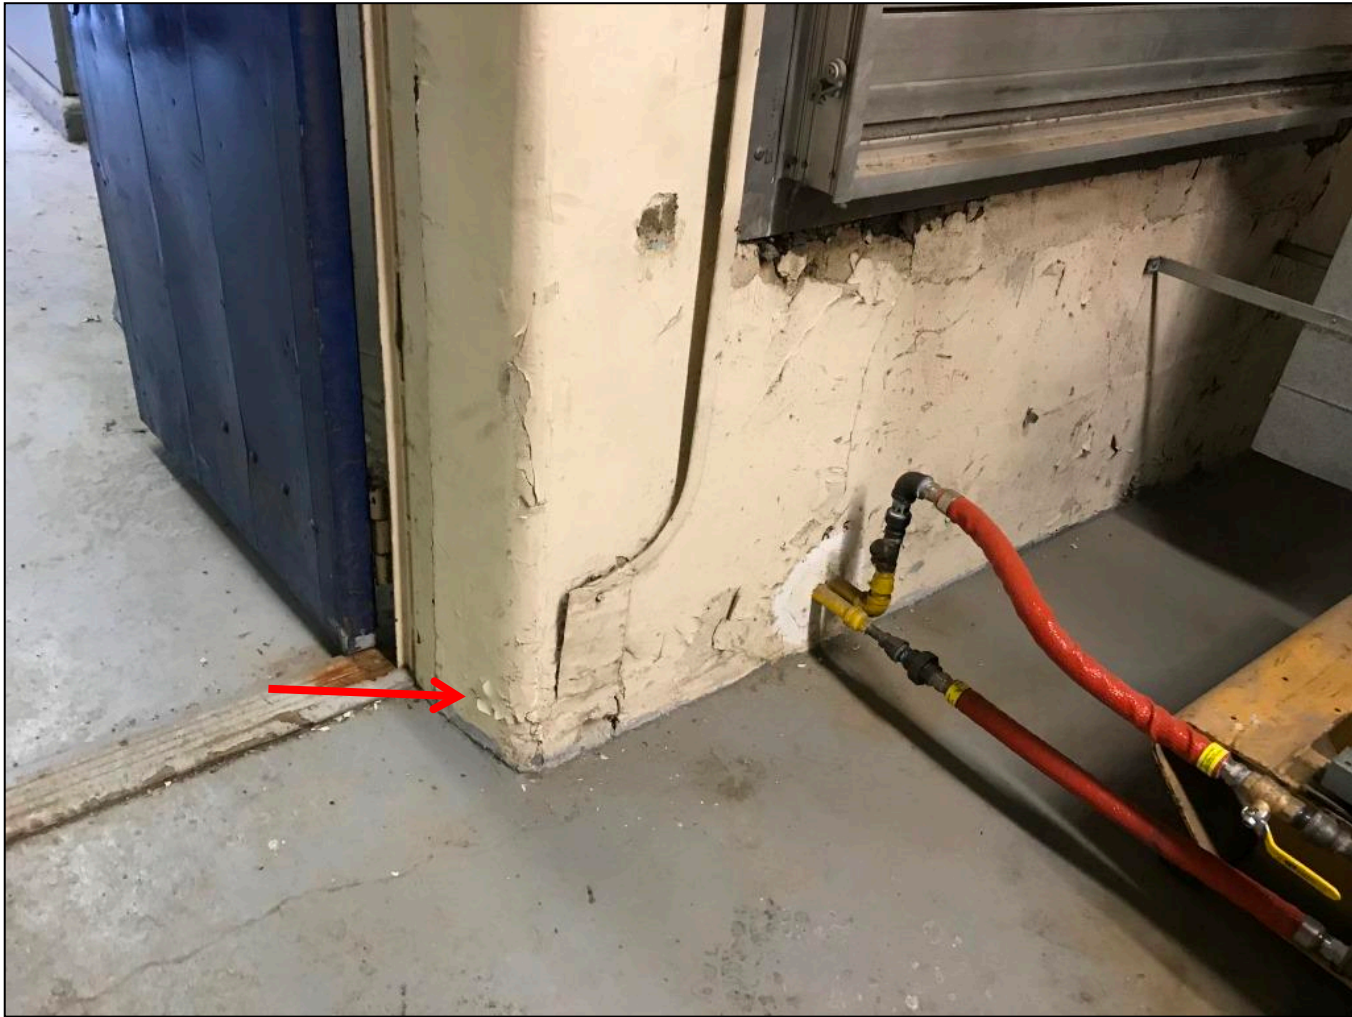
Photo 4: Main Floor, Room 110 – Beige Paint (Lead Containing)

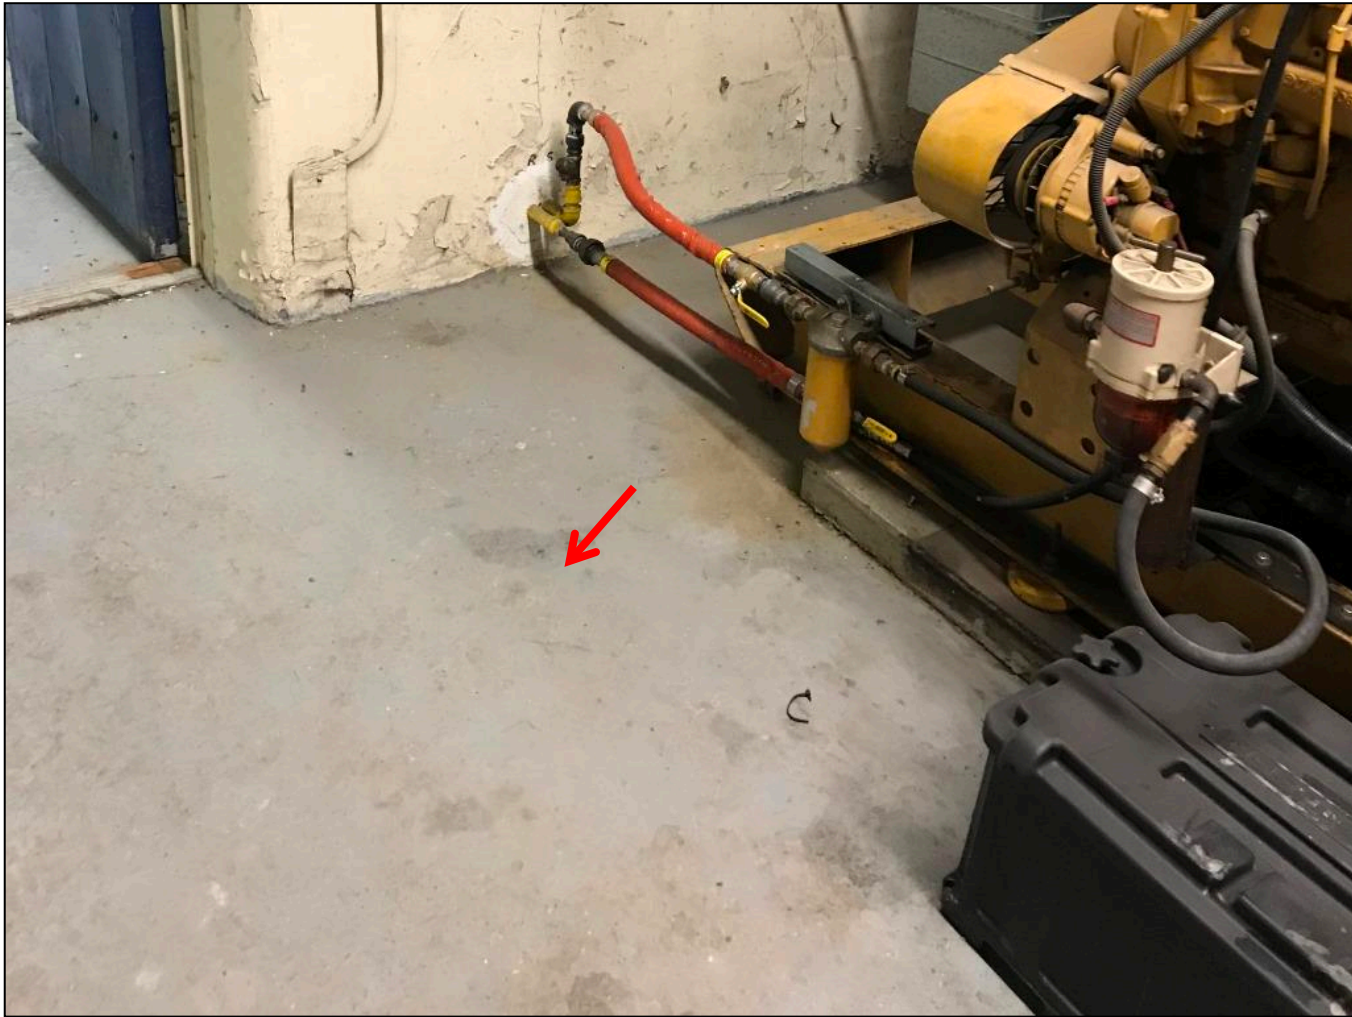
Photo 5: Main Floor, Room 112 – Grey Paint (Low Lead Containing)

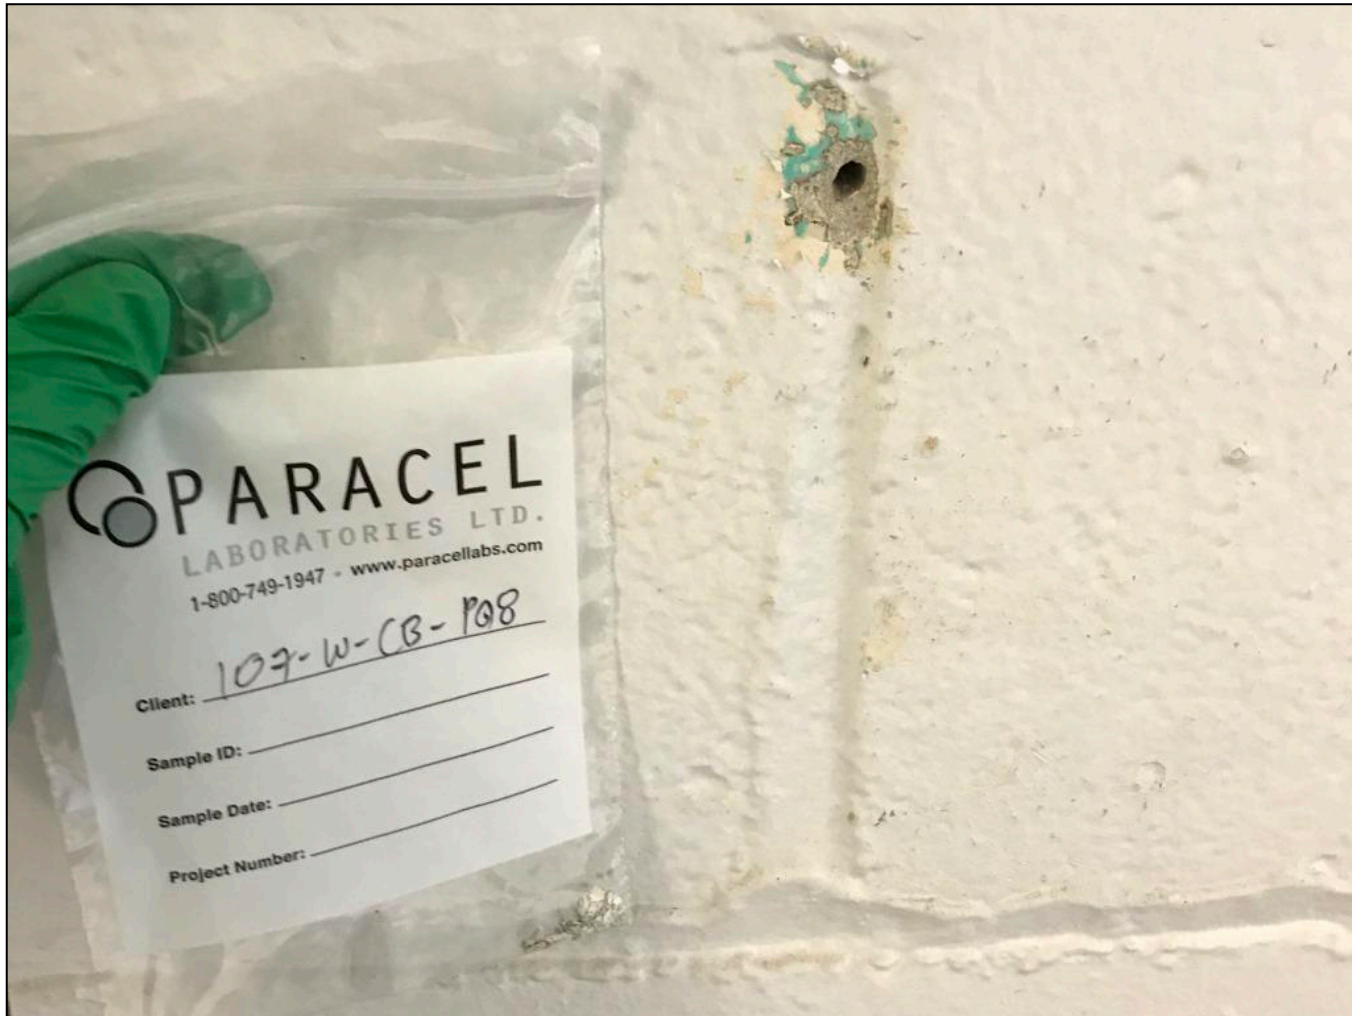
Photo 6: Main Floor, Room 107 – White, Beige, Green, Brown
Paint (Lead Containing)
