Asbestos Reassessment

CCGS Limnos
Vessel Number 328088
370 Dalhousie Street,
Amherstburg, Ontario

July 16, 2019

Pinchin File: 241027

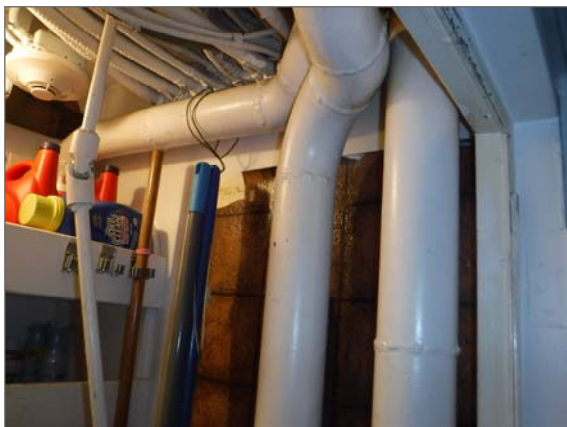
Parging cement, containing chrysotile asbestos (sample 0004A-C, lab report reference 2556487-2556489), was previously noted on the fittings (elbows, tees, valves, hangers, etc.) in the Utility Locker and Dry Storage Area (Location 16). Parging cement was not observed during this assessment.

Uninsulated piping Utility and Dry storage Area (Location 16)

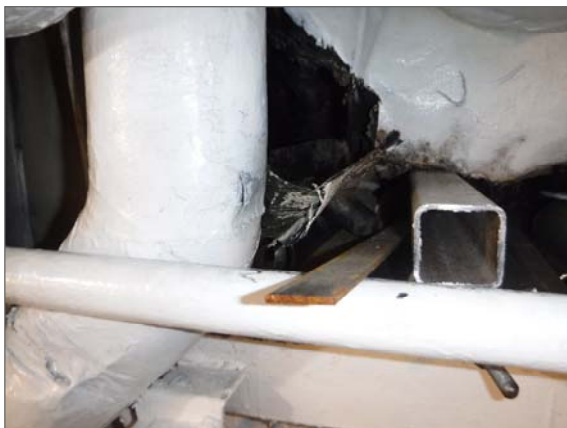
The white lagging compound covering the canvas and fiberglass on ductwork in the Engine Room (Location 29) was sampled and does not contain asbestos (sample S0016A-C, lab reference 71912988).

The client identified yellow suspect insulation covering the fiberglass on ductwork in the Engine Room (Location 29) was sampled and does not contain asbestos (sample S0017A-C, lab reference 71912988)

Client identified lagging compound and suspect insulation.

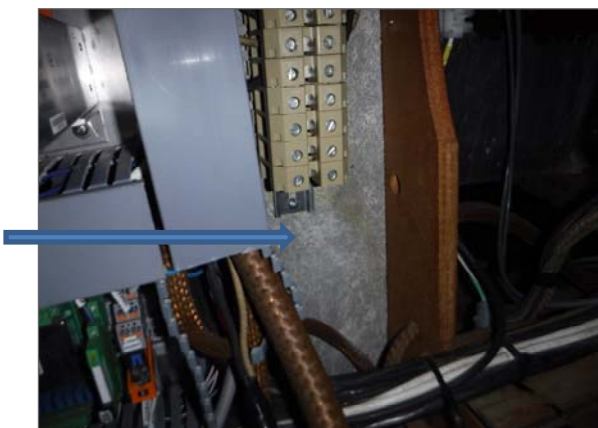
Transite cement board, containing chrysotile asbestos (samples S0021A-C, lab reference 71912988), is present behind the electrical panel in the Wheel House (Location 1). Transite is a non-friable material and was observed in good condition.

Asbestos-containing transite

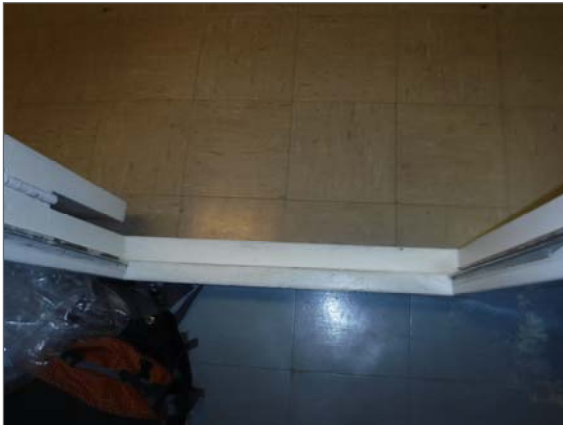
The asbestos-containing vinyl floor tiles are a non-friable material and were observed in good condition.

Asbestos-containing 9"x9" beige vinyl floor tiles; depicting painted and not painted conditions.

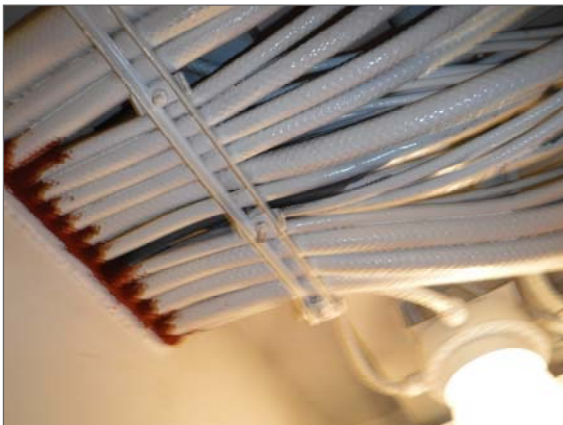
The red firestopping sealant covering the pipe and conduit penetrations throughout the vessel was sampled and does not contain asbestos (samples S0013A-C; lab report reference 71912988).

Non-asbestos red fire stopping

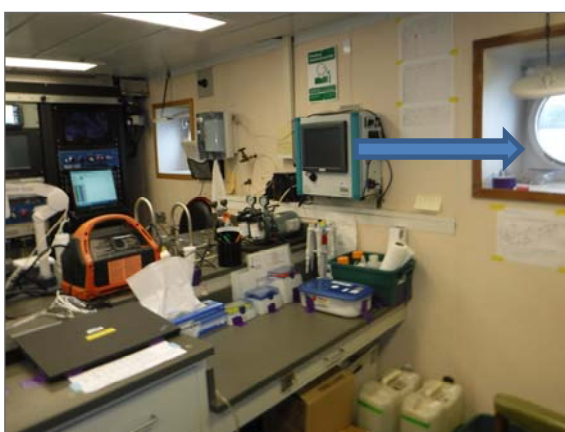
| Material and Colour | Location (Location #) | Quantity | Sample Number | Asbestos Type |
|---|--|---|---|---|
| Caulking, brown | Window frames in the Lab (Location 6) | 80 LF | S0014A-C, lab report reference 71912988 | None Detected |

Non-asbestos brown window caulking.

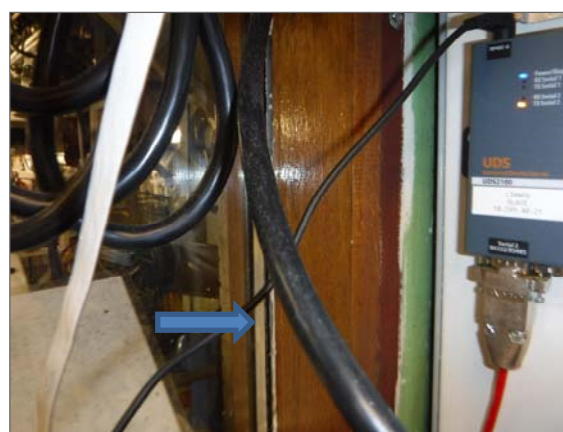
| Material and Colour | Location (Location #) | Quantity | Sample Number | Asbestos Type |
|---|--|---|---|---|
| Caulking, white | Window frames in the Engine Room (Location 29) | 80 LF | S0015A-C, lab report reference 71912988 | None Detected |

Non-asbestos white window caulking.

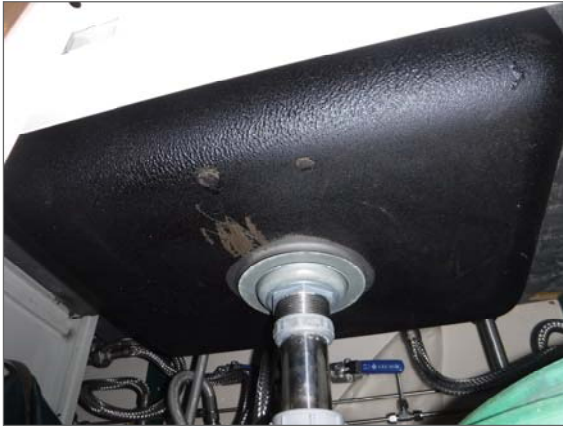
Non-asbestos black sink mastic.

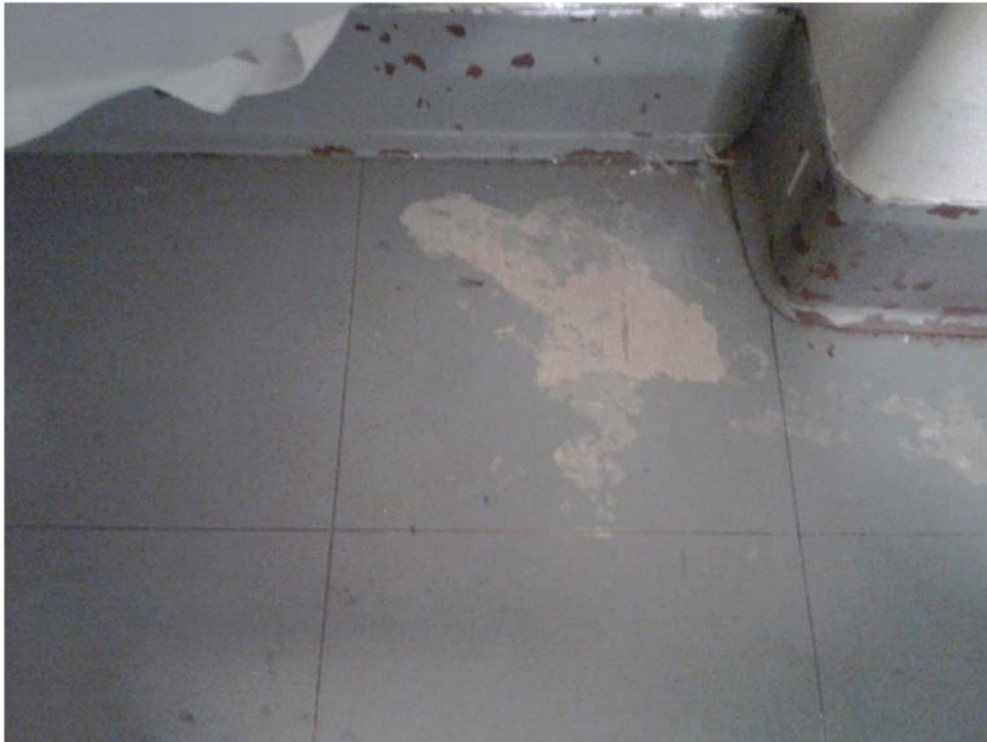
Vinyl Floor Tile and Mastic, In closet 9x9 grey painted brown with brown streak, V9000, Corridor (Loc. 3)

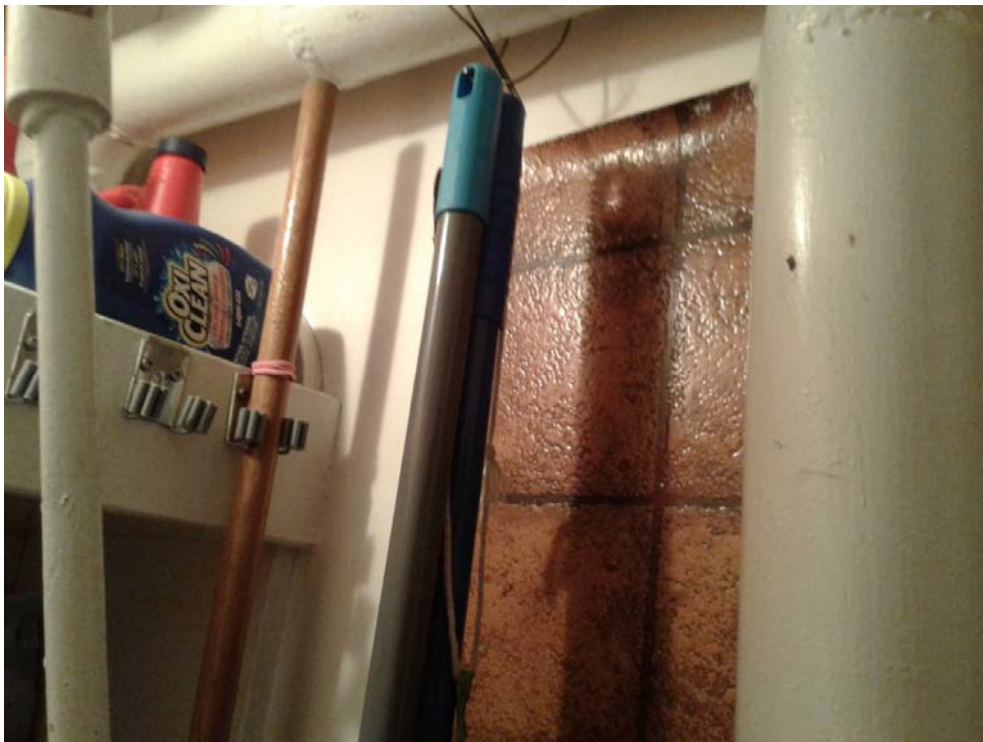
Wall covering, Brick pattern vinyl sheet flooring, S0009C, Utility Locker And dry Storage (Loc. 16)

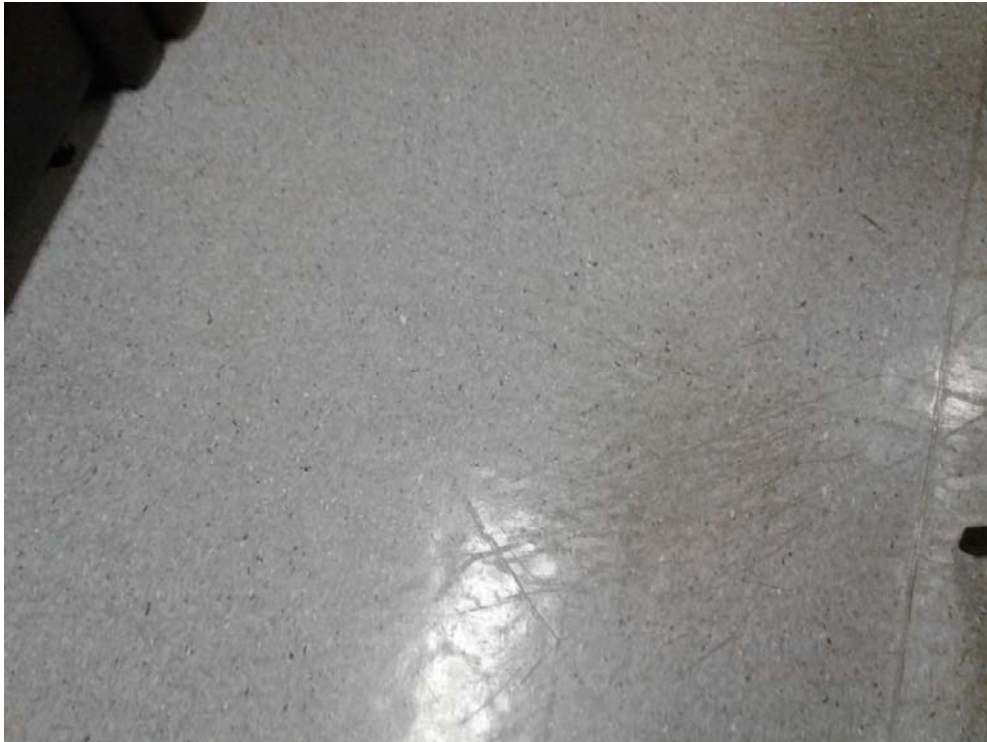
Vinyl Sheet Flooring, Grey with grey and white smear pattern, S0010A, Scientist & Officers Mess (Loc. 19)

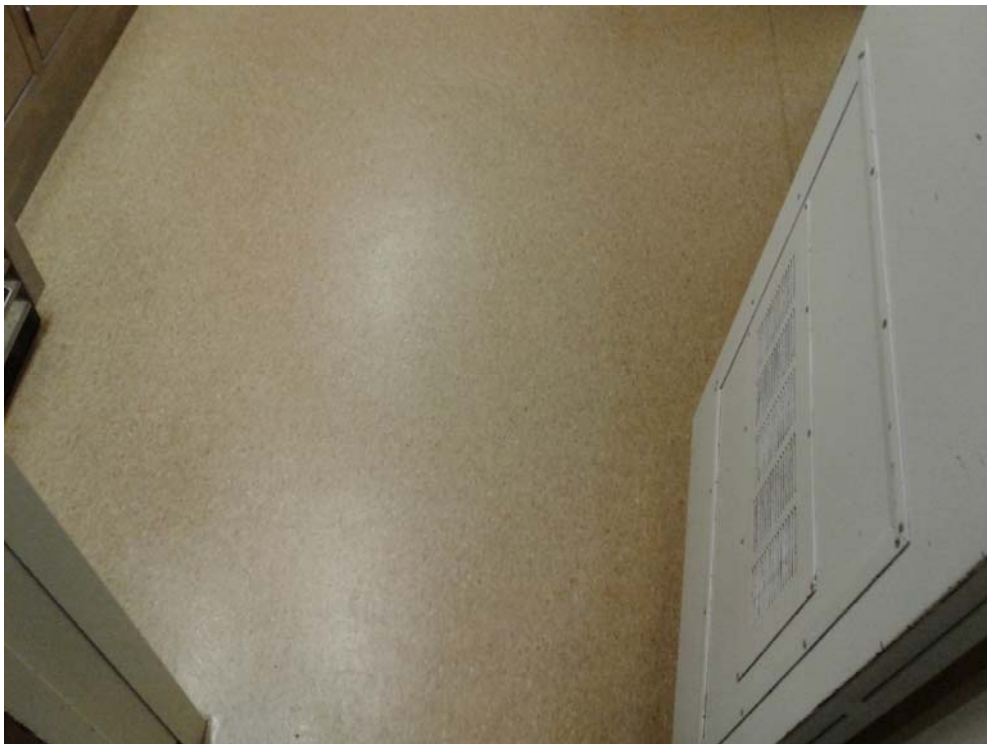
Vinyl Sheet Flooring, New install, , Crew's Mess (Loc. 21)
