DESIGNATED SUBSTANCES AND HAZARDOUS MATERIALS SURVEY

**6248 8th Line
Egbert, Ontario**

ISSUED: March 27, 2018

OESN PROJECT #: 00603.003

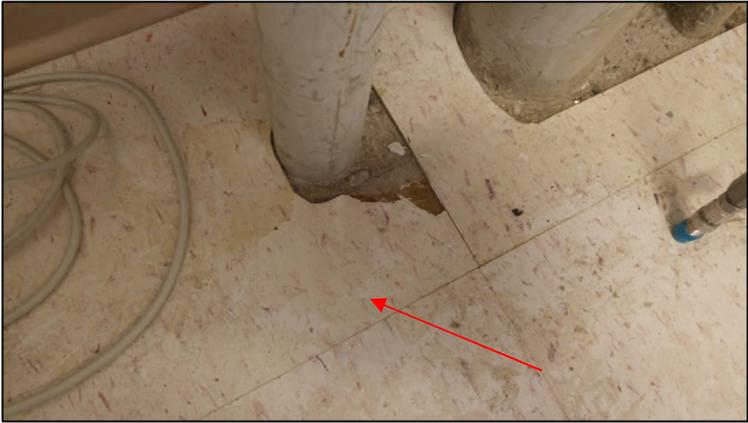
<p>Sample Identification 00603.003-F01 00603.003-F02 00603.003-F03</p> <p>Sample Code HF-01</p>
	<p>Sample Location of Material 1001</p>
	<p>Sample Description 12" VFT – White w/ Red Fleck</p>
	<p>Quantity of Material -</p>
	<p>Condition of Material -</p>
<p>Analytical Result: None Detected</p>

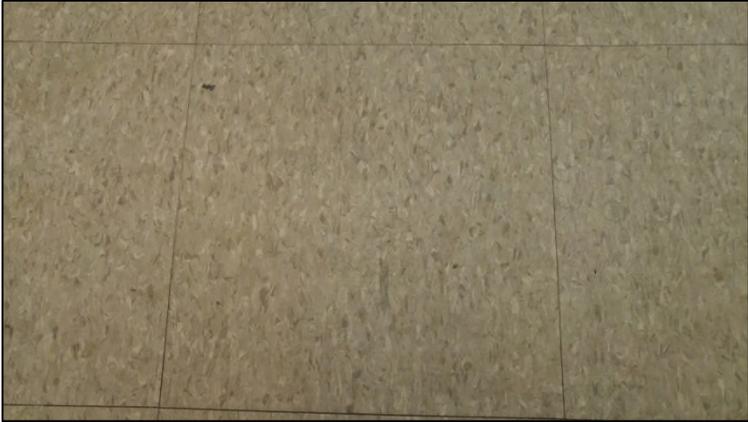
<p>Sample Identification 00603.003-F04 00603.003-F05 00603.003-F06</p> <p>Sample Code HF-02</p>
	<p>Sample Location of Material 1003</p>
	<p>Sample Description 12" VFT – Beige with White/Grey Fleck</p>
	<p>Quantity of Material -</p>
	<p>Condition of Material -</p>
<p>Analytical Result: None Detected</p>

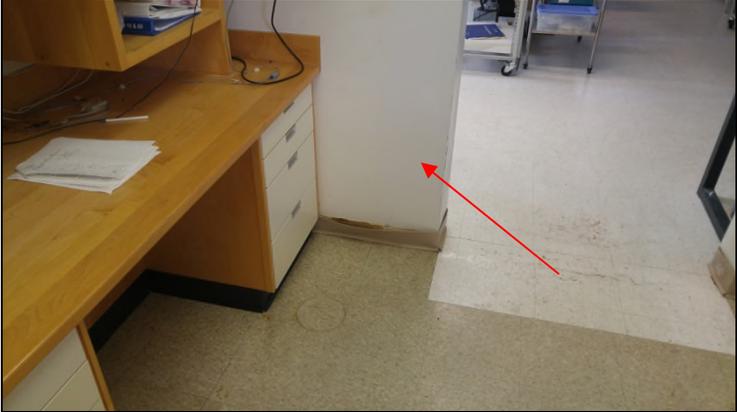
<p>Sample Identification 00603.003-W01 00603.003-W02 00603.003-W03 00603.003-W04 00603.003-W05</p> <p>Sample Code HW-01</p>
	<p>Sample Location of Material Various locations interior</p>
	<p>Sample Description Gypsum w/ compound</p>
	<p>Quantity of Material -</p>
	<p>Condition of Material -</p>
<p>Analytical Result: None Detected</p>

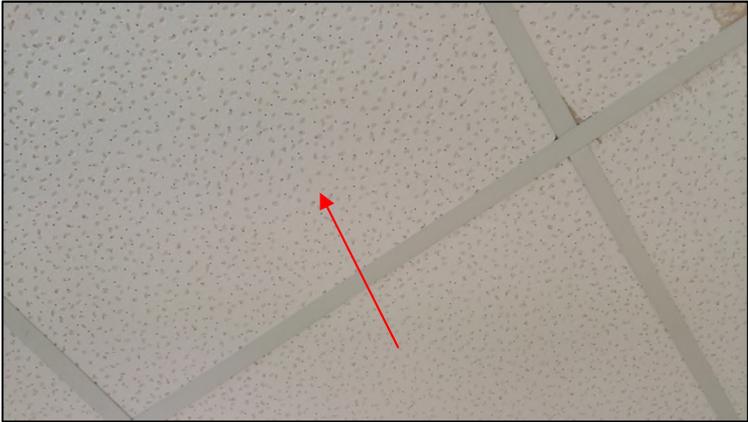
<p>Sample Identification 00603.003-C01 00603.003-C02 00603.003-C03</p> <p>Sample Code HC-01</p>
	<p>Sample Location of Material 1001</p>
	<p>Sample Description 2'x4' Lay-in Acoustic Tile – Large Strata w/ Dots</p>
	<p>Quantity of Material -</p>
	<p>Condition of Material -</p>
<p>Analytical Result: None Detected</p>

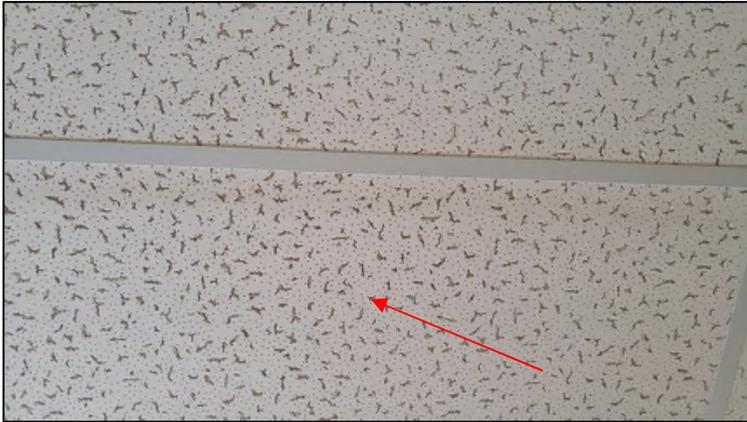
<p>Sample Identification 00603.003-C04 00603.003-C05 00603.003-C06</p> <p>Sample Code HC-02</p>
	<p>Sample Location of Material 1003</p>
	<p>Sample Description 2'x4' Lay-in Acoustic Tile – Large Fissure w/ Dots</p>
	<p>Quantity of Material -</p>
	<p>Condition of Material -</p>
<p>Analytical Result: None Detected</p>

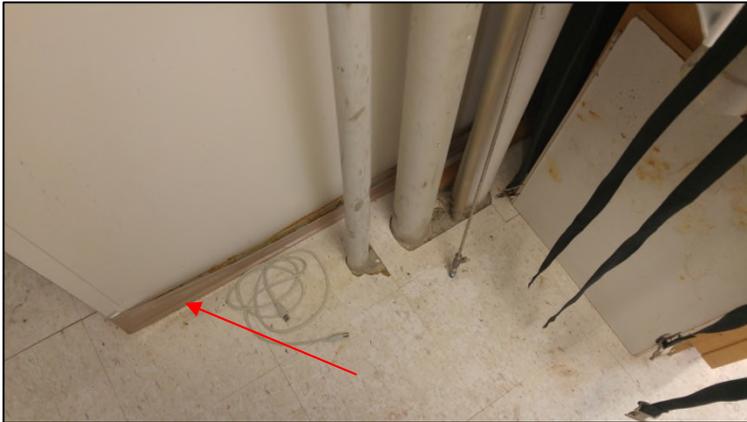
<p>Sample Identification 00603.003-M01 00603.003-M02 00603.003-M03</p> <p>Sample Code HM-01</p>
	<p>Sample Location of Material 1003</p>
	<p>Sample Description Base Cove – Beige</p>
	<p>Quantity of Material -</p>
	<p>Condition of Material -</p>
<p>Analytical Result: None Detected</p>

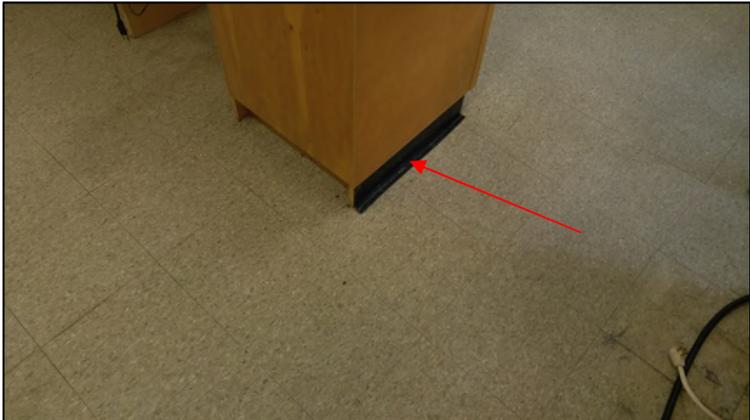
<p>Sample Identification 00603.003-M04 00603.003-M05 00603.003-M06</p> <p>Sample Code HM-02</p>
	<p>Sample Location of Material 1003</p>
	<p>Sample Description Base Cove - Black</p>
	<p>Quantity of Material -</p>
	<p>Condition of Material -</p>
<p>Analytical Result: None Detected</p>

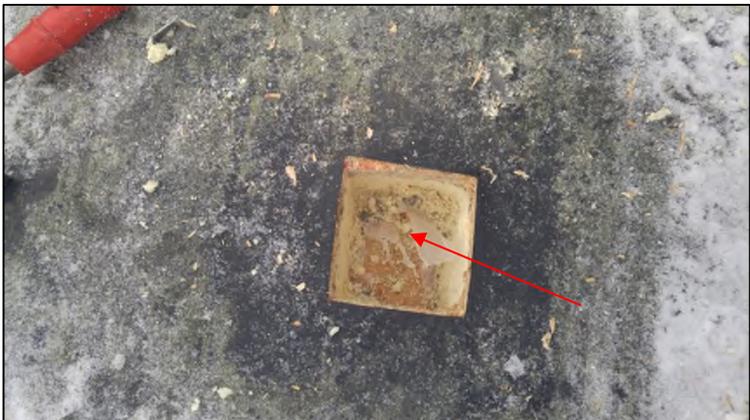
<p>Sample Identification 00603.003-R01 00603.003-R02 00603.003-R03</p> <p>Sample Code HR-01</p>
	<p>Sample Location of Material exterior</p>
	<p>Sample Description Roof Material</p>
	<p>Quantity of Material -</p>
	<p>Condition of Material -</p>
<p>Analytical Result: None Detected</p>

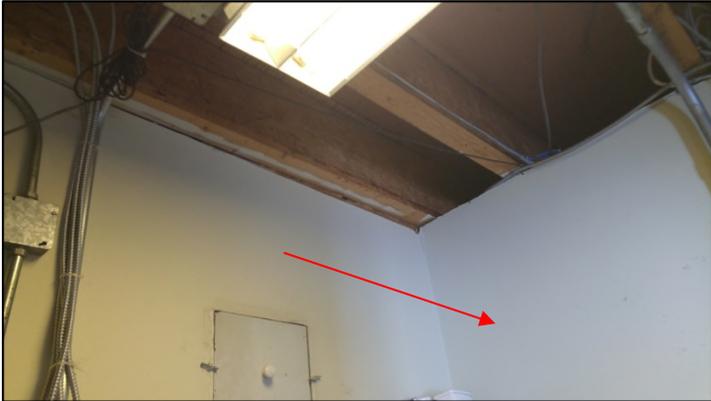
Sample Identification White Paint - Walls 00603.003-P01
	Arsenic Content <50 µg/g
	Mercury Content <2 µg/g
	Lead Content <5 µg/g

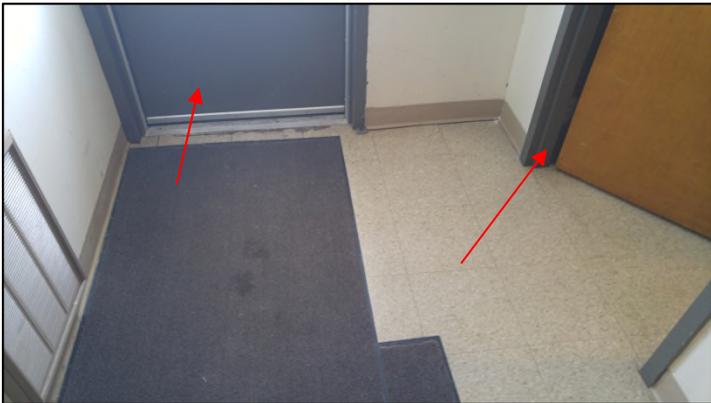
Lead content was confirmed in grey paint used on doors and door frames.

Sample Identification Grey Paint – Doors/Door Frame 00603.003-P02
	Arsenic Content <50 µg/g
	Mercury Content <2 µg/g
	Lead Content 689 µg/g
