CBSA – FRASER POE DEMOLITION OF EXISTING SLAB AND REPAVING

**PRE-DEMOLITION HAZARDOUS BUILDING MATERIALS
ASSESSMENT**

Stantec Consulting Ltd. (Stantec) was retained by Public Works and Government Services Canada (PWGSC) on behalf of the Canada Border Services Agency (CBSA) to conduct a pre-demolition hazardous building materials assessment of the Fraser Port of Entry Traffic Building located at KM 36.7 South Klondike Highway, Northern BC.

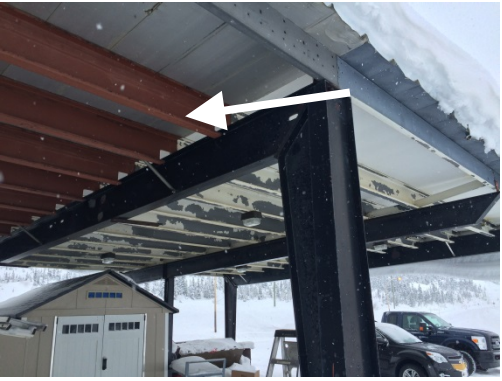
Identified LCP Description	Photo
<p>Red primer on structural steel components throughout the main building and the exterior canopy.</p> <p>This paint was observed to be in good condition (not bubbling, flaking or peeling).</p>

Corrective action or remedial work on paint applications containing any concentration of lead should be undertaken in a manner so as to avoid generating fine particulate matter or dust (i.e., avoid sanding). Airborne lead dust or fumes should not exceed BC Reg. 296/97 8-hour Occupational Exposure Limit (OEL) of 0.05 milligram per cubic metre (mg/m³) during the removal of paints and products containing any concentration of lead. The use of personal protective equipment is recommended to reduce the potential for over-exposure to lead dust.

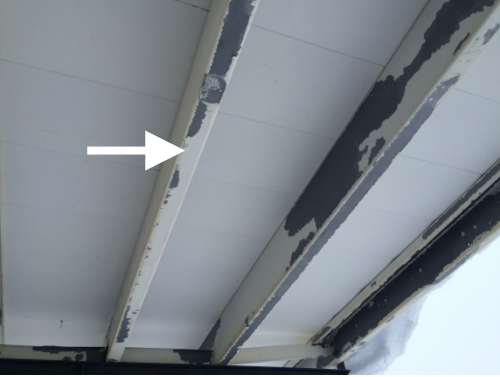
Identified LCP Description	Photo
<p>Cream paint on steel canopy on north side of building (exterior). This paint was observed to be in poor condition (bubbling, flaking or peeling).</p>

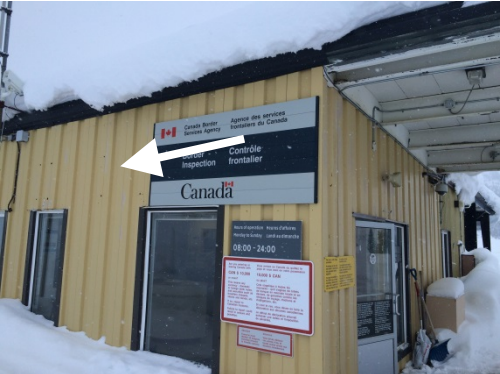
<p>Yellow paint on corrugated siding (exterior). This paint was observed to be in good condition (not bubbling, flaking or peeling).</p>
