February 5, 2021

Subject: **Hazardous Building Materials Report**
Georges Island National Historic Site, Halifax NS
Our ref.: 2000155.000

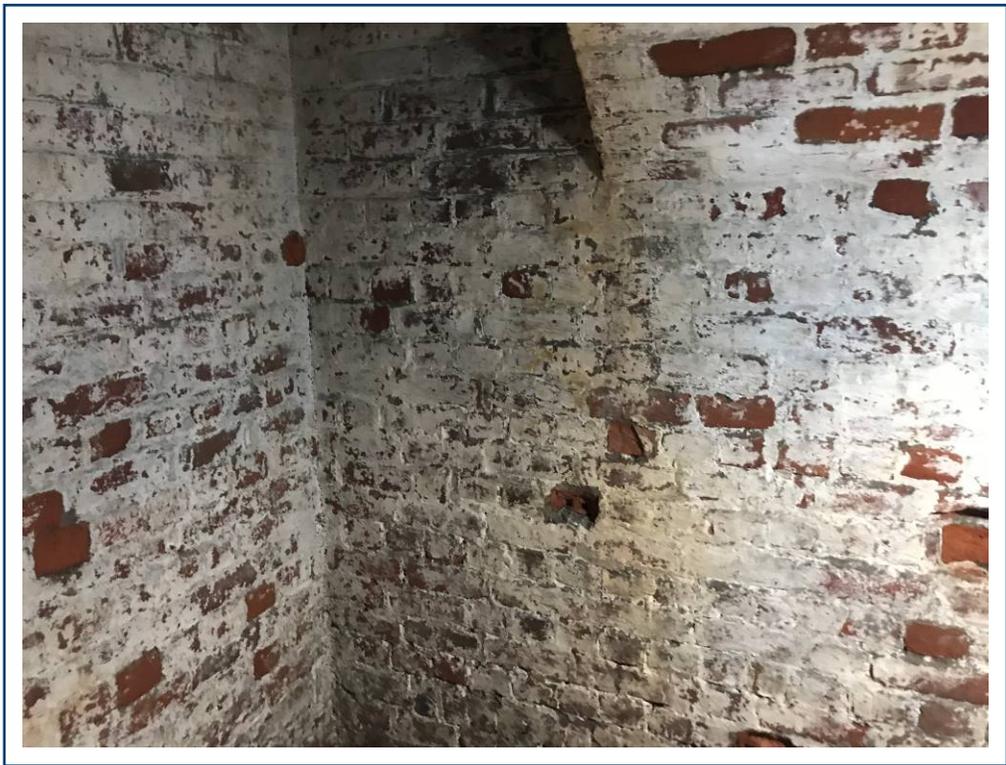
It should be noted that hazardous building materials identified in the main magazine and tunnels (specifically, painted surfaces in poor condition) could not be quantified due to complex design of the underground system and the varying coverage and condition of the paint. As such, photos of the tunnels showing paint samples T-P4 and T-P6 (white on brick walls) are included in Appendix D.

PHOTO 1 — East to West Tunnel, showing white paint in poor condition (note how the condition of the paint varies)

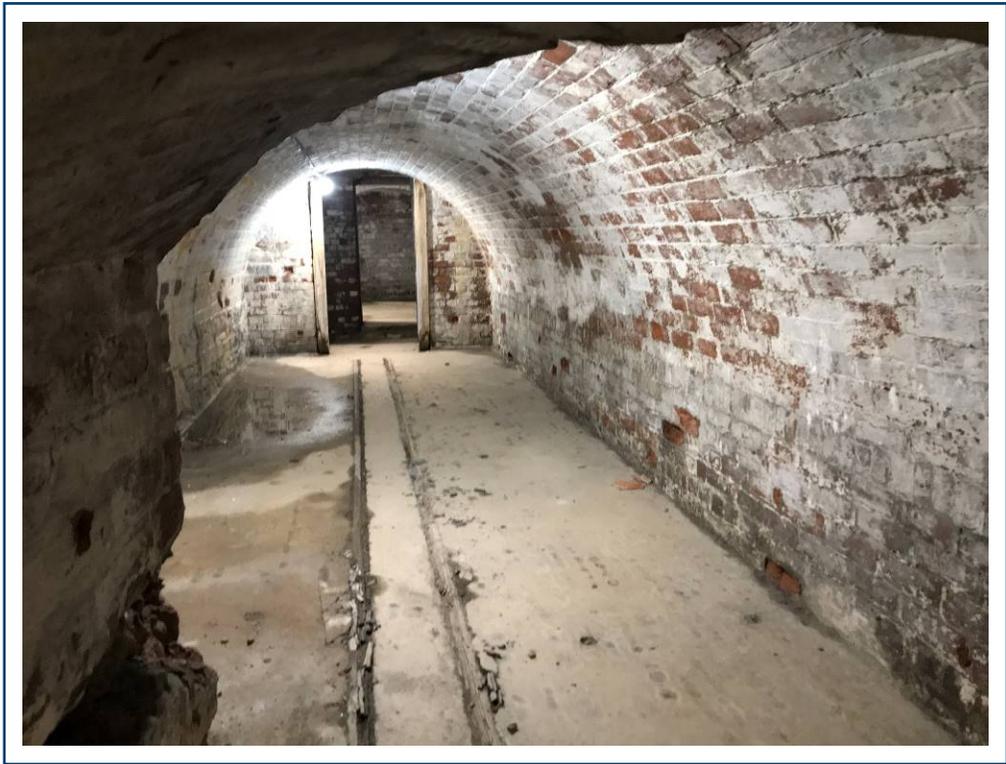
PHOTO 2 — East to West Tunnel, showing white paint in poor condition (note how the condition of the paint varies)

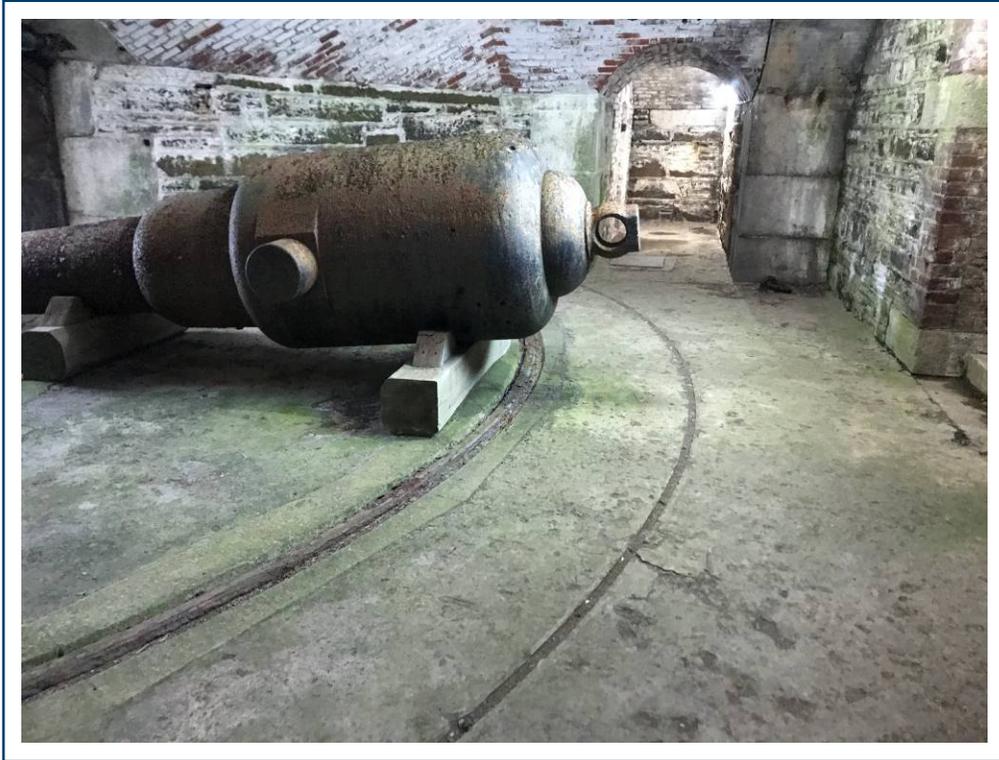
PHOTO 3 — Lower Battery South, note the painted black cannon.

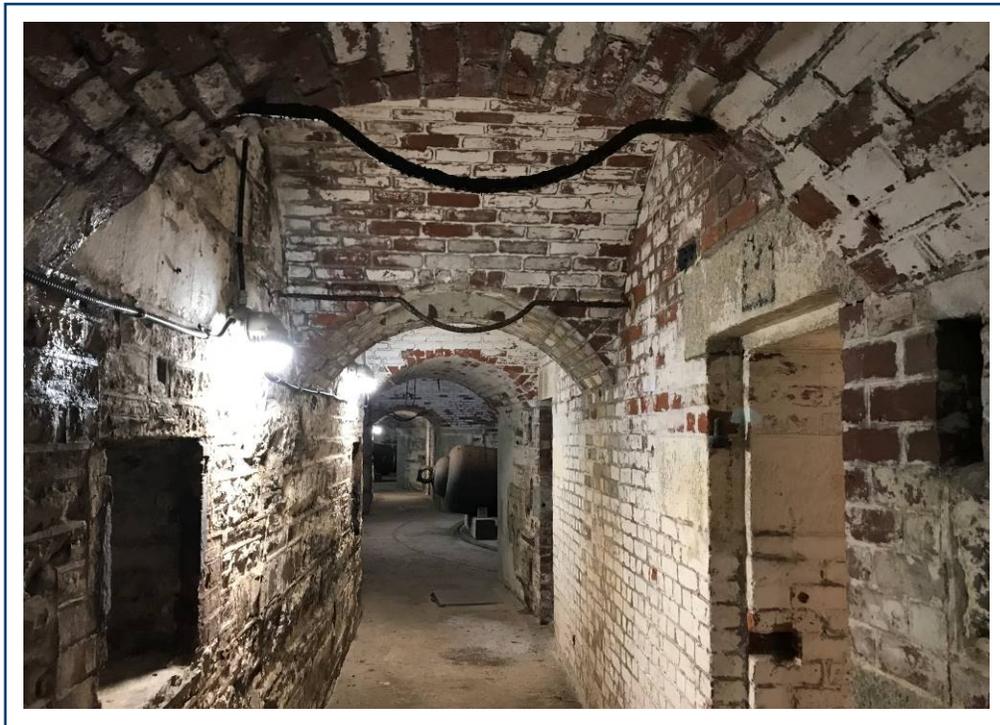
PHOTO 4 — Lower Battery South showing white paint in poor condition (note how the condition of the paint varies)
