Parks Canada (PCA) – Wood Buffalo NP  
Hay Camp Rd – Culvert Washout Inspection

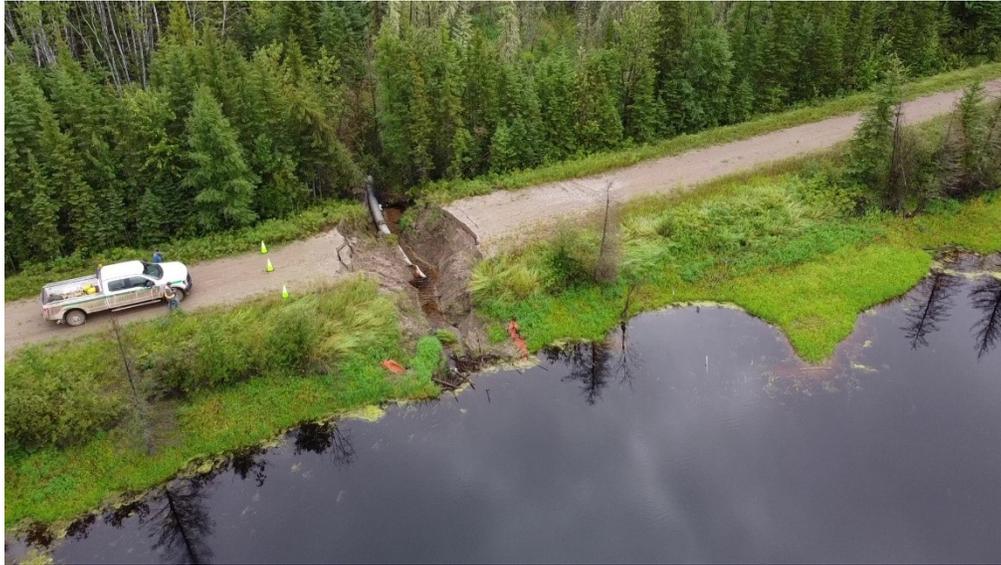
Aug, 2020 condition: photo taken looking east toward Slave river.

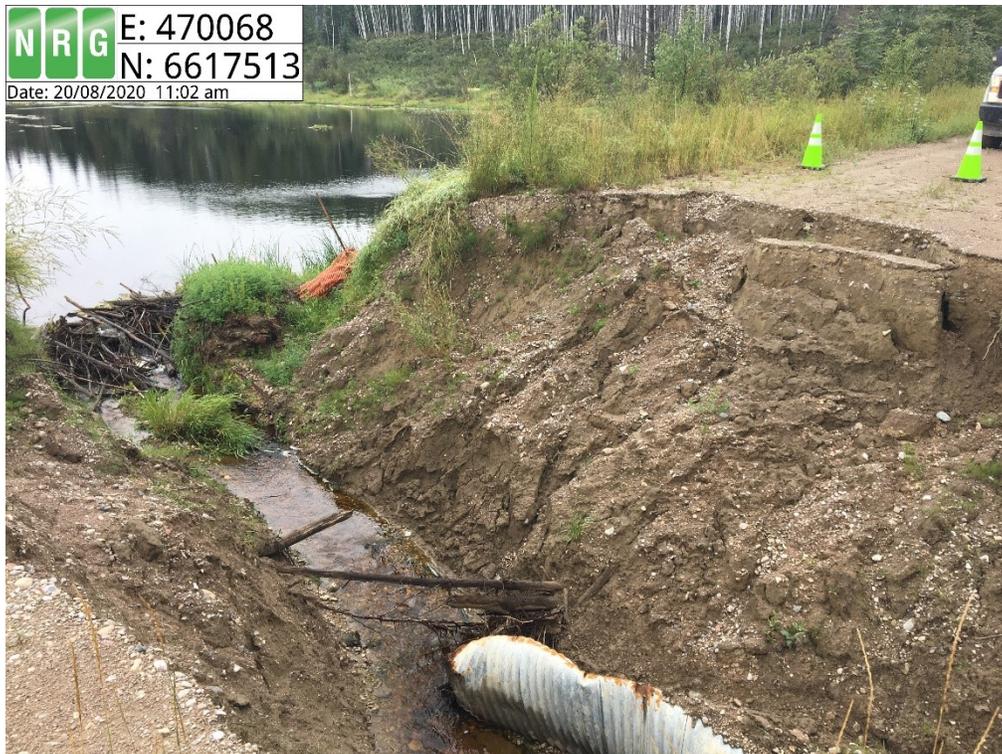
Aug, 2020 condition: photo looking west toward unnamed tributary.

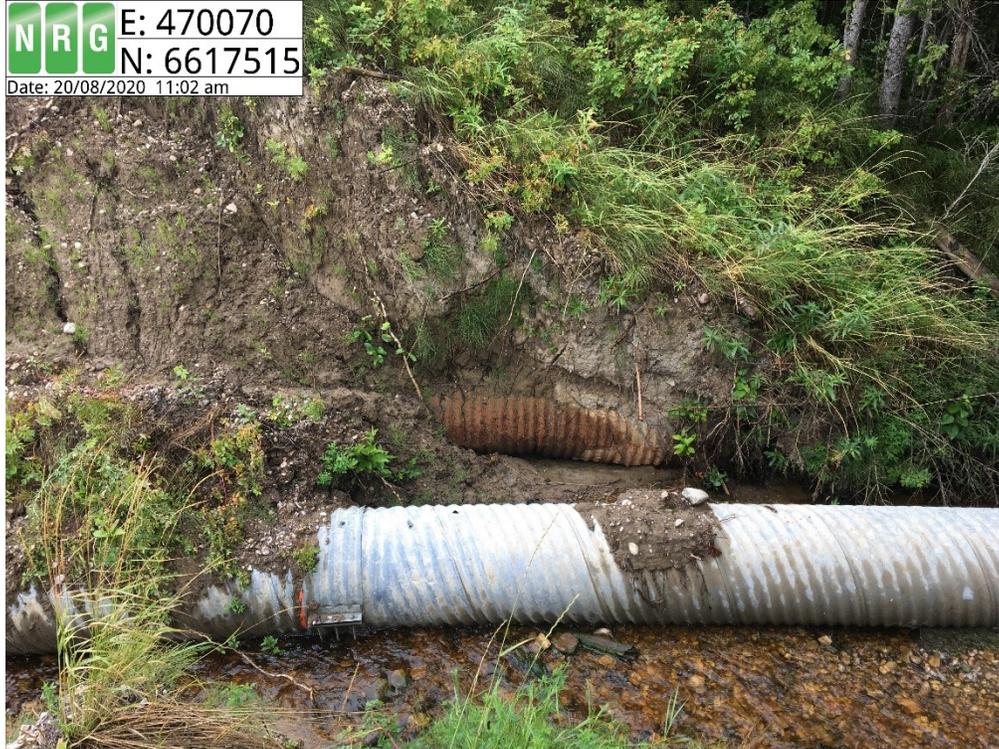
Aug, 2020 condition: both ~600mm dia. existing culverts to be removed.

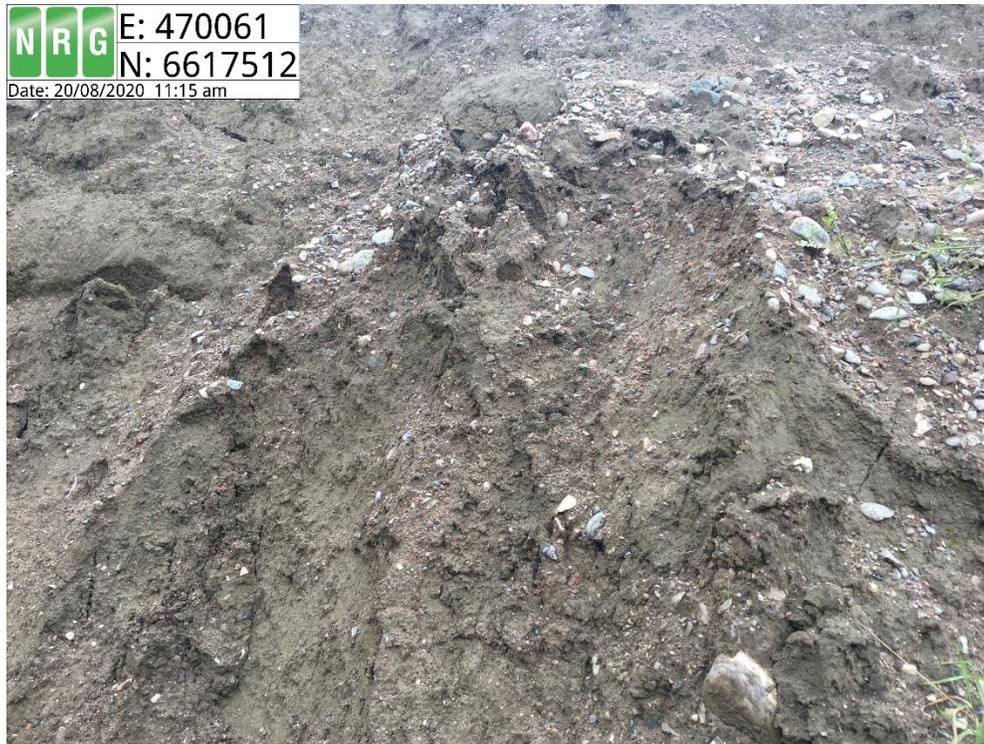
Aug, 2020 condition: in-situ material is damp silty/ clayey gravel.

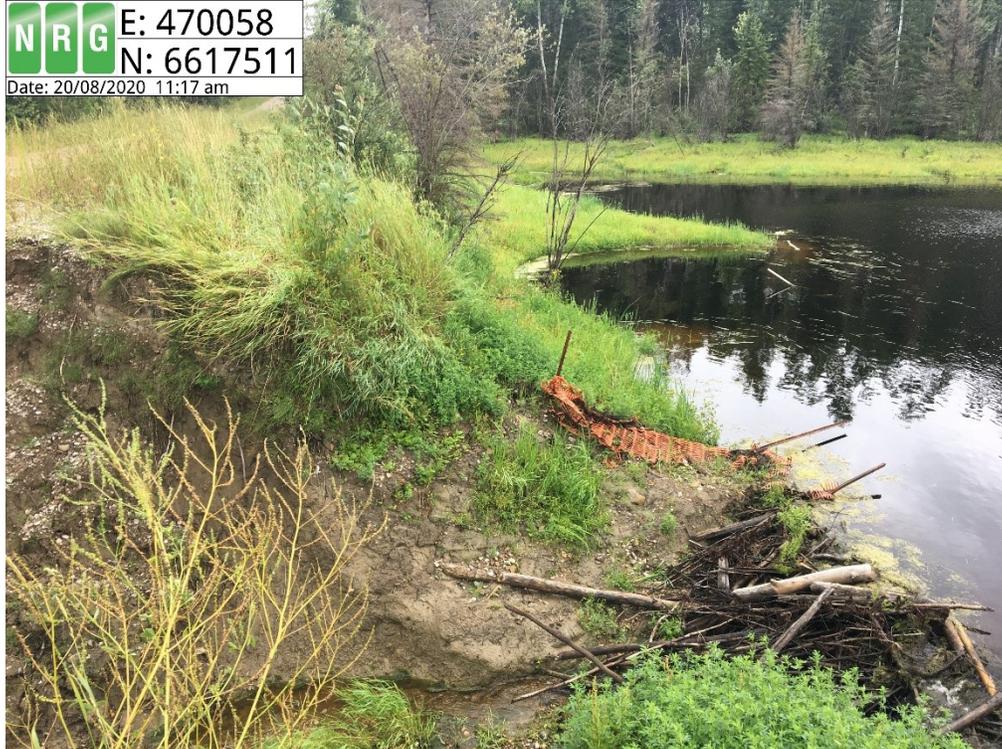
Aug, 2020 condition: west side slope on upstream (unnamed tributary) side.

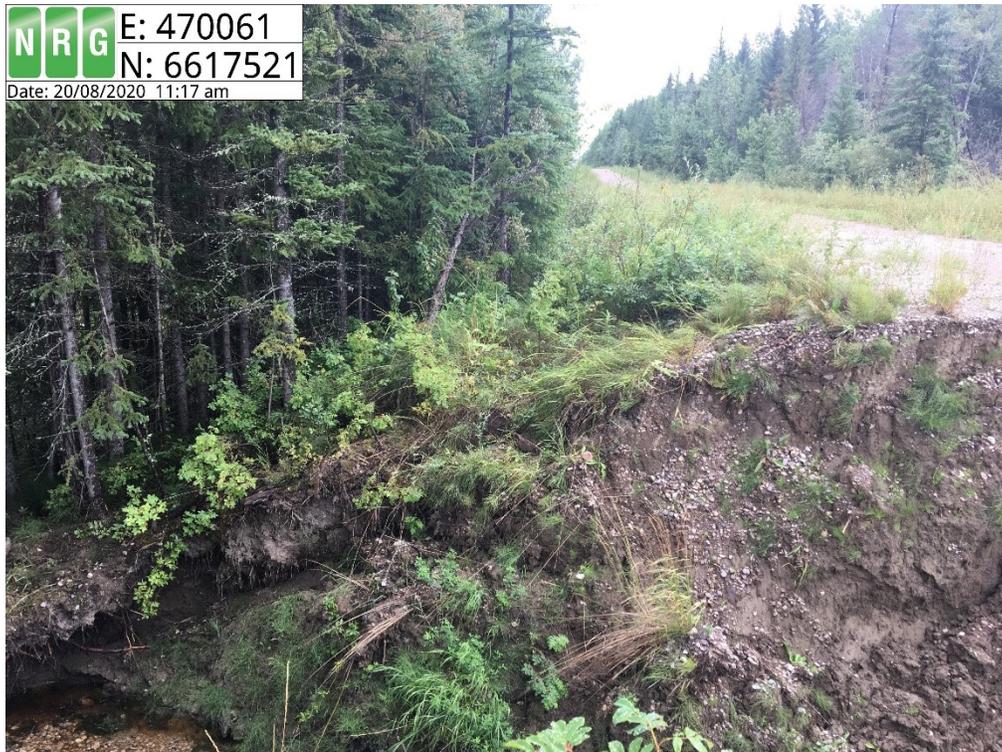
Aug, 2020 condition: east side slope on downstream (Slave river) side.
