# LASALLE CAUSEWAY BASCULE BRIDGE

## COUNTERWEIGHT REHABILITATION STUDY

### Inspection Report | FINAL DRAFT

PSPC Project No. R.108246.001

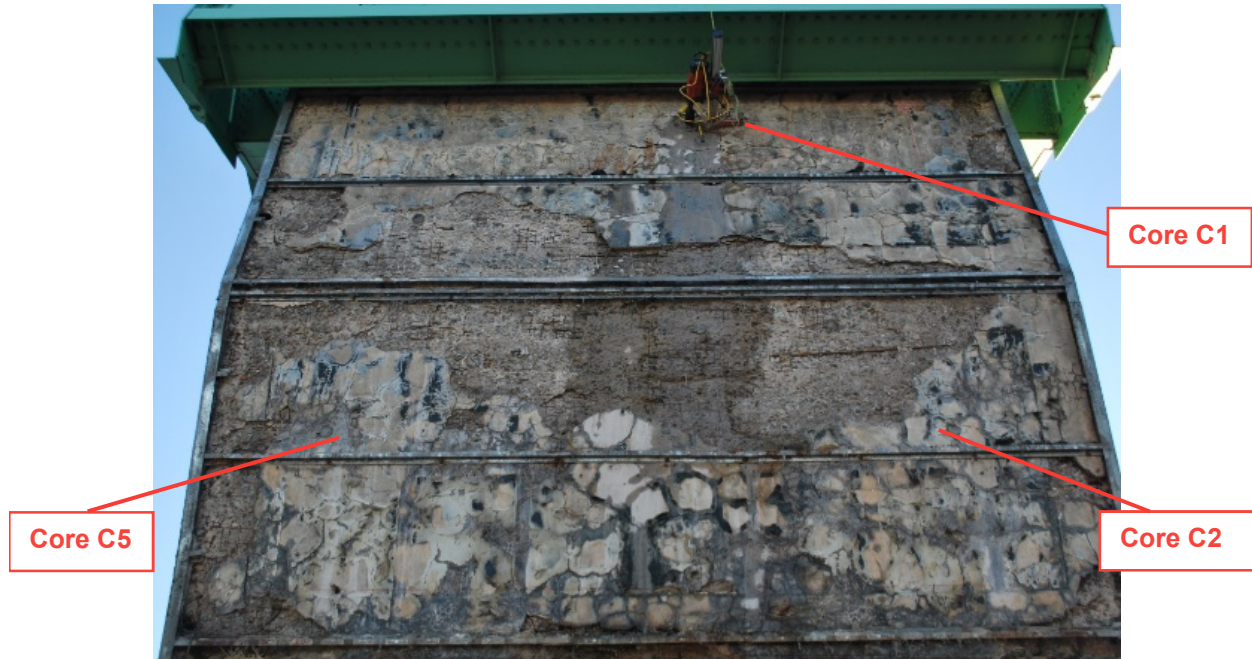
Three cores (C1, C2 and C5) were removed from this face (top middle, middle right (South), and bottom left (North)). These cores and core holes, were used to measure compressive strength and carbonation depth as presented in **Section 4.2.1** and **4.2.2** respectively.

Figure 4-1: West face of Counterweight showing signs of spalling, delamination, and reinforcing corrosion (approximate core locations and areas of spalling and delamination are presented in Appendix C, detailed core locations found in Appendix A)

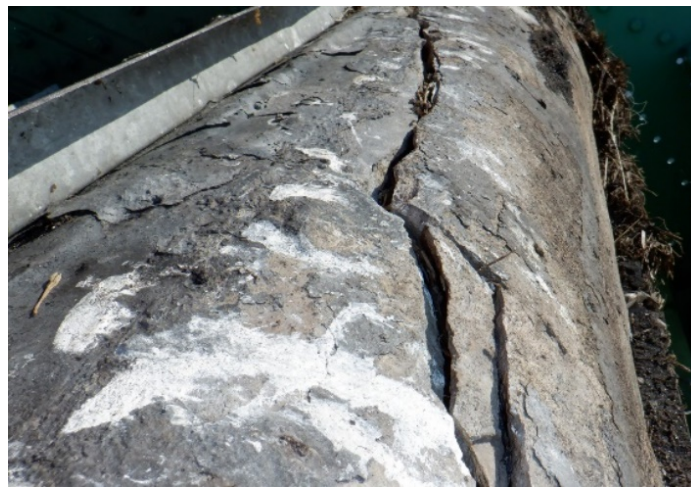
Figure 4-2: Crack (15 mm – 25 mm in width) running along top edge of West face.

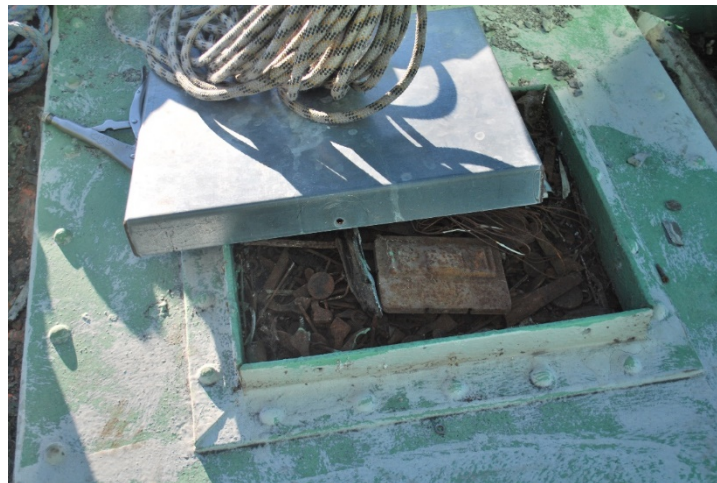
**Figure 4-5: Metal debris inside compartment on top face of Counterweight.**

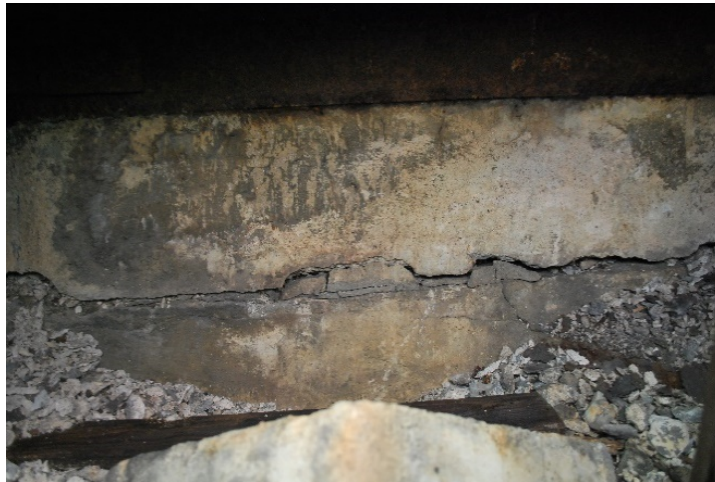
Overall, the concrete condition inside the four compartments is in very poor condition showing excessive cracking at the base of each compartment along with what appears to be construction joints. Fragments of concrete were also found at the base of each compartment, which are likely the result of freeze-thaw damage causing spalling as presented in **Figure 4-6**. Cracking at the base of these compartments are a concern as they may be connected to the large crack at the top of the West face. While outside the scope of this report, measures to address concrete cracking will be submitted in a separate report.

**Figure 4-6: Fragments of deteriorated concrete and cracking along construction joint inside compartment on top face (second from South end) of Counterweight.**

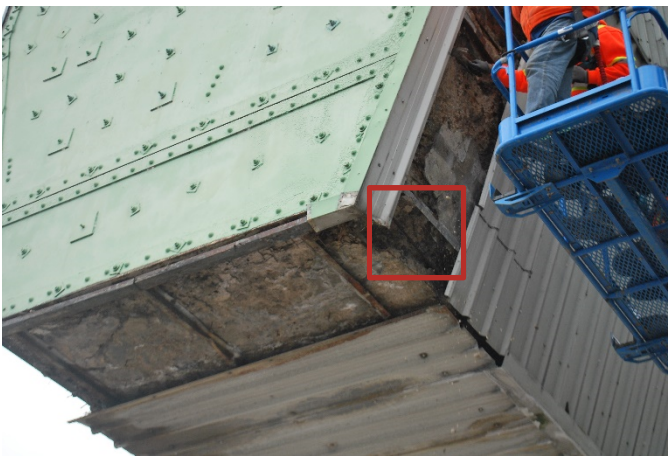
**Figure 4-7: Bottom South East corner of East face showing cracking and areas of spalling. South end of bottom face also shown.**

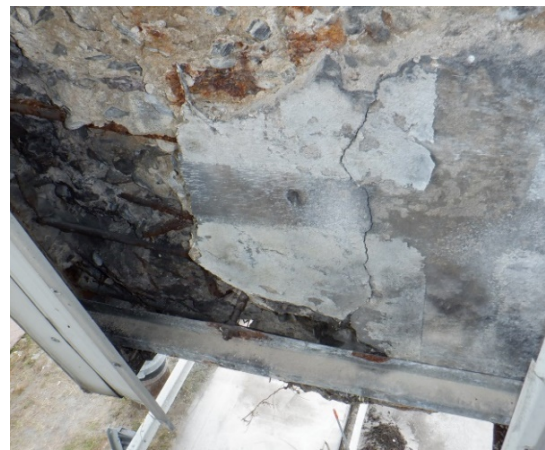
**Figure 4-8: Zone indicated by red box in Figure 4-7 (Bottom South East corner of East face).**

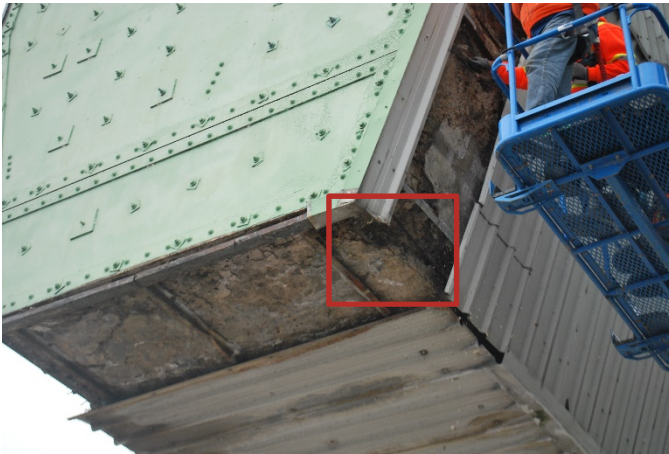
**Figure 4-9: Concrete section loss and exposed reinforcing steel showing generalized corrosion of South end of bottom face.**

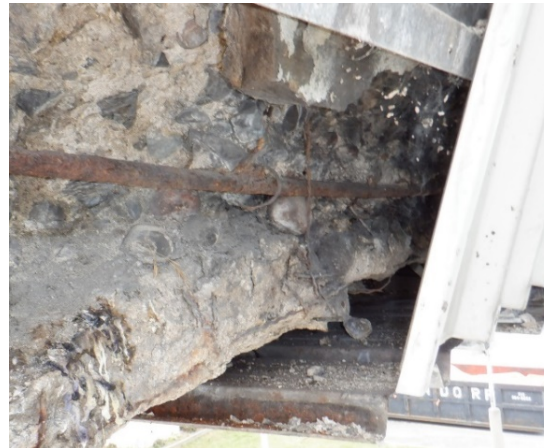
**Figure 4-10: Zone indicated by red box in Figure 4-9 (South East corner of bottom South face).**

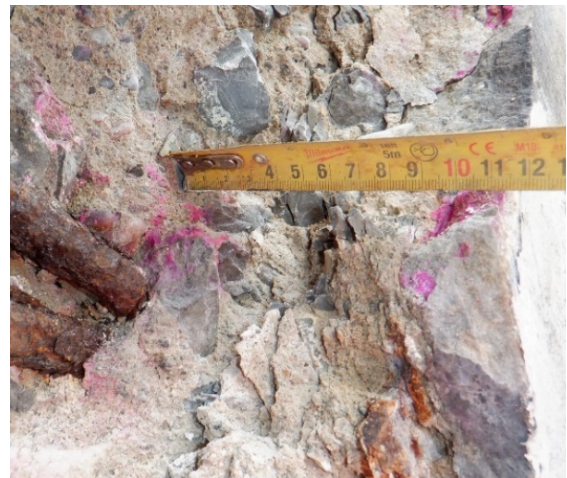
**Figure 4-12: Zone indicated by red box in Figure 4-11 (North East bottom corner of East face).**

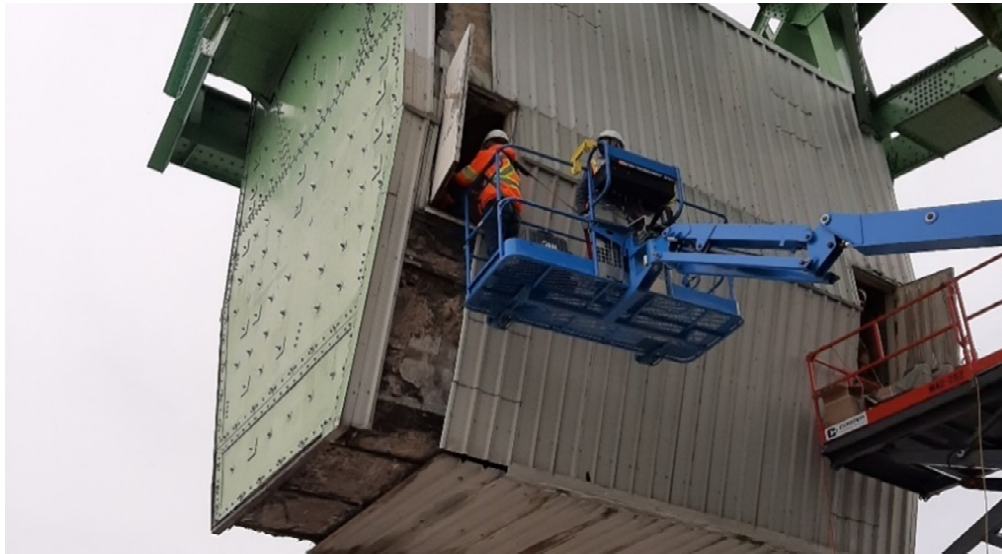
Similar to the top face, the East face has two compartments, with steel doors as shown in **Figure 4-13** and **Figure 4-14**. Overall, the steel doors are in poor condition and were difficult to open and close. Concrete inside each compartment found on the East face is also in poor condition showing map cracking and efflorescence on the ceiling of each compartment and areas of surface scaling on the walls. In an attempt to determine the performance of sound concrete, not directly exposed to cyclic freezing and thawing, cores C3 and C4 were removed from inside of the right compartment.

**Figure 4-13: Workers inspecting South compartment on East face**

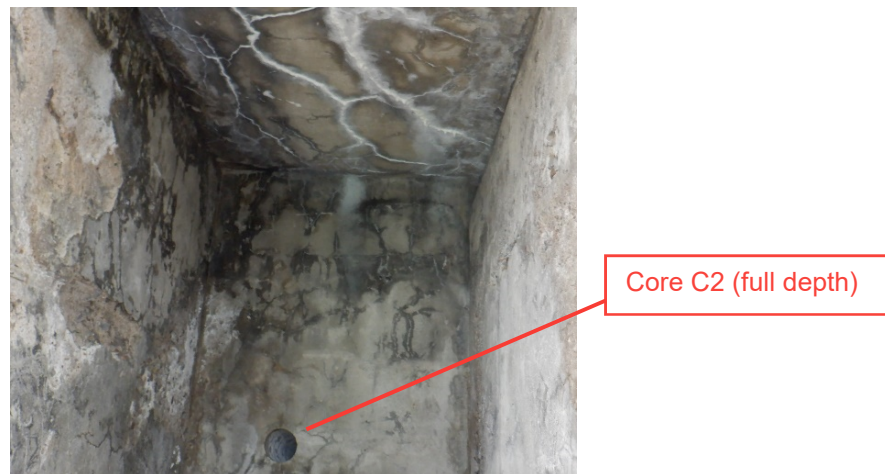
**Figure 4-14: Ceiling of South compartment showing severe signs of map cracking and efflorescence. Full depth (core hole C2) shown.**

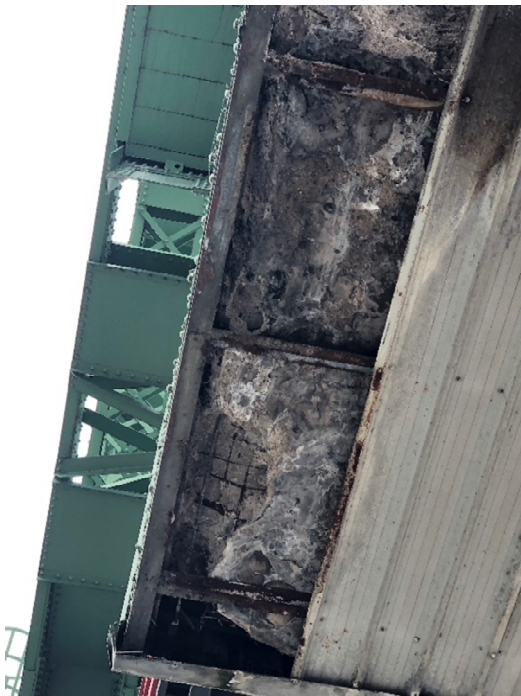
**Figure 4-16: Condition of underside of counterweight. North end shown**

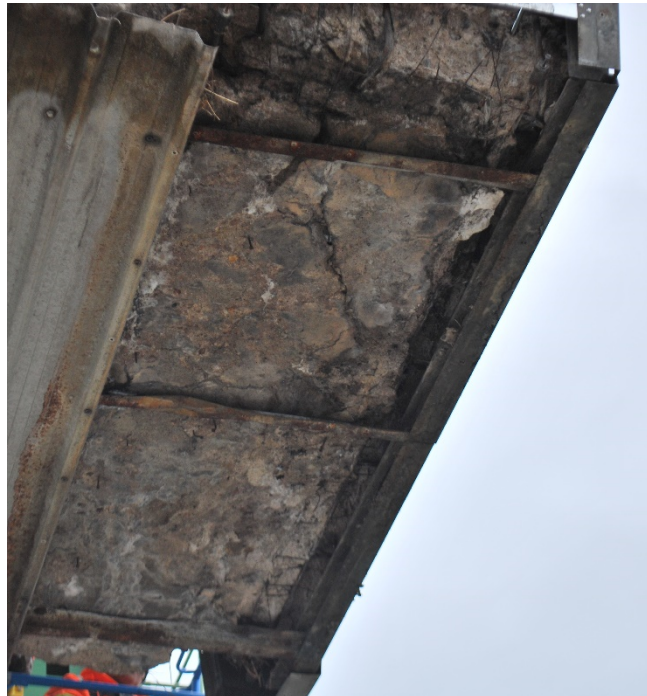
**Figure 4-17: Condition of underside of counterweight. South end shown.**

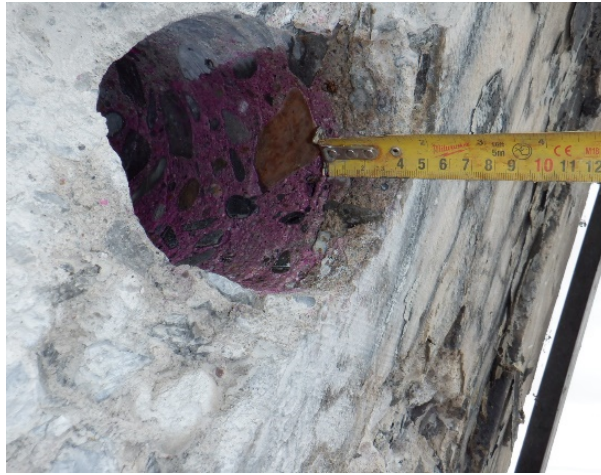
was mounted to sound concrete, it can be assumed that the carbonation depth on the West face is in the range of 90 mm – 115 mm. Based on original drawings and steel reinforcements penetrated during coring, the carbonation depth has reached reinforcing mesh and a layer of reinforcement at cover depths of 50 mm and 55 mm, respectively.

**Figure 4-18: Carbonation depth at core location C2**

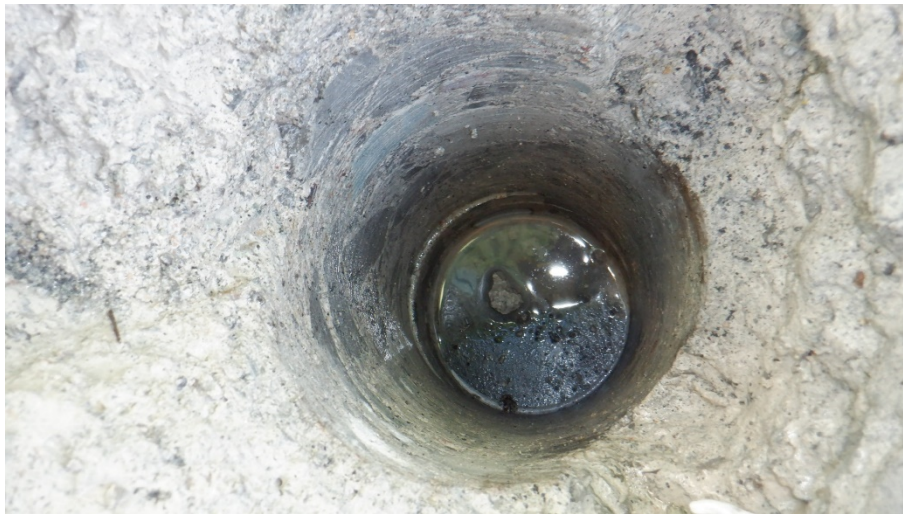
The condition of the Counterweight steel truss was assessed through limited removals and the available access holes from the top of the Counterweight. It was noted upon removing the cladding that a black coating resembling roof tar had previously been placed on the concrete face, presumably to act as waterproofing. Core holes (cores C6 and C7) to allow inspection on the North East and South East corners of the top of the counterweight concrete were drilled, revealing two horizontal gusset plates approximately 300 mm deep, as illustrated in **Figure 4-19**. The embedded steel plates showed very little deterioration. It is inferred given the condition of the plates that the steel further into the Counterweight would likely also be in good condition, as the potential infiltration of water should be less severe with depth.

**Figure 4-19: Counterweight truss steel plate exposed. Core hole C7 shown.**

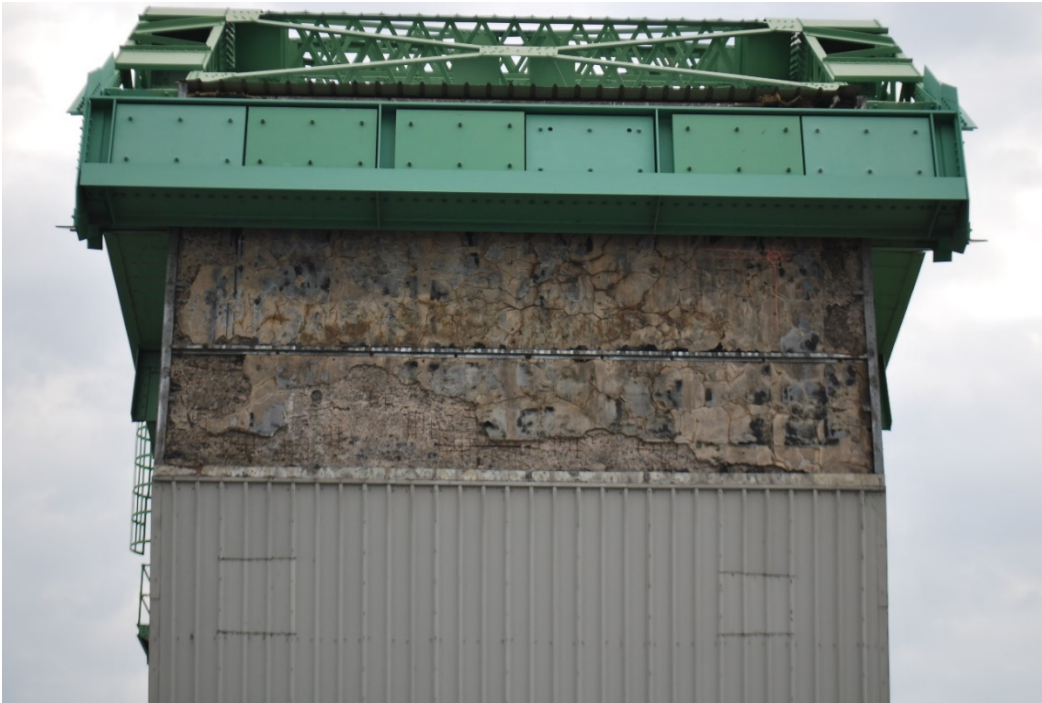
Figure A1 – Steel cladding removed from top half of West face. Underlying concrete showing areas of spalling, and map cracking.

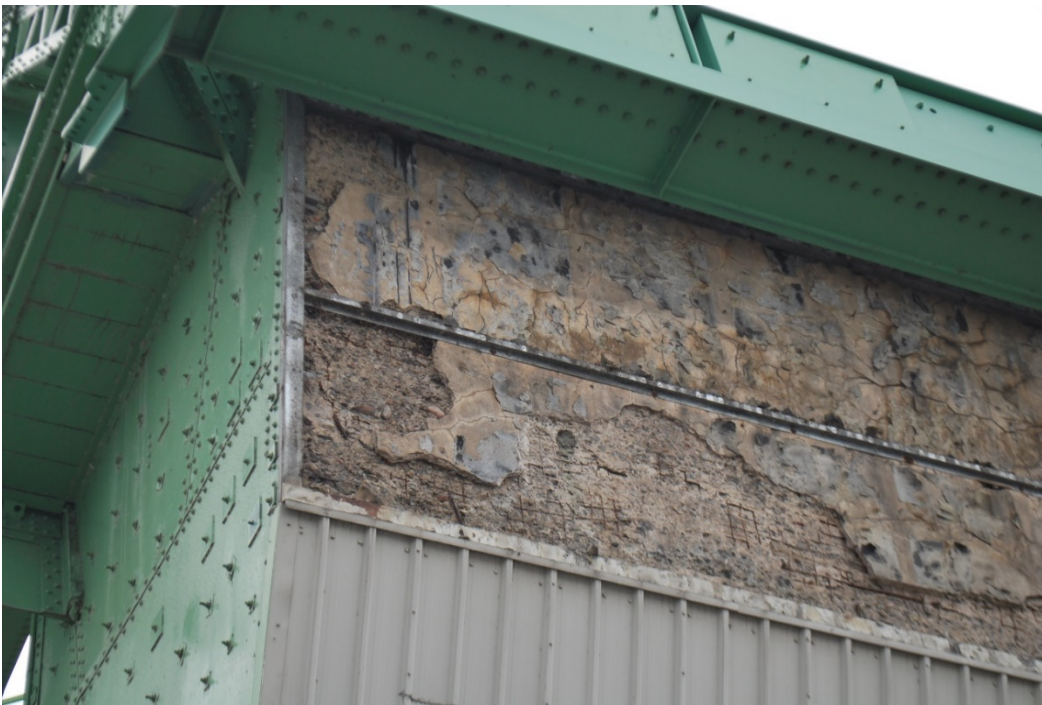
Figure A2 – Delamination, surface cracking and exposed reinforcing mesh. Concrete was originally designed with a concrete cover depth of 50mm over the reinforcing mesh.

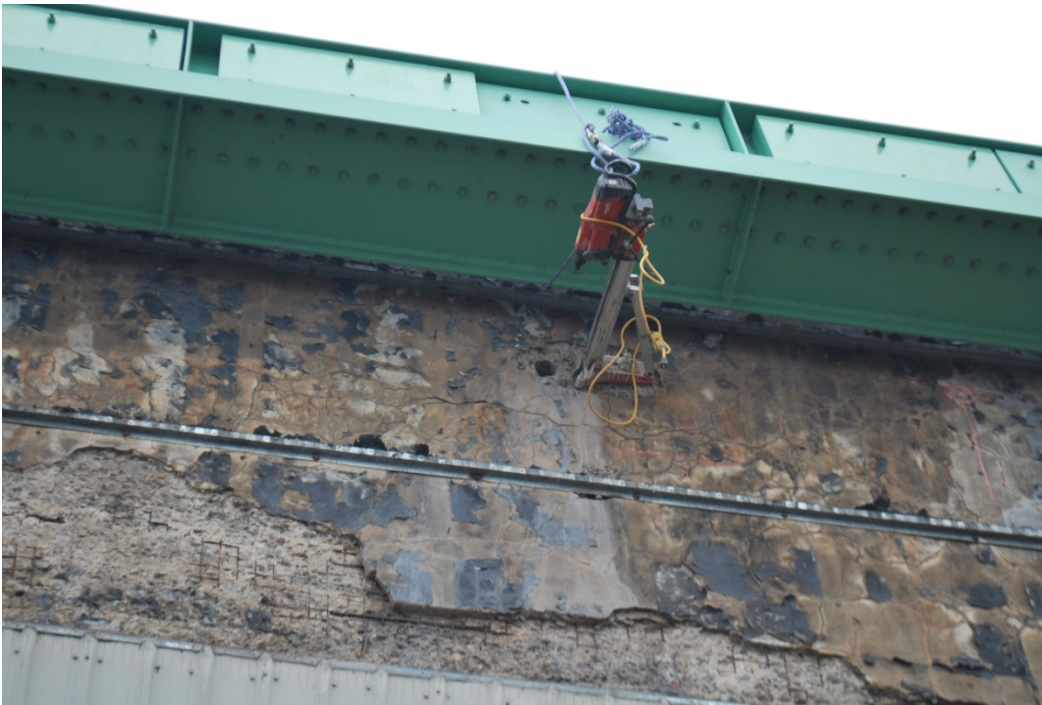
**Figure A5 – Concrete coring at location C1. Area surrounding core location shows original yet delaminated concrete. Exposed reinforcing mesh and spalled concrete is present.**

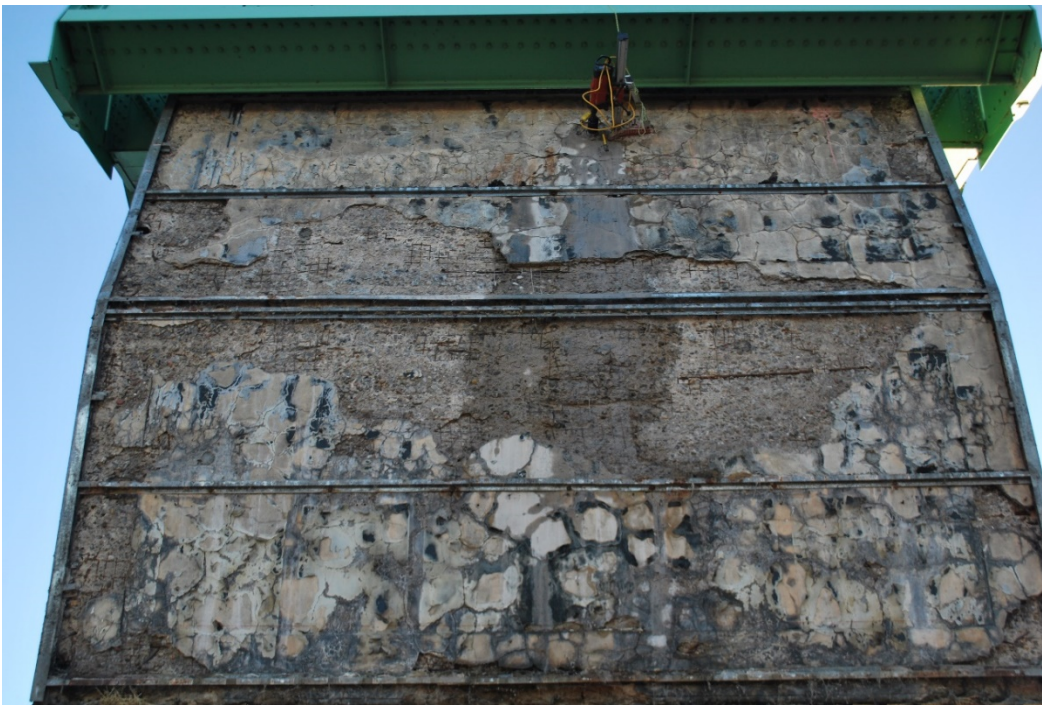
**Figure A6 – Steel cladding removed from entirety of West face. Spalling and exposed reinforcing mesh in center portion of the face in addition to areas of delamination and cracking at top and bottom areas.**

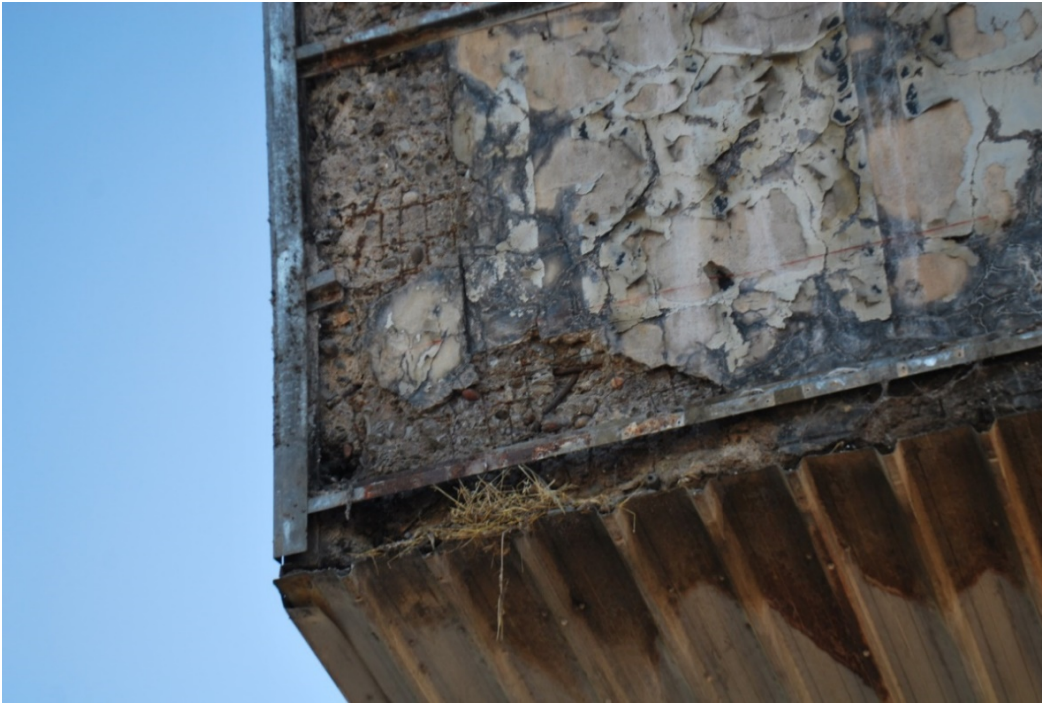
Figure A7 – North West bottom corner of West face showing concrete loss, spalling, exposed reinforcing steel and surface cracking. Corrosion observed along angle iron embedded in concrete.

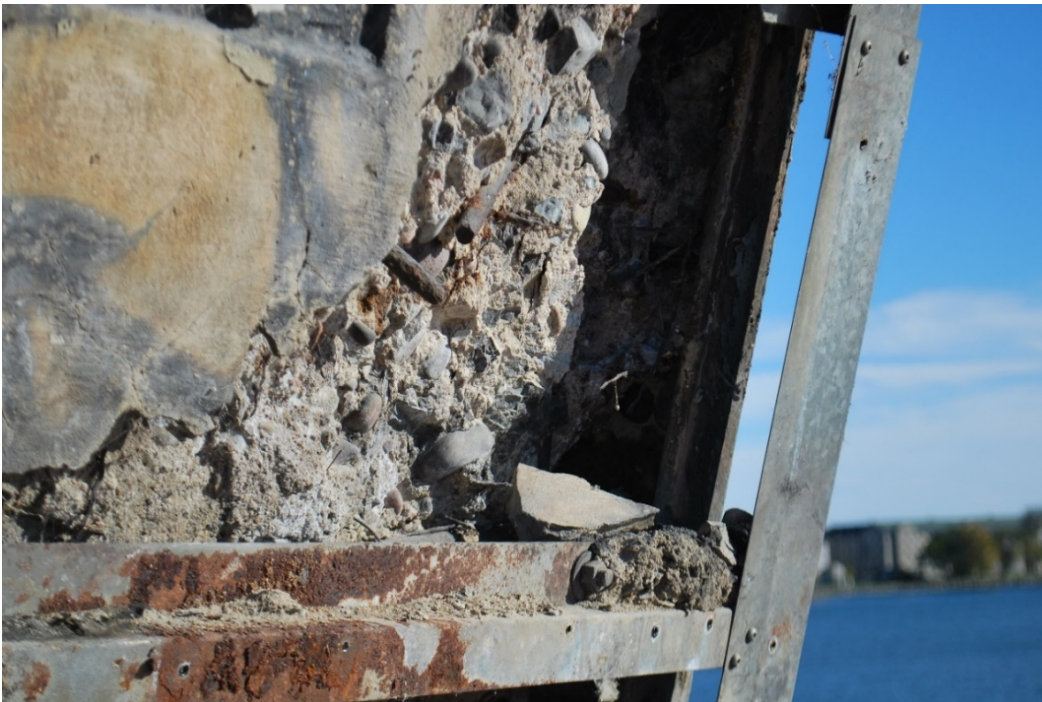
Figure A8 – South West bottom corner of West face showing concrete loss, spalling, exposed reinforcing steel and surface cracking. Corrosion observed along angle iron embedded in concrete.

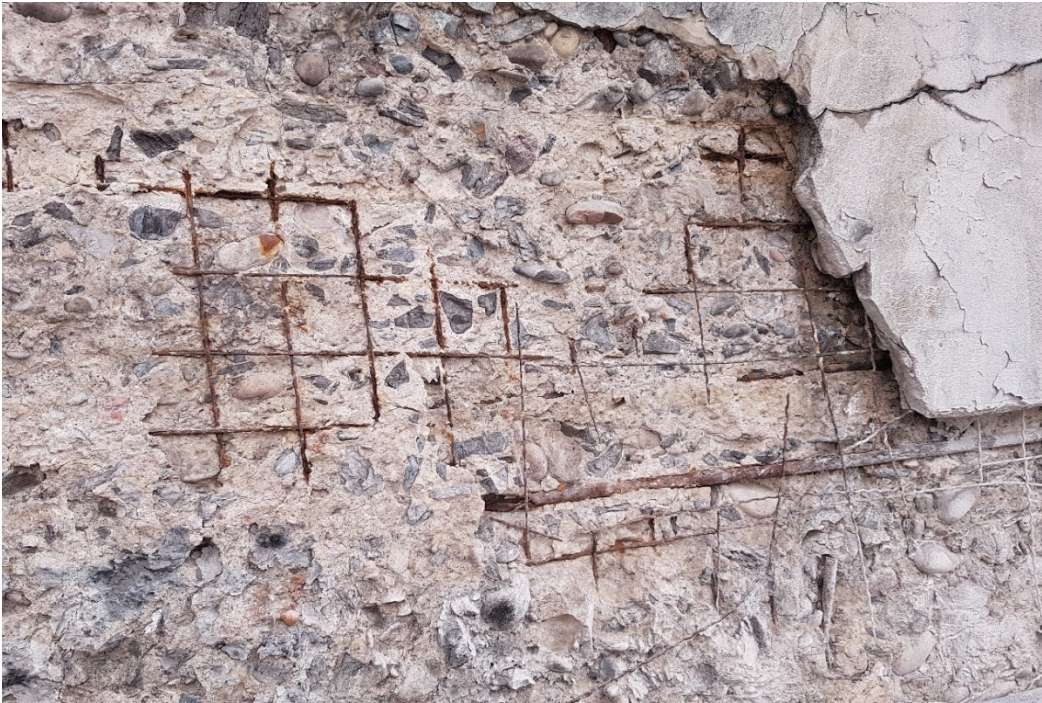
Figure A11 - Concrete condition in center portion of West face showing surface delamination, exposed reinforcing steel and steel mesh.

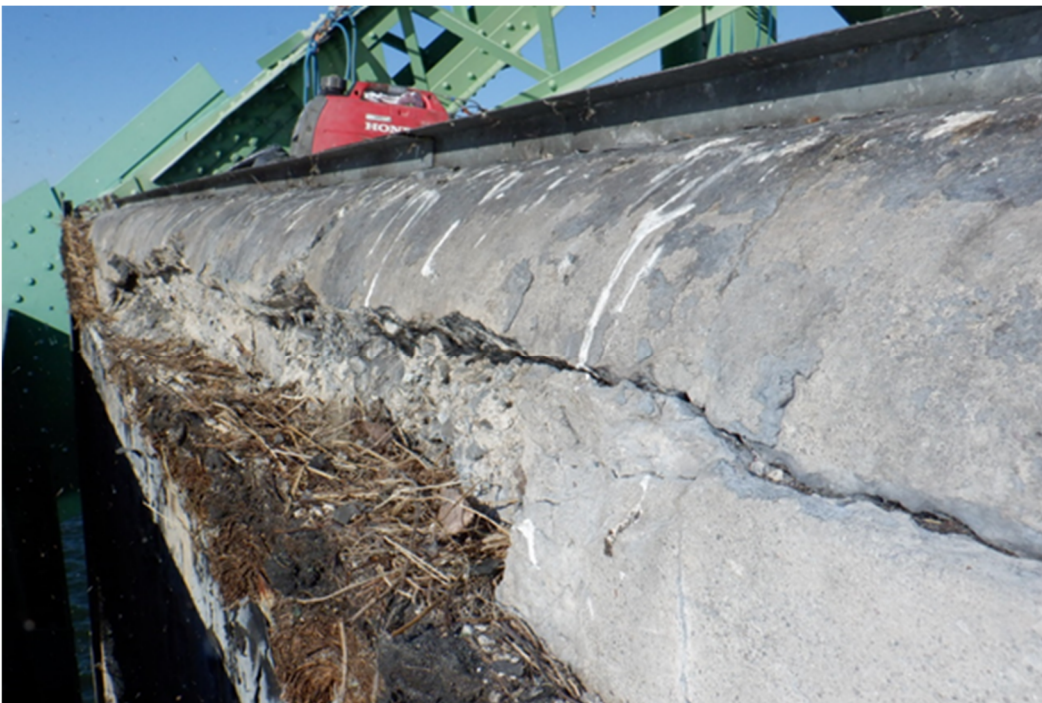
Figure A12 – Top edge of West face. Crack, 25 mm – 50 mm in width running entire top edge of West face. Debris shown is assumed to be from birds nesting.

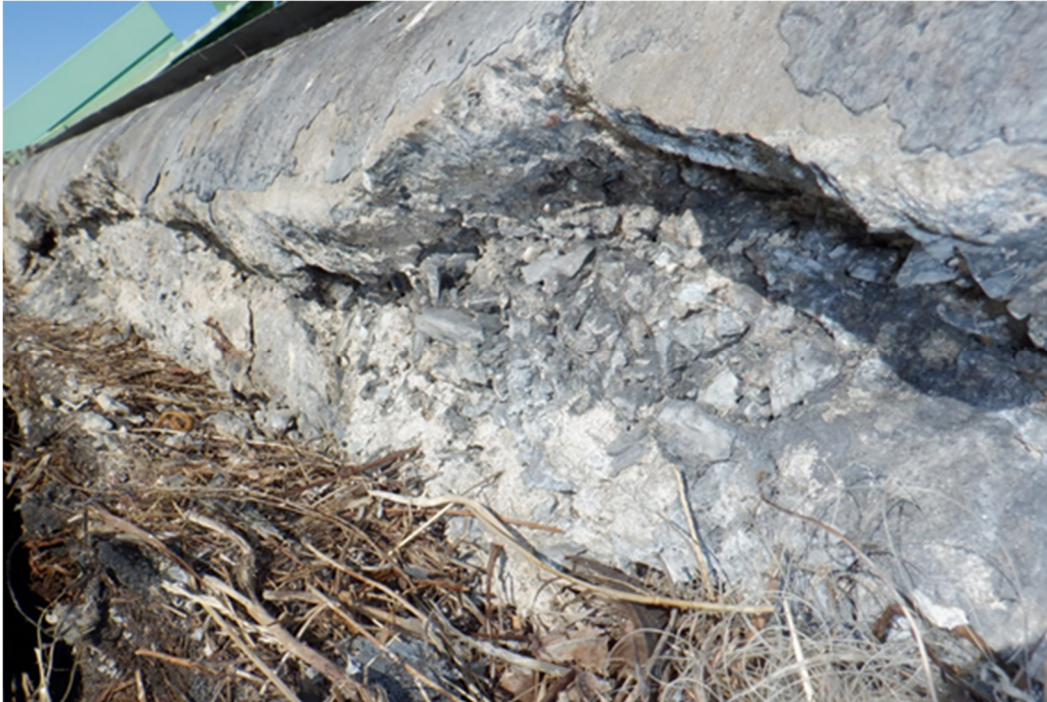
Figure A13 – Spalling at concrete found at the top of the West face (same location as in Figure A.12). Feather shown indicates debris is from birds nesting.

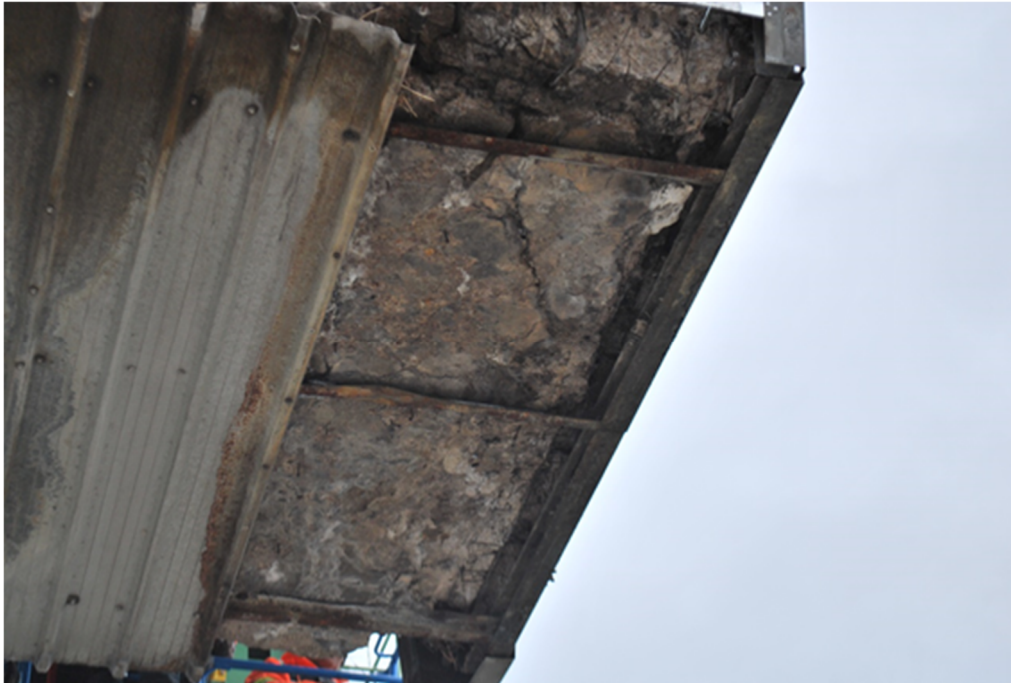
Figure A15 – Condition of concrete on South end of bottom face. Localized areas of cracking, delamination and spalling. Angle iron embedded in concrete is in poor condition showing generalized corrosion.

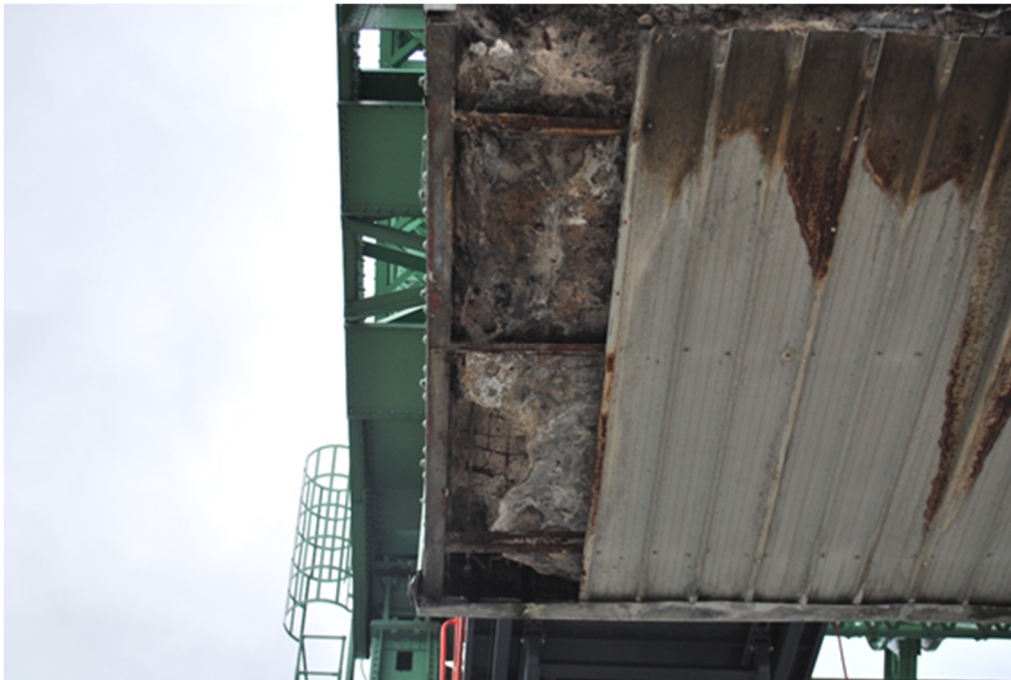
Figure A16 – Condition of concrete on North end of bottom face. Localized area of cracking, delamination and spalling. Surface staining is observed on remaining steel cladding.

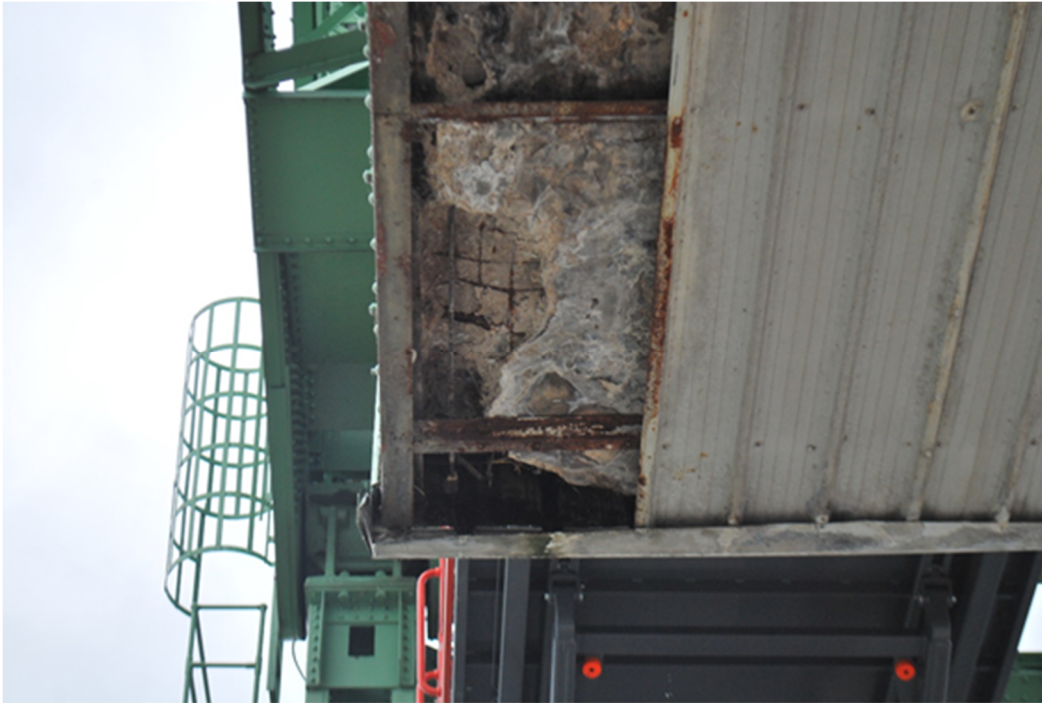
Figure A17 – Test pit taken from North East corner of bottom face. Underlying steel reinforcement showing severe signs of corrosion.

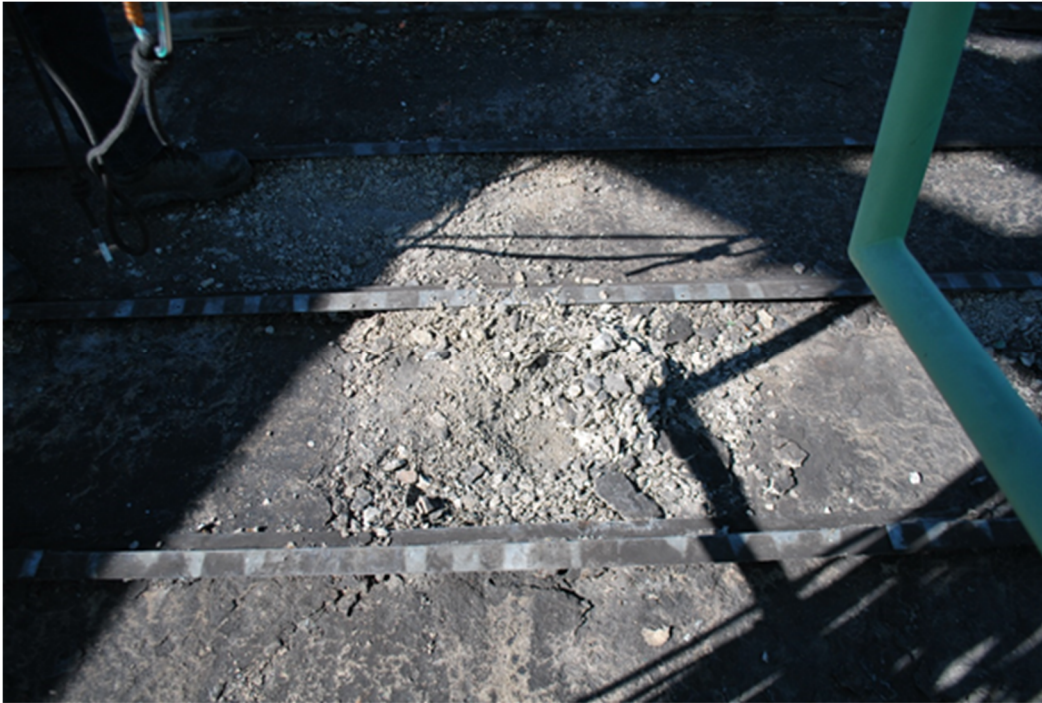
Figure A19 – Surface scaling on the top face (concrete fragments 10-50mm in diameter).

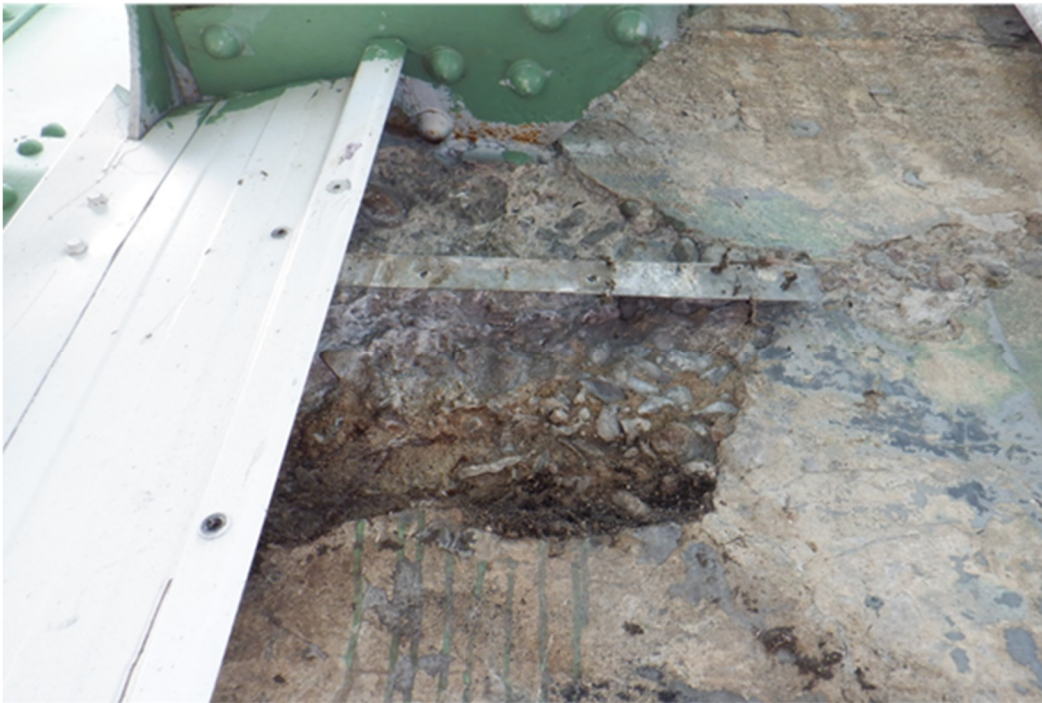
Figure A23 – Surface spalling on South end of East face

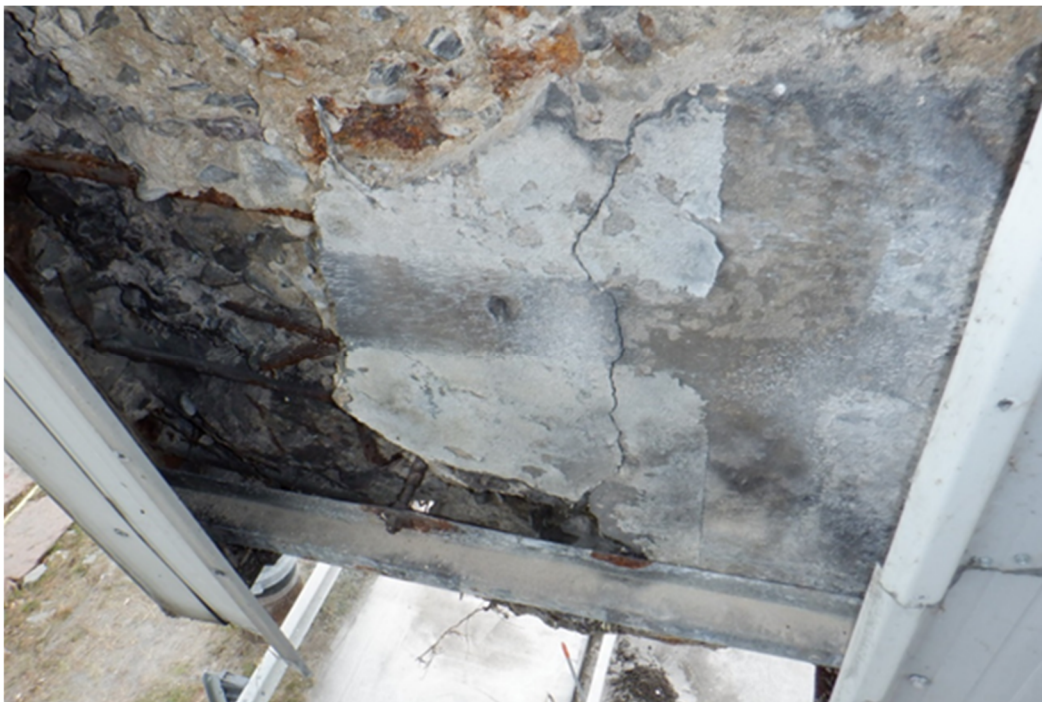
Figure A24 – Bottom left hand corner of East face showing signs of spalling, cracking, exposed reinforcement and areas of corrosion.

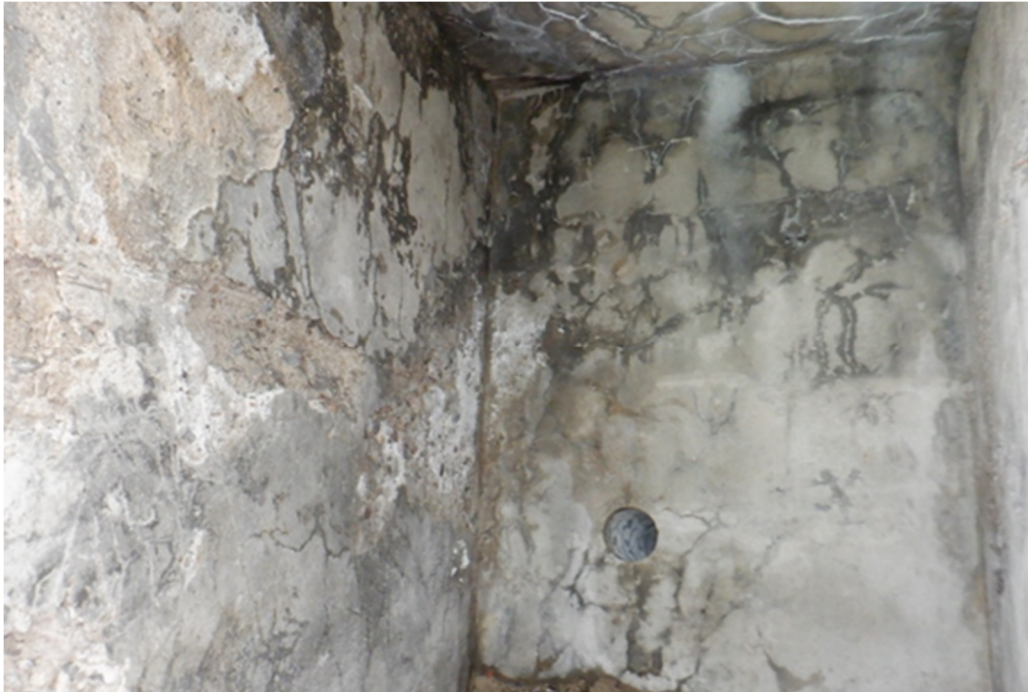
**Figure A25 – Condition of concrete inside South compartment on East face. Excessive map cracking on the ceiling of compartment resulting in efflorescence. Core hole is that of C2 taken from the West face which protruded the entire thickness of the counterweight.**

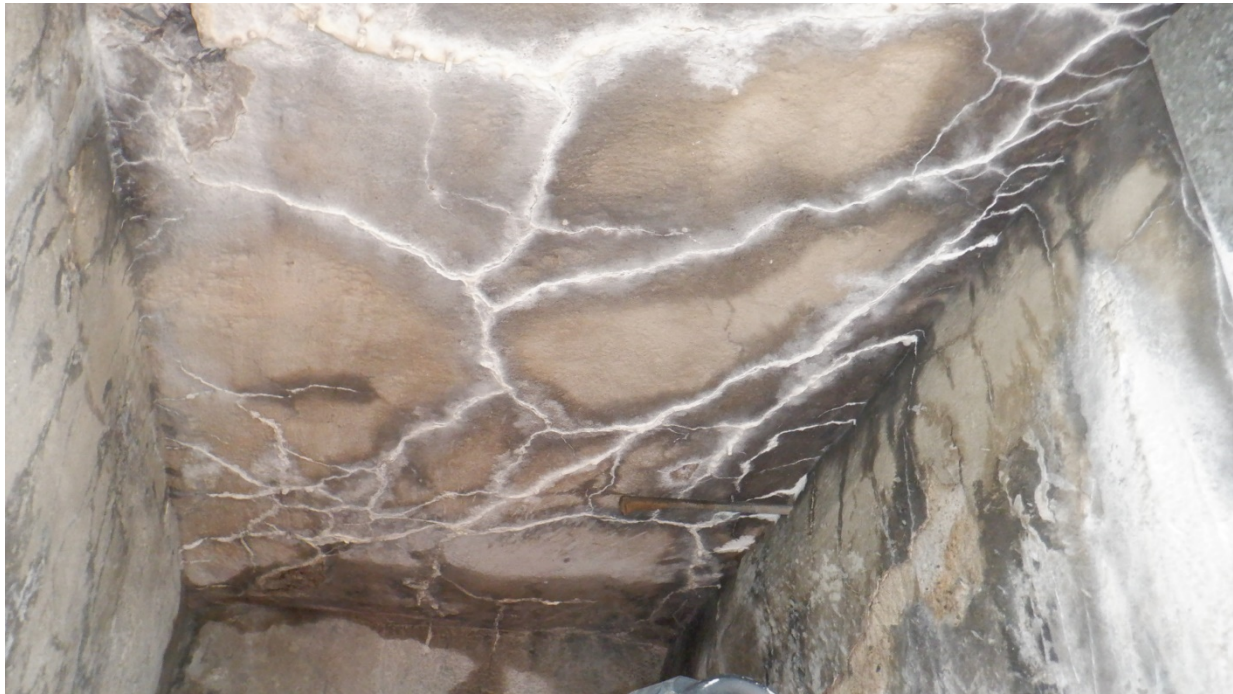
**Figure A26 – Condition of concrete inside North compartment on East face. Excessive map cracking on the ceiling of compartment resulting in efflorescence.**

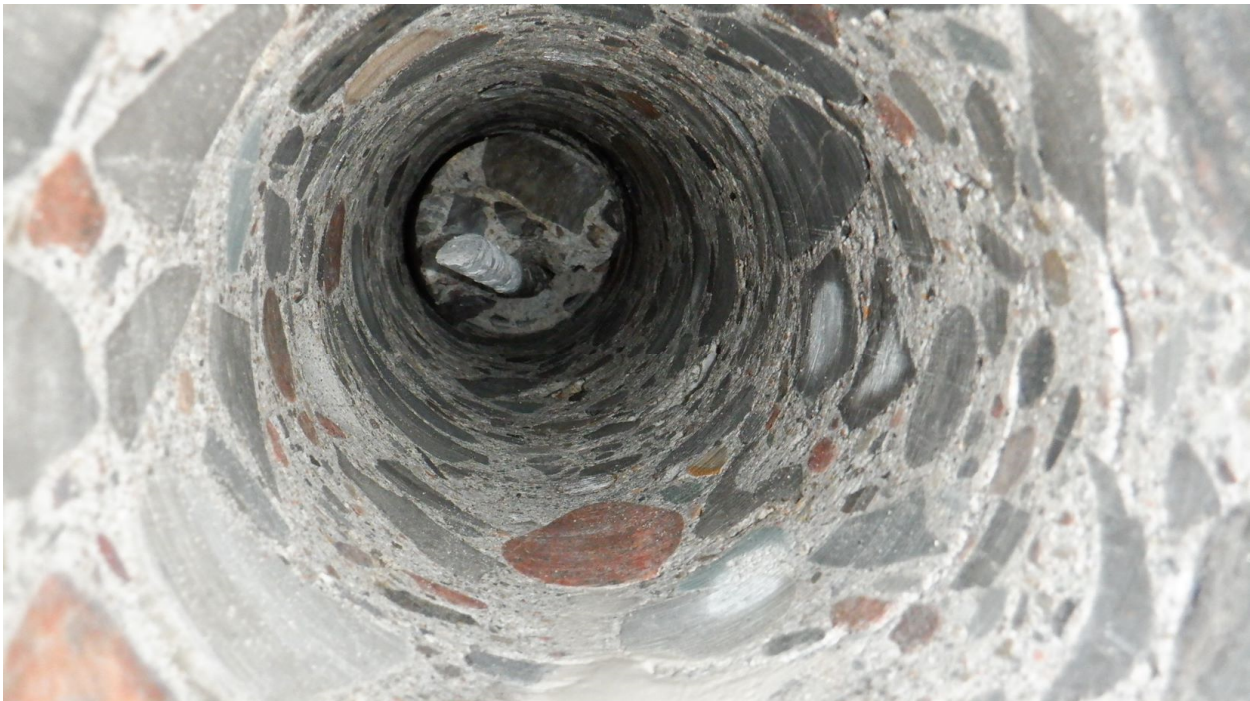
Figure A28 – Core holes C3. Cracking observed along core hole to depths of approximately 385 mm.

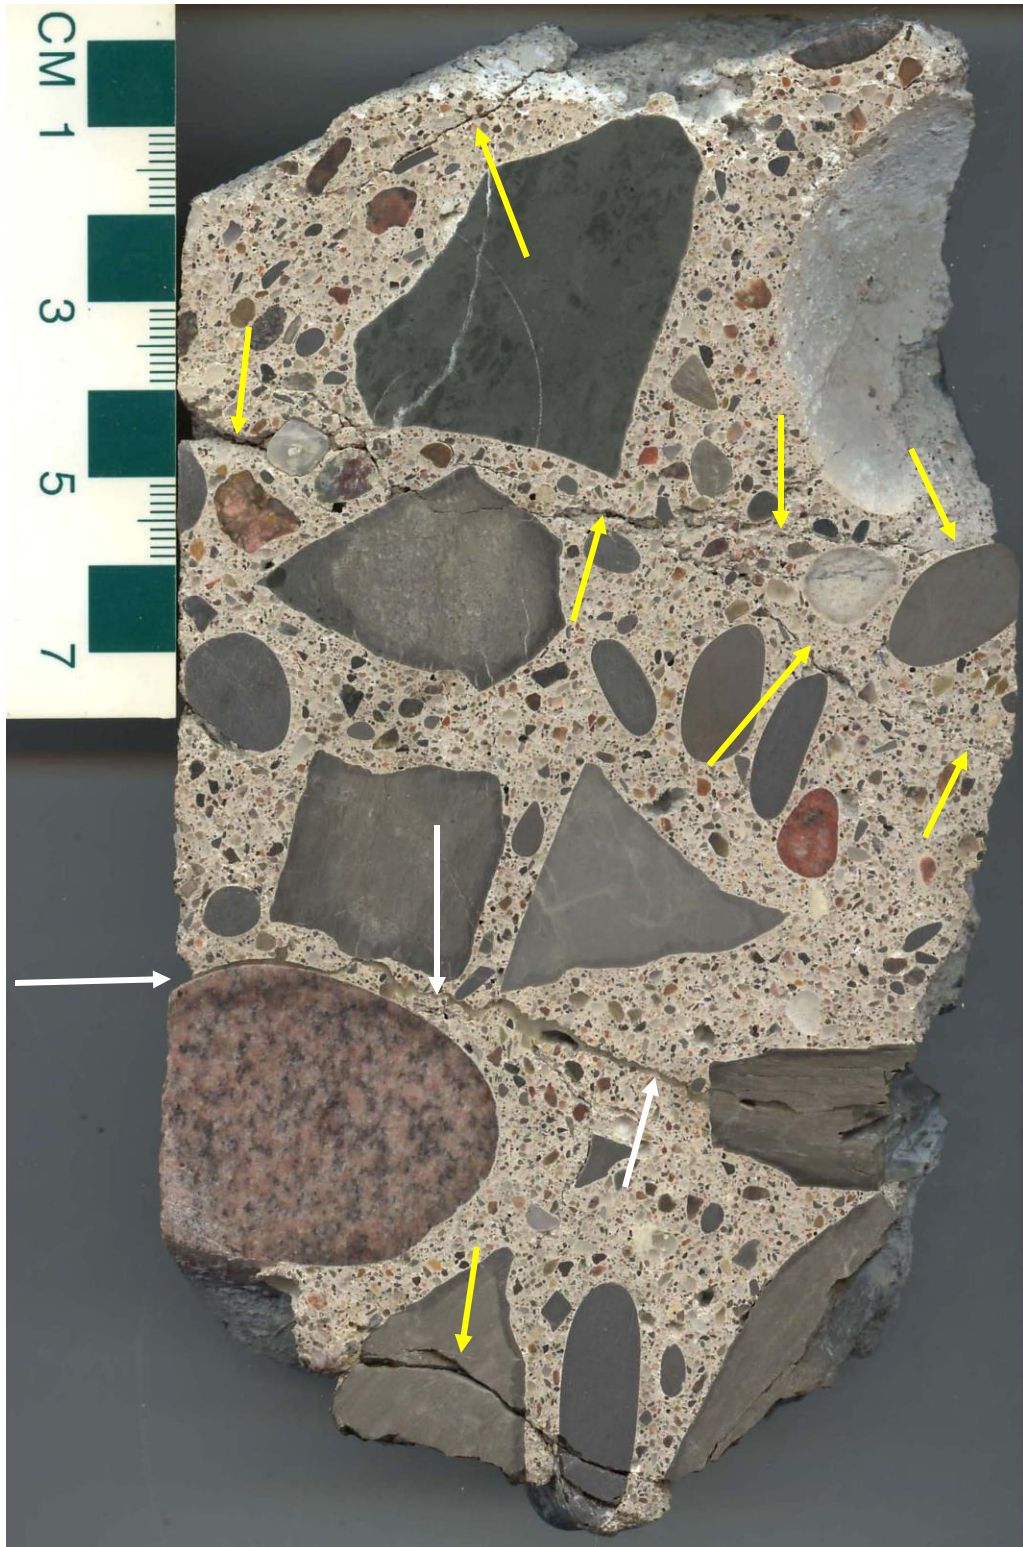
Figure 2: Core 5. White arrows show location of crack that was glued with epoxy during sample preparation. Yellow arrows indicate other significant cracks.
