Subject: LaSalle Causeway Counterweight Memorandum (DRAFT)

The following is a Counterweight Memorandum as part of the LaSalle Causeway 2019 Comprehensive Detailed Annual Inspection (CDI) project for the LaSalle Causeway in Kingston, Ontario. The CDI was completed in accordance with Public Services and Procurement Canada (PSPC) Standing Offer EQ754-161365/001/PWL, Project Number R.090045.001.

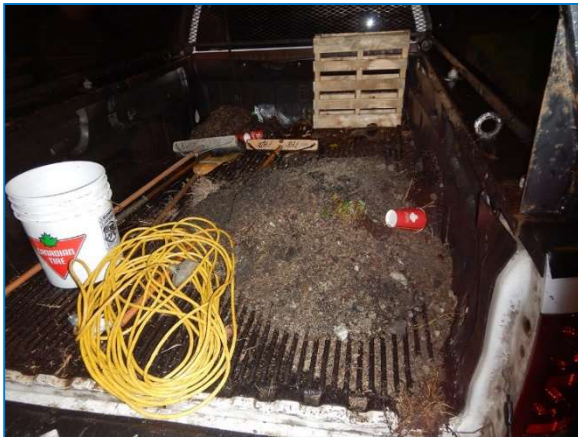
As observed during the CDI, the north east area had the most amount of debris with the remaining areas having less to slightly less debris, with all areas having some amount of debris. The north east area also had the most observed concrete section loss, with the corner area having the most loss which extended up approximately 300 mm. The debris appeared to consist of disintegrated concrete, aggregate, and possibly some organics as evidenced by blackish soil looking material. The organic looking material was generally located towards the south end of the counterweight on both the east and west sides. All the material was damp. A guesstimate of the weight of material removed was in the 45 to 70 kg (100 to 150 lb.) range. See Photo 1.

Photo 1 Debris - Removed

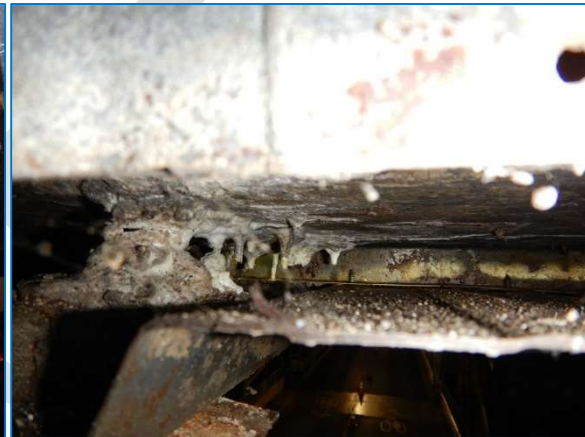
Where visible the counterweight concrete was generally in poor condition exhibiting disintegration, spalling, efflorescence with and without stalactites and stalagmites. See Photo 2. There were areas of exposed and corroding reinforcing steel and wire mesh. The reinforcing steel bars were round, not deformed, which is reflective of the vintage of the structure. See Photo 3.

Photo 2 Soffit - Efflorescence, Stalactites, Stalagmites, Typ.

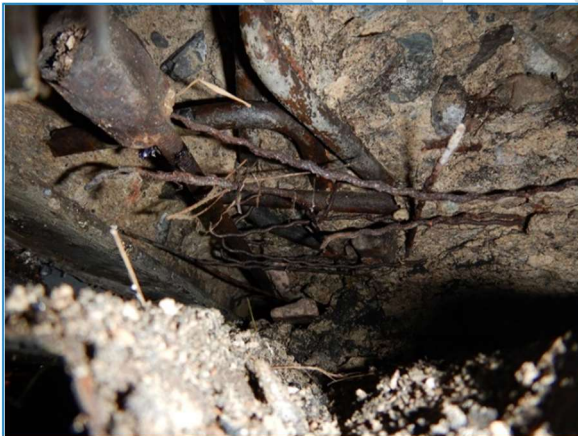
Photo 3 Soffit - South East Region

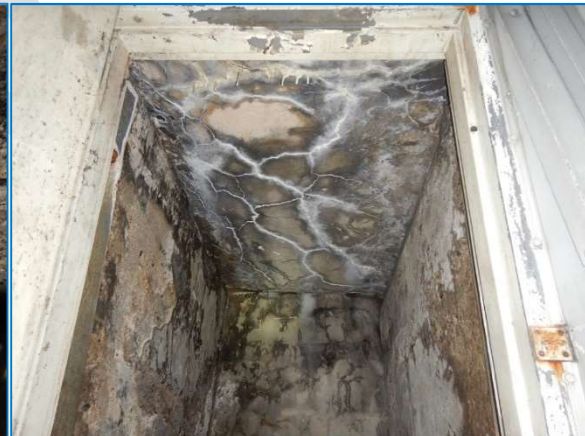
The two north east and south east facing access doors were opened to observe the interior space which was an empty chamber. The south east chamber concrete was sounded with a hammer, many areas were hollow or soft sounding, i.e. deep concrete disintegration, particularly on the south face, the soffit had pattern and alligator cracking with efflorescence and stalactites, and the floor had the best sounding concrete. See Photo 4. The north east chamber concrete was sounded with a hammer, some areas were hollow or soft sounding, i.e. deep concrete disintegration, particularly on the south face, the soffit had pattern and alligator cracking with efflorescence and stalactites, and the floor had the best sounding concrete. Overall, the concrete in the north space was in slightly better condition than the south space. Both hatch doors needed to be wedged into place to be closed, the hinges are loose and in poor condition.

Photo 4 Chamber - South East

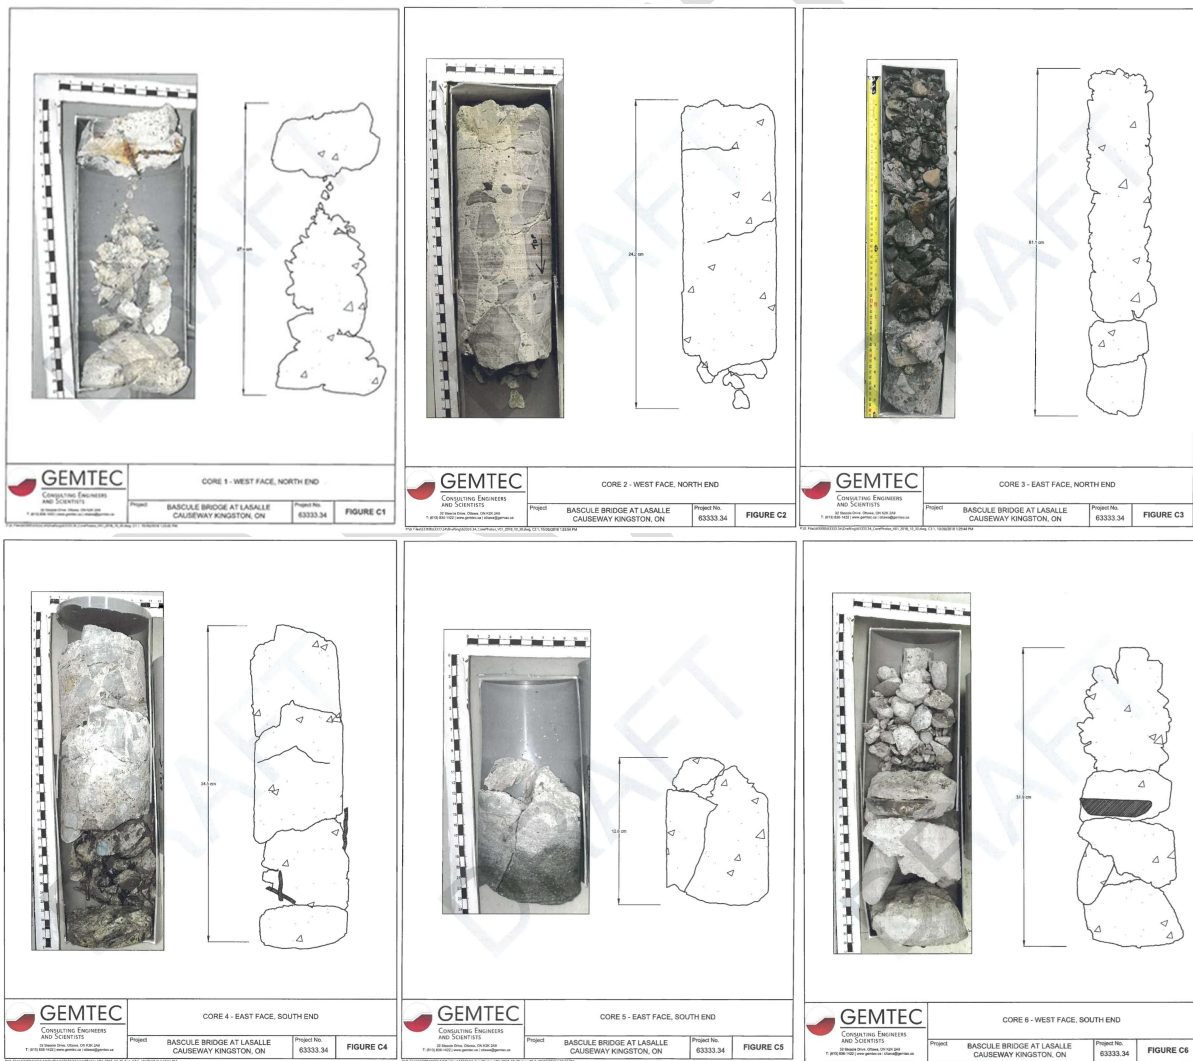
Figure 1 Cores – Core # 1 to 6 Cross Sections

A total of six 100 mm diameter cores ranging in depth from 126 mm to 611 mm were taken from the east and west faces. The average depth of the six cores was 320 mm. Due to the poor quality of the concrete in the cores extracted it was only possible to test a single core sample for compressive strength, Core #2, which was obtained from the west face, north end, top. The result indicated a compressive strength of 11.9 MPa at an approximate depth of 50 to 255 mm. Based on the MTO Structure Rehabilitation Manual, structural concrete with compressive strengths under 20 MPa is of poor quality. In general, and in relation to the core locations, the edges and particularly the lower portions of the counterweight are in poor condition, with the exception of Core #2 located in the upper region. See Figure 1.

1. **Investigation;** Build on the existing inspection and condition survey data via obtaining additional concrete deep cores to provide insights into the condition of the interior mass of the counterweight. The cores should be of relatively small diameter, in the 50 mm range, to reduce the risk of intersecting or damaging internal reinforcing steel and other structural elements. The cores should extend to approximately the centre of the counterweight if taken from the east and west faces, or full depth if taken from one face. Coring procedures should be confirmed with a provider(s) of this service as part of the investigation planning.

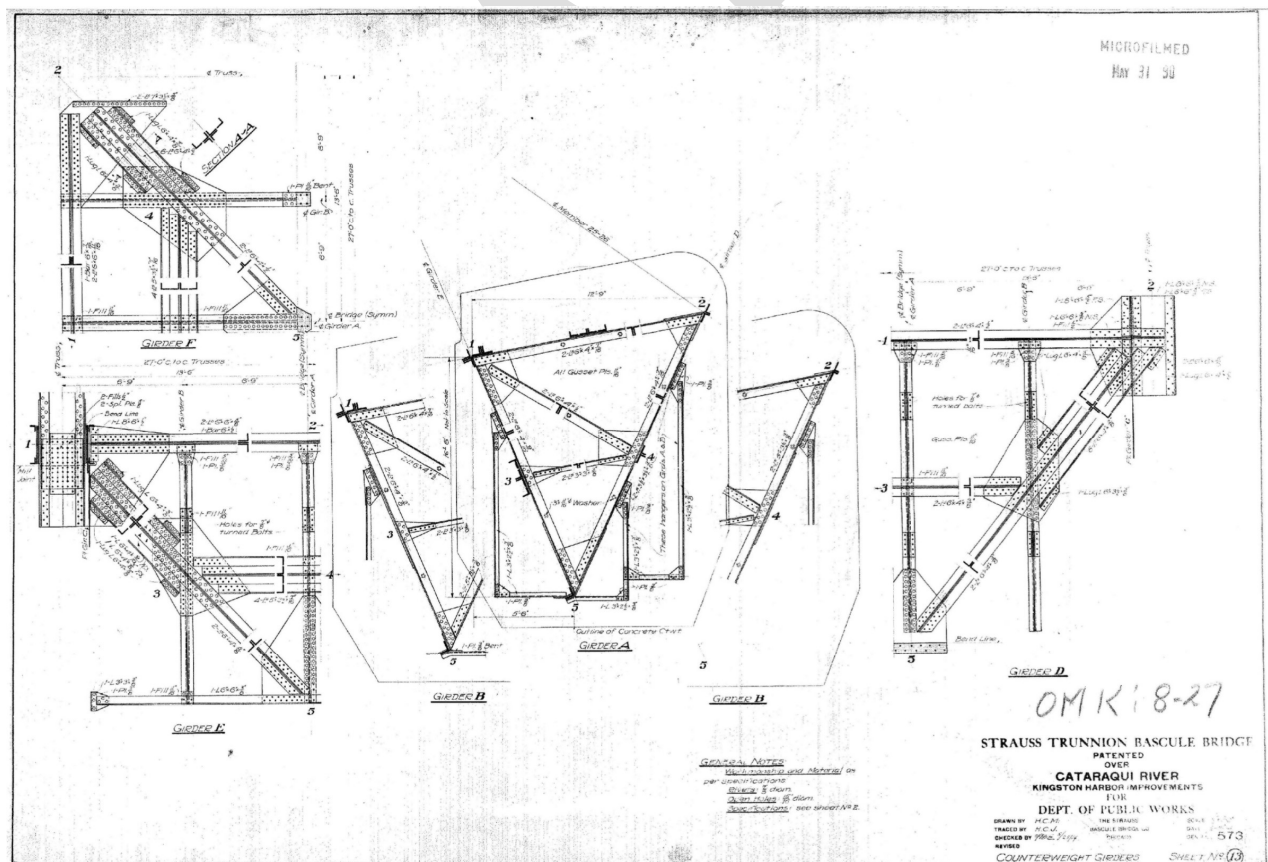
Figure 2 Counterweight Structural Steel

From available drawings it appears there are three triangular shaped steel frames spanning east west within the counterweight that provide structure and support for the concrete. The drawings are dated and may not fully reflect the current configuration of the counterweight; however, they are likely indicative of the general structure. See Figure 2.

As the three triangular shaped steel frames (Girders A and B in the original design drawings) span east west within the counterweight, it follows that the cores should be taken in an east west direction, but care needs to be taken to avoid the two inclined steel frames (Girders D and E in the original design drawings) that span north-south. There are also numerous threaded rods running north-south to be considered. A mapping exercise based on existing drawings to document the internal structure is recommended to aid in determining suitable core locations.
