LaSalle Causeway Bascule Bridge 2018 Comprehensive Detailed Inspection Report

Project Number: R. 090045.001

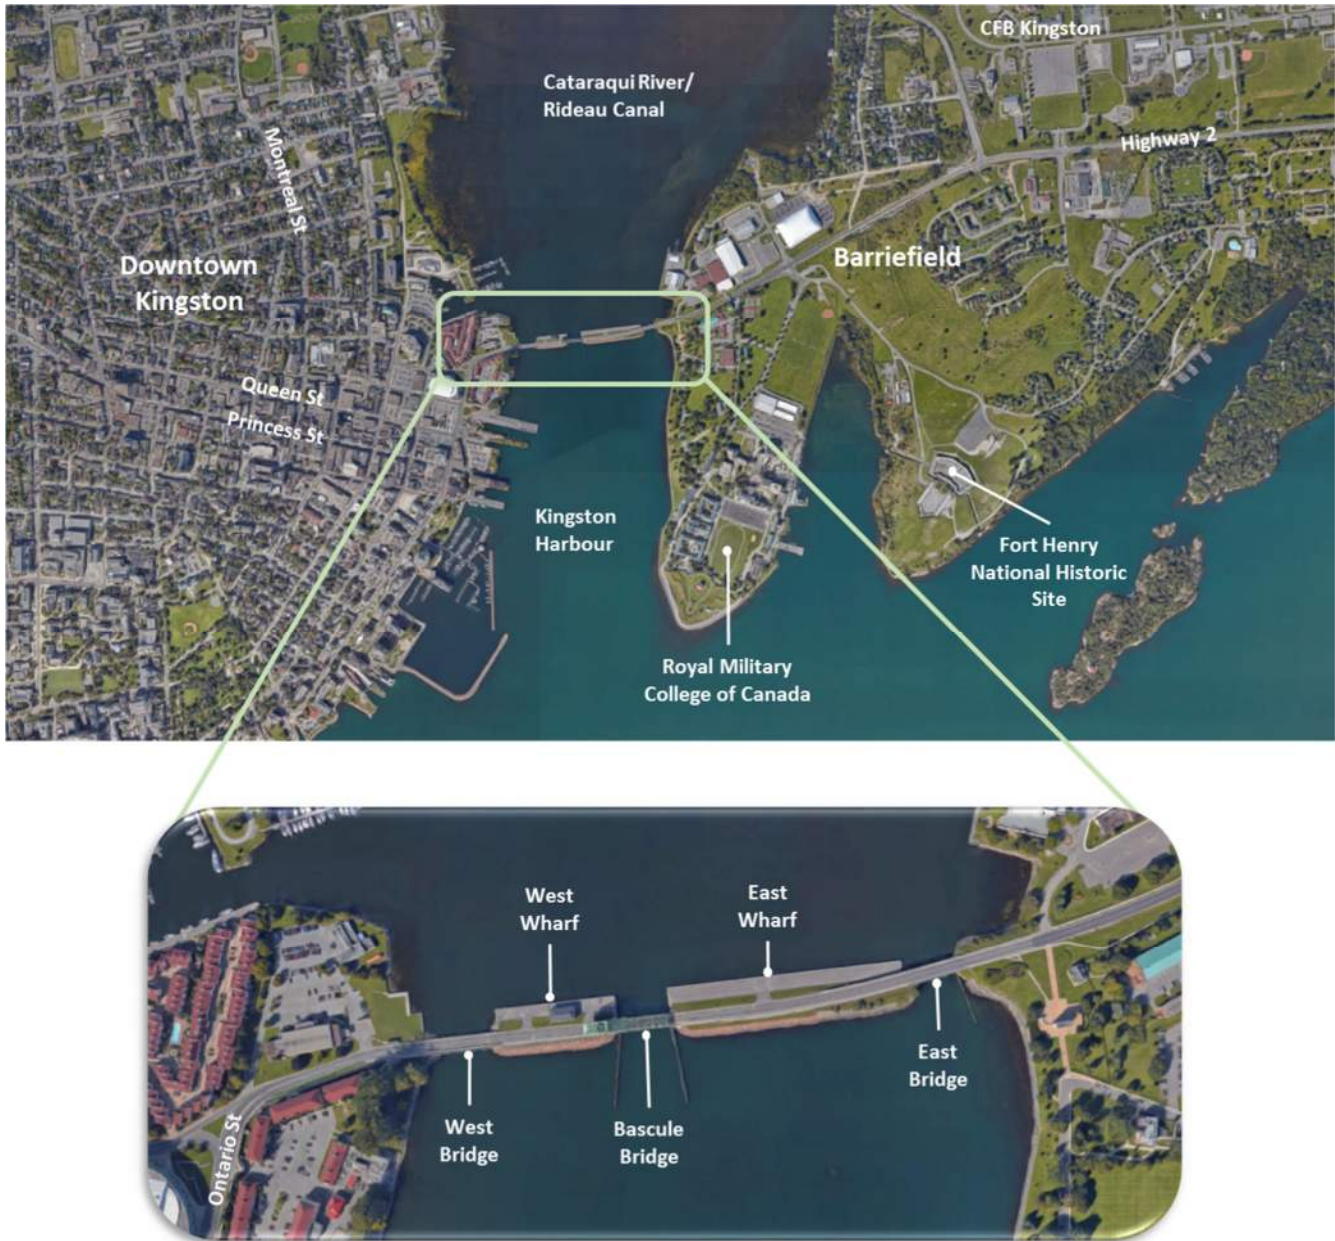
Figure 1: Key Plan (from Google Maps)

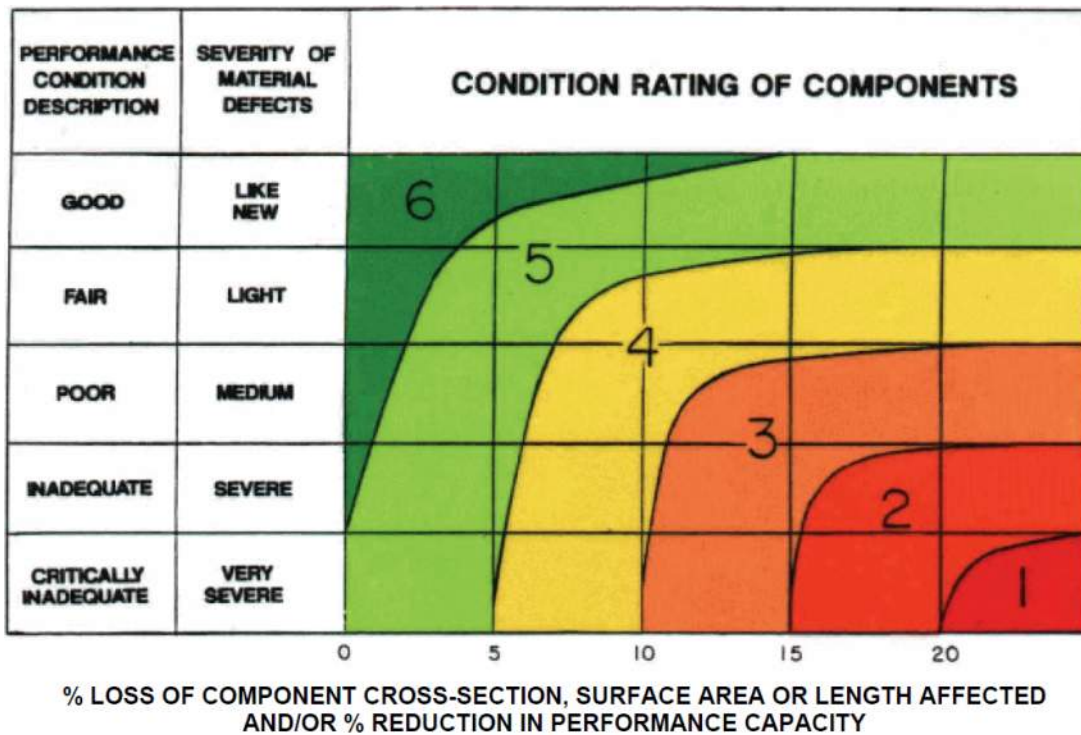
Figure 5: Figure 2.2 of the BIM - Condition Rating of Primary Components

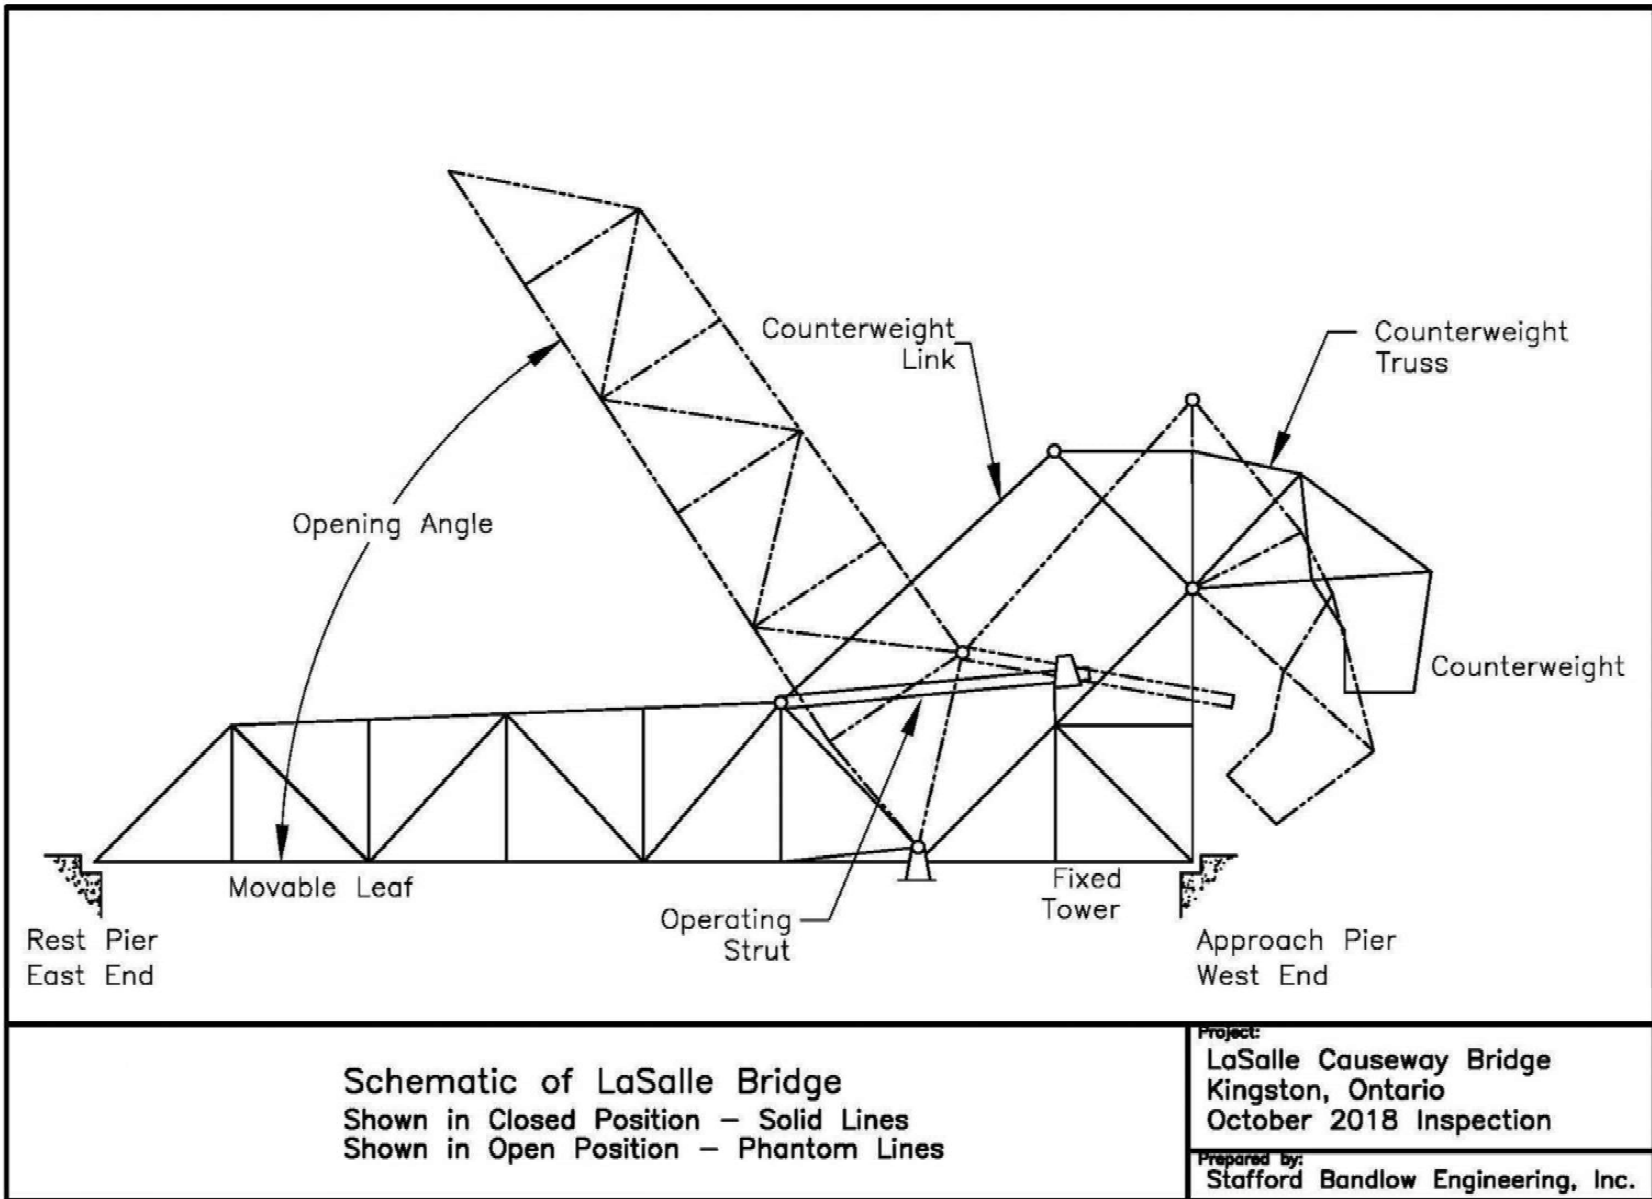
Figure 6: Schematic of Bascule Bridge

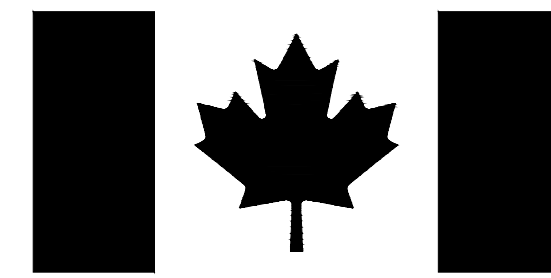
Public Services and
Procurement Canada

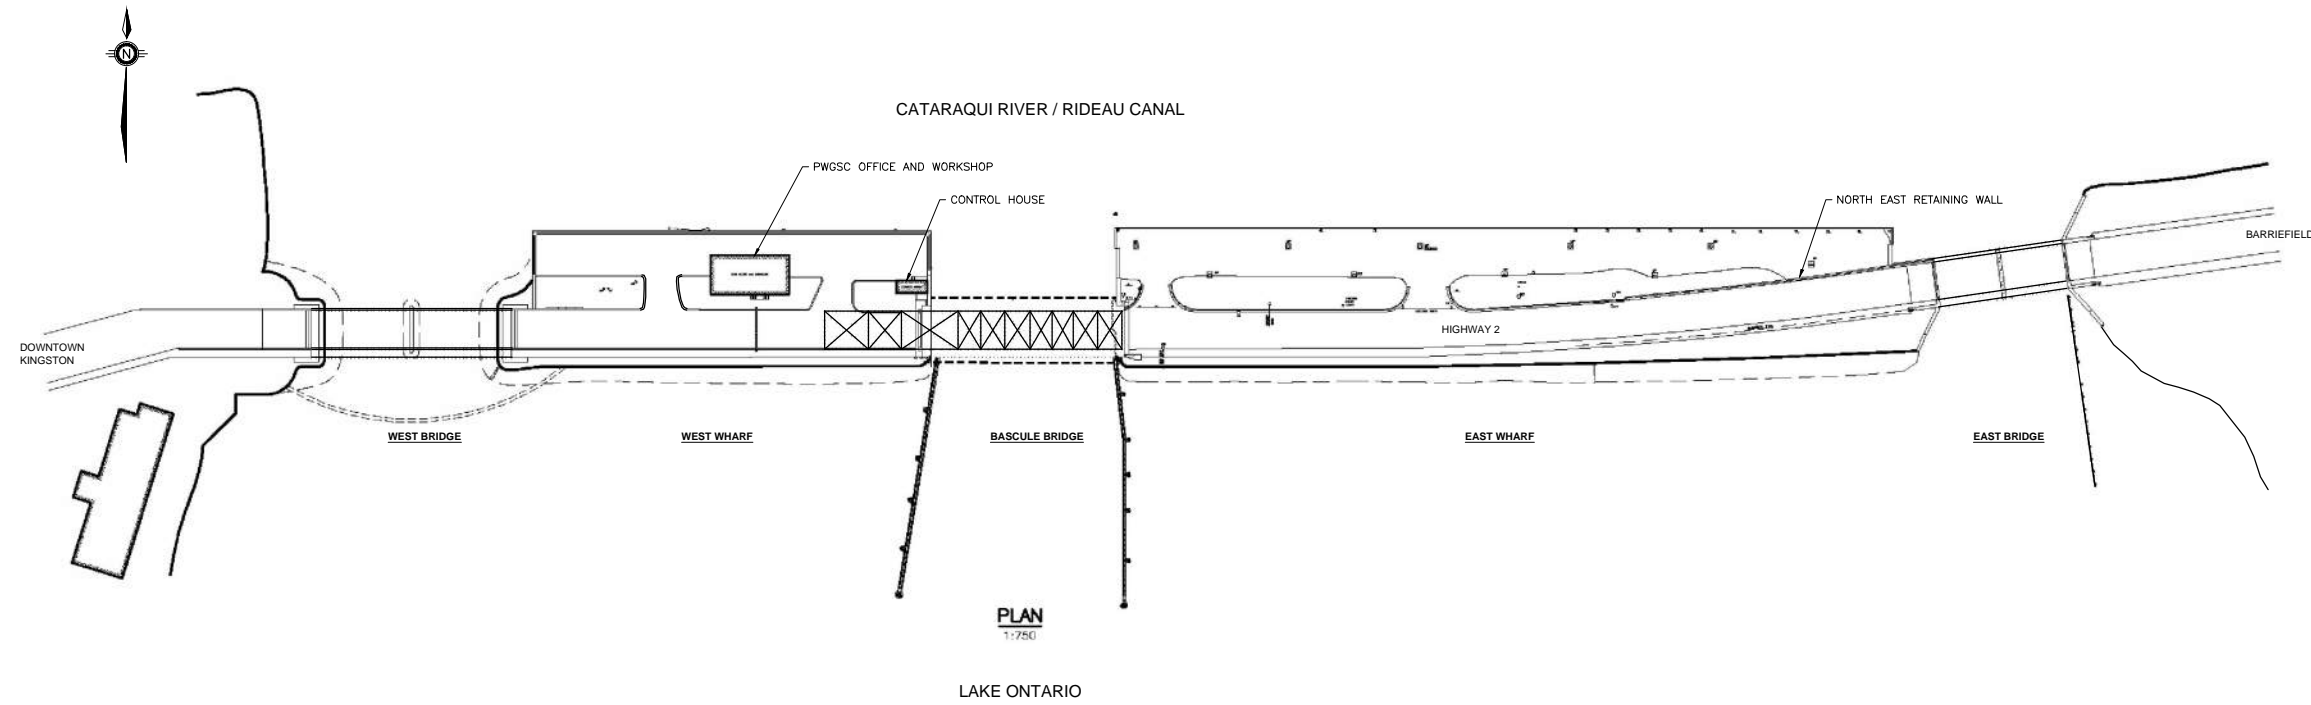
revision	description	date

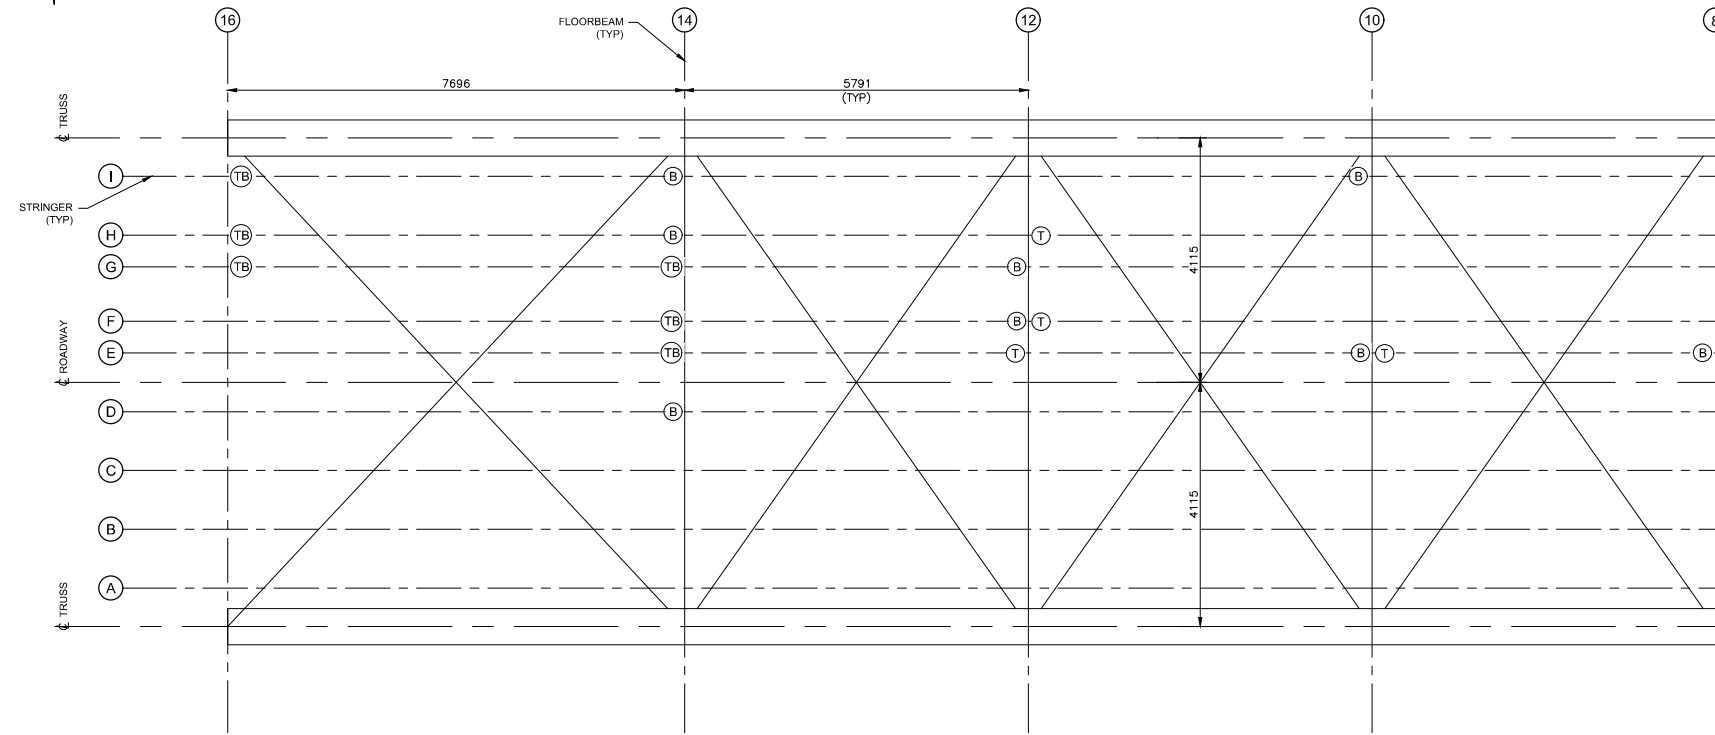
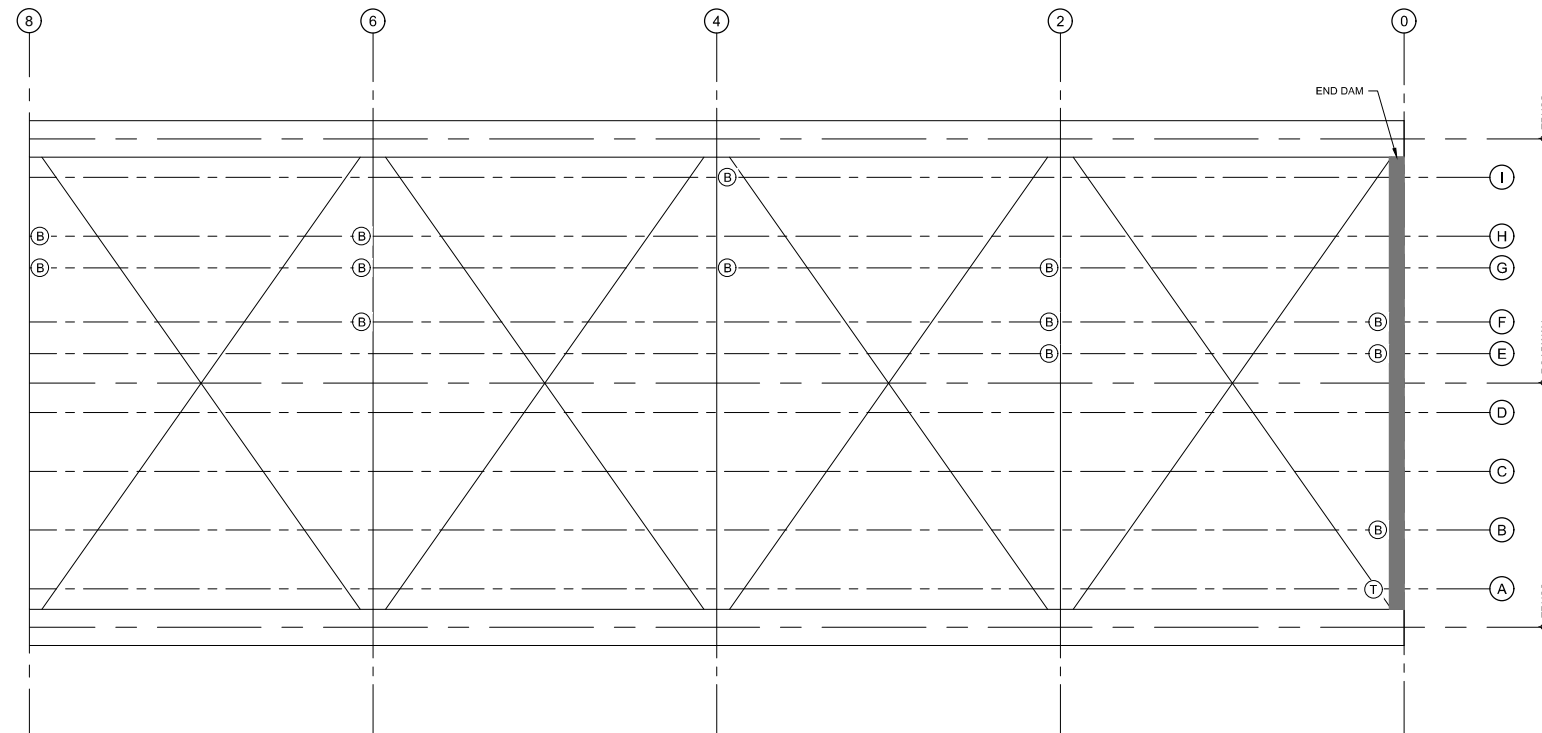
LEGEND / LÉGENDE
 (T) CRACK/NOTCH FOUND AT TOP COPE
 (B) CRACK/NOTCH FOUND AT BOTTOM COPE
 (TB) CRACK/NOTCH FOUND AT TOP & BOTTOM COPE

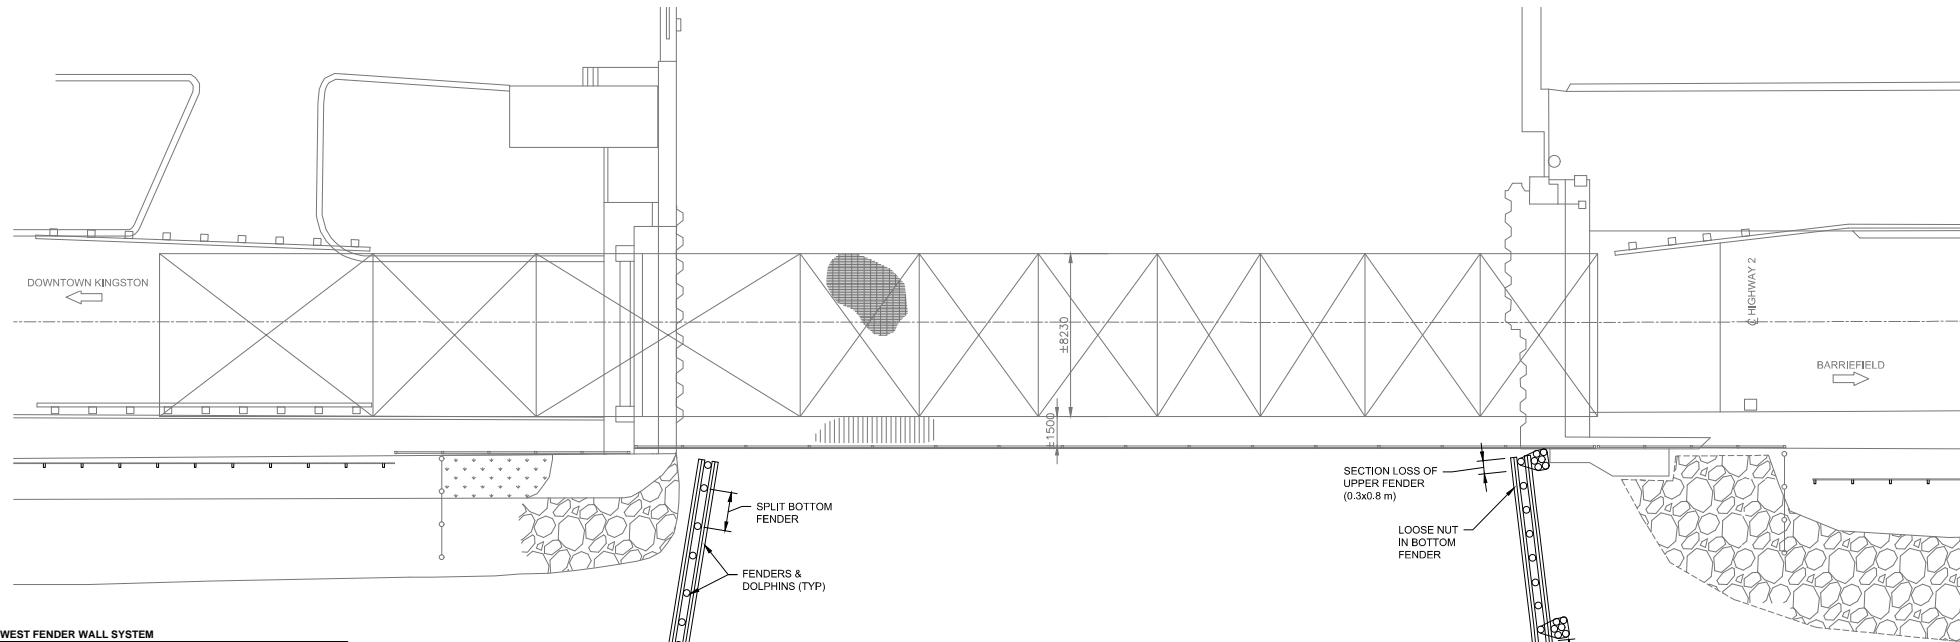
PILE DETERIORATION - WEST FENDER WALL SYSTEM

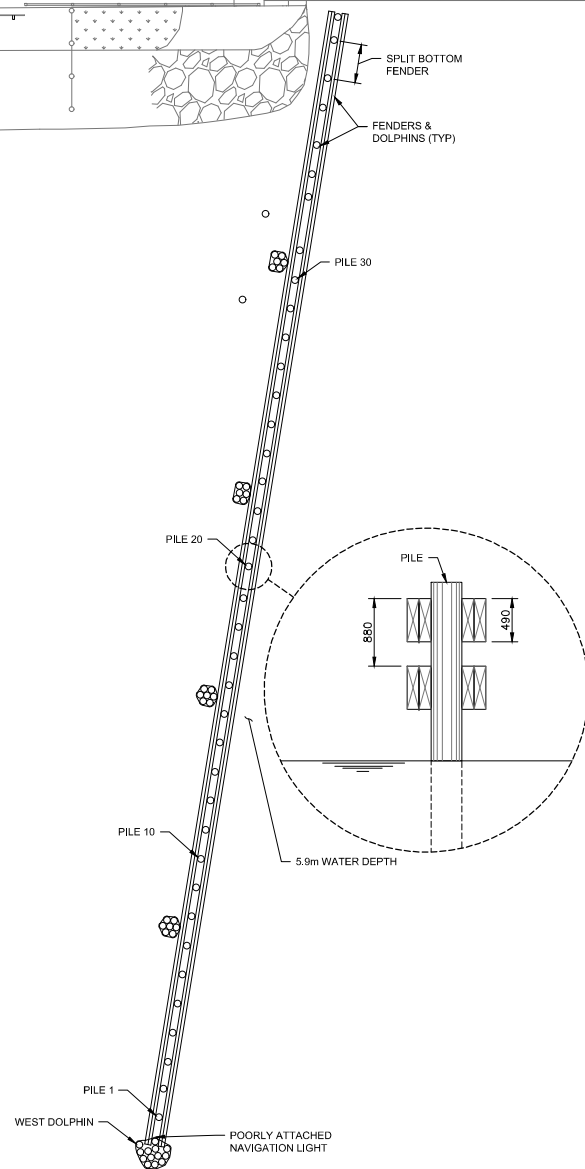
NOTE:
30 TO 50mm THICK ZEBRA MUSCLE GROWTH ENDING 1000mm± FROM WATER LINE

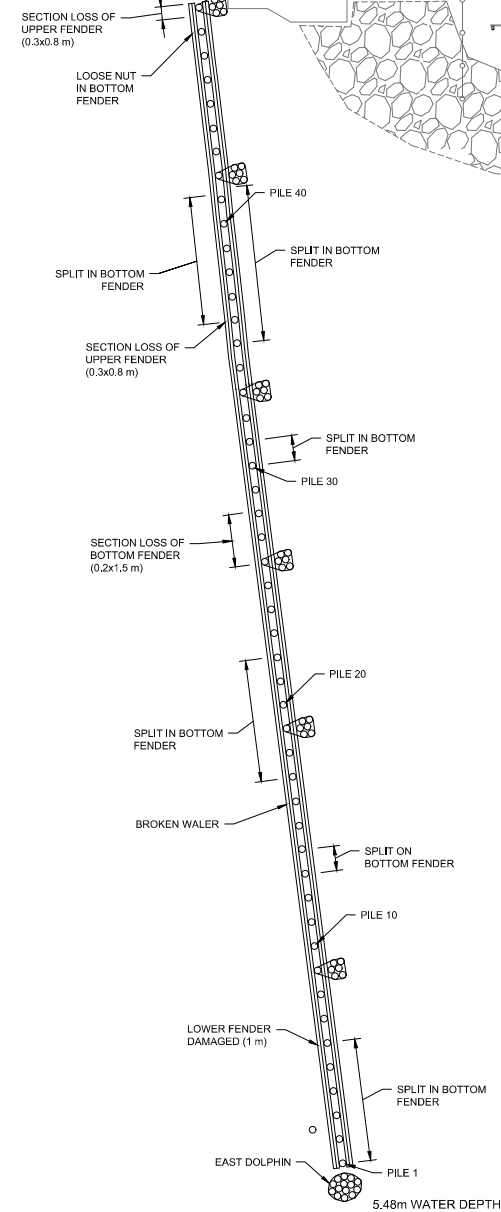
PILE DETERIORATION - EAST FENDER WALL SYSTEM

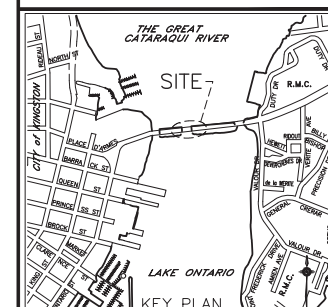
Contractor to verify all dimensions & conditions on site and immediately notify the engineer of all discrepancies.
L'entrepreneur doit vérifier les dimensions et conditions sur le site et en aviser l'ingénieur immédiatement de toute divergence.

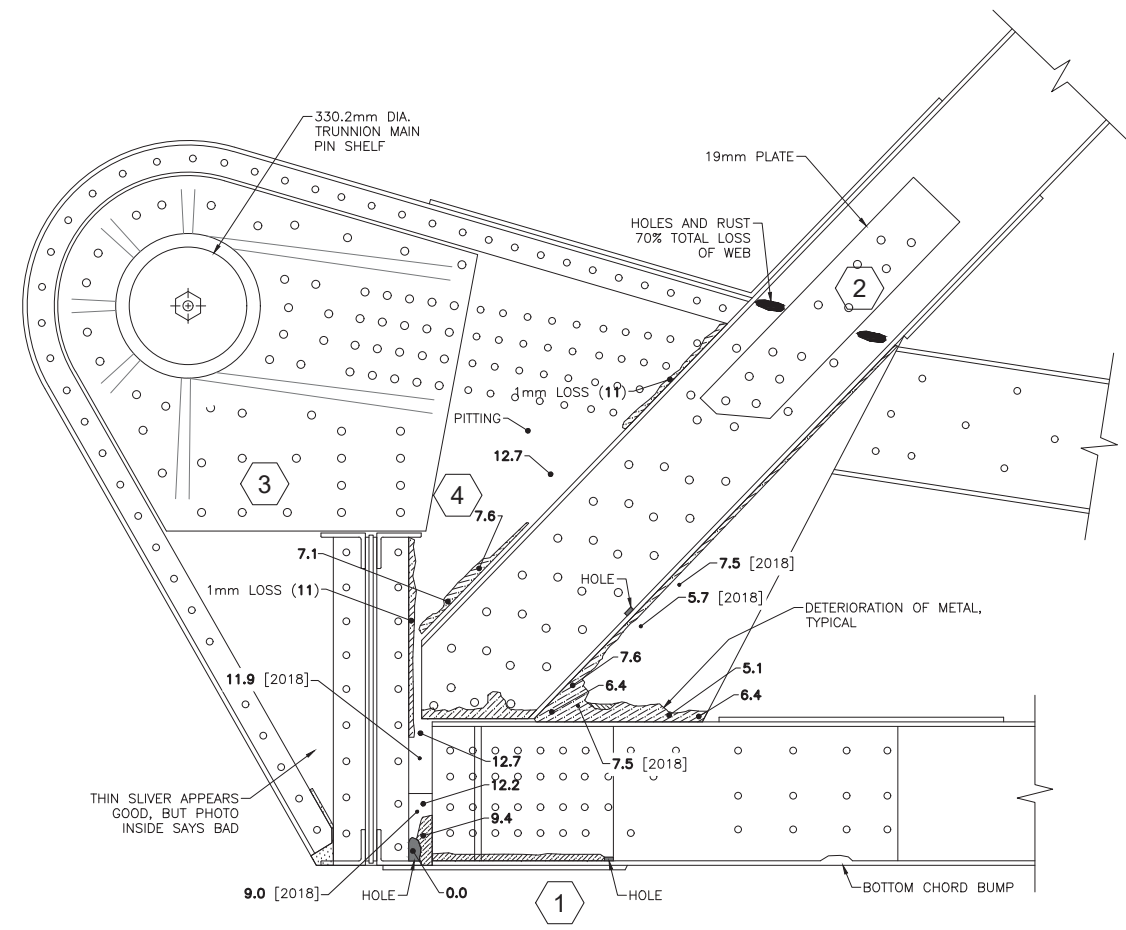
(A) ELEVATION: SOUTH TRUNNION EXTERIOR PLATE EXTERIOR DETERIORATION
1:10

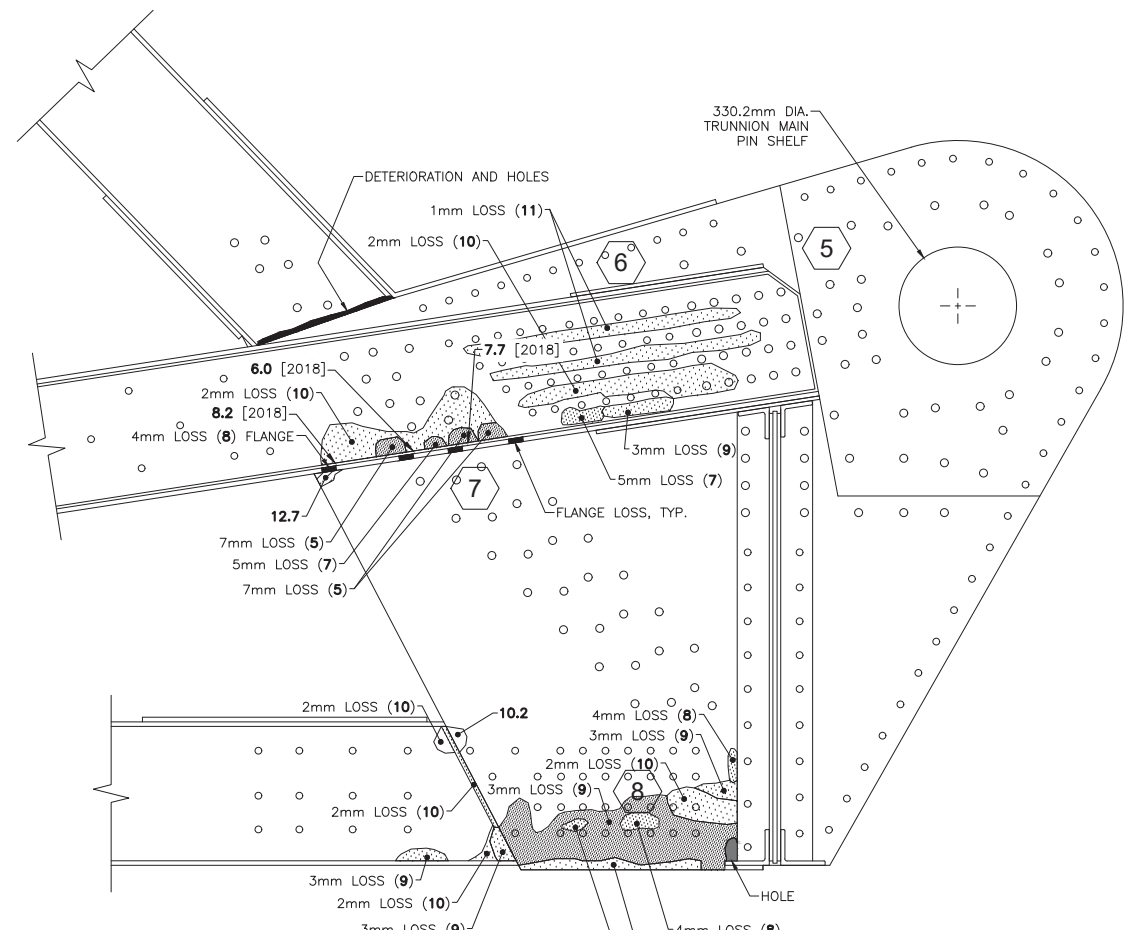
(B) ELEVATION: SOUTH TRUNNION EXTERIOR PLATE INTERIOR DETERIORATION
1:10

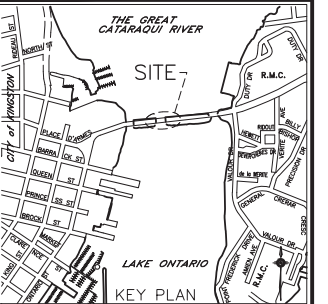
Contractor to verify all dimensions & conditions on site and immediately notify the engineer of all discrepancies.

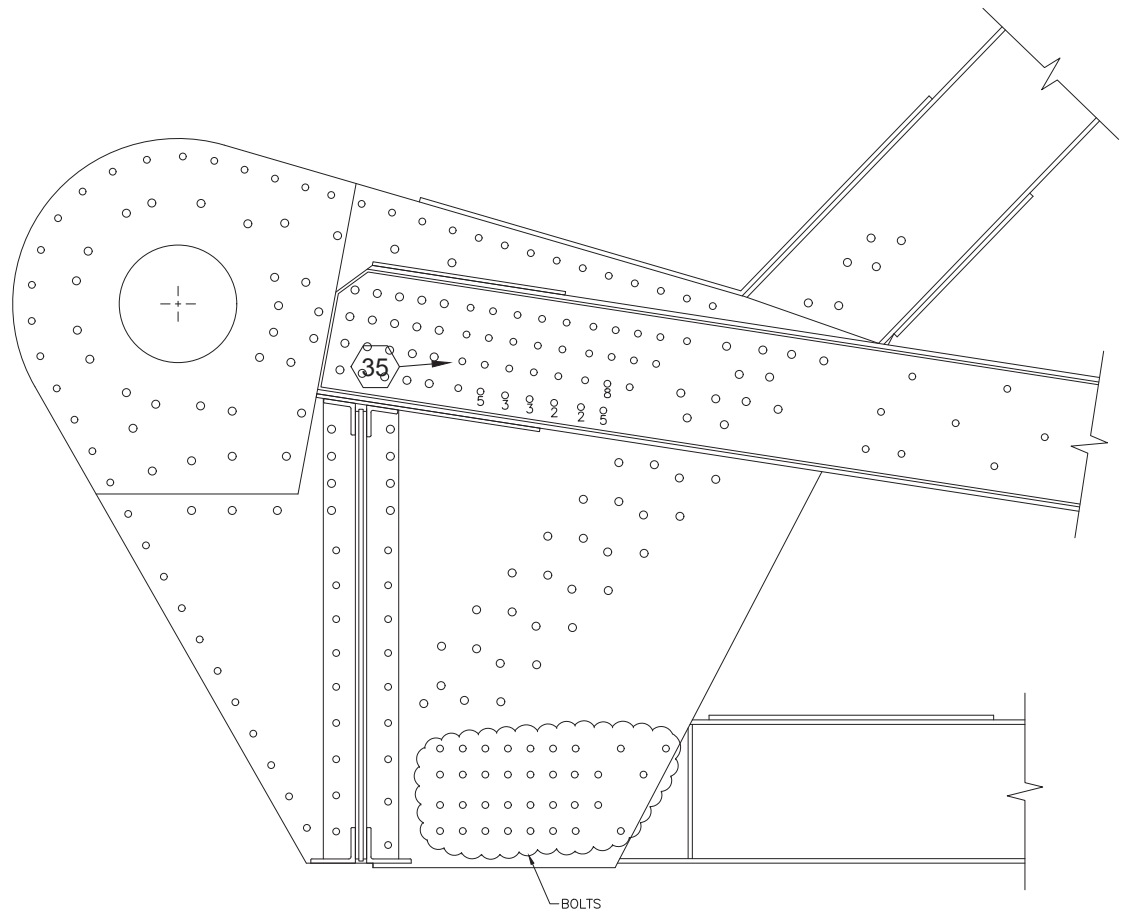
C ELEVATION: SOUTH TRUNNION INTERIOR PLATE
INTERIOR DETERIORATION

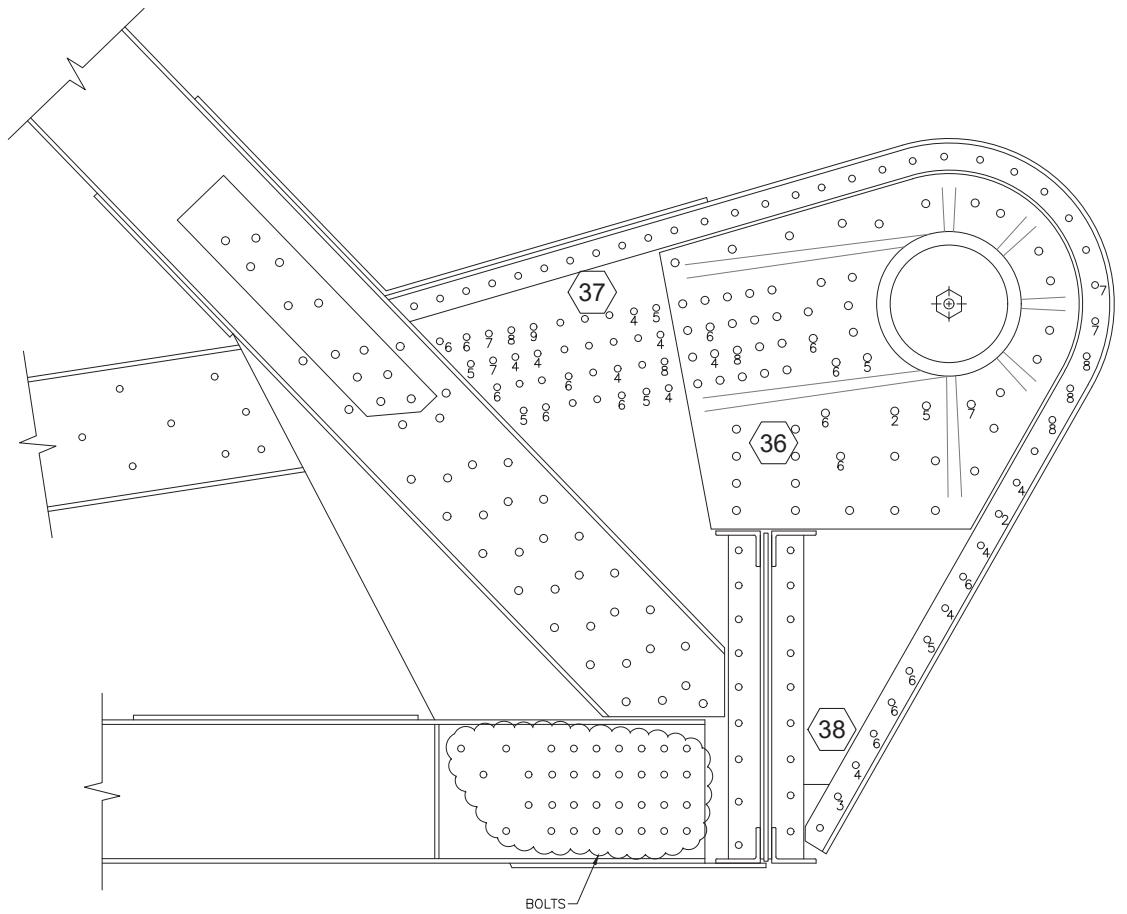
D ELEVATION: SOUTH TRUNNION INTERIOR PLATE
EXTERIOR DETERIORATION

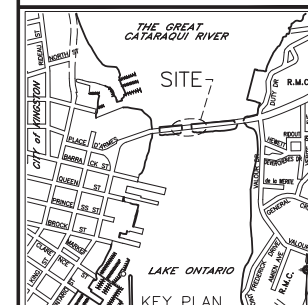
Contractor to verify all dimensions & conditions on site and immediately notify the engineer of all discrepancies.

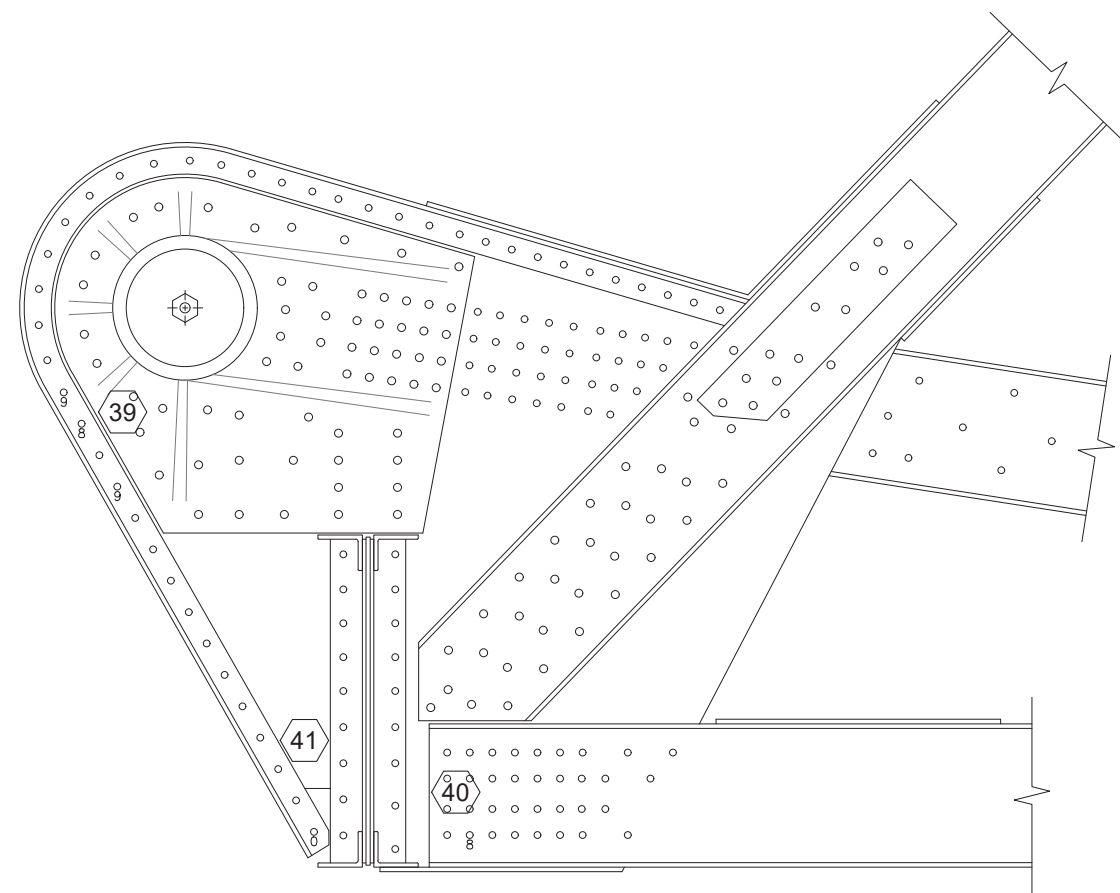
E ELEVATION: NORTH WEST CORNER INTERIOR PLATE
EXTERIOR DETERIORATION
1:10

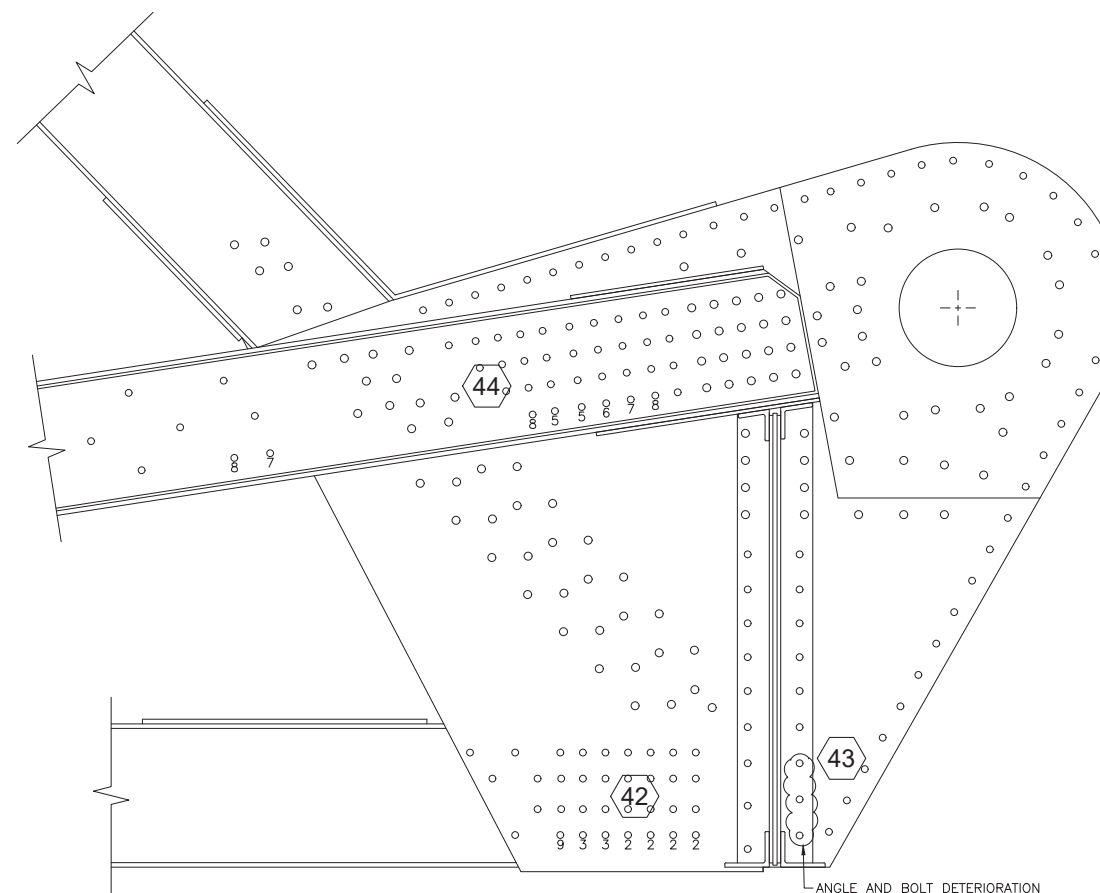
F ELEVATION: NORTH WEST CORNER INTERIOR
INTERIOR DETERIORATION
1:10

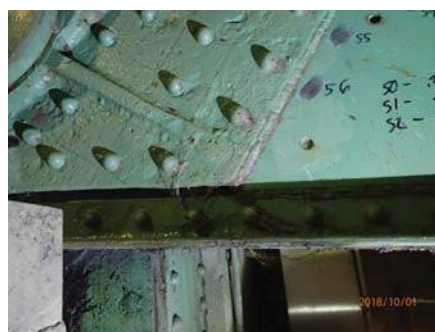
ANGLE AND BOLT DETERIORATION
CHECK WHEN RAISED

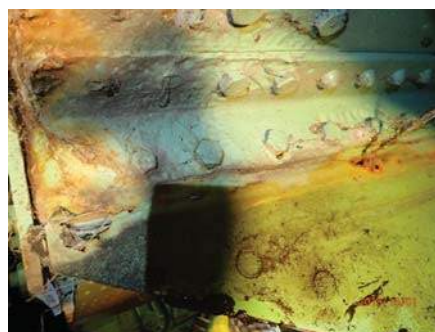
- 4mm LOSS (B) PLATE SECTION LOSS (REMAINING THICKNESS IN MILLIMETRES BASED ON 12mm THICKNESS)
- 9.0 [2018] REMAINING THICKNESS IN MILLIMETRES BASED ON ULTRASONIC MEASUREMENTS [YEAR MEASUREMENT TAKEN]
- 7 REMAINING THICKNESS IN MILLIMETRES. BASED ON ULTRASONIC MEASUREMENTS
- 3 DETERIORATED RIVETS PERCENT SECTION REMAINING DIVIDED BY 10 (i.e. 1=10%, 2=20%, 3=30%, ETC.)
- 99 PHOTOGRAPH KEY
- * PHOTO FROM 2015 MMM GROUP LIMITED REPORT

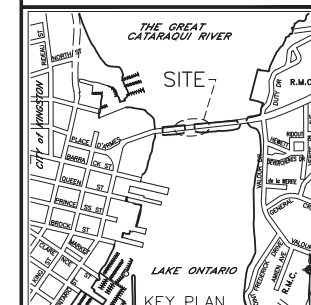
Contractor to verify all dimensions & conditions on site and immediately notify the engineer of all discrepancies.

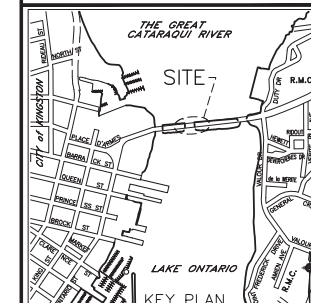
Contractor to verify all dimensions & conditions on site and immediately notify the engineer of all discrepancies.

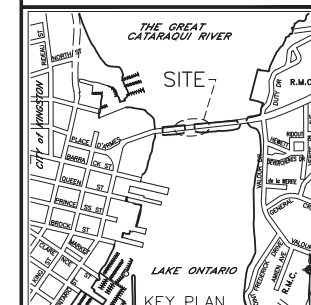
Contractor to verify all dimensions & conditions on site and immediately notify the engineer of all discrepancies.

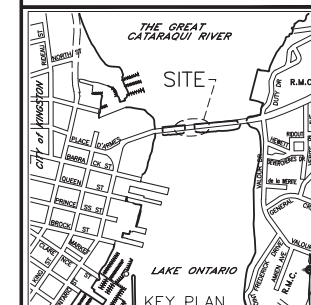
Contractor to verify all dimensions & conditions on site and immediately notify the engineer of all discrepancies.

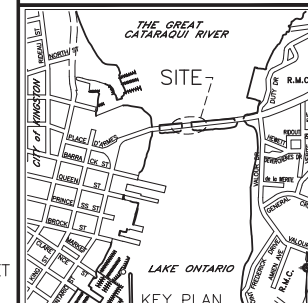
Contractor to verify all dimensions & conditions on site and immediately notify the engineer of all discrepancies.

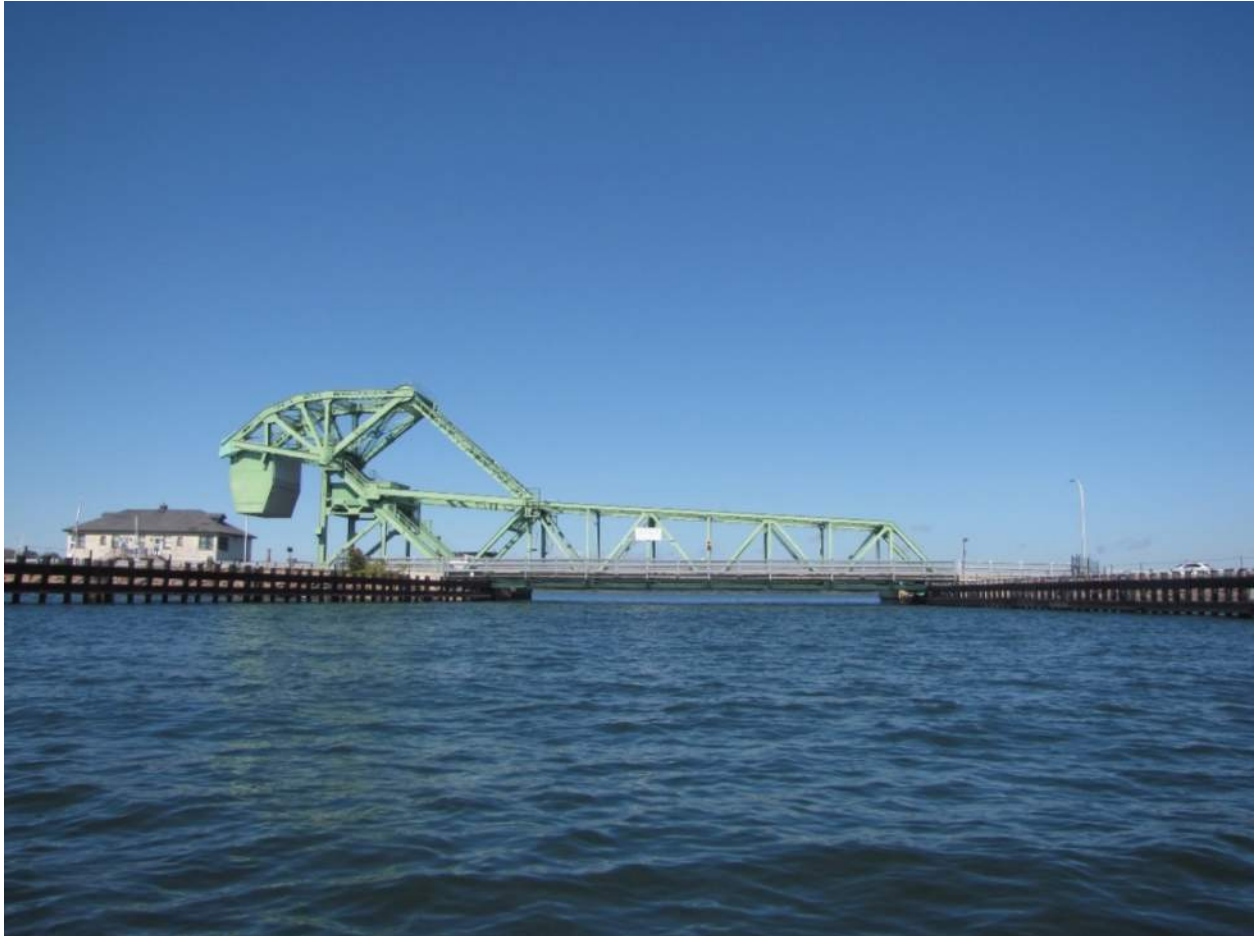
Photo S1: South elevation.

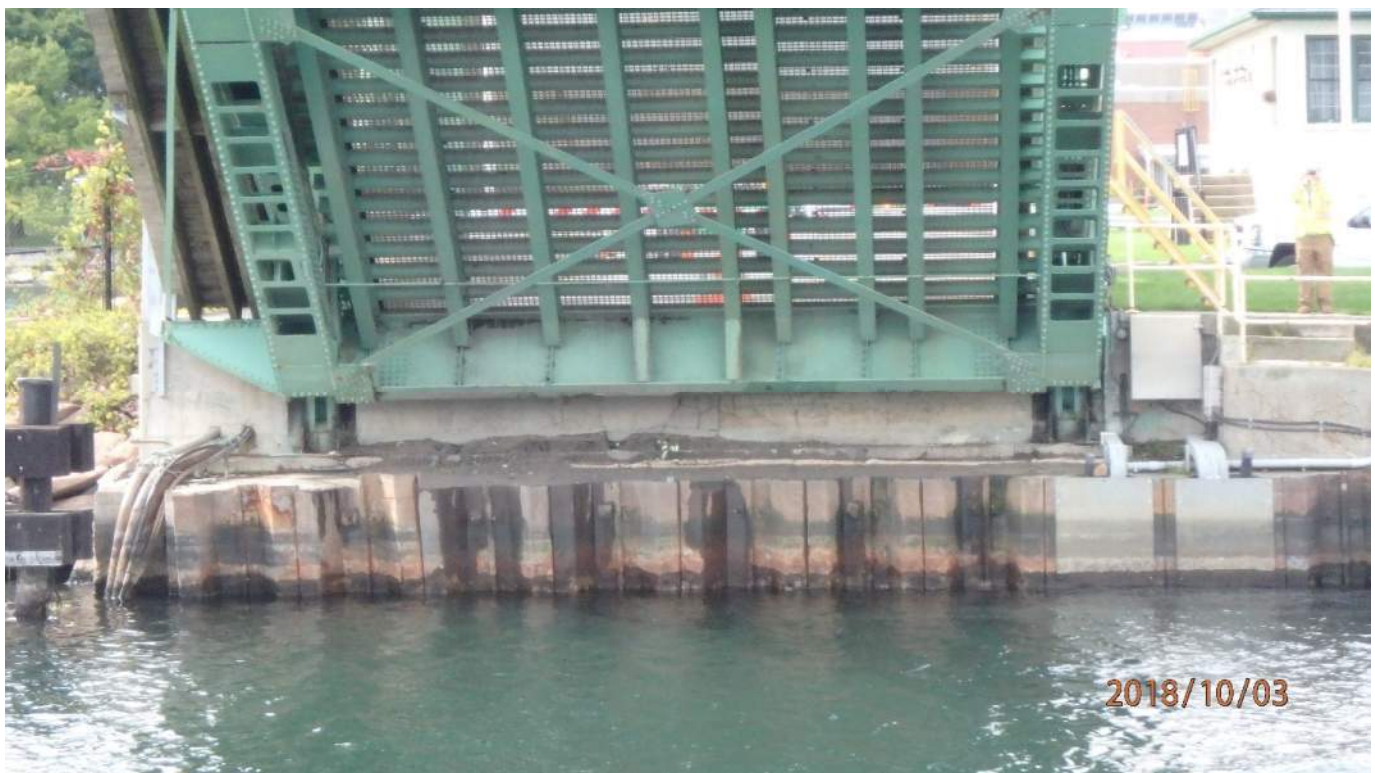
Photo S9: West abutment. Note the map cracking in the ballast wall.

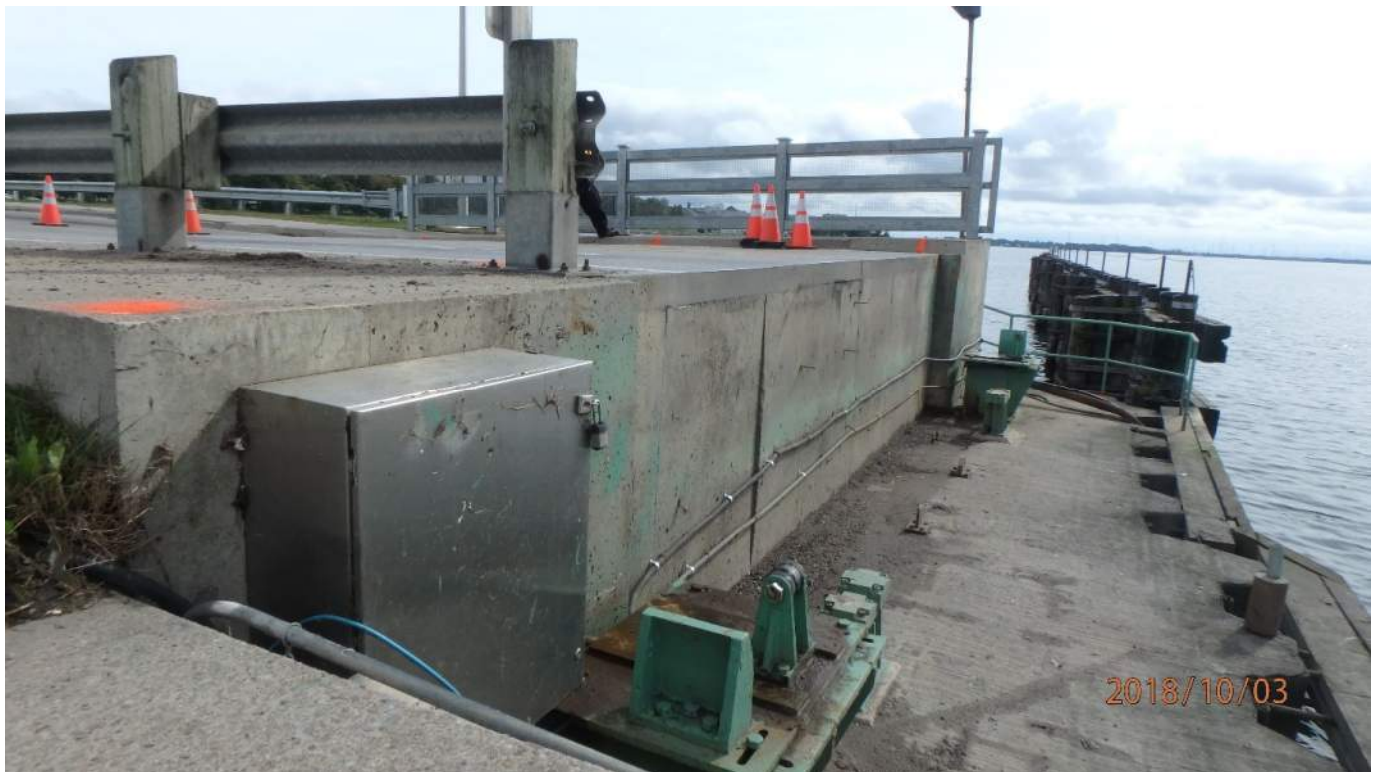
Photo S10: East abutment, looking south.

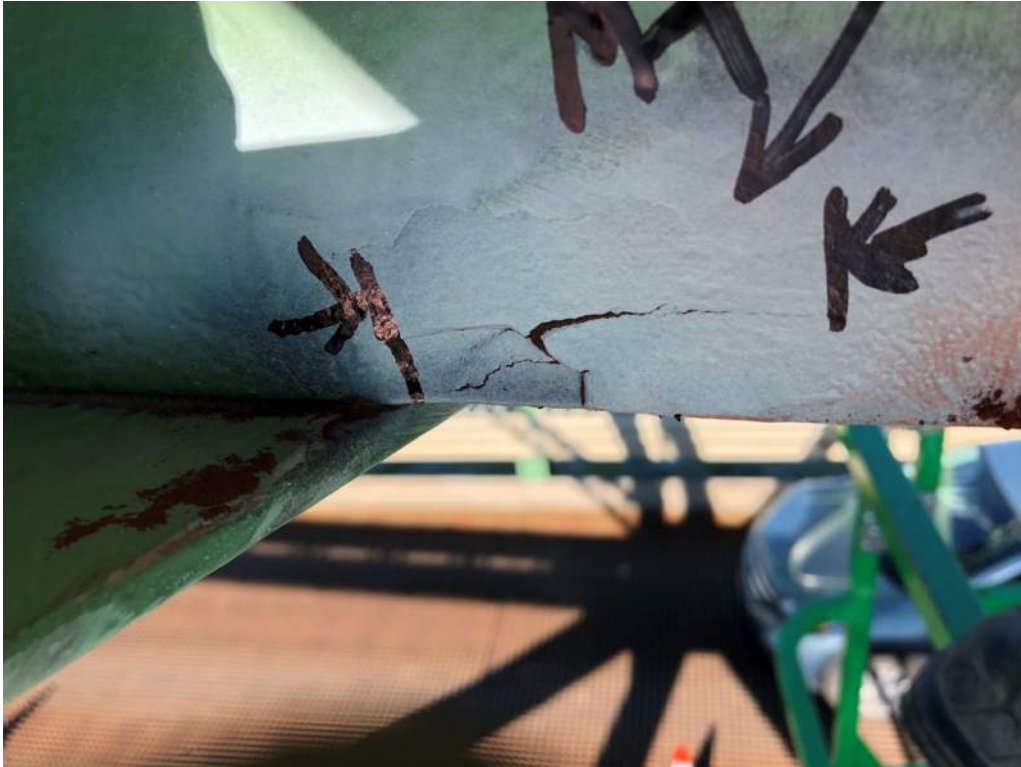
Photo S12: Leaf truss top chord member 3S-5S has a 60mm long lamination defect with a possible crack (photo by Brouco NDT).
