LaSalle Causeway Bascule Bridge 2018 Comprehensive Detailed Inspection Report

Project Number: R. 090045.001

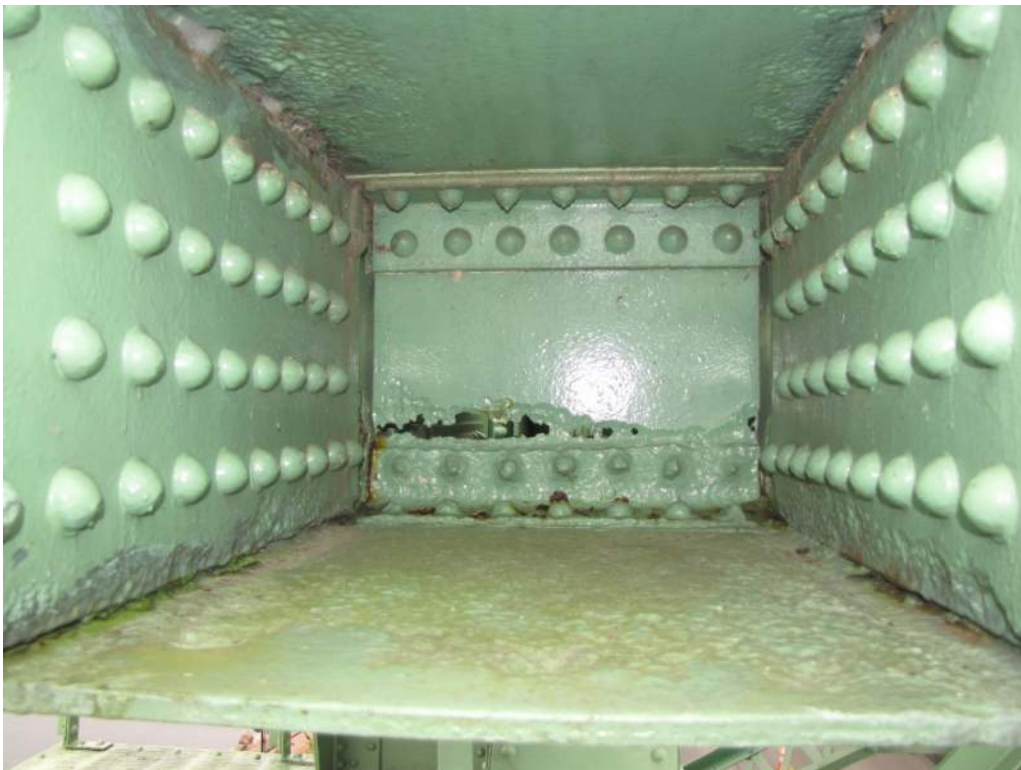
Photo S13: Perforation and severe pitting of diaphragm inside top chord member 11S-13S near node 13S.

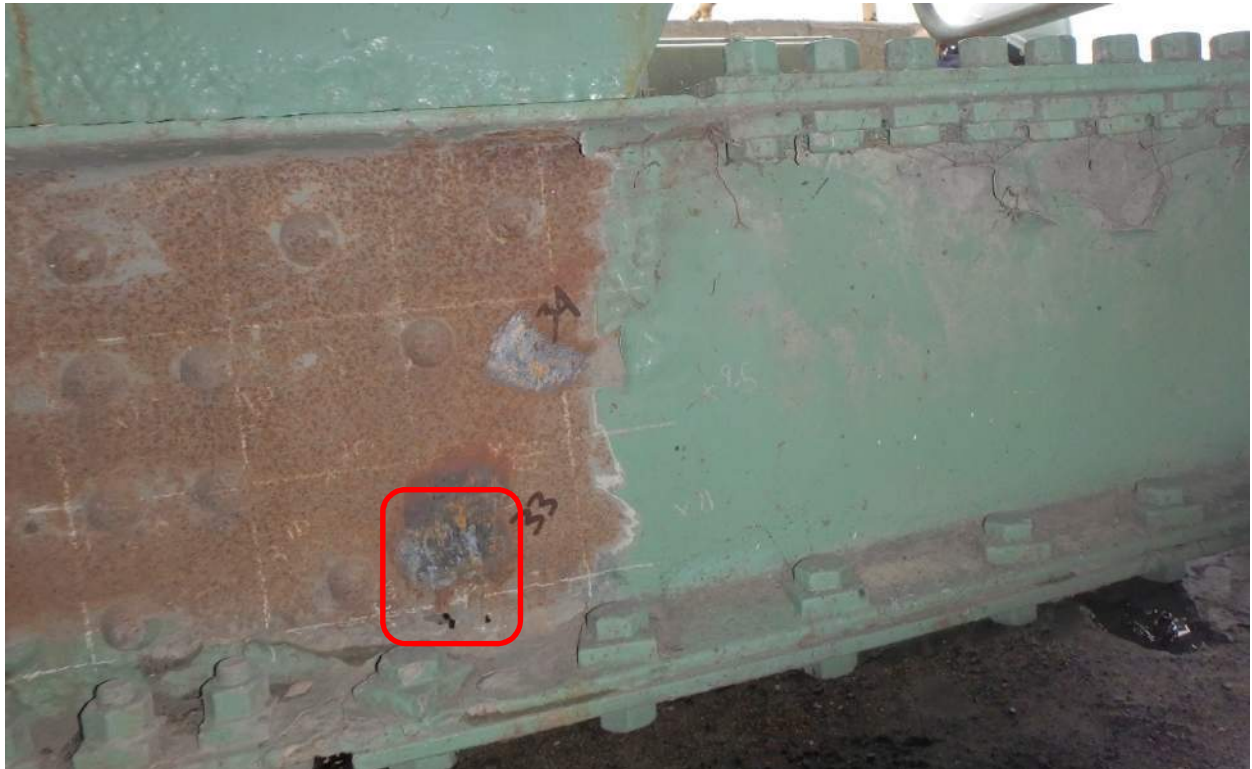
Photo S14: Perforation in the web of bottom chord member 14N-16N near node 16N and generalized light corrosion.

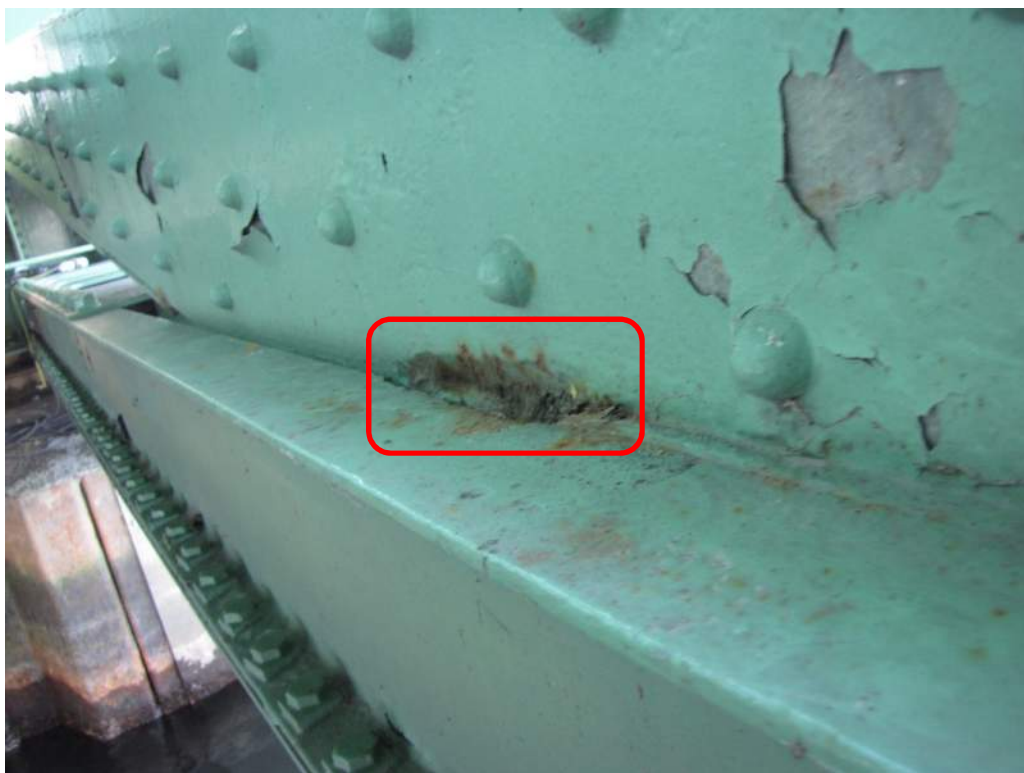
Photo S15: Severe pitting and rust jacking between member 14N-15N and 14N-16N.

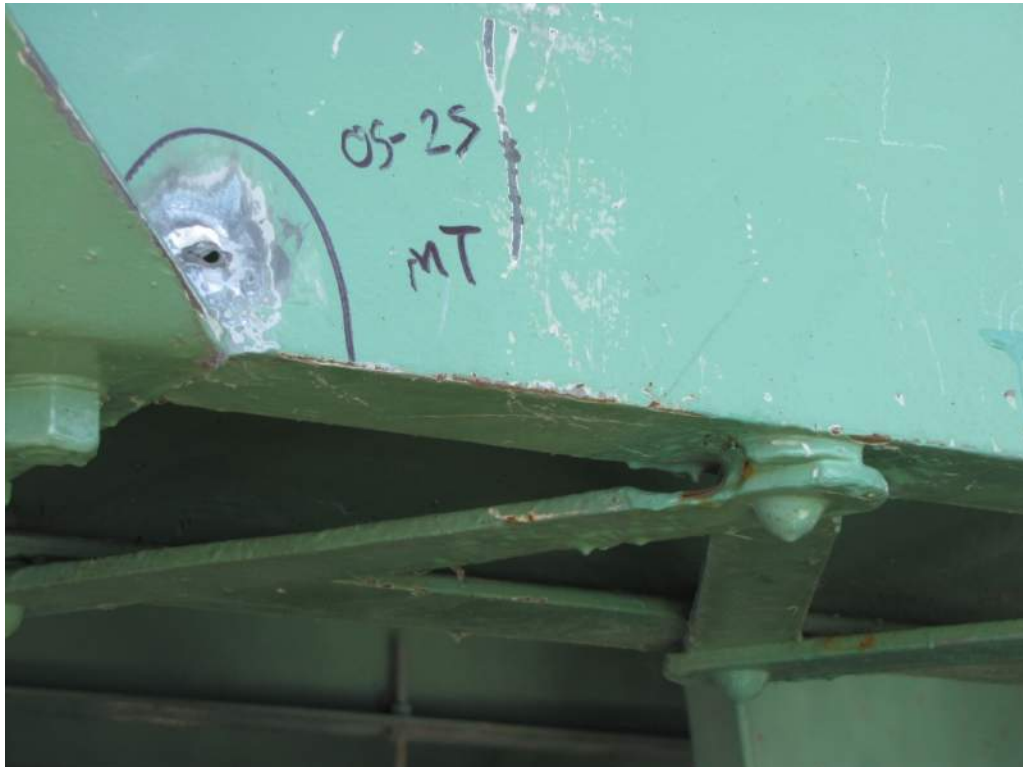
Photo S16: Severe localized section loss and perforation in web of south channel of leaf truss bottom chord member 05-2S at node 2S adjacent to the sidewalk floor beam connection.

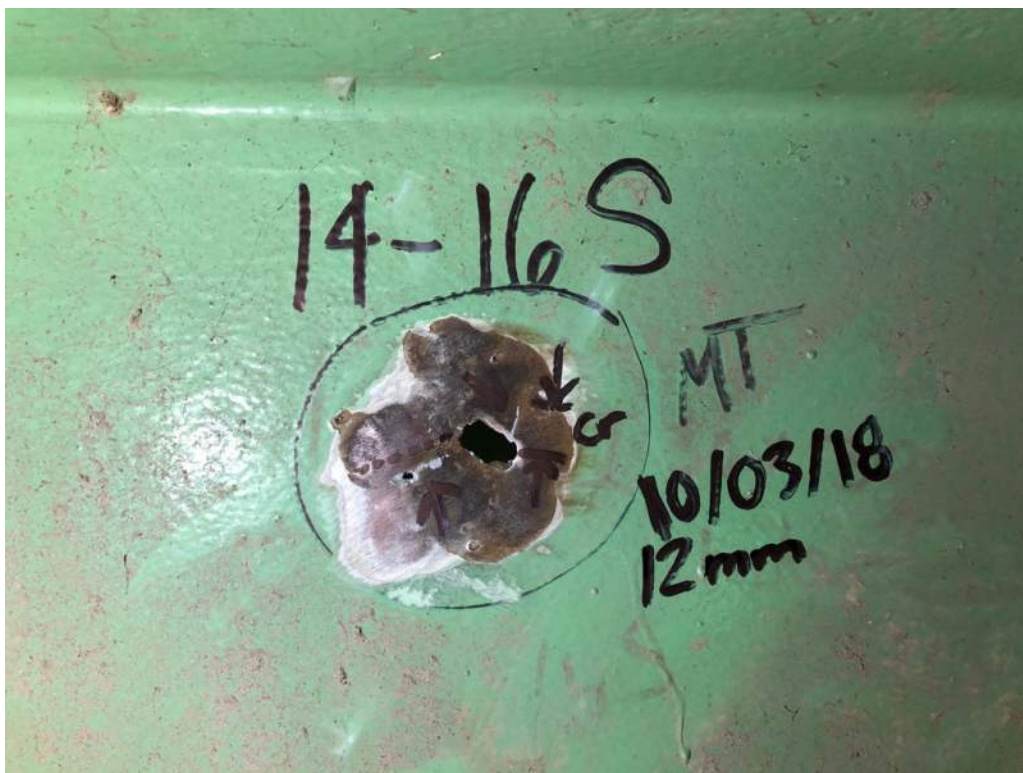
Photo S19: Perforation and 12mm long crack in interior channel of bottom chord member 14S-16S (photo by Brouco NDT).

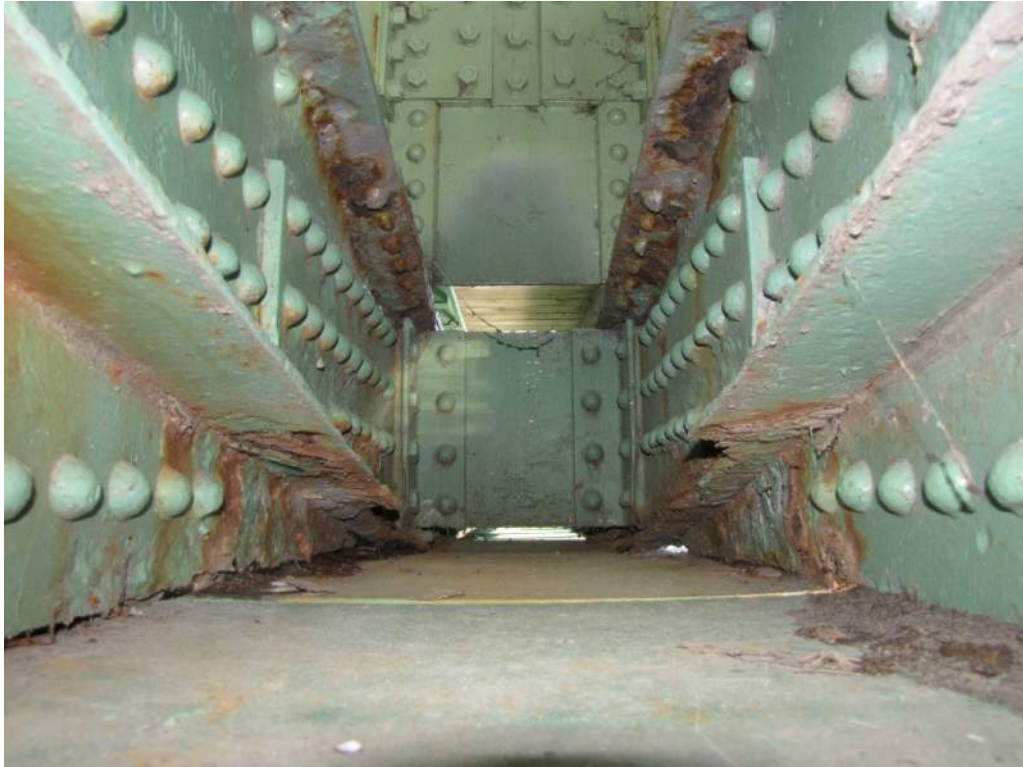
Photo S20: Severe localized pitting and section loss of flanges where 14S-16S and 14S-15S intersect. Several rivet heads have over 75% section loss.

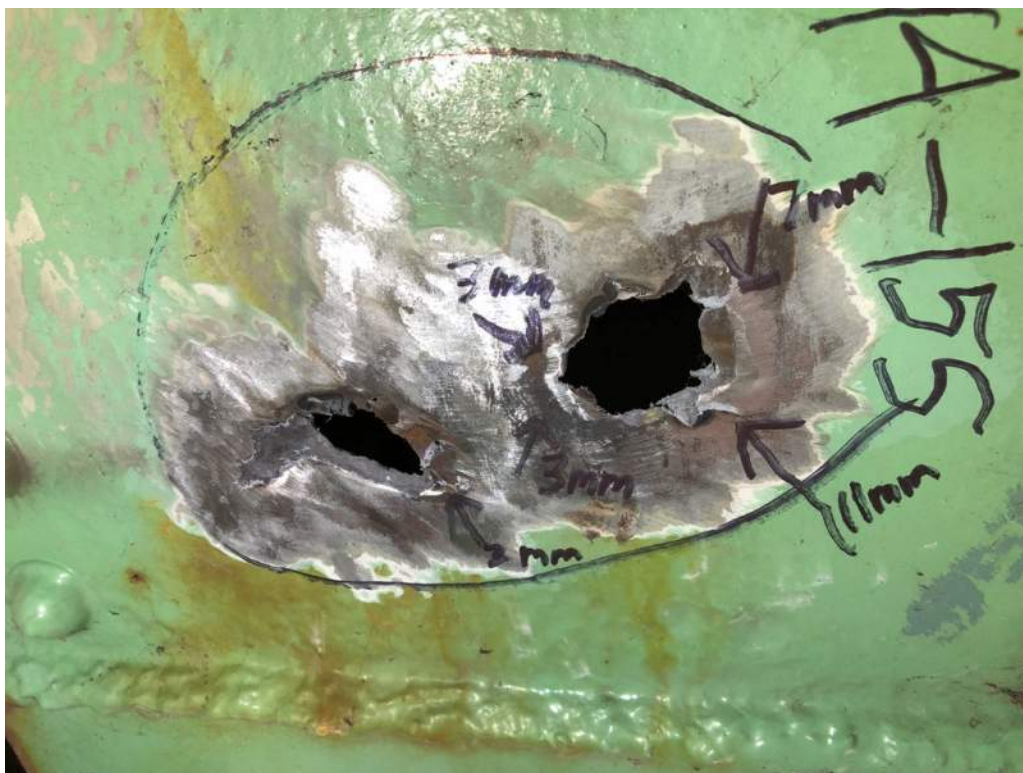
Photo S21: Perforations and cracks in bottom batten plate of bottom chord member 14S-15S near node 15S. The cracks range in length from 3mm to 11mm (photo by Brouco NDT).

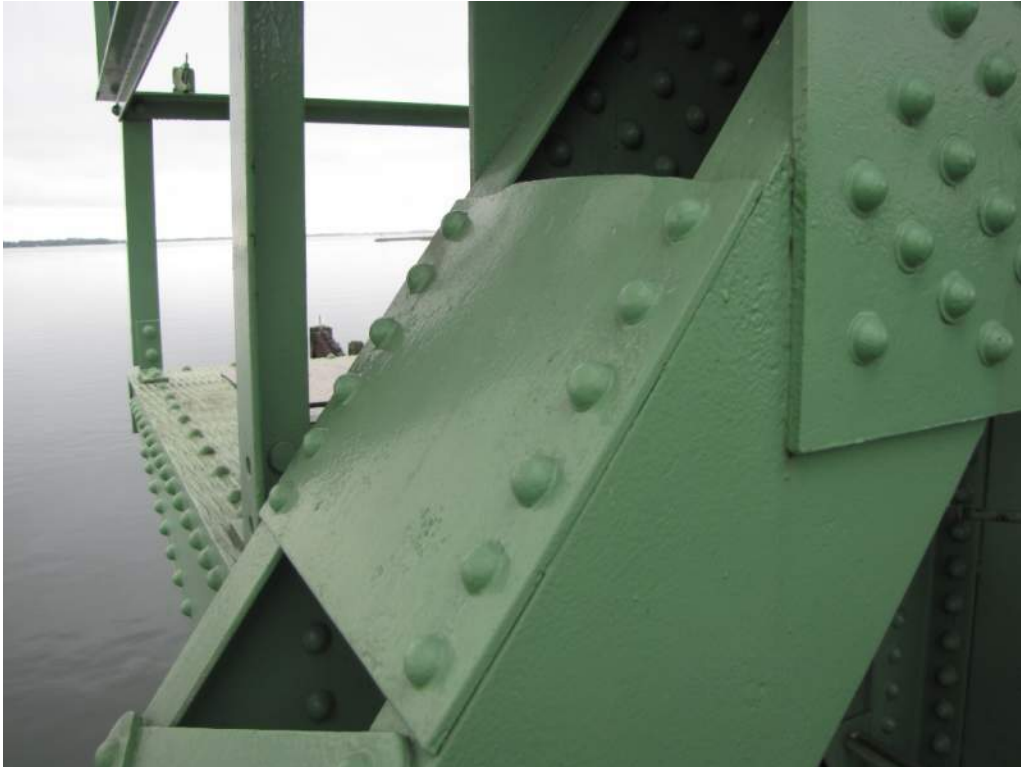
Photo S22: The upper batten plate of diagonal member 12S-13S near node 13S is deformed.

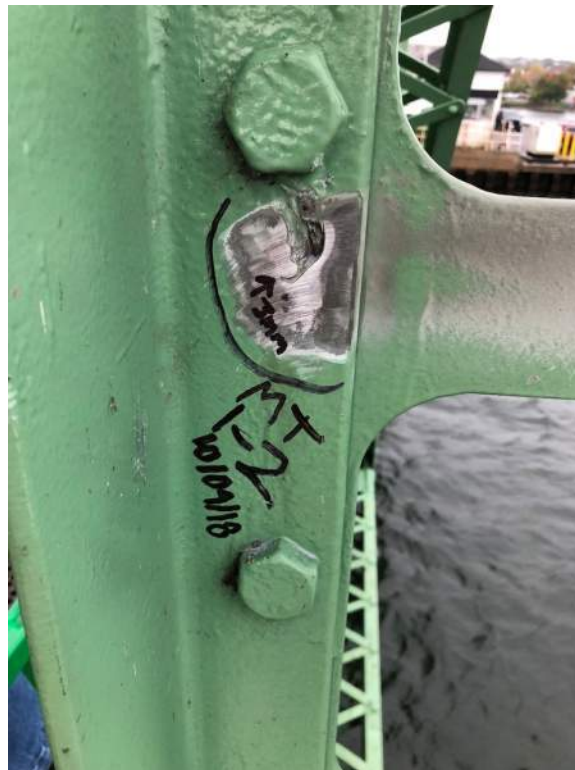
Photo S23: Suspected crack at flame-cut hole in southeast angle of vertical member 1N-2N (photo by Brouco NDT).

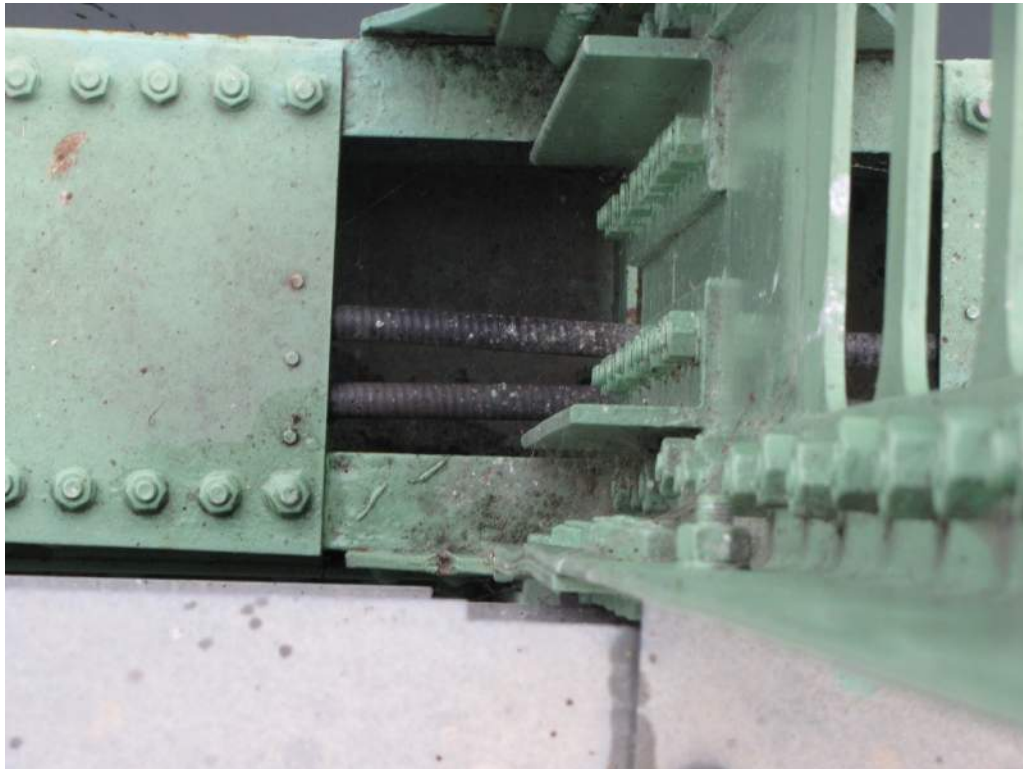
Photo S24: The outstanding leg of the southwest angle of 1N-2N is bent above the bottom chord.

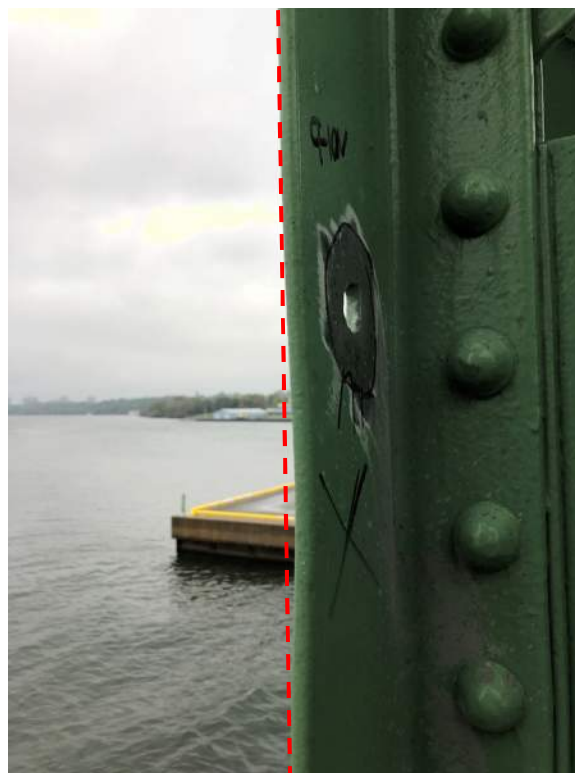
Photo S25: Deformation of the northwest leg of vertical member 9N-10N was noted below the flame-cut hole (photo by Brouco NDT).

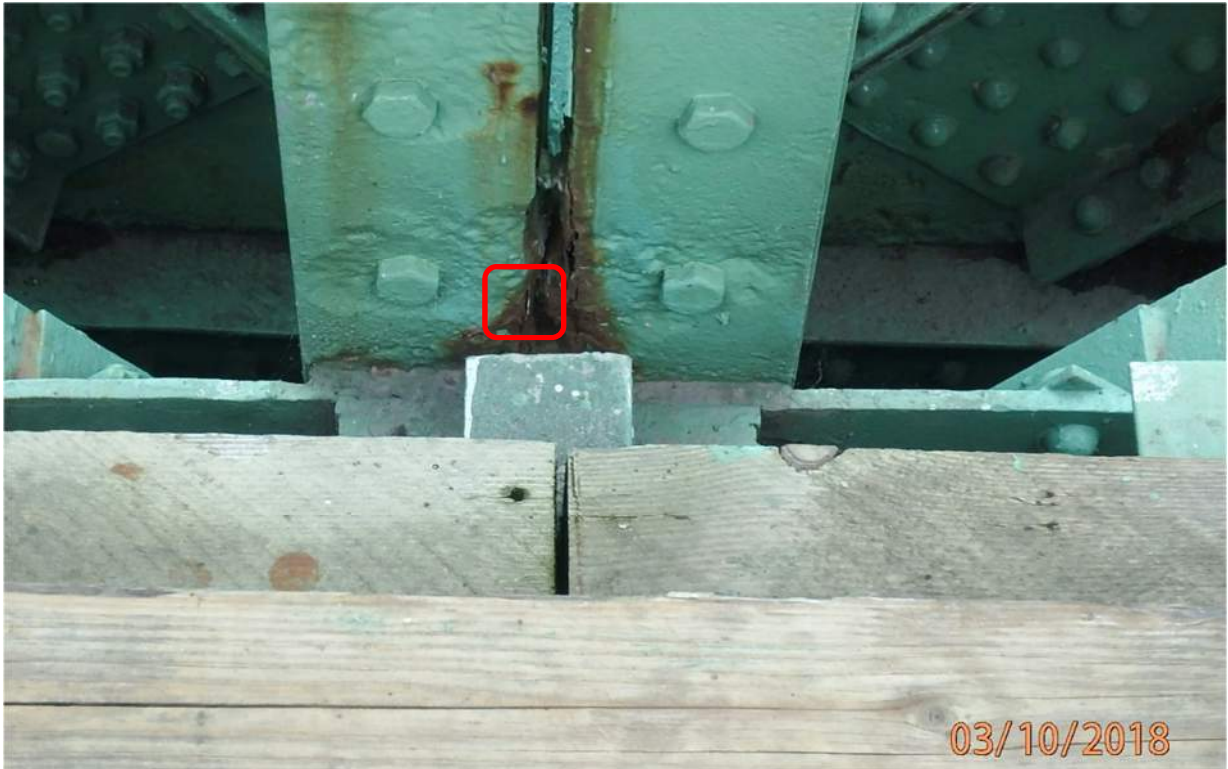
Photo S26: Very severe pitting with a small perforation in the south angles of vertical member 9N-10N above node 10.

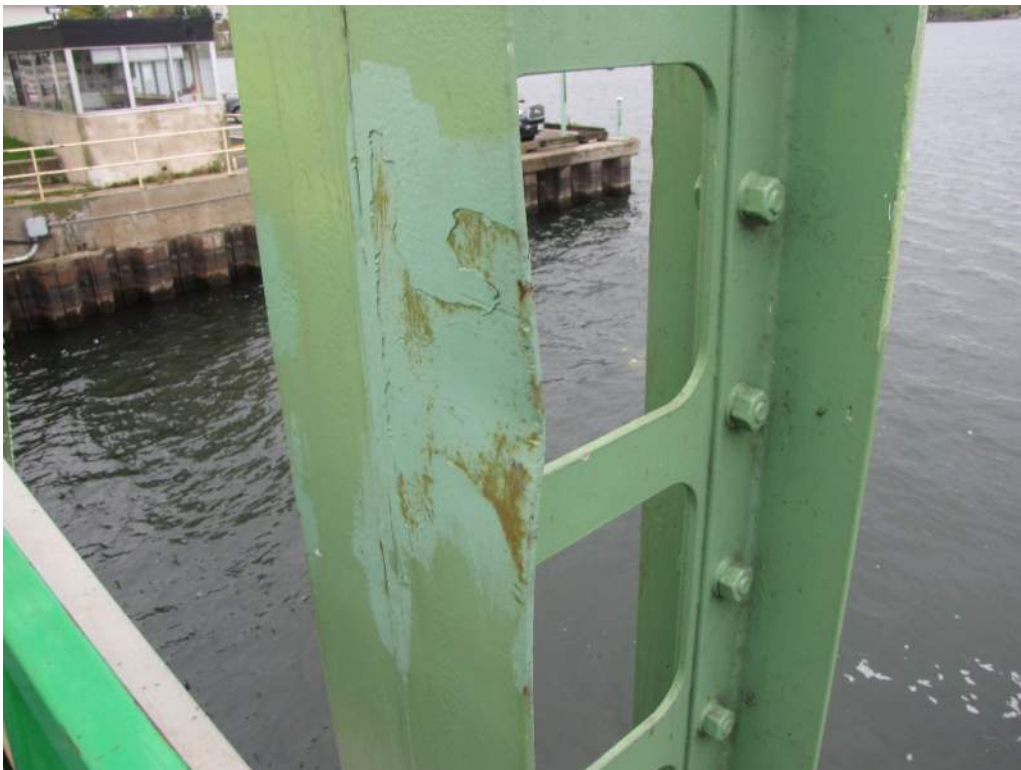
Photo S27: Impact damage to vertical member 9N-10N has bent a portion of the southeast flange.

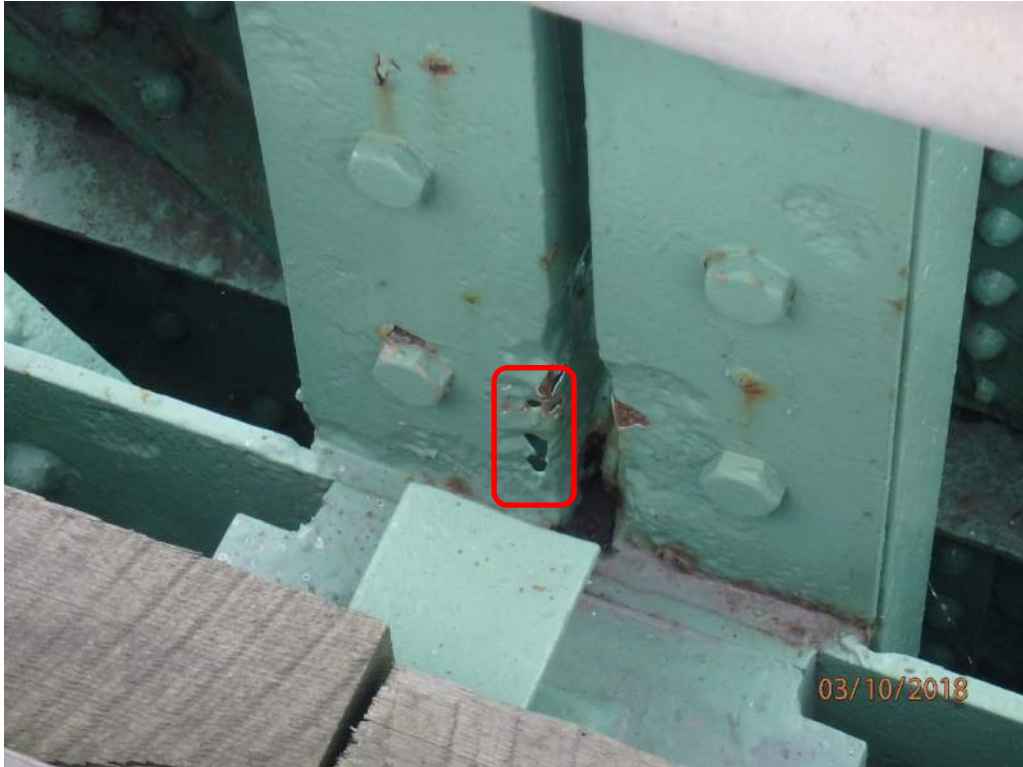
Photo S28: Perforation in the south angles of vertical member 11N-12N above node 12.

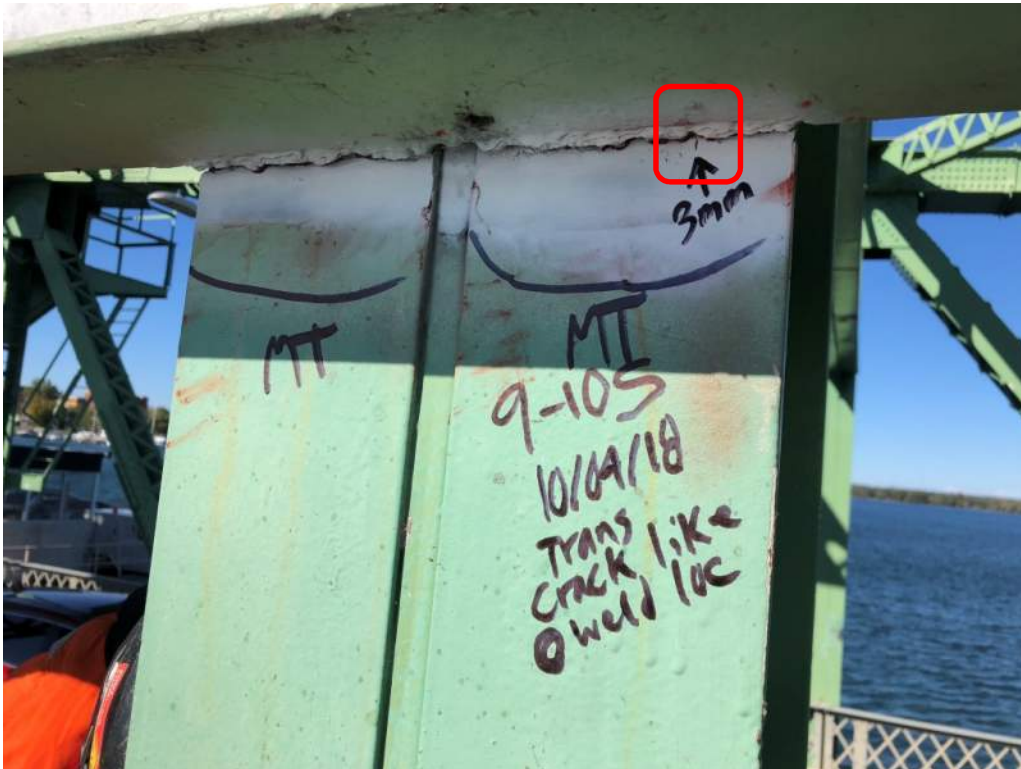
Photo S30: 3mm long crack in top of southeast leg of vertical member 9S-10S at weld location (photo by Brouco NDT).

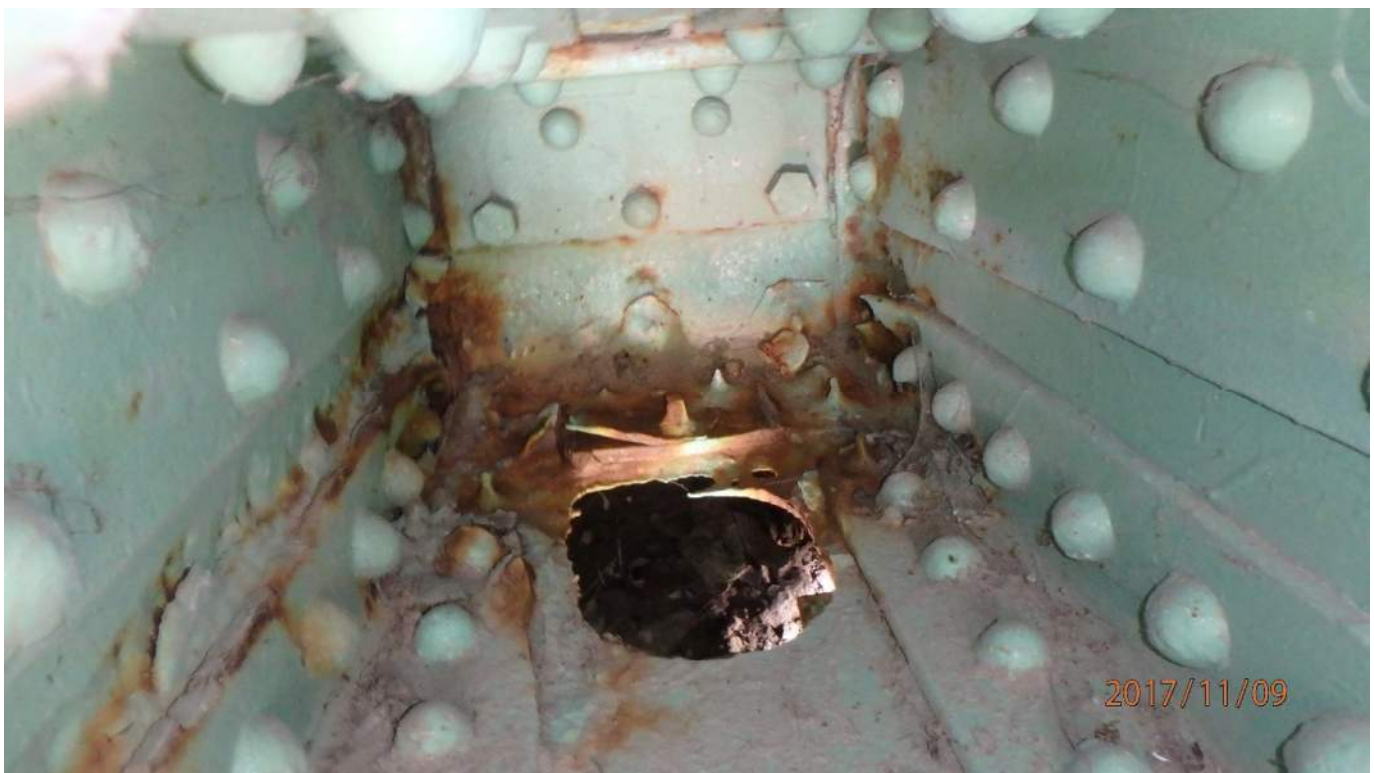
Photo S31: Severe corrosion and section loss of rivet heads at the base of 15N-17N and section loss of the gusset plate at the main trunnion (photo from 2017 inspection).

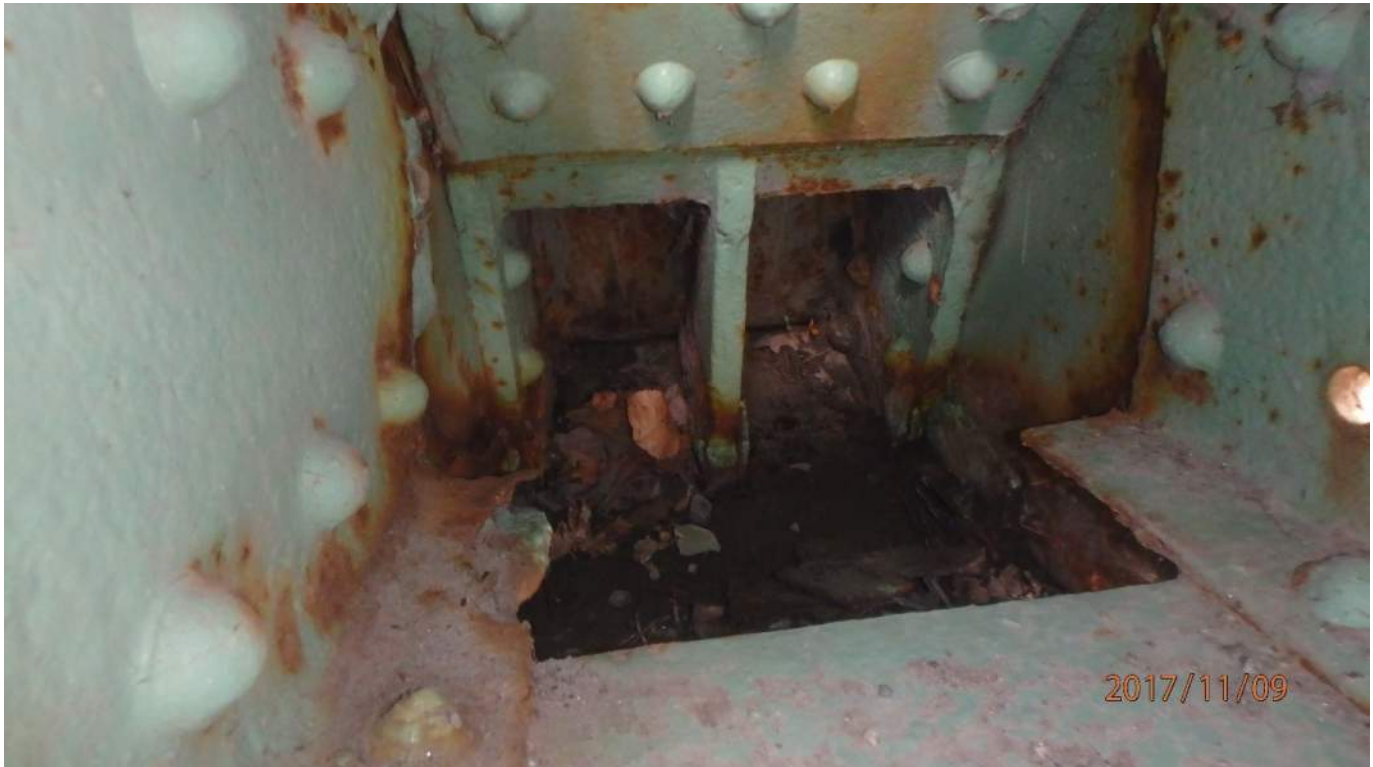
Photo S32: View of the west side of the north trunnion. Note the loss of the bottom flange of the north channel of tower truss member 15N-18N (photo from 2017 inspection).

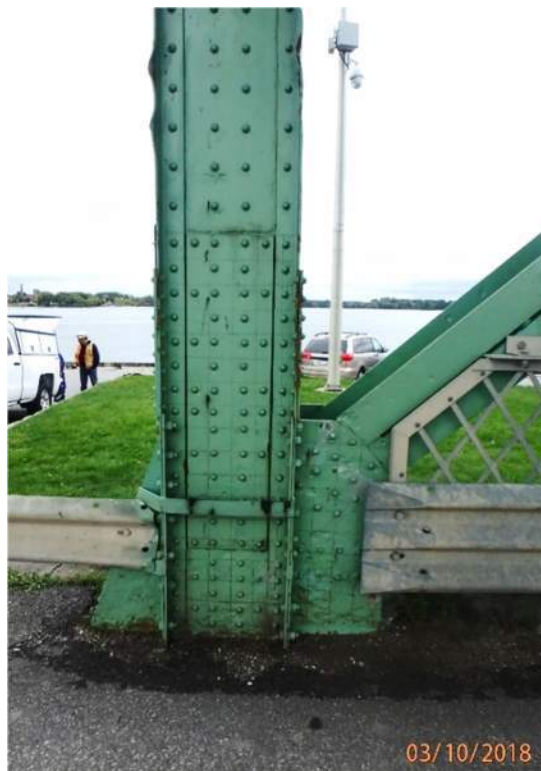
Photo S35: Tower truss vertical member 19N-20N has severe section loss in the rivet heads and web plate at roadway level and deformation (likely due to impact damage) in the southeast and southwest flanges.

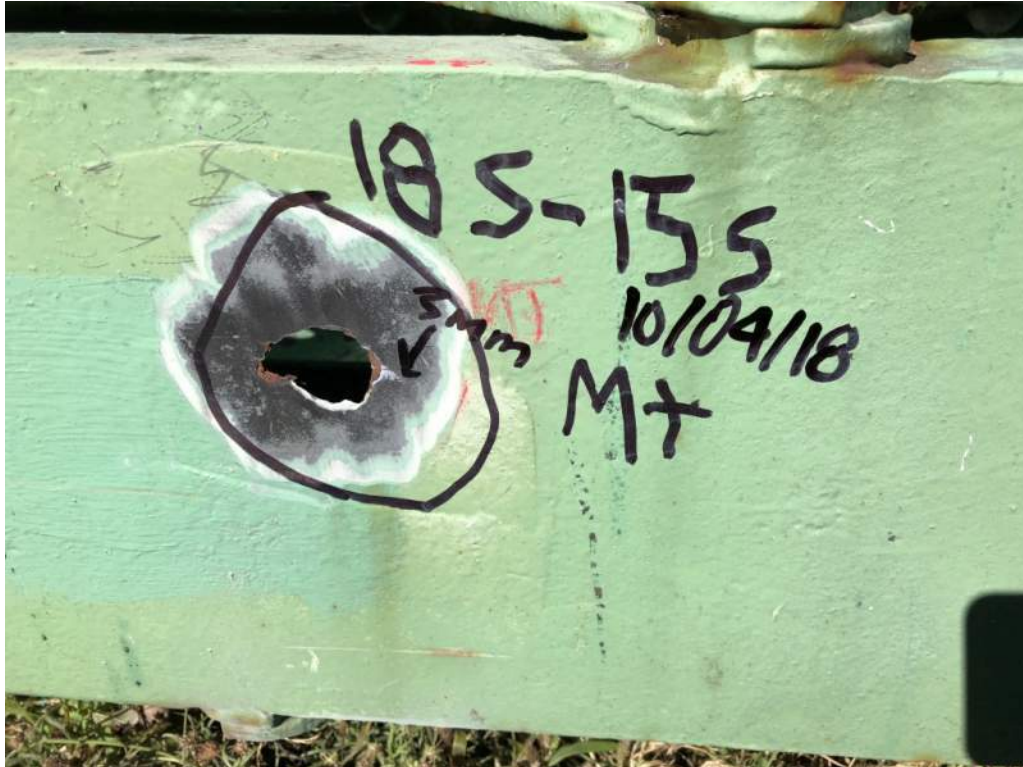
Photo S36: Perforation and 3mm long crack in south channel of tower truss bottom chord member 15S-18S (photo by Brouco NDT).

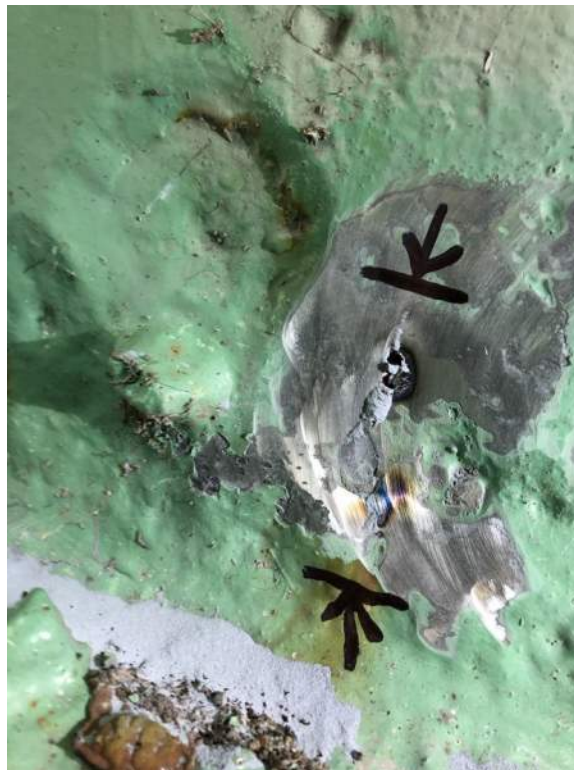
Photo S37: Perforation and 60mm long crack in south channel of tower truss bottom chord member 18S-19S (photo by Brouco NDT).

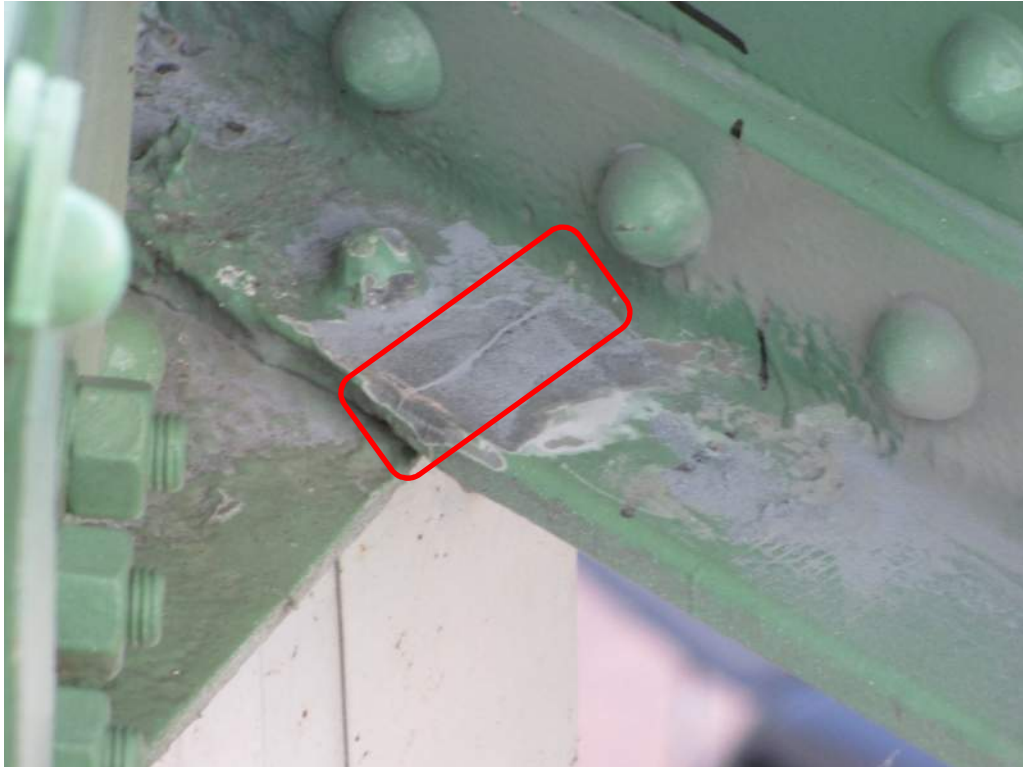
Photo S38: Crack across full width of bottom leg of interior angle of 21N-27N counter weight truss member at node 27N.

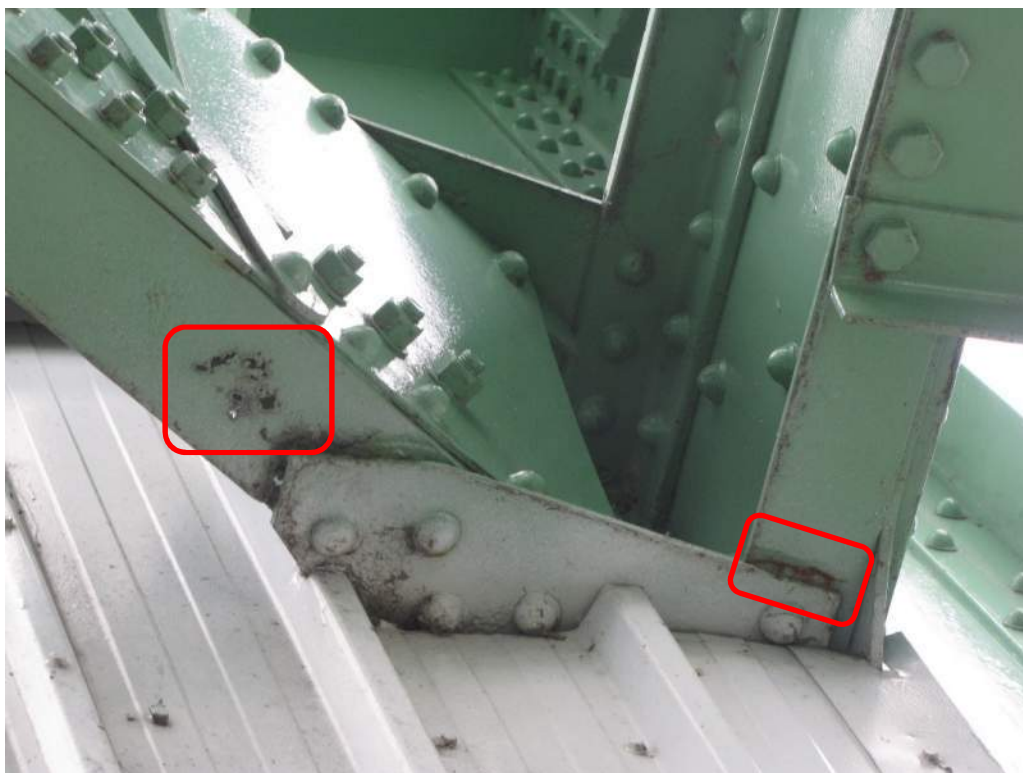
Photo S39: The northwest end of counterweight truss cross bracing 21S-27N has several perforations in the lower flange (left). Note the crack in the south lower flange of member 21N-27N (right).

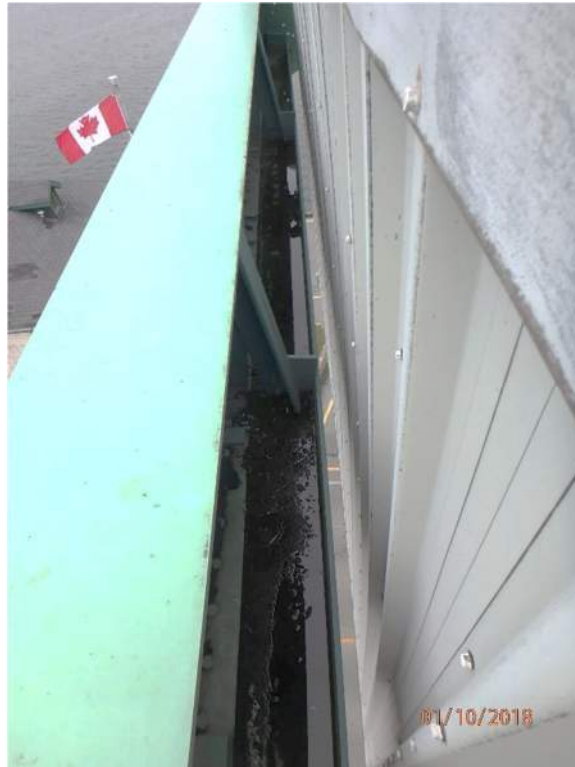
Photo S40: Debris and water are collecting on member 26N-26S.

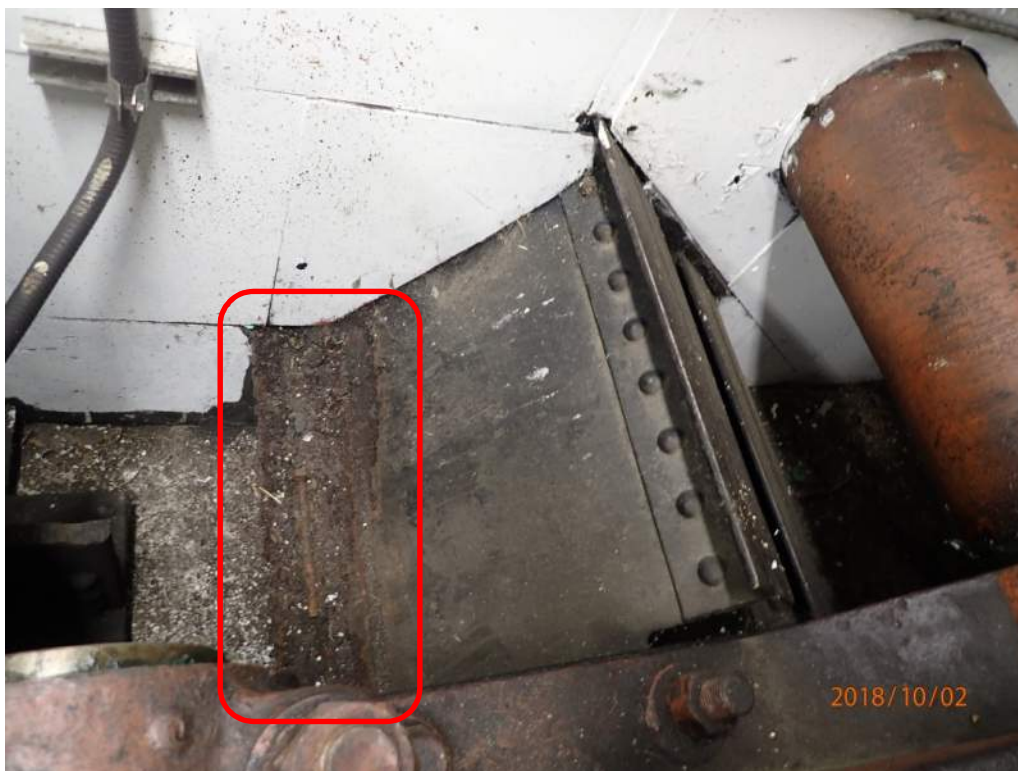
Photo S41: Severe corrosion on the bottom flange of the northeast transverse strut in the mechanical room.

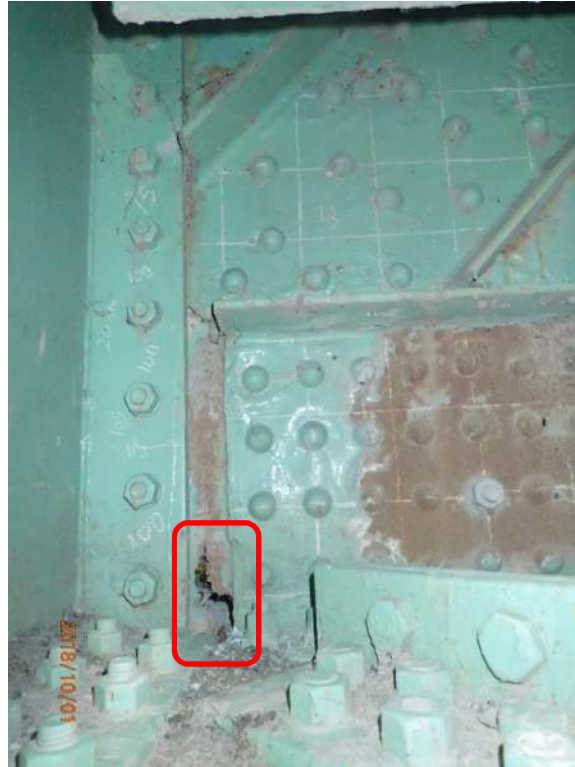
Photo S42: The interior vertical gusset plate at node 16N exhibits severe section loss and a perforation with a crack.

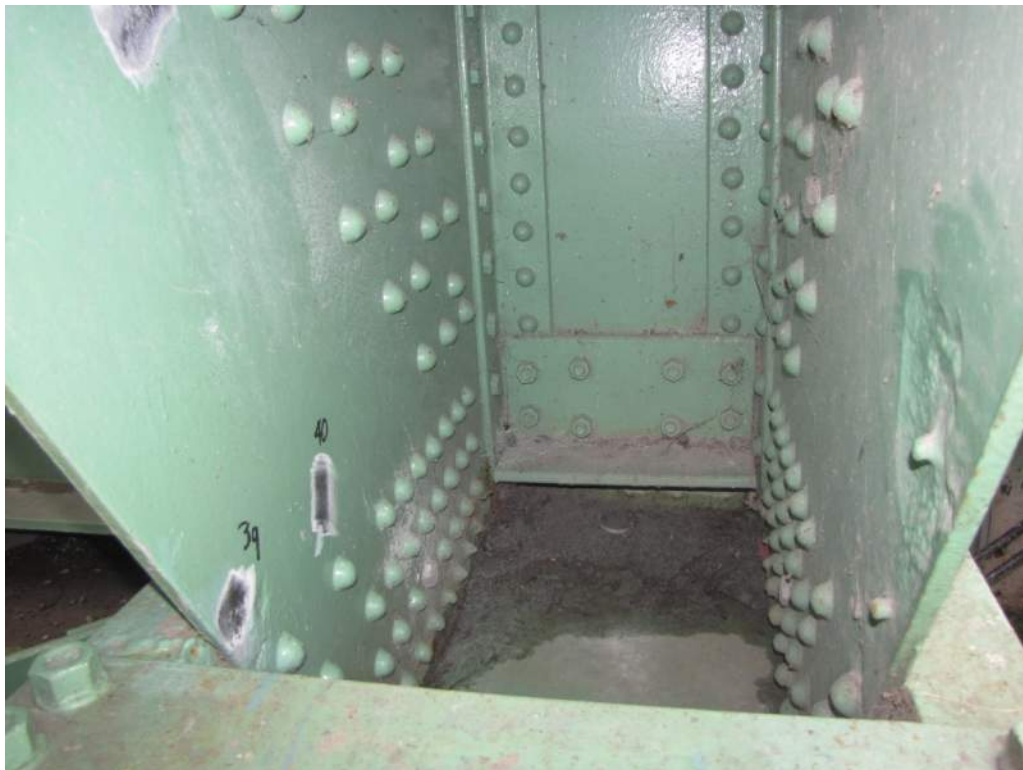
Photo S43: The interior faces of the plates and rivet heads at the base of the north trunnion have localized severe section loss.

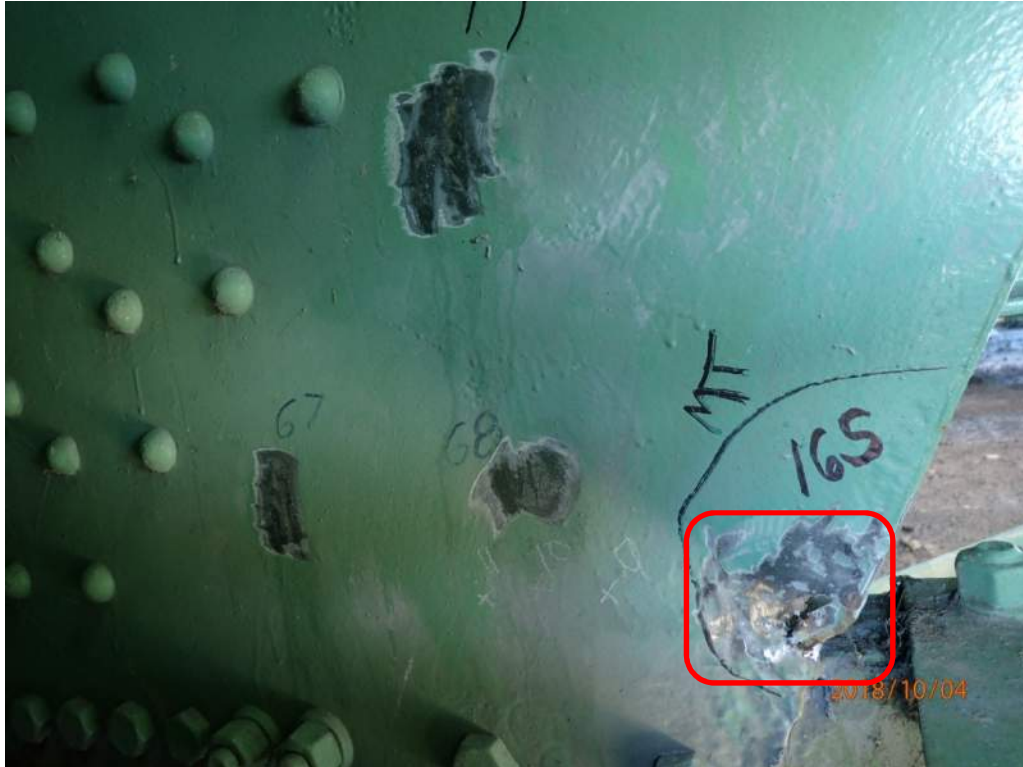
Photo S46: View of the interior of the north plate of the south trunnion below deck level. A crack was found at the perforation circled.

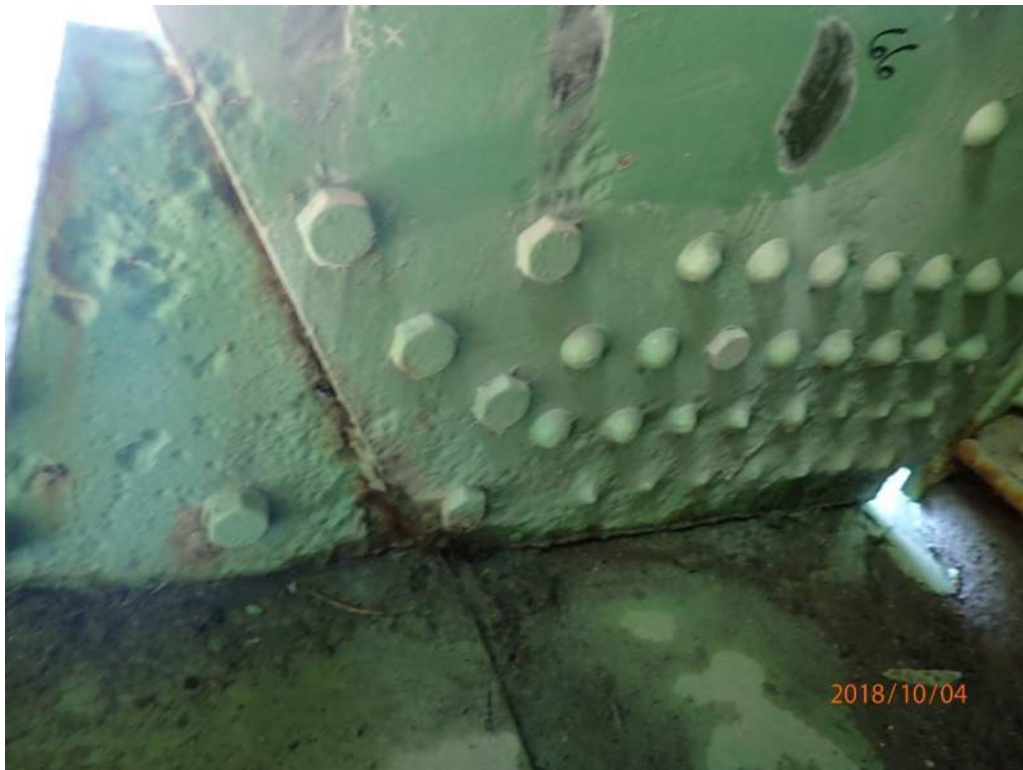
Photo S47: Severe pitting at the base of the interior face and rivet heads of the south plate of the south trunnion.

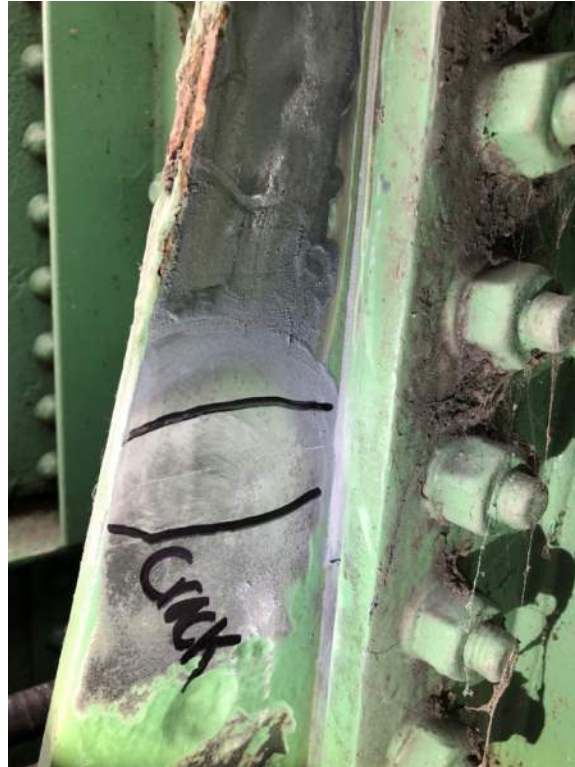
Photo S50: Crack in southwest vertical gusset plate at 2N (photo by Brouco NDT).

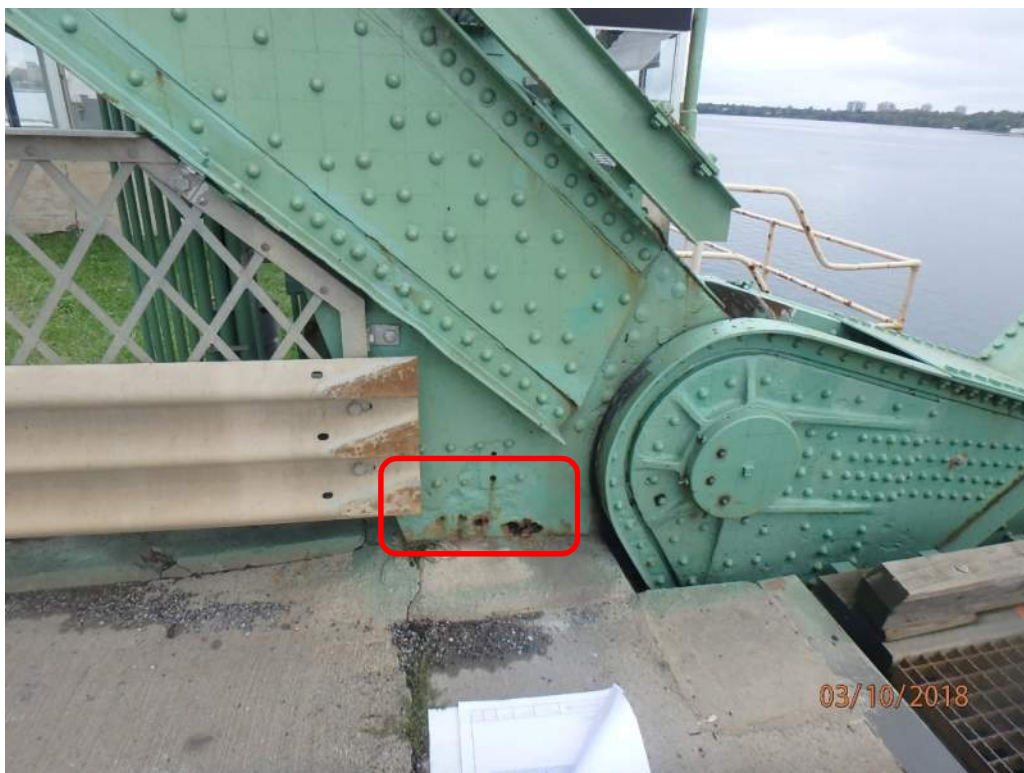
Photo S51: The vertical gusset plate at node 15N at roadway level exhibits very severe section loss and perforations.
