LaSalle Causeway Bascule Bridge 2018 Comprehensive Detailed Inspection Report

Project Number: R. 090045.001

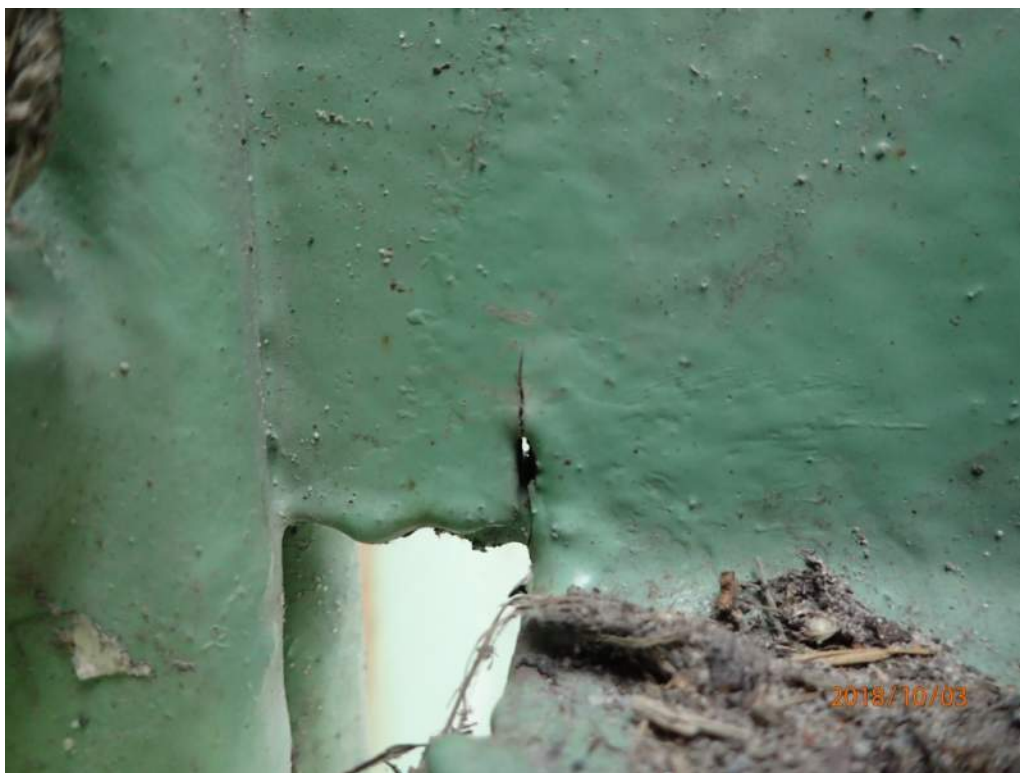
Photo S53: 15mm notch/crack in the bottom cope of Stringer E (FB0-FB2) at FB0.

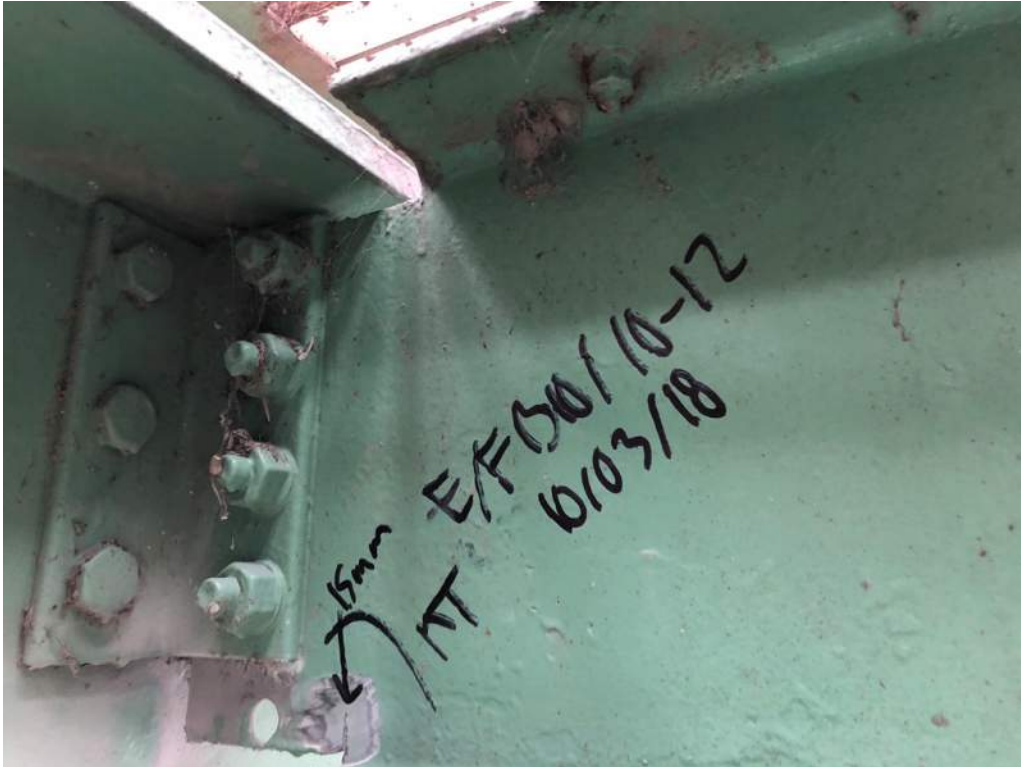
Photo S54: 15mm notch/crack in the bottom cope of Stringer E (FB10-FB12) at FB10 (photo by Brouco NDT).

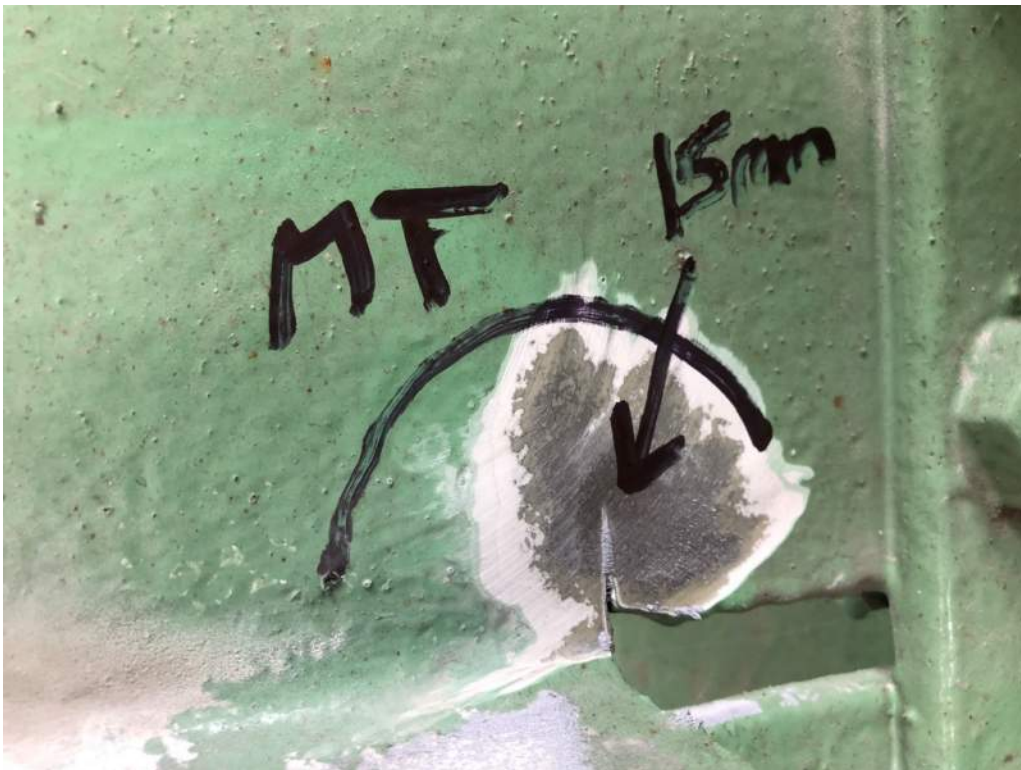
Photo S55: 15mm notch/crack in the bottom cope of Stringer D (FB14-FB16) at FB14 (photo by Brouco NDT).

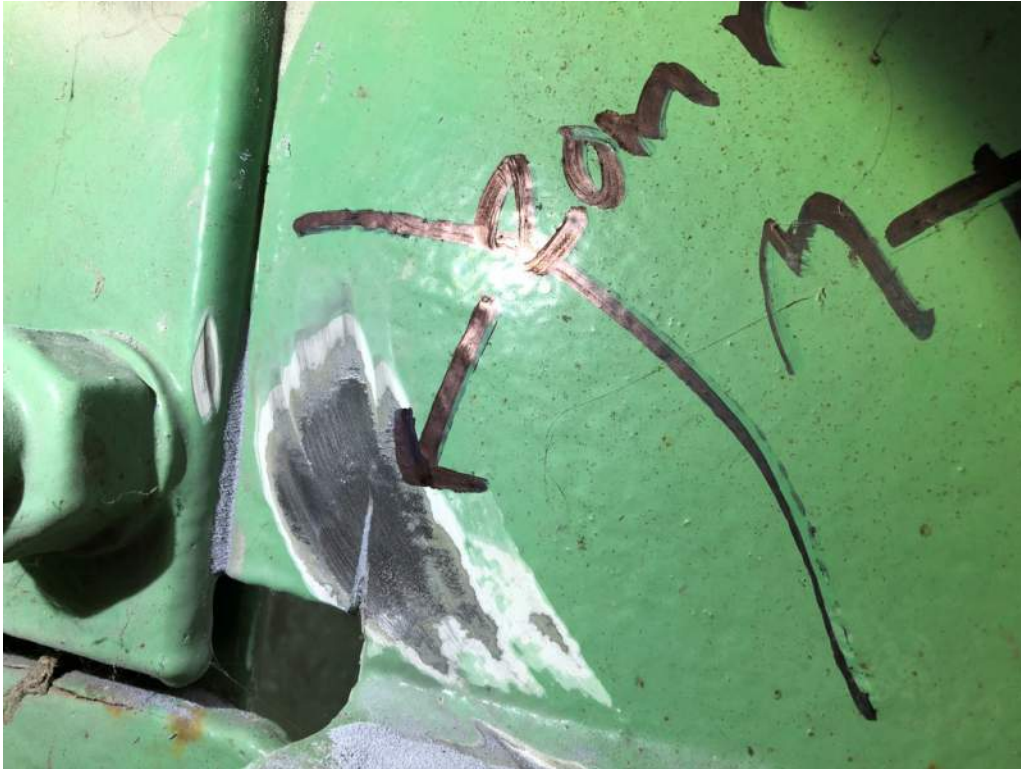
Photo S56: 20mm notch/crack in the bottom cope of Stringer E (FB14-FB16) at FB14 (photo by Brouco NDT).

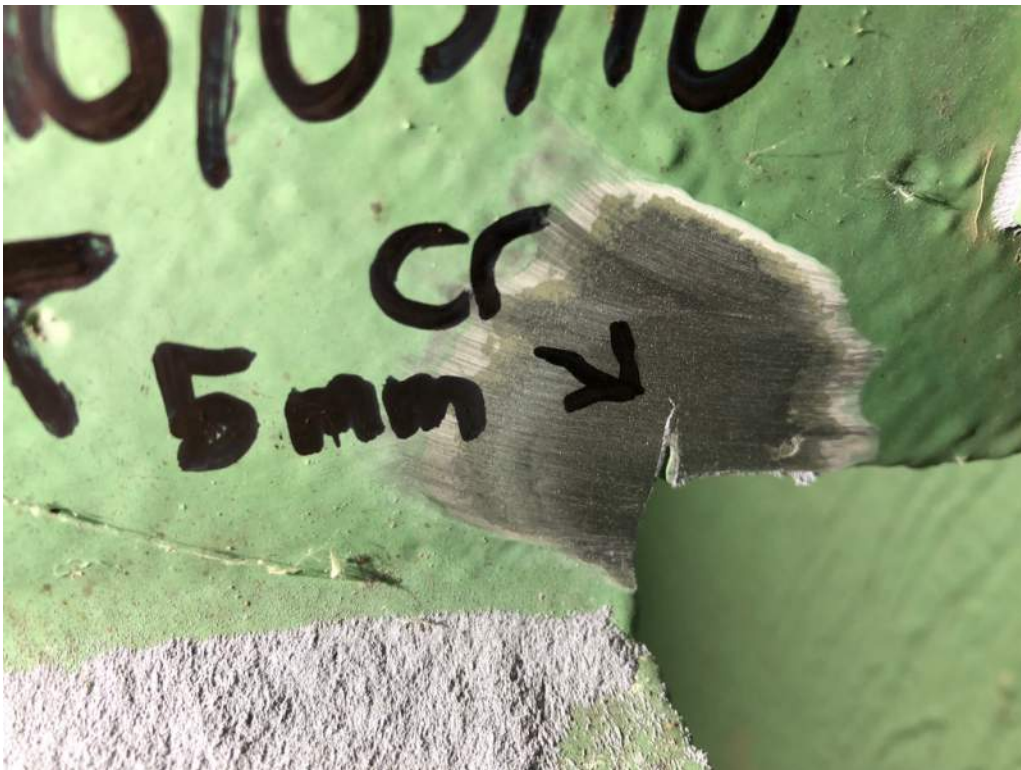
Photo S57: 5mm notch/crack in the bottom cope of Stringer I (FB14-FB16) at FB14 (photo by Brouco NDT).

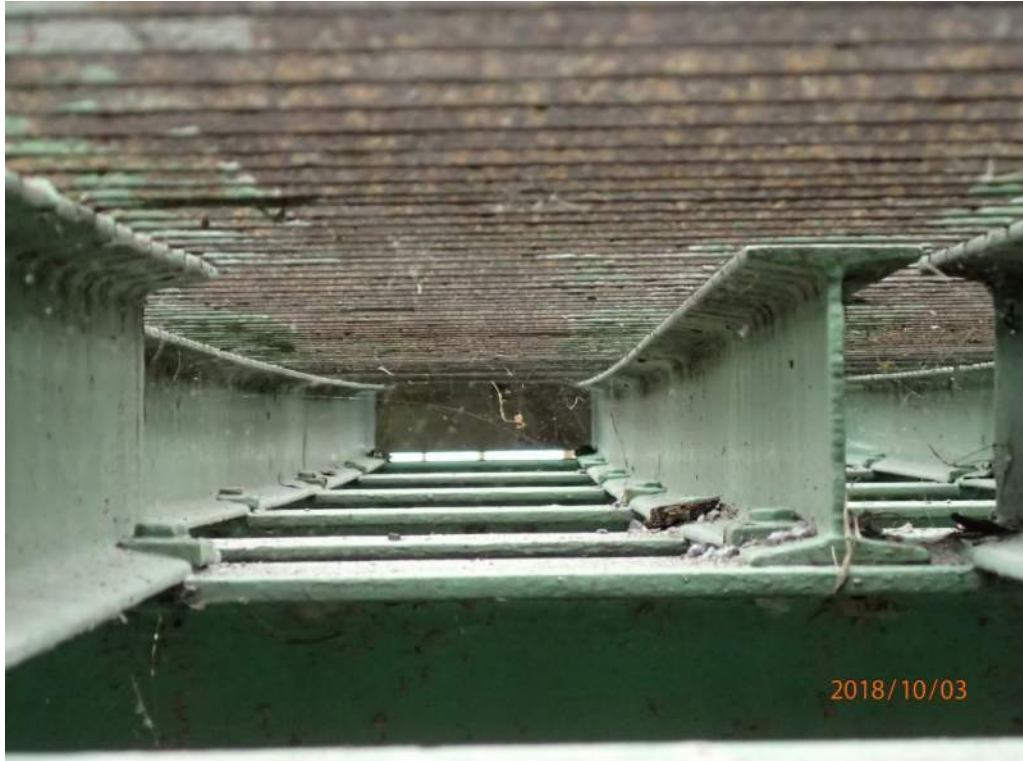
Photo S58: The sills supporting the deck grating are typically permanently deflected.

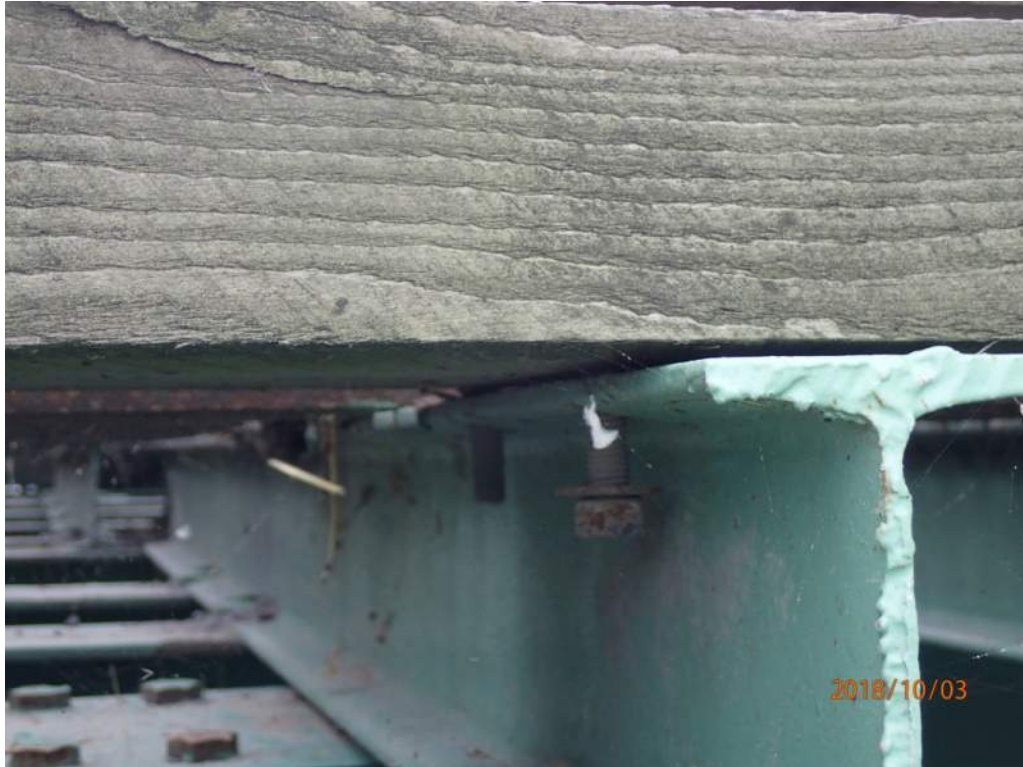
Photo S60: Several of the bolts connecting the north timber curb to the sills at the east end are loose.

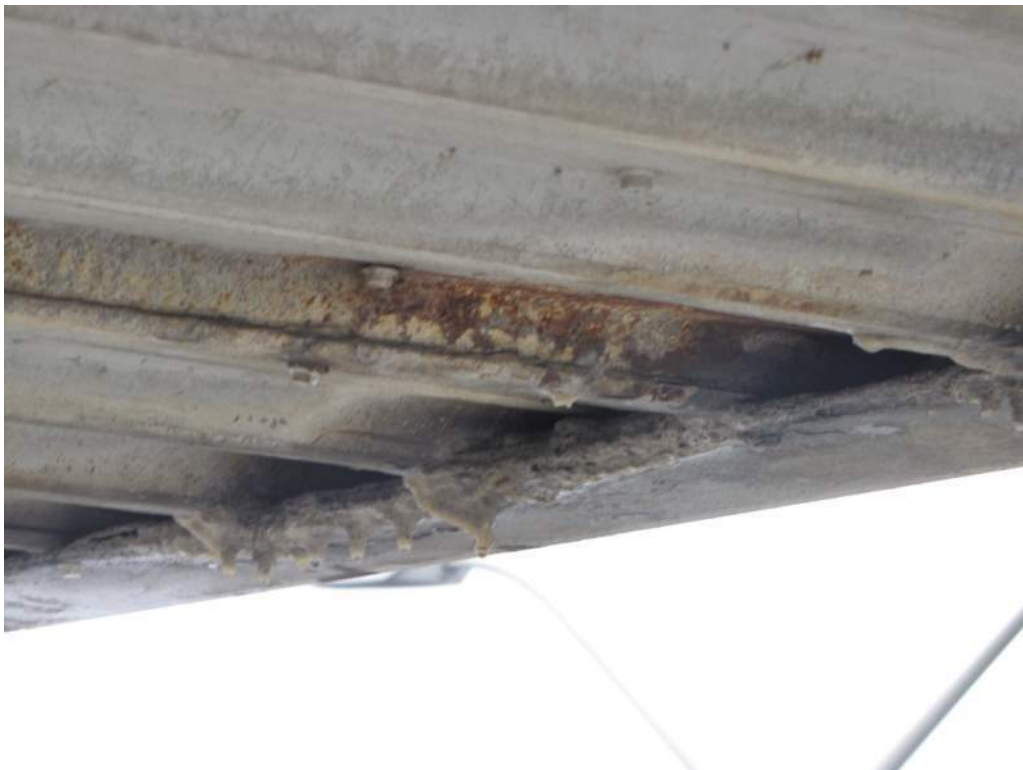
Photo S61: The underside of the east edge of the counterweight panelling is leaking and exhibits corrosion and efflorescence deposits.

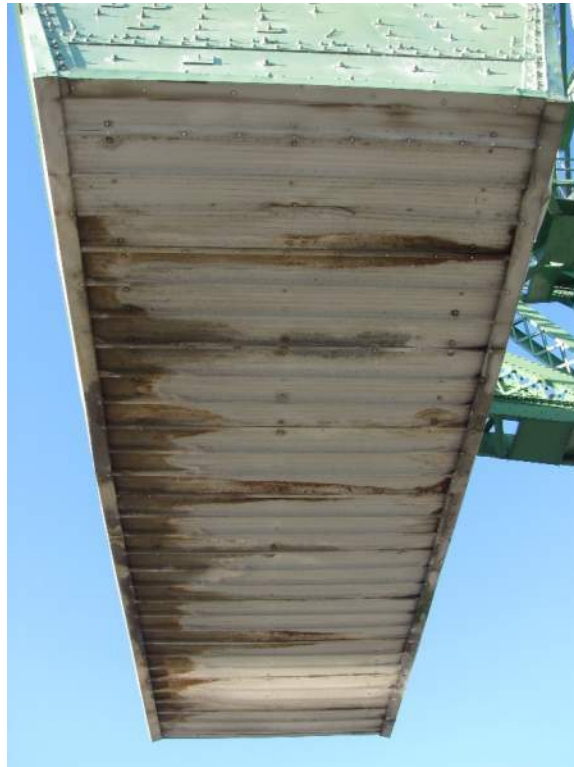
Photo S62: The panels on the underside of the counterweight have widespread corrosion and wet areas/stains.

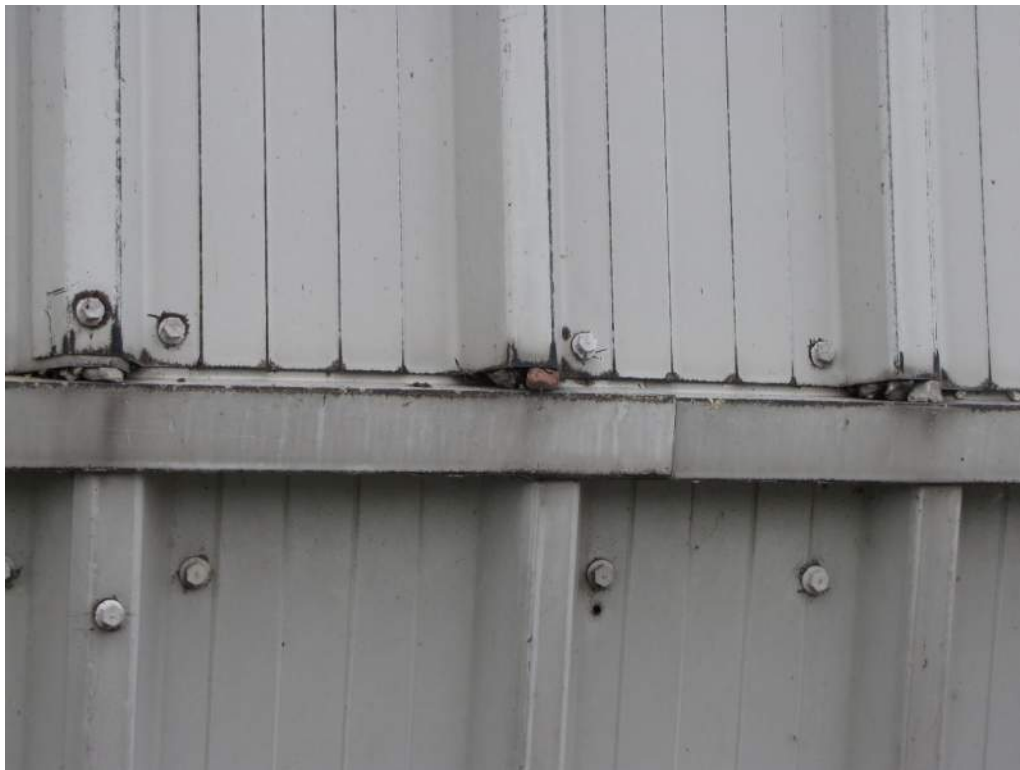
Photo S63: Gaps in the counterweight panels are permitting smaller pieces of aggregate from the disintegrated counterweight concrete to fall onto the roadway below.

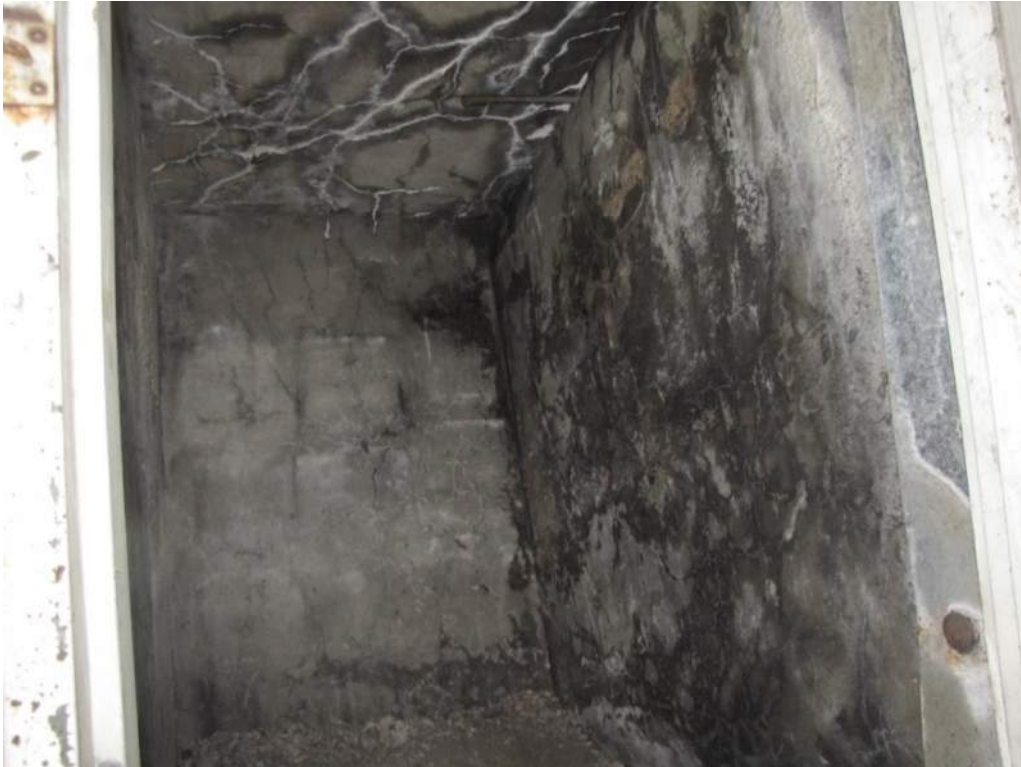
Photo S64: Spalls, disintegration, map cracking, efflorescence deposits, and wet stains were typically noted in the counterweight concrete inside the two voids in the east face (photo from 2017 inspection).

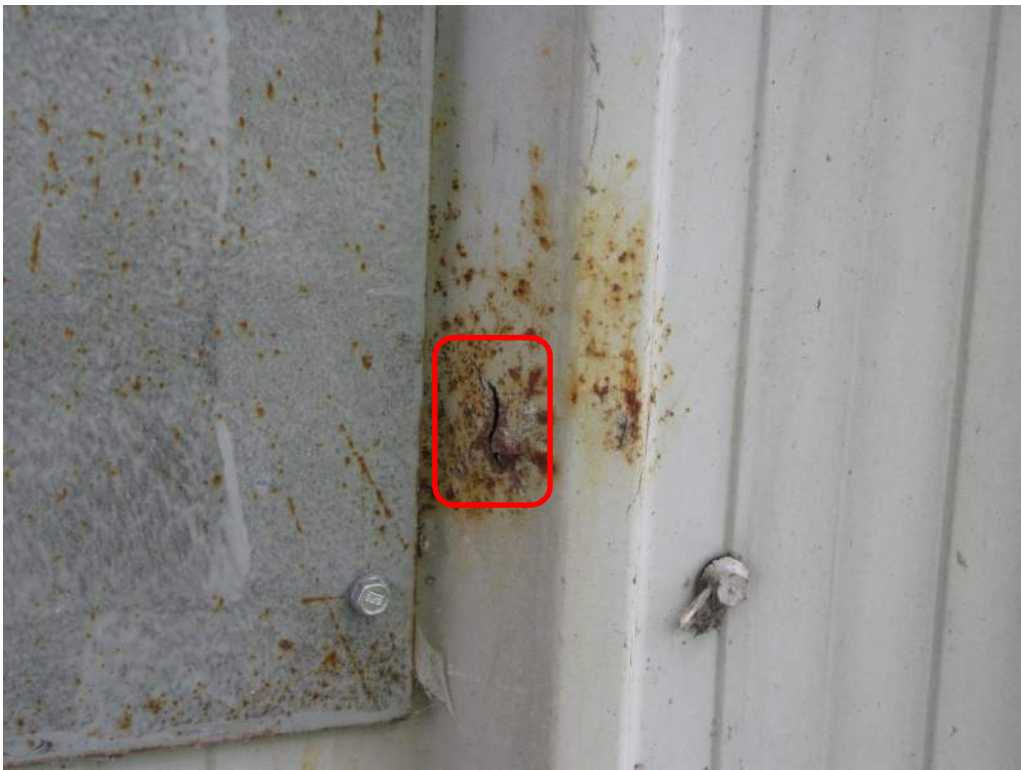
Photo S65: There is a small perforation beneath the north door in the east face of the counterweight panels adjacent to the previous repair.

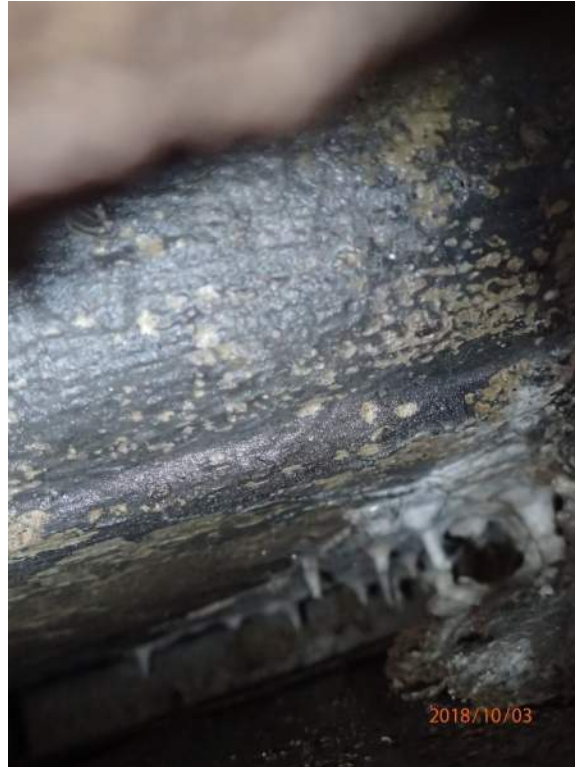
Photo S66: Efflorescence deposits and staining on the underside of the counterweight concrete.

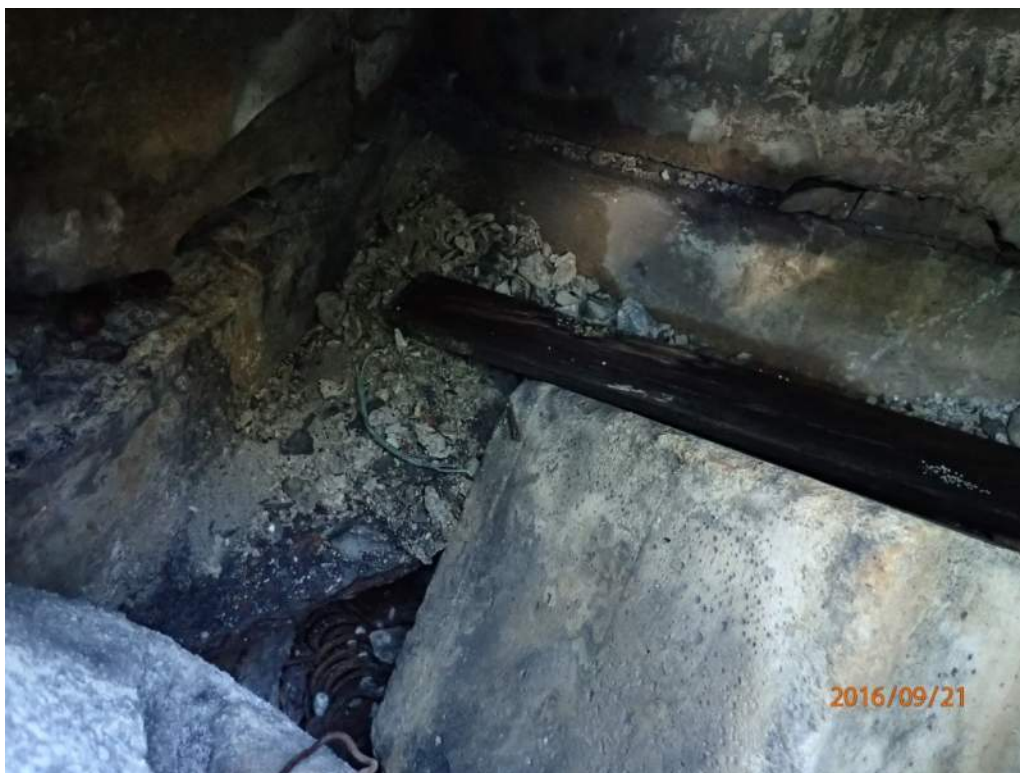
Photo S67: The concrete in the two upper chambers in the top face of the counterweight exhibits spalls, disintegration, and wet areas (2016 photo).

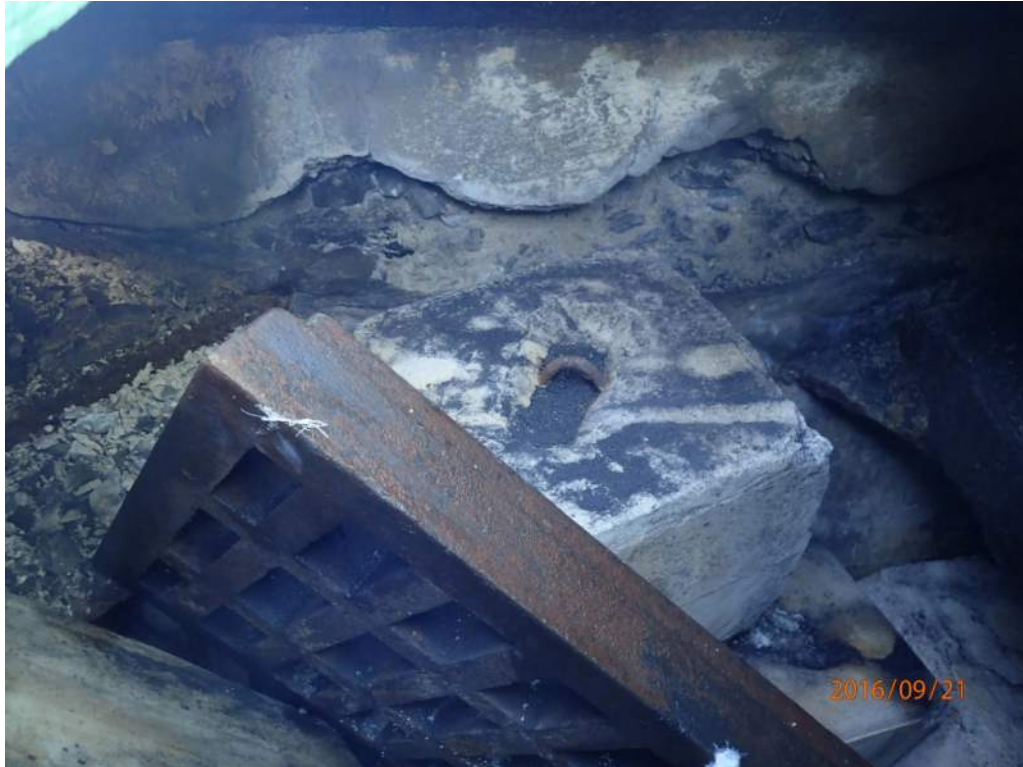
Photo S68: The concrete in the two upper chambers in the top face of the counterweight exhibits spalls, disintegration, and wet areas (2016 photo).

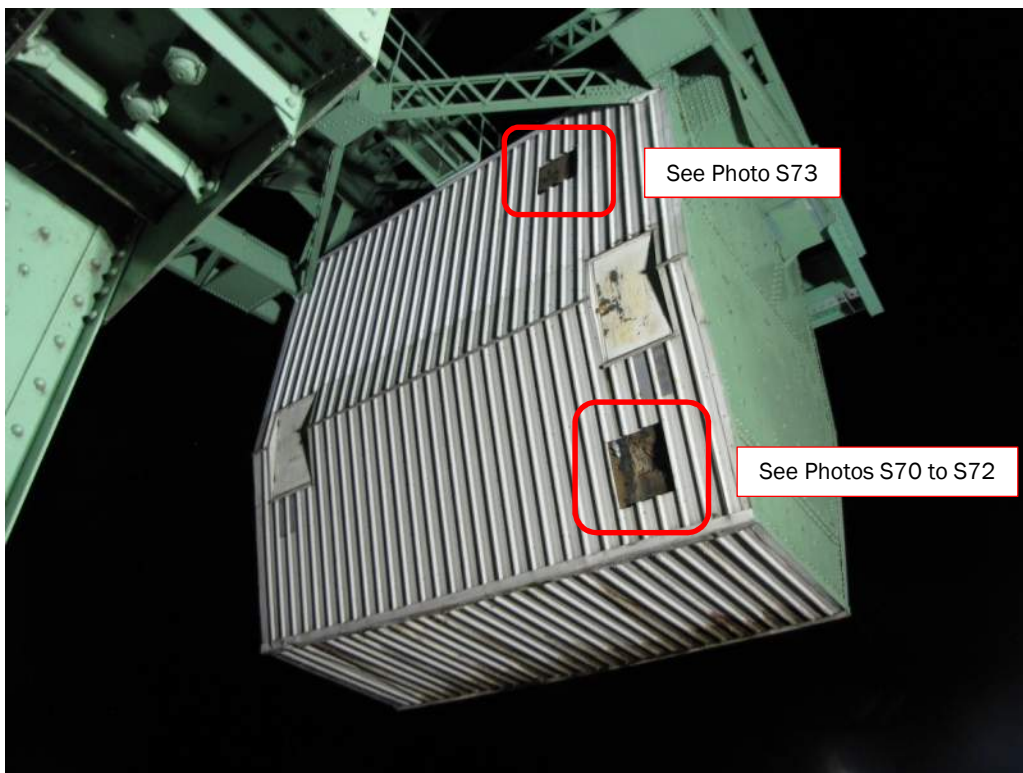
Photo S69: Locations of cladding removal in the northeast corner of the counterweight.

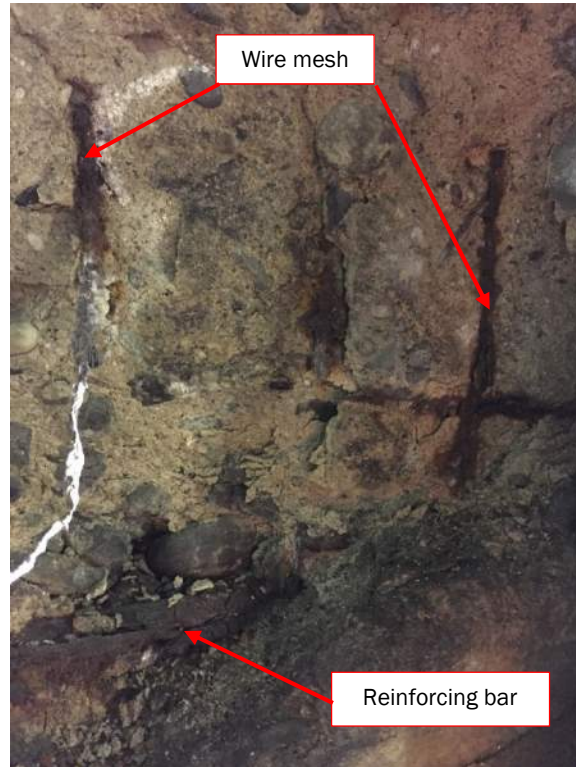
Photo S70: The counterweight concrete in the lower northeast corner exhibits a very severe spall/disintegration, delaminated areas, and exposed and corroded reinforcing bars and wire mesh.

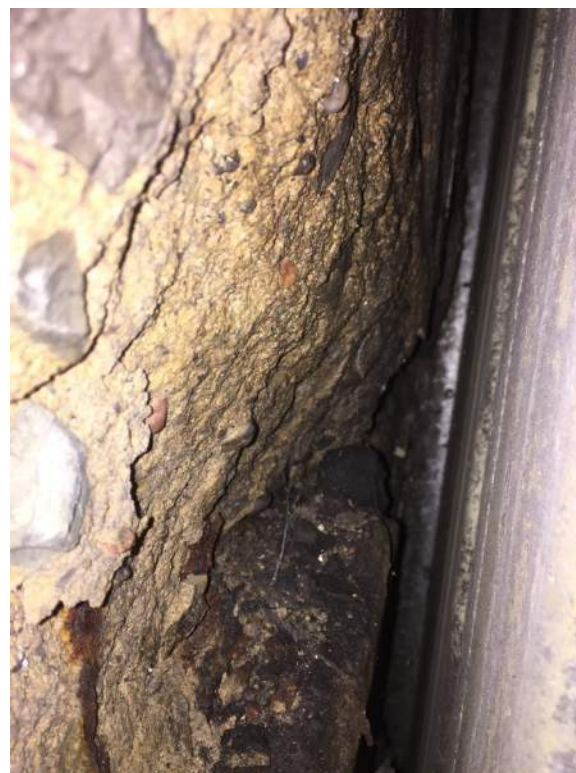
Photo S71: Very severe spall/disintegration of the counterweight concrete in the lower northeast corner (looking north).

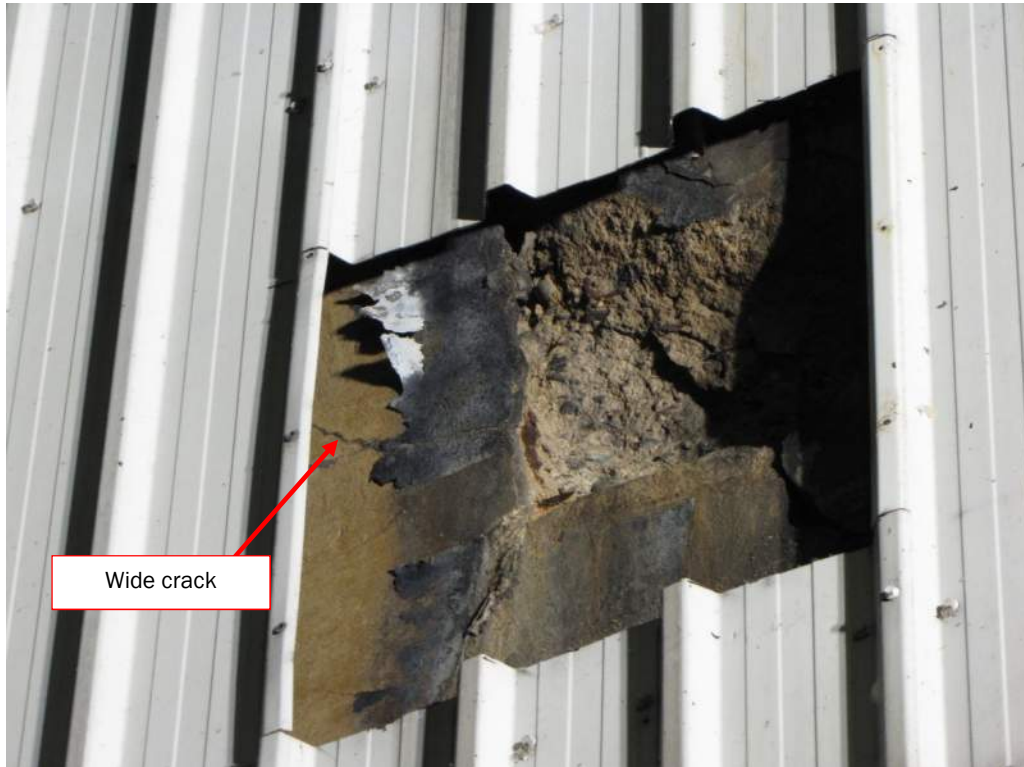
Photo S72: The counterweight concrete in the lower northeast corner has a severe spall/disintegration and a wide diagonal crack that extends at least 2 metres.

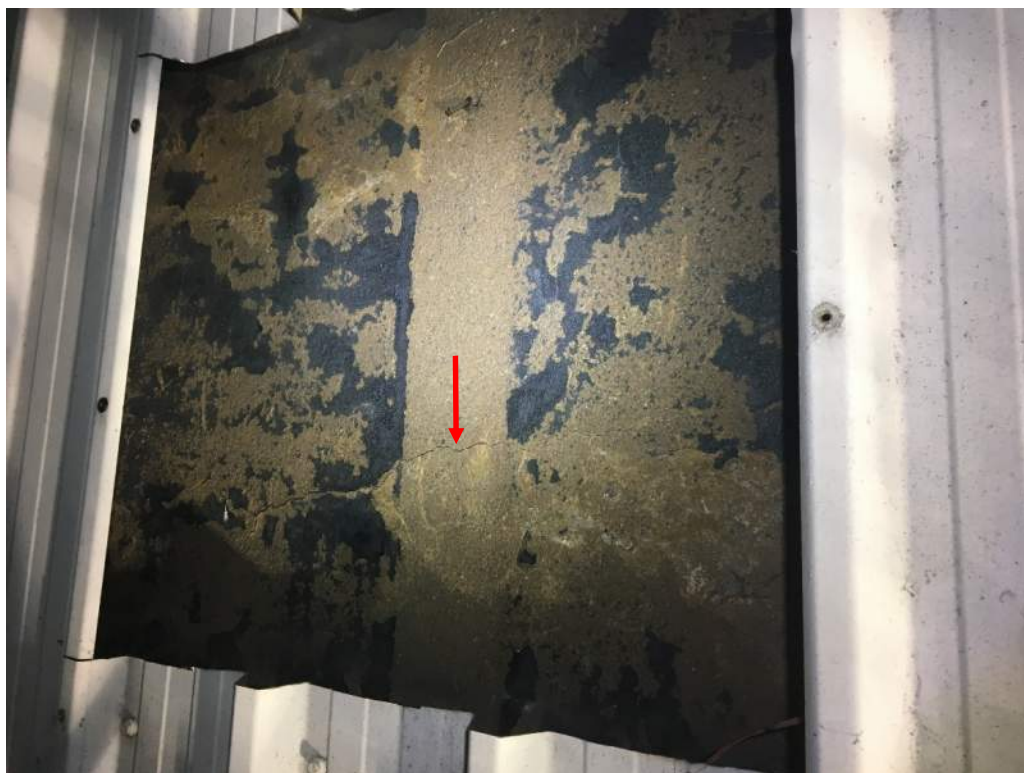
Photo S73: The counterweight concrete in the upper northeast corner has a wide crack but is otherwise in generally good condition (photo by Gemtec).

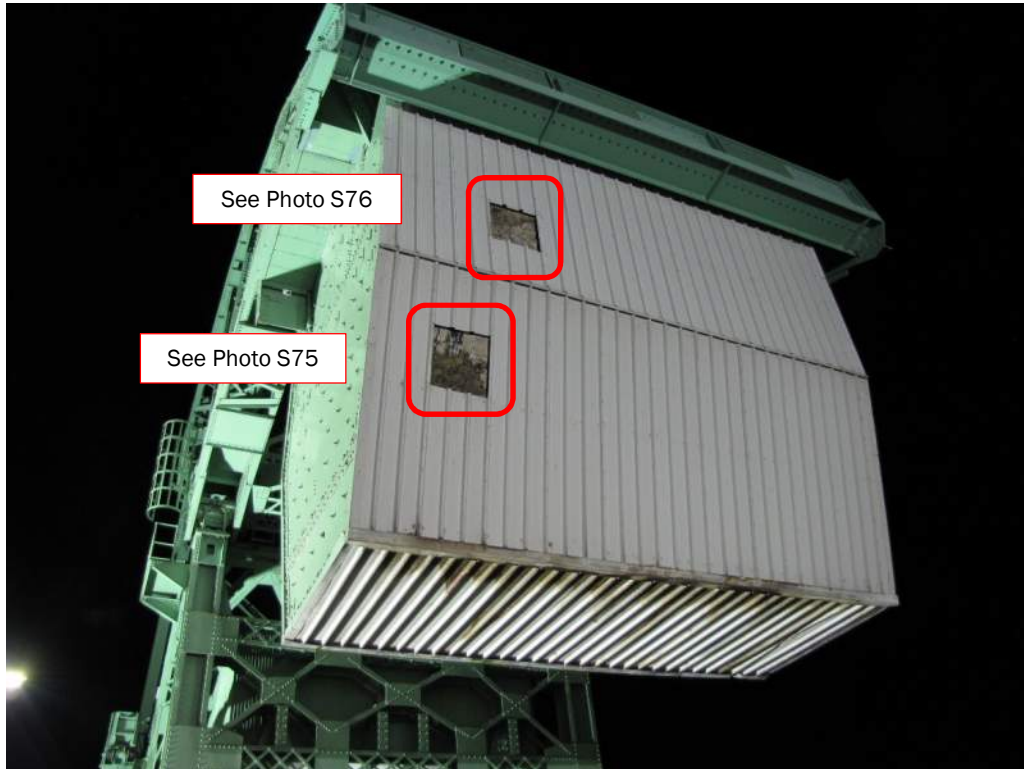
Photo S74: Locations of panel removal in the northwest corner of the counterweight.

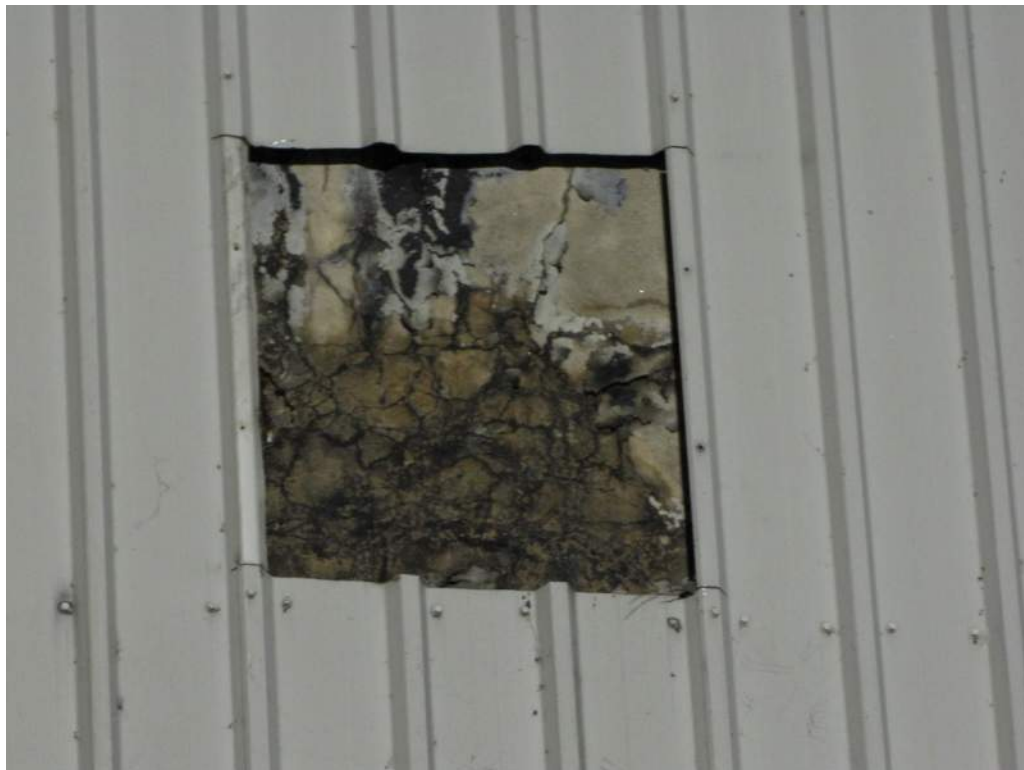
Photo S75: The counterweight concrete in the lower northwest corner exhibits widespread wide map cracking and a wet area.

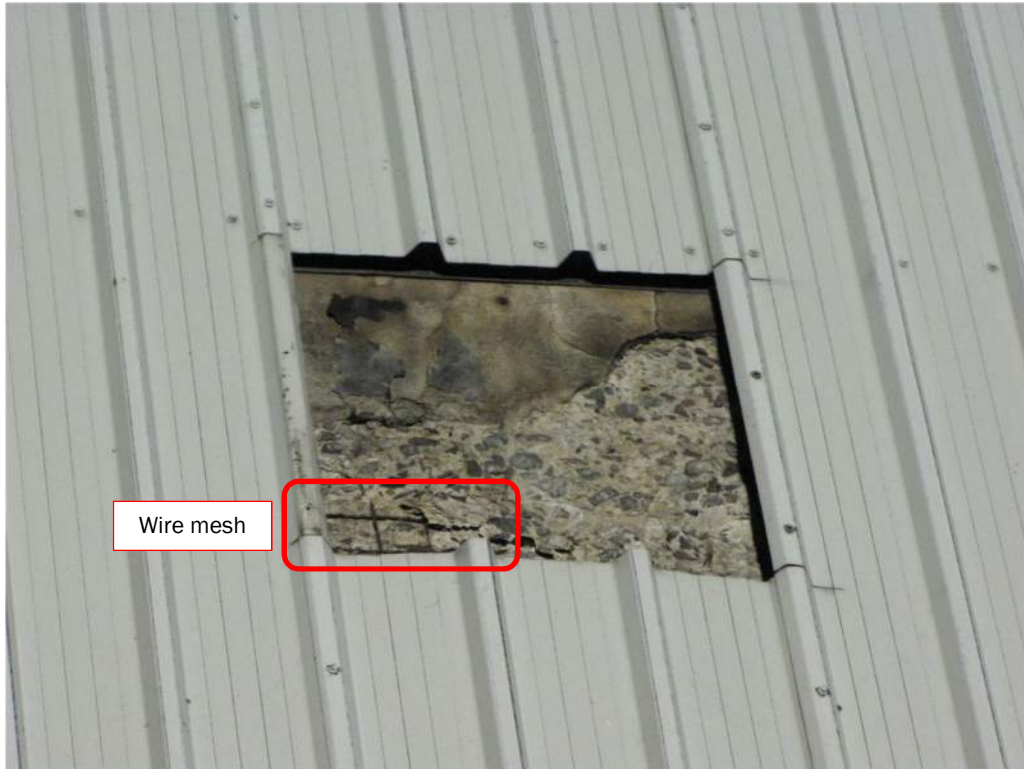
Photo S76: The counterweight concrete in the upper northwest corner exhibits a large area of disintegration, delaminated areas, and exposed and corroded wire mesh.

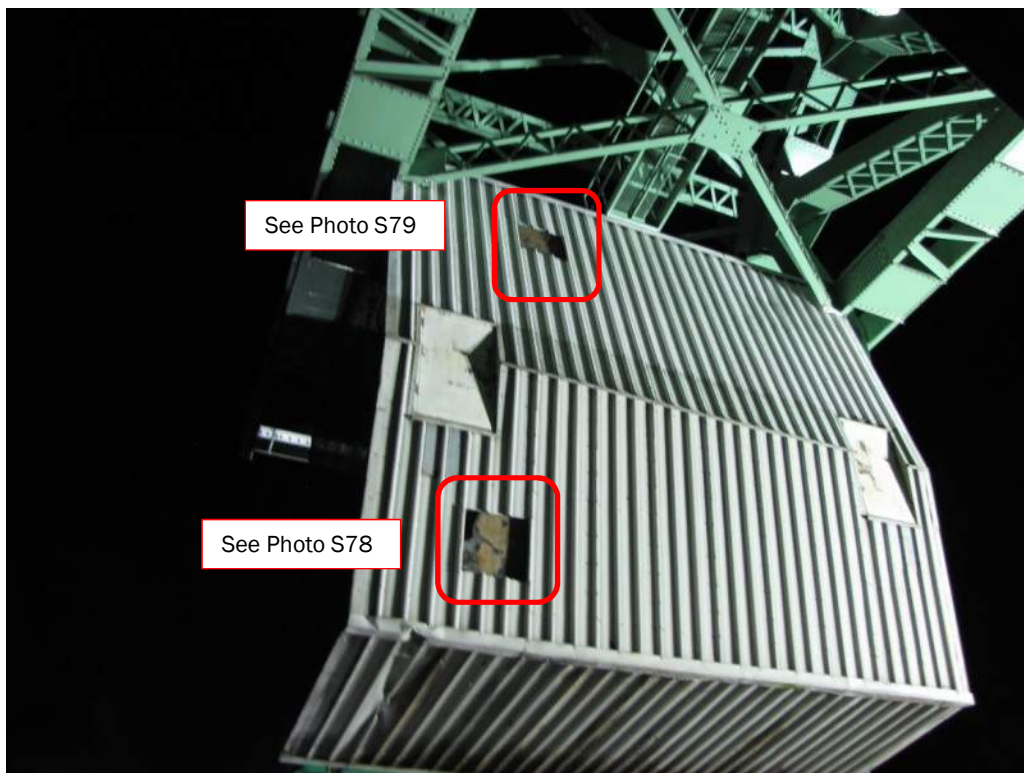
Photo S77: Locations of panel removal in the southeast corner of the counterweight.

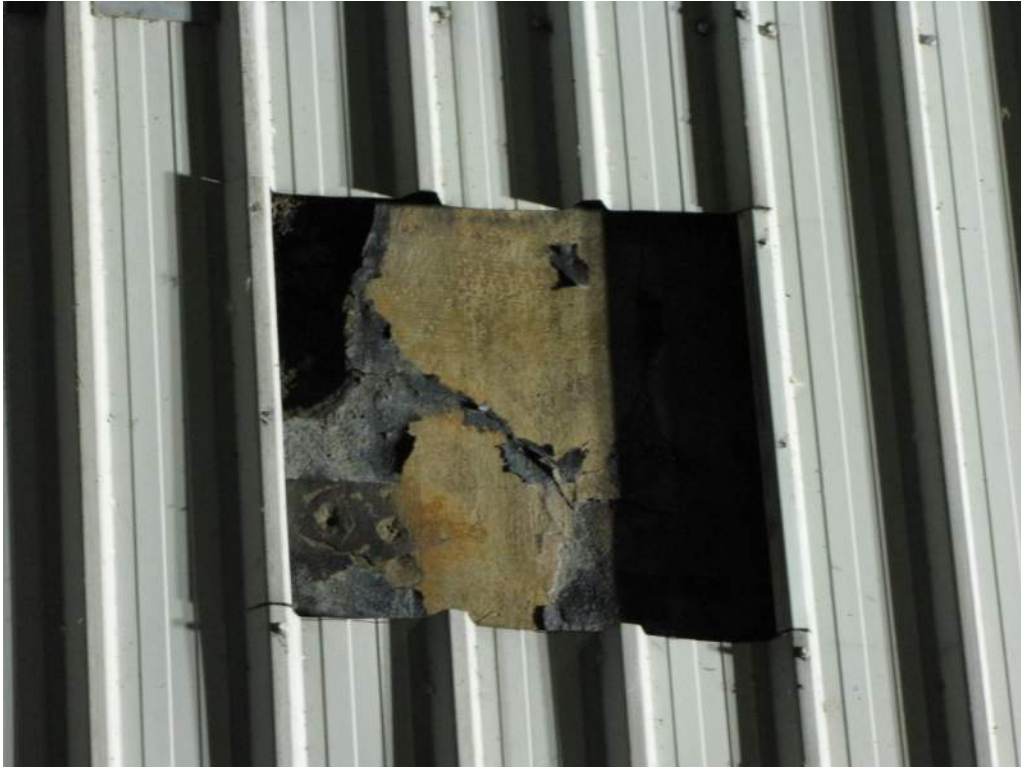
Photo S78: The counterweight concrete in the lower northwest corner exhibits a severe spall and wide cracks.

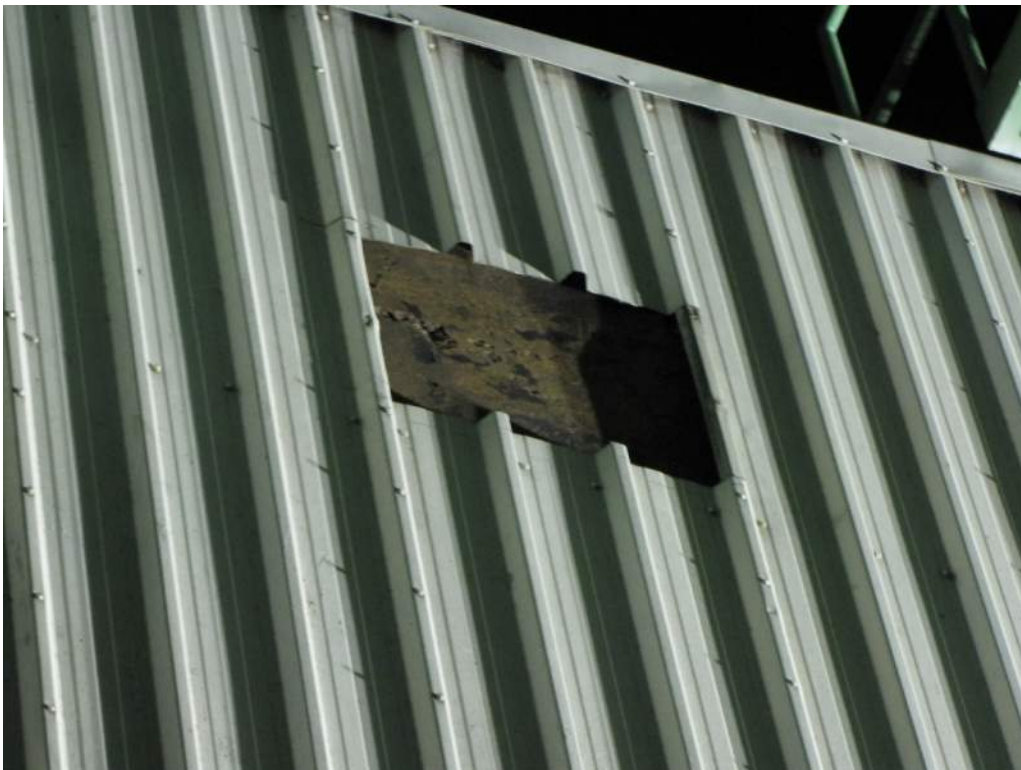
Photo S79: The counterweight concrete in the upper northwest corner exhibits wide cracks.

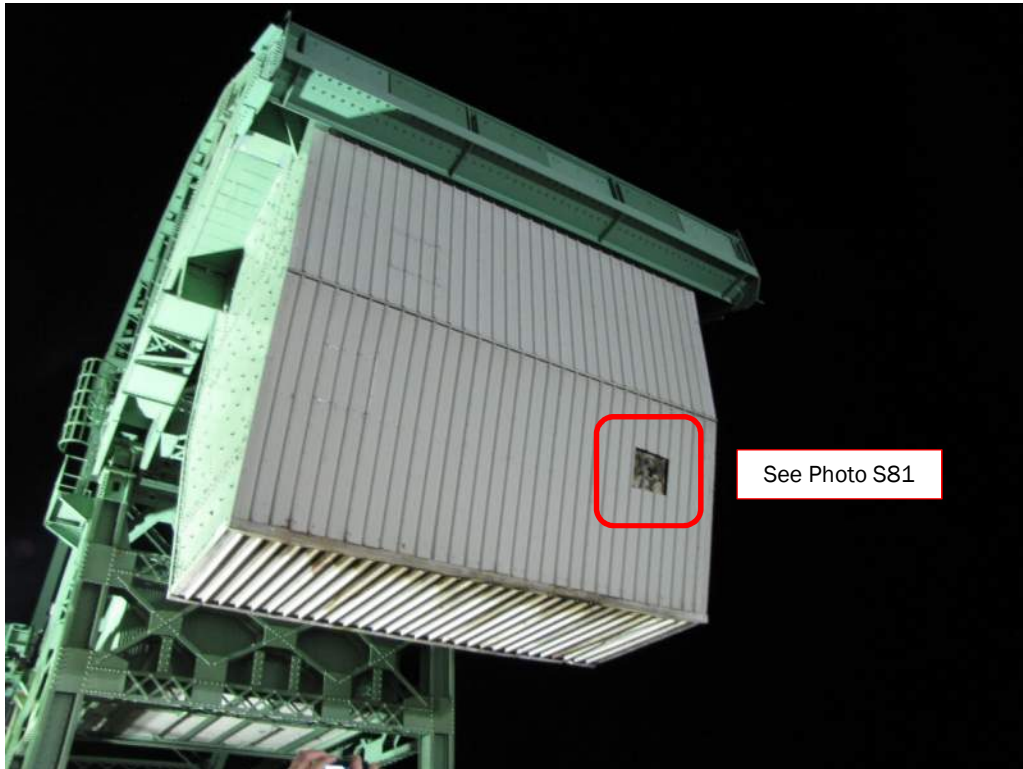
Photo S80: Location of panel removal in the southwest corner of the counterweight.

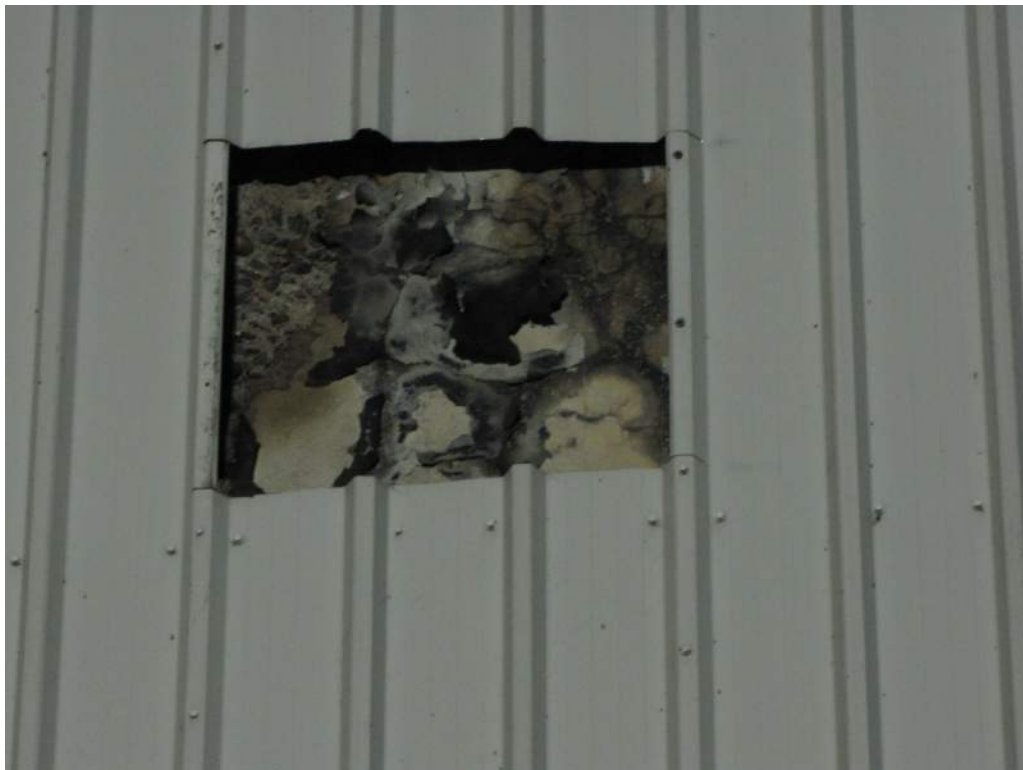
Photo S81: The counterweight concrete in the lower southwest corner exhibits an area of disintegration, and map cracking with wet stains.

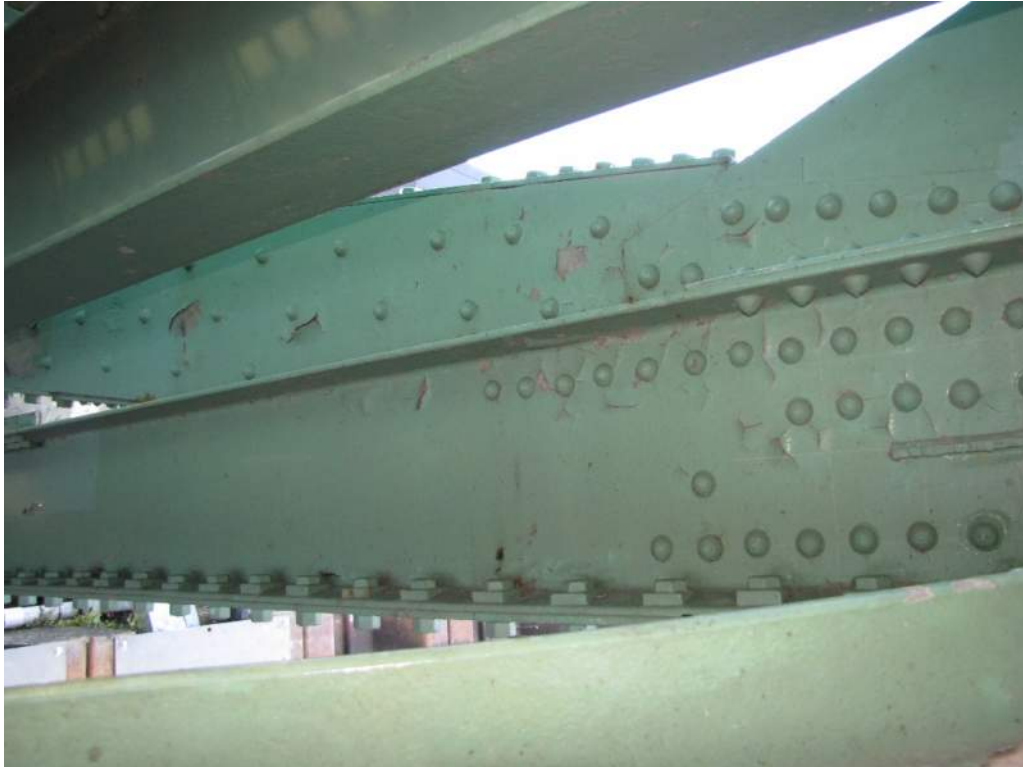
Photo S82: The painted coating is cracking and peeling off at several locations on the structure (members 14N-15N and 14N-16N shown).

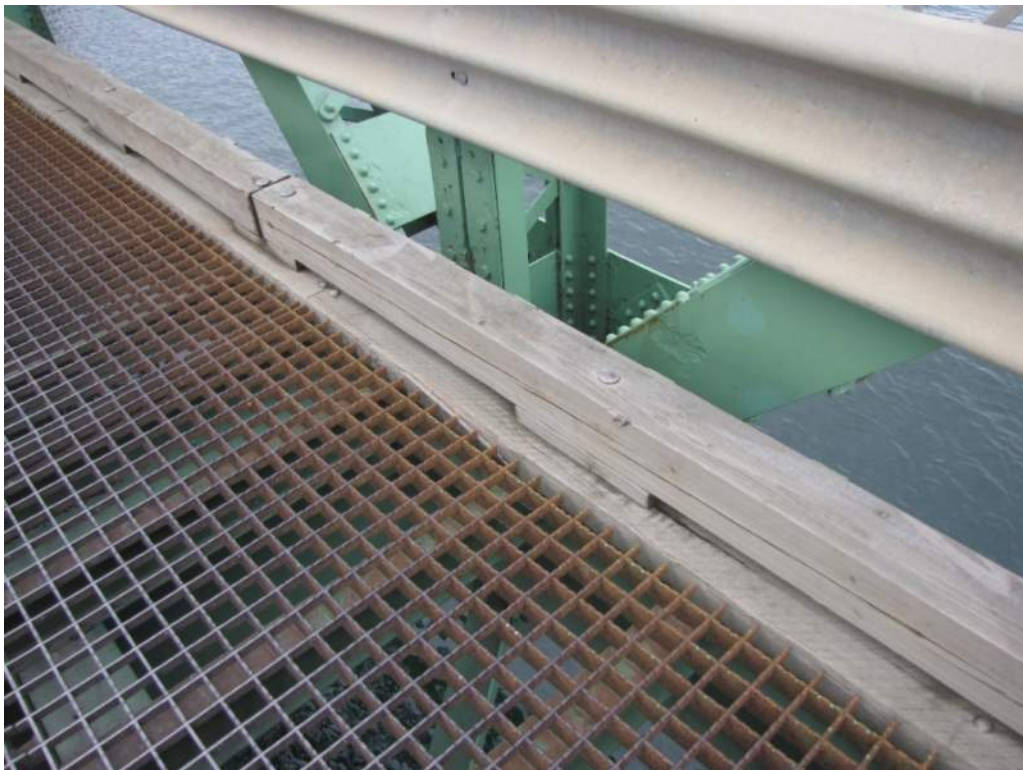
Photo S83: The roadway grating has widespread light to medium corrosion along the north and south edges (north side shown).
