LaSalle Causeway Bascule Bridge 2018 Comprehensive Detailed Inspection Report

Project Number: R. 090045.001

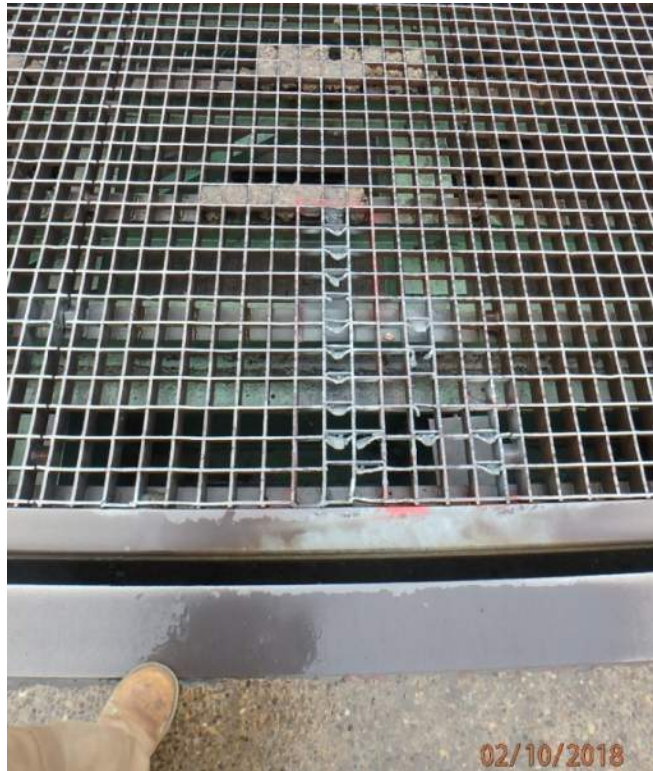
Photo S84: Repairs have recently been carried out to areas of the steel deck grating with broken and bent bars (east end shown).

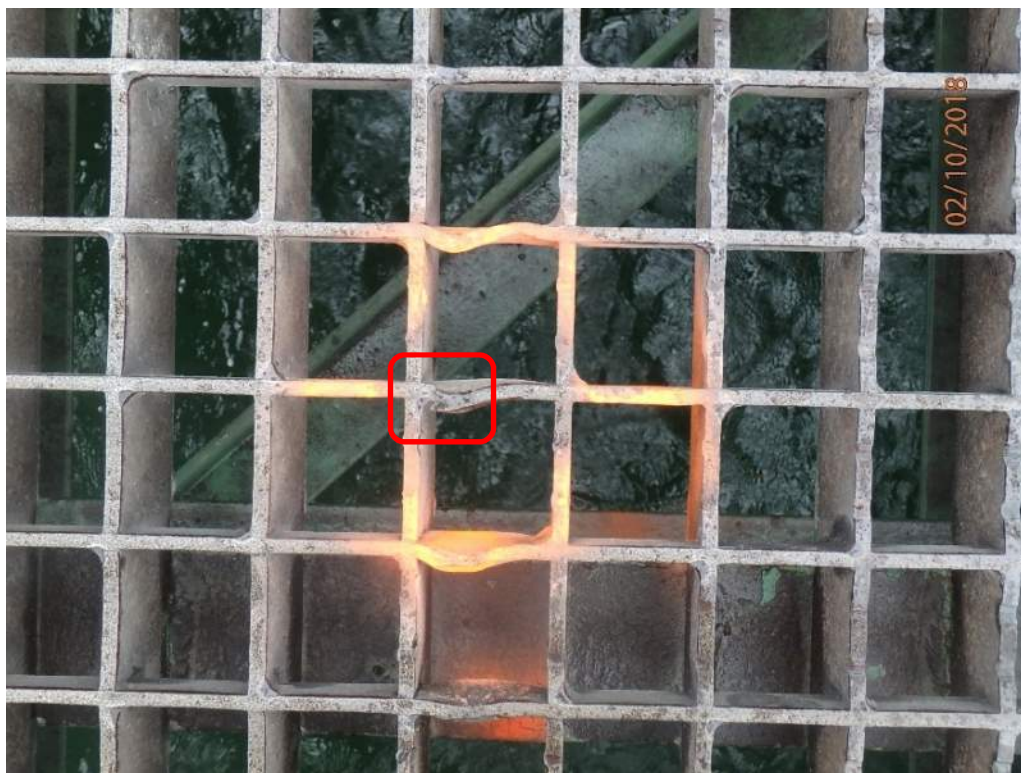
Photo S85: Cracked bar in deck grating panel 14-15 B. The serrated edges have been completely worn away within the wheel tracks.

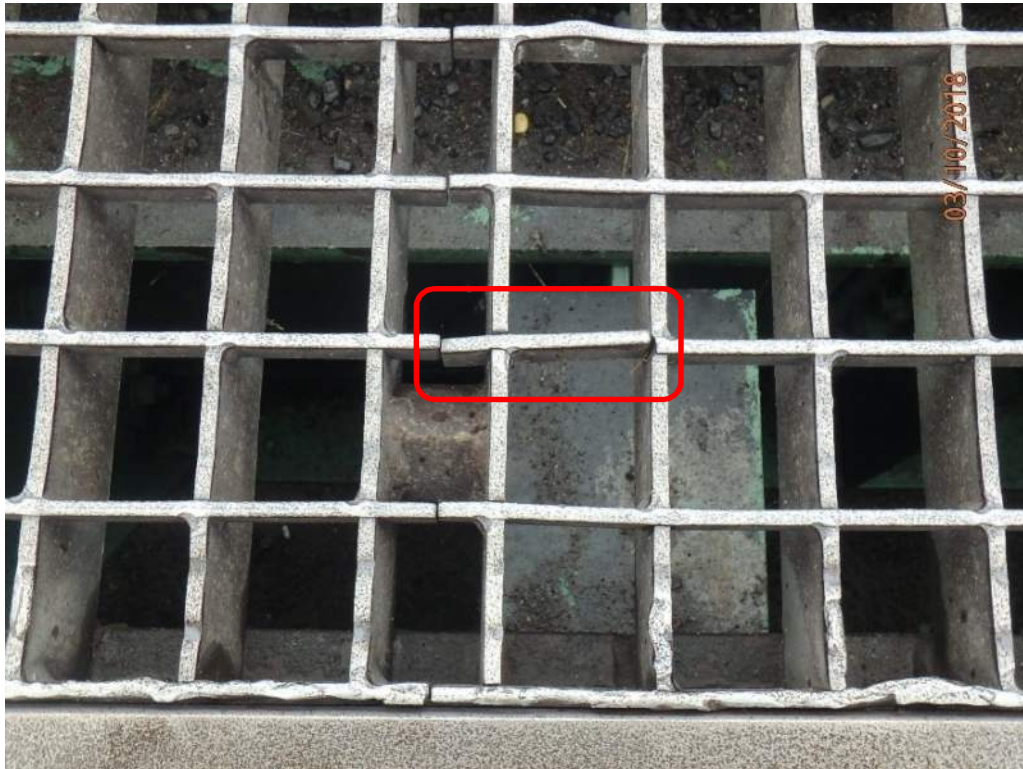
Photo S86: Broken bar in deck grating panel 0-2 G. The serrated edges have been completely worn away within the wheel tracks.

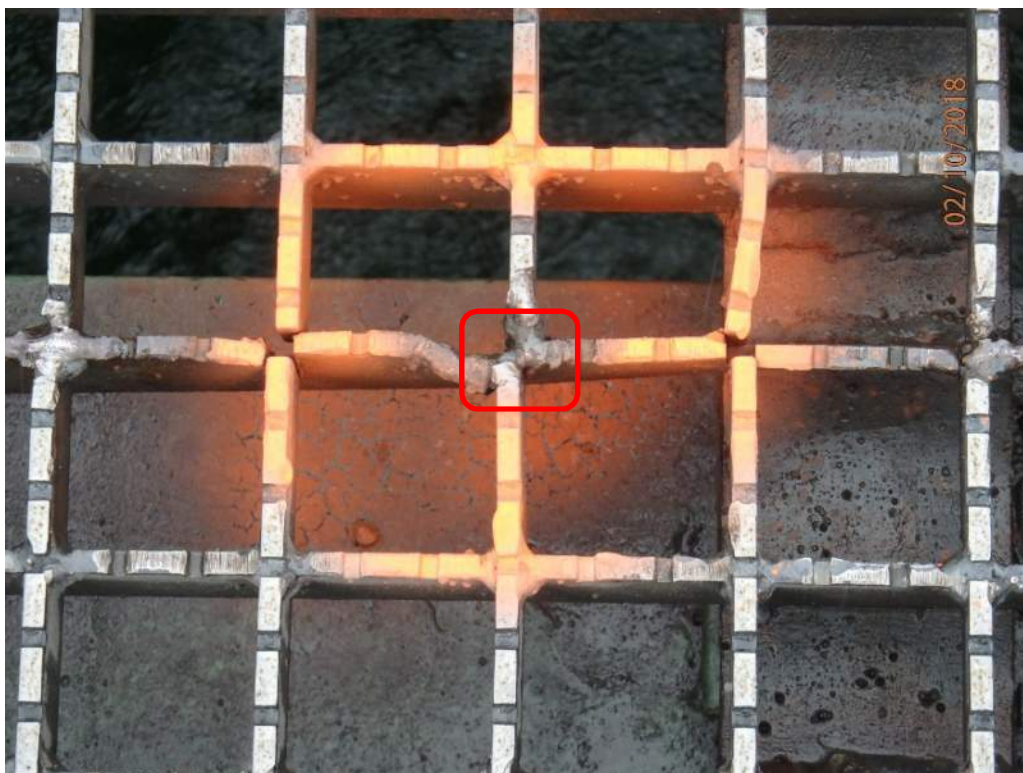
Photo S87: Cracked weld in deck grating panel 10-12 C.

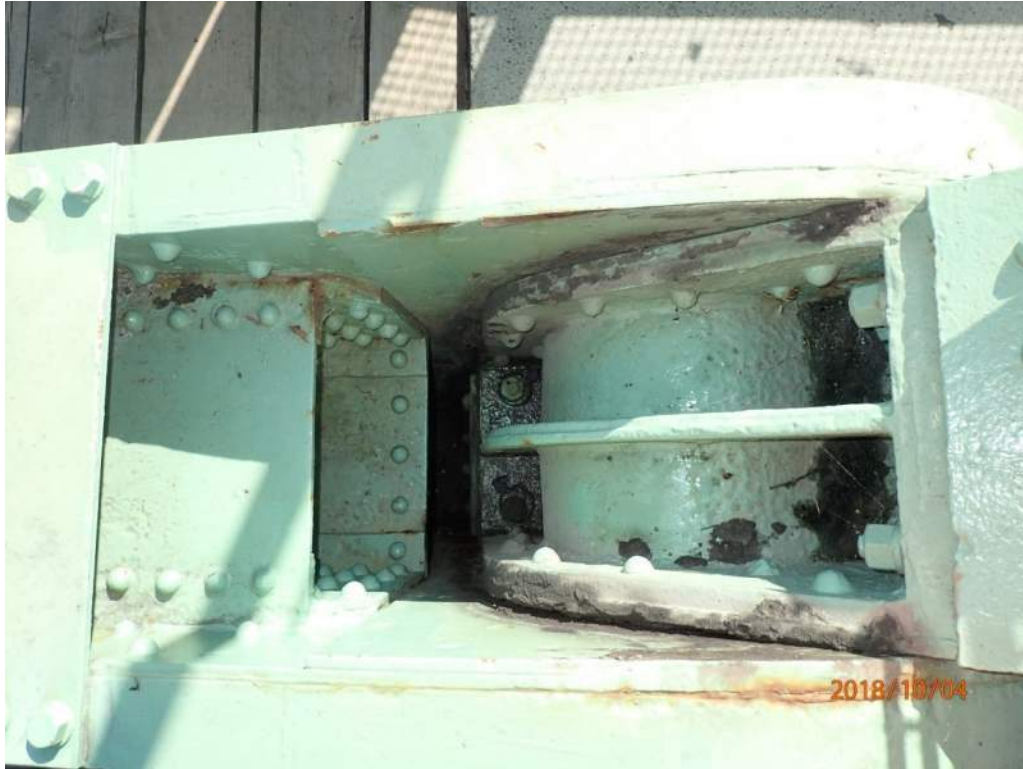
Photo S88: View of the top of the south trunnion.

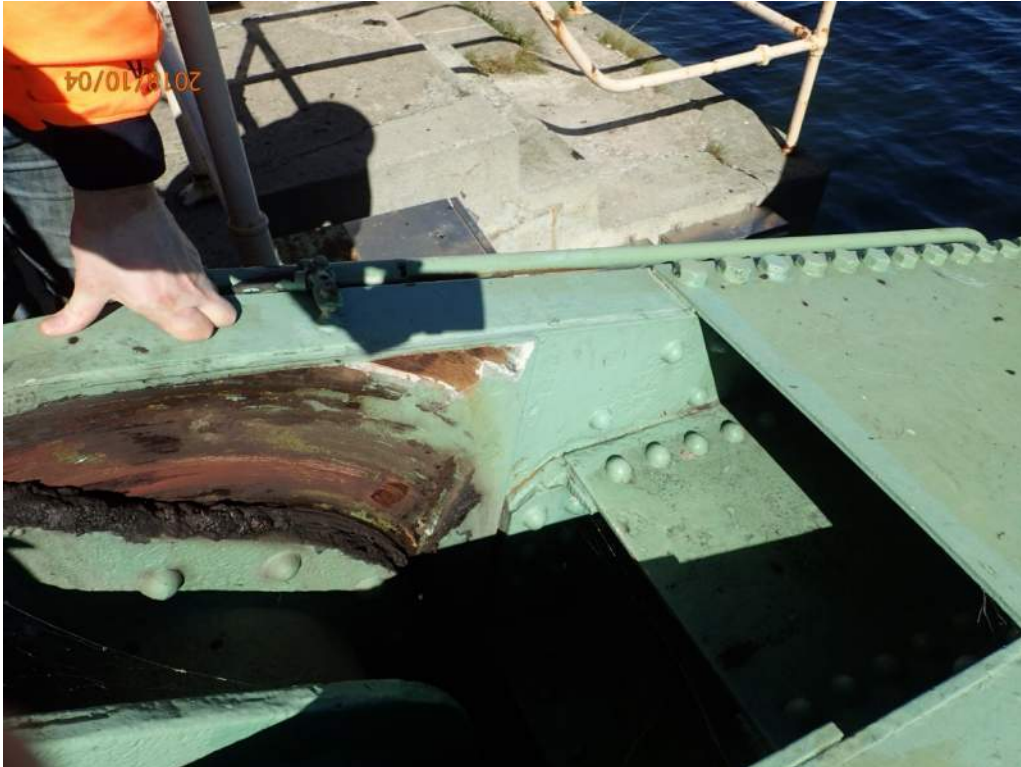
Photo S90: Areas of coating on the interior of the north plate of the north trunnion have been worn away.

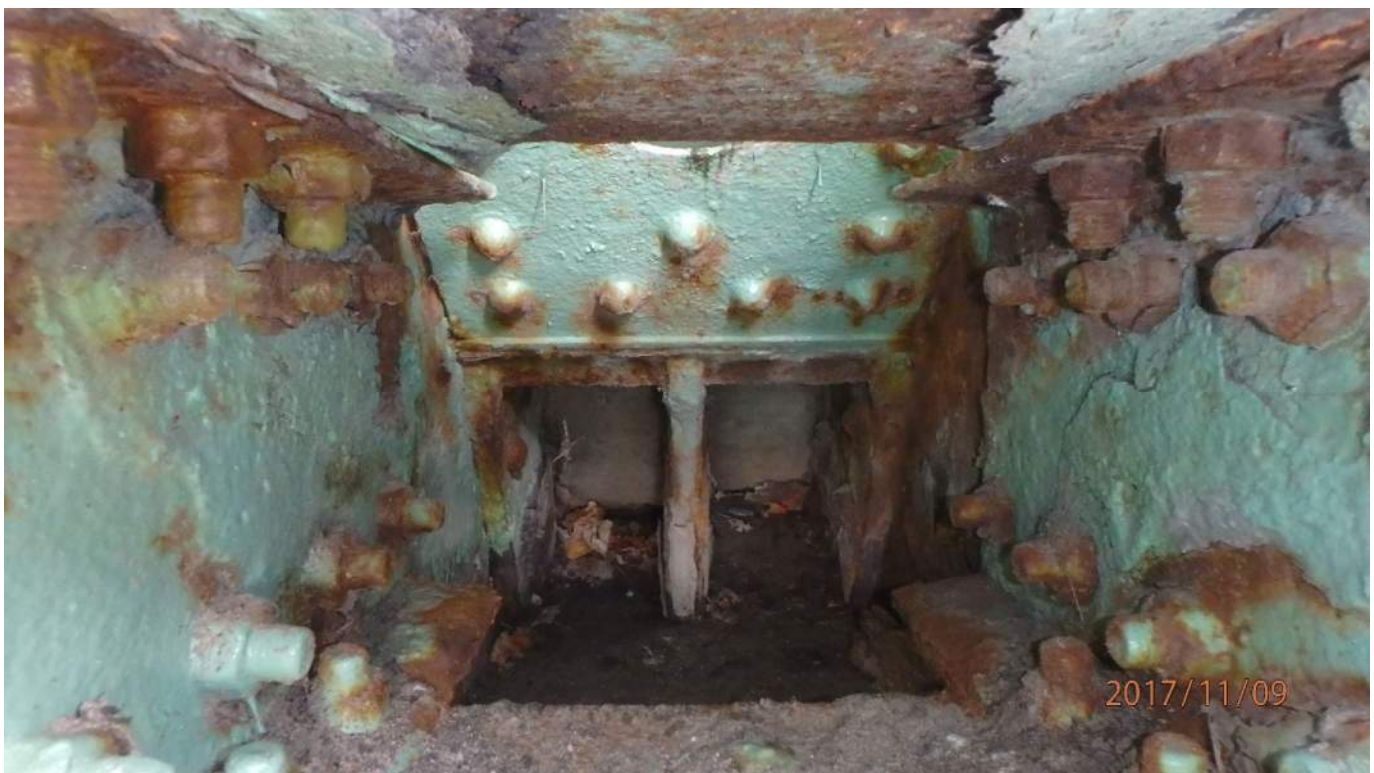
Photo S91: View of the west side of the south trunnion. Note the severe corrosion of member 15S-18S (photo from 2017 inspection).

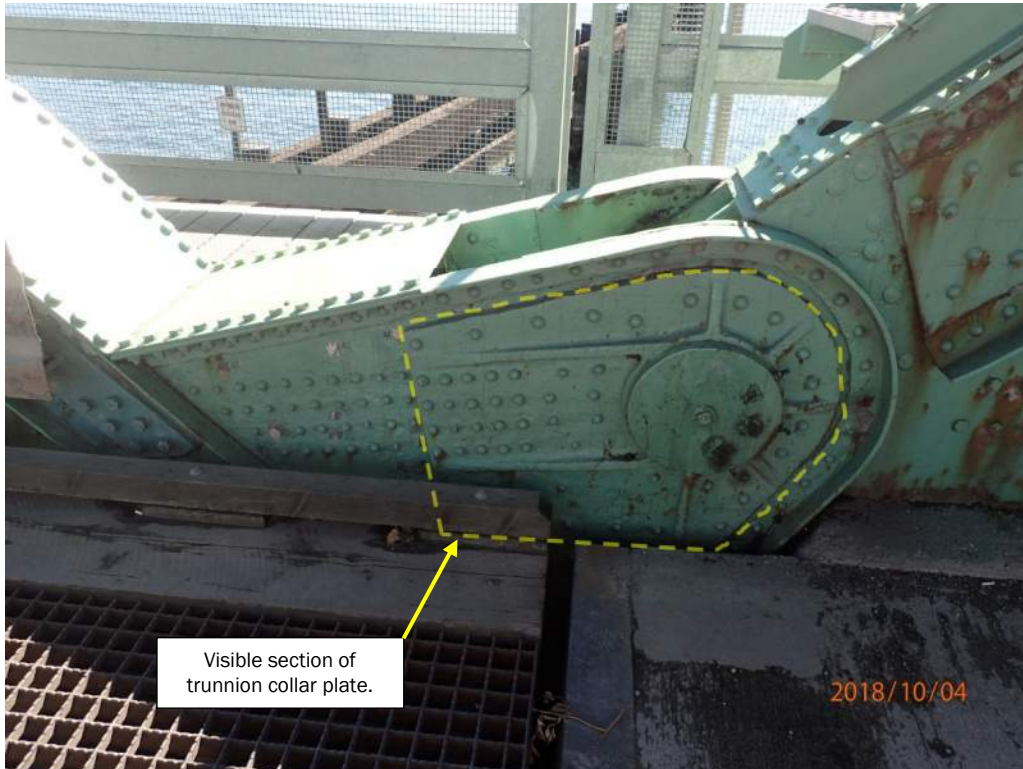
Photo S92: The north (roadway) side of the south trunnion.

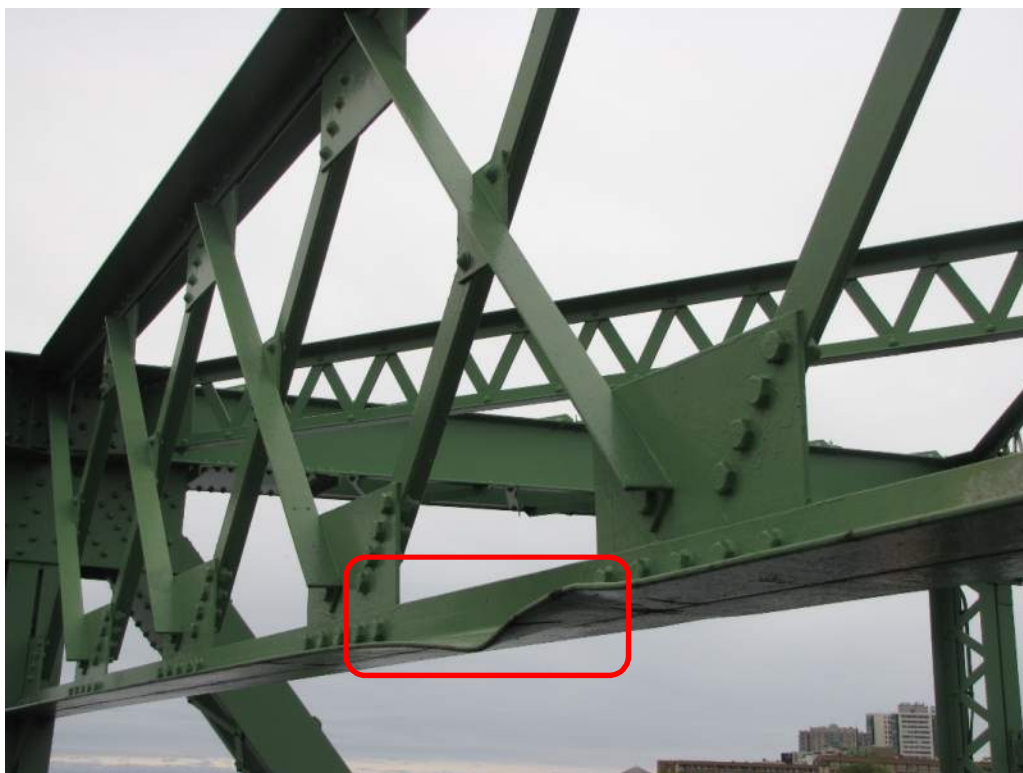
Photo S95: Severe impact damage to the bottom east angle of sway brace member 5S-5N.

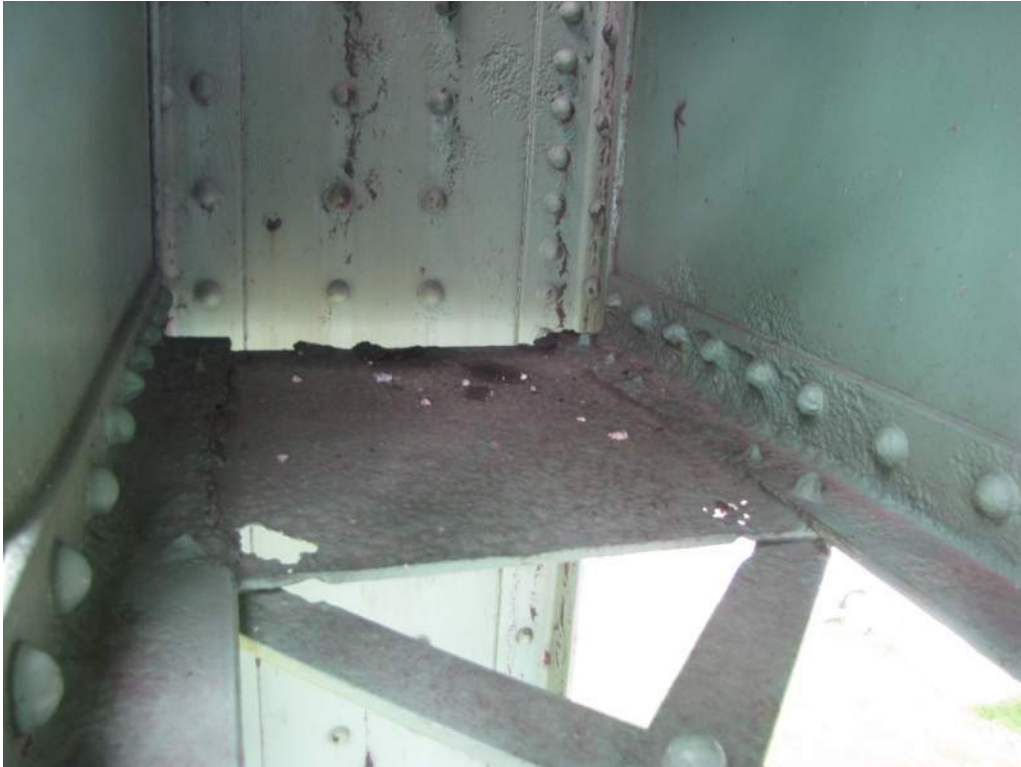
Photo S96: Tower truss sway bracing member 20N-20S has several perforations and deep pitting in the bottom gusset plate and severe section loss of the rivet heads at node 20N.

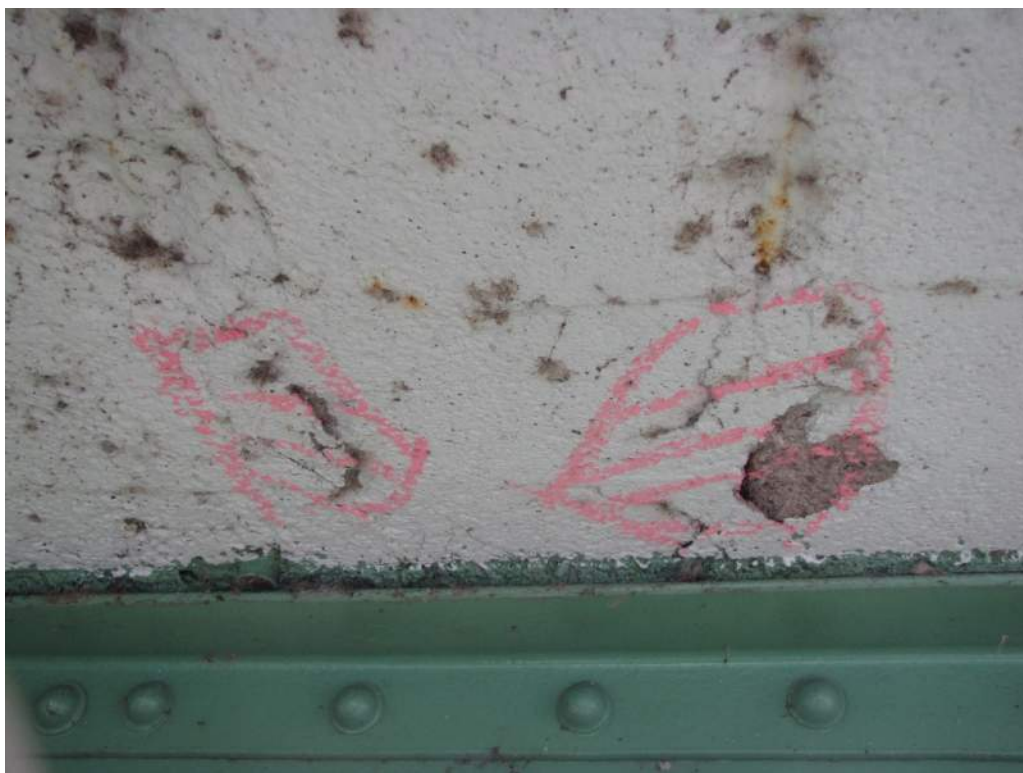
Photo S101: The mechanical room soffit exhibits several spalls and delaminated areas. Scaling of the delaminated areas is recommended as they are located over the roadway.

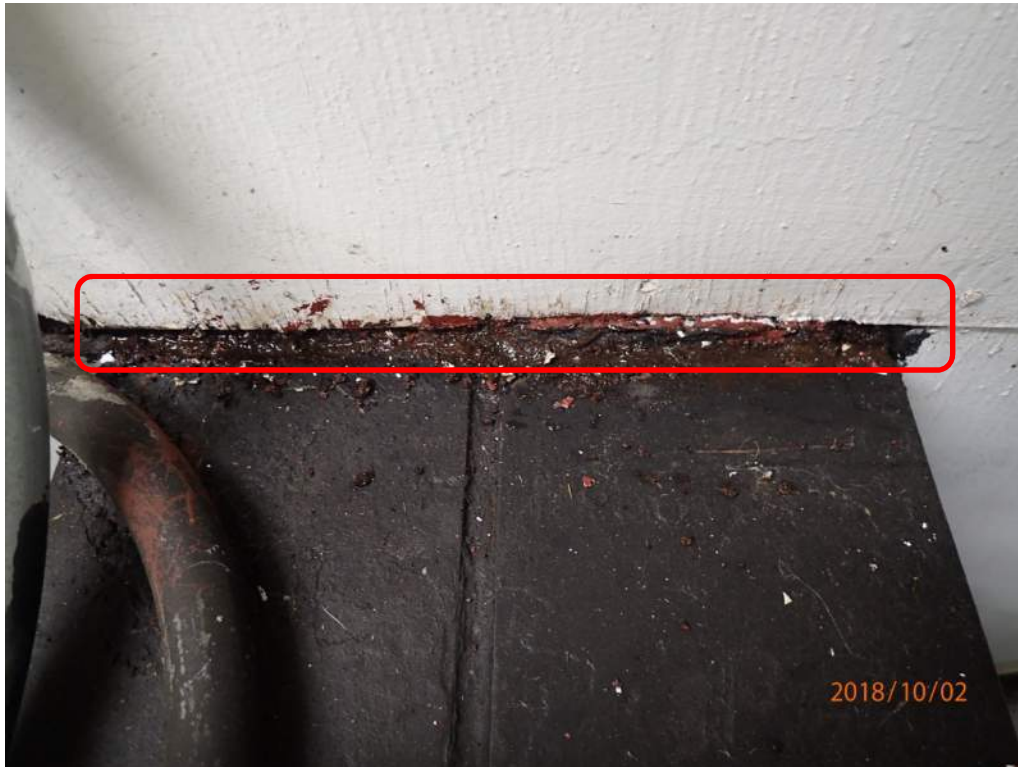
Photo S102: Water was leaking into the northwest corner of the mechanical room during the inspection. Over time this has caused corrosion of the top flange of one of the steel beams supporting the motors.

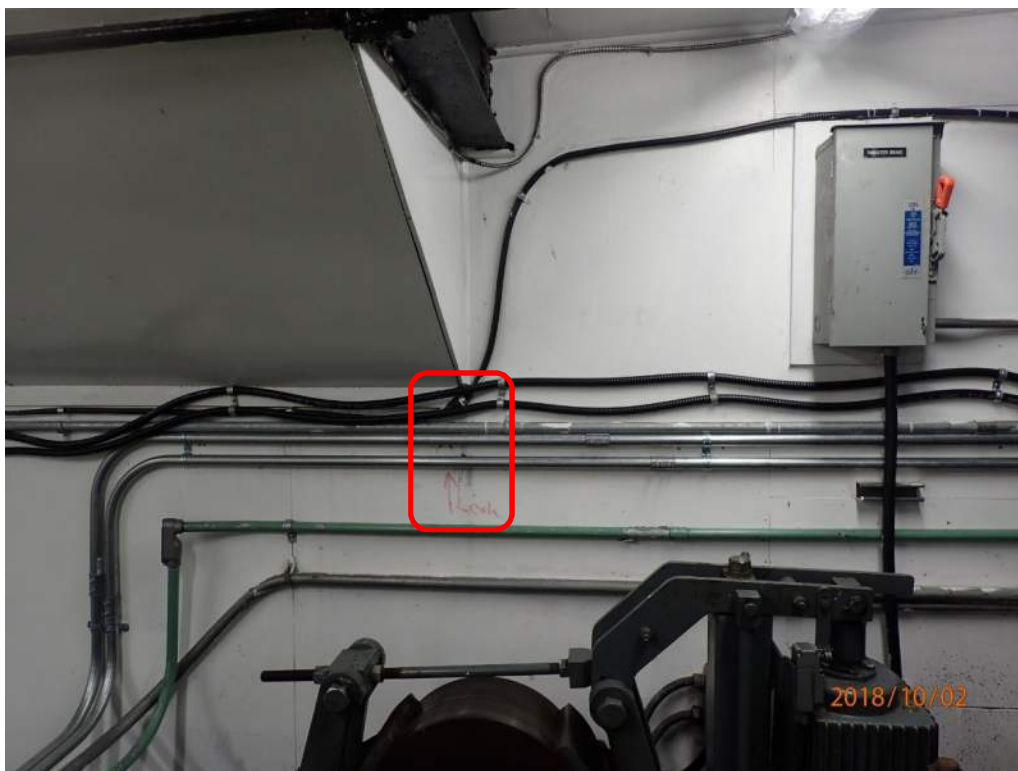
Photo S103: Water was leaking into the north side of the mechanical room during the inspection.

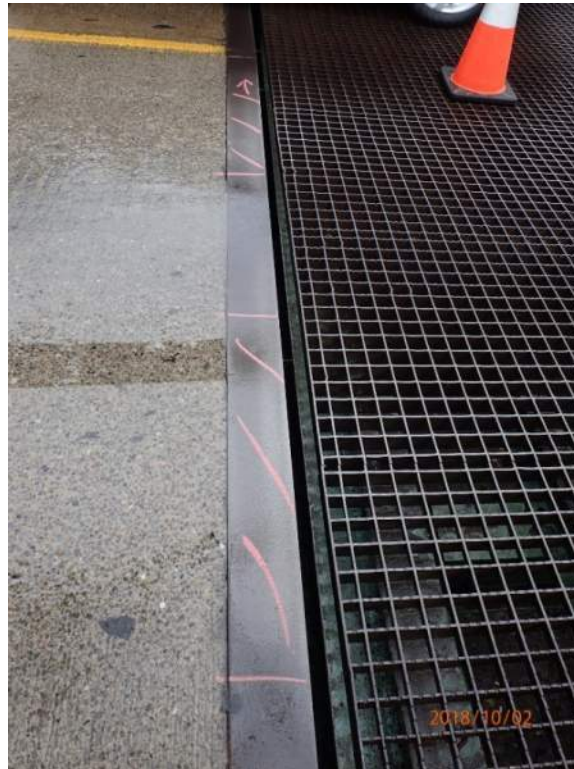
Photo S104: Areas of the west joint armoring sound hollow when tapped, indicating a void between the angle and underlying concrete.

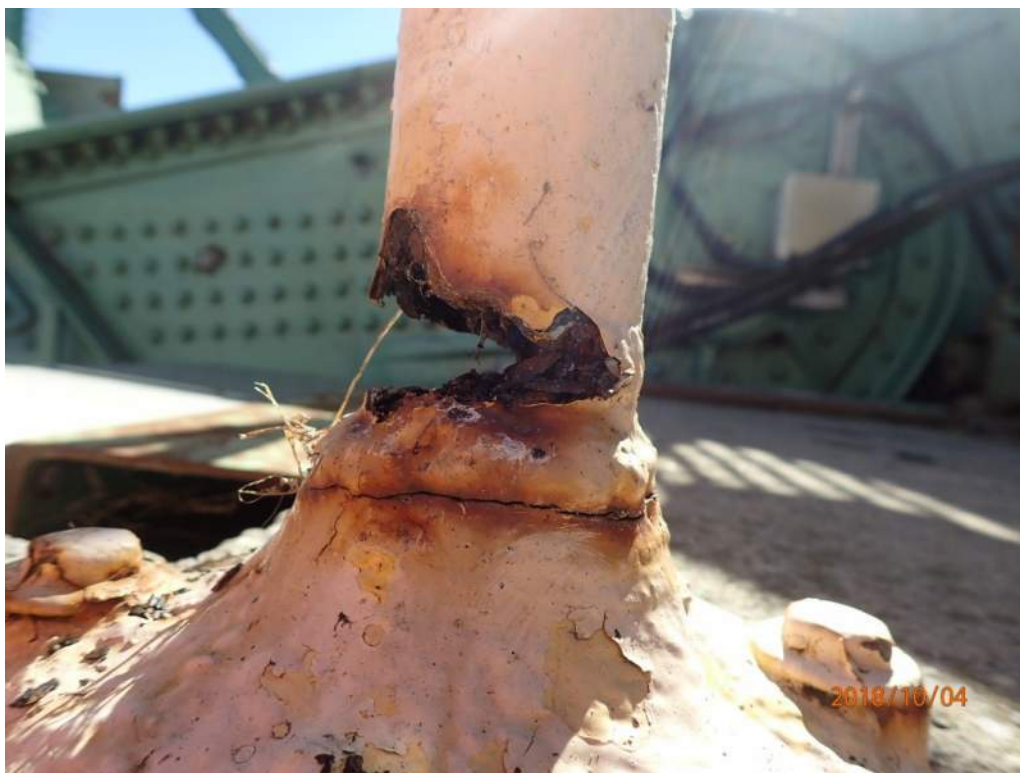
Photo S105: Two of the railing posts between the north trunnion and the control room are perforated at the base (north post shown, south post similar). These posts were subsequently repaired in October 2018.

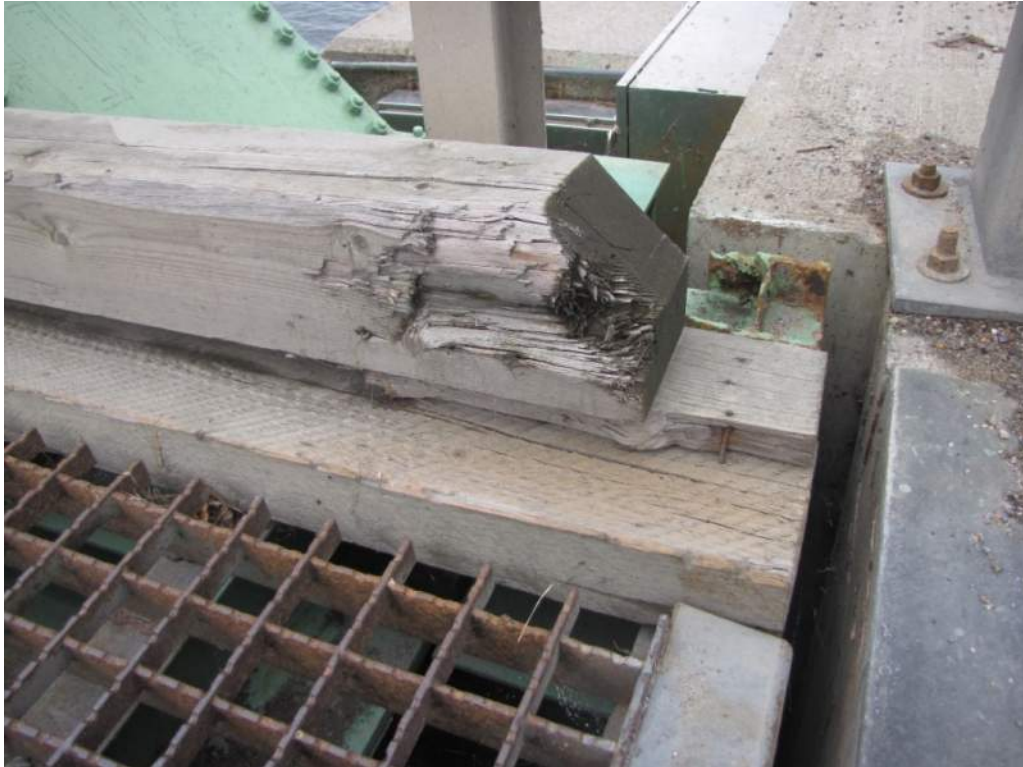
Photo S106: The east end of the north timber curb has some impact damage and is not anchored to the deck.

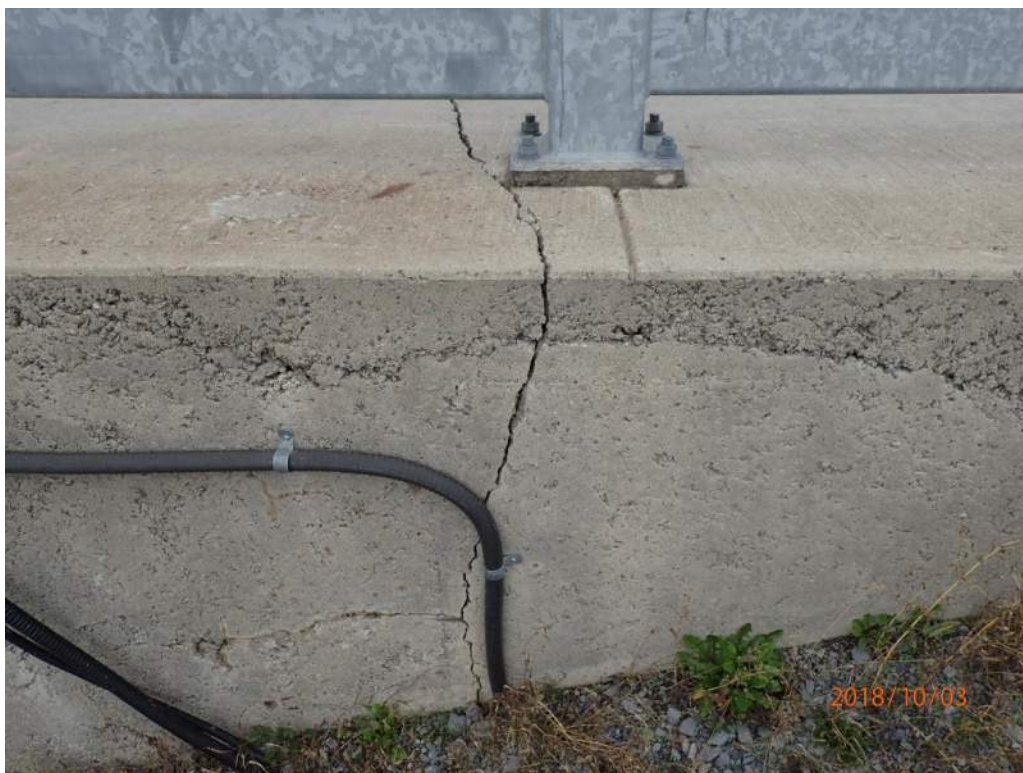
Photo S107: A wide crack in the southeast wingwall extends across the sidewalk.

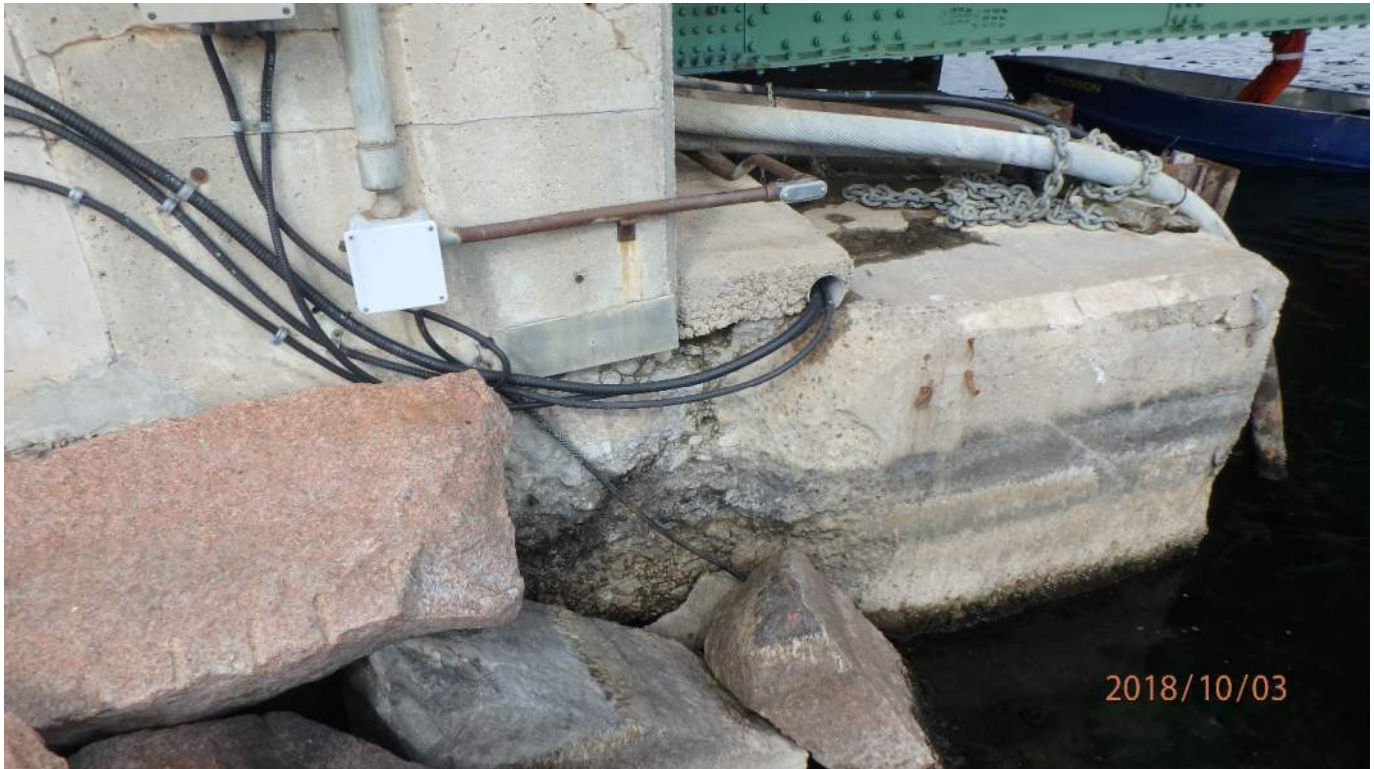
Photo S108: Very severe spall at the base of the southwest wingwall at the interface with the abutment.

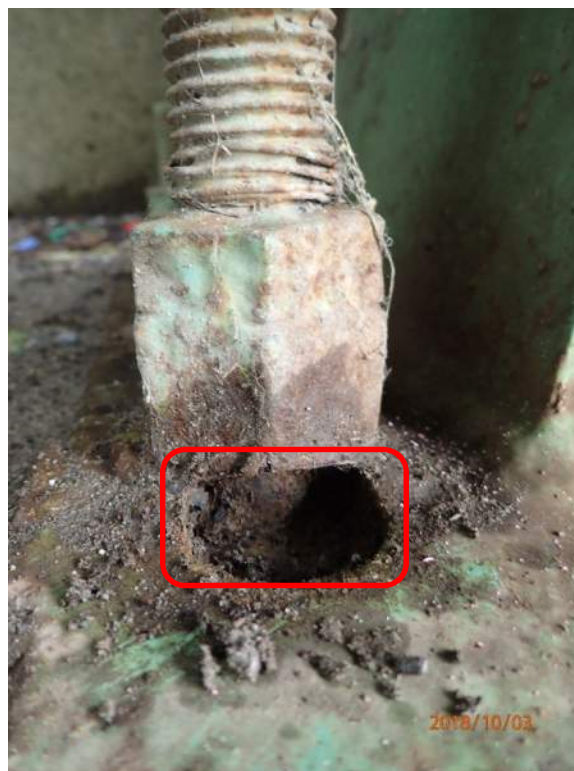
Photo S109: The northwest anchor bolt of the southeast live load support is bent and exhibits medium to severe corrosion.

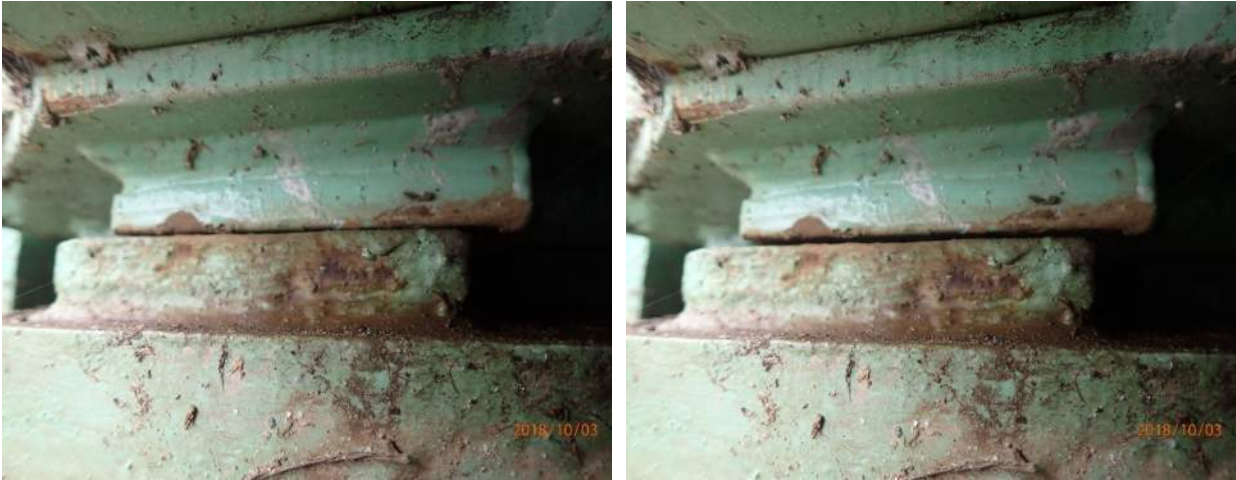
Photo S110: The leaf span is not fully seated on the northeast live load support (right) and only seats fully when vehicles are on the east end of the deck (left).

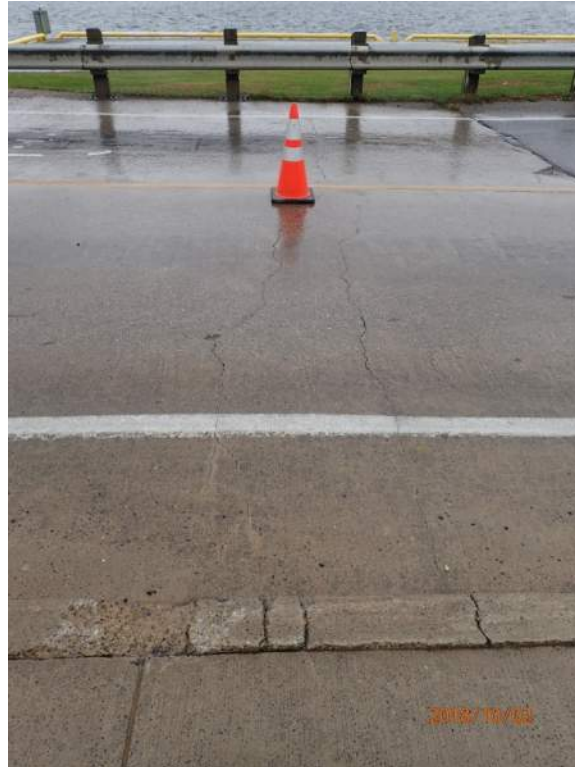
Photo S112: There are two wide cracks that extend across the full width of the east approach slab.

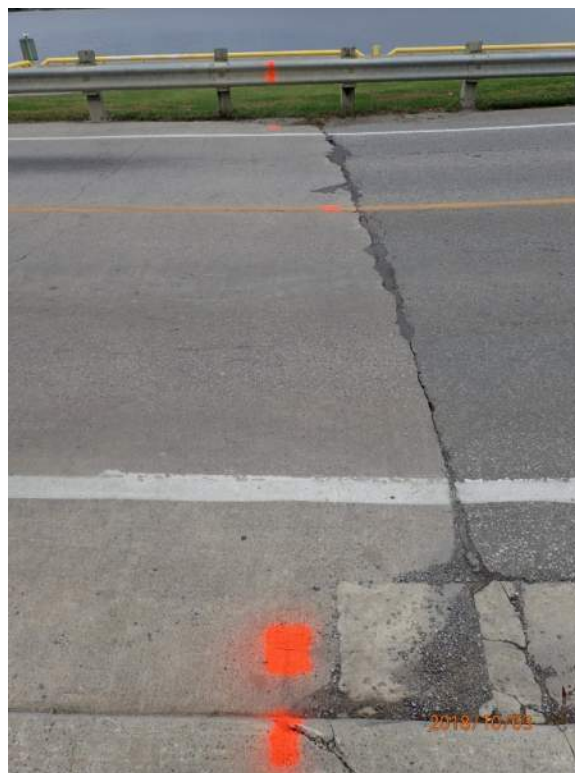
Photo S113: There is a wide crack and patched potholes at the interface between the east approach slab and adjacent roadway wearing surface.

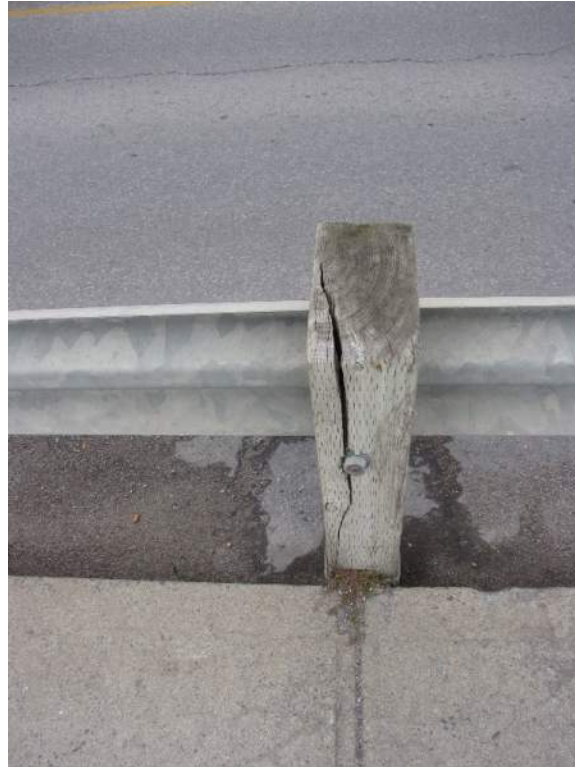
Photo S114: A timber post in the southwest guiderrail has been split by vehicular impact.

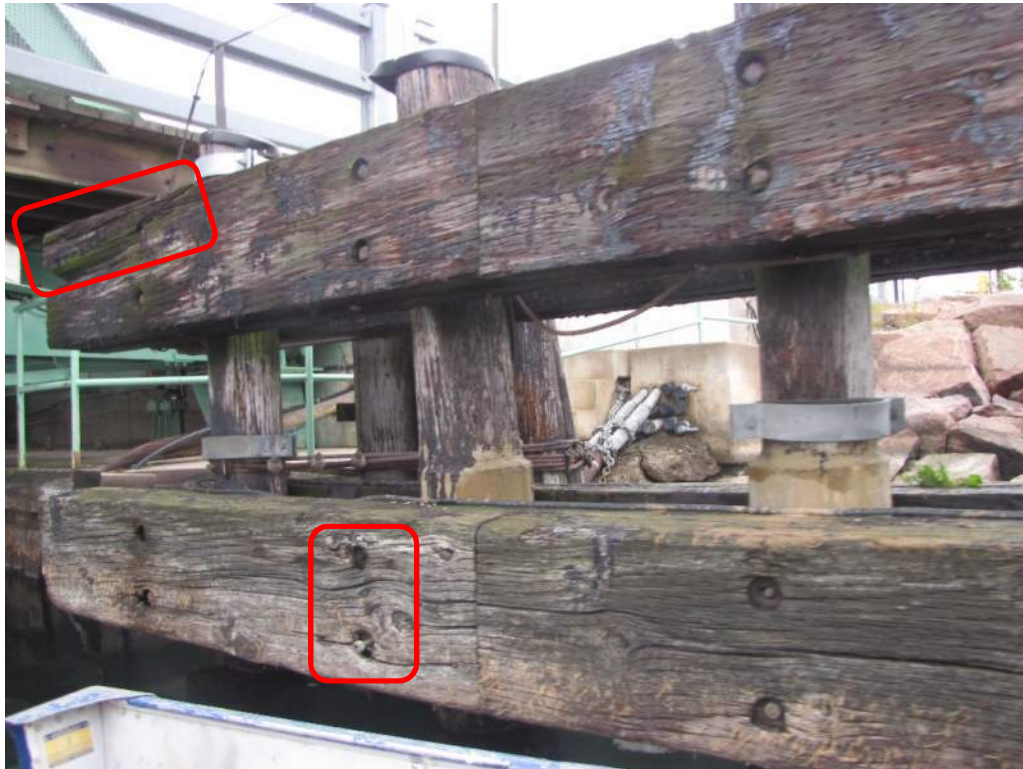
Photo S116: Severe rot in the upper fender at the north end of the east training wall. Note the loose (lower) and missing (upper) bolted connections in the lower fender.

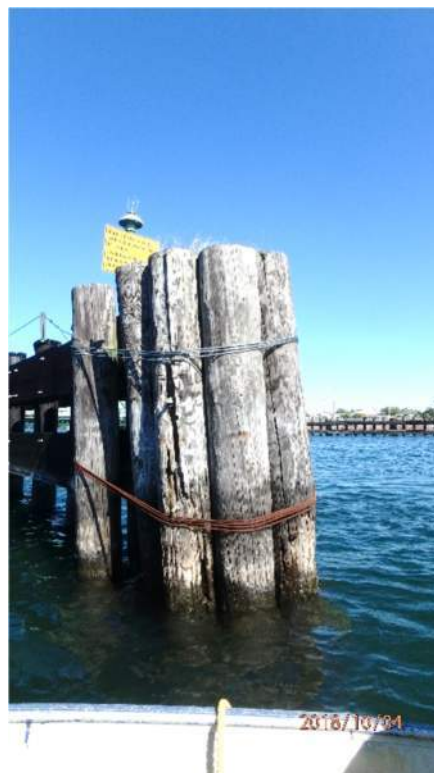
Photo S117: The lower cables securing the dolphin to the south end of the west training wall are loose and corroded. One pile has broken off.

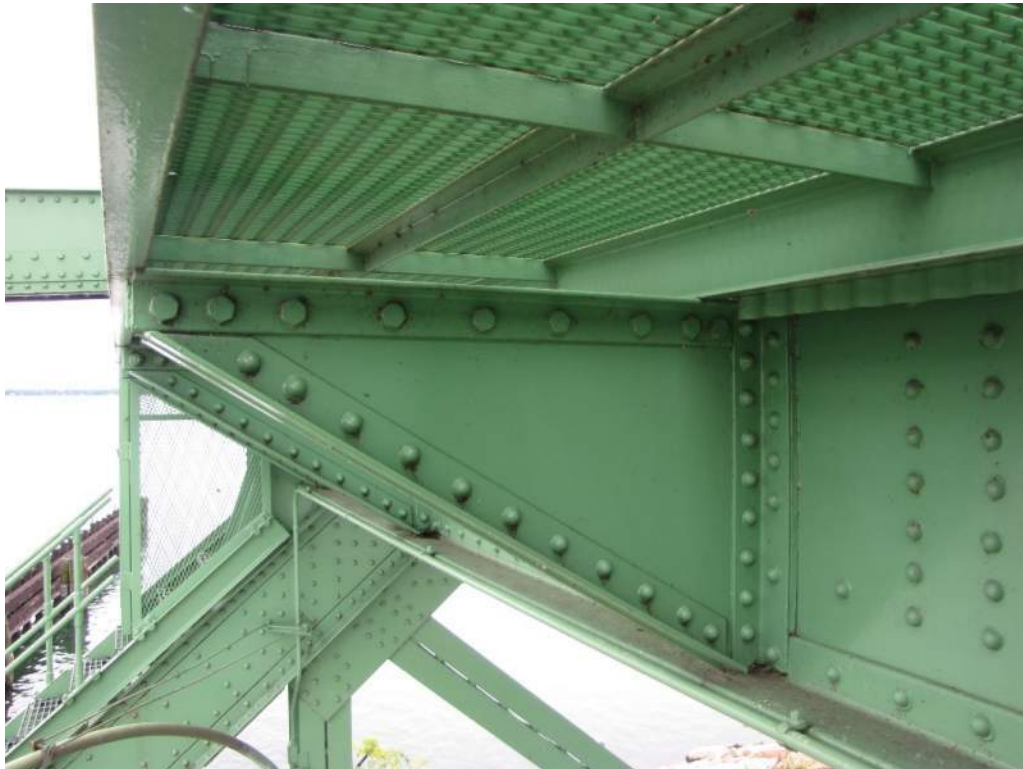
Photo S118: The east C-channel supporting the catwalk outside the mechanical room is supported by the tapered cantilevered members below but only 25mm of the bottom flange is actually supported.

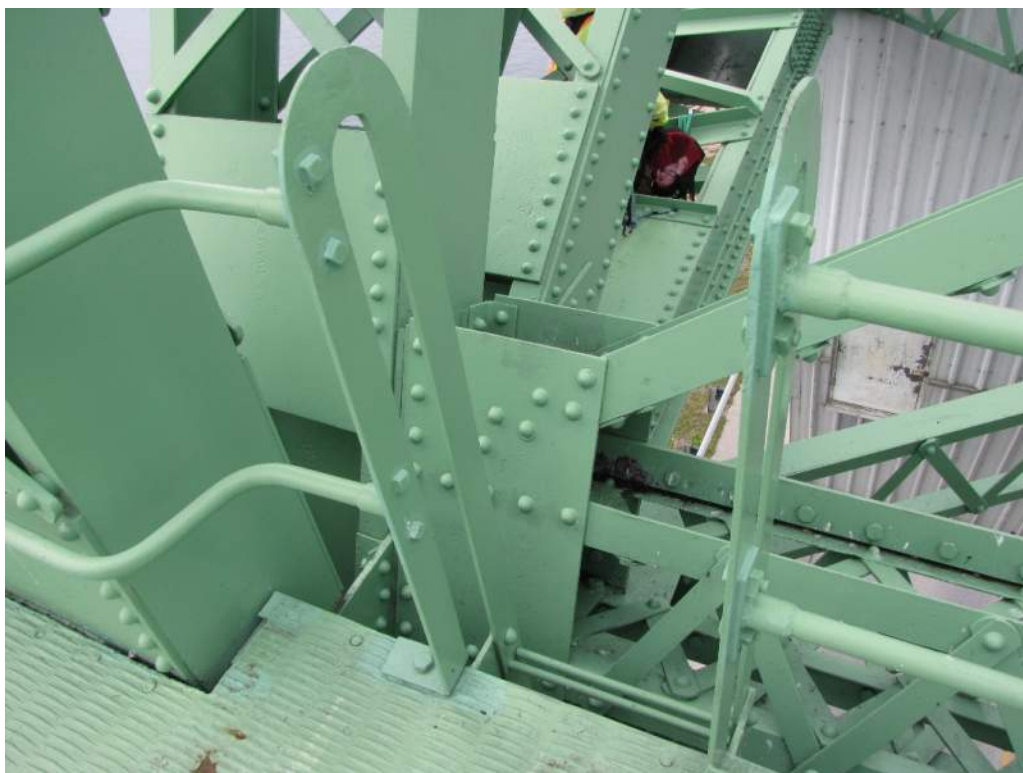
Photo S119: There are no safety chains across the two open sections of the west railing on catwalk 21N-21S which is a potential failing hazard (south side shown).

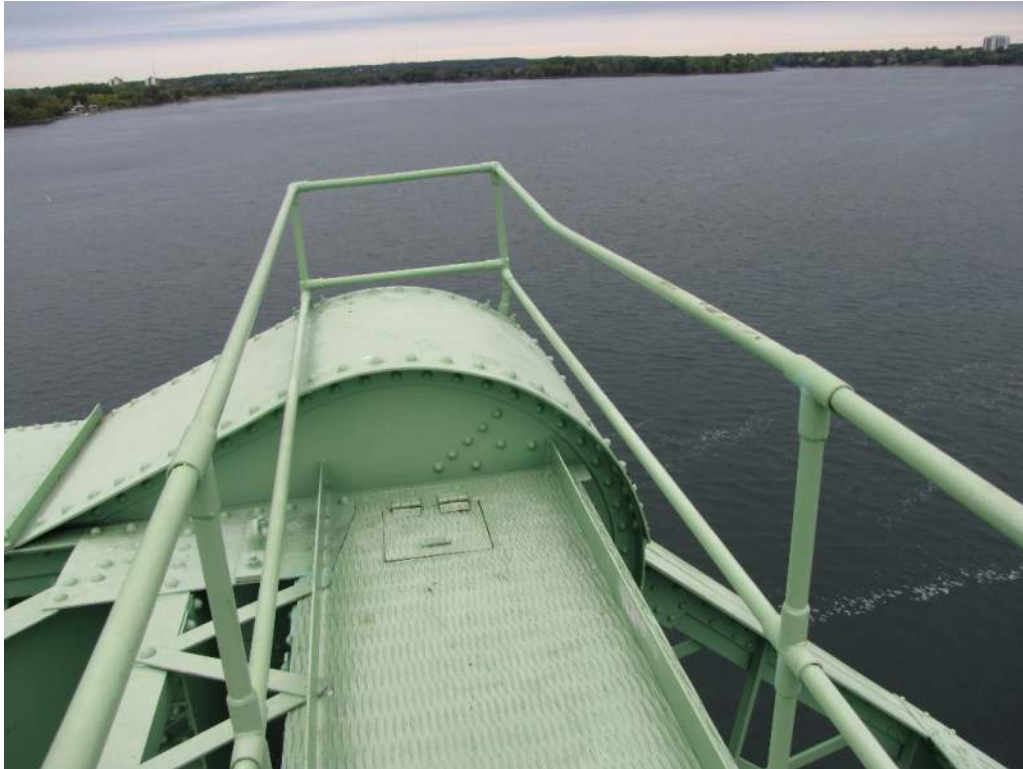
Photo S120: Bent catwalk safety railing above node 22N.

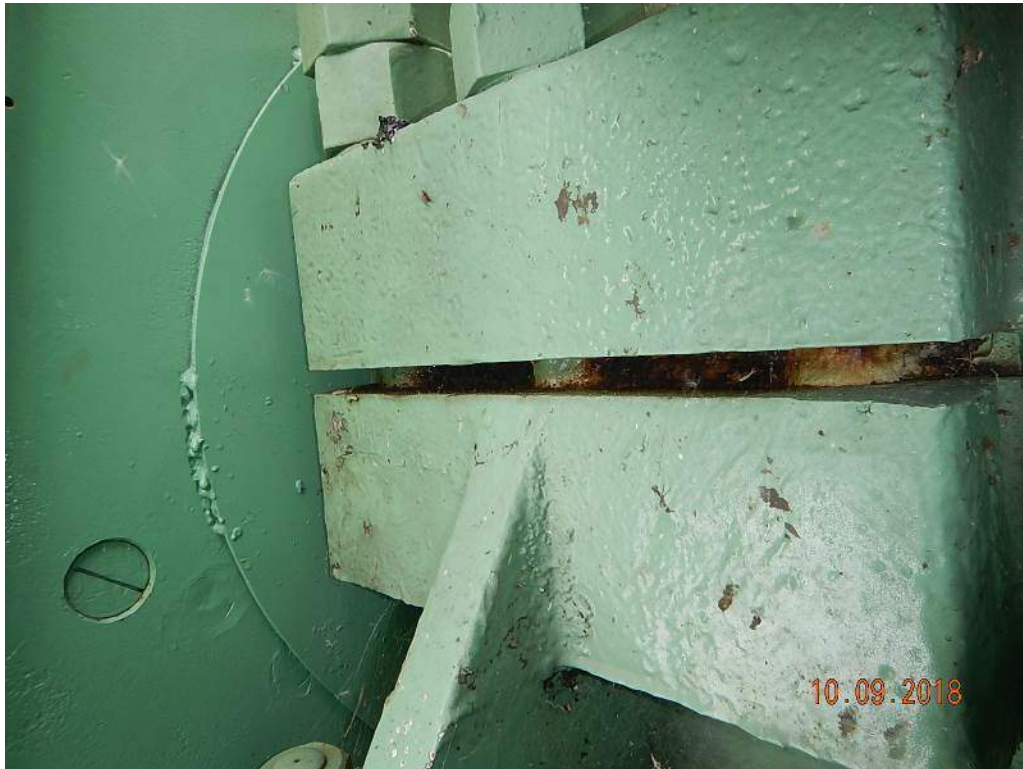
Photo M1: Span Drive Machinery B1-N Bearing. There is light paint deterioration and corrosion between the bearing cap and base at the upper split line. B1-S Bearing is similar.

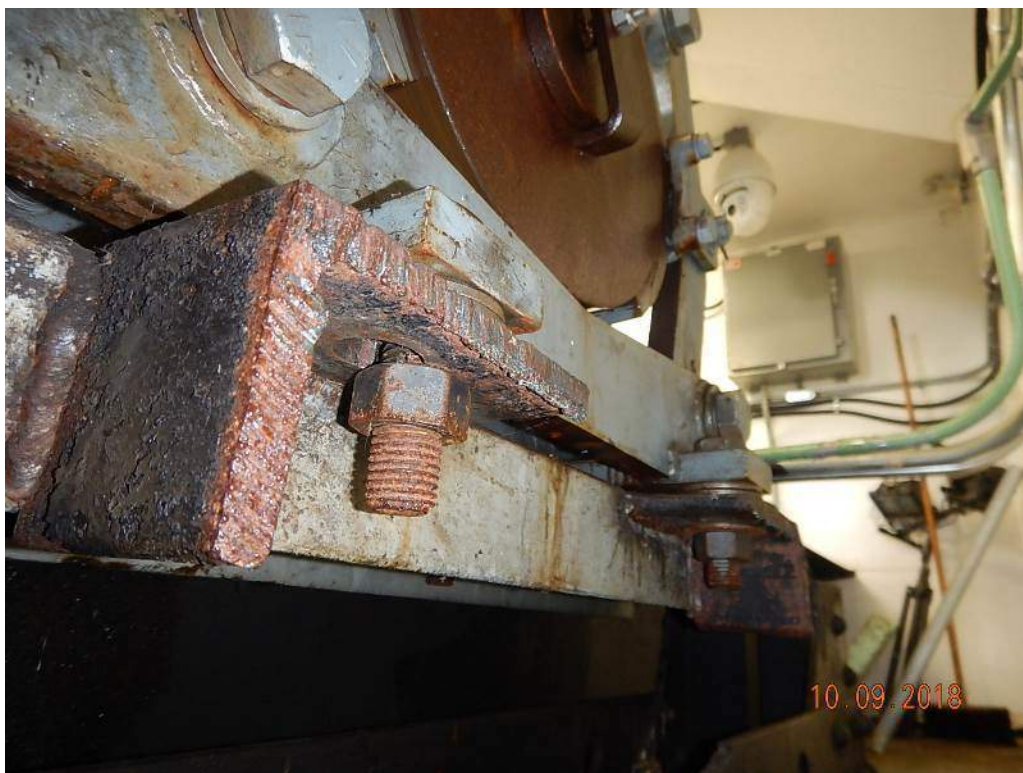
Photo M2: Span Drive Machinery Brake. The north east mounting bolt nut has poor bearing. The mounting bolt and surrounding areas are lightly corroded.
